PRESERVATION PLAN AND RECOMMENDATIONS FOR THE COTTAGE CEMETERY, AUGUSTA, GEORGIA

Prepared By:
Michael Trinkley, Ph.D.
and
Debi Hacker

CHICORA RESEARCH CONTRIBUTION 493

May 2008

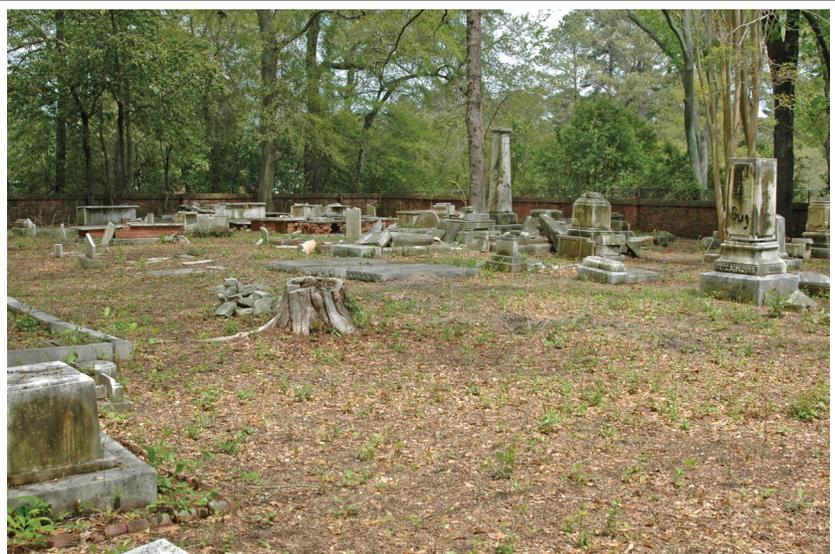
Figure 5. Interior of the cemetery showing its deteriorated condition. View to the east.

- these may have unmarked burials or they may have one time been densely vegetated. There is much evidence of an earlier restoration effort, including abundant simple epoxy repairs (virtually all have failed) and some use of Portland cement mortar (primarily on wall repairs, which are still standing).

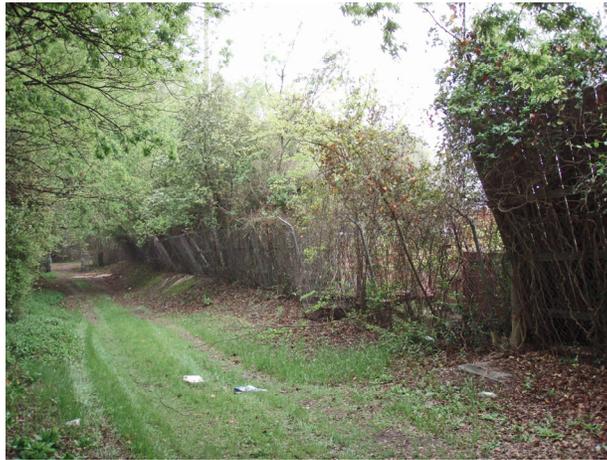
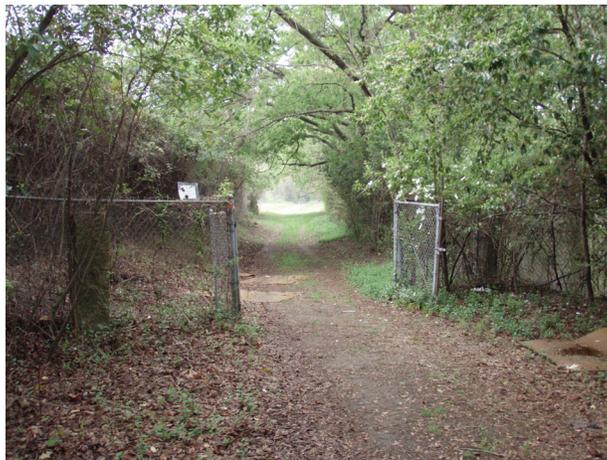
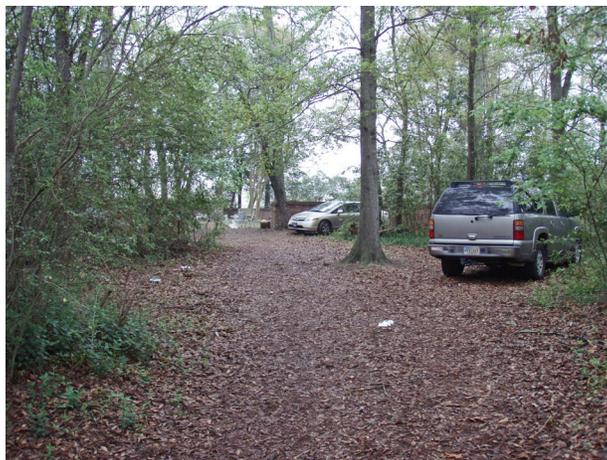
Figure 9. Access road and conditions. Top, condition of road, vegetation, and fence to south of the road; Middle, entrance looking out toward Winesap Way; Bottom, parking at entrance to the cemetery.

Briefly, we would like to see the existing 20-foot corridor opened to at least 18 feet, allowing 2-feet of vegetative buffer along the border with the Apple Valley lots. This would entail the cutting and removing of the vegetation.

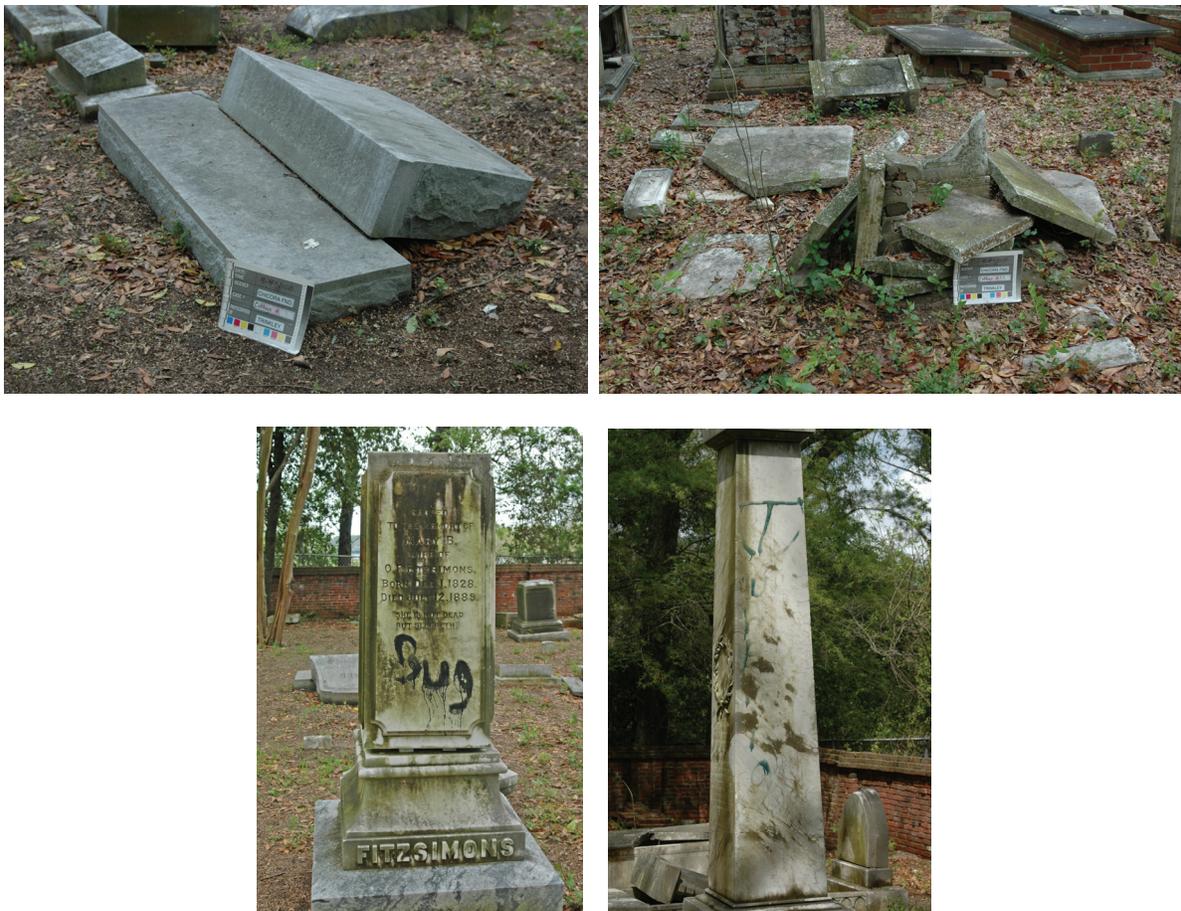
Figure 11. Examples of vandalism in the cemetery include toppling of monuments, breaking of monuments, and spray painted graffiti.

It is only through this consistent presence of both law enforcement and the public that vandalism will be reduced.

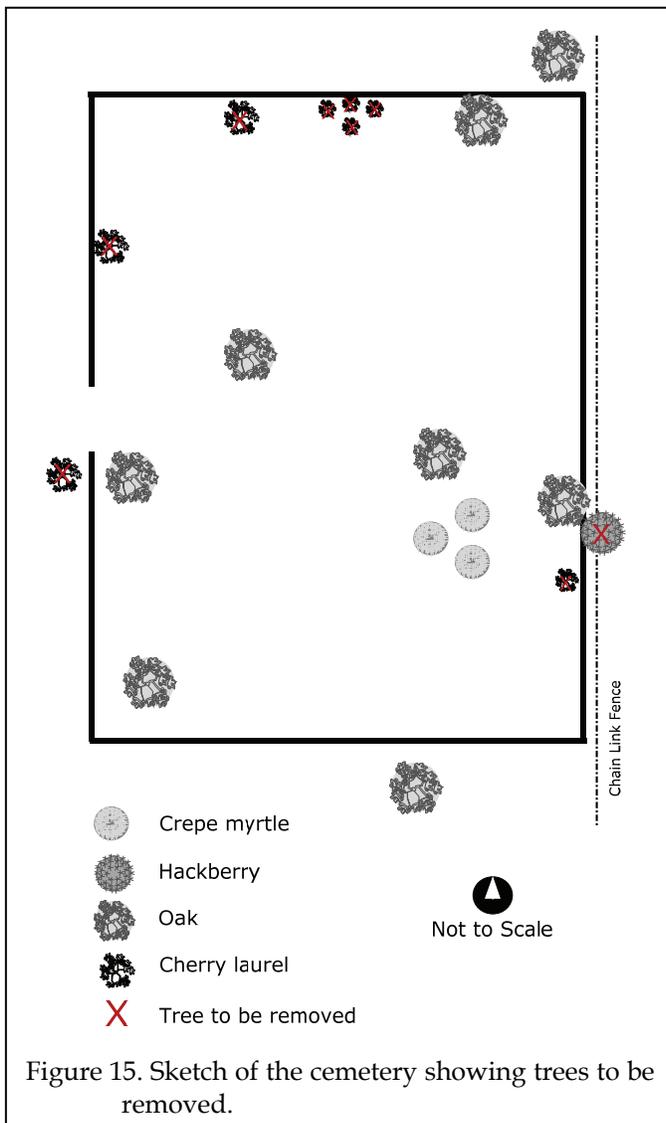
Figure 15. Sketch of the cemetery showing trees to be removed.

We do not recommend replanting for any of the trees that are removed. The cemetery will continue to have six very attractive oaks, as well as the three crepe myrtles. This provides adequate vegetation to maintain the historic appearance of the cemetery.

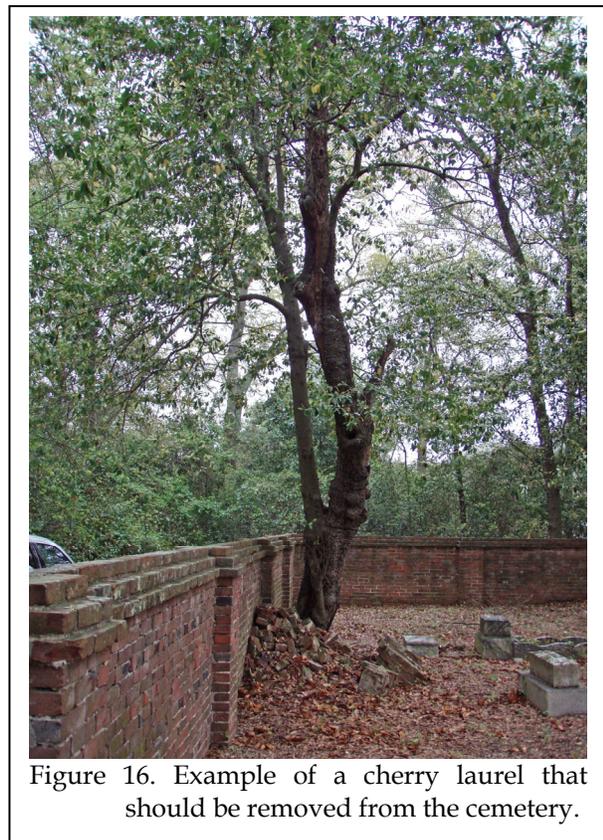
Figure 16. Example of a cherry laurel that should be removed from the cemetery.

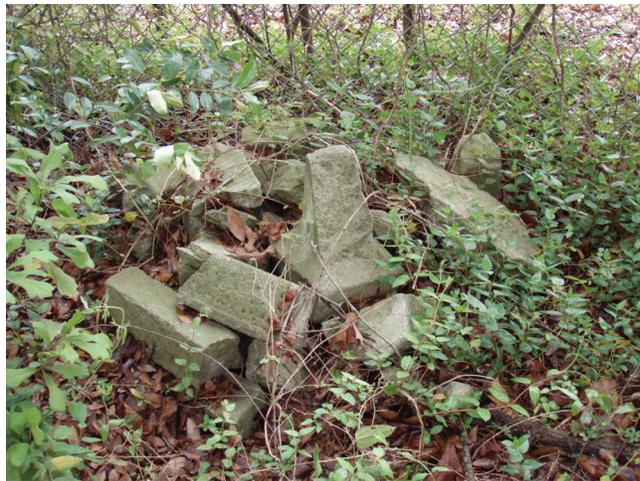
Figure 17. Fragments of stones found piled in the woods beyond the brick wall. These should be carefully collected and stored.

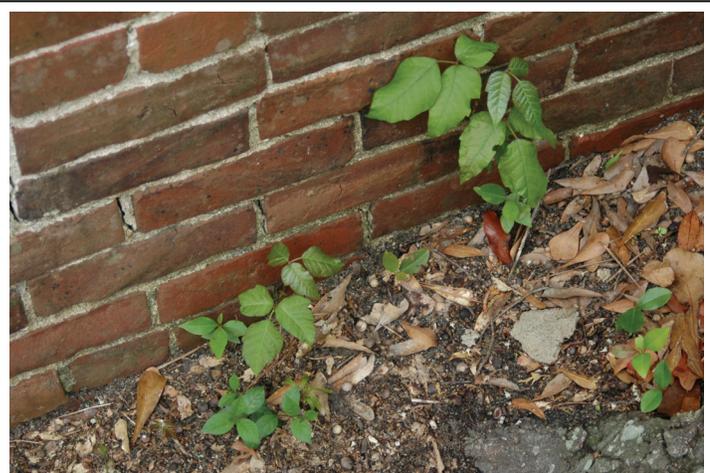
Figure 18. Poison ivy growing along the cemetery wall.

Chemical control is limited to non-selective post-emergence herbicides, with Roundup Pro® being the compound of choice since it translocates to roots of perennial vines.³ However, you may need to make repeated applications to completely kill a perennial vine with a deep, well-established root system. It is necessary to use a directed or shielded spray to avoid contact with the bark of desirable plants, as well as to avoid stones.

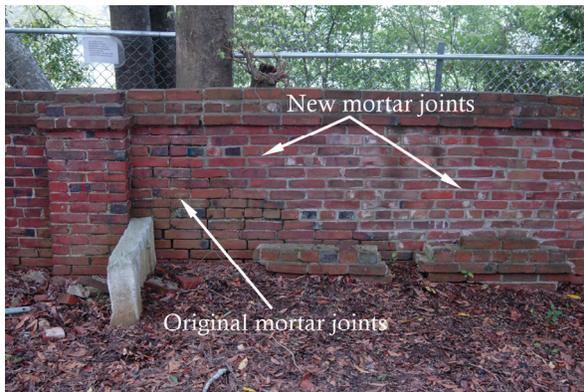
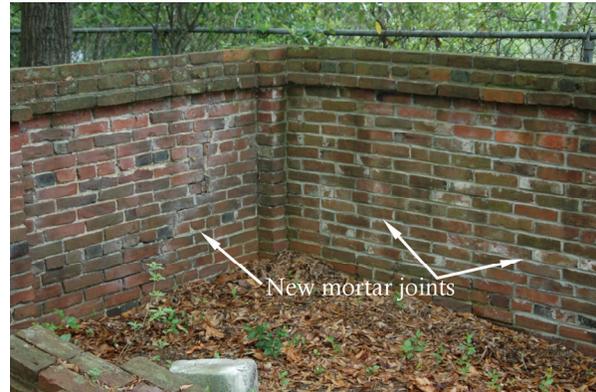
Figure 20. Two areas of wall repair. Note the light colored (new) mortar and the loss of the original bonding pattern. Note also on the left photo areas of brickwork requiring repointing, as well as sections of old wall lying on the ground.

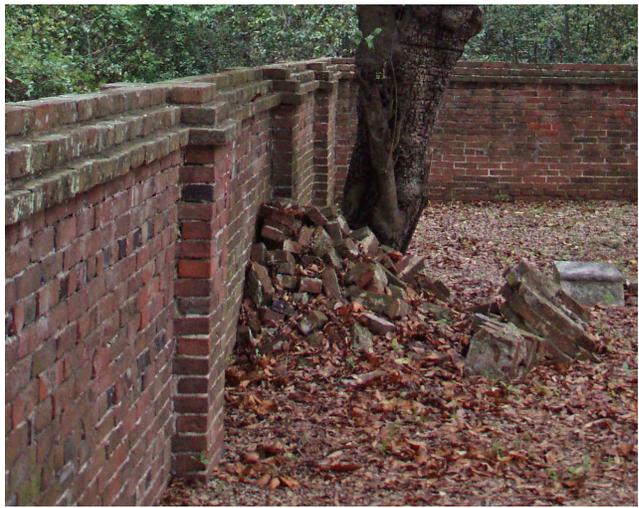
Figure 21. Brick pile along the west cemetery wall.

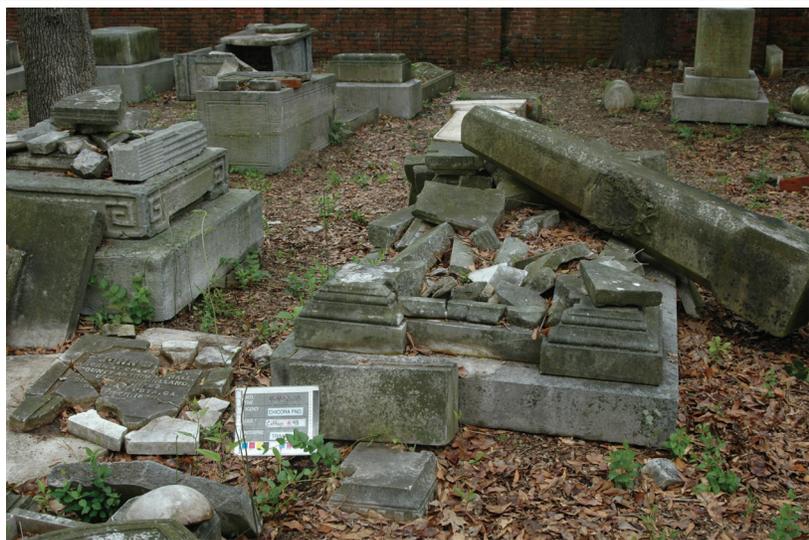
Figure 22. Example of badly damaged and heavily fragmented monument.

The caregivers should realistically evaluate their fund raising abilities and determine how long it will be before conservation efforts may begin. If the repair of monuments is more than a year away, it may be appropriate to collect these smaller fragments,

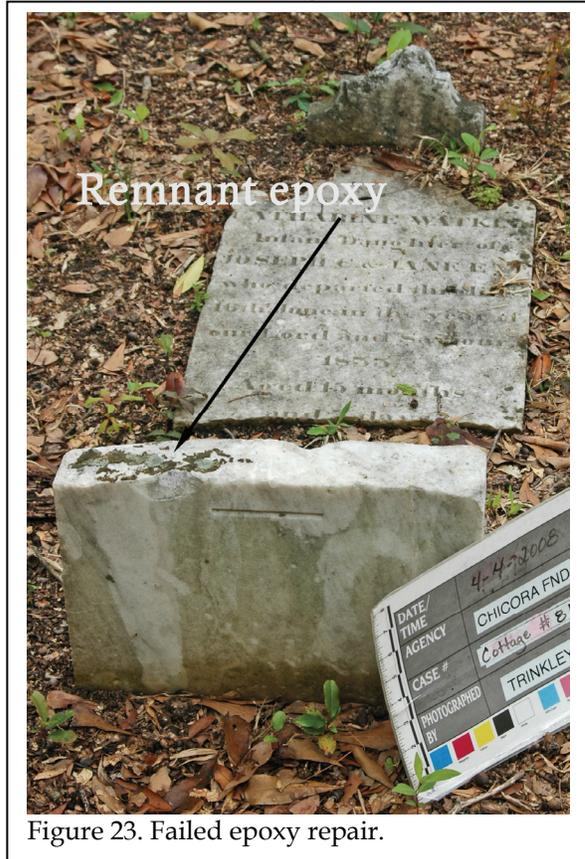
We see many examples of “simple epoxy repairs” at Cottage Cemetery. Virtually

Figure 23. Failed epoxy repair.

After many such repairs it will be necessary to fill the voids with a natural cementitious composite stone material resembling the original as closely as possible in texture, color, porosity, and strength. This type of repair may be used to fill gaps or losses in marble and is often used to help slow scaling of bedded sandstone exposed to the elements.

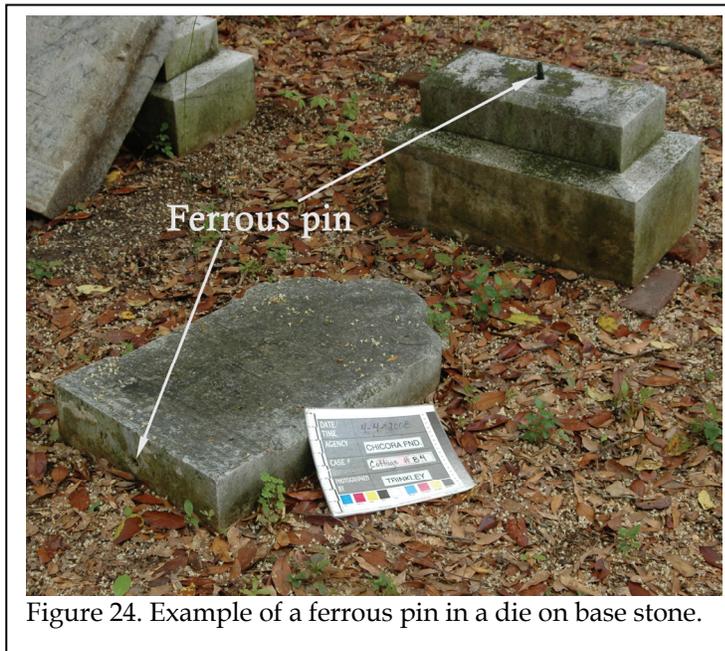
Figure 24. Example of a ferrous pin in a die on base stone.

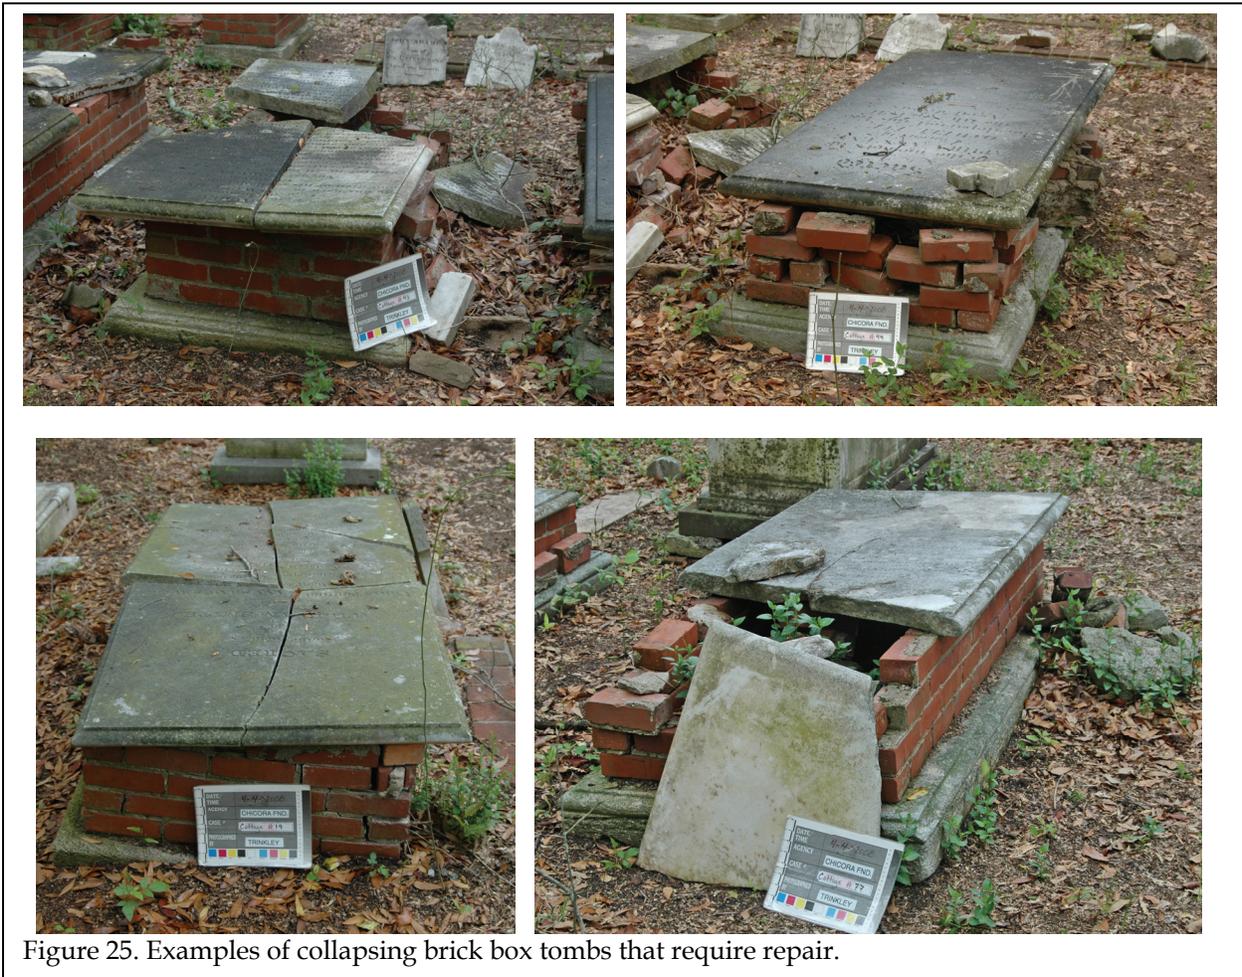
With that said, it is important to realize that many of the monuments in the Cottage Cemetery have been heavily damaged. For several, the damage is very extensive and the fragments – at least those observed during this assessment – are very small. It is our opinion that for several markers repair *is not feasible* – either in terms of the current technology or in terms of the costs associated. For these we

Figure 25. Examples of collapsing brick box tombs that require repair.
