PRESERVATION ASSESSMENT AND PLAN FOR THE OLD ATHENS CEMETERY, ATHENS, GEORGIA

Chicora Research Contribution 459

Prepared By: Michael Trinkley, Ph.D. and Debi Hacker

December 22, 2006

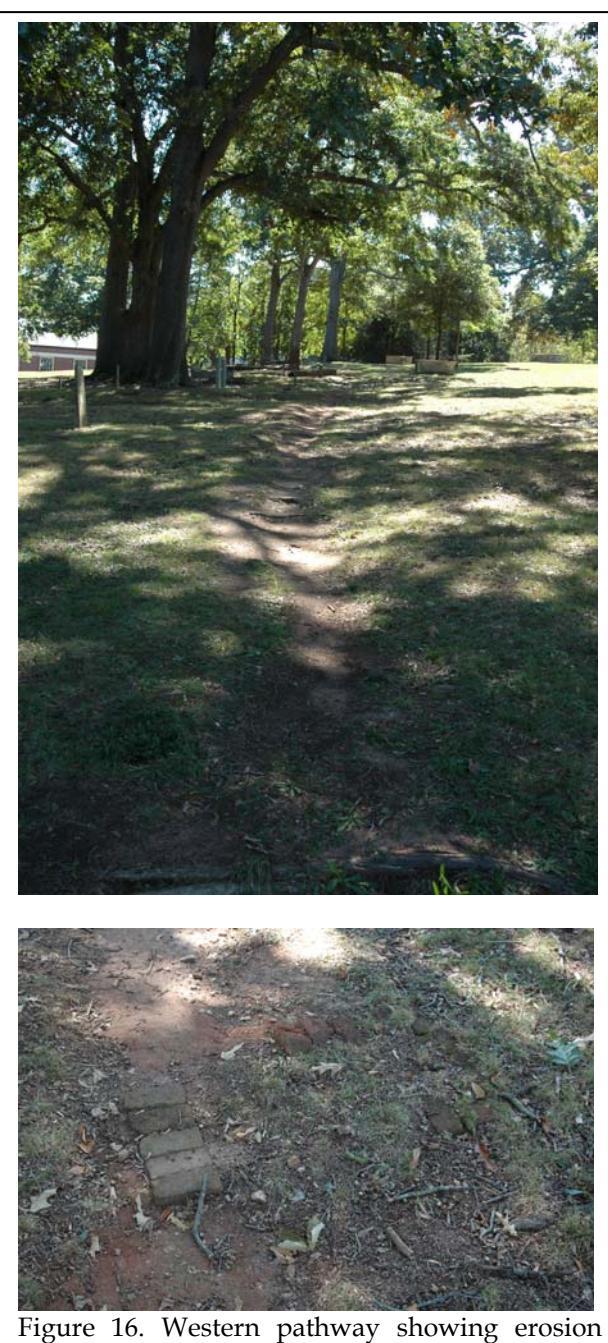
igure 16. Western pathway showing erosion (top) and tomb exposed in path (bottom).

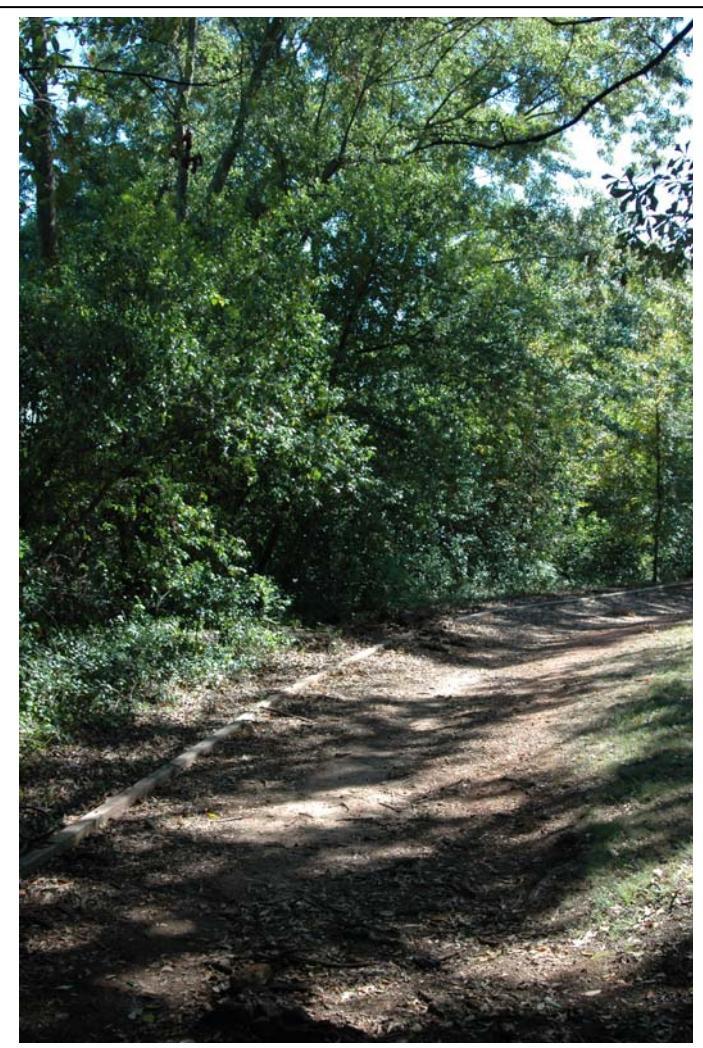
Figure 17. Path at eastern edge of the cemetery.

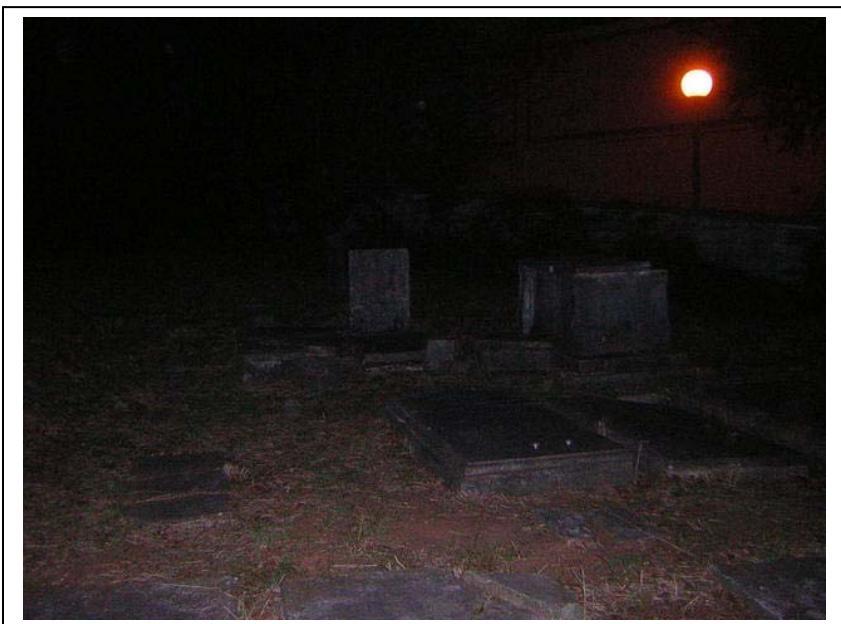
Figure 21. Photograph taken by a paranormal investigator in the Old Athens Cemetery about 9:00pm. Note the limited light from the Art School lamps; even the photograph flash provided only limited lighting. This photo also shows several candles on a ledger.

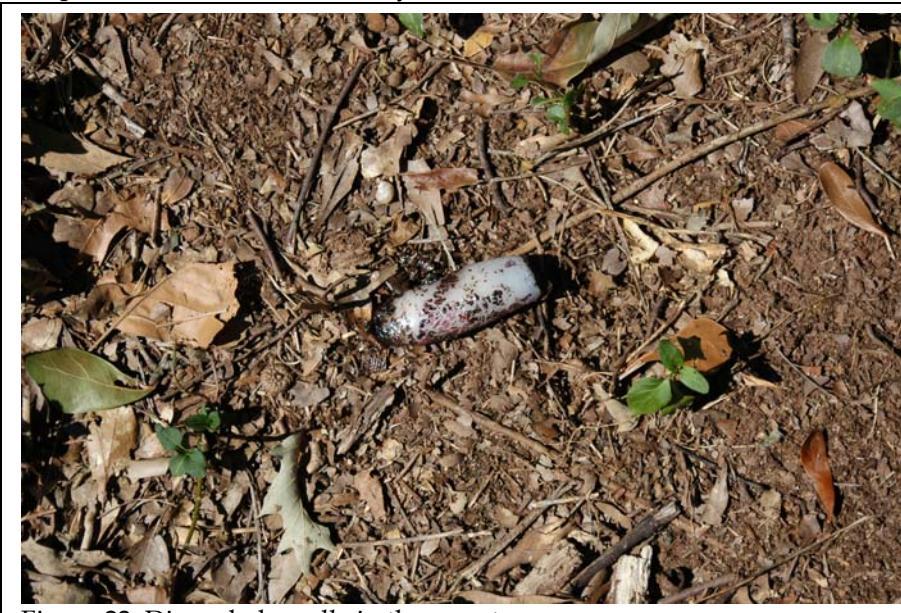
Figure 22. Discarded candle in the cemetery.

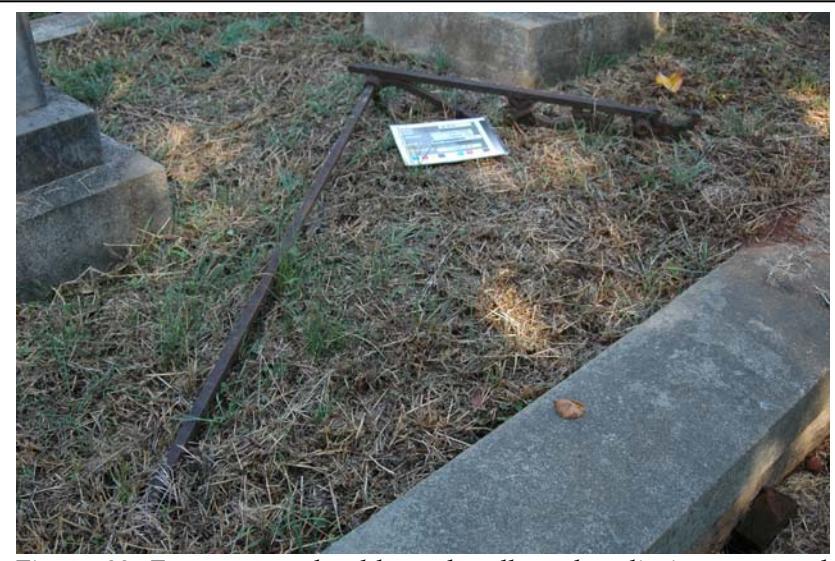
Figure 23. Fence parts should not be allowed to lie in or around plots, but should be collected and secured.

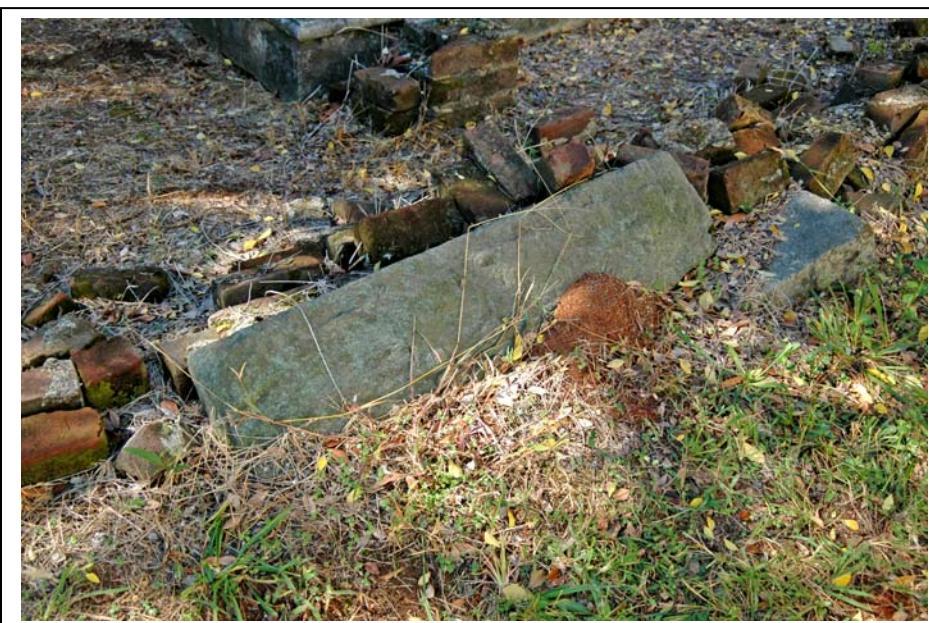
Figure 24. Crumbling plot wall. The brick wall has almost entirely collapsed and this is the only stone cap that hasn't been stolen.

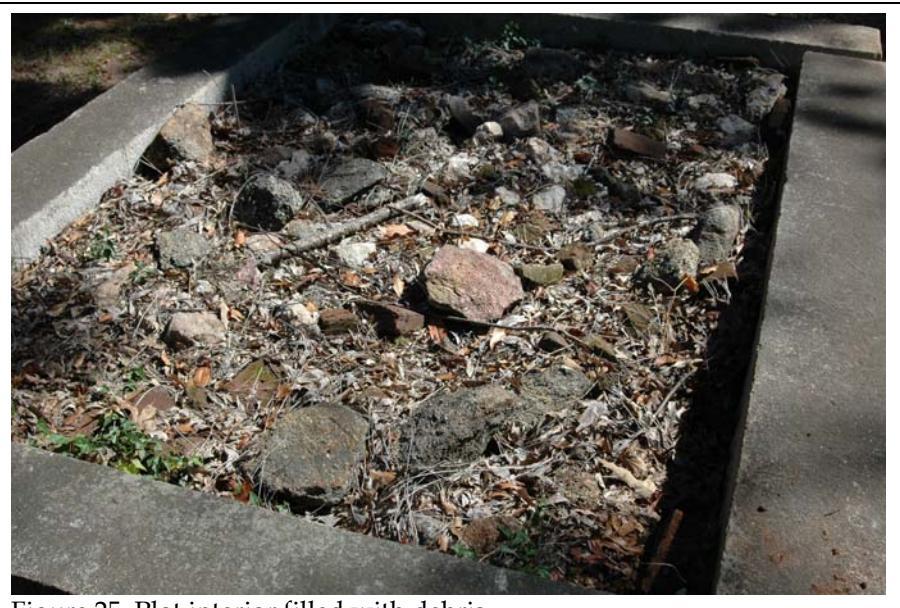
Figure 25. Plot interior filled with debris.

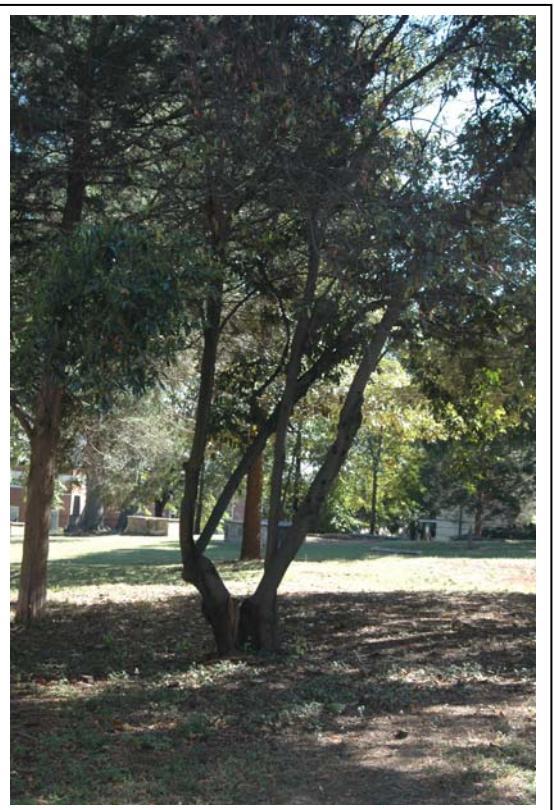
Figure 27. Diseased cherry laurel that should be removed from the cemetery. Adjacent stumps should also be cut off at ground level. All stumps should be poisoned to prevent suckers.

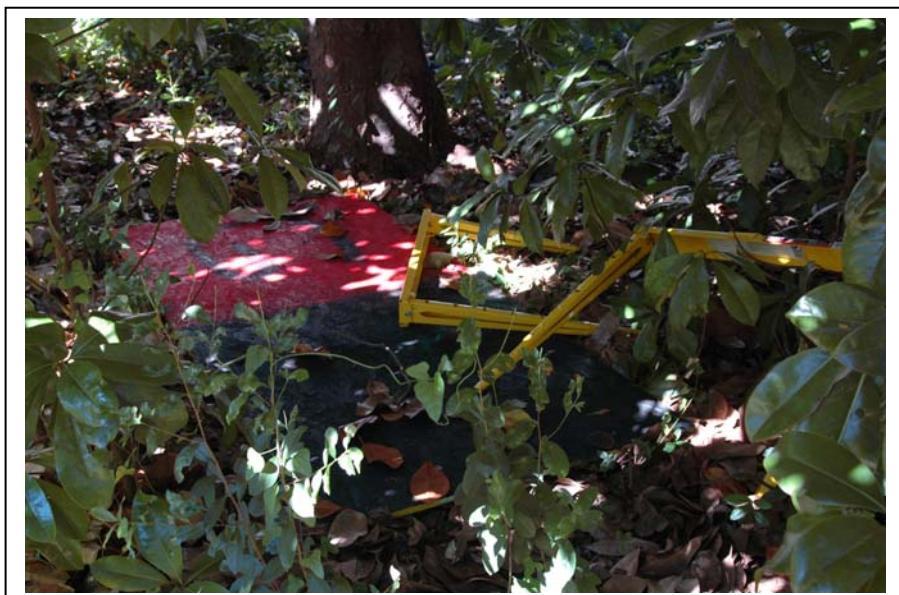
Figure 28. Debris hidden under the magnolia in the cemetery. We recommend clearance pruning to raise the branches and provide sight lines under the tree.

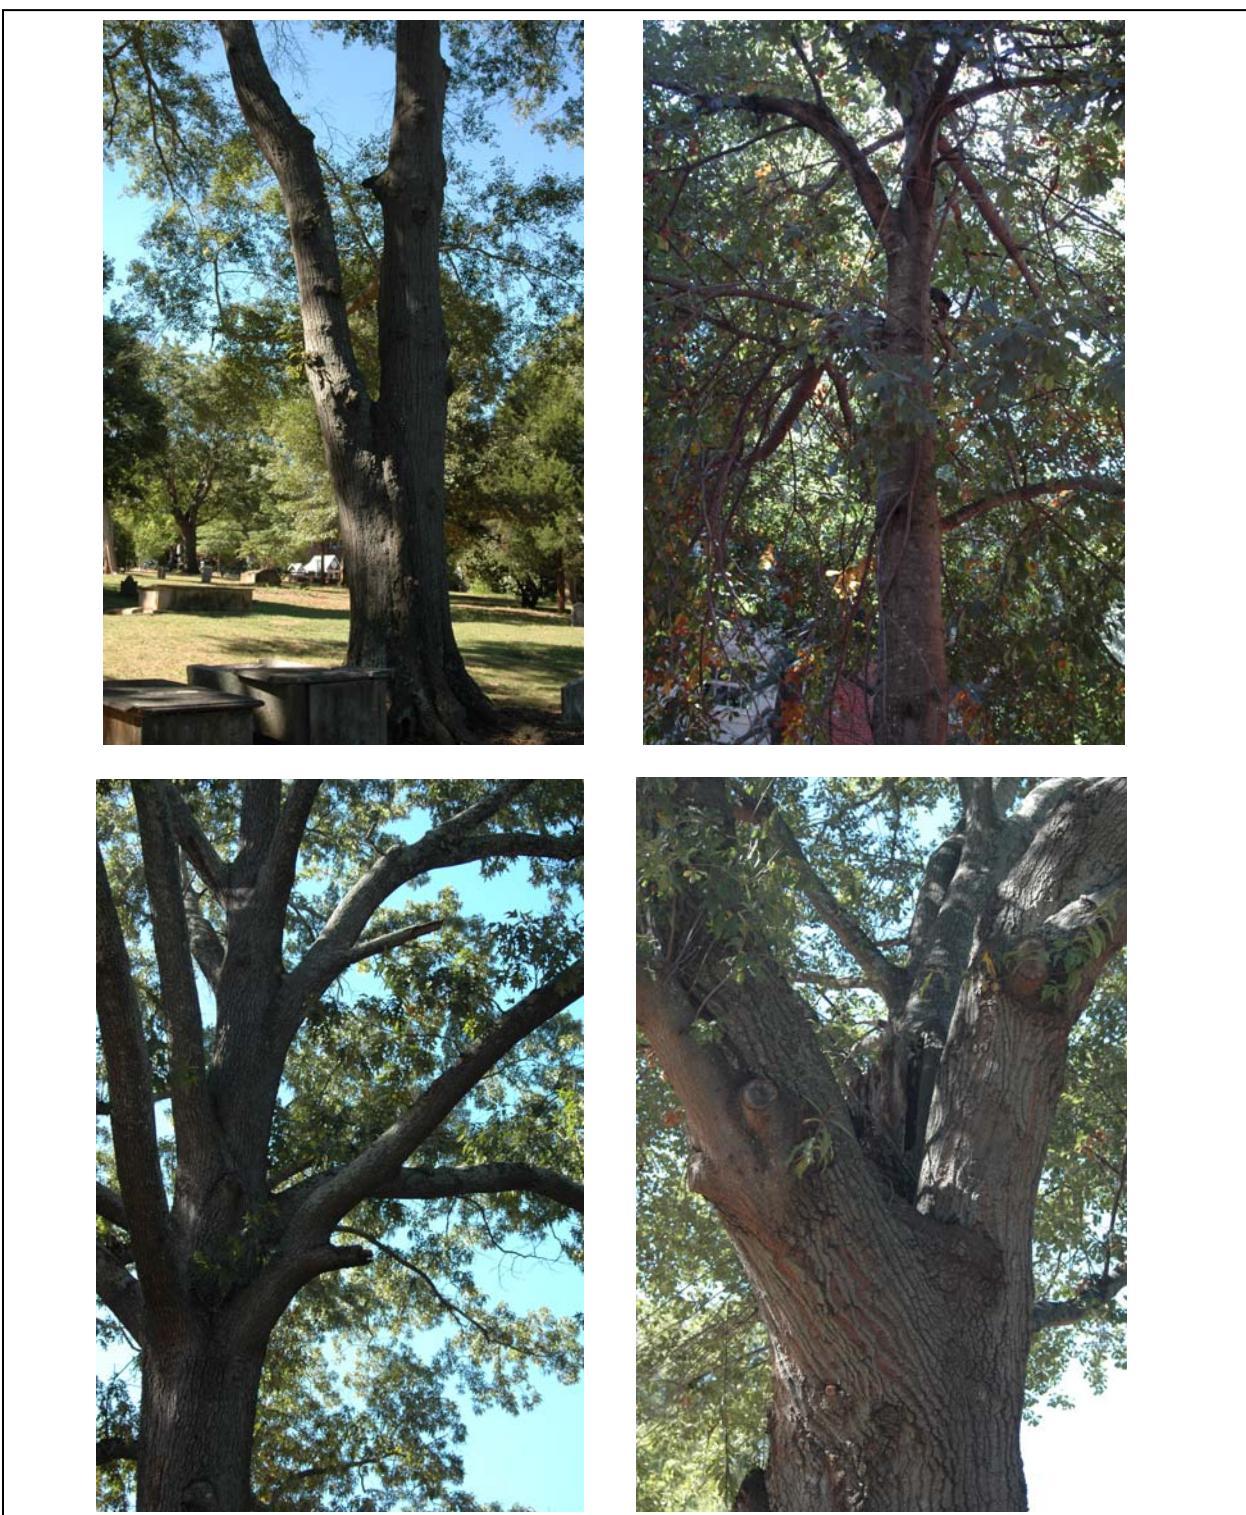
Figure 30. Pruning problems. Upper left, weak branch overhanging tombs. Upper right, dead wood that needs to be removed. Lower left, broken limbs. Lower right, damage and disease.

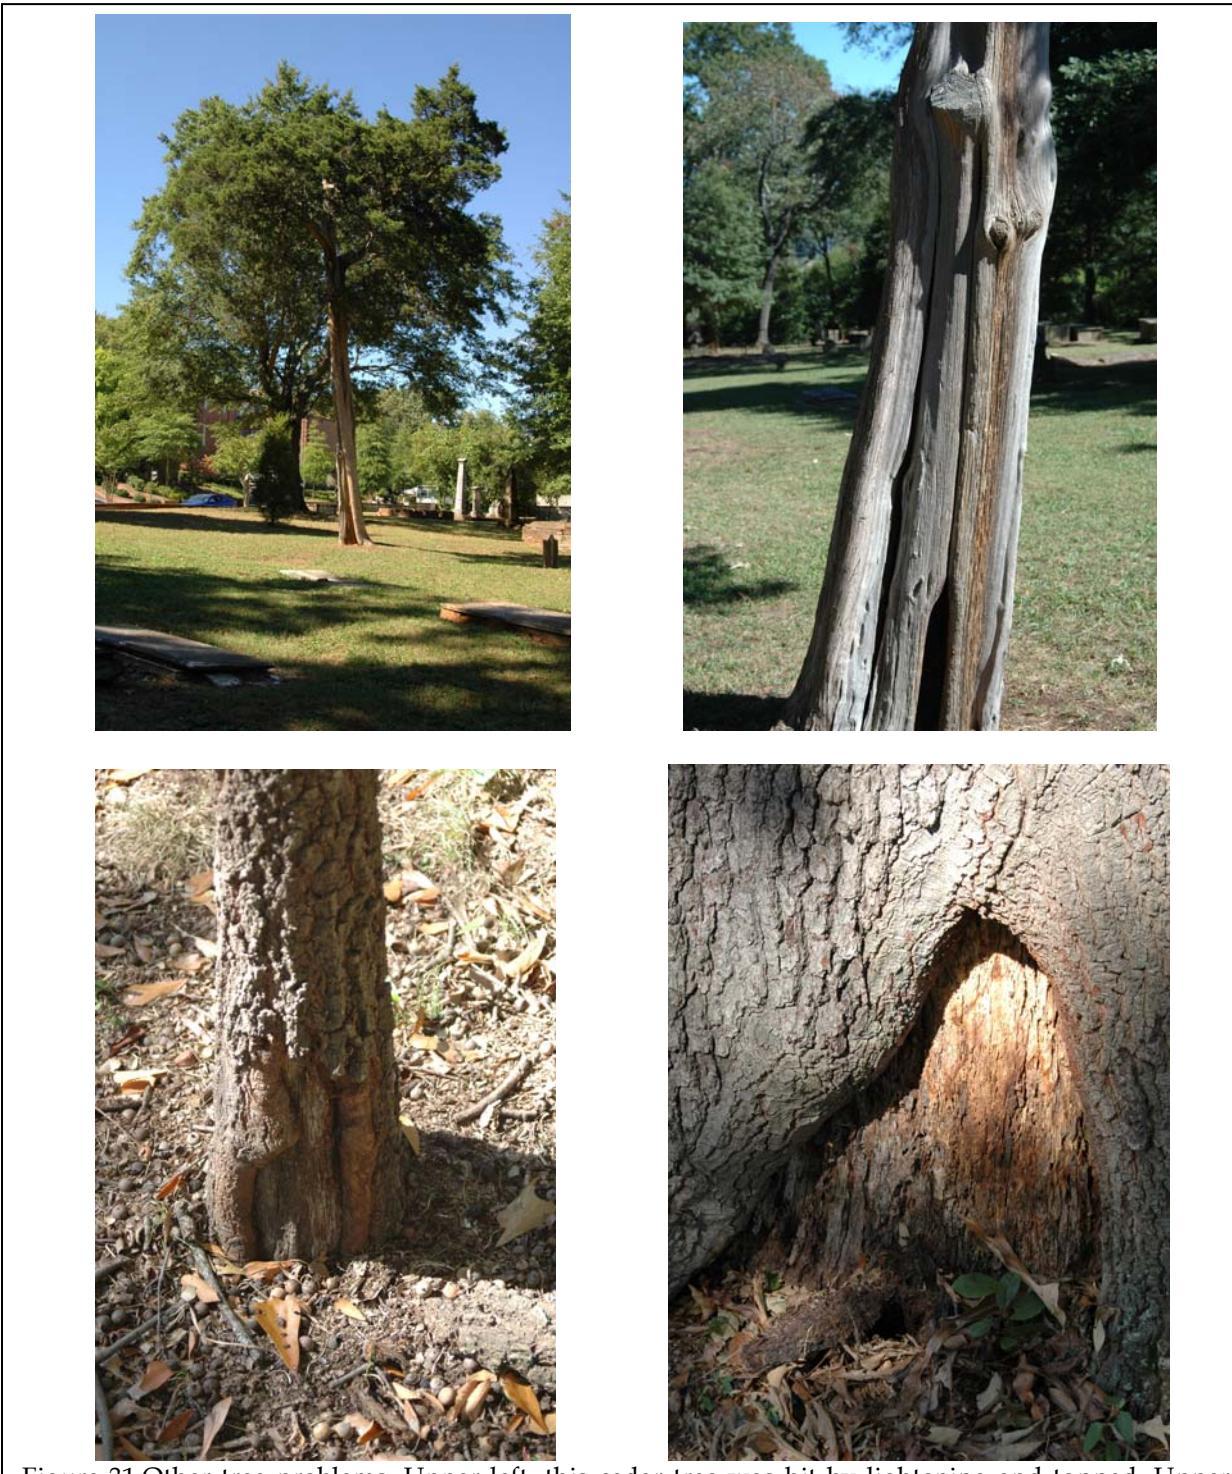
Figure 31.Other tree problems. Upper left, this cedar tree was hit by lightening and topped. Upper right, the tree is cracked and has termites, indicating dead wood. Consideration should be given to removal and replacement. Lower left and right, evidence of old wounds with extensive rot. The extent of damage should be evaluated.

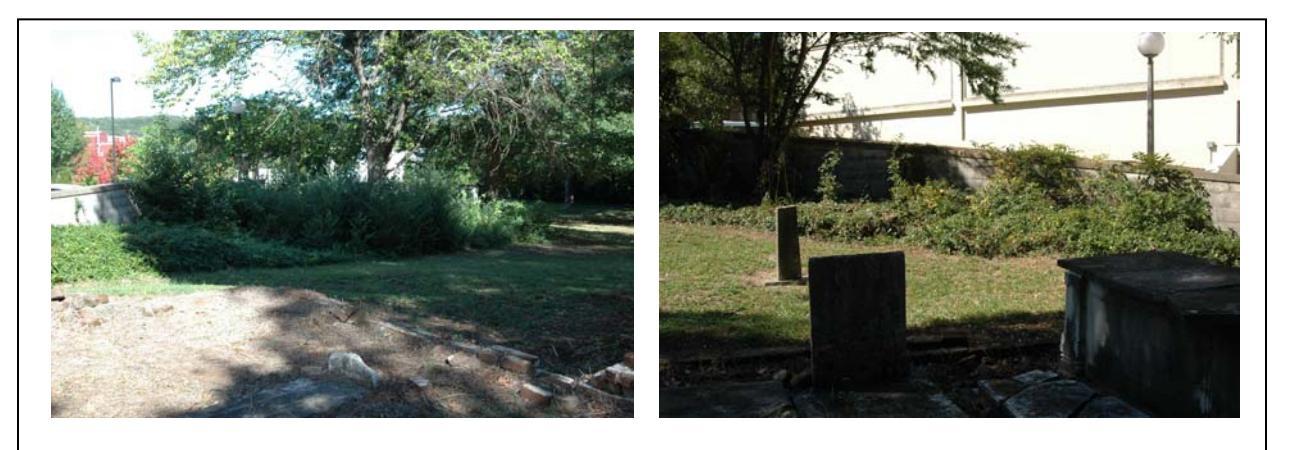
Figure 32. Examples of the massed vegetation in several areas along the north edge of the cemetery. It is poorly tended and poses a security risk. We recommend removal and either reworking the block wall or planting of individual, historically appropriate, specimens.

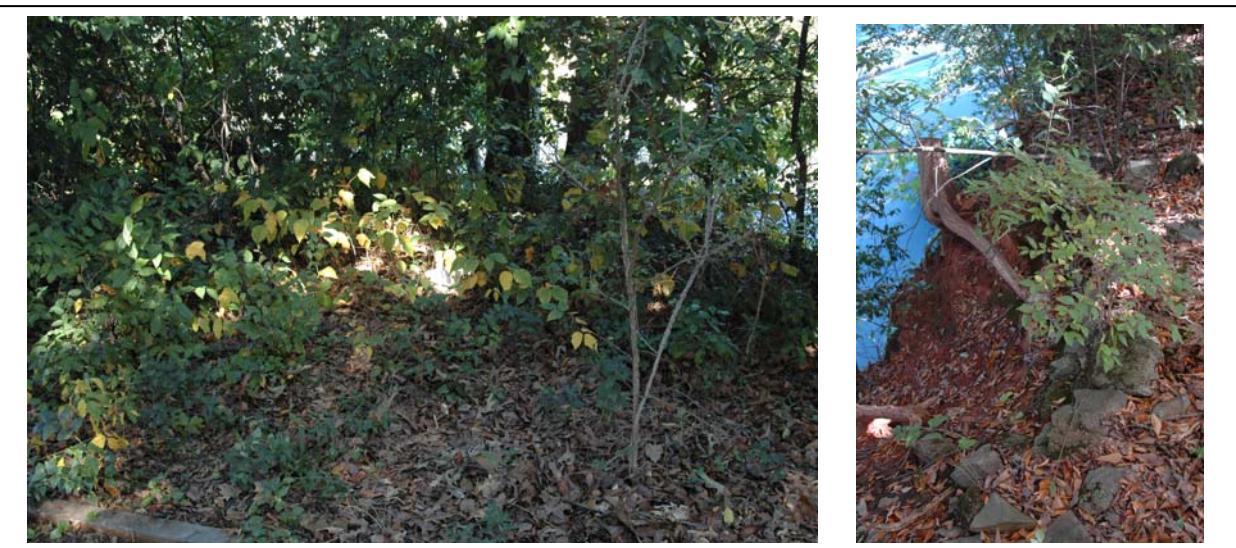
Figure 33. Vegetation at edge of the slope (on the left) and the nearly vertical drop off (on the right). Note also the remnant wall, today at the edge of the slope. In 1983 it was 5-10 feet from the edge, helping to document the extent of erosion.

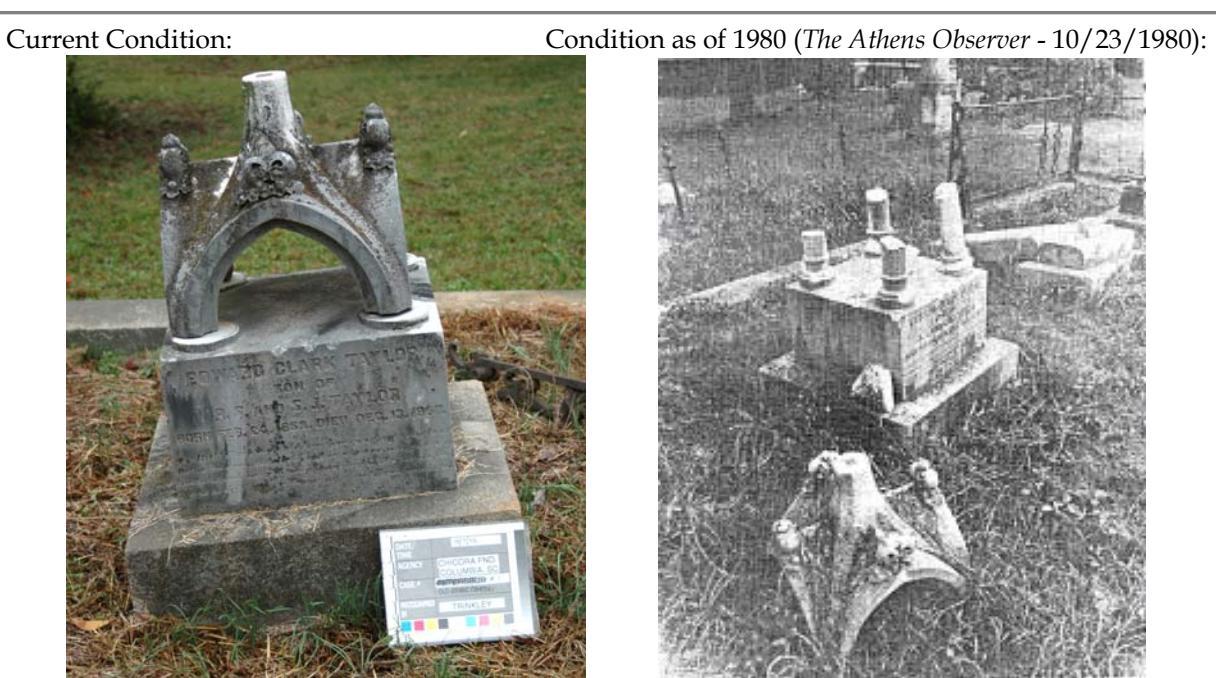
Old Moi	Athens Ceme nument Treatr	tery, Athens, GA nent Proposal	Section:	Plo	ot: 2
Namo	e: Edward Lampkir	n Material: 🖂	marble 🗌 granite 🗌	brick 🛛 othe	r: reported to be Italian
Туре	pe: headstone footstone die on base tab in socket box other: obelisk				
	Position: faller	ı 🛛 tilted 🗌 unstable 🗌	unattached/loose 🗌 m	ussing	
ondition	Deterioration: delamination/	broken 🗌 cracked 🔲 loss detachment 🗌 spalling 🗌	ses □ flaking/sugaring] missing fragments □	$\frac{1}{2}$ ferrous pi other:	ns 🗌 brass pins
ng Cc	Extent: 🗌 extensi	ve >50%	⊠ minimal <25% □ 1	not applicable	
Existi	Failed/Old Treatn	nents: metal adhesive	es/coatings	other:	
	Soiling: 🔀 biolog	ical 🗌 staining 🗌 efflores	scence 🛛 other: atmosj	pheric, probably	y gypsum crust
egy	Position: reset possible new b	/level in ground reset/ ase required stabilize for	level to existing base [undation] reset with (] construct new 0:1:3 mix 🔲 re	base 🗌 resquare set with compound

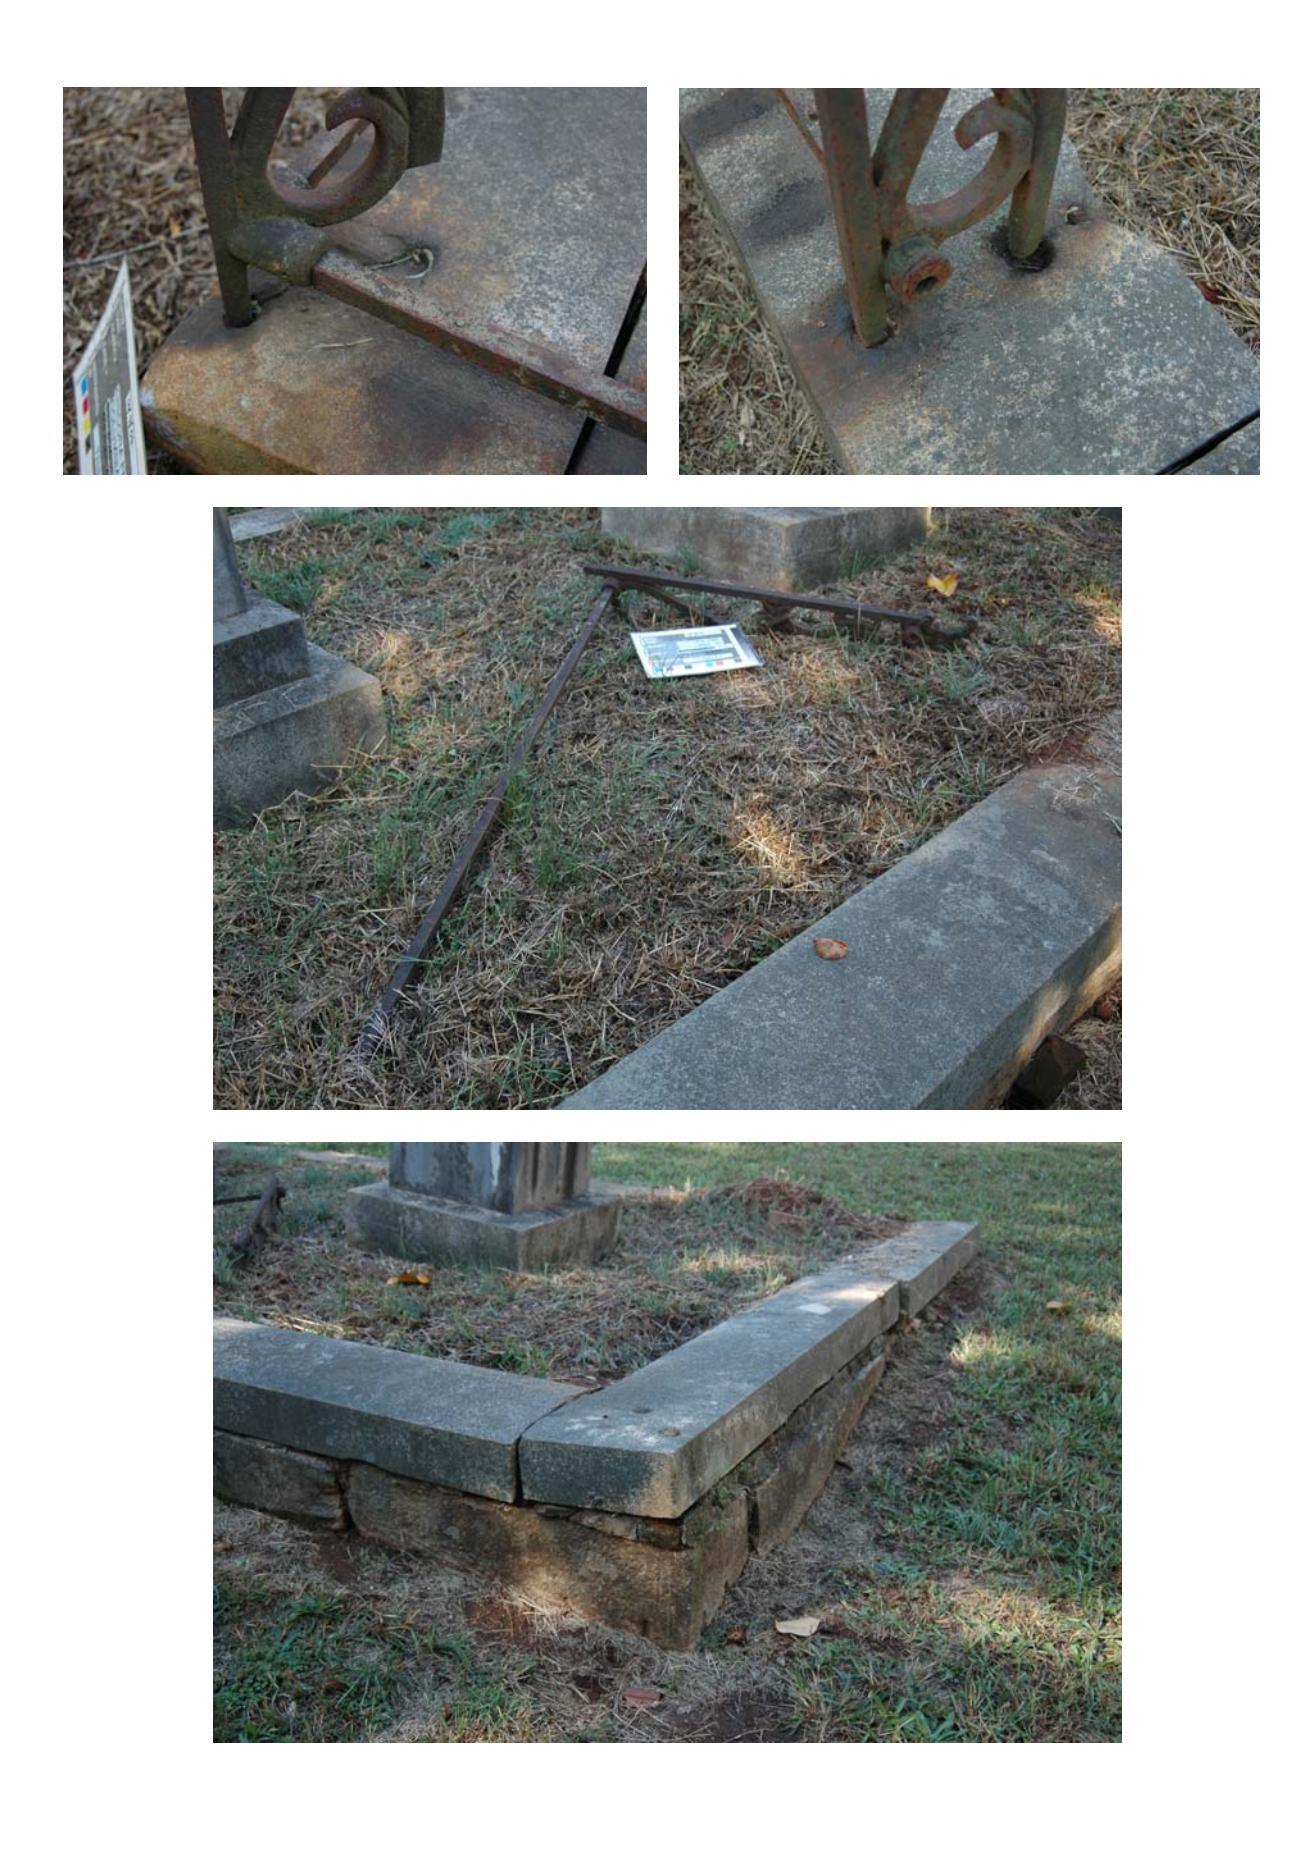
Mo	Athens Ceme nument Treatr	tery, Athens, GA nent Proposal	Section:	Ple	ot: 4
Nam	Name: Lampkin Material: 🛛 marble 🗌 granite 🖾 brick 🔲 other:				
Туре	$\mathbf{ype:}$ \Box footstone \Box die on base \Box tab in socket \boxtimes box \Box other:				
	Position: faller	ı 🗌 tilted 🗌 unstable 🗌 una	attached/loose 🗌 r	nissing	
ndition	Deterioration: A delamination/	broken 🗌 cracked 🔲 losses detachment 🗌 spalling 🗌 m	☐ flaking/sugarin issing fragments ∑	lg □ ferrous pi] other: modern	ins 🔲 brass pins brick surrounds failing
ng Cc	Extent: 🗌 extensi	ve >50% 🛛 partial 25-50% 🗌] minimal <25%	not applicable	
Existi	Failed/Old Treatn	nents: metaladhesives/c	coatings	🔀 other: mode	rn brick w/OPC mortar
	Soiling: 🔀 biolog	ical 🛛 staining 🗌 efflorescer	nce 🗌 other:		
egy	Position: reset possible new b	:/level in ground □ reset/level ase required □ stabilize found	el to existing base [lation 🗌 reset with	☐ construct new 0:1:3 mix ☐ re	v base 🔲 resquare eset with compound

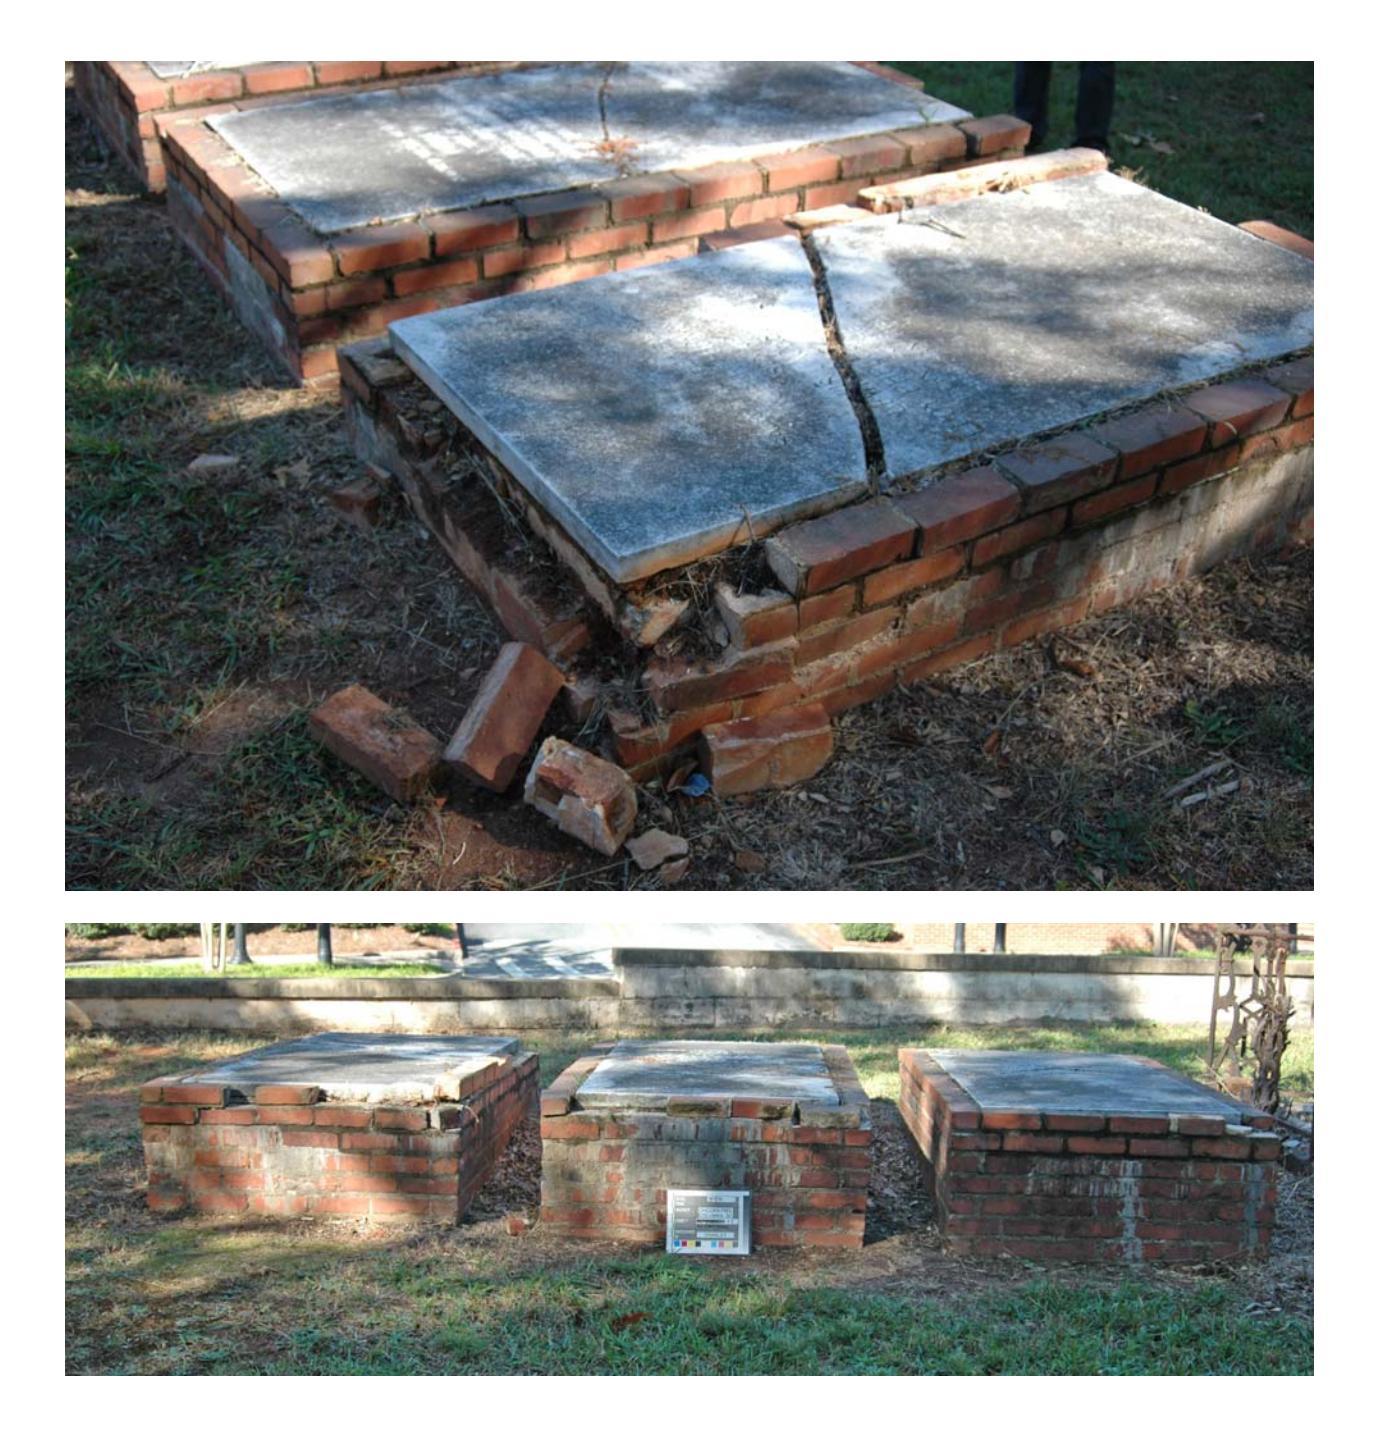
Mo	Athens Cemeter nument Treatme	ry, Athens, GA nt Proposal	Section:	Plot: 5
Nam	e: unknown	Material: 🗌 n	narble 🗌 granite 🛛	🛾 brick 🛛 other: stucco
Туре	e: 🗌 headstone 🔲 foo	otstone 🗌 die on base 🗌	tab in socket 🗌 bo	x ⊠ other: obelisk w/vault
	Position:fallen [nattached/loose	missing
Condition	Deterioration: Deterioration: Deterioration/det delamination/det extensive damage to D	oken 🗌 cracked 🔲 losses achment 🔲 spalling 🔲 r brick vault (overall conditic	s [] flaking/sugarir missing fragments [] on unknown); stucco f	ng 🔲 ferrous pins 🗌 brass pins 🛿 other: mortar friable/sanding; failing; graffiti
ting C	Extent: extensive >	>50% 🗌 partial 25-50% [🛾 minimal <25% 🗌	not applicable
Exis	Failed/Old Treatmen	.ts: metaladhesives/	coatings mortar	other:
	Soiling: Diological	l 🗌 staining 🗌 effloresco	ence 🛛 other: graffi	.ti
<u>sy</u>	Position: reset/le	vel in ground	vel to existing base ndation 🗌 reset with	☐ construct new base ☐ resquare 0:1:3 mix ☐ reset with compound

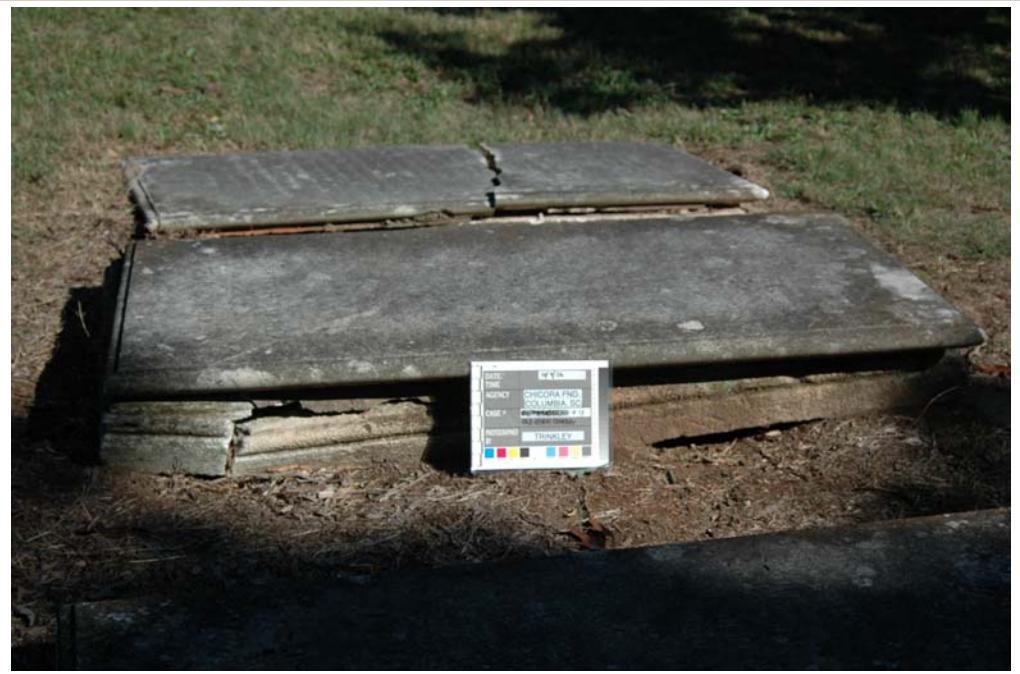
Moi	nument Treatment Propo	is, GA sal	Section:	Ple	ot: 14	
Nam	e: Rebekah Bostick	Material: 🔀 marb	le 🗌 granite 🗌 bi	rick 🛛 othe	er: local stone foundation	
Туре	: headstone footstone	die on base 🔲 tab	in socket 🗌 box [other: ledg	ger on foundation	
	Position: ☐ fallen ⊠tilted ⊠	unstable 🛛 unatta	ached/loose 🗌 miss	ing		
ndition	Deterioration: ⊠ broken □ cra □ delamination/detachment □	icked 🗌 losses 🗌] spalling 🗌 miss] flaking/sugaring ing fragments 🔲 ot	ferrous pi her:	ins 🗌 brass pins	
ng Co	Extent: extensive >50% pa	artial 25-50% 🗌 m	inimal <25% 🗌 not	applicable		
Existi	Failed/Old Treatments: metal	adhesives/coa	tings 🗌 mortar 🗌	other:		
	Soiling: 🛛 biological 🗌 stainin	efflorescence	other:			
egy	Position: reset/level in groun possible new base required	nd ⊠reset/level t ⊠stabilize foundati	to existing base \Box contains \Box reset with 0:1	onstruct new :3 mix 🔲 re	v base 🔲 resquare eset with compound

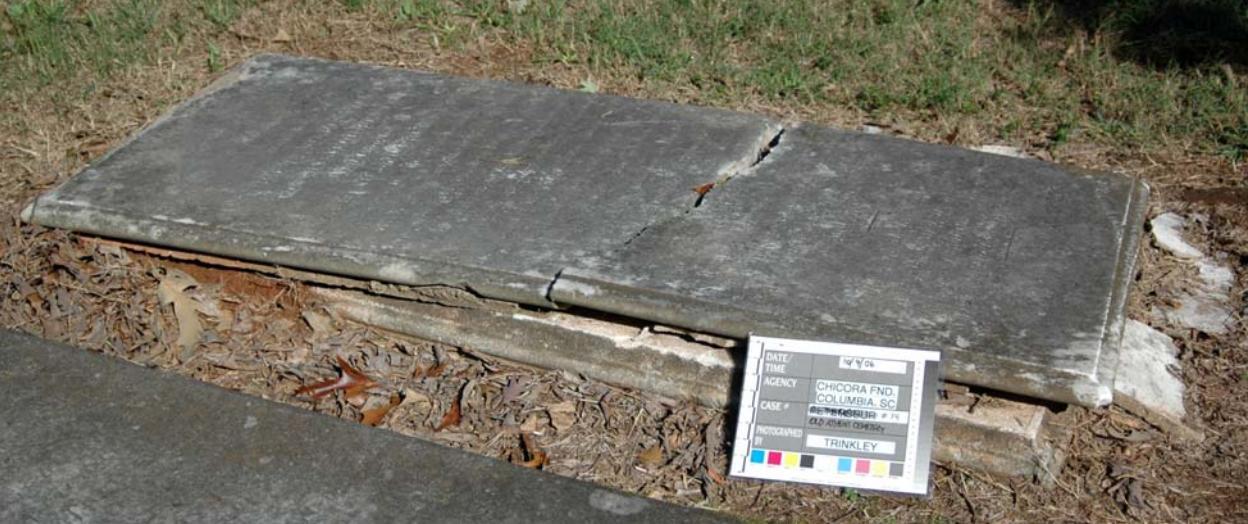
Old Moi	Athens Ceme nument Treatn	tery, Athens, GA nent Proposal	Section:	Plot: 15			
Namo	e: unknown	Material : 🔀 m	narble 🗌 granite	S brick D other:			
Туре	pe: ☐ headstone ☐ footstone ☐ die on base ☐ tab in socket ⊠ box ☐ other:						
	Position:fallen	tilted 🛛 unstable 🗌 ur	nattached/loose 🗌 r	missing			
ondition	Deterioration: \square delamination/o	broken 🗌 cracked 🔲 losses detachment 🗌 spalling 🔲 n	flaking/sugarin flaking/sugarin	ng 🔲 ferrous pins 🗌 brass pins] other:			
ing Co	Extent: extensive >50% partial 25-50% minimal <25% not applicable						
Existi	Failed/Old Treatments: metal adhesives/coatings mortar other:						
	Soiling: 🔀 biolog	ical 🗌 staining 🗌 effloresce	ence 🗌 other:				
egy	Position: reset	/level in ground ⊠ reset/lev ase required □ stabilize foun	vel to existing base $\begin{bmatrix} \\ \\ \\ \\ \\ \\ \end{bmatrix}$ reset with	□ construct new base □ resquare 0:1:3 mix □ reset with compound	l

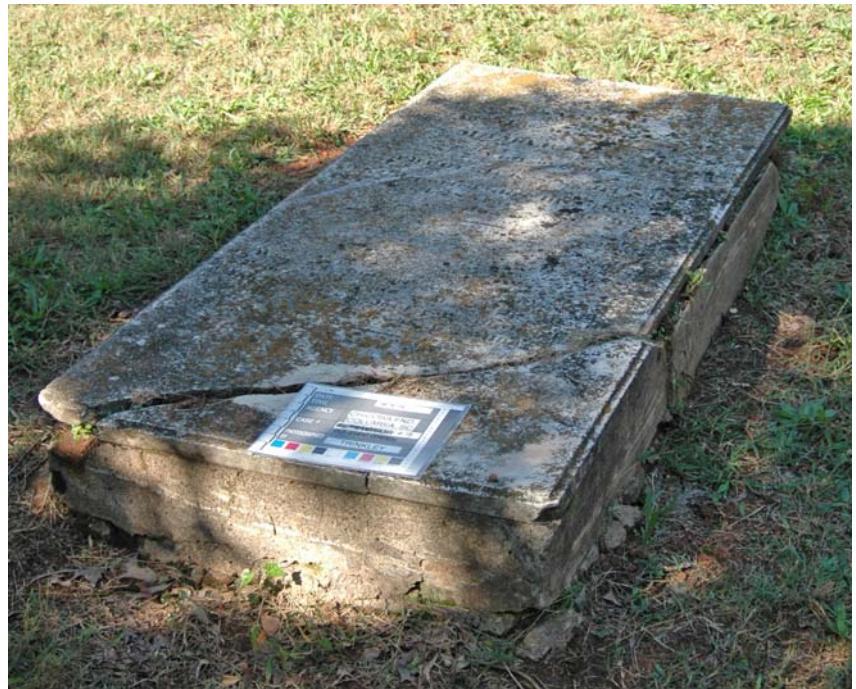
Old Moi	Athens Cemel nument Treatn	tery, Athens, GA nent Proposal	Section:	Plo	ot: 16
Name	e: Samuel Maxwell	Material: 🔀 mar	ble 🗌 granite 🗌]brick] othe	r:
Type	: 🛛 headstone 🗌	footstone 🗌 die on base 🗌 ta	b in socket 🗌 boy	x 🗌 other:	
	Position: fallen		tached/loose 🗌 r	nissing	
ndition	Deterioration: I delamination/c	broken 🗌 cracked 🔲 losses detachment 🗌 spalling 🗌 mis	☐ flaking/sugarin sing fragments ∑	ıg 🔲 ferrous pi 🛾 other: failed rej	ns 🔲 brass pins pair (top in storage)
ng Co	Extent: 🗌 extensive >50% 🔀 partial 25-50% 🗌 minimal <25% 🗌 not applicable				
Existi	Failed/Old Treatm	eents: metaladhesives/co	atings	🛛 other: nylon	blind pin repair
	Soiling: 🔀 biologi	ical 🗌 staining 🗌 efflorescene	e 🗌 other:		
egy	Position: I reset, possible new ba	/level in ground reset/level ase required stabilize founda	to existing base [ution] reset with	☐ construct new 0:1:3 mix ☐ re	base 🗌 resquare set with compound

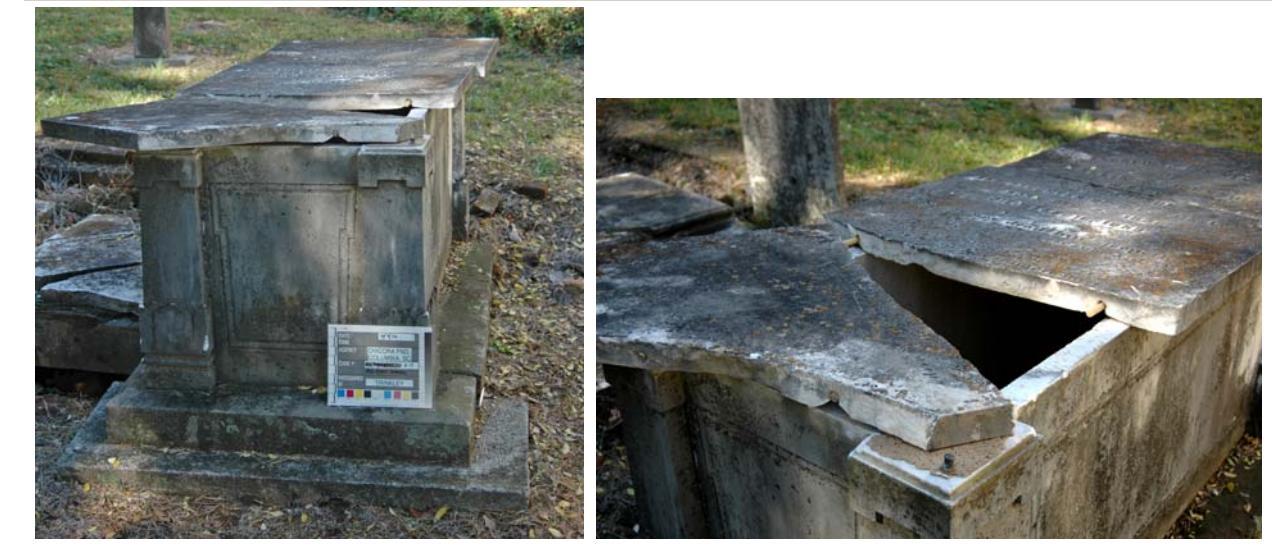
Mo1	Athens Cemetery nument Treatmen	7, Athens, GA t Proposal	Section:	Plo	ot: 18	
Nam	e: unknown	Material: 🔀 mar	ble 🗌 granite 🔲	brick 🗌 othe	r:	
Туре	: headstone 🗌 foot	stone 🗌 die on base 🗌 ta	b in socket 🛛 box	other:		
	Position: fallen	tilted 🗌 unstable 🛛 unat	tached/loose 🗌 mi	ssing		
ondition	Deterioration: brok	en □ cracked □ losses [chment □ spalling ⊠ mis	☐ flaking/sugaring sing fragments □	ferrous pi other:	ns 🗌 brass pins	
ng Ct	Extent: 🔀 extensive >5	50% 🗌 partial 25-50% 🔲 1	ninimal <25% 🗌 n	ot applicable		
Existi	Failed/Old Treatments	: metaladhesives/co	atings 🗌 mortar [🛾 other: Portla	nd cement	
	Soiling: 🛛 biological	Staining efflorescence	e 🗌 other:			
egy	Position: reset/lev possible new base r	el in ground ⊠reset/level equired □ stabilize founda	to existing base \Box tion \boxtimes reset with 0	construct new	base 🗌 resquare eset with compound	
t Strat	Failed Treatments:	drill/grind 🔀 hand tools	solvents oth	er:

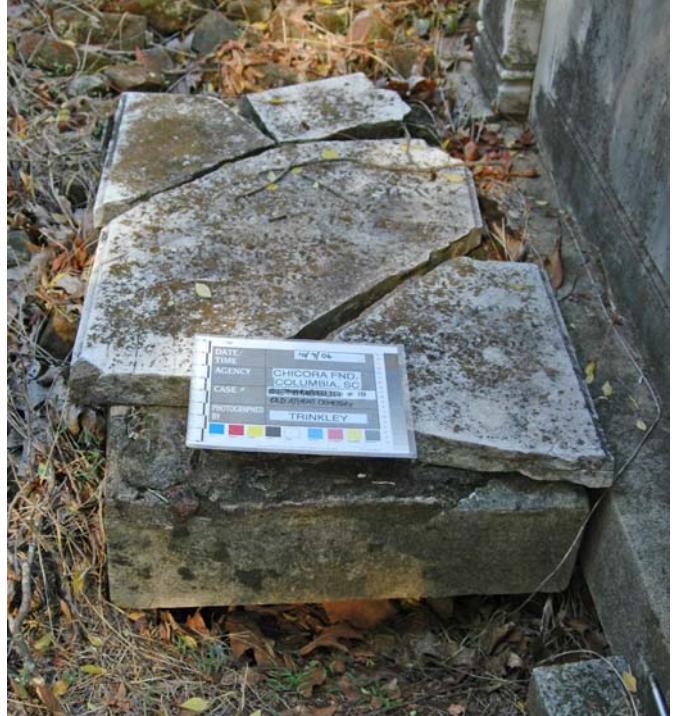
Old Moi	Athens Ceme nument Treatr	tery, Athens, GA nent Proposal	Section:	Pl	ot: 19
Nam	e: unknown	Material: 🔀 m	arble 🗌 granite 🗌] brick 🗌 othe	er:
Туре	$: \boxtimes$ headstone \boxtimes	footstone 🗌 die on base 🔲	tab in socket 🗌 boy	∝ ⊠ other:	
	Position: faller	u 🗌 tilted 🛛 unstable 🖾 un	attached/loose 🗌 r	nissing	
ondition	Deterioration: delamination/	broken □ cracked □ losses detachment □ spalling ⊠ m	☐ flaking/sugarin hissing fragments ☐	g 🔲 ferrous p] other:	ins 🗌 brass pins
ng Cc	Extent: 🗌 extensi	ve >50% 🛛 partial 25-50% 🗌] minimal <25%	not applicable	
Existi	Failed/Old Treatments: metal adhesives/coatings mortar other:				
	Soiling: 🔀 biolog	ical 🛛 staining 🗌 effloresce	nce other:		
egy	Position: reset possible new b	/level in ground ⊠ reset/lev ase required □ stabilize found	el to existing base [dation] reset with	☐ construct new 0:1:3 mix ☐ re	v base 🔲 resquare eset with compound
: Strat	Failed Treatments	classical drill/grind hand tools	s 🗌 solvents 🗌 ot	her:

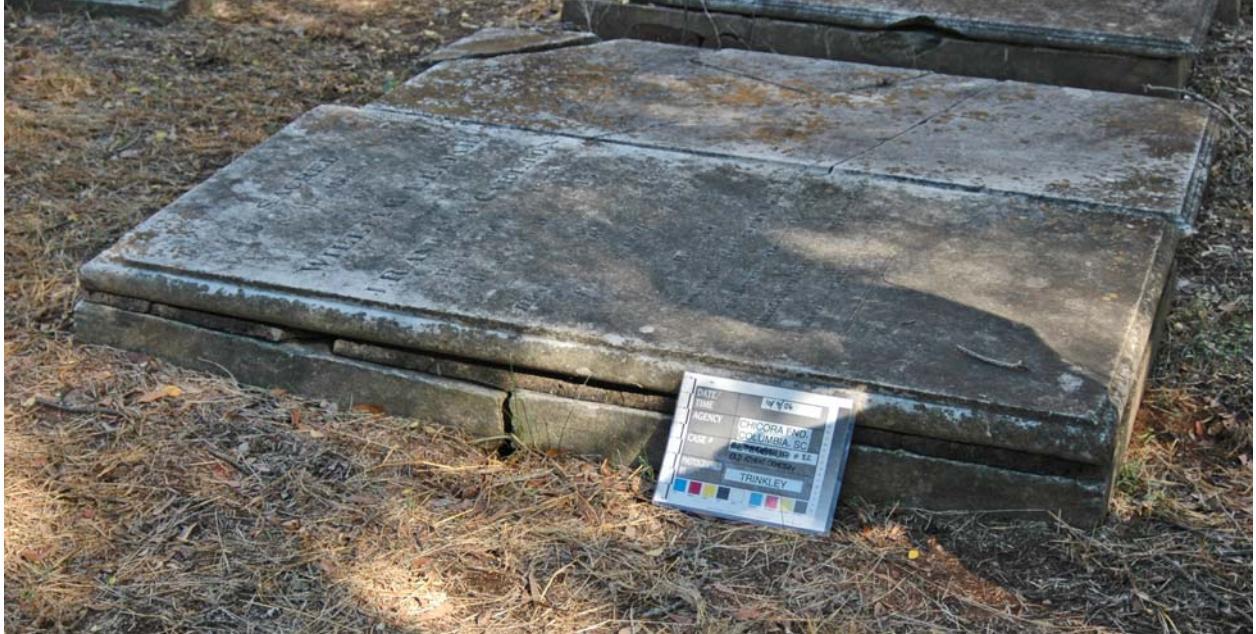
Old Moi	Athens Ceme nument Treatn	tery, Athens, GA nent Proposal	Section:	Plot: 23		
Namo	e: William Elijah	Material: 🔀	marble 🗌 granite 🗌] brick 🔲 other:		
Туре	: headstone	footstone 🗌 die on base 🗌] tab in socket 🗌 bo>	🕻 🖂 other: ledger		
	Position:fallen	tilted 🗌 unstable 🛛 u	ınattached/loose 🗌 r	nissing		
ondition	Deterioration: A delamination/o	broken 🗌 cracked 🔲 losse detachment 🗌 spalling 🔲	es 🔲 flaking/sugarin missing fragments 🗌	g 🔲 ferrous pins 🔲] other:	brass pins	
ng Co	Extent: 🔀 extensive >50% 🗌 partial 25-50% 🗌 minimal <25% 🗌 not applicable					
Existi	Failed/Old Treatments: metal adhesives/coatings mortar other:					
	Soiling: 🔀 biolog	ical 🛛 staining 🗌 efflorese	cence other:			
egy	Position: reset	/level in ground ⊠ reset/le ase required □ stabilize fou	evel to existing base [ndation 🛛 reset with	☐ construct new base 0:1:3 mix ☐ reset wit	resquare th compound	
t Strat	Failed Treatments	\therefore drill/grind \square hand too	ols 🗌 solvents 🗌 ot	her:

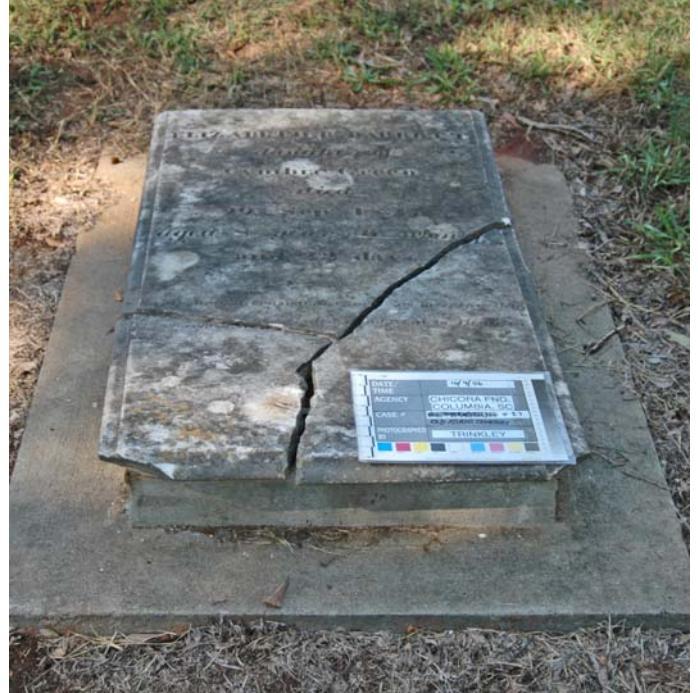
Monument Treatment Proposal		Section:	Plot: 28	
Name: Sarah Wallis Material: 🛛 marble 🗌 granite 🗌 brick 🗌 other:				brick other:
Type	headstone	footstone 🗌 die on base 🗌	tab in socket 🗌 boy	🗙 🔀 other: ledger
	Position: faller	tilted 🗌 unstable 🛛 un	nattached/loose 🗌 r	nissing
ndition	Deterioration: delamination/	broken 🗌 cracked 🔲 losses detachment 🗌 spalling 🔲 r	3 □ flaking/sugarin nissing fragments □	g 🔲 ferrous pins 🗌 brass pins] other:
ng Cc	Extent: 🗌 extensiv	ve >50% 🗌 partial 25-50% [⊠ minimal <25% 🔲	not applicable
Existi	Failed/Old Treatn	nents: metaladhesives/	'coatings	other:
	Soiling: 🔀 biolog	ical 🛛 staining 🗌 effloresco	ence 🗌 other:	
egy	Position: reset	/level in ground ⊠ reset/le ase required □ stabilize four	vel to existing base [udation 🛛 reset with	☐ construct new base ☐ resquare 0:1:3 mix ☐ reset with compound
: Strat	Failed Treatments	: drill/grind hand tool	s 🗌 solvents 🗌 ot	her:
