PRESERVATION ASSESSMENT AND PLAN FOR THE OLD ATHENS CEMETERY, ATHENS, GEORGIA

Chicora Research Contribution 459

Prepared By: Michael Trinkley, Ph.D. and Debi Hacker

December 22, 2006

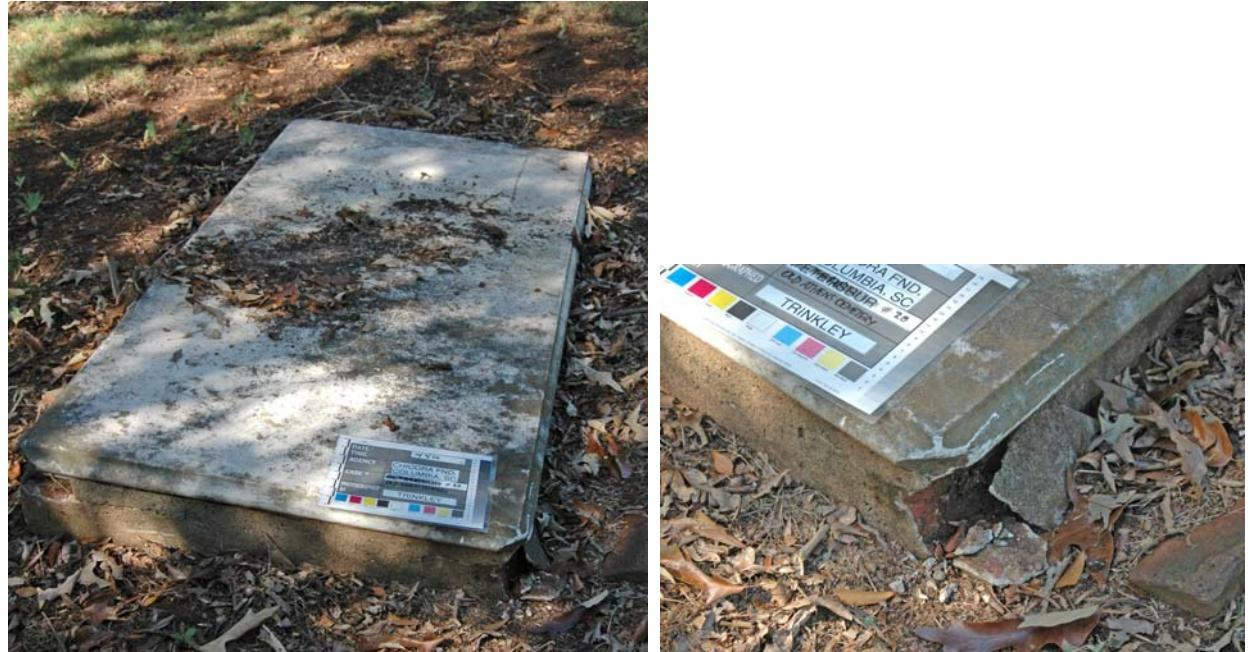
Mo1	Athens Cemetery, Athens, GA nument Treatment Proposal	Section:	Plot: 29		
Nam	e: David Thomas Material:	🛛 marble 🗌 granite 🗌 b	prick 🗌 other:		
Туре	: headstone footstone die on base	tab in socket box	\boxtimes other: possibly box covered in OPC		
	Position: fallen tilted unstable	🛛 unattached/loose 🗌 mis	ssing		
ng Condition	Deterioration: broken cracked le le delamination/detachment spalling	osses	☐ ferrous pins ☐ brass pins other:		
	Extent: extensive >50% partial 25-50	% 🔀 minimal <25% 🗌 no	ot applicable		
Existi	Failed/Old Treatments: metaladhesi	ves/coatings mortar mortar] other:		
	Soiling: Soilogical Staining efflo	rescence 🗌 other:			
egy	Position: ☐ reset/level in ground ⊠ reset ☐ possible new base required ☐ stabilize	et/level to existing base \Box foundation \boxtimes reset with 0:	construct new base 🛛 resquare 1:3 mix 🔲 reset with compound		
: Strat	Failed Treatments: drill/grind hand	tools solvents othe	r:

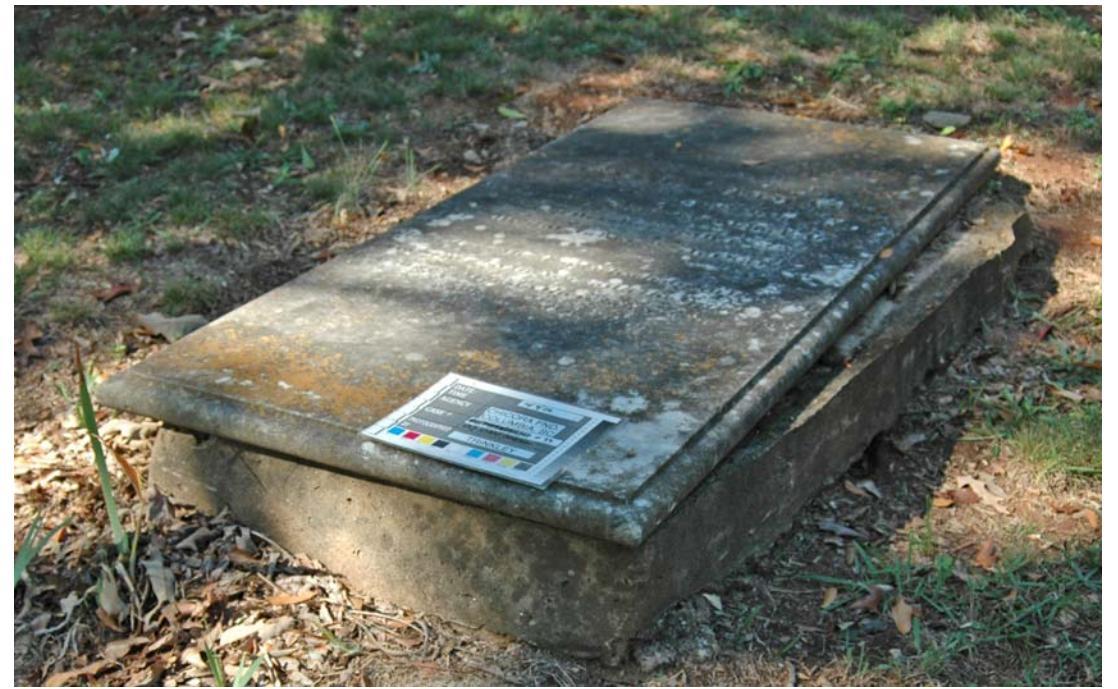
Athens Cemetery, nument Treatment	, Athens, GA Proposal	Section:	Plo	ot: 30	
e: Elizabeth Griswold	Material: 🔀	marble 🗌 granite 🗌] brick 🔲 othe	er:	
\Box headstone \Box foots	tone 🔲 die on base 🗌] tab in socket 🗌 box	other:		
Position: X fallen t	ilted 🗌 unstable 🗌 ı	ınattached/loose 🗌 m	nissing		
Deterioration: ⊠ broken □ cracked □ losses □ flaking/sugaring □ ferrous pins □ brass pins □ delamination/detachment □ spalling ⊠ missing fragments □ other:					
Extent: 🗌 extensive >50% 🛛 partial 25-50% 🗌 minimal <25% 🔲 not applicable					
Failed/Old Treatments: metal adhesives/coatings mortar other:					
Soiling: X biological	⊠ staining □ efflores	cence other:			
Position: I reset/leve possible new base re	l in ground ☐ reset/le quired	evel to existing base [ndation] reset with] construct new 0:1:3 mix □ re	v base 🔲 resquare eset with compound	
Failed Treatments:	drill/grind 🗌 hand too	ols 🗌 solvents 🗌 otl	ner:

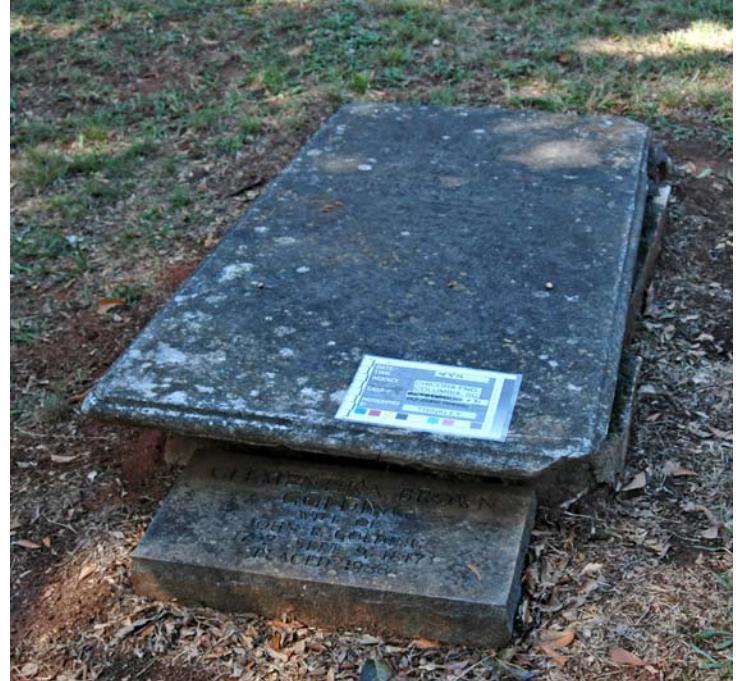
Old Mor	Athens Ceme nument Treatn	tery, Athens, GA nent Proposal	Section:	Plot: 32	
Name	e: unknown	Material: 🔀 m	arble 🗌 granite 🗌	brick other:	
Type:	headstone	footstone 🗌 die on base 🗌	tab in socket 🛛 boy	c i other:	
	Position: fallen	tilted 🛛 unstable 🖾 ur	nattached/loose 🗌 r	nissing	
ondition	Deterioration:	broken □ cracked □ losses detachment □ spalling ⊠ n	flaking/sugarin fissing fragments	g 🔲 ferrous pins 🗌 brass pins] other:	
ng C(Extent: 🗌 extensiv	ve >50% 🛛 partial 25-50% 🗌] minimal <25%	not applicable	
Existi	Failed/Old Treatm	nents: metaladhesives/	coatings	other:	
	Soiling: 🔀 biolog	ical 🛛 staining 🗌 effloresce	nce other:		
egy	Position: reset	/level in ground ⊠ reset/lev ase required □ stabilize foun	vel to existing base [dation] reset with	☐ construct new base ☐ resquare 0:1:3 mix ☐ reset with compound	
t Strat	Failed Treatments	: drill/grind hand tools	s 🗌 solvents 🗌 ot	her:	
reatmen	Treatment: cor	e drill □ drill and pin □ sir point ⊠ other: replace two m	nple adhesive repair issing corners that se	injection grout replace bricks rve to tie together side and end panels

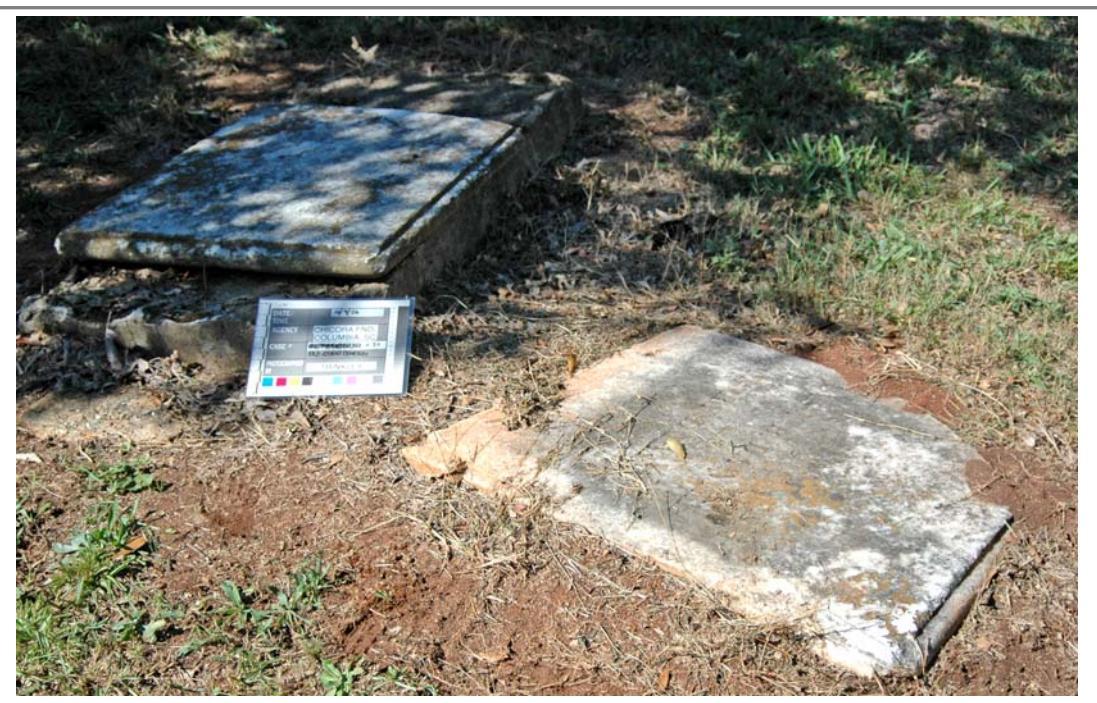
Old Mor	Athens Cemel nument Treatn	tery, Athens, GA nent Proposal	Section:	Ple	ot: 34
Name	:[]Dougherty	Material: 🔀 n	narble 🛛 granite 🗌] brick 🗌 othe	er:
Туре:	headstone	footstone 🗌 die on base 🗌	tab in socket 🛛 boy	x 🗌 other:	
	Position: fallen	☐tilted ☐ unstable ⊠ u	nattached/loose 🗌 r	nissing	
ondition	Deterioration: ⊠ broken □ cracked □ losses □ flaking/sugaring □ ferrous pins □ brass pins □ delamination/detachment □ spalling ⊠ missing fragments □ other:				
ing Co	Extent: extensiv	ze >50% ⊠ partial 25-50% [] minimal <25%	not applicable	
Existi	Failed/Old Treatm	ents: metaladhesives/	coatings mortar	🛛 other: nylon	pins
	Soiling: 🔀 biologi	cal 🛛 staining 🗌 effloresce	ence 🗌 other:		
8y	Position: reset, possible new ba	/level in ground ⊠ reset/le ase required □ stabilize four	vel to existing base [ndation 🔀 reset with	☐ construct new 0:1:3 mix ☐ re	v base 🔲 resquare eset with compound
Strate	Failed Treatments	: drill/grind hand tool	ls 🗌 solvents 🛛 ot	ther: remove exis	sting pins

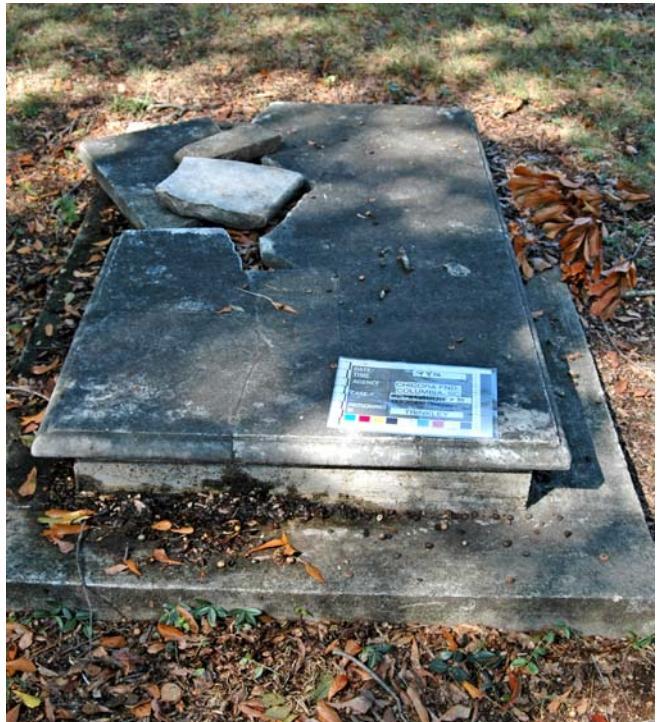
Old Mo	Athens Cemetenument Treatm	ery, Athens, GA ent Proposal	Section:	Plot: 36
Nam	e: unknown	Material: 🔀 m	arble 🗌 granite 🗌	brick 🗌 other:
Туре	: 🗌 headstone 🔲 fe	ootstone 🗌 die on base 🗌	tab in socket 🗌 box	t 🔀 other:
	Position: fallen	☐tilted ☐ unstable ⊠ un	attached/loose 🗌 n	nissing
ndition	Deterioration: D beterioration beterioration/de	roken 🗌 cracked 🔲 losses etachment 🗌 spalling 🔀 rr	☐ flaking/sugarin ussing fragments ☐	g 🔲 ferrous pins 🗌 brass pins other:
ng Co	Extent: 🛛 extensive	e >50% 🗌 partial 25-50% 🗌] minimal <25%	not applicable
Existi	Failed/Old Treatme	ents: metal adhesives/o	coatings	🛛 other: nylon pins
	Soiling: 🔀 biologic	al 🛛 staining 🗌 effloresce	nce 🗌 other:	
egy	Position: reset/	level in ground ⊠ reset/lev se required □ stabilize found	vel to existing base [dation ⊠ reset with	☐ construct new base ☐ resquare 0:1:3 mix ☐ reset with compound
t Strat	Failed Treatments:	drill/grind hand tools	s 🗌 solvents 🛛 ot	her: remove nylon pins

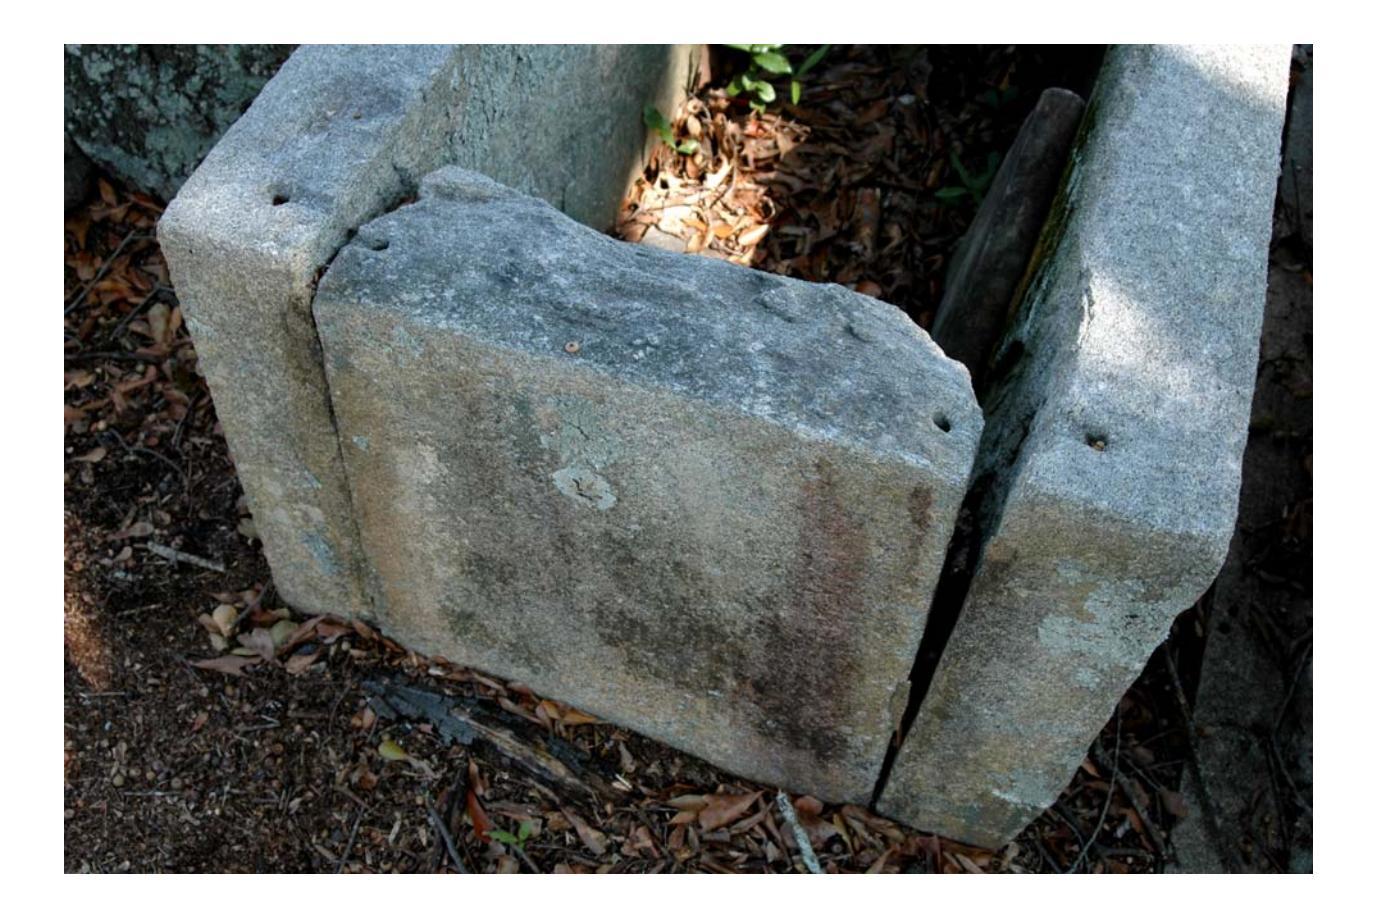
Old Moi	Athens Ceme nument Treatr	tery, Athens, GA nent Proposal	Section:	Plot: 3	9	
Name	e: Martha Graham	Material: 🔀 n	narble 🗌 granite 🗌	brick 🗌 other:		
Туре	headstone	footstone 🗌 die on base 🗌] tab in socket 🗌 box	🗙 🔀 other: ledger		
	Position: faller	u 🗌 tilted 🗌 unstable 🛛 u	nattached/loose 🗌 n	nissing		
ndition	Deterioration: delamination/	broken 🗌 cracked 🔲 losse detachment 🗌 spalling 🕅 1	s 🔲 flaking/sugarin missing fragments 🗌	g 🔲 ferrous pins [] other:	brass pins	
ng Cc	Extent: 🔀 extensive >50% 🗌 partial 25-50% 🗌 minimal <25% 🗌 not applicable					
Existi	Failed/Old Treatn	nents: metaladhesives/	coatings mortar	other:		
	Soiling: 🔀 biolog	ical 🛛 staining 🗌 effloresc	ence other:			
egy	Position: reset	/level in ground ⊠ reset/le ase required □ stabilize four	vel to existing base $\begin{bmatrix} \\ ndation \end{bmatrix}$ reset with	☐ construct new bas 0:1:3 mix ☐ reset v	e 🗌 resquare with compound

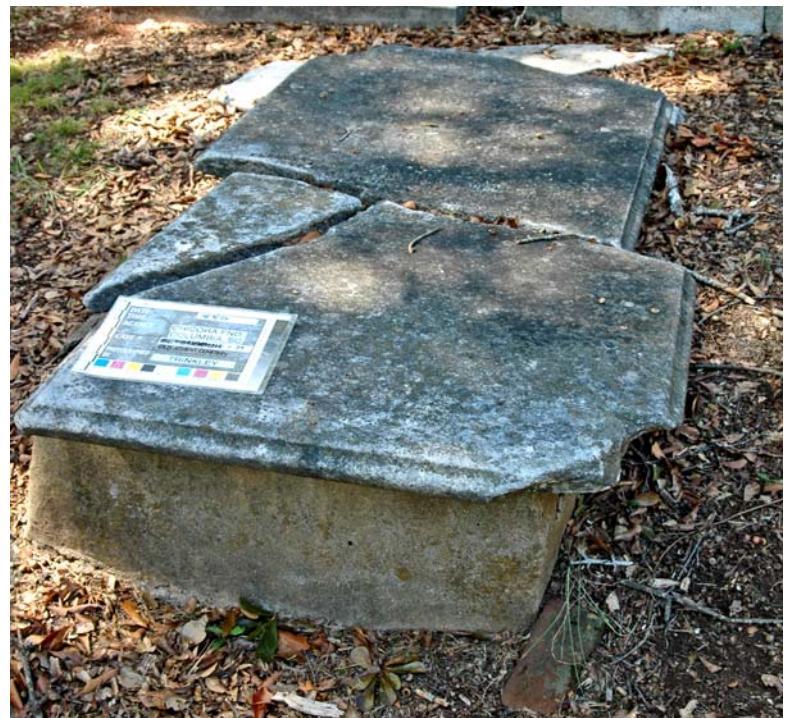
Old Mo	Athens Cemete	ry, Athens, GA ent Proposal	Section:	Plot: 40			
Nam	e: unknown	Material: 🔀 n	narble 🗌 granite 🗌	brick 🔲 other:			
Туре	pe: \square headstone \square footstone \square die on base \square tab in socket \square box \square other:						
	Position: fallen tilted unstable unattached/loose missing						
ondition	Deterioration: X br	oken 🗌 cracked 🗌 losses tachment 🗌 spalling 🔀 n	flaking/sugaring	g \Box ferrous pins \Box brass pins other:			
ng Cc	Extent: 🔀 extensive	>50% 🗌 partial 25-50% 📋	minimal <25%	not applicable			
Existi	Failed/Old Treatmen	nts: metaladhesives/	coatings mortar	🛛 other: nylon pins			
	Soiling: 🛛 biologica	l 🛛 staining 🗌 effloresce	ence 🗌 other:				
egy	Position: reset/le	evel in ground 🗌 reset/lev e required 🗌 stabilize foun	vel to existing base [dation] reset with] construct new base ☐ resquare 0:1:3 mix ☐ reset with compound			
: Strat	Failed Treatments:	drill/grind hand tool	s 🗌 solvents 🗌 otl	ner:

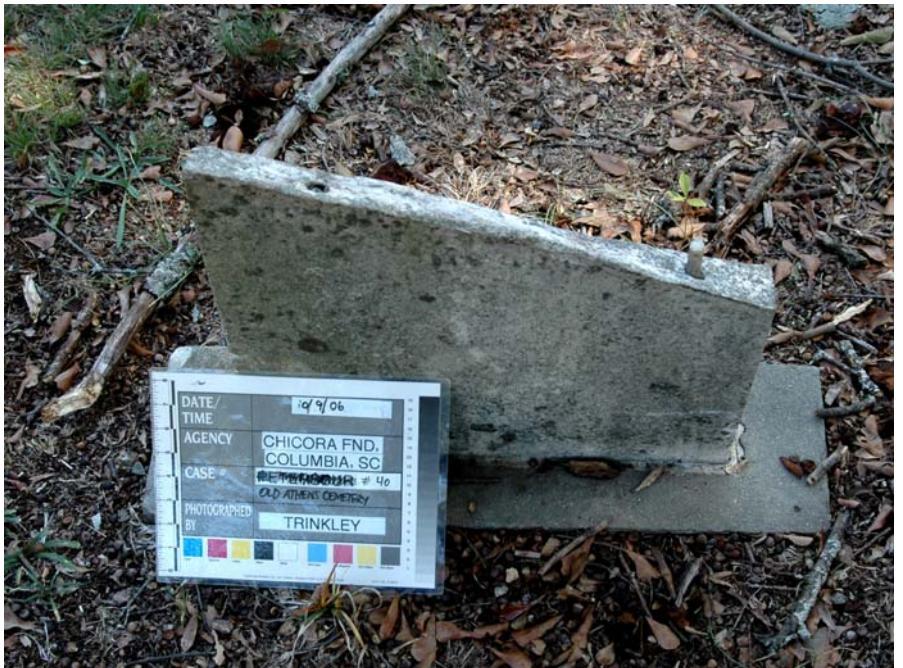
Monument Treatment Proposal			Section:	Plot: 41	
Nam	e: unkown	Material: 🔀	marble 🗌 granite 🗌] brick 🗌 other:	
Type rando	: headstone Dom parts	footstone 🗌 die on base 🗌] tab in socket 🗌 box	: 🛛 other: unknown, appear to be	
	Position:fallen	tilted unstable 🛛 u	ınattached/loose 🗌 n	nissing	
ndition	Deterioration: delamination/o	broken 🗌 cracked 🔲 losse detachment 🗌 spalling 🔀	es 🔲 flaking/sugarin missing fragments 🗌	g 🔲 ferrous pins 🗌 brass pins] other:	
ng Cc	Extent: 🔀 extensiv	ve >50%	minimal <25%	not applicable	
Existi	Failed/Old Treatm	nents: metaladhesives	/coatings	other:	
	Soiling: 🔀 biolog	ical 🛛 staining 🗌 efflorese	cence other:		
egy	Position: reset possible new ba	/level in ground □ reset/le ase required □ stabilize fou	evel to existing base [ndation] reset with	☐ construct new base ☐ resquare 0:1:3 mix ☐ reset with compound	
t Strat	Failed Treatments	: drill/grind hand too	ols 🗌 solvents 🗌 ot	her:

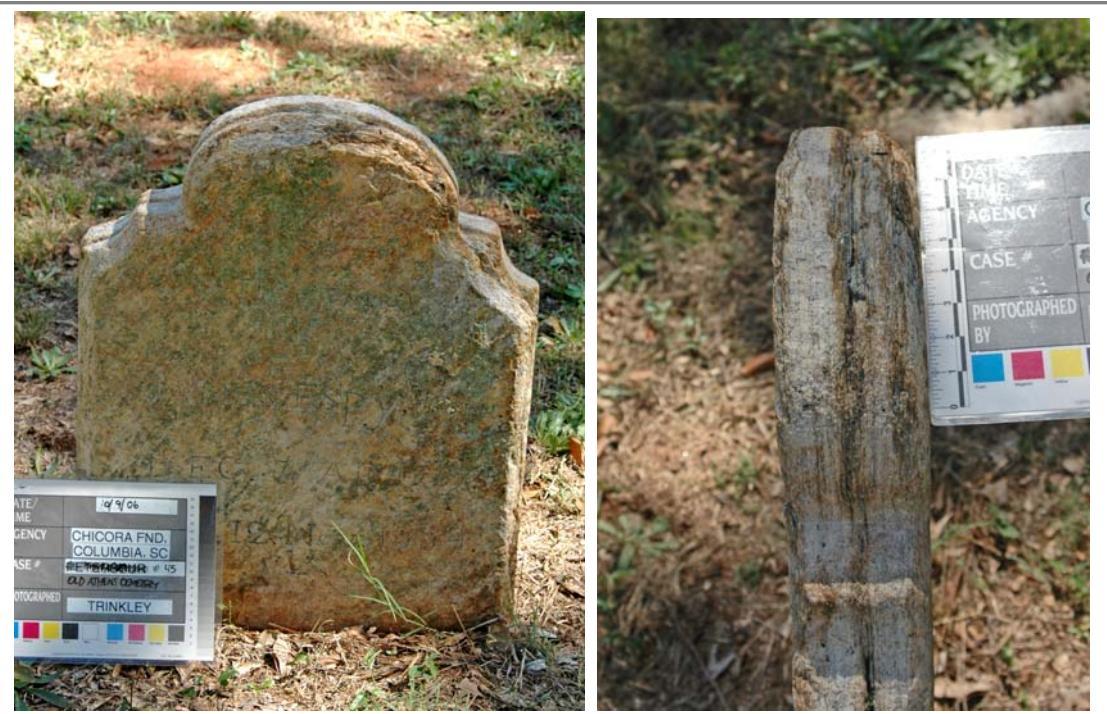
Old Mor	Athens Ceme nument Treatn	tery, Athens, GA nent Proposal	Section:	Plo	ot: 46	
Name	Name: Mrs. R. [H.] Bass Material: I marble granite brick other:					
Type	Type: headstone footstone die on base tab in socket box other:					
	Position: fallen	tilted 🗌 unstable 🛛	unattached/loose 🗌 m	uissing		
ndition	Deterioration:	broken 🗌 cracked 🔲 los detachment 🗌 spalling 🗌	ses [] flaking/sugaring] missing fragments [X]	g 🔲 ferrous pi other: box cove	ins 🔲 brass pins ered in OPC	
g Cor	Extent: 🗌 extensiv	ve >50% 🛛 partial 25-50%	minimal <25%	not applicable		
Existin	Failed/Old Treatm removing sections	nents:	es/coatings	🛛 other: OPC i	s spalling in a few areas,	
	Soiling: 🔀 biologi	ical 🛛 staining 🗌 efflore	scence 🗌 other:			
egy	Position: reset	/level in ground	′level to existing base □ pundation ⊠ reset with	$]$ construct new 0:1:3 mix \square re	v base 🗌 resquare eset with compound	
t Strat	Failed Treatments	: drill/grind hand to	ools 🗌 solvents 🗌 oth	her:

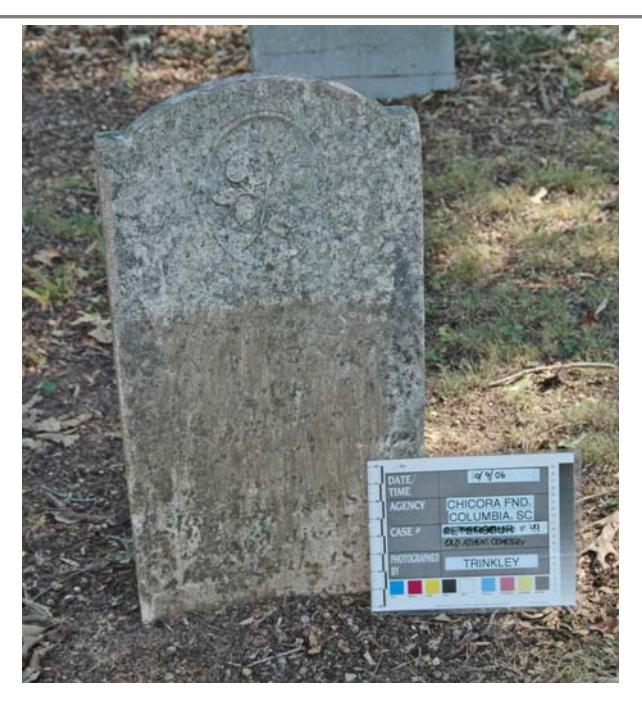
Old Moi	Athens Cemeter nument Treatmer	y, Athens, GA nt Proposal	Section:	Plot: 50			
Name	Iame: Elizabeth Yoakem ? Material: ⊠ marble □ granite □ brick □ other:						
Туре	ype: \square headstone \square footstone \square die on base \square tab in socket \square box \square other:						
	Position: A fallen]tilted 🗌 unstable 🗌 ur	nattached/loose 🗌 m	iissing			
ondition	Deterioration: Show brown by	ken 🗌 cracked 🗌 losses achment 🗌 spalling 🔲 r	s 🔲 flaking/sugaring nissing fragments 🛛	g ferrous pins brass pins other: very recent break, possible			
ting C	Extent: extensive >50% partial 25-50% minimal <25% not applicable						
Exis	Failed/Old Treatment	t s: metaladhesives/	′coatings ☐mortar	other:			
	Soiling: 🔀 biological	Staining effloresco	ence 🗌 other:				
egy	Position: reset/lev possible new base	vel in ground 🗌 reset/le required 🗌 stabilize four	vel to existing base [ndation] reset with	☐ construct new base ☐ resquare 0:1:3 mix ☐ reset with compound

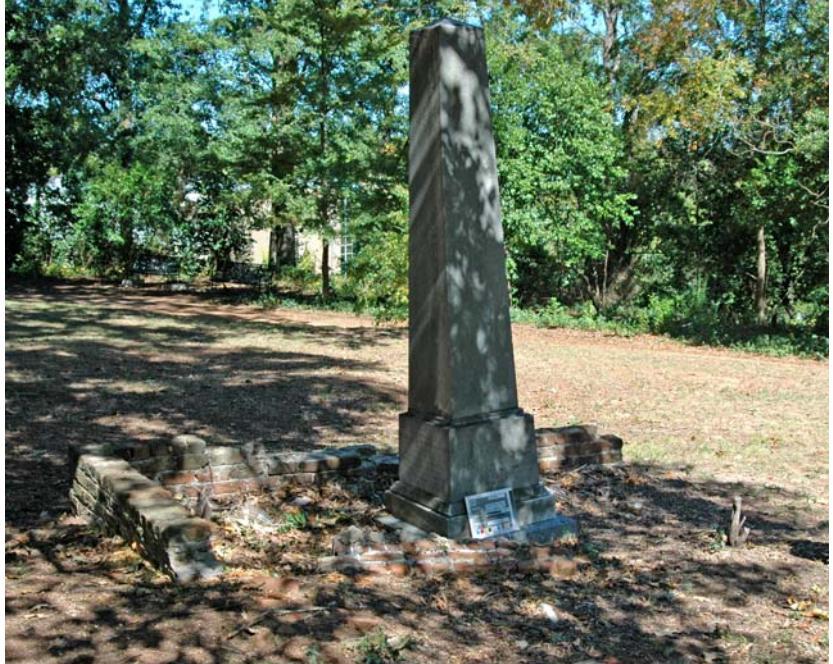
Old Mor	Athens Ceme nument Treatn	tery, Athens, GA nent Proposal	Section:	Plo	ot: 54 wall	
Name	e: Hardeman	Material: 🗌	marble 🗌 granite 🔀] brick 🗌 othe	r:	
Type	headstone	footstone 🔲 die on base [tab in socket box	other: plot	wall	
	Position: A fallen tilted unstable unattached/loose missing					
ndition	Deterioration:	broken 🗌 cracked 🔲 loss detachment 🗌 spalling 🛛	es 🔲 flaking/sugaring missing fragments 🗌	g 🔲 ferrous pi] other:	ns 🗌 brass pins	
ng Cc	Extent: 🔀 extensive >50% 🗌 partial 25-50% 🗌 minimal <25% 🗌 not applicable					
Existi	Failed/Old Treatm	nents: metaladhesives	s/coatings	other:		
	Soiling: 🗌 biologi	ical 🗌 staining 🗌 efflores	cence other:			
egy	Position: reset, possible new ba	/level in ground □ reset/l ase required □ stabilize fou	level to existing base [undation] reset with] construct new 0:1:3 mix □ re	base 🔲 resquare eset with compound	
t Strat	Failed Treatments	: drill/grind hand to	ols 🗌 solvents 🗌 oth	her:

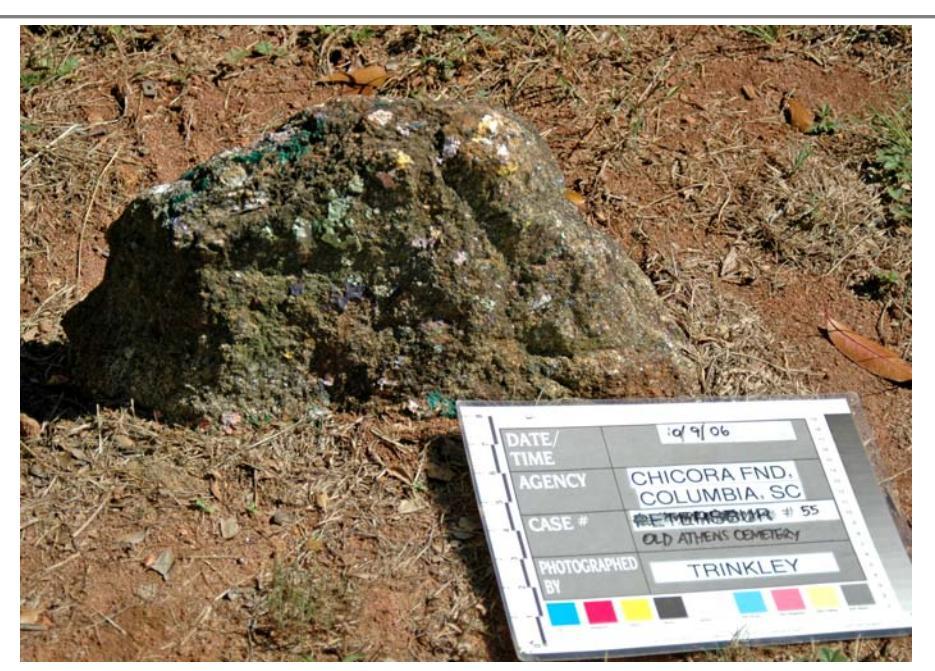
Old Moi	Athens Ceme nument Treatn	tery, Athens, GA nent Proposal	Section:	Plot: 56	
Namo	e: Samuel Pressley	Material: 🔀 m	arble 🗌 granite 🗌	brick other:	
Туре	: headstone	footstone 🗌 die on base 🗌	tab in socket 🗌 box	x 🛛 other: ledger	
	Position:fallen	i □tilted □ unstable ⊠ ur	nattached/loose 🗌 r	nissing	
ondition	Deterioration: delamination/o	broken □ cracked □ losses detachment □ spalling ⊠ n	flaking/sugarin	g 🔲 ferrous pins 🗌 brass pins] other:	
ing Co	Extent: 🔀 extensive >50% 🗌 partial 25-50% 🗌 minimal <25% 🗌 not applicable				
Existi	Failed/Old Treatm	nents: metaladhesives/	coatings mortar	other:	
	Soiling: 🔀 biolog	ical 🛛 staining 🗌 effloresce	ence 🗌 other:		
egy	Position: reset	/level in ground ⊠ reset/lev ase required □ stabilize foun	vel to existing base $\begin{bmatrix} \\ dation \end{bmatrix}$ reset with	☐ construct new base ☐ resquare 0:1:3 mix ☐ reset with compound	
t Strat	Failed Treatments	: drill/grind hand tools	s 🗌 solvents 🗌 ot	her:

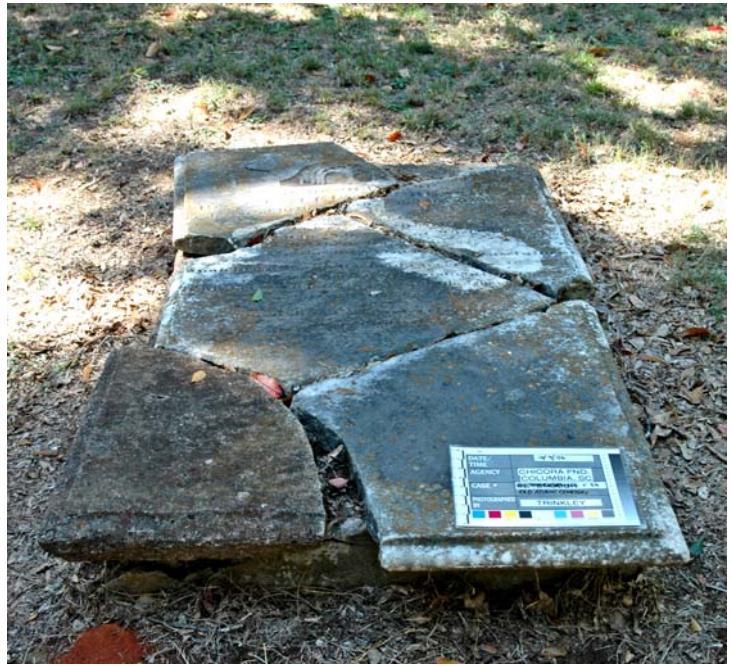
Old Moi	Athens Ceme nument Treatr	tery, Athens, GA nent Proposal	Section:	Plo	t: 57		
Name	e: Mrs. Mary Gorley	Material: 🖂 1	marble 🗌 granite 🗌] brick 🗌 other	:		
Туре	pe: \Box headstone \Box footstone \Box die on base \Box tab in socket \boxtimes box \Box other:						
Position: fallen tilted unstable unattached/loose missing							
ndition	Deterioration: delamination/	broken 🗌 cracked 🔲 losse detachment 🗌 spalling 🔲 :	s 🔲 flaking/sugarin missing fragments 🗌	g 🔲 ferrous pin] other:	ns 🔲 brass pins		
ng Cc	Extent: extensive >50% partial 25-50% minimal <25% not applicable						
Existi	Failed/Old Treatn	nents: 🗌 metal 🛛 adhesives,	/coatings	other:			
	Soiling: 🔀 biolog	ical 🛛 staining 🗌 effloresc	ence other:				
egy	Position: reset possible new b	/level in ground 🗌 reset/le ase required 🔲 stabilize four	evel to existing base [ndation] reset with	☐ construct new 0:1:3 mix ☐ res	base 🔲 resquare set with compound

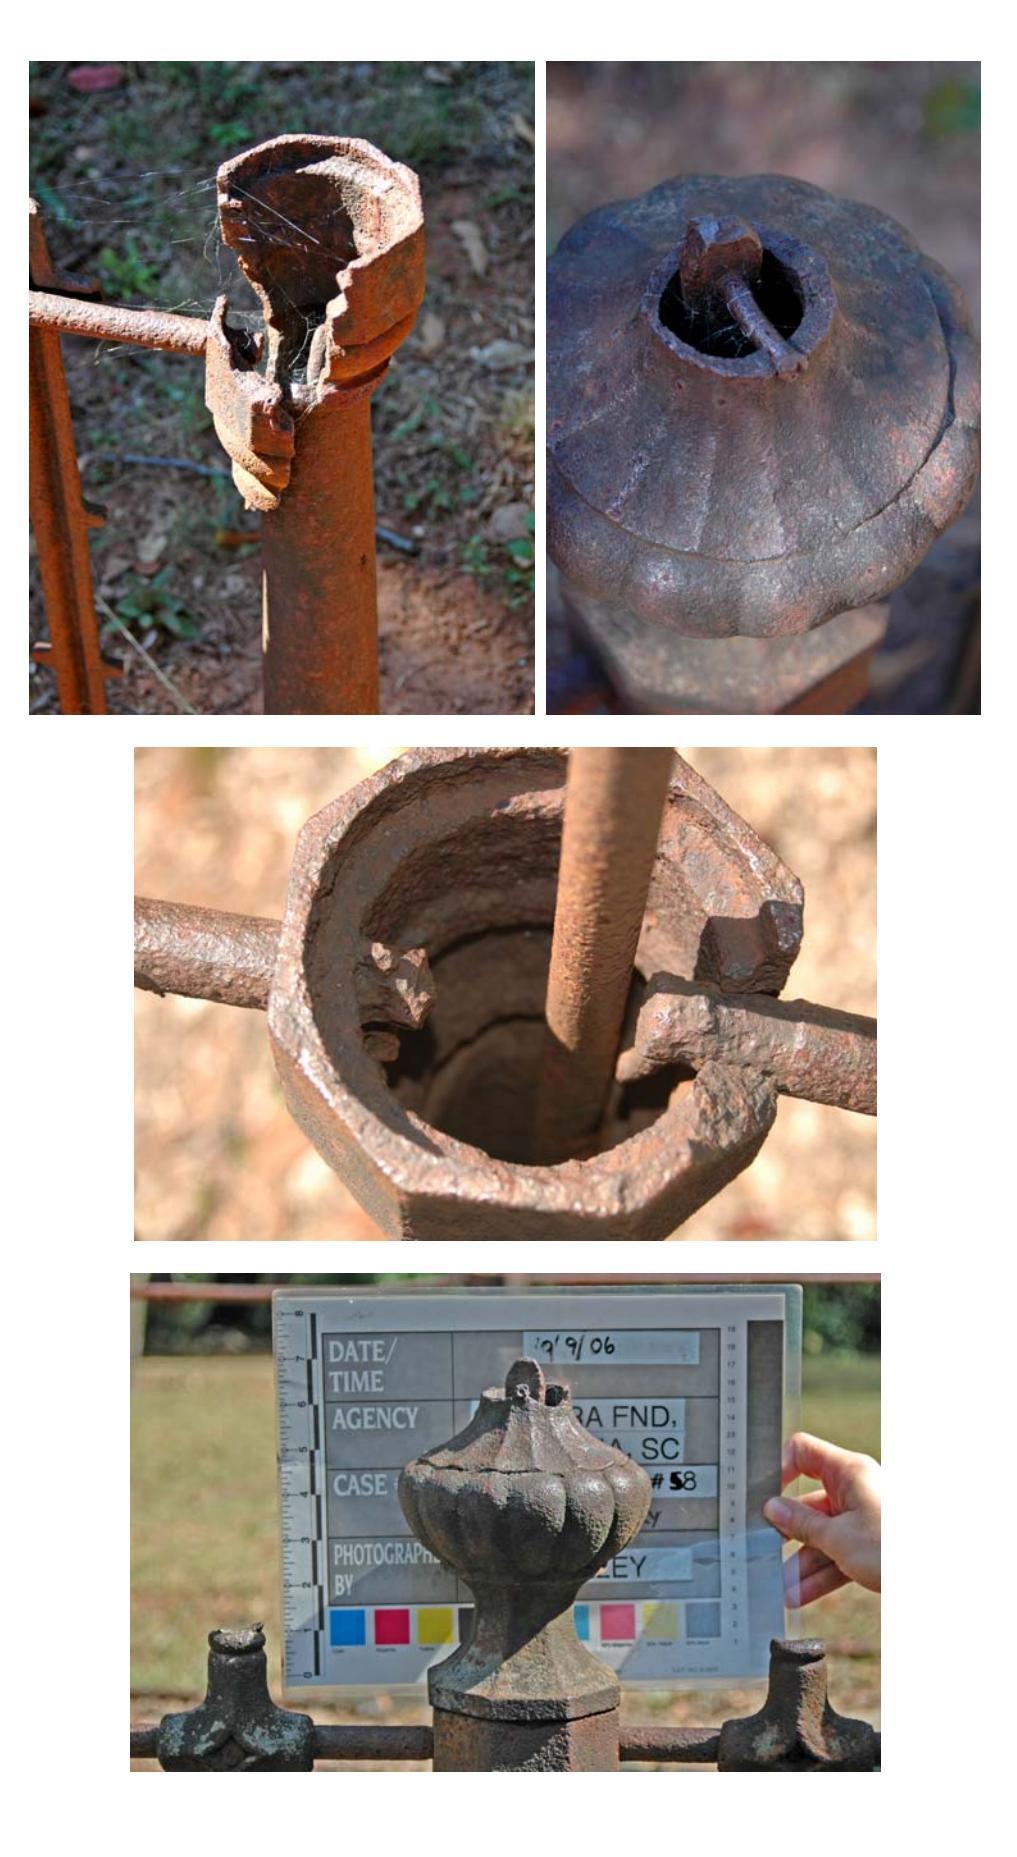
Monument Treatment Proposal			Section:	Plot: 59	
Name	e: unknown	Material: 🔀 marb	le 🗌 granite 🗌 brick 🗌	other:	
Type	: 🛛 headstone 🗌	footstone 🗌 die on base 🗌 tab	in socket 🗌 box 🗌 other:	:	
	Position: fallen		iched/loose 🛛 missing		
ndition	Deterioration: \square delamination/c	broken 🗌 cracked 🔲 losses 🗌 letachment 🗌 spalling 🔀 missi] flaking/sugaring 🔲 ferro ng fragments 🗌 other:	ous pins 🗌 brass pins	
g Cor	Extent: 🗌 extensiv	7e >50% ⊠ partial 25-50% □ m	inimal <25% 🔲 not applica	ıble	
Existin	Failed/Old Treatm	nents: ☐ metal ⊠adhesives/coat	ings 🗌 mortar 🛛 other: p	previous repair failed, top	
	Soiling: 🔀 biologi	ical 🛛 staining 🗌 efflorescence	other:		
egy	Position: reset, possible new ba	/level in ground 🔲 reset/level t ase required 🔲 stabilize foundati	o existing base \Box construct on \Box reset with 0:1:3 mix	t new base 🔲 resquare 🗌 reset with compound	
t Strat	Failed Treatments	: drill/grind hand tools] solvents 🔲 other:

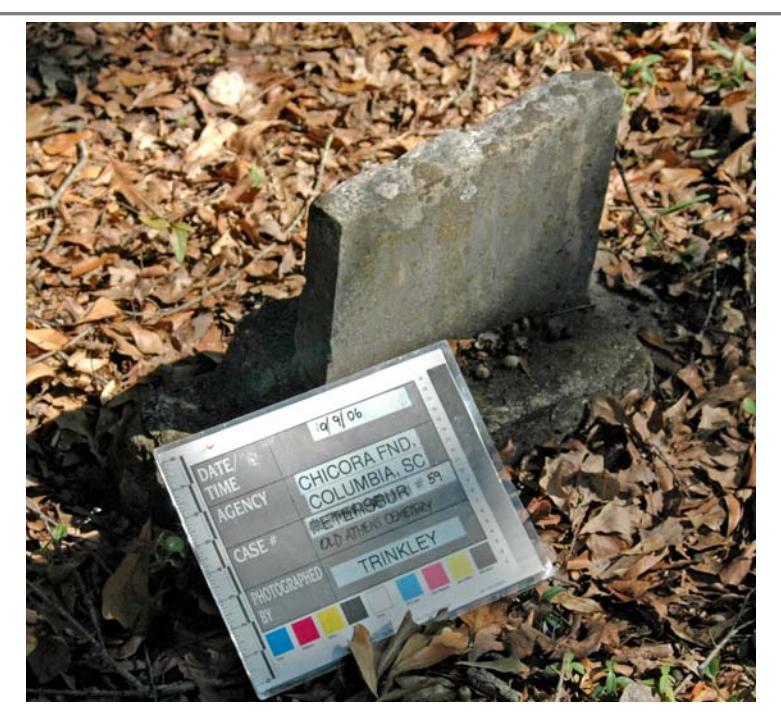
Monument Treatment Proposal		Section:	Plo	ot: 60	
Name: unknown		Material: [$erial: \square$ marble \square granite \square brick \square other:		
Type	Type: ☐ headstone ☐ footstone ☐ die on base ☐ tab in socket ☐ box ⊠ other: ledger				
dition	Position: fallen	tilted unstable] unattached/loose 🛛 miss	sing	
	Deterioration: \square delamination/d	broken 🗌 cracked 🔲 lo detachment 🗌 spalling [sses \Box flaking/sugaring \Box missing fragments \Box ot	ferrous pi her:	ns 🗌 brass pins
lg Cor	Extent: 🗌 extensiv	ve >50% 🛛 partial 25-50%	minimal <25% not	applicable	
Existin	Failed/Old Treatm	nents: metaladhesiv	es/coatings 🗌 mortar 🛛	other: old re	pair, failed and now
	Soiling: 🔀 biologi	ical 🛛 staining 🗌 efflor	escence 🗌 other:		
Treatment Strategy	Position: □ reset/level in ground ⊠ reset/level to existing base □ construct new base □ resquare □ possible new base required □ stabilize foundation ⊠ reset with 0:1:3 mix □ reset with compound

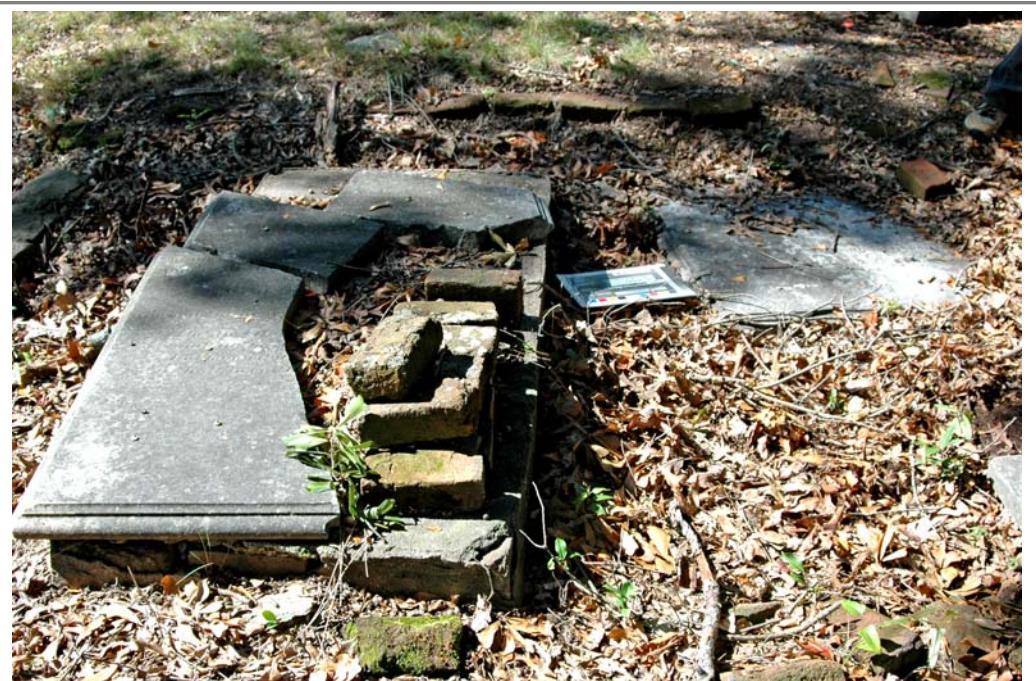
Old Moi	Athens Ceme nument Treatn	tery, Athens, GA nent Proposal	Section:	Ple	ot: 62
Name	Name: McKinley Material:		\Box marble \Box granite \boxtimes brick \Box other:		
Туре	y pe: ☐ headstone ☐ footstone ☐ die on base ☐ tab in socket ☐ box ⊠ other: brick plot wall				
Existing Condition	Position: X fallen	tilted 🗌 unstable 🔀	unattached/loose 🛛 m	nissing	
	Deterioration: broken cracked losses flaking/sugaring ferrous pins brass pins delamination/detachment spalling missing fragments other:				
	Extent: 🔀 extensive >50% 🗌 partial 25-50% 🗌 minimal <25% 🗌 not applicable				
	Failed/Old Treatments: metal adhesives/coatings mortar other:				
	Soiling: Diolog	ical 🗌 staining 🗌 efflore	scence 🗌 other:		
Treatment Strategy	Position: reset	/level in ground	level to existing base □ undation □ reset with (] construct new 0:1:3 mix 🔲 re	v base 🗌 resquare eset with compound
	Failed Treatments	: 🗌 drill/grind 🔲 hand to	ools 🗌 solvents 🗌 oth	her:
