## CONSERVATION TALK

Michael Trinkley

### Slate Monument Problems

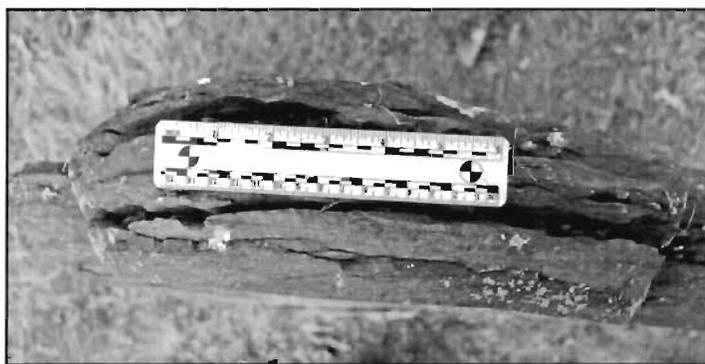
Example of spalling with extensive damage. Notice the leaves and vegetation in the cracks.

So what causes slate deterioration? One documented factor may be seasonal saturation and desiccation in climates with distinct wet and dry seasons. Rainwater infiltrates the stone; where clay minerals are present along cleavage traces, the rock can be hydrated, causing expansion. As the stone dries or dehydrates, there is shrinkage. Cracks develop along the cleavage planes, thus exposing the stone to additional damage.

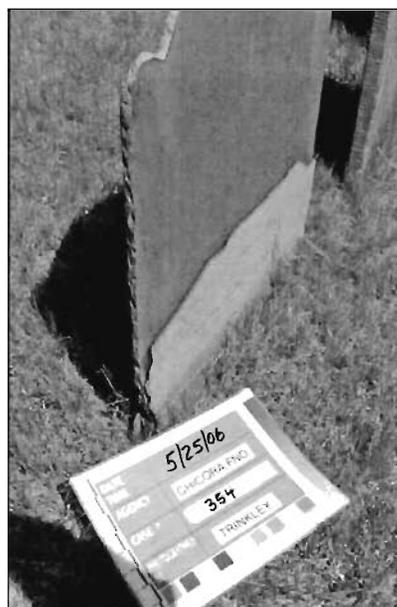
Cracking and spalling with the entire face of the slate headstone lost.

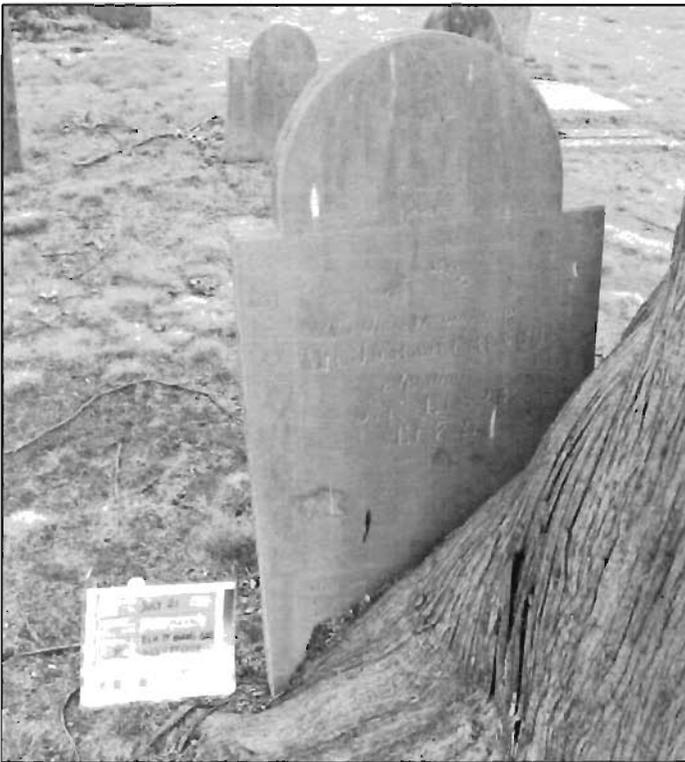
Tree growing into a slate headstone. Excavation and resetting a foot away is sufficient to prevent damage to both the monument and the tree.

Slate, like sandstone, may be subject to taking up salt in solution that then crystallizes, causing spalling, although this seems to be a relatively rare situation. Slate may also be affected by the growth of roots that wedge the rock apart. Moss, fungi and lichen all have potential to damage slate physically through their rhizoids, hyphae and rhizines.

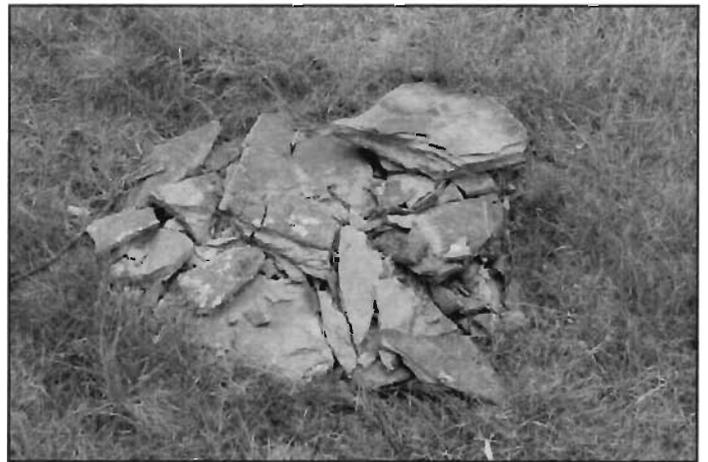
In this case the mower ran over the slate stone hidden by tall grass. Here the remnant pieces are piled up.

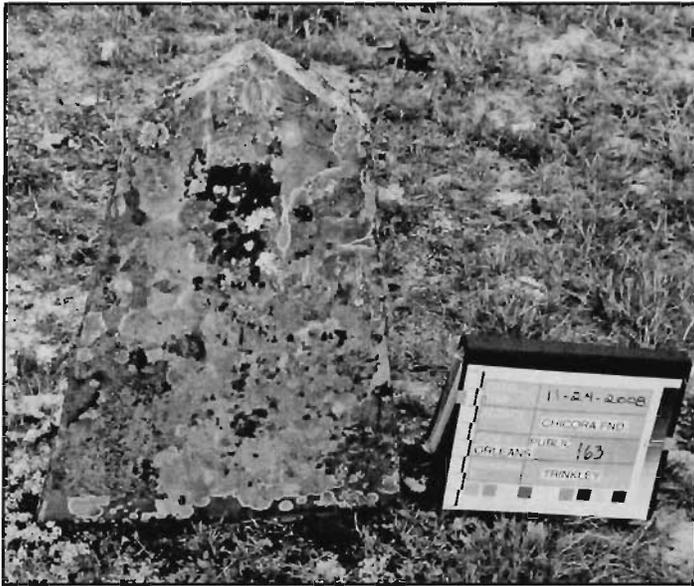
The inscription on this stone has been completely obscured by heavy lichen growth that requires treatment with a biocide in order to allow the stone to be legible.

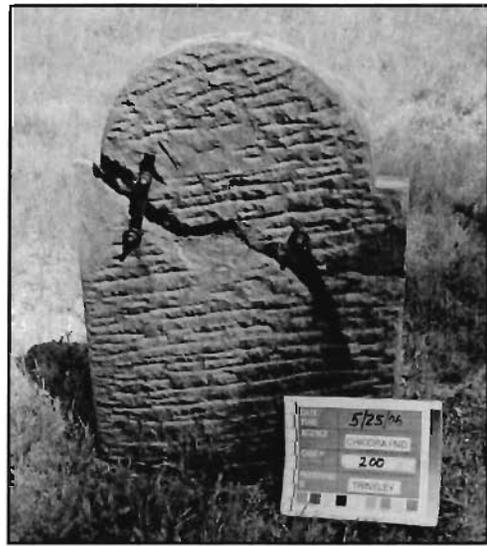
Example of an old repair using ferrous straps and bolts. As these corrode, the iron jacking will begin cracking the stone causing additional damage.

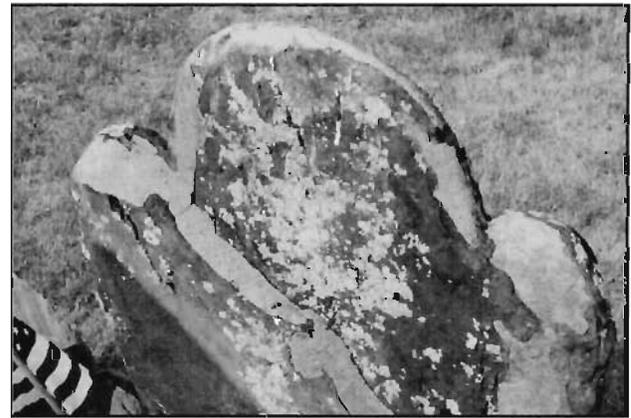
Cracks repaired in the past using a mortar to shed water. Although not color matched, the infill has served its purpose, but is beginning to crack and requires replacement.
