**GRAVE INVENTORY AND PRESERVATION
RECOMMENDATIONS FOR THE
WALKER FAMILY CEMETERY,
GREENVILLE COUNTY, SOUTH CAROLINA**

Prepared By:
Michael Trinkley, Ph.D.
and
Debi Hacker

Chicora Foundation Research Series 248

April 6, 1998

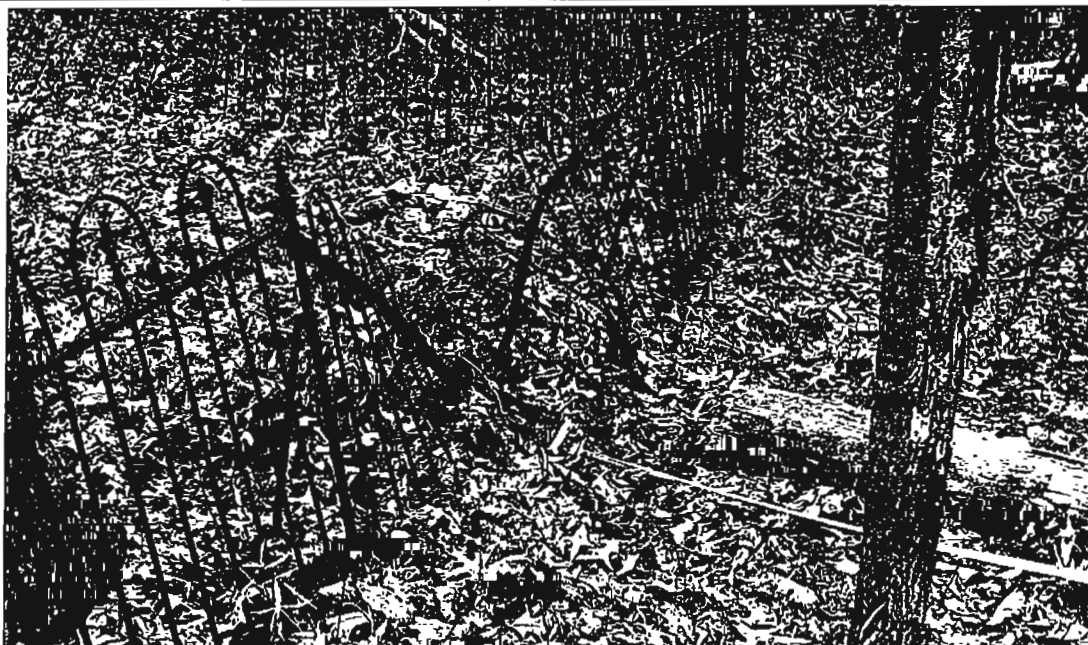
Figure 7. Portion of the cast iron fence damaged by a falling tree. View to the south-southeast.

Currently, the cast iron fence exhibits a number of very serious problems. In several areas trees have fallen on the fence, causing extensive crushing and twisting (Figure 7). In one area a tree has been allowed to grow up next to the fence, distorting its alignment. Decorative portions have been either vandalized or damaged by the vegetation. There are also numerous areas where connectors have corroded, reducing support for the fence segments (Figure 8).

The fence should be restored, not only to preserve the ambience of the cemetery, but also to help ensure the protection of the graves it encloses. Sections of the fence may need to be removed and straightened. Lost elements may need to be recast and replaced. Loose or missing connectors will need to be replaced with stainless steel fittings. Finally, the entire fence will need to be cleaned and repainted, preferably with a volatile corrosion inhibitor.
