RECONNAISSANCE PRESERVATION
ASSESSMENT OF THE SUMMERVILLE
CEMETERY, AUGUSTA, GEORGIA

CHICORA RESEARCH CONTRIBUTION 305

Prepared By:
Michael Trinkley, Ph.D.

September 20, 2000

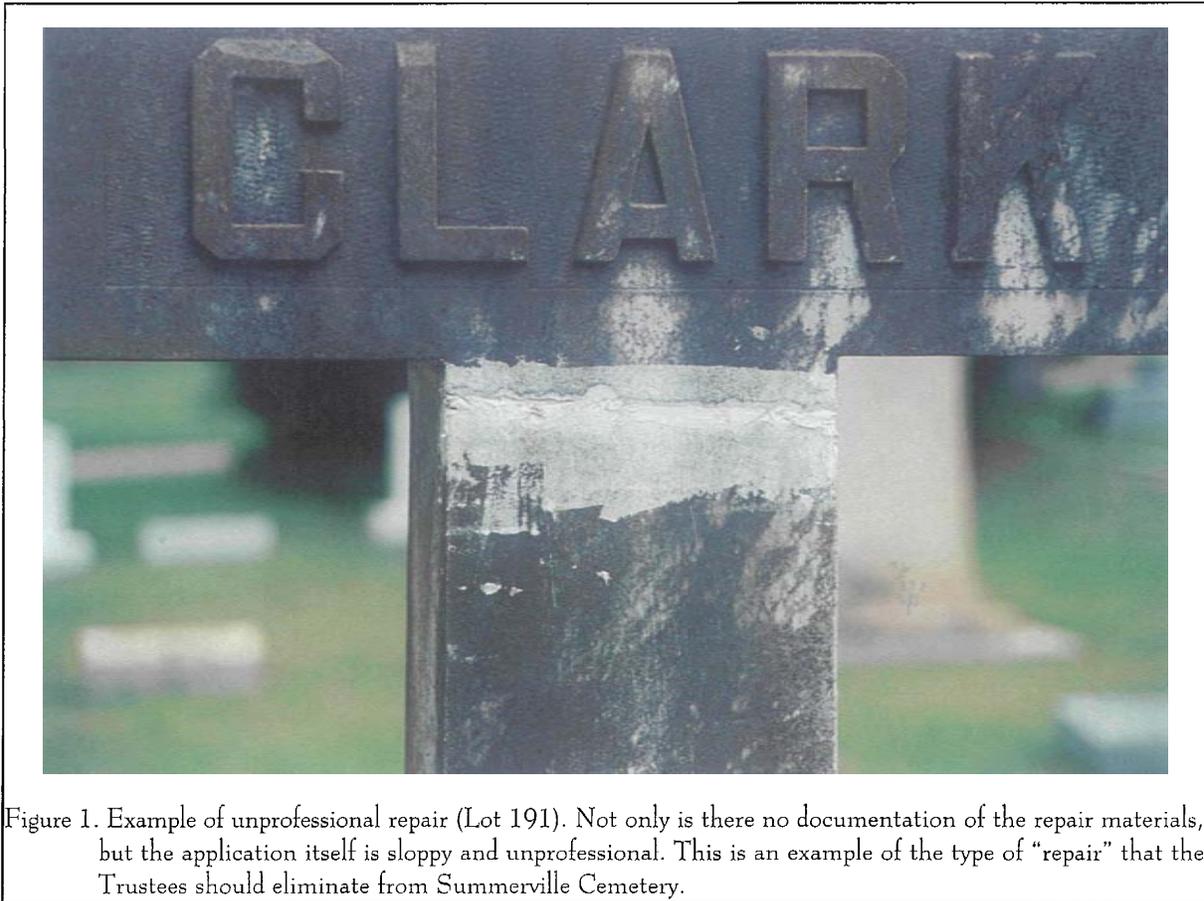
Figure 1. Example of unprofessional repair (Lot 191). Not only is there no documentation of the repair materials, but the application itself is sloppy and unprofessional. This is an example of the type of “repair” that the Trustees should eliminate from Summerville Cemetery.

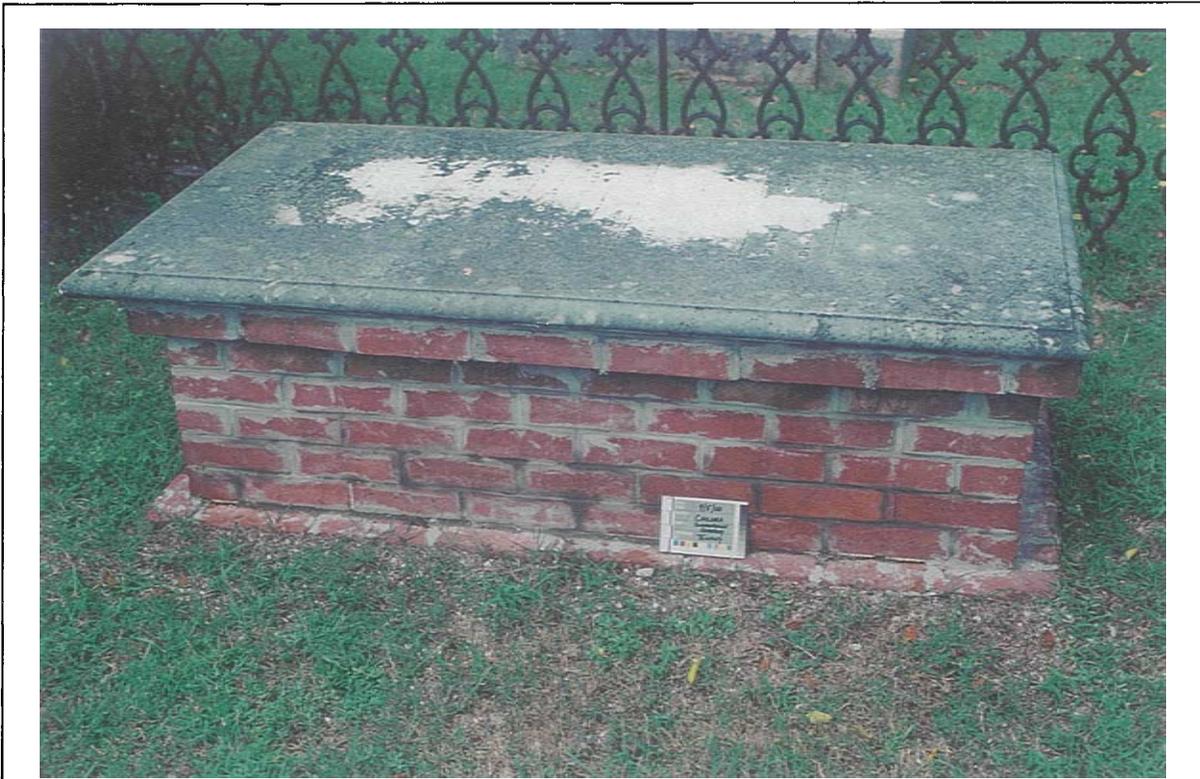
Figure 2. Rebuilt box tomb (Lot C). The use of modern brick and hard mortar, coupled with a lack of care in finishing the joints and cleaning the brick has resulted in an inappropriate “restoration” that detracts from the historic integrity of Summerville Cemetery. Such work should not be allowed.

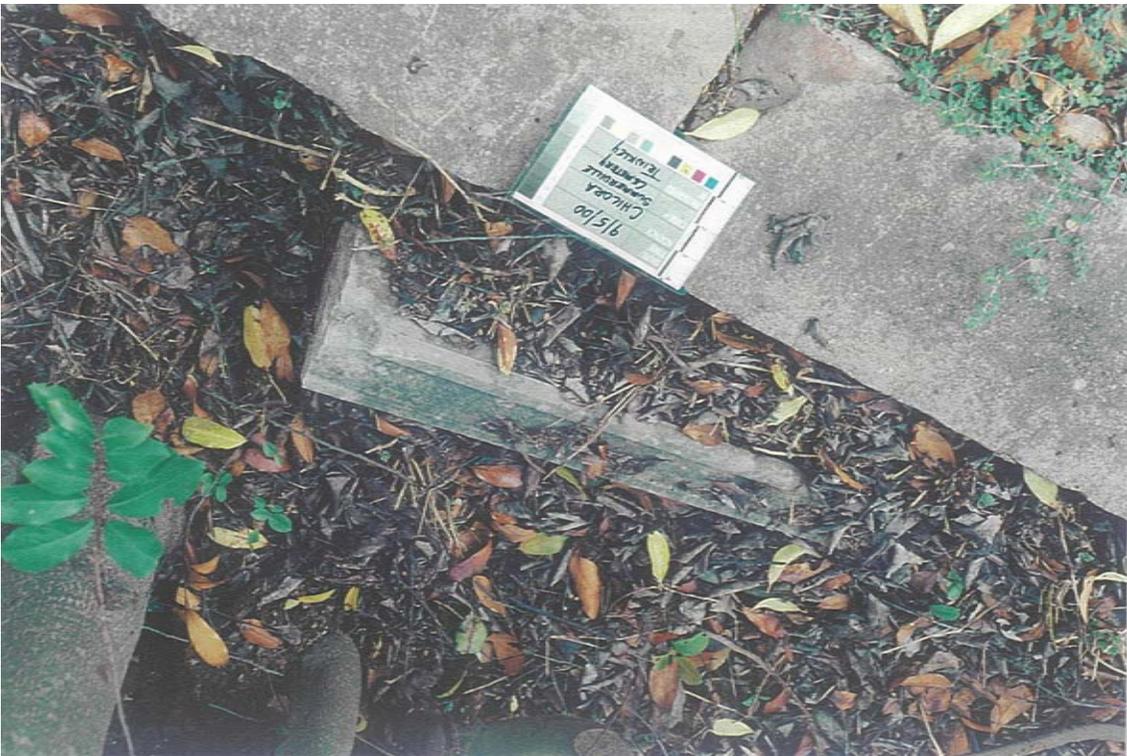
Figure 3. Lost obelisk fragment (Lot 46). This broken fragment of a marble obelisk was found tossed aside in the leaves at the edge of a lot. These are the sorts of fragments which should be carefully gathered up and safely stored until their original location can be identified and repairs made. Additional monument fragments were found in Lots 9 and 10. Fence fragments were found scattered on walkways.

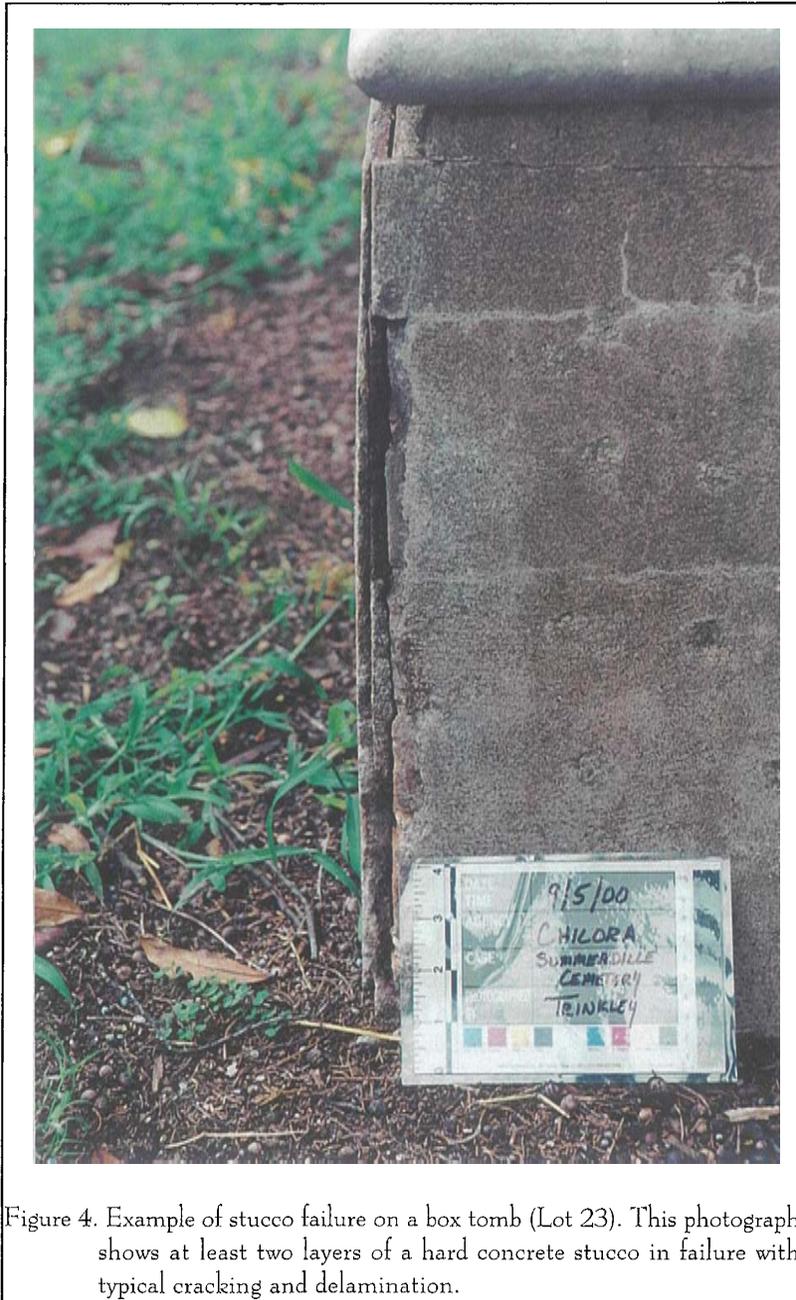
Figure 4. Example of stucco failure on a box tomb (Lot 23). This photograph shows at least two layers of a hard concrete stucco in failure with typical cracking and delamination.

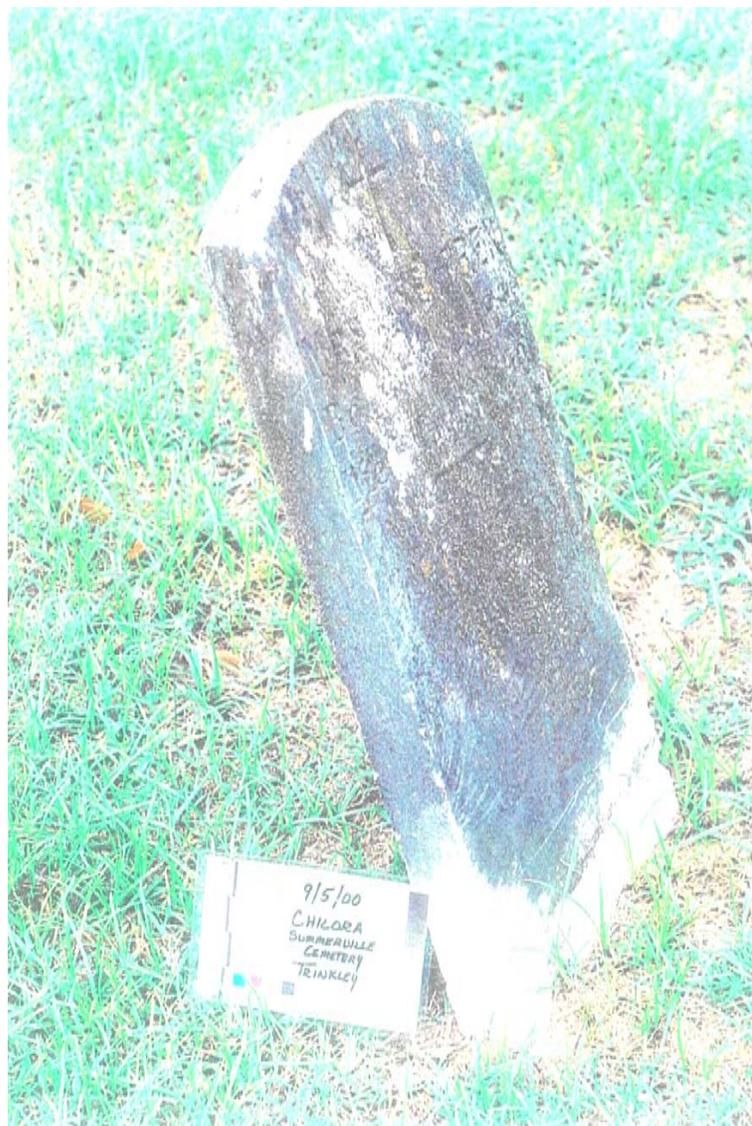
Figure 5. Example of mower damage (Lot 45). This marble head stone, which needs to be reset, also shows evidence of extensive mower damage (the nicks and lost material on the edges) as well as improper use of nylon string trimmer (the parallel “scratches” across the stone face). This is evidence of improper mowing techniques and a lack of care.

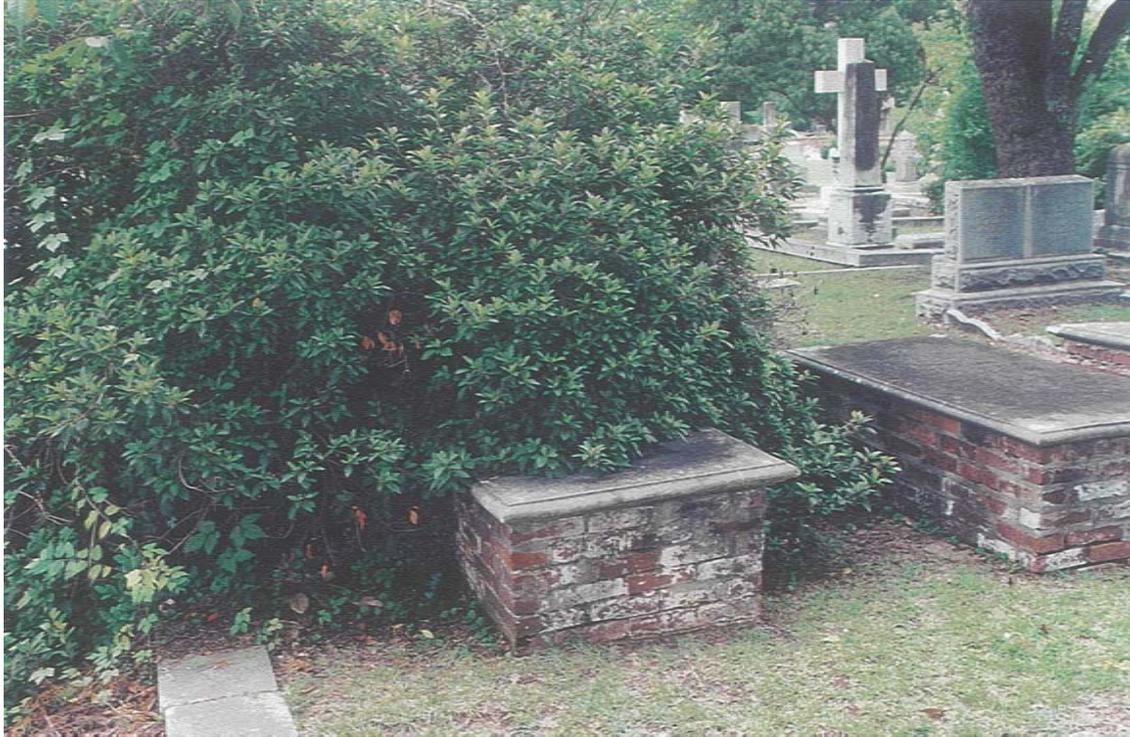
Figure 6. Example of unpruned plant taking over Lot 40. This azalea needs careful pruning for both its health and also to remove it from the box tomb. This dense vegetation will ultimately result in deterioration of the marble and the mortar joints.

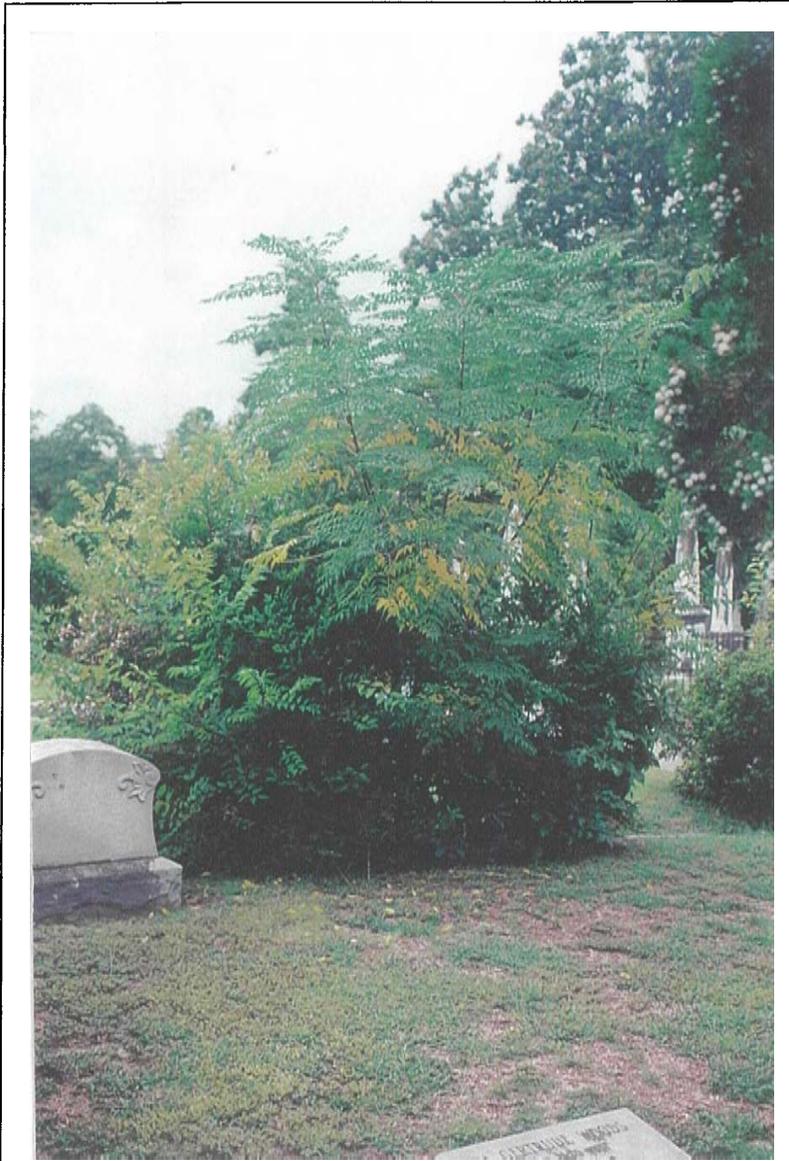
Figure 7. Example of intrusive vegetation growing up inside an ornamental (Lot 193). The size of these scrub trees, growing up within an ornamental reveals that no effort has been made to remove "weedy" plants for several years. This should be an immediate goal of landscaping.

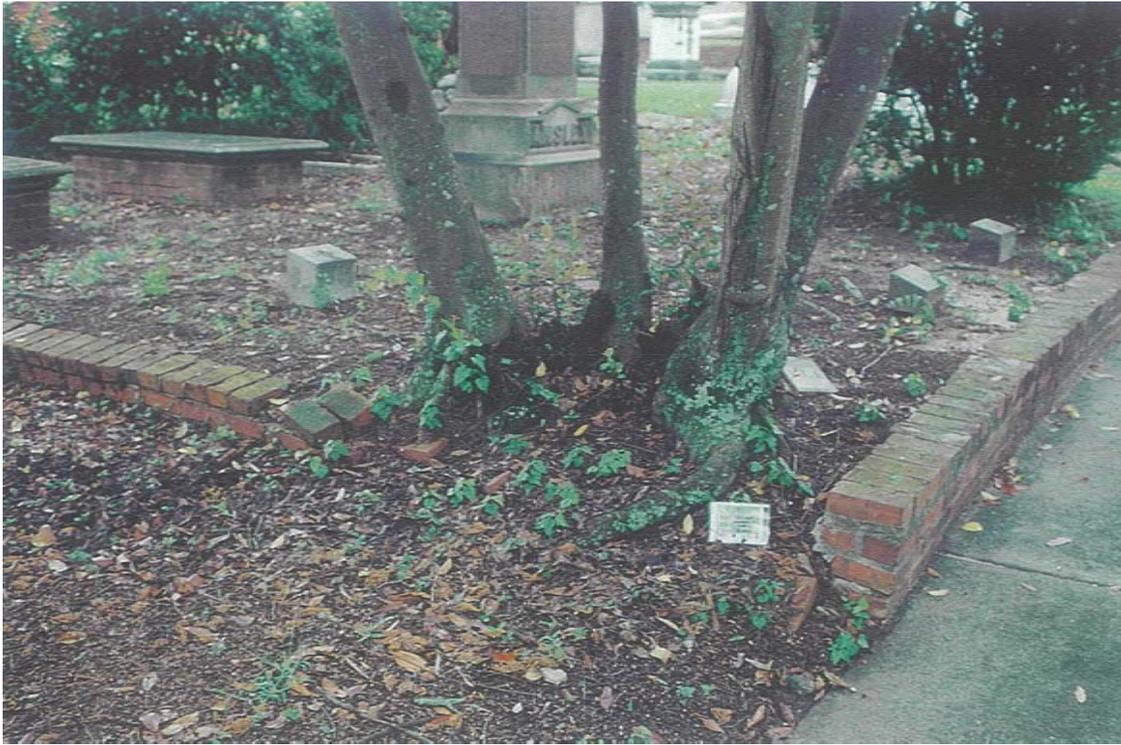
Figure 8. Example of “weedy” tree species growing from suckers off earlier cut stumps (Lots 13/14). Unattended these trees have caused extensive damage in this brick wall. These trees should be immediately removed, the wall taken apart and rebuilt to preservation specifications.

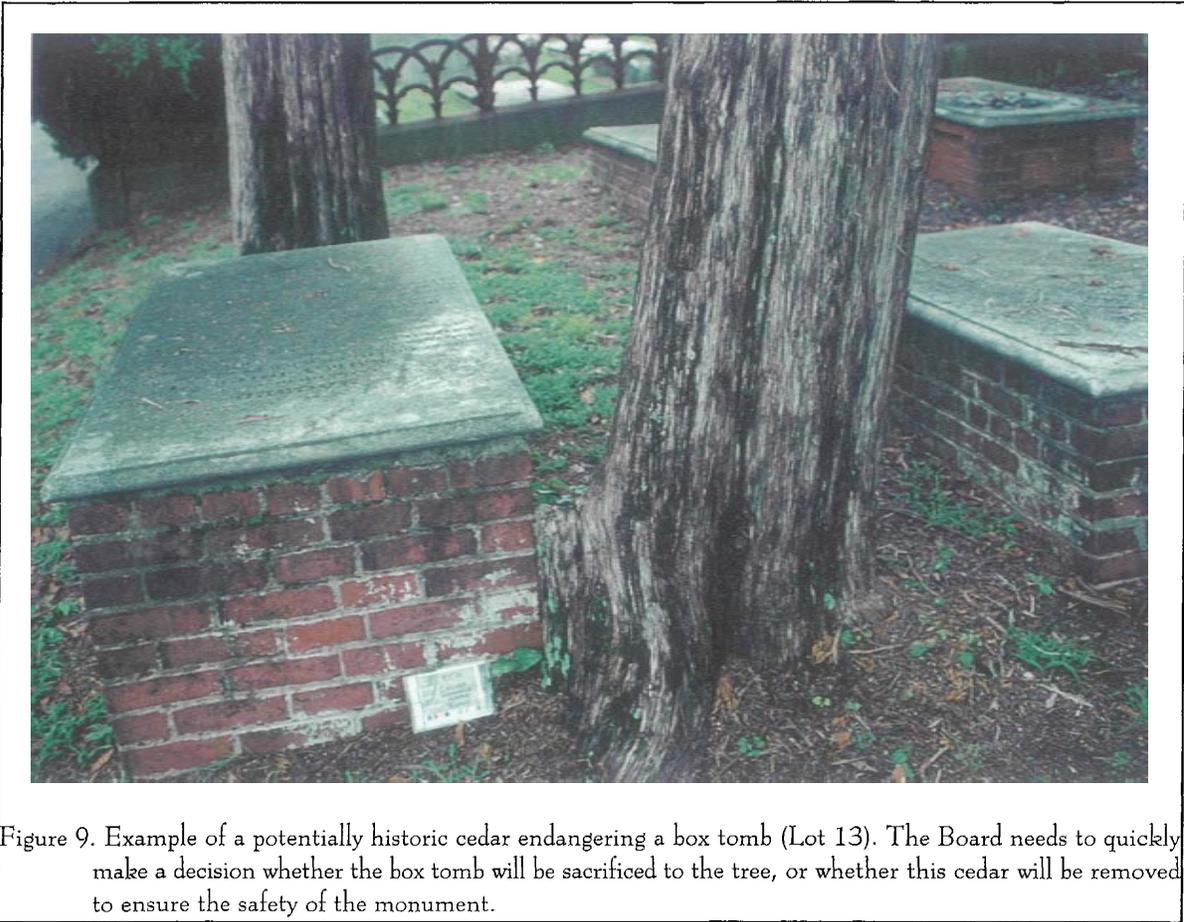
Figure 9. Example of a potentially historic cedar endangering a box tomb (Lot 13). The Board needs to quickly make a decision whether the box tomb will be sacrificed to the tree, or whether this cedar will be removed to ensure the safety of the monument.

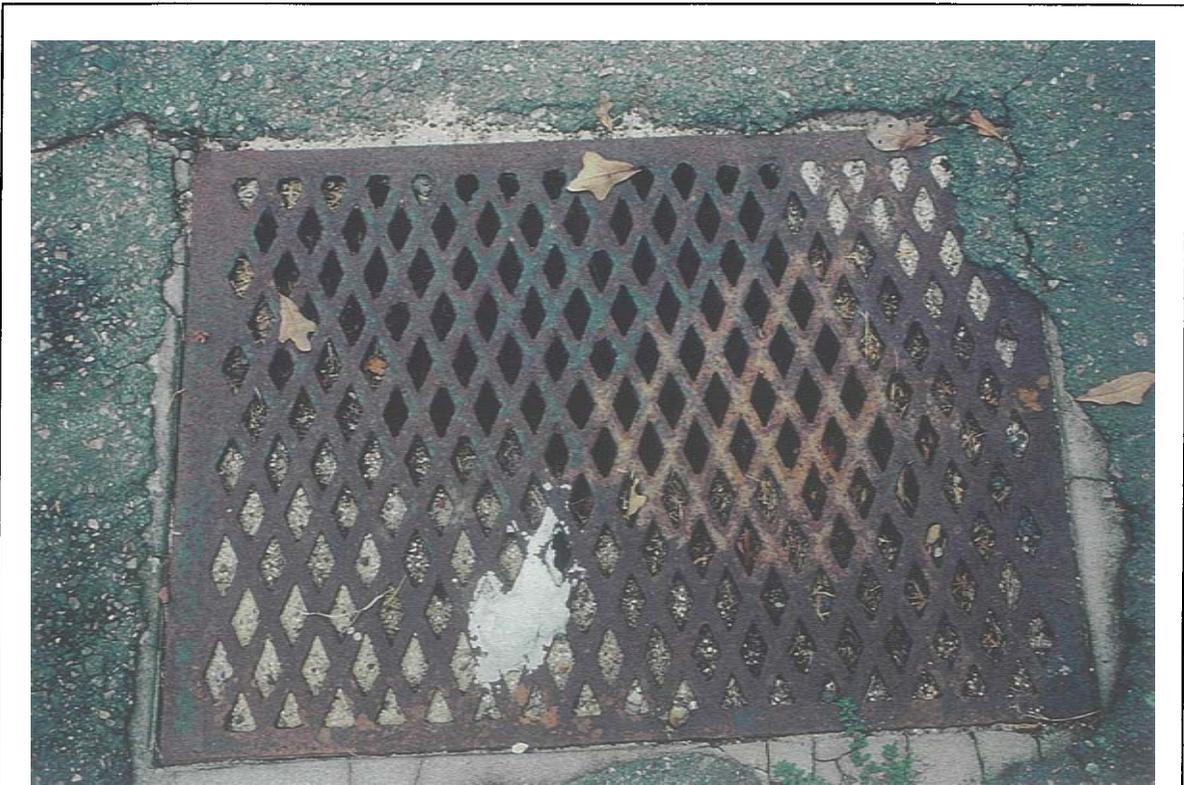
Figure 10. Example of a clogged drain. Other drains are completely clogged and some even have vegetation growing in them. These need immediate cleaning and repair.

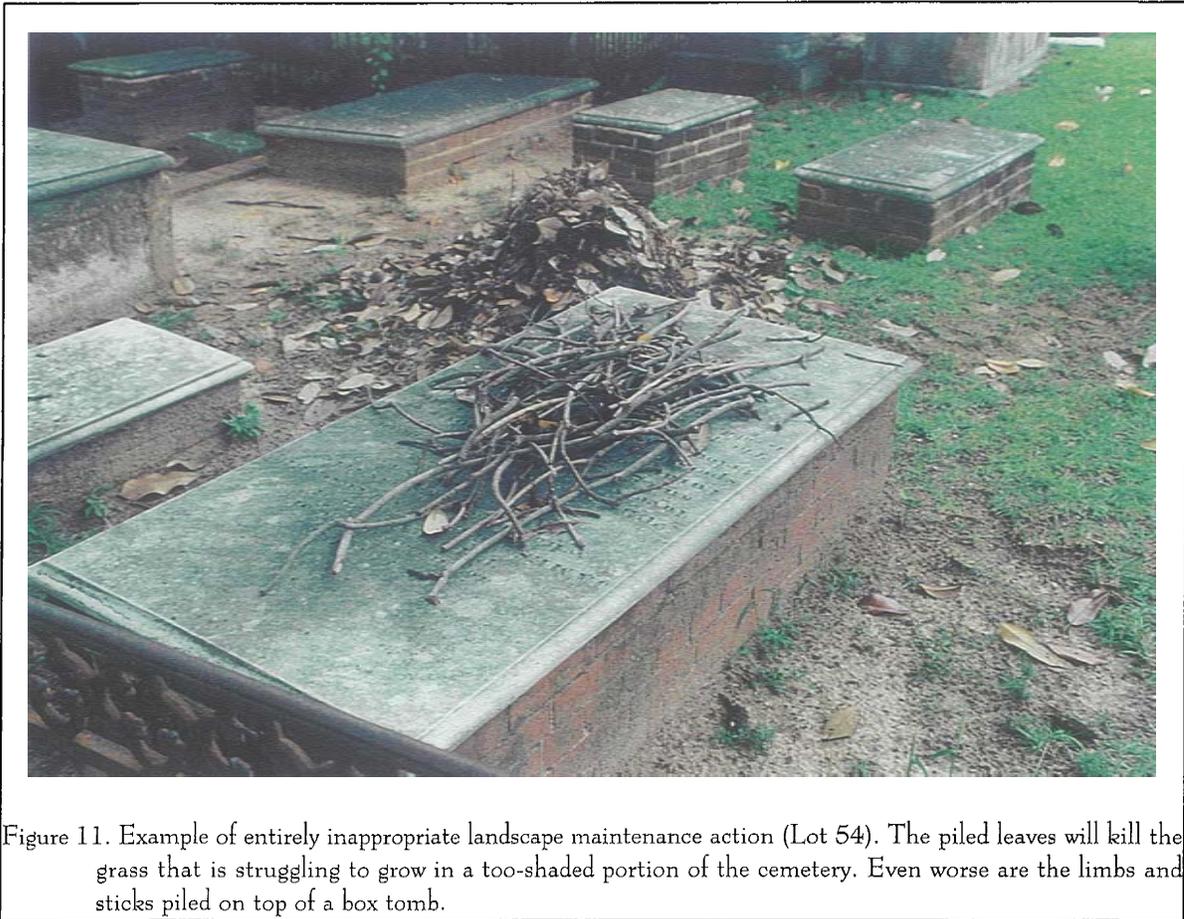
Figure 11. Example of entirely inappropriate landscape maintenance action (Lot 54). The piled leaves will kill the grass that is struggling to grow in a too-shaded portion of the cemetery. Even worse are the limbs and sticks piled on top of a box tomb.

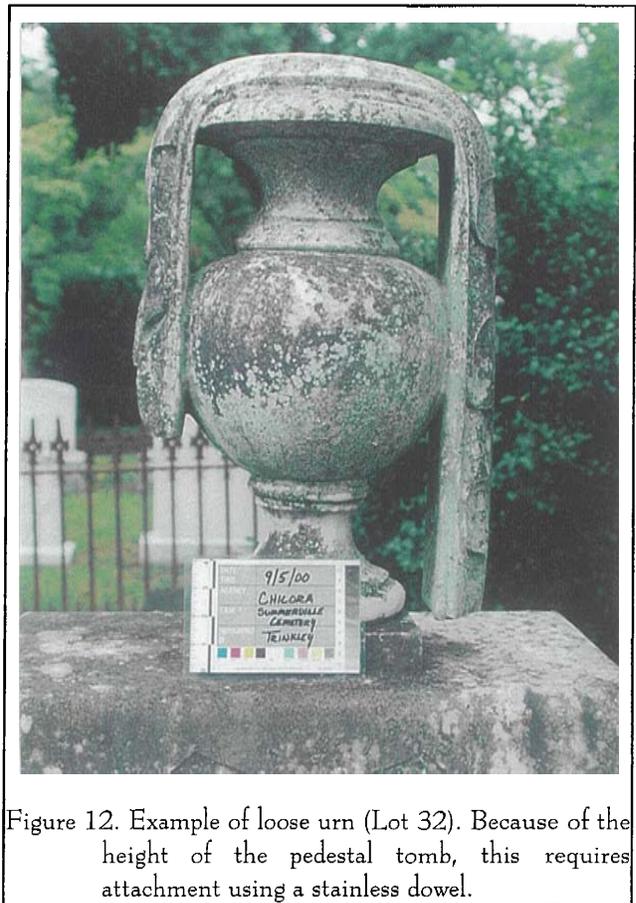
Figure 12. Example of loose urn (Lot 32). Because of the height of the pedestal tomb, this requires attachment using a stainless dowel.

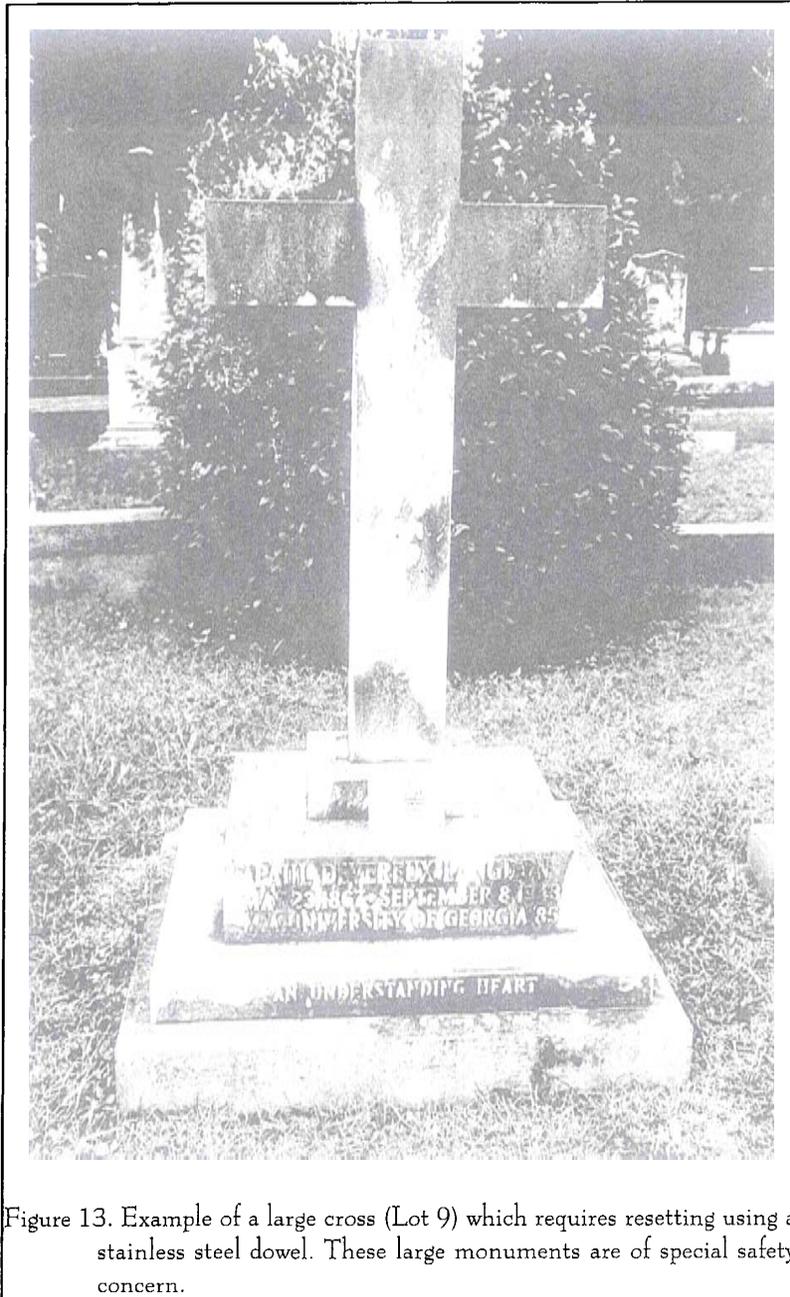
Figure 13. Example of a large cross (Lot 9) which requires resetting using a stainless steel dowel. These large monuments are of special safety concern.

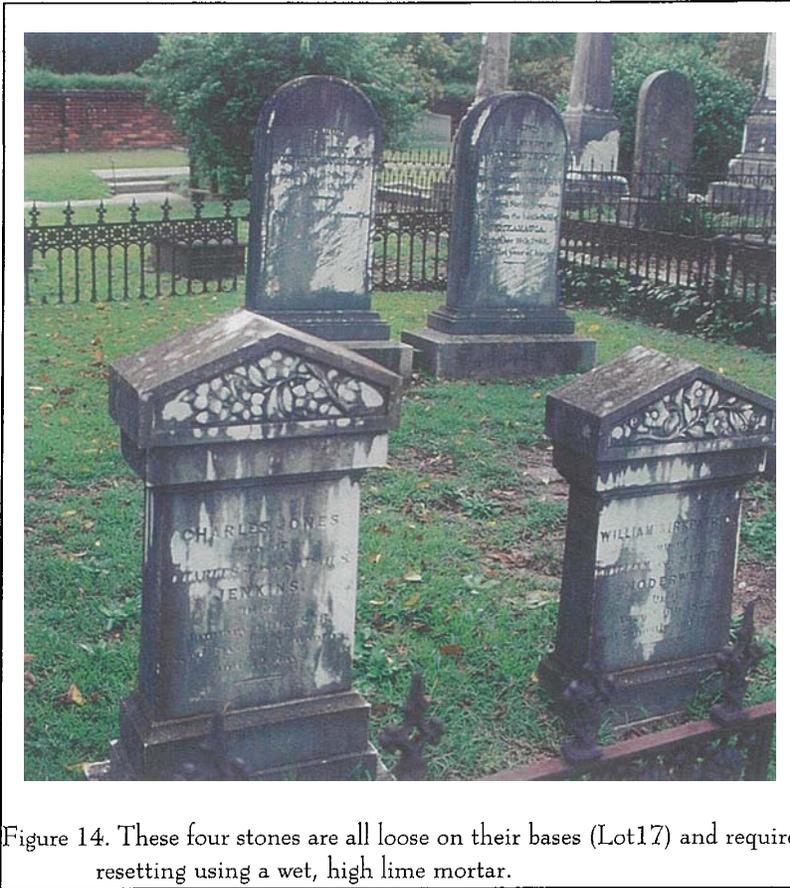
Figure 14. These four stones are all loose on their bases (Lot 17) and require resetting using a wet, high lime mortar.

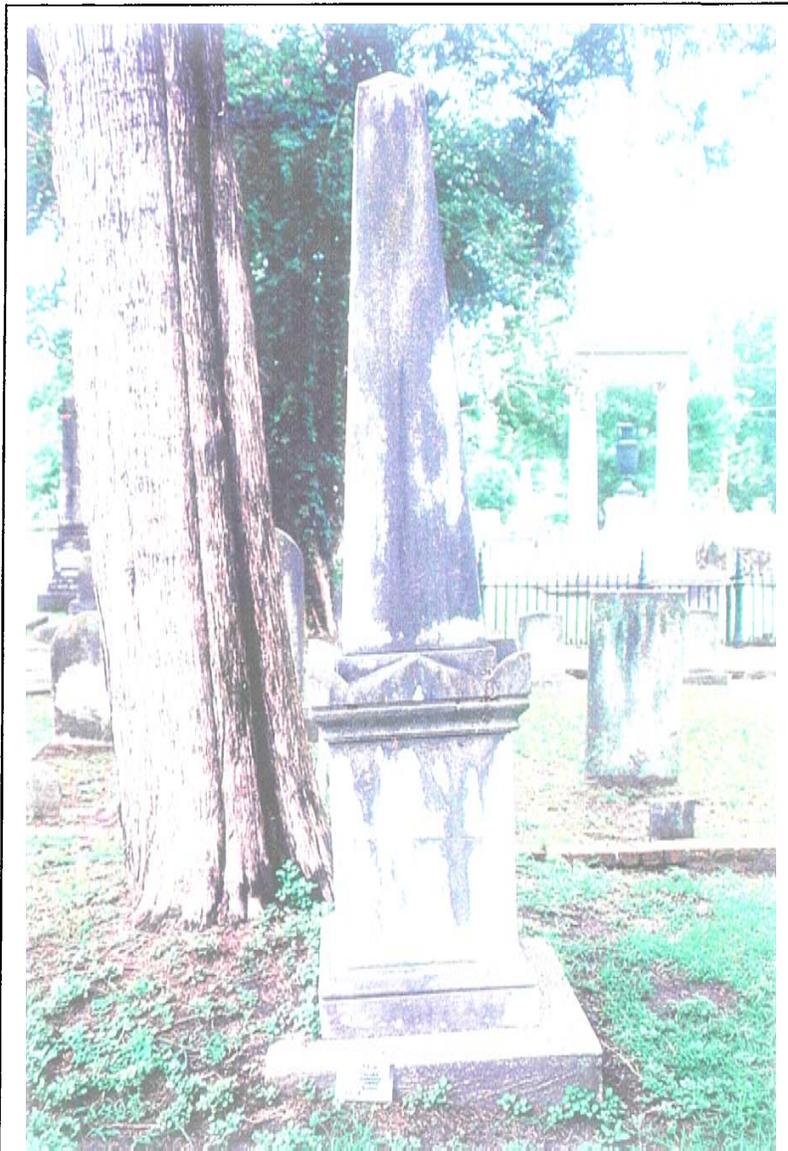
Figure 15. Example of leaning obelisk (Lot7). This stone will need to be disassembled, a foundation established, and the stone erected again.

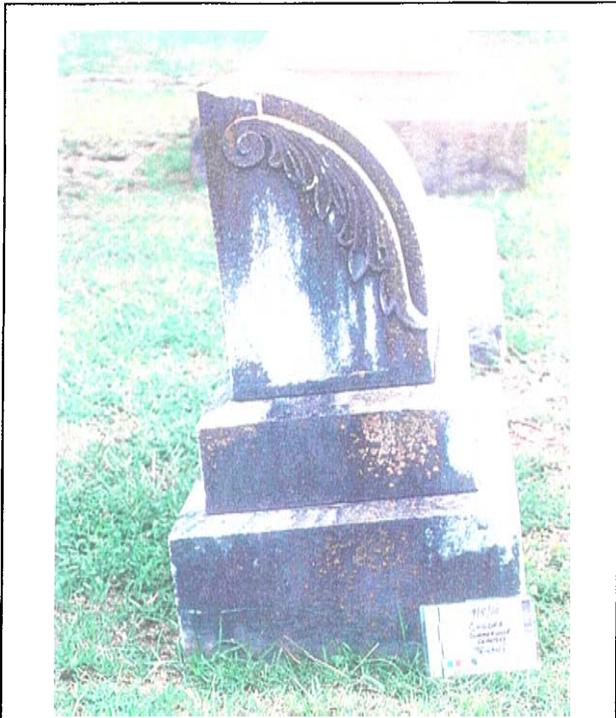
Figure 16. Example of small, leaning monument (Lot 188). These are relatively easy to reset, but early action will prevent additional damage and more costly repairs.

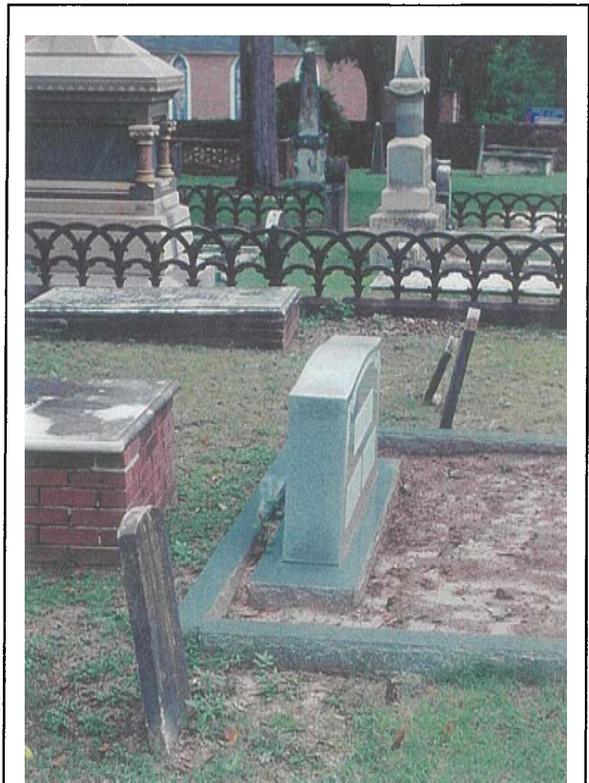
Figure 17. Leaning headstones (Lot 5). Resetting stones such as these is simple and inexpensive.

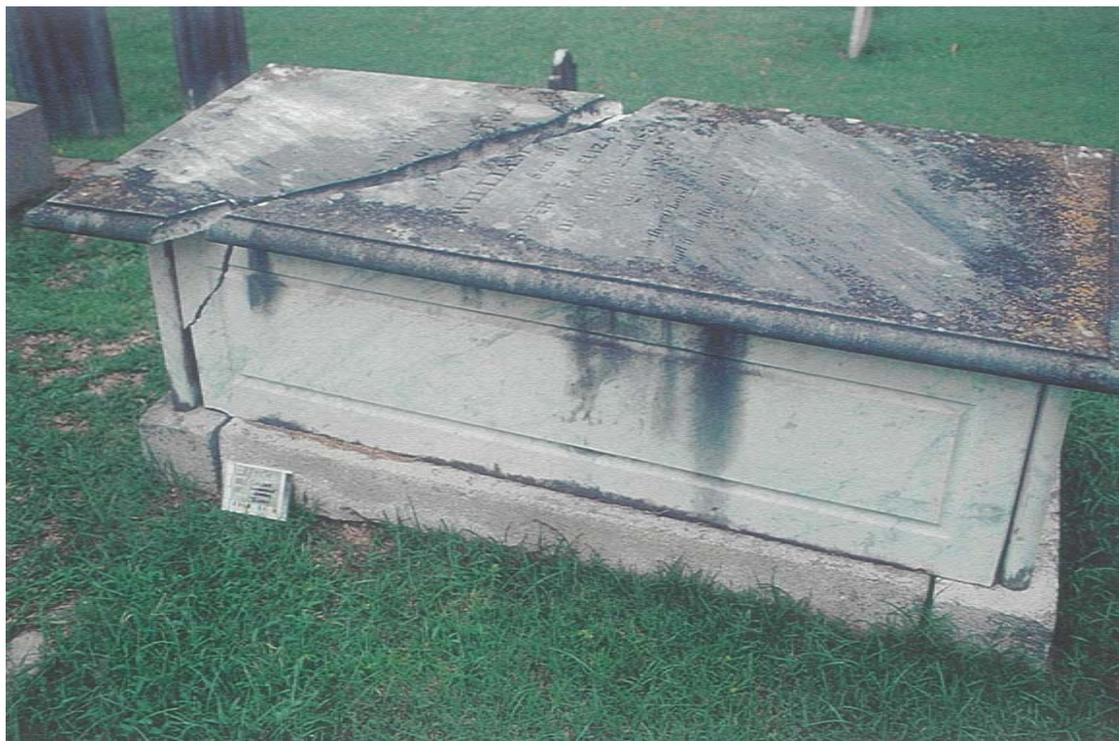
Figure 18. Box tomb with foundation problems causing damage to the side and top ledger (Lot 20). This is one of the more complex repairs.

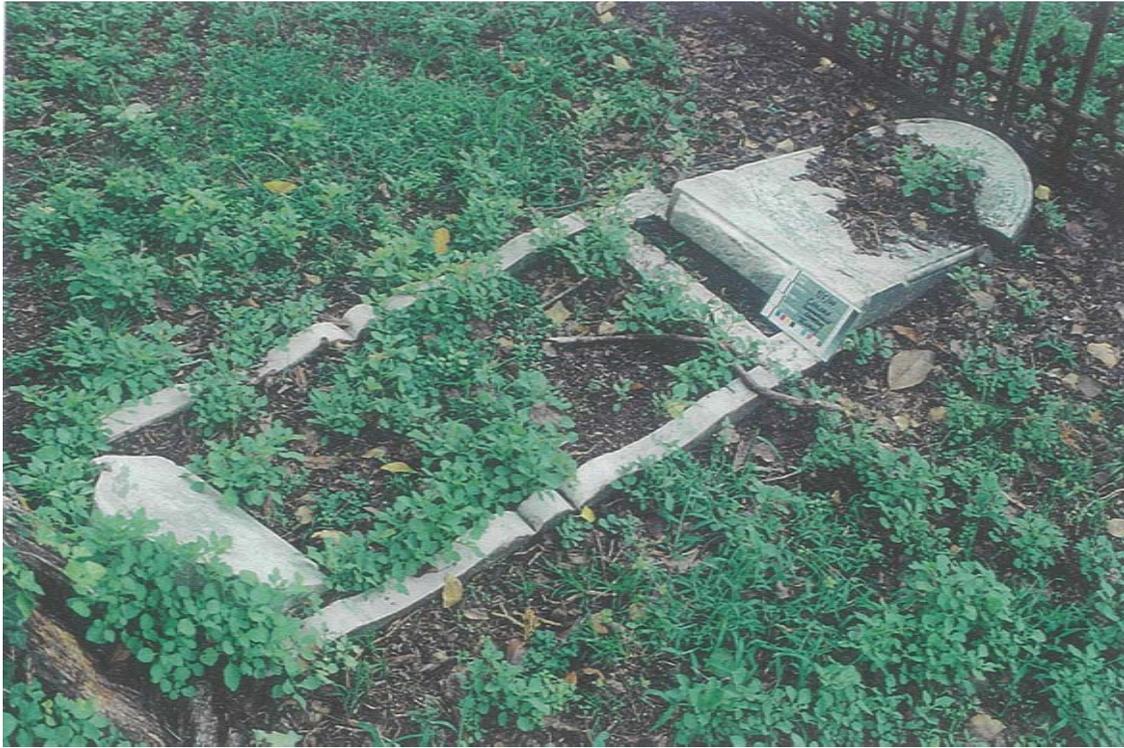
The break of the headstone of a cradle grave on **Lot 24** is especially instructive. As the stone fell, it broke — providing a perfect example of why it is so critical to reset those loose stones previously discussed before they fall and are damaged. Resetting is always far less expensive than repair. In this case it will be necessary to drill and pin the stone using nylon rods.

Figure 19. Collapsed headstone of a cradle grave (Lot 24). This illustrates why resetting intact loose monuments is so critical. Had this stone been reset before it fell, no costly repairs would have been necessary. Now, it will be necessary to drill and pin this stone, then reset it in the cradle tab — a more costly and time consuming operation.

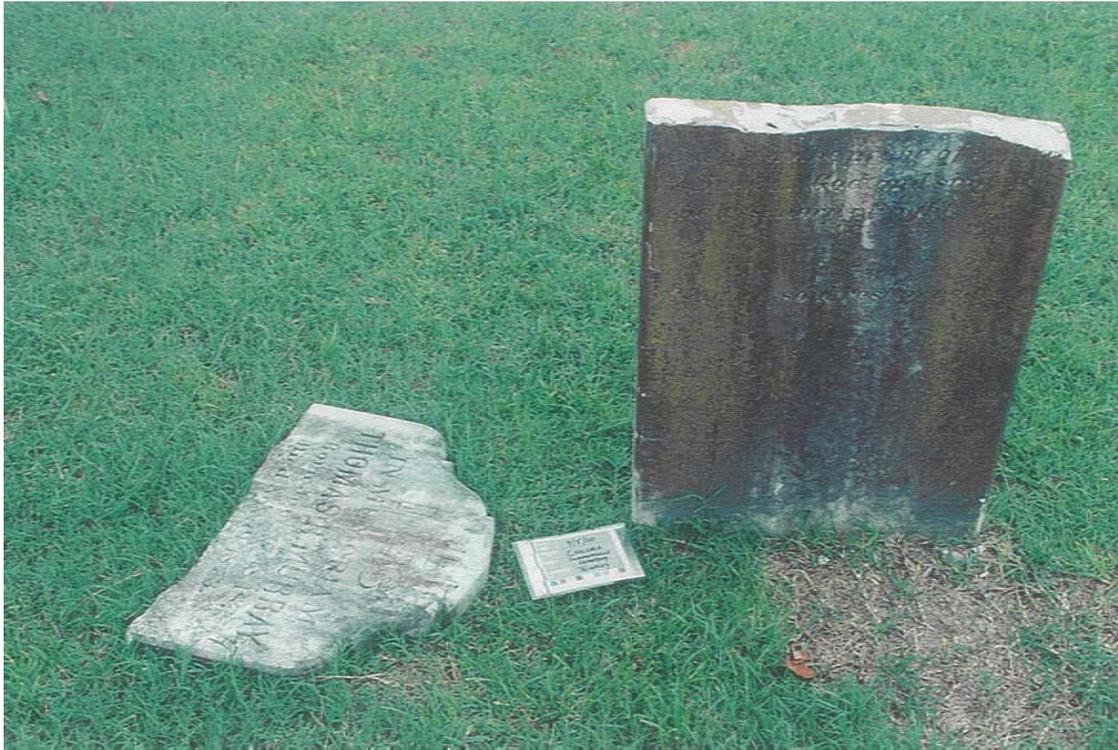
Figure 20. Example of simple headstone repair (Lot 56). This stone will require drilling and insertion of nylon pins for support.

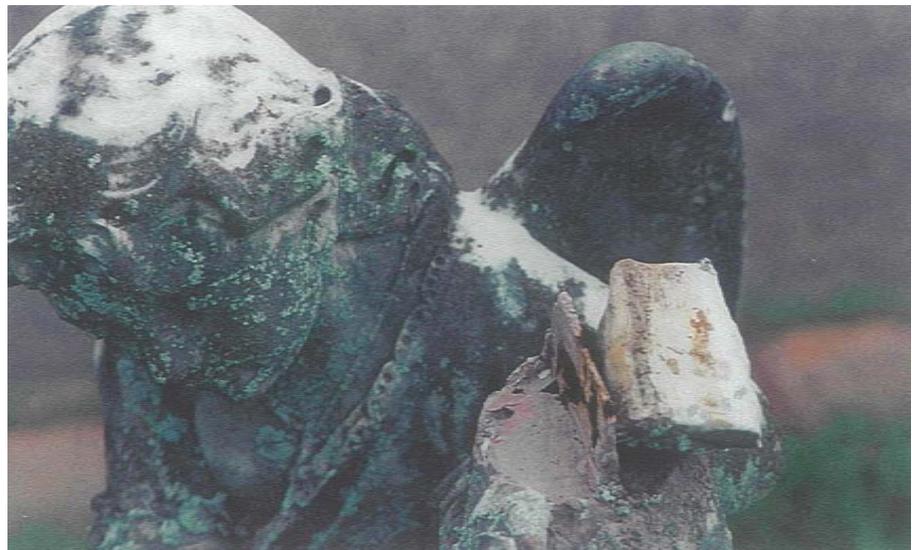
Lot I contains a very beautiful three-dimension sculpture of an angel clinging to a cross, which is broken. This was originally sculpted with the cross being a separate part, held on using an iron wedge.

Figure 21. Broken cross (Lot I). Metal wedge will need to be removed before any repairs can be done.

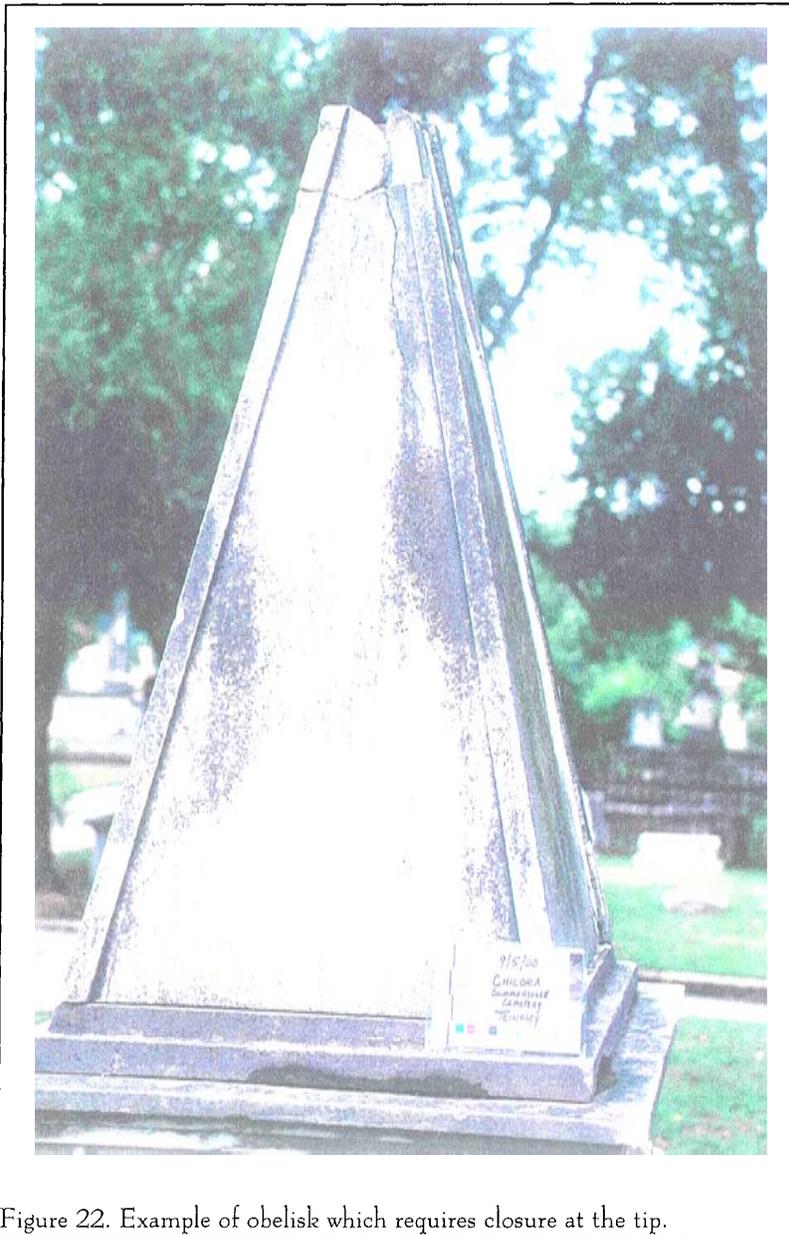
Figure 22. Example of obelisk which requires closure at the tip.

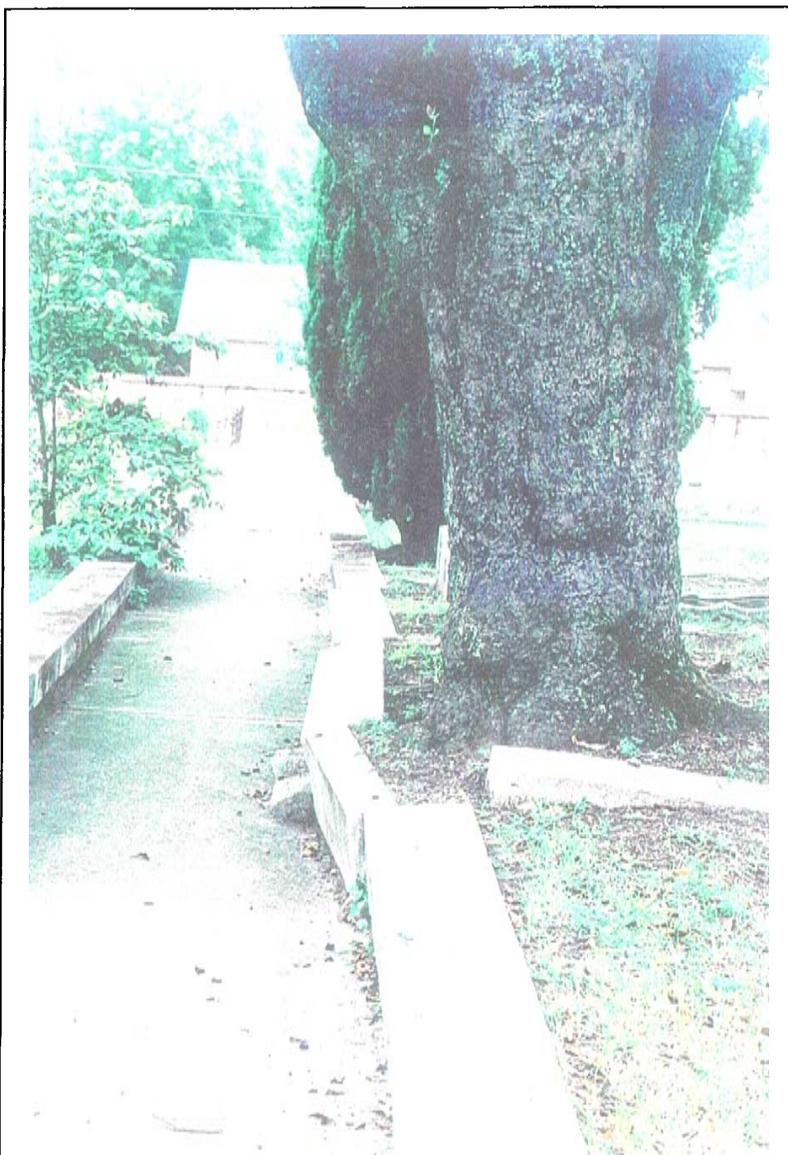
Figure 23. Large tree disrupting coping along the pathway (Lot 50). Removal is not appropriate here since the tree is part of the historic landscape. It may be possible, however, to cut back the roots, allowing the coping to be reset.

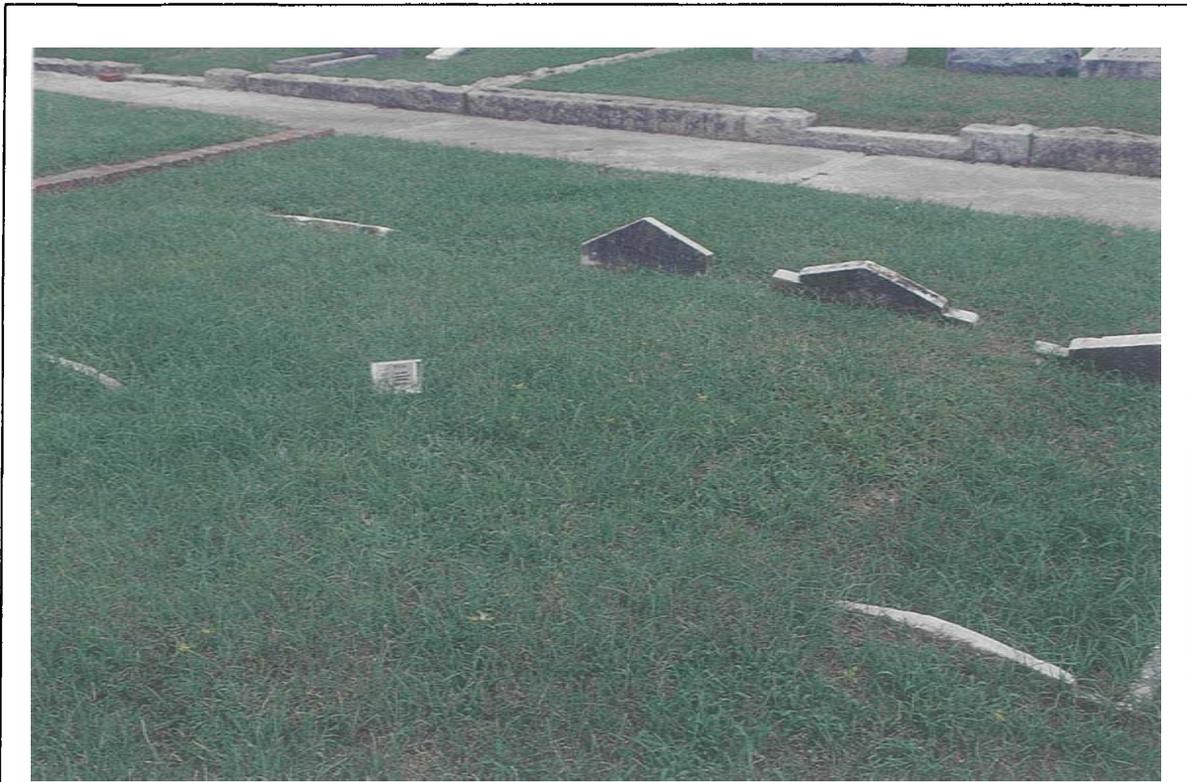
Figure 24. Example of simple cradle graves almost entirely lost below grade (Lot 65). Here it will take extensive, but careful, excavation to reveal the cradles before they can be raised to their proper level and set on better foundations.

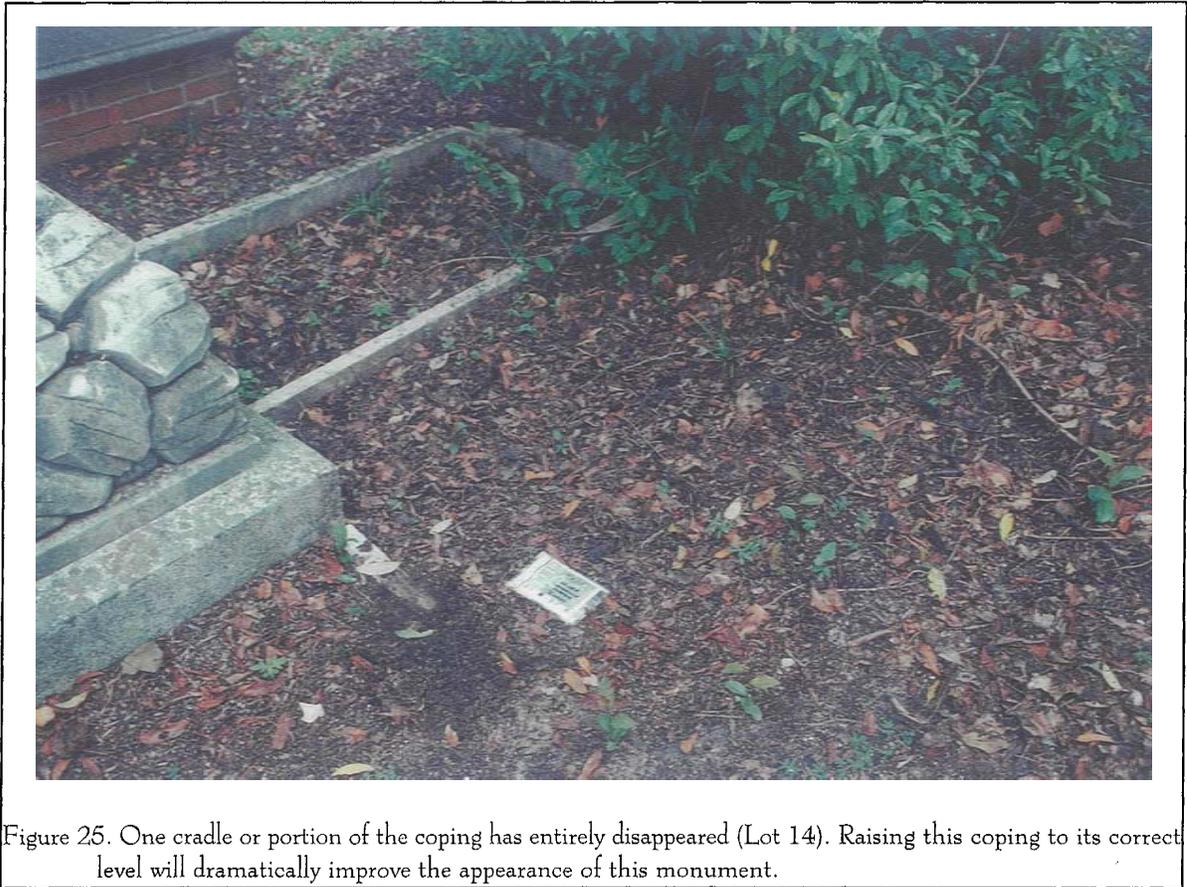
Figure 25. One cradle or portion of the coping has entirely disappeared (Lot 14). Raising this coping to its correct level will dramatically improve the appearance of this monument.
