RECONNAISSANCE PRESERVATION
ASSESSMENT OF THE SUMMERVILLE
CEMETERY, AUGUSTA, GEORGIA

CHICORA RESEARCH CONTRIBUTION 305

Prepared By:
Michael Trinkley, Ph.D.

September 20, 2000

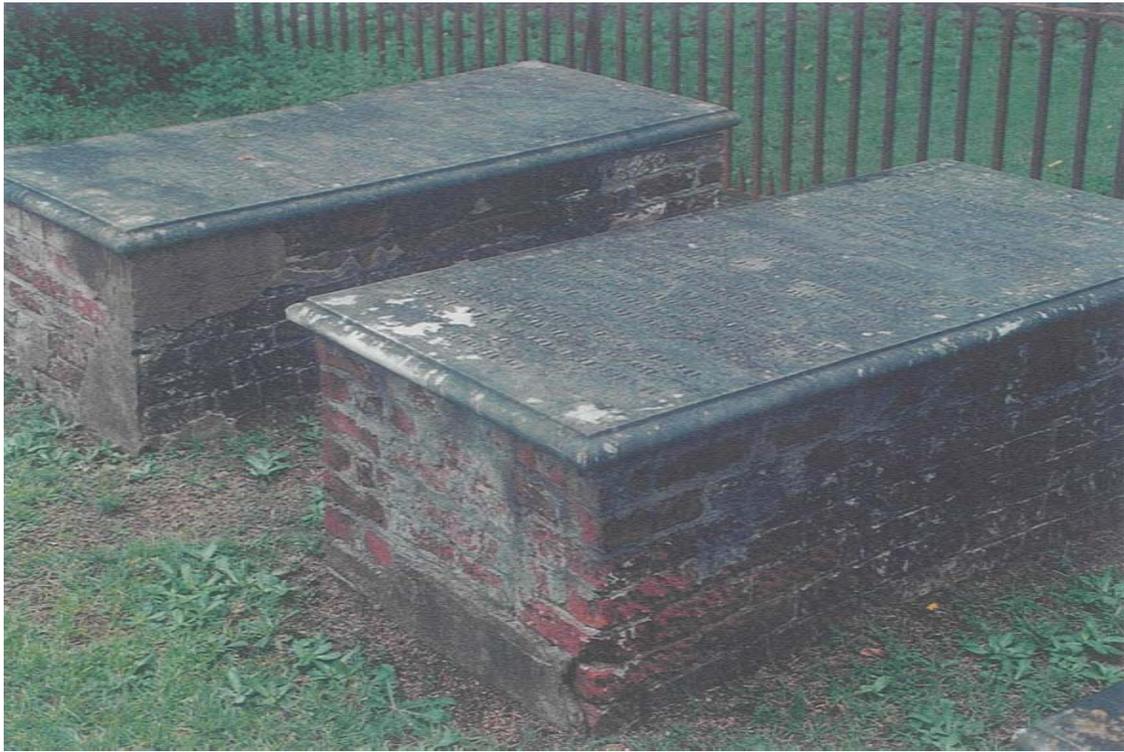
Figure 26. Box tombs in Lot 32 which were originally stuccoed.

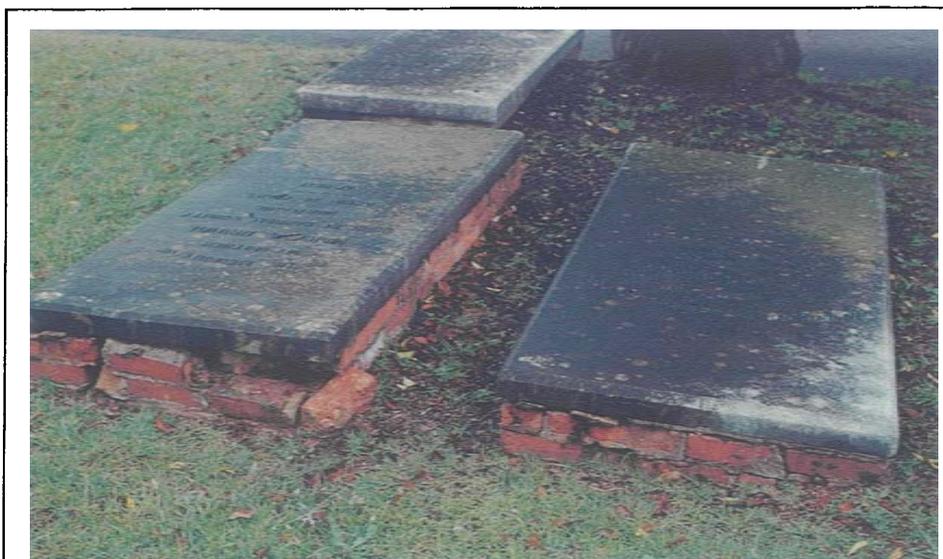
Finally, there are two low brick supports on Lot 147 which are badly deteriorating. It appears that very soft bricks were used and that these bricks are now failing. One corner has already collapsed and as the

Figure 27. Deteriorating brick supports for ledgers (Lot 147).

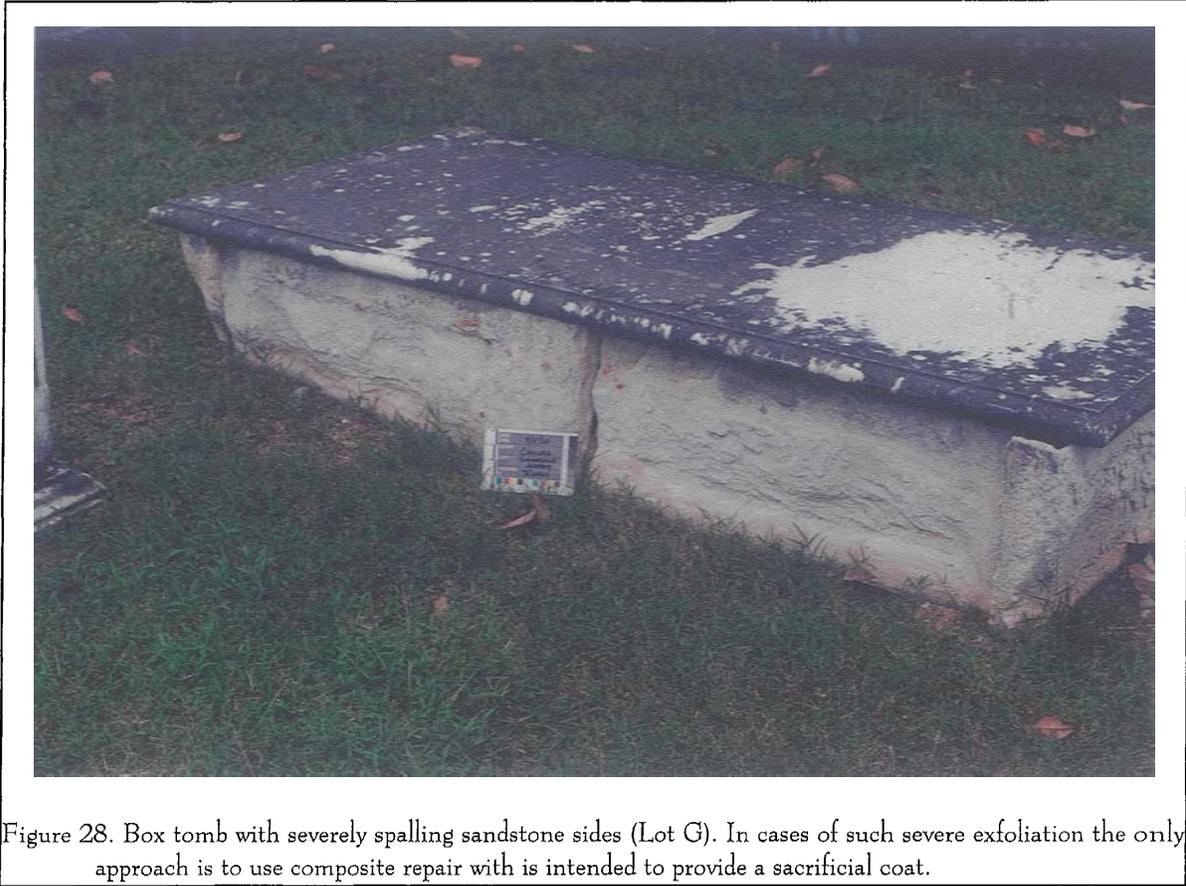
Figure 28. Box tomb with severely spalling sandstone sides (Lot G). In cases of such severe exfoliation the only approach is to use composite repair with is intended to provide a sacrificial coat.

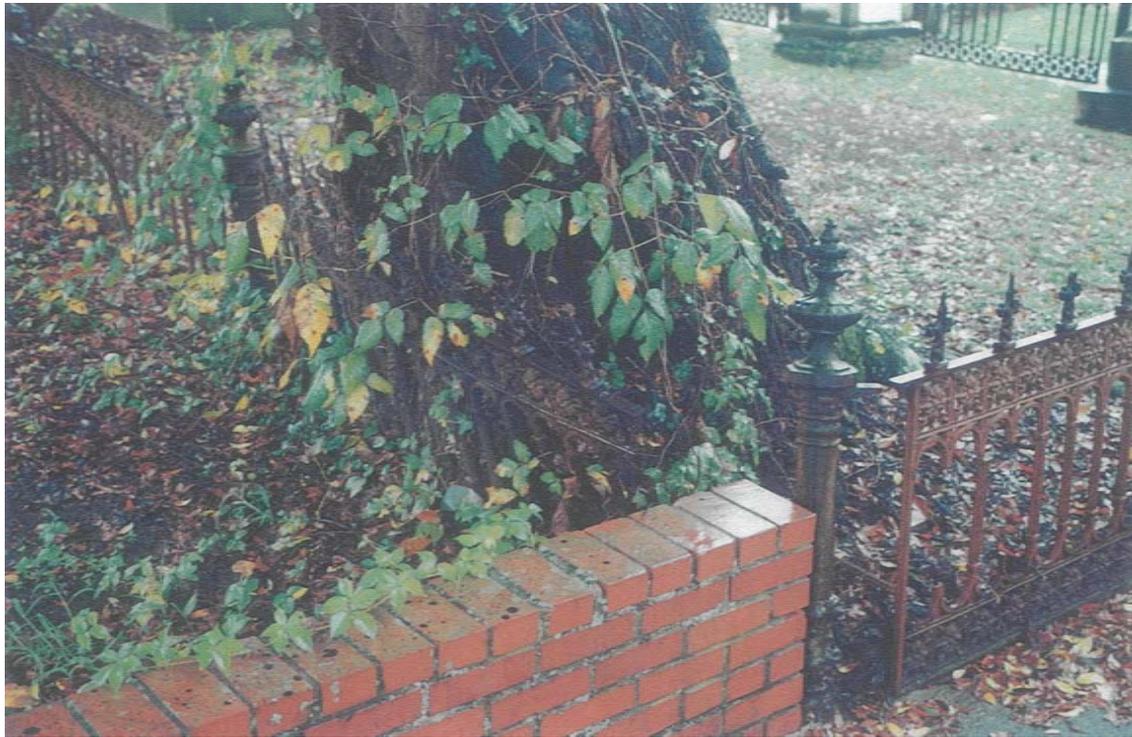
Figure 29. Example of tree which has been allowed to damage a fence segment (Lots 16/17). In this case the only choice is to remove the fence section and place it in storage. The aisle way segment should also be reattached to the corner newel post. This photograph also illustrates the large quantity of poison ivy which has been allowed to grow unchecked in the cemetery. This must be removed before any ironwork can begin.

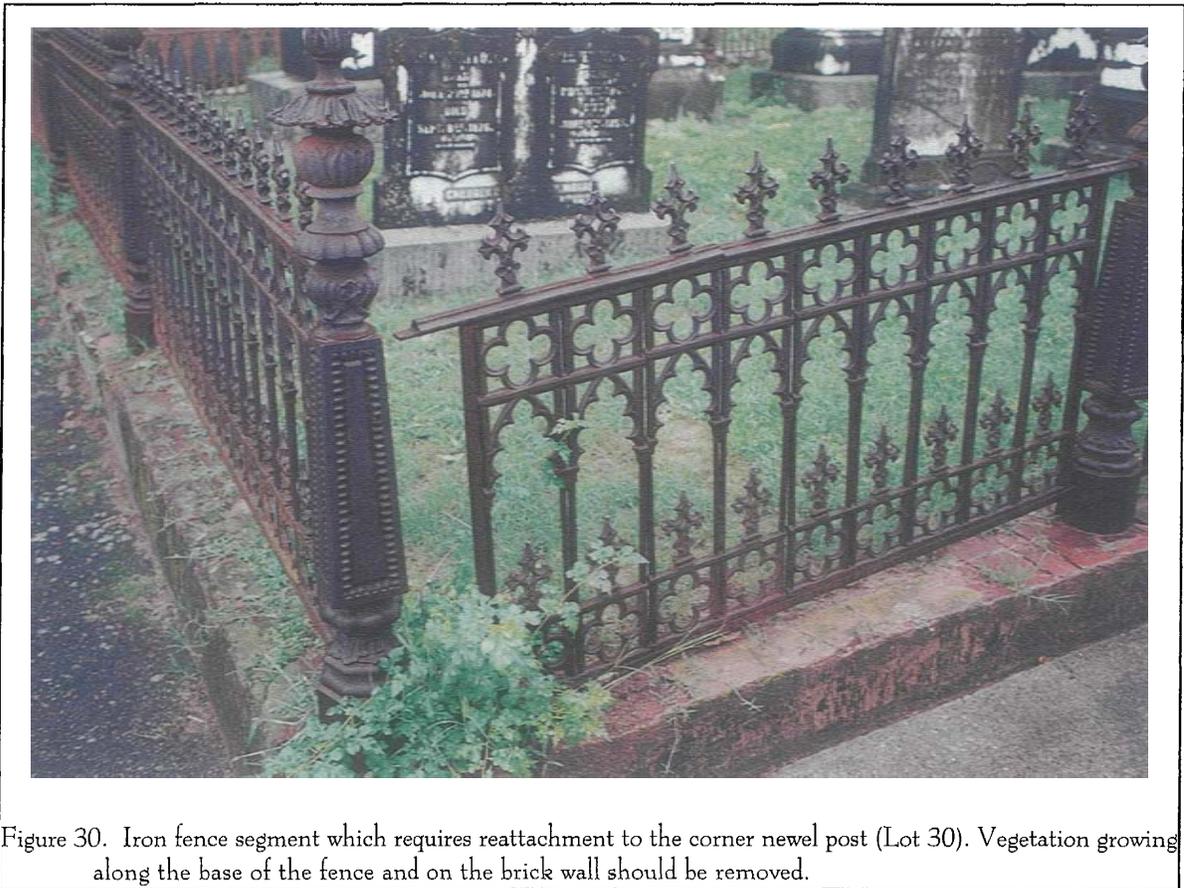
Figure 30. Iron fence segment which requires reattachment to the corner newel post (Lot 30). Vegetation growing along the base of the fence and on the brick wall should be removed.

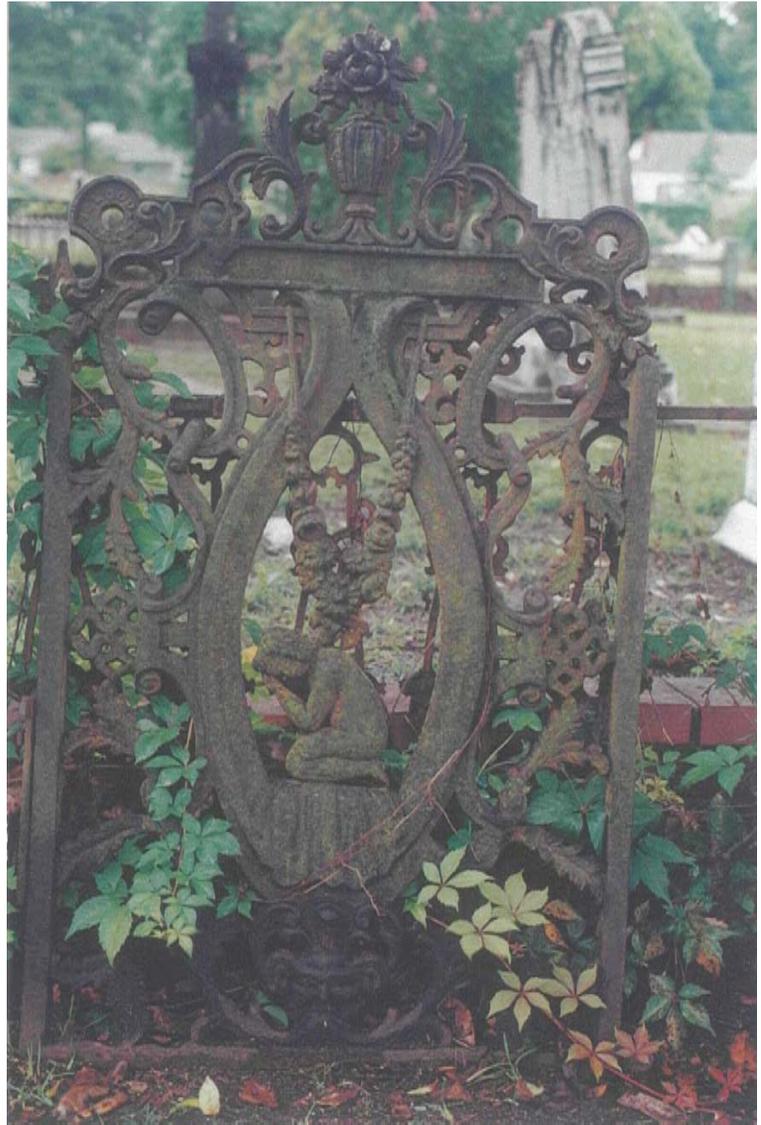
Figure 31. Gate propped up inside the fence at Lot 31. This should receive a very high priority for resetting since it is an attractive target for theft. Similar gates can easily bring \$300 to \$500 in Savannah antique stores.
