**MONROVIA UNION CEMETERY, CHARLESTON  
COUNTY, SOUTH CAROLINA**

Prepared By:  
Michael Trinkley, Ph.D., RPA

## **Chicora Research Contribution 339**

October 3, 2001

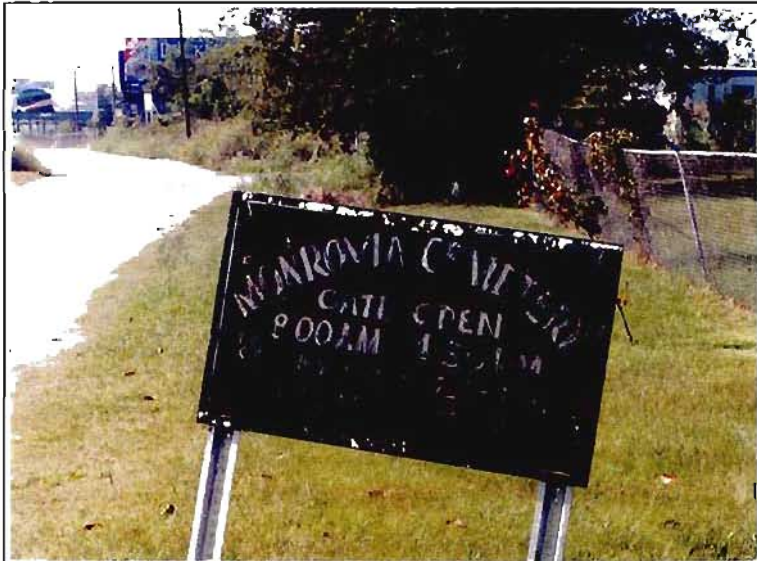
Figure 11. Sign for the Monrovia Cemetery, view to the south.

entrance is marked by a faded and somewhat dilapidated sign (Figure 11). Only one of the three phone numbers shown on the sign appears to still be associated with the cemetery. There is a chain link fence just beyond the road and a

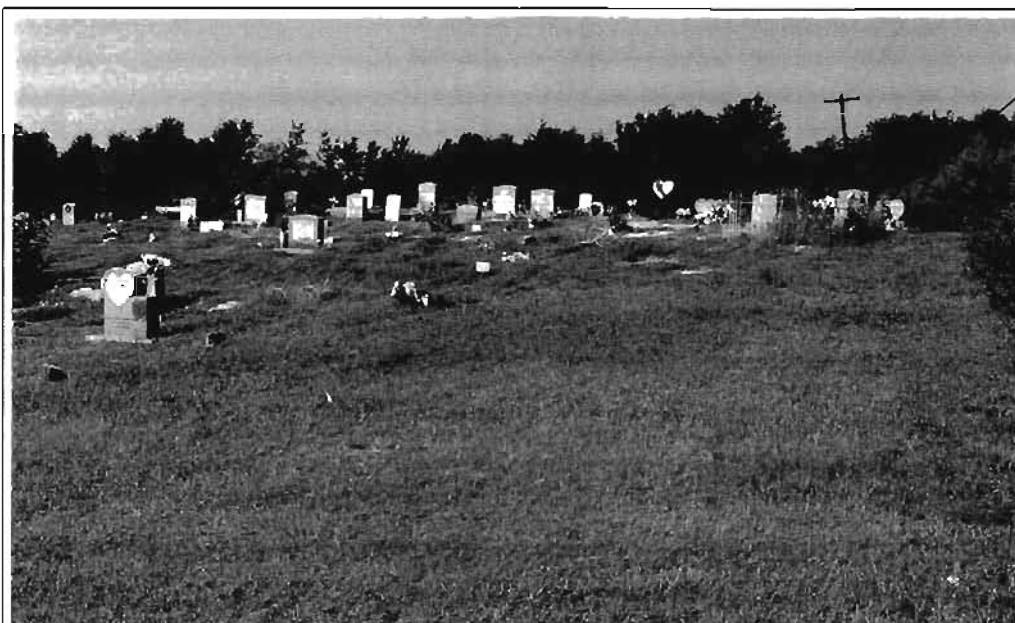
In the northern quadrant of the cemetery there is a noticeable rise, about 2 to 3 feet in height (Figure 13; see also Figure 2). The area is heavily dominated by twentieth century vault burials (burials where a concrete vault

Figure 13. View of the rise in the northwestern quadrant of the cemetery looking west

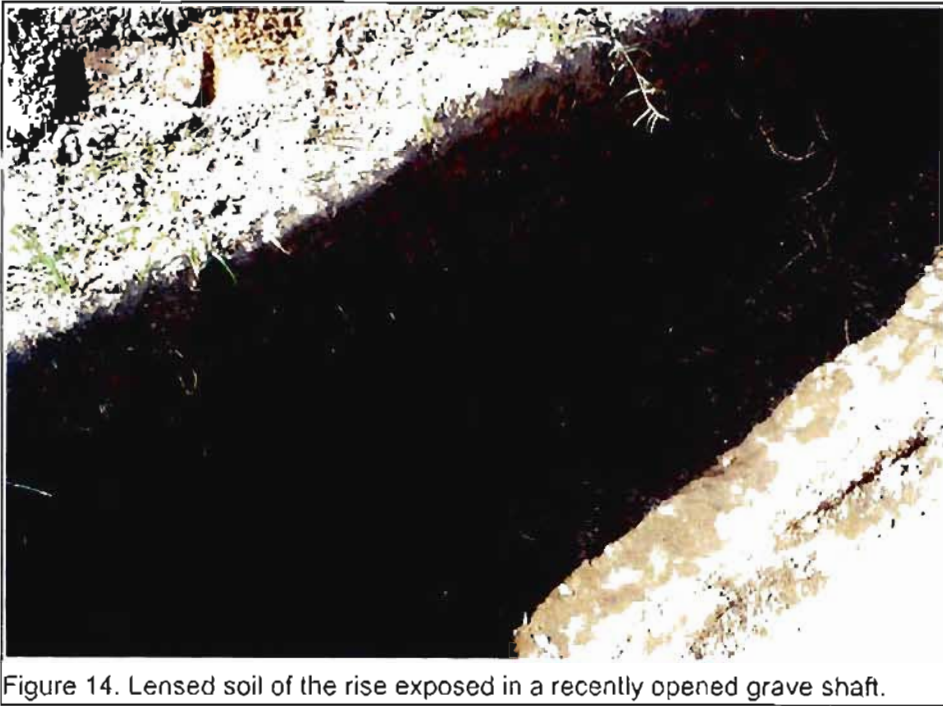
is used as the flush to ground marker). A recently opened grave reveals that this rise or mound is artificial, consisting of lensed soil (Figure 14). It is likely that this rise and its associated activities are what are so clearly seen in the 1949 aerial. It is, however, uncertain whether this represents fill soil brought into the cemetery specifically to raise the level of the ground in this area, or whether it represents spoil from graves which was dumped in this one area and spread out. Regardless, it appears to be relatively modern and the soil does not appear to contain any industrial material, any mucked soils, or phosphate debris. In other words, it appears to originate with the cemetery.

Figure 14. Lensed soil of the rise exposed in a recently opened grave shaft.

Consequently, our best recommendation is that all ground disturbing activities within 30 feet of the ditch be carefully monitored for any evidence of bones, coffin parts, or other unusual features. In particular all work *within* the ditch should be very carefully conducted, removing only limited quantities of soil at a time. This should be coupled with careful visual inspection for any rectangular stains which might represent grave shafts. Again, any identification of bone, wood, or metal fragments from the ditch area should be treated as potential graves and further evaluated.

We also recommend against any fill activities associated with the ditch. While the current plans suggest that the cemetery limits, in some areas, are south of the ditch, this does not seem consistent with the historic evidence. Consequently, even fill activities have the potential to alter the nature of the cemetery and potentially disturb burials.
