PRESERVATION PLANNING FOR ST. ELIZABETHS WEST CAMPUS CEMETERY, ST. ELIZABETHS HOSPITAL, WASHINGTON, DC

Research Contribution 472

Michael Trinkley
Debi Hacker

June 2007

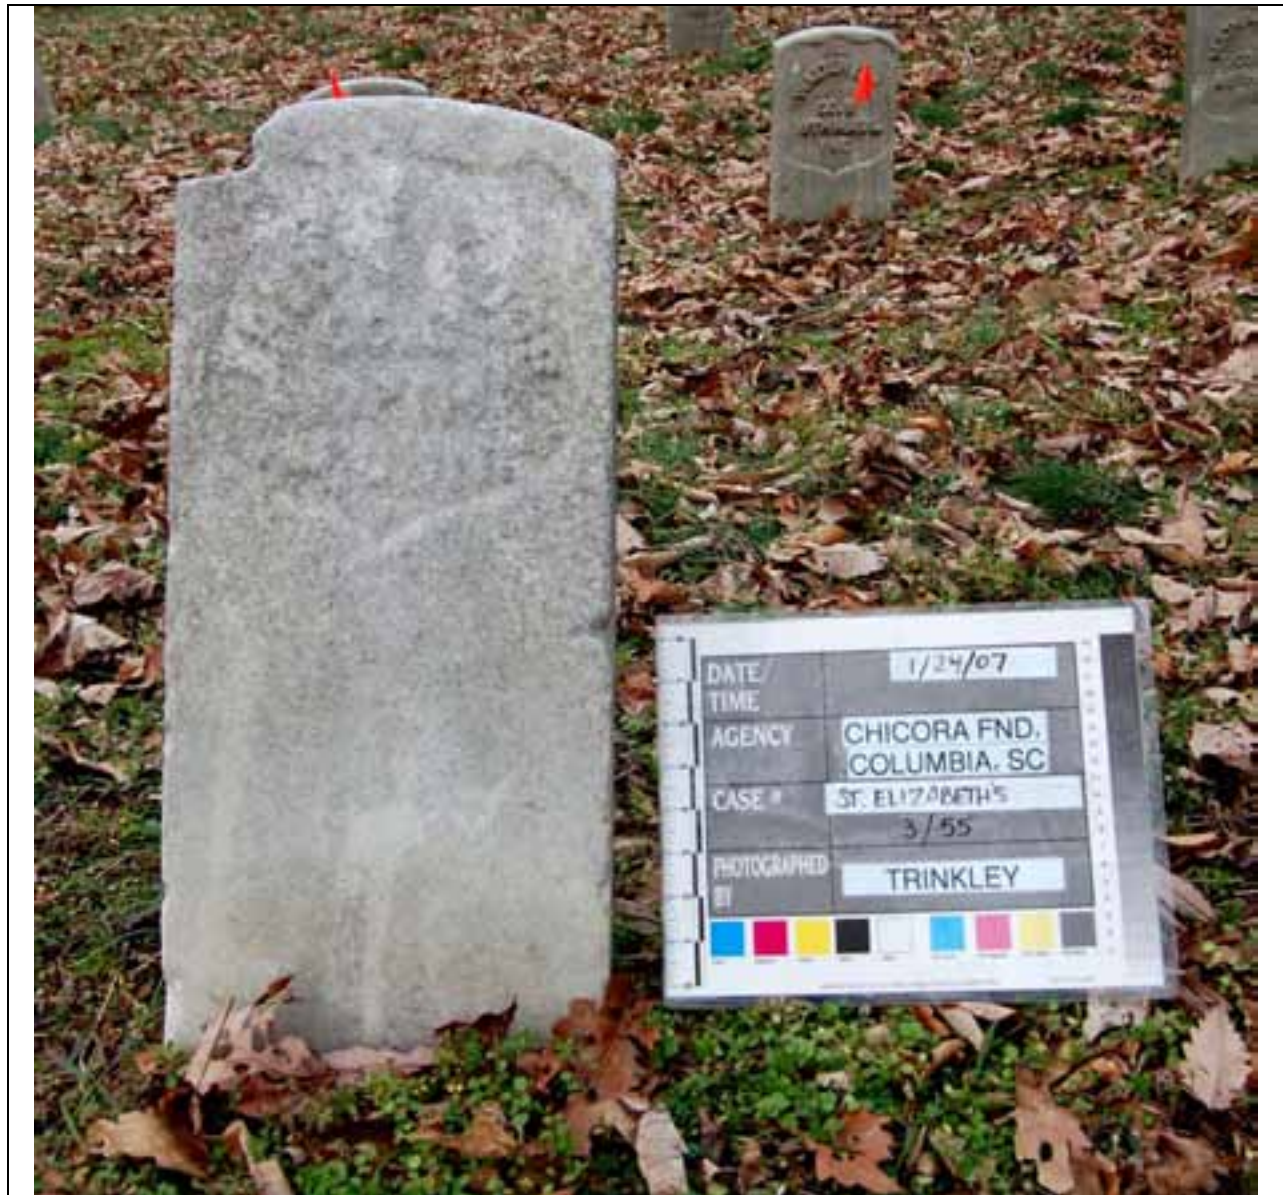
Current Condition Photograph on Rear

Condition of Marker: ☒ weathered ☐ cracked ☒ broken ☐ vandalized
☐ unattached ☐ loose ☐ biologicals ☐ stained
☐ repaired ☒ portions missing: upper left corner
☒ tilted: degrees: 45 E-W N-S Other:

Condition of Grave: probably displaced from proper location in Row 1; grave satisfactory

| <input type="checkbox"/> Consider replacement with "XA" NCA marker | fiscal year |

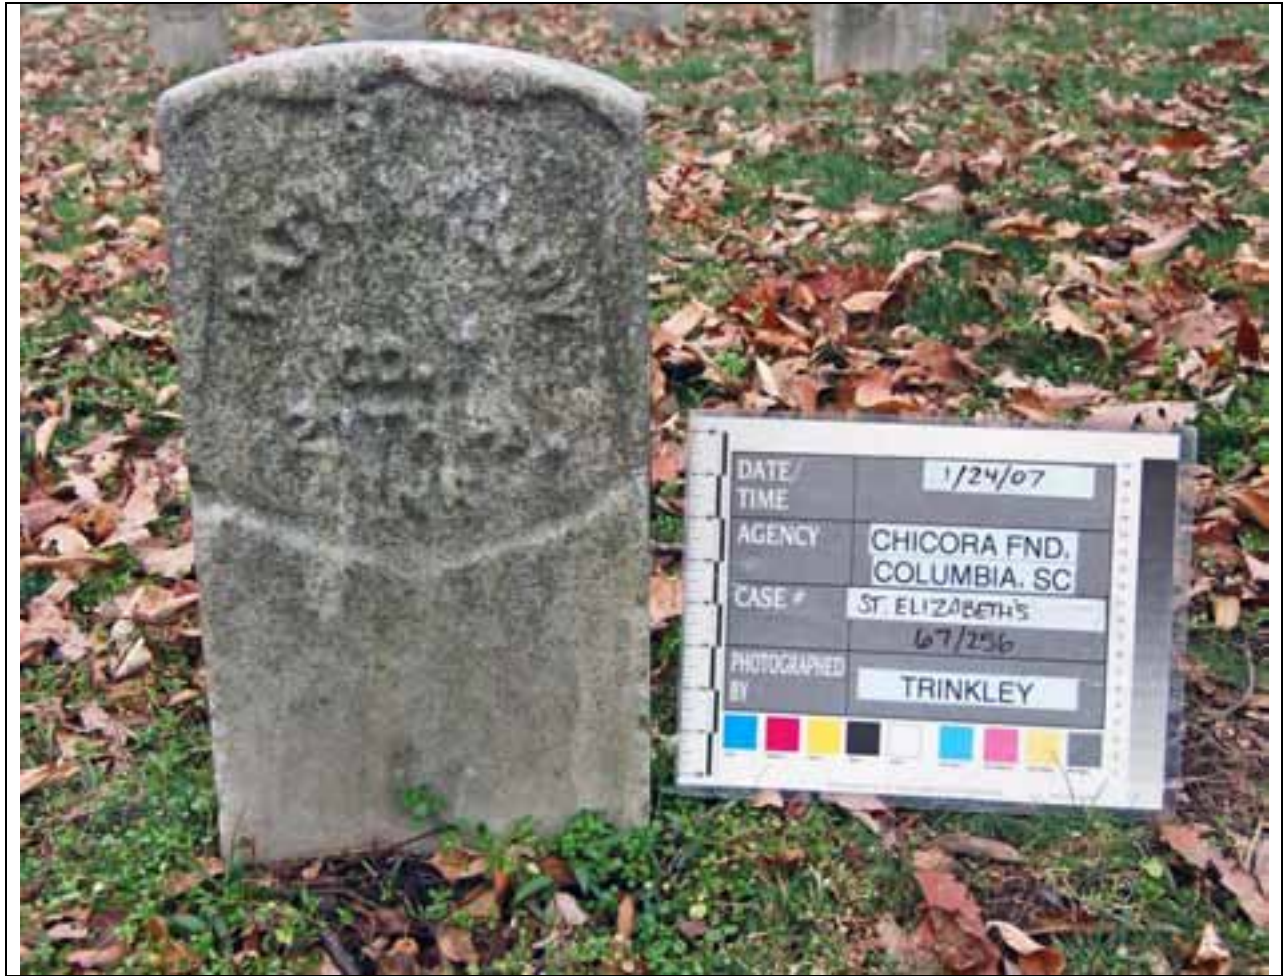
Condition of Marker: ☒ weathered ☐ cracked ☐ broken ☐ vandalized
☐ unattached ☐ loose ☒ biologicals ☐ stained
☐ repaired ☐ portions missing:
☒ tilted: degrees: 5 E-W N-S Other: spall in face

Condition of Grave: satisfactory

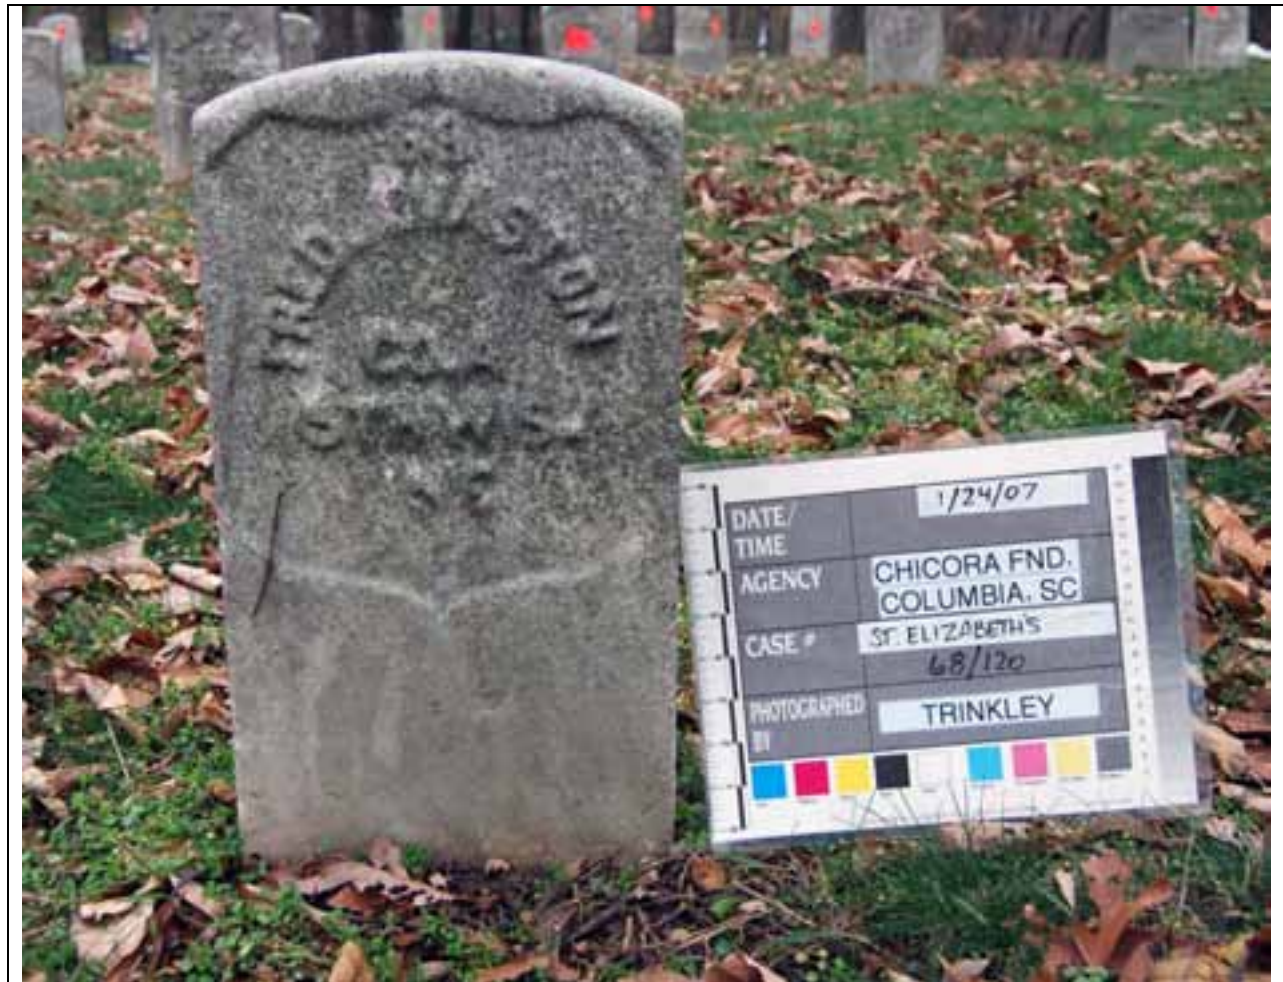
Condition of Marker: ☒ weathered ☐ cracked ☐ broken ☐ vandalized
☐ unattached ☐ loose ☒ biologicals ☐ stained
☐ repaired ☒ portions missing: chips left side
☒ tilted: degrees: 10 E-W N-S Other:

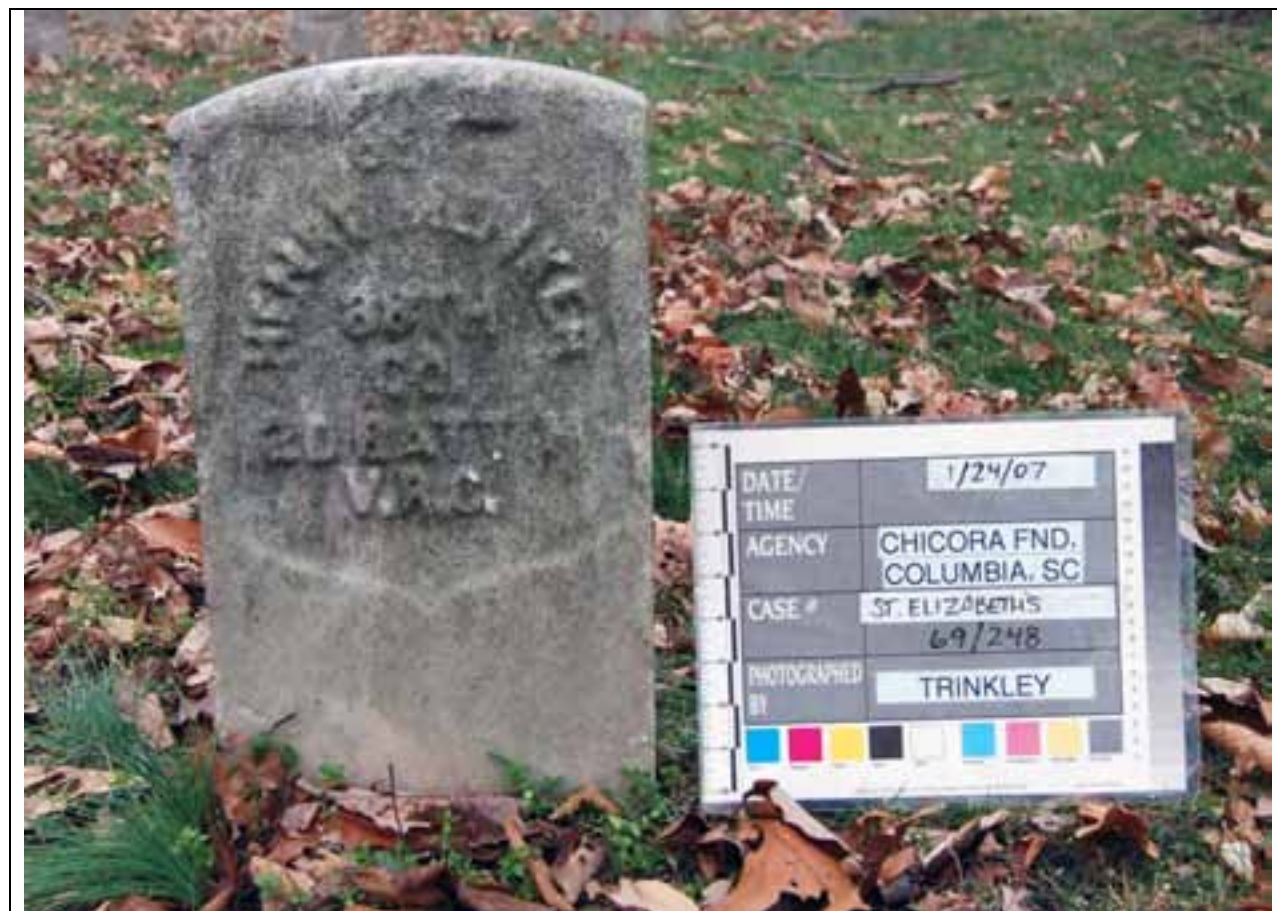
Condition of Marker: ☒ weathered ☐ cracked ☐ broken ☐ vandalized
☐ unattached ☐ loose ☒ biologicals ☐ stained
☐ repaired ☒ portions missing: chip lower right
☒ tilted: degrees: 10 E-W 5 N-S Other: mower damage

Condition of Grave: satisfactory

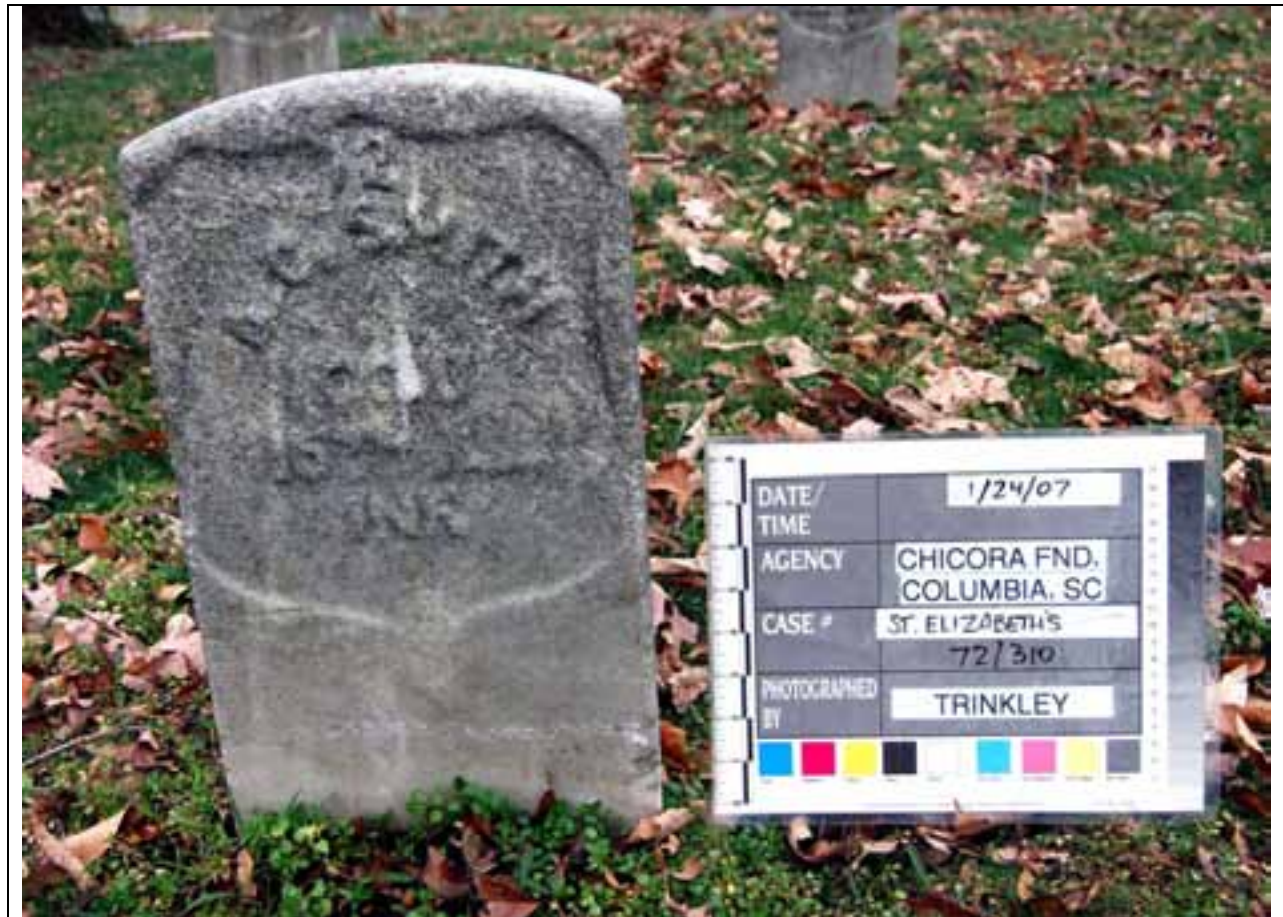
Condition of Marker: ☒ weathered ☐ cracked ☐ broken ☐ vandalized
☐ unattached ☐ loose ☒ biologicals ☐ stained
☐ repaired ☒ portions missing: chips top, lower right
☒ tilted: degrees: 10 E-W 10 N-S Other: mower damage

Condition of Grave: satisfactory

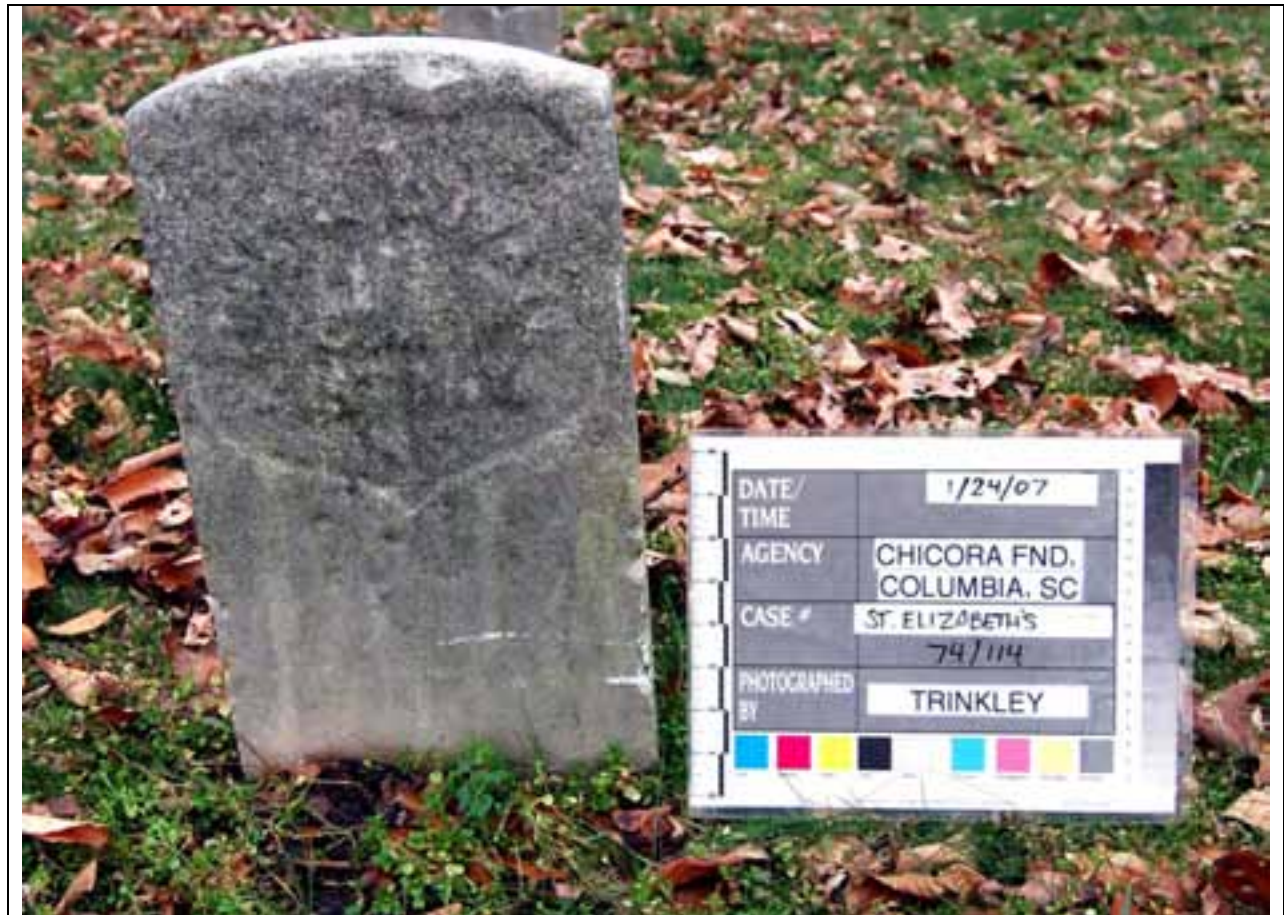
Condition of Marker: ☒ weathered ☐ cracked ☒ broken ☐ vandalized
☐ unattached ☐ loose ☒ biologicals ☐ stained
☐ repaired ☐ portions missing:
☒ tilted: degrees: 40 E-W N-S Other:

Condition of Grave: satisfactory

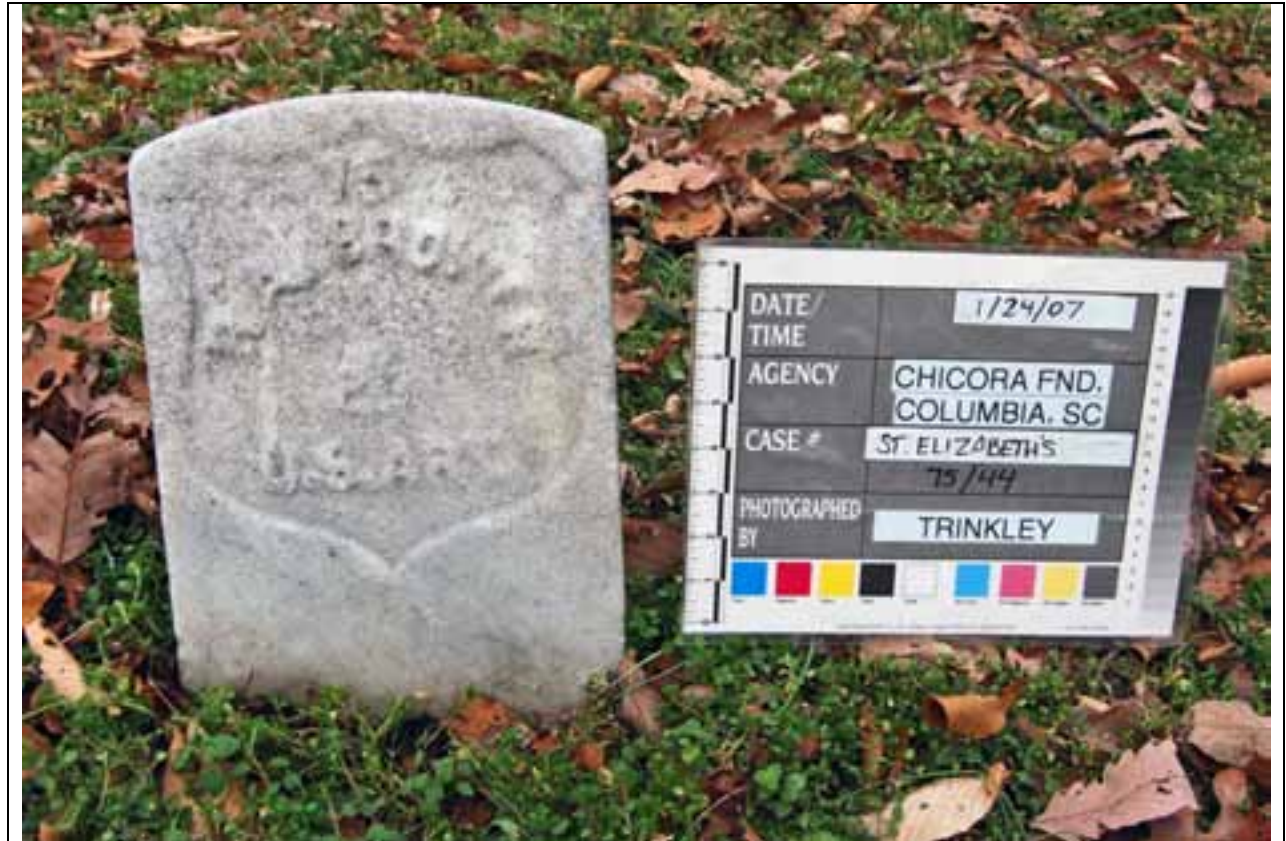
Condition of Marker: ☒ weathered ☐ cracked ☐ broken ☐ vandalized
☐ unattached ☐ loose ☒ biologicals ☐ stained
☐ repaired ☒ portions missing: chips right and left sides
☐ tilted: degrees: 5 E-W N-S Other: new damage to right top

Condition of Grave: satisfactory

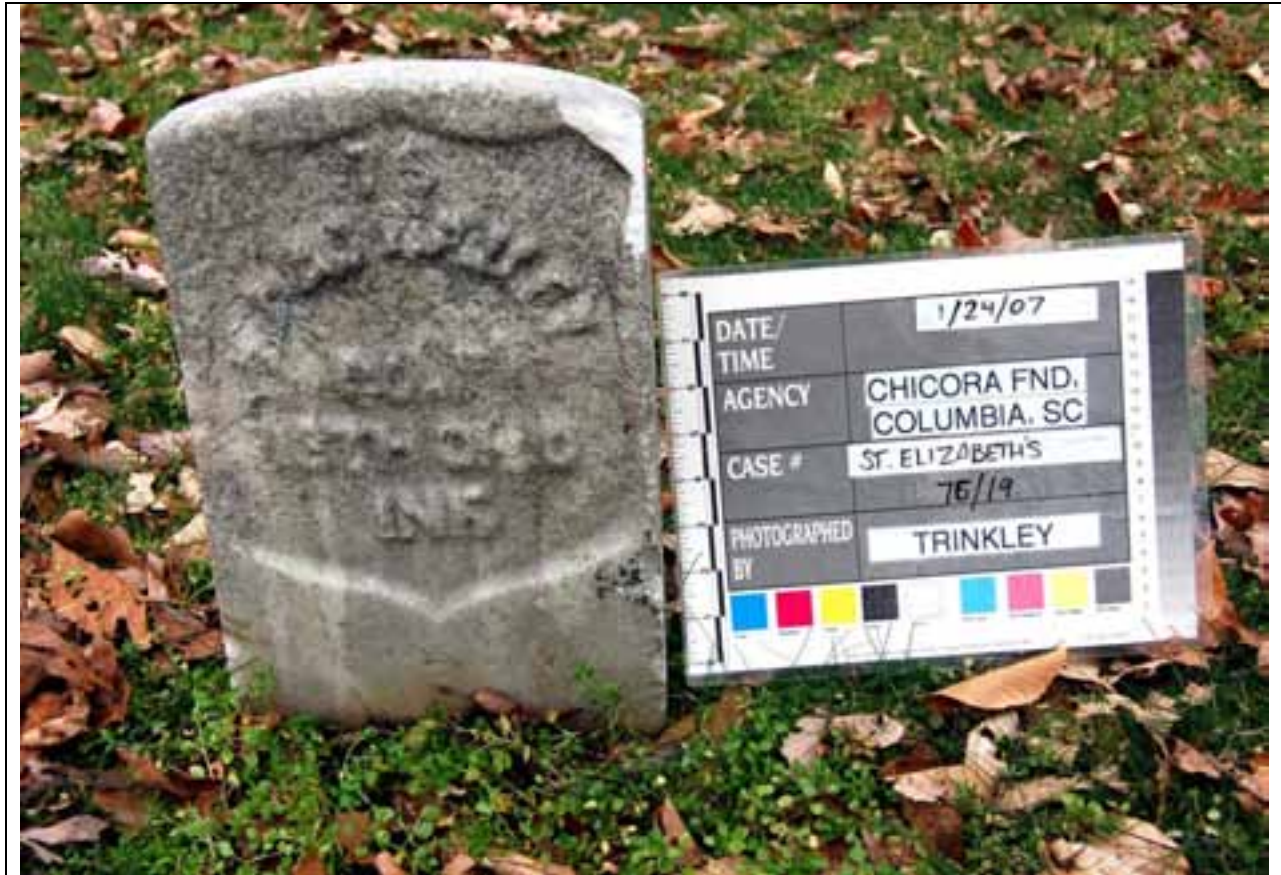
Condition of Marker: ☒ weathered ☐ cracked ☐ broken ☐ vandalized
☐ unattached ☐ loose ☐ biologicals ☐ stained
☐ repaired ☒ portions missing: right and left sides
☒ tilted: degrees: 5 E-W N-S Other:

Condition of Grave: satisfactory

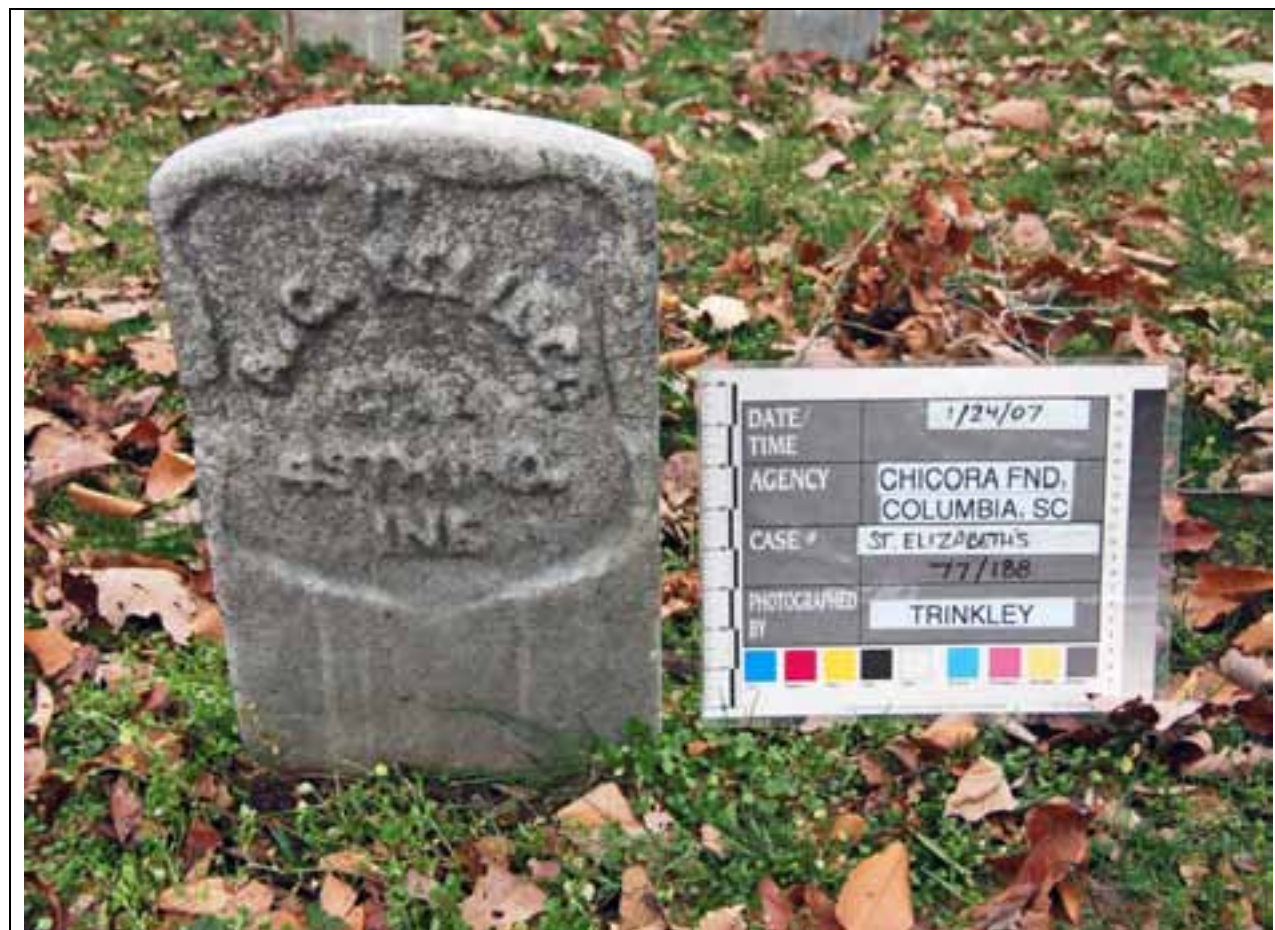
Condition of Marker: ☒ weathered ☐ cracked ☐ broken ☐ vandalized
☐ unattached ☐ loose ☒ biologicals ☐ stained
☐ repaired ☐ portions missing:
☒ tilted: degrees: 10 E-W 5 N-S Other: mower damage

Condition of Grave: satisfactory

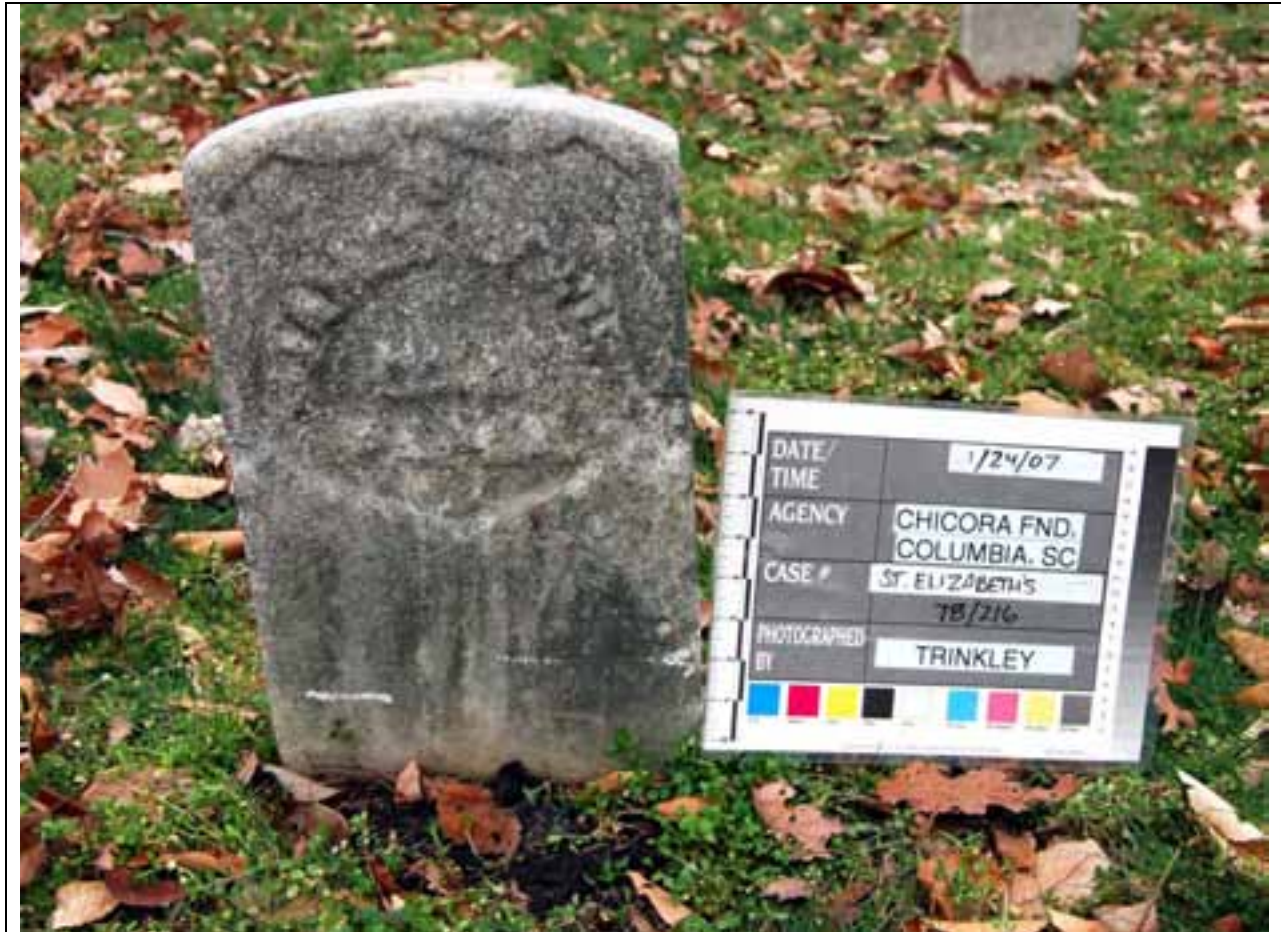
Condition of Marker: ☐ weathered ☐ cracked ☐ broken ☐ vandalized
☐ unattached ☐ loose ☐ biologicals ☐ stained
☐ repaired ☒ portions missing: chips left and right sides
☒ tilted: degrees: 20 E-W N-S Other:

Condition of Grave: satisfactory

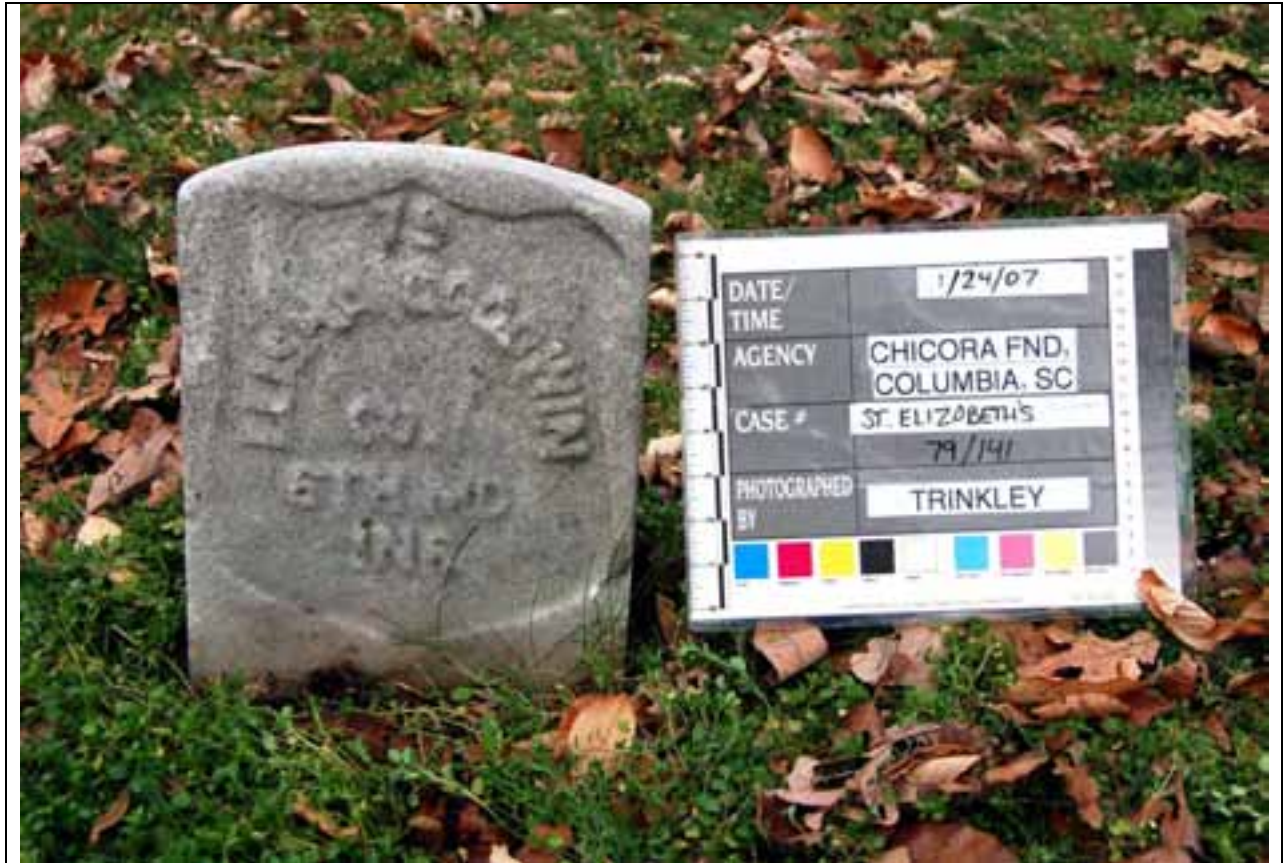
Condition of Marker: ☒ weathered ☐ cracked ☐ broken ☐ vandalized
☐ unattached ☐ loose ☒ biologicals ☐ stained
☐ repaired ☒ portions missing: chip right side
☒ tilted: degrees: 10 E-W 5 N-S Other: set high

Condition of Grave: satisfactory

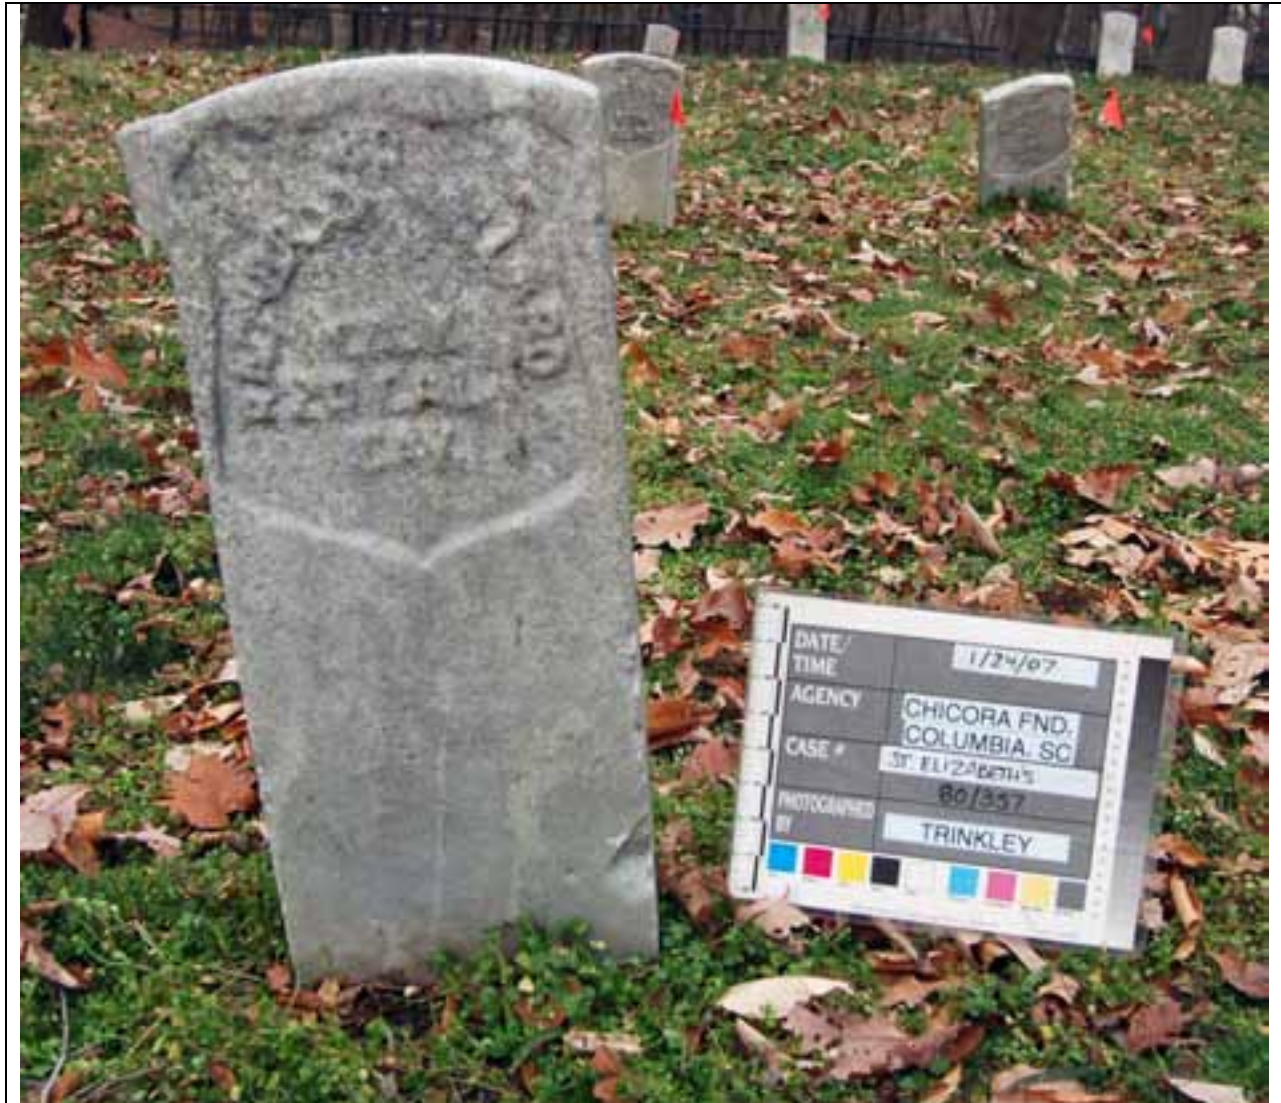
Condition of Marker: ☒ weathered ☐ cracked ☒ broken ☐ vandalized
☐ unattached ☐ loose ☐ biologicals ☐ stained
☐ repaired ☒ portions missing: base of stone
☐ tilted: degrees: E-W N-S Other:

Condition of Grave: not associated with grave; probably transported downslope from Row 2

| <input checked="" type="checkbox"/> Consider replacement with "XA" NCA marker | fiscal year | |

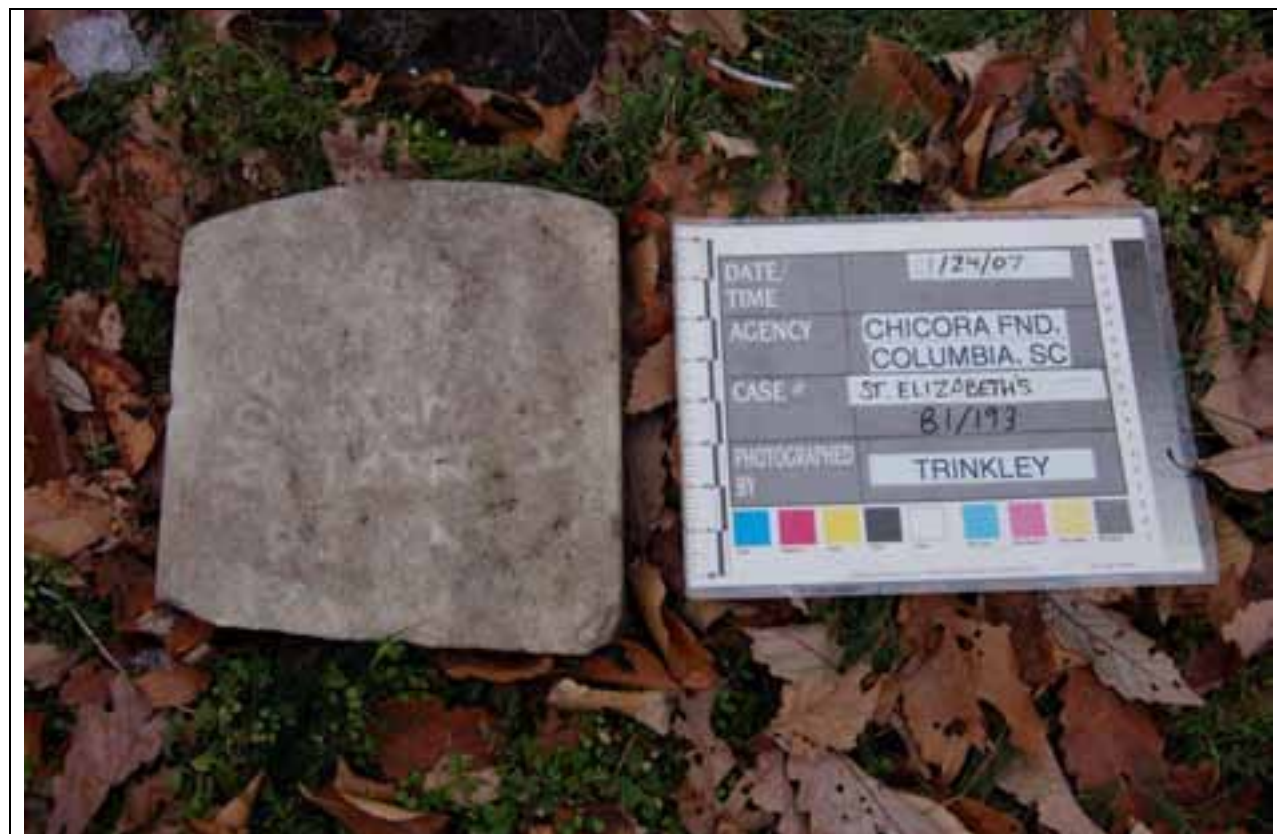
Condition of Marker: ☒ weathered ☐ cracked ☒ broken ☐ vandalized
☐ unattached ☐ loose ☐ biologicals ☐ stained
☐ repaired ☒ portions missing: lower half of stone
☐ tilted: degrees: E-W N-S Other: flat on ground

Condition of Grave: satisfactory

| <input checked="" type="checkbox"/> Consider replacement with "XA" NCA marker | fiscal year |

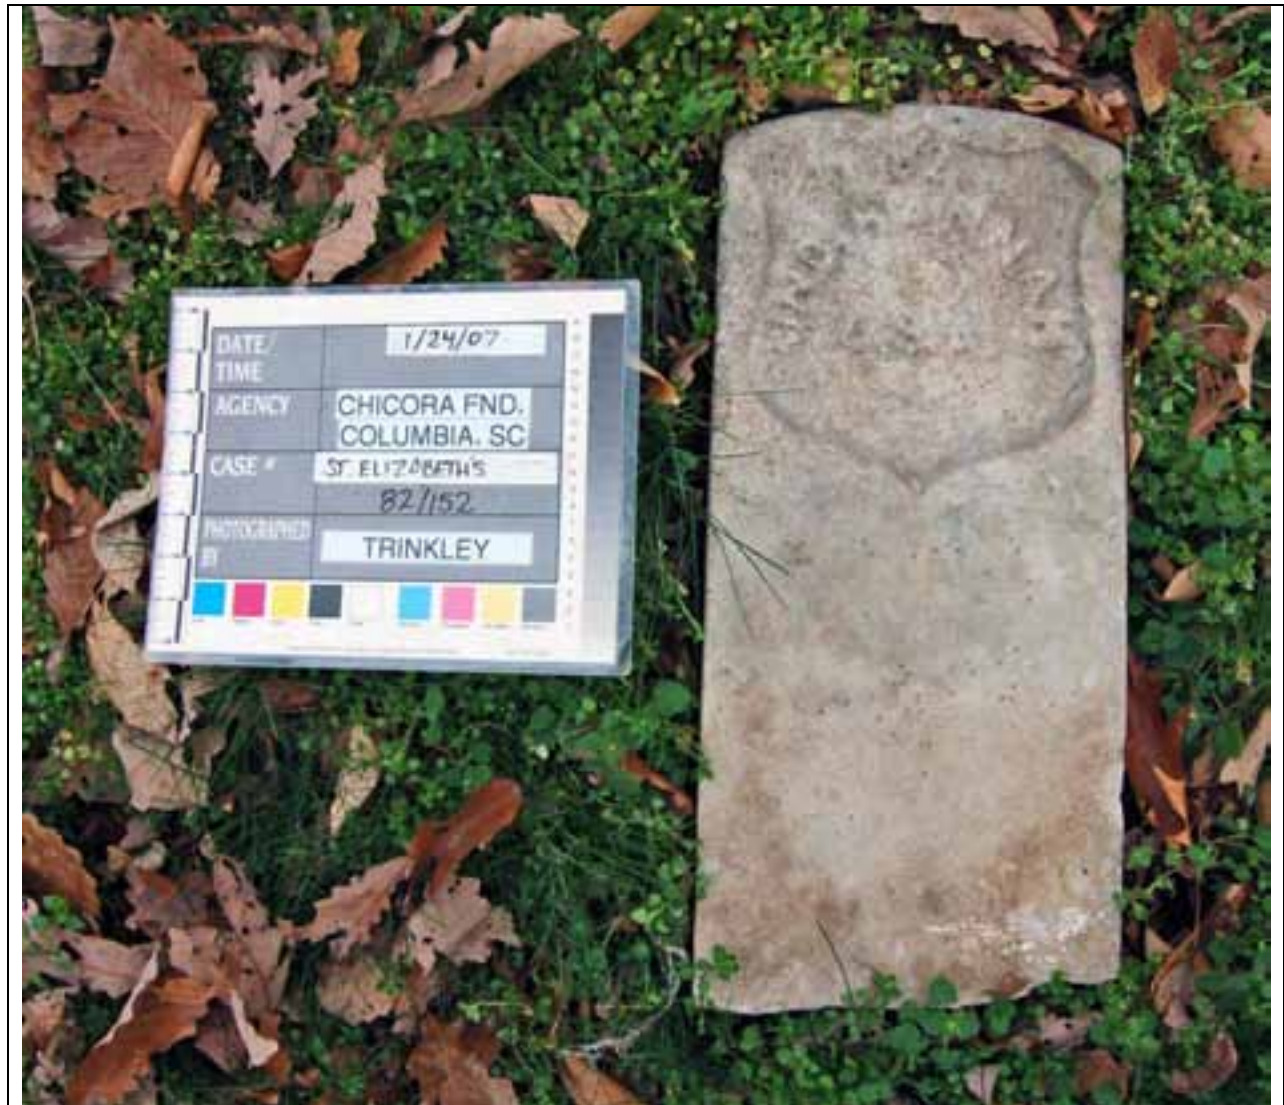
Condition of Marker: ☐ weathered ☐ cracked ☐ broken ☐ vandalized
☐ unattached ☐ loose ☒ biologicals ☐ stained
☐ repaired ☒ portions missing: chip upper left side
☒ tilted: degrees: 45 E-W 10 N-S Other:

Condition of Grave: satisfactory

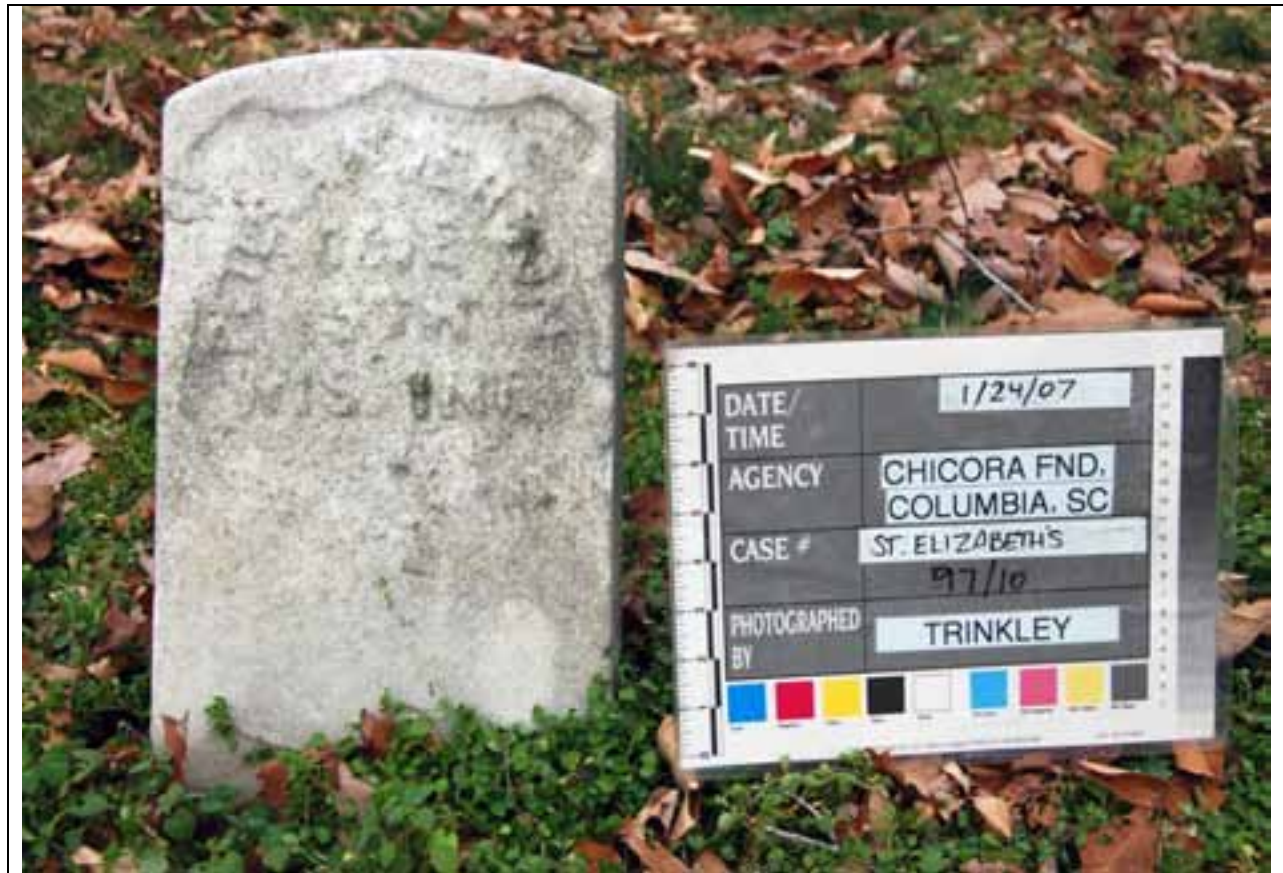
Condition of Marker: ☐ weathered ☐ cracked ☒ broken ☐ vandalized
☐ unattached ☐ loose ☐ biologicals ☐ stained
☐ repaired ☒ portions missing: lower half of stone
☐ tilted: degrees: E-W N-S Other: flat on ground

Condition of Grave: satisfactory

| <input checked="" type="checkbox"/> Consider replacement with "XA" NCA marker | fiscal year |

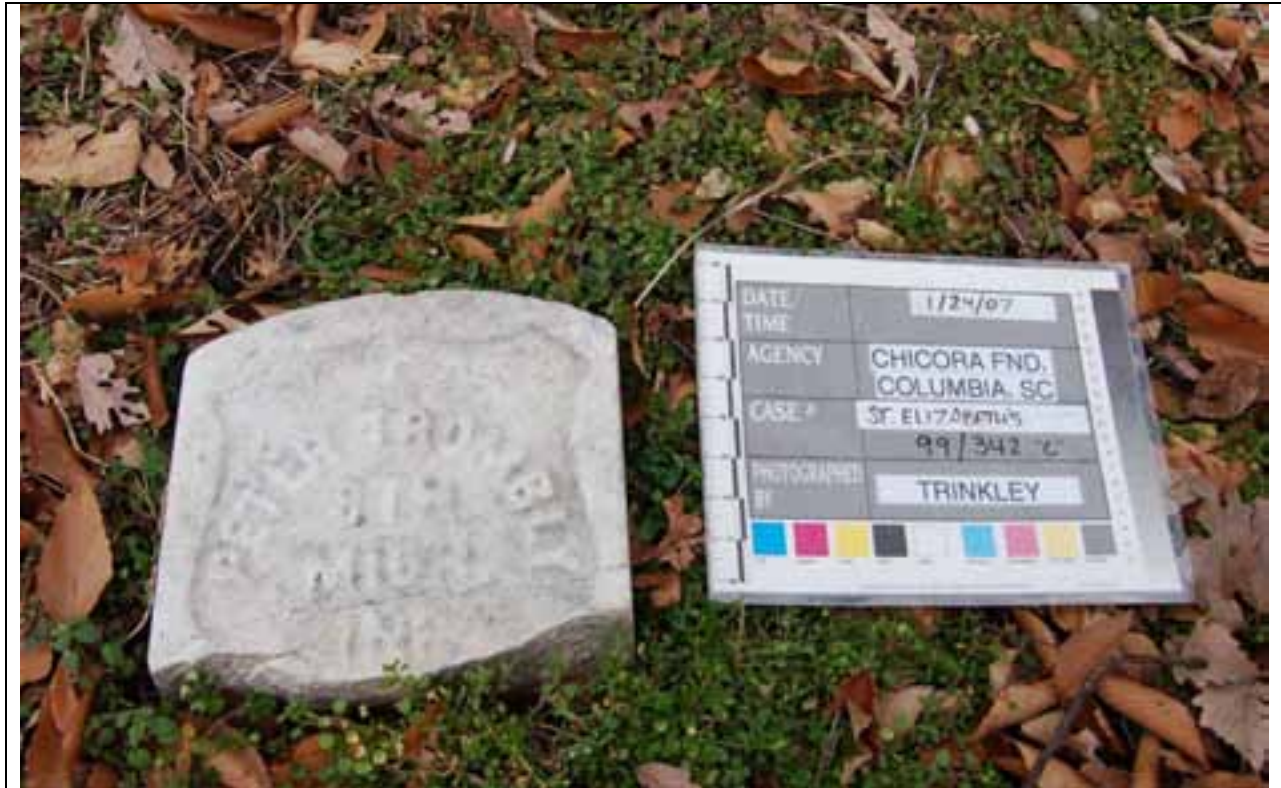
Condition of Marker: ☒ weathered ☐ cracked ☒ broken ☐ vandalized
☐ unattached ☐ loose ☐ biologicals ☐ stained
☐ repaired ☐ portions missing: center top & R. upper front corner
☒ tilted: degrees: 10 E-W N-S Other:

Condition of Grave: satisfactory

| <input checked="" type="checkbox"/> Consider replacement with "XA" NCA marker | fiscal year |

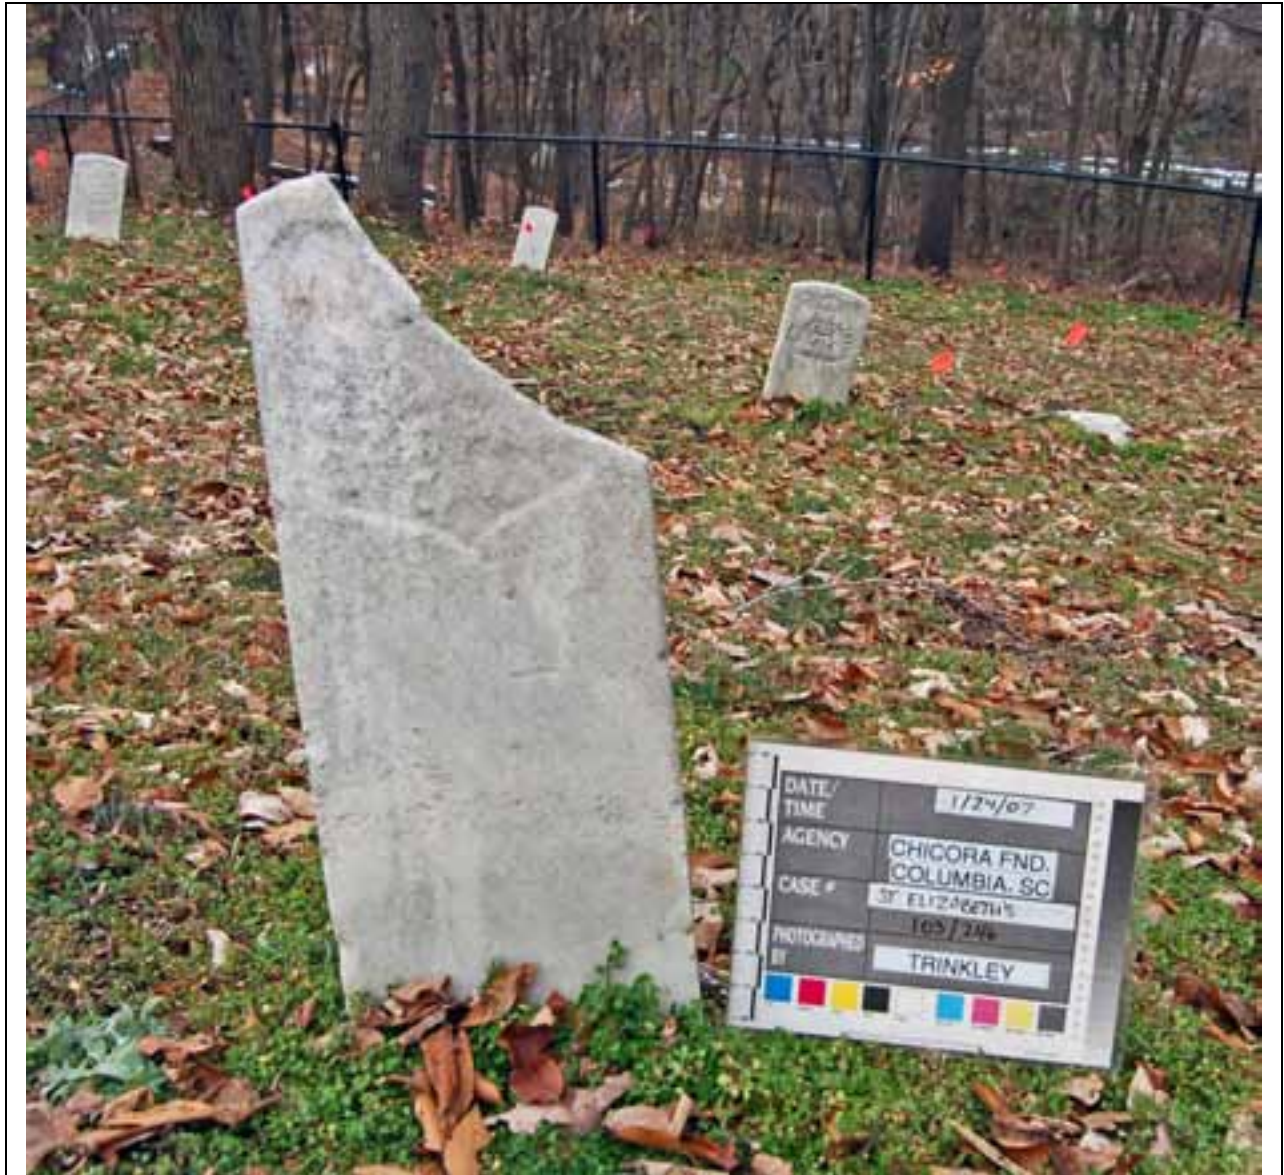
Condition of Marker: ☒ weathered ☐ cracked ☐ broken ☐ vandalized
☐ unattached ☐ loose ☐ biologicals ☐ stained
☐ repaired ☒ portions missing: chips right and left sides
☒ tilted: degrees: 15 E-W N-S Other:

Condition of Grave: satisfactory

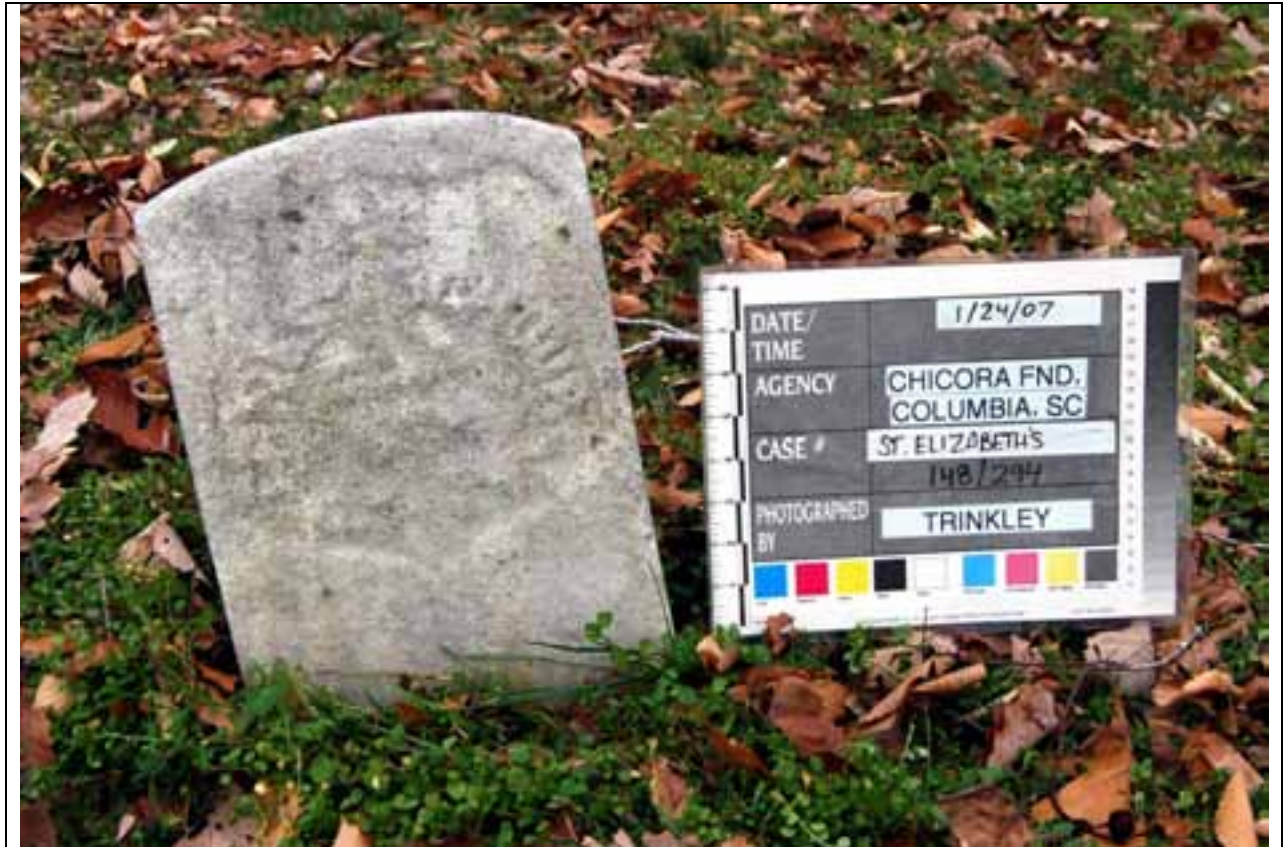
Condition of Marker: ☒ weathered ☐ cracked ☐ broken ☐ vandalized
☐ unattached ☐ loose ☒ biologicals ☒ stained
☐ repaired ☒ portions missing: chipped right and left sides
☒ tilted: degrees: 5 E-W N-S Other: mower damage

Condition of Grave: satisfactory

| <input type="checkbox"/> Consider replacement with "XA" NCA marker | fiscal year |
