PRESERVATION PLANNING FOR ST. ELIZABETHS WEST CAMPUS CEMETERY, ST. ELIZABETHS HOSPITAL, WASHINGTON, DC

Research Contribution 472

Michael Trinkley
Debi Hacker

June 2007

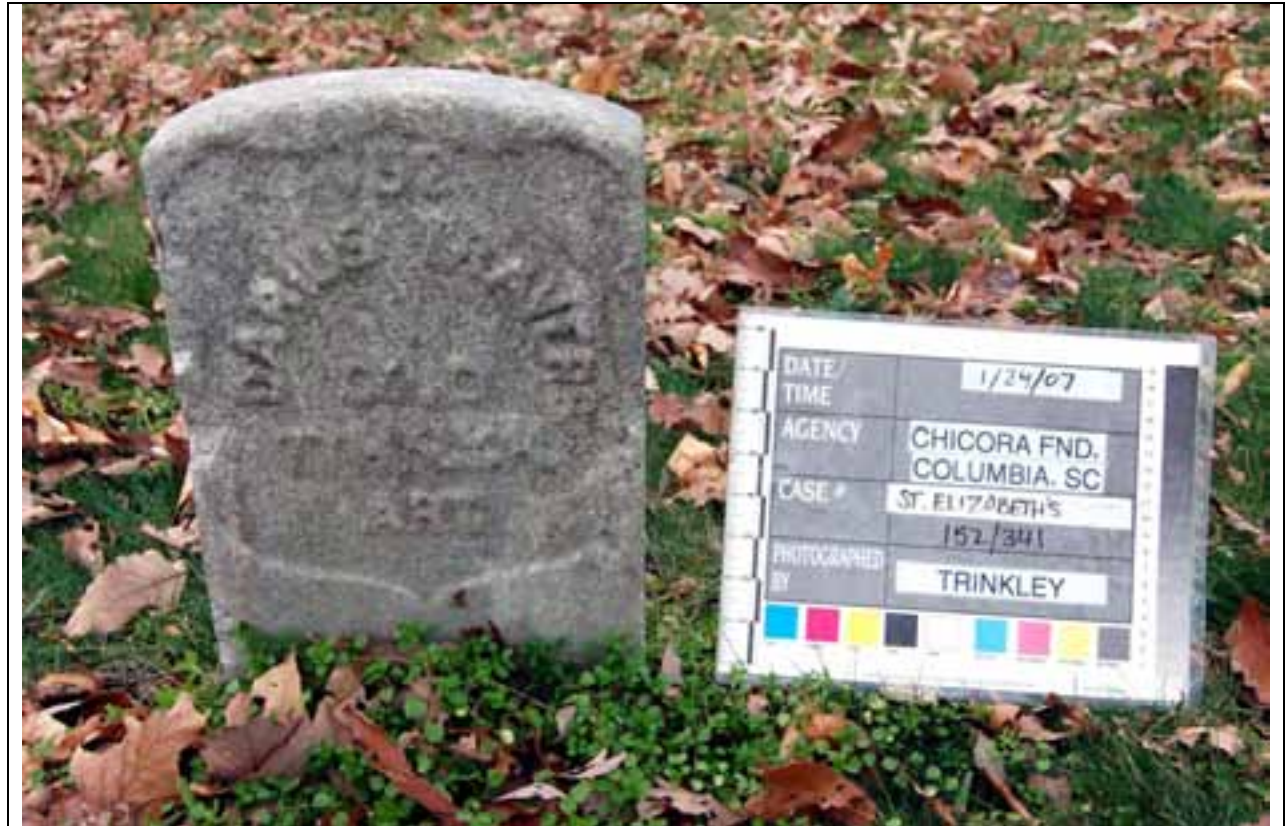
Condition of Marker: ☒ weathered ☐ cracked ☐ broken ☐ vandalized
☐ unattached ☐ loose ☒ biologicals ☒ stained
☐ repaired ☒ portions missing: chips lower right
☒ tilted: degrees: 10 E-W N-S Other: spalling at top

Condition of Grave: satisfactory

| <input type="checkbox"/> Consider replacement with "XA" NCA marker | fiscal year |

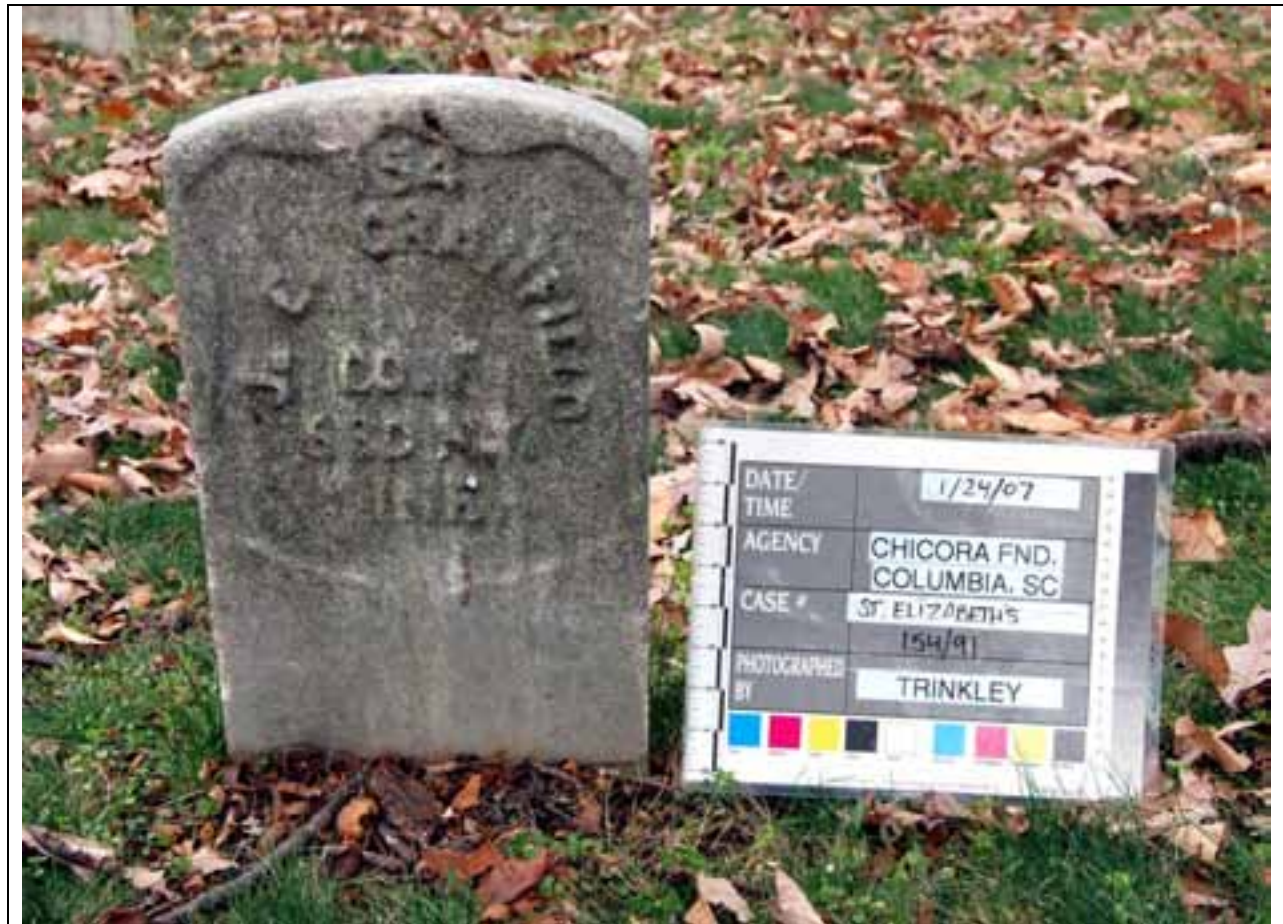
Condition of Marker: ☒ weathered ☐ cracked ☐ broken ☐ vandalized
☐ unattached ☐ loose ☐ biologicals ☐ stained
☐ repaired ☐ portions missing:
☒ tilted: degrees: 10 E-W 5 N-S Other: mower damage

Condition of Grave: satisfactory

| <input type="checkbox"/> Consider replacement with "XA" NCA marker | fiscal year |

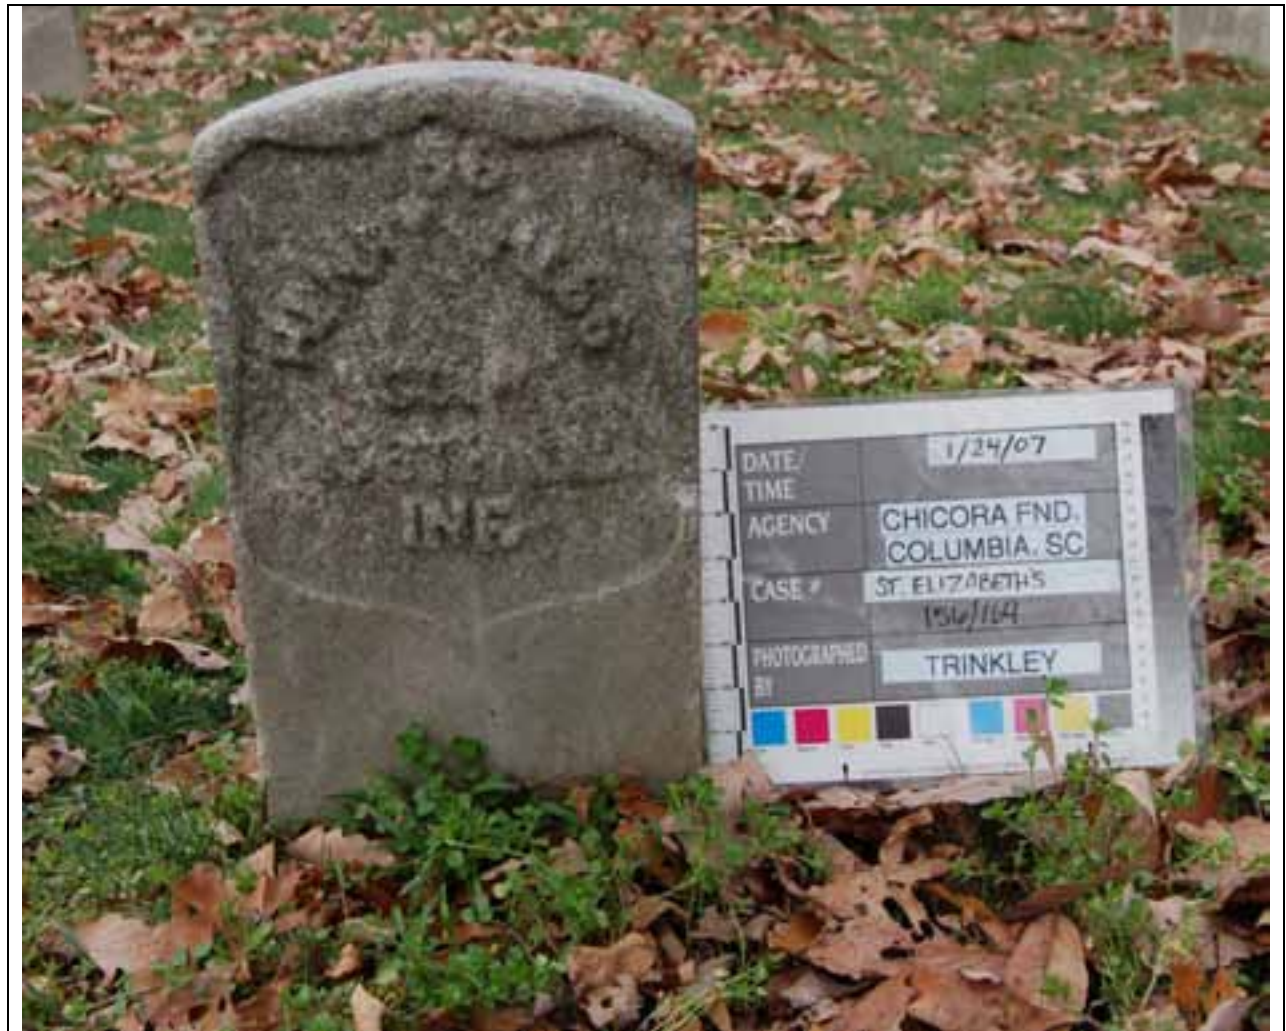
Condition of Marker: ☒ weathered ☐ cracked ☐ broken ☐ vandalized
☐ unattached ☐ loose ☐ biologicals ☐ stained
☐ repaired ☐ portions missing:
☒ tilted: degrees: 10 E-W 5 N-S Other: mower damage

Condition of Grave: satisfactory

| <input type="checkbox"/> Consider replacement with "XA" NCA marker | fiscal year |

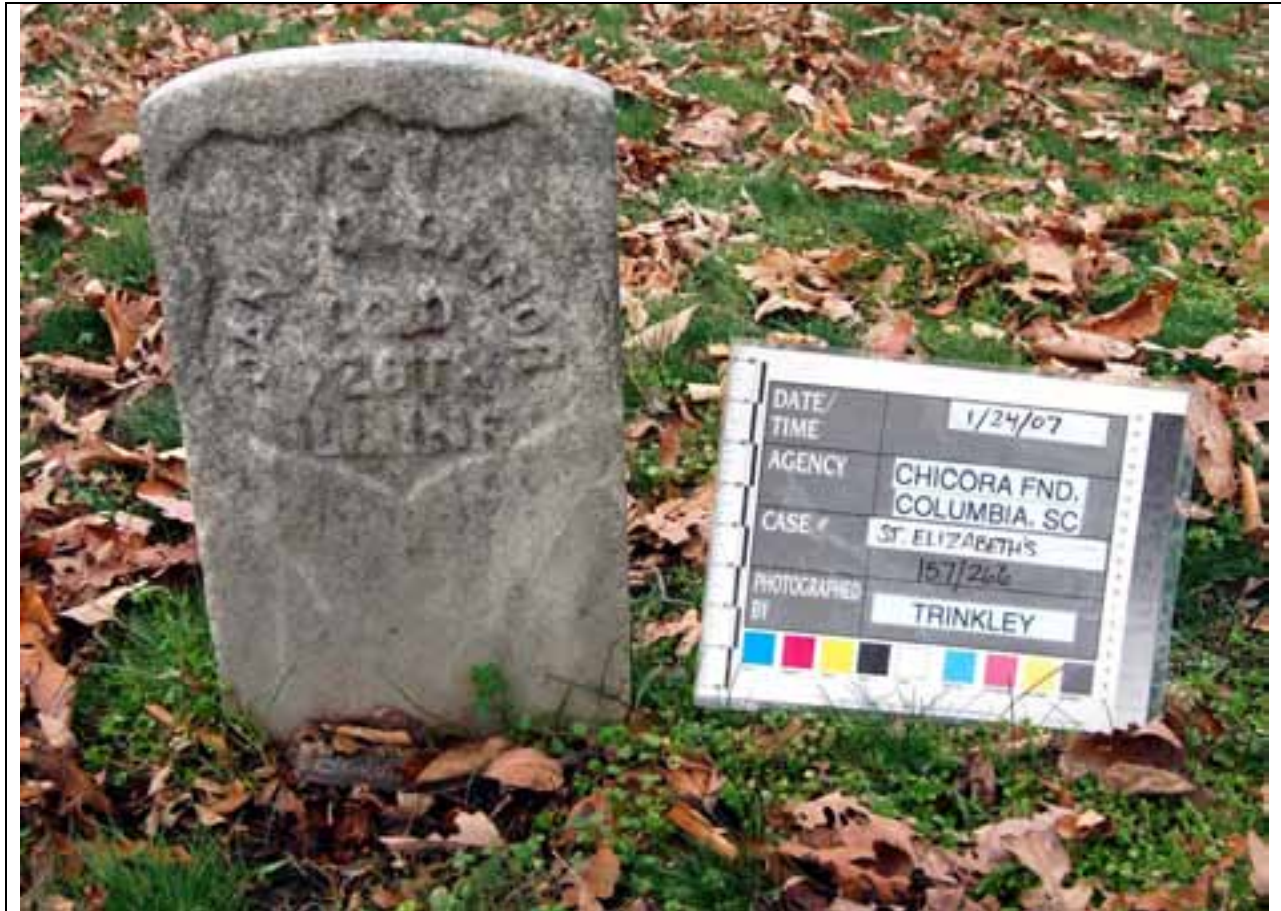
Condition of Marker: ☒ weathered ☐ cracked ☐ broken ☐ vandalized
☐ unattached ☐ loose ☐ biologicals ☐ stained
☐ repaired ☒ portions missing: chips left side
☒ tilted: degrees: 5 E-W N-S Other: mower damage

Condition of Grave: satisfactory

| <input type="checkbox"/> Consider replacement with "XA" NCA marker | fiscal year |

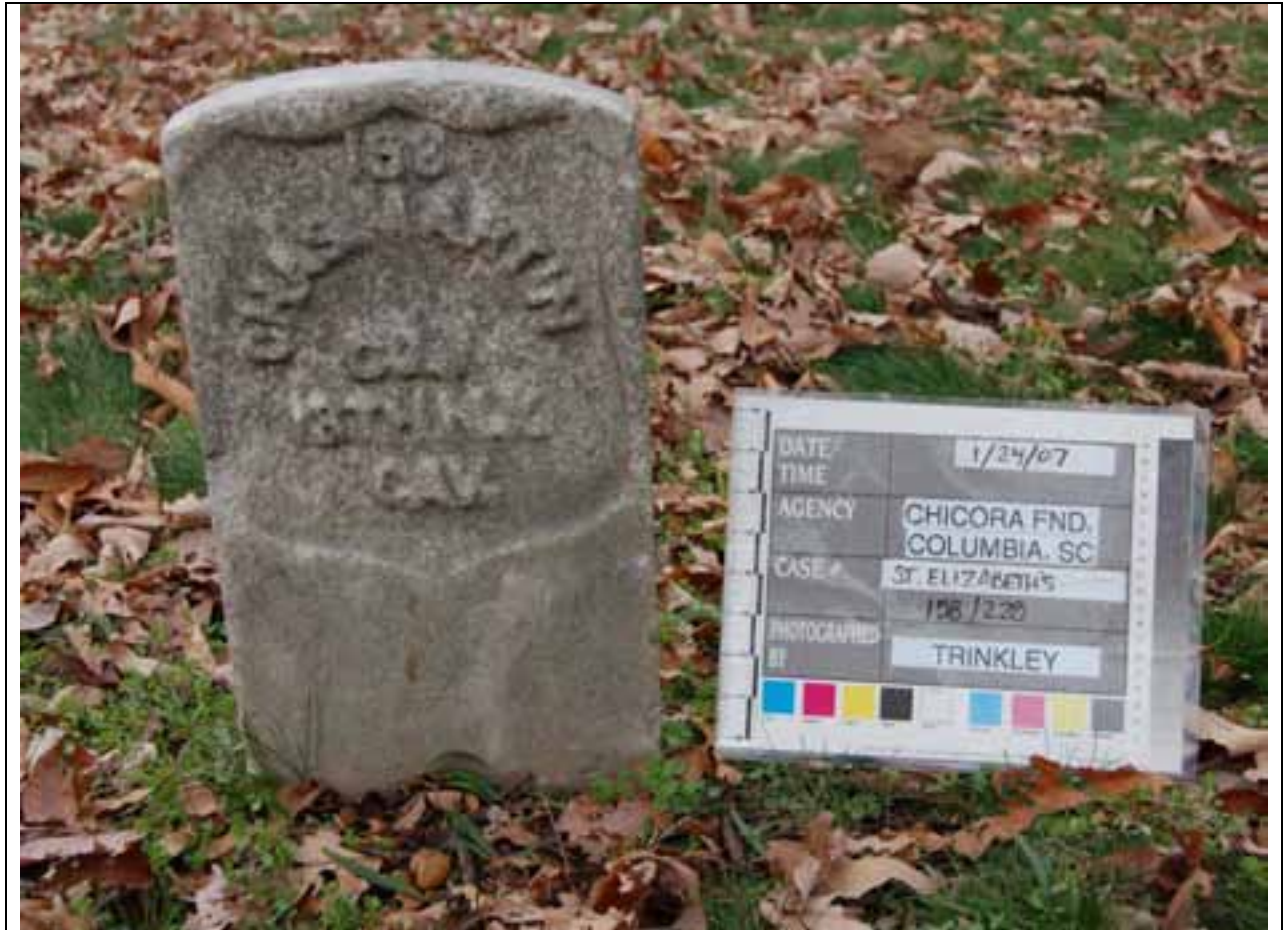
Condition of Marker: ☒ weathered ☐ cracked ☐ broken ☐ vandalized
☐ unattached ☐ loose ☐ biologicals ☐ stained
☐ repaired ☐ portions missing:
☒ tilted: degrees: 5 E-W N-S Other: mower damage

| <input type="checkbox"/> Consider replacement with "XA" NCA marker | fiscal year |

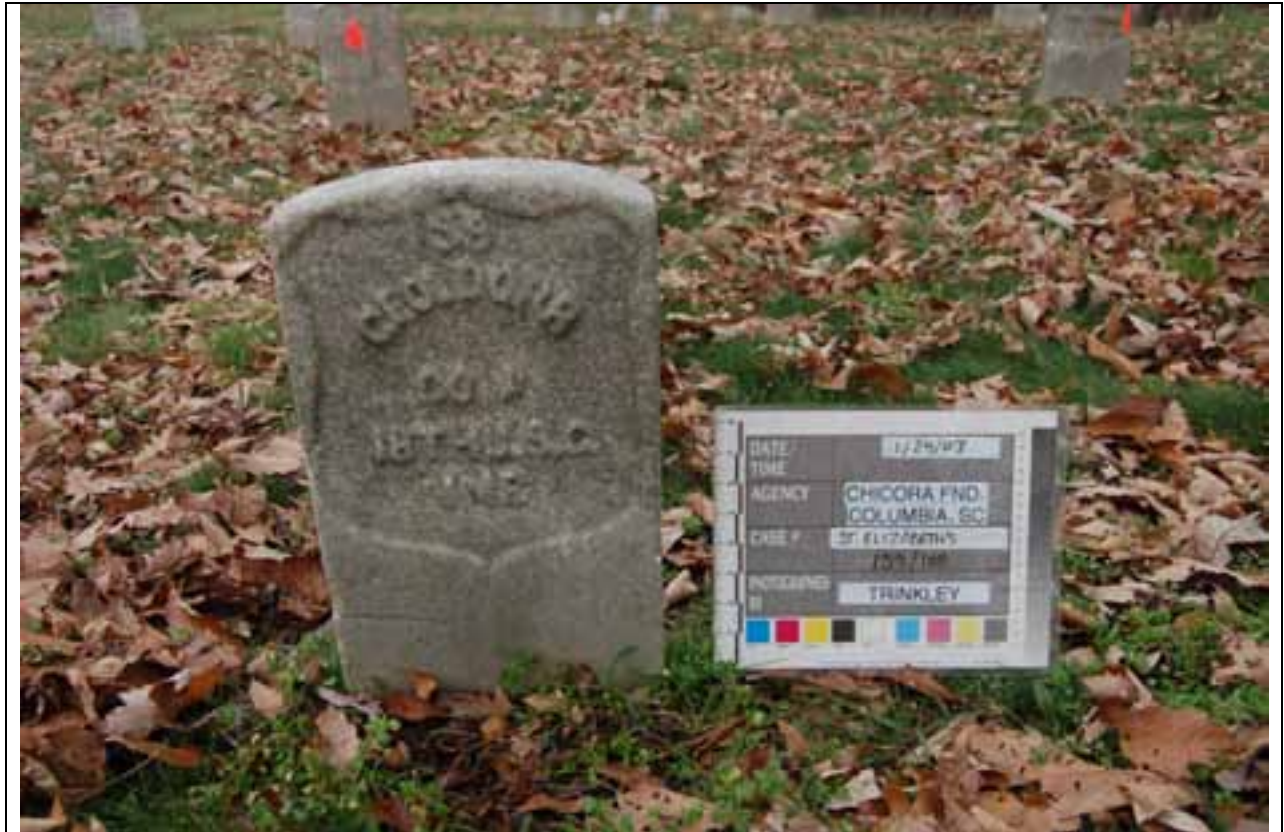
Condition of Marker: ☒ weathered ☐ cracked ☐ broken ☐ vandalized
☐ unattached ☐ loose ☒ biologicals ☒ stained
☐ repaired ☒ portions missing: chips top right and left side
☒ tilted: degrees: 10 E-W N-S Other:

Condition of Grave: satisfactory

| <input type="checkbox"/> Consider replacement with "XA" NCA marker | fiscal year |

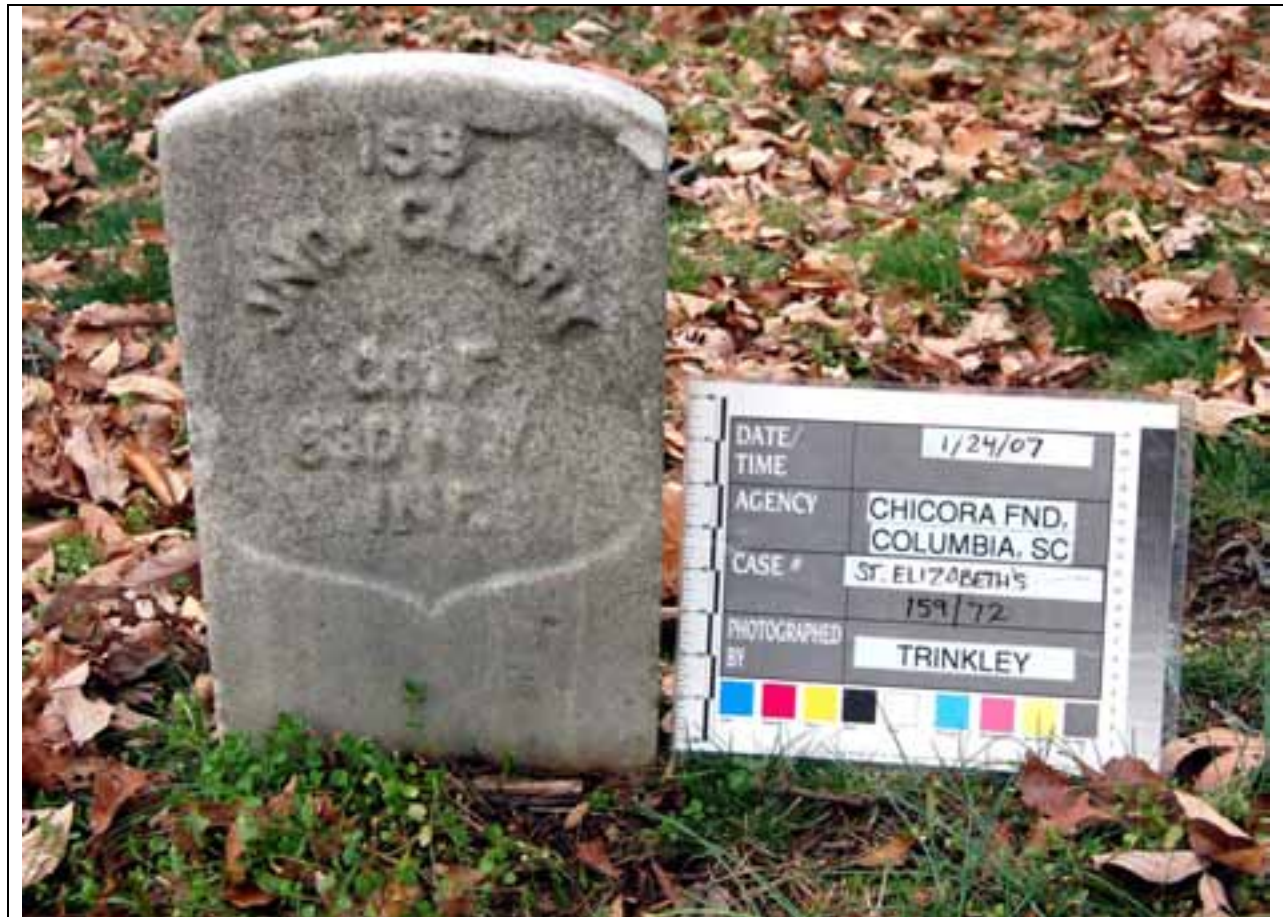
Condition of Marker: ☒ weathered ☐ cracked ☐ broken ☐ vandalized
☐ unattached ☐ loose ☐ biologicals ☐ stained
☐ repaired ☐ portions missing:
☒ tilted: degrees: 5 E-W N-S Other:

Condition of Grave: satisfactory

| <input type="checkbox"/> Consider replacement with "XA" NCA marker | fiscal year |

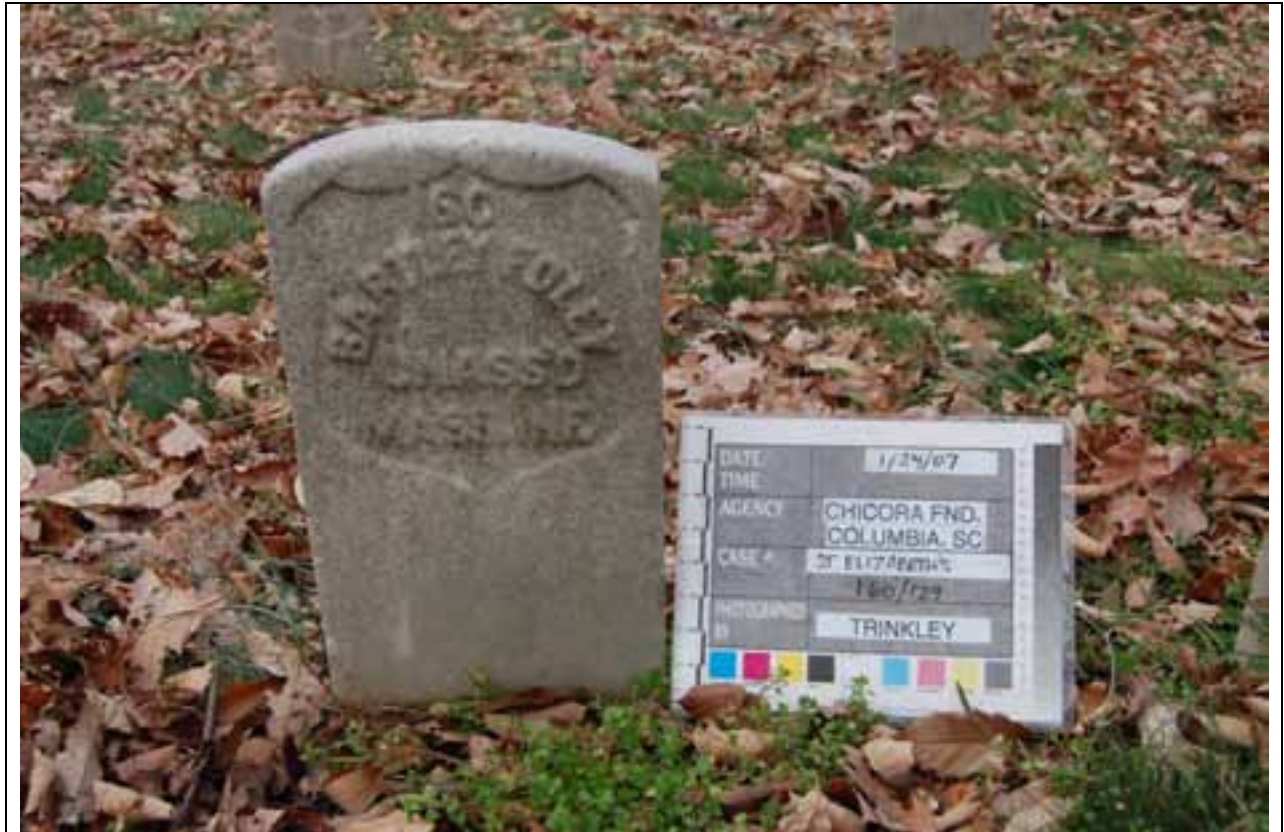
Condition of Marker: ☒ weathered ☐ cracked ☐ broken ☐ vandalized
☐ unattached ☐ loose ☐ biologicals ☐ stained
☐ repaired ☒ portions missing: chips left side
☒ tilted: degrees: 5 E-W 5 N-S Other:

Condition of Grave: satisfactory

| <input type="checkbox"/> Consider replacement with "XA" NCA marker | fiscal year |

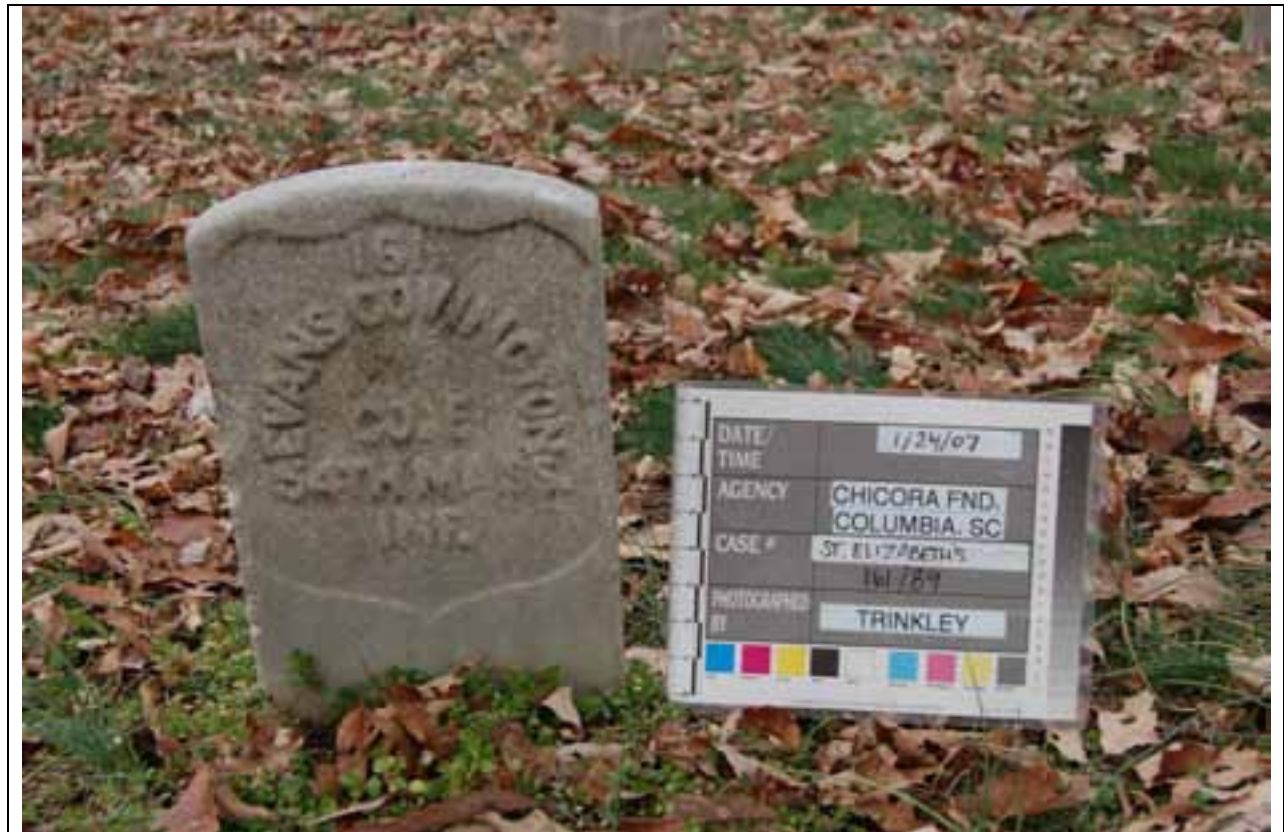
Condition of Marker: ☒ weathered ☐ cracked ☐ broken ☐ vandalized
☐ unattached ☐ loose ☐ biologicals ☐ stained
☐ repaired ☒ portions missing: chips left side
☒ tilted: degrees: 5 E-W 5 N-S Other:

Condition of Grave: satisfactory

| <input type="checkbox"/> Consider replacement with "XA" NCA marker | fiscal year |

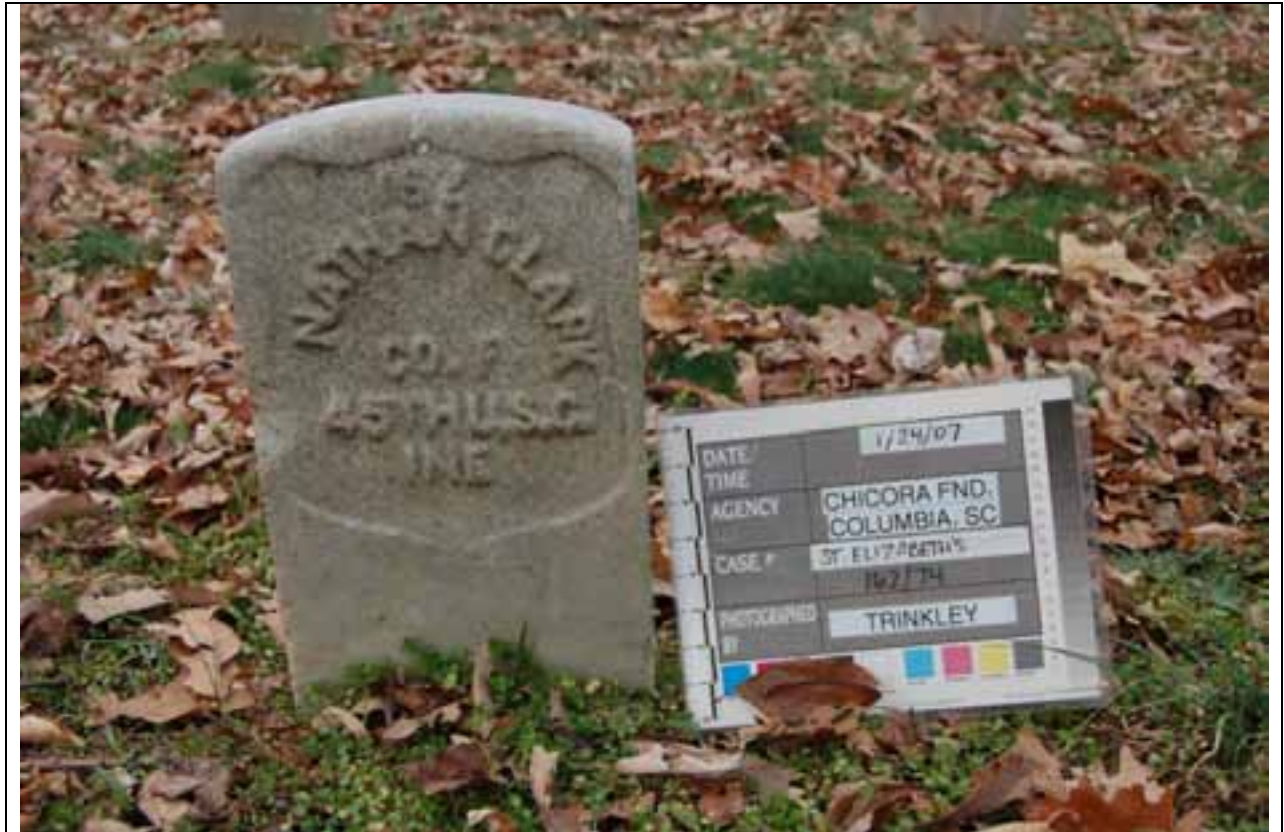
Condition of Marker: ☒ weathered ☐ cracked ☐ broken ☐ vandalized
☐ unattached ☐ loose ☐ biologicals ☐ stained
☐ repaired ☐ portions missing:
☒ tilted: degrees: 10 E-W 5 N-S Other: mower damage

Condition of Grave: satisfactory

| <input type="checkbox"/> Consider replacement with "XA" NCA marker | fiscal year | |

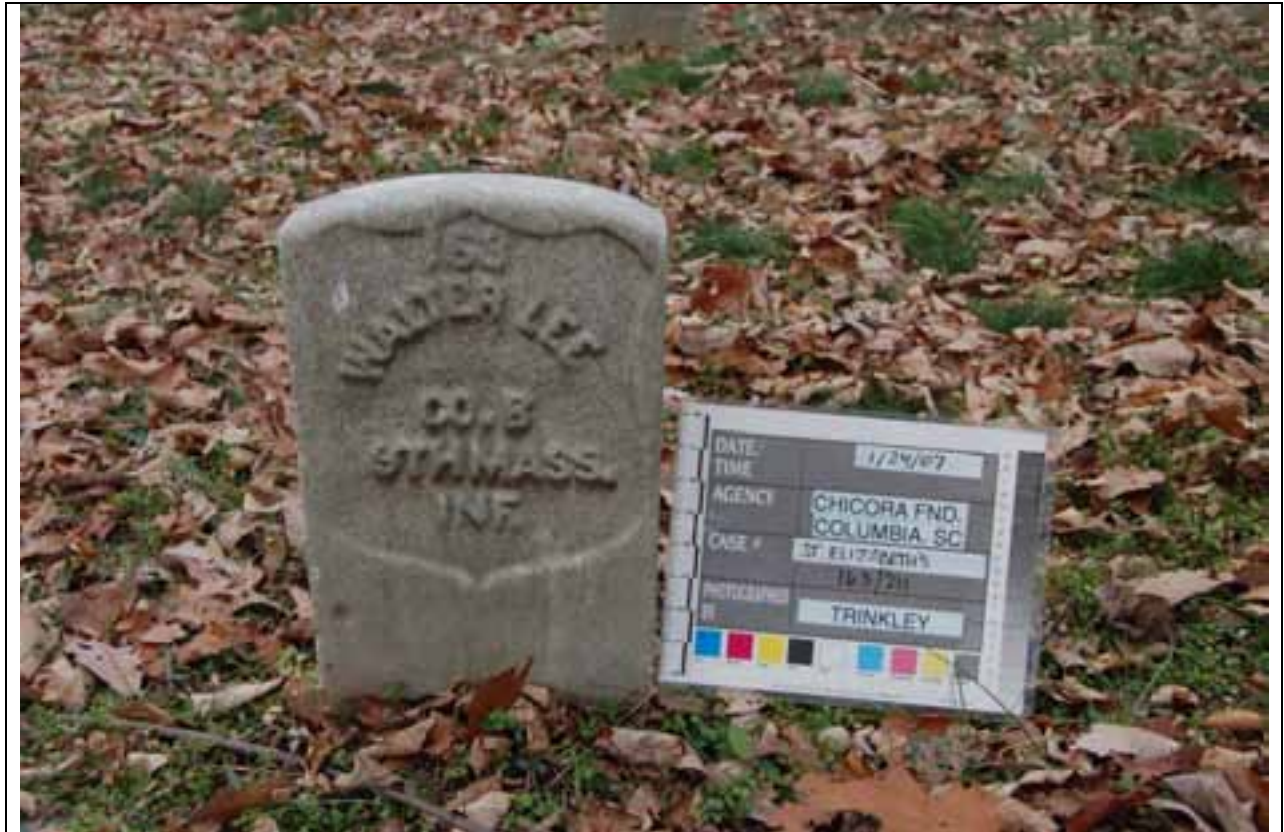
Condition of Marker: ☒ weathered ☐ cracked ☐ broken ☐ vandalized
☐ unattached ☐ loose ☒ biologicals ☒ stained
☐ repaired ☒ portions missing: chips top, right and left sides
☒ tilted: degrees: 5 E-W 5 N-S Other: mower damage; spalling

Condition of Grave: satisfactory

| <input type="checkbox"/> Consider replacement with "XA" NCA marker | fiscal year |

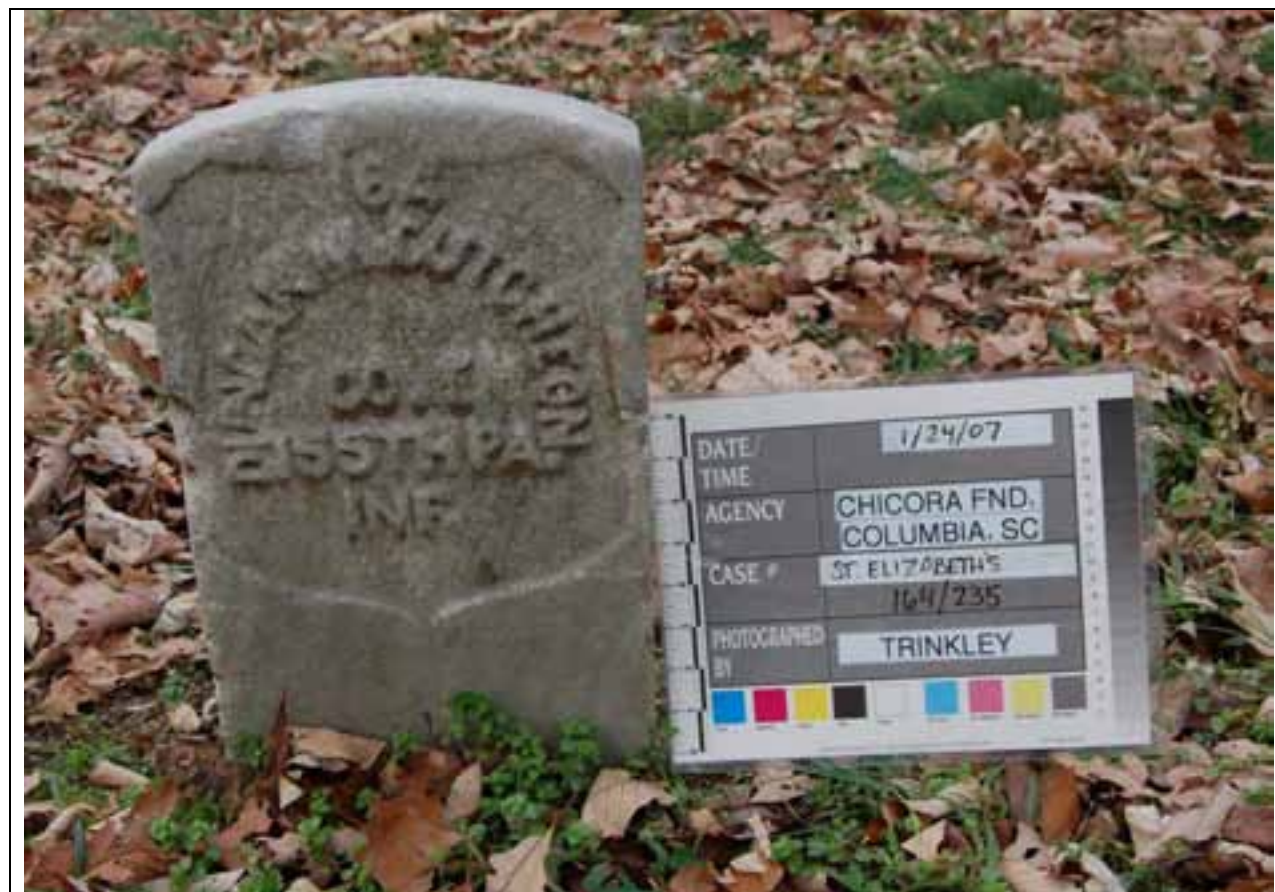
Condition of Marker: ☒ weathered ☐ cracked ☐ broken ☐ vandalized
☐ unattached ☐ loose ☐ biologicals ☐ stained
☐ repaired ☒ portions missing: chip left side
☒ tilted: degrees: 5 E-W 5 N-S Other: mower damage

Condition of Grave: satisfactory

| <input type="checkbox"/> Consider replacement with "XA" NCA marker | fiscal year | |

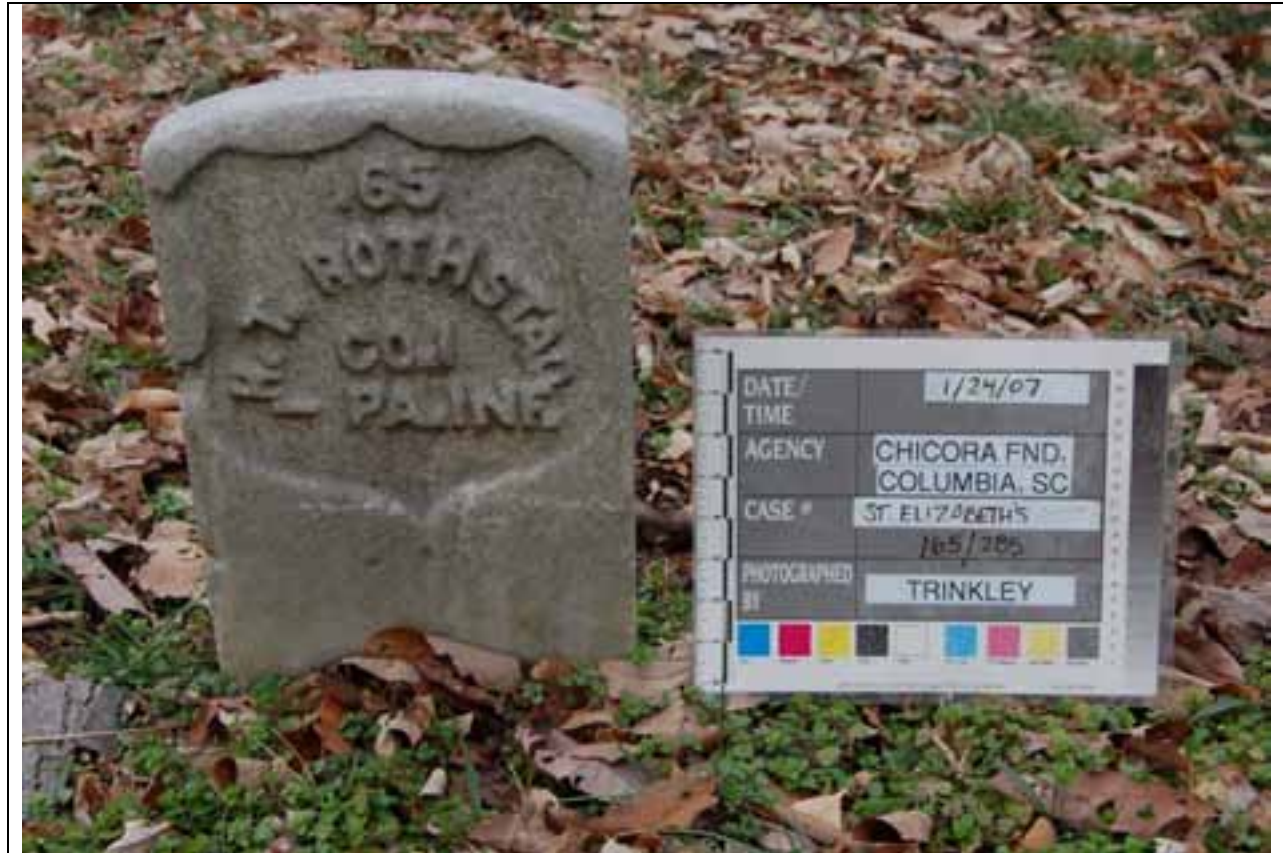
Condition of Marker: ☒ weathered ☐ cracked ☐ broken ☐ vandalized
☐ unattached ☐ loose ☐ biologicals ☐ stained
☐ repaired ☒ portions missing: chips right and left sides
☒ tilted: degrees: 5 E-W 5 N-S Other: mower damage

Condition of Grave: satisfactory

| <input type="checkbox"/> Consider replacement with "XA" NCA marker | fiscal year |

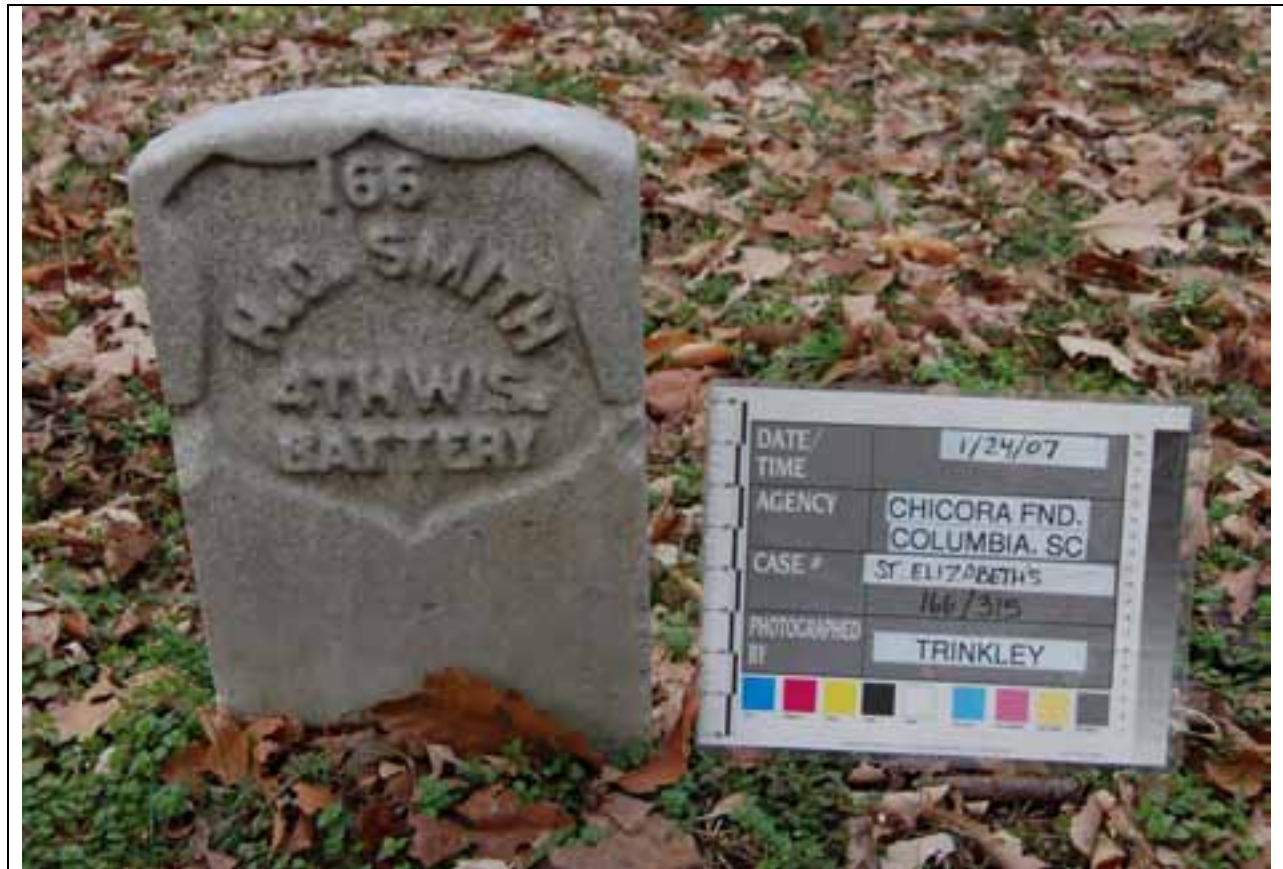
Condition of Marker: ☒ weathered ☐ cracked ☐ broken ☐ vandalized
☐ unattached ☐ loose ☒ biologicals ☒ stained
☐ repaired ☒ portions missing: chips left side
☒ tilted: degrees: 5 E-W N-S Other: mower damage

| <input type="checkbox"/> Consider replacement with "XA" NCA marker | fiscal year |

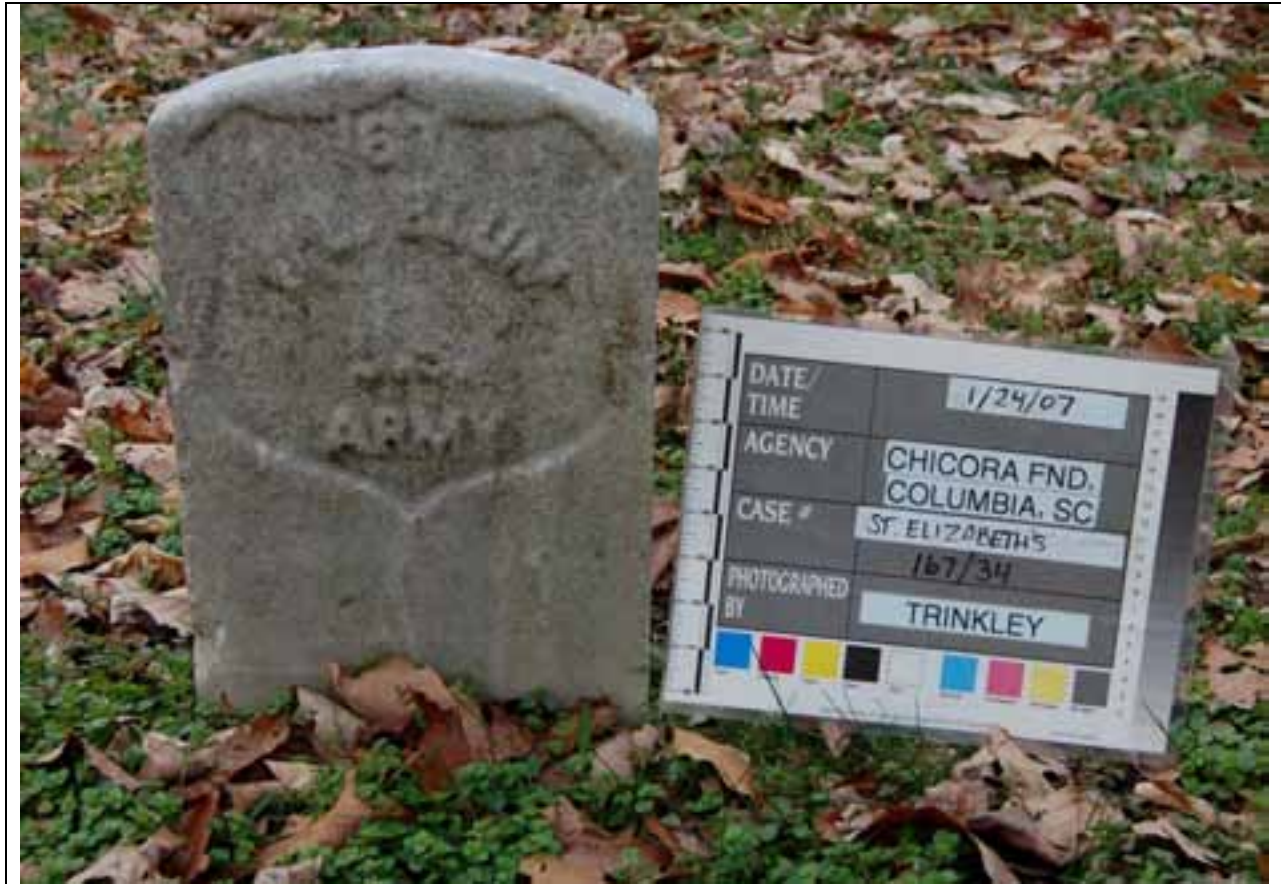
Condition of Marker: ☒ weathered ☐ cracked ☐ broken ☐ vandalized
☐ unattached ☐ loose ☐ biologicals ☐ stained
☐ repaired ☒ portions missing: chips right and left sides
☒ tilted: degrees: 5 E-W N-S Other: abrasion in shield

Condition of Grave: satisfactory

| <input type="checkbox"/> Consider replacement with "XA" NCA marker | fiscal year |

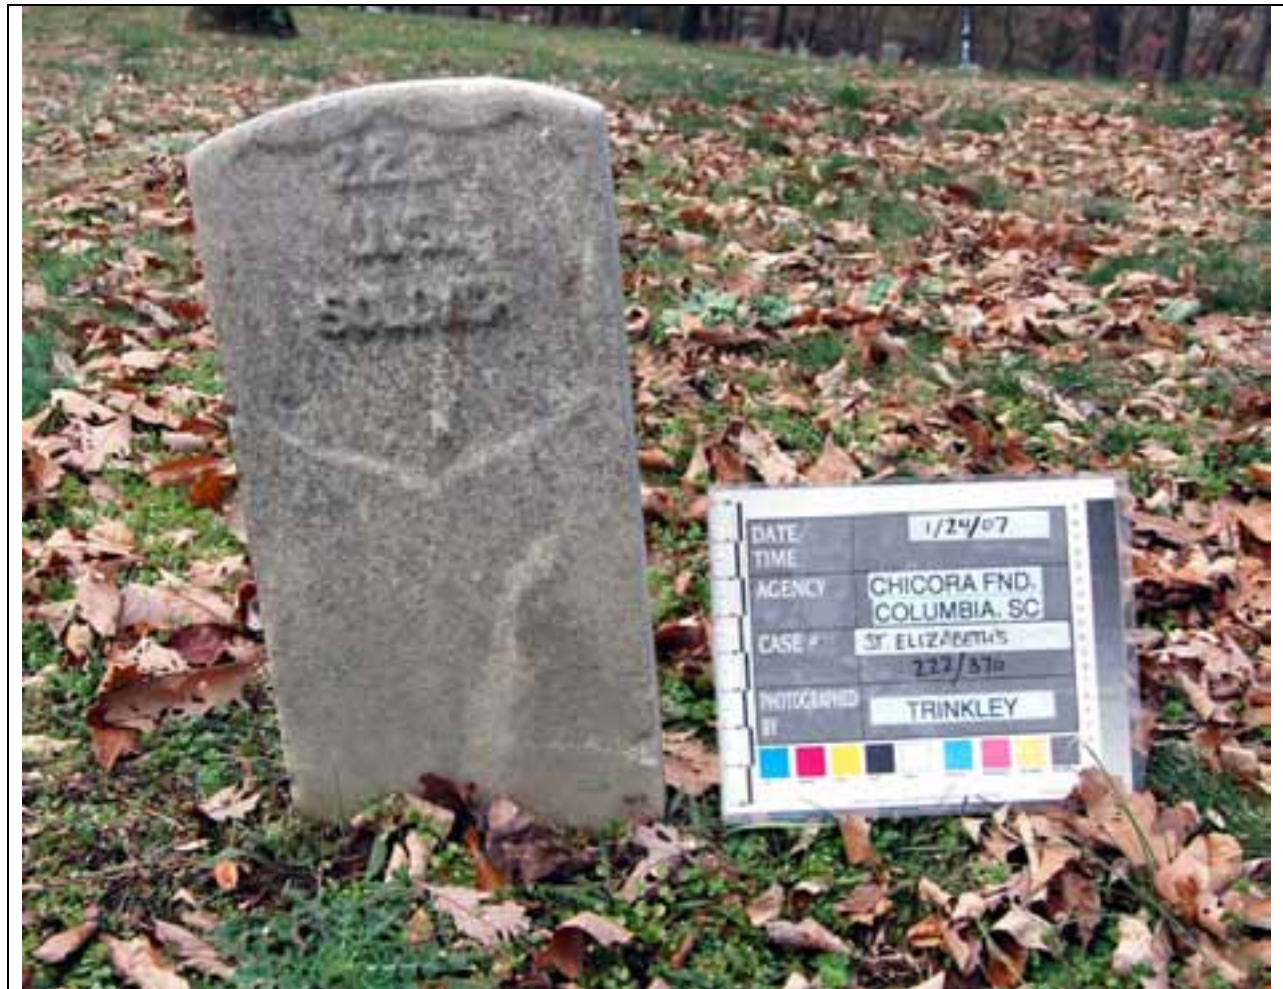
Condition of Marker: ☒ weathered ☐ cracked ☐ broken ☐ vandalized
☐ unattached ☐ loose ☐ biologicals ☐ stained
☐ repaired ☒ portions missing: chips right and left sides
☒ tilted: degrees: 10 E-W 10 N-S Other:

Condition of Grave: satisfactory

| <input type="checkbox"/> Consider replacement with "XA" NCA marker | fiscal year |

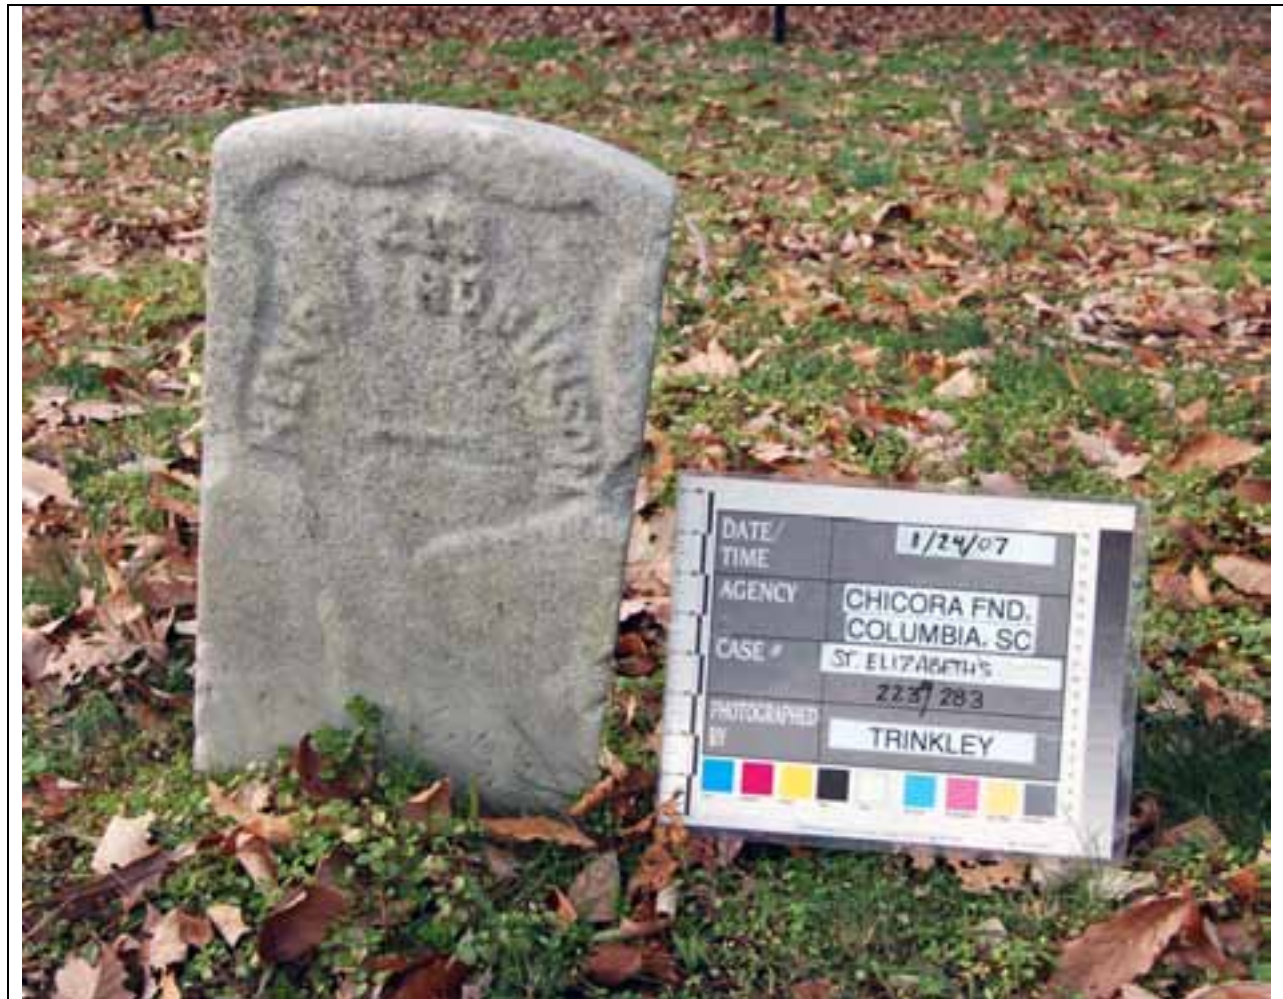
Condition of Marker: ☒ weathered ☐ cracked ☐ broken ☐ vandalized
☐ unattached ☐ loose ☐ biologicals ☐ stained
☐ repaired ☒ portions missing: chips left side
☒ tilted: degrees: 10 E-W N-S Other: mower damage

Condition of Grave: satisfactory

| <input type="checkbox"/> Consider replacement with "XA" NCA marker | fiscal year |

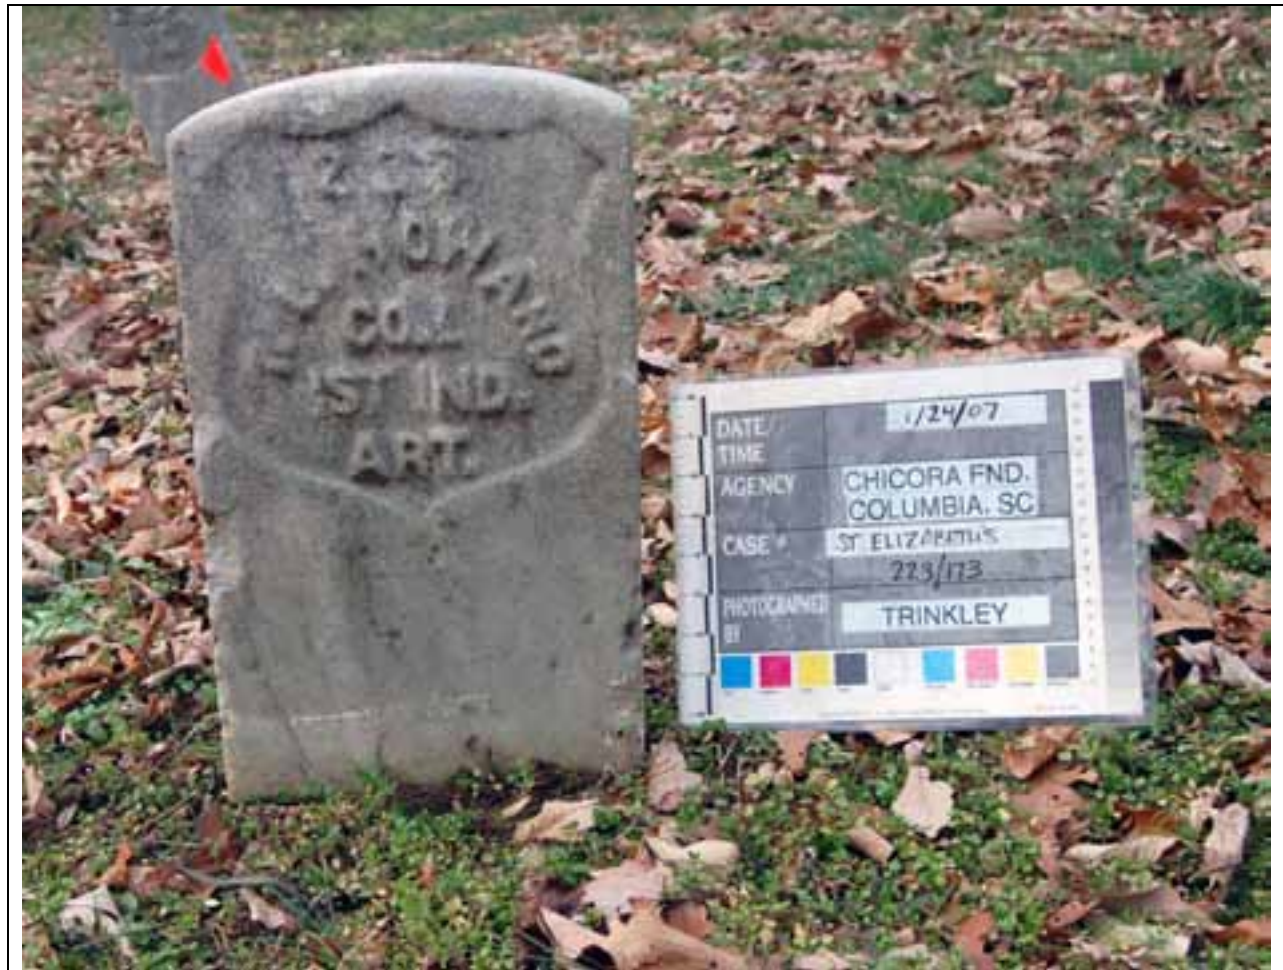
Condition of Marker: ☒ weathered ☐ cracked ☐ broken ☐ vandalized
☐ unattached ☐ loose ☒ biologicals ☒ stained
☐ repaired ☒ portions missing: chip left side
☒ tilted: degrees: 10 E-W N-S Other: mower damage

Condition of Grave: satisfactory

| <input type="checkbox"/> Consider replacement with "XA" NCA marker | fiscal year |
