PRESERVATION PLANNING FOR ST. ELIZABETHS WEST CAMPUS CEMETERY, ST. ELIZABETHS HOSPITAL, WASHINGTON, DC

Research Contribution 472

Michael Trinkley
Debi Hacker

June 2007

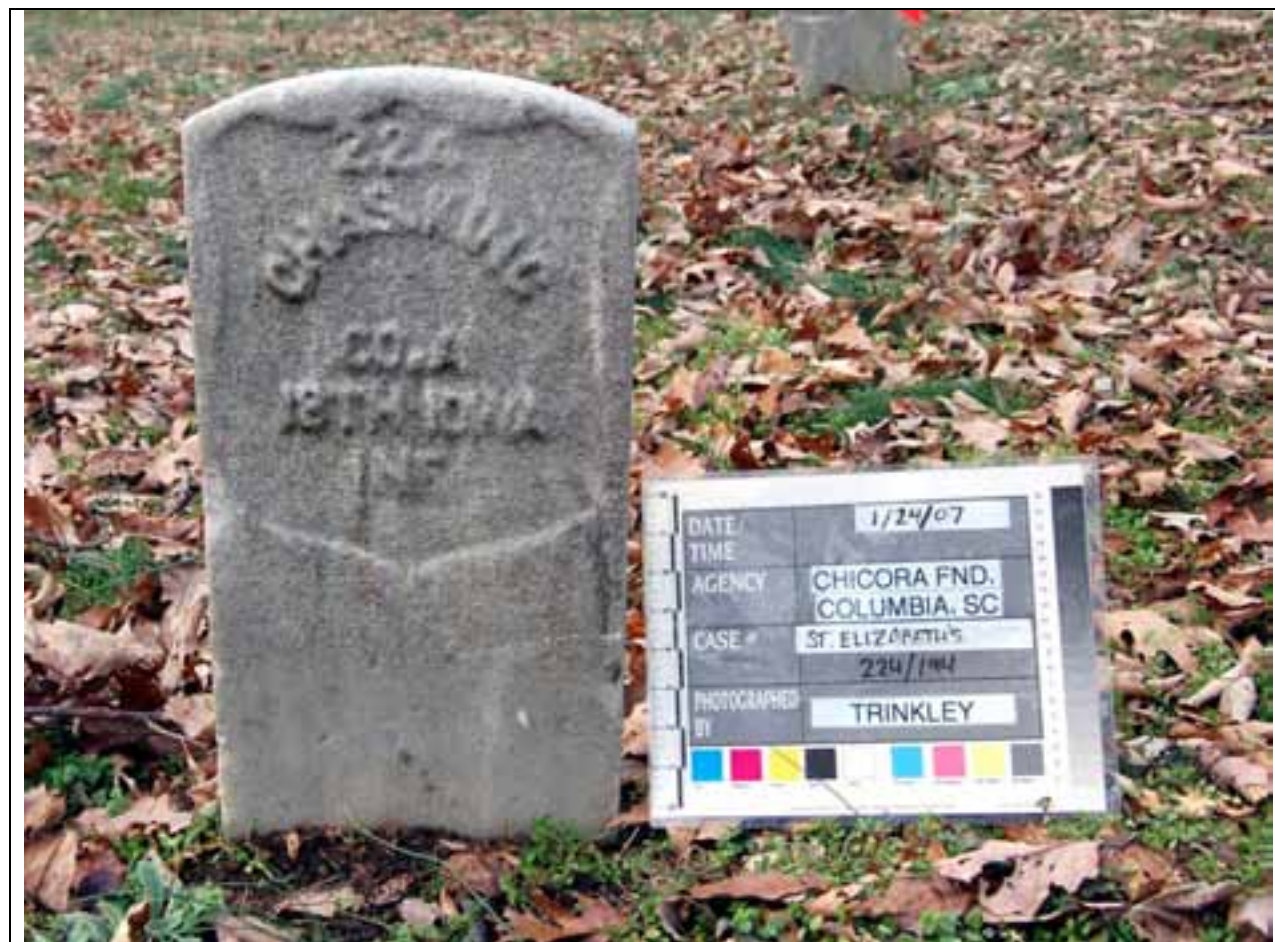
Condition of Marker: ☒ weathered ☐ cracked ☐ broken ☐ vandalized
☐ unattached ☐ loose ☐ biologicals ☒ stained
☐ repaired ☒ portions missing: chips left side
☒ tilted: degrees: 10 E-W N-S Other: mower damage

Condition of Grave: satisfactory

| <input type="checkbox"/> Consider replacement with "XA" NCA marker | fiscal year |

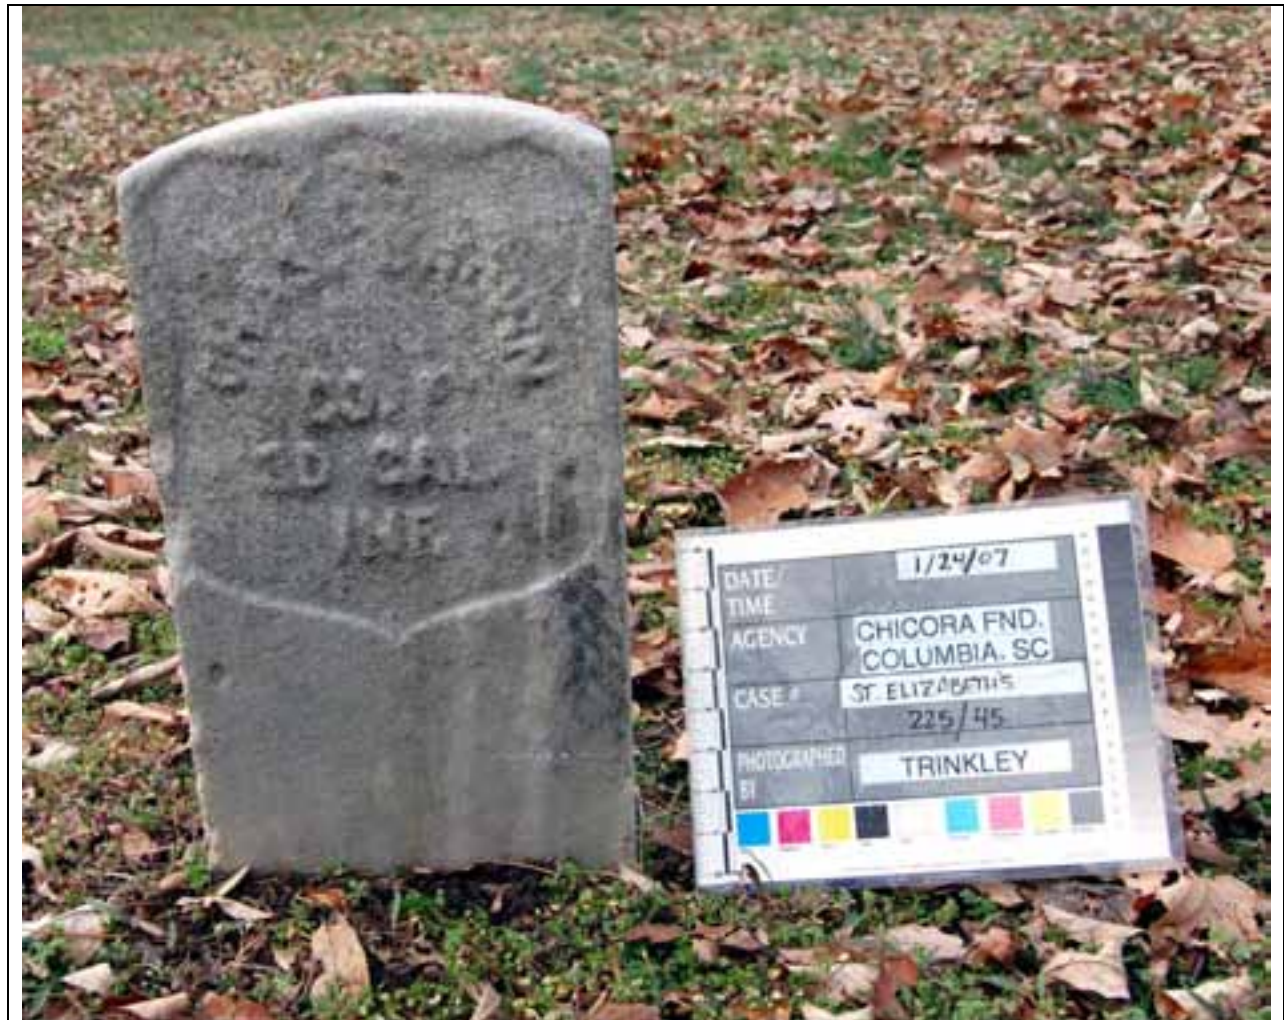
Condition of Marker: ☒ weathered ☐ cracked ☐ broken ☐ vandalized
☐ unattached ☐ loose ☐ biologicals ☐ stained
☐ repaired ☒ portions missing: chips left side
☒ tilted: degrees: 10 E-W 10 N-S Other:

Condition of Grave: satisfactory

| <input type="checkbox"/> Consider replacement with "XA" NCA marker | fiscal year |

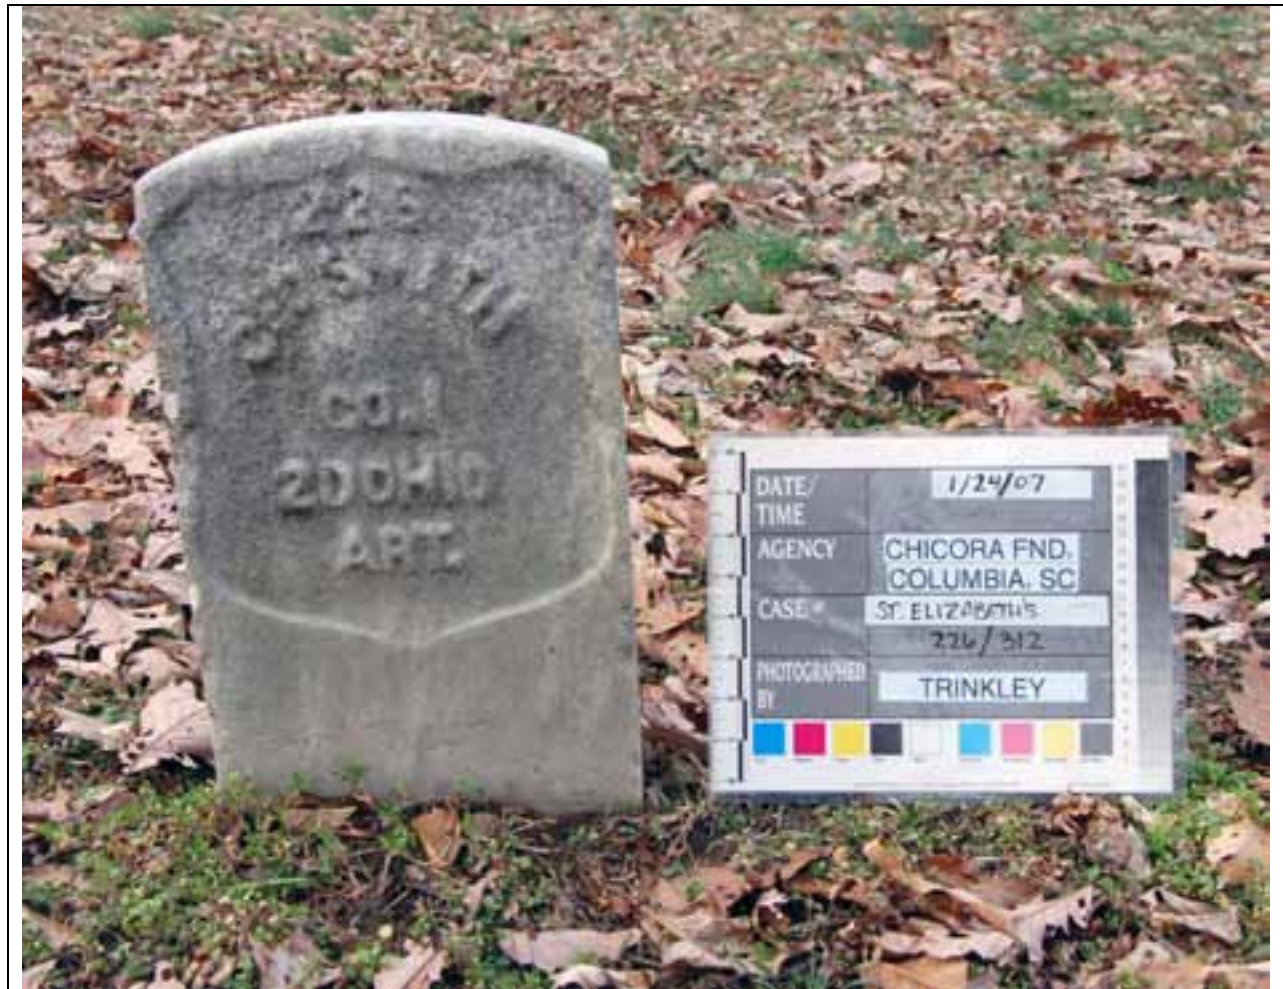
Condition of Marker: ☒ weathered ☐ cracked ☐ broken ☐ vandalized
☐ unattached ☐ loose ☐ biologicals ☐ stained
☐ repaired ☒ portions missing: chips right and left sides
☒ tilted: degrees: 10 E-W 15 N-S Other: mower damage

Condition of Grave: satisfactory

| <input type="checkbox"/> Consider replacement with "XA" NCA marker | fiscal year |

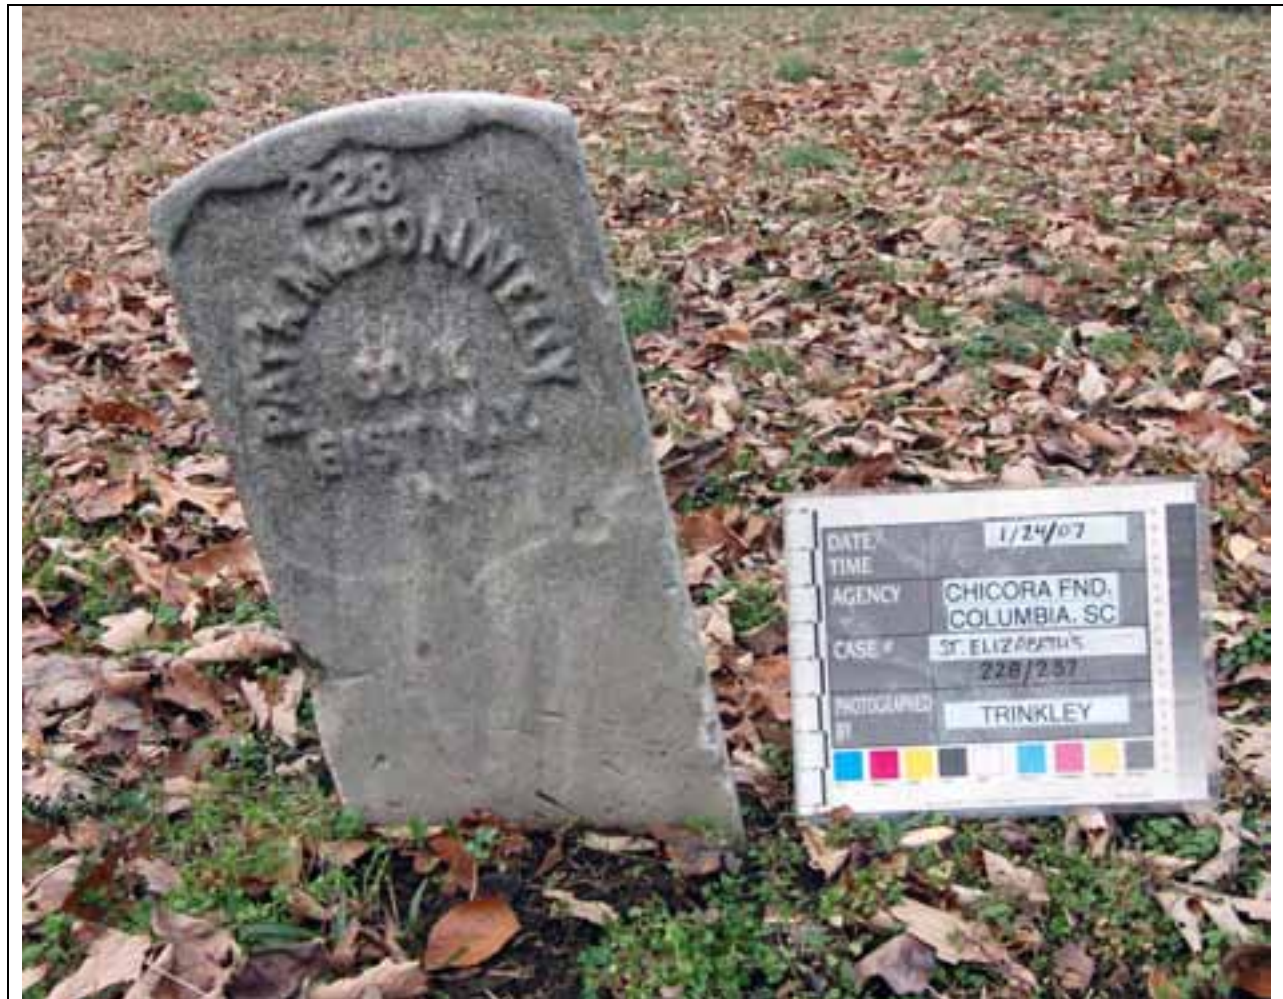
Condition of Marker: ☒ weathered ☐ cracked ☒ broken ☐ vandalized
☐ unattached ☐ loose ☐ biologicals ☐ stained
☐ repaired ☒ portions missing: base
☐ tilted: degrees: E-W N-S Other: flat on ground

Condition of Grave: satisfactory

| <input checked="" type="checkbox"/> Consider replacement with "XA" NCA marker | fiscal year |

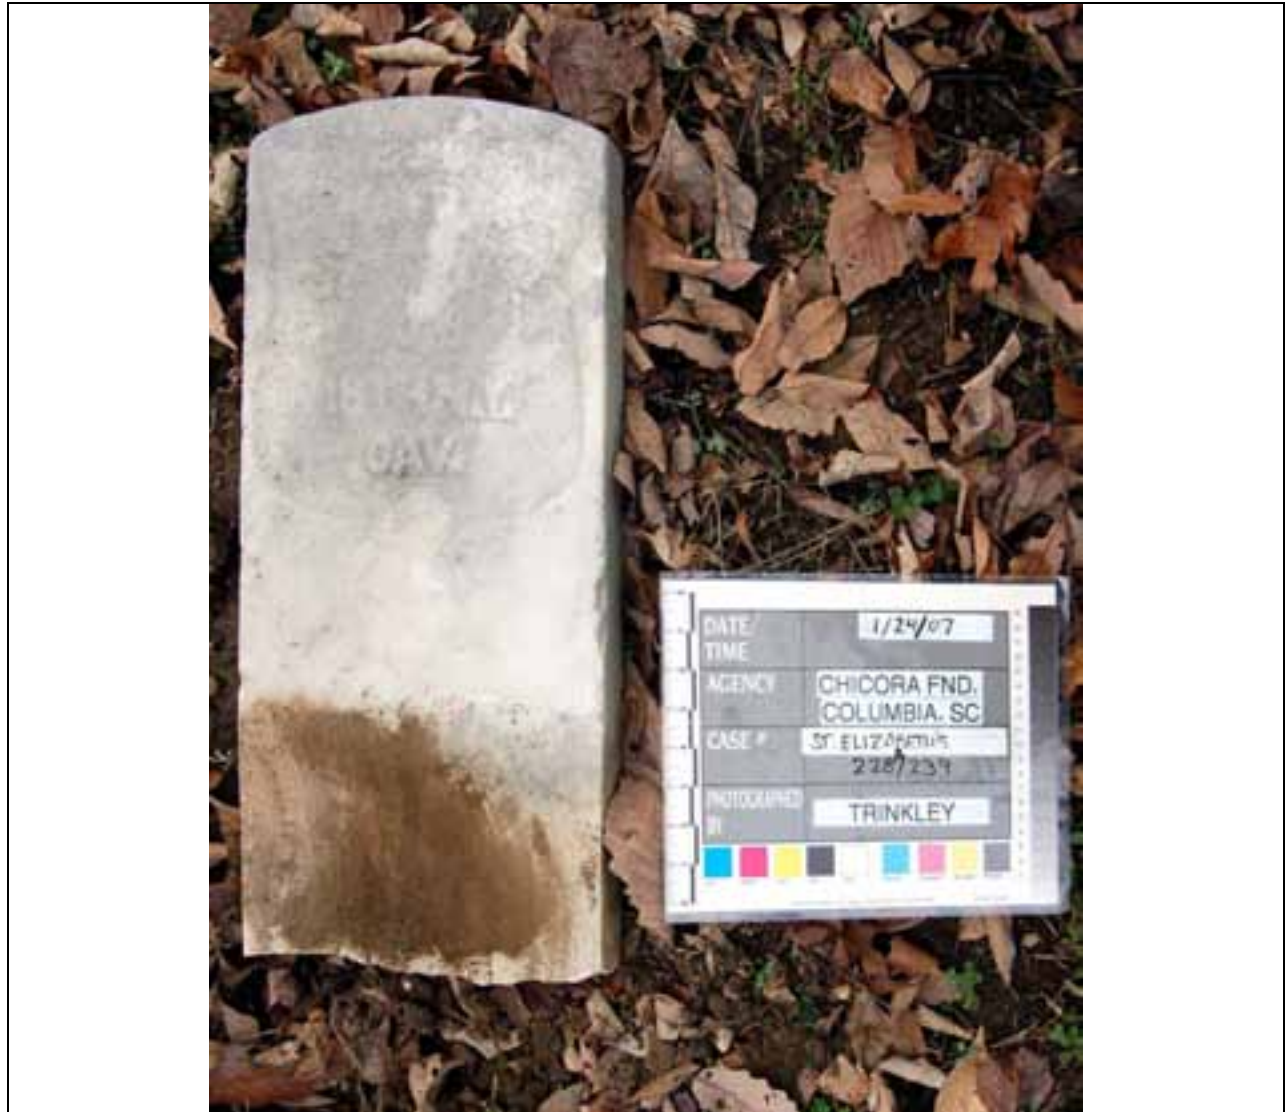
Condition of Marker: ☒ weathered ☐ cracked ☒ broken ☐ vandalized
☐ unattached ☐ loose ☐ biologicals ☐ stained
☐ repaired ☒ portions missing: chips left edge
☒ tilted: degrees: 10 E-W 5 N-S Other: mower damage

Condition of Grave: satisfactory

| <input type="checkbox"/> Consider replacement with "XA" NCA marker | fiscal year |

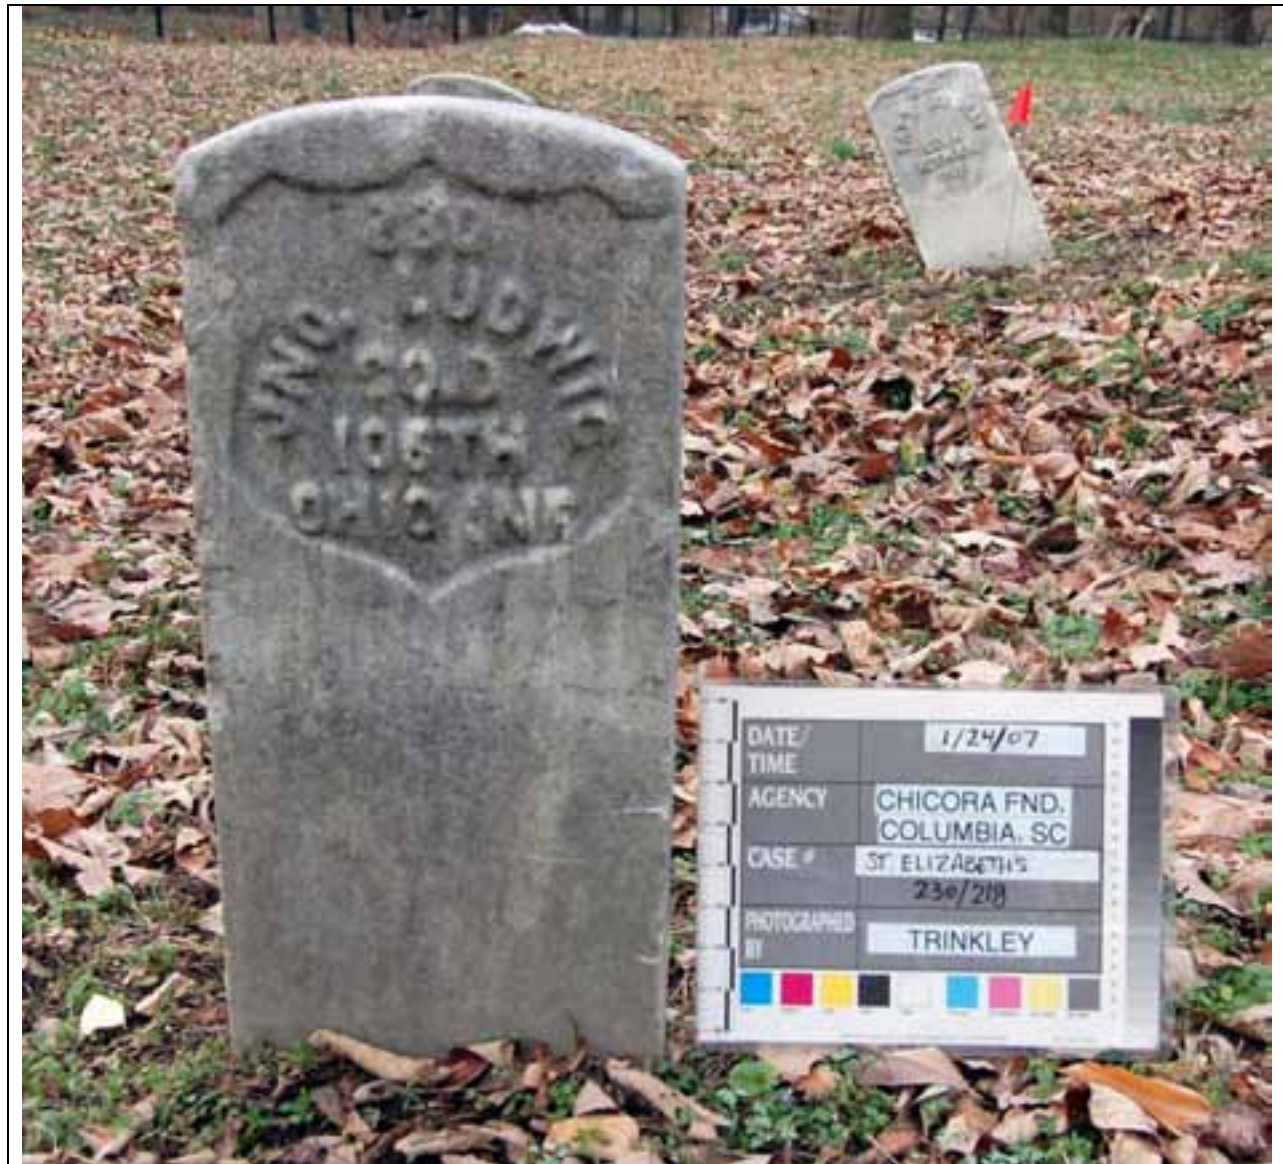
Condition of Marker: ☒ weathered ☐ cracked ☒ broken ☐ vandalized
☐ unattached ☐ loose ☐ biologicals ☐ stained
☐ repaired ☒ portions missing: lower half of stone
☐ tilted: degrees: E-W N-S Other: flat on ground

Condition of Grave: satisfactory

| <input checked="" type="checkbox"/> Consider replacement with "XA" NCA marker | fiscal year |

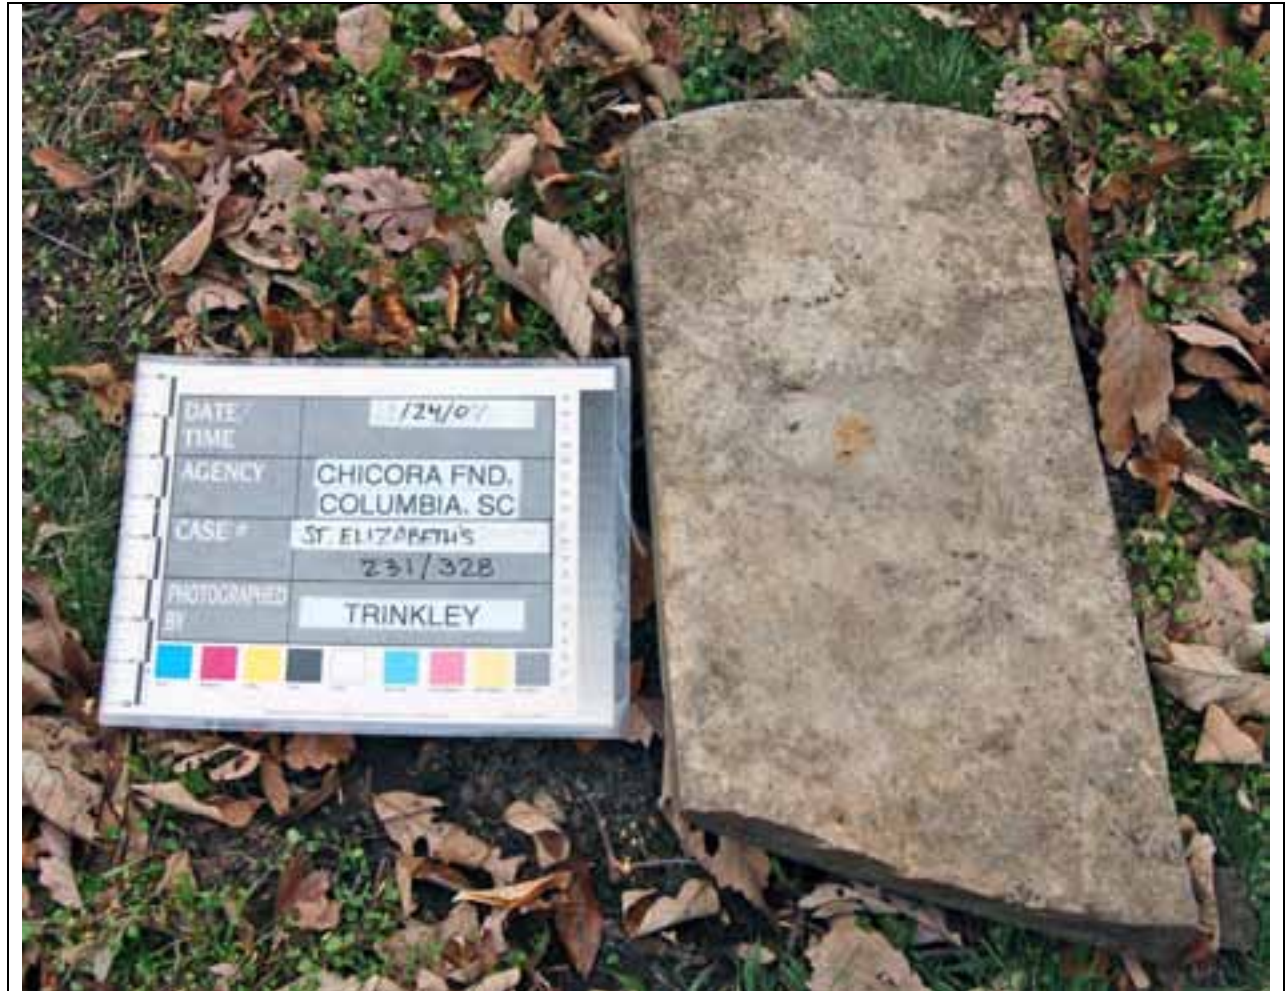
Condition of Marker: ☒ weathered ☐ cracked ☐ broken ☐ vandalized
☐ unattached ☐ loose ☐ biologicals ☐ stained
☐ repaired ☒ portions missing: CHIPS
☒ tilted: degrees: 100 E-W 50 N-S Other:

Condition of Grave: satisfactory

| <input type="checkbox"/> Consider replacement with "XA" NCA marker | fiscal year |

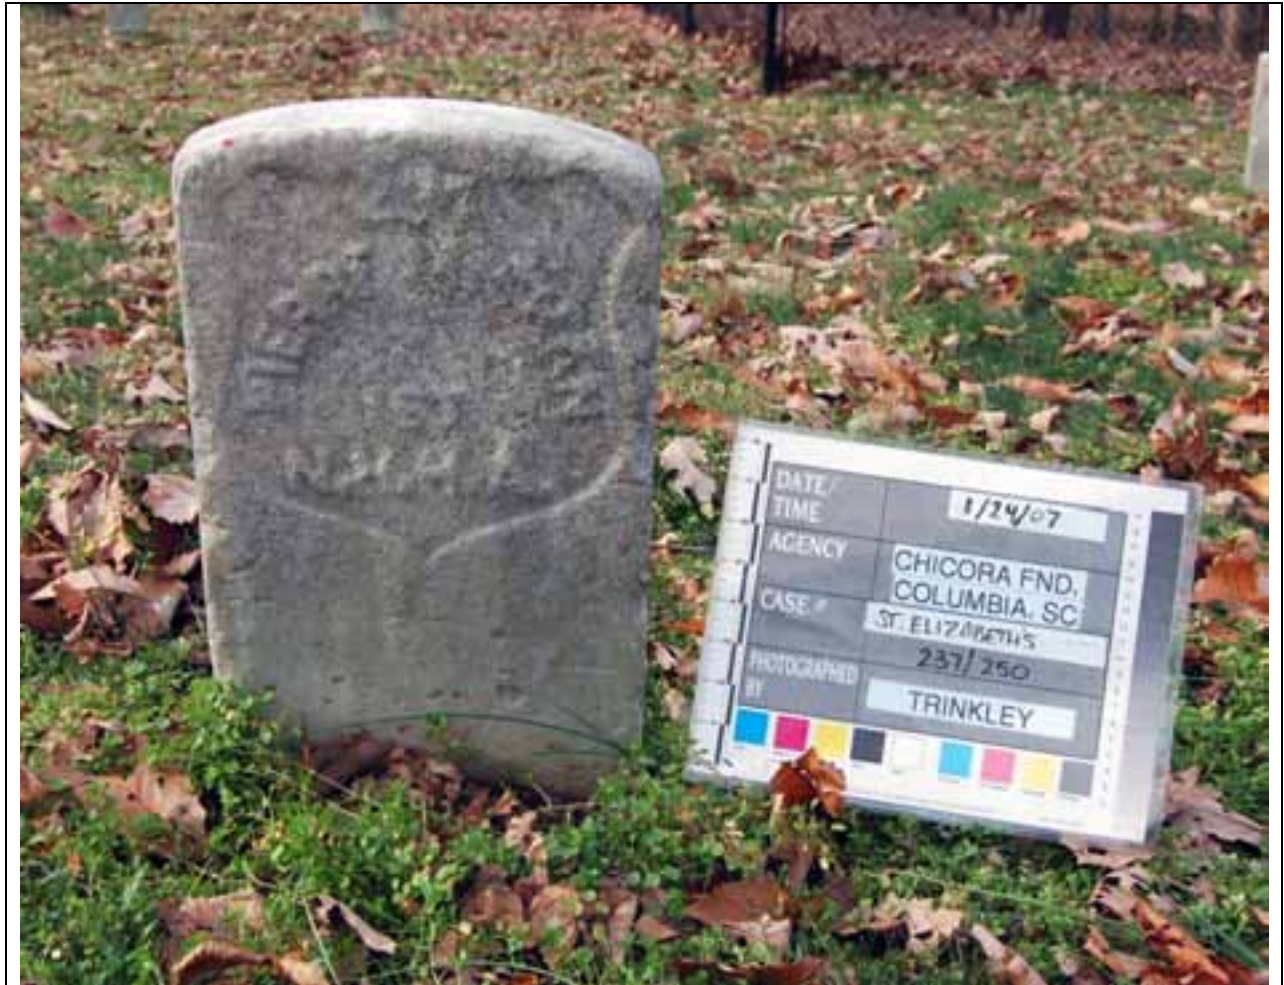
Condition of Marker: ☒ weathered ☐ cracked ☐ broken ☐ vandalized
☐ unattached ☐ loose ☐ biologicals ☐ stained
☐ repaired ☒ portions missing: chips left edge
☒ tilted: degrees: 10 E-W 5 N-S Other: mower damage

Condition of Grave: satisfactory

| <input type="checkbox"/> Consider replacement with "XA" NCA marker | fiscal year |

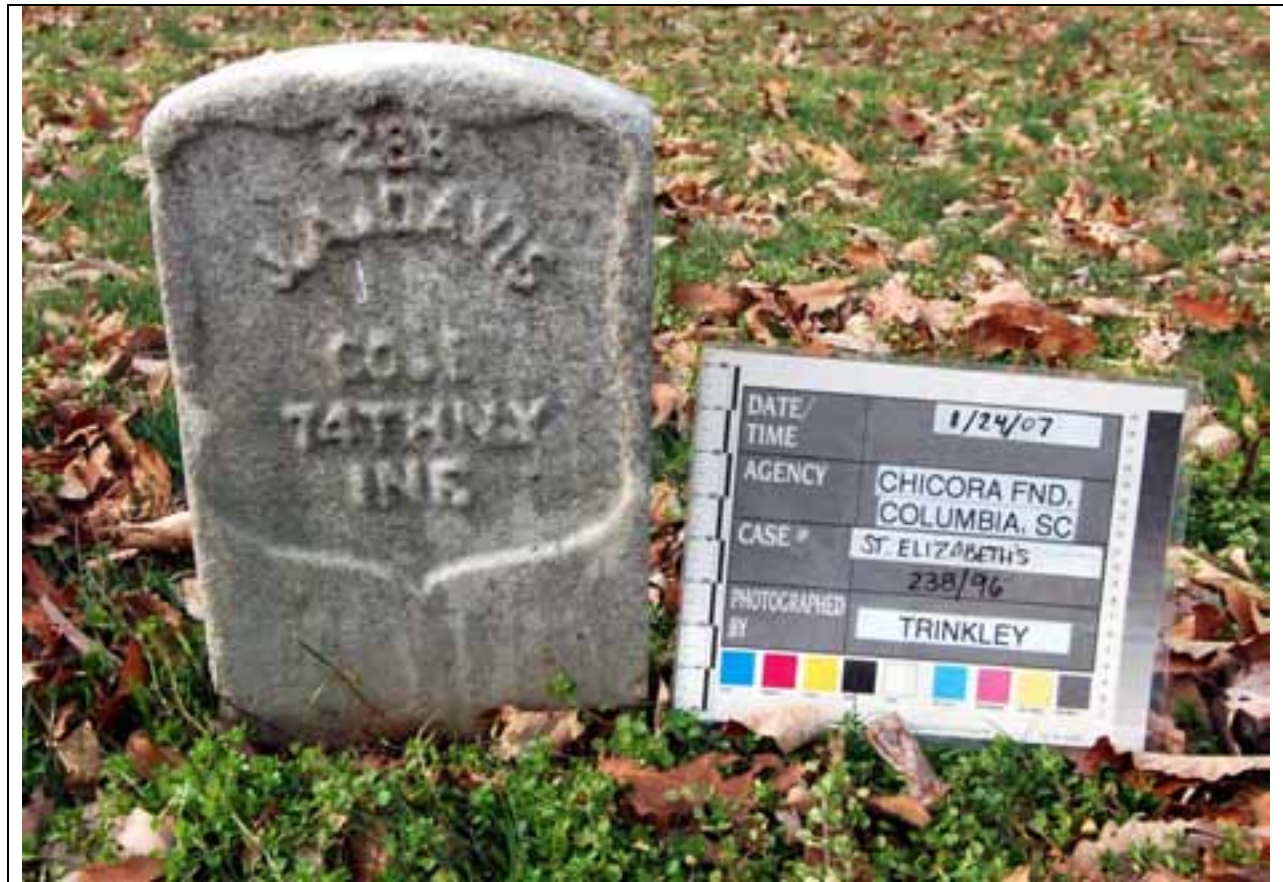
Condition of Marker: ☒ weathered ☐ cracked ☐ broken ☐ vandalized
☐ unattached ☐ loose ☐ biologicals ☐ stained
☐ repaired ☒ portions missing: chips right side
☒ tilted: degrees: 5 E-W N-S Other: mower damage

Condition of Grave: satisfactory

| <input type="checkbox"/> Consider replacement with "XA" NCA marker | fiscal year |

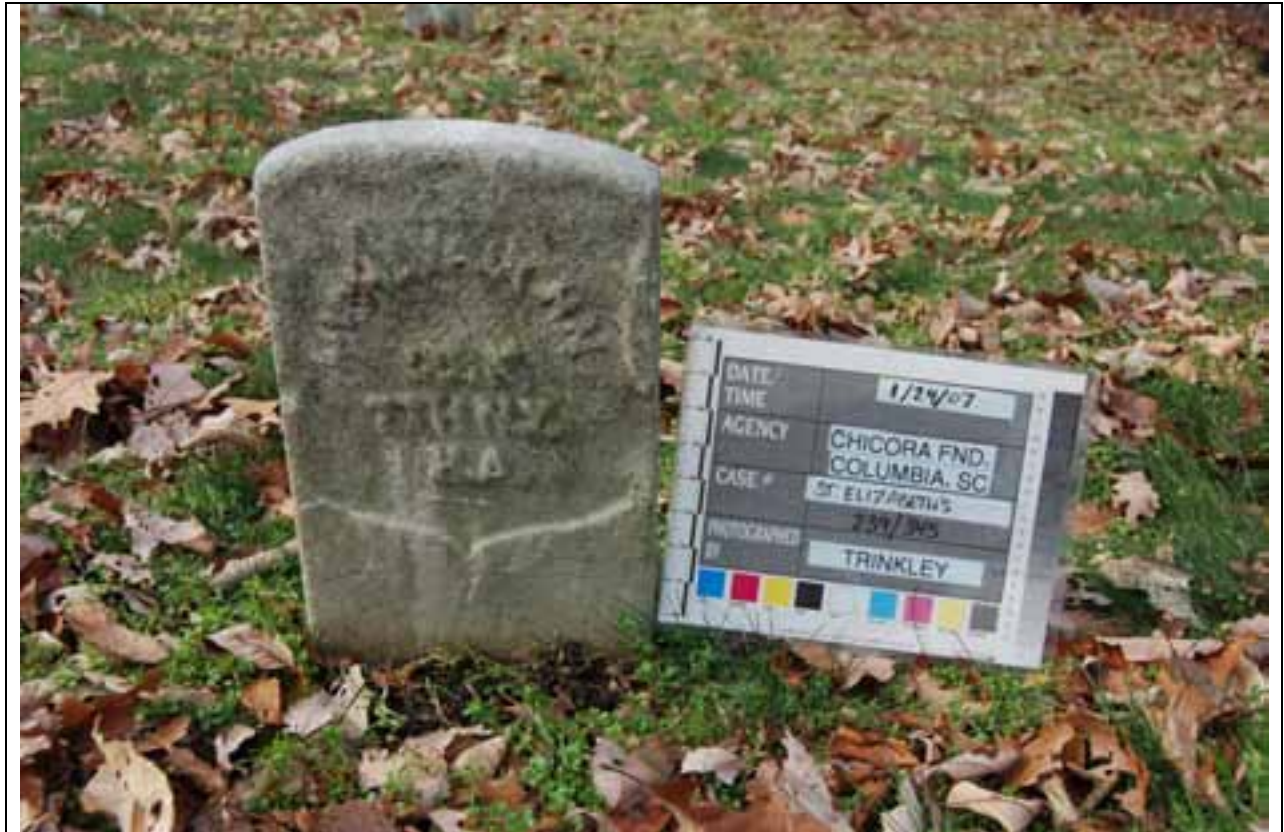
Condition of Marker: ☒ weathered ☐ cracked ☐ broken ☐ vandalized
☐ unattached ☐ loose ☐ biologicals ☐ stained
☐ repaired ☐ portions missing:
☒ tilted: degrees: 5 E-W N-S Other: mower damage

Condition of Grave: satisfactory

| <input type="checkbox"/> Consider replacement with "XA" NCA marker | fiscal year |

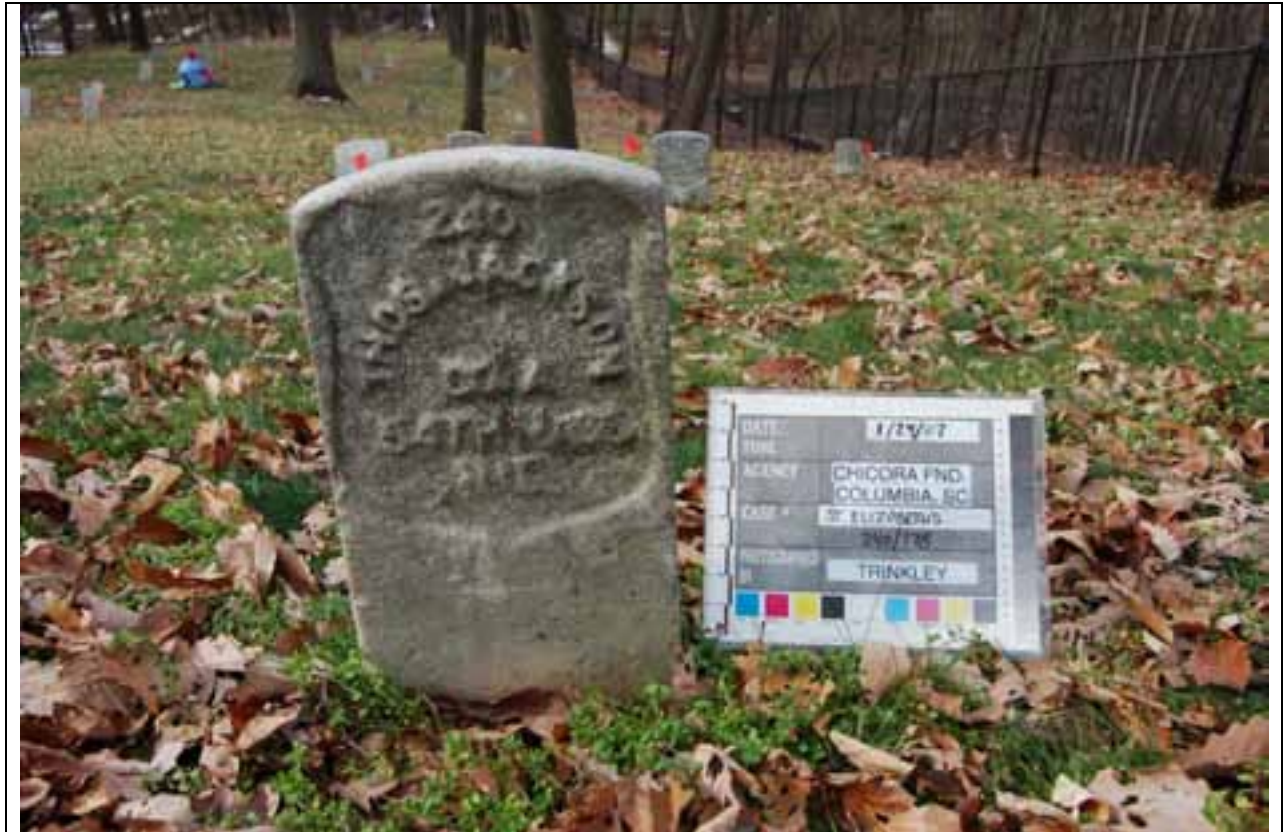
Condition of Marker: ☒ weathered ☐ cracked ☐ broken ☐ vandalized
☐ unattached ☐ loose ☐ biologicals ☐ stained
☐ repaired ☐ portions missing:
☒ tilted: degrees: 10 E-W 5 N-S Other:

Condition of Grave: satisfactory

| <input type="checkbox"/> Consider replacement with "XA" NCA marker | fiscal year |

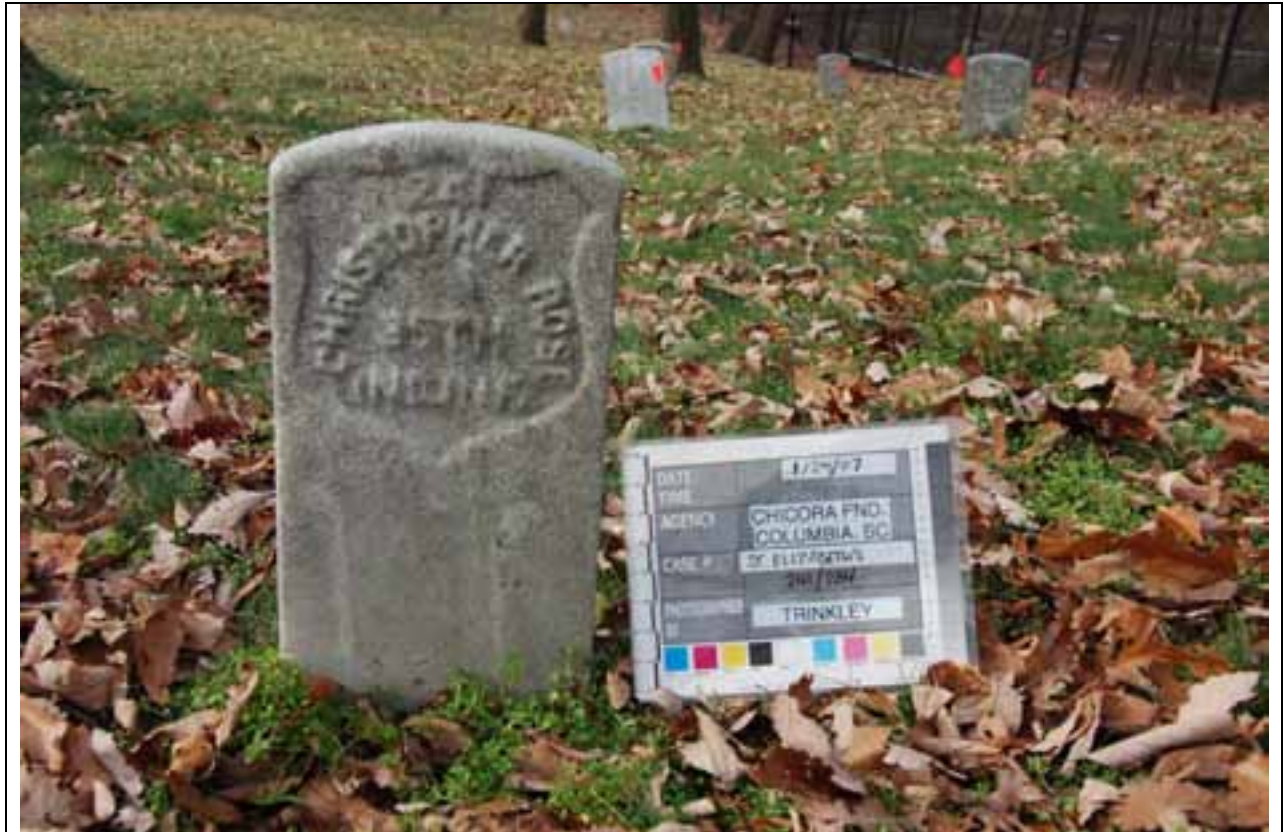
Condition of Marker: ☒ weathered ☐ cracked ☐ broken ☐ vandalized
☐ unattached ☐ loose ☐ biologicals ☐ stained
☐ repaired ☒ portions missing: chips right and left sides
☒ tilted: degrees: 5 E-W 10 N-S Other: mower damage

Condition of Grave: satisfactory

| <input type="checkbox"/> Consider replacement with "XA" NCA marker | fiscal year |

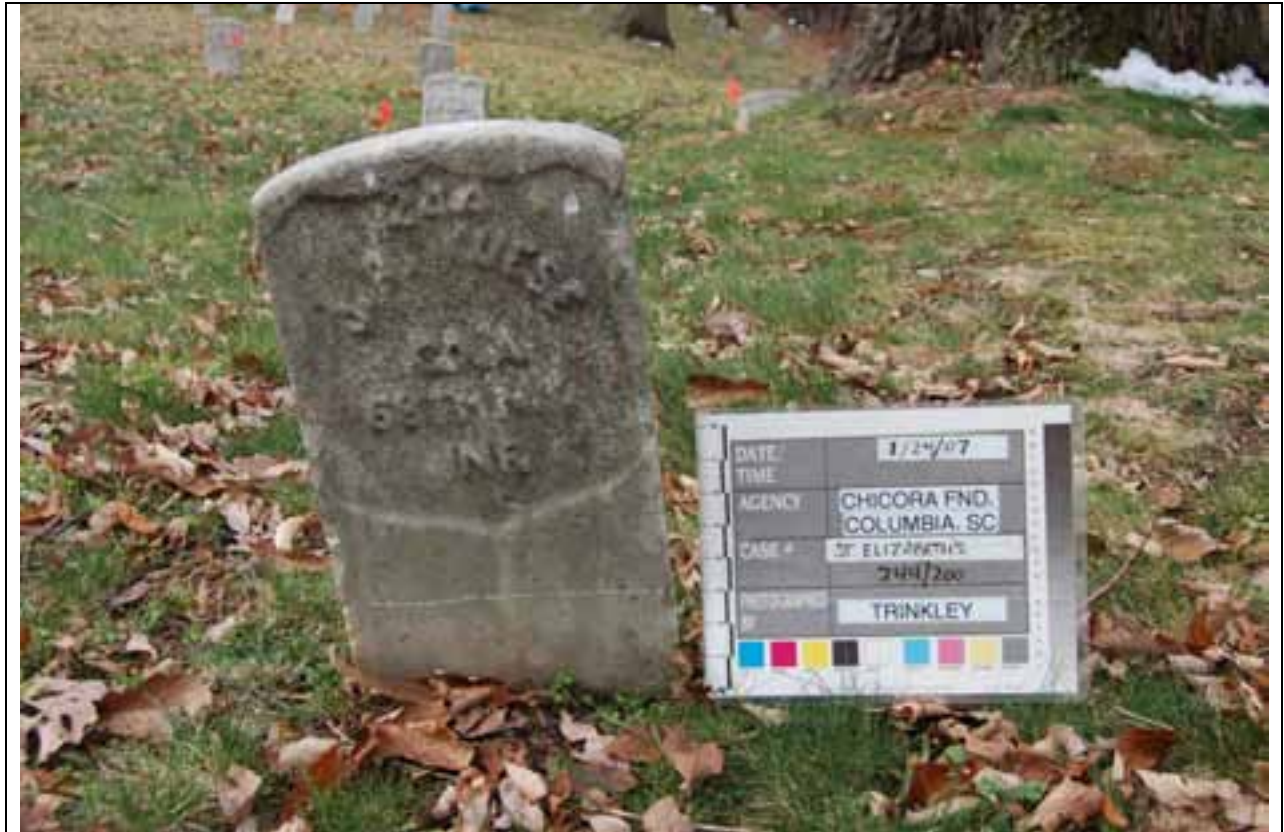
Condition of Marker: ☒ weathered ☐ cracked ☐ broken ☐ vandalized
☐ unattached ☐ loose ☐ biologicals ☐ stained
☐ repaired ☒ portions missing: chips left side
☒ tilted: degrees: 10 E-W N-S Other: spalling

Condition of Grave: satisfactory

| <input type="checkbox"/> Consider replacement with "XA" NCA marker | fiscal year |

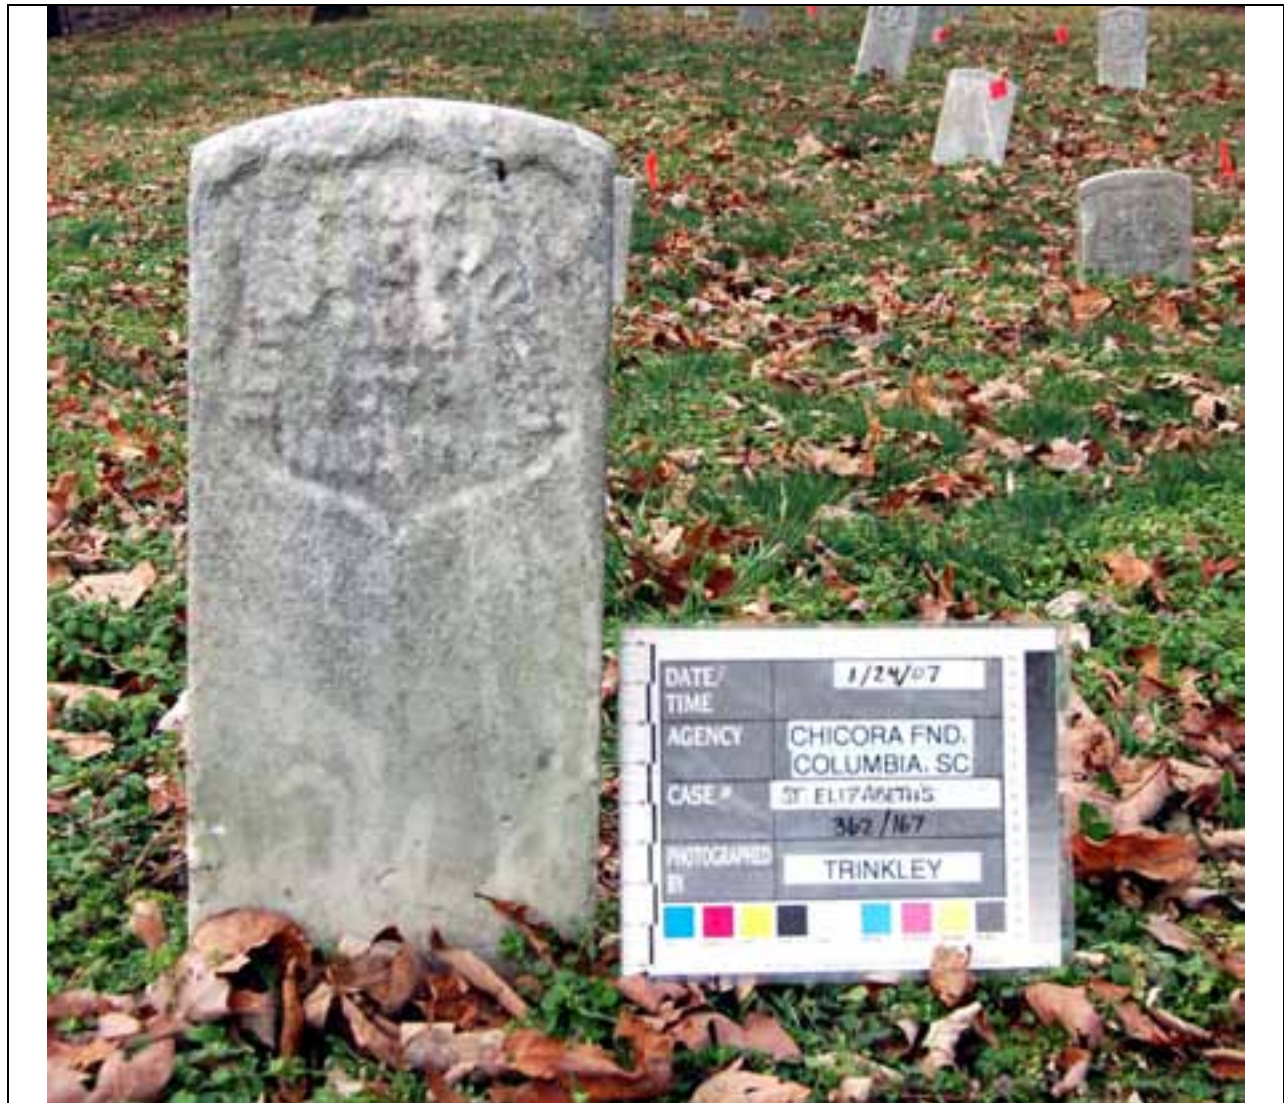
Condition of Marker: ☒ weathered ☐ cracked ☐ broken ☐ vandalized
☐ unattached ☐ loose ☐ biologicals ☐ stained
☐ repaired ☒ portions missing: chips left edge
☒ tilted: degrees: 12 E-W N-S Other: mower damage

Condition of Grave: satisfactory

| <input type="checkbox"/> Consider replacement with "XA" NCA marker | fiscal year |

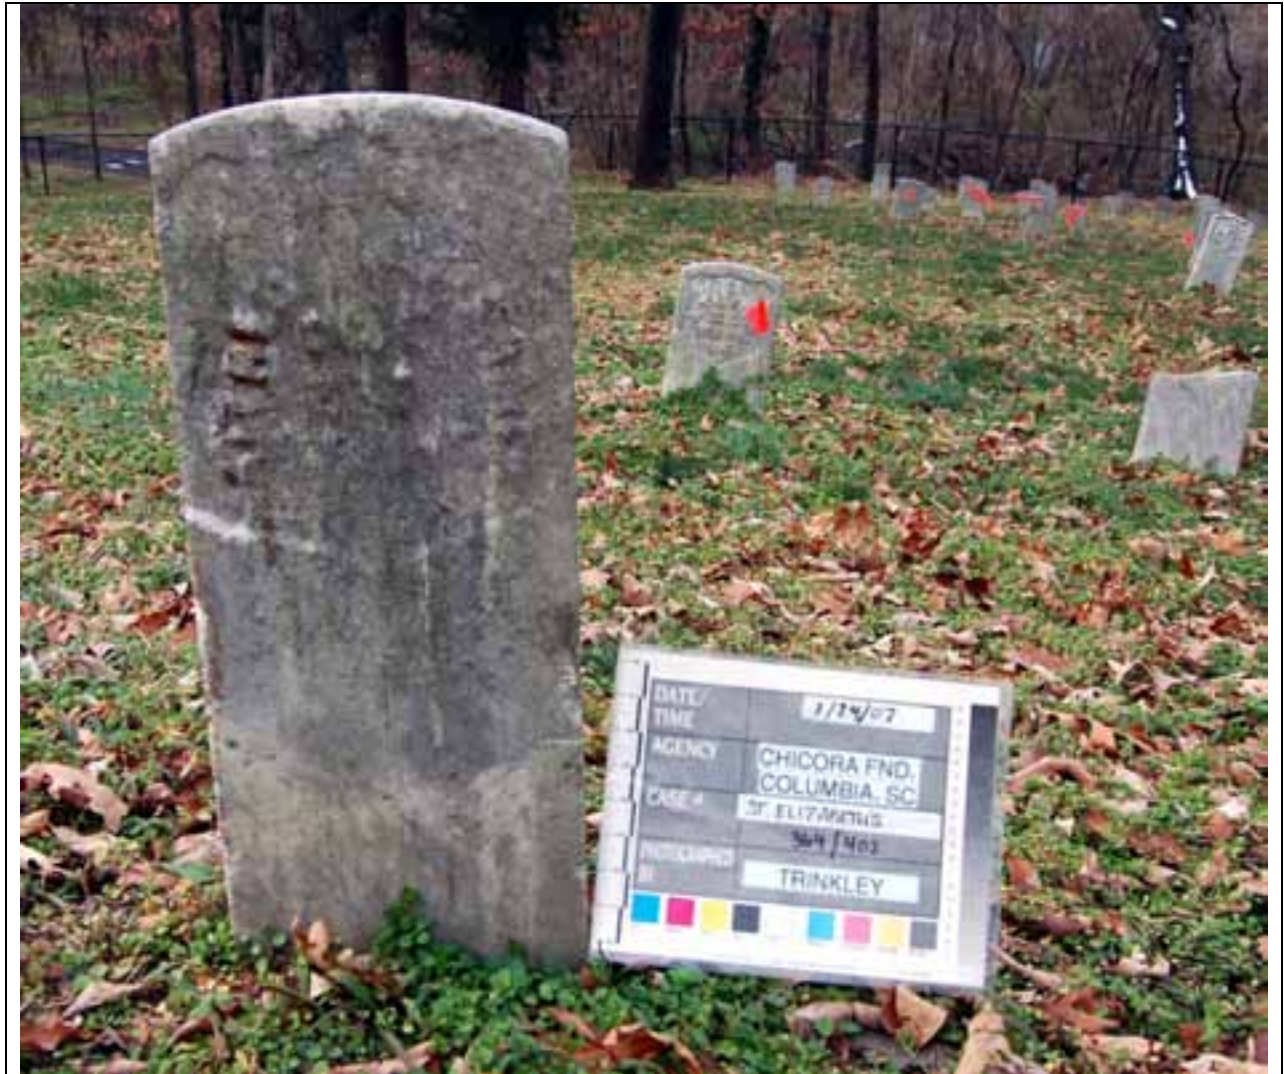
Condition of Marker: ☒ weathered ☐ cracked ☐ broken ☐ vandalized
☐ unattached ☐ loose ☐ biologicals ☒ stained
☐ repaired ☒ portions missing: chip left edge
☒ tilted: degrees: 30 E-W 10 N-S Other: spalling; mower damage

Condition of Grave: satisfactory

| <input type="checkbox"/> Consider replacement with "XA" NCA marker | fiscal year |

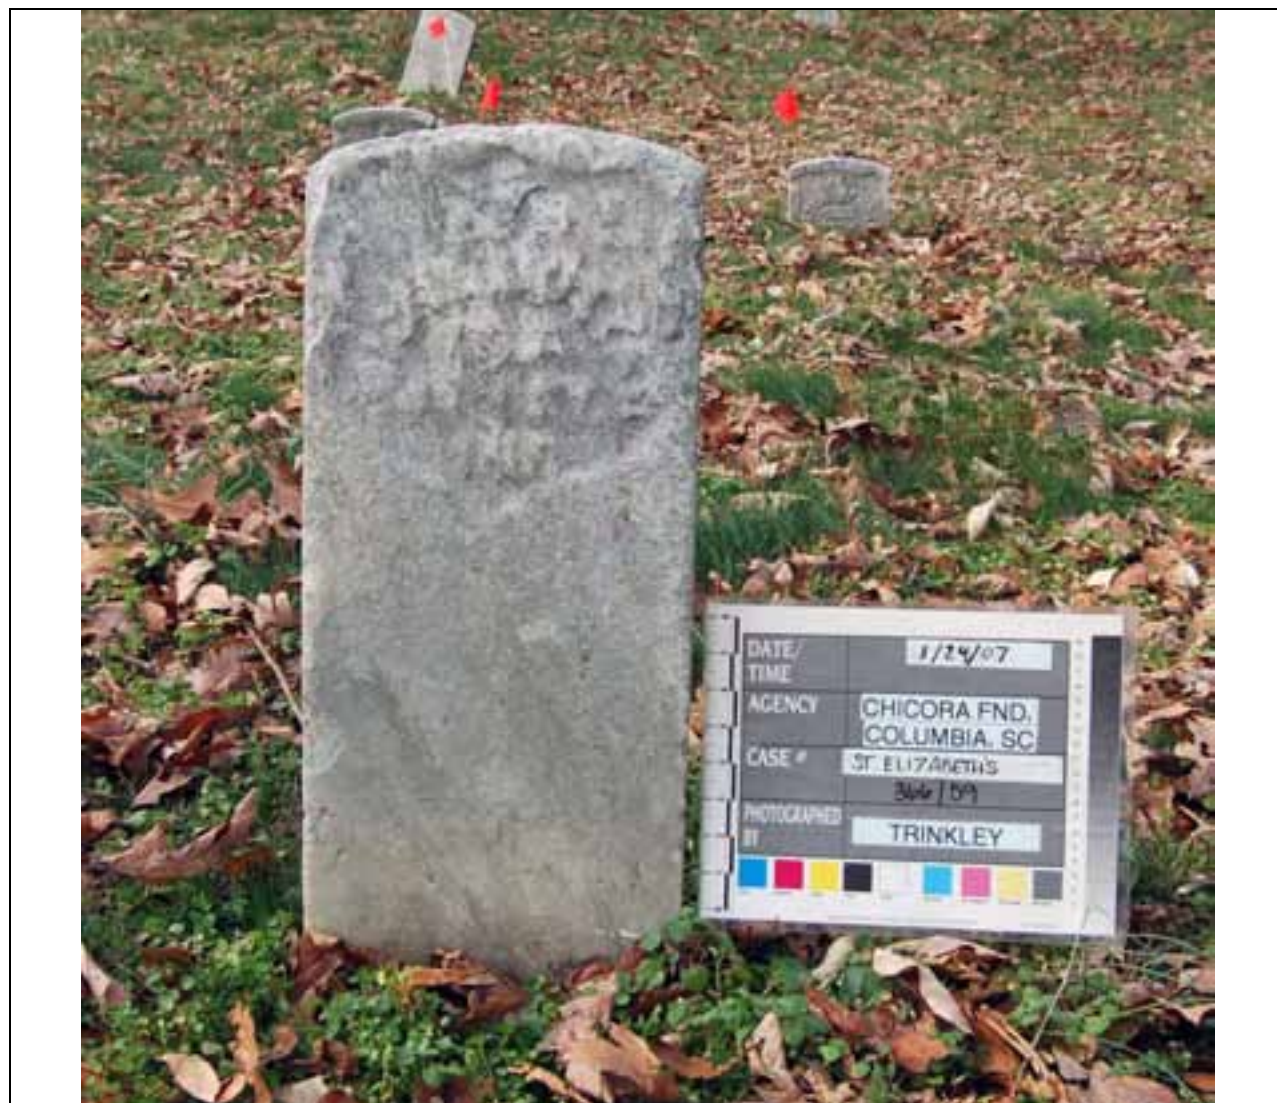
Condition of Marker: ☒ weathered ☐ cracked ☐ broken ☐ vandalized
☐ unattached ☐ loose ☒ biologicals ☒ stained
☐ repaired ☒ portions missing: chips left edge
☒ tilted: degrees: 25 E-W 15 N-S Other: spalling; mower damage

| <input type="checkbox"/> Consider replacement with "XA" NCA marker | fiscal year |

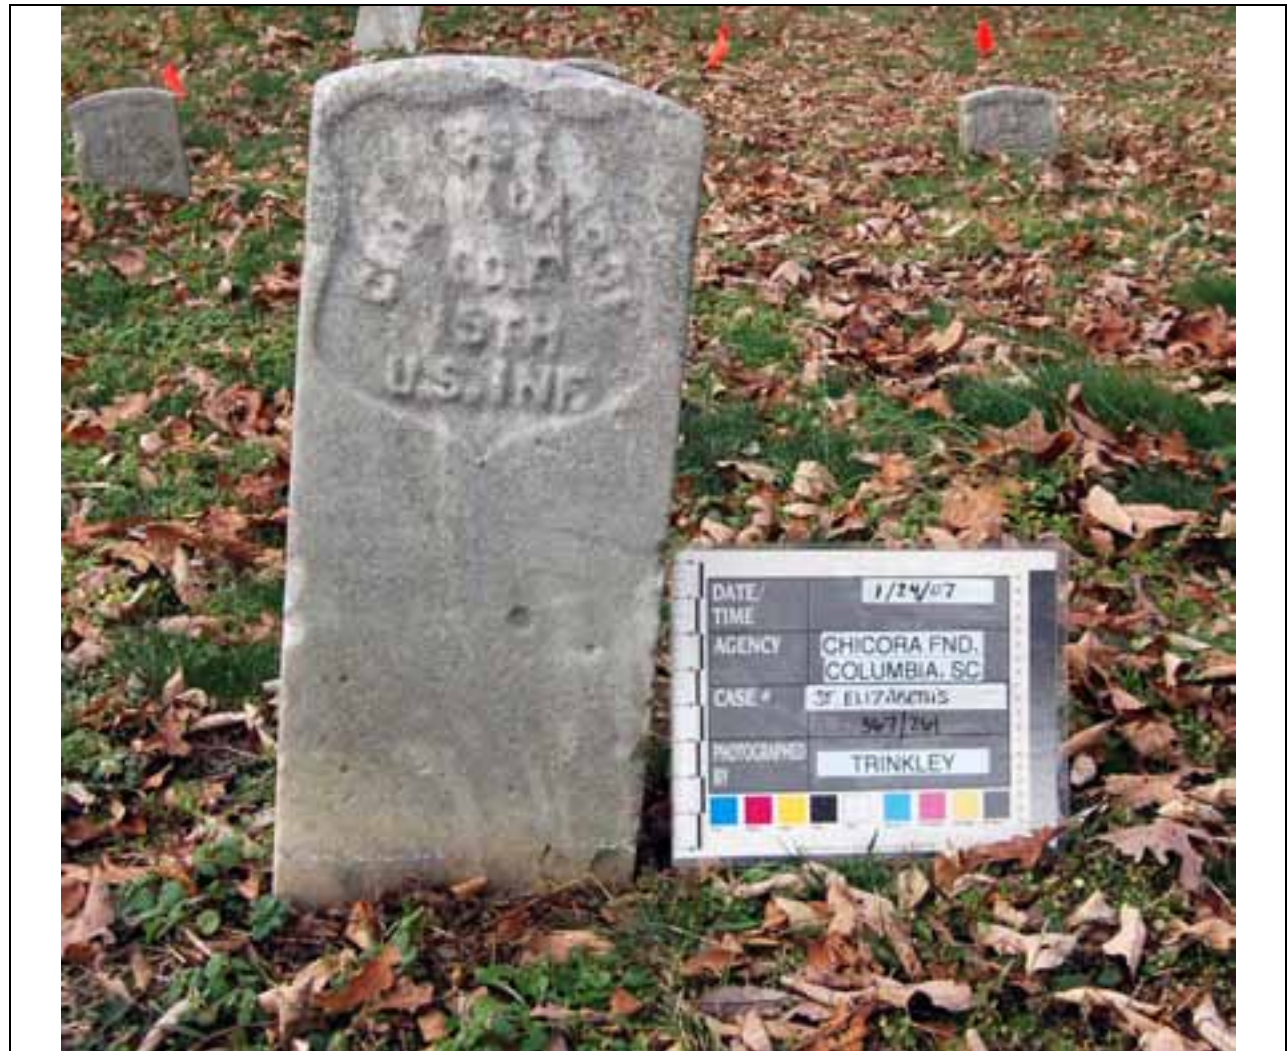
Condition of Marker: ☒ weathered ☐ cracked ☐ broken ☐ vandalized
☐ unattached ☐ loose ☐ biologicals ☐ stained
☐ repaired ☒ portions missing: chips left edge and left corner
☒ tilted: degrees: 12 E-W 7 N-S Other: mower damage

Condition of Grave: satisfactory

| <input type="checkbox"/> Consider replacement with "XA" NCA marker | fiscal year |
