PRESERVATION PLANNING FOR ST. ELIZABETHS WEST CAMPUS CEMETERY, ST. ELIZABETHS HOSPITAL, WASHINGTON, DC

Research Contribution 472

Michael Trinkley
Debi Hacker

June 2007

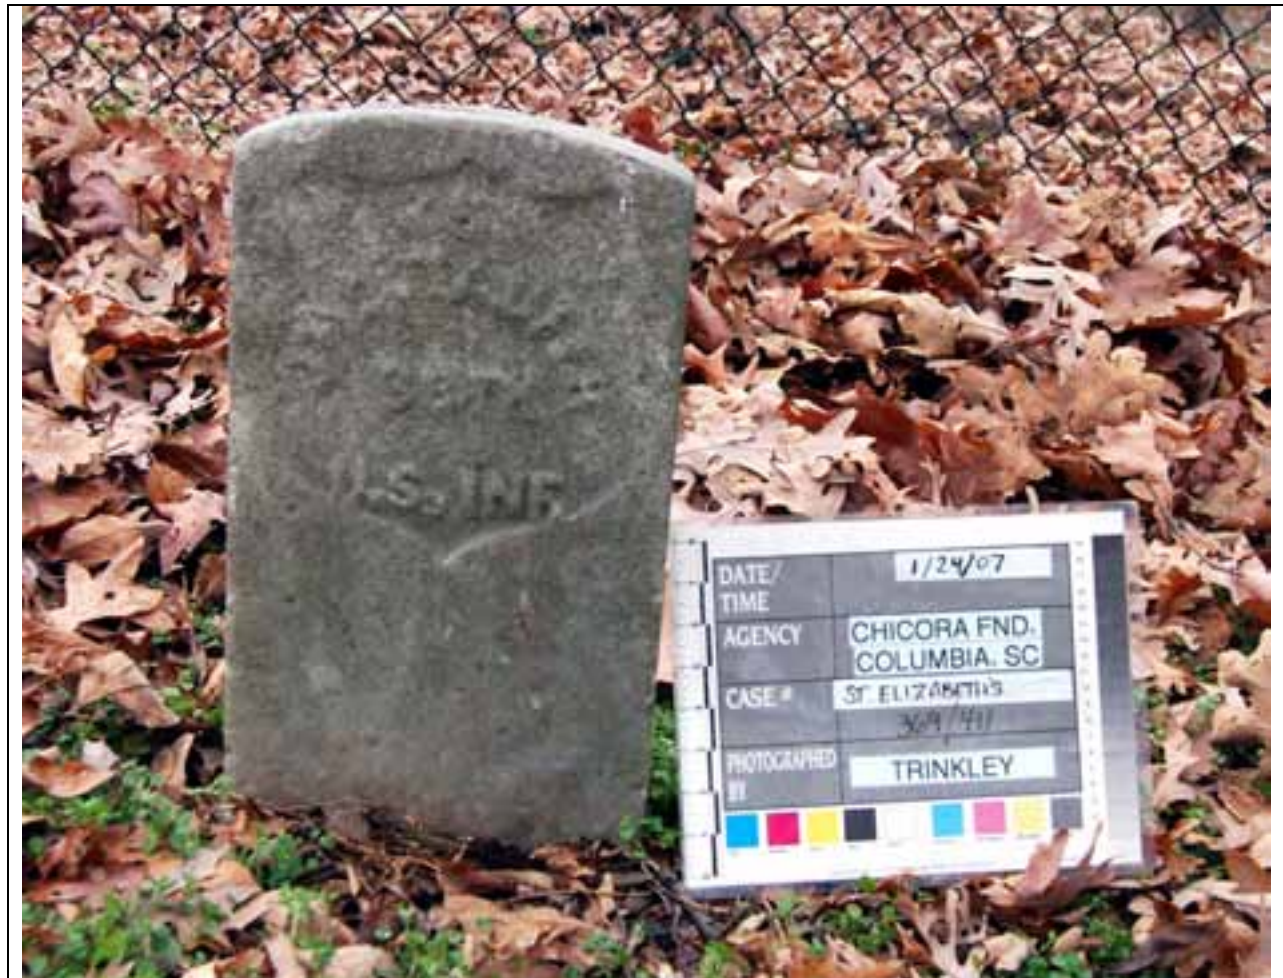
Condition of Marker: ☒ weathered ☐ cracked ☐ broken ☐ vandalized
☐ unattached ☐ loose ☐ biologicals ☐ stained
☐ repaired ☐ portions missing:
☒ tilted: degrees: 22 E-W 12 N-S Other: spalling

Condition of Grave: satisfactory

| <input type="checkbox"/> Consider replacement with "XA" NCA marker | fiscal year |

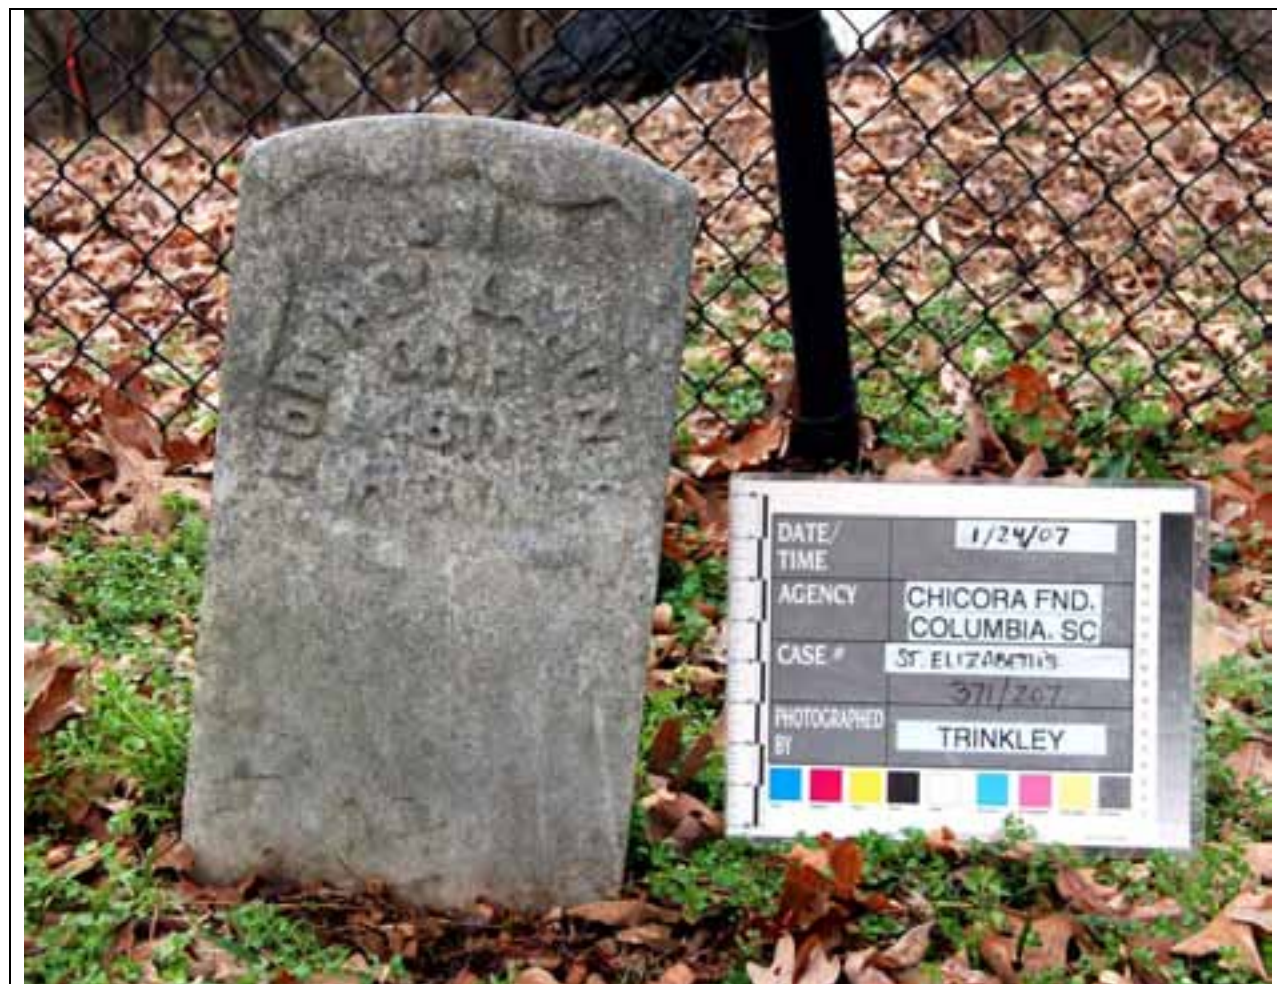
Condition of Marker: ☒ weathered ☐ cracked ☐ broken ☐ vandalized
☐ unattached ☐ loose ☐ biologicals ☒ stained
☐ repaired ☐ portions missing:
☒ tilted: degrees: 15 E-W 15 N-S Other: spalling; abrasion

Condition of Grave: satisfactory

| <input type="checkbox"/> Consider replacement with "XA" NCA marker | fiscal year |

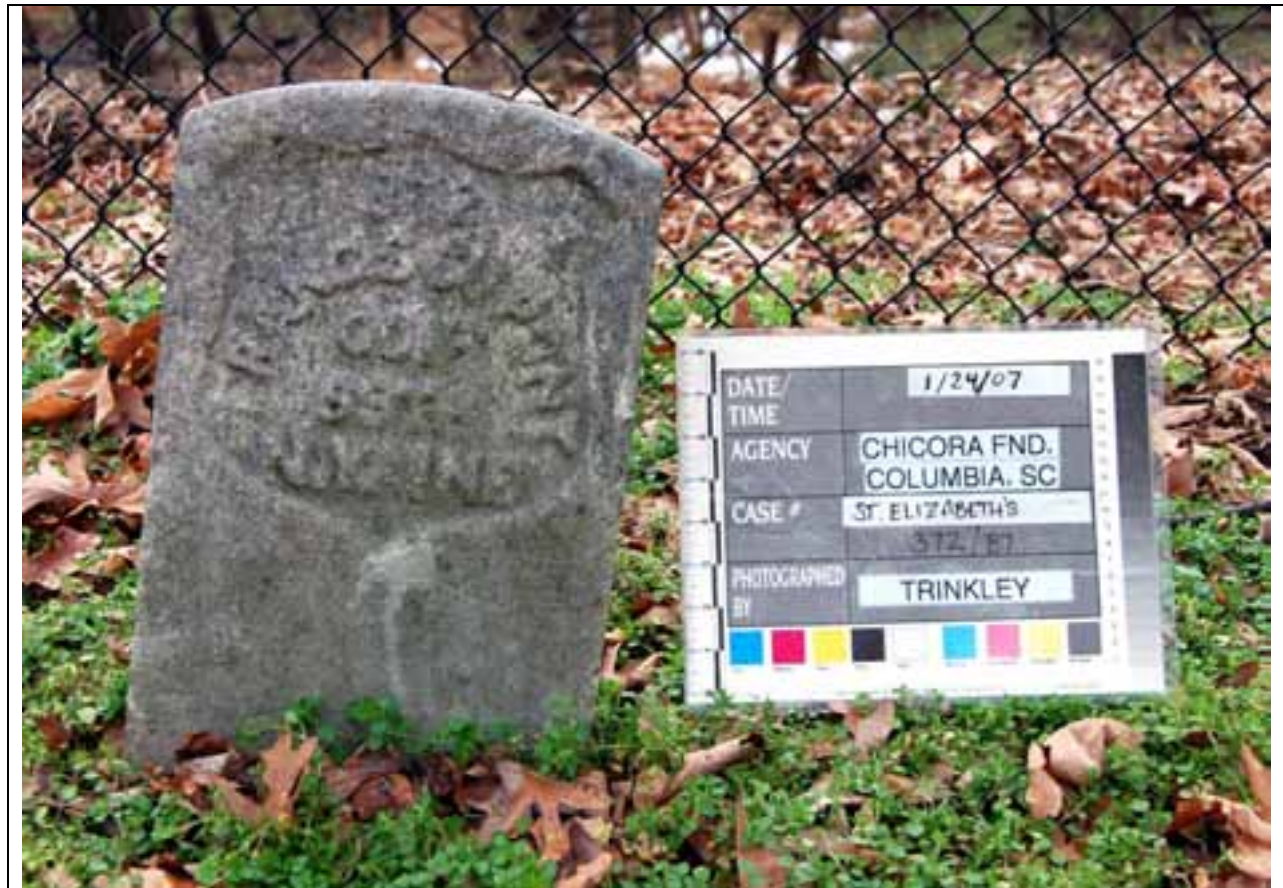
Condition of Marker: ☒ weathered ☐ cracked ☐ broken ☐ vandalized
☐ unattached ☐ loose ☐ biologicals ☐ stained
☐ repaired ☒ portions missing: chips right and left sides
☒ tilted: degrees: 15 E-W 5 N-S Other:

Condition of Grave: satisfactory

| <input type="checkbox"/> Consider replacement with "XA" NCA marker | fiscal year |

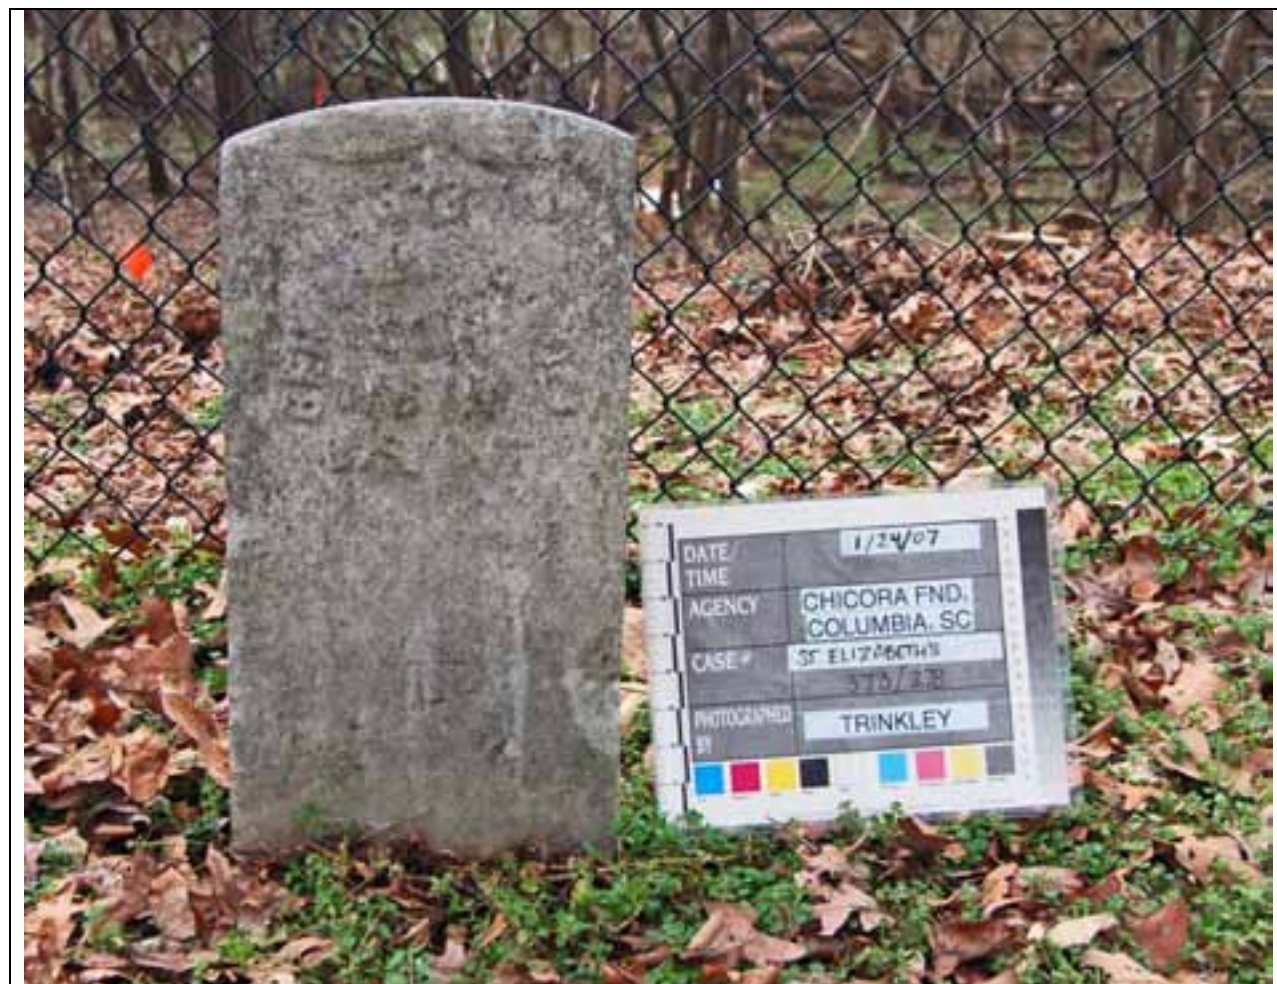
Condition of Marker: ☒ weathered ☒ cracked ☐ broken ☐ vandalized
☐ unattached ☐ loose ☐ biologicals ☐ stained
☐ repaired ☐ portions missing:
☒ tilted: degrees: 30 E-W 8 N-S Other:

Condition of Grave: satisfactory

| <input type="checkbox"/> Consider replacement with "XA" NCA marker | fiscal year |

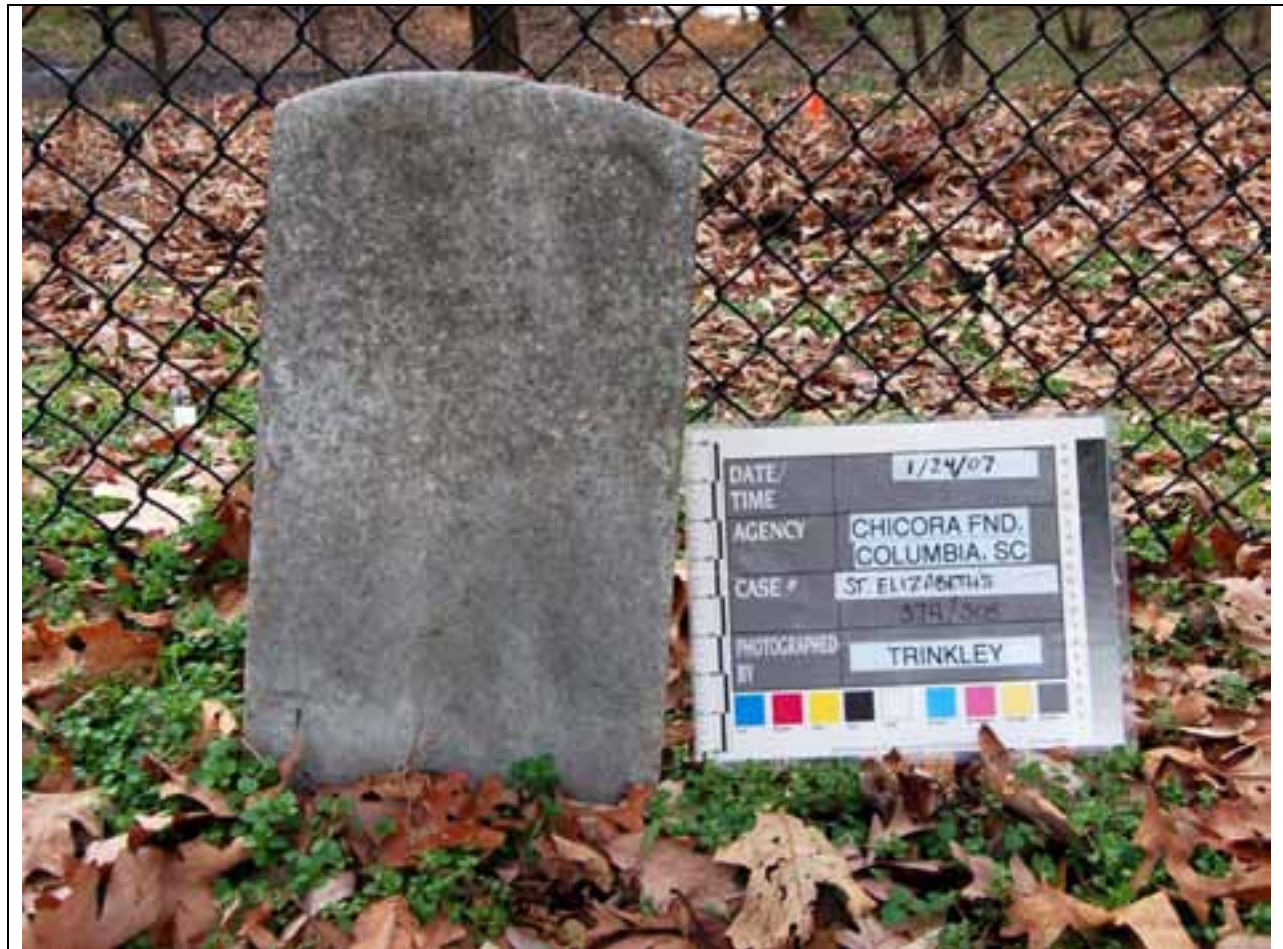
Condition of Marker: ☒ weathered ☐ cracked ☐ broken ☐ vandalized
☐ unattached ☐ loose ☐ biologicals ☐ stained
☐ repaired ☐ portions missing:
☒ tilted: degrees: 18 E-W 4 N-S Other:

Condition of Grave: satisfactory

| <input type="checkbox"/> Consider replacement with "XA" NCA marker | fiscal year |

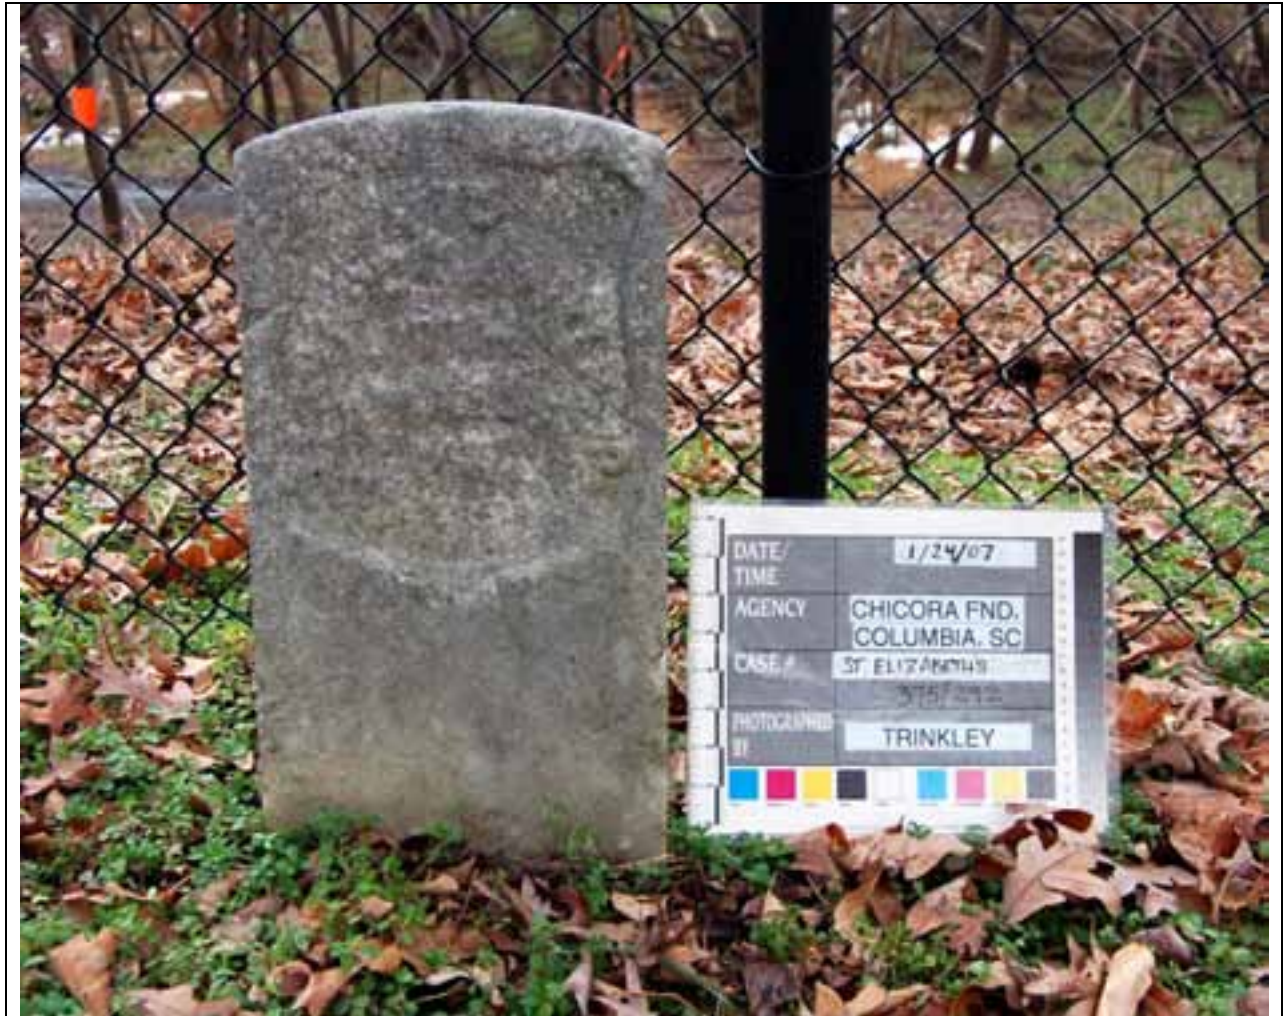
Condition of Marker: ☒ weathered ☒ cracked ☐ broken ☐ vandalized
☐ unattached ☐ loose ☐ biologicals ☒ stained
☐ repaired ☒ portions missing: chips right and left sides
☒ tilted: degrees: 15 E-W 8 N-S Other: mower damage

Condition of Grave: satisfactory

| <input type="checkbox"/> Consider replacement with "XA" NCA marker | fiscal year |

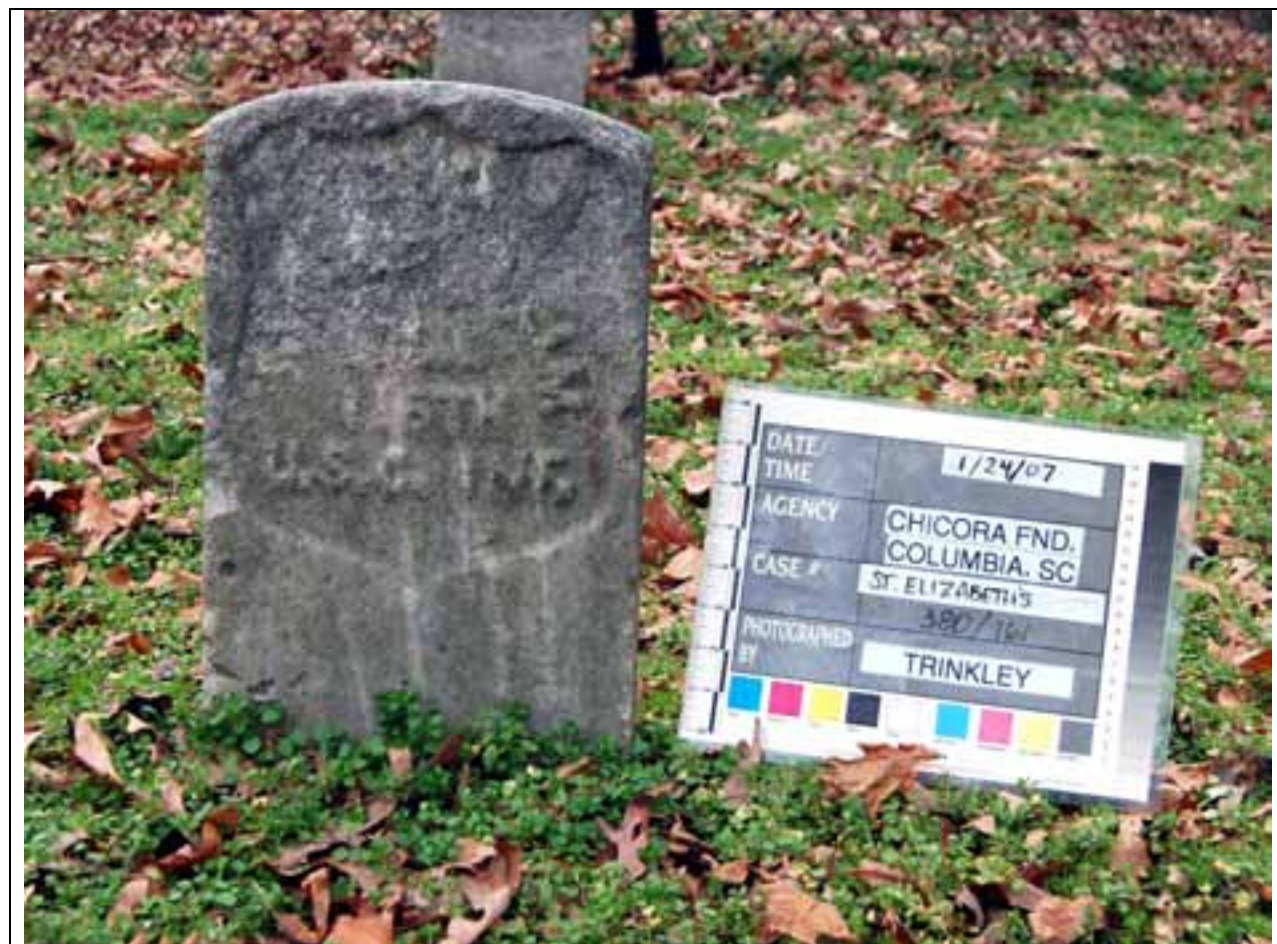
Condition of Marker: ☒ weathered ☒ cracked ☐ broken ☐ vandalized
☐ unattached ☐ loose ☐ biologicals ☐ stained
☐ repaired ☐ portions missing:
☒ tilted: degrees: 12 E-W 8 N-S Other: mower damage

Condition of Grave: satisfactory

| <input type="checkbox"/> Consider replacement with "XA" NCA marker | fiscal year |

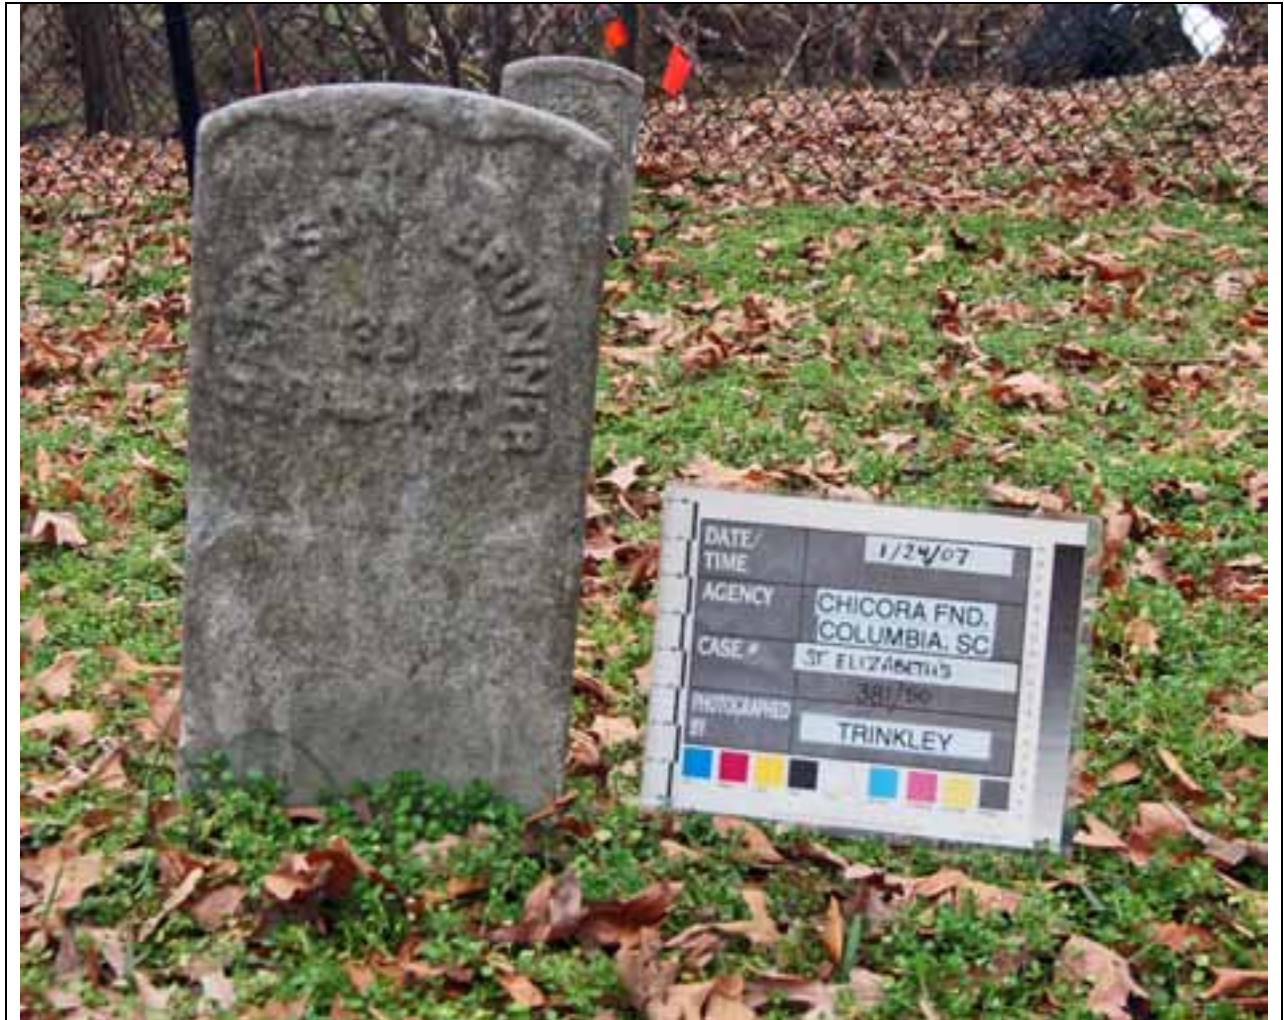
Condition of Marker: ☒ weathered ☐ cracked ☐ broken ☐ vandalized
☐ unattached ☐ loose ☐ biologicals ☐ stained
☐ repaired ☒ portions missing: chips left side
☒ tilted: degrees: 25 E-W 8 N-S Other:

Condition of Grave: satisfactory

| <input type="checkbox"/> Consider replacement with "XA" NCA marker | fiscal year |

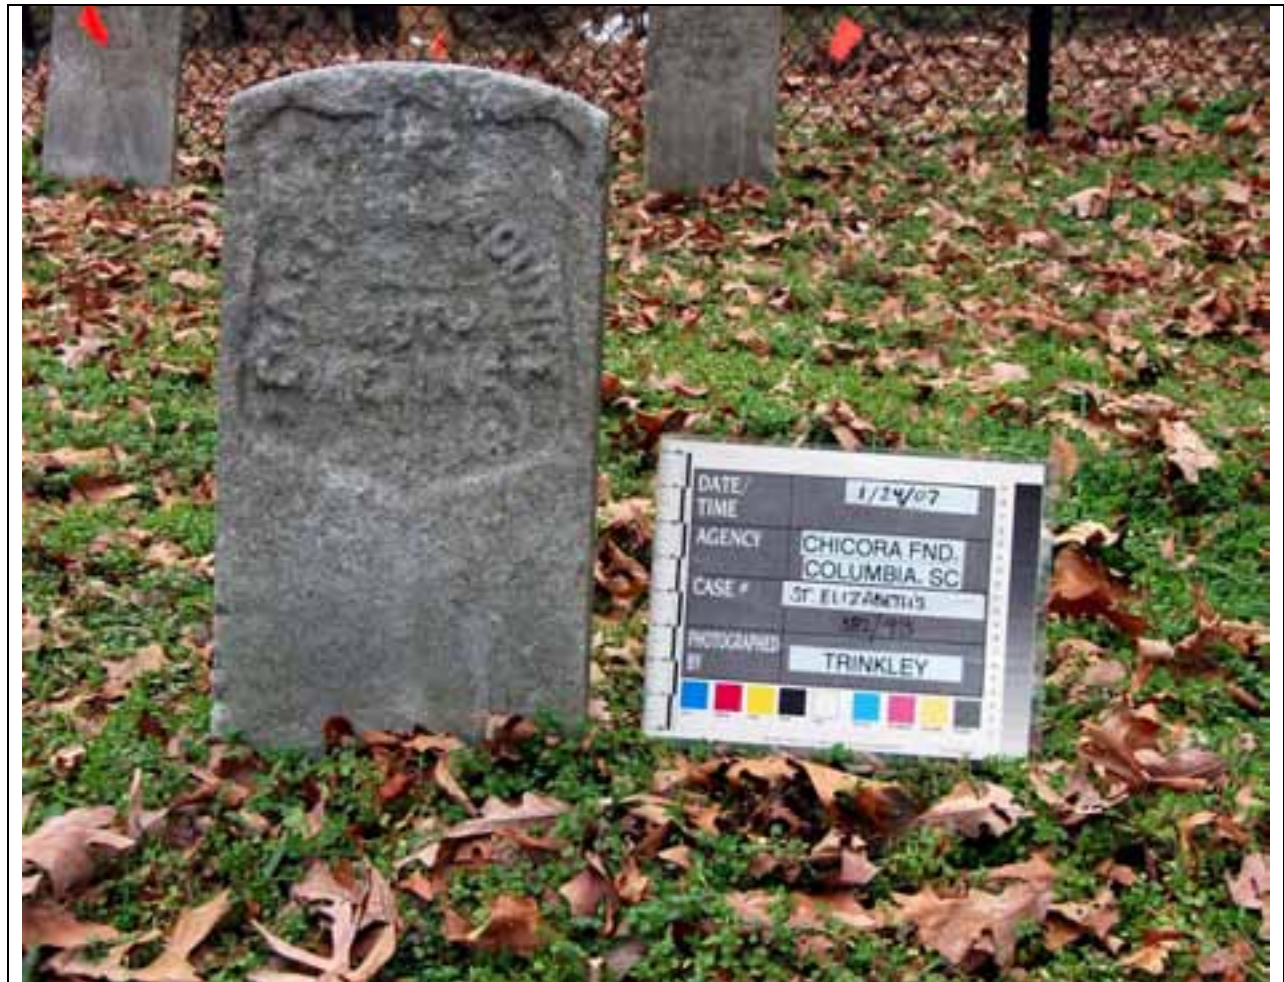
Condition of Marker: ☒ weathered ☐ cracked ☐ broken ☐ vandalized
☐ unattached ☐ loose ☐ biologicals ☐ stained
☐ repaired ☐ portions missing:
☒ tilted: degrees: 24 E-W 5 N-S Other: mower damage

Condition of Grave: satisfactory

| <input type="checkbox"/> Consider replacement with "XA" NCA marker | fiscal year |

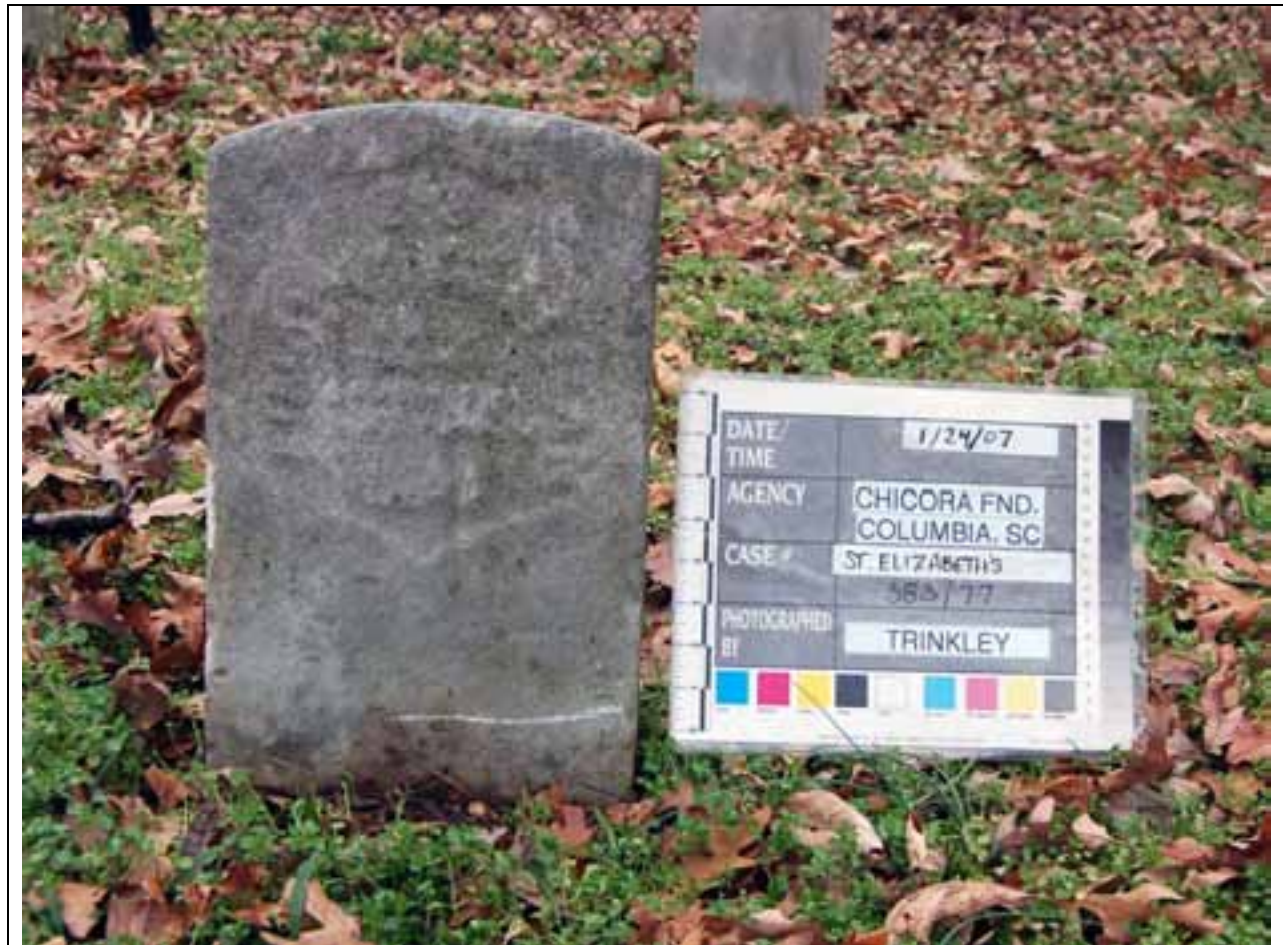
Condition of Marker: ☒ weathered ☐ cracked ☐ broken ☐ vandalized
☐ unattached ☐ loose ☒ biologicals ☒ stained
☐ repaired ☒ portions missing: chips right side
☒ tilted: degrees: 25 E-W 6 N-S Other: mower damage

Condition of Grave: satisfactory

| <input type="checkbox"/> Consider replacement with "XA" NCA marker | fiscal year |

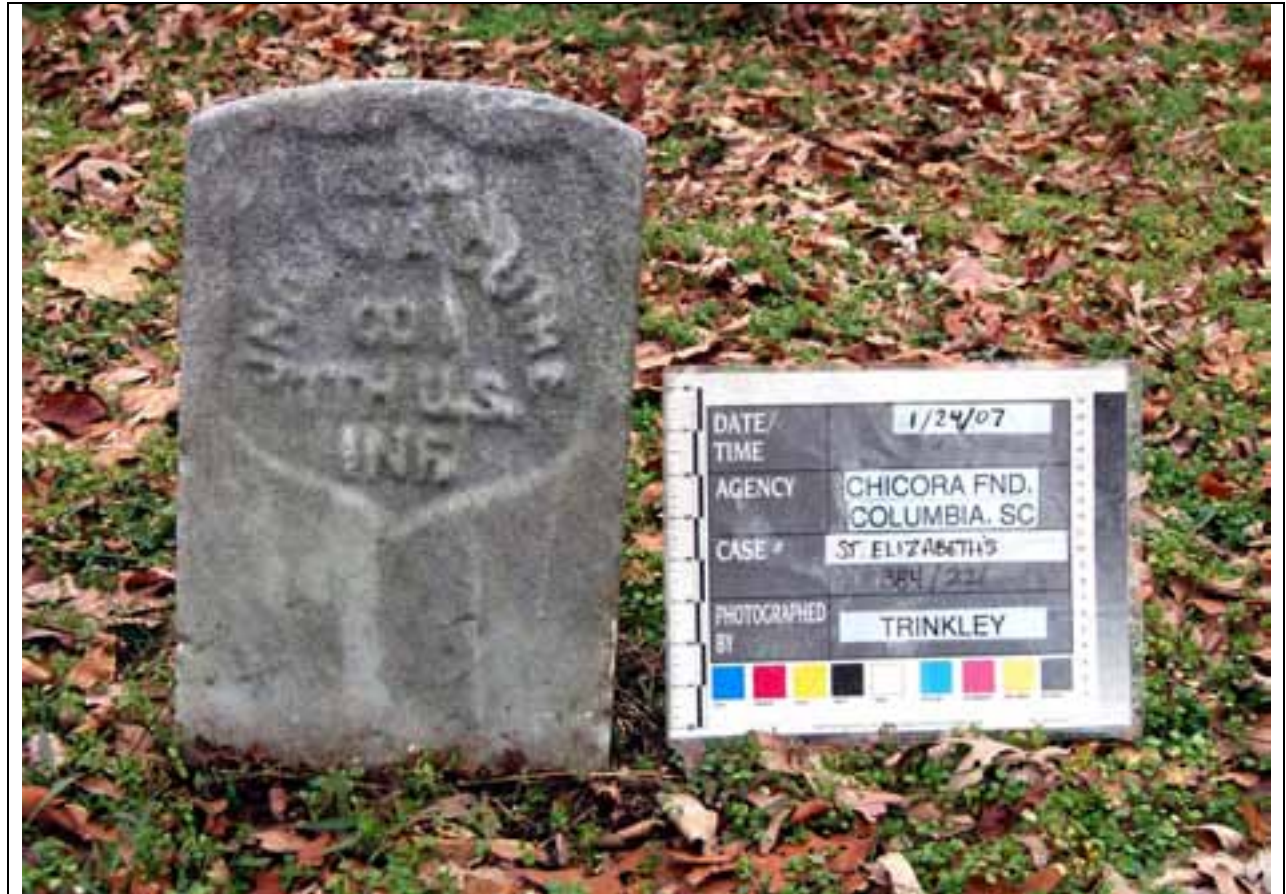
Condition of Marker: ☒ weathered ☐ cracked ☐ broken ☐ vandalized
☐ unattached ☐ loose ☒ biologicals ☐ stained
☐ repaired ☒ portions missing: chips
☒ tilted: degrees: 24 E-W 2 N-S Other:

Condition of Grave: satisfactory

| <input type="checkbox"/> Consider replacement with "XA" NCA marker | fiscal year |

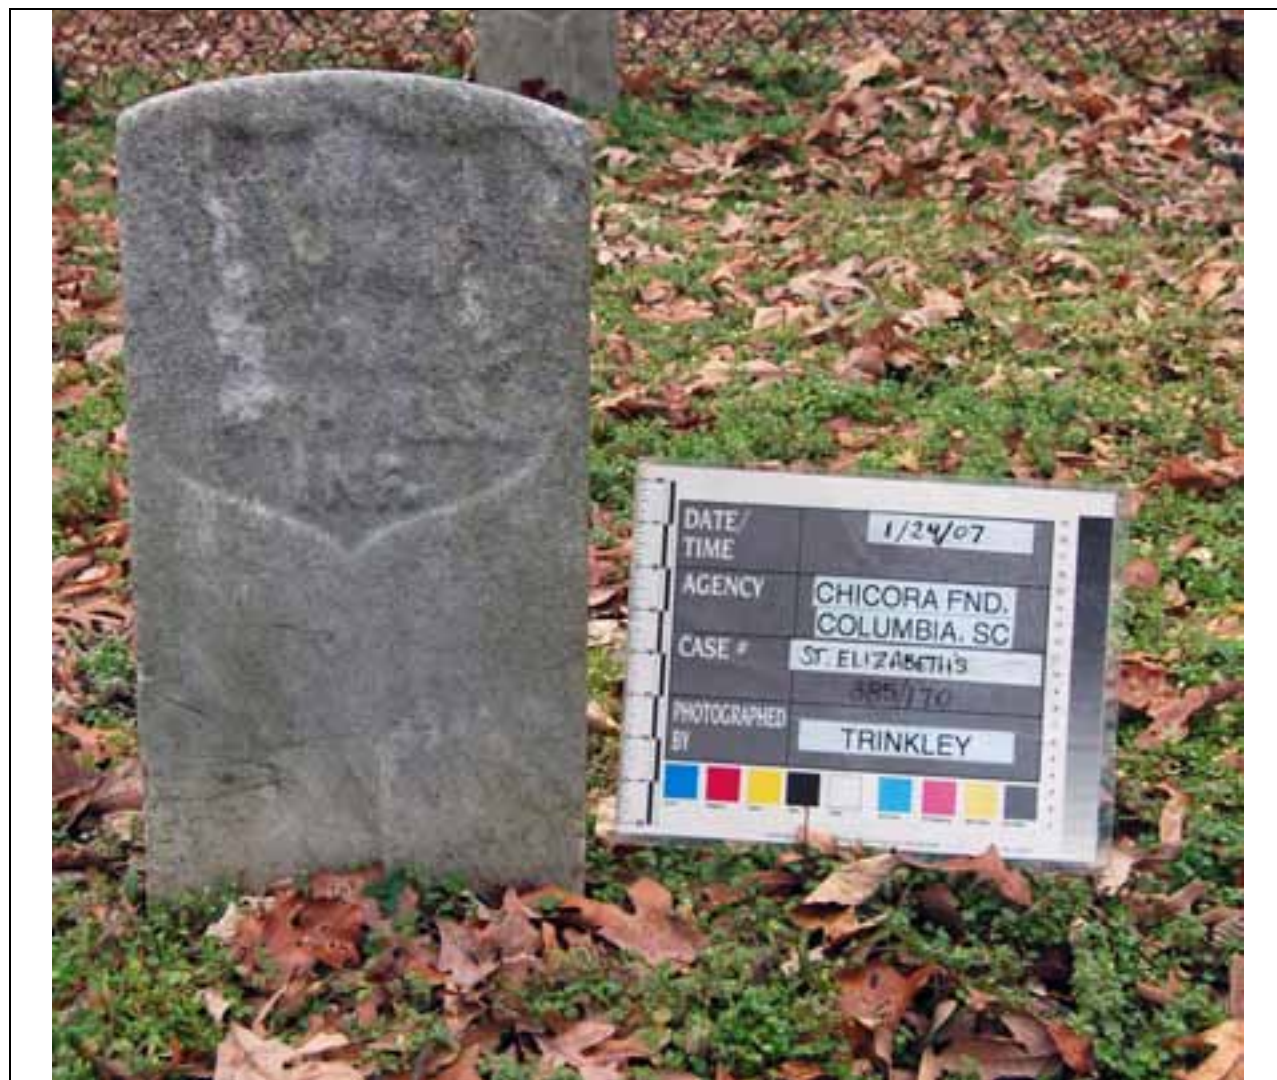
Condition of Marker: ☒ weathered ☐ cracked ☐ broken ☐ vandalized
☐ unattached ☐ loose ☐ biologicals ☒ stained
☐ repaired ☒ portions missing: chipped left corner
☒ tilted: degrees: 5 E-W 15 N-S Other:

Condition of Grave: satisfactory

| <input type="checkbox"/> Consider replacement with "XA" NCA marker | fiscal year |

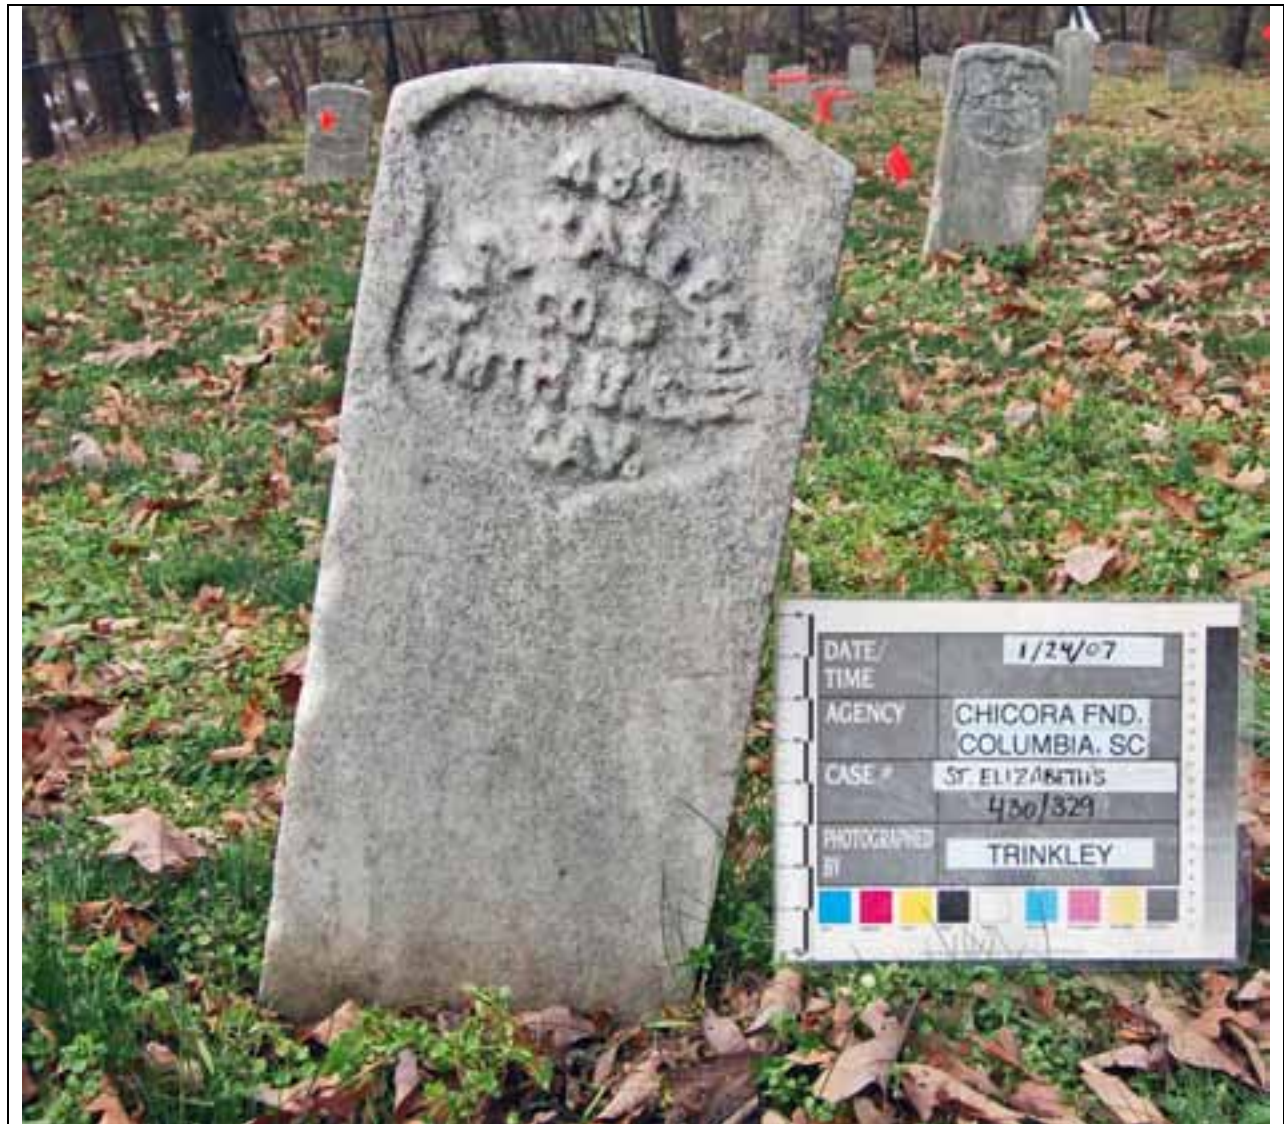
Current Condition Photograph on Rear

Condition of Marker: ☒ weathered ☐ cracked ☐ broken ☐ vandalized
☐ unattached ☐ loose ☐ biologicals ☐ stained
☐ repaired ☐ portions missing:
☒ tilted: degrees: 10 E-W 13 N-S Other:

Condition of Grave: satisfactory

| <input type="checkbox"/> Consider replacement with "XA" NCA marker | fiscal year |

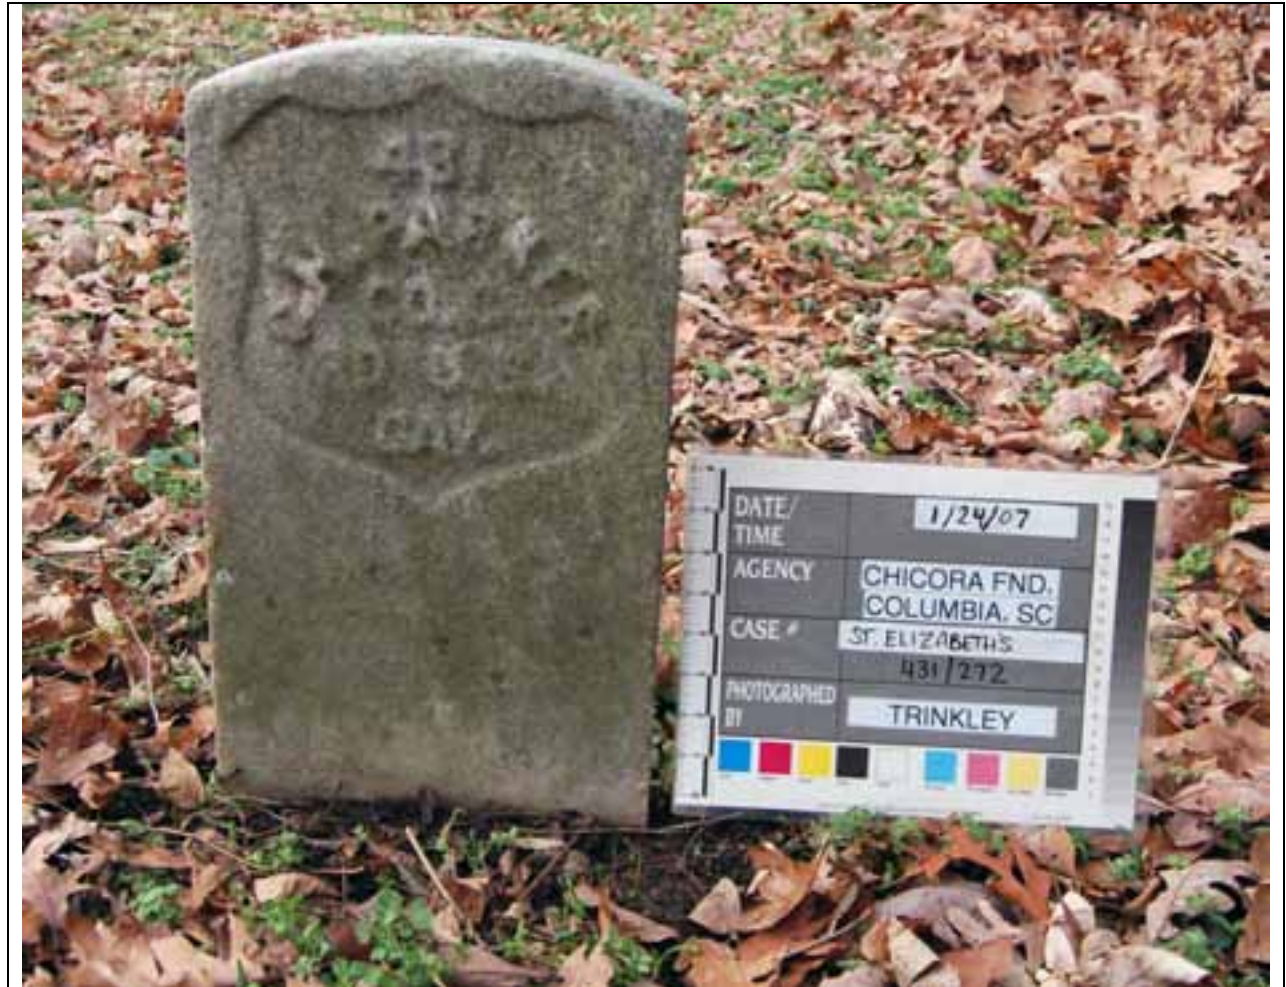
Current Condition Photograph on Rear

Condition of Marker: ☒ weathered ☐ cracked ☐ broken ☐ vandalized
☐ unattached ☐ loose ☐ biologicals ☐ stained
☐ repaired ☐ portions missing:
☒ tilted: degrees: 40 E-W N-S Other:

Condition of Grave: satisfactory

| <input type="checkbox"/> Consider replacement with "XA" NCA marker | fiscal year |

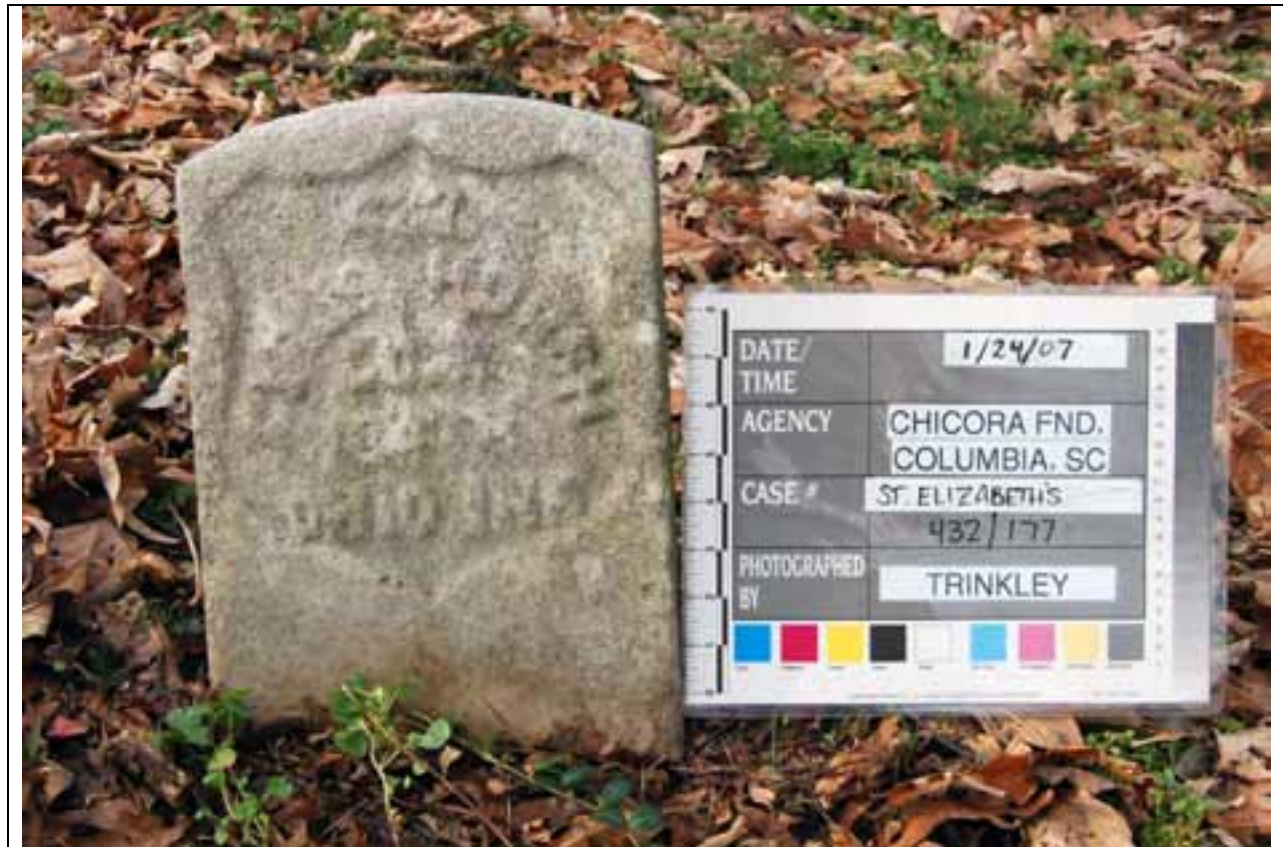
Current Condition Photograph on Rear

Condition of Marker: ☒ weathered ☐ cracked ☐ broken ☐ vandalized
☐ unattached ☐ loose ☒ biologicals ☒ stained
☐ repaired ☒ portions missing: chips left edge
☒ tilted: degrees: 10 E-W 7 N-S Other:

Condition of Grave: satisfactory

| <input type="checkbox"/> Consider replacement with "XA" NCA marker | fiscal year |

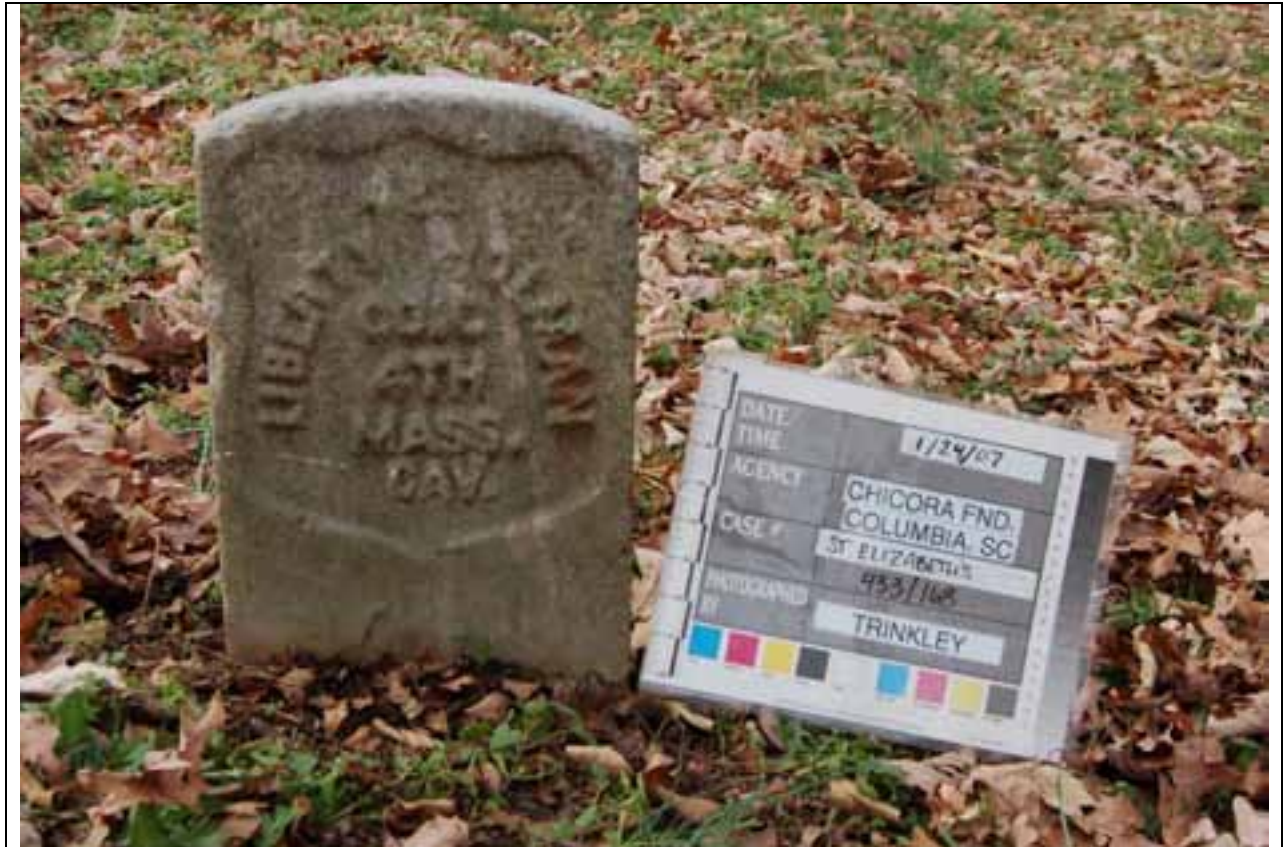
Current Condition Photograph on Rear

Condition of Marker: ☒ weathered ☐ cracked ☐ broken ☐ vandalized
☐ unattached ☐ loose ☐ biologicals ☒ stained
☐ repaired ☒ portions missing: extensive damage left edge
☒ tilted: degrees: 14 E-W 10 N-S Other: mower damage

Condition of Grave: satisfactory

| <input type="checkbox"/> Consider replacement with "XA" NCA marker | fiscal year |

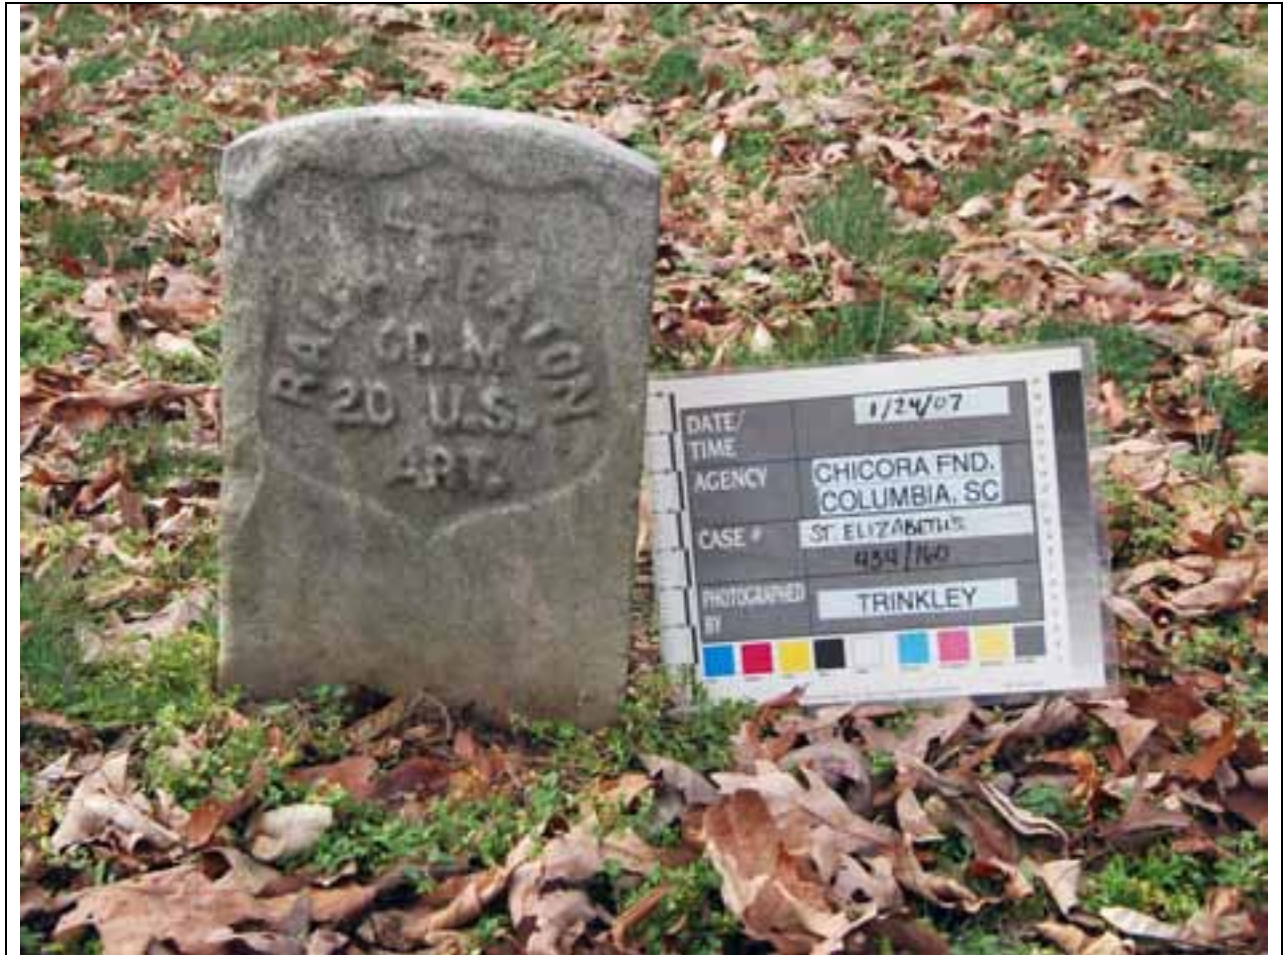
Current Condition Photograph on Rear

Condition of Marker: ☒ weathered ☐ cracked ☐ broken ☐ vandalized
☐ unattached ☐ loose ☒ biologicals ☒ stained
☐ repaired ☐ portions missing:
☒ tilted: degrees: 34 E-W 15 N-S Other:

Condition of Grave: satisfactory

| <input type="checkbox"/> Consider replacement with "XA" NCA marker | fiscal year |
