PRESERVATION PLANNING FOR ST. ELIZABETHS WEST CAMPUS CEMETERY, ST. ELIZABETHS HOSPITAL, WASHINGTON, DC

Research Contribution 472

Michael Trinkley
Debi Hacker

June 2007

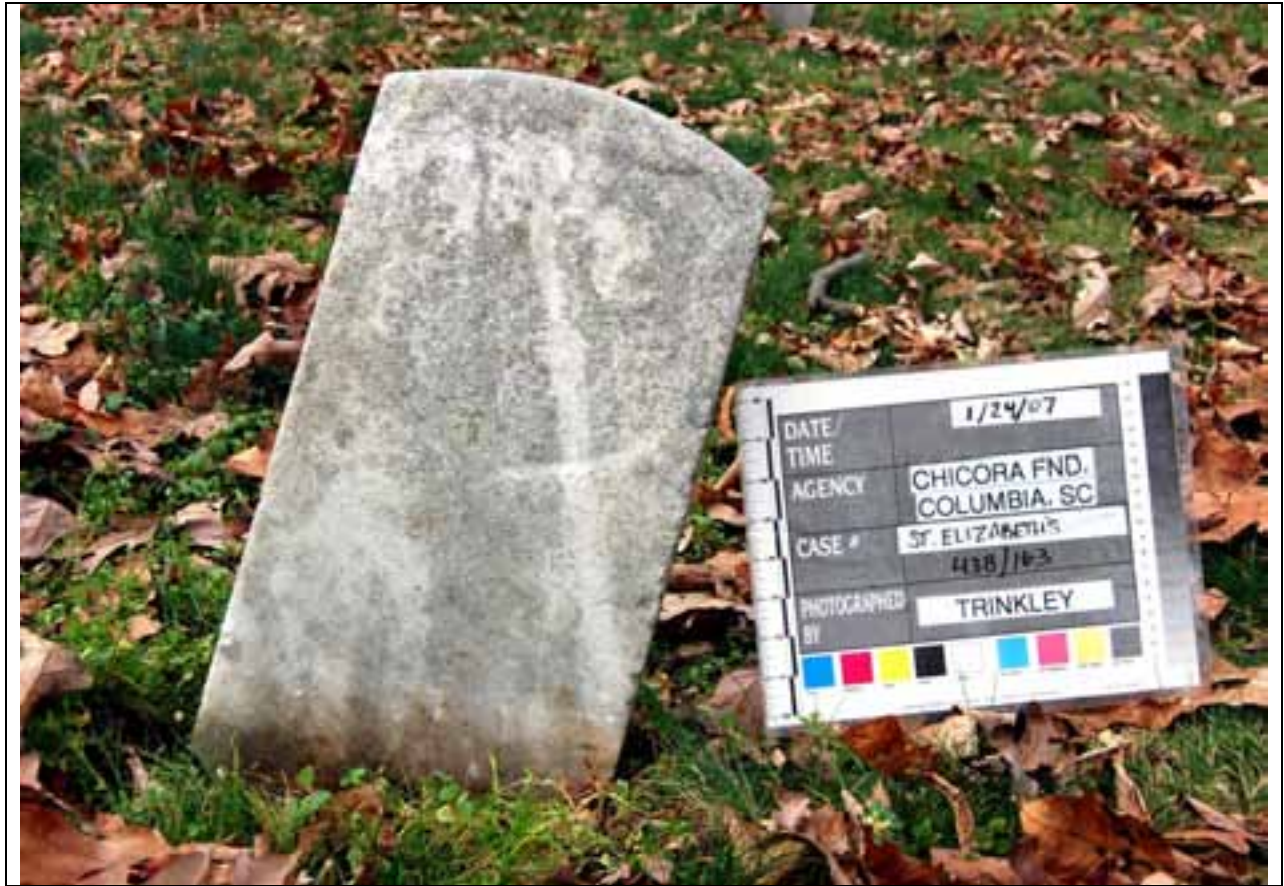
Current Condition Photograph on Rear

Condition of Marker: ☐ weathered ☐ cracked ☒ broken ☐ vandalized
☐ unattached ☐ loose ☐ biologicals ☐ stained
☐ repaired ☒ portions missing: upper half of tombstone
☒ tilted: degrees: 15 E-W N-S Other:

Condition of Grave: satisfactory

| <input checked="" type="checkbox"/> Consider replacement with "XA" NCA marker | fiscal year | |

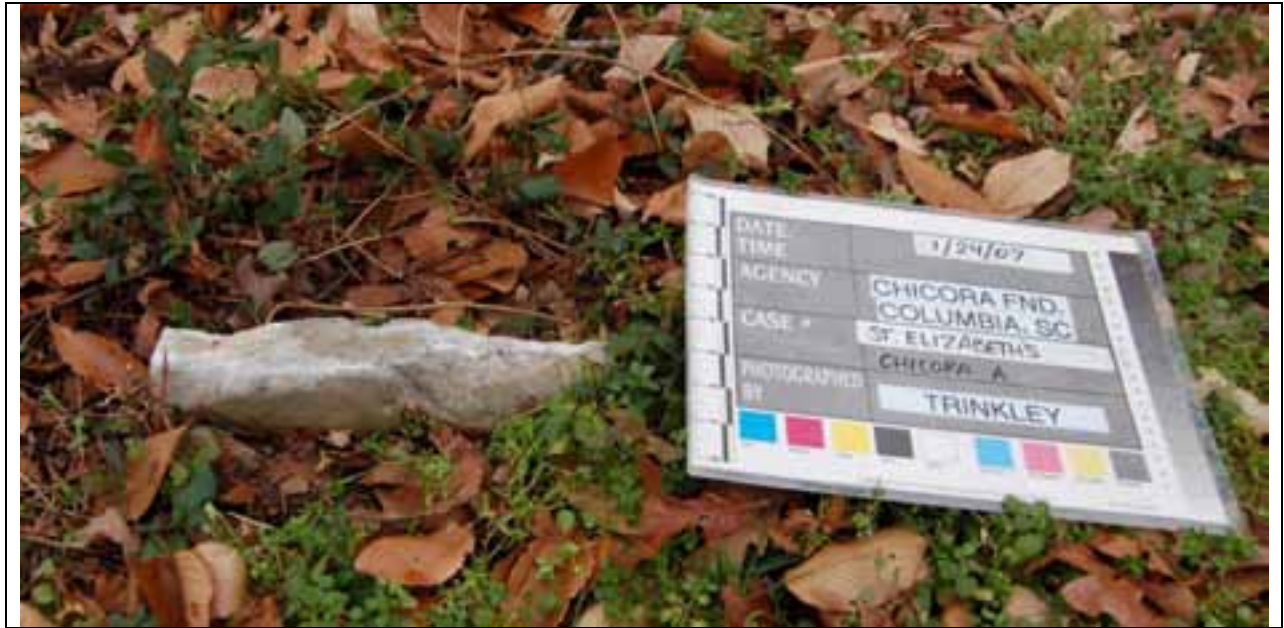
Current Condition Photograph on Rear

Condition of Marker: ☐ weathered ☐ cracked ☒ broken ☐ vandalized
☐ unattached ☐ loose ☐ biologicals ☐ stained
☐ repaired ☒ portions missing: upper half of tombstone
☐ tilted: degrees: E-W N-S Other:

Condition of Grave: satisfactory

| <input checked="" type="checkbox"/> Consider replacement with "XA" NCA marker | fiscal year |

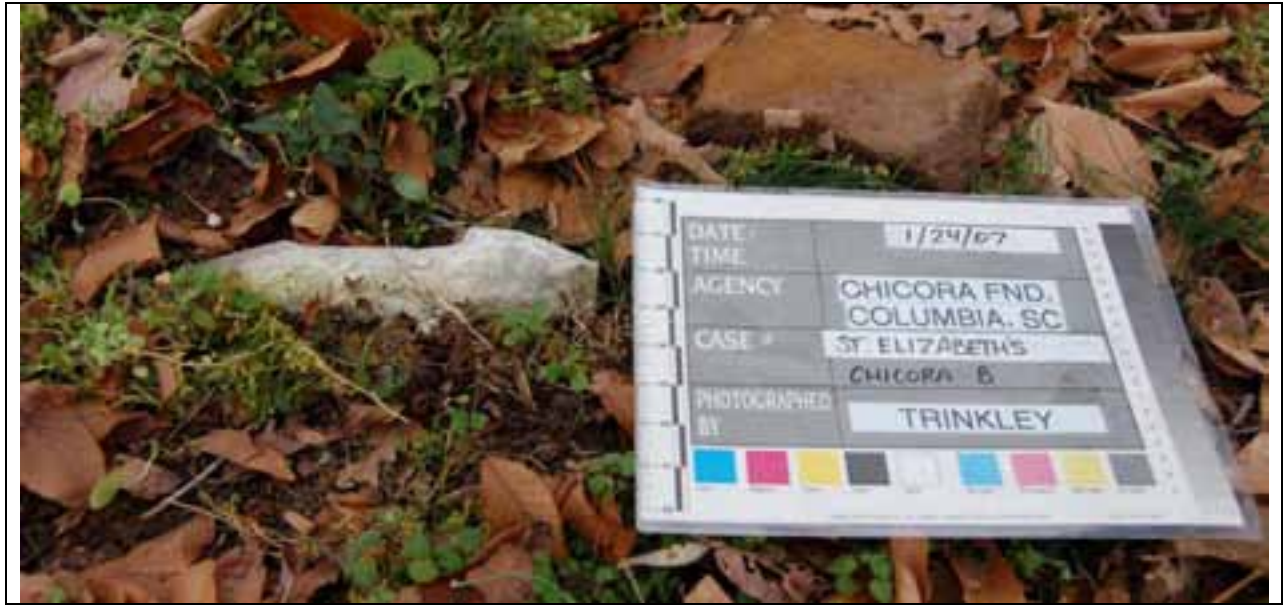
Current Condition Photograph on Rear

Condition of Marker: ☒ weathered ☐ cracked ☐ broken ☐ vandalized
☐ unattached ☐ loose ☐ biologicals ☐ stained
☐ repaired ☐ portions missing:
☒ tilted: degrees: 10 E-W N-S Other:

Condition of Grave: satisfactory

| <input type="checkbox"/> Consider replacement with "XA" NCA marker | fiscal year | |

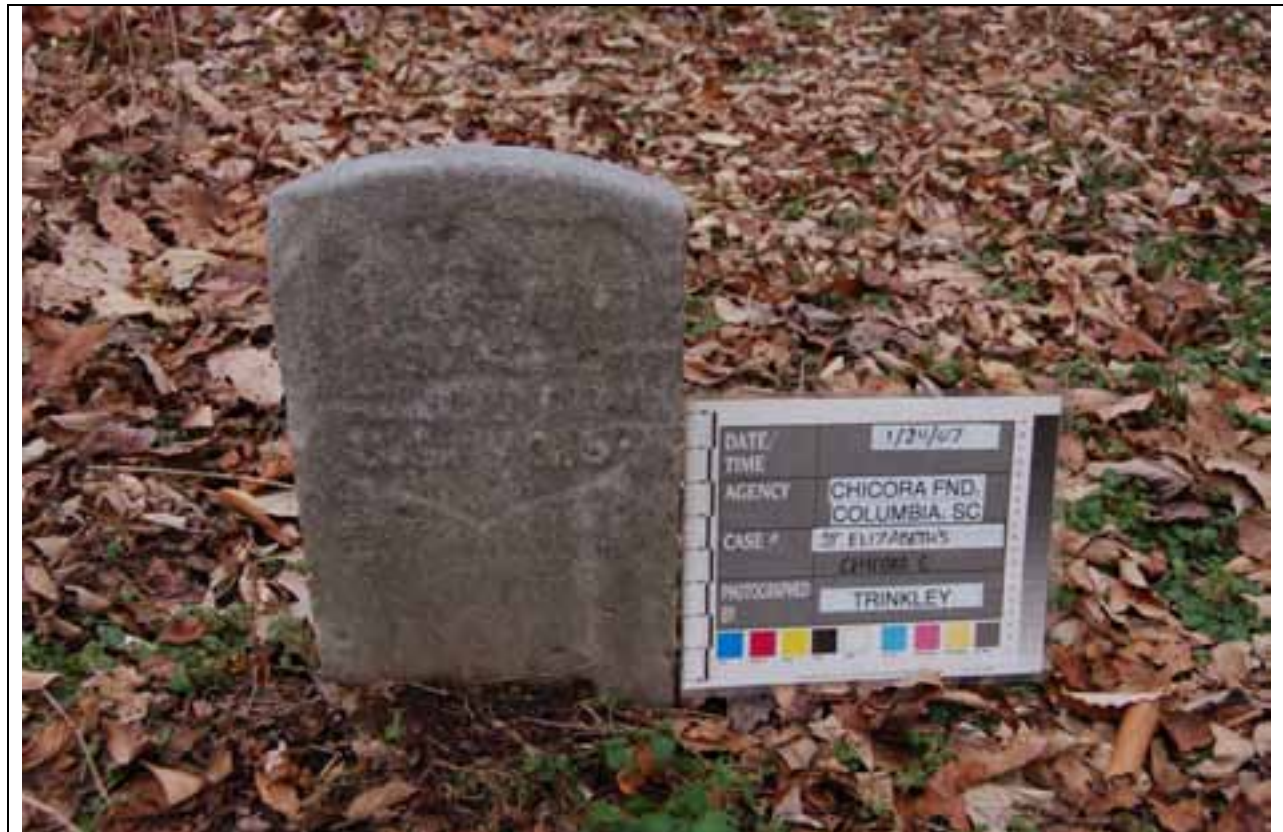
Current Condition Photograph on Rear

Condition of Marker: ☐ weathered ☐ cracked ☒ broken ☐ vandalized
☐ unattached ☐ loose ☐ biologicals ☐ stained
☐ repaired ☒ portions missing: upper half of stone
☐ tilted: degrees: E-W N-S Other:

Condition of Grave: unknown

| <input type="checkbox"/> Consider replacement with "XA" NCA marker | fiscal year |

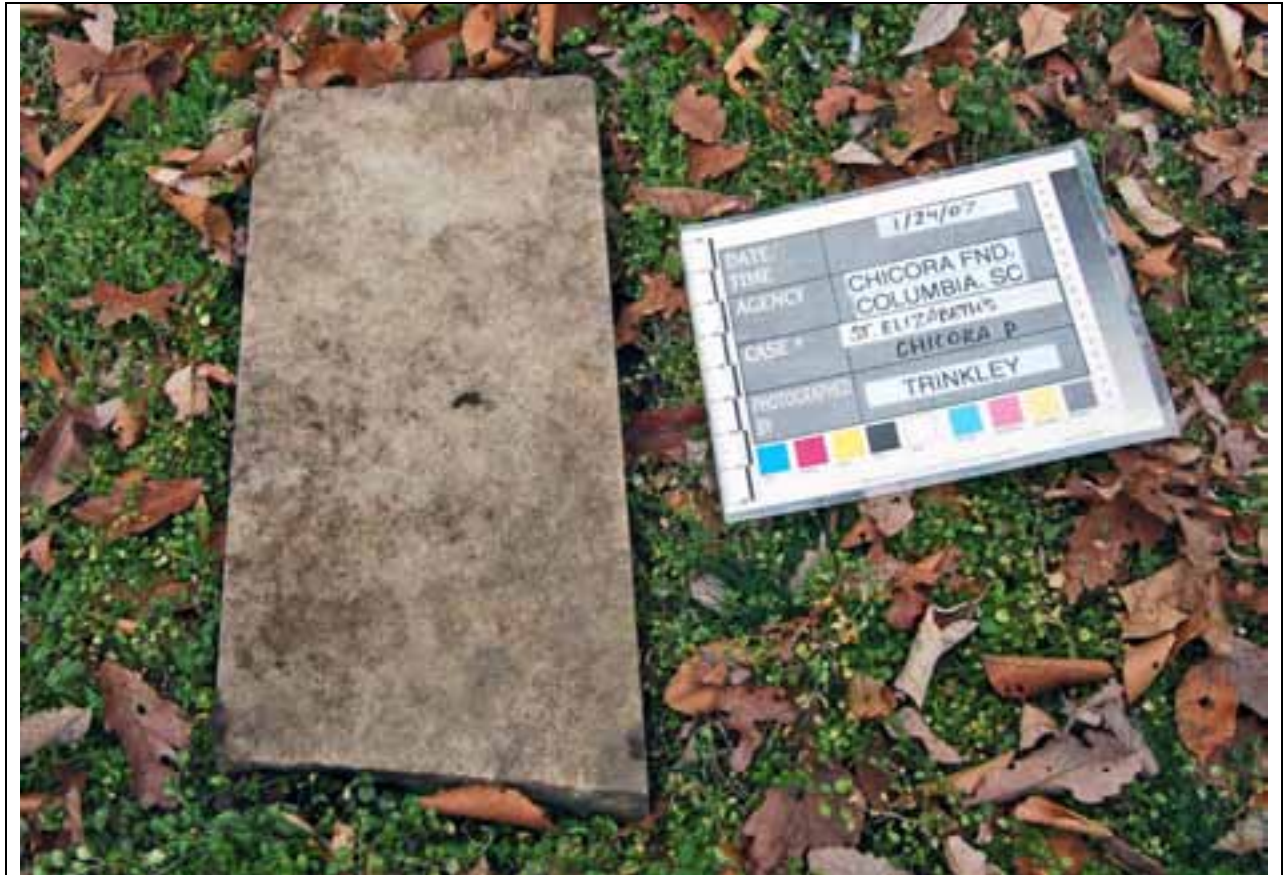
Current Condition Photograph on Rear

Condition of Marker: ☐ weathered ☐ cracked ☒ broken ☐ vandalized
☐ unattached ☐ loose ☐ biologicals ☐ stained
☐ repaired ☒ portions missing: upper half of stone
☐ tilted: degrees: E-W N-S Other:

Condition of Grave: satisfactory

| <input checked="" type="checkbox"/> Consider replacement with "XA" NCA marker | fiscal year |

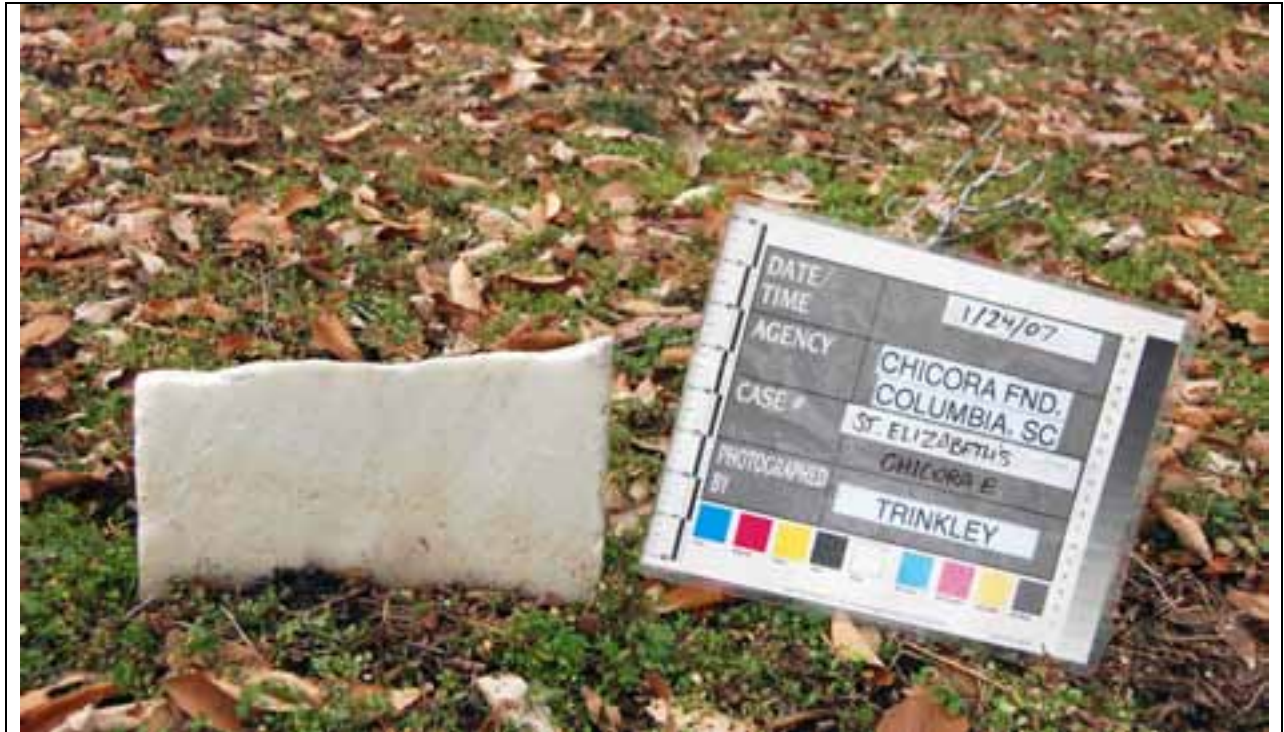
Current Condition Photograph on Rear

Condition of Marker: ☐ weathered ☐ cracked ☒ broken ☐ vandalized
☐ unattached ☐ loose ☐ biologicals ☐ stained
☐ repaired ☒ portions missing: upper half of stone
☐ tilted: degrees: E-W N-S Other: flat on ground

Condition of Grave: unknown

| <input type="checkbox"/> Consider replacement with "XA" NCA marker | fiscal year |

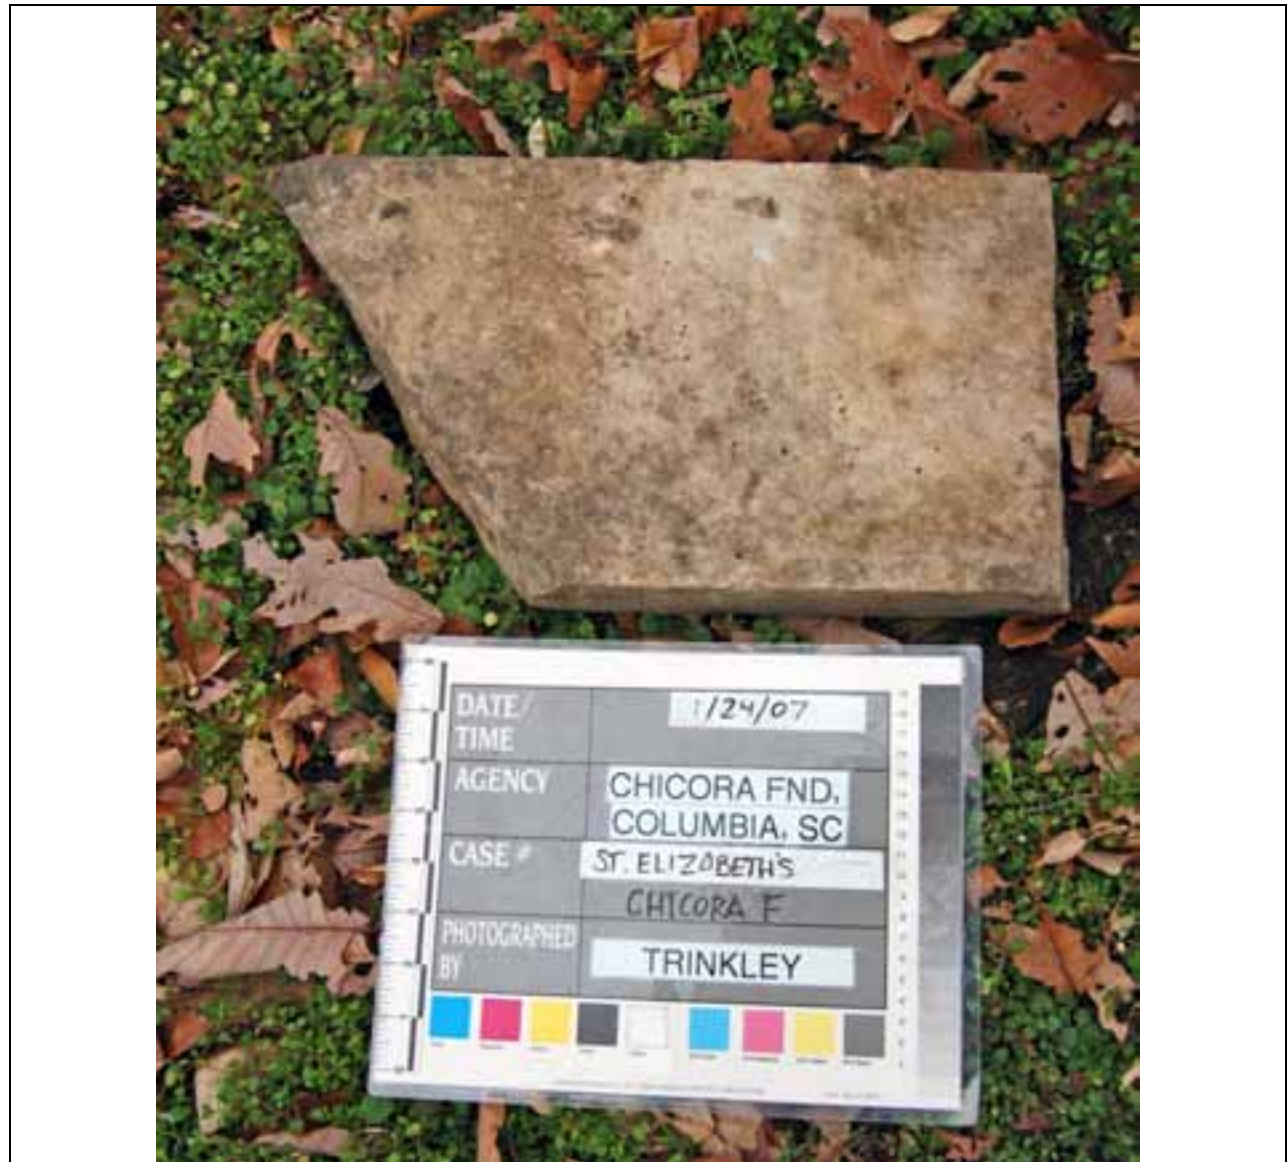
Current Condition Photograph on Rear

Condition of Marker: ☐ weathered ☐ cracked ☒ broken ☐ vandalized
☐ unattached ☐ loose ☐ biologicals ☐ stained
☐ repaired ☒ portions missing: upper half of stone
☒ tilted: degrees: 40 E-W N-S Other:

Condition of Grave: satisfactory

| <input checked="" type="checkbox"/> Consider replacement with "XA" NCA marker | fiscal year |
