PRESERVATION PLAN AND RECOMMENDATIONS FOR THE COLEMAN-LEIGH-WARREN CEMETERY, AUGUSTA, GEORGIA

Chicora Research Contribution 483

January 2008

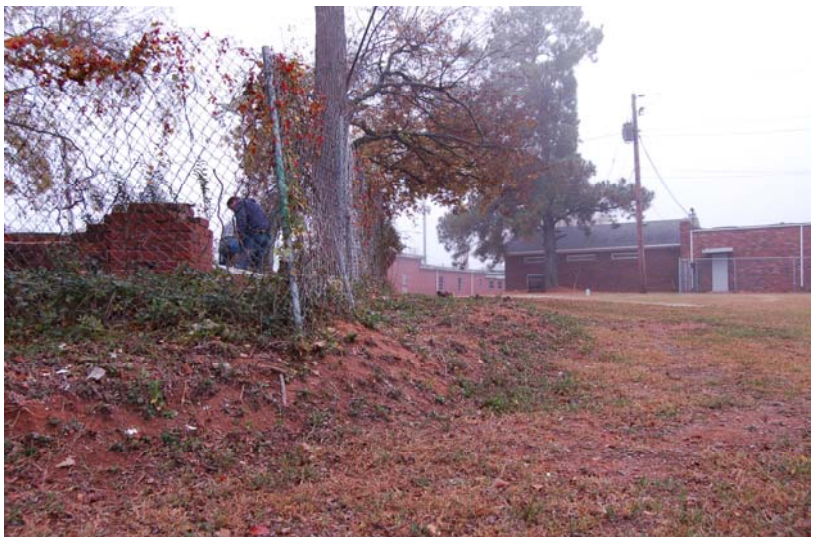
Figure 4. View of the commercial development to the south of the cemetery. This photo also shows the cut bank that has been taken up the fenced edge of the cemetery.

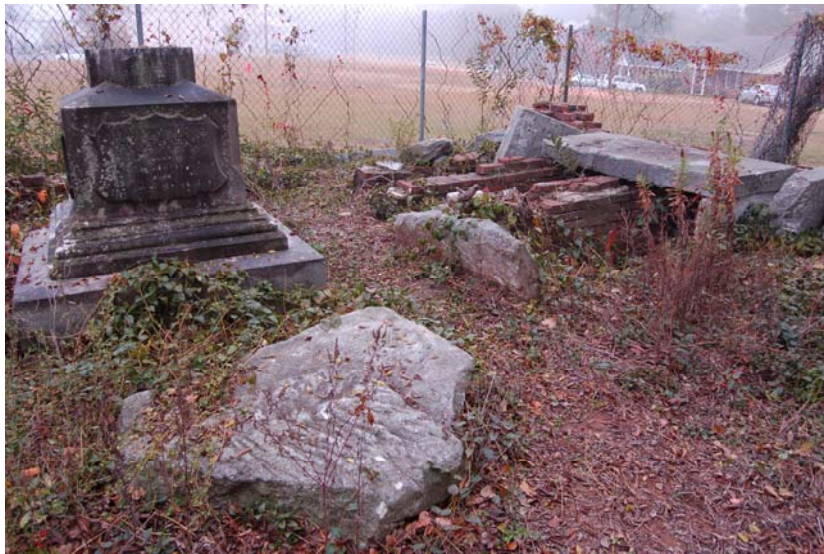
three-dimensional monuments remaining in the cemetery, although there are numerous low and heavily damaged tombs (Figure 5). The original entrance to the cemetery faces east and is not currently usable. The cemetery lacks landscaping; the large hackberry trees are in poor health and do little to enhance the property.

Figure 5. Interior of the cemetery showing its ruinous condition. View to the northwest.

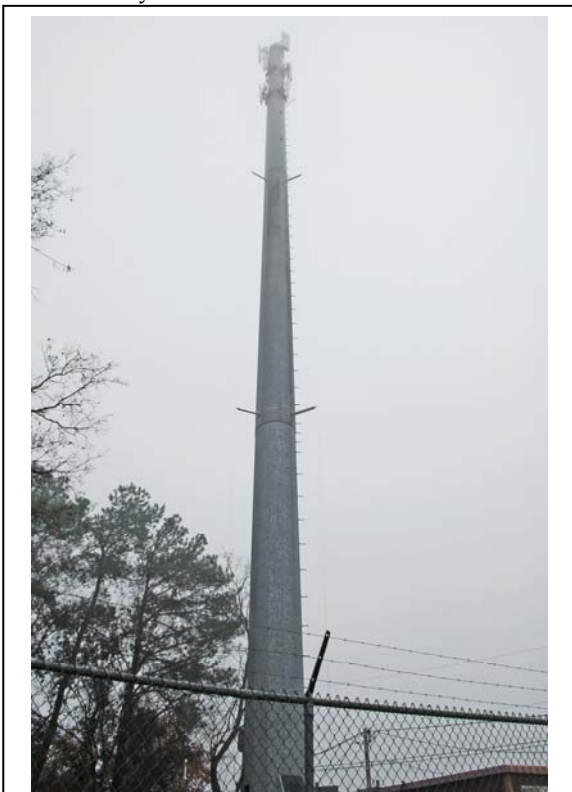
Figure 9. The Alltel tower dominates the visual landscape, significantly dwarfing the cemetery.

A final issue involves access by maintenance vehicles for the Alltel tower. We presume that the lease provides use of this easement. The primary concern is the visual intrusion (see Figure 9); although the Friends should fully inform themselves of the provisions of this lease and any liability they may be exposed to as its result.

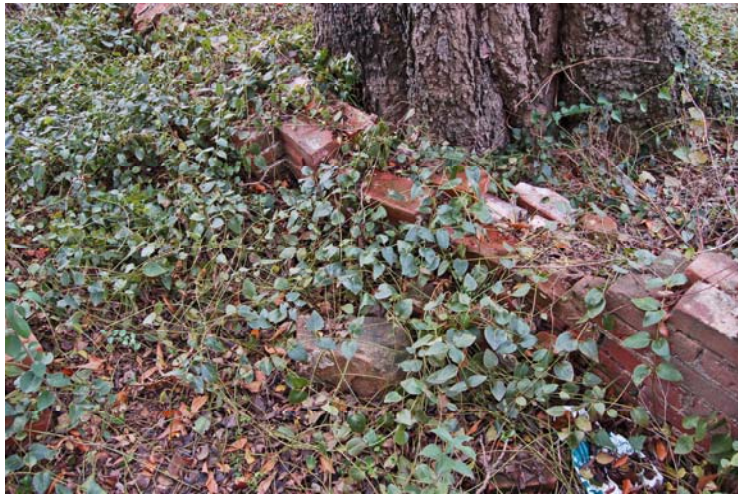
Figure 10. Extensive ground cover in the cemetery.

Pedestrian access is also hampered by the dense, and hazardous, ground cover that has overtaken the cemetery. This groundcover is especially dangerous to the elderly and those lacking sure footing. It is made even more treacherous by the abundant brick rubble and uneven ground.

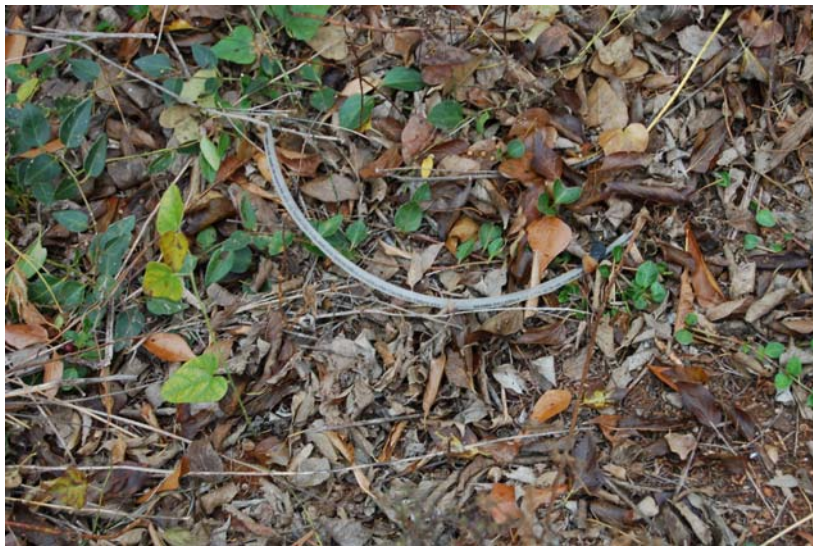
Figure 12. Drug paraphernalia found on the cemetery property during this assessment

vegetation keep at the current level, but even improved. The better the visibility, the less likely criminals will seek out the property.

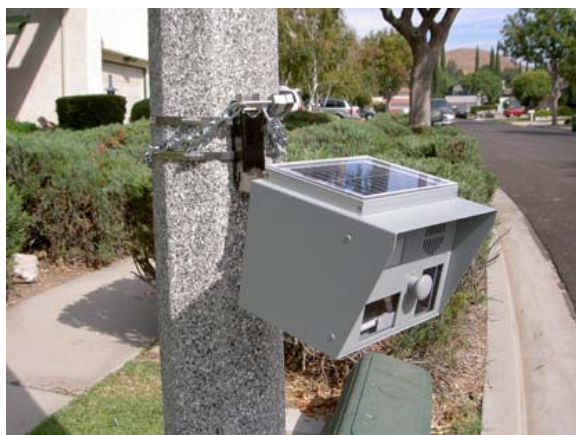
(<http://www.qstartech.com>). This self-contained digital system is motion activated; a photograph is taken (a flash unit allows night photographs at 100 feet), and a customized recorded announcement is played. Units are solar powered, eliminating the need for

Figure 13. Example of the Q-Star Flashcam 880.

electrical connections. Photographs are high resolution and time/dated stamped. Units can be downloaded wirelessly. Although not inexpensive, they are among the most affordable solutions for cemeteries facing on-going vandalism and theft problems.

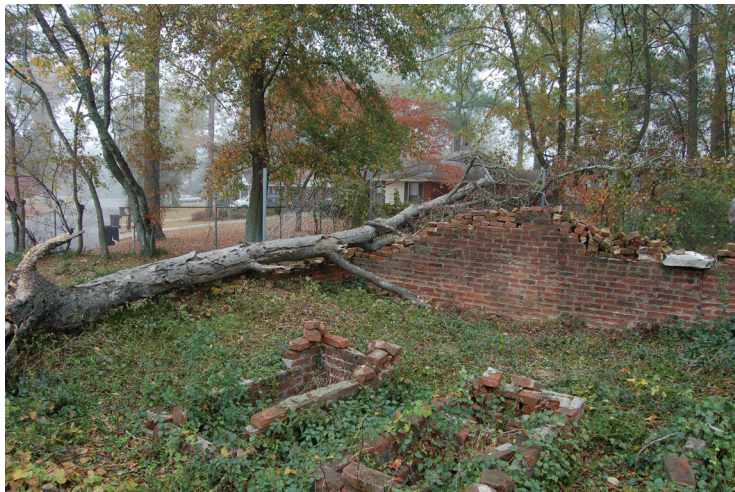
The cemetery today contains five trees, all hackberry (*Celtis occidentalis*). The tree self-seeds and is considered invasive. It suffers from

Figure 14. Rotted hackberry branch and pre-existing damage to the cemetery wall.

a variety of problems under the best of circumstances, including significant surface roots that can lift sidewalks, weak collar formation, susceptibility to breakage, and large amounts of litter.

Specifically, we recommend additional historical research in order to resolve uncertainties regarding the cemetery and its use. We also recommend that the hackberry trees in the cemetery – all in poor condition and endangering the public and the cemetery – be removed by an ISA Certified Arborist. They will be replanted, perhaps with Eastern red cedar.

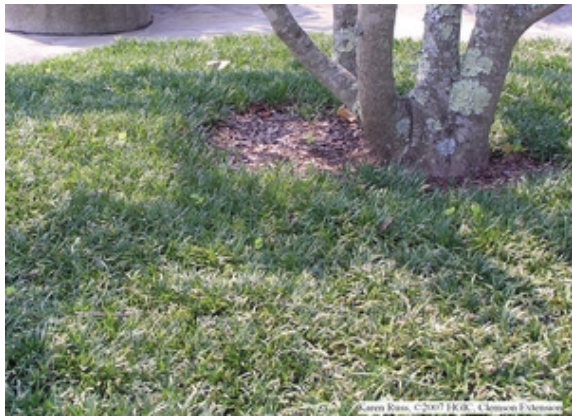
Dwarf mondo is established vegetatively. The cemetery plot would first be well prepared, with the soil treated with an herbicide such as Roundup to eliminate competition. Afterwards soil amendments can be added, including a complete organic fertilizer. Individual tufts should be planted about 2-inches apart and it may require up to 3 years for the plants to completely fill in.

An annual top-dressing of 1/2 inch of compost spread over the mondo grass bed helps promote lateral spread of rhizomes and provides micronutrients and small, slowly released amounts of nitrogen. Compost is

Figure 15. Dwarf mondo grass (photo courtesy Clemson University).

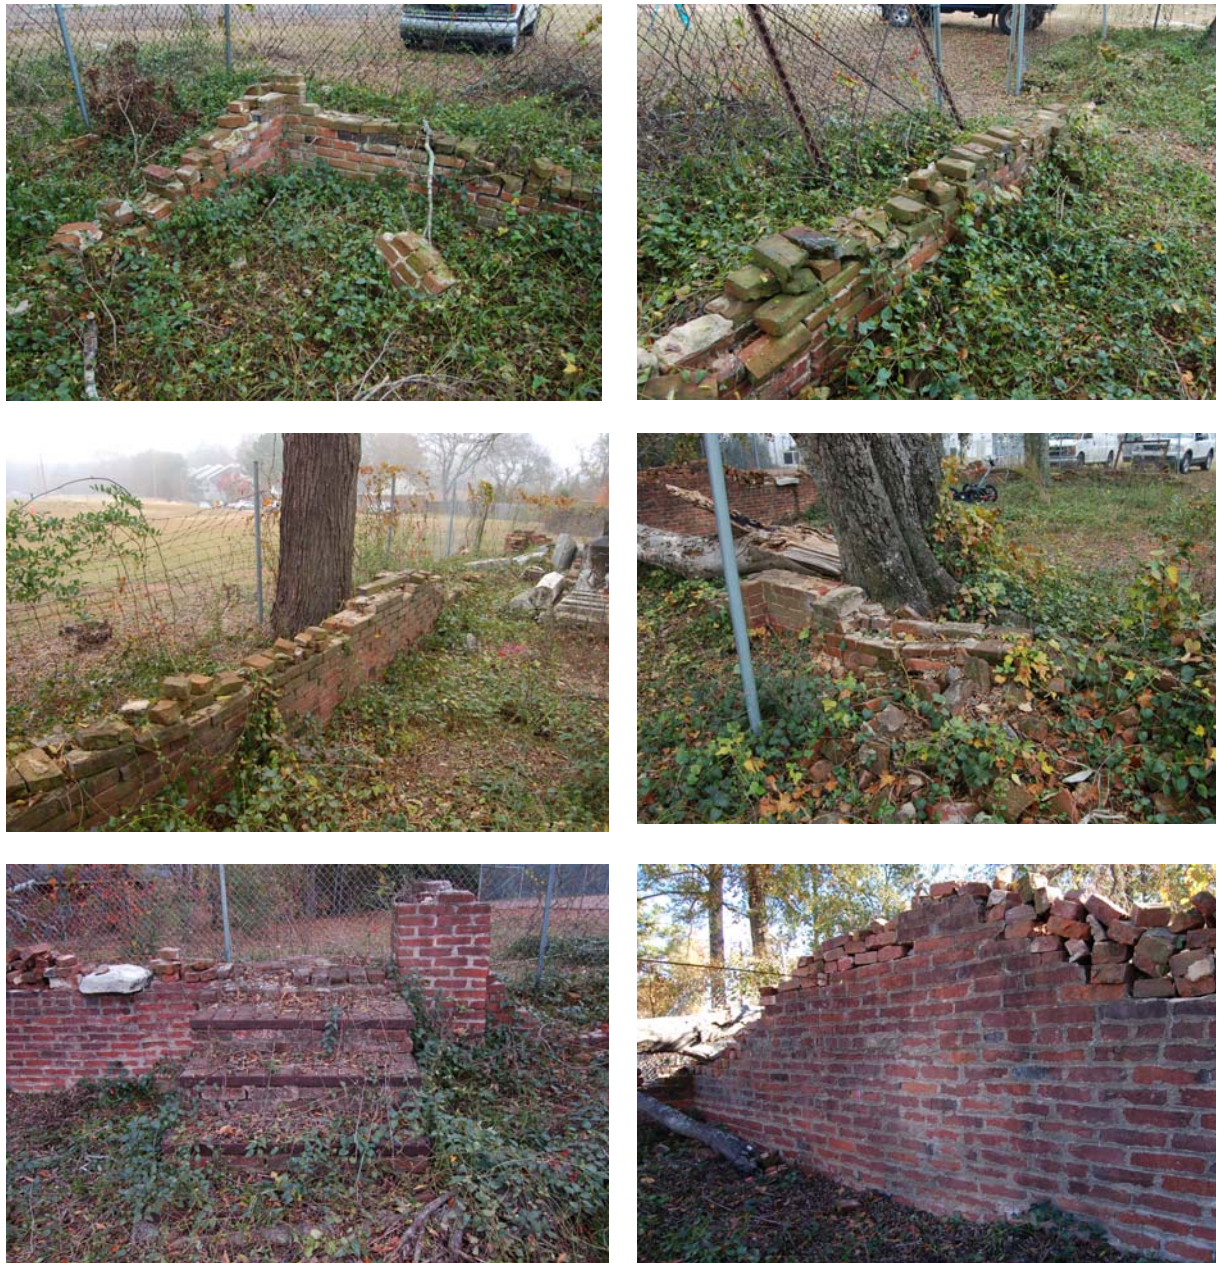
The original wall, double wythe, was laid in common bond with headers every 10th course. The brick used in the wall construction averages 8½ to 9 inches in length, 4⅛ to 4¼ inches in width, and 2½ to 2¾ inches in thickness. Approximately 2-foot square columns are found at the wall corners and about every 13 feet along the walls.

Figure. 16. Condition of the surrounding brick wall. From upper left to lower right: southeast corner; south wall; west wall; north wall, showing tree damage shifting a section of the wall outward; close-up of the steps on the east wall with metal banding; portion of the interior east wall showing repointing with hard Portland cement mortar.

Today the wall ranges from less than a foot high to about 3 feet in height, with the best preservation along the east where steps over the wall allowed access into the cemetery. Preservation along the west and south walls is far worse, with the wall barely breaking through the vinca in some areas.

This work can be accomplished only after vegetation is removed, all loose brick is recovered, and the soils are graded. With an established grade to work from the treatment of the boxes will be somewhat similar to the previous discussion of the wall. A major difference, however, is that we have found little original brickwork in the box. Therefore, it is not necessary to cut out OPC joints. What is necessary is to stabilize the box and rebuild them to a consistent height of six courses above grade.

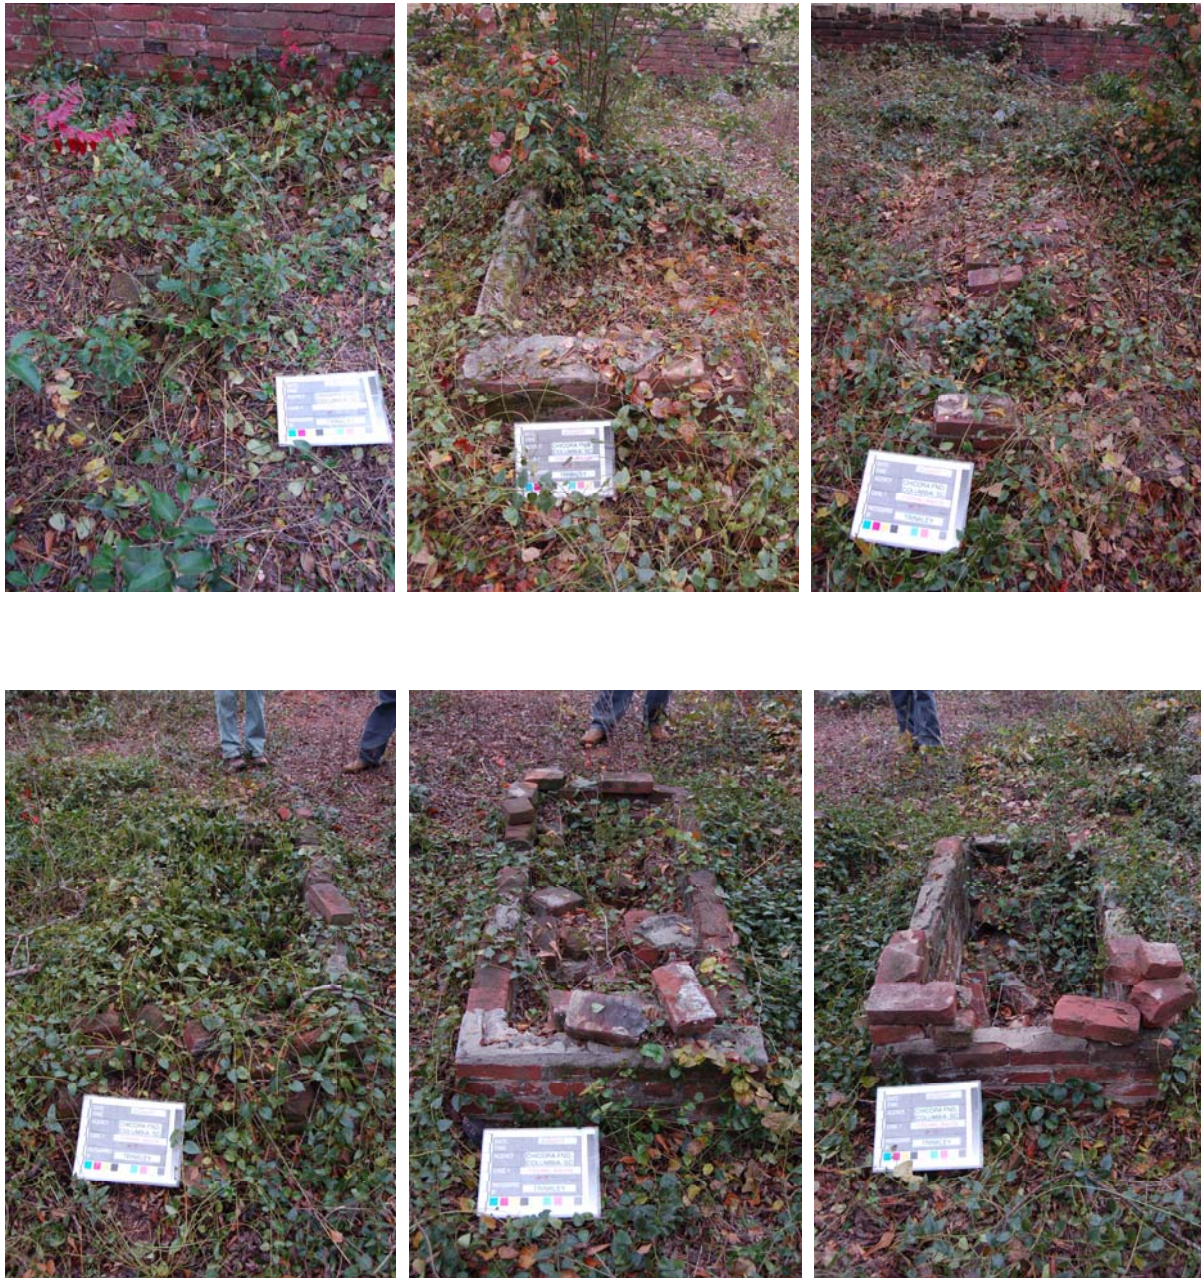
Figure 17. Box tomb remains at the Coleman-Leigh-Warren Cemetery. From upper left to lower right, number 1(unknown), 8 (Lucy G.W.B. Coleman), 7 (William H. Warren), 9 (Robert M. Warren), 10 (Lindsay Coleman), and 11 (Sarah Coleman).

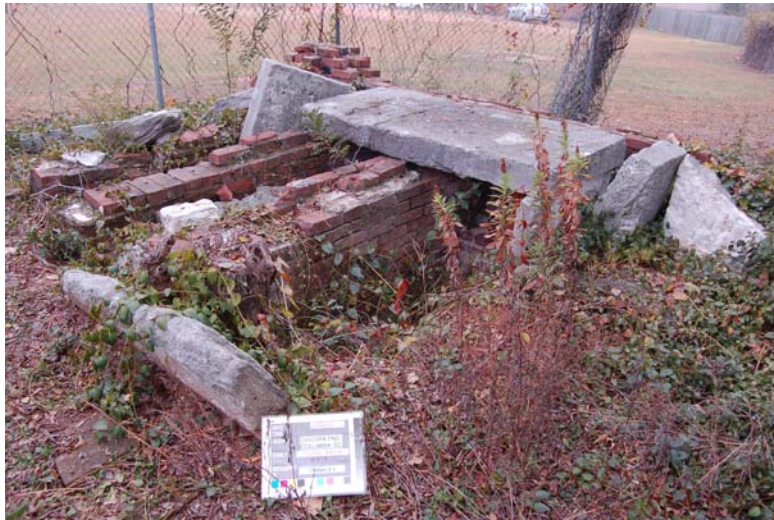
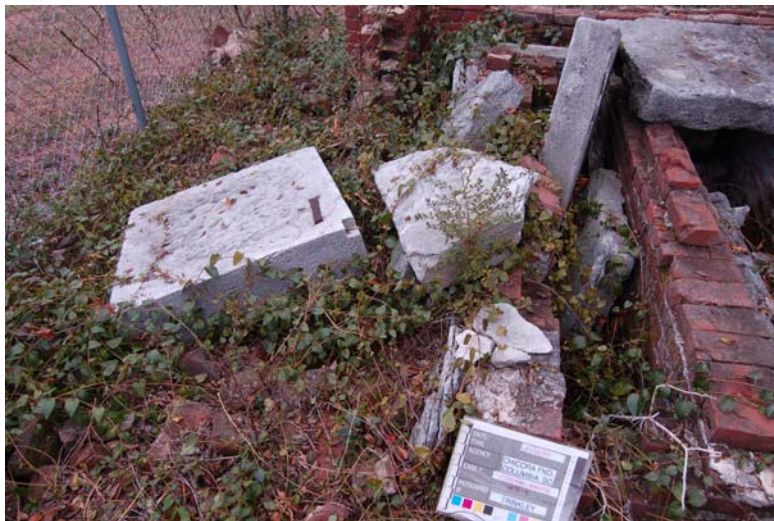
Figure 18. Box tomb of the Leigh Family (4-6).

All but one of the six single box are single wythe. The one exception has double wythe head and foot, with single wythe side walls. Consequently, each box will require approximately 150 brick, of which perhaps only 50 are currently present, leaving a deficit of approximately 600 brick.

Until such funds are available, we recommend preparing a simple marble slab with the names of the Leigh family originally interred in the three box tombs and erect it on top of the rebuilt boxes. This would ensure that the graves

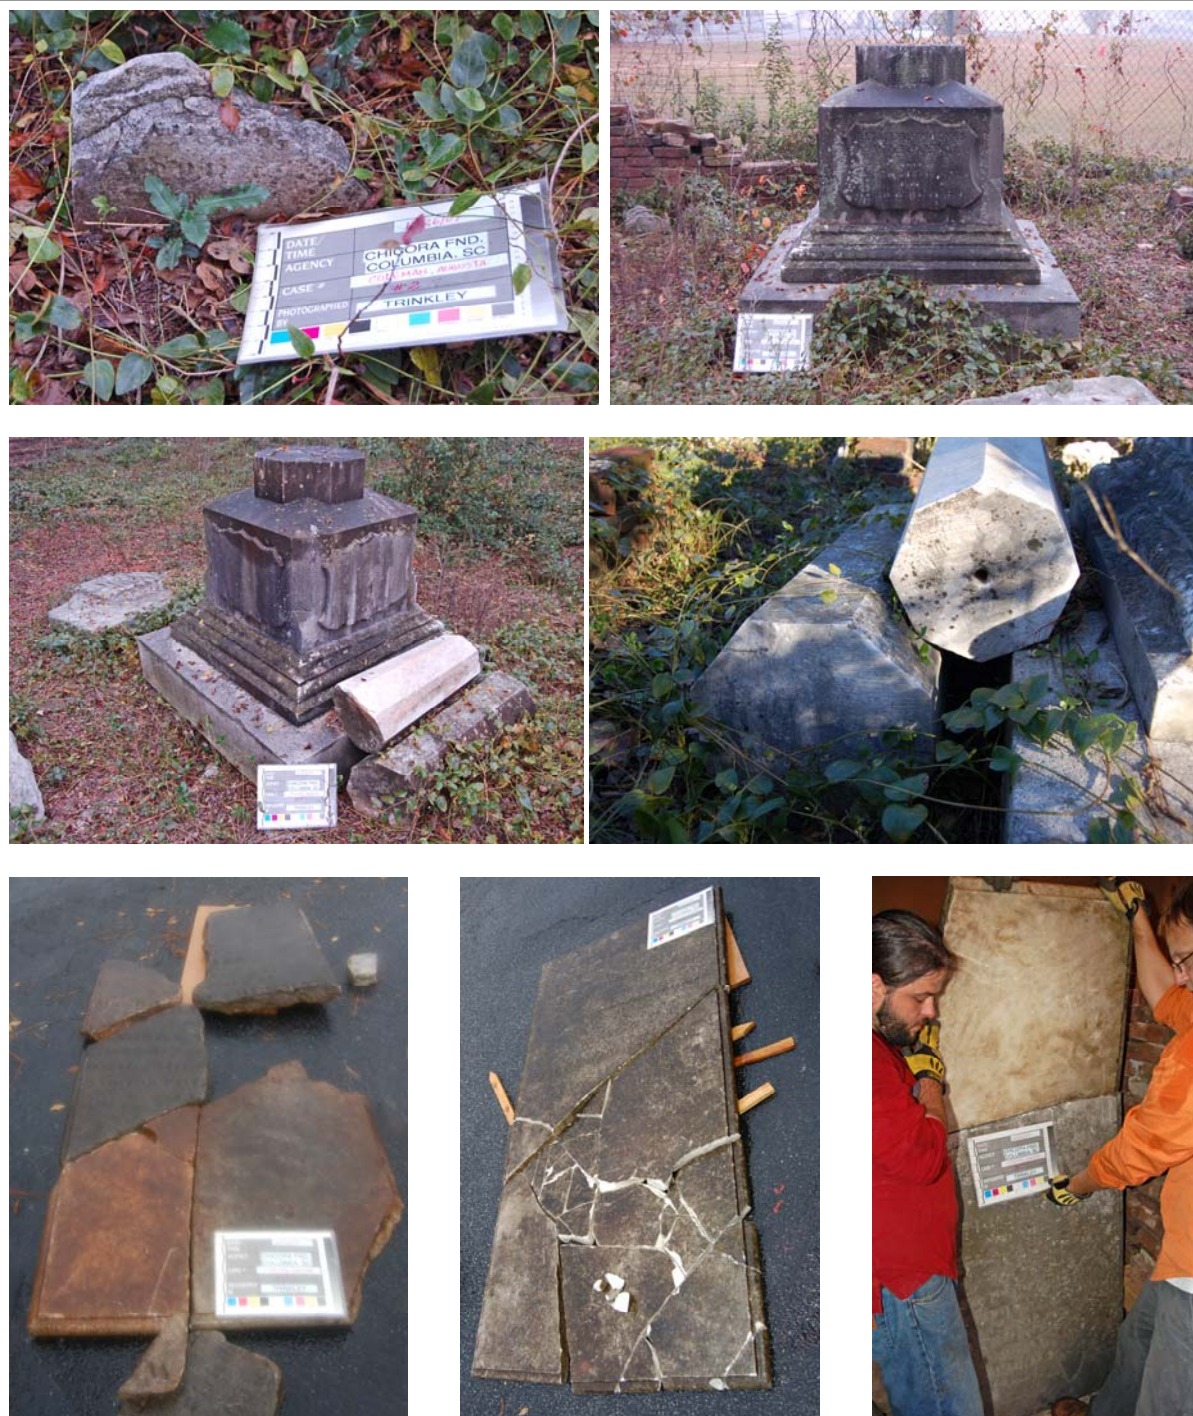
Figure 19. Marble monuments from the Coleman-Leigh-Warren Cemetery. For upper left to lower right: 2 - Walter Leigh Warren; 3, Warren monument - front, oblique, and close-up of the broken column; 11, Sarah Coleman; 7, William H. Warren; 10, Lindsay Coleman.

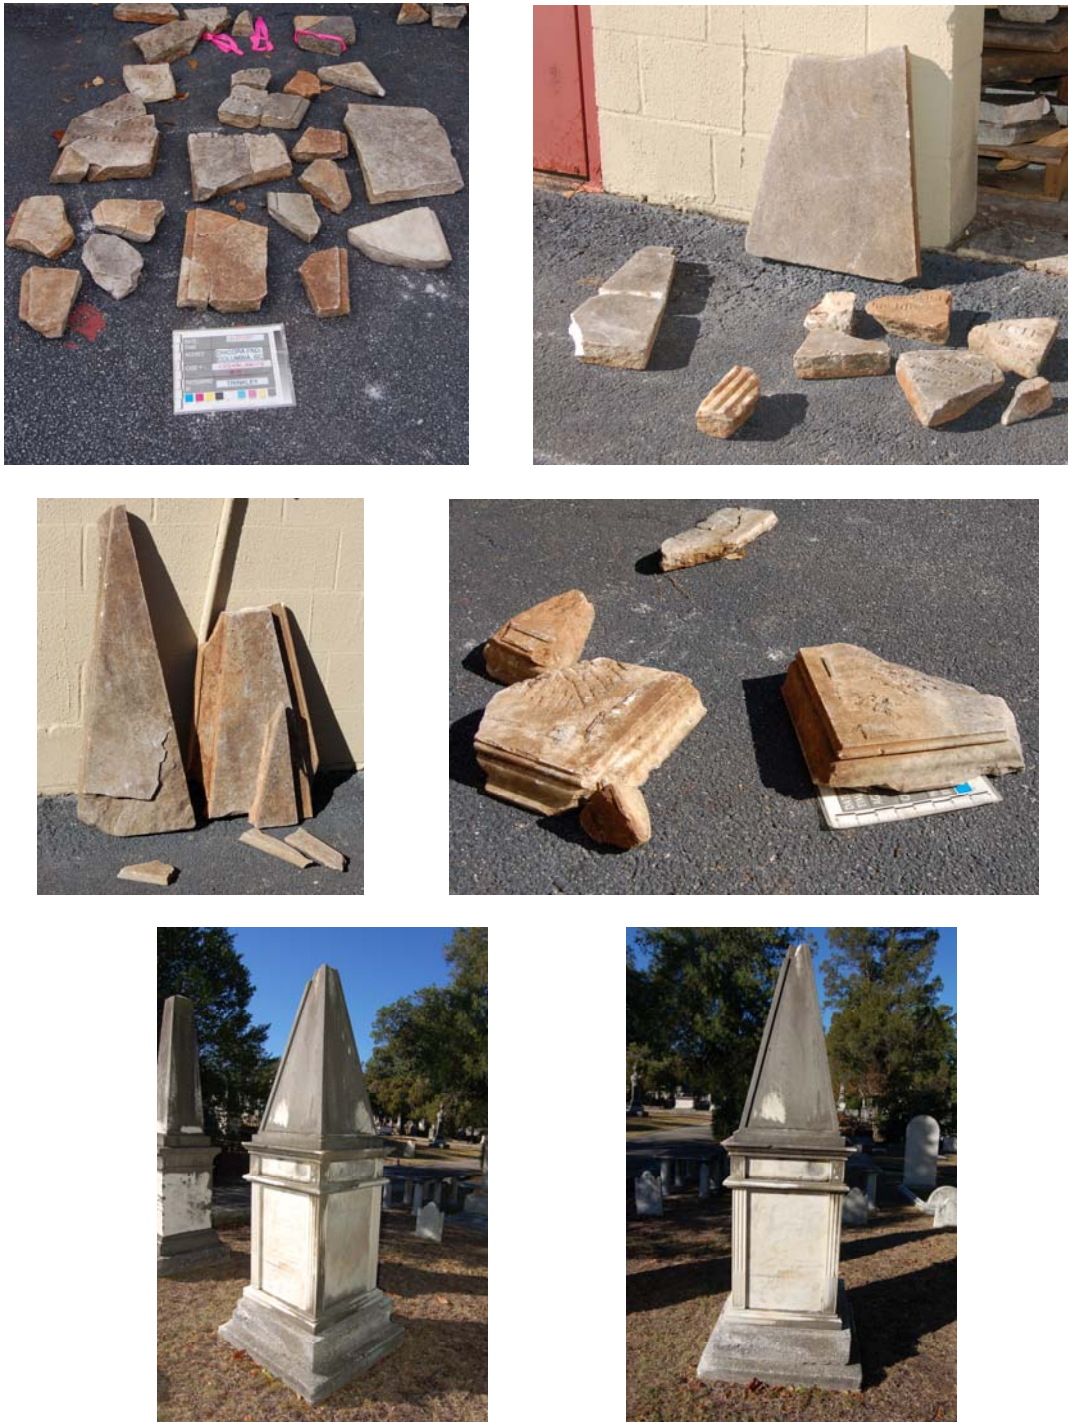
Figure 20. Examples of monuments identified as not suitable for repair. In the upper left is a photograph of fragments thought to represent the remains of 8, Lucy G.W.B. Coleman. The remaining photographs in the first and second rows are of various fragments associated with monument 4-6, Leigh. The bottom two photographs are of a similar monument in Augusta's Summerville Cemetery.

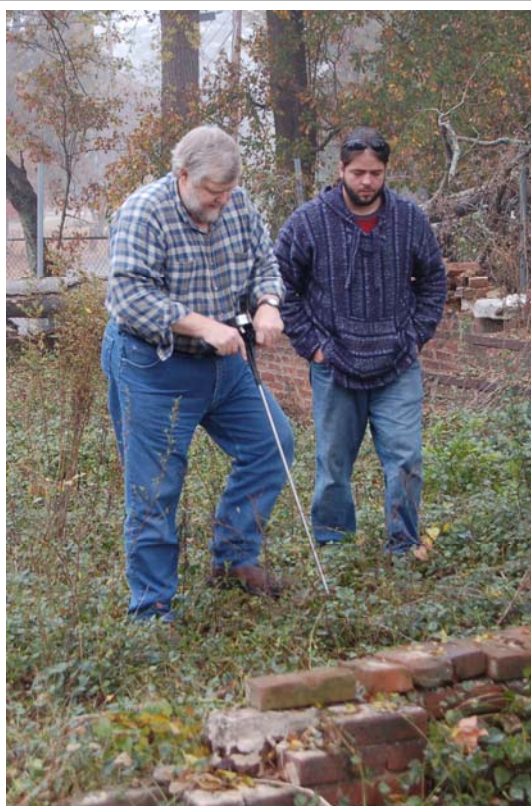
Figure 21. Use of a penetrometer in the cemetery.

successful. In the area south of the cemetery we encountered significant quantities of gravel. The origin of this material is unknown, although it may be associated with the use of the area for parking during the Masters Tournament. In addition, compaction readings were even higher than within the enclosure – 300+ psi. These readings were found consistently as we moved to the west. Of course in this direction the upper 2 feet of soil has been removed and the area is known to have been used for parking.

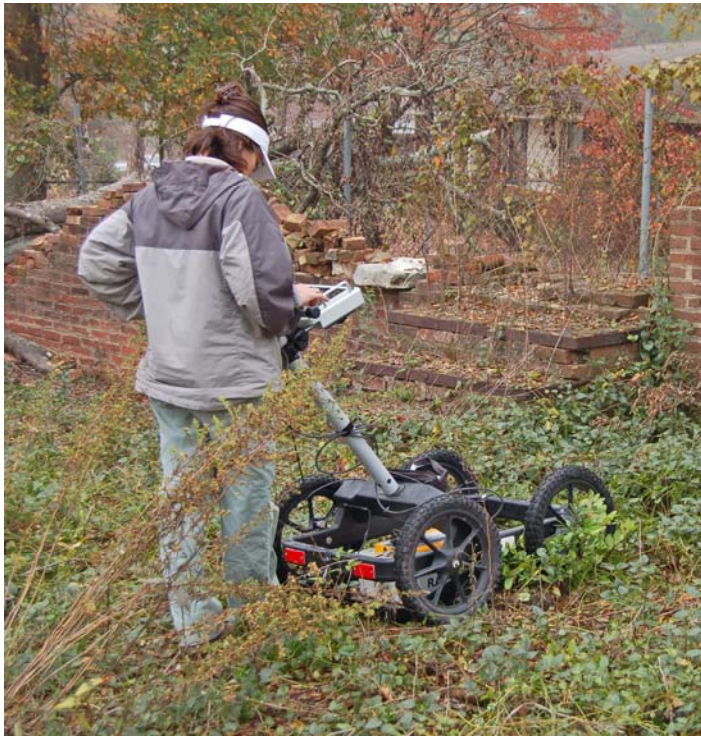
interfaces between materials with differing dielectric constants. The intensity of the reflected signal is a function of the contrast in the dielectric constant at the interface, the conductivity of the material which the wave is traveling through, and the frequency of the signal. The profiling recorder receives the signal

Figure 22. GPR survey within the cemetery.

from the antenna and produces a continuous cross section of the subsurface interface reflections, referred to as "reflectors," "reflector events," or "anomalies." The skilled operator seeks to identify those reflectors or anomalies that are most consistent with grave shaft excavations.
