# **ASSESSMENT AND RECOMMENDATIONS FOR THE THOMASVILLE, GEORGIA CEMETERIES**

**Chicora Research Contribution 485**

Prepared By:  
Michael Trinkley, Ph.D.  
and  
Debi Hacker

January 31, 2008

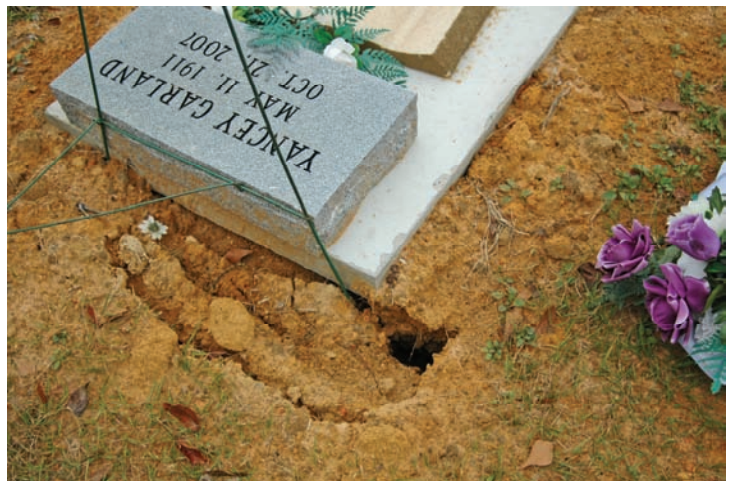
Figure 4. Example of improperly backfilled grave. Although only three months old, the grave is already collapsing. This is disrespectful to the family and a safety hazard.

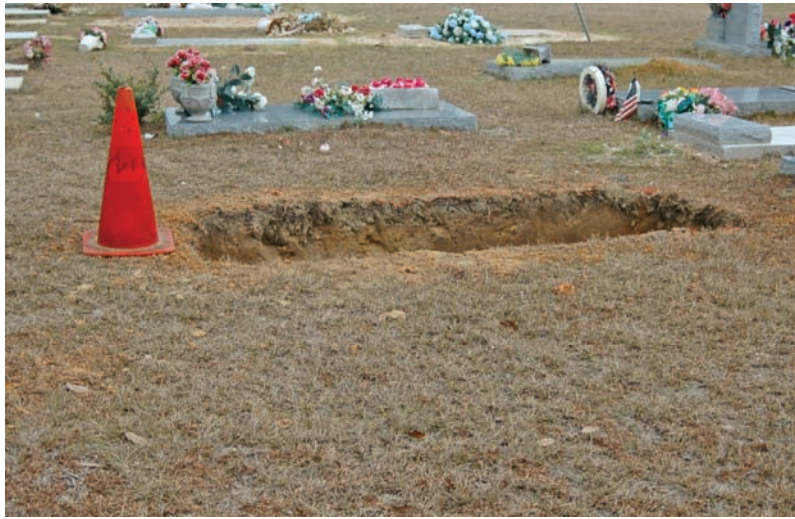
Figure 5. Open graves are safety hazards and should be prohibited.

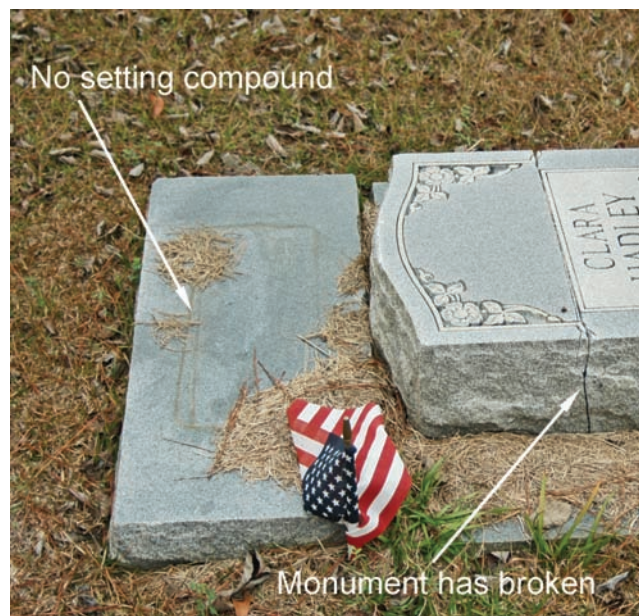
Figure 6. This granite die on base monument was set without using setting compound. This allowed the die to be easily displaced – and as it fell it broke. Its repair will be a significant expense (\$600) that could have been prevented using \$5 worth of setting compound.

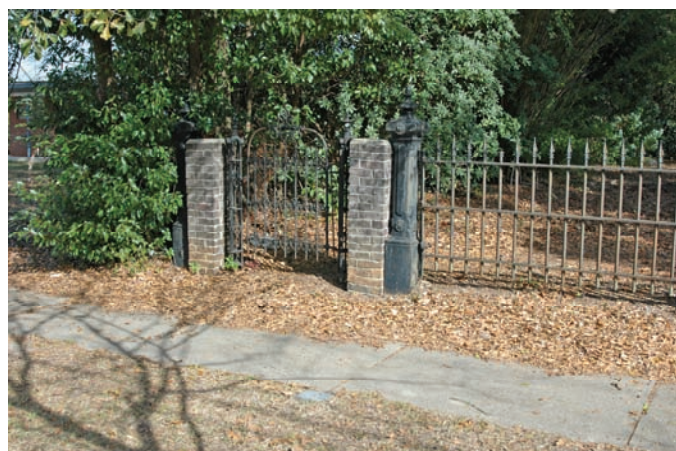
The walking tour stops at the cemetery's northwest corner, the location of a pedestrian gate. There is no signage and the gate takes you into a poorly maintained area littered with trash along the American Legion fence row.

Figure 12. The entrance off Madison Street is the primary stopping point for walking tours. The area is overgrown and littered with trash – presenting a poor first impression.

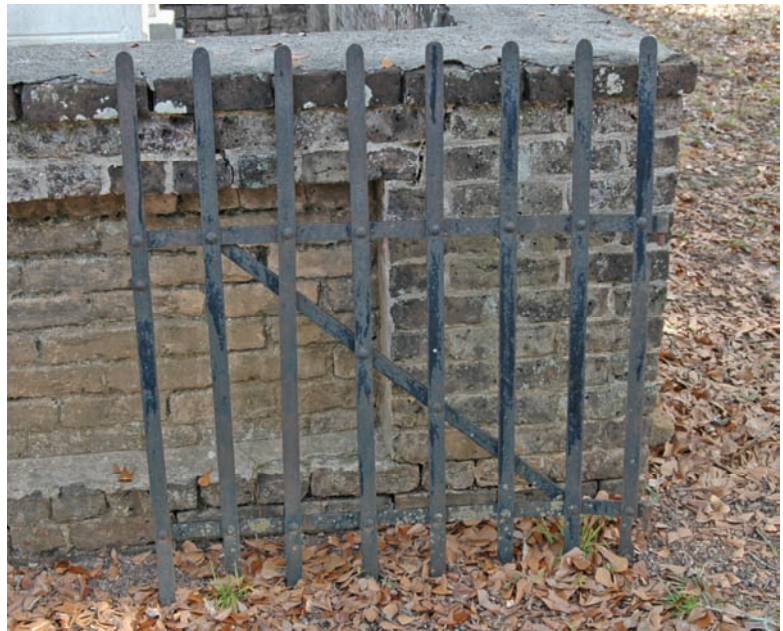
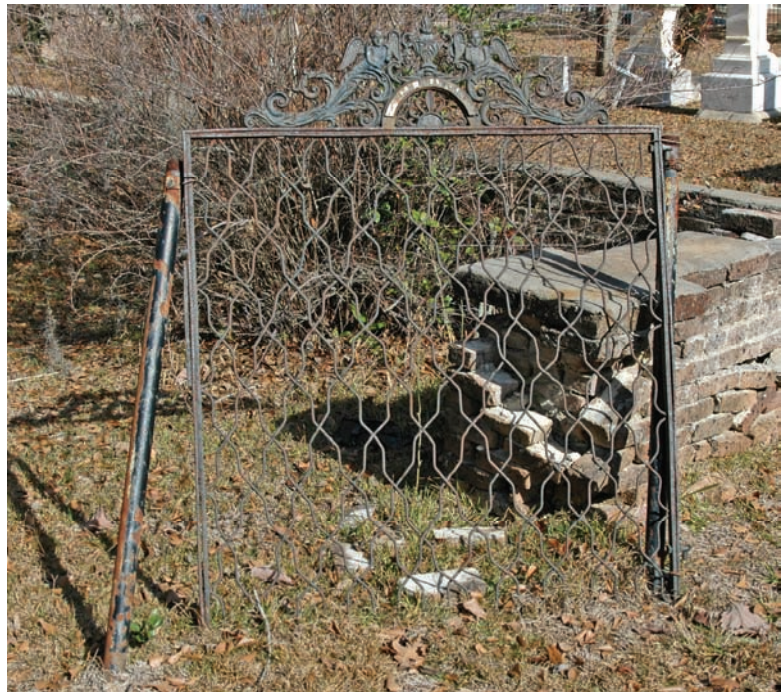
Figure 13. Examples of gates in Old Cemetery that are susceptible to easy theft.

Much of the iron work in the cemetery is unique and beautiful. It would command very high prices among those collecting and selling this type of material. Many of the gates (see Figure 13) are unsecured and present easy targets for theft.

We strongly recommend that all gates be secured. It is a simple maintenance step to use woven stainless steel wire to secure gates to their hinge posts. This allows the gate to open and close, but makes it considerably more difficult to lift the gate off its hinges and steal it.

The per gate cost is less than \$20 and the time involved is about 15 minutes each.

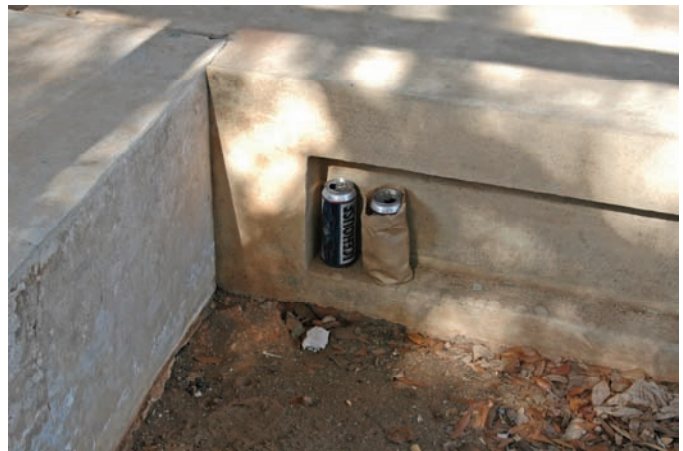
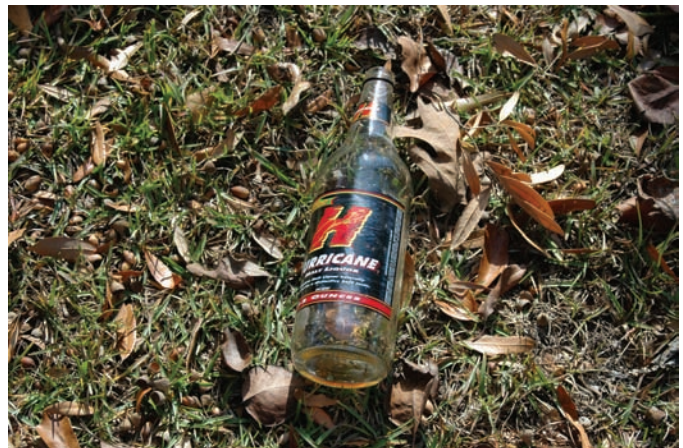
Figure 14. Examples of alcohol containers in Old Cemetery.

We are informed that Public Works does not visit Old Cemetery on a regular basis, especially during the winter months. This is clearly evident by the accumulations of trash (Figures 14 and 25). This trash clearly reveals why cemetery maintenance is a year-round, not seasonal, undertaking.

A more significant presence of city maintenance workers, coupled with a more aggressive police presence, is needed to curb this problem.

drunkenness; consumption of alcoholic beverages on municipal property prohibits the consumption or possession of alcohol on city property, including the cemetery. City Code Section 11-18 Littering public property or waters prohibited, makes the discard of these materials in the cemetery illegal. Other city codes deal with both criminal trespass and injury or defacing public property. There are therefore ample means for the city to reduce this problem.

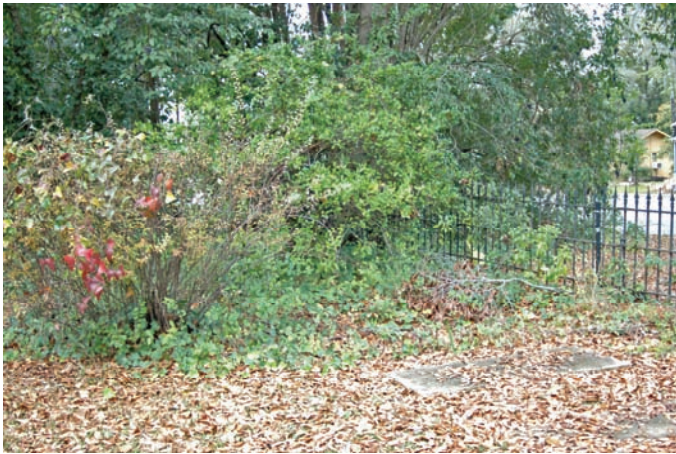
Figure 15. Dense, overgrown vegetation such as this provides hiding places for the homeless, drug users, and criminals – it should be carefully pruned.

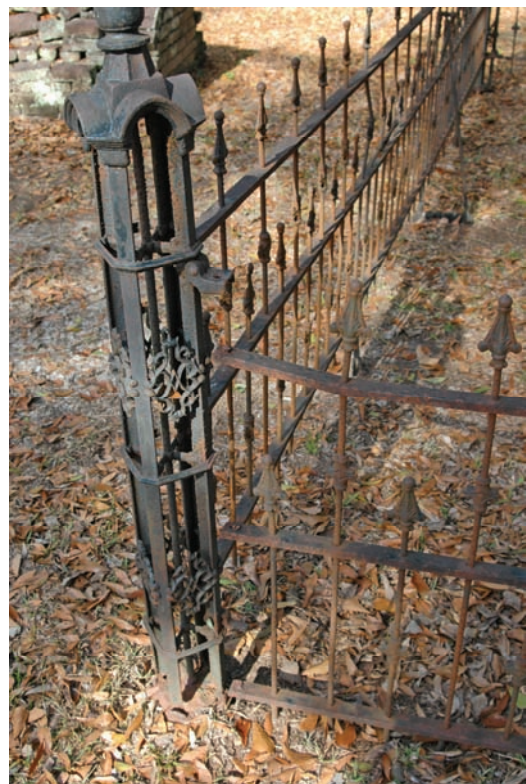
Figure 16. Damaged connectors on a plot fence. Note also the lack of a protective coating.

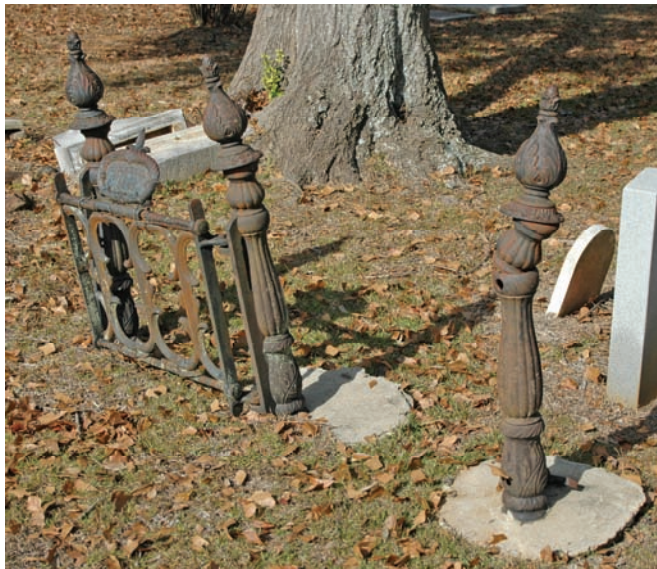
Figure 17. Although most of this fence is now missing, with appropriate repairs the ironwork can still contribute to the cemetery landscape.

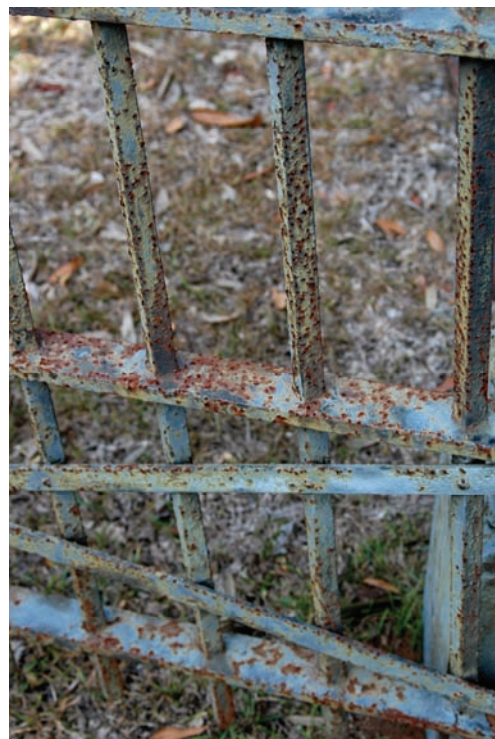
Figure 18. Example of heavy corrosion on the cemetery's boundary

Sandblasting the ironwork should be prohibited – it is unnecessarily aggressive, has the potential to damage surrounding stone, and can result in unnecessary lead

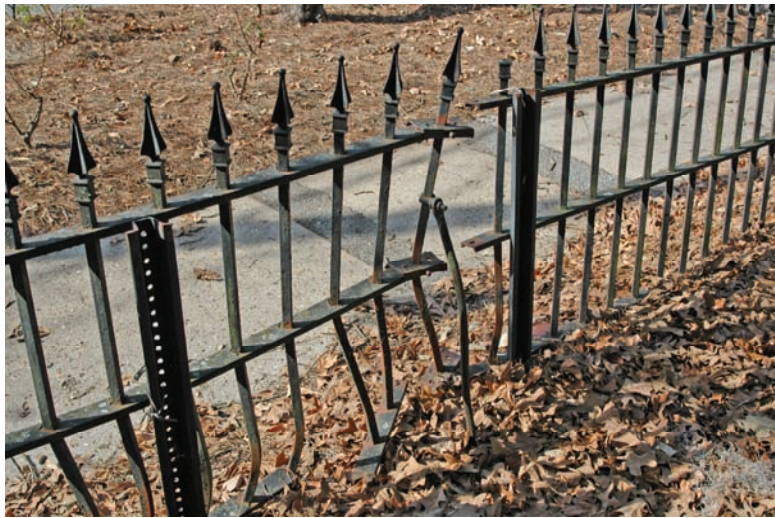
Figure 19. Damaged fence section. This requires disassembly, straightening, and replacement. Note also the sign supports holding up the fence.

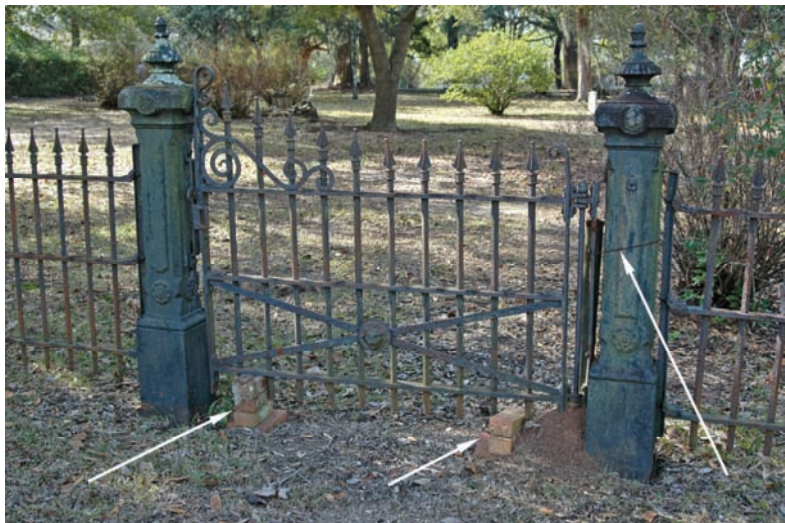
Figure 20. Boundary fence gate supported by bricks and wire.

Unfortunately, sections of this fence are in poor condition and the City must devote immediate attention to its repair.

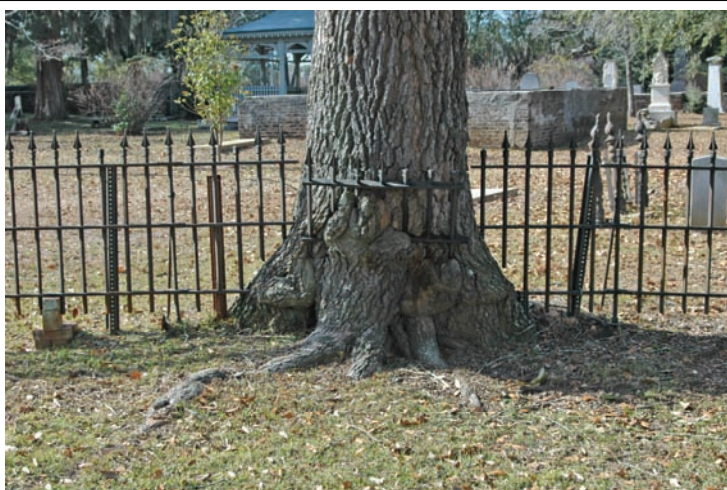
Figure 21. Tree that has grown into and displaced the boundary fence.

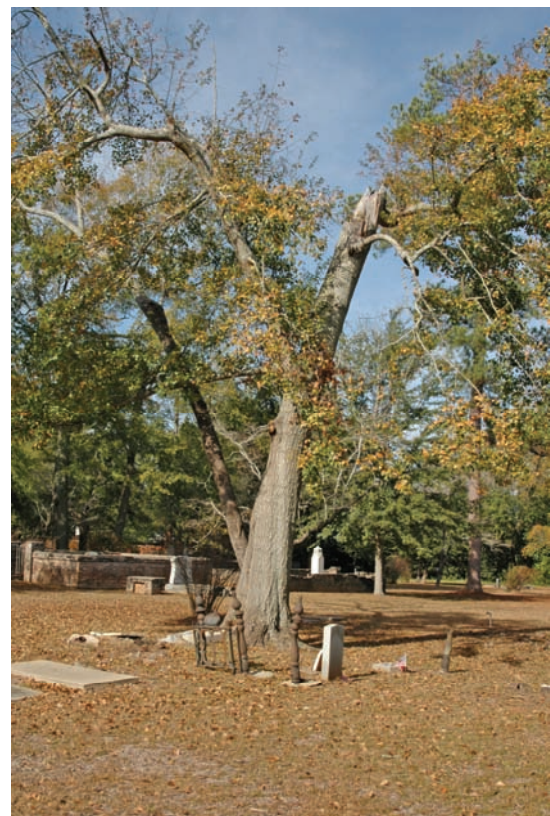
Figure 22. Example of a badly diseased tree that should be immediately removed as both a hazard to the public and stones.

If the tree is larger than 8-inches dbh or it will need to be topped and removed in sections, then it is critical that an ISA Certified Tree Worker/Climber be retained. Any effort to remove such trees in house will pose a

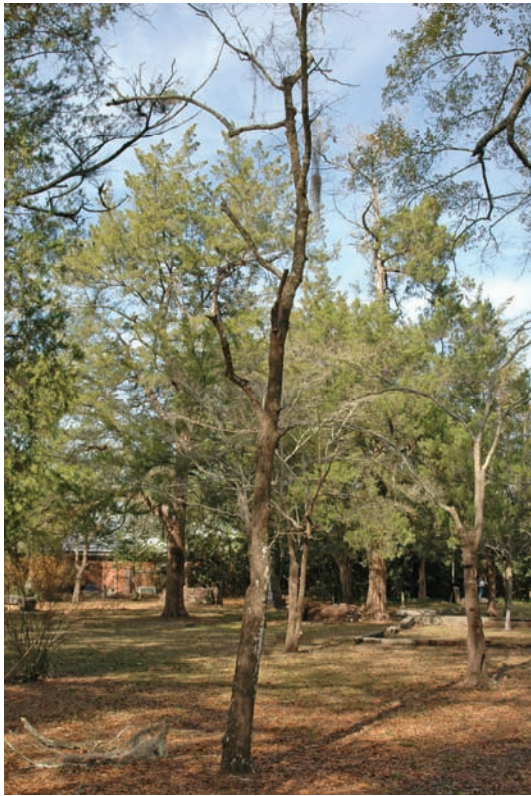
Figure 23. This dogwood, planted in full sun, is diseased and should be removed.

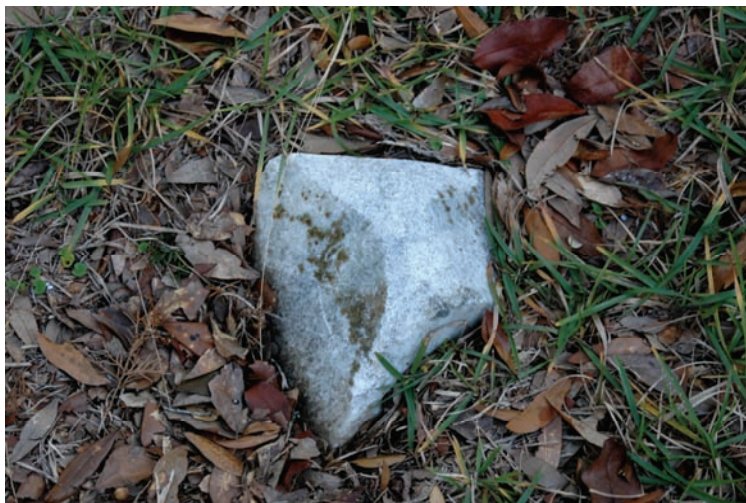
Figure 24. Monument repeatedly scalped by mowing.

The use of these large riding mowers, however, can be problematical, especially in a setting such as Old Cemetery with many walls, fences, and three-dimensional monuments. Figure 24 shows that the crews are not always careful in operating the equipment and these mowers are capable of causing extensive damage to monuments.

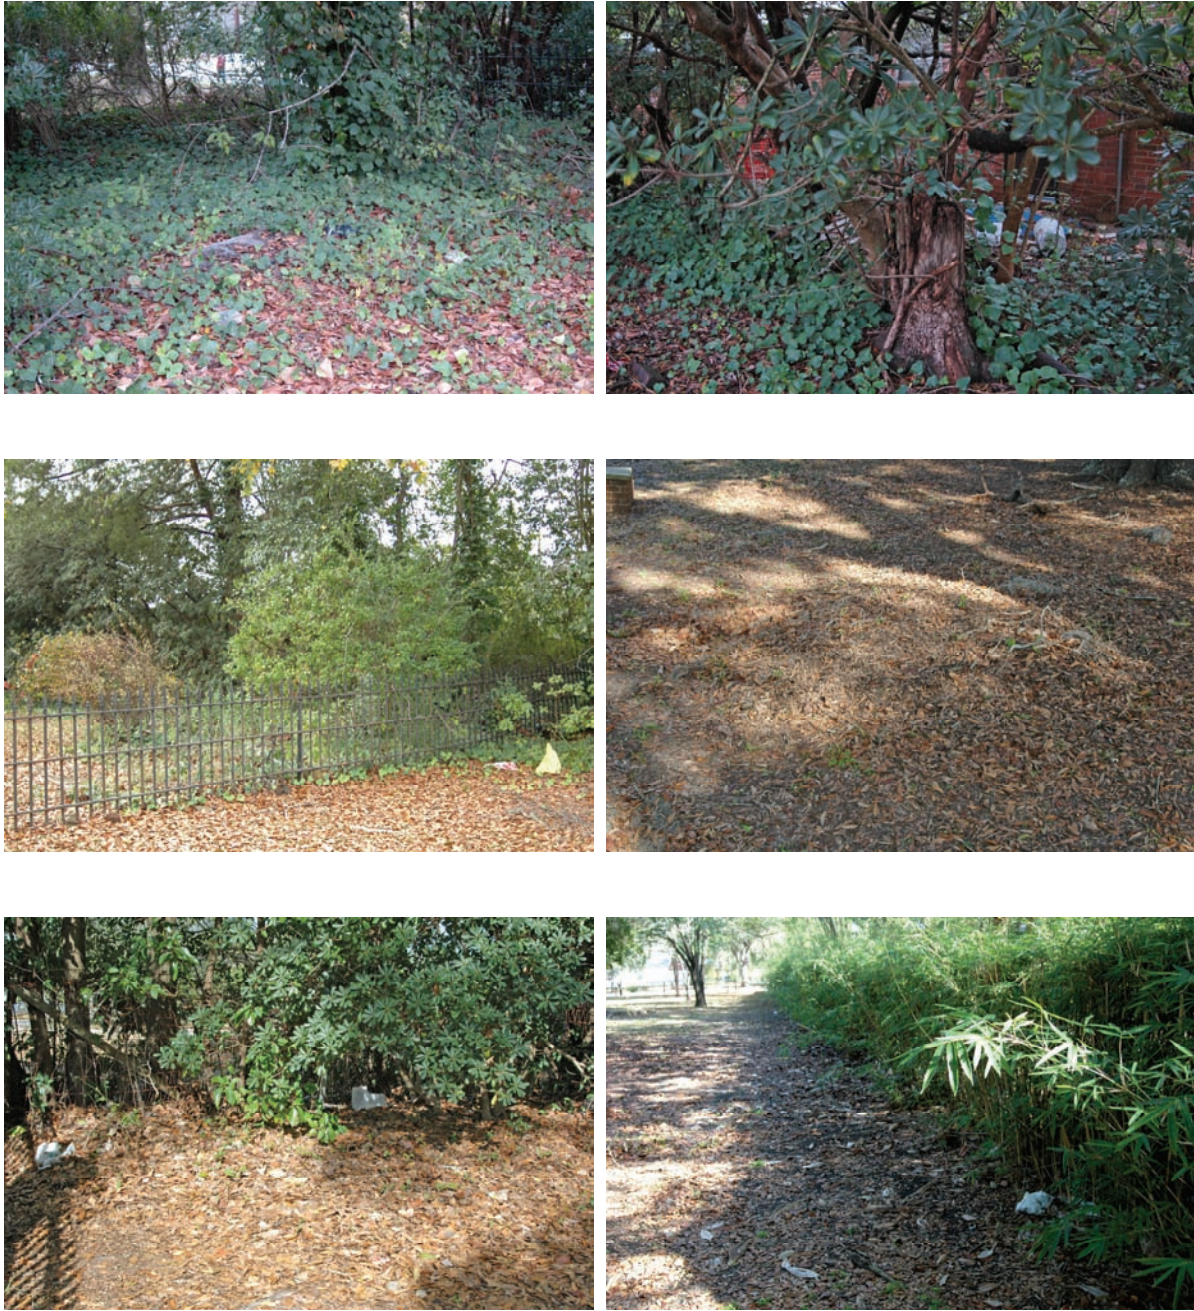
Figure 25. Problems along the northern and southern property lines. Upper left to lower right: dense ivy in the northeast corner; ivy, sickly tree, and trash along northern property line; dense vegetation in southwest corner; one of many leaf piles in the southwestern corner of the cemetery; trash and dense vegetation along fence line; trash and dense bamboo along the southern fence line.

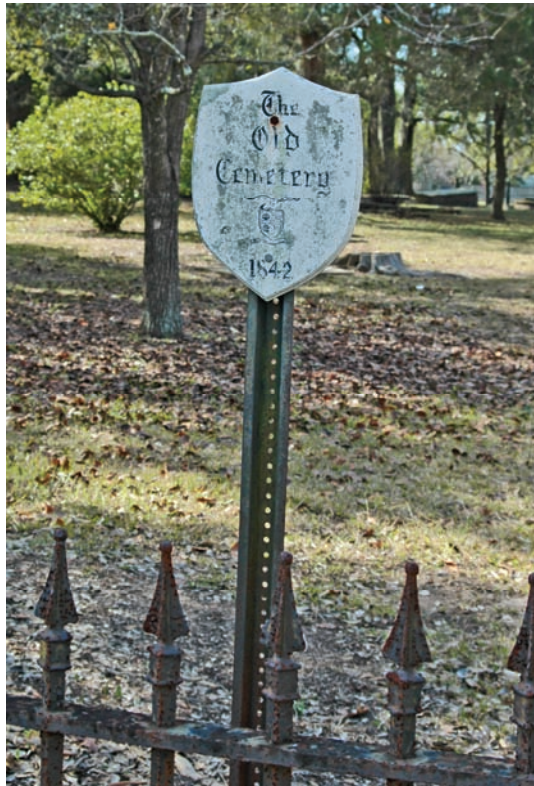
Figure 26. Signage at Old Cemetery is inadequate and in poor condition.

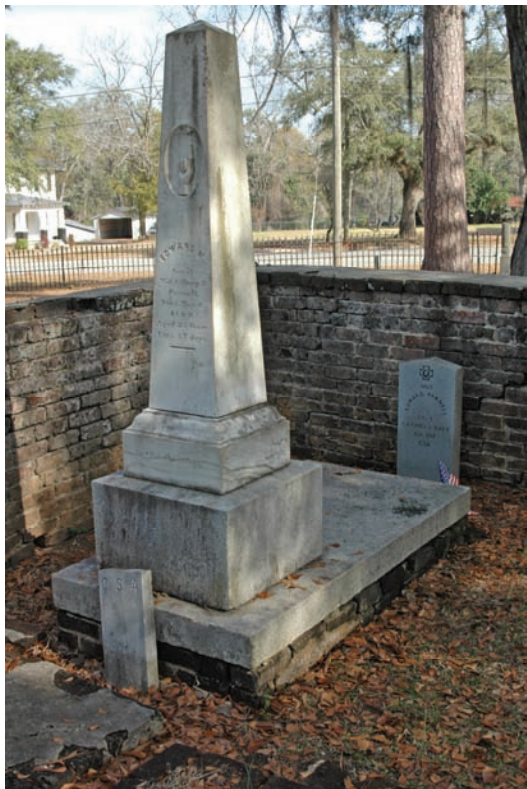
Figure 27. This grave is marked by three monuments, including the recently placed VA marker. The use of this free government marker is in violation of VA policy. It also detracts from the historical integrity of the cemetery.

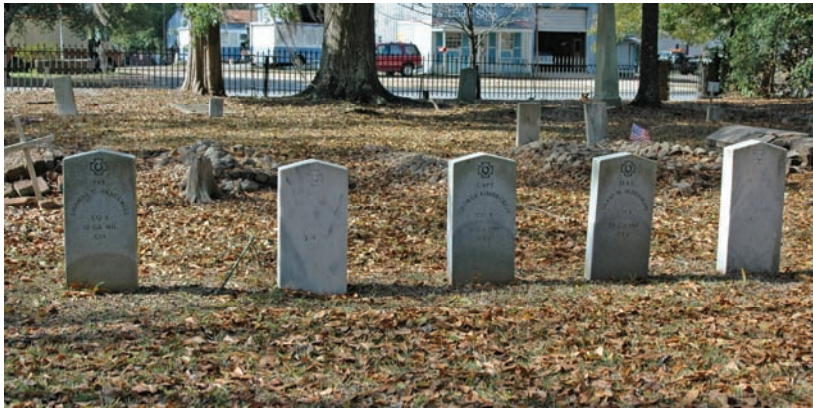
Figure 28. This line of VA military stones appeared in the cemetery where no graves had been previously marked. It is questionable that these individuals are actually buried at these locations and VA policy stipulates that the stones should read "In Memory Of."

markers, apparently for the same individual, are found in different locations – calling into question the actual location of the grave. In fact, the VA clearly states, "for all deaths occurring before September 11, 2001, the VA may provide a headstone or marker only for graves that are not marked with a private headstone." Thus the duplicate markings are in violation of the Department of Veterans Affairs clearly stated policy.

In one location a line of modern markers has appeared, with no indication that the individuals are actually buried in that location. The VA policy for such

markers clearly states that since the grave is not known, the markers should “bear an ‘In Memory of’ inscription, as their first line.” They do not.

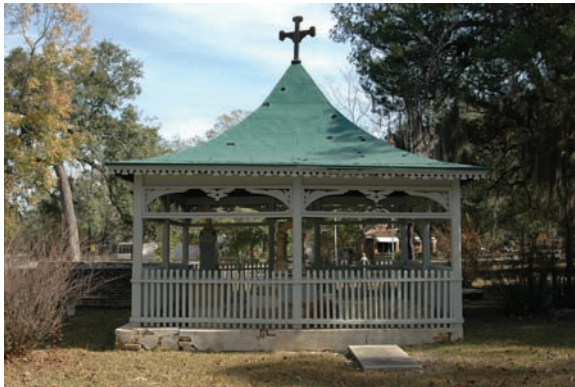
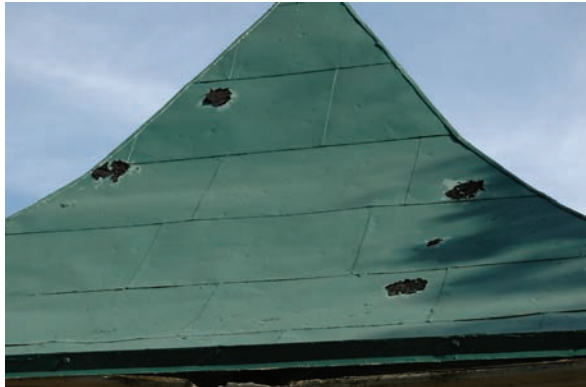
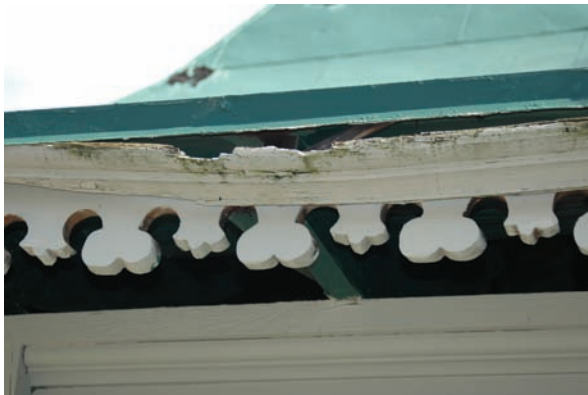
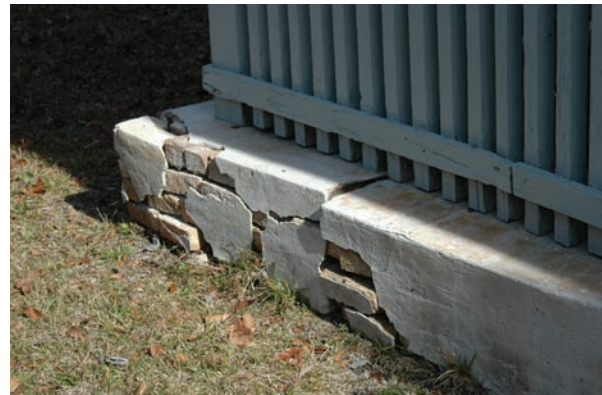
Figure 29. Old Cemetery gazebo showing roof deterioration, rotted trim, and foundation collapse.

- ❖ Improving the entrance to Laurel Hill would improve the appearance and character of the cemetery.
- ❖ The gazebo in Old Cemetery requires a detailed structure report that can prioritize repair needs and evaluate the damaged foundation.

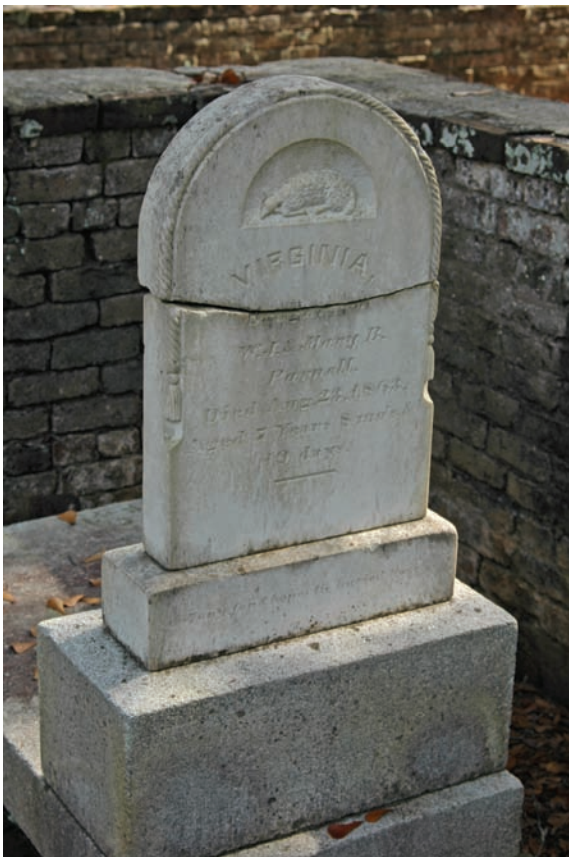
Figure 30. Broken, unstable stone that is a hazard to the public. Repair should be a high priority.

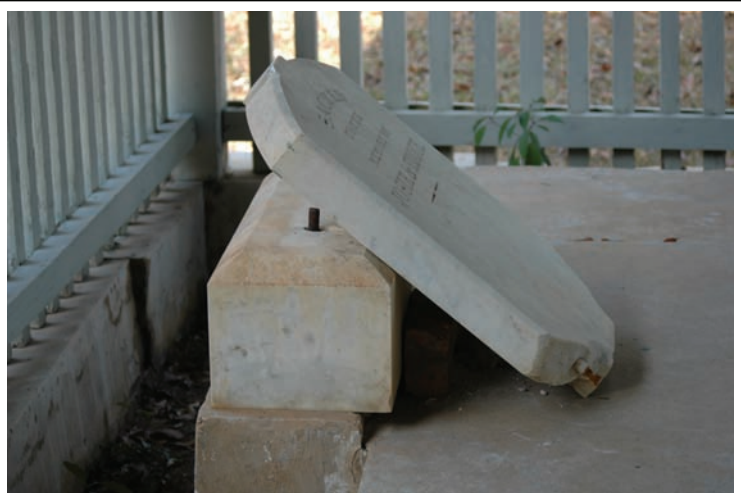
Figure 31. Stone with damage from ferrous pins. Note the loss to the lower corners of the monument.

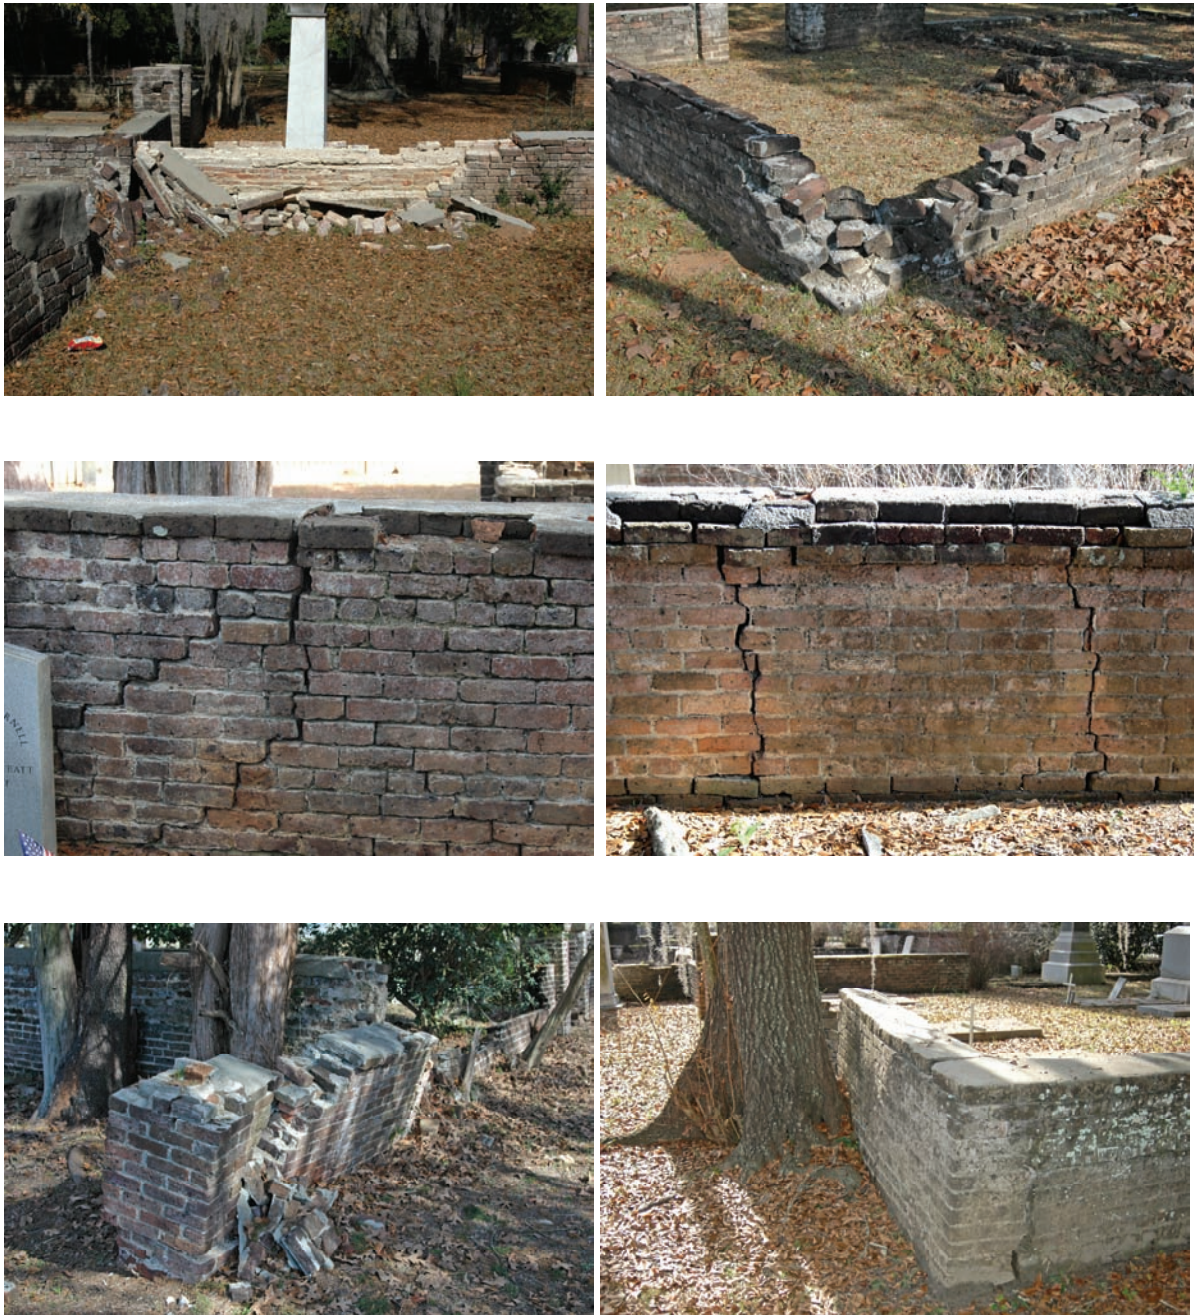
Figure 32. Brick wall problems at Old Cemetery. The top two photographs show walls that have collapsed. Substantial portions of these walls will need to be rebuilt. The middle two photographs reveal extensive cracking and settling. Some cracks may be repaired, others will necessitate rebuilding a section of the wall after foundation repair. The bottom two photographs show walls damaged by trees. In these cases the health of the trees will determine if the tree can be removed and the wall rebuilt.

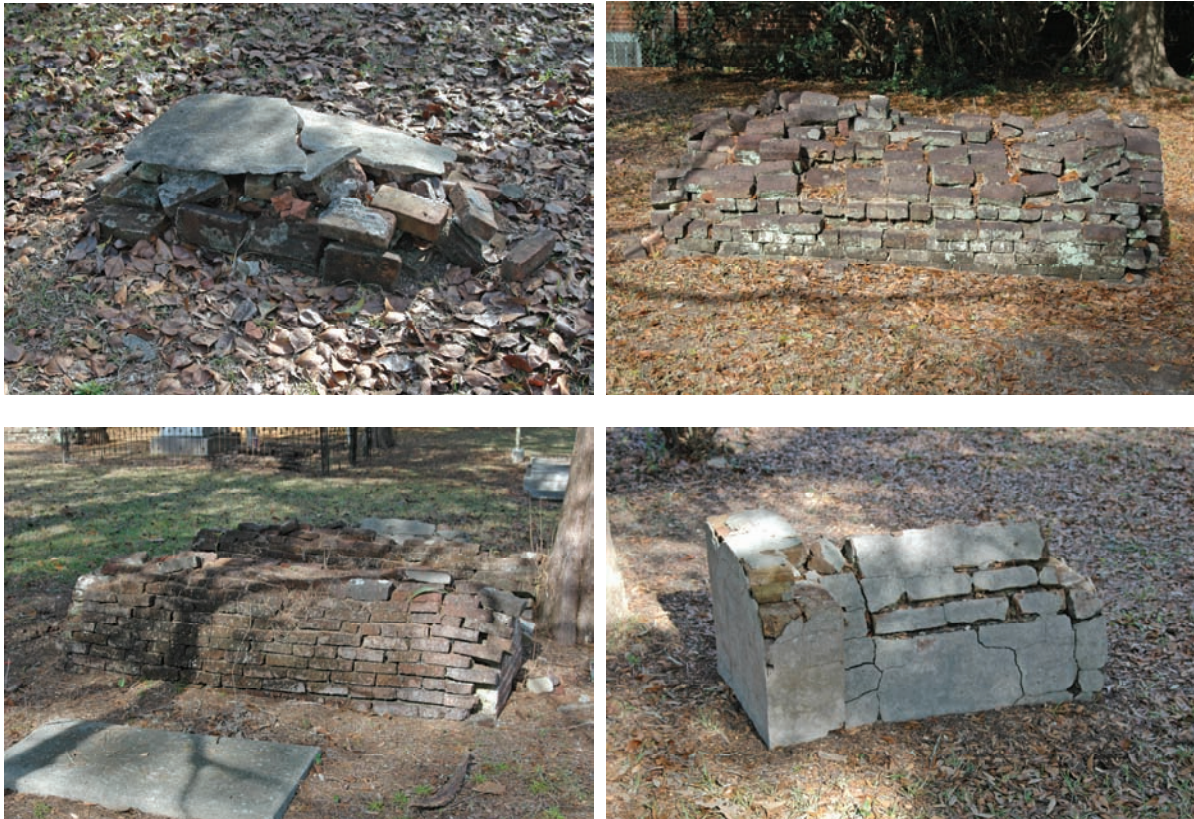
Figure 33. Brick tomb problems at Old Cemetery. These “oven” tombs are in poor condition and will require extensive reconstruction. The use of hard Portland cement stucco is especially problematical and much will need to be stripped off.

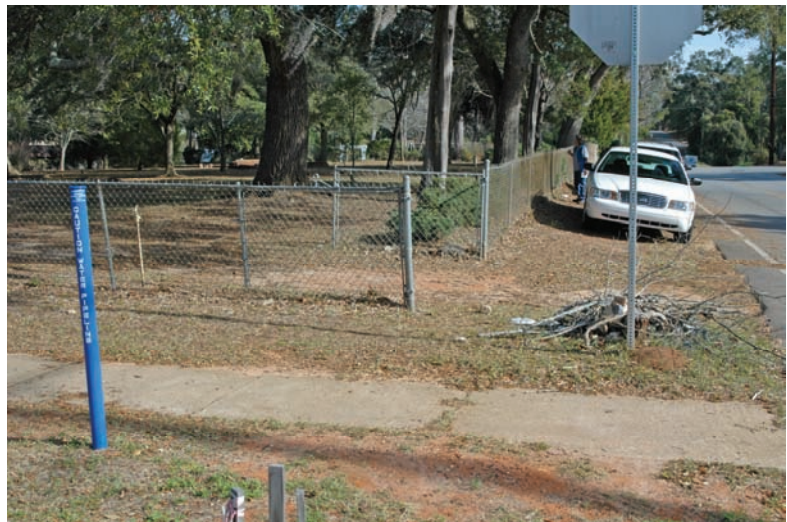
Figure 36. View of the entrance to Flipper, showing parking, trash, and lack of signage.

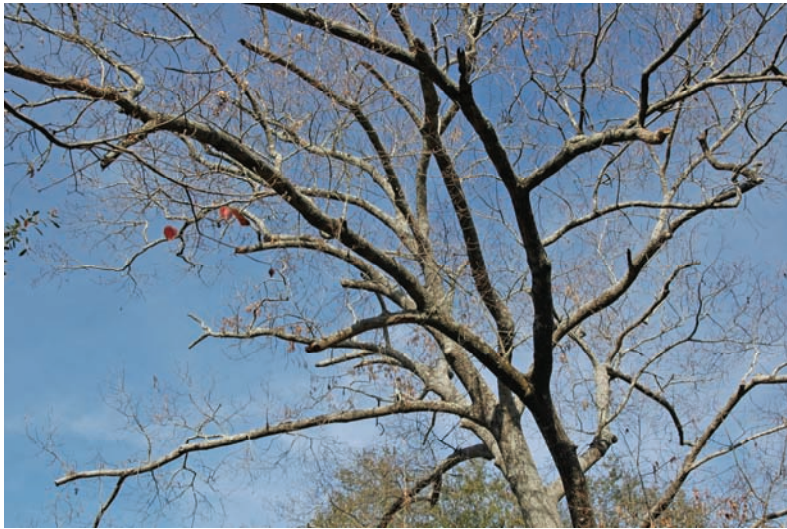
Figure 38. Example of a tree requiring clean pruning. Note the large number of damaged and broken limbs.

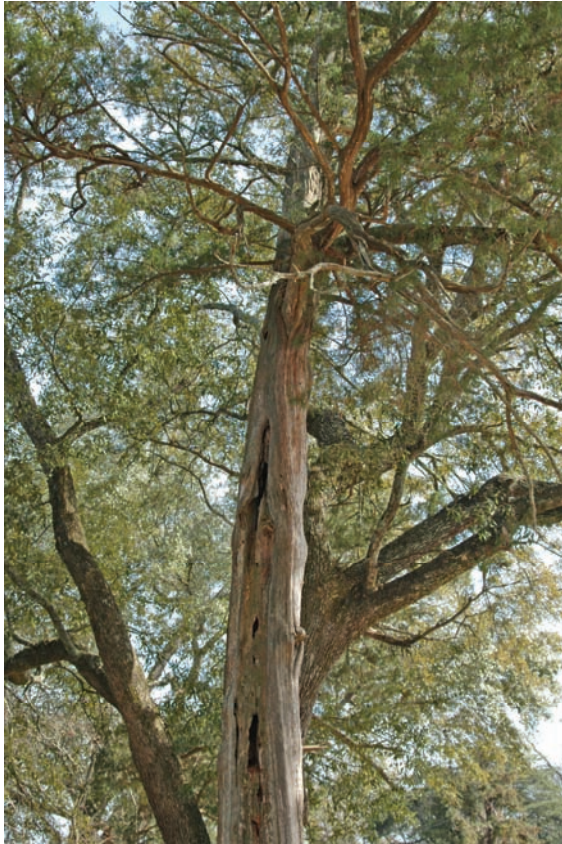
Figure 40. One of dead or dying cedars that requires immediate removal.

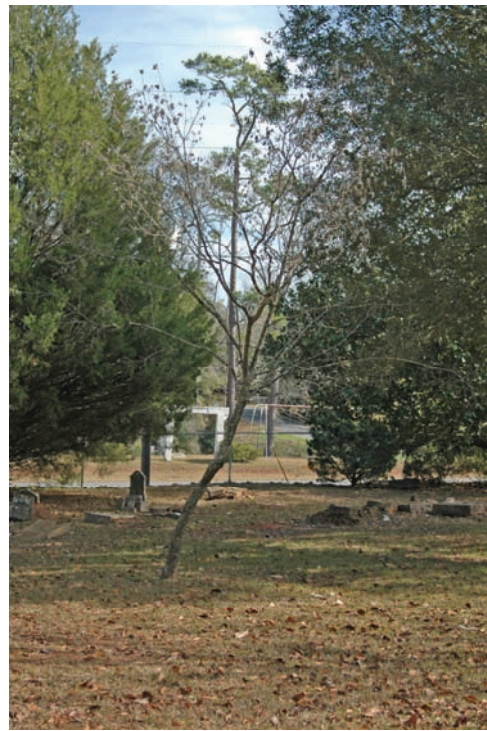
Figure 41. Dogwood planted in an poor location and dying.

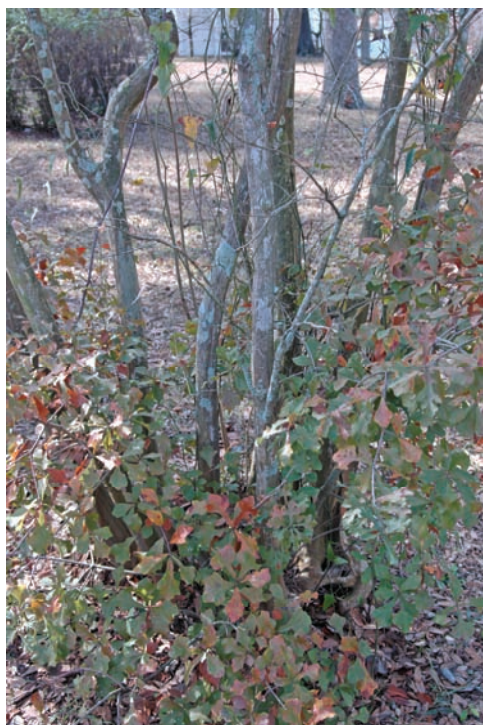
Figure 42. Example of a crepe myrtle that requires pruning. Note the basal sprouts and "trash" vegetation growing up in the crepe myrtle.

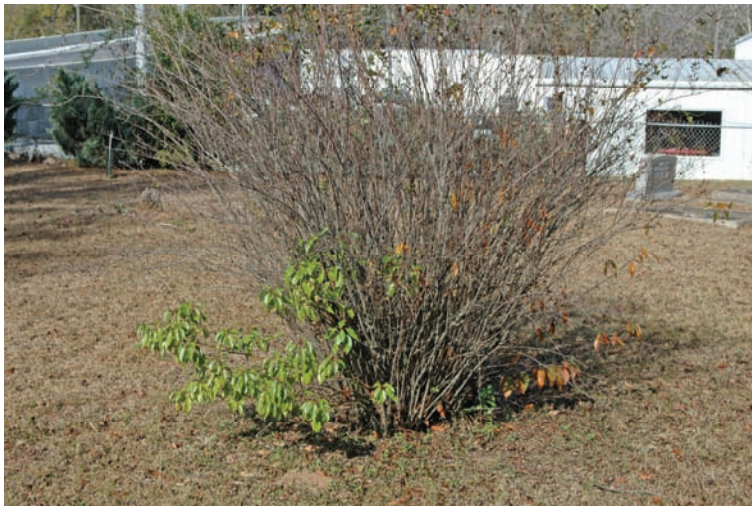
Figure 43. Thick, poorly cared-for spirea that needs renewal pruning.

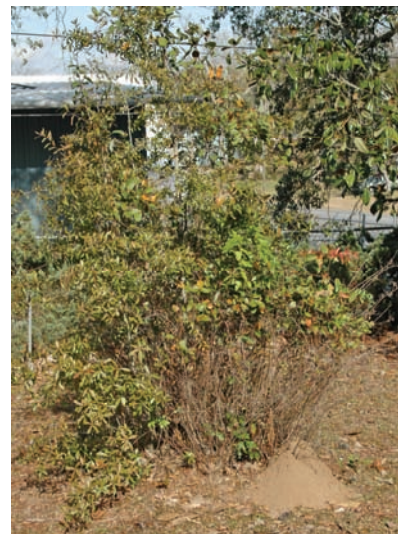
Figure 44. Shrub that require extensive pruning.

- ❖ The shrubbery at the cemeteries requires extensive rejuvenation pruning by a trained horticulturalist. Those performing future pruning must be adequately trained in the correct process to avoid causing irreparable damage to the plantings.

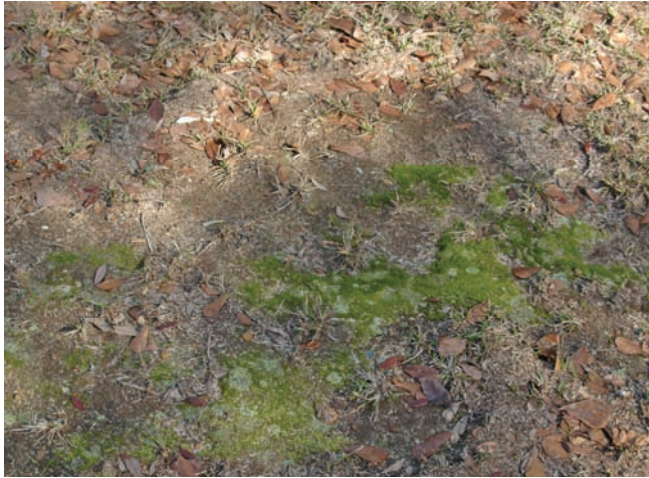
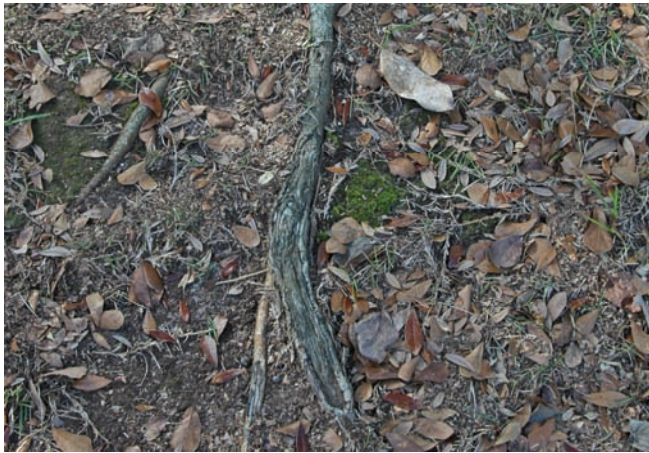
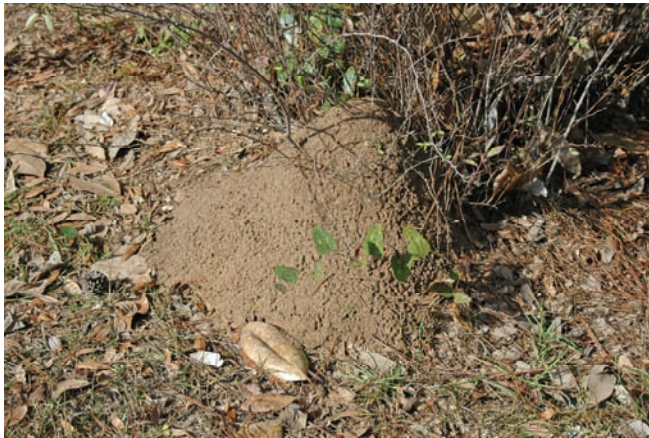
Figure 45. Example of turfgrass issues at Flipper. Top, compacted soil with moss; middle, surface roots being scalped by mowing; bottom, one of the numerous fire ant piles.

Unaddressed in Flipper Cemetery are the numerous fire ant mounds. One survey done in 1998 concluded that 33,000 people in the state of South Carolina sought medical attention as a result of fire ant stings. Of those 15% had severe localized allergic reactions and 2% had severe systemic reactions resulting in anaphylactic shock. The city leaves itself open to significant liability by failing to adequately treat these mounds.

Regardless of grass, we recommend that the amount be reduced in Flipper Cemetery by converting areas in dense shade to mulch. Most grasses (including centipede, buffalo, and bahiagrass) will not grow in shade and efforts to do so will result in thin, weedy, and stressed turf. In addition, tree health will increase by converting such areas to 2-3 inches (no more) of mulch.

The use of the nylon trimmers is an acceptable practice, but it is critical that a very light weight line be used – along with worker attention – to minimize damage to soft stone such as marble. Currently 0.095-inch line is being used. This is acceptable, but we would like to see the cemetery staff switch to a 0.065-inch line which is even safer for use around stones.

An excellent fire ant publication is [www.clemson.edu/sandhill/userfiles/file308.pdf](http://www.clemson.edu/sandhill/userfiles/file308.pdf). Bait products such as Amdro, Award, or Logic are effective on individual mounds, although control is not immediate. Broadcast applications, however, are even better and it appears that a mixture of 3/4 lb. hydramethylnon in baited granules (under trade names "Amdro" or "Siege") and 3/4 lb s-methoprene in baited granules (under trade name "Extinguish") applied per acre is even more effective. Amdro/Siege, a metabolic inhibitor, takes 3-6 weeks after ants consume it to show an effect and the effect lasts for several months until a re-invasion occurs. Extinguish is a growth regulator that takes longer to show an impact, but then can last a year or more.

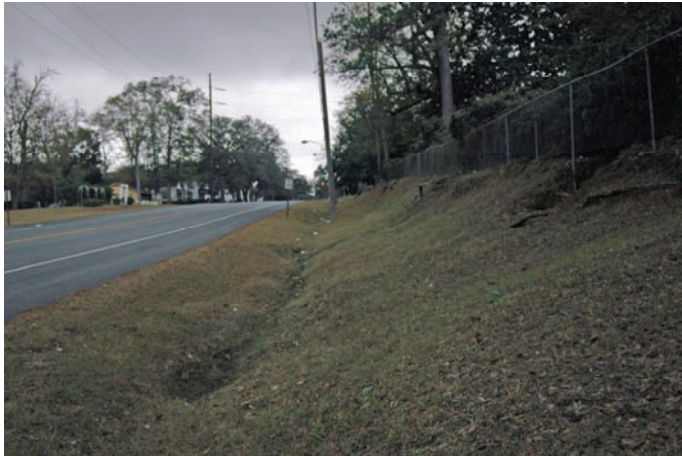
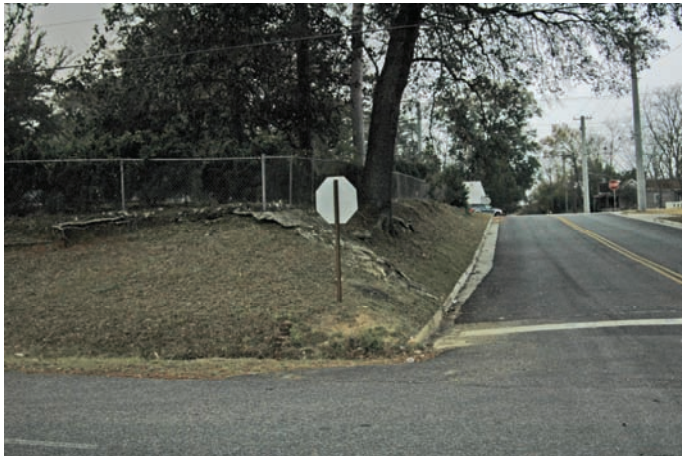
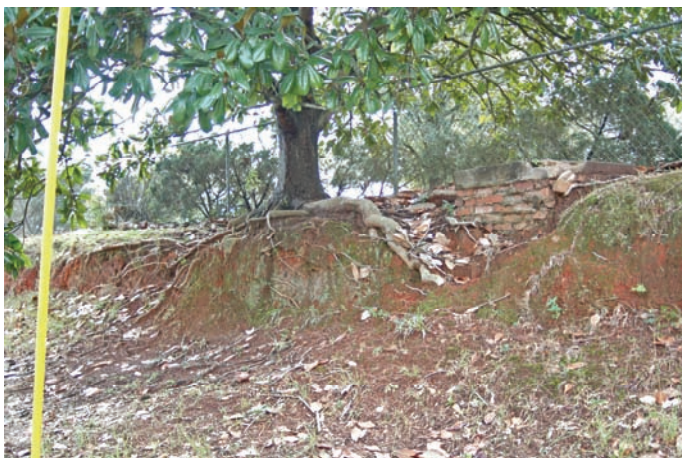
Figure 46. Erosion at Flipper Cemetery. Top illustrates typical vegetated slope along Broad Street. Middle illustrates corner of Broad and Walcott where concrete was used to channel water. Bottom illustrates a brick vault in erosional area and bare soil on steep bank.

Street on the north and Broad Street along the east. As shown in Figure 46, most of these slopes are 1:1.5 or less and well vegetated. There are, however, several areas that approach 1:0.5 and that lack vegetation. It is in these areas that there is significant erosion. In some areas it appears that concrete has been used in an effort to channel water. The concrete has failed and erosion is pronounced. The effect this has on cemetery aesthetics is clear enough, but we are also concerned that this erosion may be exposing graves and human remains. At least one clearly marked grave (brick vault with ledger) was found along Broad, half within the cemetery and half on the outside of the chain link fence. The brickwork reveals that it was not originally built to be exposed, so this erosion has occurred since 1936.

We are informed that Public Works does not visit Flipper Cemetery on a regular basis, especially during the winter months. This is clearly evident by the accumulations of trash, especially along the roadsides (see Figure 46 top). This trash clearly reveals why cemetery maintenance is a year-round, not seasonal, undertaking.

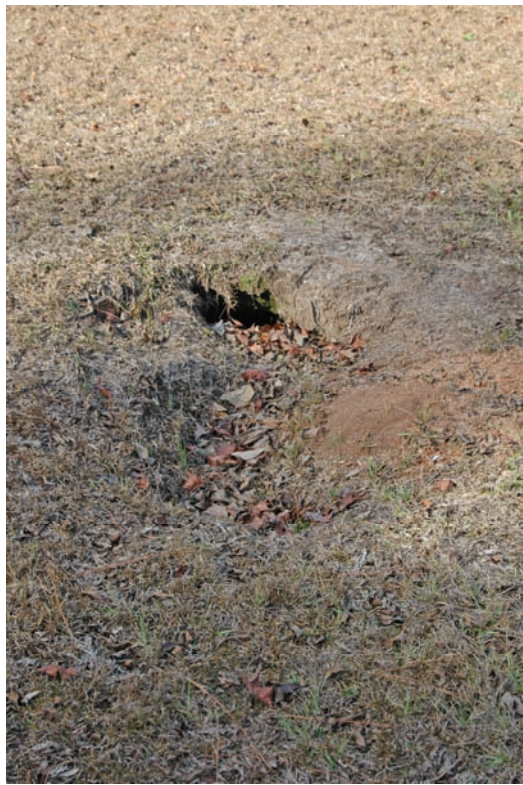
Figure 47. Example of sinking grave in Flipper Cemetery that poses a hazard to the public.
