# **ASSESSMENT AND RECOMMENDATIONS FOR THE THOMASVILLE, GEORGIA CEMETERIES**

**Chicora Research Contribution 485**

Prepared By:  
Michael Trinkley, Ph.D.  
and  
Debi Hacker

January 31, 2008

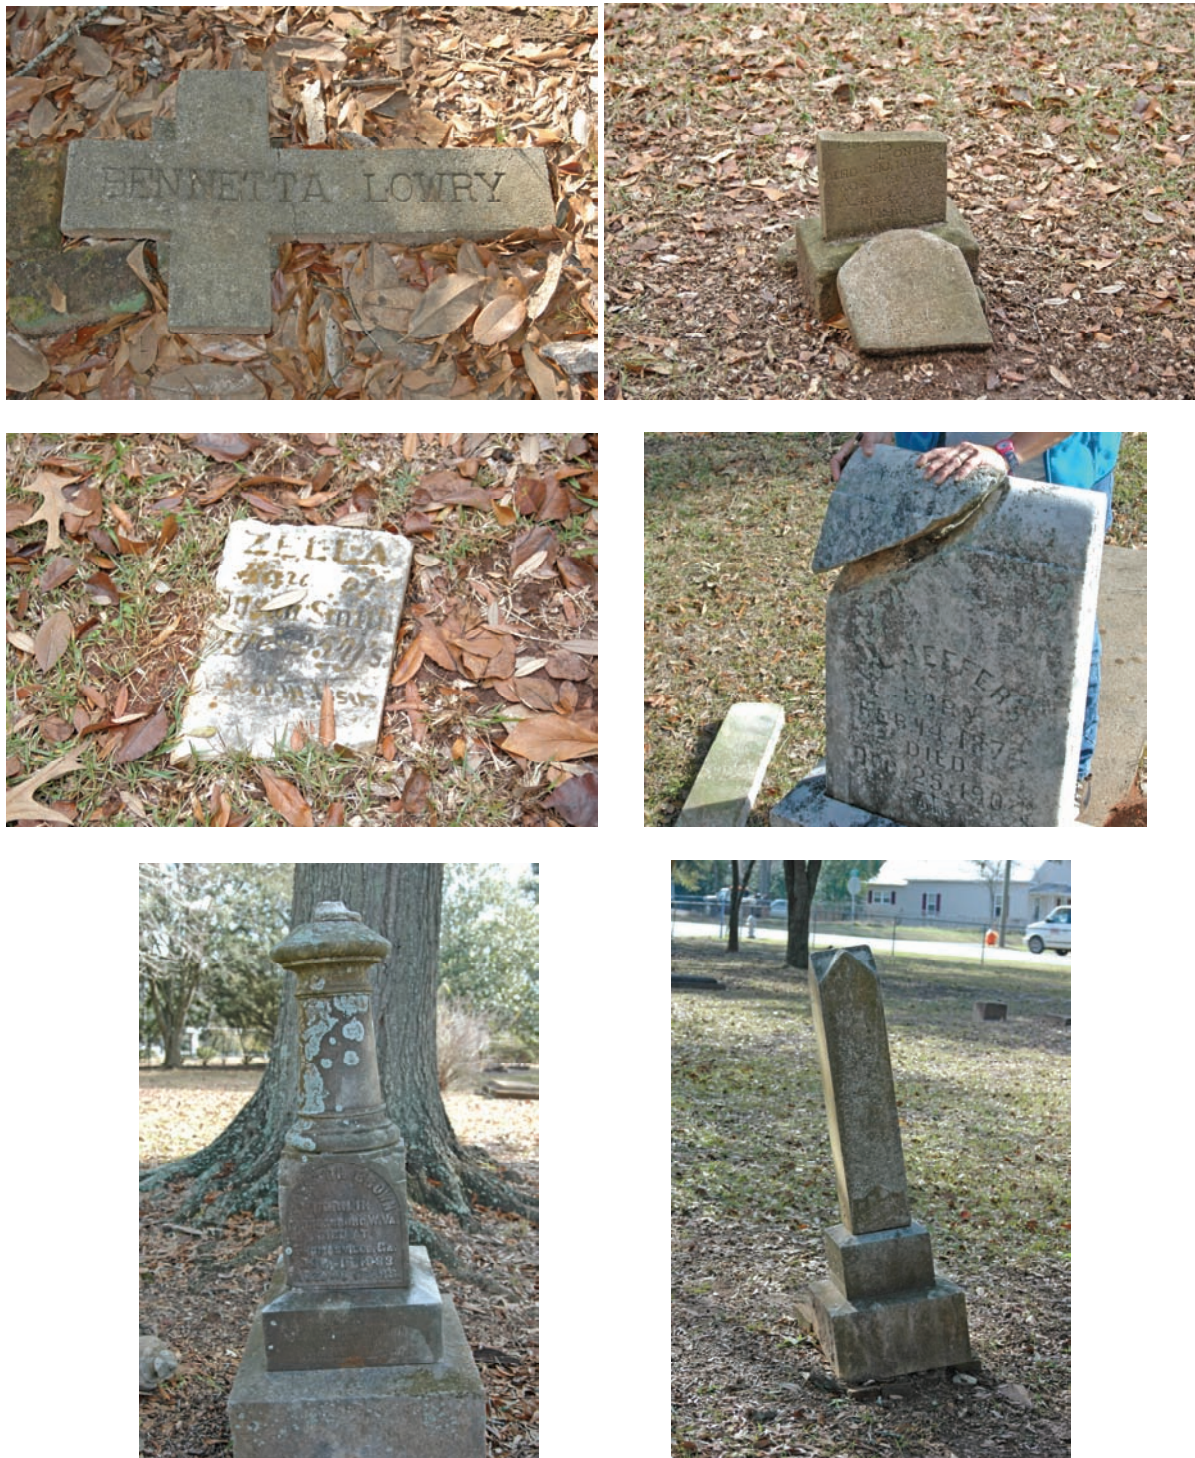
Figure 49. Conservation issues at Flipper Cemetery. Top photos illustrate broken concrete monuments. Middle photos illustrate broken marble stones. Bottom photos illustrate severely leaning monuments that require resetting.

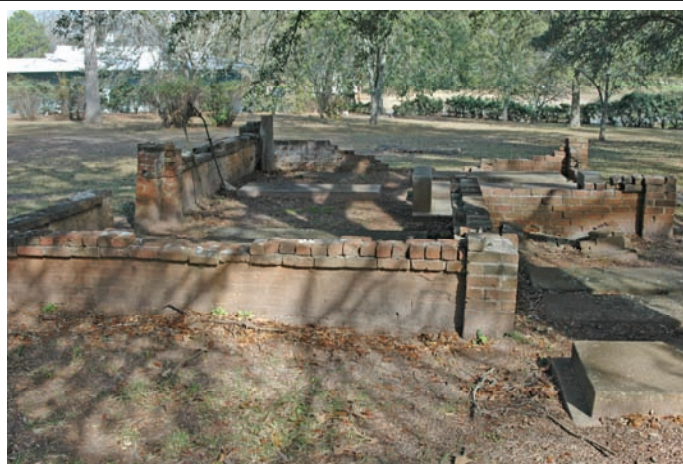
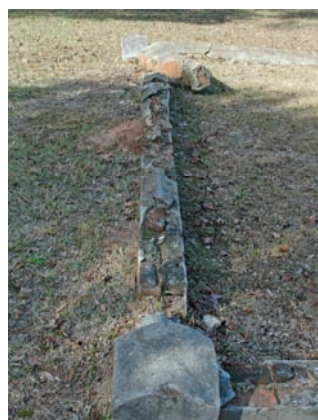
There is much less brickwork in Flipper than is found in Old Cemetery. What is present, however, is not in good condition and it requires quick intervention to prevent additional deterioration and increased repair costs.

Figure 50. Top photo illustrates brick wall with missing sections and brick requiring repointing. The bottom photo illustrates brick coping deteriorated through Portland cement stucco and mechanical damage.

We estimate that 70 linear feet of brick wall require attention. Unlike Old Cemetery, there are no brick tombs standing in Flipper Cemetery.

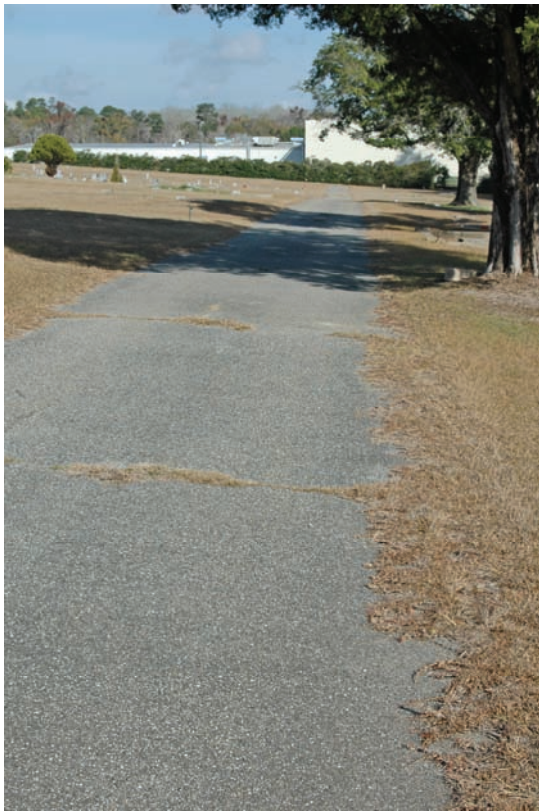
Figure 54. The paved roads in the new section of Magnolia Cemetery are cracked and require filling or sealing. The roads should also be regularly edged.

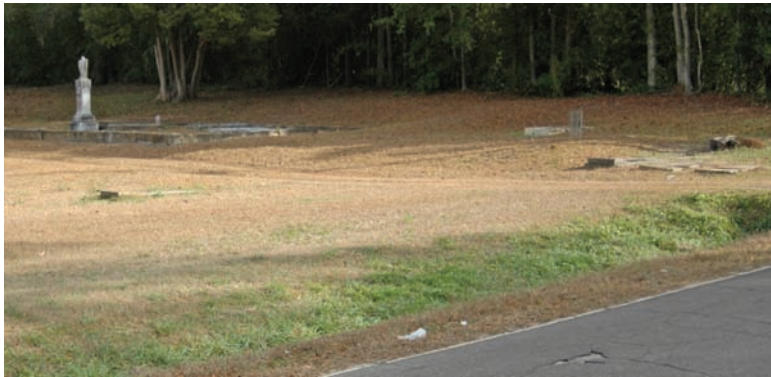
Figure 55. Poorly defined dirt roadway in the old section.

In the old section there is a single dirt road that is poorly defined by two ruts (Figure 55). It was in satisfactory condition, although our visit occurred during a significant drought. It seems unlikely that the road will hold up well during prolonged rain.

It is critical that the city eliminate this behavior. We recommend not only adding this to signage (discussed below), but the roadway in this cemetery should be paved in order to emphasize the appropriate driving area.

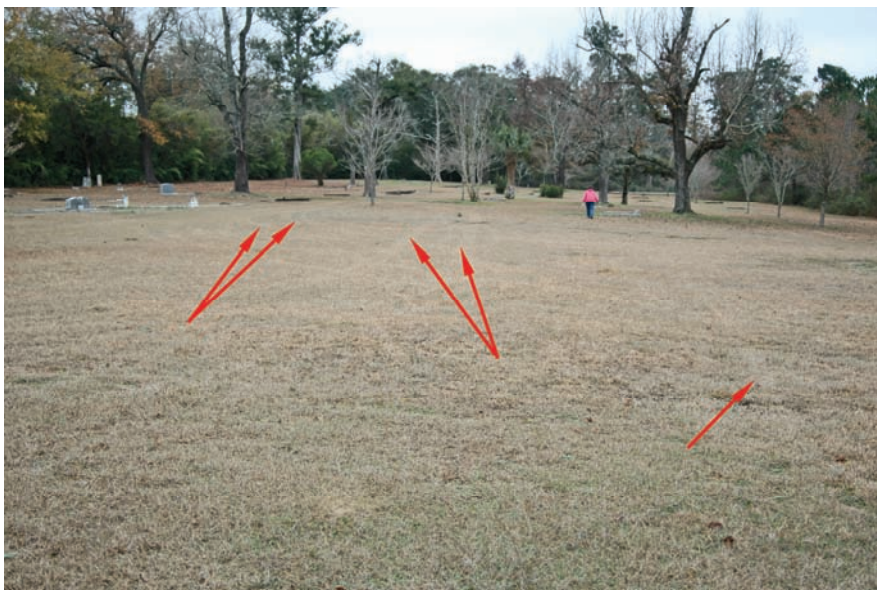
Figure 56. Tire tracks are clearly visible across the old section of Magnolia. This is disrespectful and dangerous. The activity must be curtailed.

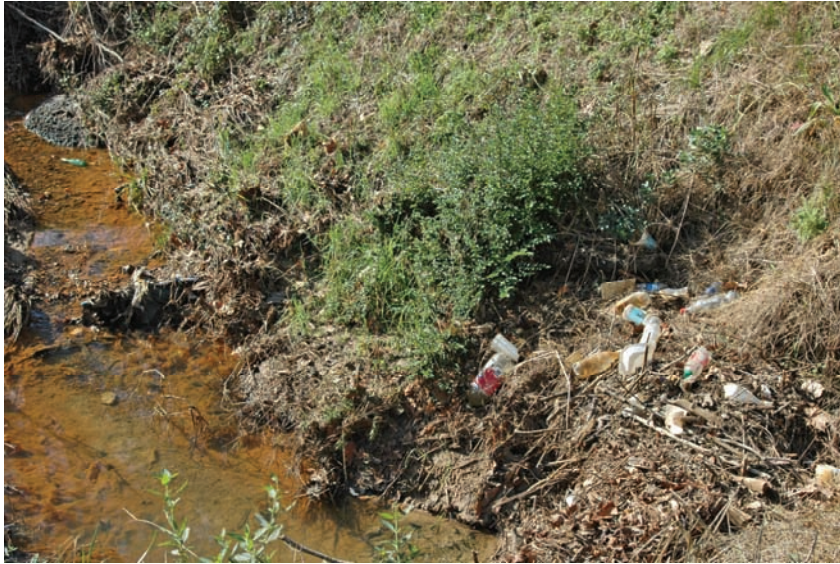
There is a small section of Oquina Creek open at the south end of the cemetery. A narrow roadway passes over the creek, but the creek bed itself is covered in litter. This presents a very poor impression of the

Figure 57. Trash in Oquina Creek. This should be cleaned by the city on a regular basis.

community and should be cleaned up immediately.

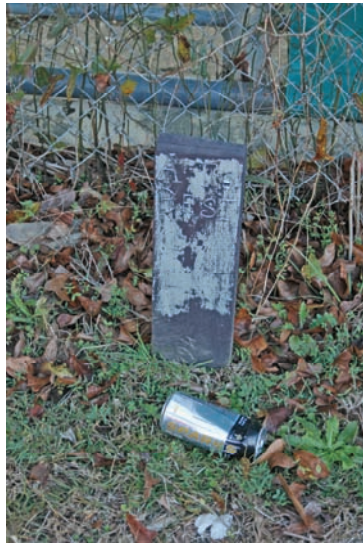
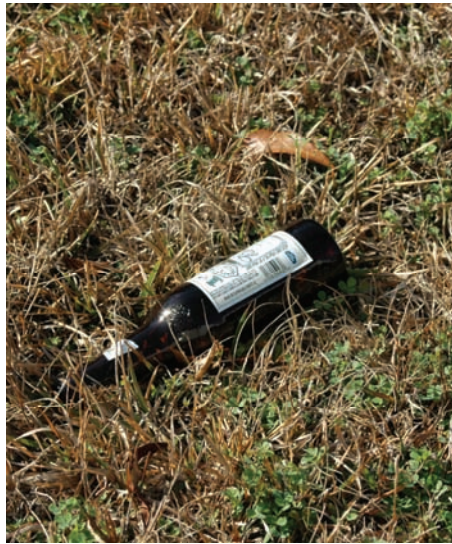
Discarded alcohol containers were found both openly discarded in the cemetery (although less commonly than at Old Cemetery). This open consumption of alcohol will

Figure 58. Alcohol containers in Old Cemetery.

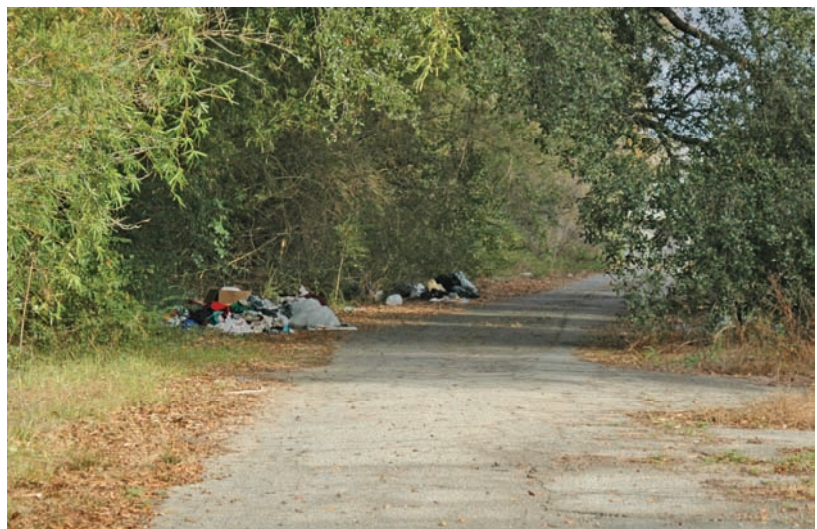
Figure 59. Dumping along the road to the east of the cemetery.

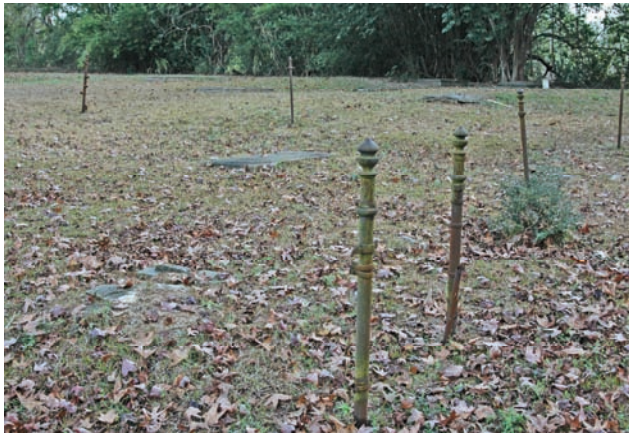
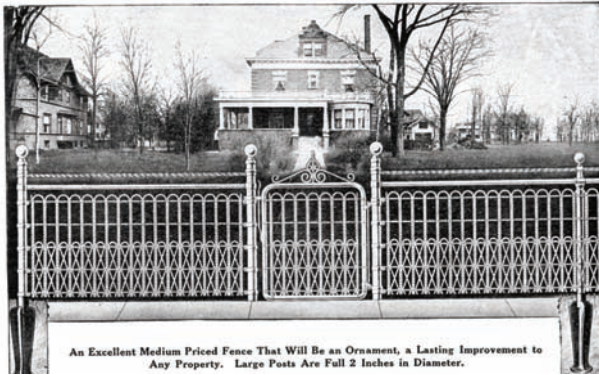
Only one plot fence and one iron railing was observed in the old section of Magnolia Cemetery. All that remains today of the fence

are the posts. They suggest the fence was probably ornate wire that eventually corroded, leaving only the posts. The posts are marked "CLEAVELAND FENCE CO. INDPLS IN."

Figure 60. The top illustration shows posts for an ornate wire fence in the old section of Magnolia Cemetery. The middle is an advertisement from the 1921 *Sears Lawn and Cemetery Steel Picket and Wire Fabric Fencing* catalog.

Although only the posts remain, we recommend that the city take steps to ensure their preservation. Those that are standing should be painted, following the instructions provide in the Old Cemetery discussions. Briefly, this work would use Rust-Oleum's Rust Reformer after lightly brushing the posts to remove loose corrosion. The Rust Reformer should then be followed by two thin coats of a flat black industrial alkyd coating.

The one post on the ground should be repaired and re-erected.

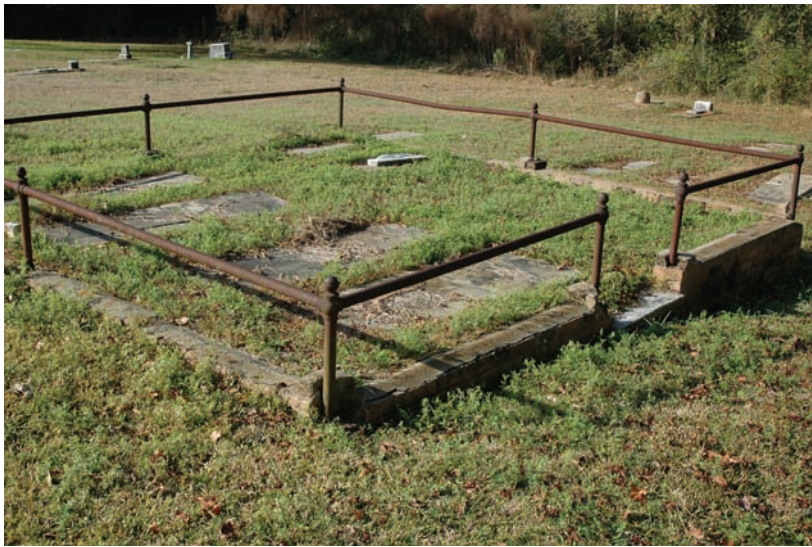
Figure 61. Example of a gas pipe rail fence in Magnolia's old section.

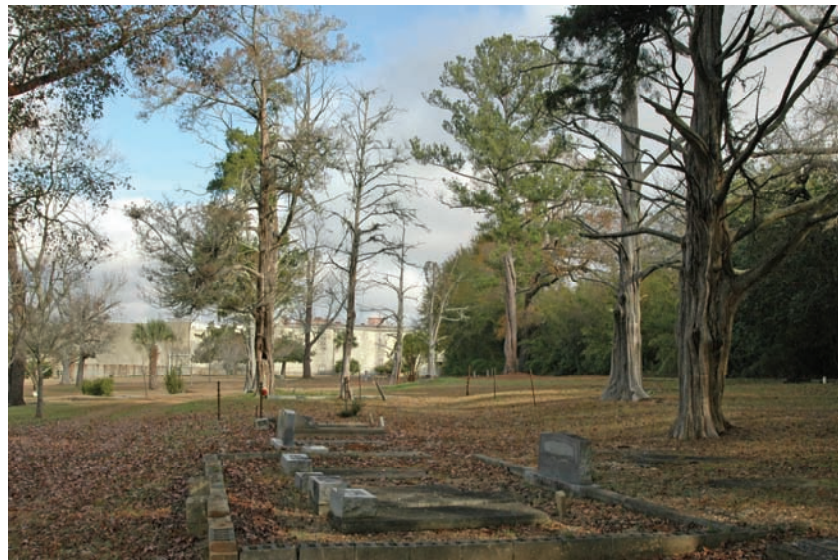
Figure 62. View of Magnolia's old section showing the forest of dead cedars.

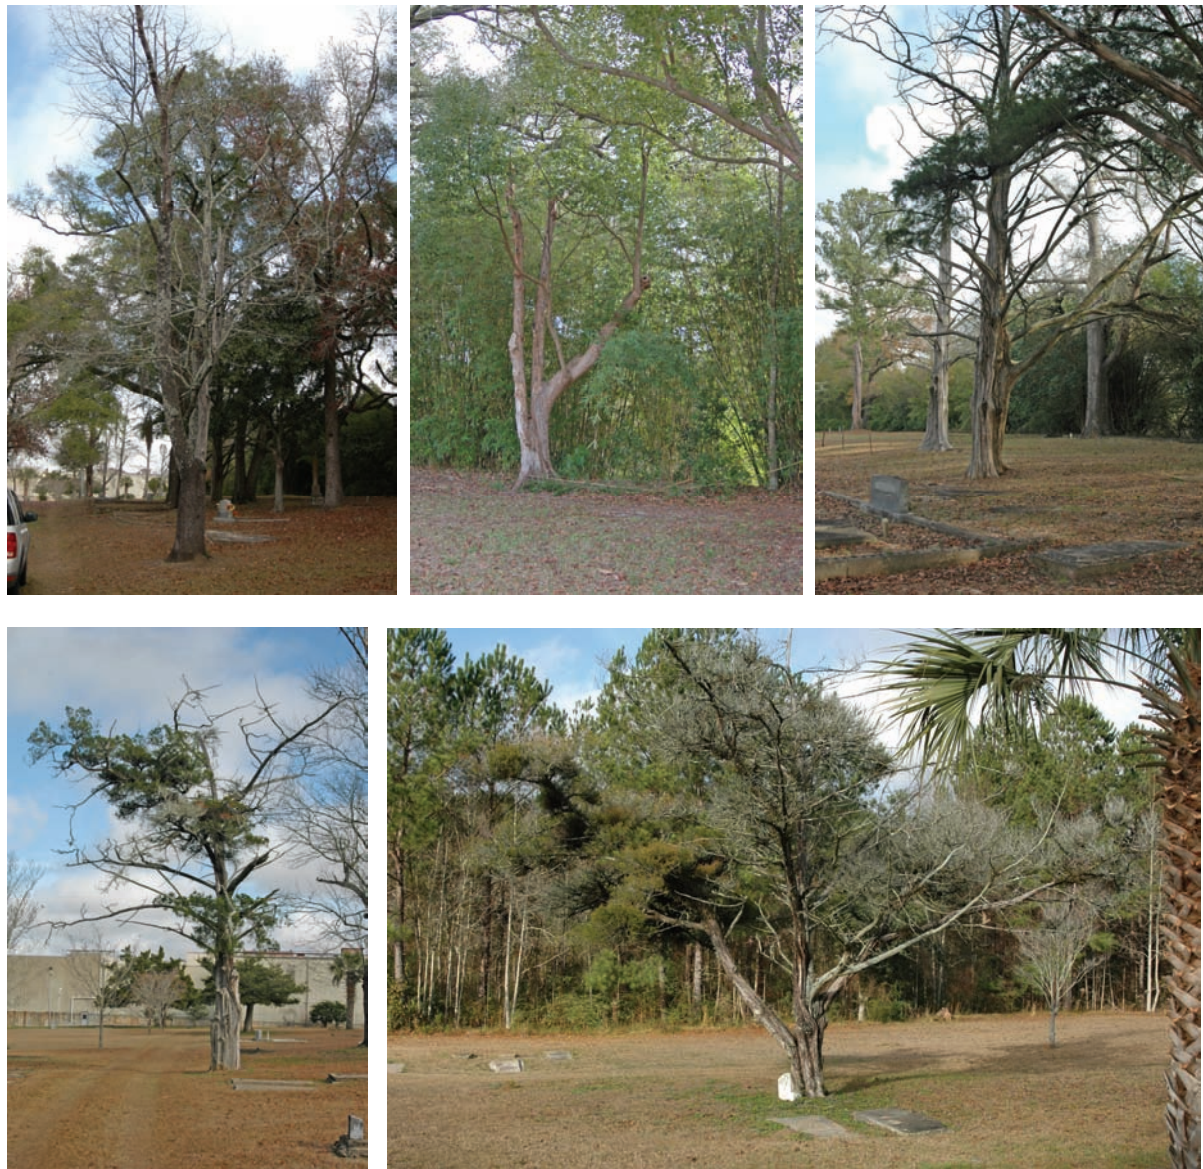
Figure 63. Tree problems at Magnolia's old section. From top left to bottom right: sickly tree with fork, one branch dead, recommended for removal; sickly tree with much dead wood, recommended for removal; dead cedar, recommended for removal; unhealthy tree, recommended for removal.

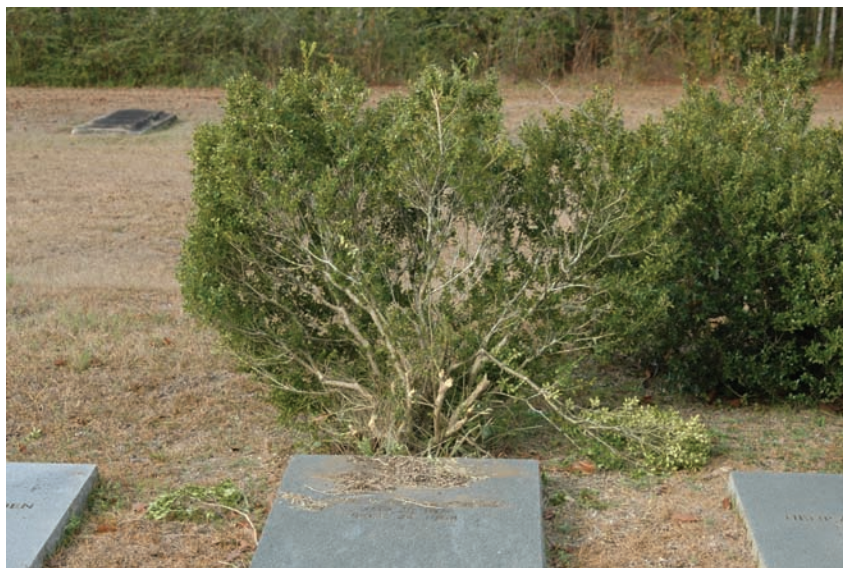
Figure 64. Inappropriately pruned boxwood. This plant has suffered from a lack of pruning (resulting in the interior bare branches) and recently has been incorrectly cut away to expose the ledger. Not only is the pruning incorrect, but the work is poorly done. These boxwoods require rejuvenation pruning.

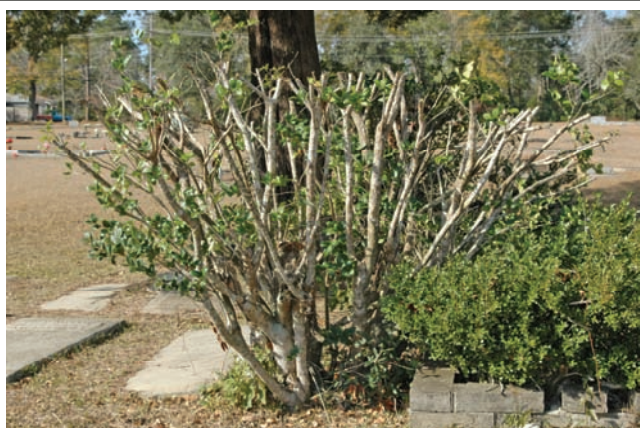
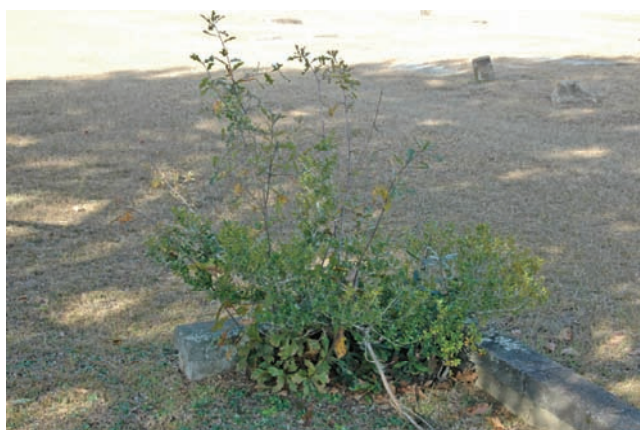
Both the ligustrum and boxwood have been ignored for years and then inappropriately pruned, resulting in significant damage to the

Figure 65. Incorrectly pruned ligustrum in the new section (top) and nearly dead boxwood with much trash vegetation in the new section (bottom).

structure and beauty of the plants. At this point the only options are either removal and replacement, or an effort to rejuvenate. We recommend an initial effort at renewal pruning. For the ligustrum this involves cutting the plants back to within 12 inches of ground level.

the gradual removal of all inappropriately pruned materials and their replacement with new arborvitae. In the future special care must be exercised to ensure those entrusted with pruning are knowledgeable and appropriately trained.

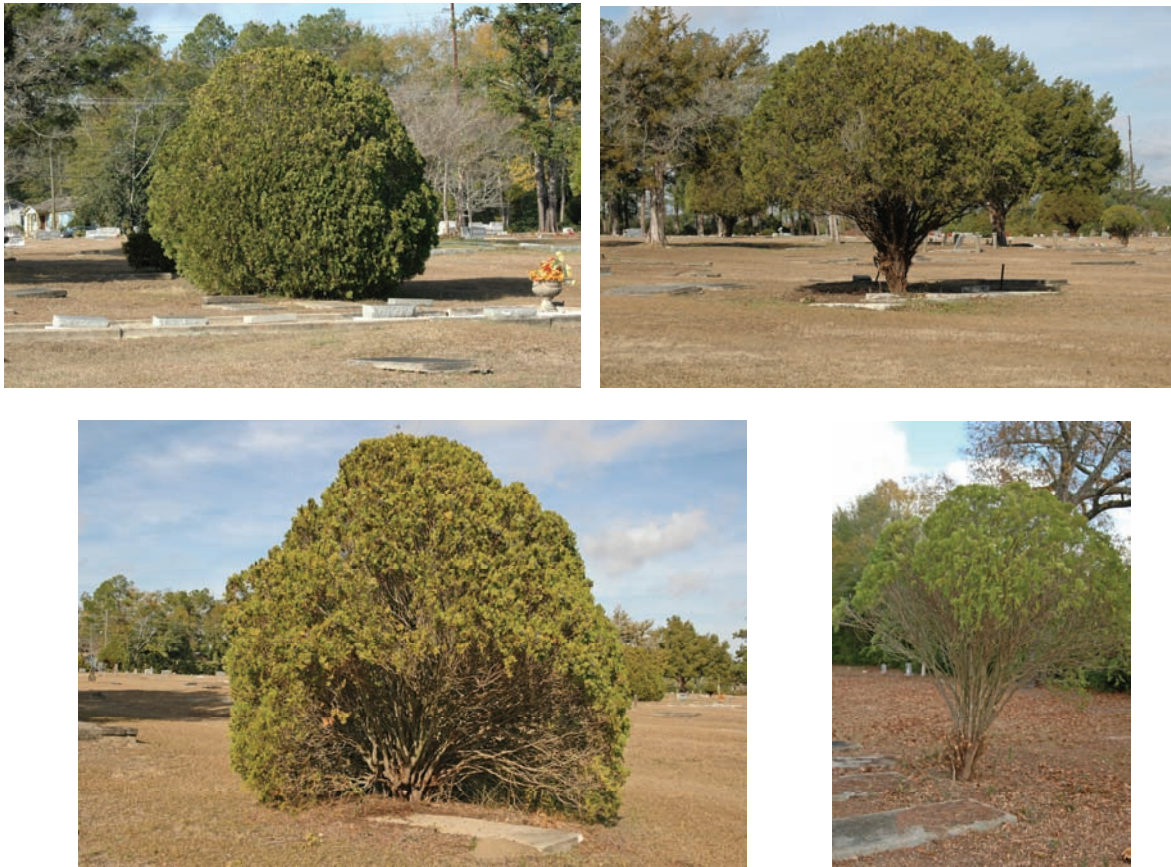
Figure 66. Arborvitae in Magnolia Cemetery. From top left to lower right: beautiful, healthy, unpruned arborvitae showing correct form; arborvitae damaged by crown raising that has created an unnatural and inappropriate mushroom shape; arborvitae that has been carved into to move the plant away from a ledger; arborvitae damage by crown raising, exposing many of the interior bare branches.

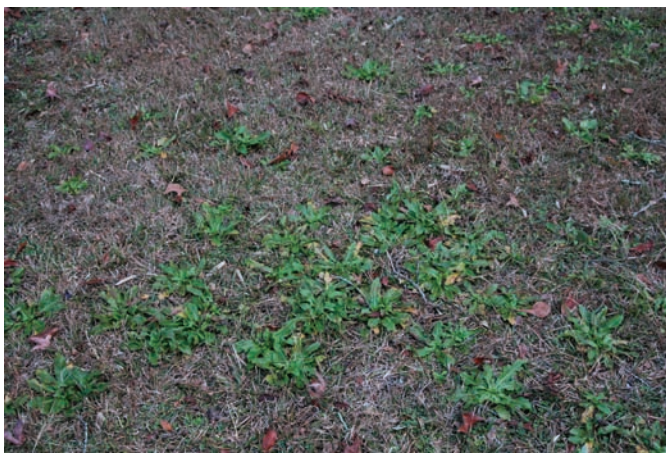
On the other hand, bahiagrass does not have good tolerance to shade or traffic. It also displays an open growth habit, which can result in encroachment of weeds into sparse areas – a very noticeable problem at Magnolia Cemetery (see Figure 67). A further problem is that the grass has low tolerance to many common herbicides that would normally be used.

Figure 67. The open growth habit of bahiagrass resulting in encroachment of broadleaf weeds into sparse areas.

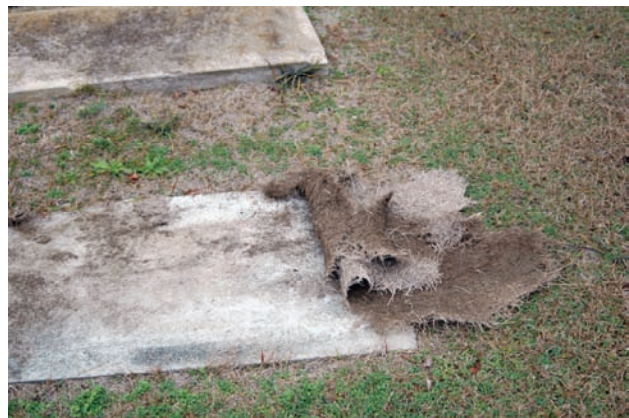
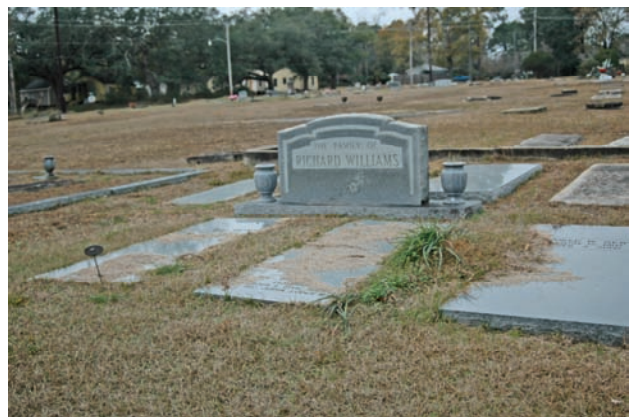
Although we are told that after mowing, monuments are blown off, this is clearly not the case (see Figure 68). The failure to clean the monuments is a significant issue and goes to a lack of proper supervision. Cleaning grass off monuments is a standard practice in the industry and must be regularly done by the city.

Figure 68. Examples of grass left on monuments in both the old and new sections of Magnolia. Some grass has been on monuments for so long it has begun to mulch down, staining the marble.

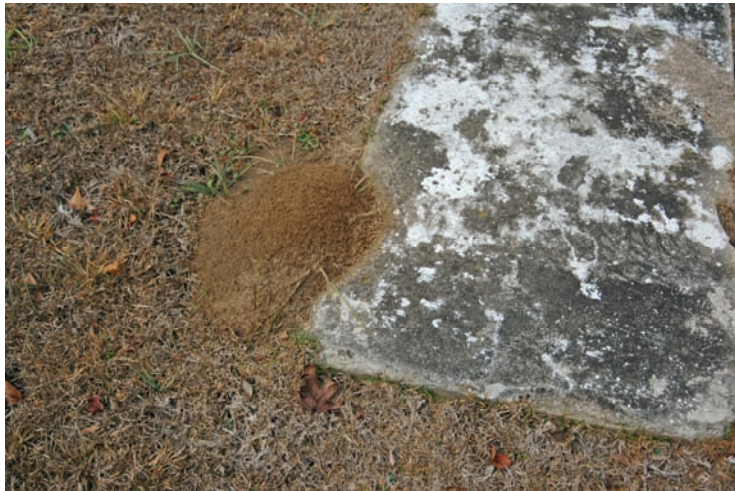
Figure 69. Fire ants in Magnolia Cemetery.

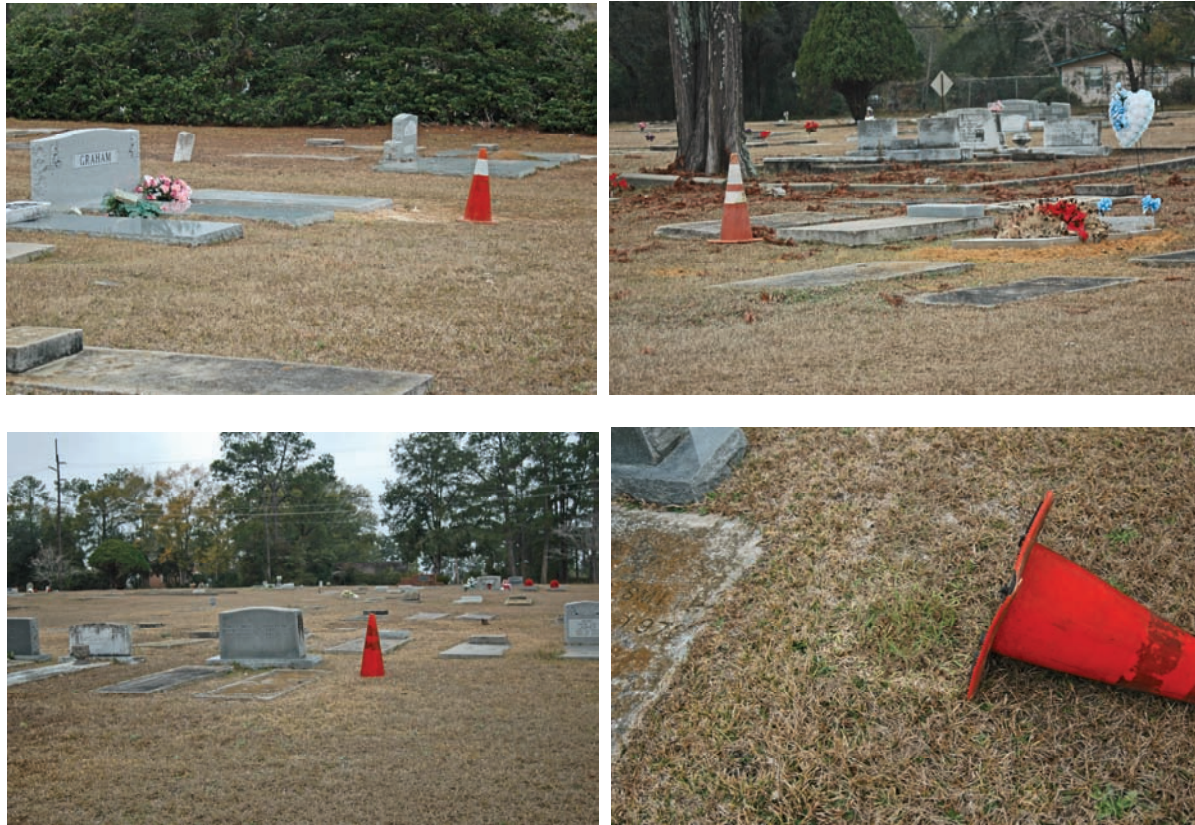
Figure 70. Cones need to be collected in a timely fashion from graves. The upper two photographs show cones at graves after burials and after the placement of monuments. The lower two photographs show a cone at a grave so long that grass under the cone has been protected from freezing weather.

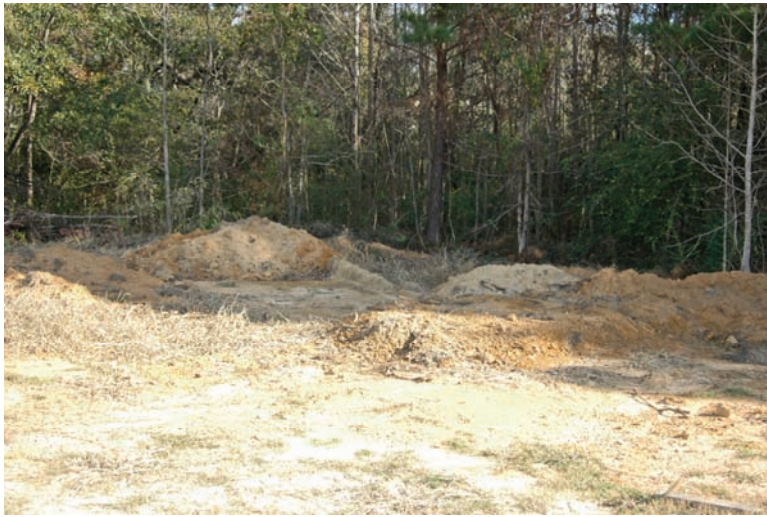
Figure 71. Spoil should be more discretely placed or removed from the cemetery.

dump excess spoil at the edge of woods bordering Oquina Creek in the new section of Magnolia (Figure 70).

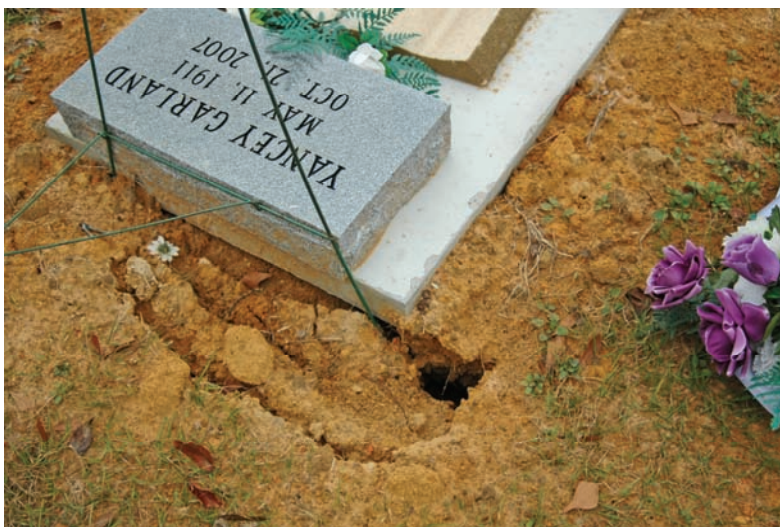
Figure 72. Grave collapsing shortly after burial from inappropriate compaction. This will lead to the displacement of the ledger.

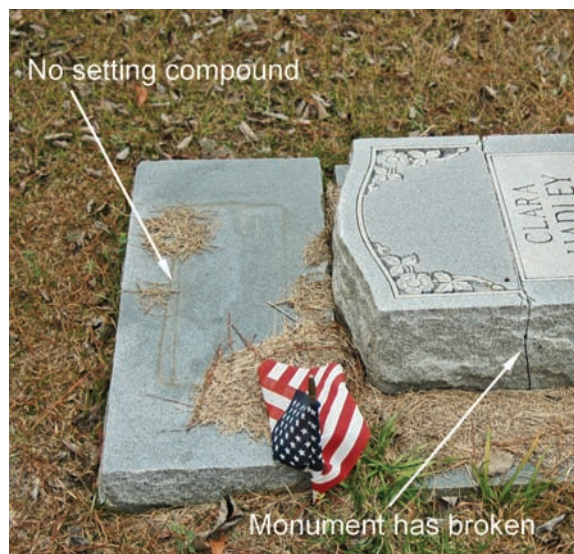
Figure 73. One example of an incorrectly set monument that has fallen and is now broken.

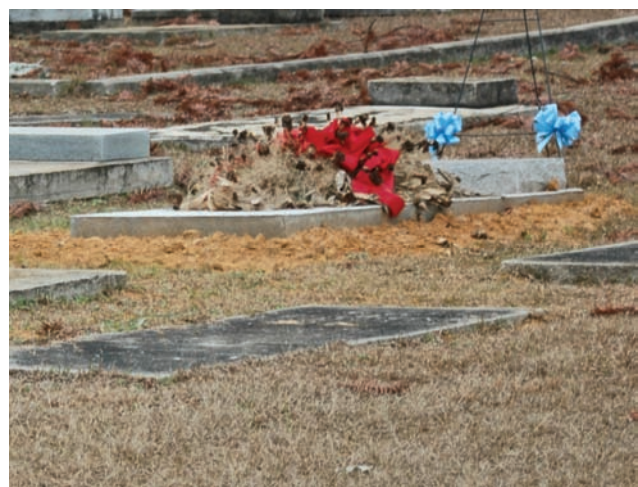
All cemeteries struggle with the issue presented by flowers on graves. We have never seen a cemetery where, for example, Christmas flowers had not been left for months – becoming faded and detracting from beauty of the cemetery grounds. Magnolia Cemetery is no exception. Figure 74 shows one such grave in Magnolia Cemetery. Decorations left months after holidays affect the beauty and dignity of the entire cemetery. We recommend that

Figure 74. Faded burial flowers still on a grave.

First, we believe that all flowers or arrangements should be removed by the cemetery staff 10 days after holidays *or* when the arrangements become unsightly. This will allow staff to remove faded flowers, Christmas decorations after the holidays, and so forth.

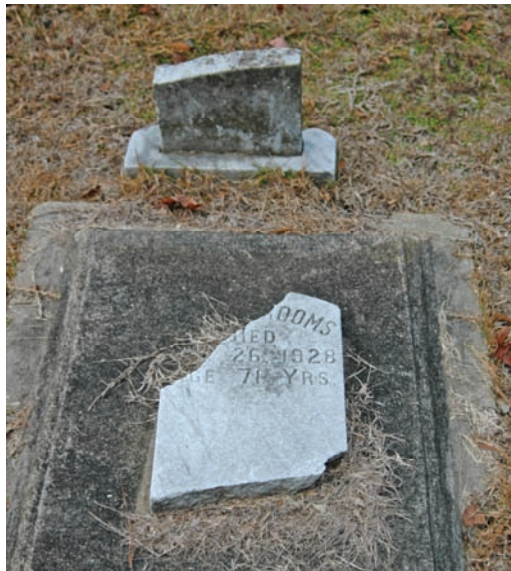
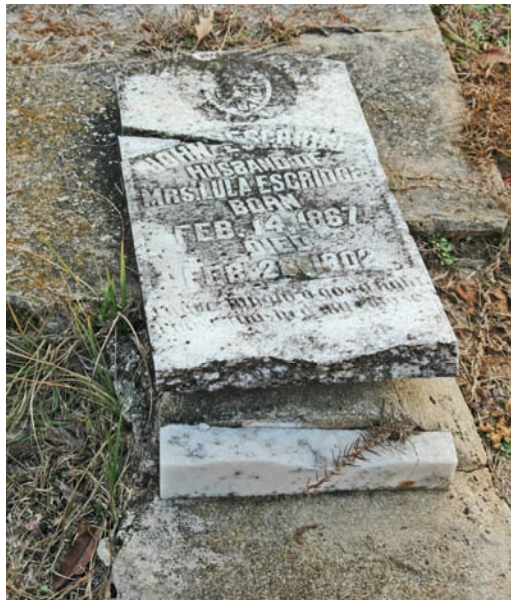
Figure 75. Examples of broken headstones requiring repair (see also Figure 73).

There are examples of broken stones (we estimate approximately 30). Many of these stones should receive a high priority for conservation treatments since the stones are either a hazard to the public (endangering visitors) or a hazard to themselves (if they fall there will be additional, significant damage that will dramatically increase the cost of repair). The identification of these stones and development of treatment proposals by a professional conservator should be a very high priority. It is only with the development of detailed treatment proposals and cost estimates that a reasonable budget for this conservation work can be determined.

Appropriate conservation treatment will usually involve drilling and pinning, carefully aligning the two fragments. Threaded 316 stainless steel rod (or occasionally nylon) and epoxy adhesives formulated for the specific stone are used in this type of repair. Diameters and lengths of pins vary with the individual application, depending on the nature of the break, the thickness of the stone, its condition, and its expected post-repair treatment.

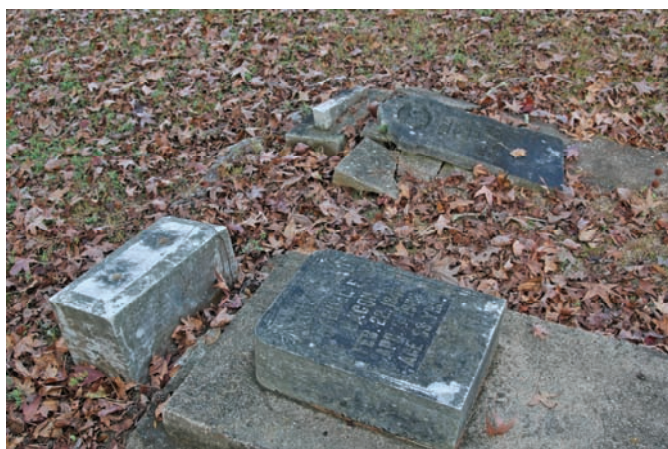
Figure 76. Example of a fallen stone (bottom) containing ferrous pins.

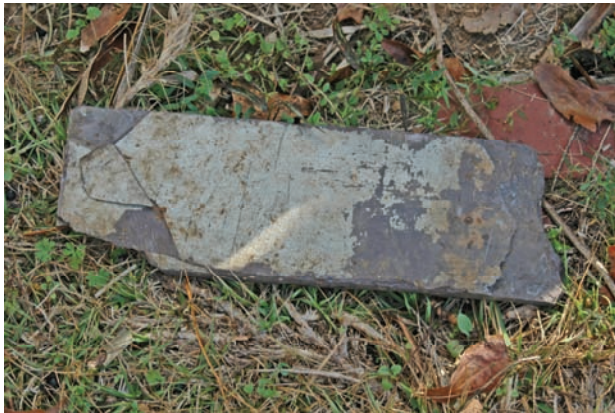
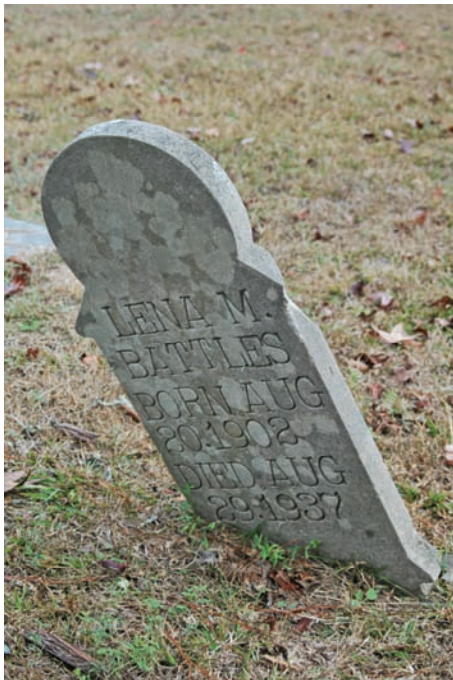
Figure 77. Stones that require resetting.

A number of stones are either leaning or out of the ground (we estimate about 20). Stones should never be reset using concrete, but rather should be set in pea gravel. This approach allows the stone some movement

should it be accidentally impacted by lawn maintenance activities. The pea gravel will also promote drainage away from the stone, helping the stone resist the uptake of soluble salts.

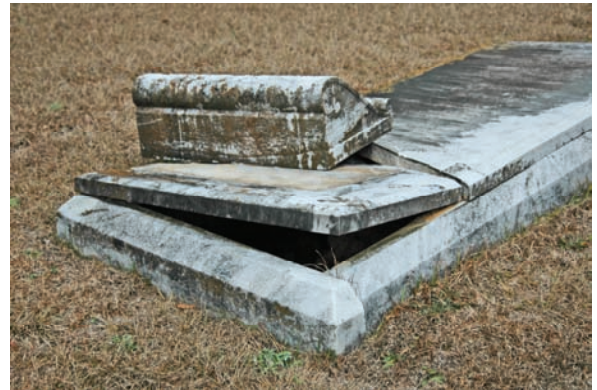
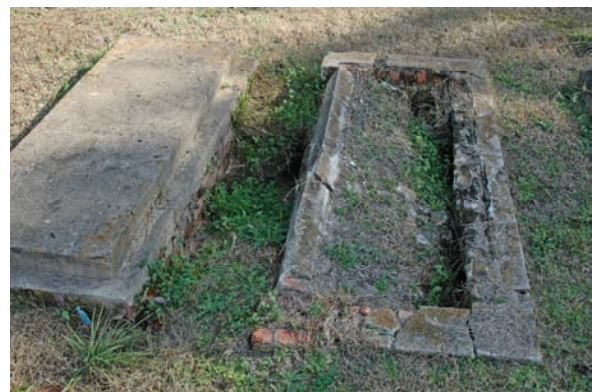
Figure 78. Examples of collapsing ledgers.

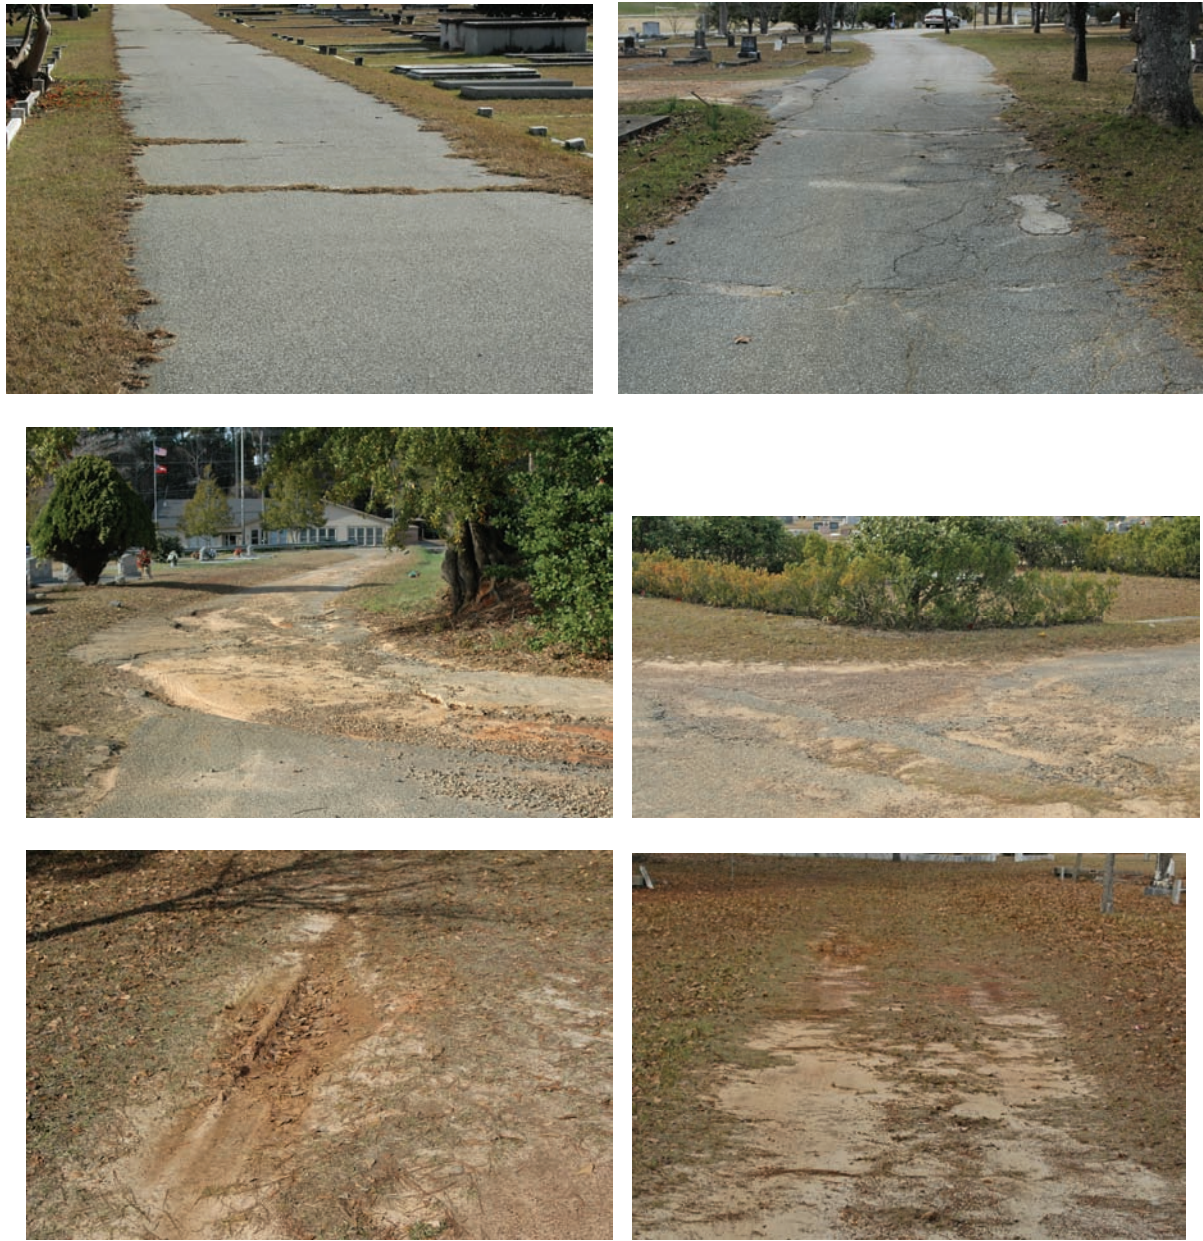
Figure 83. Road problems in Laurel Hill Cemetery. From upper left to lower right: paved road in the new section showing cracking, note that grass is not being edged; paved road in the old section showing cracking and previous patch repairs, again note the absence of edging; deteriorated roadway showing erosion and inappropriate (and ineffective) concrete patch; deteriorated roadway in the new section; rutted dirt roadway in the old section, indicating that these roads get muddy during rainy weather; heavily compacted dirt roadway in the old section that disappears with no clear or certain pathway.

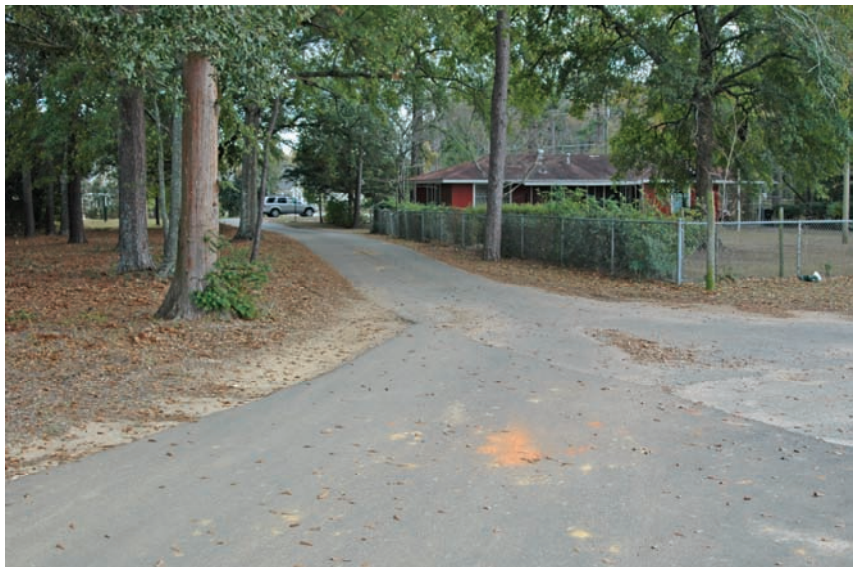
Figure 85. Road at the rear of the cemetery connecting Remington Street with Laurel Hill. This road should be closed to tighten the boundaries and prevent through-traffic. The lot could then be sold by the city or converted into burial spaces.

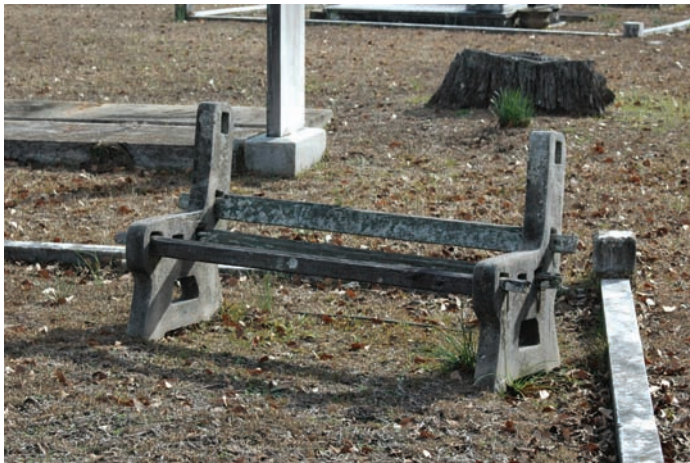
Figure 86. Bench in poor condition.

Although features such as urns are present on many lots, they tend to be in relatively good condition. The one bench we found in the cemetery (Figure 86), however, is in very poor condition.

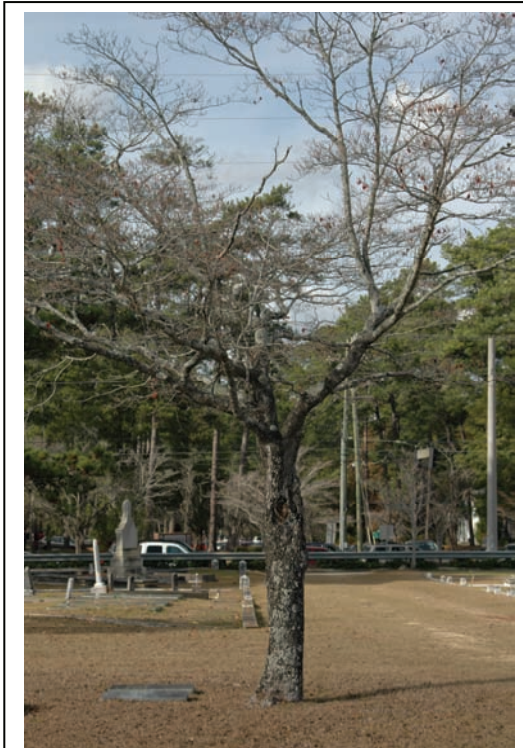
Figure 87. Sickly dogwood in full sun.

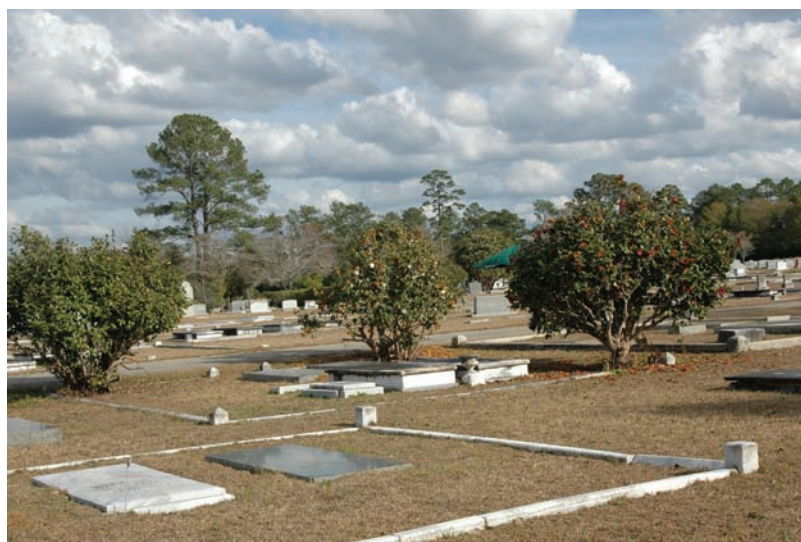
Figure 89. Camellias in full sun. All require rejuvenation pruning.

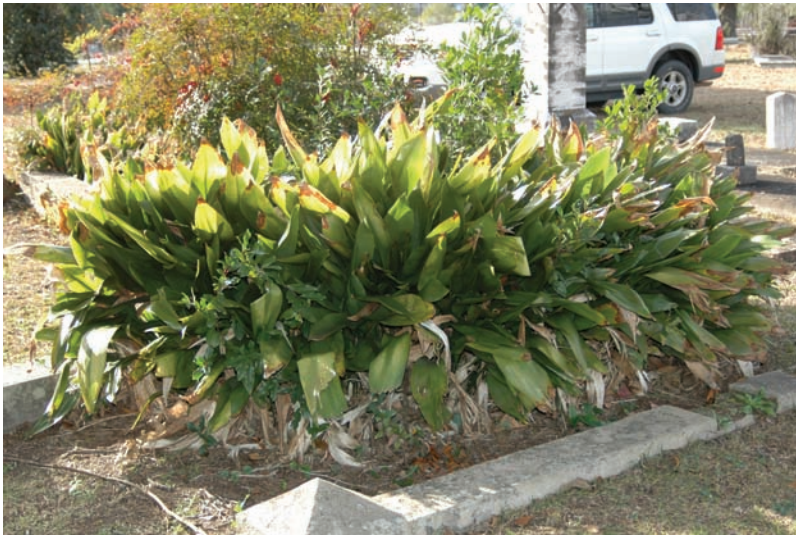
Figure 90. Cast iron plant in full sun.

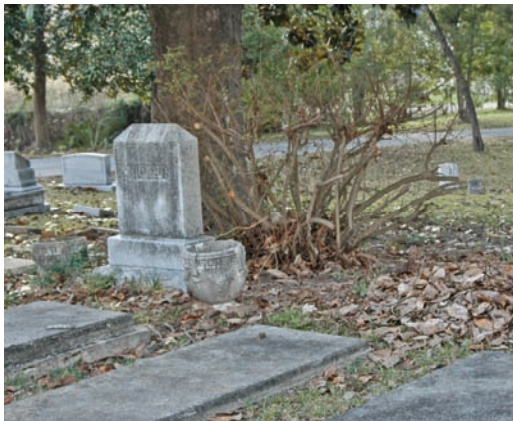
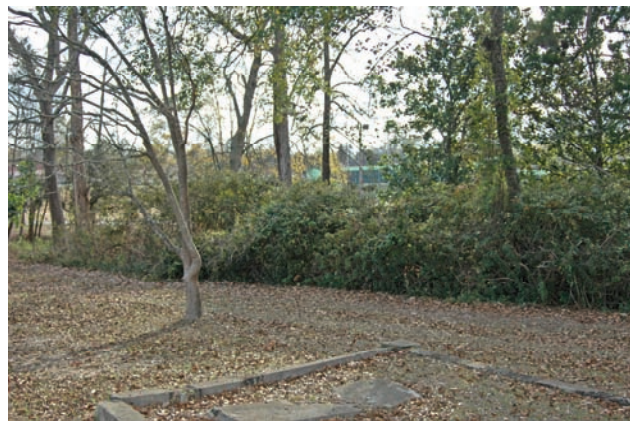
Figure 91. Badly pruned azalea on the left, clump of densely overgrown azaleas on the right.

Azaleas were noted in several locations throughout the cemetery. Individual, old specimens were observed that had suffered from very poor pruning. They were also found as borders in several plots.

Rejuvenation pruning may be useful, although many are in very poor condition and the approach may not be entirely successful.

Otherwise, it may be appropriate to remove the azaleas and replace with new plantings.
