# **ASSESSMENT AND RECOMMENDATIONS FOR THE THOMASVILLE, GEORGIA CEMETERIES**

**Chicora Research Contribution 485**

Prepared By:  
Michael Trinkley, Ph.D.  
and  
Debi Hacker

January 31, 2008

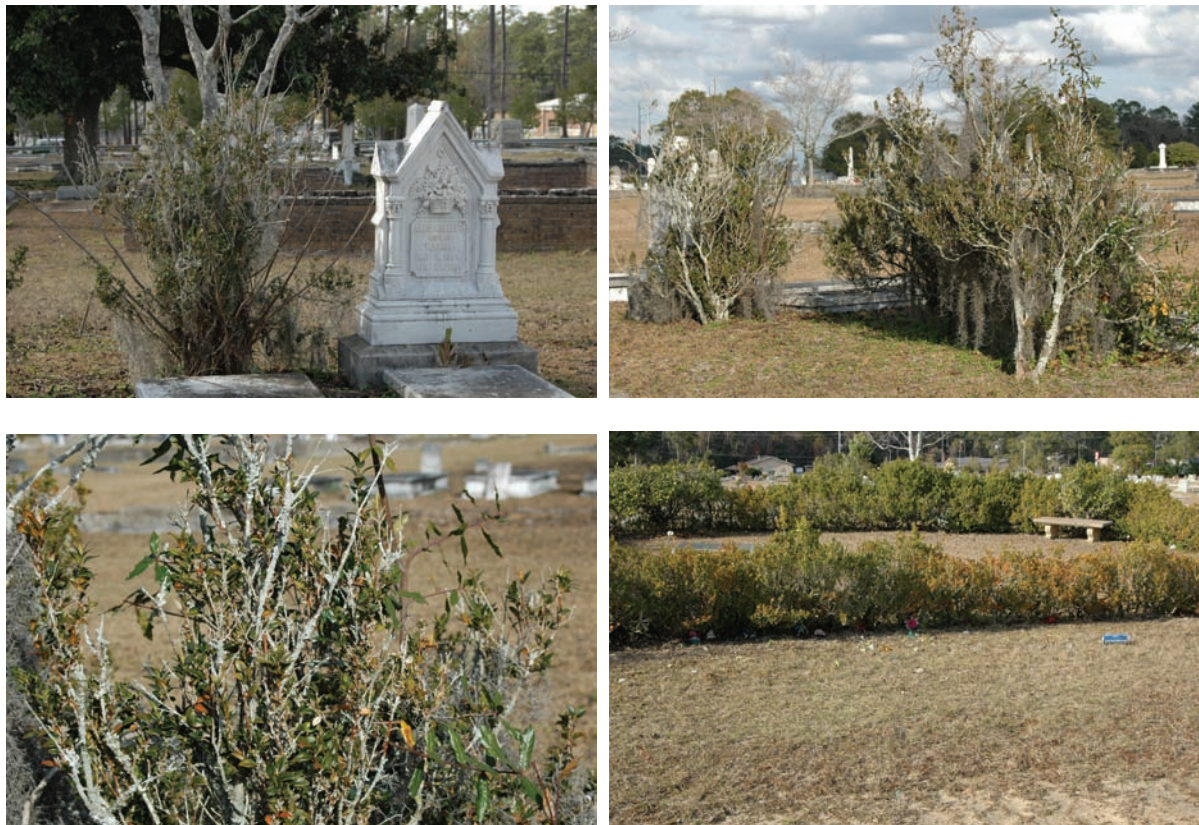
Figure 92. Dead and dying boxwoods. The first three photos show plants in such poor health that they should be removed. The hedge of boxwoods may be salvageable using rejuvenation pruning.

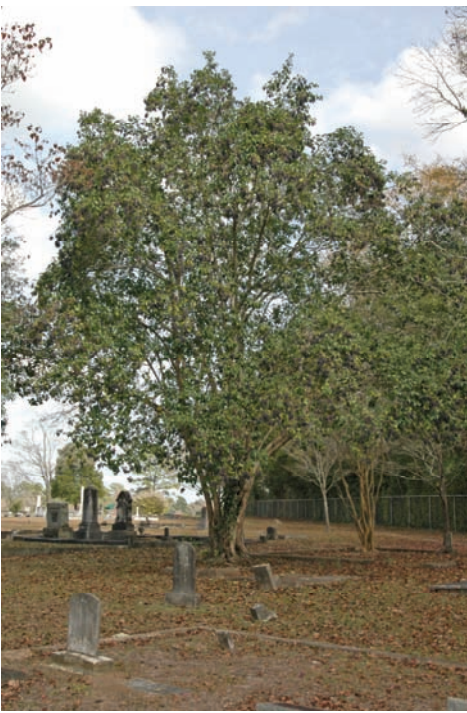
Figure 93. Ligustrum at Laurel Hill. The top photos shows a very old and beautiful ligustrum that should be carefully protected. Middle shows dead ligustrum. At the bottom is a poorly pruned ligustrum in overgrown plot.

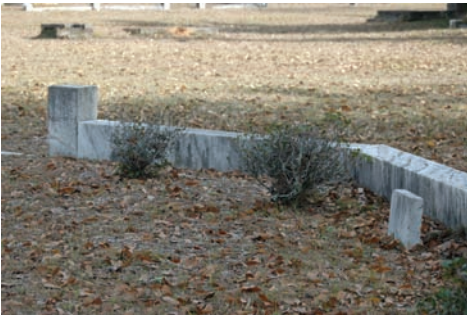
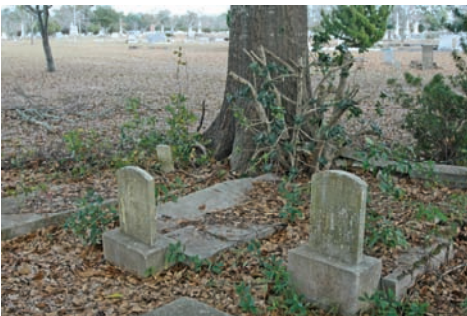
Many other ligustrum, however, have either been very poorly pruned or are dying. As with the other plants discussed here, some are suitable for very drastic rejuvenation pruning, while others simply require removal and replanting.

Other pruning issues include the failure to remove trash vegetation. For example, Figure 93 shows a poorly pruned ligustrum, yet the remainder of the plot is overrun in smilax and other weedy plants. Figure 94 illustrates additional examples of junky vegetation that should be removed during routine landscape activities.

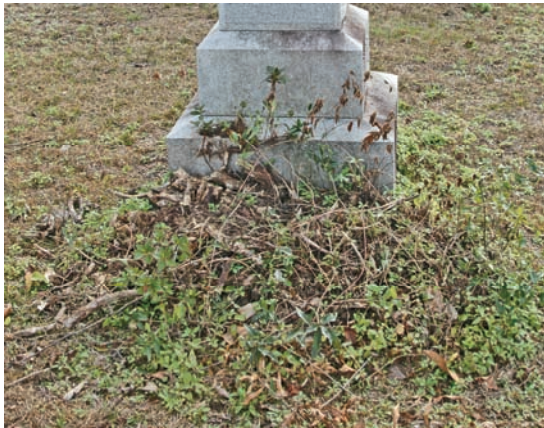
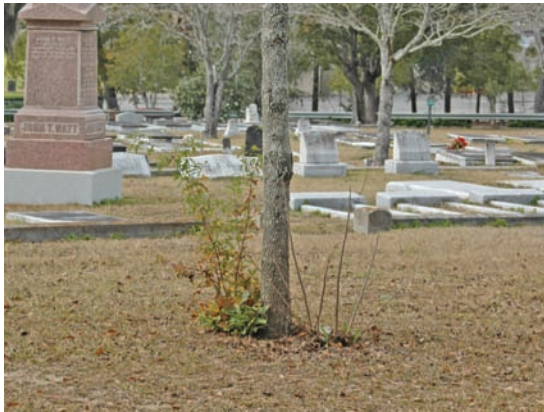
Figure 95. Trash vegetation that should be removed during routine lawn maintenance.

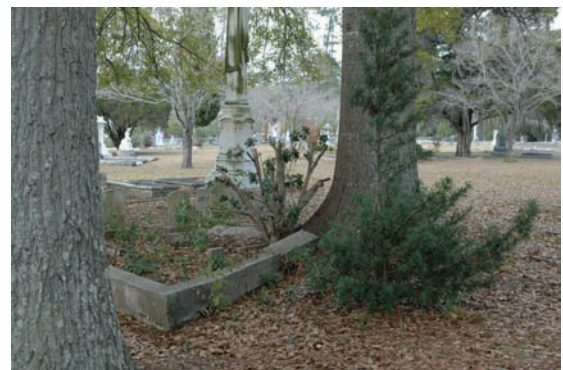
We also saw at least one example where plants were indiscriminately added with no understanding of long-term consequences. Figure 96 shows one such situation. A yew (*Taxus x media*) was planted in very close

proximity to old and historically valuable oaks. This yew will grow to a height of 6-12 feet, with a spread of 8-10 feet – totally encompassing the plot and other vegetation.

Figure 96. Yew incorrectly planted in close proximity to existing historically sensitive vegetation.

Given its location, it is unlikely that the yew can be removed without causing damage to the nearby oaks. We recommend that it be cut down.

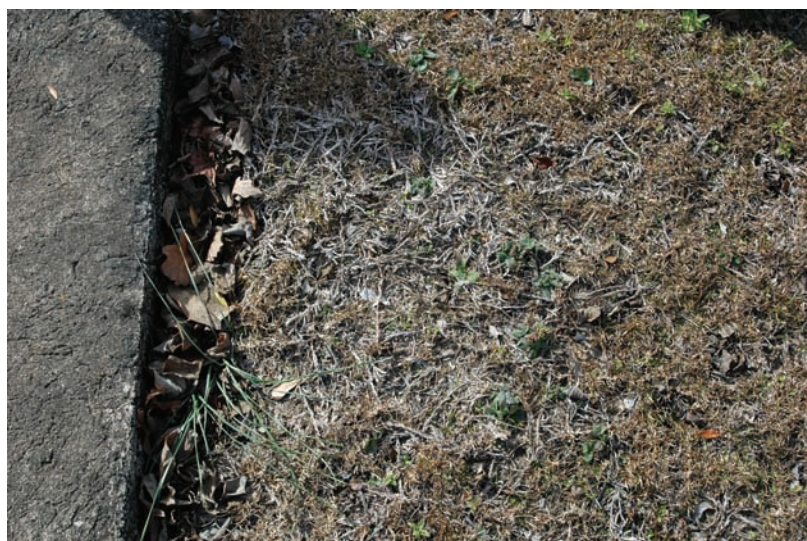
Figure 97. Area of thatch and grass die-off at Laurel Hill. Note invading broadleaf weeds.

Bahiagrass is prone to thatch build-up, evident in Laurel Hill (Figure 97). We suspect that the soils also require aeration – a practice that should be undertaken on a rotating basis throughout the cemetery.

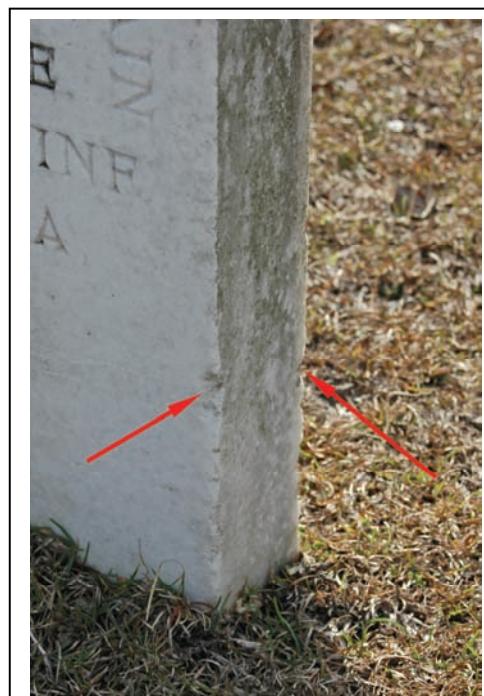
Figure 99. Mower damage.

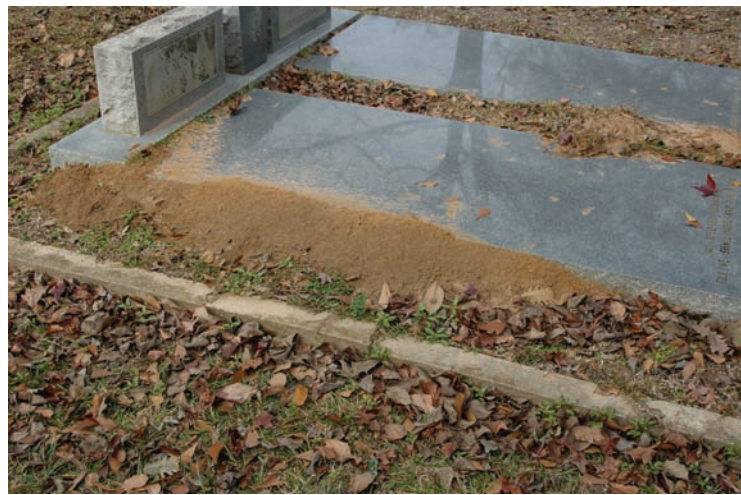
Figure 100. Fire ants in Laurel Hill Cemetery.

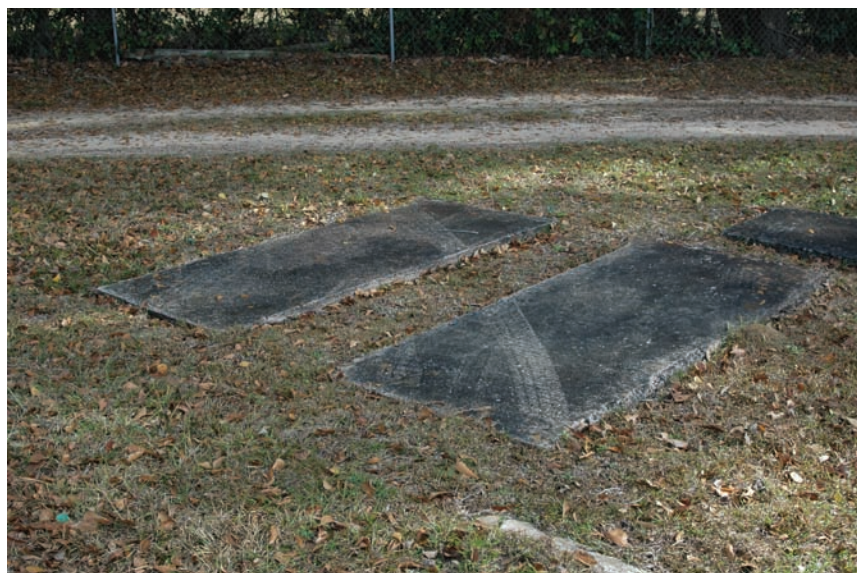
Figure 101. Tire tracks across ledgers in Laurel Hill.

During our visit to Laurel Hill we observed tire tracks on several ledgers (Figure 101). This is unacceptable and the practice must stop immediately.

Not only is it disrespectful to treat a gravesite in this manner, but it is very dangerous. Driving on these ledgers could cause them to collapse - potentially damaging the vehicle, injuring passengers, and even damaging the human remains.

If it is absolutely necessary to operate over monuments, the city should use mud tracks - platforms designed to distribute equipment weight and prevent damage (although commercially available, even ¾-inch plywood is satisfactory).

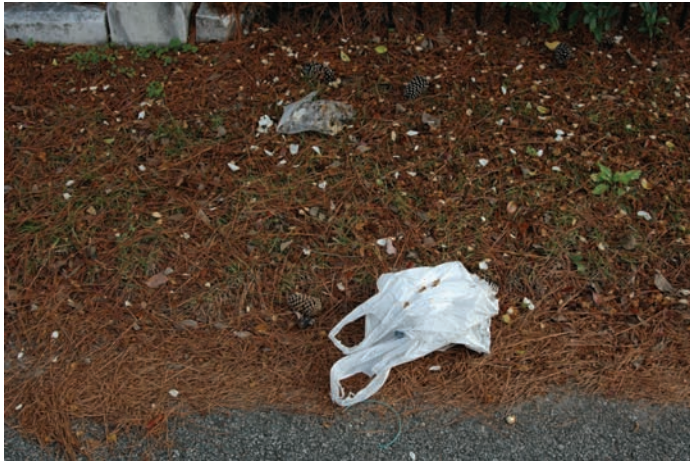
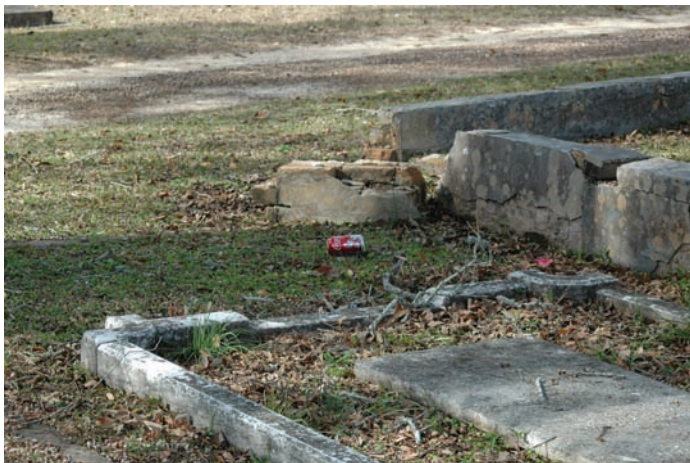
Figure 102. Trash in the cemetery was clearly visible along roads.

Trash was observed collecting along plot edges (see Figure 92 for a particularly disturbing example). Other trash was clearly visible along road sides (Figure 102). It is critical that the city maintenance crew walk the cemetery at least three times a week to collect trash. This can typically be done with other work, such as blowing off the roads, collecting dead flowers, and so forth.

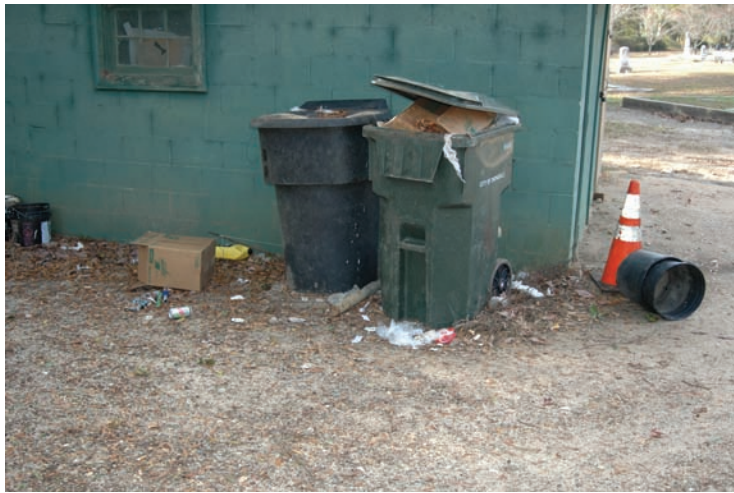
Along the edge of the property there is a building with signage indicating that it is used to store pesticides. If this sign is correct, then this entire building should be moved off-site. There is no reason to store this amount of pesticides on the cemetery property.

Adjacent to this building is a pile of discarded plastic pots, a large concrete piling, and a number of trash containers. All this debris should be immediately removed.

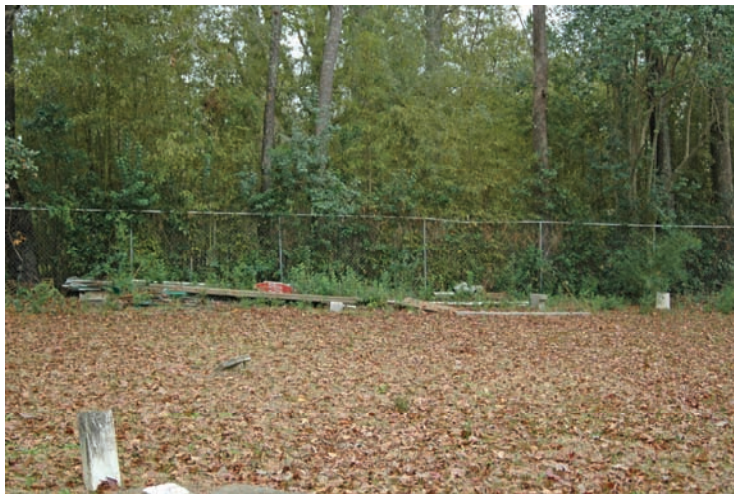
Adjacent to the maintenance shed is a fenced area containing additional plastic pots, as well as what appear to be cuttings. This area should be cleaned up. Those plants still alive and useful should be stored at an appropriate location where they can receive care. Those that are not useful should be discarded.

The city should insist that its cemetery maintenance area look neat and clean at all times. It should reflect the pride that Public Works, the city, and the community take in the cemetery.

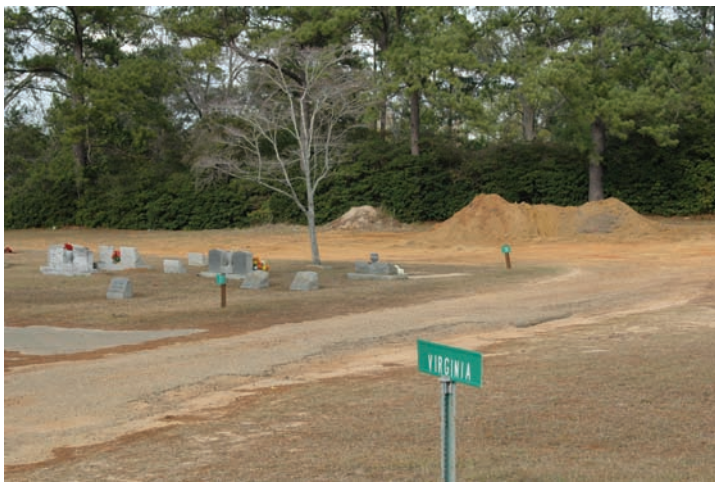
Figure 104. Soil piles at the edge of the cemetery. Spoil should be removed from the cemetery or screened from view.

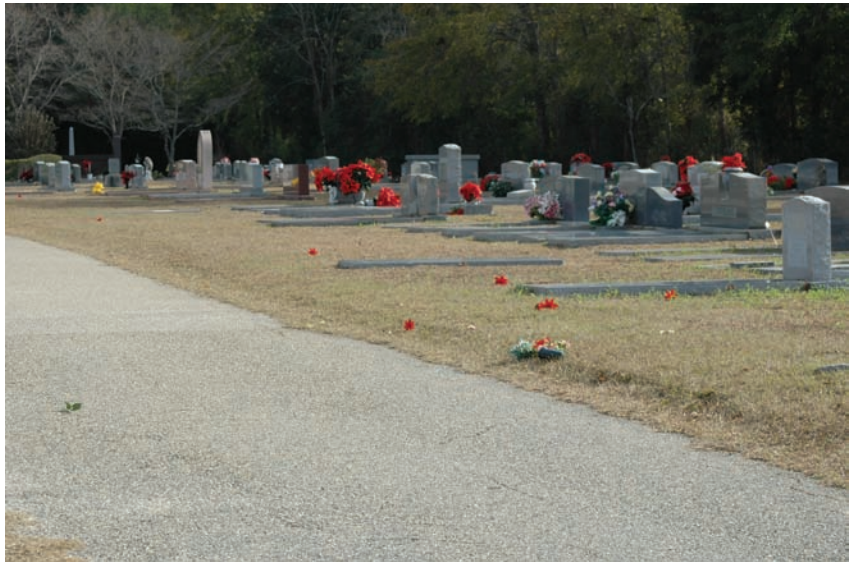
Figure 105. Plastic Christmas flowers strewn about the cemetery detracts from the beauty and dignity of Laurel Hill.

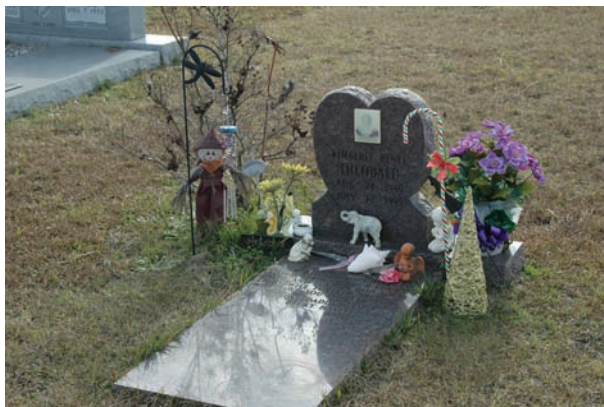
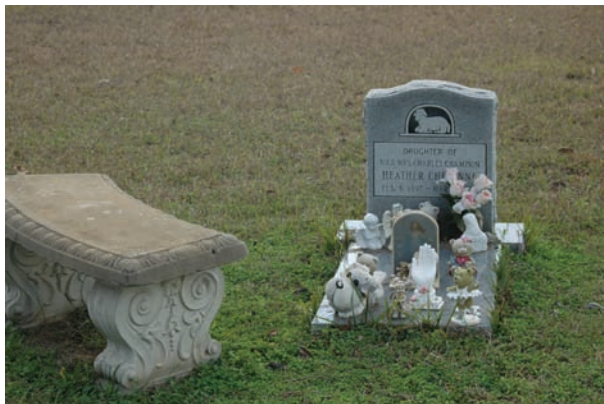
Figure 106. Examples of cluttered graves that make it difficult to adequately trim the grass and pose a hazard to the cemetery workers.

Second, we recommend that the city establish a regulation that all floral must be placed in vases integral to the stone or that a vase mounted vase holder be used. These choices provide a wide range of cost options for families while still ensuring that the maintenance staff can perform their duties. These are available from a variety of monument companies for about \$20 retail or could be

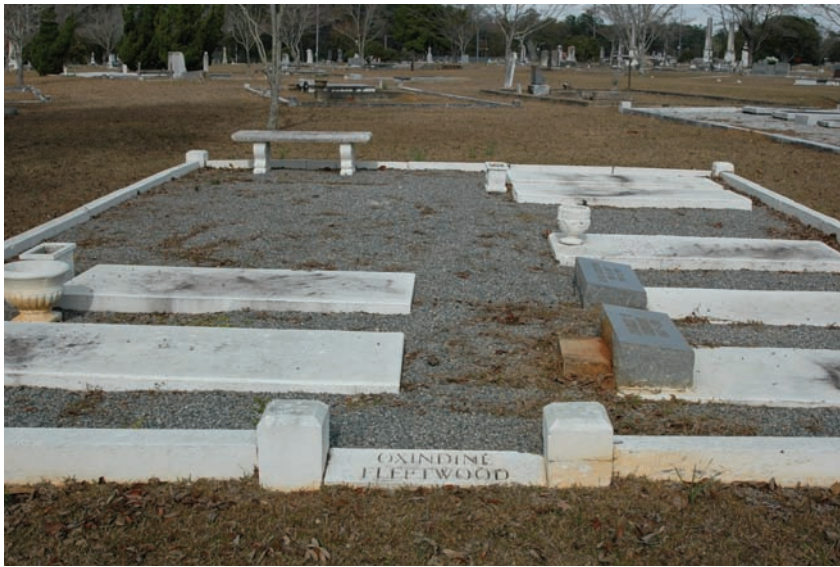
Figure 107. Graveled plot showing abundant weeds. These plots are harsh and detract from the overall cemetery appearance. They should be discouraged and gradually converted into grass.

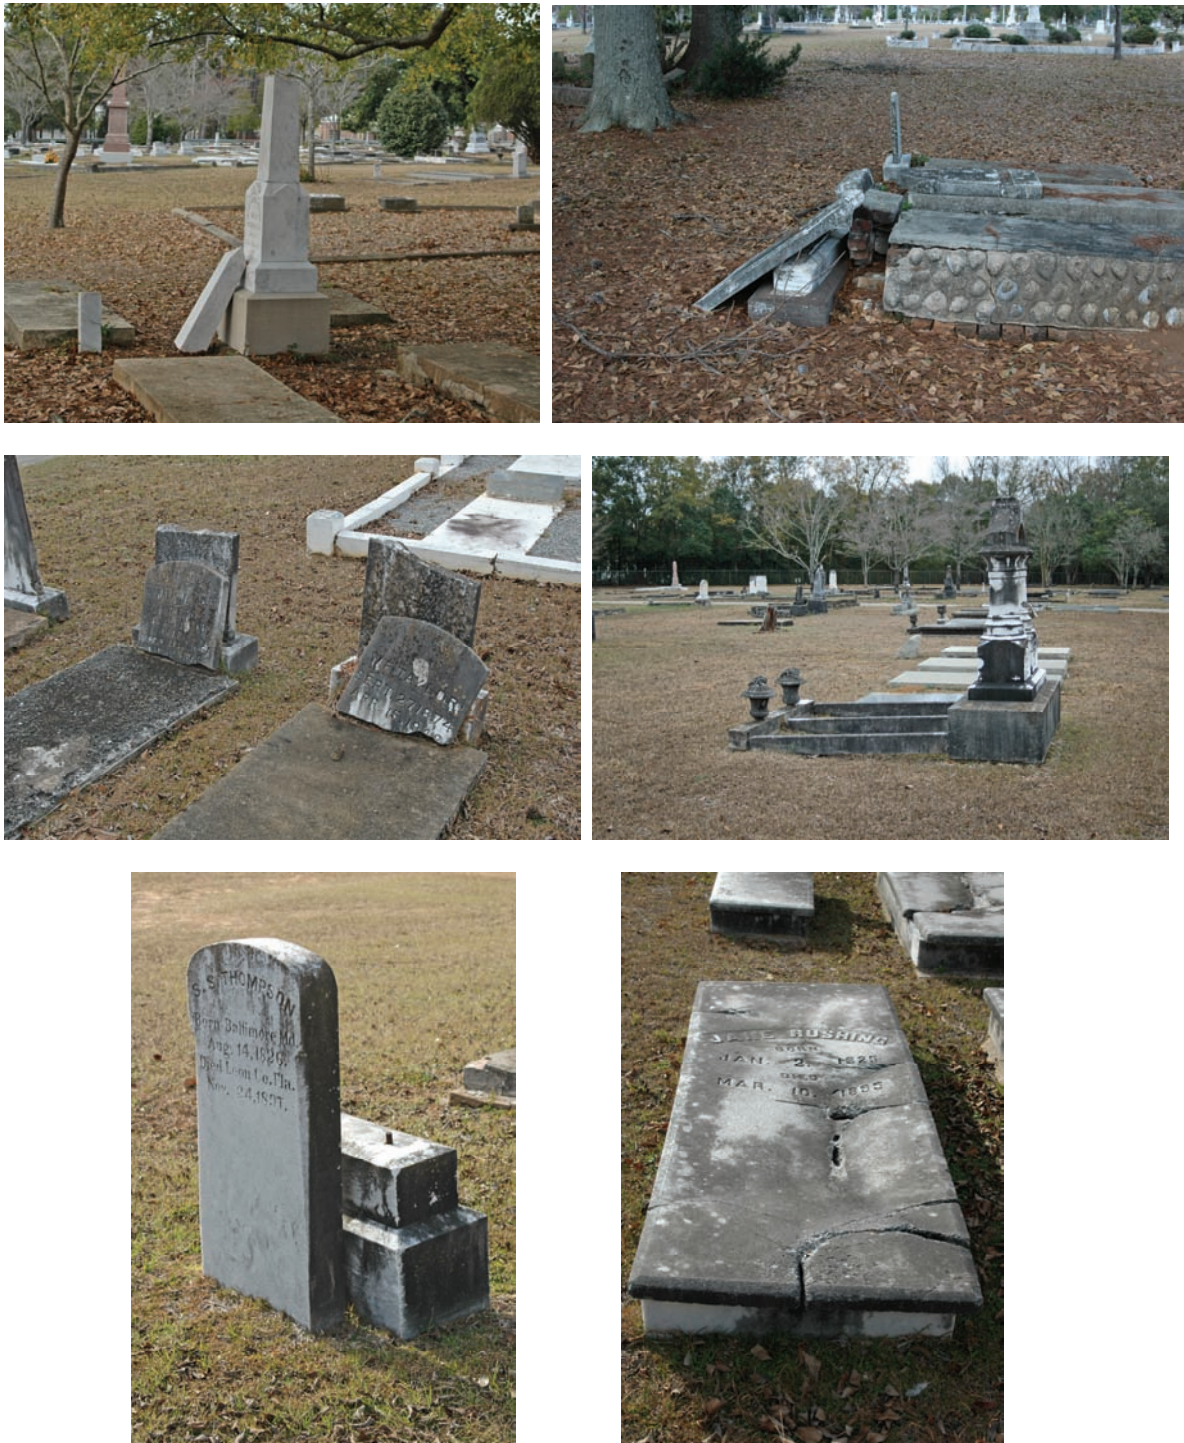
Figure 108. Typical stone conservation issues at Laurel Hill. From upper left to lower right: broken obelisk; tab in socket with broken tab; broken headstones; elevated monument with cradle side boards elevated; die on base with ferrous pins; extensively sugaring and warping ledger.

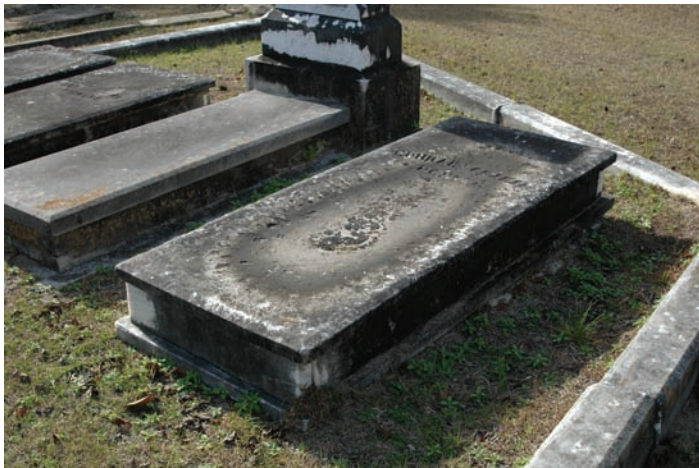
Figure 109. Example of a warped ledger showing water ponding on it.

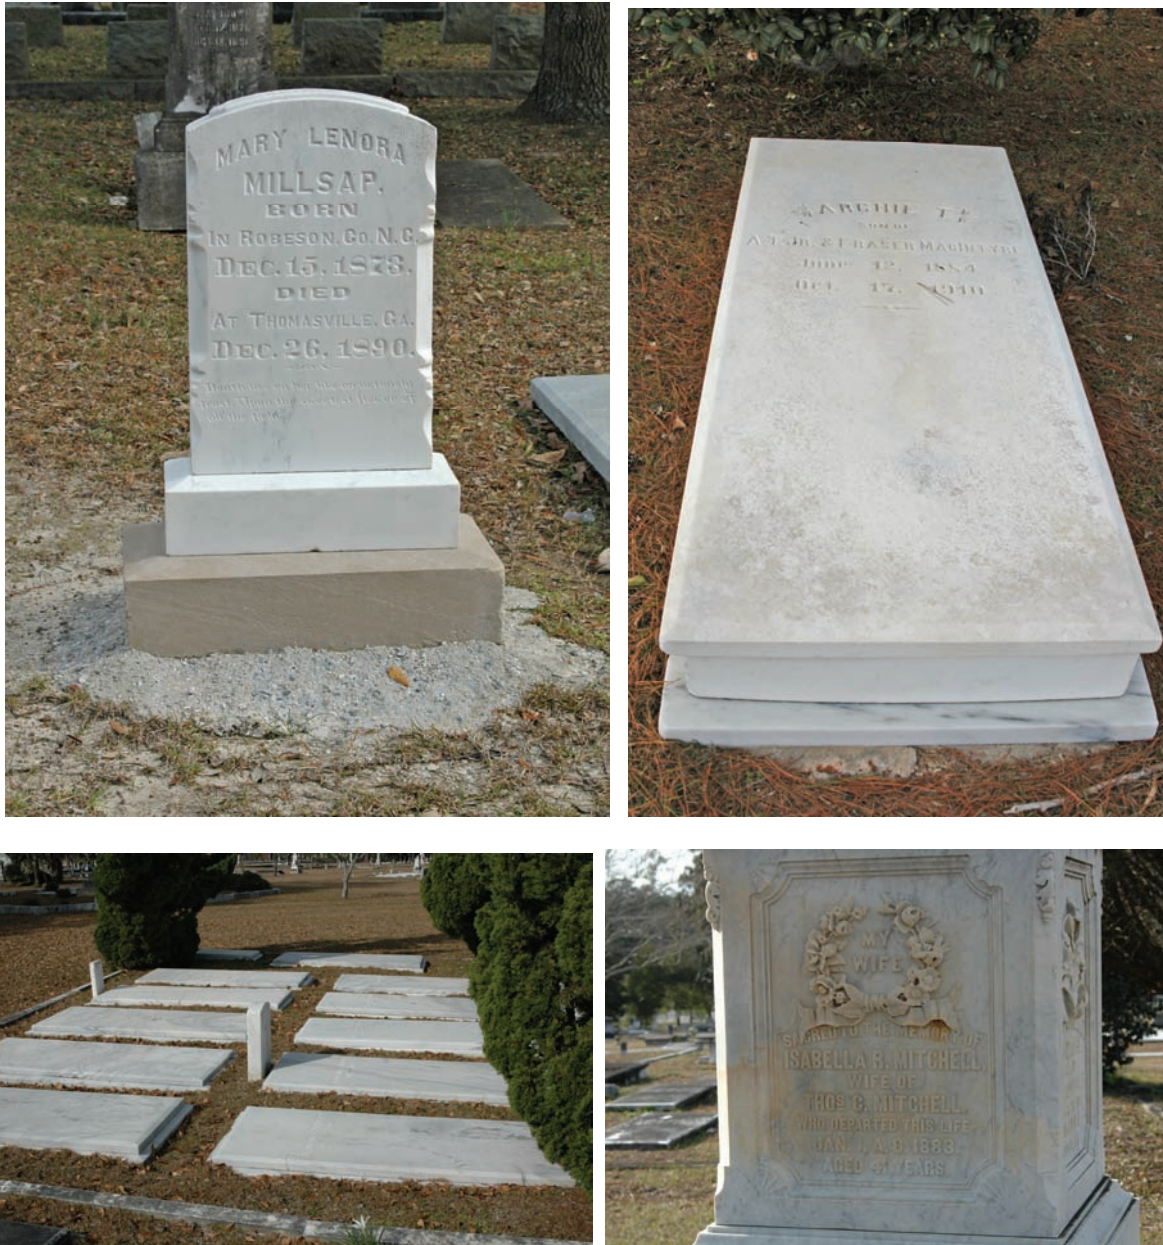
Figure 110. Examples of incorrect cleaning are found throughout Laurel Hill and these practices are causing significant damage and disfigurement. From upper left to lower right: monument cleaned using acid, resulting in surface erosion (this monument is also set too high, on a mass of Portland cement); ledger inappropriately cleaned with acid; entire plot cleaned with acid which destroys the historic patina and makes it appear as though the stones were set yesterday; monument cleaned with sodium hypochlorite leaving a yellow stain.

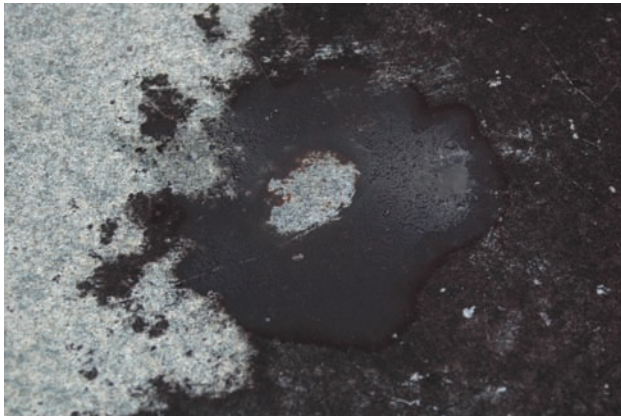
Figure 111. Soiling easily removed with just water.

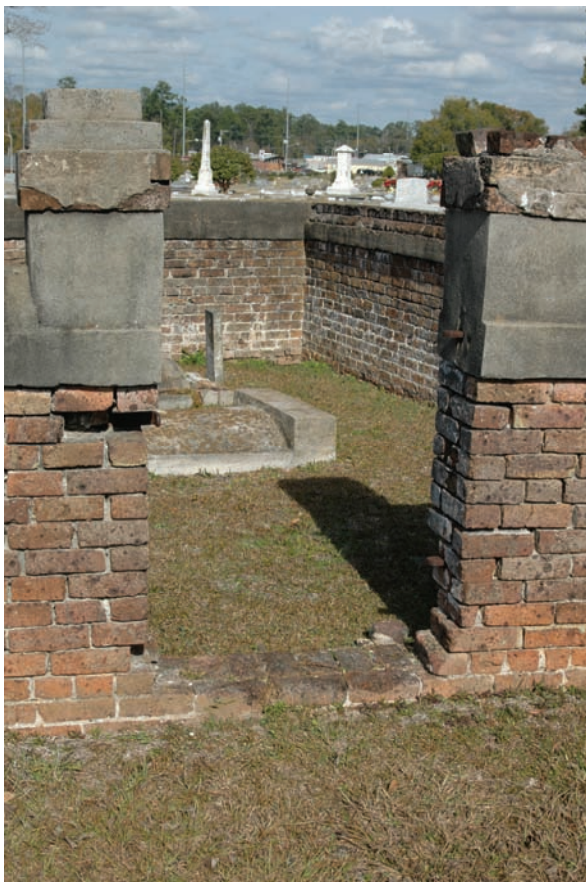
Figure 112. Brick plot that requires repointing.

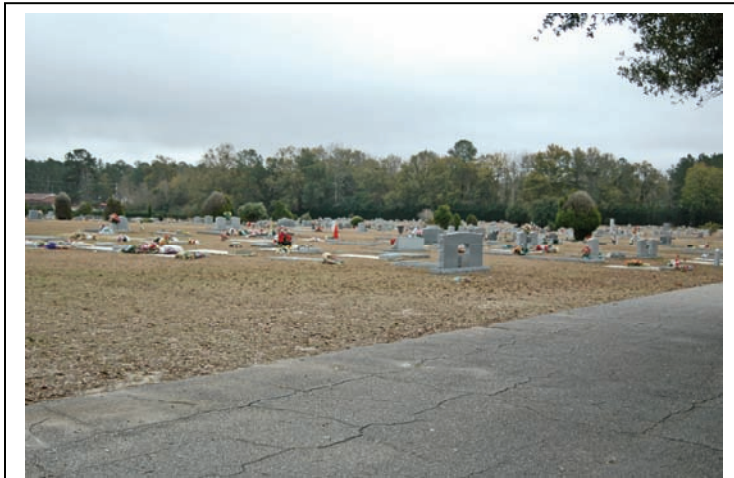
Figure 114. View of Peaceful Rest Cemetery, note also the deteriorating road condition.

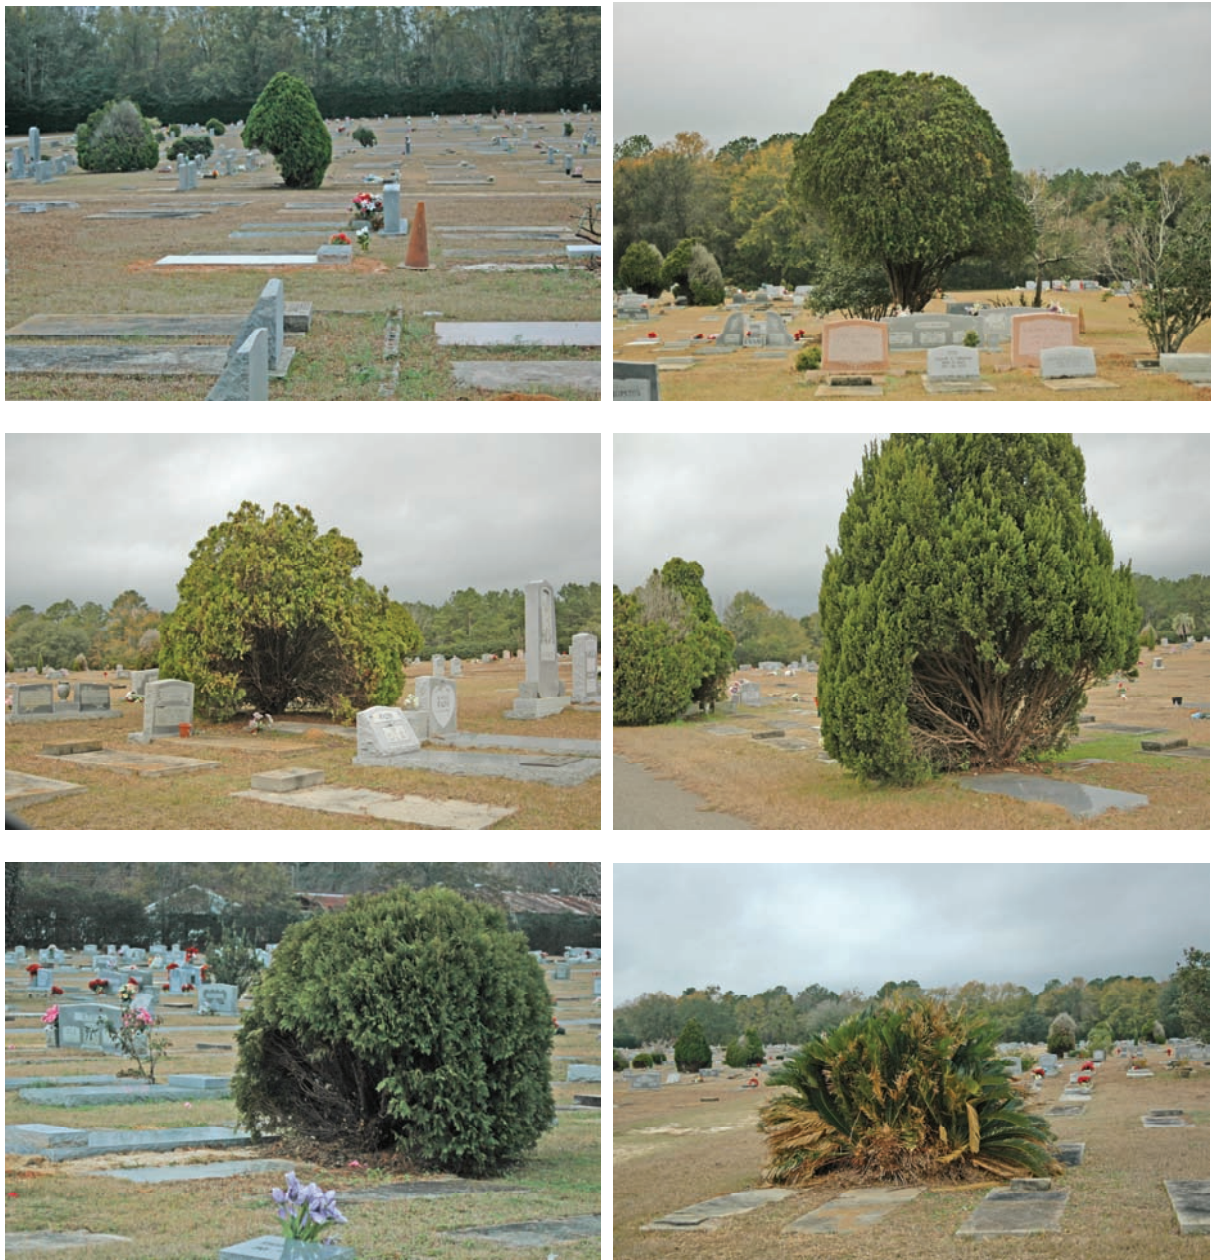
Figure 115. Landscaping issues at Peaceful Rest. The first five photos show a variety of arborvitae mutilated by inappropriate pruning. Several of the photos also show arborvitae with deadwood which should have been pruned out, but that was untouched. The lower right photo shows a sago palm damaged by the cold. It was badly pruned, exposing the heart of the palm. The arborvitae must all be removed and replaced with new plantings – damage this severe cannot be repaired. It is critical that the city ensure its employees are adequately trained to care for the cemetery landscape.

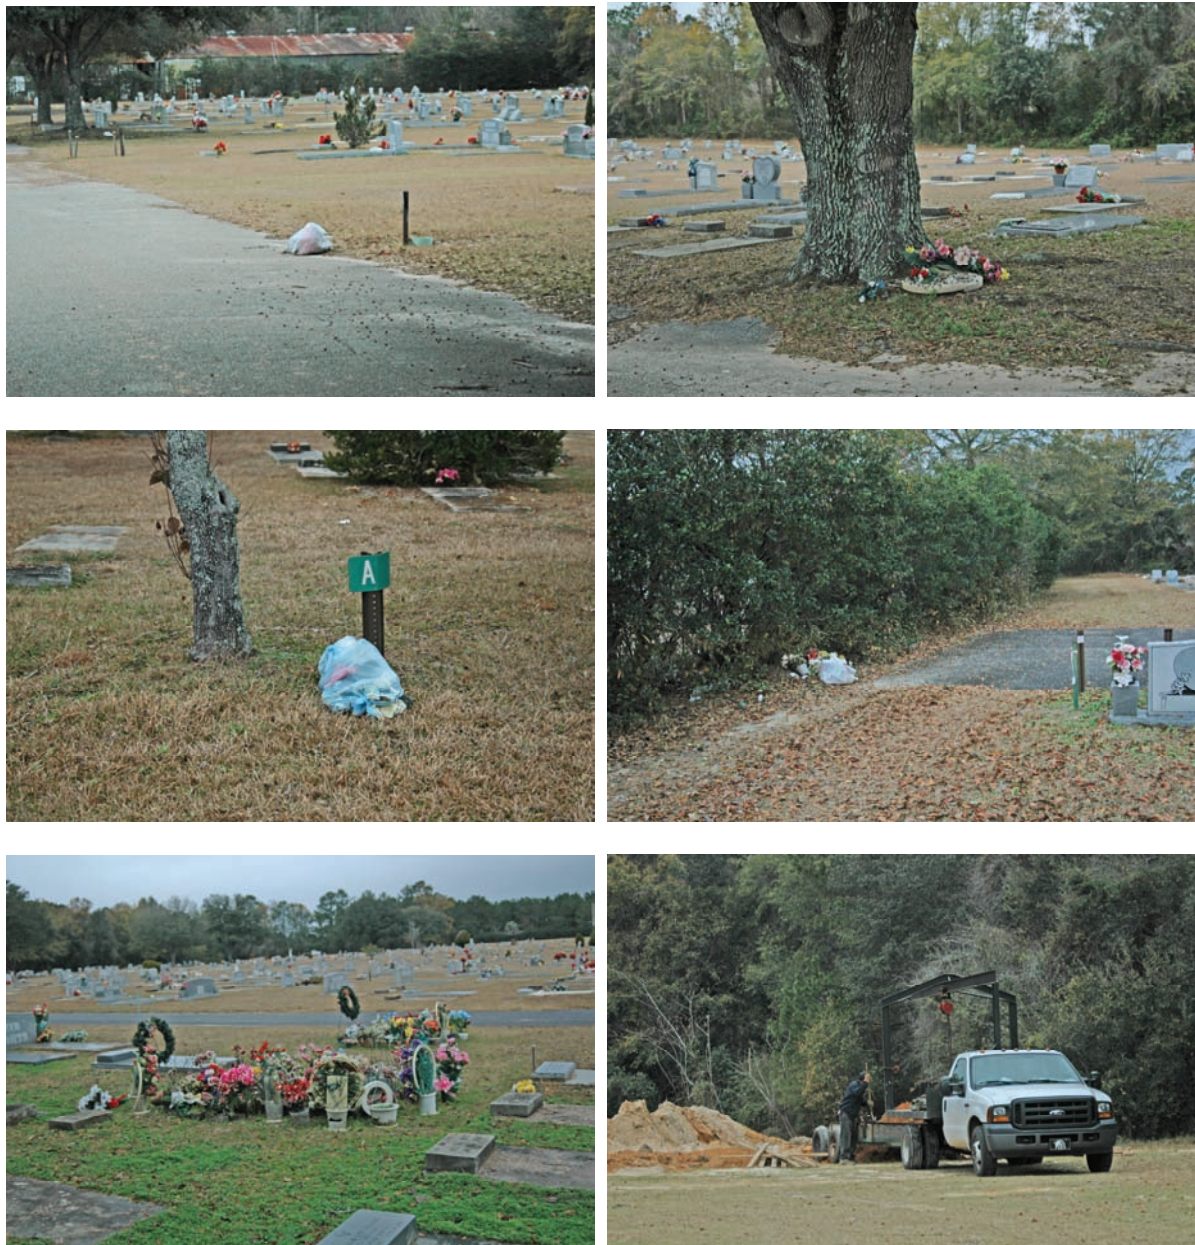
Figure 116. Concerns at Peaceful Rest. The first four photos show a variety of trash piles situated around the cemetery. These must be collected on a routine basis and at least twice a week. The bottom row left photo shows several graves with dense flowers that impede lawn care. The cemetery must have regulations regarding how long temporary decorations may remain. The lower right photo shows a grave digging company dumping soil and debris in the spoil pile. These debris should either be removed from the cemetery or screed from public view. Currently the pile is immediately on the right as one enters the cemetery.
