# **PRESERVATION ASSESSMENT OF THE CHRIST CHURCH CEMETERY, GREENVILLE, S.C.**

Prepared By:  
Michael Trinkley, Ph.D.  
and  
Debi Hacker

Prepared For:  
Christ Church Episcopal Church  
10 North Church Street  
Greenville, SC 29601

August 28, 2008

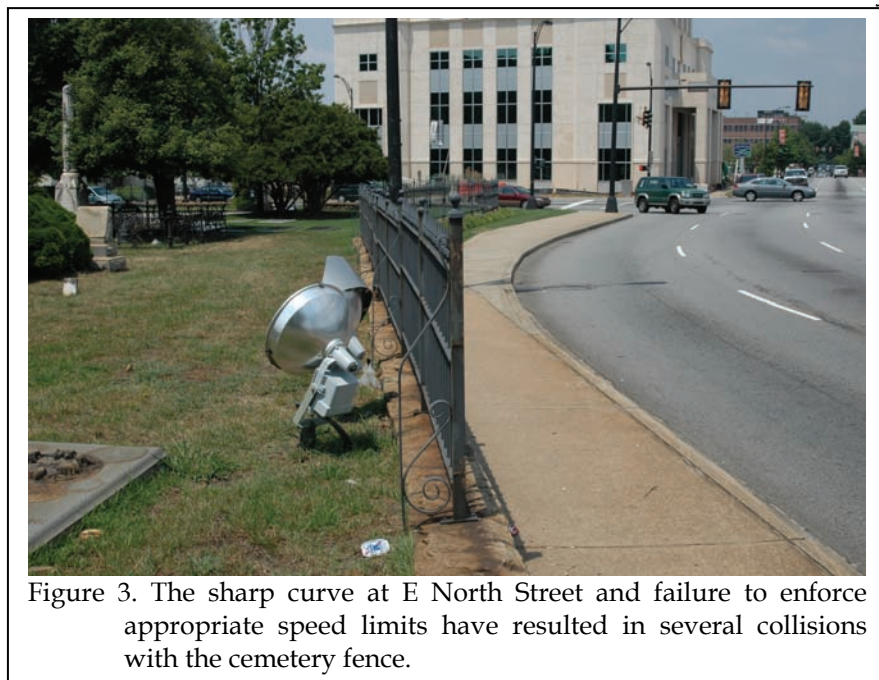
Figure 3. The sharp curve at E North Street and failure to enforce appropriate speed limits have resulted in several collisions with the cemetery fence.

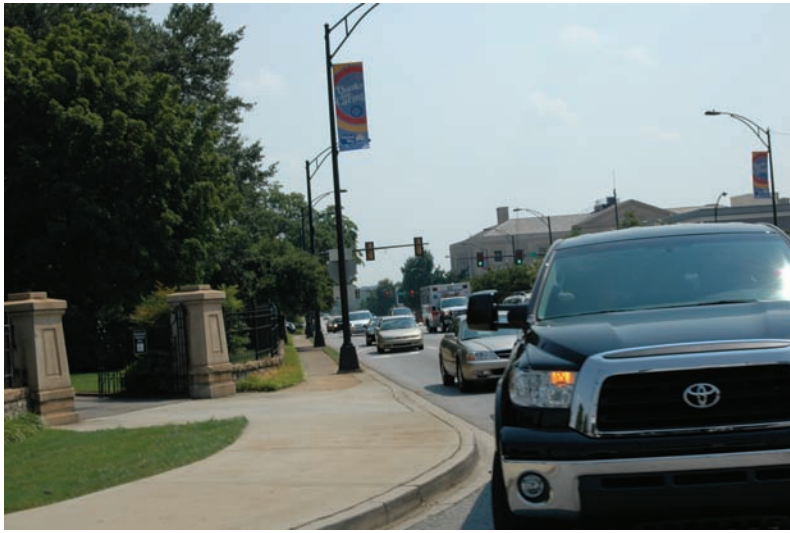
Figure 4. Accessing the cemetery is difficult because of heavy traffic on N Church Street and the proximity of the entrances to the intersection with E North Street.

Traffic is equally heavy on N. Church Street (which is also US29, a major area highway which joins with I-185), especially during rush hours, and this makes accessing the cemetery through its main entrances very difficult (Figure 4). The oldest sections of the cemetery, situated closest to the church, are at the same elevation as the nearby streets - so there is little reduction in either the noise or visual intrusion of traffic. Efforts have been made to use vegetative screenings and this effort is at least partially effective.

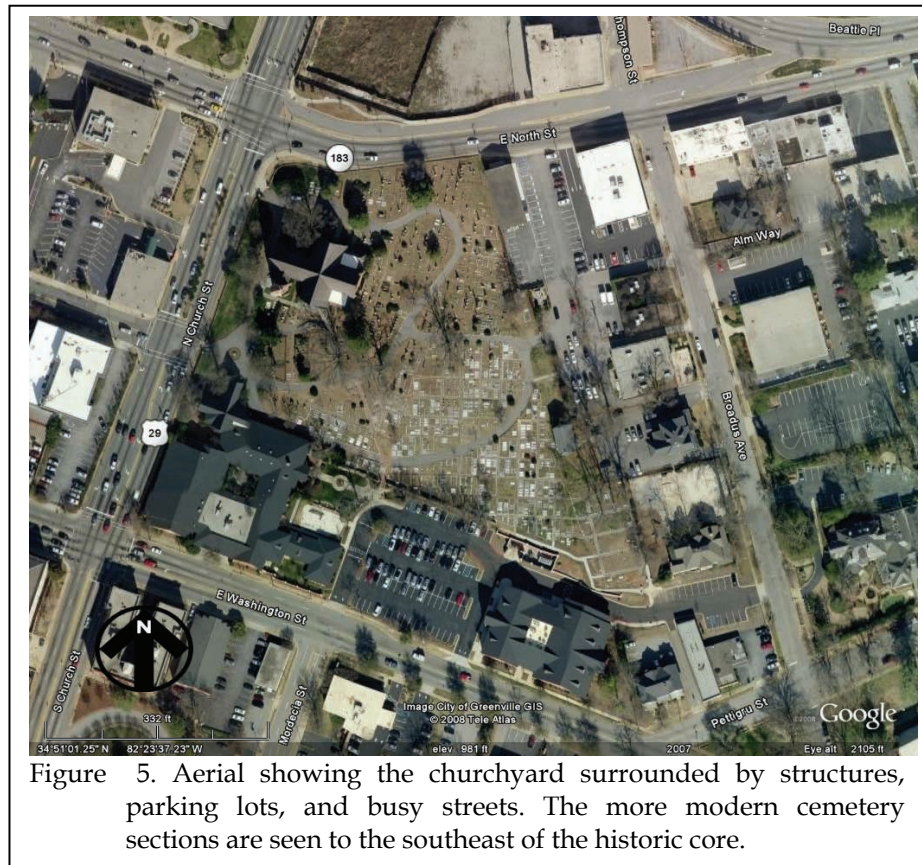
Figure 5. Aerial showing the churchyard surrounded by structures, parking lots, and busy streets. The more modern cemetery sections are seen to the southeast of the historic core.

The topography of the cemetery is relatively level, although the ground does slope from an elevation of about 992 feet in the northeast to 974 feet along its southern edge (Figure 5). This is part of Greenville's overall slope southward, toward the Reedy River. Nevertheless, the cemetery is about 2,500 feet from the 500 year flood zone.

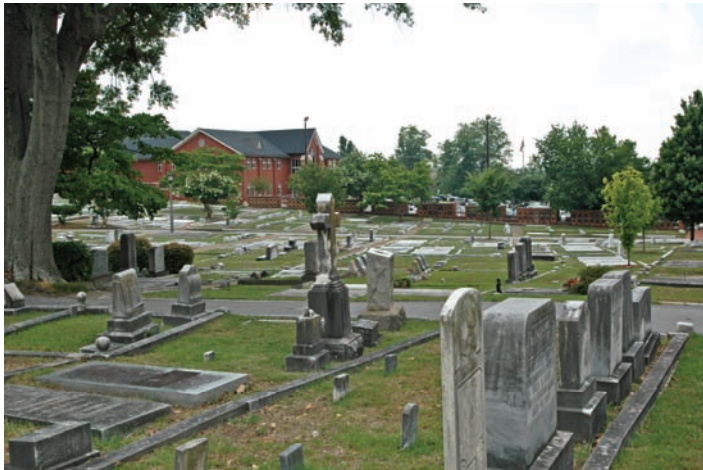
Figure 7. View from the older section southward, showing the newer section that more closely resembles a memorial park cemetery. At the far edge of the cemetery is the columbarium wall.

The newer sections of Christ Church (such as Sections V and VI) exhibit characteristics of these changes in cemetery design. The newer sections have little vegetation, are more open with a memorial park appearance. The newest addition has been the columbarium wall along the south edge. Although introduced as early as the late nineteenth century, columbaria did not receive much attention until the 1930s, and it wasn't until the 1980s that they were integrated into Arlington National Cemetery (Prothero 2001:116-118).

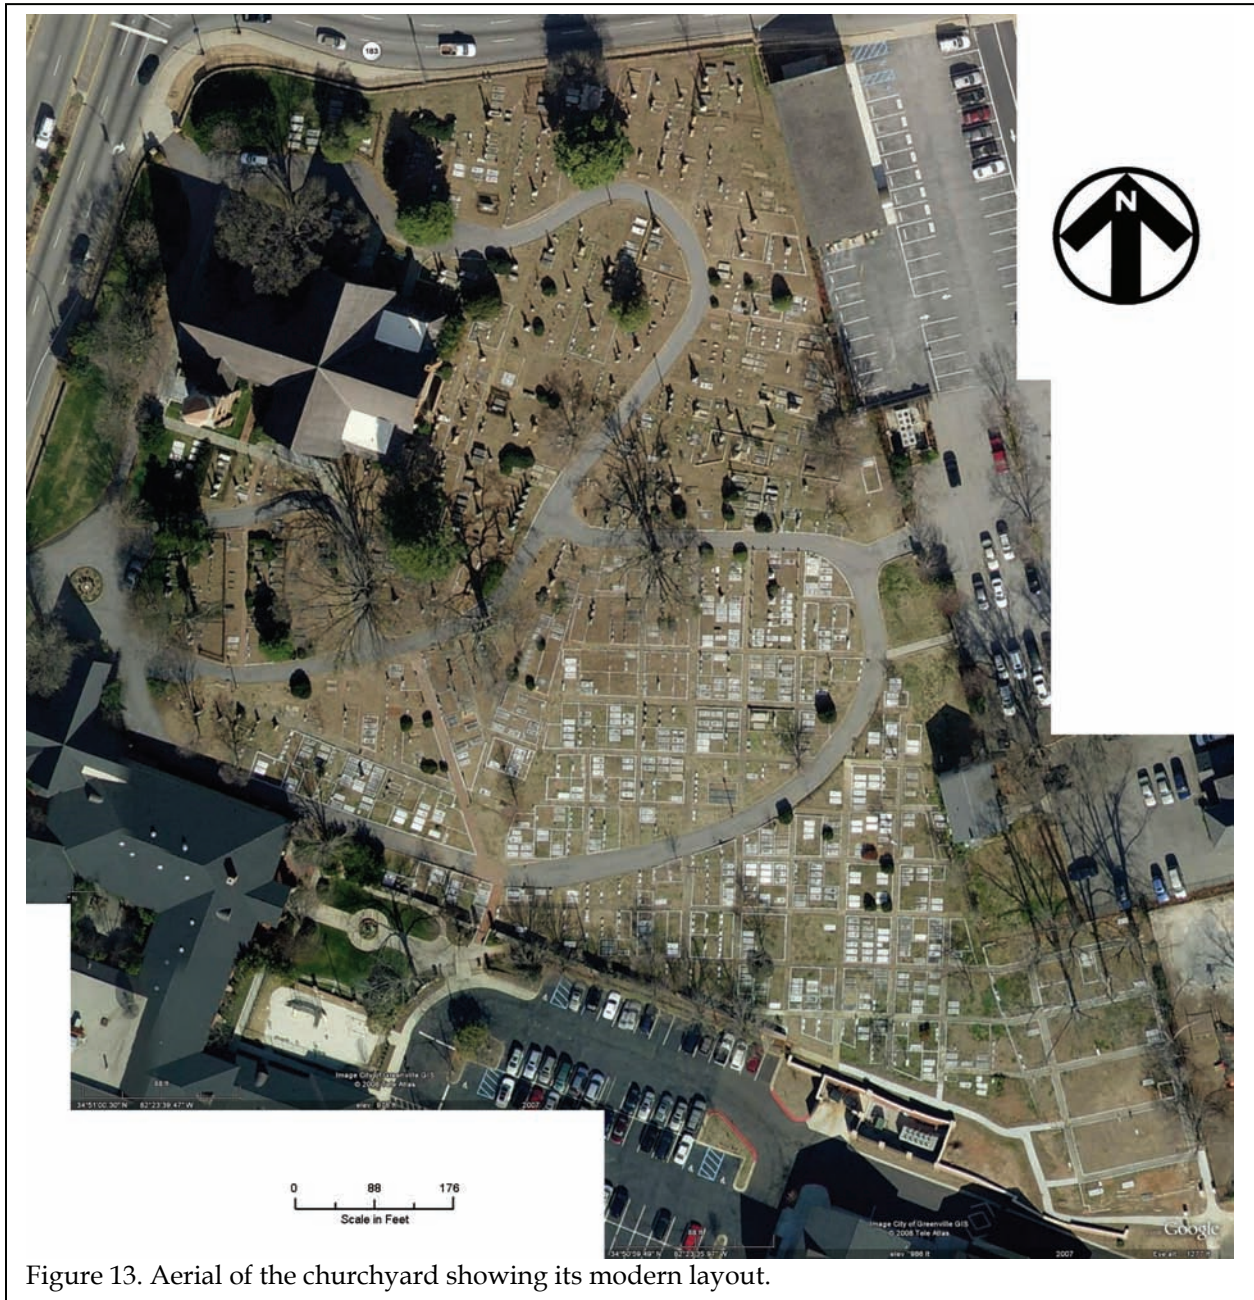
Figure 13. Aerial of the churchyard showing its modern layout.

No digital map exists showing the entire cemetery. Figure 13, however, provides a good approximation, revealing the roads, vegetation, and plot arrangements.

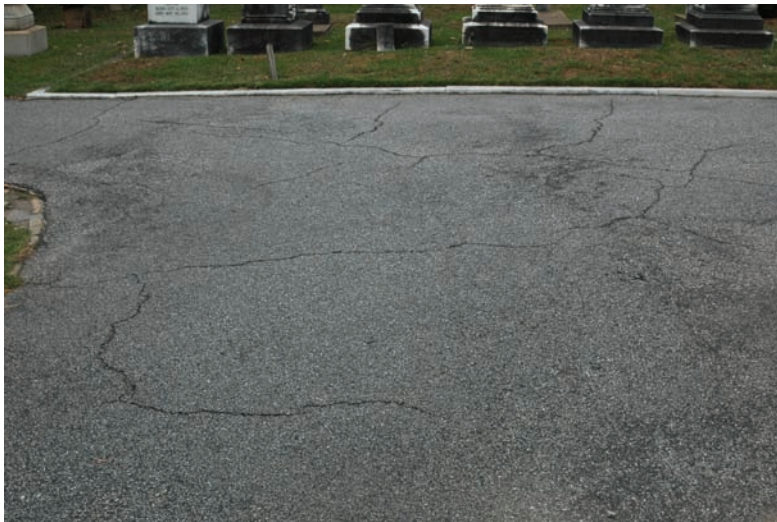
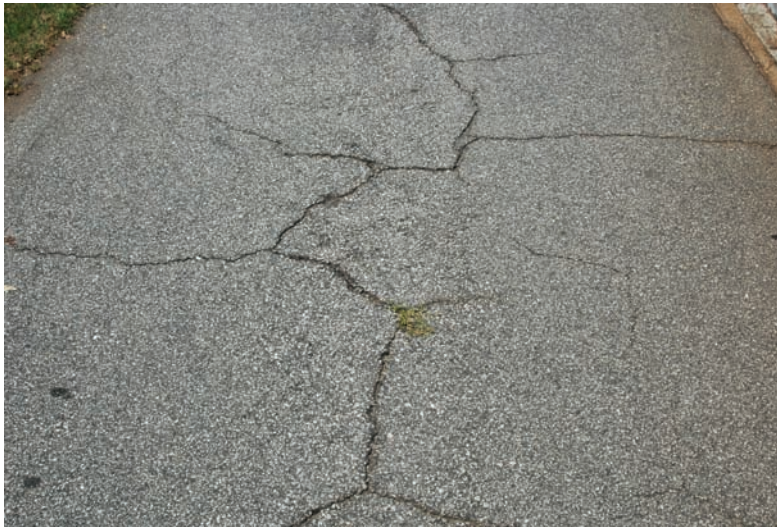
Figure 15.Examples of the road deterioration in the cemetery.

recommend that the cemetery consult with a geotechnical engineer and obtain detailed specifications for the work. The cemetery should also be aware that asphalt prices are up 25.9% from a year ago and are unlikely to decline anytime soon. Thus, any additional delays in resolving the road problems will simply increase the cost to the church.

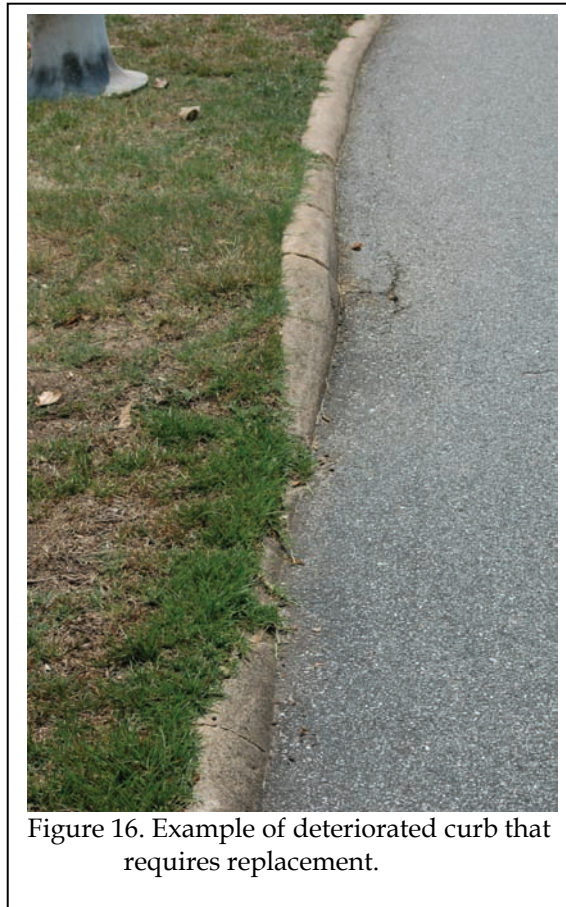
The concrete curbs are generally in acceptable condition, although we did observe several areas of extensive deterioration (Figure 16). These problem areas need to be cut out and replaced. It is critical that replacements match the original, historic curbing in composition, design, color, and texture. It is also important that the original curb profile be matched (at least two profiles are present in the cemetery). Companies such as Dee Concrete Accessories produce profiling tools to match precise

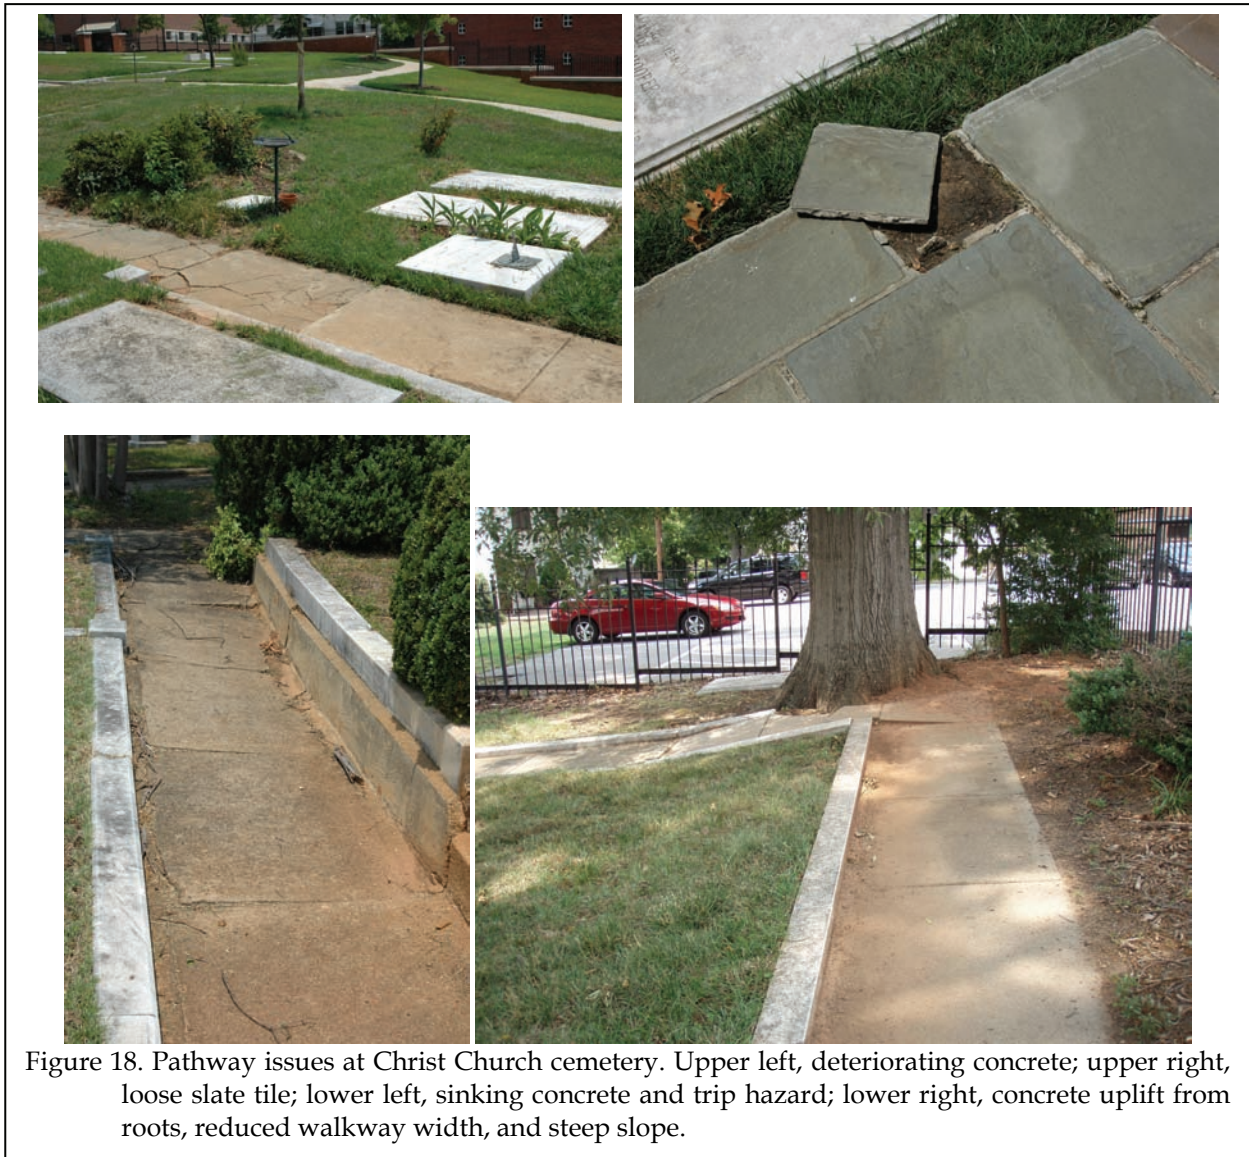
Figure 18. Pathway issues at Christ Church cemetery. Upper left, deteriorating concrete; upper right, loose slate tile; lower left, sinking concrete and trip hazard; lower right, concrete uplift from roots, reduced walkway width, and steep slope.

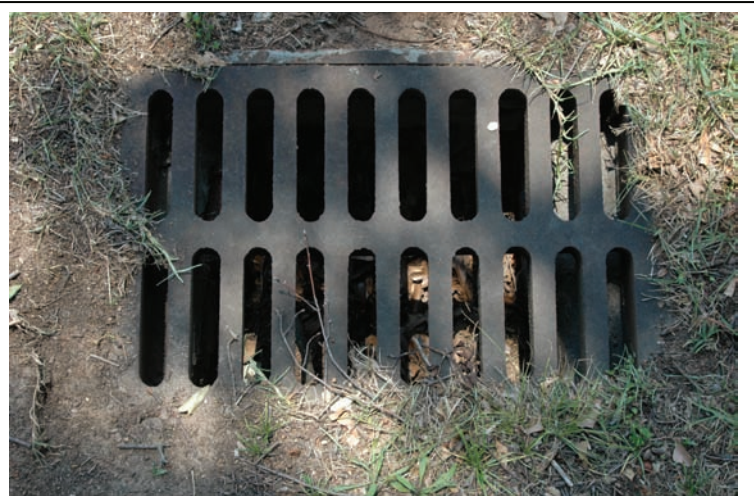
The cemetery does include below grade drains. The condition of these drains is uncertain. It is also unknown if the drains have a collection sump (an area between the bottom of the outgoing pipe and the bottom of the drain) to trap sediment and other debris. The few that we examined reveal collections of leaf litter and soil (Figure 19).

Figure 19. One of the cemetery drains, showing an accumulation of leaves and other debris. These should be cleaned on a yearly basis.

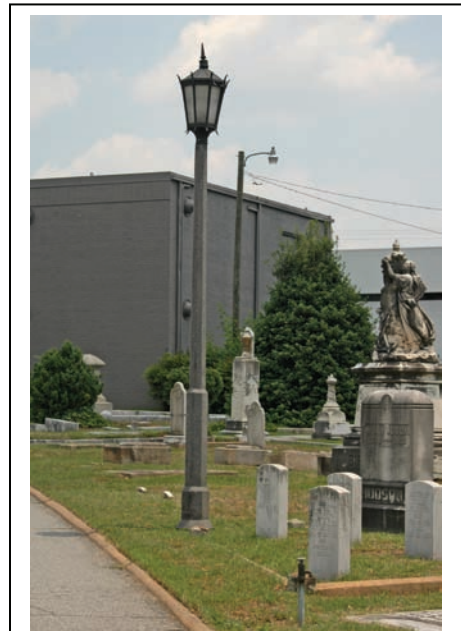
Figure 20. Example of the two types of lighting fixtures in the cemetery. In the foreground is a pole lamp with underground service. In the background is a “cobra head” lamp with overhead wiring.

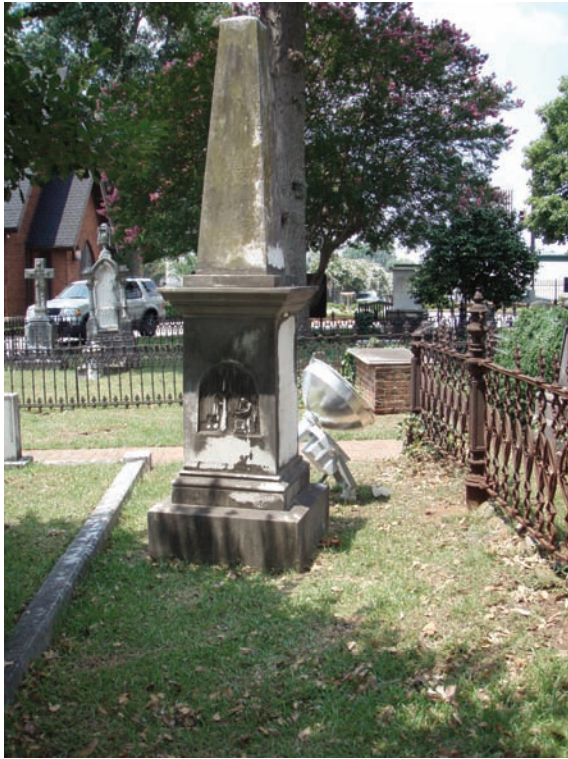
Figure 21. Example of intrusive lighting that should be avoided.

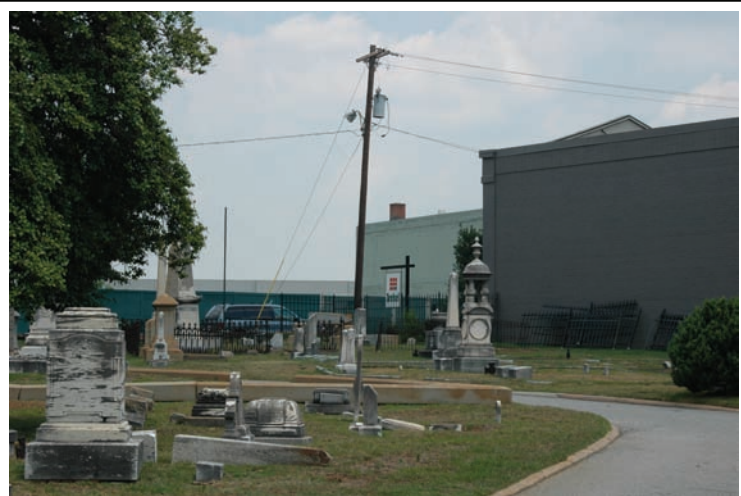
Figure 22. "Cobra head" lamp in the area of recent vandalism.

In addition, we note that the area hardest hit by the recent vandalism would have been lit by a municipal street lamp (Figure 22) – so clearly it had little effect. We do not recommend any additional lighting.

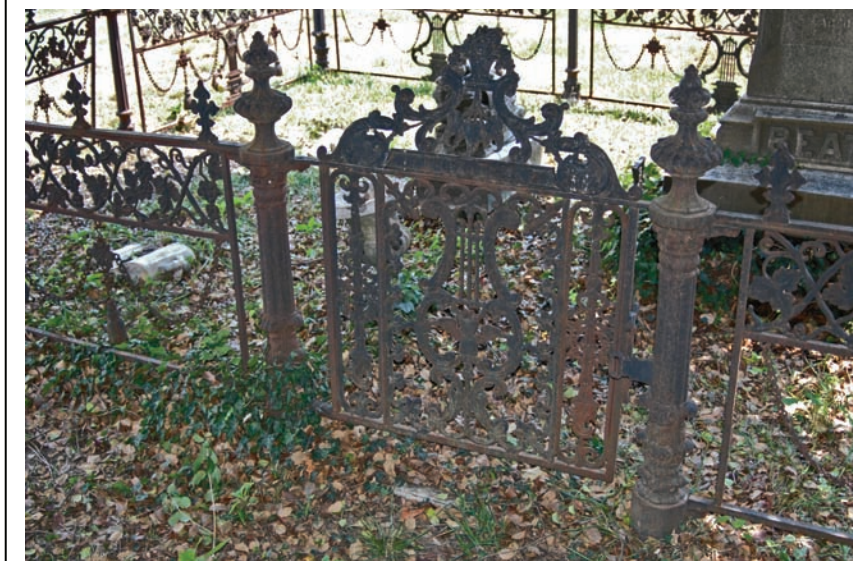
Figure 23. Gates such as these are unsecured and provide an easy target for thieves.

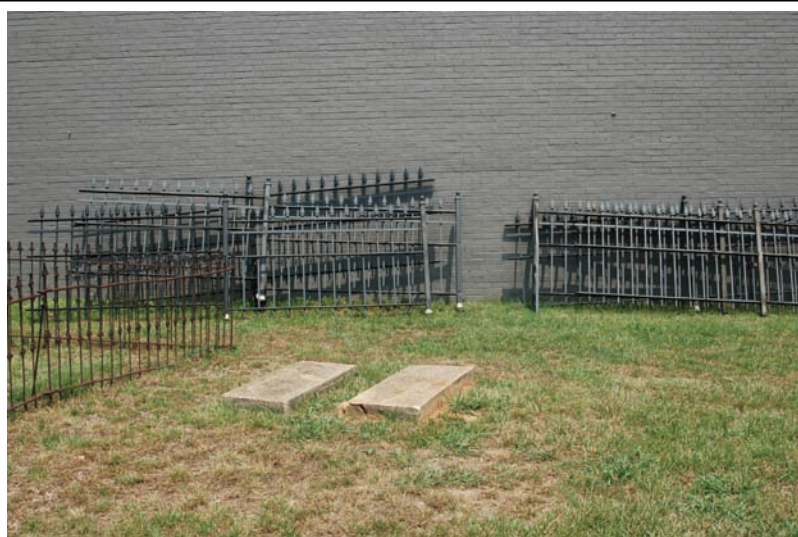
Figure 23. Loose sections of the boundary fence should be secured together to minimize the potential for their theft.

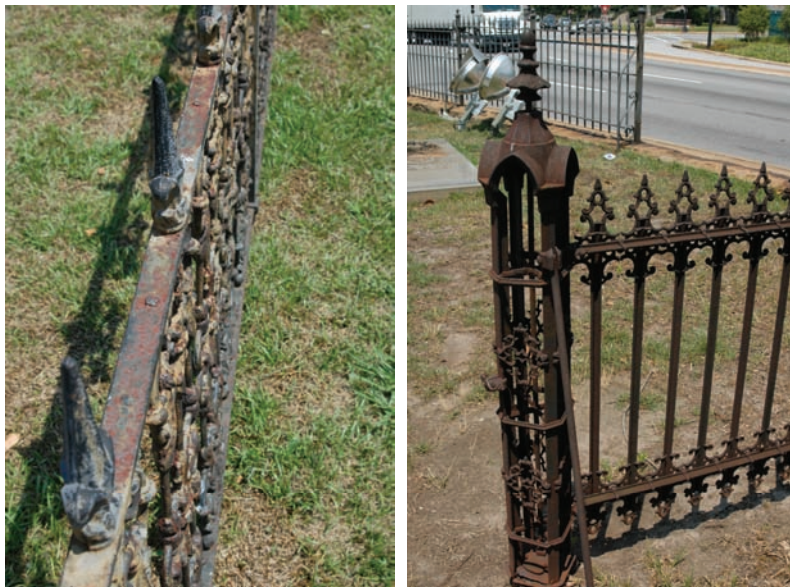
Figure 24. Two examples of ironwork that require cleaning and painting. The example on the left illustrates a failed coating, while the fence on the right exhibits only bare metal.

All painting should be by brush - no sprayers should be used since they allow drift onto nearby stones. Tarps should be used to protect vegetation and adjacent stones from brush splatter.

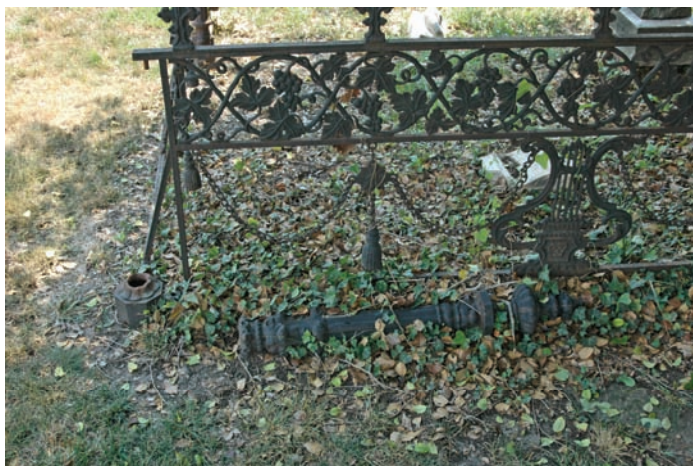
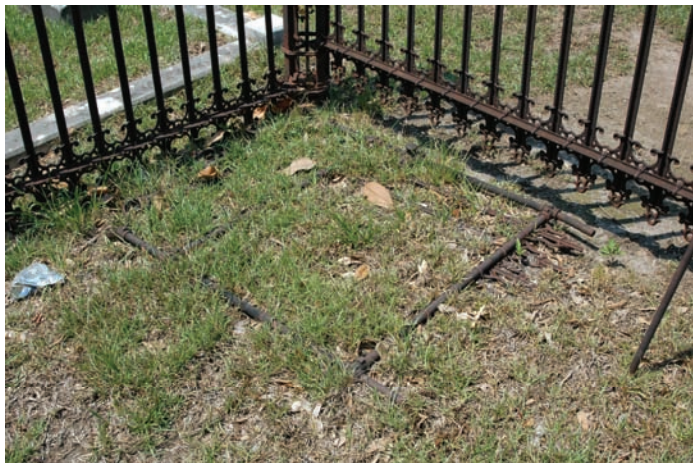
Figure 25. Examples of loose fence parts that should be collected and safely stored.

Figure 25 also shows an example of a broken corner post. Figure 26 shows a broken connector. There are many similar examples in the cemetery. We recommend that the church obtain detailed plot-by-plot assessments to determine the cost of making critical repairs. It is important to understand that welding of these fences is difficult and is not always the appropriate repair technique. In particular, cast iron is difficult to weld and repair should only be attempted by very skilled individuals. Welds must be continuous and ground smooth to prevent any areas that would allow moisture to collect. In some cases,

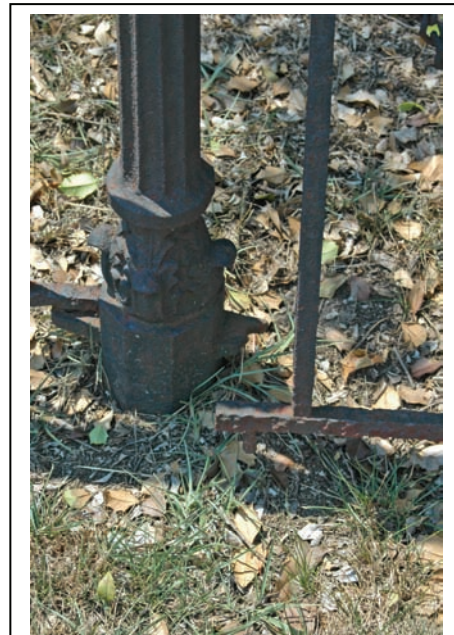
Figure 26. Example of a broken connector where welding is an inappropriate repair technique.

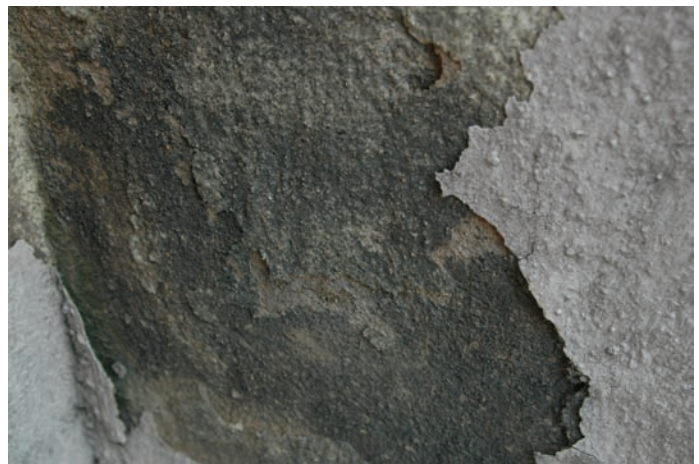
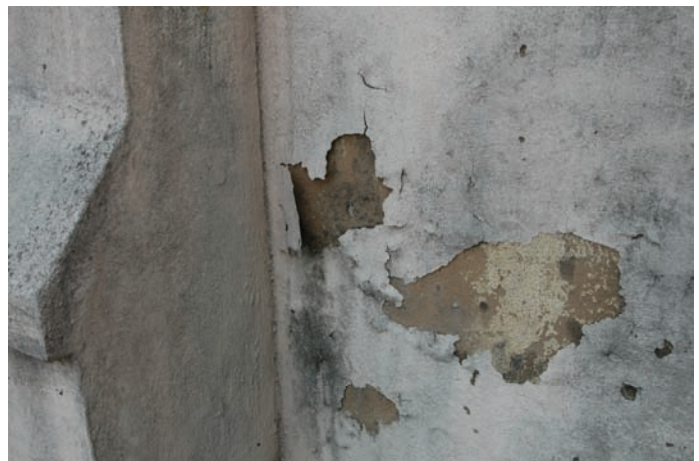
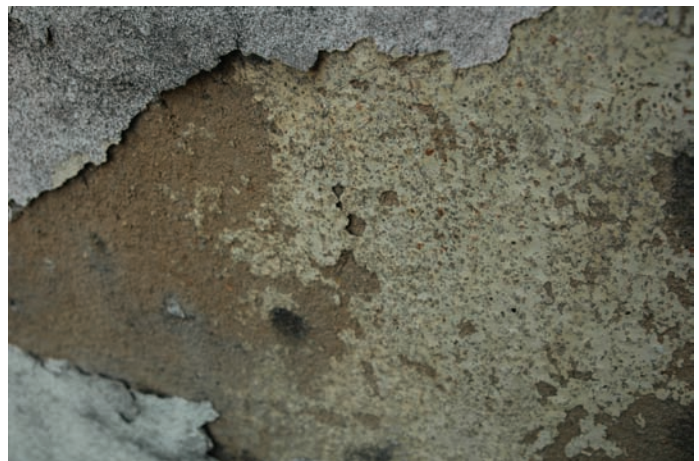
The family tomb in the cemetery has been improperly sealed and this has resulted in moisture being trapped in the masonry. This coating is now failing, resulting in additional damage. We recommend that the coating be removed and the tomb's stucco be repaired using historically appropriate materials. The cost of this work will be approximately \$15,000.

Today this coating is failing because moisture has found its way into the masonry from the inside and has no way to escape. Below this modern coating can be seen the earlier (and perhaps

Figure 27. Failing non-breathable coating that has been applied to the mausoleum. Bottom photo shows the original colored whitewash over the lime-based stucco.

Intervention will include the removal of the modern coating, repair of the underlying stucco as may be necessary, and reapplication of either a colored whitewash or the use of a

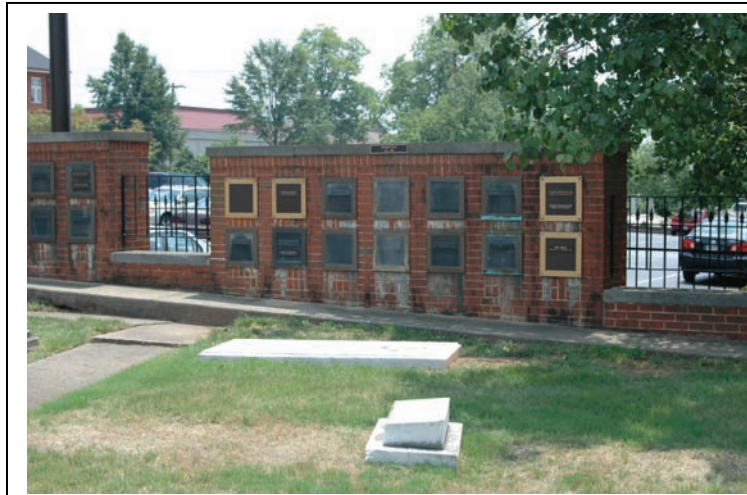
The columbarium is suffering from active bronze disease - the deterioration or corrosion of the bronze. In addition, many covers are improperly mounted. Much of the masonry is being affected by salt deposits. Cleaning and coating of the bronze will cost an estimated \$12,000.

Figure 28. Columbarium showing evidence of bronze disease and salt staining.

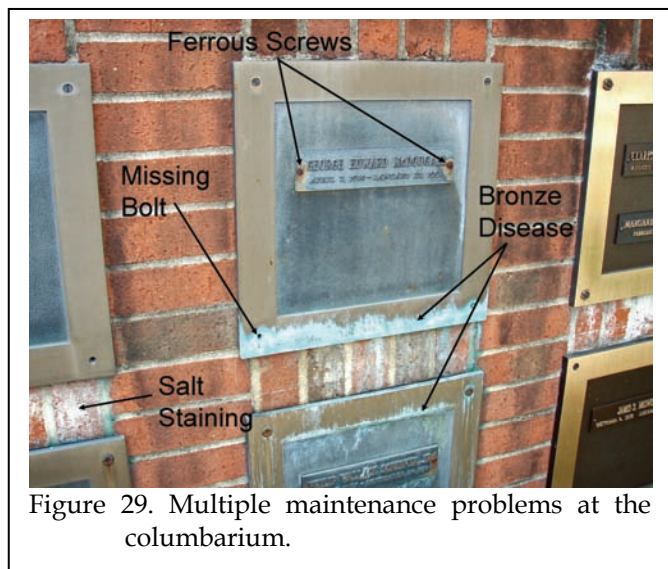
Careful inspection also reveals that many of the screws or bolts are missing and many do not have their appropriate decorative heads. These are also maintenance issues that should be corrected.

Figure 29. Multiple maintenance problems at the columbarium.

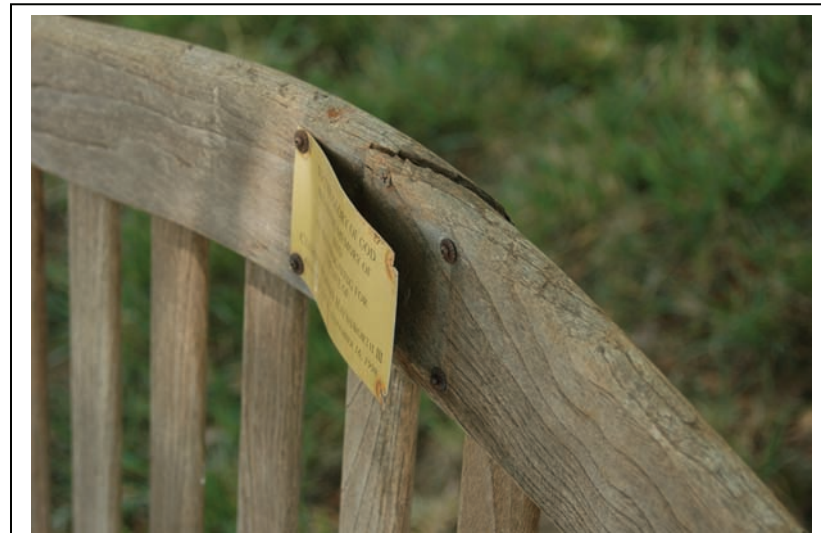
Figure 30. Cemetery bench placed in 1998 that requires replacement or maintenance.

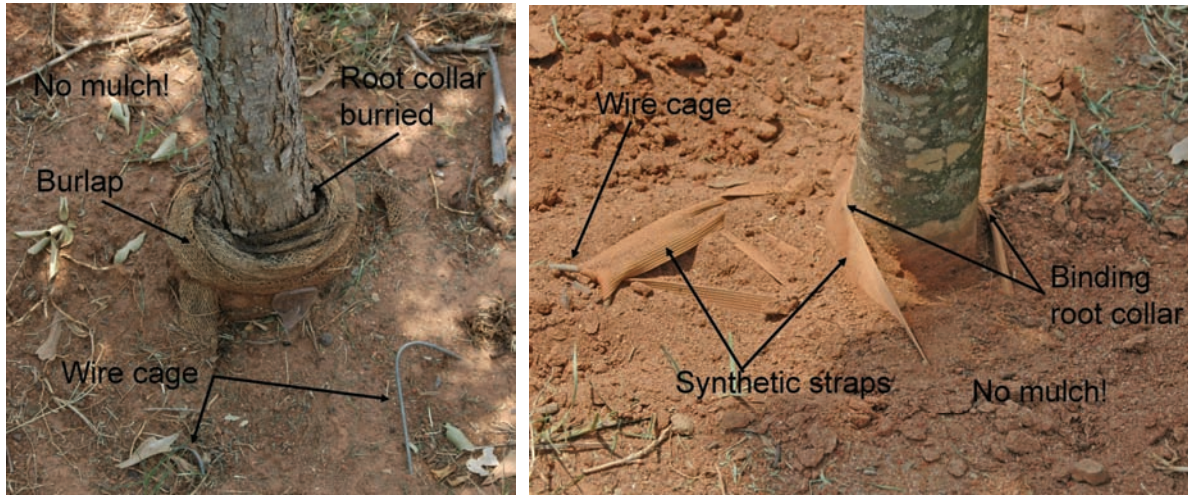
Of special concern is the planting technique. Often trees are planted too deeply, with the root collar being buried. This will stress, and often kill, the tree. The root collar

Figure 33. Planting issues. Photos reveal a variety of problems with newly planted trees in the cemetery.

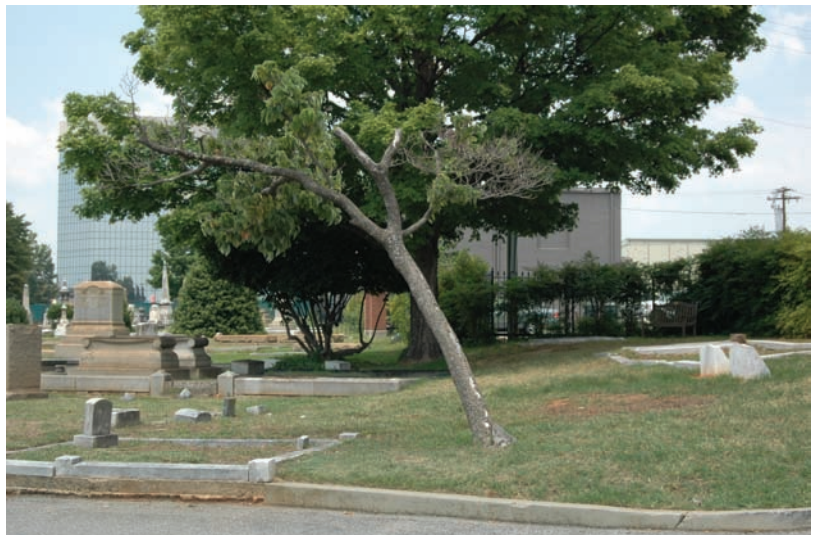
Figure 34. Planted in full sun, this dogwood has died back to the point that little is left. Notice the dead branches, the loss of its primary leader, and the peeling bark. The tree should be removed and replaced with an appropriate species.

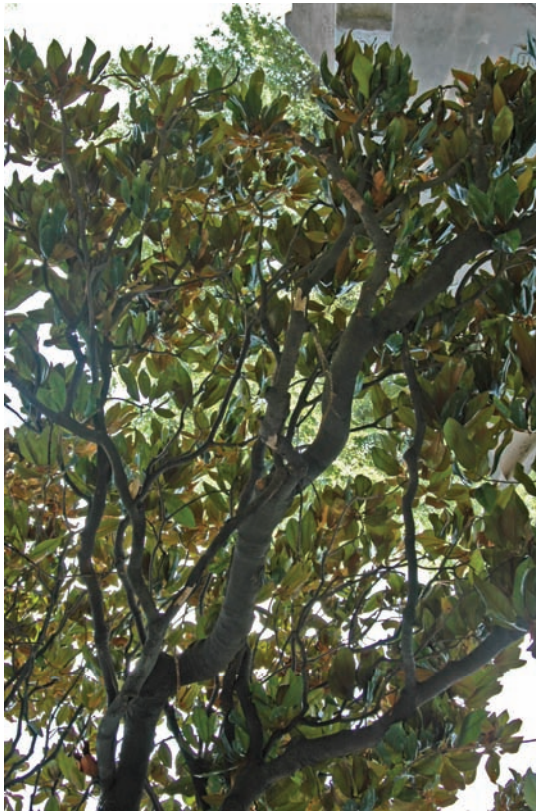
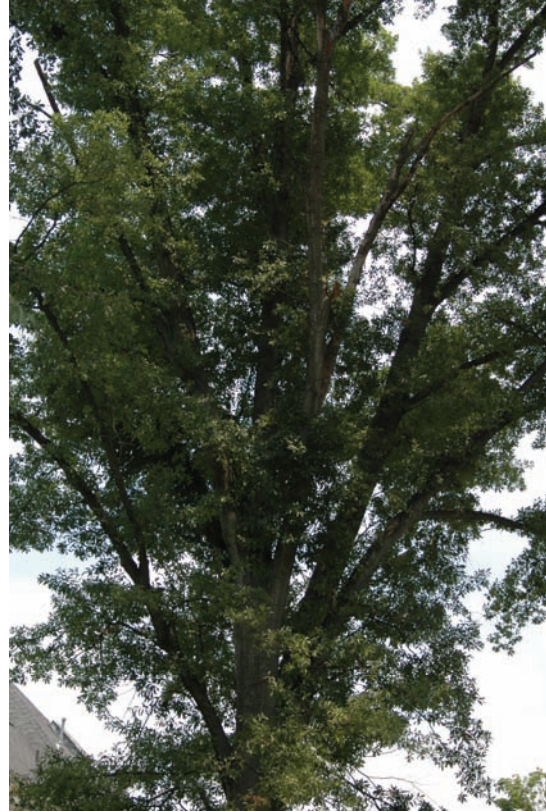
Figure 35. Tree pruning needs in the cemetery. On the left is a magnolia with many crossed and damaged branches (note the loss of bark). On the right this canopy needs to be thinned and dead wood removed.

Thus, many of the trees require pruning for either thinning or cleaning. Thinning is a technique of pruning that removes selected branches to increase light and air movement through the crown. This also decreases weight

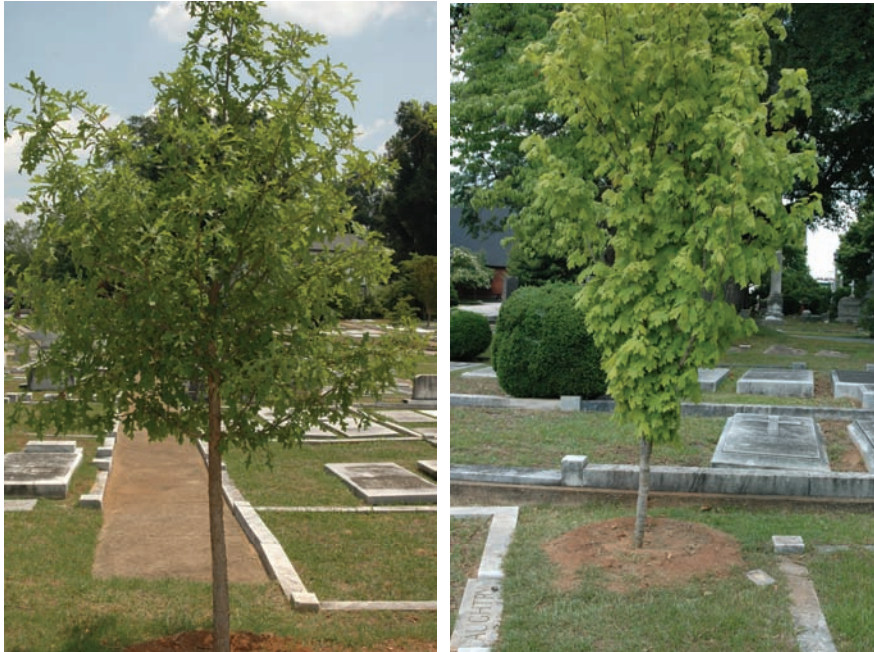
Figure 36. Two young trees that should receive pruning to improve their structure.

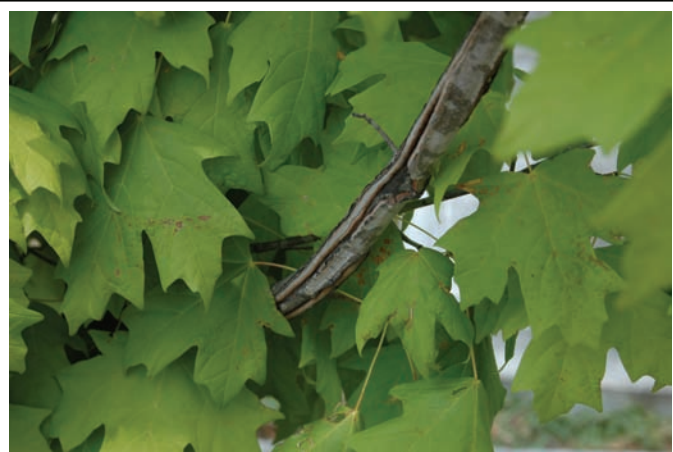
Figure 37. Freeze damage to bark that should have been pruned out.

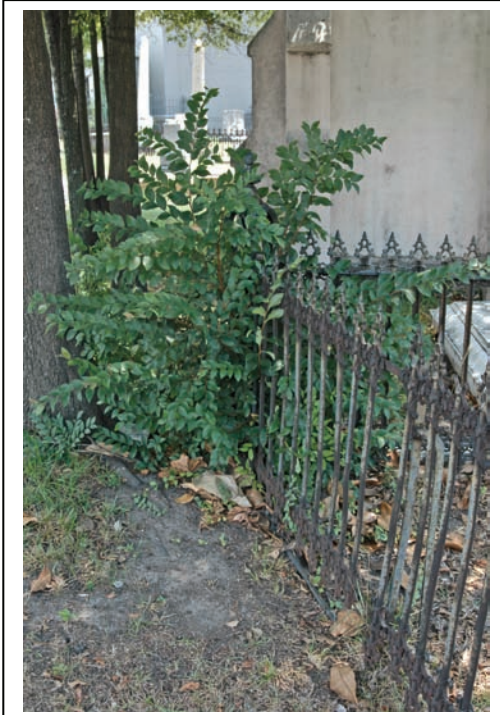
Figure 38. Example of volunteer growth that should be removed before it harms the ironwork.

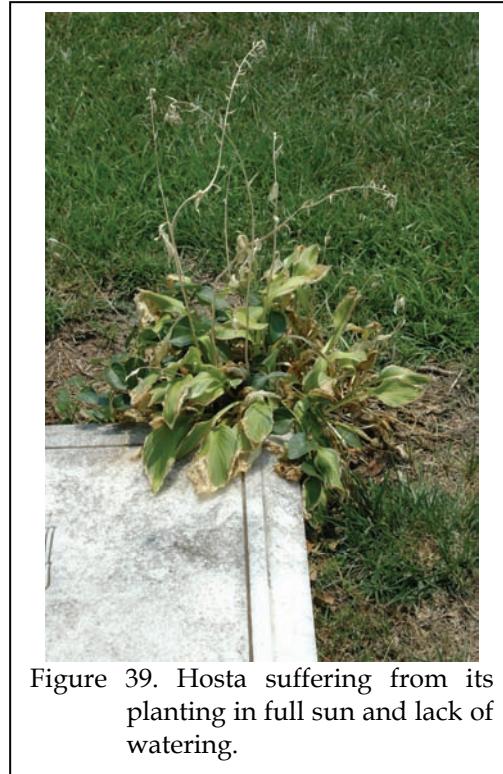
Often, when left to their own devices, the public will select plantings that are grossly inappropriate – either for a cemetery or for the specific location in the cemetery. As one example, we found a hosta – a shade and moisture loving plant – planted in full sun (Figure 39).

Figure 39. Hosta suffering from its planting in full sun and lack of watering.

The cemetery should establish a rule requiring approval of any plantings and

specifying that any unapproved plantings will be removed. If such a rule already exists, it should be enforced.

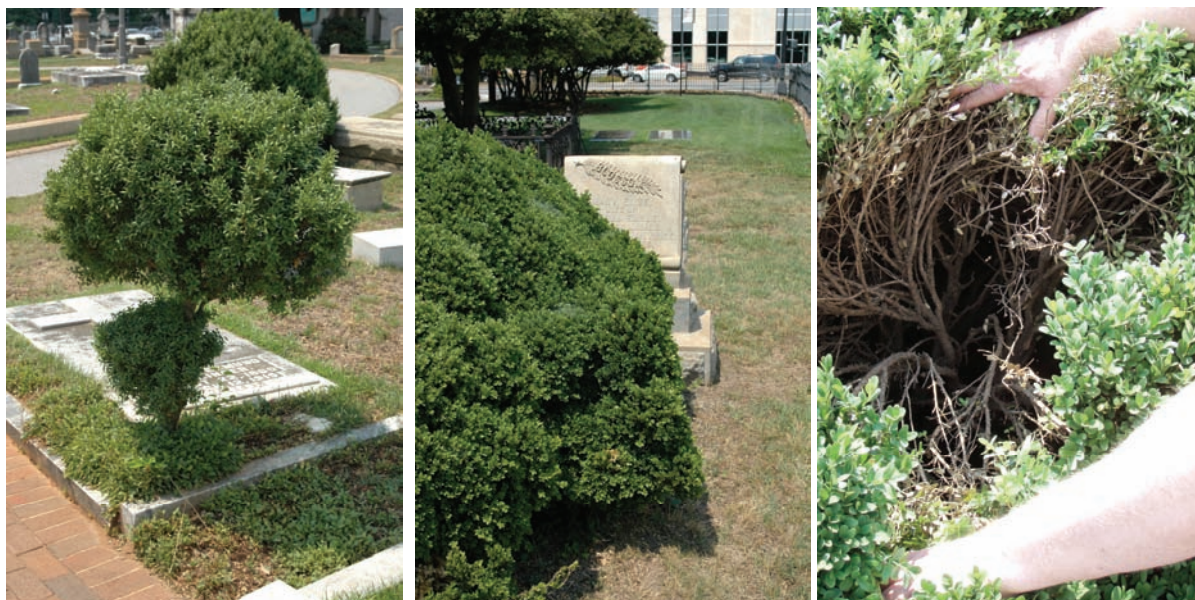
Figure 40. Shrubbery problems at Christ Church. Clockwise: inappropriately pruned boxwood giving it a fanciful shape; unpruned boxwood that is overwhelming its stone; the interior of the boxwood is dead because of inappropriate shearing; spirea that has been incorrectly pruned to an unnatural shape, destroying its beauty; planting overwhelmed by trash vegetation that has never been removed; leggy boxwood that should be either removed or pruned for renewal; ivy is damaging to stone and masonry and should not be allowed to climb stones.

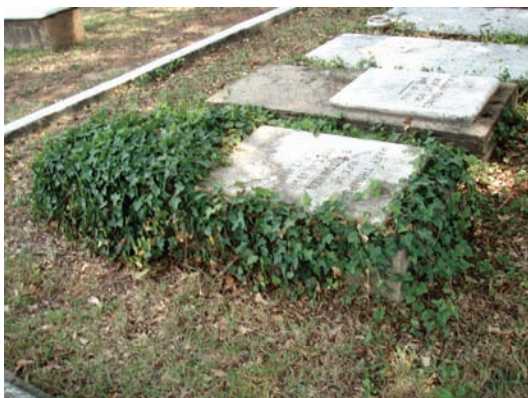
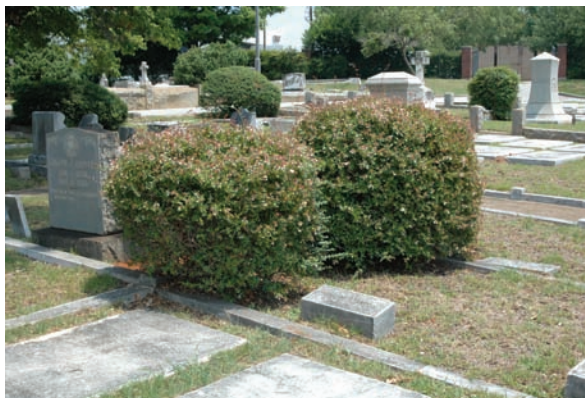
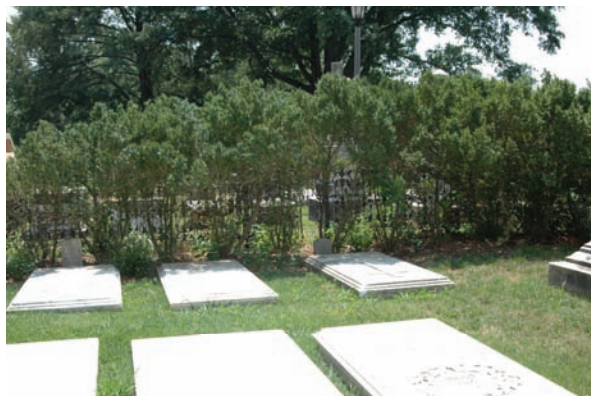
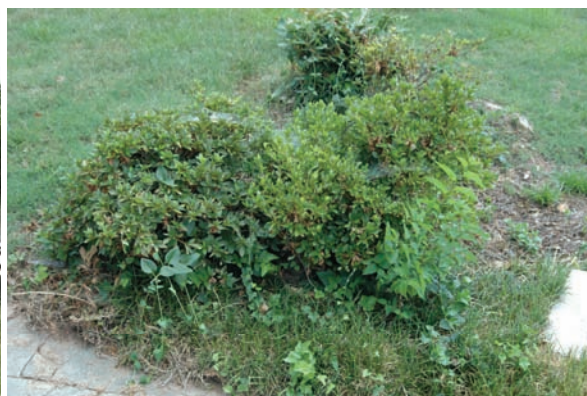
It is again in the category of pruning maintenance that we see the greatest problems at Christ Church Cemetery. In general the shrubbery has been either over pruned, creating unnatural and fanciful shaped creations, incorrectly pruned, to allow the accumulation of significant amounts of deadwood, or the shrub has simply not been pruned (Figure 39).

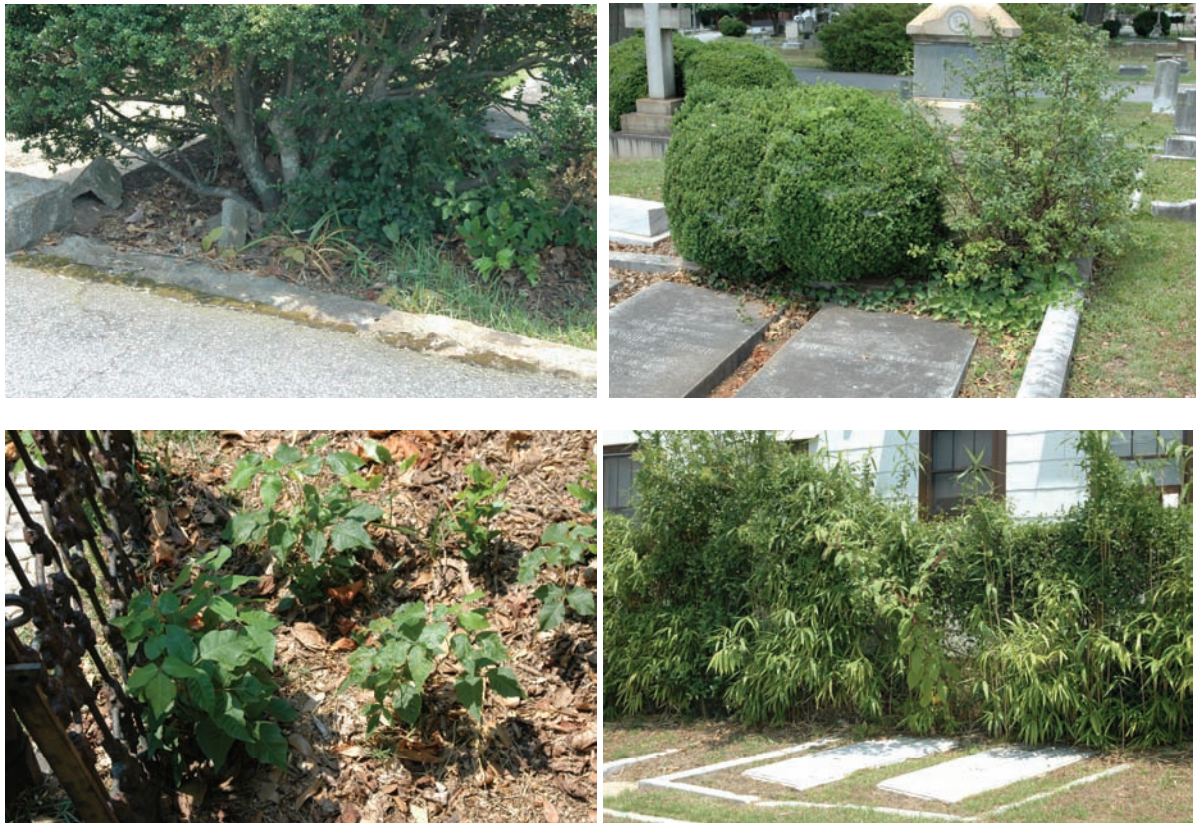
Figure 41. Examples of trash vegetation that is being allowed to overtake some landscape. The upper left photo illustrates a range of weedy plants in the shadow of a boxwood, as well as broken masonry; upper right shows weedy vegetation to the right of a boxwood that has been ignored for so long that it is beginning to compete with the boxwood for space. The lower left photo shows a number of poison ivy plants along a cemetery fence; lower right shows abundant trash and weedy plants along the eastern fence line, beginning to overtake plots.

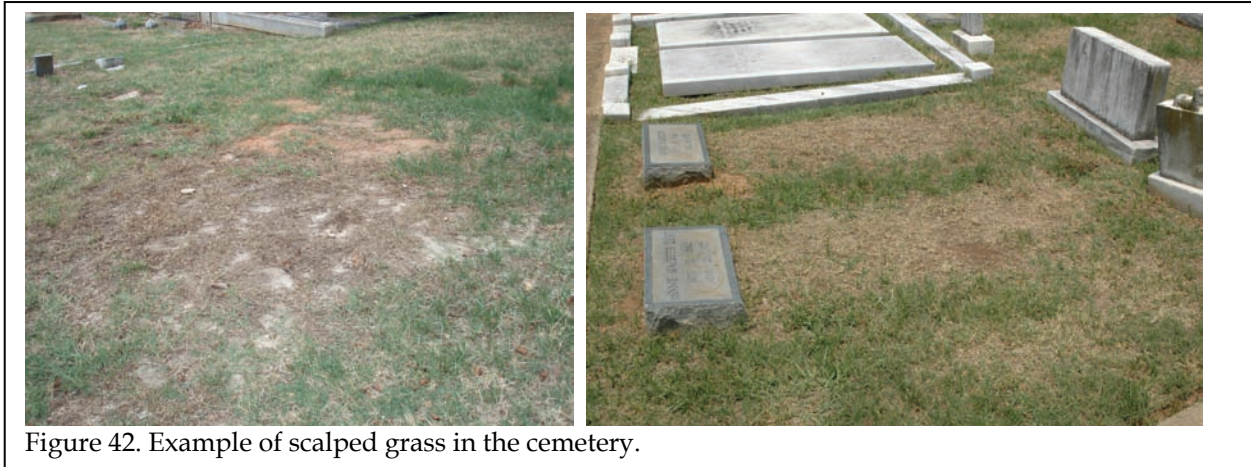
Figure 42. Example of scalped grass in the cemetery.
