# **PRESERVATION ASSESSMENT OF THE CHRIST CHURCH CEMETERY, GREENVILLE, S.C.**

Prepared By:  
Michael Trinkley, Ph.D.  
and  
Debi Hacker

Prepared For:  
Christ Church Episcopal Church  
10 North Church Street  
Greenville, SC 29601

August 28, 2008

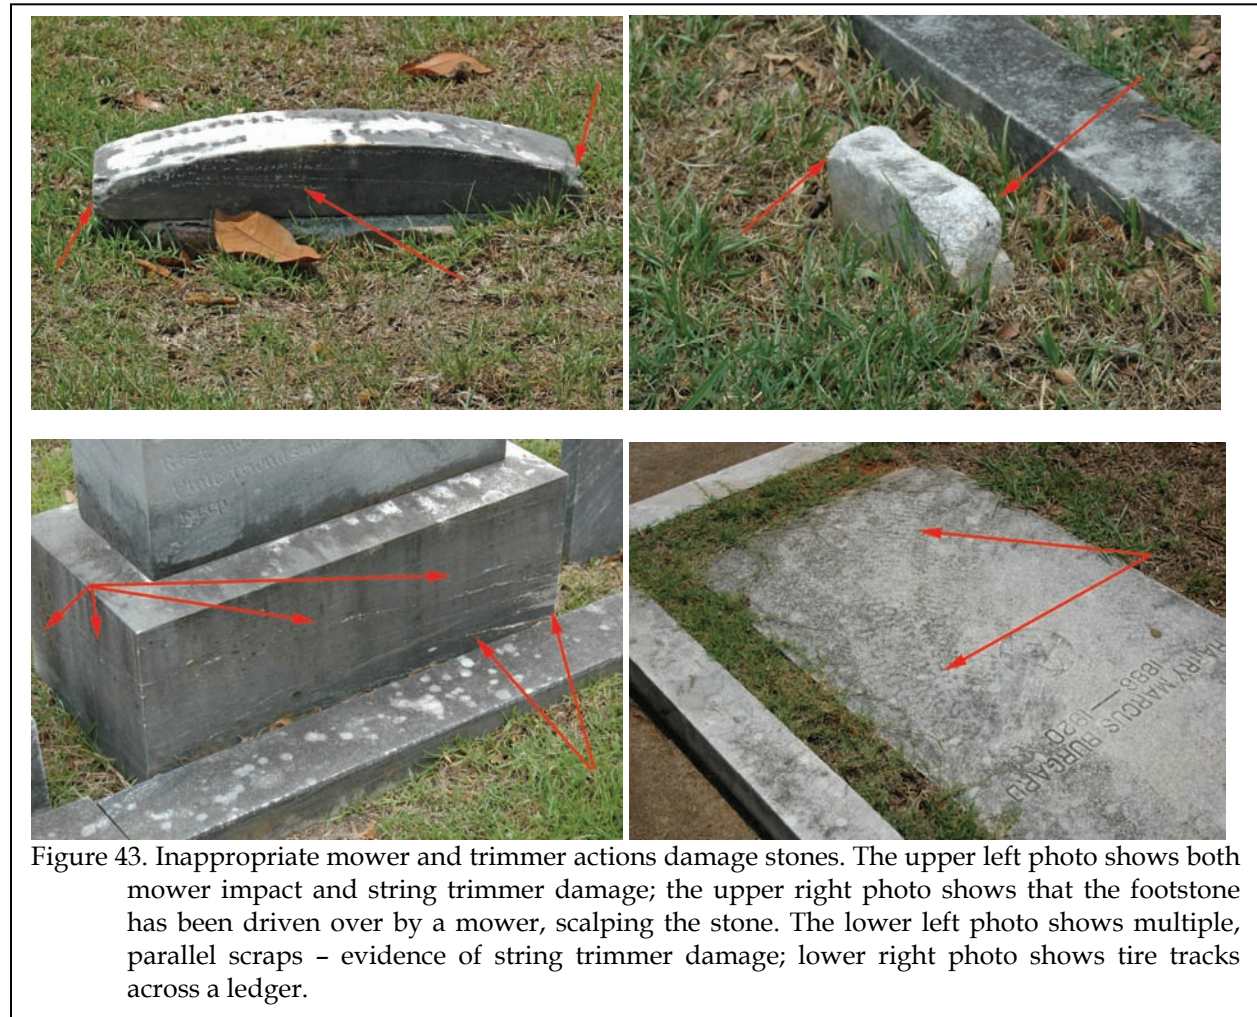
Figure 43. Inappropriate mower and trimmer actions damage stones. The upper left photo shows both mower impact and string trimmer damage; the upper right photo shows that the footstone has been driven over by a mower, scalping the stone. The lower left photo shows multiple, parallel scraps - evidence of string trimmer damage; lower right photo shows tire tracks across a ledger.

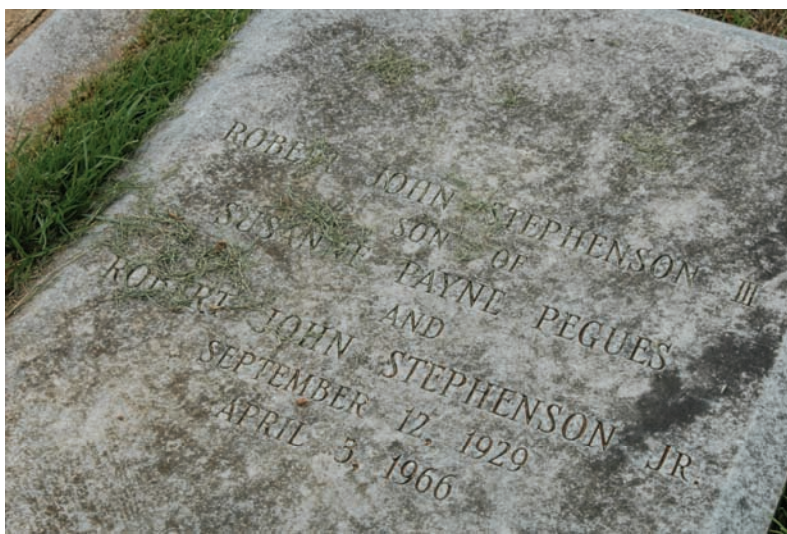
Figure 44. Stones are not swept off after mowing and trimming, leaving the clippings to coat the stone. This is inappropriate.

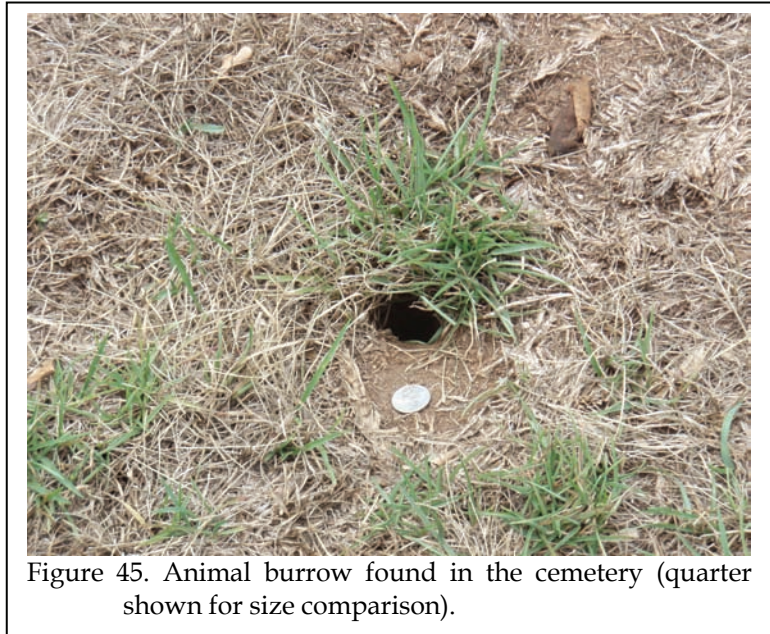
Figure 45. Animal burrow found in the cemetery (quarter shown for size comparison).

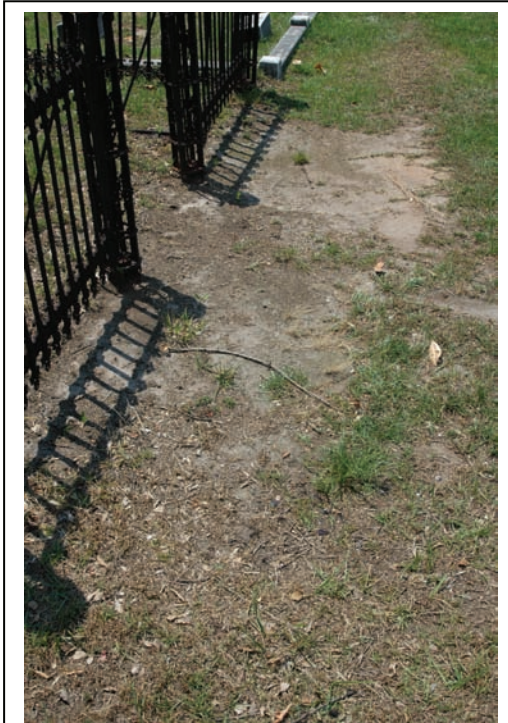
Figure 46. Examples of heavily compacted area requiring renovation.

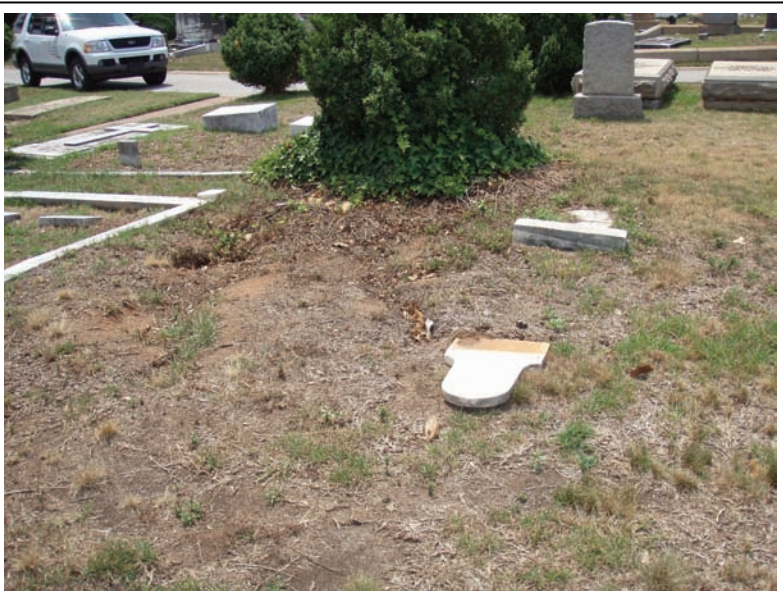
Figure 47. Dead grass, and compacted, infertile soil has lead to an invasion of weeds in this area of the cemetery.

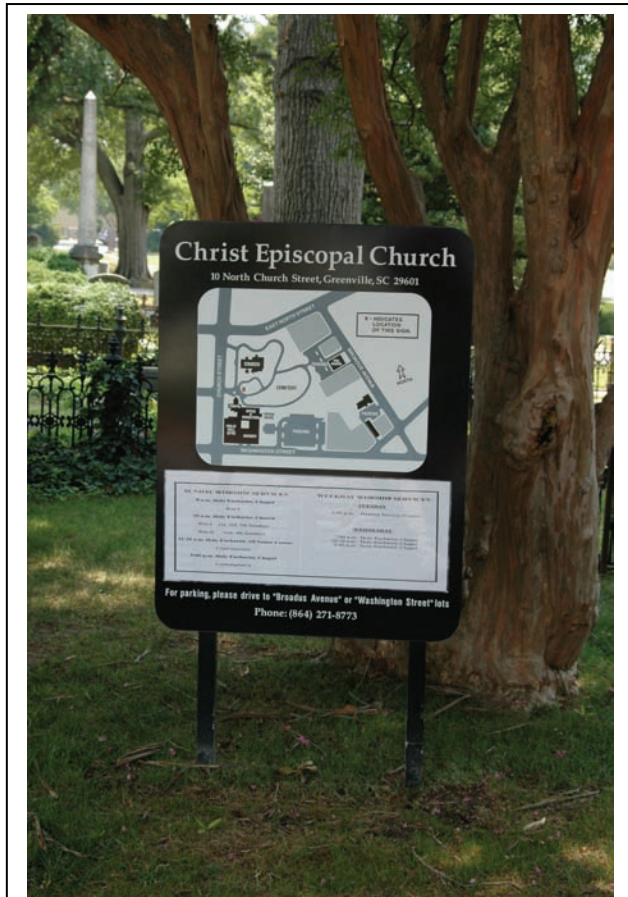
Figure 48. The only signage at the Christ Church cemetery fails to provide any information about the cemetery.

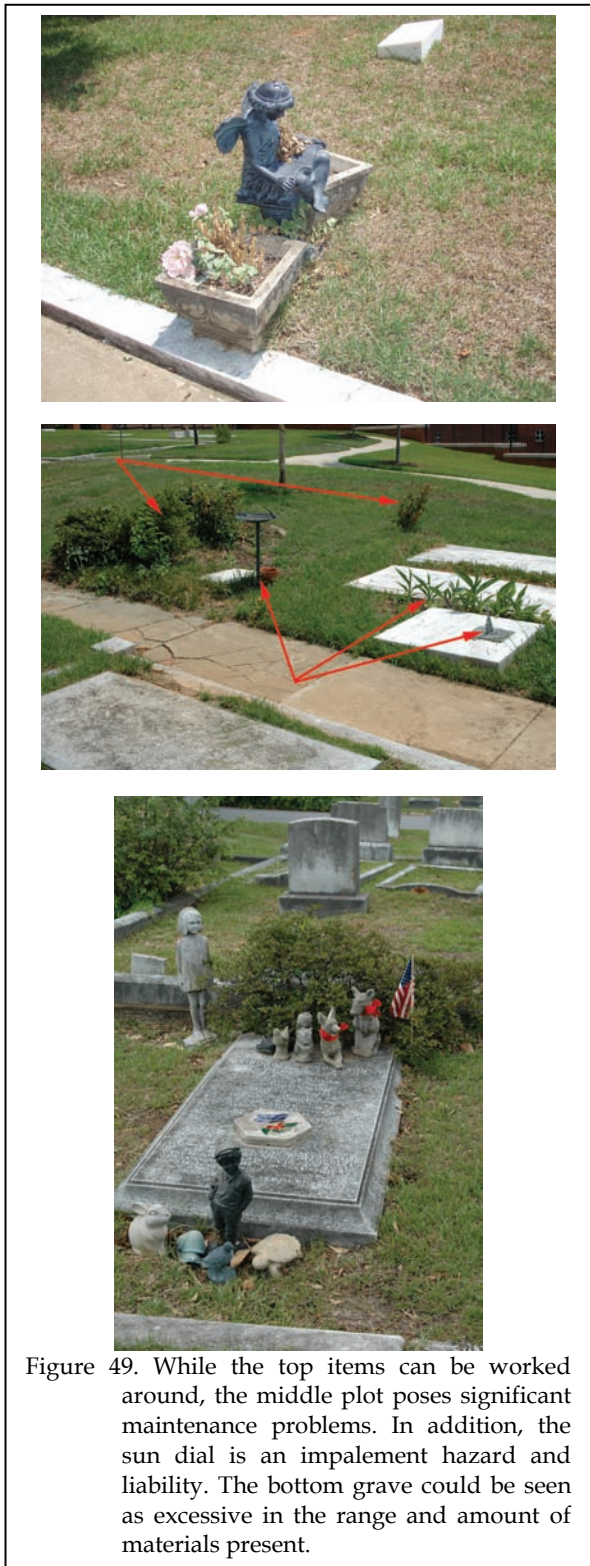
Figure 49. While the top items can be worked around, the middle plot poses significant maintenance problems. In addition, the sun dial is an impalement hazard and liability. The bottom grave could be seen as excessive in the range and amount of materials present.

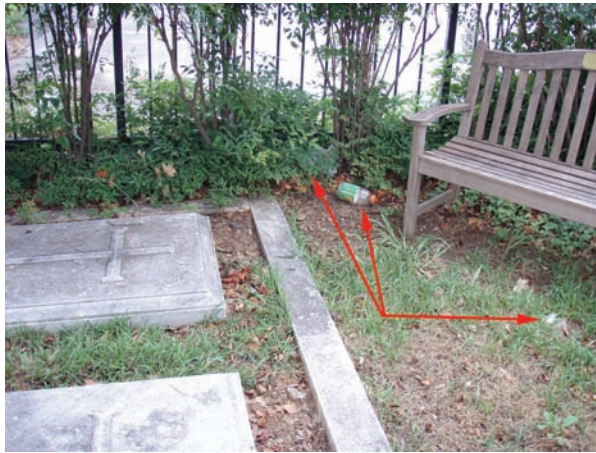
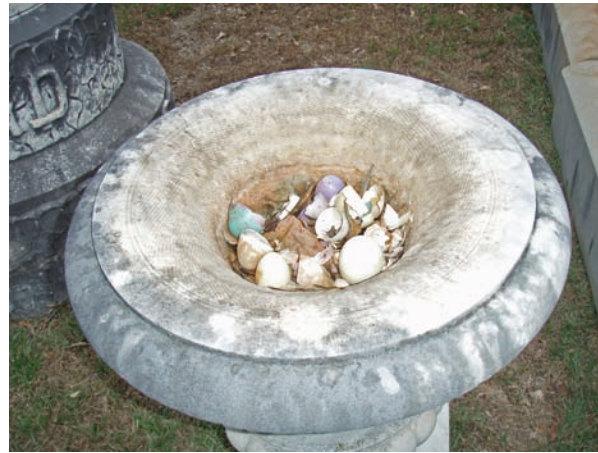
Figure 50. Accumulations of trash in the cemetery indicate that the landscape maintenance crews must do a better job at collecting debris.

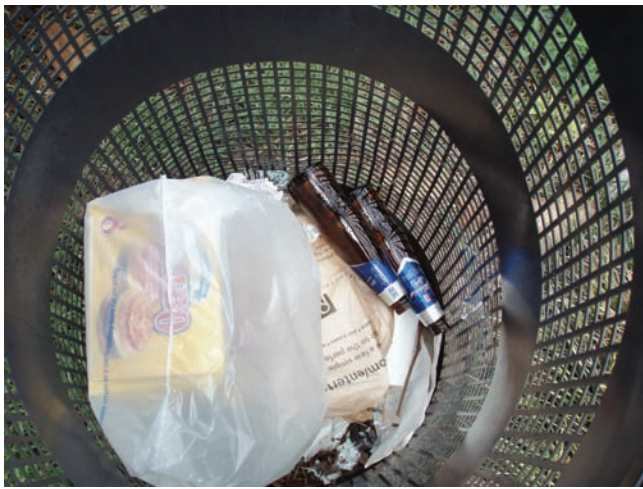
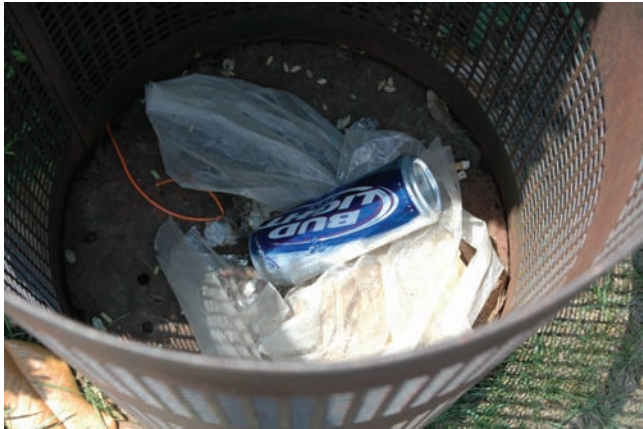
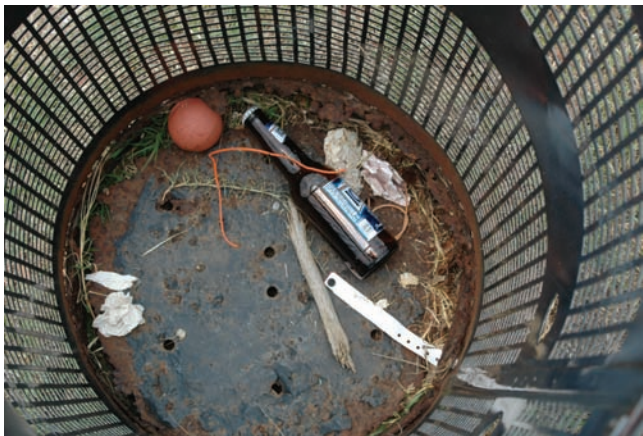
We are also concerned that of the three trash cans examined, all contained trash and each one contained one or more alcohol containers (Figure 51).

Figure 51. All of the examined trash cans at Christ Church contained beer bottles. An effort must be made to reduce the amount of alcohol passing through the cemetery. Trash cans must also be emptied more frequently.

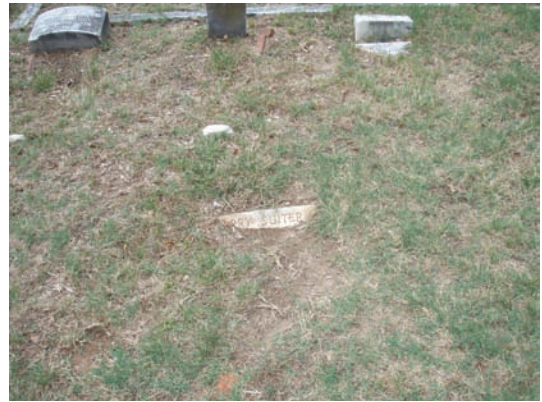
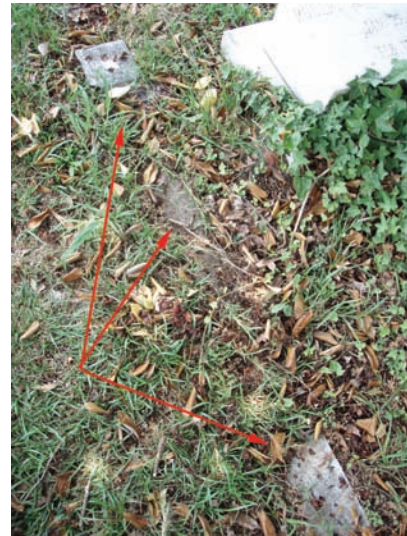
There are areas in the cemetery where coping and monuments have begun to disappear below the turf. This is generally the result of either graves collapsing and allowing stones to sink or soil building up around interment as the spoil is not removed. Figure 52 illustrates several of these problems.

Figure 52. Marker and coping disappearing below the ground surface.

Resetting can be accomplished by excavating the items, infilling with pea gravel to provide a stable base, and replacing the monument or curbing, ensuring that it is plumb and level.

The grounds should be examined at least yearly to identify stones that require resetting. This is often done in the winter after

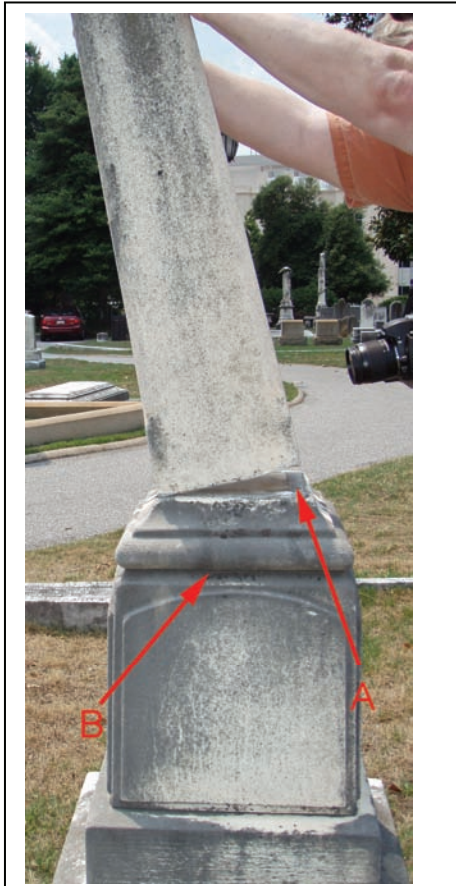
Figure 53. Example of improper repair. Monument setting compound was used to reset the obelisk at A, but this has failed with very little force. In addition, the base is also unattached at B. This monument represents a serious threat to the public.

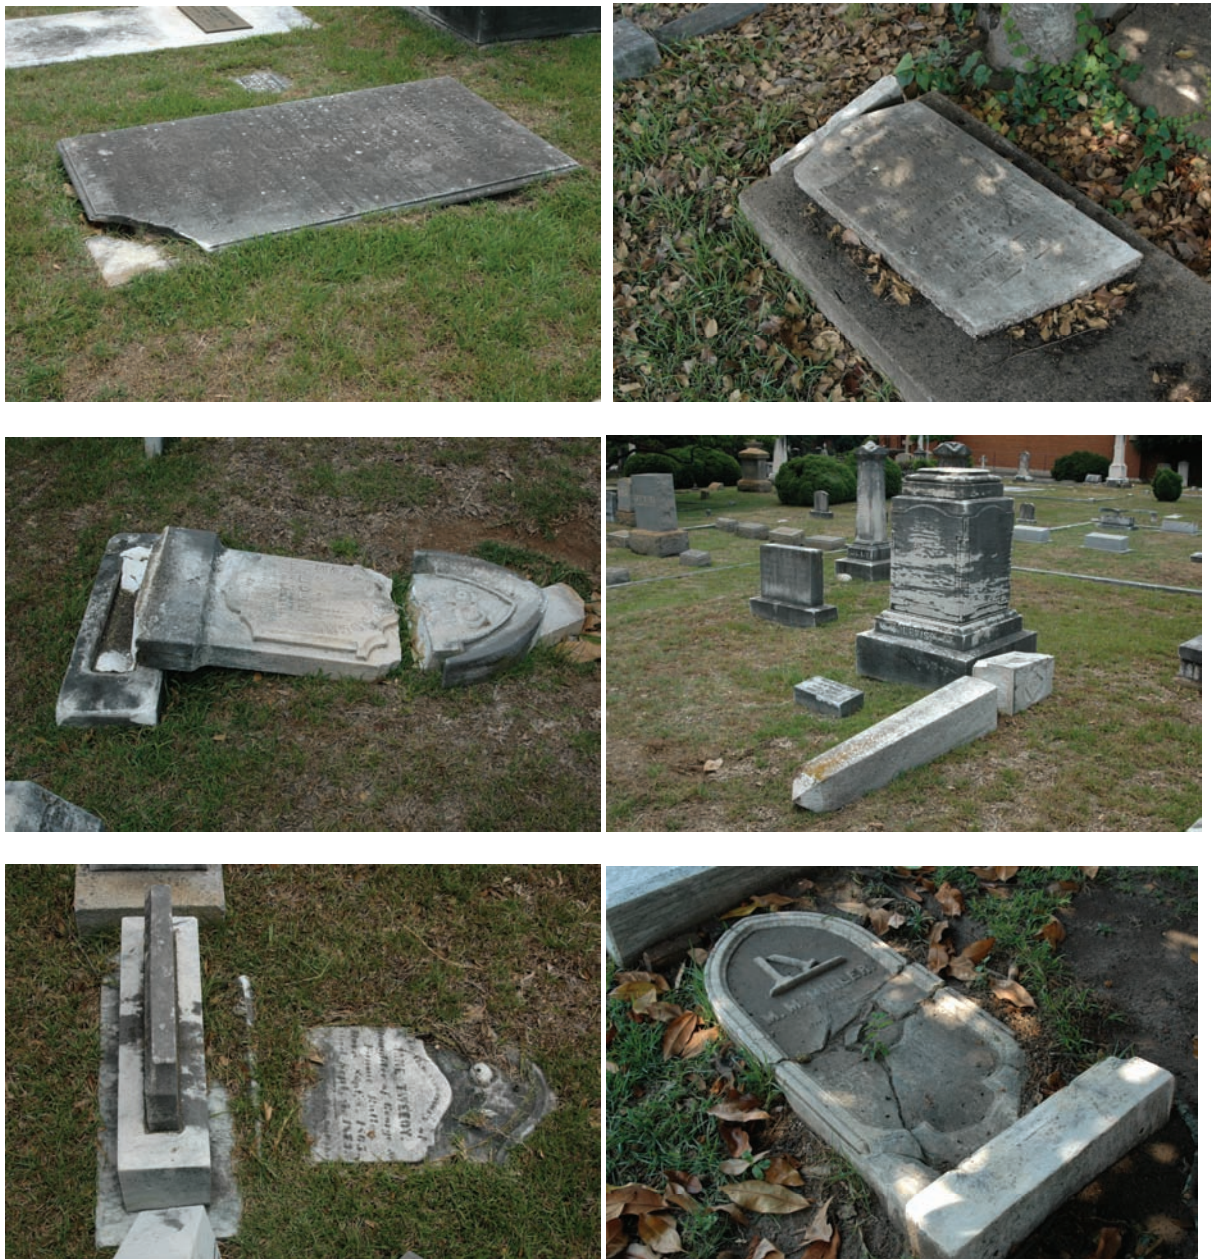
Figure 54. Examples of broken stones requiring professional conservation. Upper left shows a broken ledger that exposed a vault below; this is a serious trip hazard. Upper right shows a broken headstone. Middle left shows a broken tab in socket; the upper portion shows a failed epoxy repair, illustrating the problem with using epoxy. Middle right shows a broken obelisk that will require pinning, as well as pinning to its base to ensure safety to the public. Lower left shows a stone broken so long ago that grass is beginning to grow over it. Lower right shows another very old damaged stone. All of these stone require drilling and pinning, with the breaks then infilled with a repair mortar.

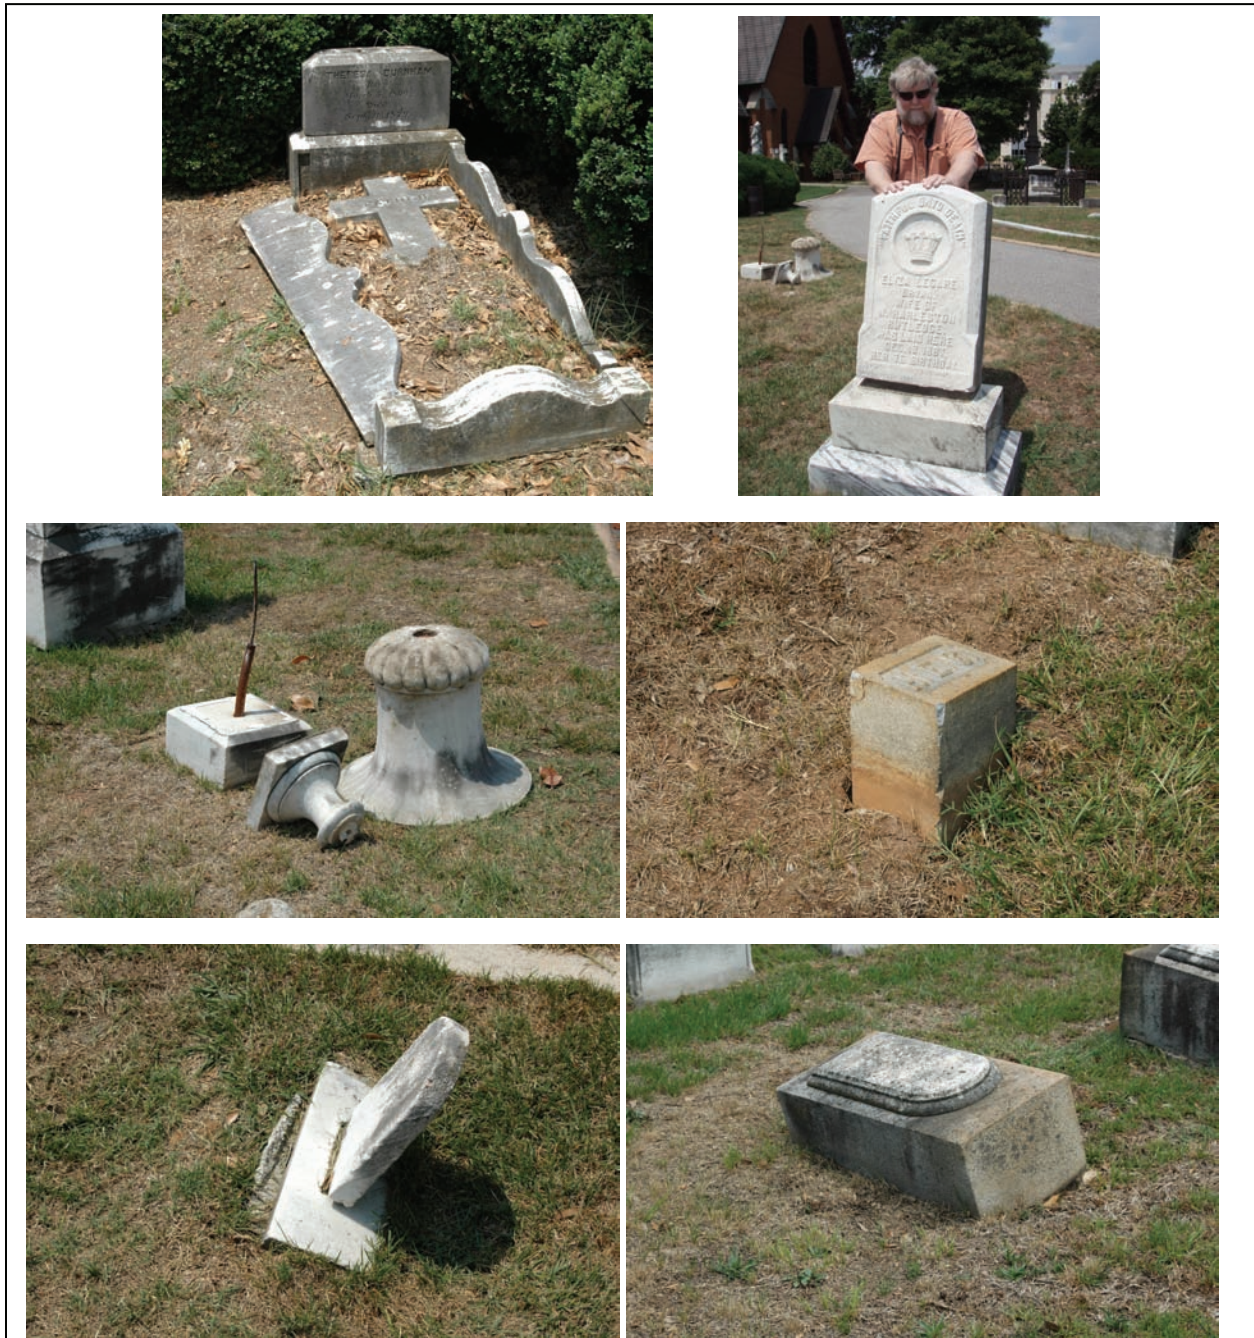
Figure 55. Other stone problems. Upper right photo shows a displaced cradle side board. The cross on the interior does not belong with this monument and should be collected and stored safely until its monument is found. Upper right monument requires pinning. Middle left monument shows an impalement hazard to the public. Middle right is an example of a monument that could easily be reset by the cemetery staff. Lower row shows examples of tilted monuments that can be reset by the cemetery staff.

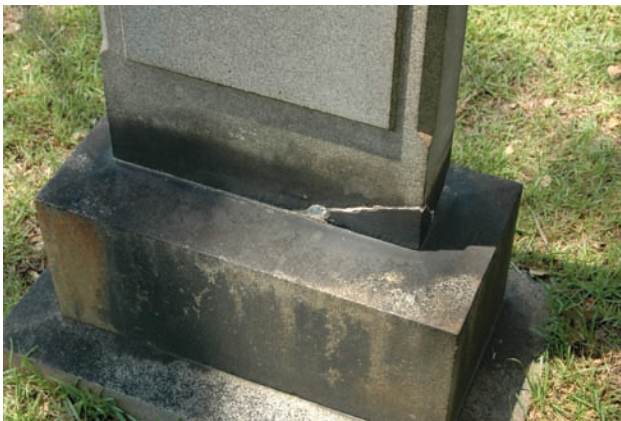
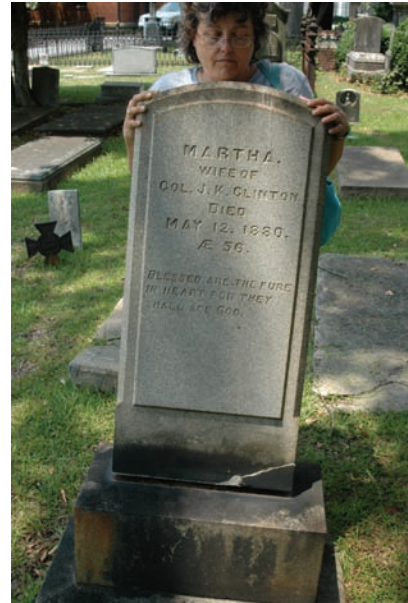
Figure 56. Inappropriate use of setting compound to “reattach” the corner of this monument did nothing to deal with the more serious problem of the monuments instability – resulting in a significant liability to the church.

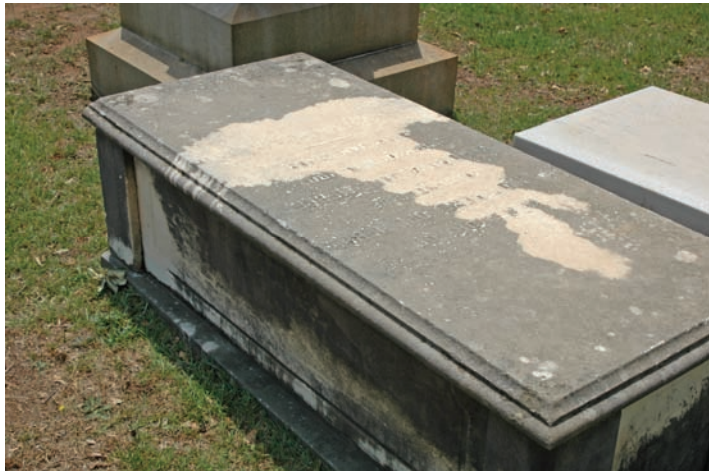
Figure 57. Bleach spilled on this stone has caused a significant disfigurement.

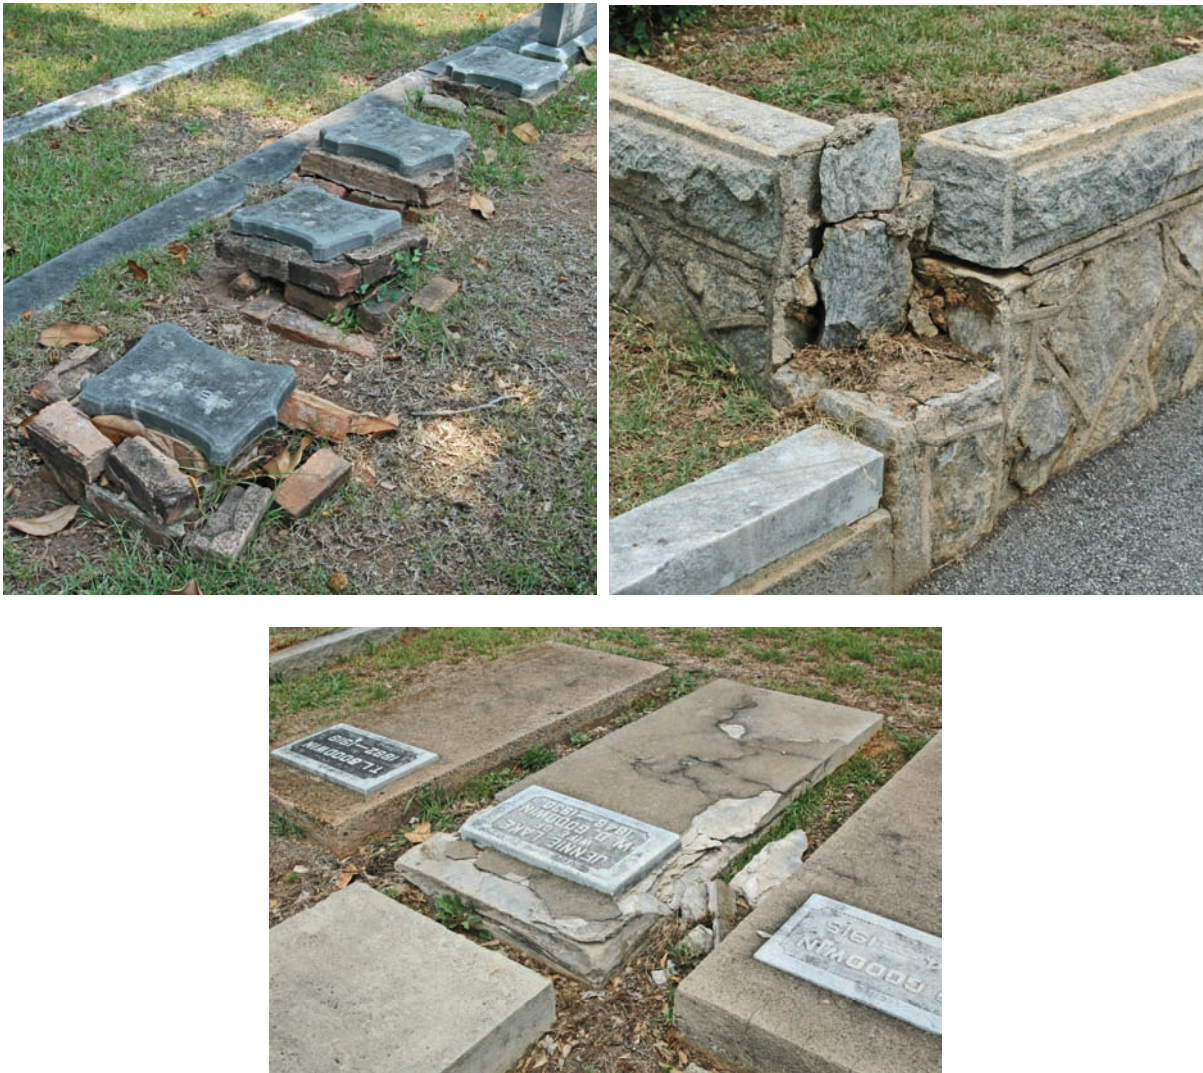
Figure 58. Examples of masonry and concrete deterioration.
