# PRESERVATION ASSESSMENT OF ST. ELIZABETHS EAST CAMPUS CEMETERY, WASHINGTON, DC

**Chicora Research Contribution 514**

June 15, 2009

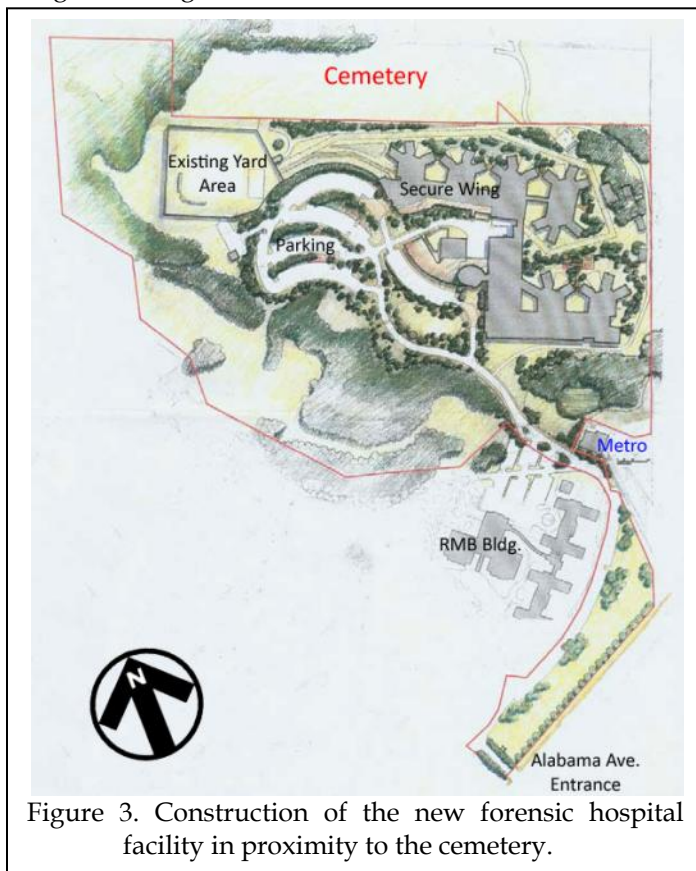
Figure 3. Construction of the new forensic hospital facility in proximity to the cemetery.

immediately to the east (Figure 3 and 4). The old building will be demolished, although the recreation yard wall may be retained.

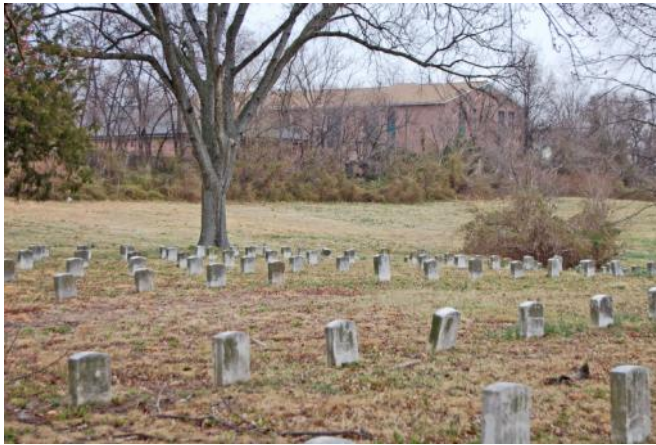
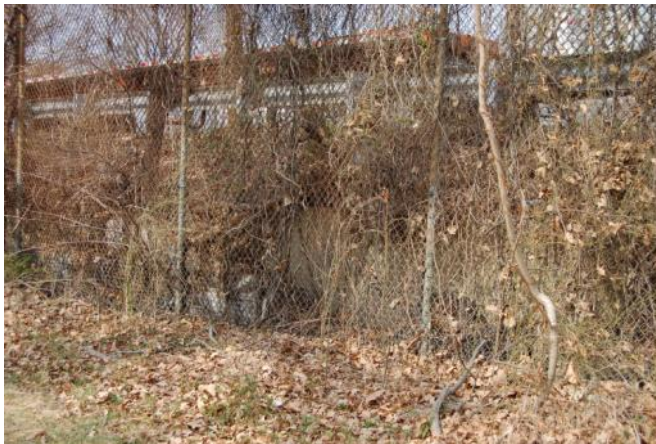
Figure 6. To the north of the cemetery are vacant apartments (top) and the elevated Robinson Place roadway (bottom).

The situation is no better to the north, where the cemetery is in very close proximity to now abandoned apartment units. The eastern portion of the cemetery is lower than the Robinson Place road access, so the road and its guardrail looms over the cemetery visitor (Figure 6).

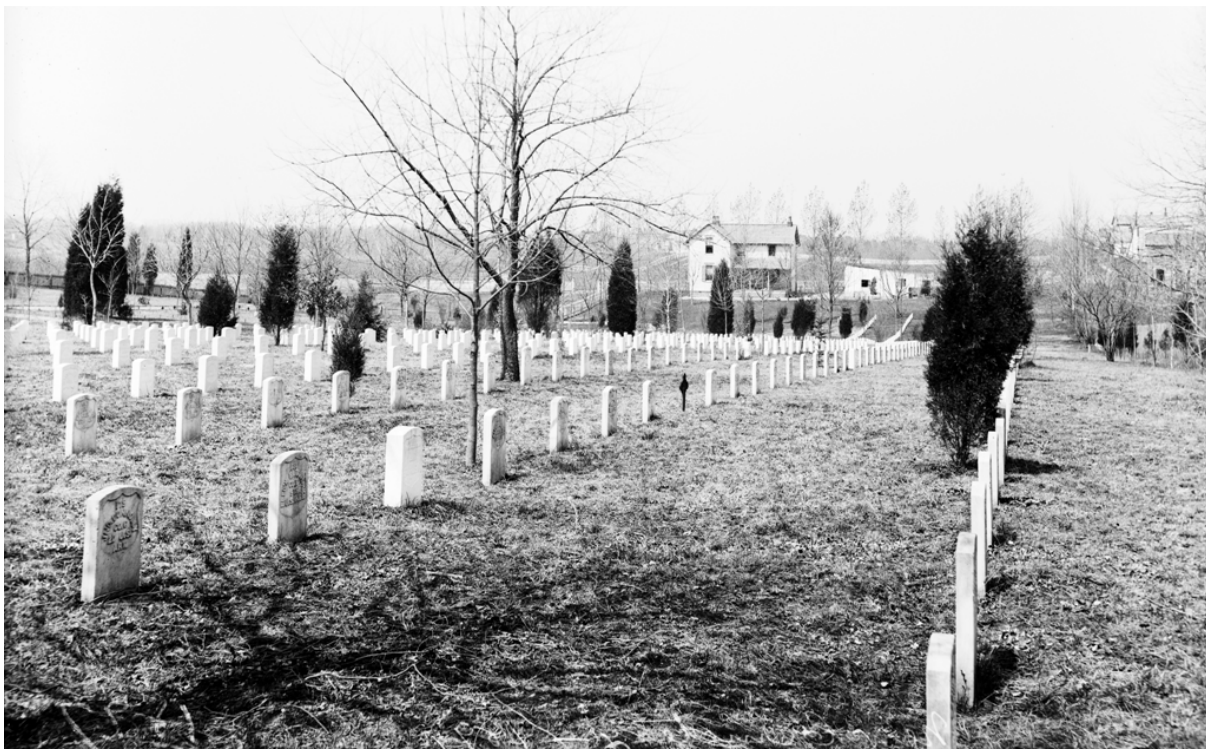
Figure 19. East Campus Cemetery in 1897, view to the west-northwest (NARA 418-G-81).

Another clue to the appearance of the cemetery at the end of the nineteenth century is provided by a photograph shown as Figure 19. This is of particular importance to us since it reveals a cemetery that is well maintained. The grass, while rough, is trimmed. We see a variety of relatively young cedars, as well as both newly planted and established deciduous trees - much more landscaping than is present today. In the background we see the picket fences that were used extensively at St. Elizabeths. The property boundary fence, at the far right of the photograph, appears to be a board fence about 5 feet in height, although it may be picket.

The next plan we have is the 1908 *Plot of the Property of the Government Hospital for the Insane* (Figure 20). This shows the cemetery as it appears on the 1890 plan. We know, based on the 1897 photograph (Figure 19) that the new western section had been prepared and opened for burials, so it is likely that this drawing doesn’t simply indicate a planned burial ground, it shows what was actually present.

The only historic photograph of the cemetery (Figure 19) reveals a young landscape – perhaps previously pasture or agricultural

these heavier stones were introduced is not known. Both style markers are clearly shown by Figure 19. Taken in 1897, this photo indicates that the thin style must have been rather quickly discontinued.

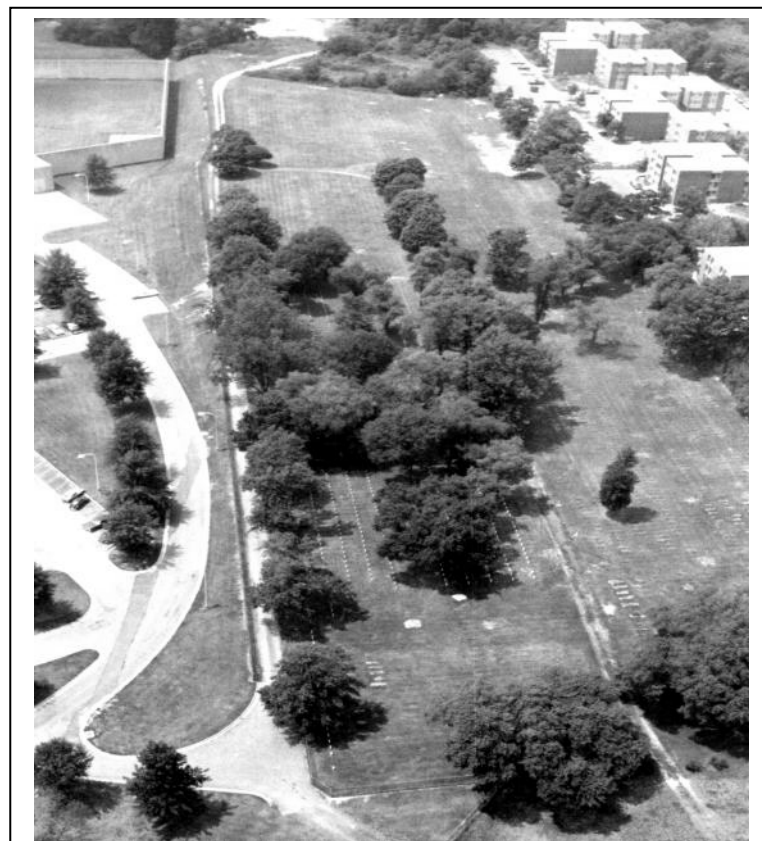
Figure 23. 1980 aerial photograph showing the western portion of the East Campus Cemetery.

Between 1937 and the early 1980s we have very little information concerning the cemetery. A 1980 oblique aerial (Figure 23) shows only the middle and western-most sections of the cemetery. It appears that trees are already becoming thinned out in sections 20-27, although the east-west road has been planted into the western extension. The central road west of the circle does not appear to have ever been developed and the road to the north of the circle is only poorly established. It appears by

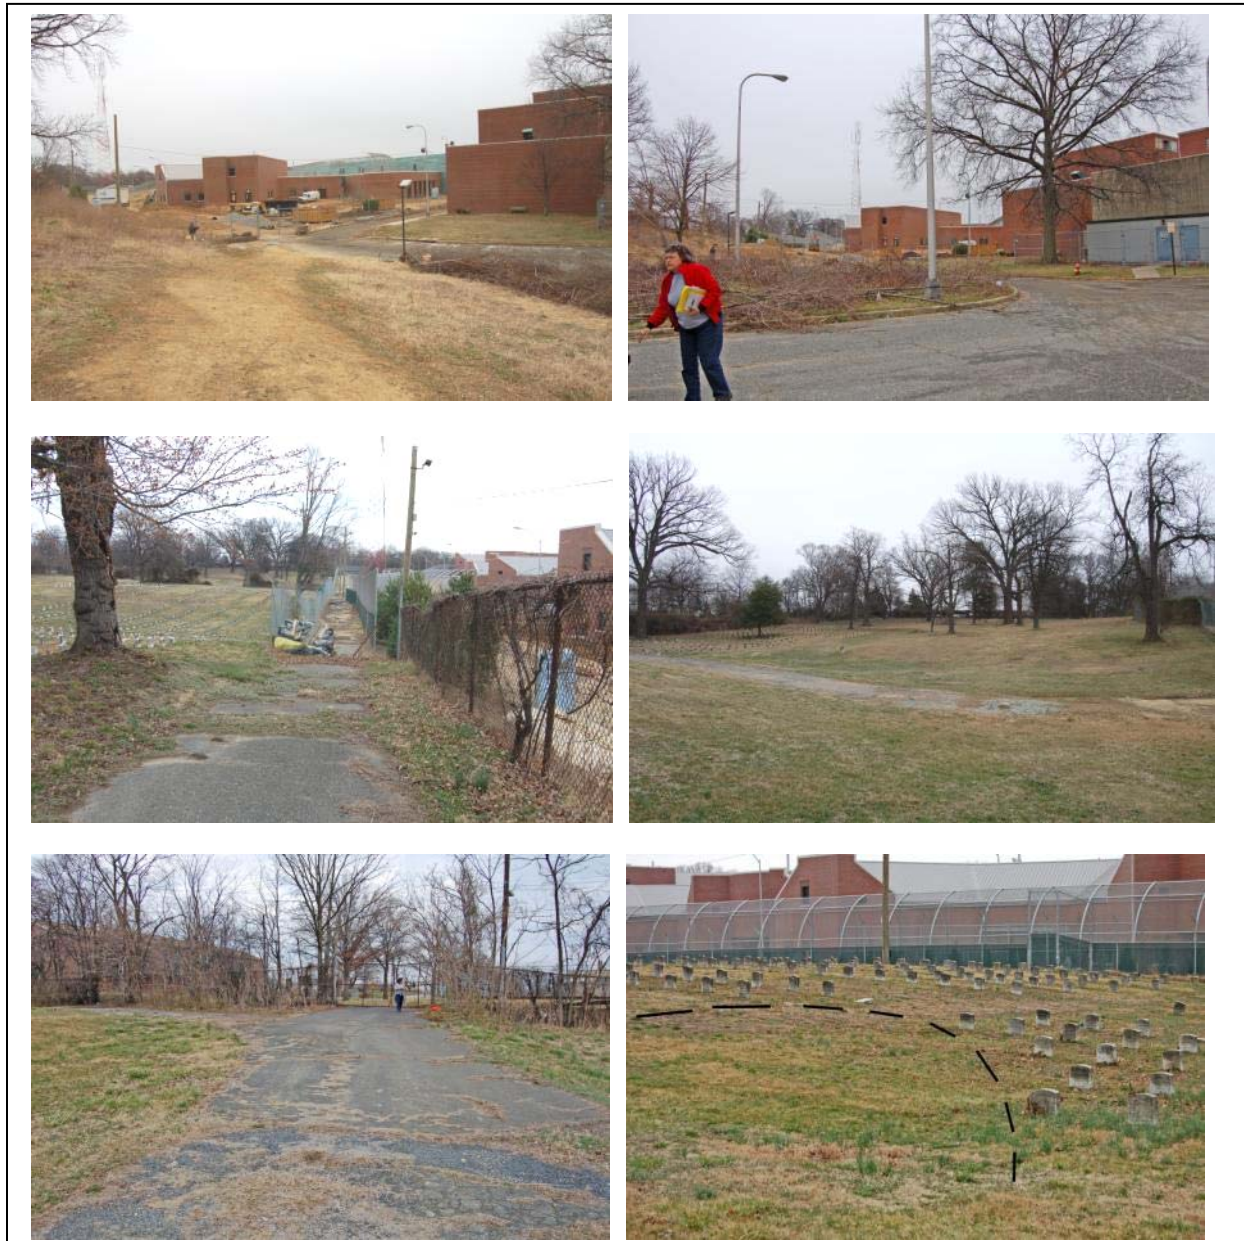
Figure 26. Access issues. Top left photo shows the dirt road from the existing parking up the slope to the cemetery. Top right photo shows the rear of the John Howard Pavilion with the cemetery to the left. Middle left shows the remnants of the asphalt road at the south edge of the cemetery. Middle right shows the asphalt road leading to the now demolished sexton's cottage. Lower left photo shows the asphalt road leading to the rear entrance into the cemetery off Robinson Place. Lower right photo shows one of the original ovals in the cemetery, with markers aligned around the open area.

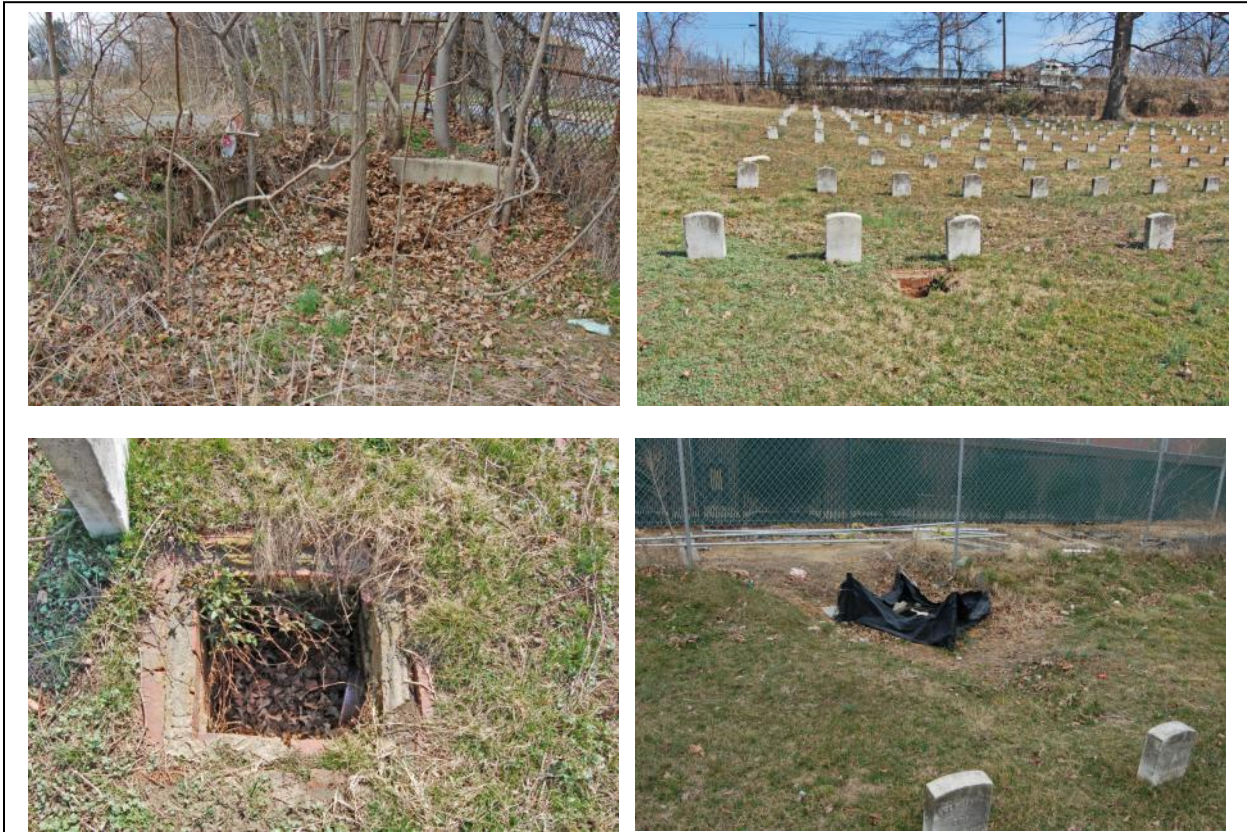
Figure 29. Drains in the East Campus Cemetery. Upper left shows what appears to be a box culvert running under Robinson Place that requires cleaning and evaluation. Upper right shows one of two brick box drains at the southern edge of Section 3. These require cleaning and video inspection. Lower left shows a close-up of the western brick box drain. Note the glazed drain pipe running southward to a modern drain close to the southern entrance gate. Lower right photo shows a modern drain at the south edge of Section 13.

The cemetery does appear to have a series of surface and subsurface drains, some appearing to have some antiquity. For example, there is a largely overgrown box culvert under Robinson Place, allowing under road drainage into the cemetery. This drain requires cleaning.

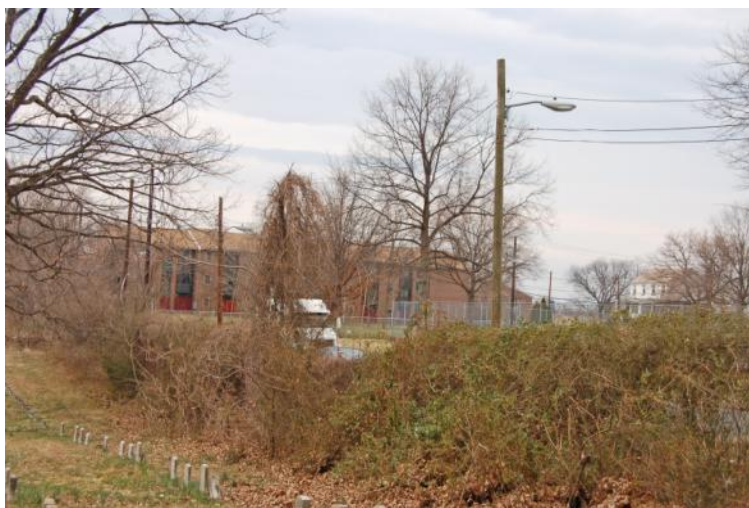
Figure 30. Example of cobra lamps along Robinson Place at the north edge of the cemetery. Note also the dilapidated and overgrown condition of the fence.

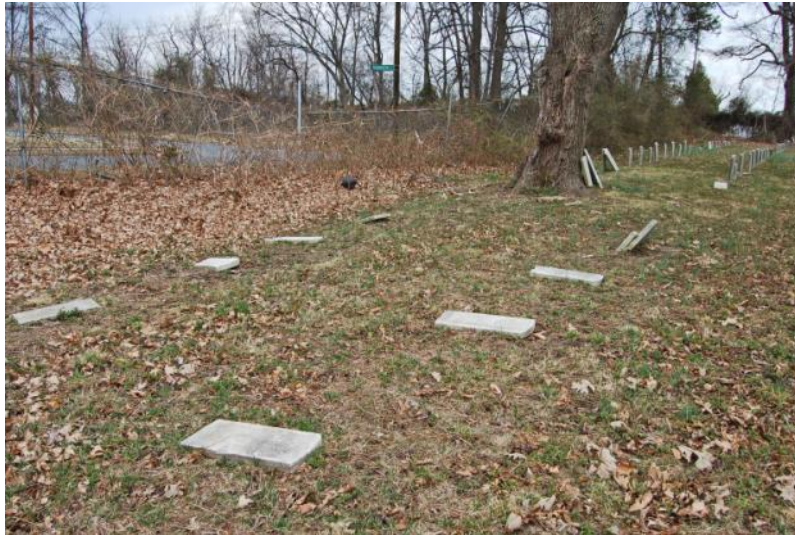
Figure 31. Multiple rows of broken stones indicate probable vandalism in the cemetery. Note proximity to damaged fence section.

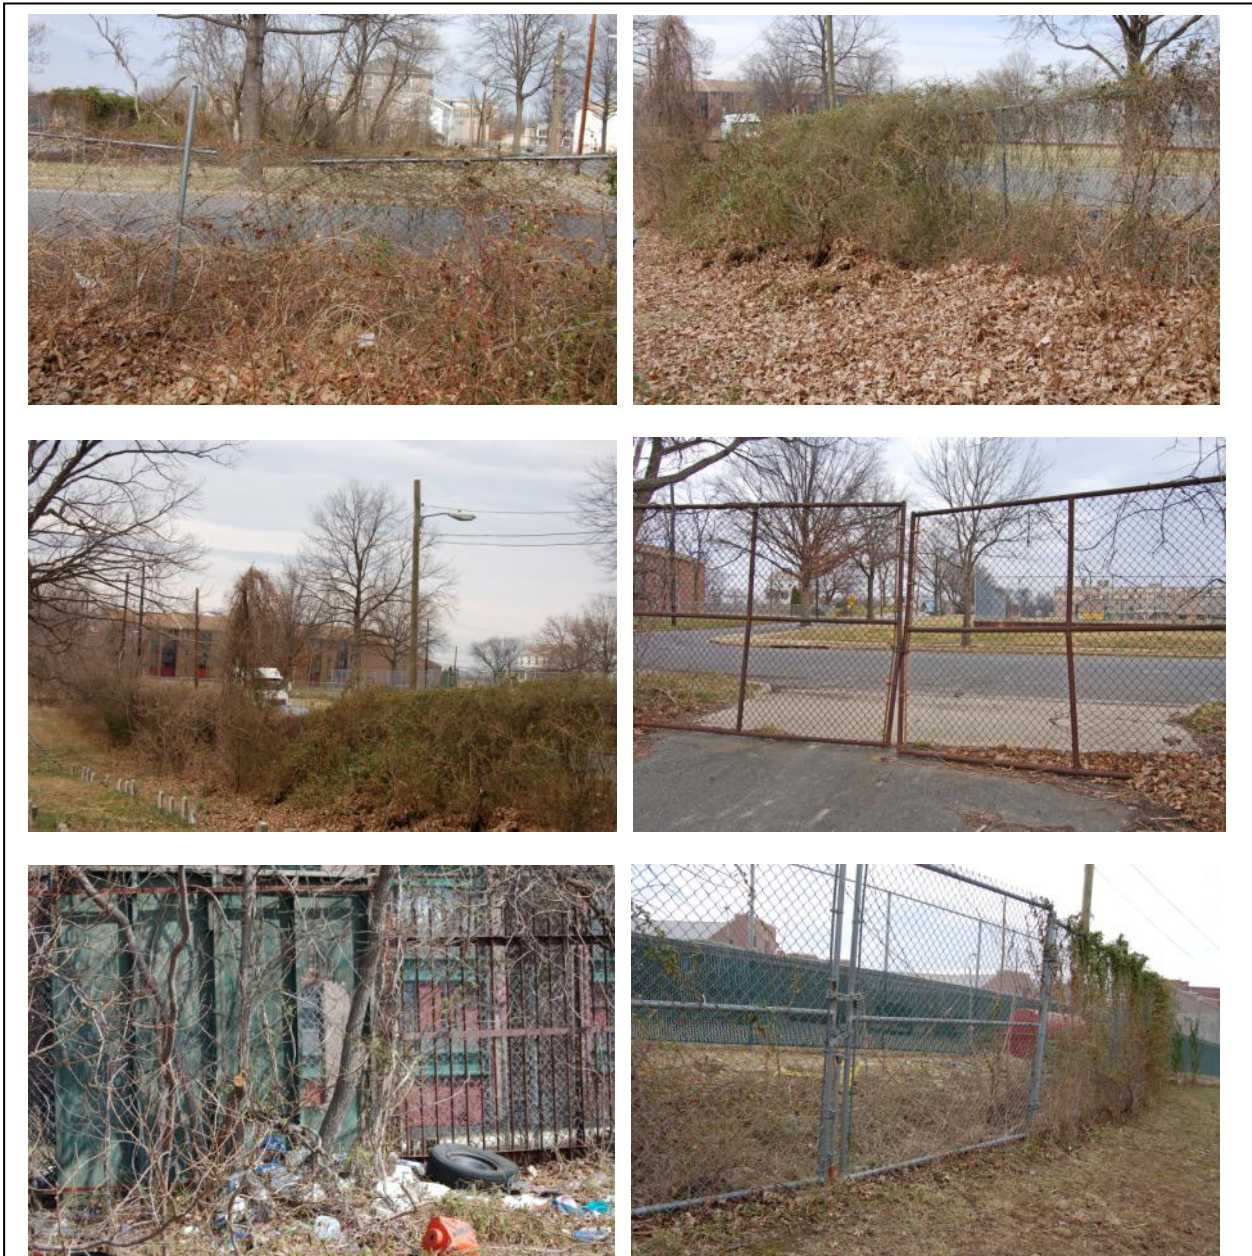
Figure 32. Problems with the existing cemetery fence. Upper left shows damaged fence along Robinson Place that can be easily scaled. Upper right shows the fence with dense vegetation. Middle left shows the same fence with so much vegetation that its condition can't be adequately assessed. All of this vegetation should be removed. Middle right shows the existing gates on Robinson Place that should be removed. Lower left shows an iron fence that offers almost no security. A section is missing and replaced with a wood insert, part of which has been chopped away, allowing easy access into the cemetery. Lower right shows the existing southern gate. A maintenance gate is needed, but probably does not need to be this wide.

The single largest cost is for a replacement, high security fence. This will help ensure the safety of visitors as well as the preservation of the graves and memorials. It will also clearly demarcate the cemetery boundaries and ensure that those boundaries are not violated. The high security fence is of special concern along the north boundary. To the east and west a normal industrial fence is sufficient. To the south we recommend consideration be given to replicating one of the property’s original wood picket fences.

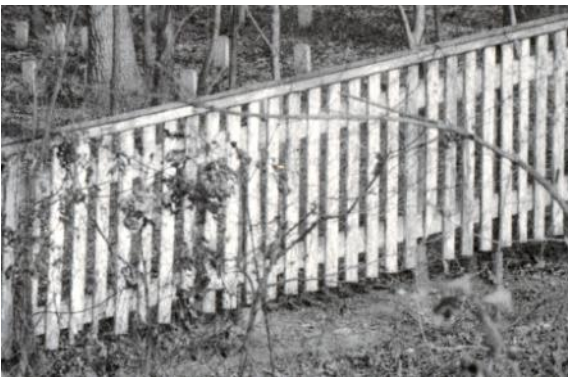
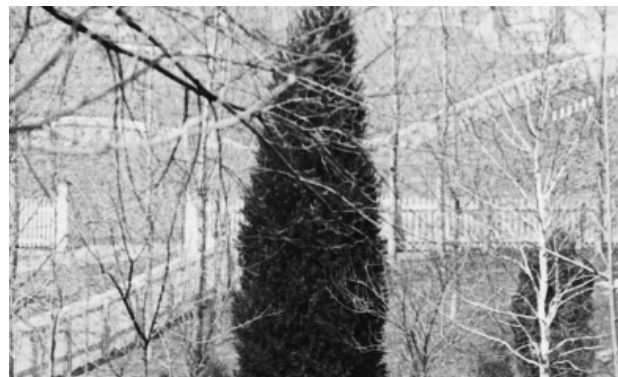
Figure 33. Examples of wood fencing used historically at St. Elizabeths. On the left is a close-up of the fence that surrounded the West Campus Cemetery. On the right is fencing that was associated with the East Campus Cemetery. Both date from 1897.

As an alternative along the south side, the hospital, as part of the National Consumer Memorial, may wish to consider the use of a wood picket fence matching those used historically. Two examples are shown in Figure 33.

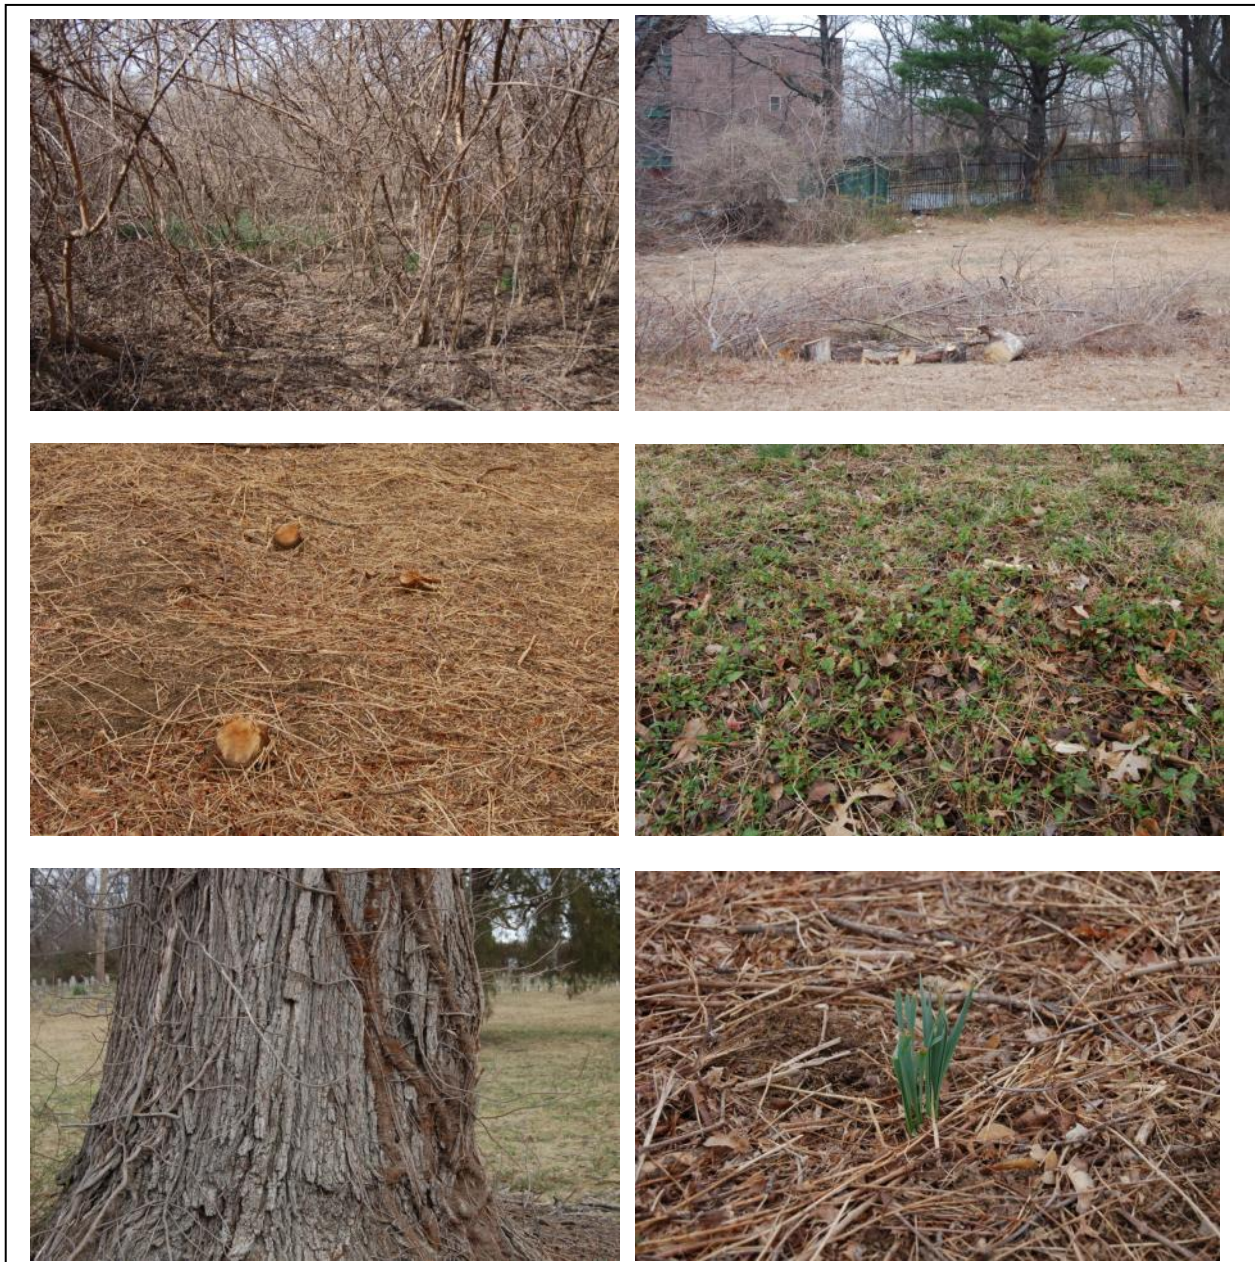
Figure 35. Vegetation clearing issues. Top left photo shows dense vegetation remaining in the western third of the cemetery that requires removal. Top right photo illustrates cut limbs and logs that should be removed from the cemetery and chipped. Middle left photo shows tree stumps that require cutting flush to the ground to allow future mowing. Middle right photo shows the dense honeysuckle that will require chemical control. Bottom left photo shows thick poison ivy vines on one of historic trees in the cemetery. These require immediate attention. Bottom right photo illustrates a small patch of daffodils – historic vegetation that should be carefully protected.

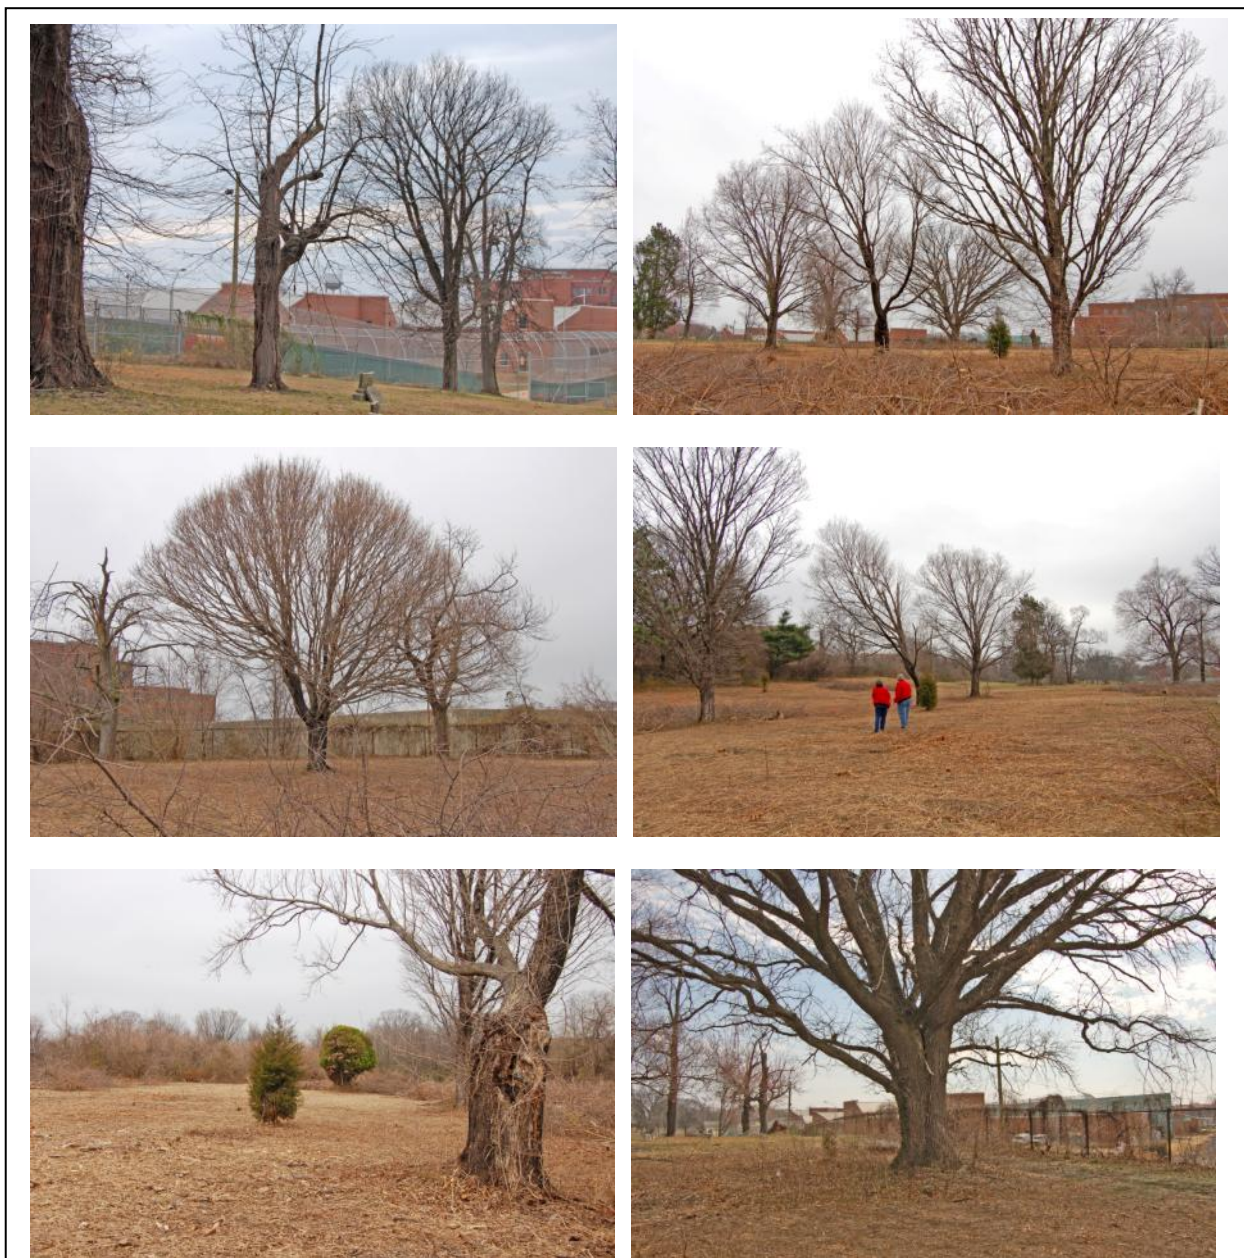
Figure 37. Tree issues in the East Campus Cemetery. Upper left photo shows a topped tree that probably requires removal and replacement. Upper right and middle left photos show a variety of trees with crossing branches that require cleaning and extensive pruning. Middle right and lower left photos show a double leader tree where one half of the tree has fallen, leaving a serious wound and extensive rot. The tree will probably require removal and replacement. Lower right photo shows a double leader tree that requires extensive pruning for the health of the tree and to reduce weight on the two trunks.

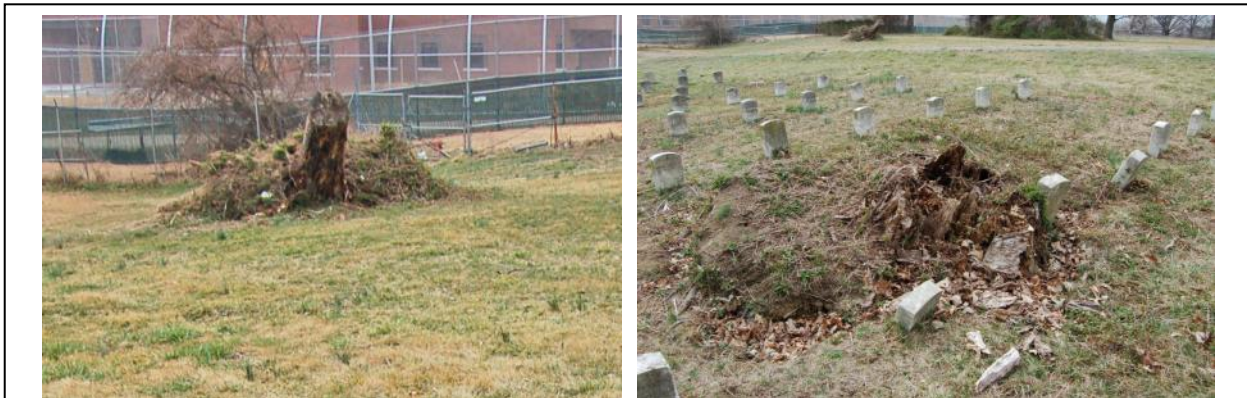
Figure 38. Two examples of improperly removed wind-downed trees. No effort has been made to remove the stumps to grade, restore the uprooted soil, or reset the stones. This demonstrates the absence of appropriate maintenance the cemetery has suffered in the past several decades.

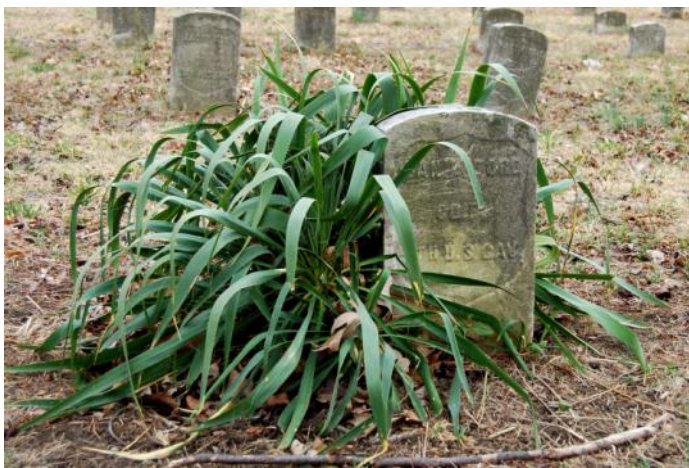
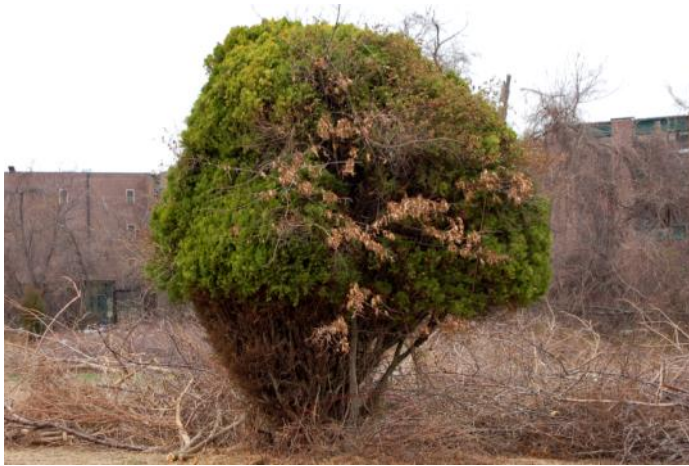
Figure 39. Shrubbery at the East Campus Cemetery. Top is a weak-leaved yucca. Bottom is an incorrectly pruned arborvitae.

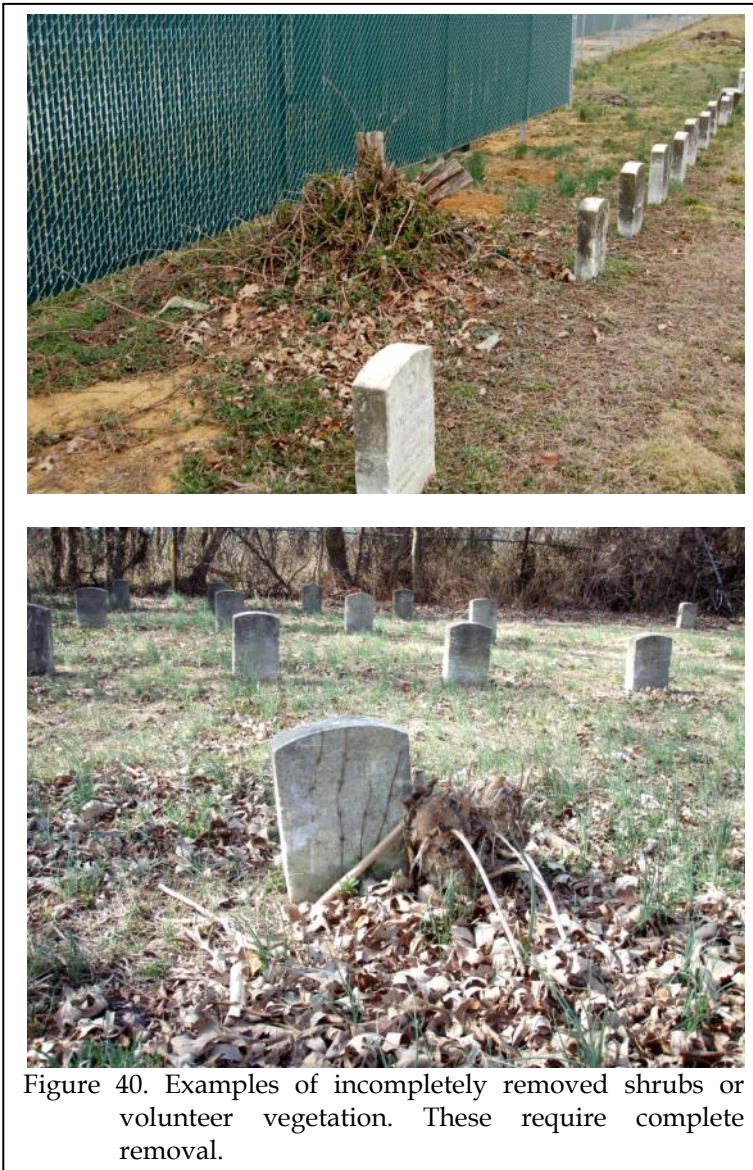
Figure 40. Examples of incompletely removed shrubs or volunteer vegetation. These require complete removal.

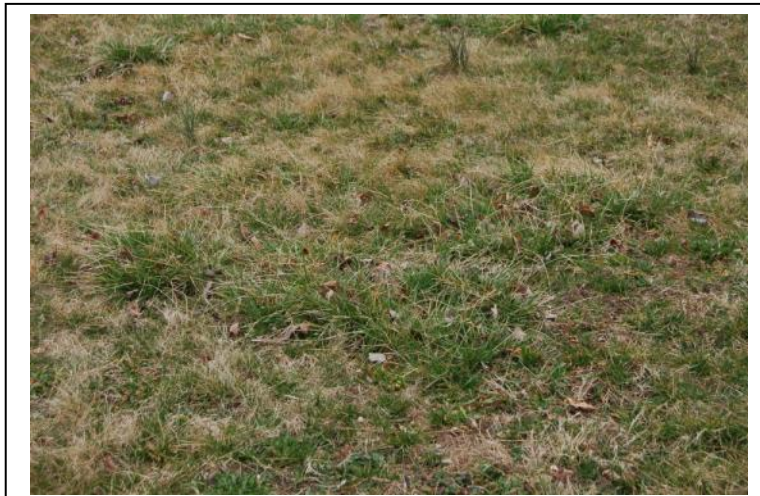
Figure 41. Turf at the East Campus Cemetery showing clumps of tall fescue and many weeds.

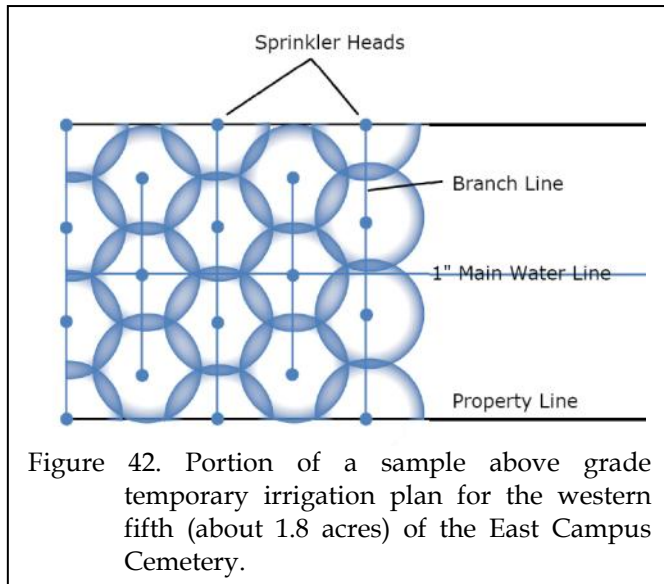
Figure 42. Portion of a sample above grade temporary irrigation plan for the western fifth (about 1.8 acres) of the East Campus Cemetery.

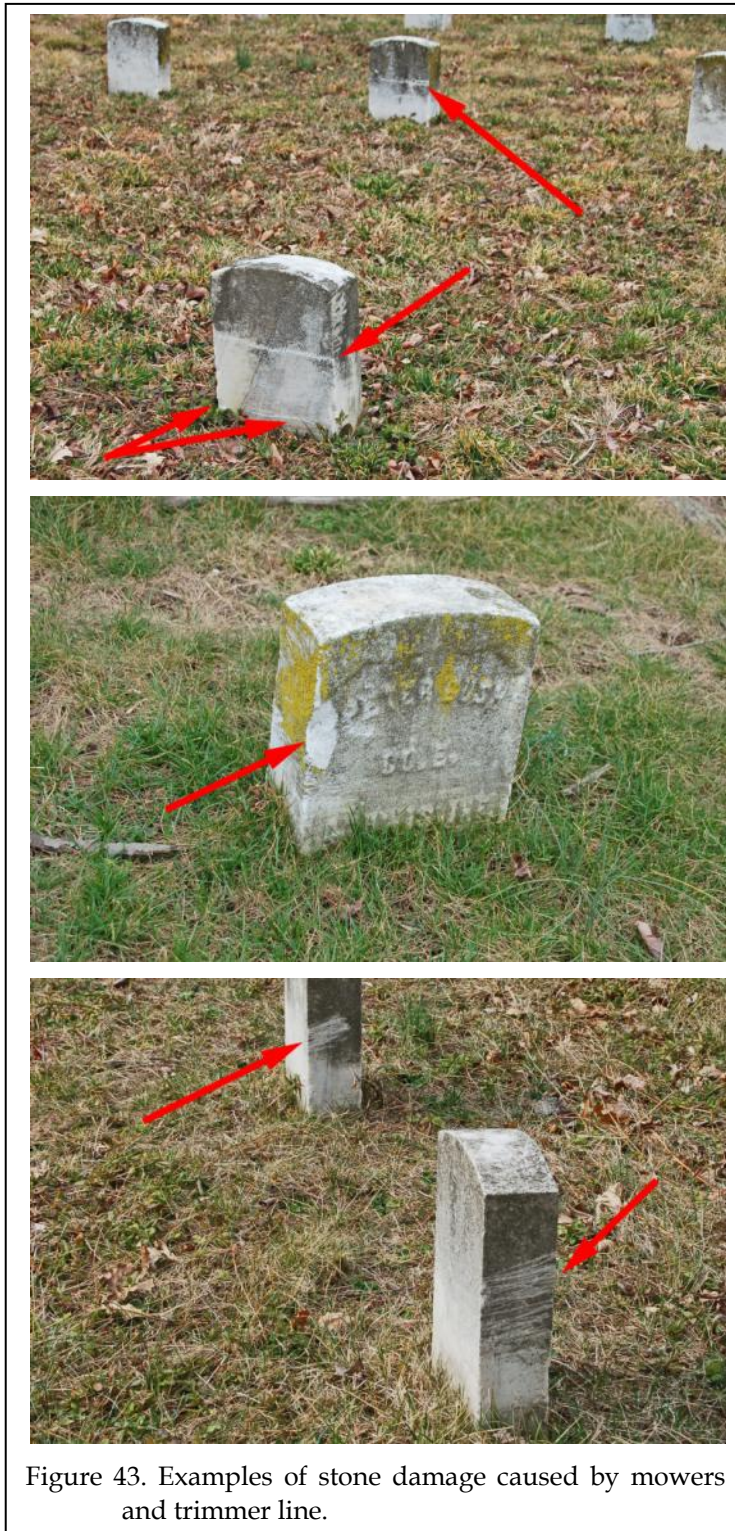
Figure 43. Examples of stone damage caused by mowers and trimmer line.

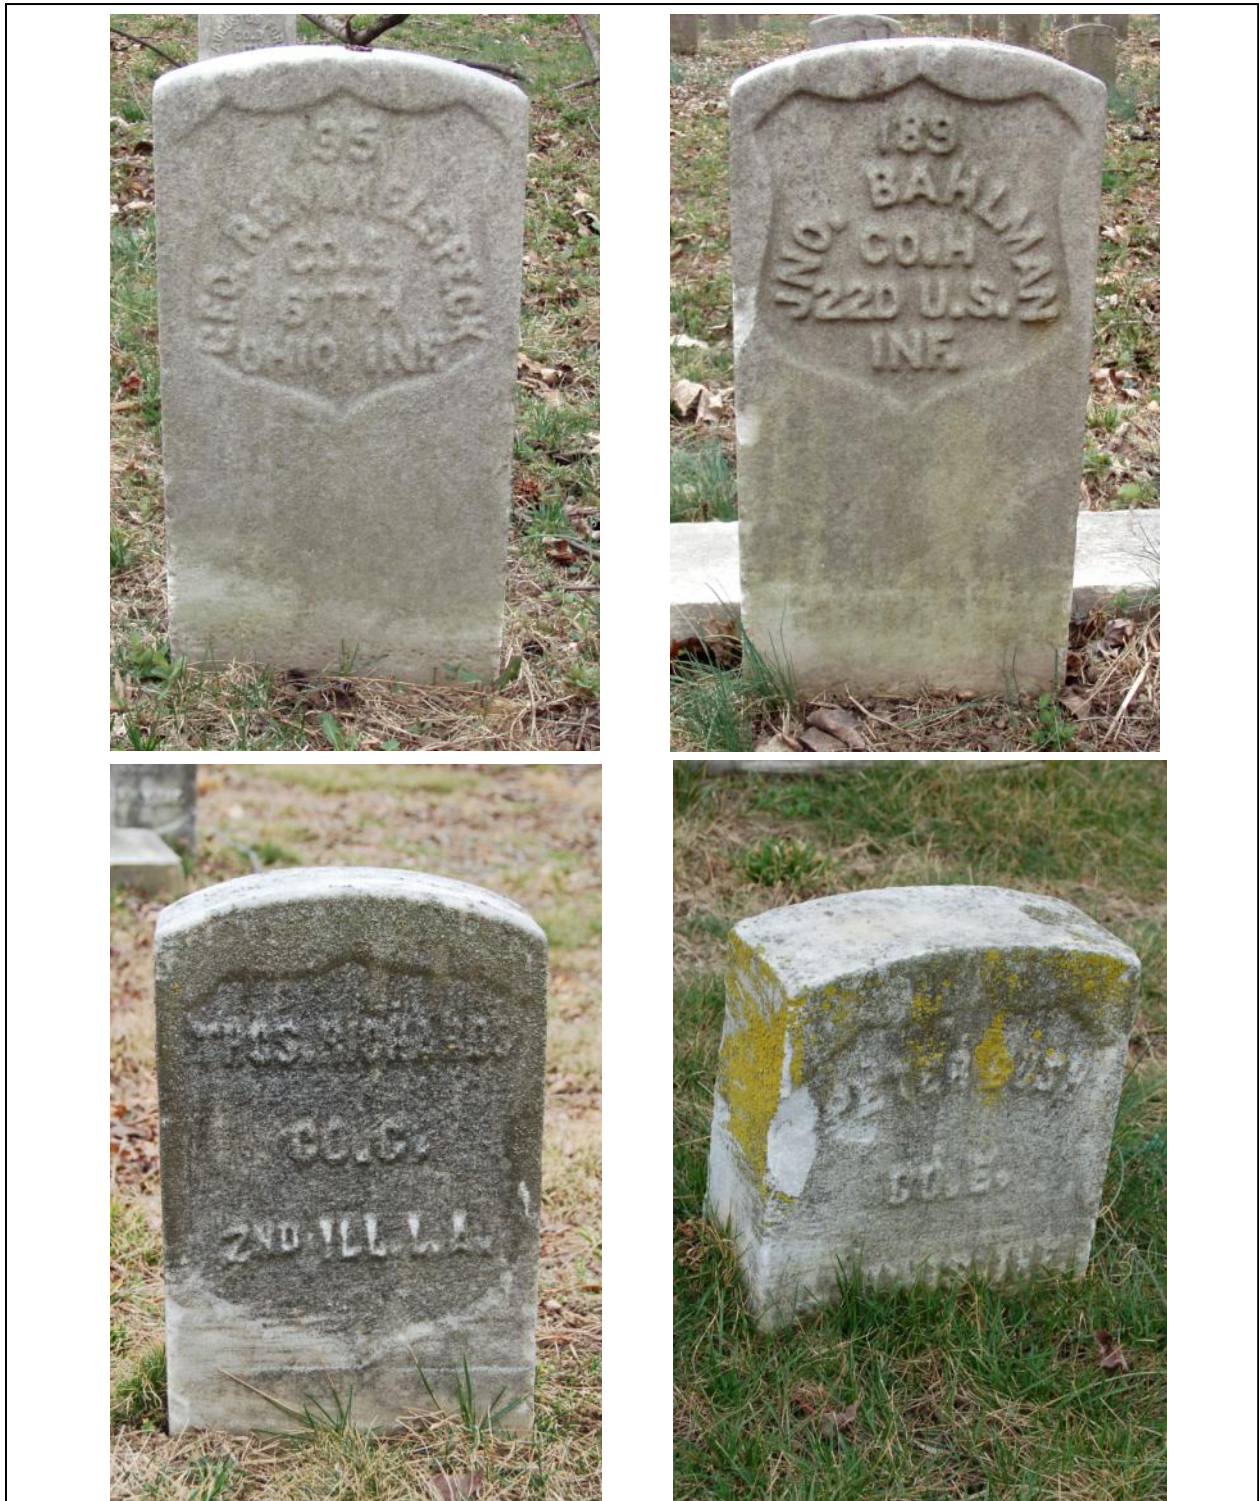
Figure 44 shows several examples of both stones styles. Of particular note is that many of these stones, regardless of their style, are suffering from extensive erosion.

Figure 44. Examples of Civil War style government stones at the East Campus Cemetery. The top row illustrates the thin, numbered style. The bottom row illustrates the more common 4-inch thick style.

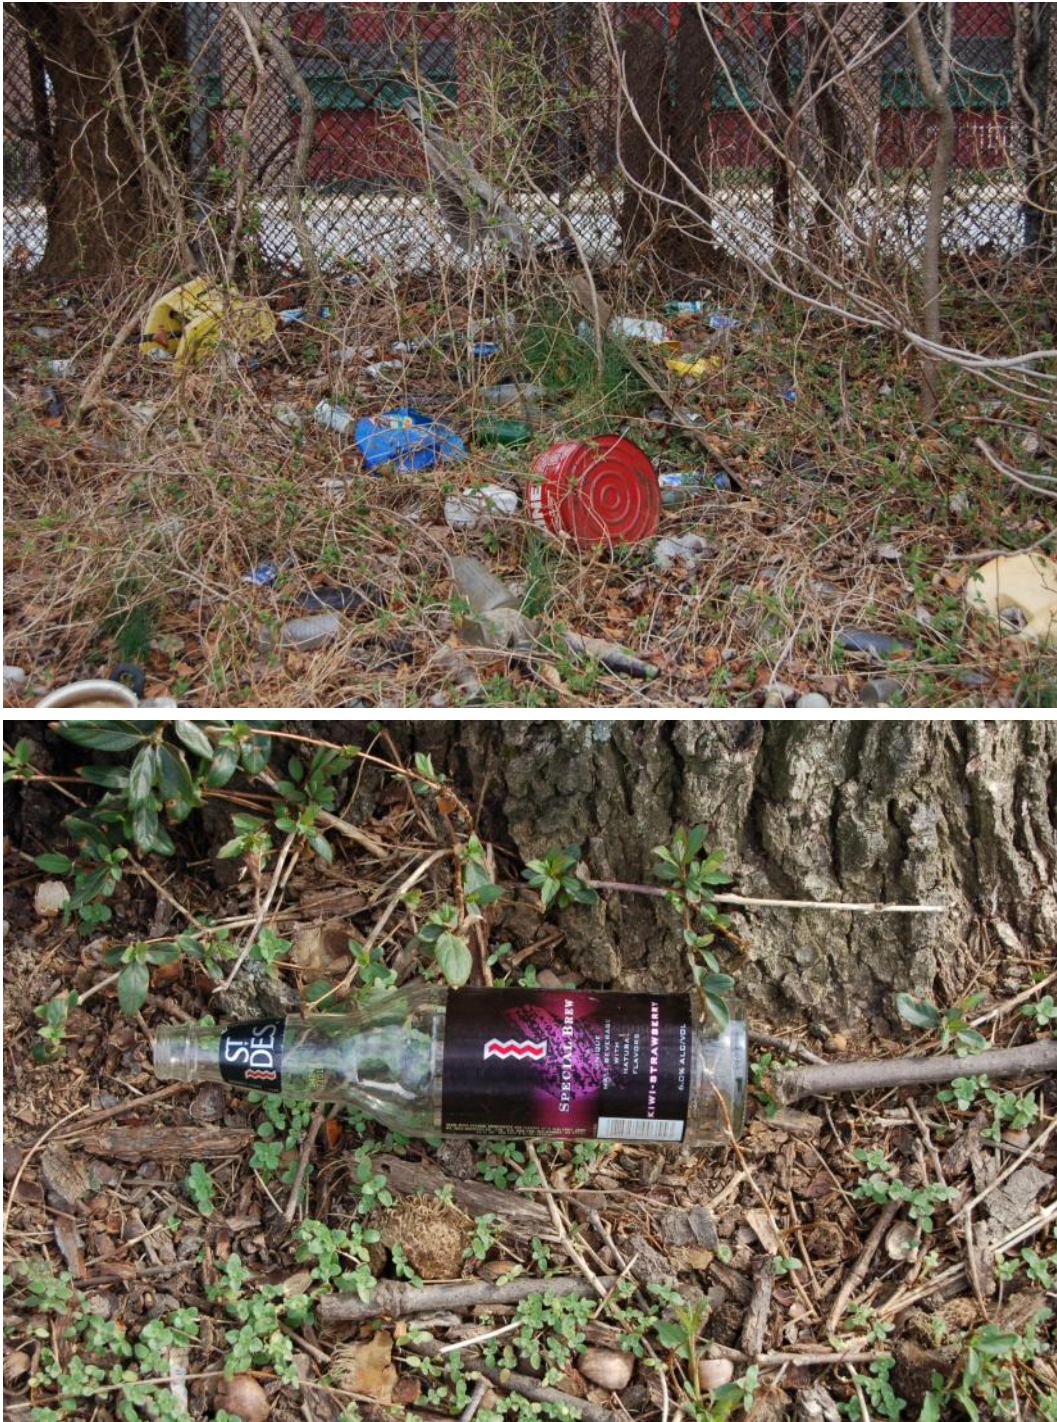
Figure 45. Trash problems in the East Campus Cemetery. The top photo illustrates the thick accumulation of trash along the north boundary fence. The bottom photo illustrates a recently discarded alcohol container inside the cemetery - indicating that the hospital still has issues with trespassers.
