# PRESERVATION ASSESSMENT OF ST. ELIZABETHS EAST CAMPUS CEMETERY, WASHINGTON, DC

**Chicora Research Contribution 514**

June 15, 2009

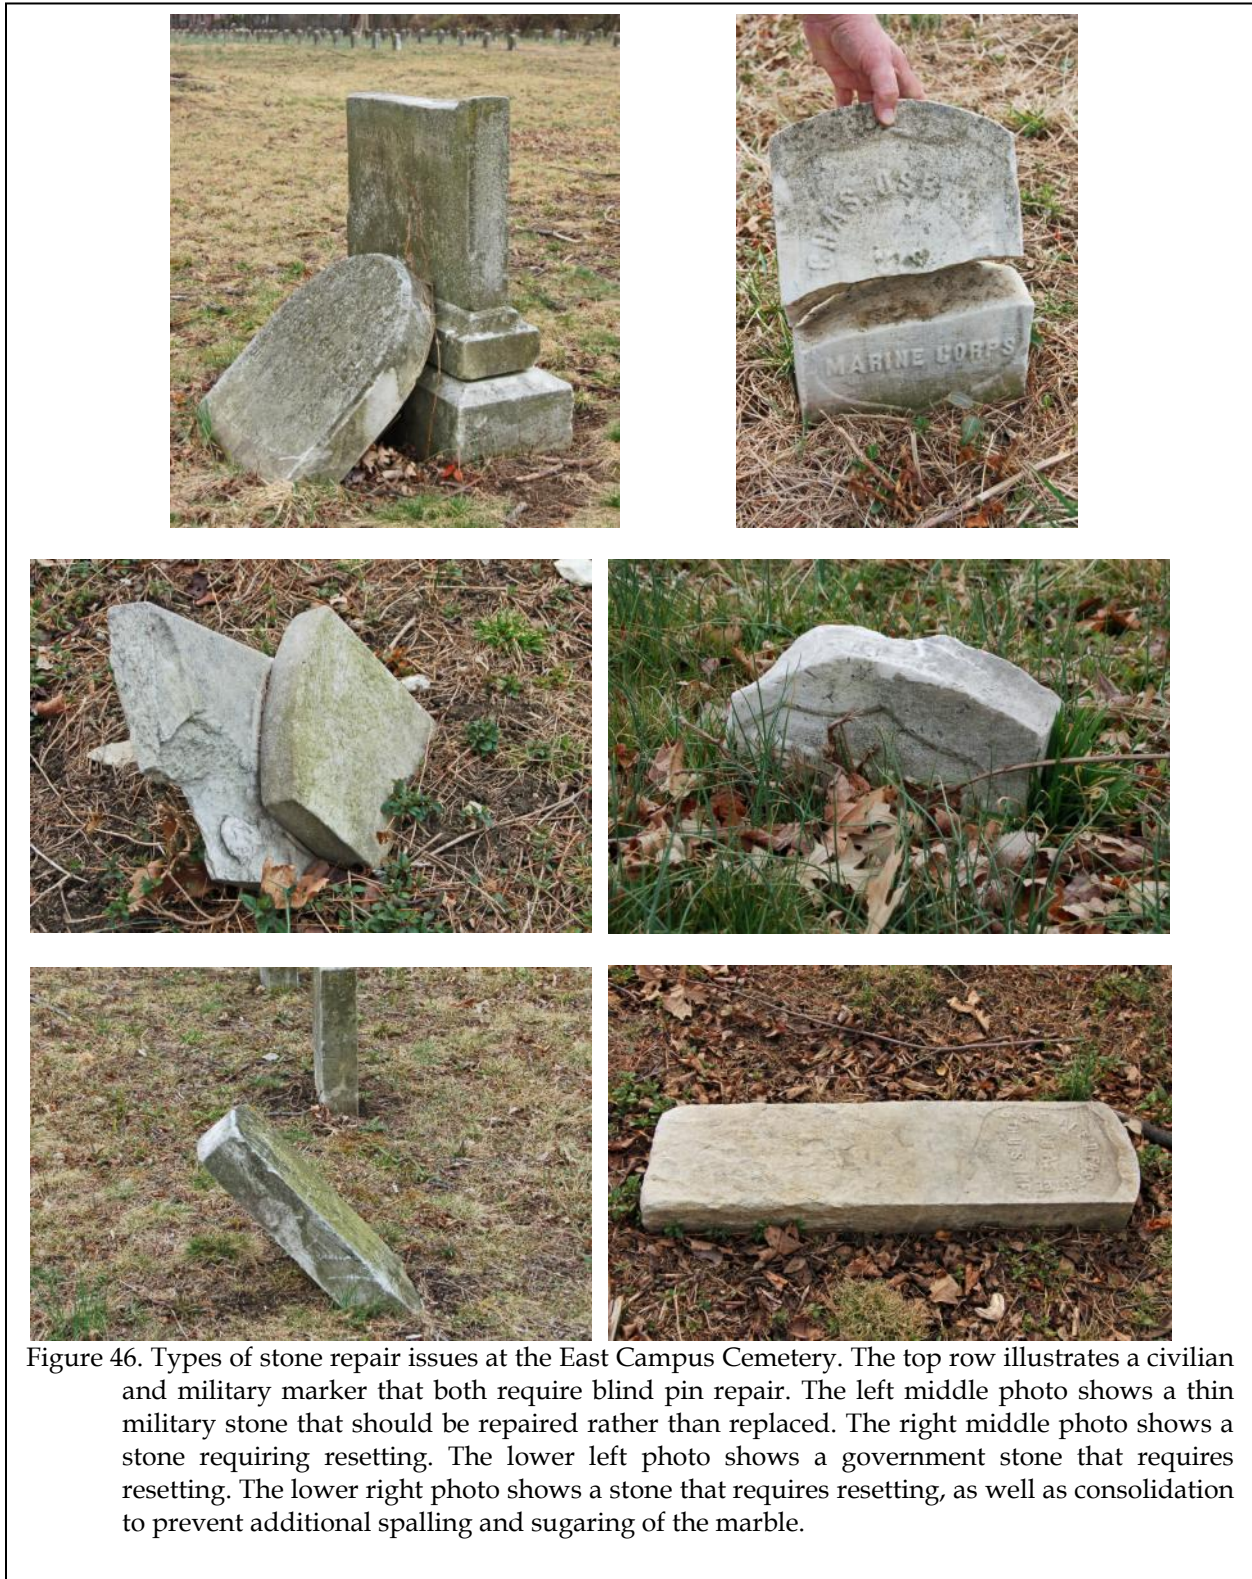
Figure 46. Types of stone repair issues at the East Campus Cemetery. The top row illustrates a civilian and military marker that both require blind pin repair. The left middle photo shows a thin military stone that should be repaired rather than replaced. The right middle photo shows a stone requiring resetting. The lower left photo shows a government stone that requires resetting. The lower right photo shows a stone that requires resetting, as well as consolidation to prevent additional spalling and sugaring of the marble.

Another critical task involves the resetting of approximately 117 stones, replacement of about 76 missing stones, and repair of at least 10 others. This work is critical to ensure that the military graves are appropriately honored.
