DRAINAGE ISSUES

Existing Conditions

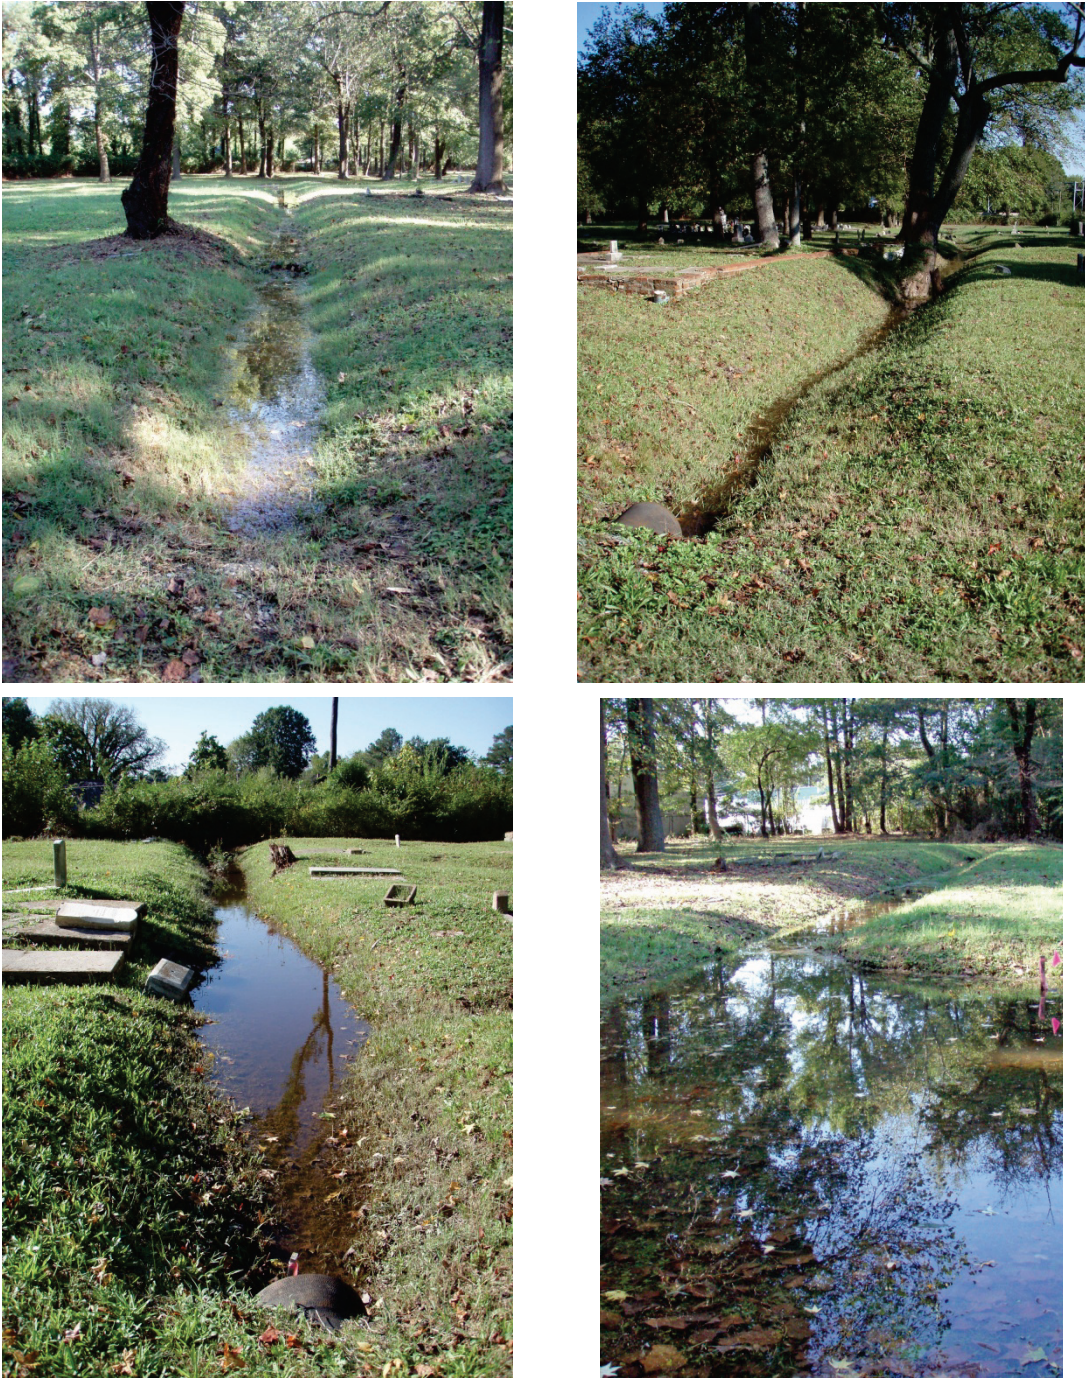
Figure 23. Water drainage in the cemetery after several days without rain. Upper left, north-south ditch near the west end of Mount Olive looking north. Upper right, north-south ditch between Mount Calvary and Mount Olive looking north. Lower left, north-south drain between Mount Calvary and Mount Olive looking south. Lower right, ditch and ponded area at the northwest corner of Mount Olive, looking southwest.

Figure 23 illustrates the condition of ditches and cemetery area at the time of our assessment, several days after the most recent rain. Ditches remained full and there were multiple areas in the cemetery where there was standing water. In addition, many of the vaults behave as reservoirs and thus were filled with water (Figure 24). Figure 25 illustrates the condition of the cemetery during a significant rain event, revealing even more significant ponding of water.

As owner of the cemetery complex the city should fulfill its own 2007 recommendation and immediately conduct a detailed assessment of drainage issues at the cemetery complex. The existing drainage issues promote mosquito development and pose significant hazards to the visiting public. The drainage problems at the cemetery are also disturbing to descendants who see the graves of loved ones consistently flooded.

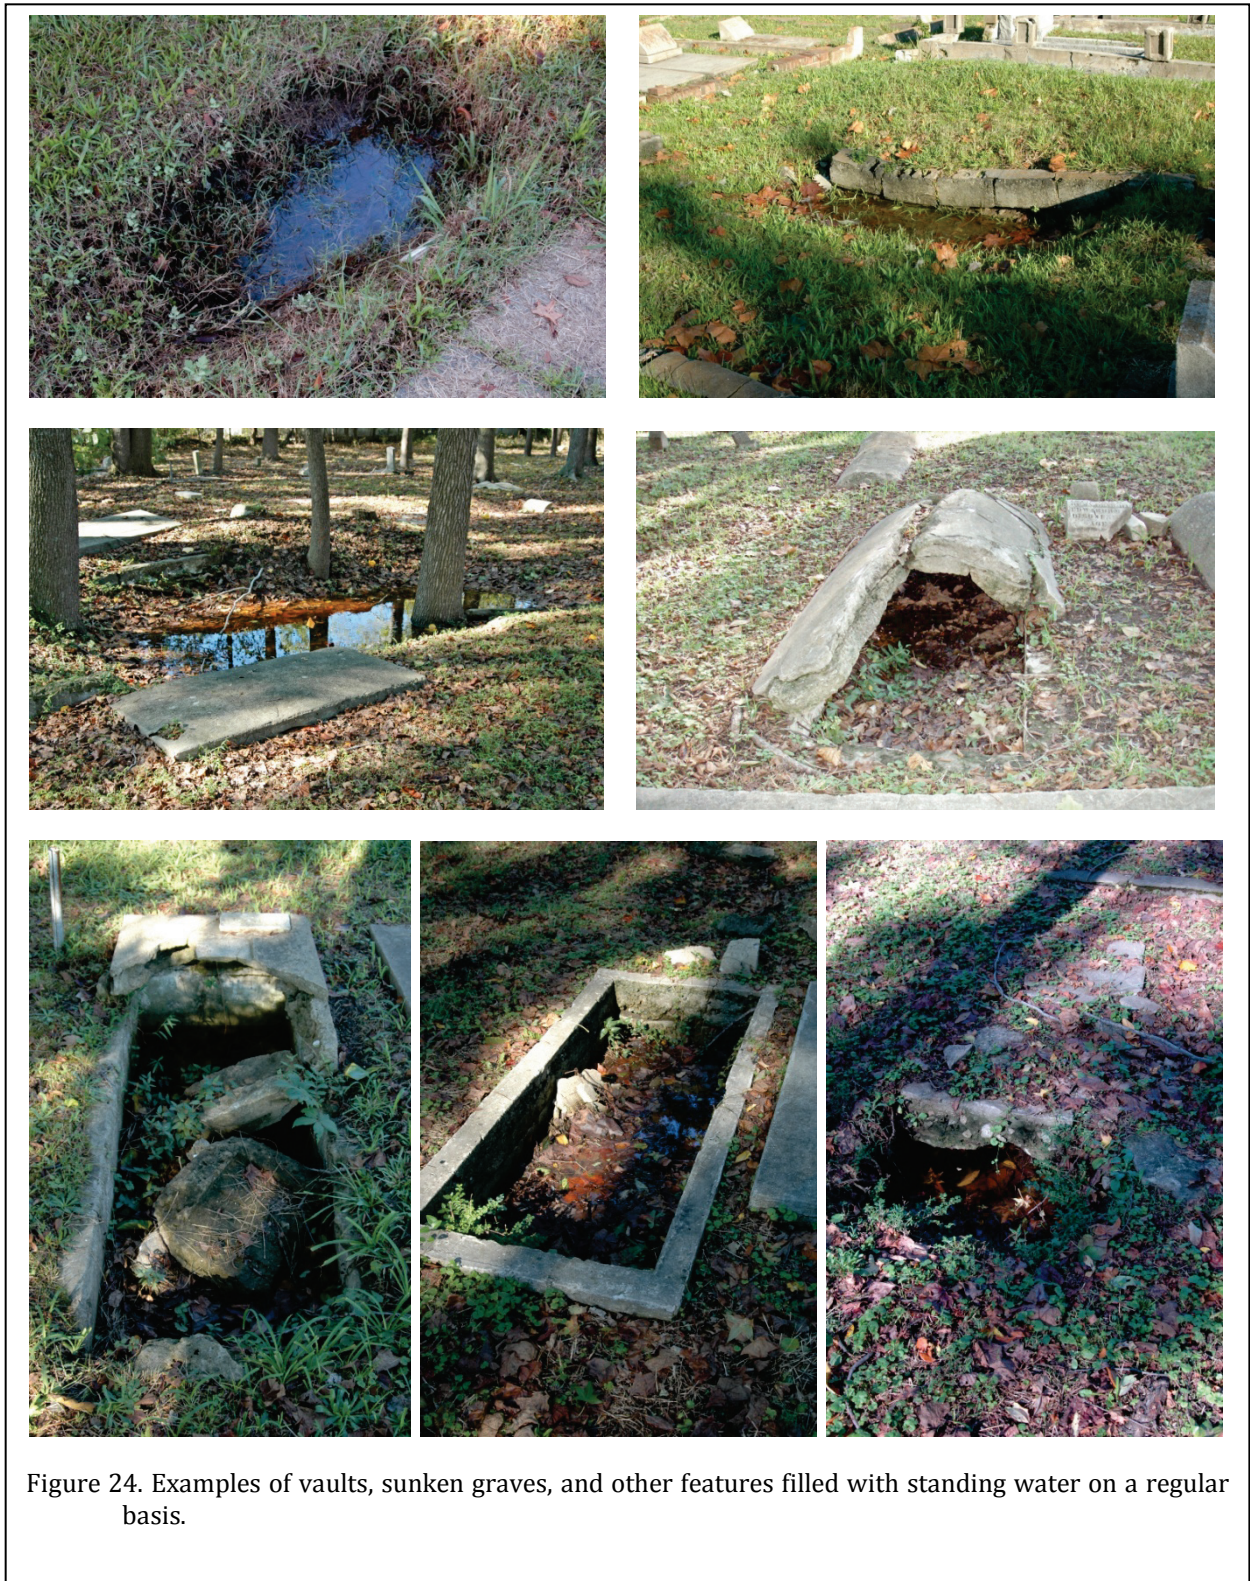
Figure 24. Examples of vaults, sunken graves, and other features filled with standing water on a regular basis.

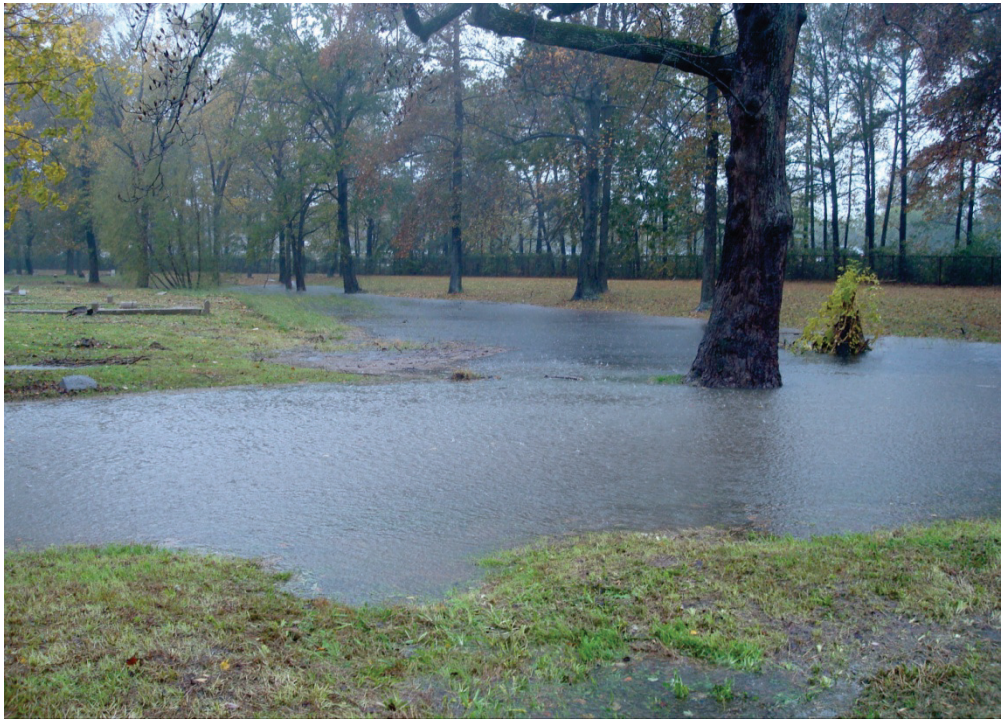
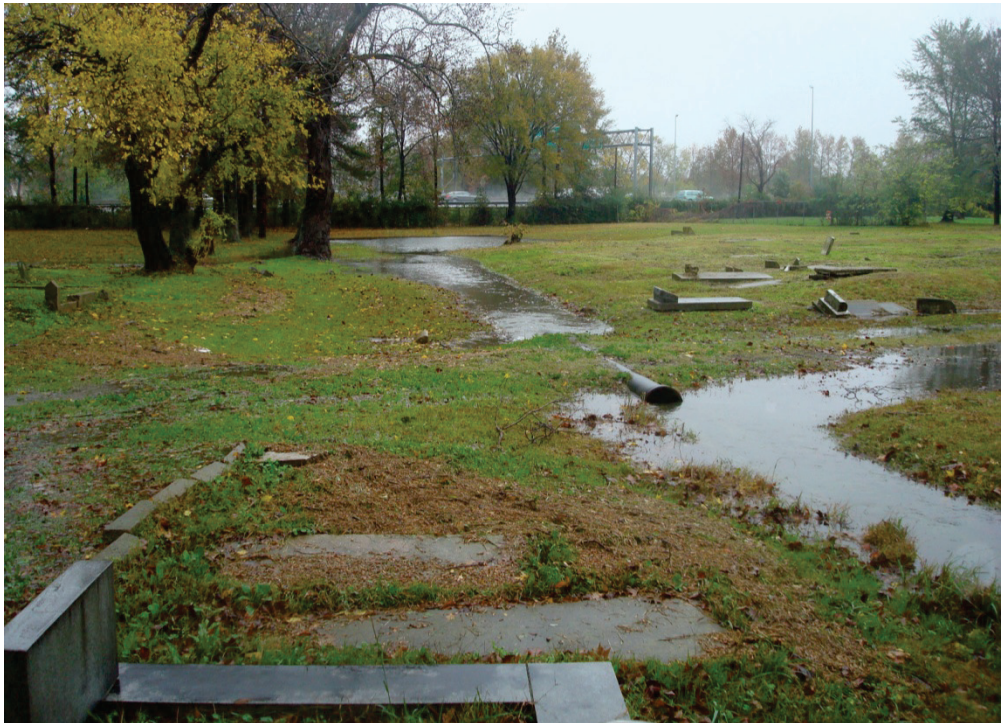
Figure 25. Drainage problems in the cemetery complex during heavy rainfall events. Photos courtesy Christina Carlton.

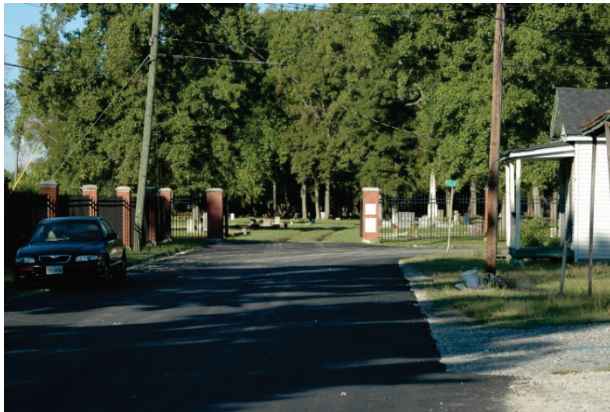
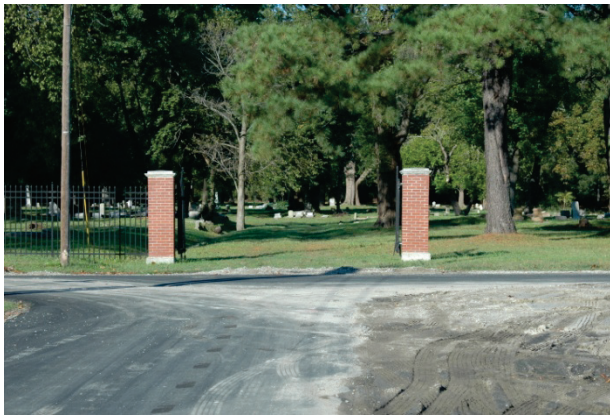
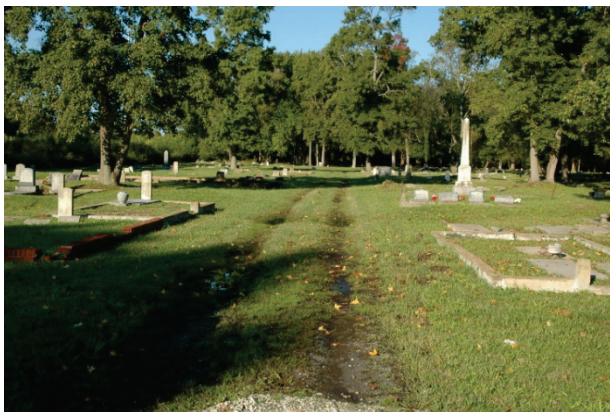
All of these roads are 8 feet in width with graves in close proximity to both shoulders. None are surfaced and all are badly rutted; their condition is made worse by the poor drainage in the cemetery and failure to maintain the roads for many years. Crossing of ditches appears to be achieved using 18-inch pipes that appear to be in satisfactory condition. The roads are relatively flat, providing no crown to promote drainage off the road. There is no evidence that the roads were ever professionally constructed.

Figure 26. Entrances to the cemetery complex. Upper photo shows the Maple Drive entrance at the end of Pulaski Street. The middle photo shows the Elm Drive entrance at the end of Calvary Street. The bottom photo shows the wet conditions and potholes in Maple Drive at the time of the assessment.

We recommend that the roadways originally identified as Maple, Elm, and Willow be graveled and identified as one-way roads. This would allow visitors to drive into the cemetery

We recommend that the city Public Works Department construct all-weather gravel roads in Mount Calvary along Maple, Elm, and Willow. The resulting road should be identified as one-way; it would provide convenient movement through the cemetery.

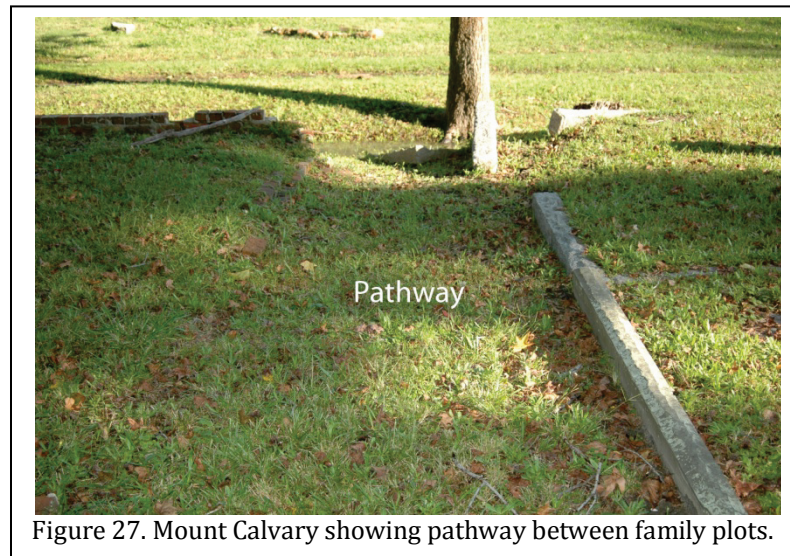
Figure 27. Mount Calvary showing pathway between family plots.

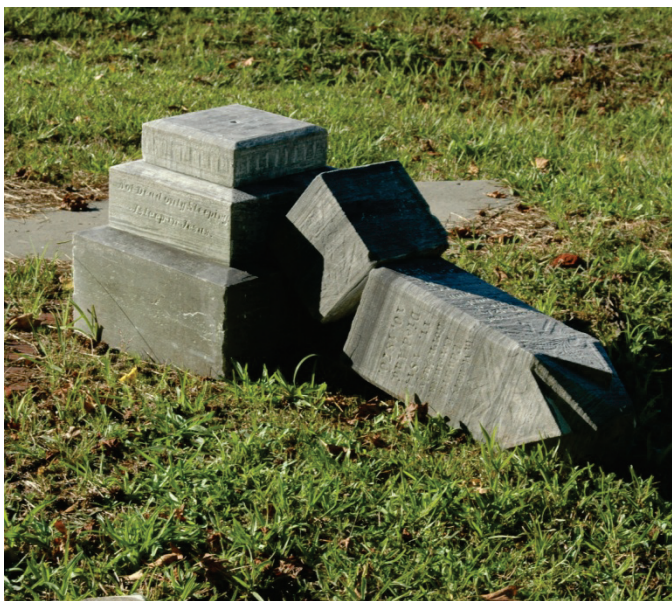
Figure 28. This stone was likely vandalized (the base is relatively level and there are no trees or stumps nearby).

It is also essential that vandalized stones be repaired. Simply allowing broken stones to remain where they fell is not only disrespectful, but it gives the entire cemetery a run-down and uncared for appearance. We know of no city that would allow park benches or picnic tables to remain in a park in a vandalized condition – they would be immediately repaired or replaced. Likewise, it is critical that vandalized stones be repaired by a stone conservator.

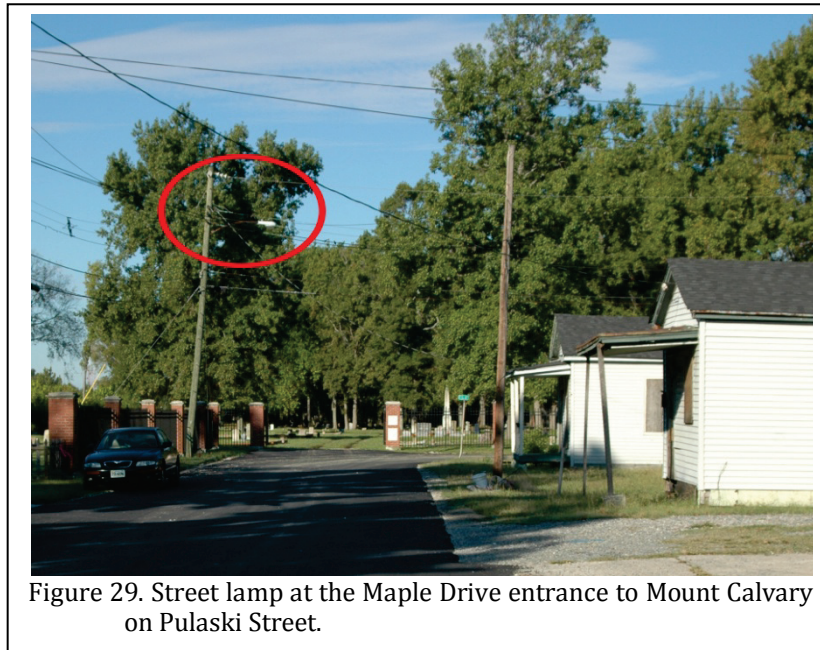
Figure 29. Street lamp at the Maple Drive entrance to Mount Calvary on Pulaski Street.

steel brackets with cobra head luminaires mounted on existing utility poles. A typical example is found immediately before the Maple Drive entrance to the cemetery on Pulaski Street (Figure 29). There are no lights within the cemetery.

We do not recommend that any additional lighting be installed.

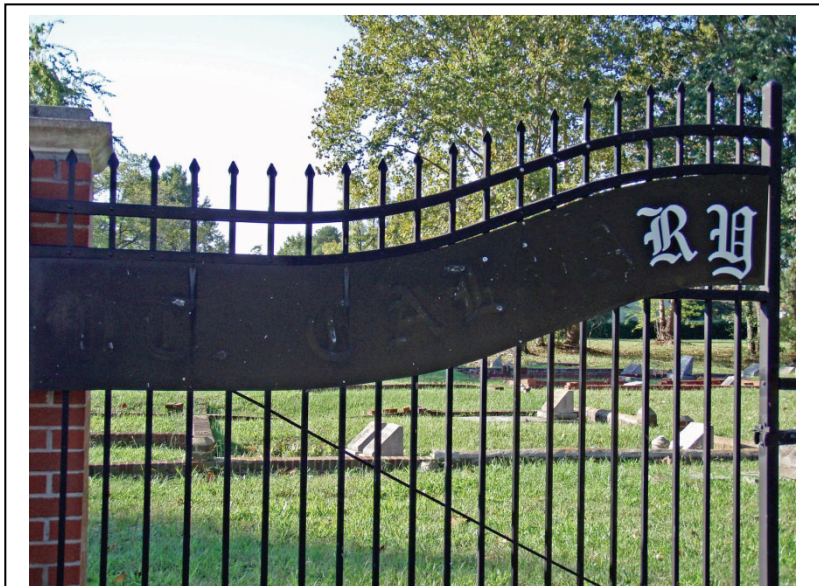
In addition, the signage on the fence has been vandalized and is partially missing. This should be immediately replaced by Parks, Recreation and Leisure Services.

Figure 30. Entrance gate to Mount Calvary showing the loss of letters that require replacement.

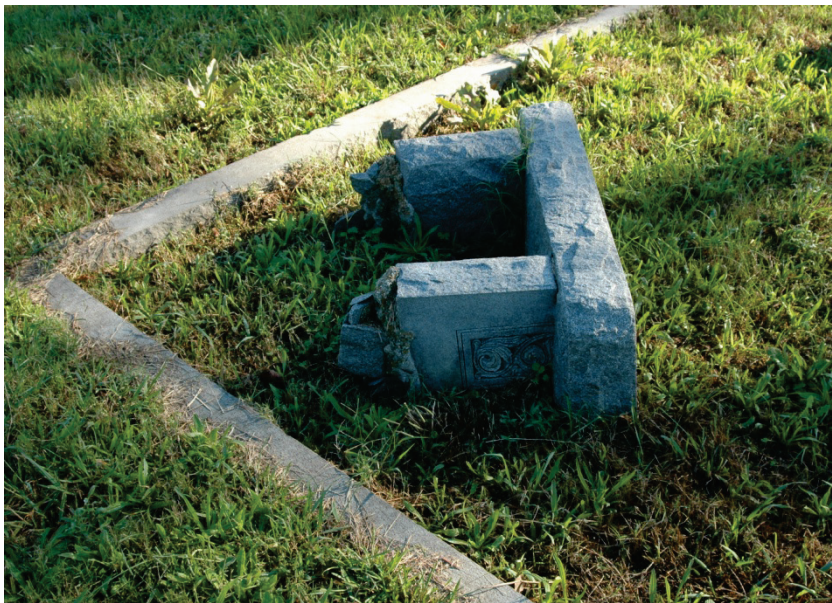
Figure 31. This monumental bench lacked an appropriate foundation, evidencing improper construction.

Figure 31 shows a granite bench, likely erected by a monument company. The bench entirely lacks a foundation – only a few granite rocks were thrown into a shallow footing for the placement of the bench. Given the shoddy construction it is no surprise that the bench failed. This documents the types of problems that occur when there is no cemetery administration to oversee monument construction.

We recommend that once consolidated, Parks, Recreation, and Leisure Services prohibit

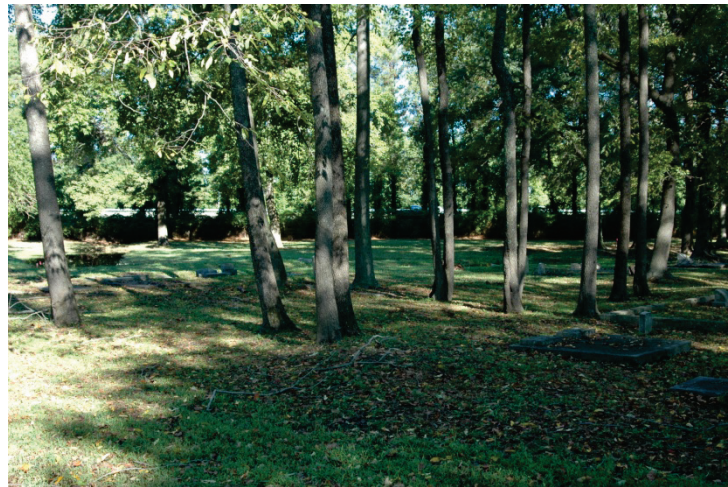
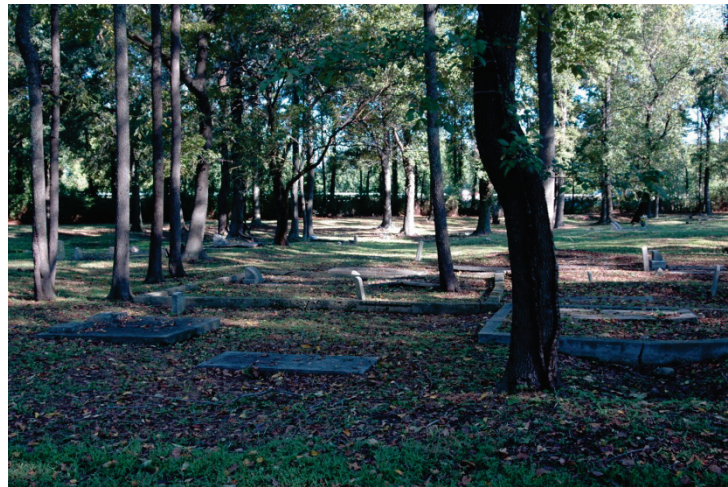
Figure 33. Dense trees in Mount Olive require thinning with the removal of all trees under 9-inch dbh.

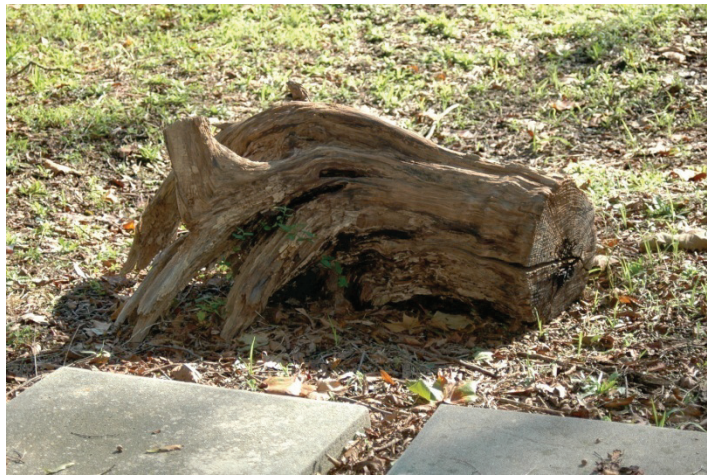
Figure 34. Stump left in the cemetery. All stumps and downed wood should be removed from the cemetery or chipped as quickly as possible.

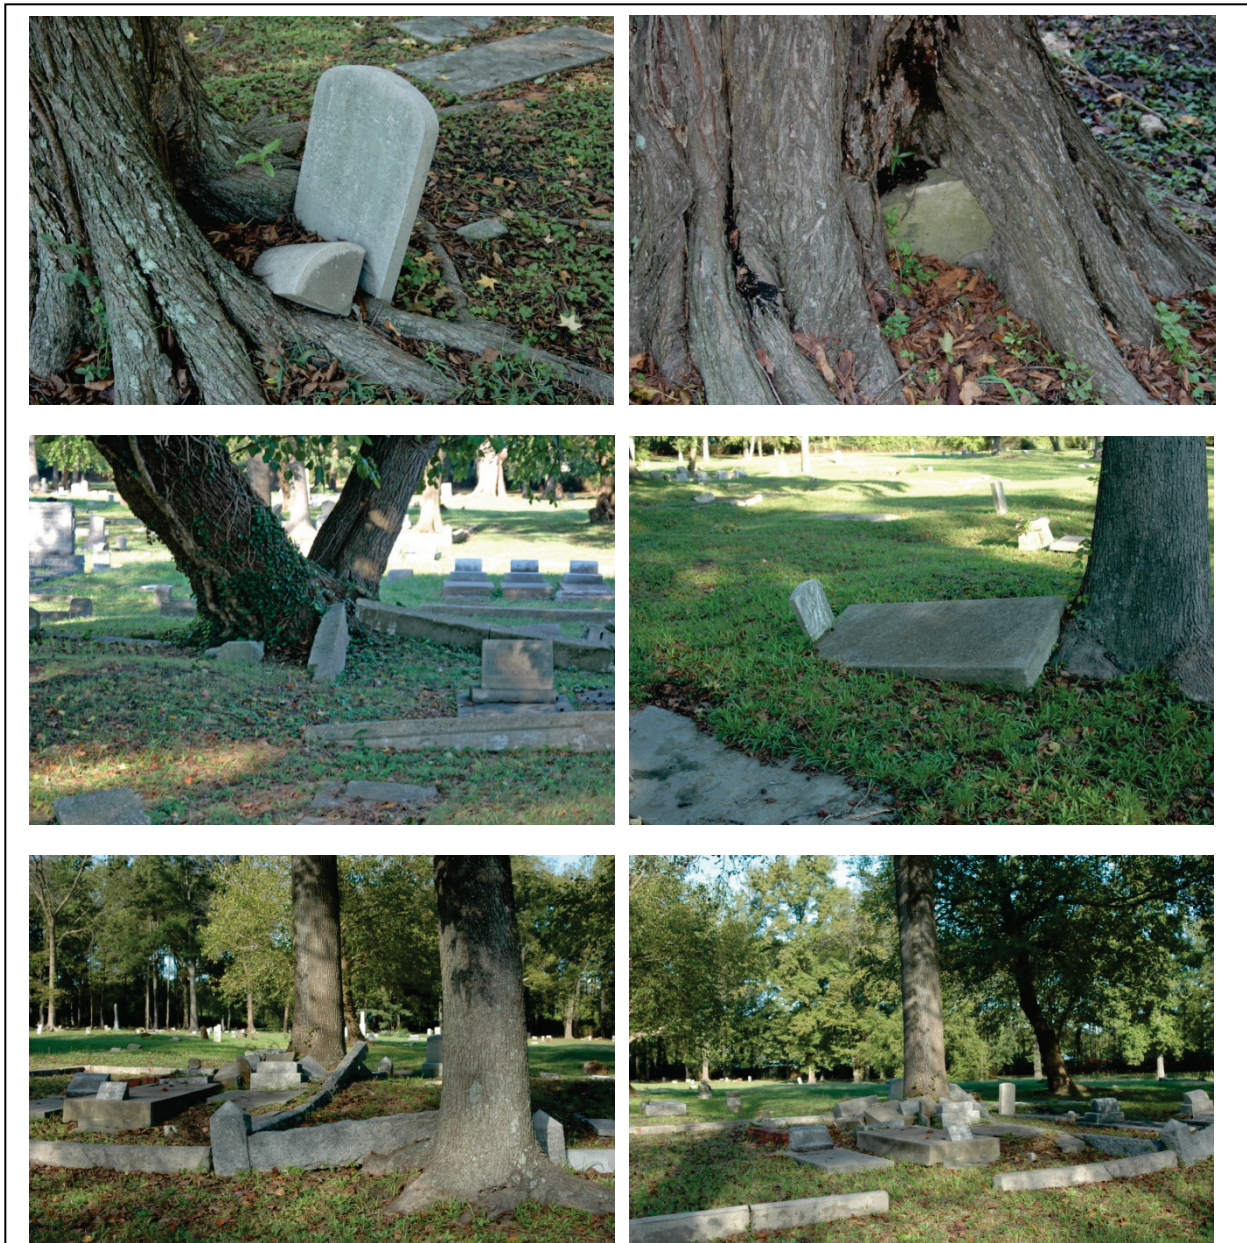
Figure 35. Examples of plots or stones damaged by tree growth. The top left photo shows a large tree with roots beginning to encompass a tablet. Here it may be possible to remove the stone without damage to the tree. The top right photo shows a stone completely grown into a tree. The stone cannot be recovered without killing the tree – which we do not recommend. Middle row left photo shows coping displaced by a large tree. We recommend relocating the coping to avoid the tree. Middle row right photo shows a large tree growing into a vault. It may be possible to relocate the vault cover and tablet. Lower row left and right photos show extensive damage to coping and stones by a large tree. Here it may be possible to relocate coping and stones to avoid the tree. In most cases the tree, if mature and healthy, should be retained.

Trees should be pruned in such a manner as to preserve the natural character of the plant and in accordance with ANSI A300 (Part 1) - 2001 standards.

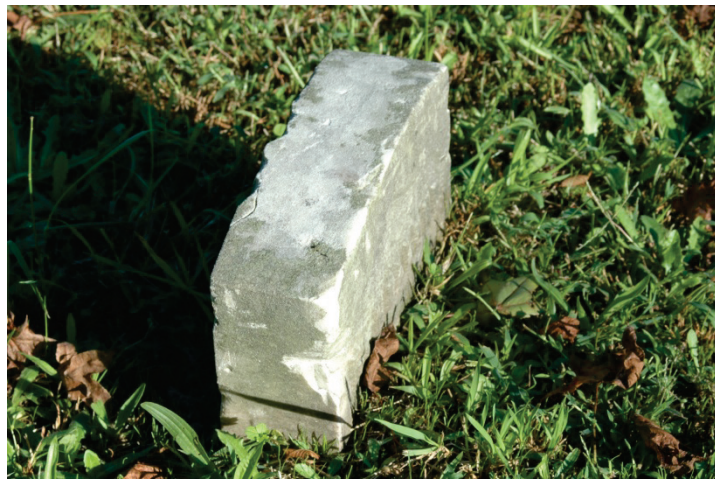
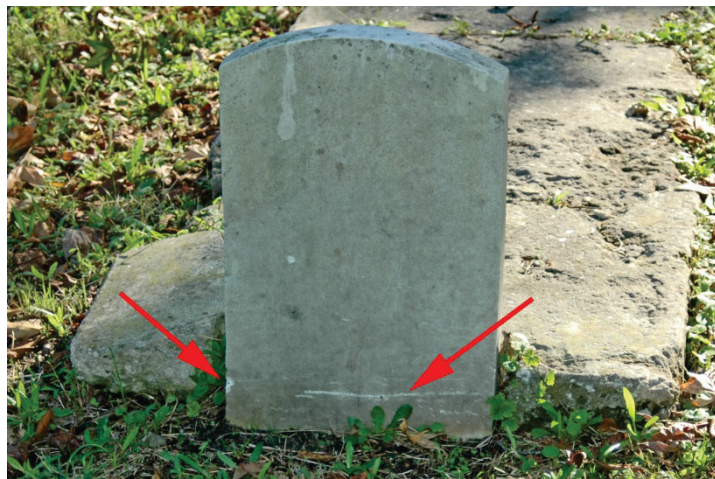
Figure 37. Damage to stones in the cemetery caused by mowers. Top photo shows numerous direct hits causing chipping. Bottom photo shows not only a direct hit on the left, but also a long scrape across the stone. These are the result of using equipment that is too large for cemetery, coupled with inattentive and unsupervised workers.

It would be far better to abandon riding mowers and convert mowing at the cemetery complex to the use of walk behind mowers with decks no larger than 21-inches. Larger mowers could be used in those areas with few or no stones – such as the potter’s field, rear portion of Mount Olive, and Fisher’s.

All mowers operating in the cemetery should have closed cell foam bumpers installed to assist in preventing damage to the stones. This should be part of the city’s contract for work in the cemetery. In addition, the city should periodically inspect the condition of the stones to ensure that no additional damage is being done during maintenance activities.
