# **PRESERVATION ASSESSMENT AND MAPPING OF THE REESE FAMILY BURYING GROUND, RICHLAND COUNTY, SC**

**Chicora Research Contribution 544**

Prepared By:  
Michael Trinkley, Ph.D.  
Debi Hacker  
Nicole Southerland

February 22, 2012

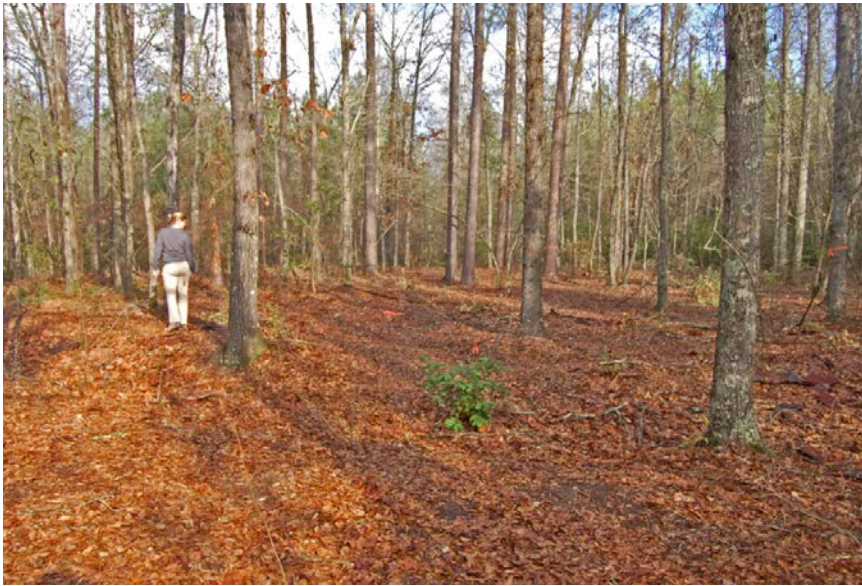
Figure 4. View of the cemetery looking northwest.

area of dense woods. Much of the surrounding area has been logged in the last 20-30 years and today consists of young pines. The cemetery area includes pine and oak hardwoods.

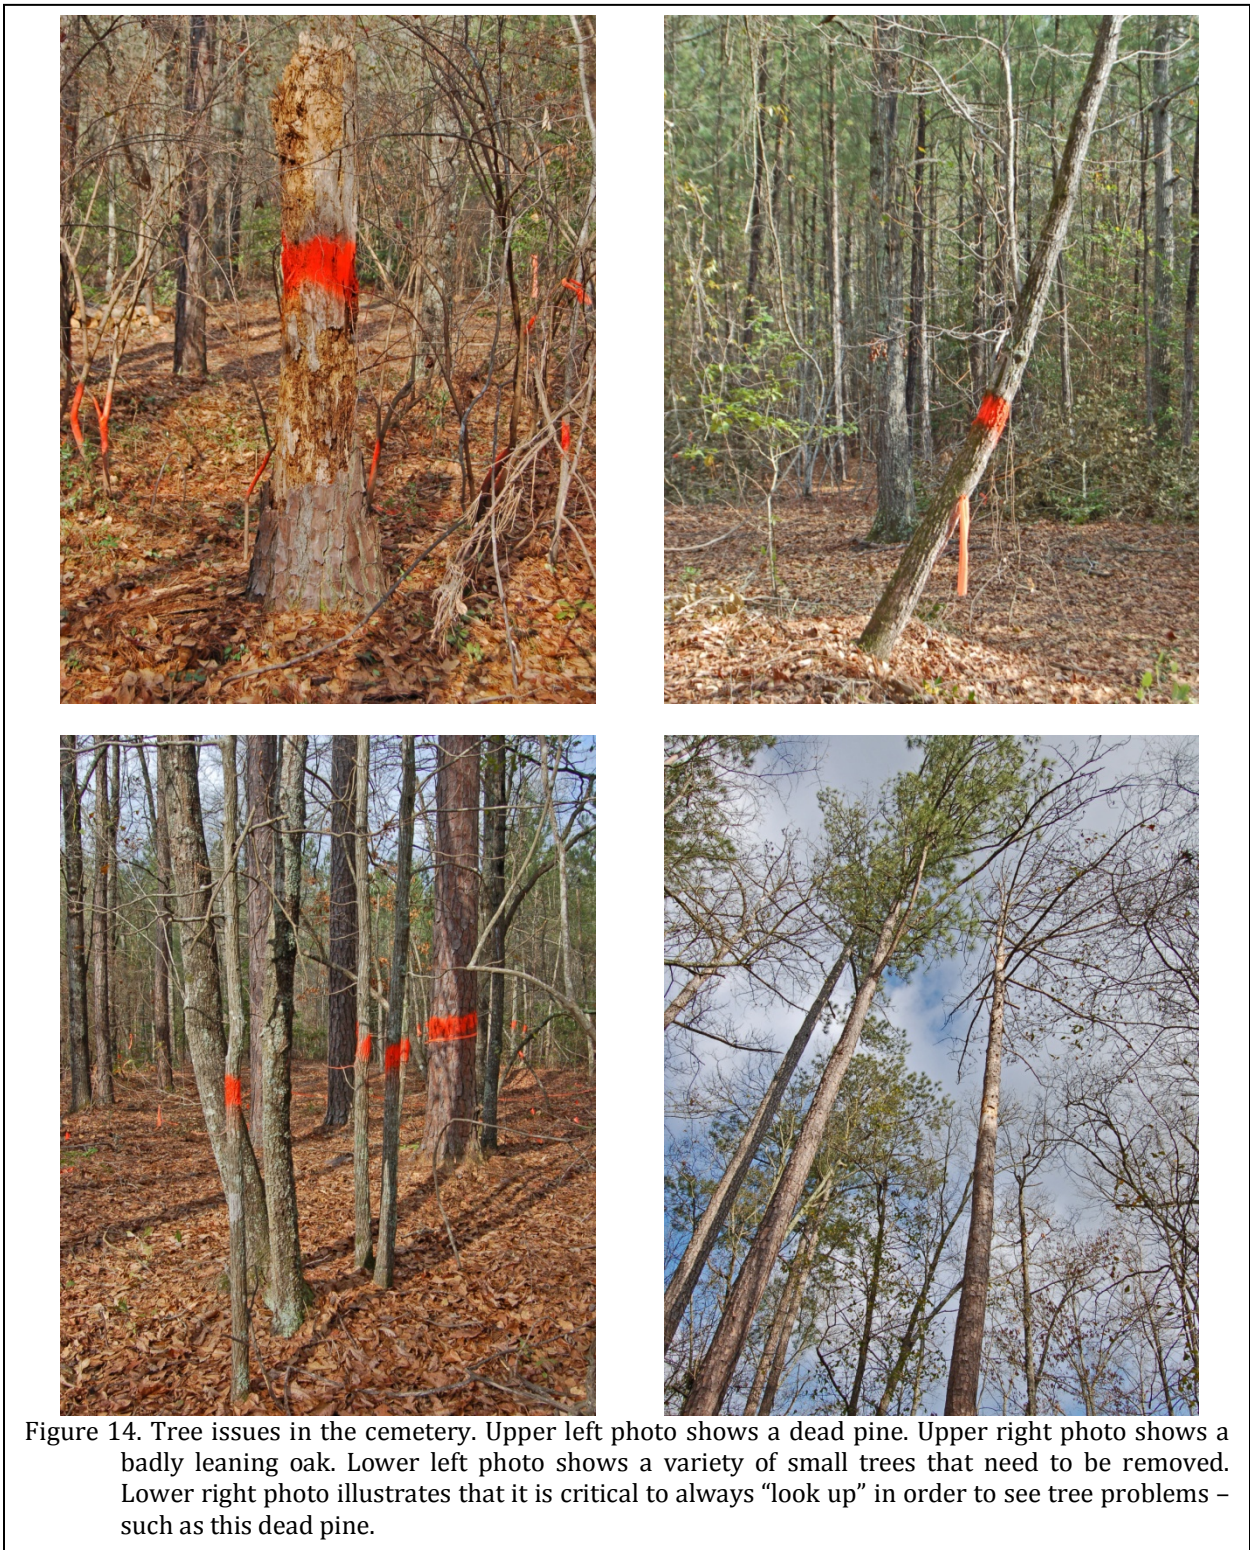
Figure 15. View of the ditch and dike that surround the cemetery.

There is no specific entry into the cemetery, which is surrounded by a low dike and ditch. We observed that even during this limited

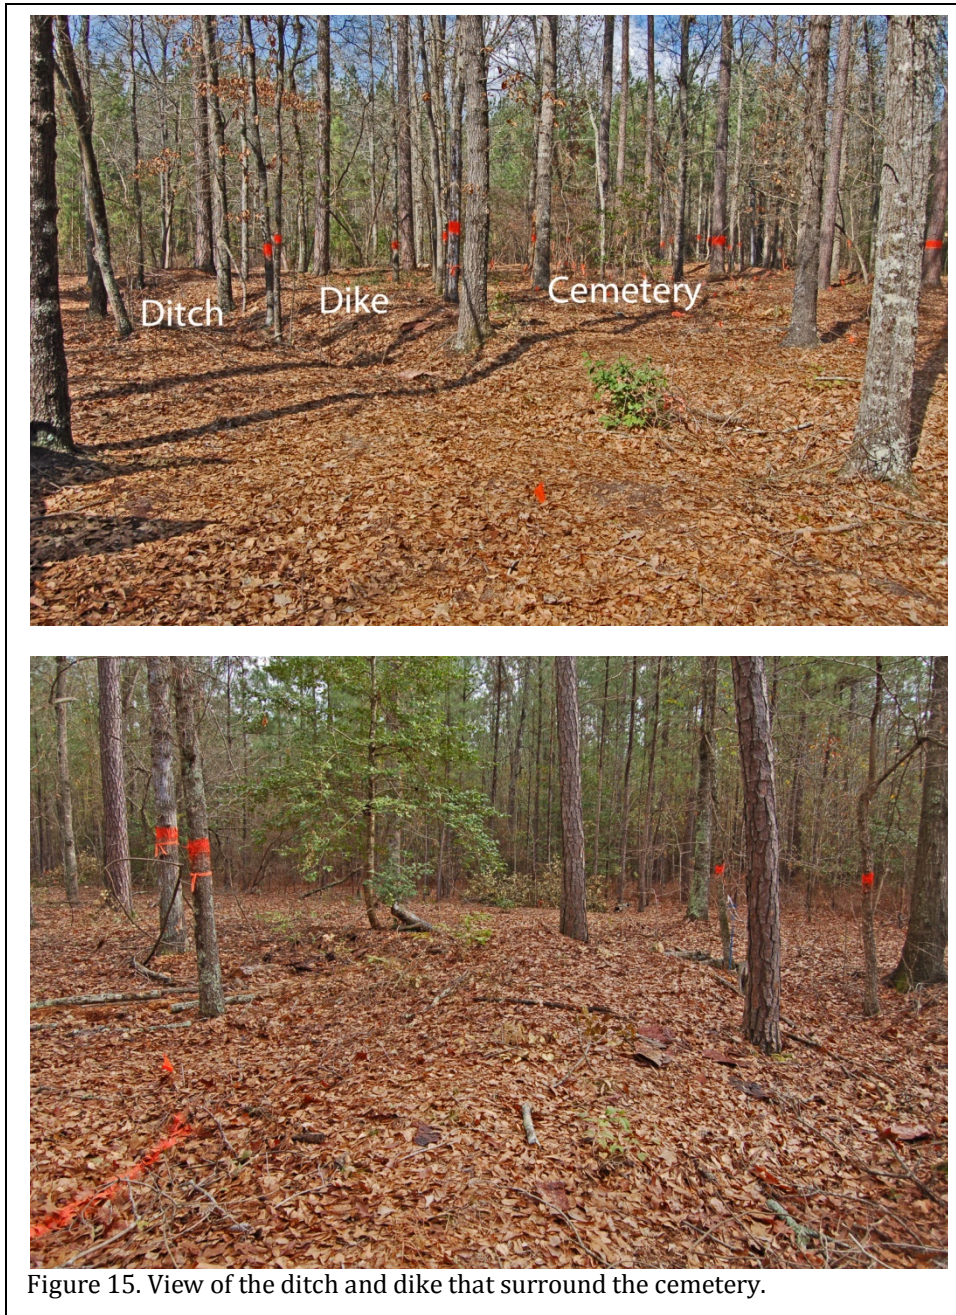
work to map the cemetery it was easy to quickly wear a pathway across these features. Thus, any significant visitation will begin to increase considerable erosion of the surrounding feature.

There is an existing level “entrance” or opening into the cemetery on the east side. The caregivers should strive to funnel visitors into the cemetery using this existing open space in order to minimize damage to the surrounding feature. One way to accomplish this is to locate signage concerning the cemetery at this natural entrance, thereby encouraging visitors to that point.

We also recommend that signage be placed in several places on the dike asking that visitors not climb or cross except at the eastern entrance.

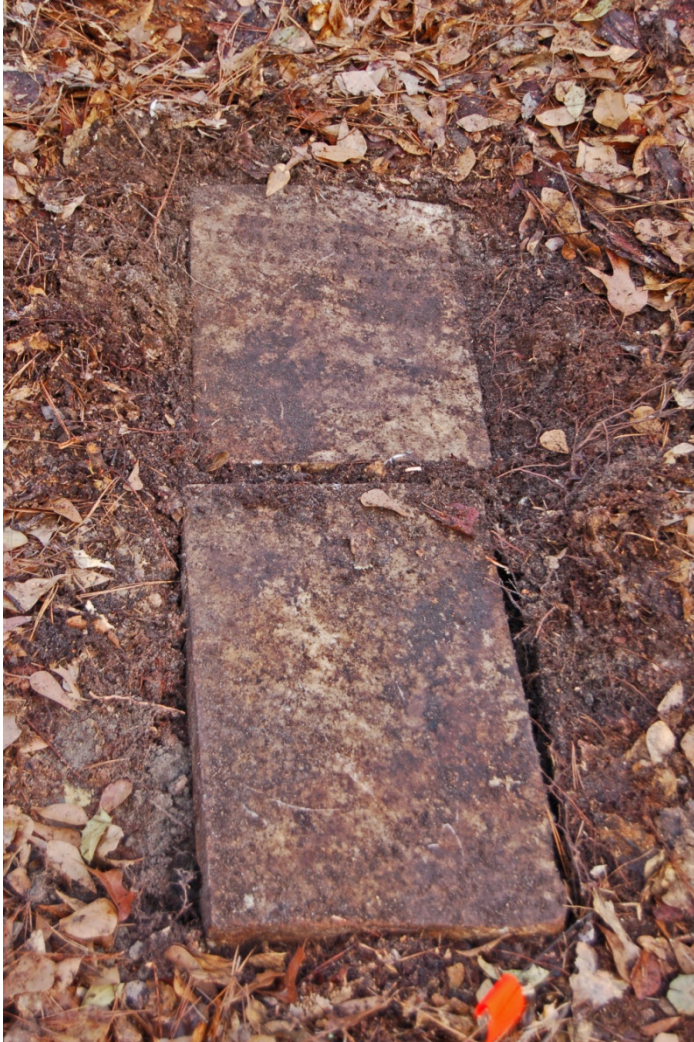
Figure 16. Broken stone for Mary H. Reese that requires conservation treatment.

With only one stone identified in this cemetery the damage is limited. It is, however, critical that appropriate conservation treatment be given a high priority since stones on the ground are subject to additional damage, increasing the eventual cost of appropriate repair.

Appropriate conservation treatment for this stone will involve drilling and pinning, carefully aligning the two fragments. Fiberglass pins and epoxy adhesives formulated for the specific stone are used in this type of repair. Diameters and lengths of pins vary with the individual application, depending on the nature of the break, the thickness of the stone, its condition, and its expected post-repair treatment.
