OCONEE HILL CEMETERY ASSESSMENT, ATHENS-CLARKE COUNTY, GEORGIA

Research Contribution 557

Michael Trinkley
Debi Hacker

February 2014

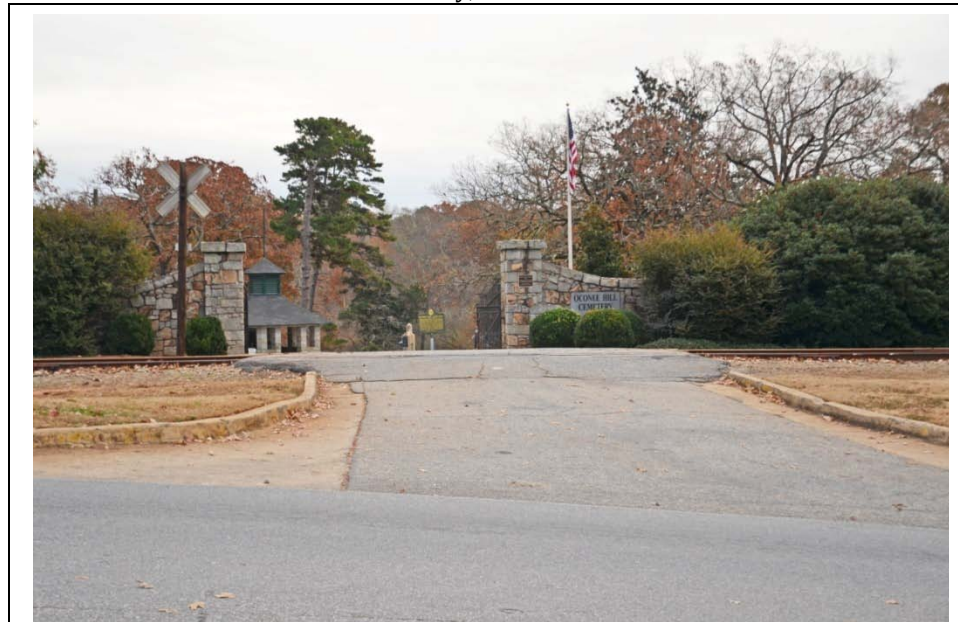
As previously discussed, the entrance to the cemetery has changed over time (see Figure 6). Today, the entrance is off East Campus Road (Figure 24), although there is a secondary entrance at the rear of the cemetery, off Carr

Figure 24. Entrance into the Cemetery from East Campus Road.

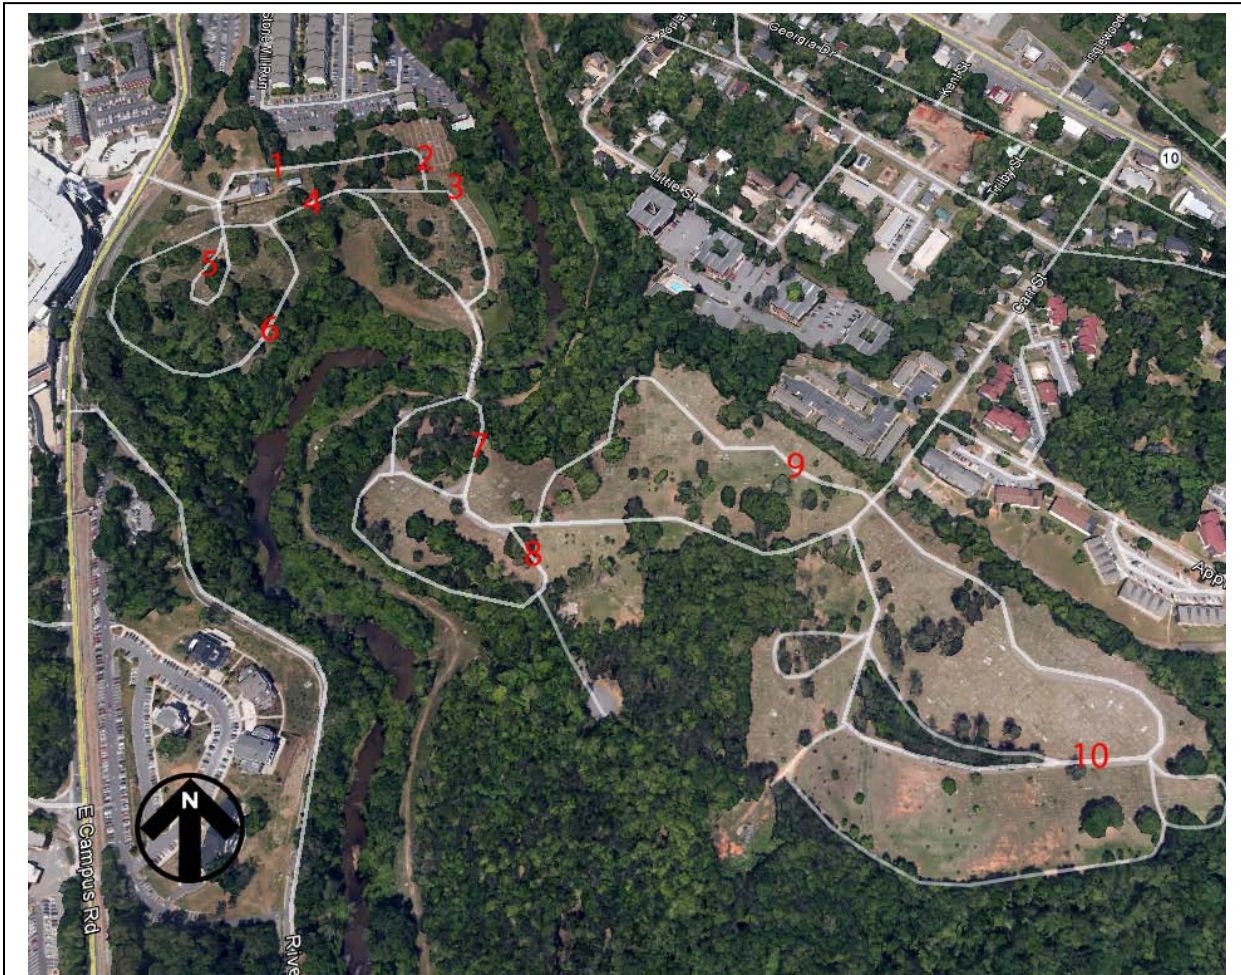
In order to better evaluate the condition of these roads, we randomly selected 10 locations to be examined (Figure 27), walking 100 feet on either side of the location. We recorded the type, quantity, and severity of each pavement distress and then determined the pavement’s rating based on a standard pavement condition index.

Common conditions included edge cracking, longitudinal cracking, transverse cracking, alligator cracking, pothole patching, and

Figure 27. Roads and assessment locations (in red numbers).

raveling. Not observed was block cracking, rutting or bleeding.

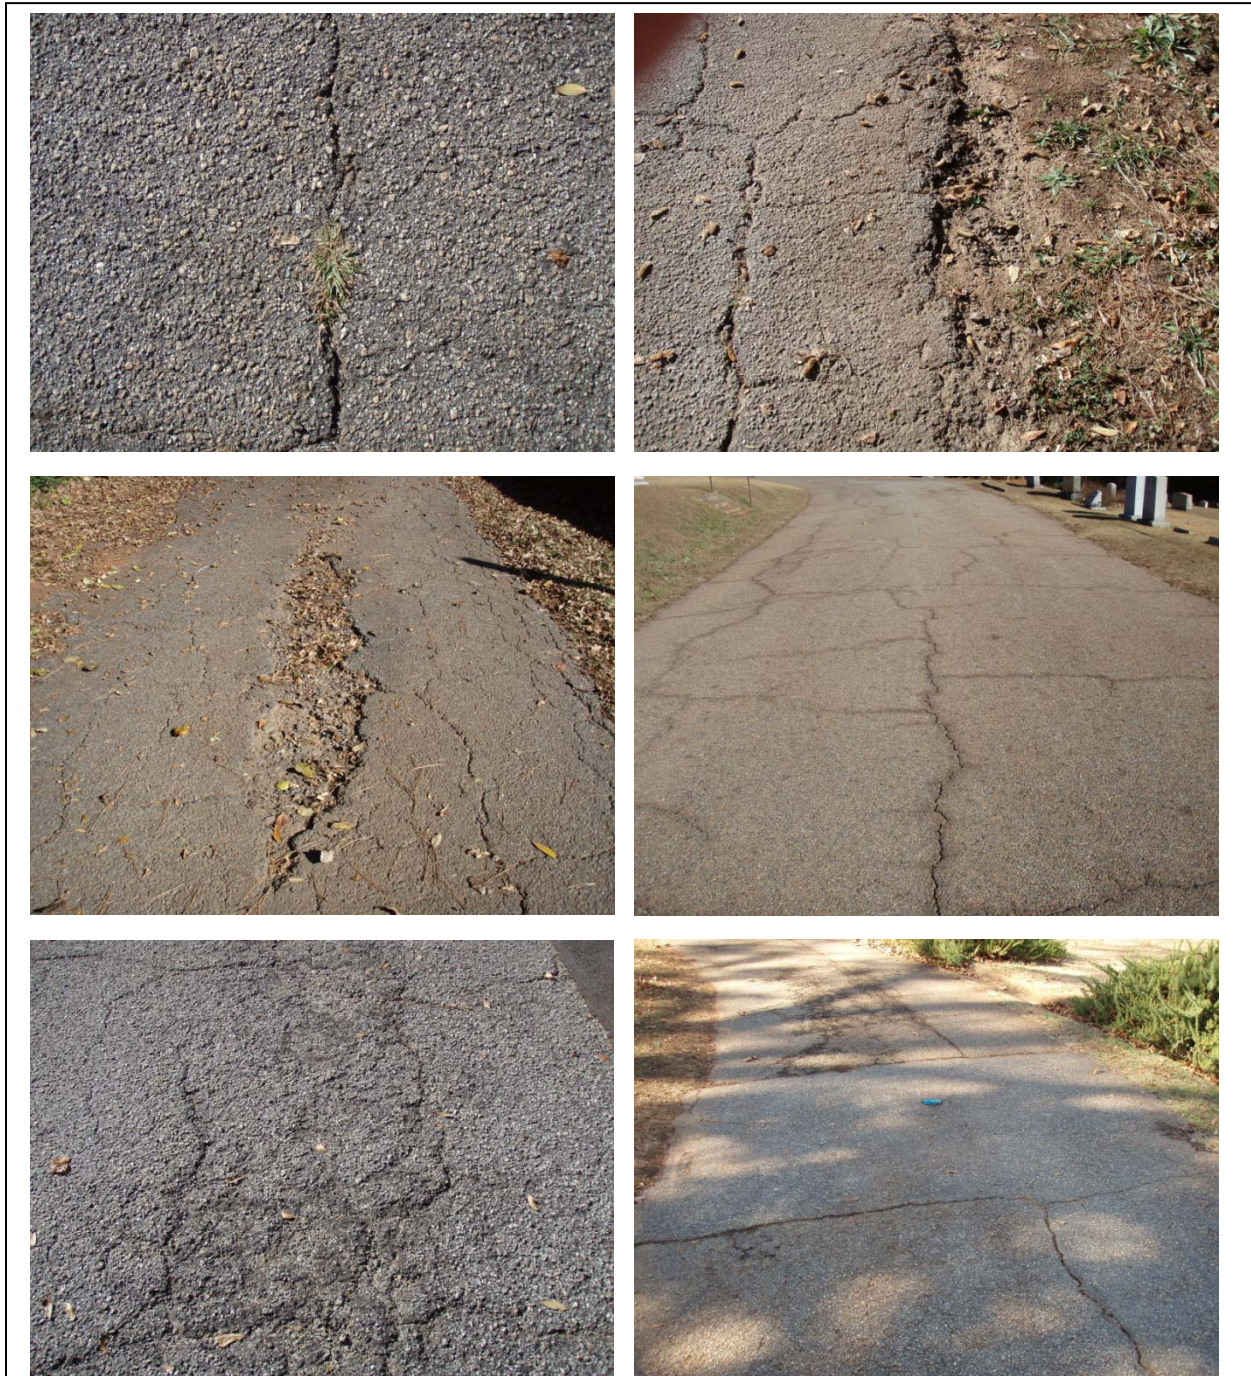
Figure 28. Typical road conditions at Oconee Hill Cemetery. Upper left photo shows a longitudinal crack with grass growing in the crack. Upper right photo shows pavement edge damage. Middle left photo shows an unrepaired pothole. Middle right photo illustrates longitudinal and transverse cracks. Note how water is retained in the cracks, causing further damage to the underlying base. Lower left photo shows raveling. Lower right photo shows a permanent patch.

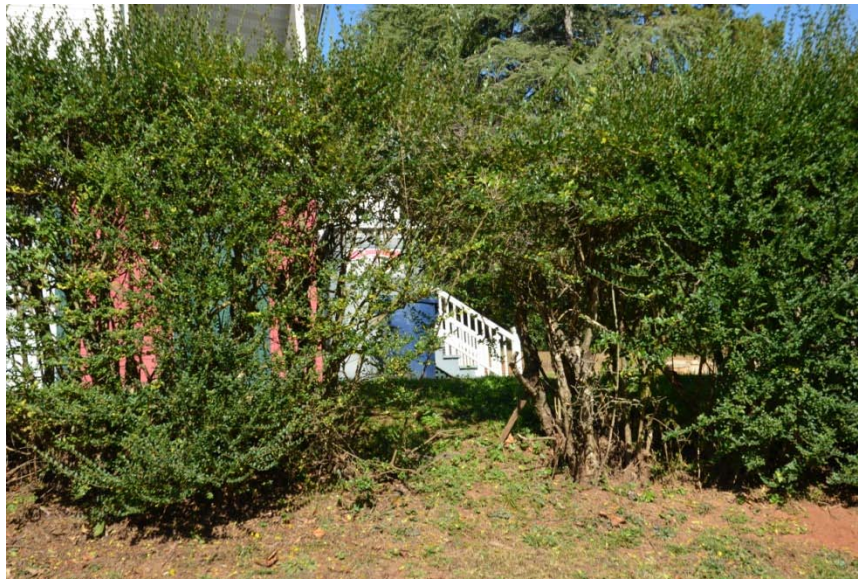
Figure 32. Informal or social trail from the North Slope Section to the Sexton's Cottage that is damaging the hedge.

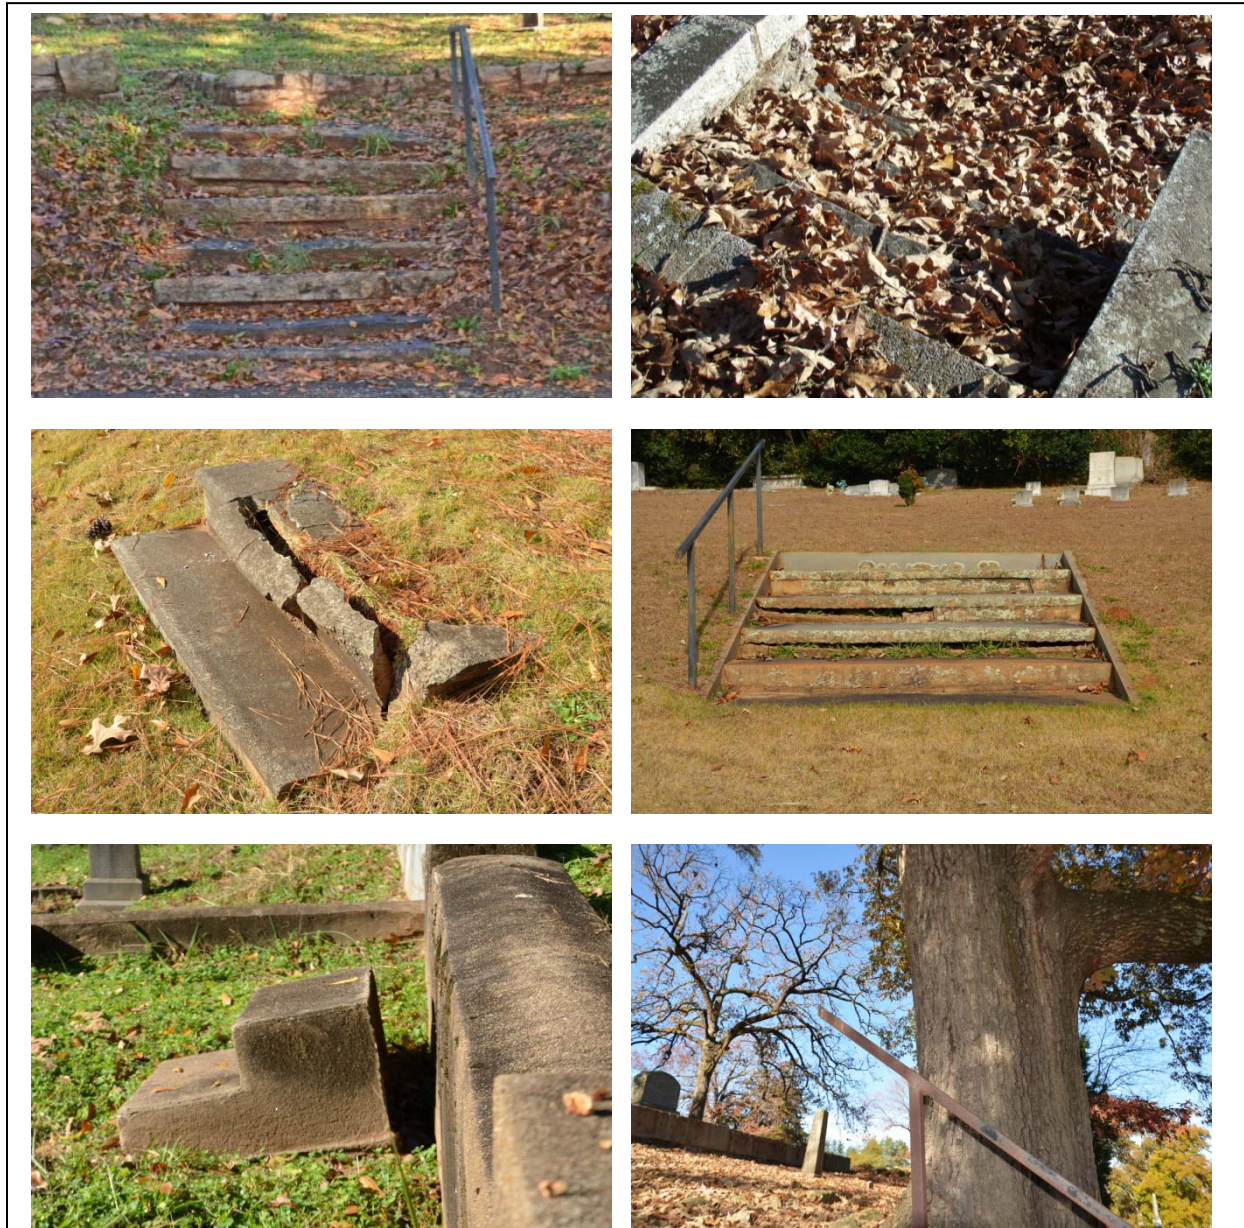
Figure 35. Stair and handrail problems. The upper left photo shows stairs with different height risers and treads of various widths. The upper left photo shows the hazard resulting from the failure to clean stairs on a regular basis. The middle left photo shows hazardous concrete stairs with extensive deterioration. The middle right photo shows stairs with damaged risers that are allowing grass to grow. Lower left photo shows stairs that have sunk into a lot, presenting a significant hazard to users. The lower right photo shows a handrail that poses a penetration hazard to pedestrians who might lose their footing on the steep slope leading to the stairs. Many of these issues require immediate intervention.

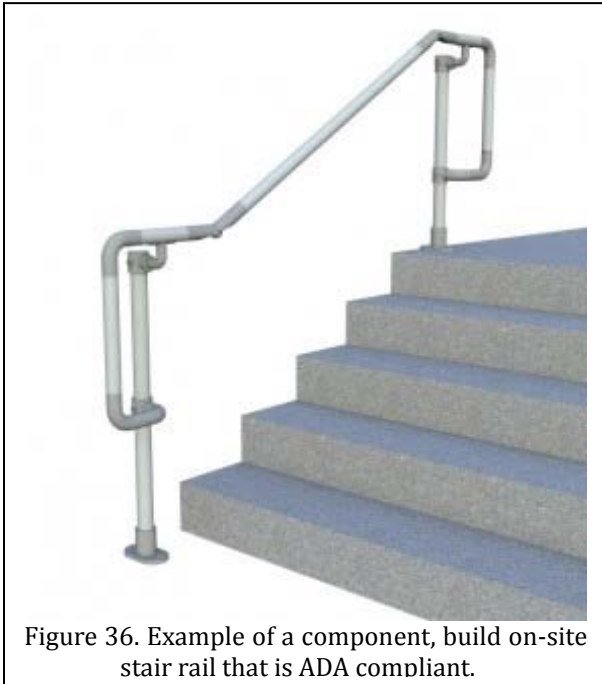
Figure 36. Example of a component, build on-site stair rail that is ADA compliant.

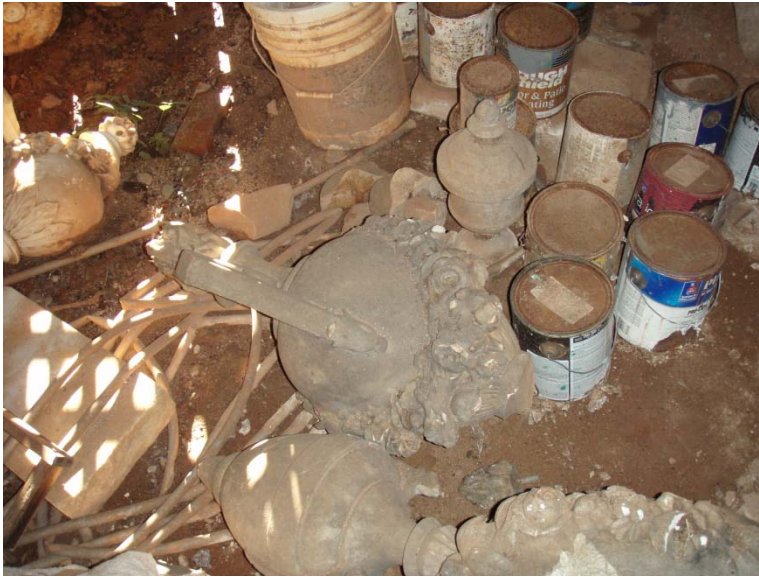
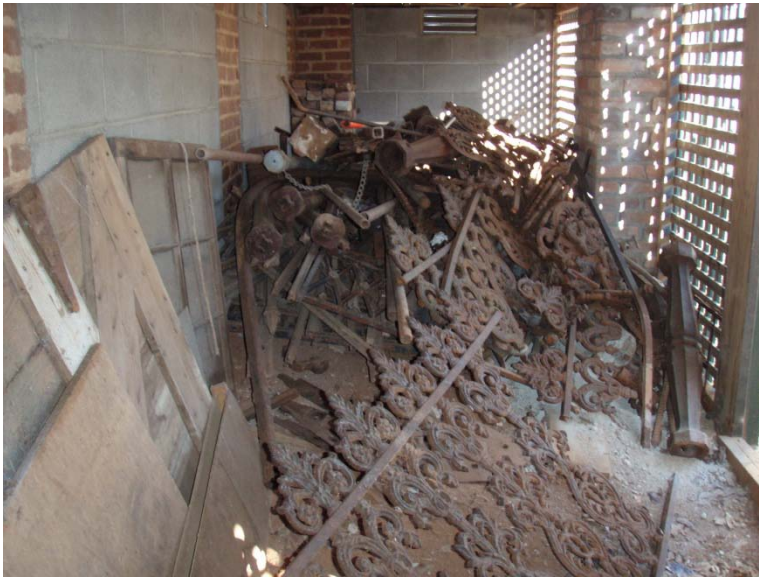
There is storage under the back porch of the cottage. Some of this represents orphan stones and fence parts. They are not well organized and none of the materials are individually identified. The iron work is laid directly on the ground, exacerbating corrosion. One of the stored stones is apparently not from Oconee Hill. We also observed a large quantity of paint cans. If these are oil based paints they are combustible and their storage here is a very poor idea. Even if they are latex, most of the cans appear old and it is unlikely the paint is still useful. Further under the house is a grinding stone, apparently left from an earlier period.

Figure 39. Storage under the Sexton's Cottage. This area must be cleaned and better organized.

A day should be spent to remove all of these materials, discarding the paint, determining if a museum might want the grinder, returning the stone that does not belong in Oconee Hill to the

Athens-Clark County Police, and restacking the remaining materials in an orderly fashion. It reflects poorly on the cemetery to have ironwork simply thrown in a pile.

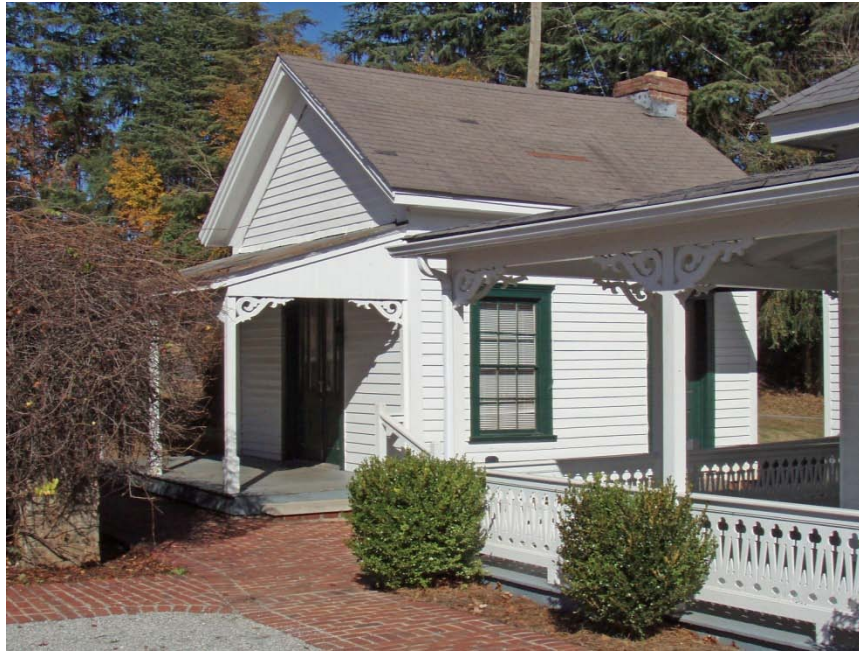
Figure 40. Oblique view of the Sexton's Office, looking northeast.

If not already, the Sexton's Office should receive the same monitoring of door contacts, glass break, and fire, as the Cottage. Not only is it an important structure in its own right, but any undetected fire in this structure would quickly spread to the Sexton's Cottage.

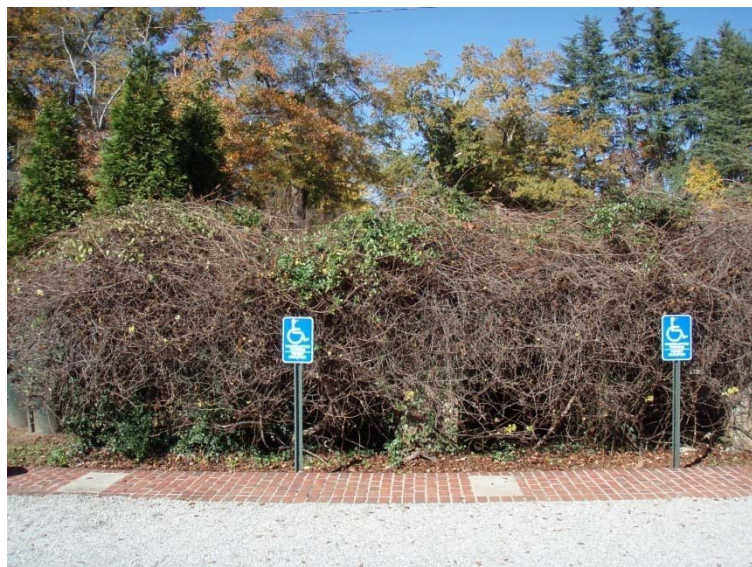
Another exceptional opportunity in the work yard is the raised bed garden. This, like the arbor, appears abandoned and clearly has not been planted in years.

Figure 41. Heavily overgrown grape arbor, looking north.

It offers an exceptional opportunity for educational plantings. It might, for example, be planted with a variety of traditional cemetery plants, such as boxwood (*Buxus sempervirens*, first mentioned in America in 1652), canna lilies (*Canna* spp., introduced in 1596), daffodil (*Narcissus* spp., introduced in

1737), iris (*Iris germanica*, first mentioned in America in 1672), snowbell (*Leucojum aestivum*), snowdrop (*Galanthus nivalis*, introduced by 1500), and climbing or rambling rose (*Rosa hybrida*).

Like the arbor, it would be possible to integrate this garden into various horticultural workshops.

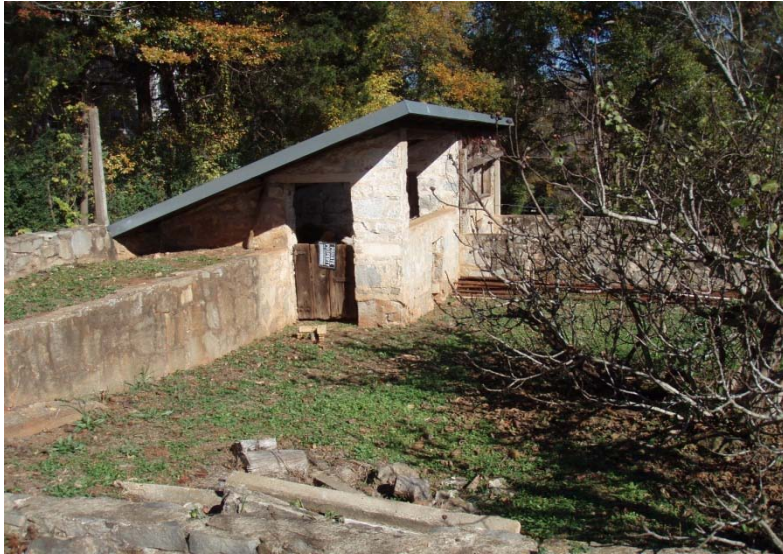
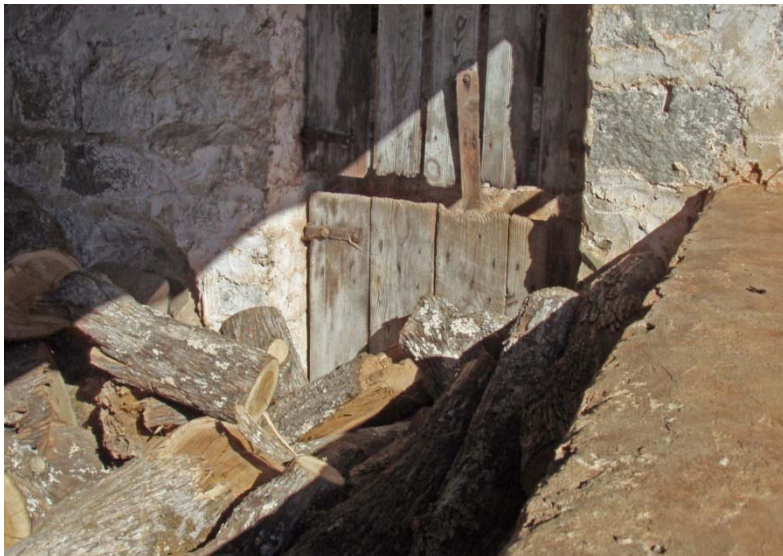
Figure 42. Animal pen. The upper photo shows the animal pen with a shed roof. To the left is the raised bed garden. The lower photo shows logs thrown into the pen – these must be removed. Note also the original hardware.

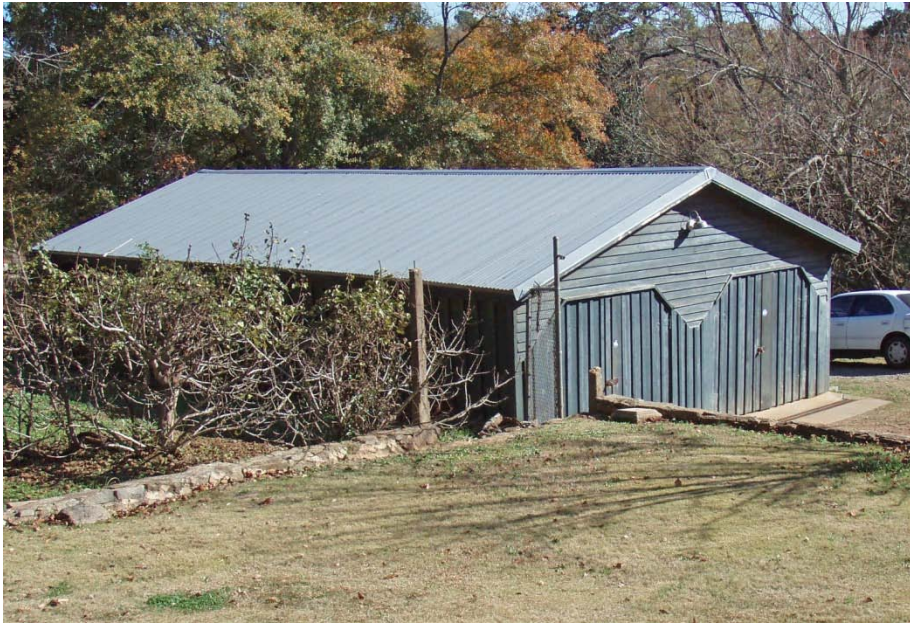
The existing maintenance building does not maintain the architectural detailing of other structures, having wood board and batten siding and a metal roof. The Friends have recently renovated this structure as well, although their focus was largely to provide deferred maintenance.

Figure 43. Oblique view of the maintenance building, looking southeast.

This, like the Sexton's Office, is a rather antiquated building. A modern maintenance building should provide a dedicated workshop (for repairing equipment, parts storage, sharpening mower blades), adequate bay space for

storage of vehicles, equipment such as a compressor (for inflating tires), an office for the foreman, a locker room for staff, and a mechanical room. This building provides only an open space into which materials are stored as best as possible.

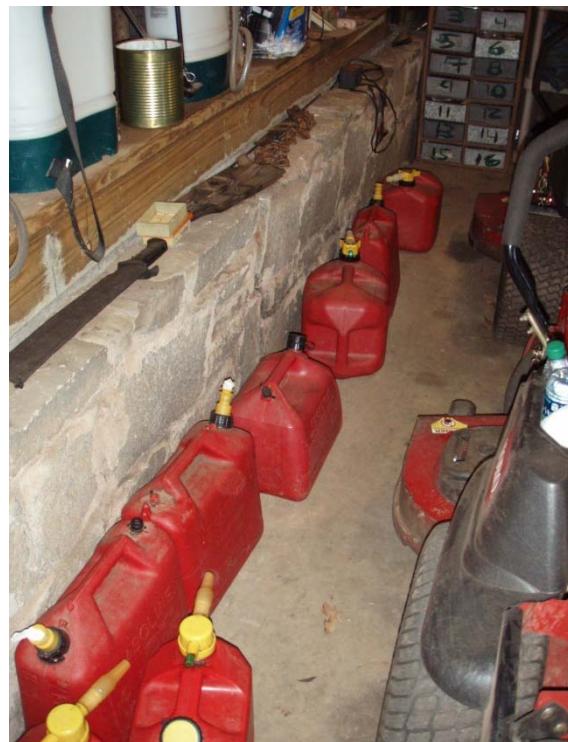
We also observed the storage of a very large quantity of plastic gasoline cans in this building. Figure 44 shows only some of the gasoline containers and we estimate that if they are all filled, this structure contains in excess of 50 gallons, exclusive of that in gasoline tanks of the three mowers and other equipment.

Of greater concern is the reliance on the use of plastic containers. OSHA 29 CFR 1926.155(l) specifies that containers must have a “flash arresting screen, spring-closing lid and spout cover and so designed that it will

safely relieve internal pressure when subjected to

Figure 44. Storage of gasoline in the Maintenance Building.

fire exposure.” Clearly, plastic containers do not meet this standard – a problem recognized by many landscape firms (see, for example, <http://www.fcps.edu/fts/safety-security/publications/seh-37.pdf>). Another safety expert provides a similar analysis (<http://www.wisesafetyenv.com/newsletter/archives/february2012/jr%20TechTalk%20Safety%20Cans%20knowing%20what%20to%20use.pdf>).

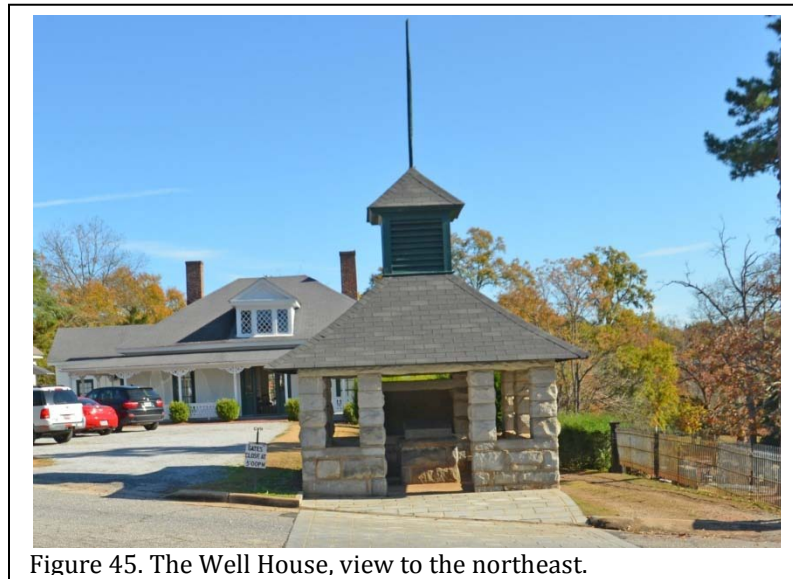
At some point the well house was modified, converting it into a focal point with no real function. The signage in the building provides no real benefits to the cemetery and consideration should be given to using the facility as an open air kiosk.

Figure 45. The Well House, view to the northeast.

A weatherproof map of the cemetery, coupled with weatherproof display racks (rules, Friends membership brochures, upcoming events) could allow this structure to play a real role in the cemetery.

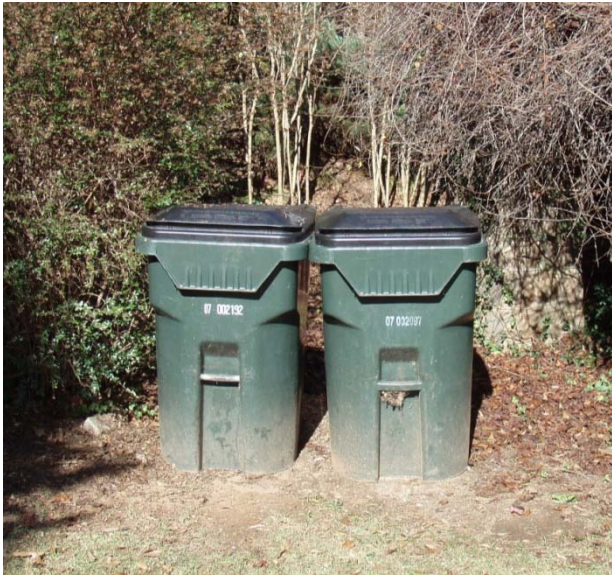
Figure 46. Trash cans off the parking lot in front of the Sexton's Cottage and adjacent to the grape arbor.

The trash containers in front of the Cottage should be moved to the location of the dumpster and all three should be surrounded by a privacy fence in order to minimize the view

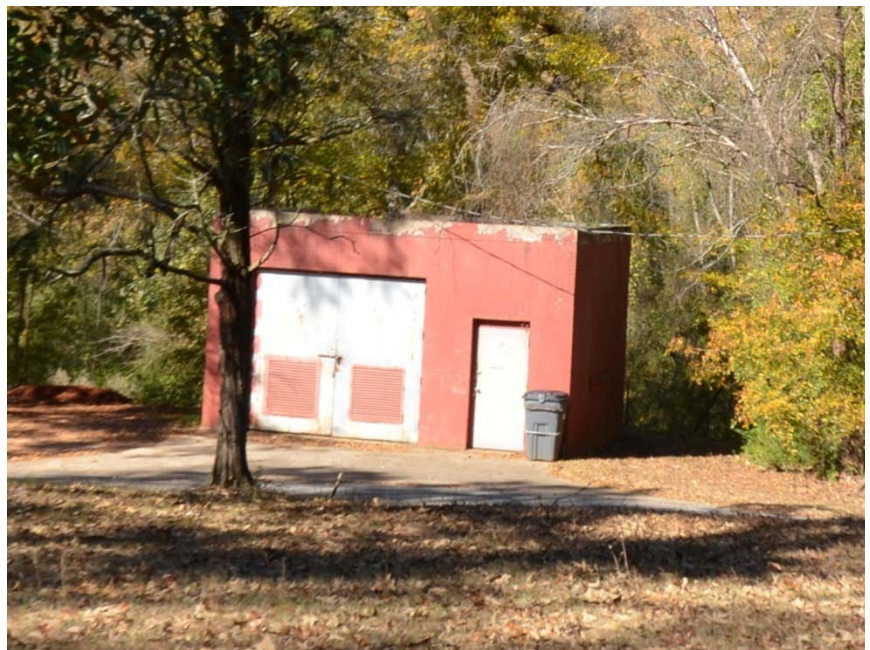
A second maintenance building is located on the south side of the river in the new section. We are told that the only item stored here is a push mower used primarily in the old sections. Rather than store the mower at this location, it would be more appropriate to move the ATV, which is used rarely and personally owned by Sexton, to this facility and locate the mower where it will be more convenient and accessible.

Figure 47. Maintenance building located in the new cemetery section.

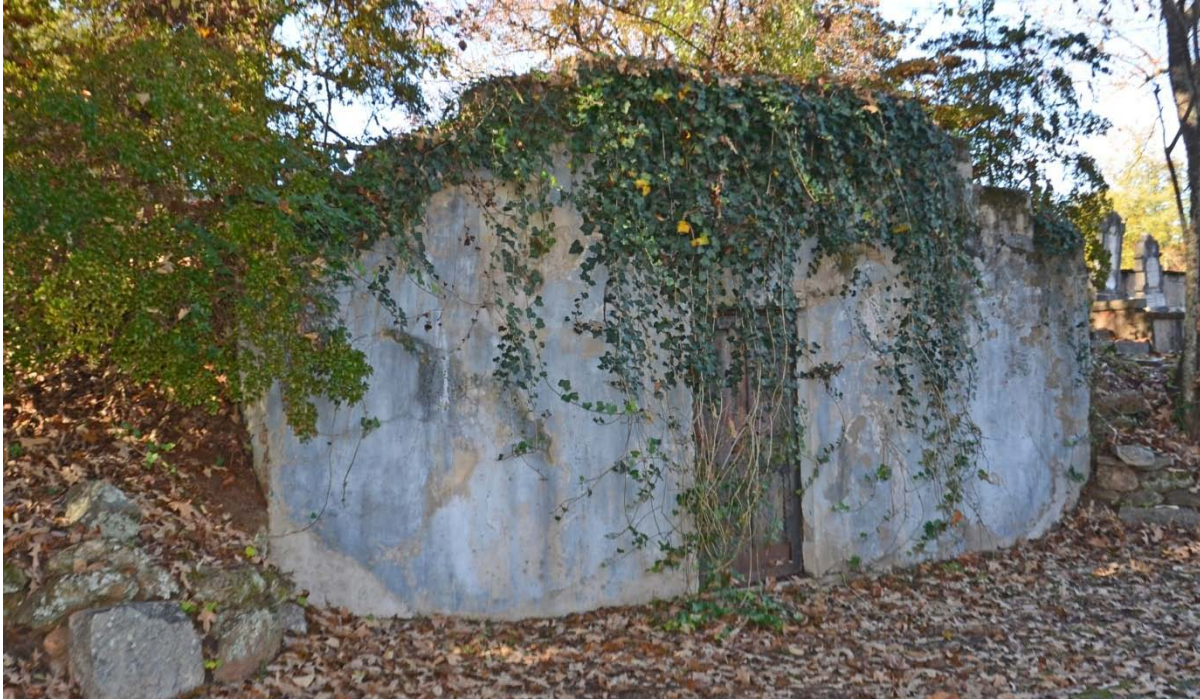
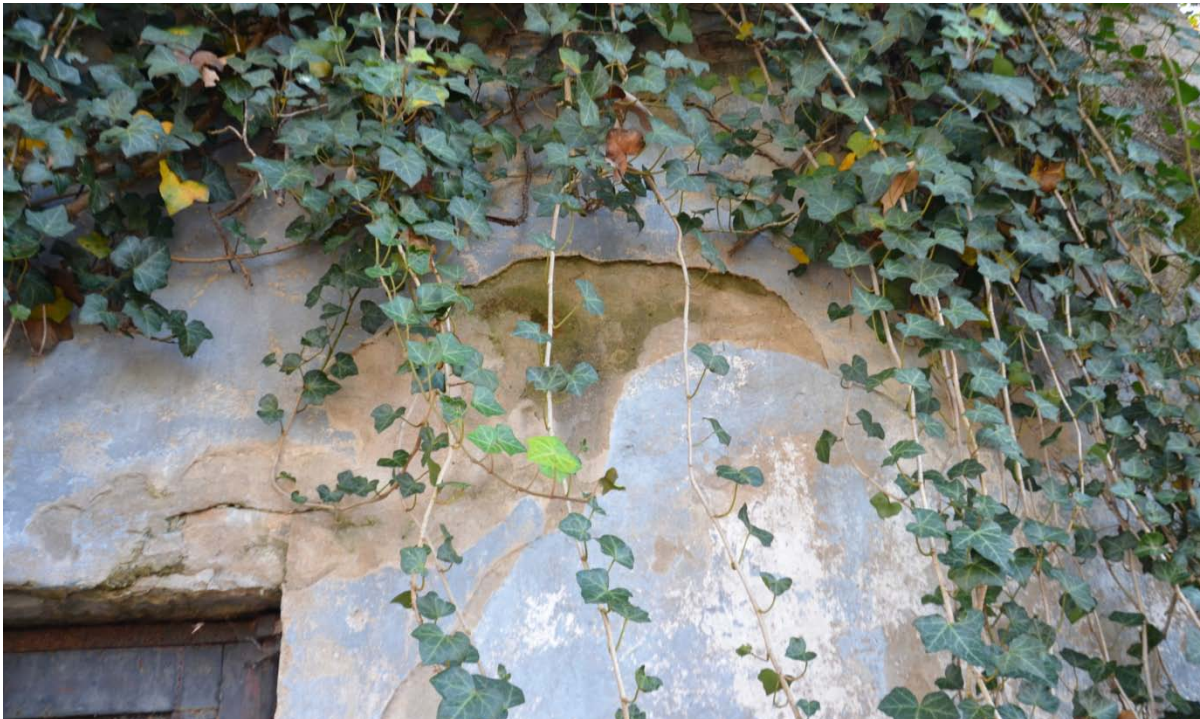
Figure 48. Holding vault. The upper photo shows the overall tomb condition. The lower photo shows spalling stucco and water damage.

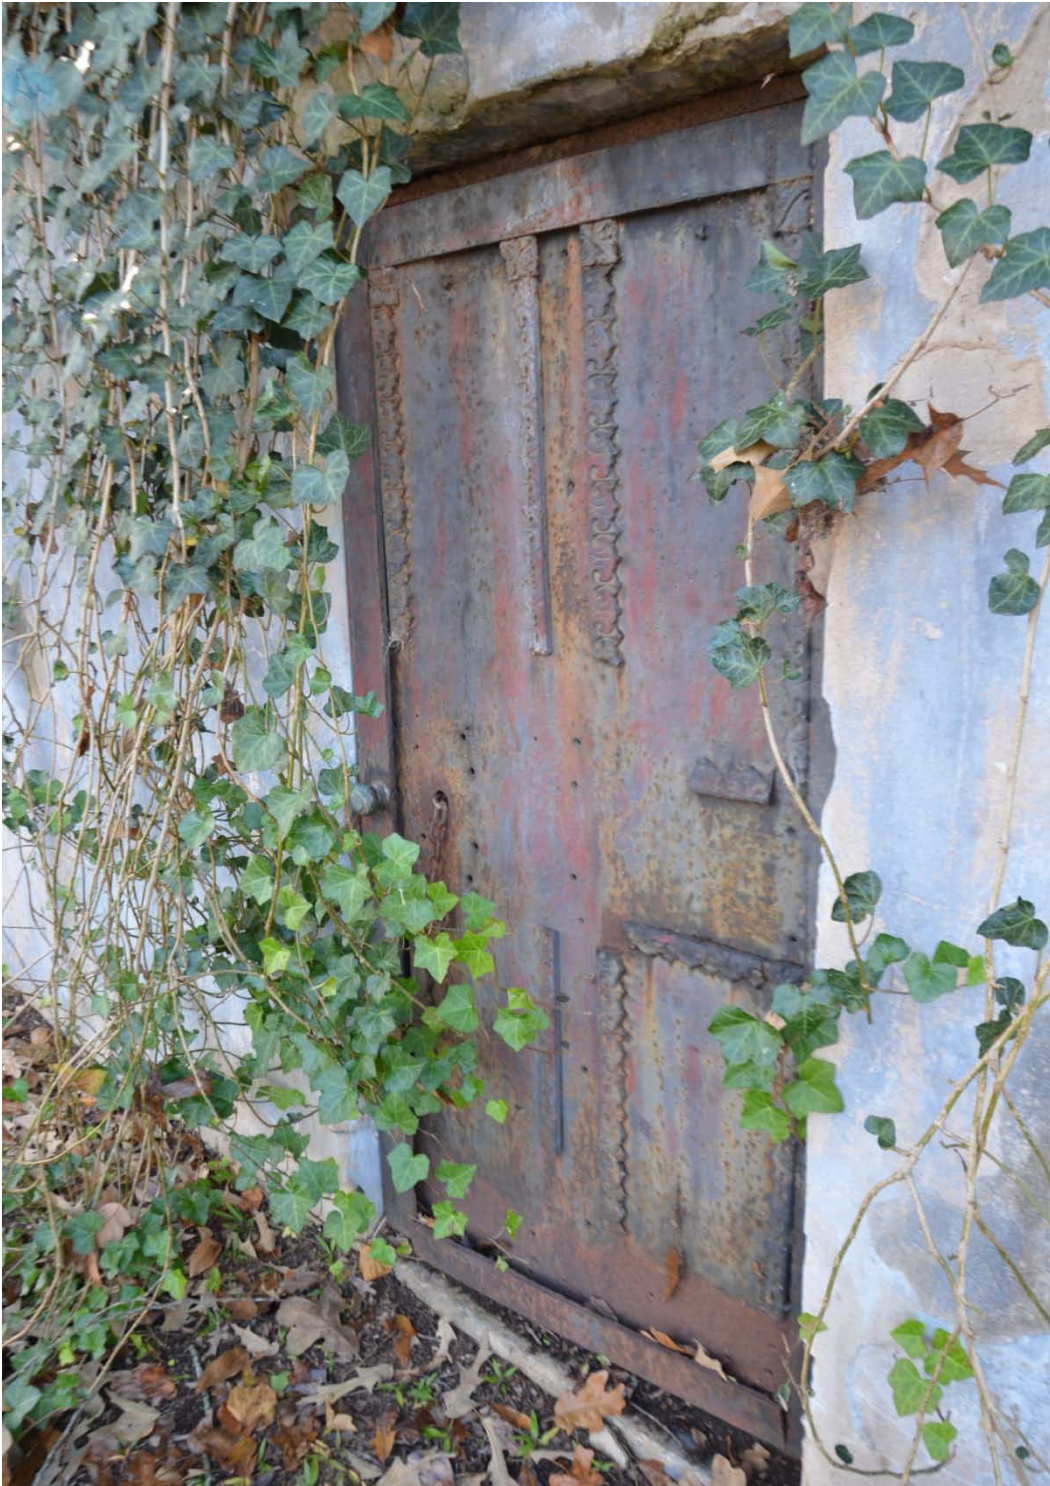
Figure 49. Holding vault. Photo of the badly damaged vault door.

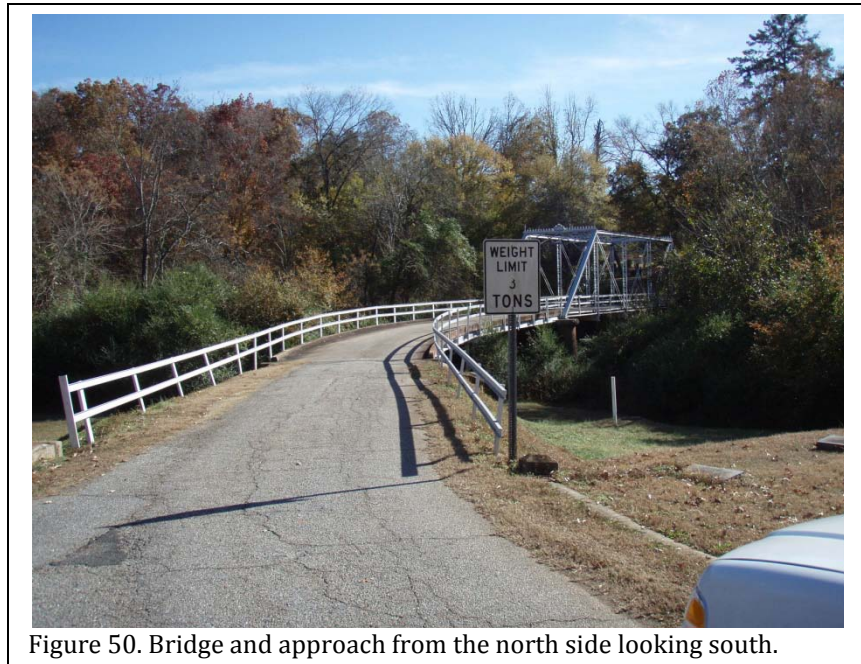
In late 2009 the cemetery bridge was evaluated by Hatch Mott MacDonald in Atlanta, Georgia (Edwards 2009). The bridge was found to consist of six spans (numbered from south to north, with the main truss span identified as Span 2).

Span 1 is the south approach supported by steel beams and is 18.1 feet in length. The span is supported by a stone abutment (Bent 1) at the south and a 14 foot high brick masonry pier at the truss span (Bent 2). There is a concrete

Figure 50. Bridge and approach from the north side looking south.

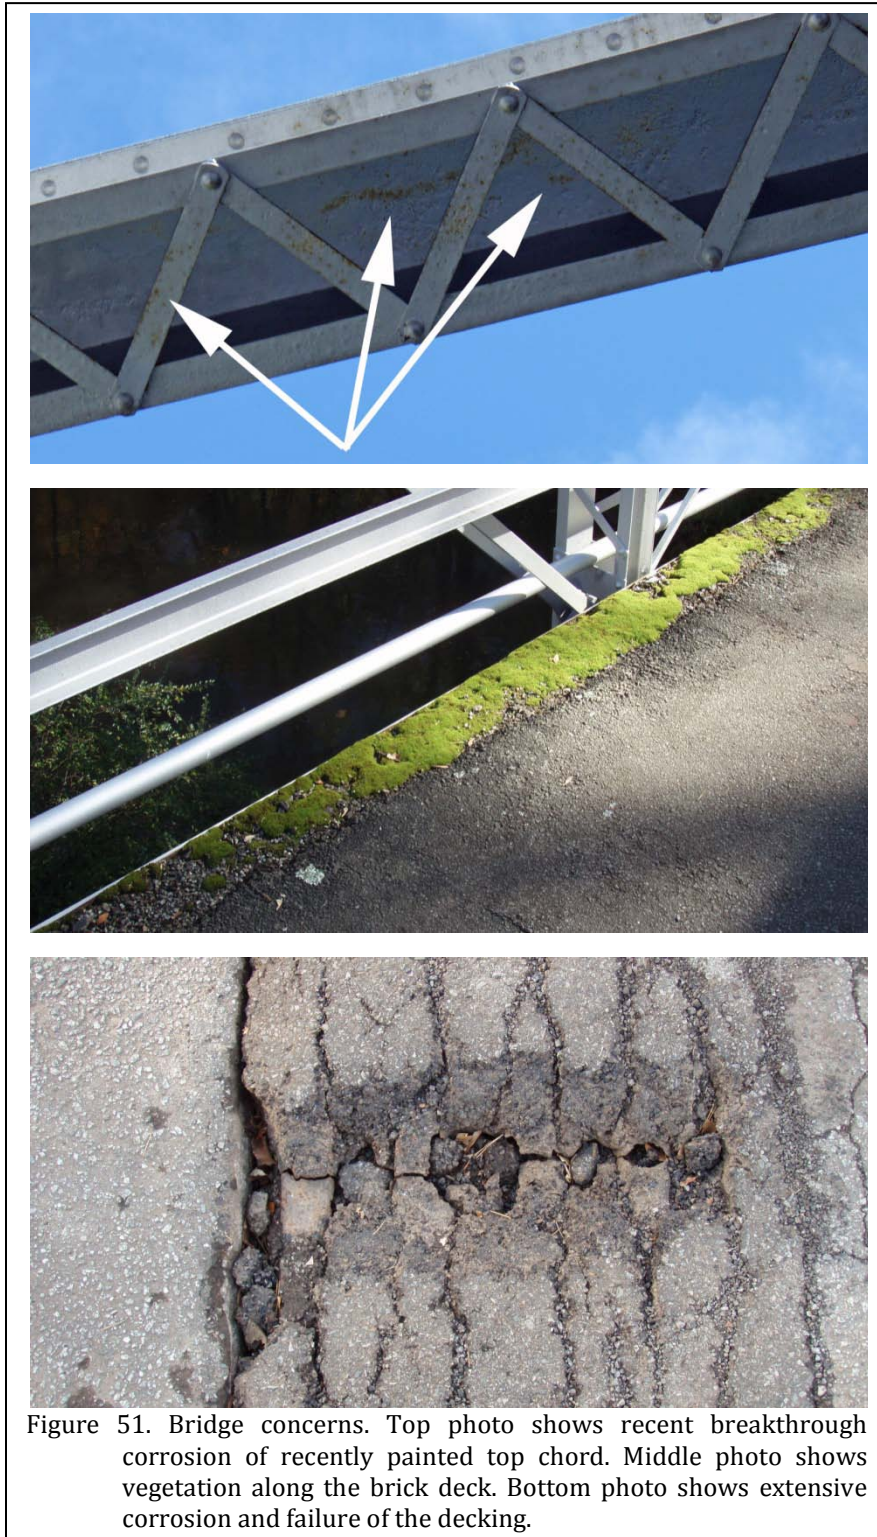
Figure 51. Bridge concerns. Top photo shows recent breakthrough corrosion of recently painted top chord. Middle photo shows vegetation along the brick deck. Bottom photo shows extensive corrosion and failure of the decking.

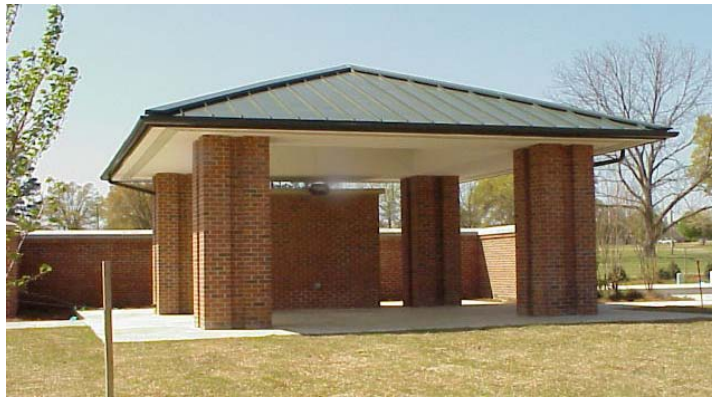
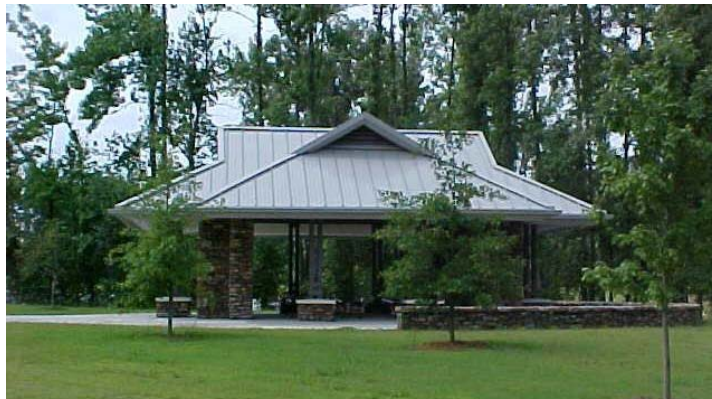
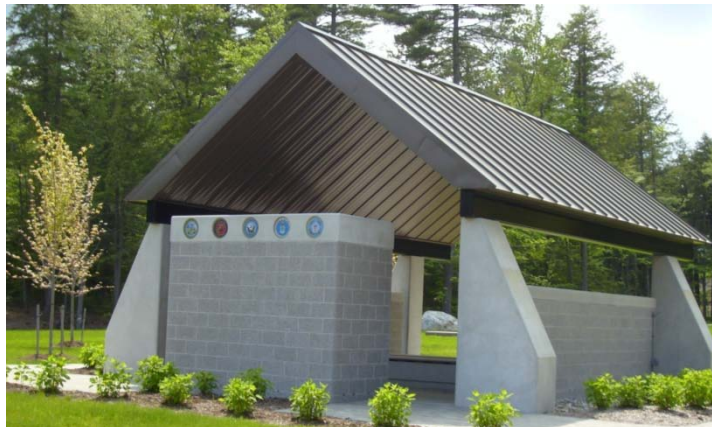
Figure 52. Three examples of VA NCA Committal Service Shelters showing different designs and materials.

Shelter is to provide a location for interment services away from the actual gravesite. It is a quiet, dignified, open, covered pavilion designed to provide temporary shelter from wind, rain, and sun.

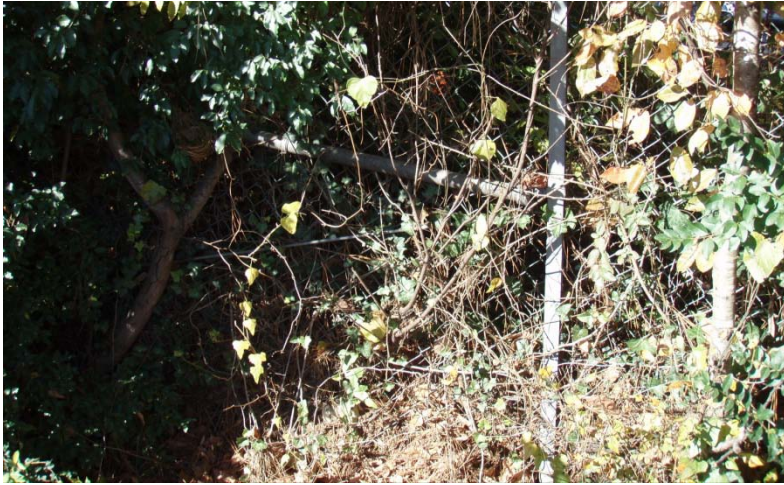
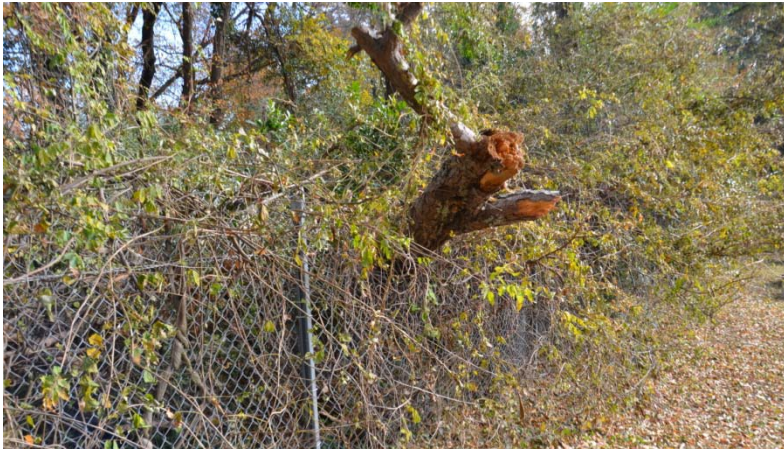
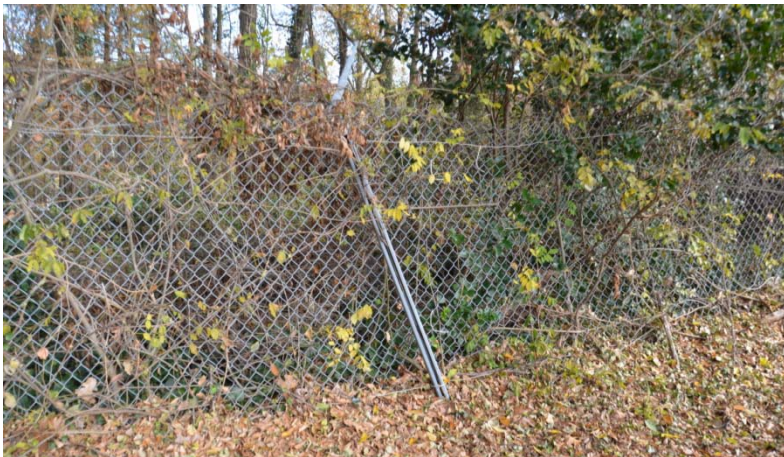
Figure 53. Fence damage, including fallen trees, overgrown fences, and collapse, that requires repair.

Once the vegetation is removed, access can be obtained to make fence repairs. These should minimally consist of resetting line posts, reattaching the fencing where necessary, and resetting and tensioning the three strands of barbed wire.

Additional fence should be erected to better control access from the railroad right-of-way at the entrance to the cemetery. While it may be impossible to totally enclose this frontage, the existing fence should be extended an additional 50 to 100 feet.

- The boundary fence should be cleared of all vegetation using a combination of brush killer and hand labor. Once cleared the fence should be inspected and repairs made as necessary.

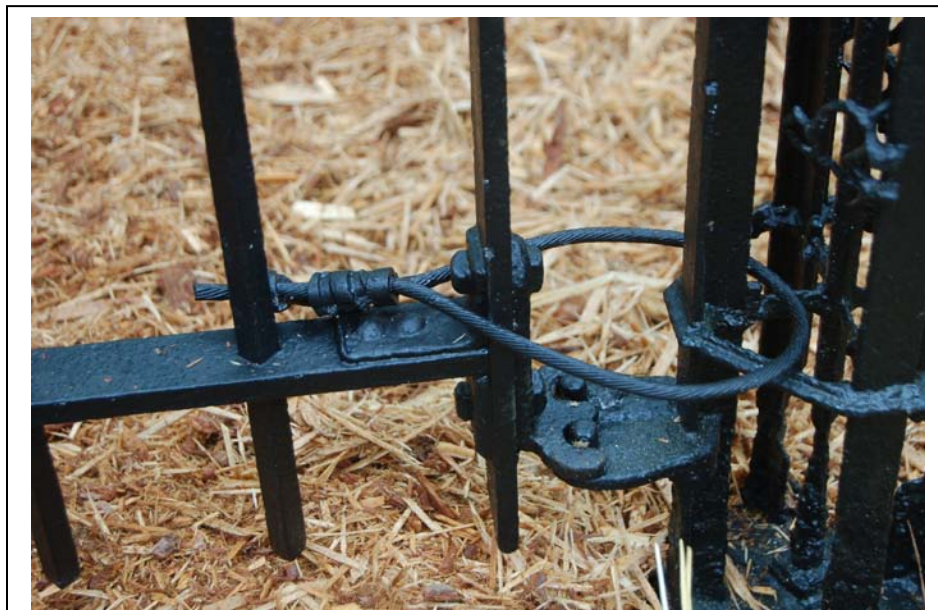
Figure 55. Example of a gate protected with stainless steel cabling that has been painted to blend with the fence.

It is a simple maintenance step to use woven stainless steel wire to secure gates to their hinge posts. This allows the gates to open and close, but makes them considerably more difficult to lift off their hinges and steal. The cost to protect gates is less than \$20 each and the time involved is about 15 minutes. This is something that the Cemetery staff, the Friends or other volunteers could easily accomplish. The NPS article, <http://crm.cr.nps.gov/archive/25-02/25-2-15.pdf> provides additional information.

- The boundary fence should be extended along the front railroad tracks for an additional 50 to 100 feet.
- All plot gates should have stainless steel cabling used to attach the gate to the hinge post to reduce the potential for theft.

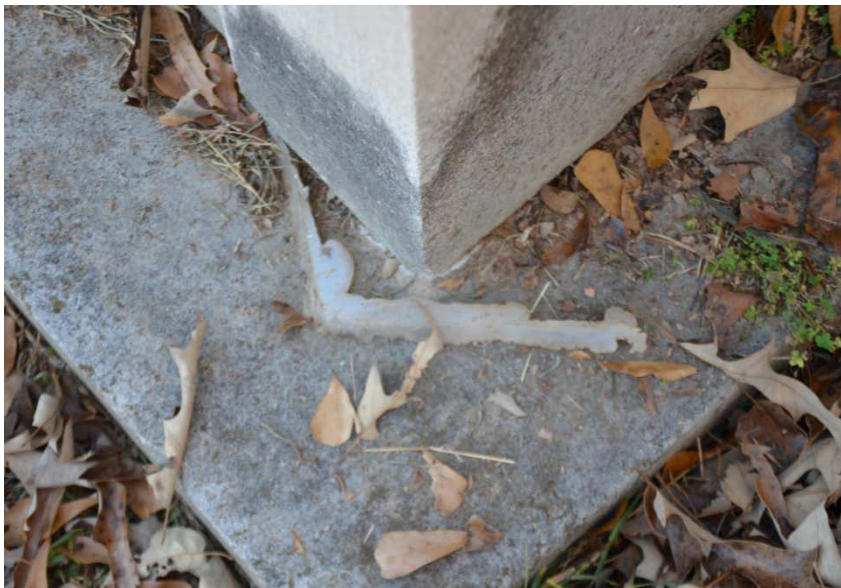
Figure 56. Silicone caulk that has failed on the Glenn Mausoleum in West Hill.

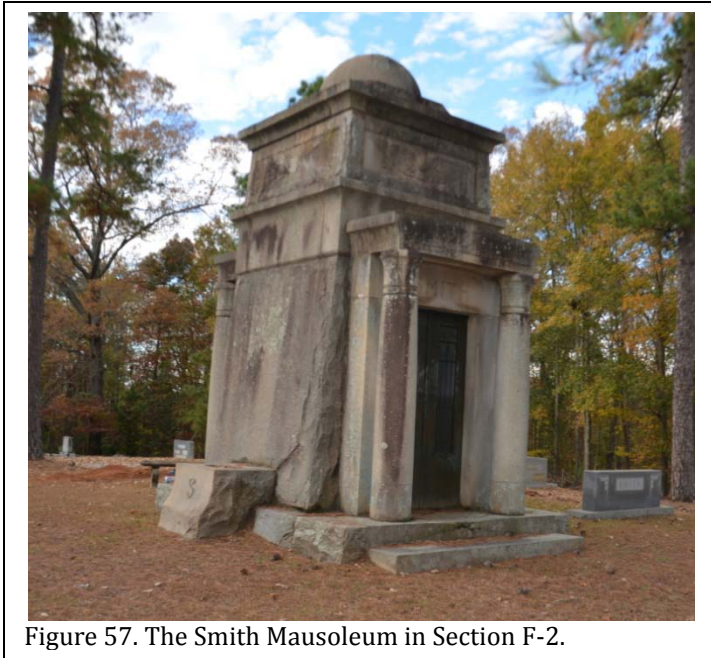
Figure 57. The Smith Mausoleum in Section F-2.

metal. The overall condition of the mausoleum is good, although the granite is stained and exhibits light lichen growth.
