OCONEE HILL CEMETERY ASSESSMENT, ATHENS-CLARKE COUNTY, GEORGIA

Research Contribution 557

Michael Trinkley
Debi Hacker

February 2014

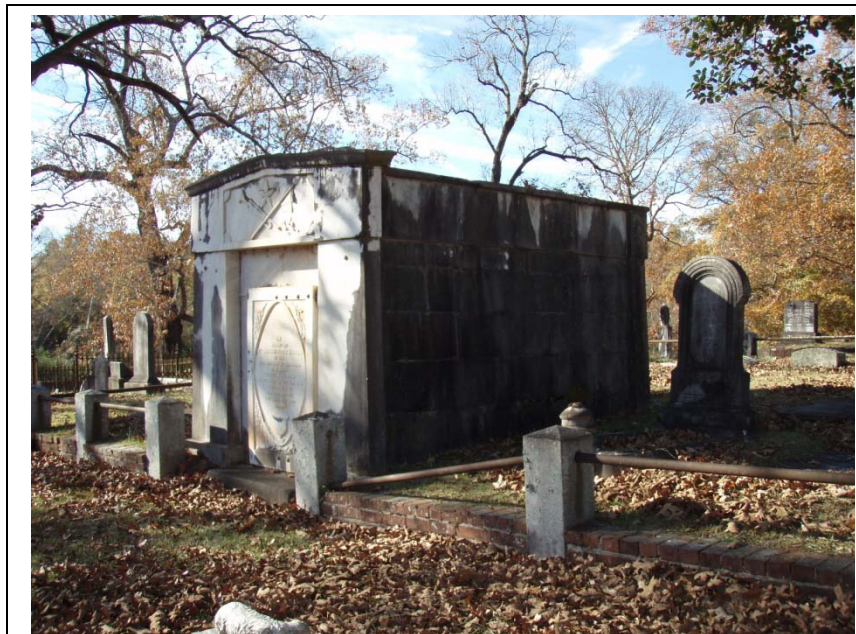
Figure 58. The Hunter Mausoleum in East Hill.

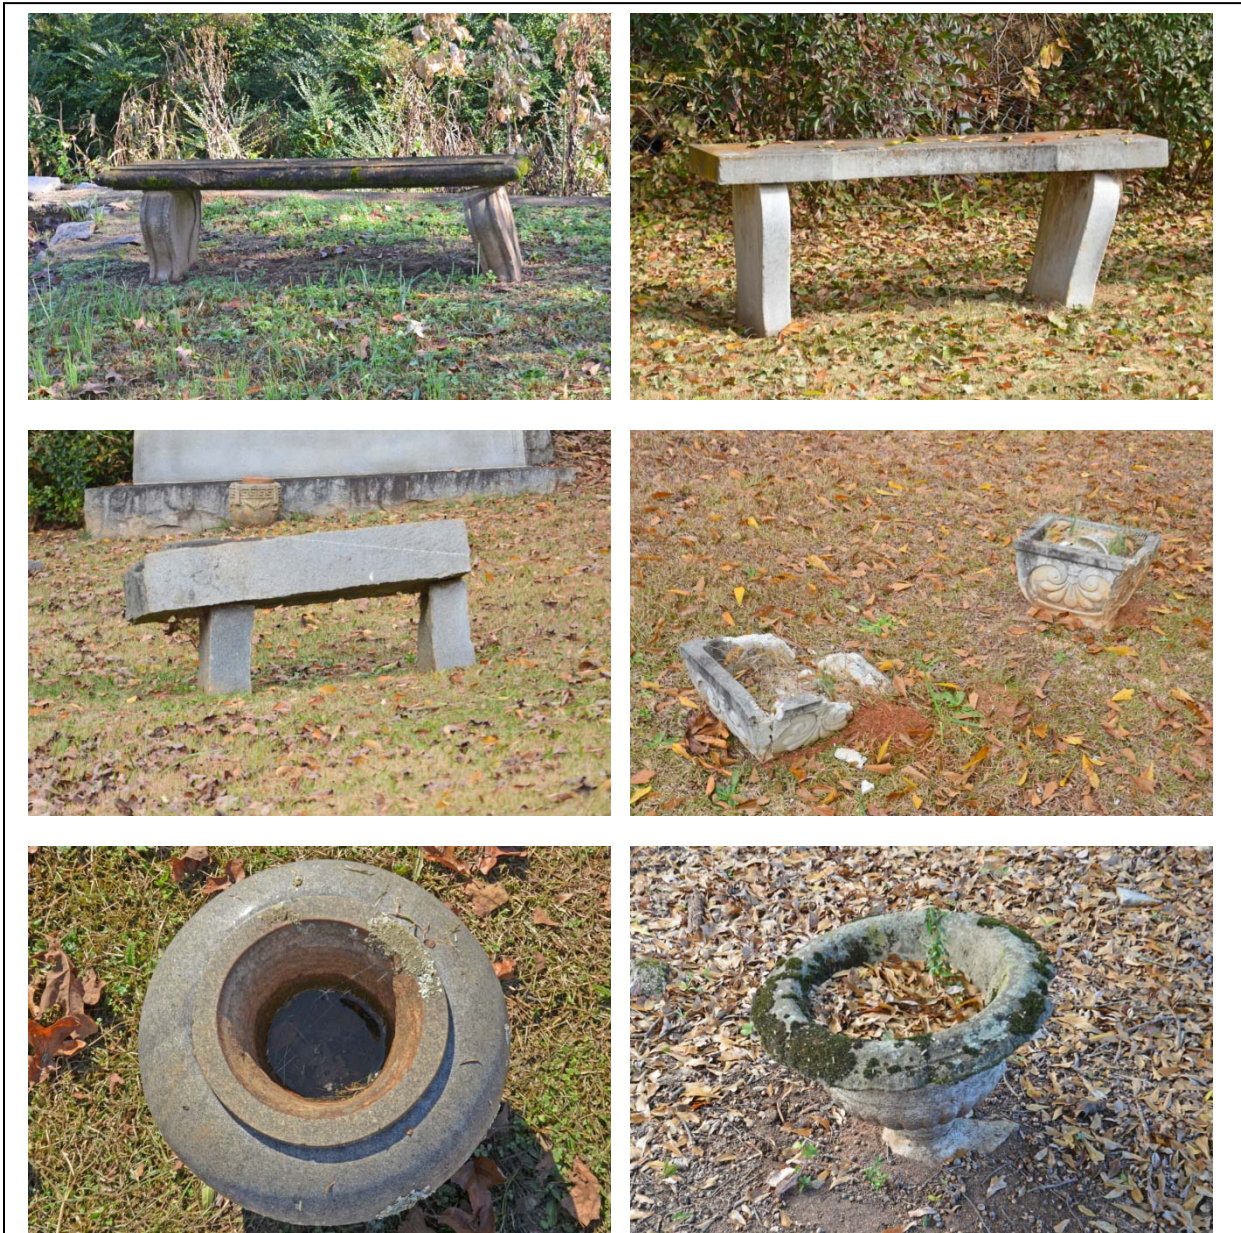
Figure 60. Bench and urn problems in the cemetery. The upper row shows two unsafe, poorly supported benches, one concrete and the other granite. The middle left photo shows a poorly set granite bench that is a safety hazard. Middle right photo shows two concrete urns, neither of which are planted. The urn on the left shows typical freeze-thaw deterioration and should be removed. The urn on the right is filled only with trash. The bottom left photo shows a polished granite urn that is partially filled with water. The bottom right photo shows a marble urn that is filled with trash and debris and which is settling in the ground.

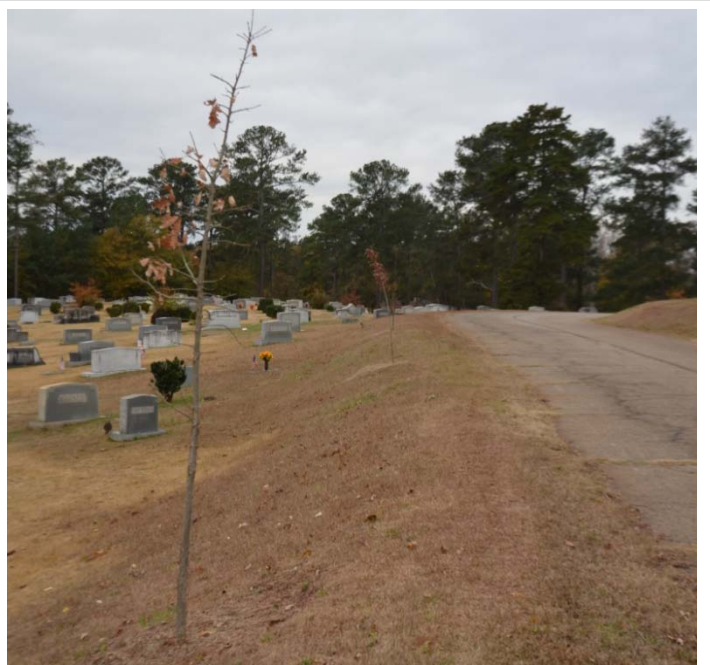
Figure 64. Small, unhealthy trees with evidence of nylon trimmer damage.

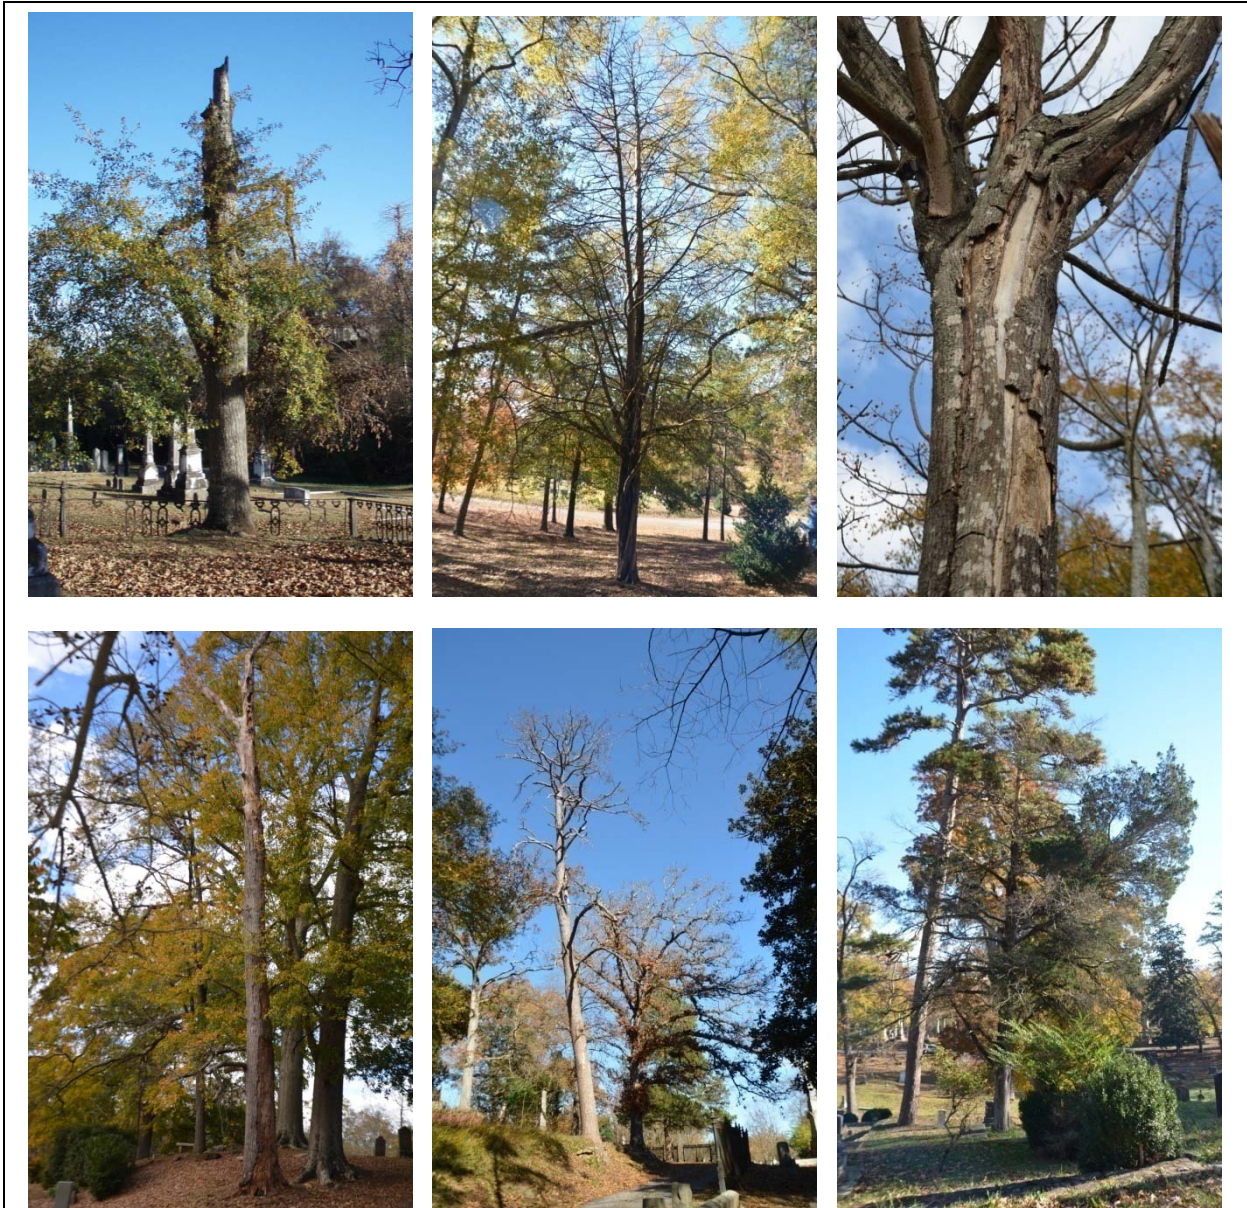
Figure 65. Examples of dead or hazard trees. Upper left, topped tree in East Hill. Upper middle, dead tree in Section A. Upper right, dying Chinaberry tree in Section Old G. Lower left, dead tree in Section B. Lower middle, dead tree in West Hill. Lower right, dead tree in Valley Section.

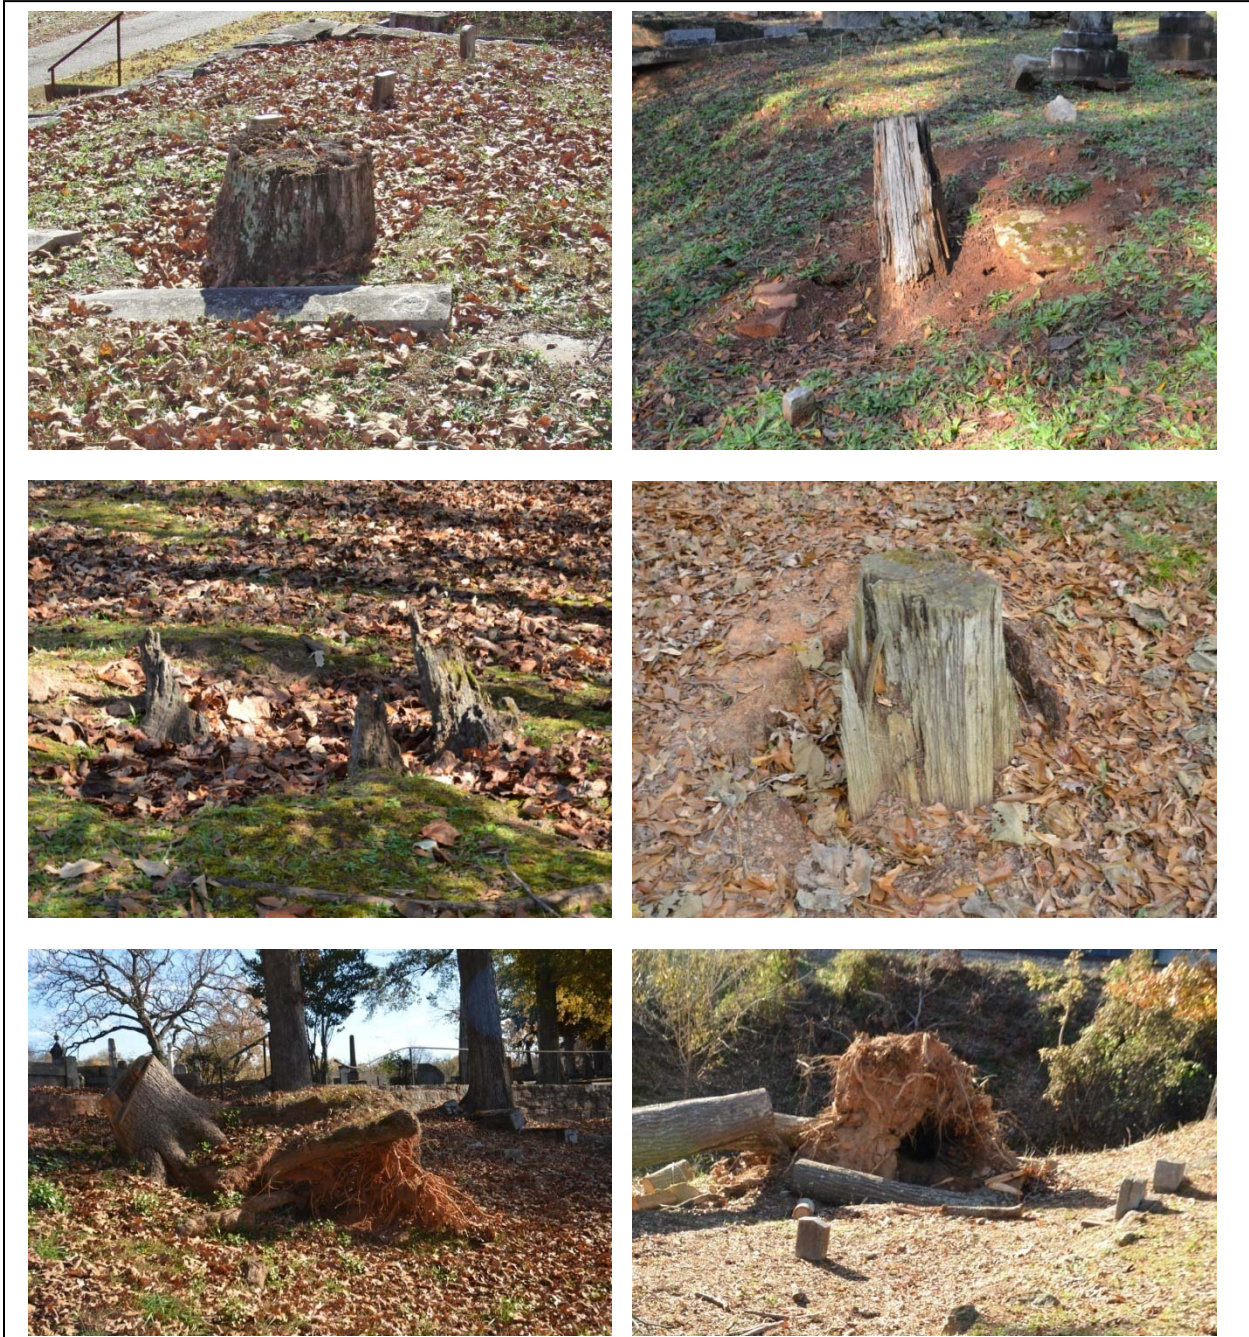
Figure 66. Examples of stumps throughout the cemetery. Upper left, East Hill. Upper right, Factory Section. Middle left, New Pauper Section. Middle right, Section B. Lower left, Valley Section. Lower right, West Hill.

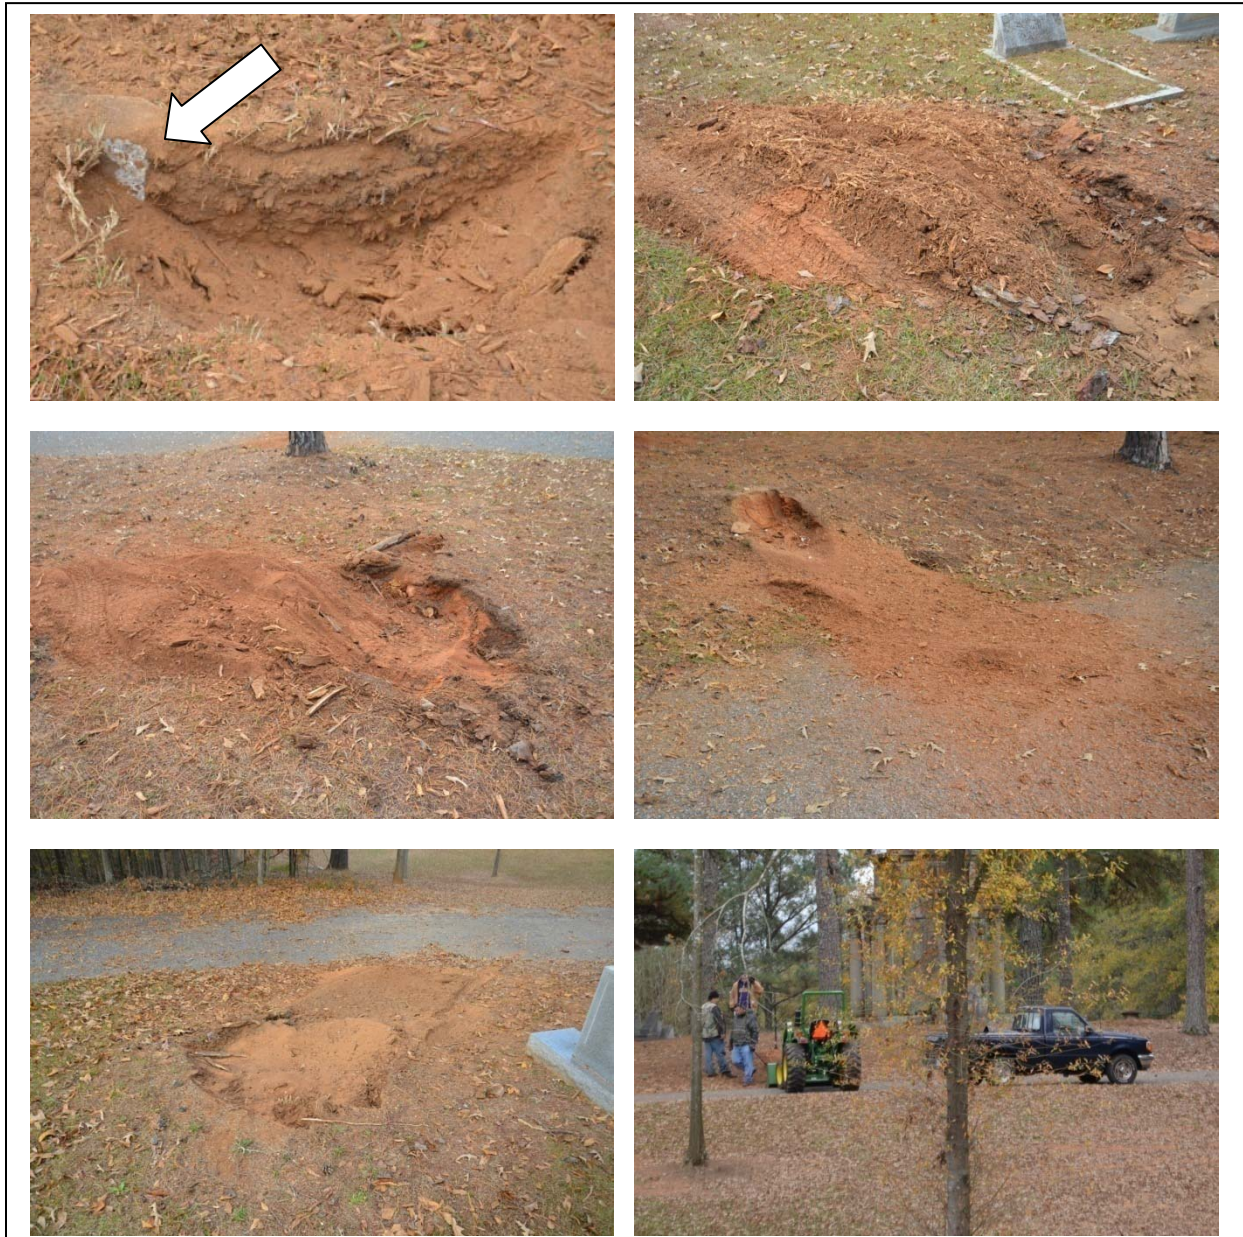
Figure 67. Stump grinding problems. Upper left, stump grinding hole, note the edge removed from the footstone by the grinder. Upper right, debris left by stump grinding. Middle left, stump grinding and debris. Middle right, stump grinding and debris left on the road by the contractor. Lower left, debris from stump grinding. Lower right, cemetery crew and cemetery equipment being used to clean up after the private stump grinding contractor. The contractor or the lot owners should have been required to correct the damage, not the cemetery.

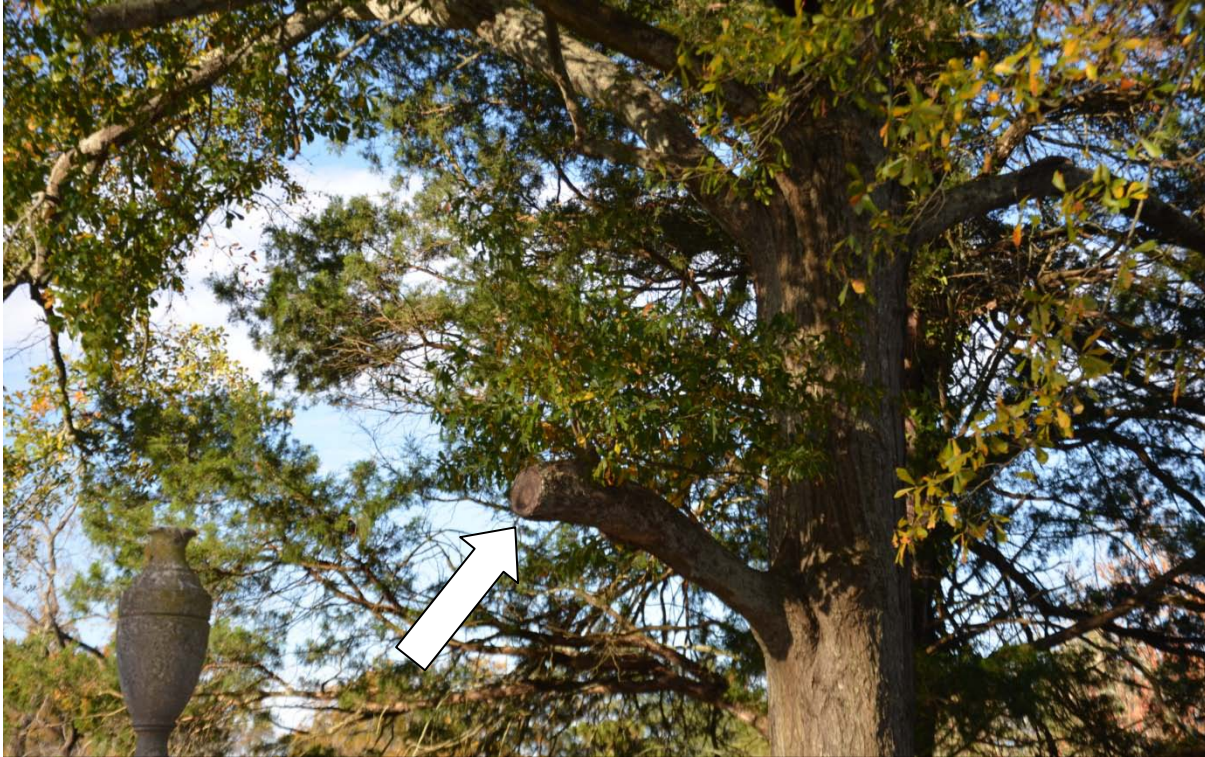
Figure 68. Tree pruning issues. The upper photo shows how trees throughout the Cemetery have been incorrectly pruned, leaving stubs. The figure below shows correct pruning technique, removing the limb back to the branch collar to allow the wound to heal properly.

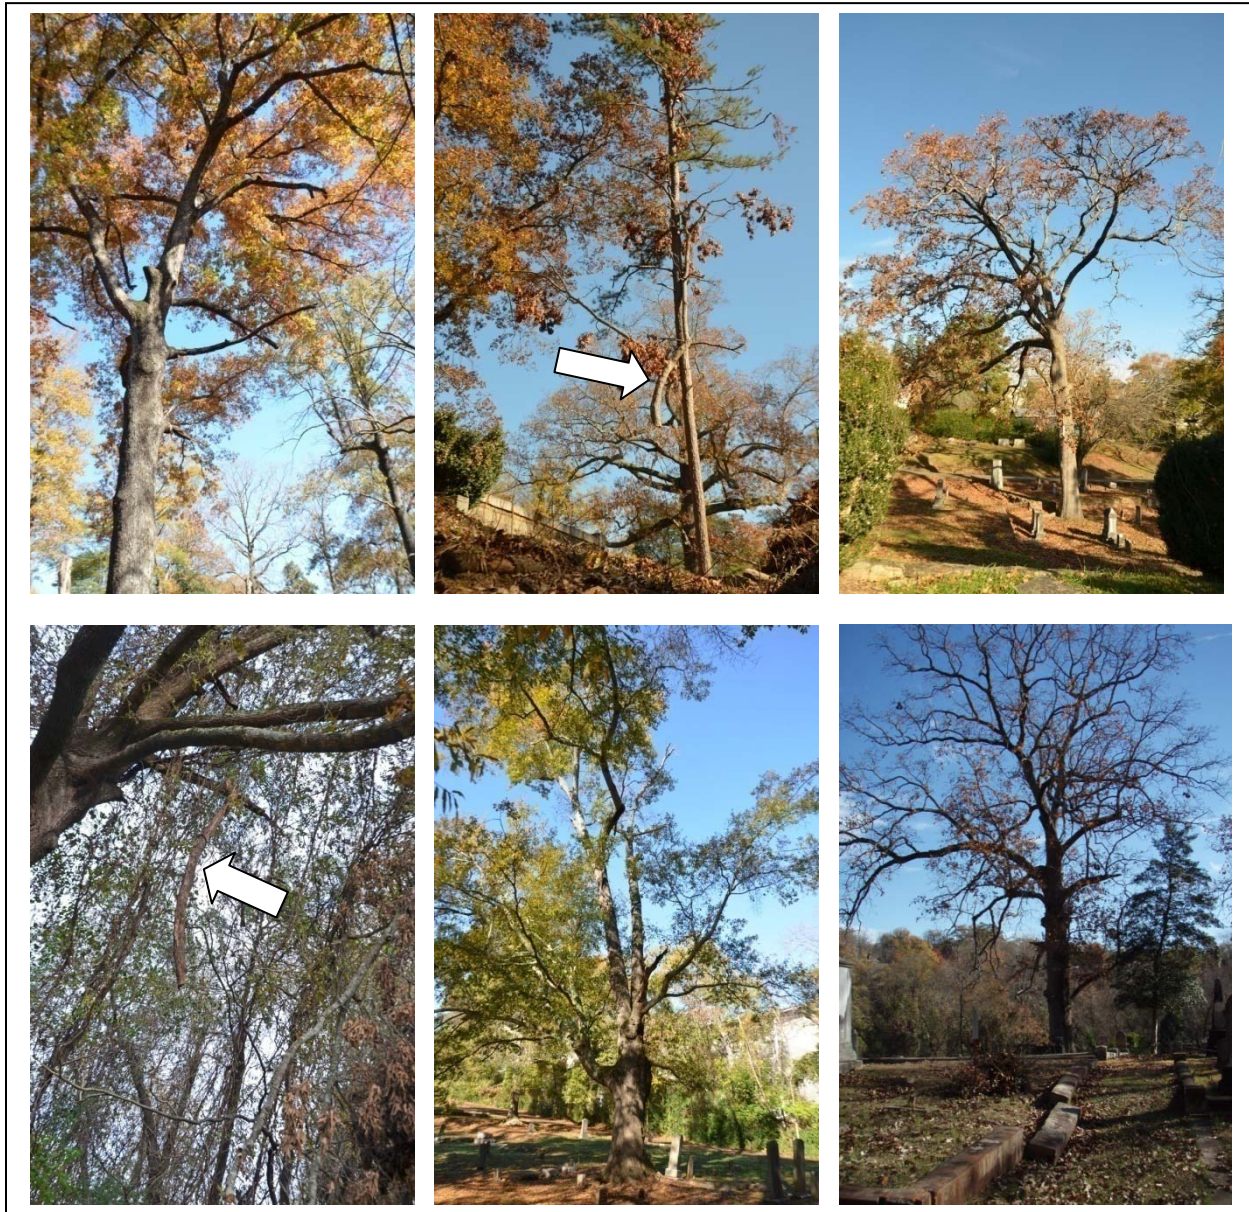
Figure 69. Examples of trees that require pruning at Oconee Hill Cemetery. Upper left, tree with dead wood in West Hill. Upper middle, “widow maker” in a West Hill tree. Upper right, tree that requires cleaning up in the Valley Section. Center left, “widow maker” in Section Old G. Center middle, tree with much dead wood in the Factory Section. Center right, tree with dead wood and that requires thinning in East Hill.

Trees should be pruned in such a manner as to preserve the natural character of the plant and in accordance with ANSI A300 (Part 1) - 2001 standards.

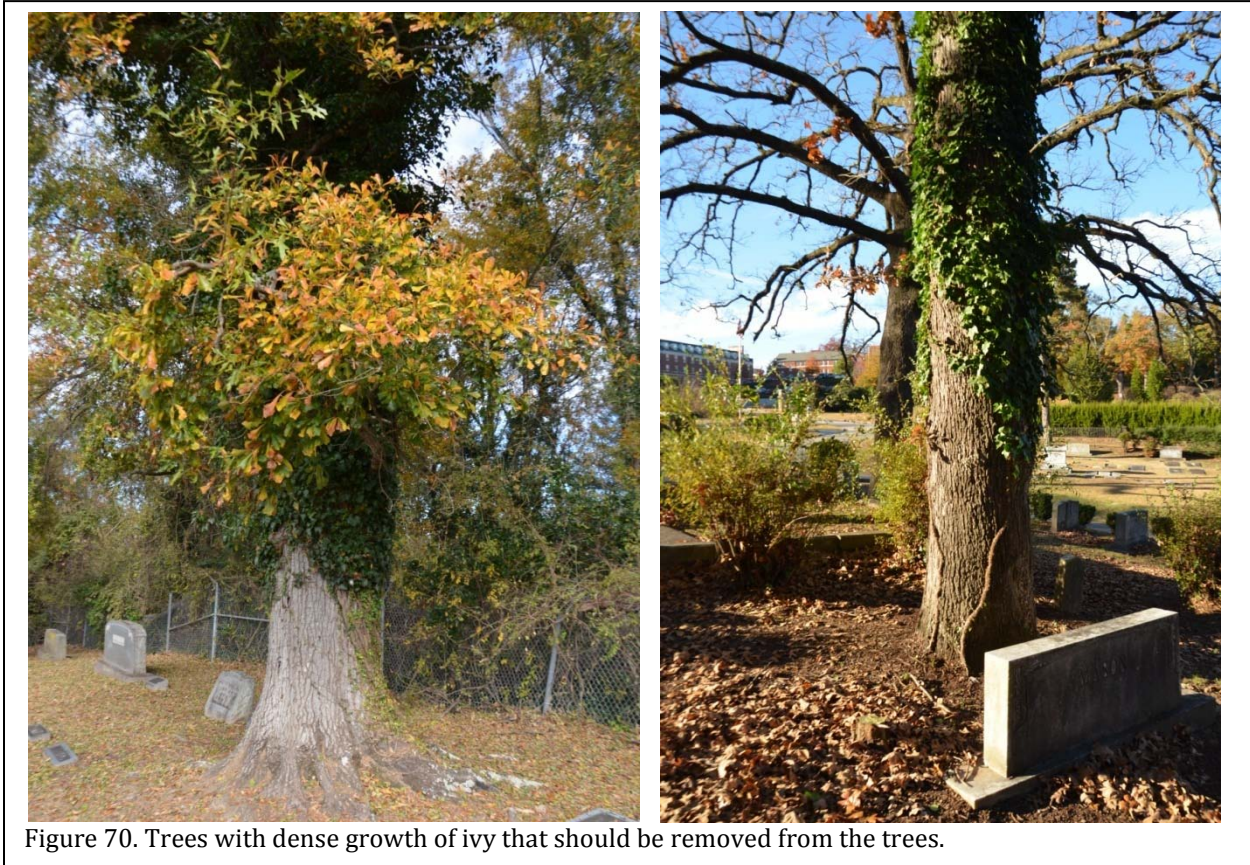
Figure 70. Trees with dense growth of ivy that should be removed from the trees.

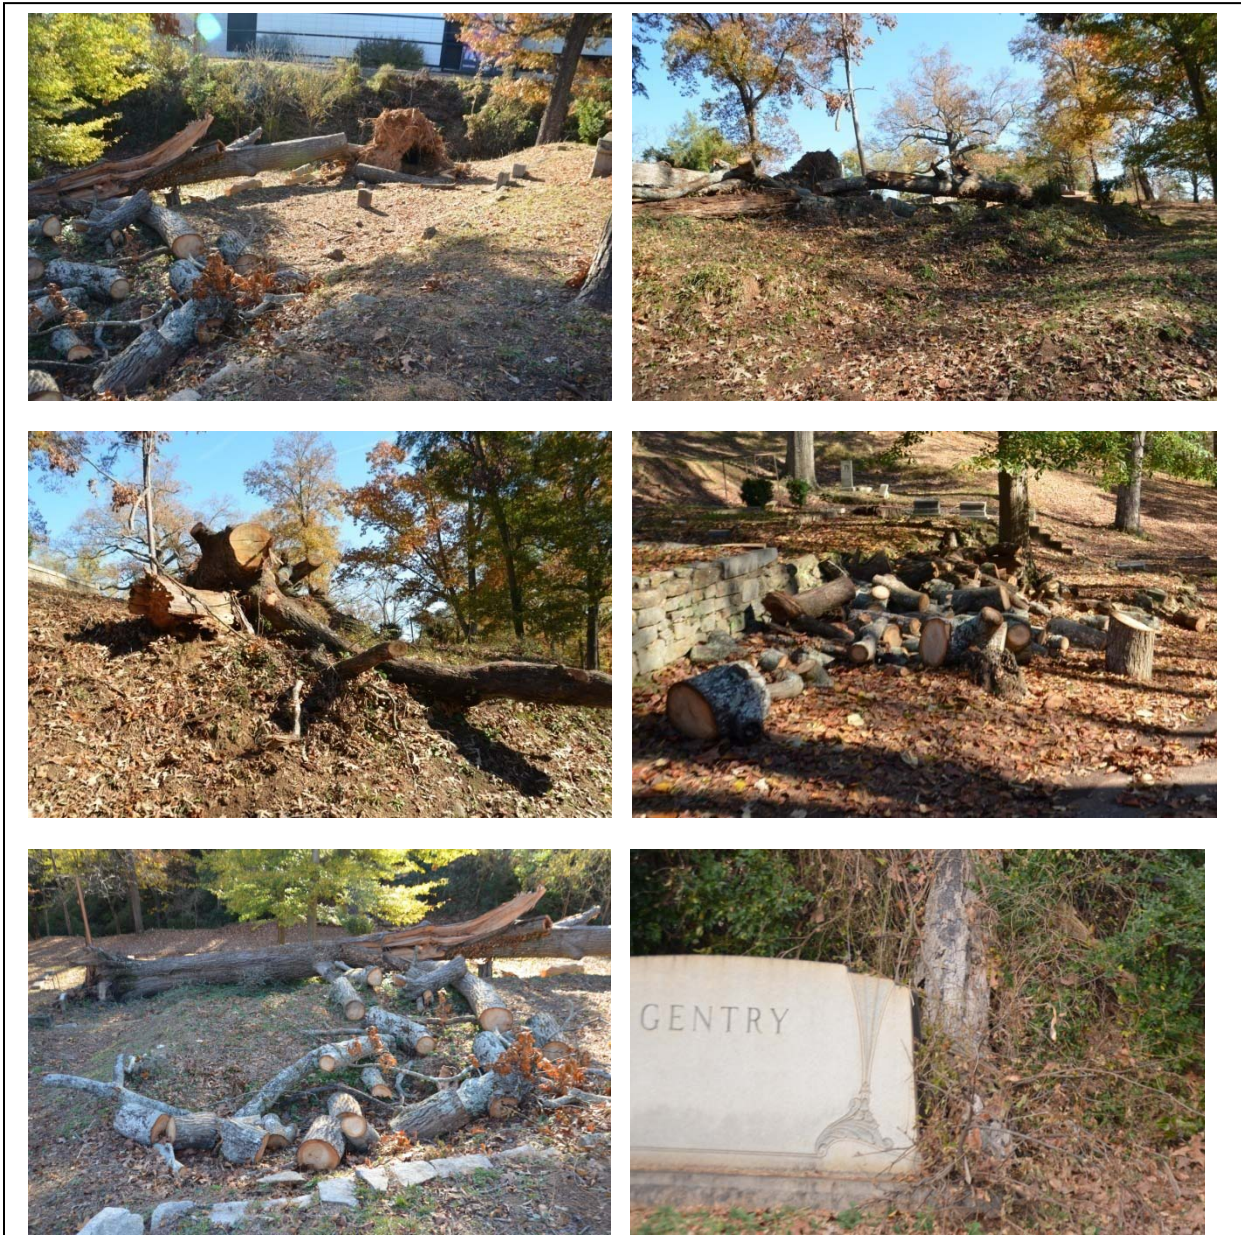
Figure 71. Tree debris in the Cemetery. The upper, middle, and lower left photos are all from extensive tree damage in West Hill. This debris has been sitting in the cemetery for weeks, if not longer. The lower right photograph shows a tree that fell on the Gentry monument months ago, but has never been cleaned up. Situations such as these suggest the Cemetery is uncaring and dramatically affects public perception of the cemetery, the staff, and the Trustees.

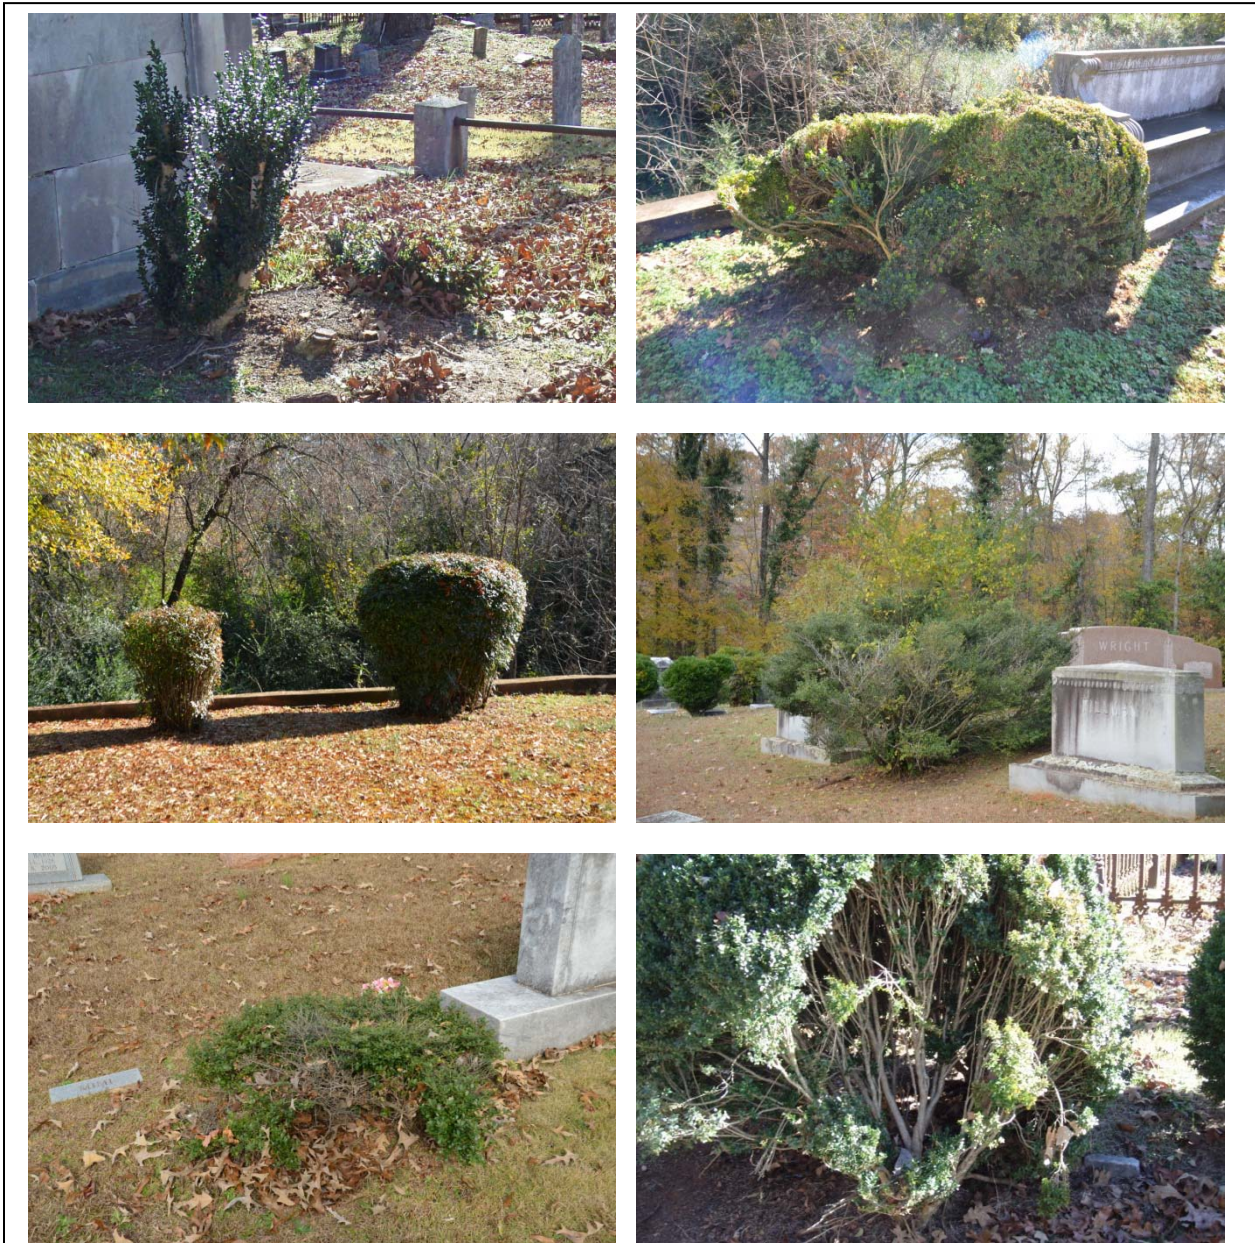
Figure 73. Examples of improperly pruned shrubs. Upper left photo shows a boxwood that was subject to incorrect renewal pruning. Upper right photo shows a sheared boxwood in a form that will promote additional interior dead wood. Middle left photo shows two nandina shrubs sheared into fanciful and unnatural shapes. Middle right photo shows a boxwood with multiple problems, including much dead wood that has been allowed to overgrow its location. Lower left and right photos show partially dead boxwoods that require removal of dead wood and renewal pruning.

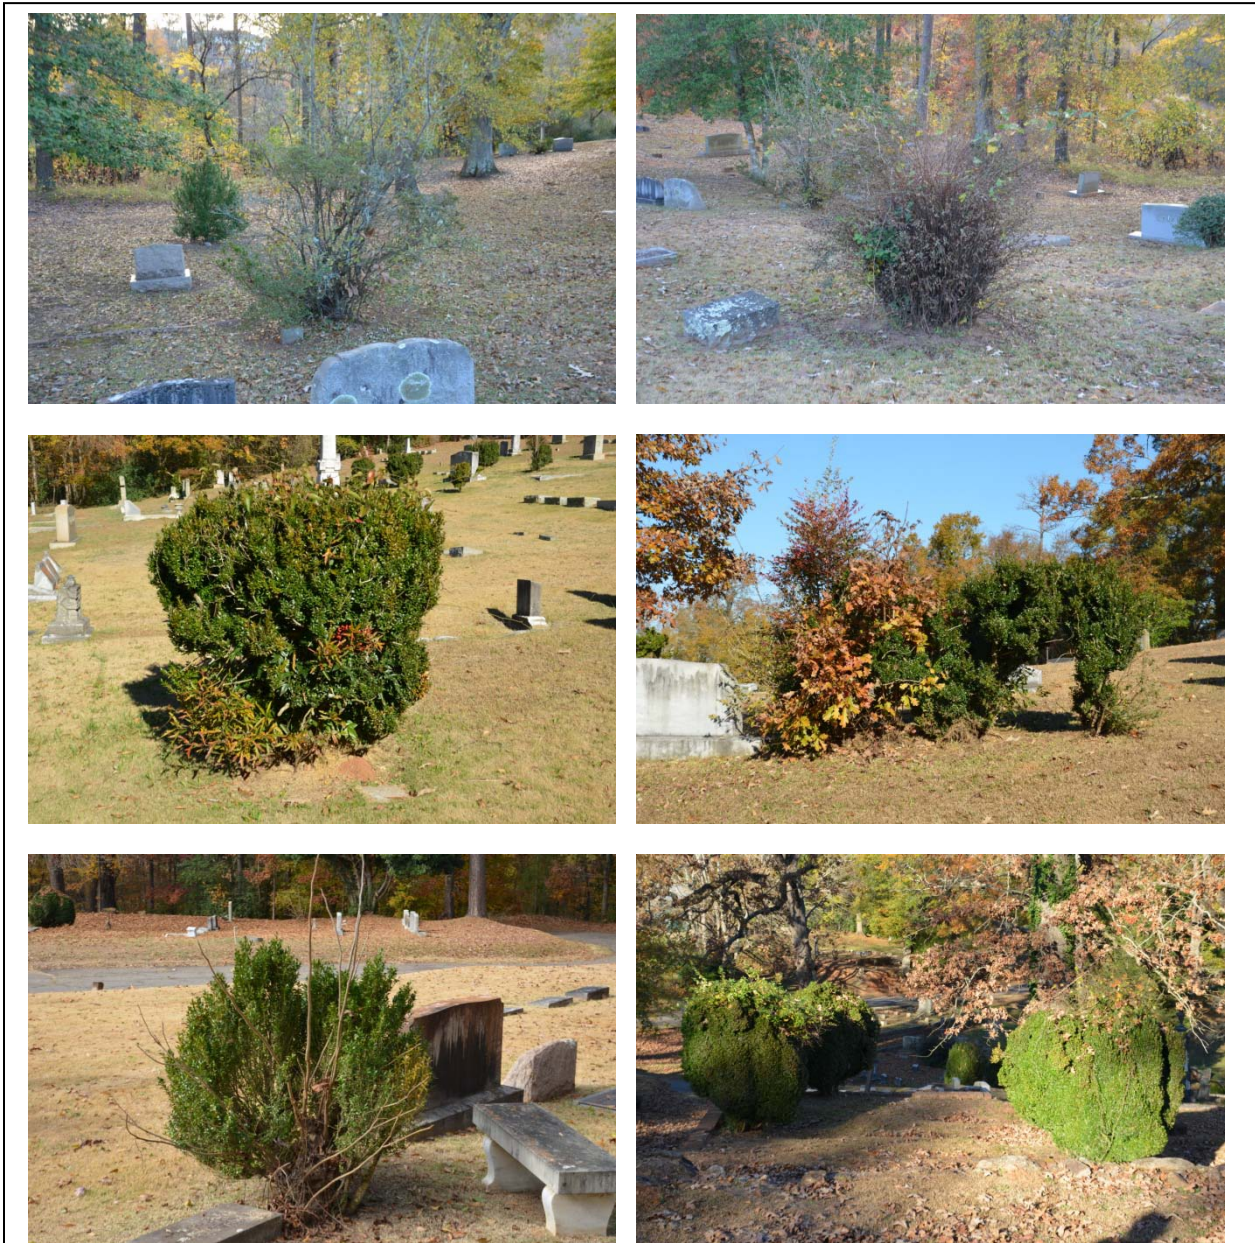
Figure 74. Examples of shrubs being overtaken by weedy plants. Upper left photo shows a dead shrub; the green leaves are from a weedy plant growing in the middle. Upper right photo shows a shrub overtaken with weedy inclusions. Middle left and right photos shows boxwoods with dense weedy plants and trees (including young oaks). Lower left, boxwood with dense weedy plant that has dropped its leaves. When blooming there would be more of the weedy species than the boxwood. Lower right, boxwoods with top hats of weedy plants (leaves brown, but not yet dropped).

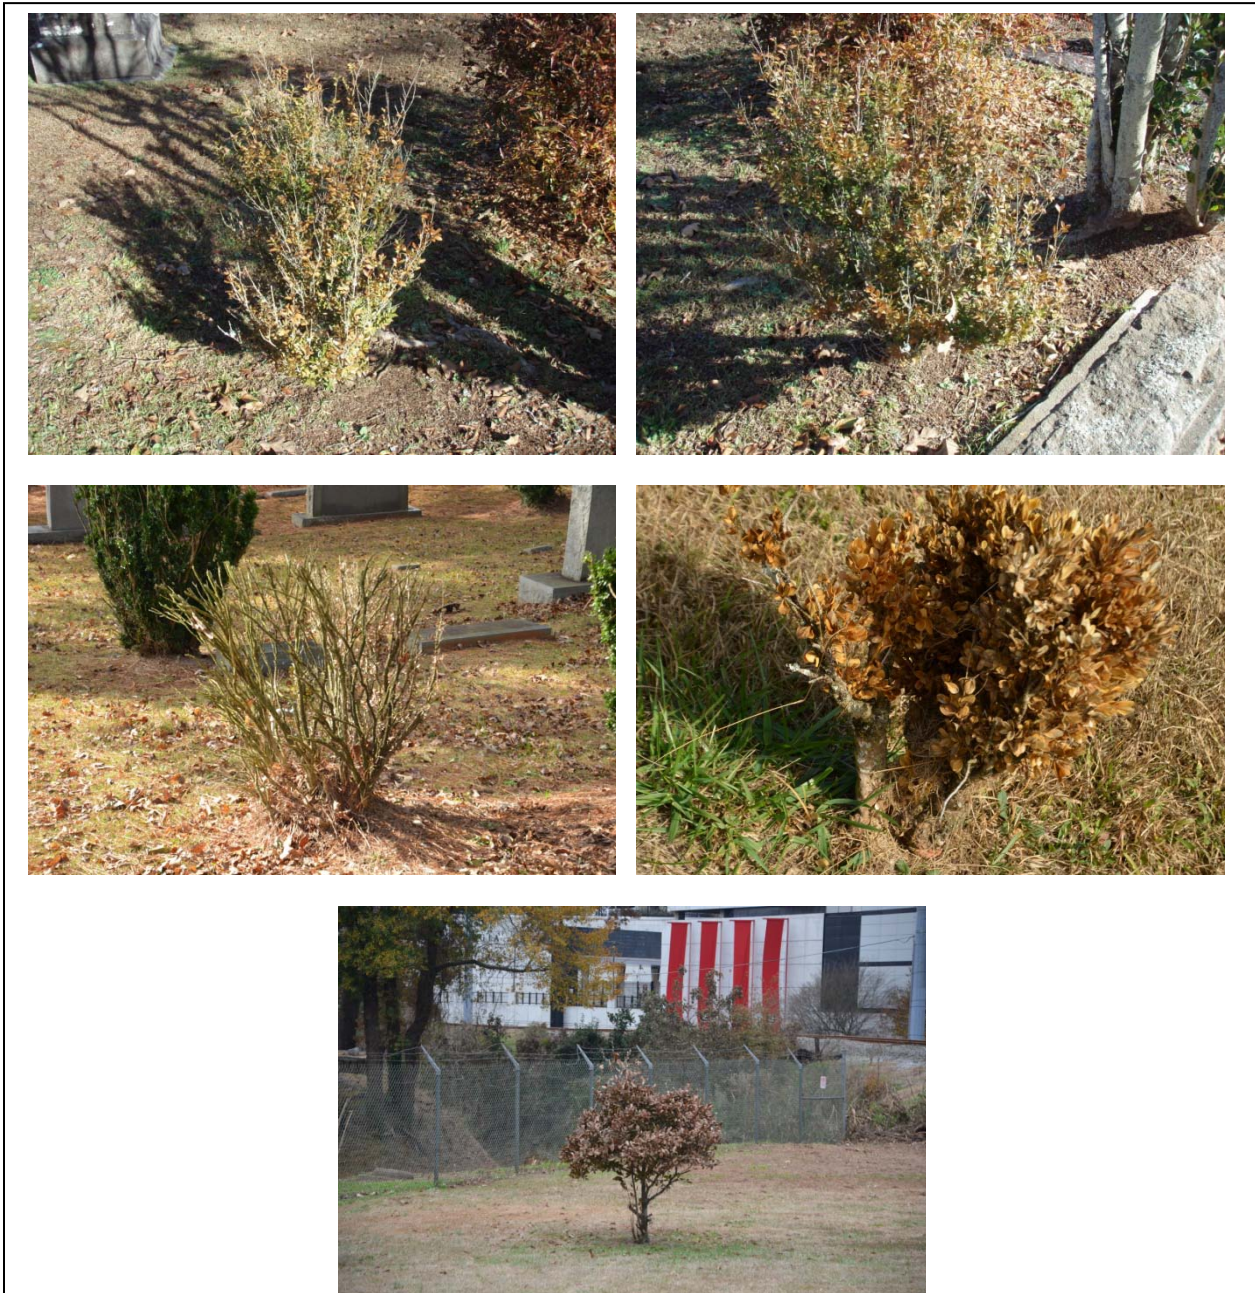
Figure 75. Examples of shrubs that should be removed. The top and middle row are all dead or dying boxwoods. Rather than leave these in the cemetery to detract from the landscape, they should be removed. They must, however, be replaced or the landscape will begin to look denuded. The bottom row shows a dead planting at the entrance to the cemetery. It is especially egregious to leave this in place since it is the first view – and impression – that visitors have.

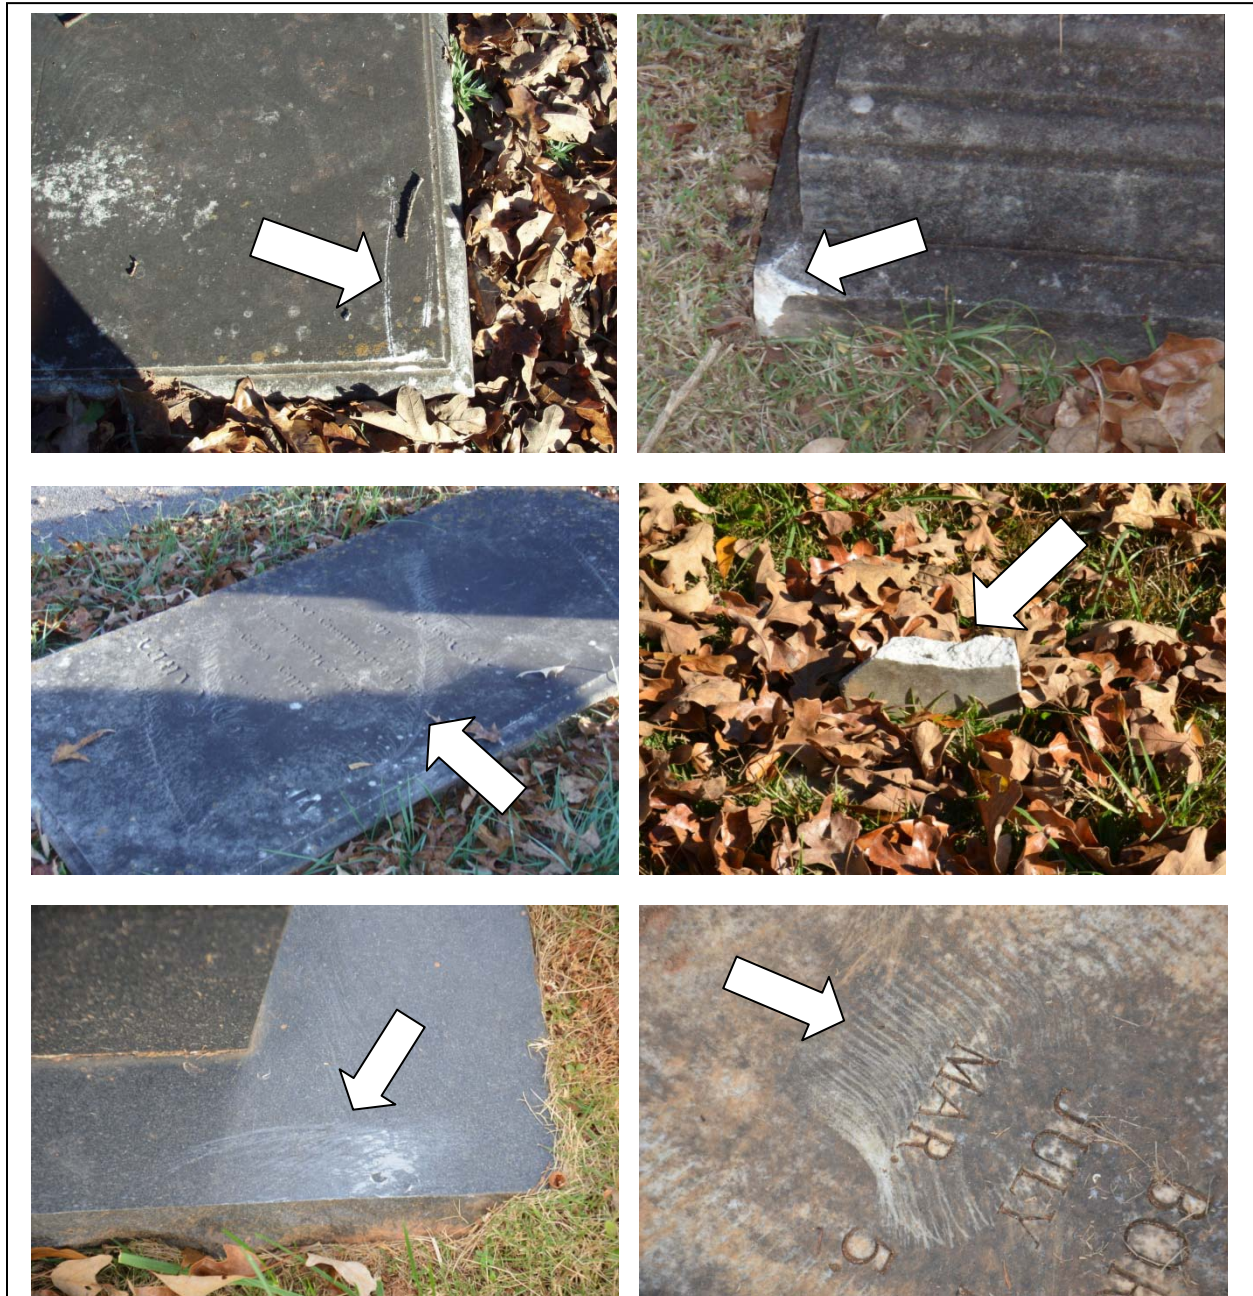
Figure 76. Damage to stones resulting from inappropriate mowing techniques. The upper left photo shows blade damage to a marble ledger. The upper right photo shows edge damage to a marble base. The middle left photo shows tire tracks across a marble ledger. The middle right photo shows a scalped marble footstone. The lower left photo shows scraping of polished granite. The lower right photo shows blade damage to a marble ledger.

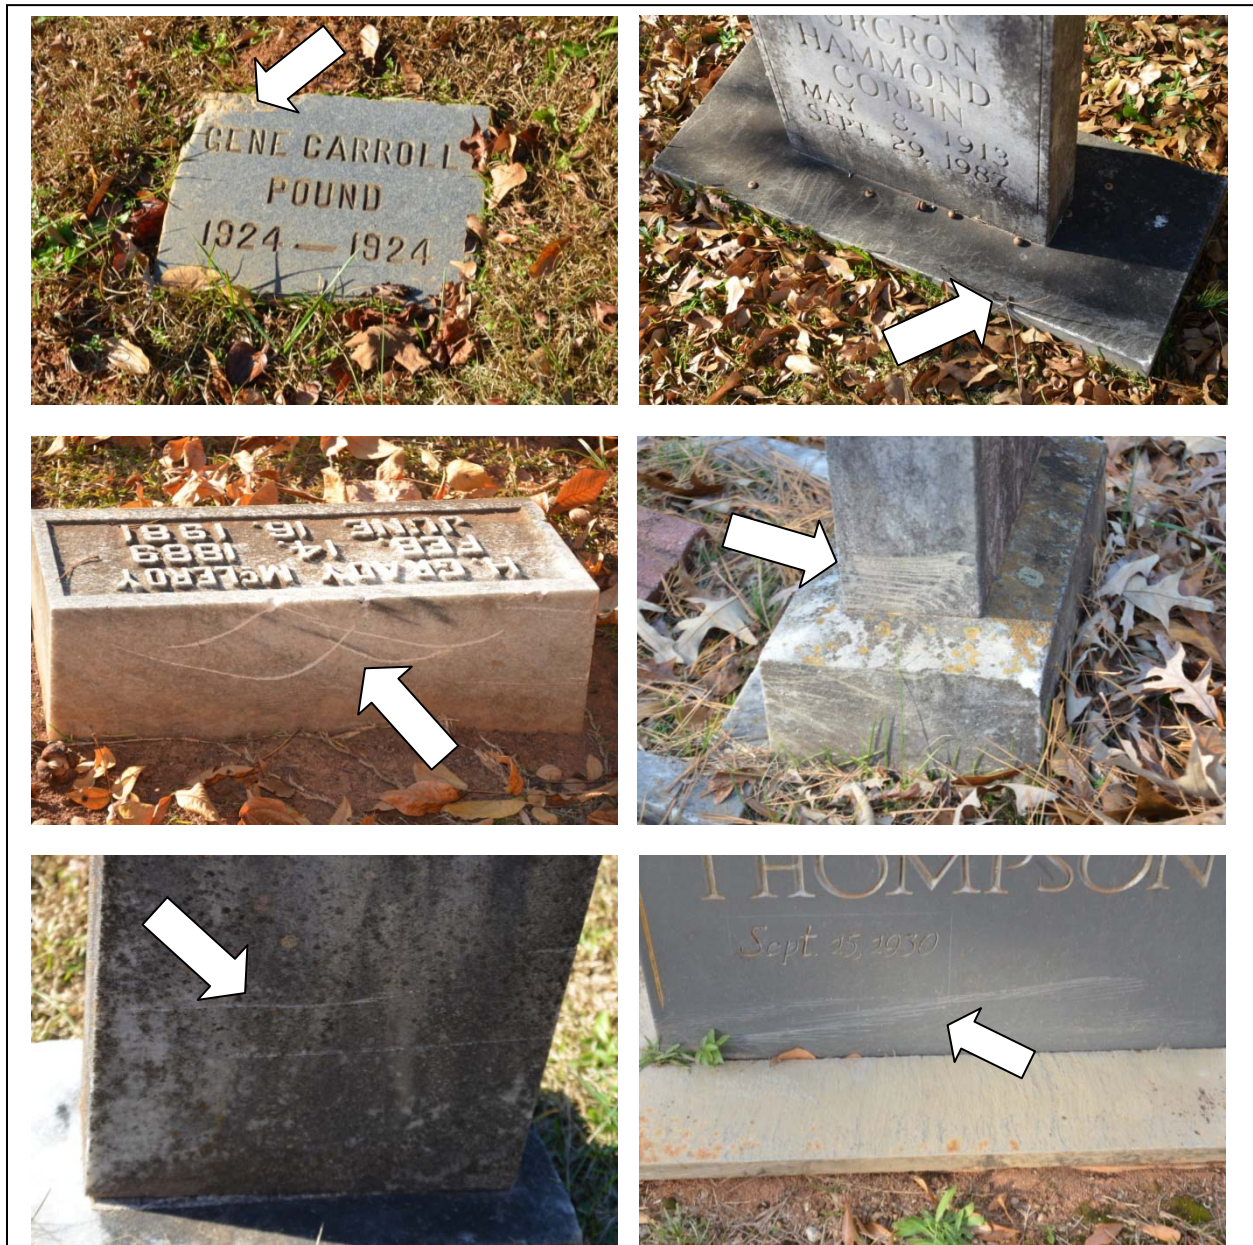
Figure 77. Damage to stones resulting from inappropriate mowing techniques. The upper left photo shows edge damage of a granite stone from mowing. The upper right photo shows marble damage from heavy nylon trimmer line and staff inattention. The middle left photo shows scraping damage to a marble stone from trying to mow too close to stones in order to minimize trimming. The middle right photo shows trimmer line damage. The lower left photo shows scraping of a marble stone from the mower deck. The lower right photo shows scraping of a granite stone from a mower deck.
