OCONEE HILL CEMETERY ASSESSMENT, ATHENS-CLARKE COUNTY, GEORGIA

Research Contribution 557

Michael Trinkley
Debi Hacker

February 2014

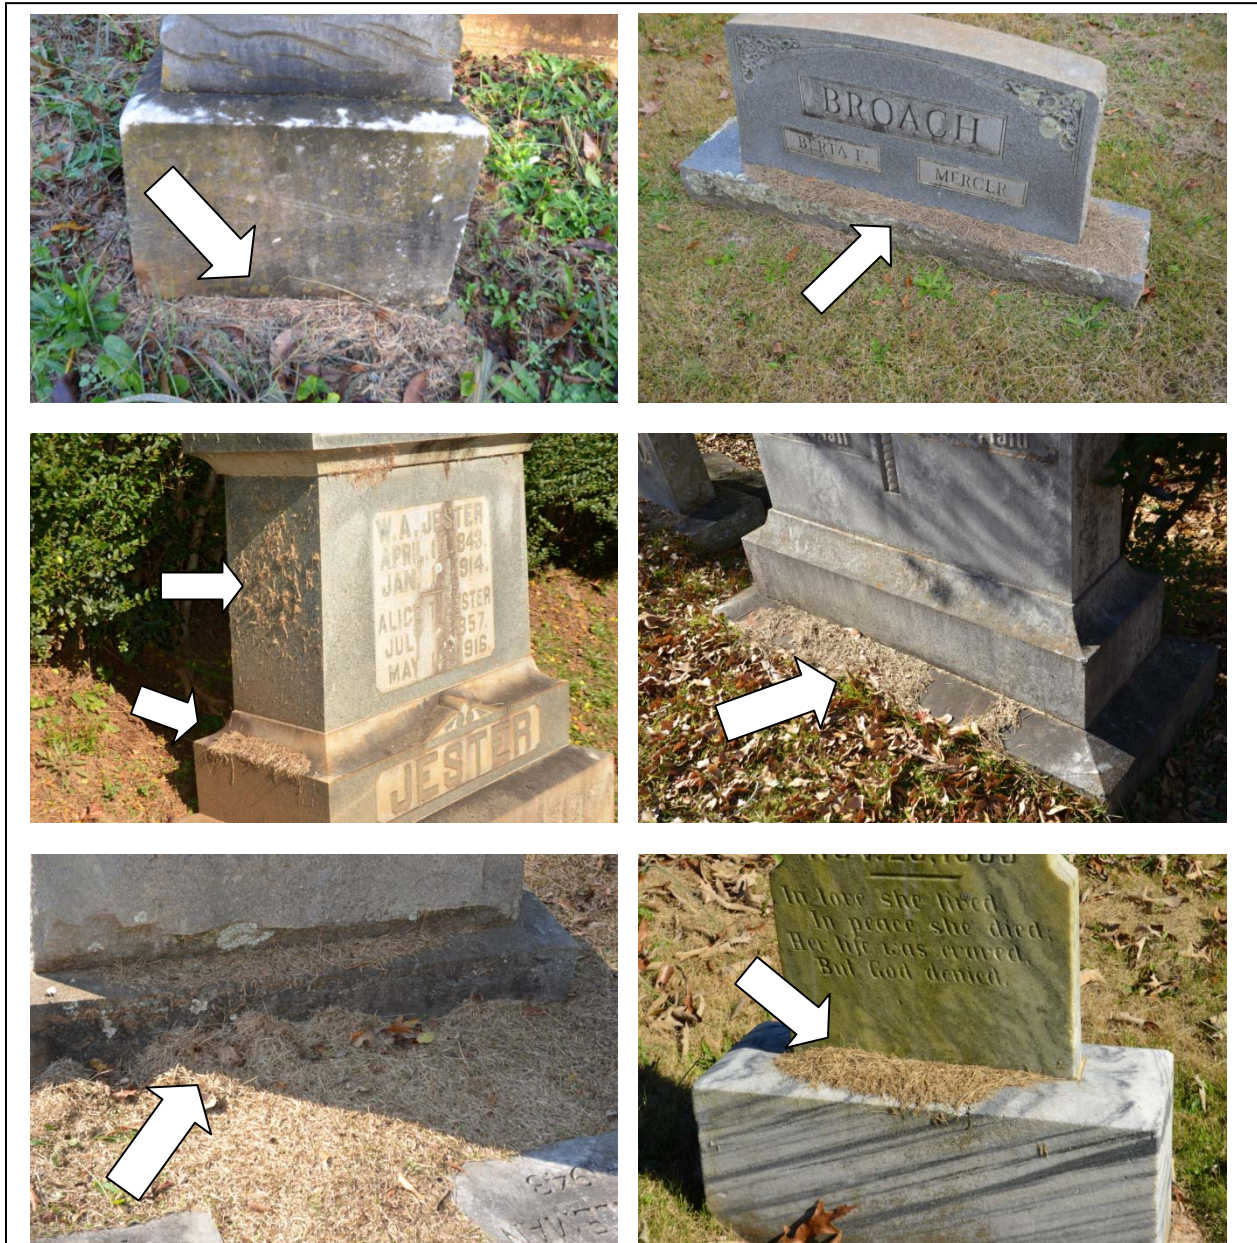
Figure 79. Grass found on monuments throughout the cemetery. The middle left photo shows grass clippings splattered against the die, probably from using a nylon trimmer in very dense, wet grass.

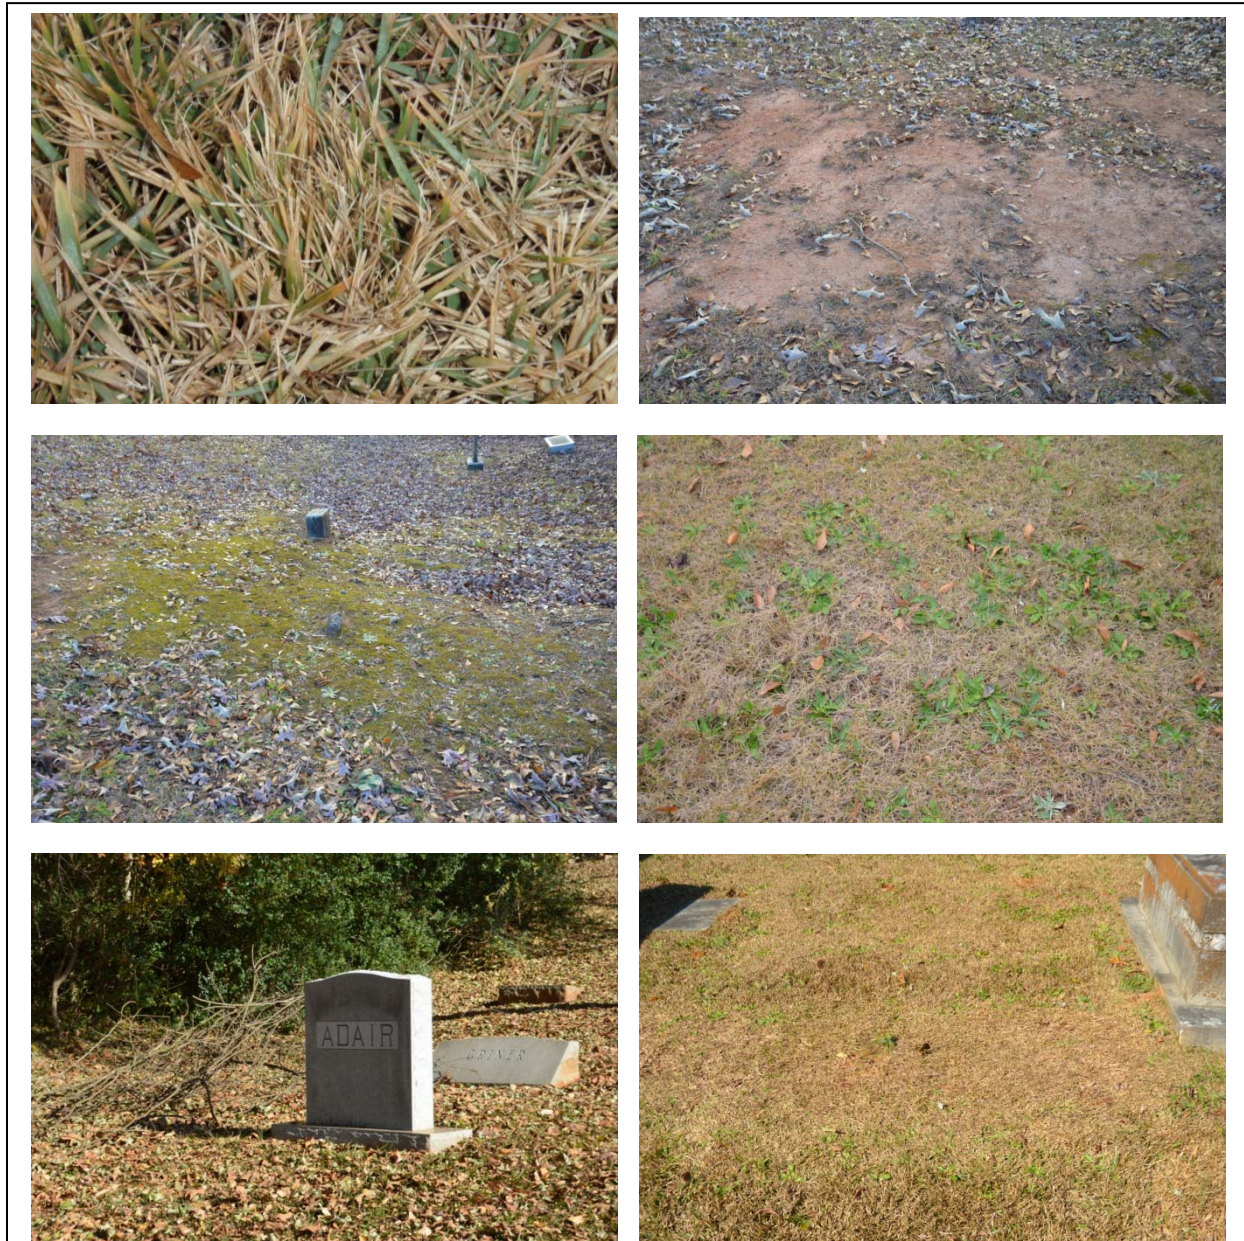
Figure 80. Other turf problems observed at Oconee Hill Cemetery. Upper left photo shows badly torn grass blades. This indicates that the mower blade was not sharp when the grass was mowed. Upper right photo shows bare, heavily compacted soil that requires aeration and seeding. Middle left photo shows an areas of heavy moss, suggesting compacted, infertile, and acidic soil. Middle right photo shows an area of dense broadleaf weeds. Lower left photo shows dense leaves and many branches that should be collected. Lower right photo shows scalped grass over a grave that had not been properly backfilled and replanted.

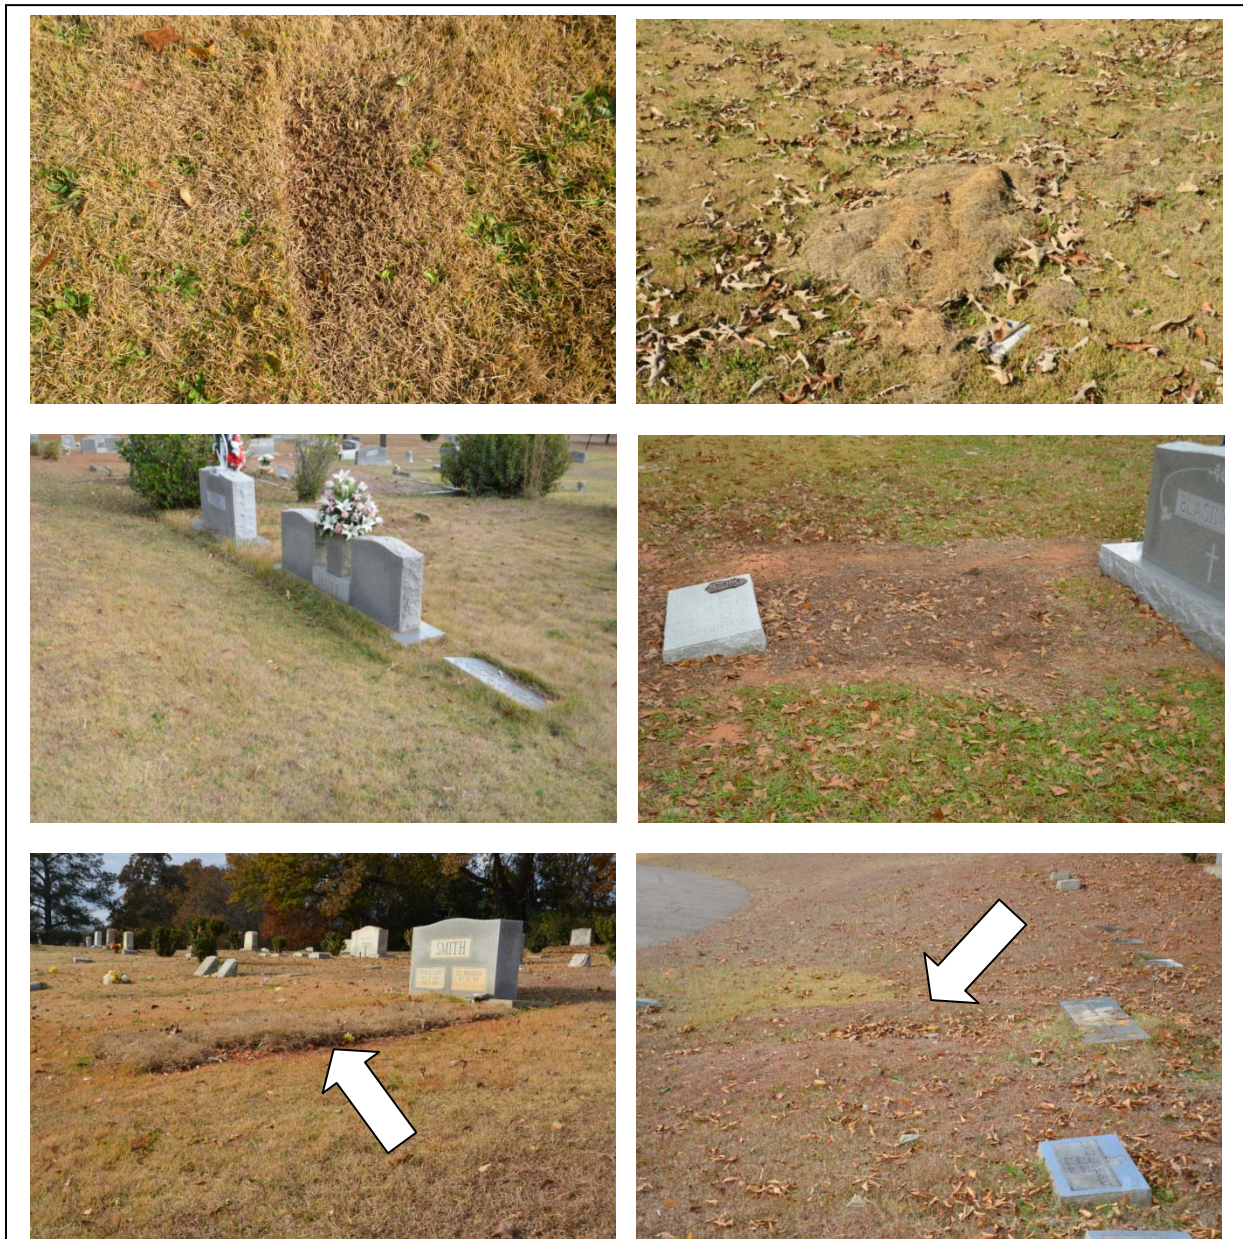
Figure 81. Other turf problems observed at Oconee Hill Cemetery. Upper left photo shows dense Bermuda grass that has been scalped. Note also the invasion of broadleaf weeds. Upper right photo shows a mass of grass clippings piled up on Bermuda grass. Middle left, grass not trimmed adjacent to a row of monuments. Middle right photo shows a month old burial with no grass or effort to seed. Lower left photo shows a recent grave where the soil has not been adequately compacted and the grass has been placed too high. This will result in the grass being scalped during future mowings. Lower right photo shows a grave that been allowed to slump. This, too, will result in scalping when the grass is cut; the grave should be refilled.

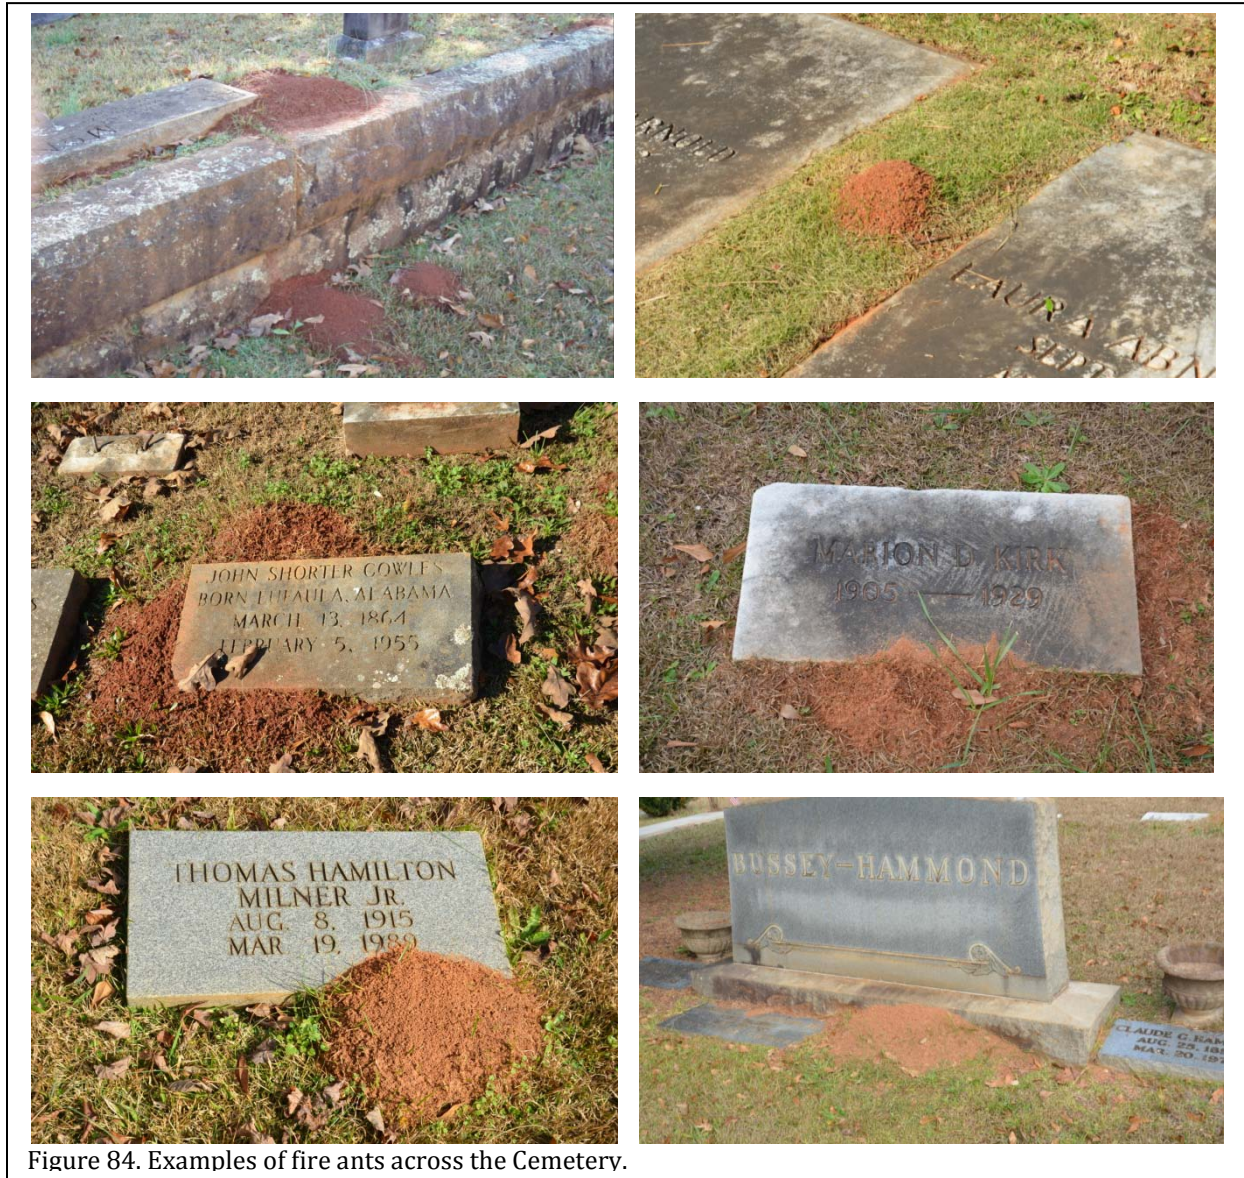
Figure 84. Examples of fire ants across the Cemetery.

While individual mounds can be treated, this approach is best used in small areas. At Oconee Hill Cemetery a far better approach is to once or twice a year, typically in April or May and again in September or October, broadcast a hydramethylnon bait such as Amdro at the rate of 1 to 2 pounds per acre. These applications will provide about 90% suppression rates, with maximum control about 2 to 4 weeks after application.

After 10-14 days the Amdro should be used as an individual mound treatment on any

mounds that continue to be a problem or that remain in high traffic areas.

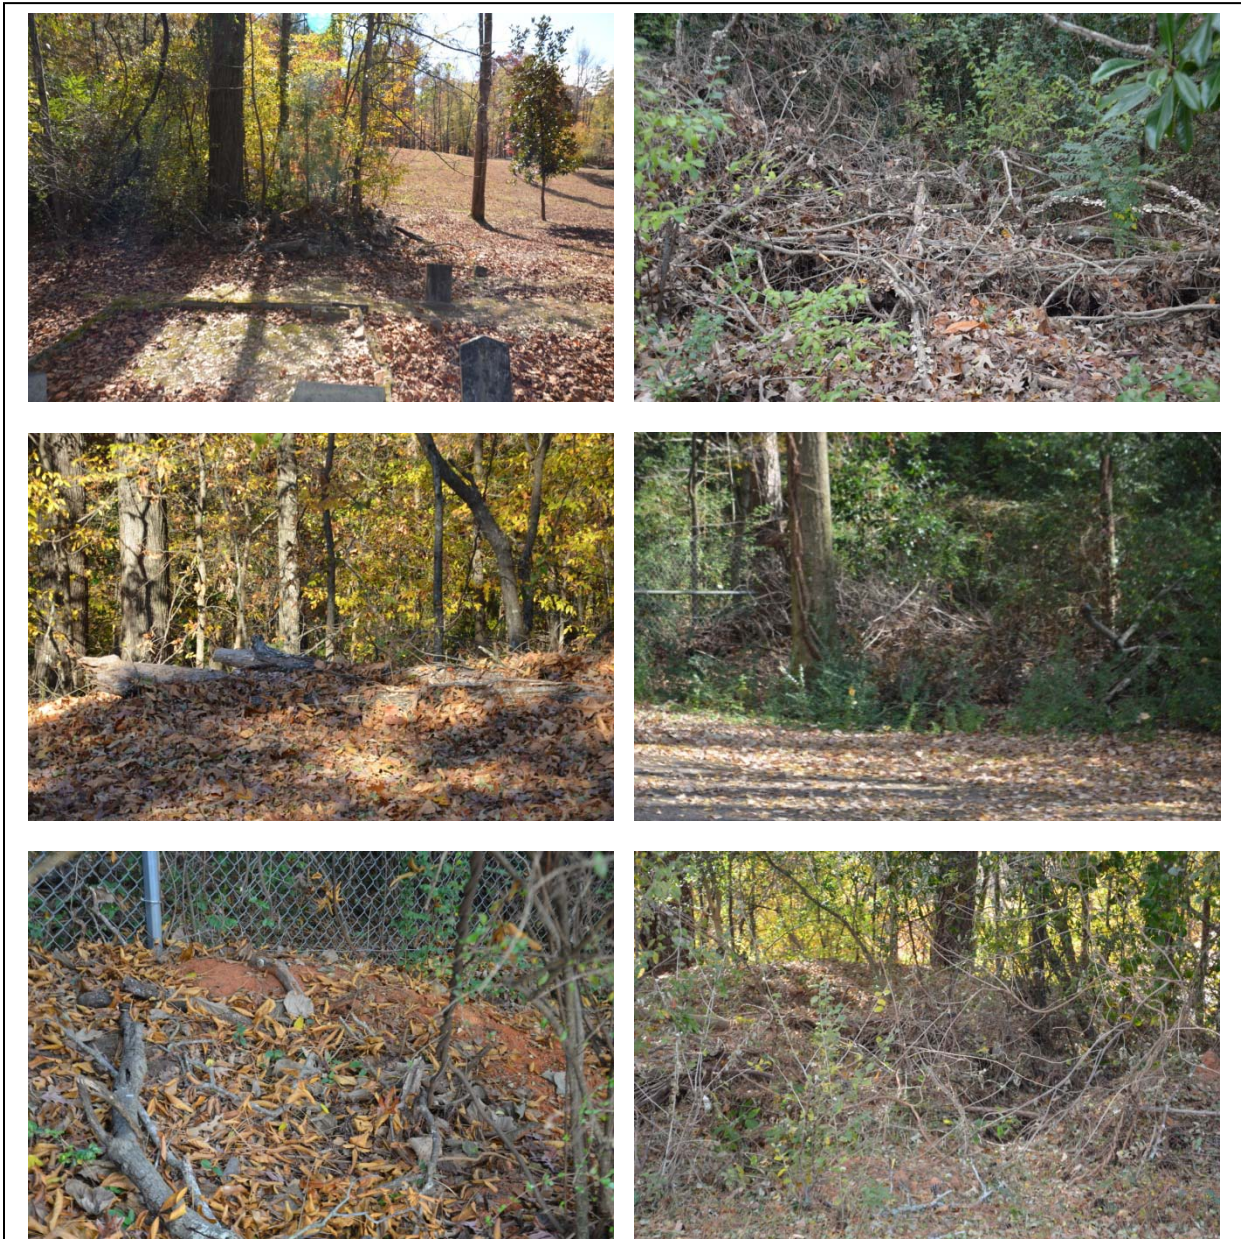
Figure 85. Trash, leaves, and limbs dumped at the edge of the Cemetery. Upper left photo shows dump at the edge of the New Pauper Section. Upper right photos shows a dump at the edge of Section B. Middle left photo shows a dump at the edge of Section D. Middle right photo shows a dump at the edge of Section New G. Lower left photo shows a dump pile at the edge of Section Old G. Lower right photo shows a dump pile at the edge of Section H. These are not isolated examples, trash piles ring the cemetery, where staff has failed to properly dispose of debris. All must be collected and, where under 4-inches, mulched.

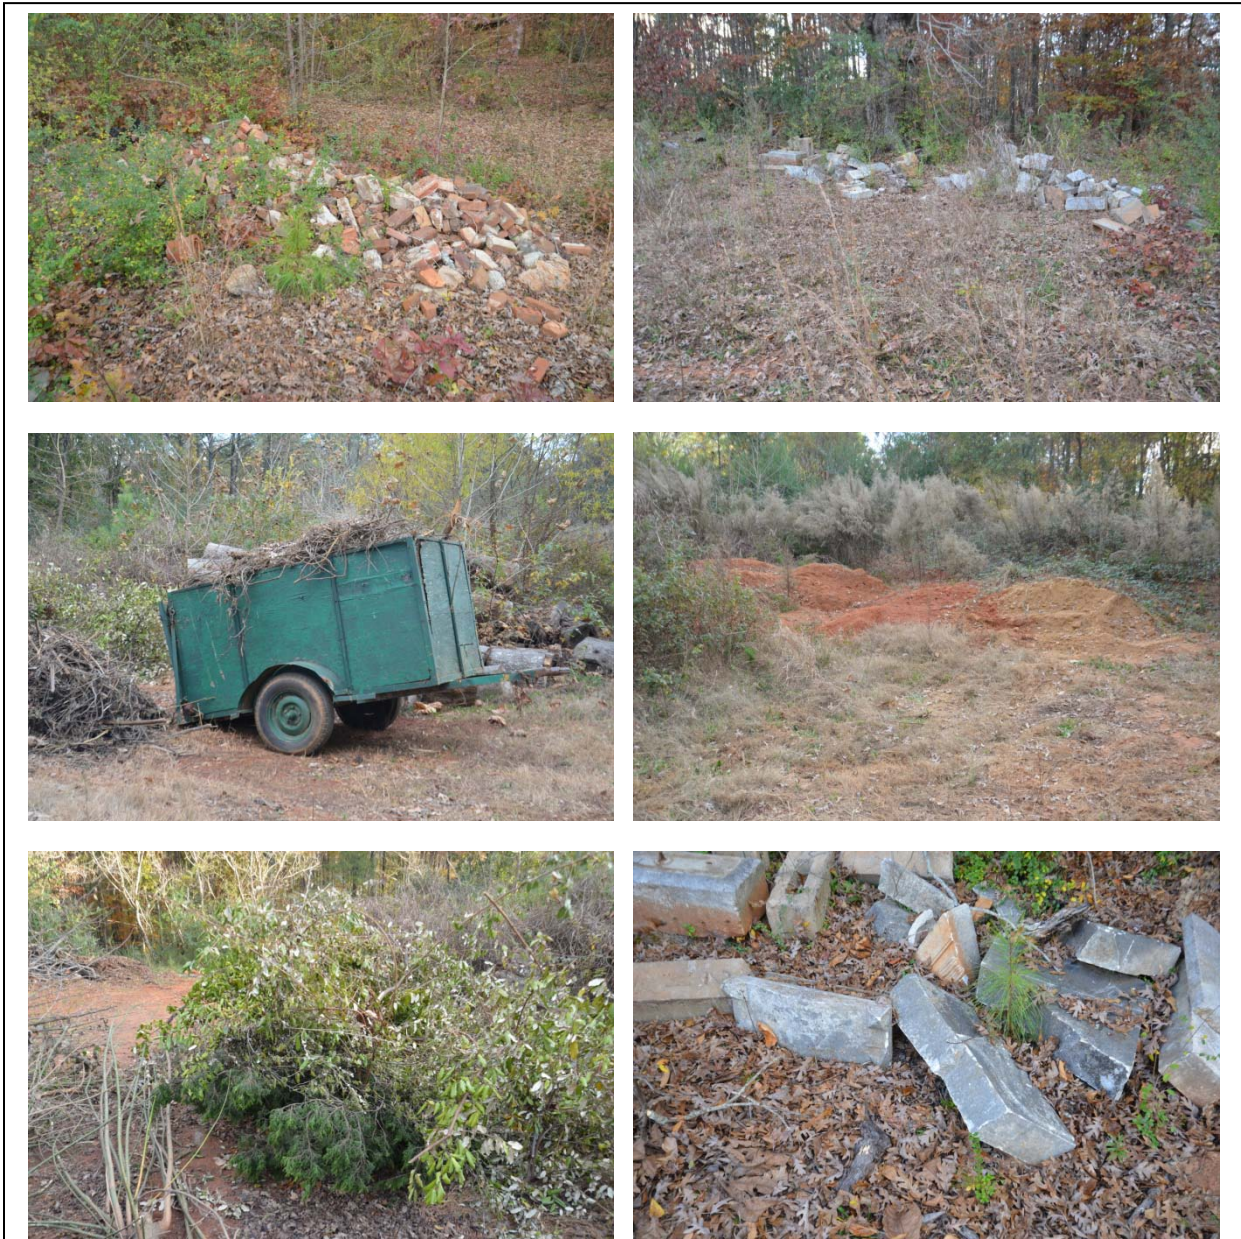
Figure 86. Dump area at Oconee Hill Cemetery. The upper left photo shows a pile of brick that could be used to rebuild walls. The upper right photo shows granite essential for repair of walls. The middle left photo shows a trailer abandoned in the dump filled with debris. The middle right shows soil left over from graves. The lower left photo shows one of many small piles of debris. Elsewhere are numerous large logs. The lower right photo shows some of the monuments and bases dumped in this location.

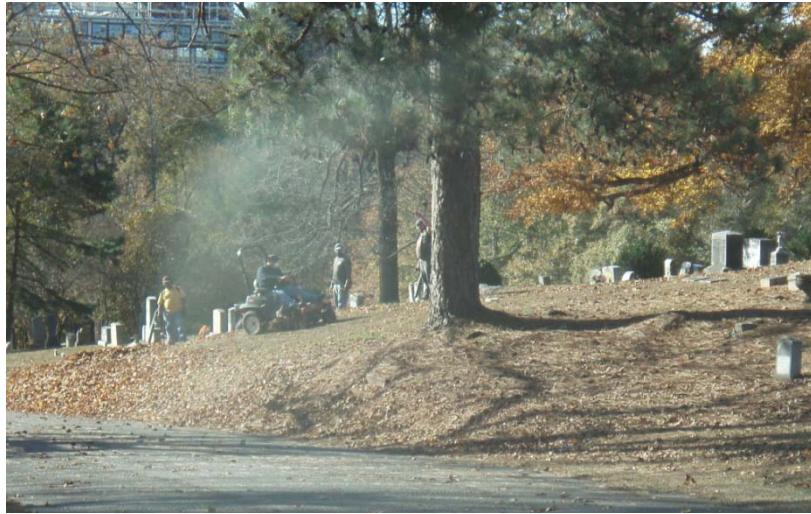
While the dump area is not generally viewed by the public, it reflects poorly on cemetery management, giving the appearance that no one really cares. This area requires immediate efforts to clean it up and make it functional.

Figure 88. The current mulching operations are ineffective and an effort should be made to improve the process.

Light brush (under 4-inches in diameter) should be mulched and a large mulch pile begun from this material and the debris gathered up

along the Cemetery edges.

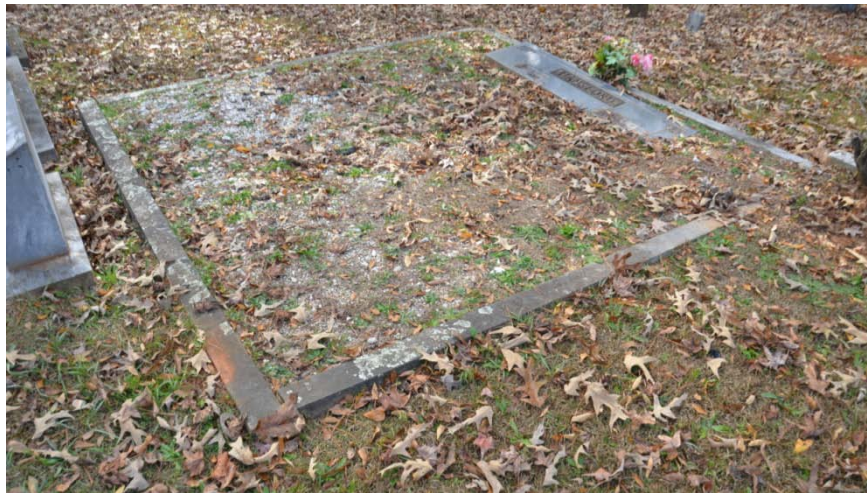
Figure 89. Graveled plot covered with weeds.

A few lot owners have chosen to use gravel, retained by coping, rather than allow the plots to be grassed. Often lot owners do this thinking that it will reduce maintenance. Unfortunately, as shown by Figure 89, this is rarely the case. In fact, these graveled lots almost always present a variety of long-term maintenance problems and the Trustees should discourage the practice whenever possible.

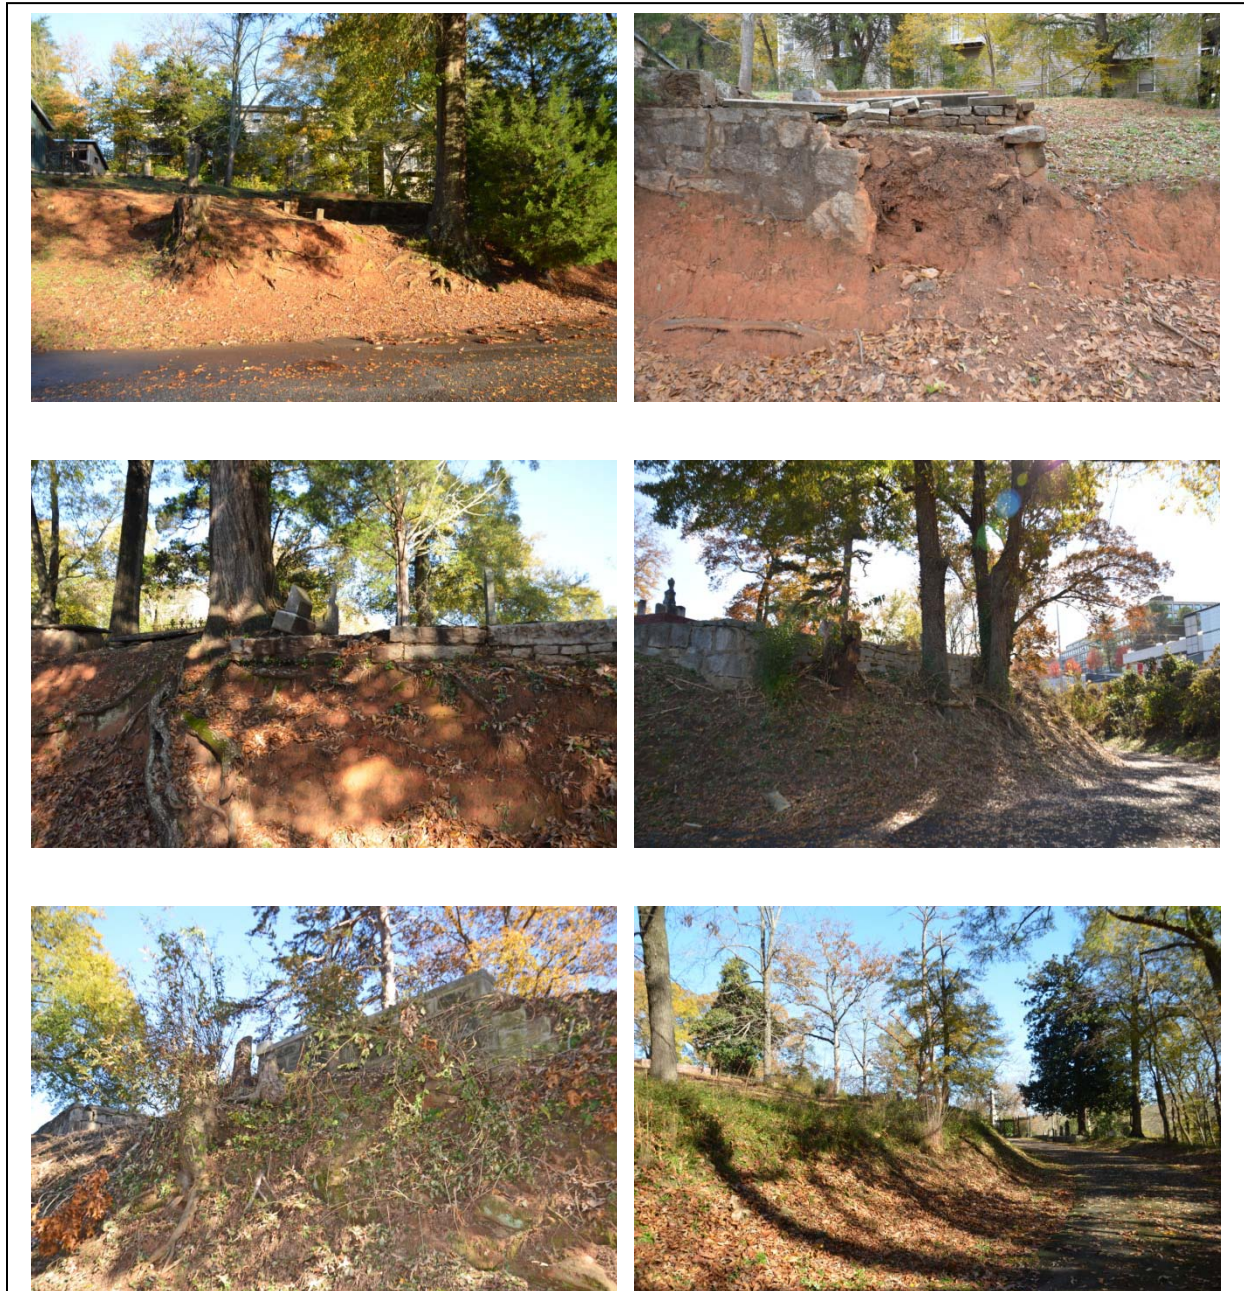
Erosion occurs in multiple areas on the west and south sides of this section, on the interior of the outer road loop. One area measures about 180 feet in length, the other about 220 feet in length, for a total of about 400 feet. The bank on the west side is about 10 to 12 feet in height, while on the south side it is about 4 feet in height. Slopes on the west side are close to vertical, while on the south side the slope is more gradual, perhaps about 45°. Vegetation was previously attempting to hold the west back, but it has recently been

Figure 90. Erosion issues at Oconee Hill Cemetery. The upper left photo show erosion along the road at Factory Hill. The upper right photo shows the loss of a plot in the Factory Section. Additional erosion will begin to expose graves. The middle left photo shows tree roots and erosion along the Factory Section road. The middle right photo shows erosion along the west bank of West Hill. The lower left photo shows the recently cleared slope of West Hill. This will promote additional erosion. The lower right photo shows the south edge of West Hill where the bank is not as high, but erosion is still a concern.

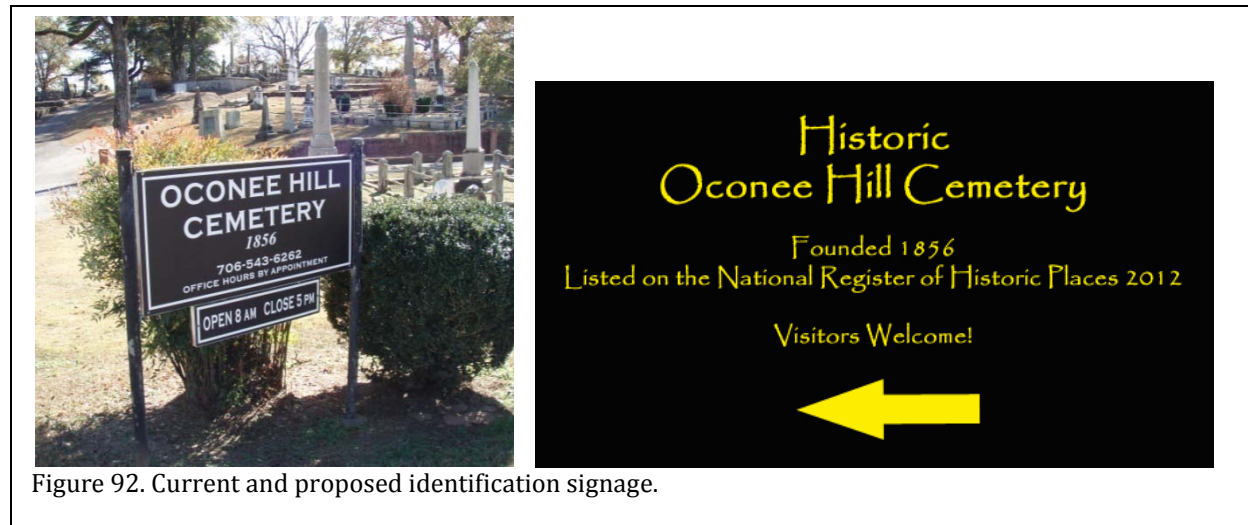
Figure 92. Current and proposed identification signage.

The current identification sign is non-descript and fails to alert visitors to the cemetery access or encourage them to visit (Figure 92).

The Cemetery must strive to develop effective and well-designed signage. Signage should combine good and consistent design, and meet the needs of visitors.

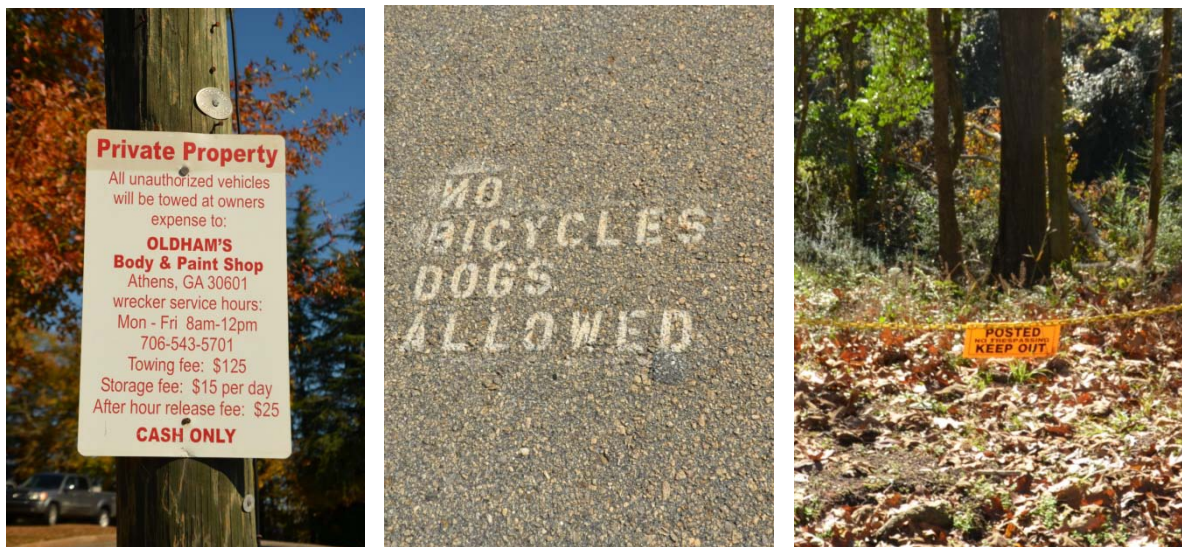
Figure 97. Inappropriate cemetery signage. All of these should be removed.

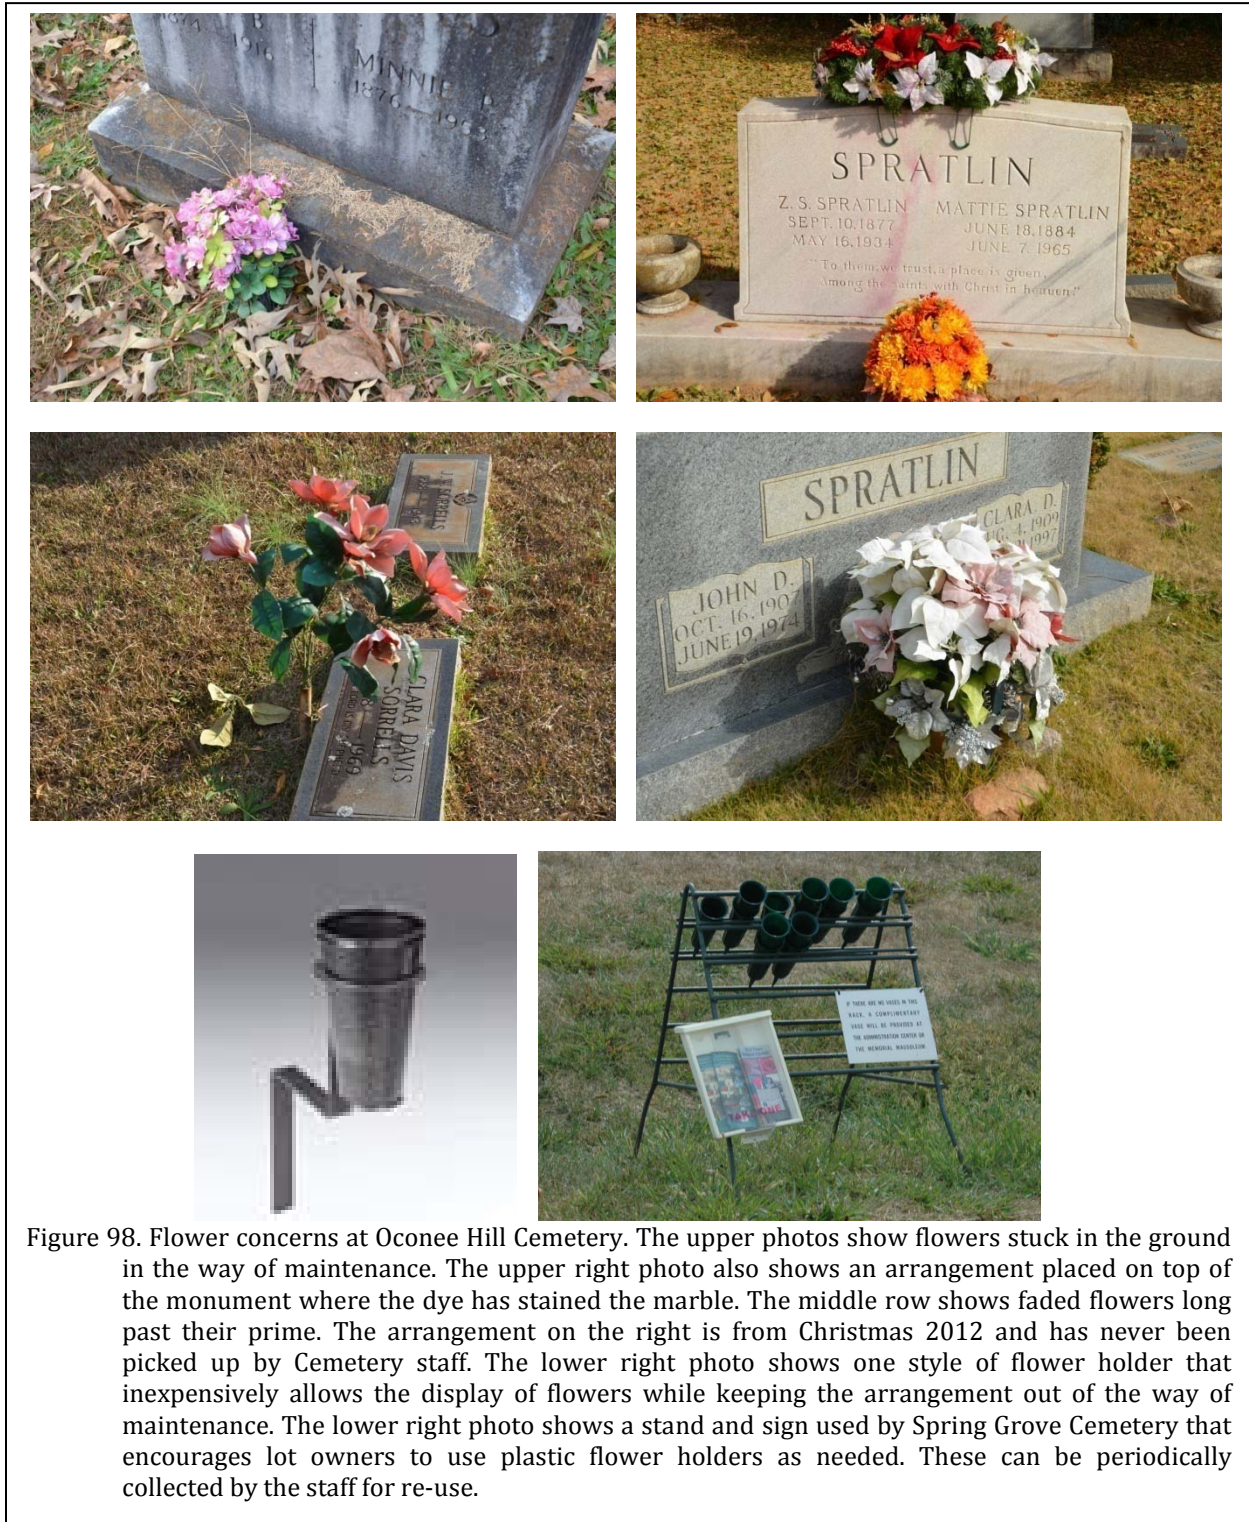
Figure 98. Flower concerns at Oconee Hill Cemetery. The upper photos show flowers stuck in the ground in the way of maintenance. The upper right photo also shows an arrangement placed on top of the monument where the dye has stained the marble. The middle row shows faded flowers long past their prime. The arrangement on the right is from Christmas 2012 and has never been picked up by Cemetery staff. The lower right photo shows one style of flower holder that inexpensively allows the display of flowers while keeping the arrangement out of the way of maintenance. The lower right photo shows a stand and sign used by Spring Grove Cemetery that encourages lot owners to use plastic flower holders as needed. These can be periodically collected by the staff for re-use.

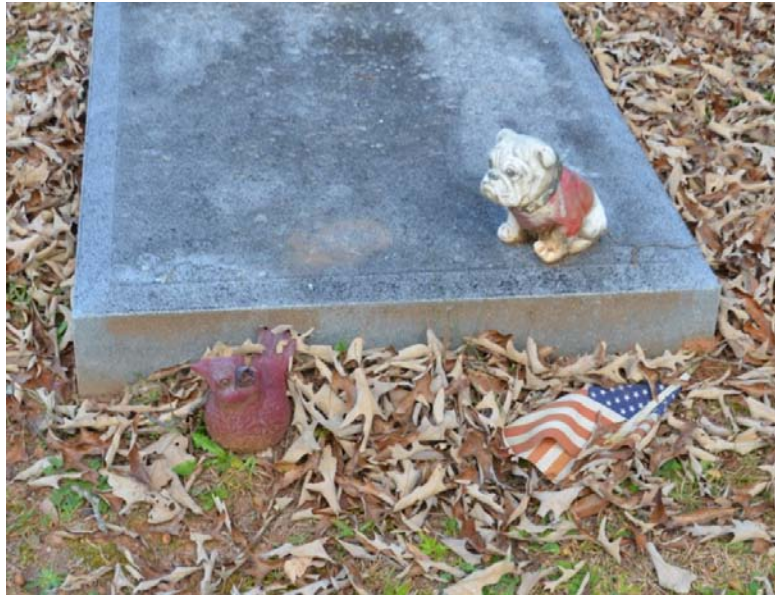
Figure 99. Example of grave decorations that are beginning to appear in Oconee Hill Cemetery.

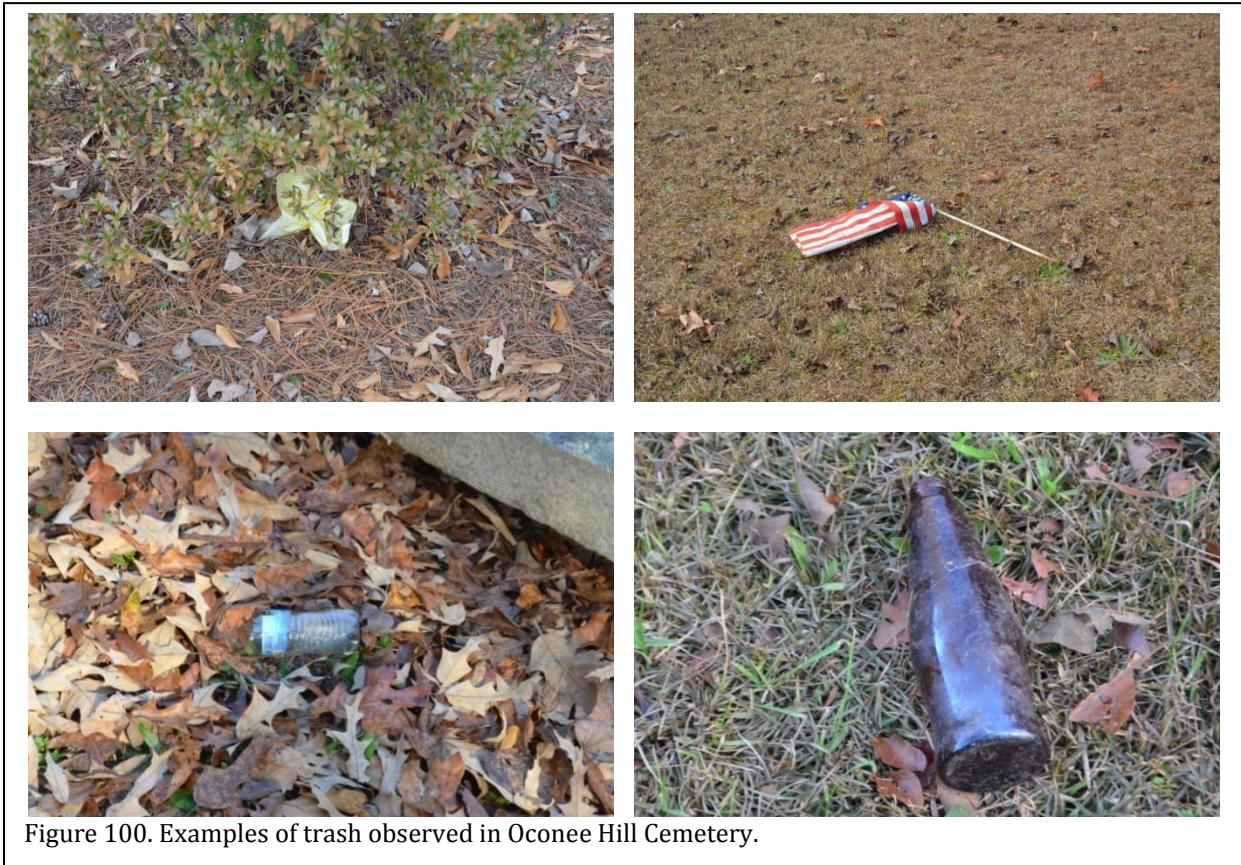
Figure 100. Examples of trash observed in Oconee Hill Cemetery.

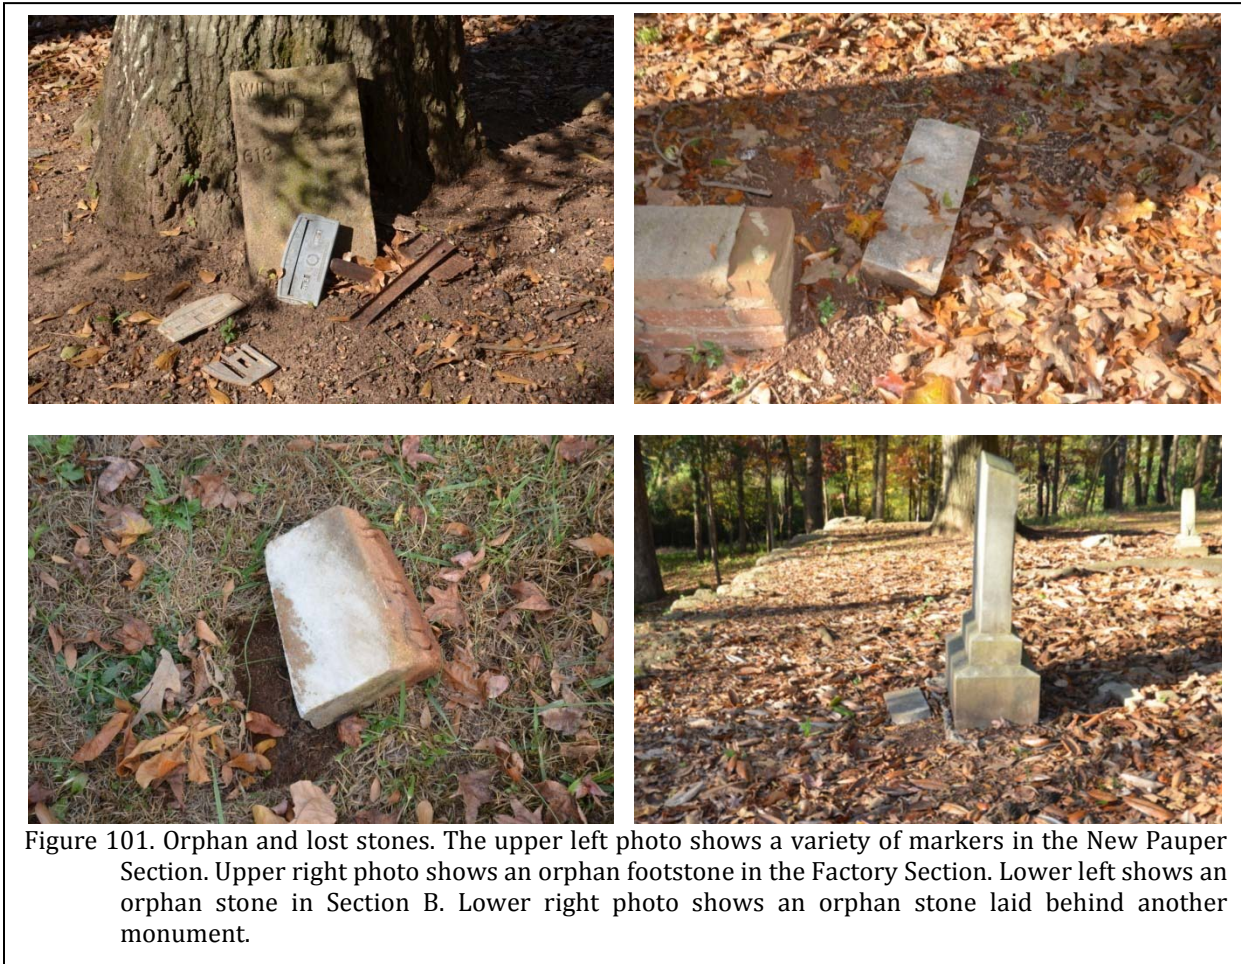
Figure 101. Orphan and lost stones. The upper left photo shows a variety of markers in the New Pauper Section. Upper right photo shows an orphan footstone in the Factory Section. Lower left shows an orphan stone in Section B. Lower right photo shows an orphan stone laid behind another monument.

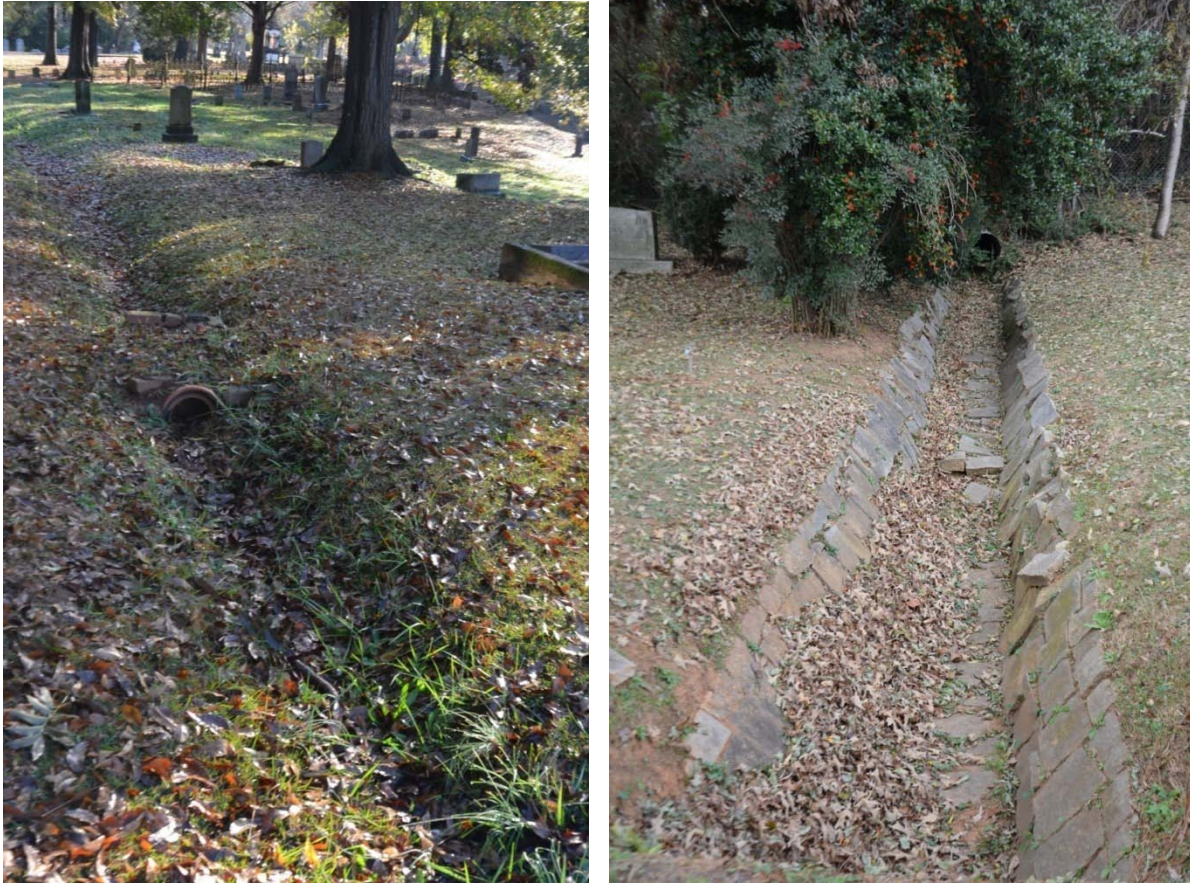
Figure 103. Cemetery surface drain problems. The upper left photo shows drainage ditch and culvert along the road of Factory Section that is not maintained. The upper right photo shows a surface drainage ditch that runs from off the cemetery property through Old G Section to a below grade drain. This drain requires cleaning and repair of the rock facing.

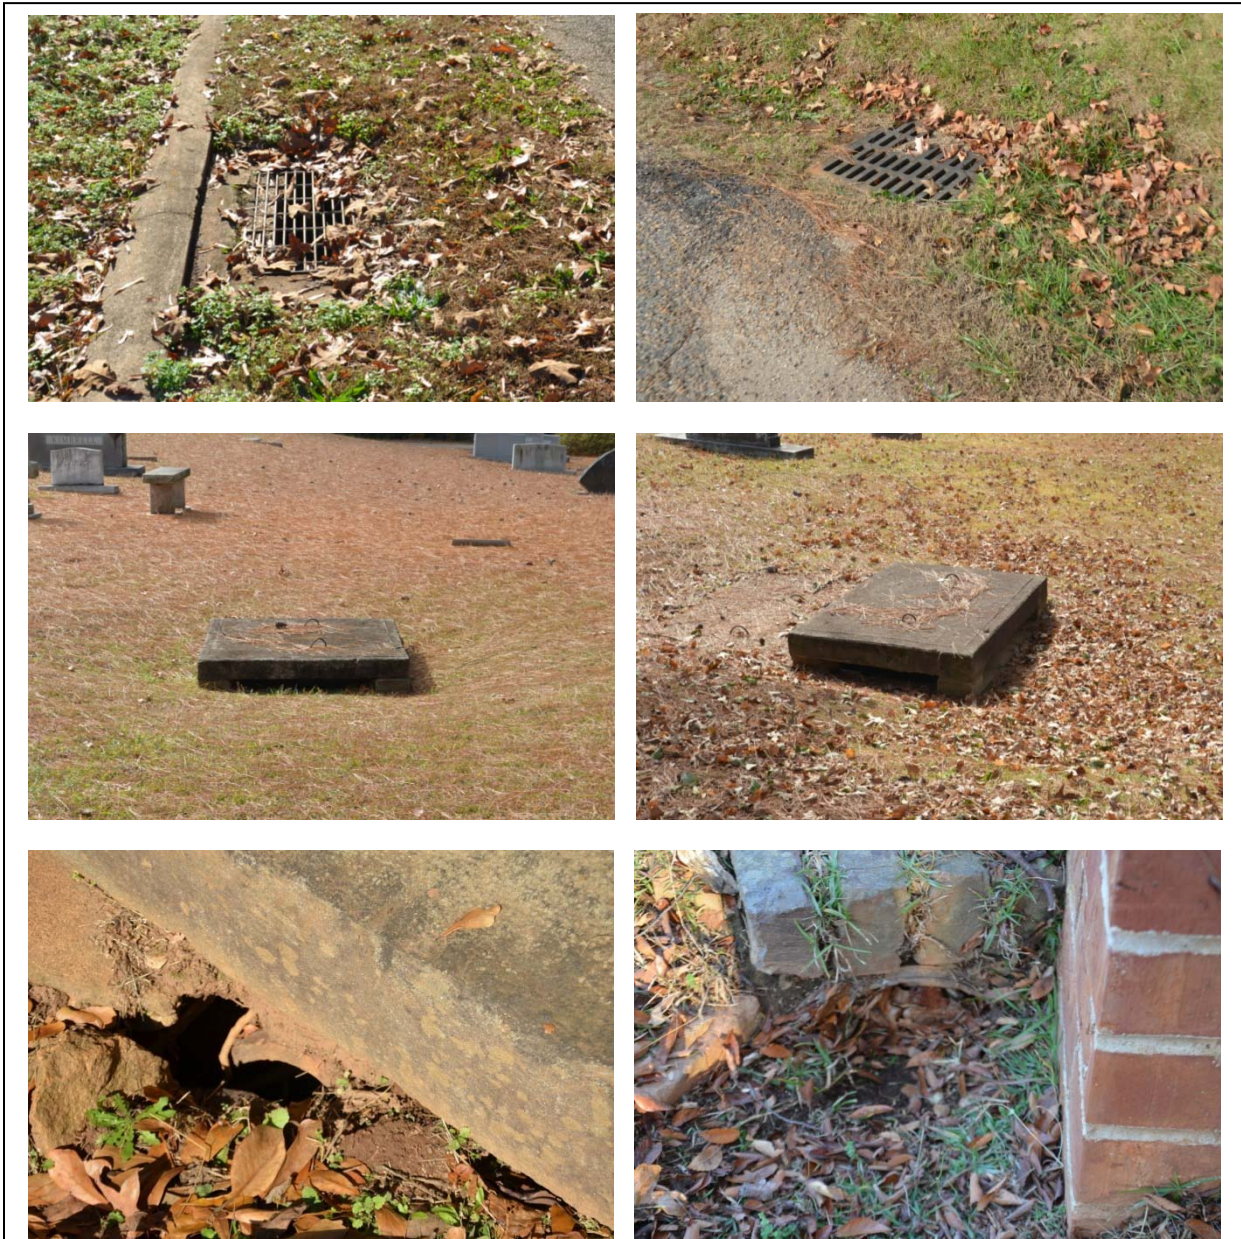
Like many cemeteries with no detailed plans, there is considerable uncertainty regarding both above and below grade drains. Where below grade drains originate and the direction of their flow is largely unknown.

Figure 104. Cemetery below grade drain problems. Upper left photo shows a below grade drain along River Road. Upper right photo shows a below grade drain at the edge of the road in Section H. Middle left photo is a below grade drain in the middle of Section H. Middle right photo is another below grade drain in Section H. Lower left photo is a below grade drain in the Valley Section, largely obscured by a set of stairs. This drain is at least 75% clogged. The lower right photo shows a below grade drain in the West Hill Section that is at least 90% clogged.

seems limited to the removal of obvious trash at inlets or catch basins. Catch basin sumps need periodic cleaning. Sediment and heavy debris can collect in the sump over long periods of time. The sediment can accumulate to the level where it restricts the outlet flow. These sumps should be cleaned at least once a year.

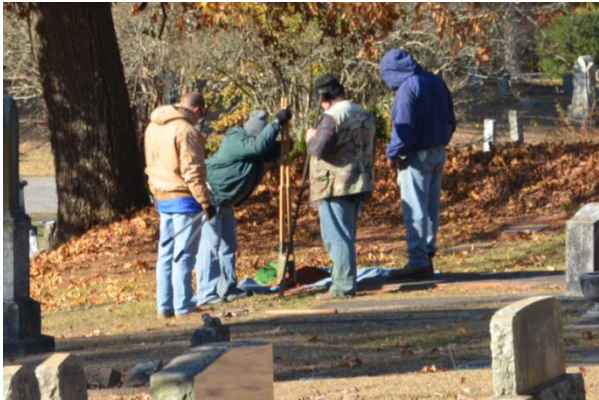
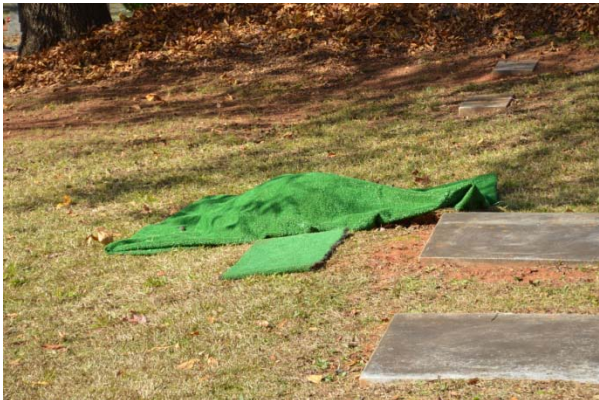
Figure 105. Preparation for cremains. The upper photo shows that four staff were required to dig the 1-square foot hole. The lower photo shows the appearance after the work was completed.

minor. It should require no more than two individuals to pull tapes in order to set the location and one individual to dig the hole. Nevertheless, the one cremains opening we observed, required four staff for about 45 minutes. This is excessive.
