OCONEE HILL CEMETERY ASSESSMENT, ATHENS-CLARKE COUNTY, GEORGIA

Research Contribution 557

Michael Trinkley
Debi Hacker

February 2014

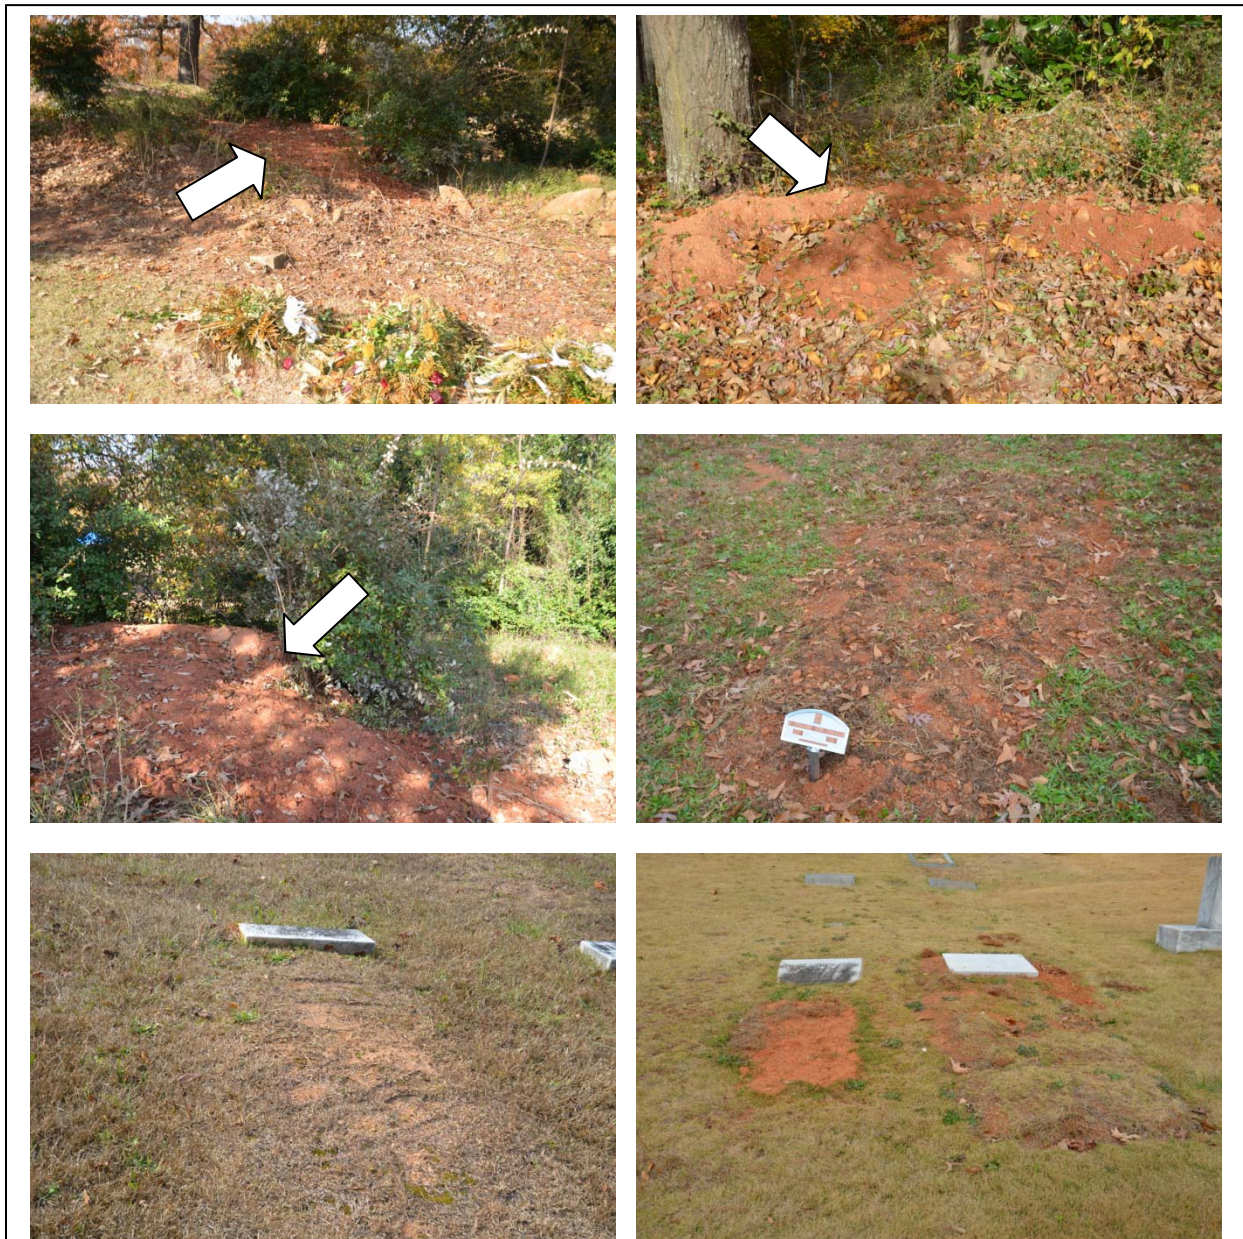
Figure 106. Problems with grave opening and closing. The upper left photo shows a recent grave (in foreground) and the remnant spoil tossed back into the shrubbery and woods (shown by arrow). Upper right and middle left photos show additional spoil piles dumped at the edge of the cemetery. Each pile is very recent, as evidenced by the lack of accumulated leaves. Middle right photo shows a recent grave, mounded, with no effort to seed or sod. Lower left photo shows a mounded grave that has been repeatedly scalped by mowing. The only solution is to reduce the mound and resod the grave. The lower right photo shows two mounded graves – one from 1997 and the other from 2012. The 1997 grave was never reseeded or sodded and the more recent grave has grass mounded so high it will die and be scalped by mowing.

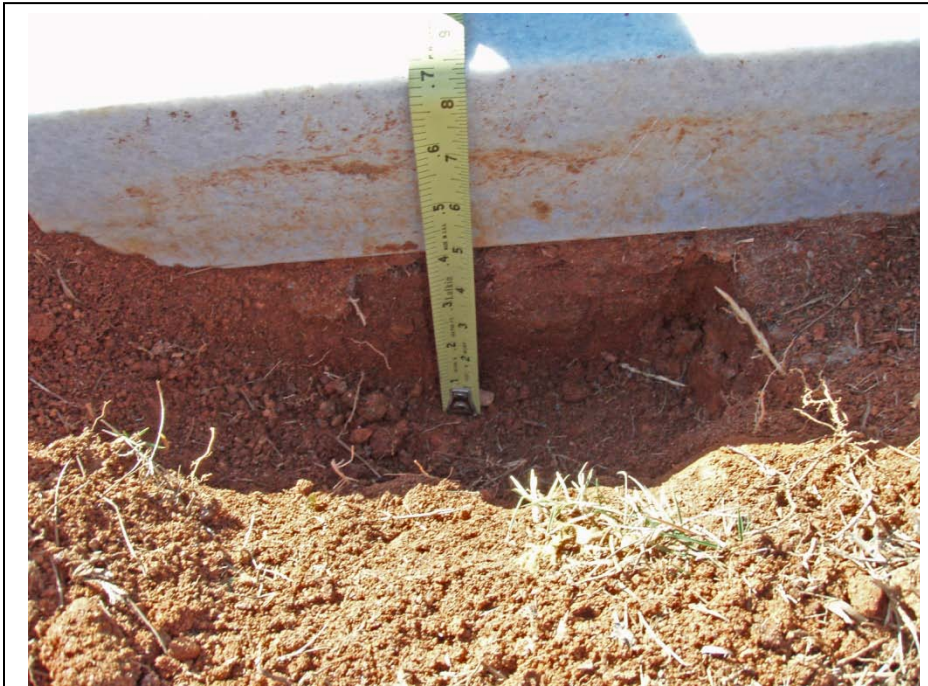
Figure 108. Monument set in 2013 showing virtually no concrete foundation – only clay soil. Scale is in tenths of feet on the left and inches on the right.

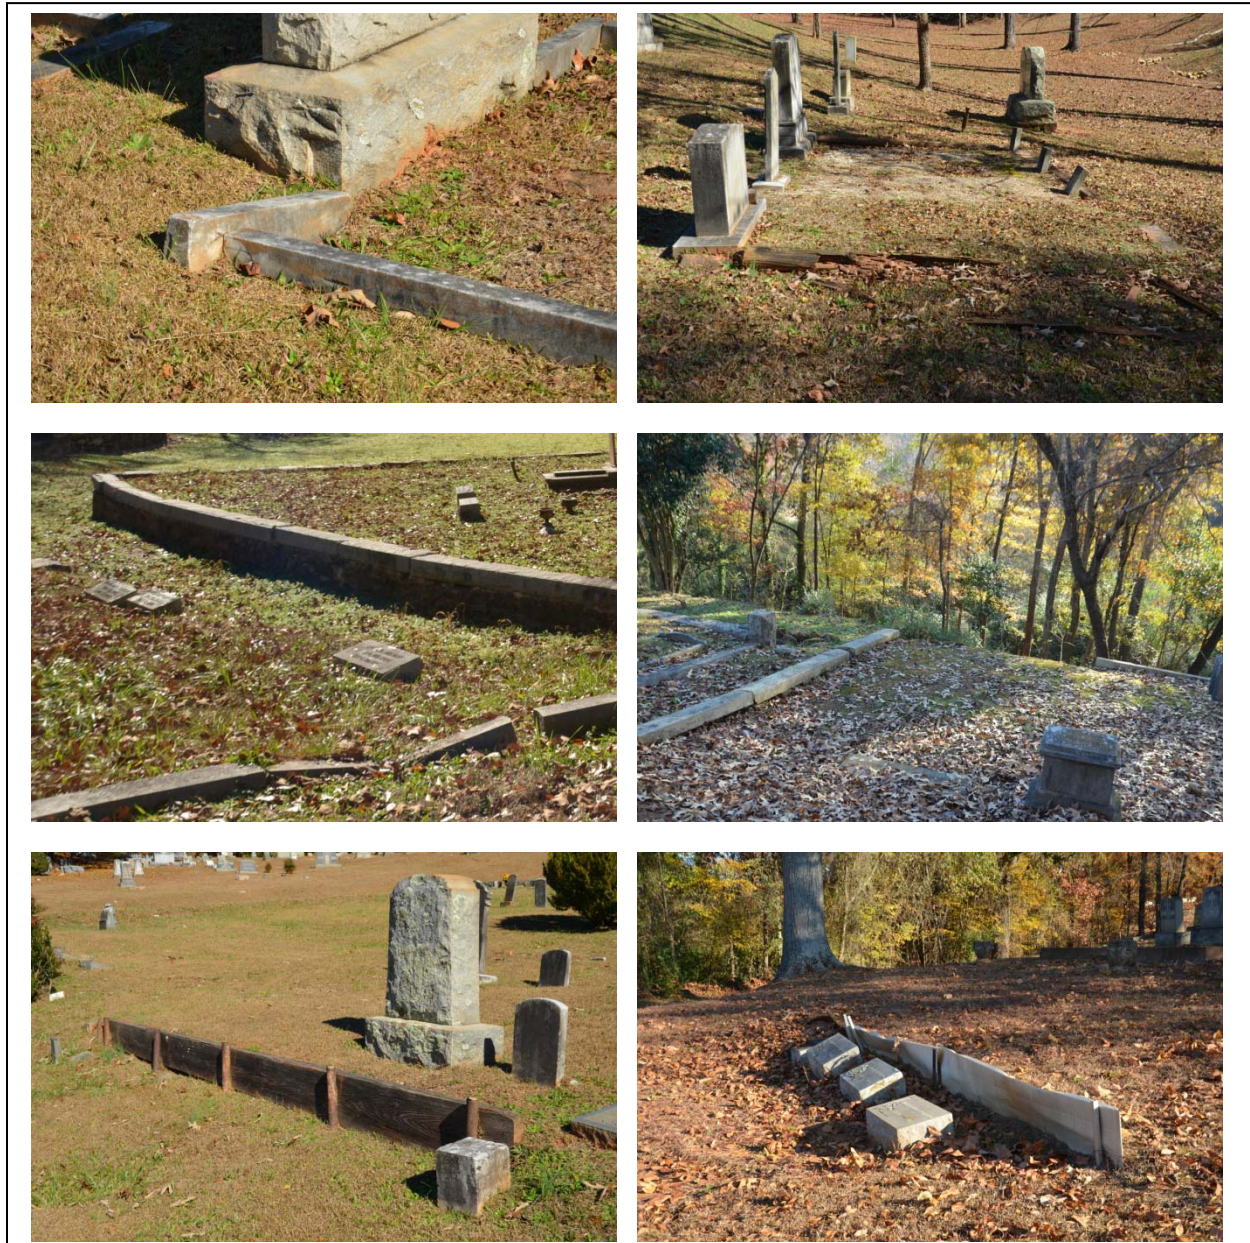
Figure 109. Plot curb issues in the Cemetery. The upper left photo shows displaced marble coping sinking into a grave. The upper right photo shows badly deteriorated wooden railroad tie curbs. The middle left photo shows broken and sinking concrete curbing. The middle right photo shows the loss of curbs over the side of a slope due to unrestrained erosion. The lower left photo shows a wood board, held by pipes that is apparently being used to control sheet erosion. The lower right photo shows a similar situation where metal skirting or siding panels have been similarly used.

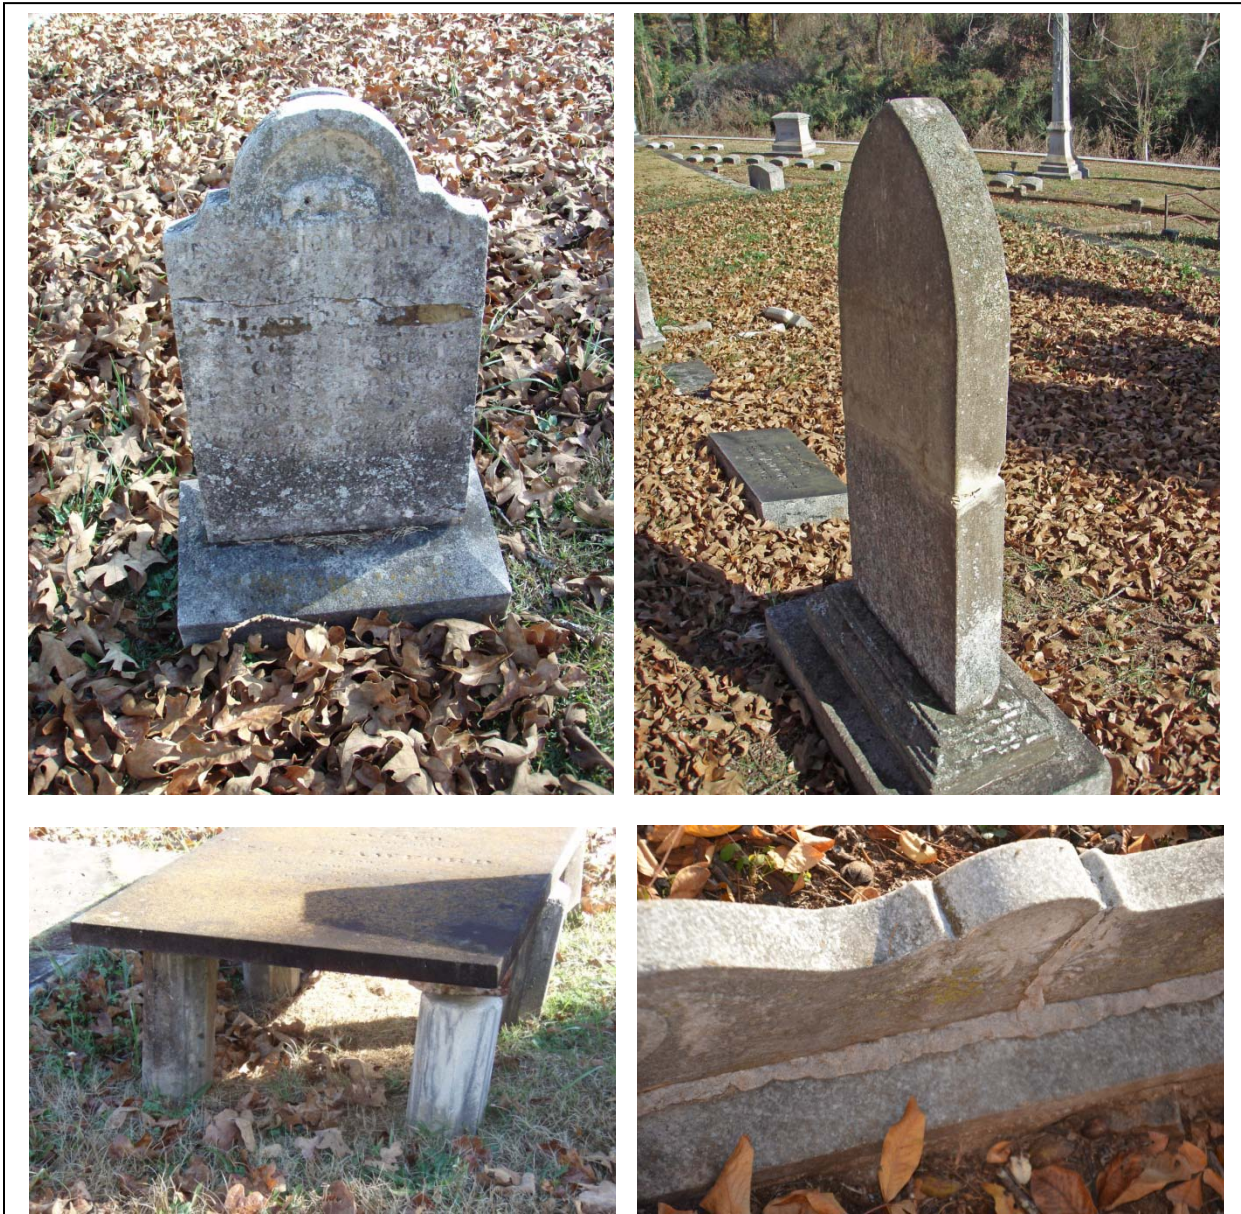
Figure 110. Examples of incorrect and poor repair practices at Oconee Hill Cemetery. Upper left shows a stone with a simple epoxy repair. The epoxy has been used as infill and has yellowed through UV exposure. Upper right is a repair using some type of mortar that has been smeared across the face and sides of the stone. There is also loss along the edge. The lower left photo shows a table tomb with a sunken leg that has been “fixed” by inserting a brick fragment in an effort to level it. The lower right photo shows a damaged marble monument repaired using some type of caulk.

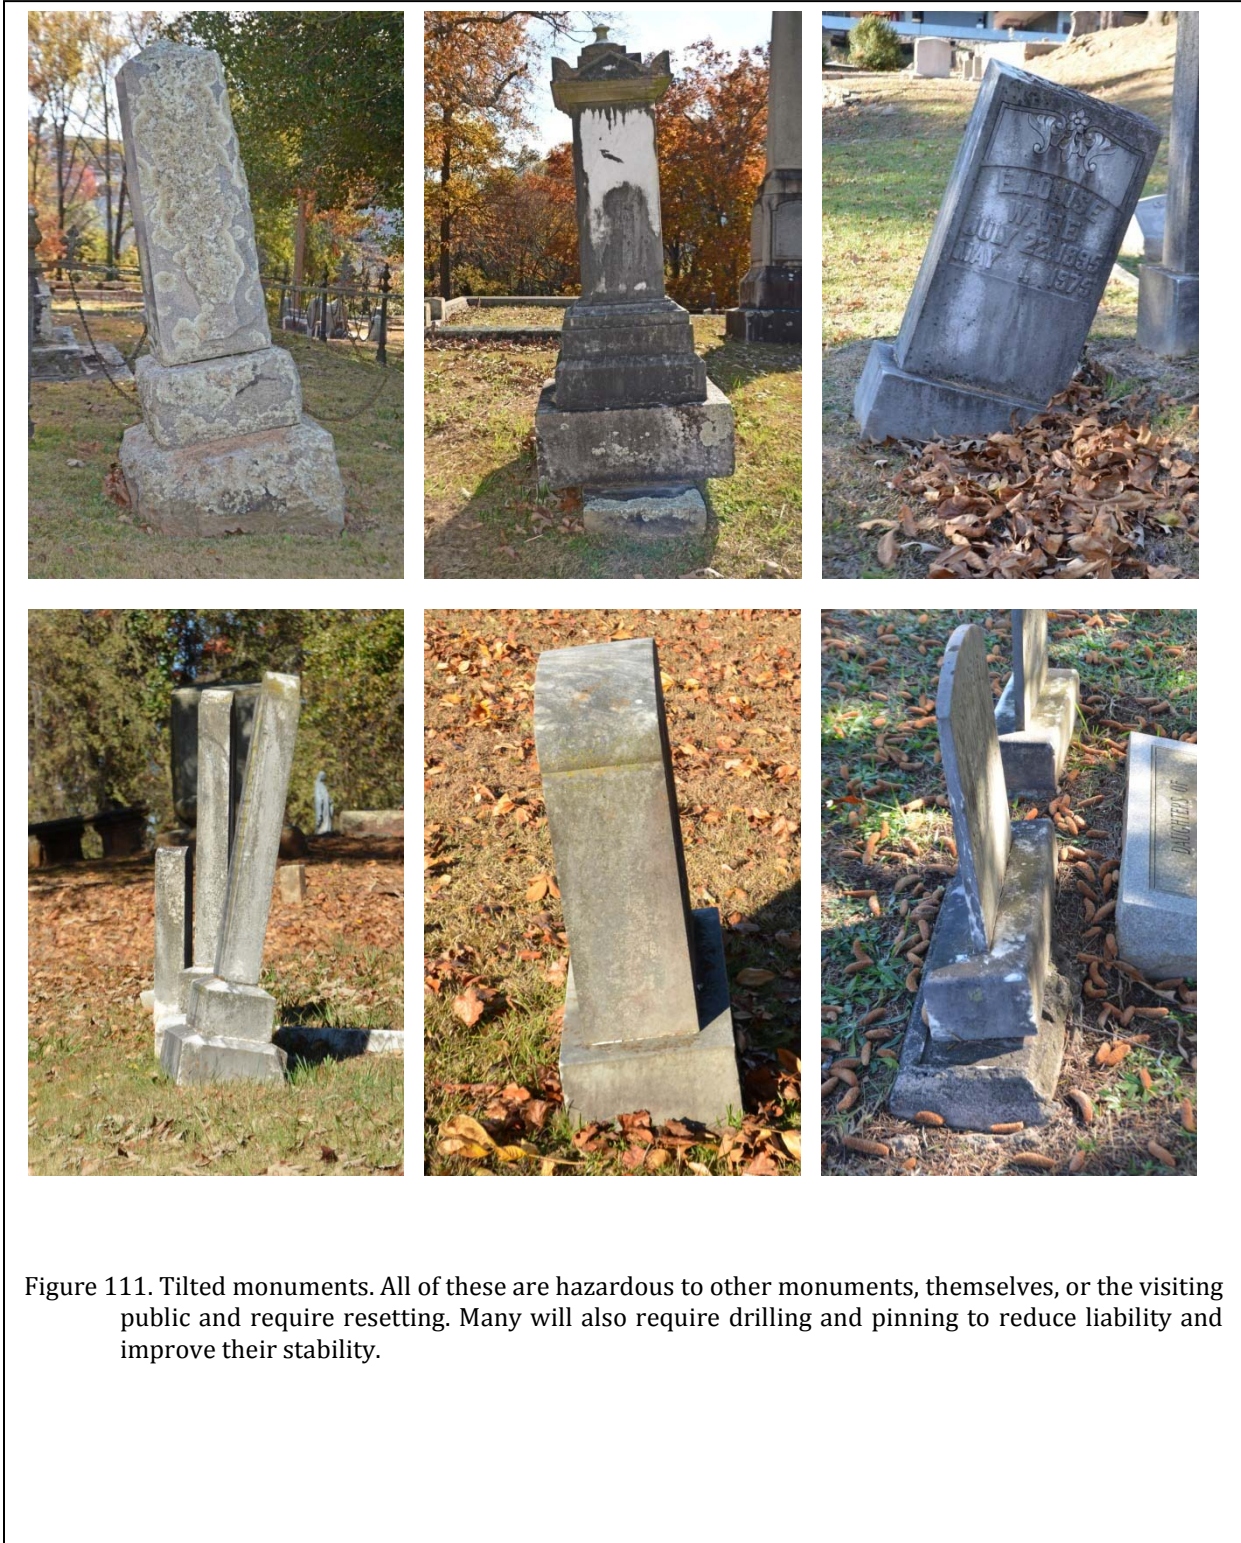
Figure 111. Tilted monuments. All of these are hazardous to other monuments, themselves, or the visiting public and require resetting. Many will also require drilling and pinning to reduce liability and improve their stability.

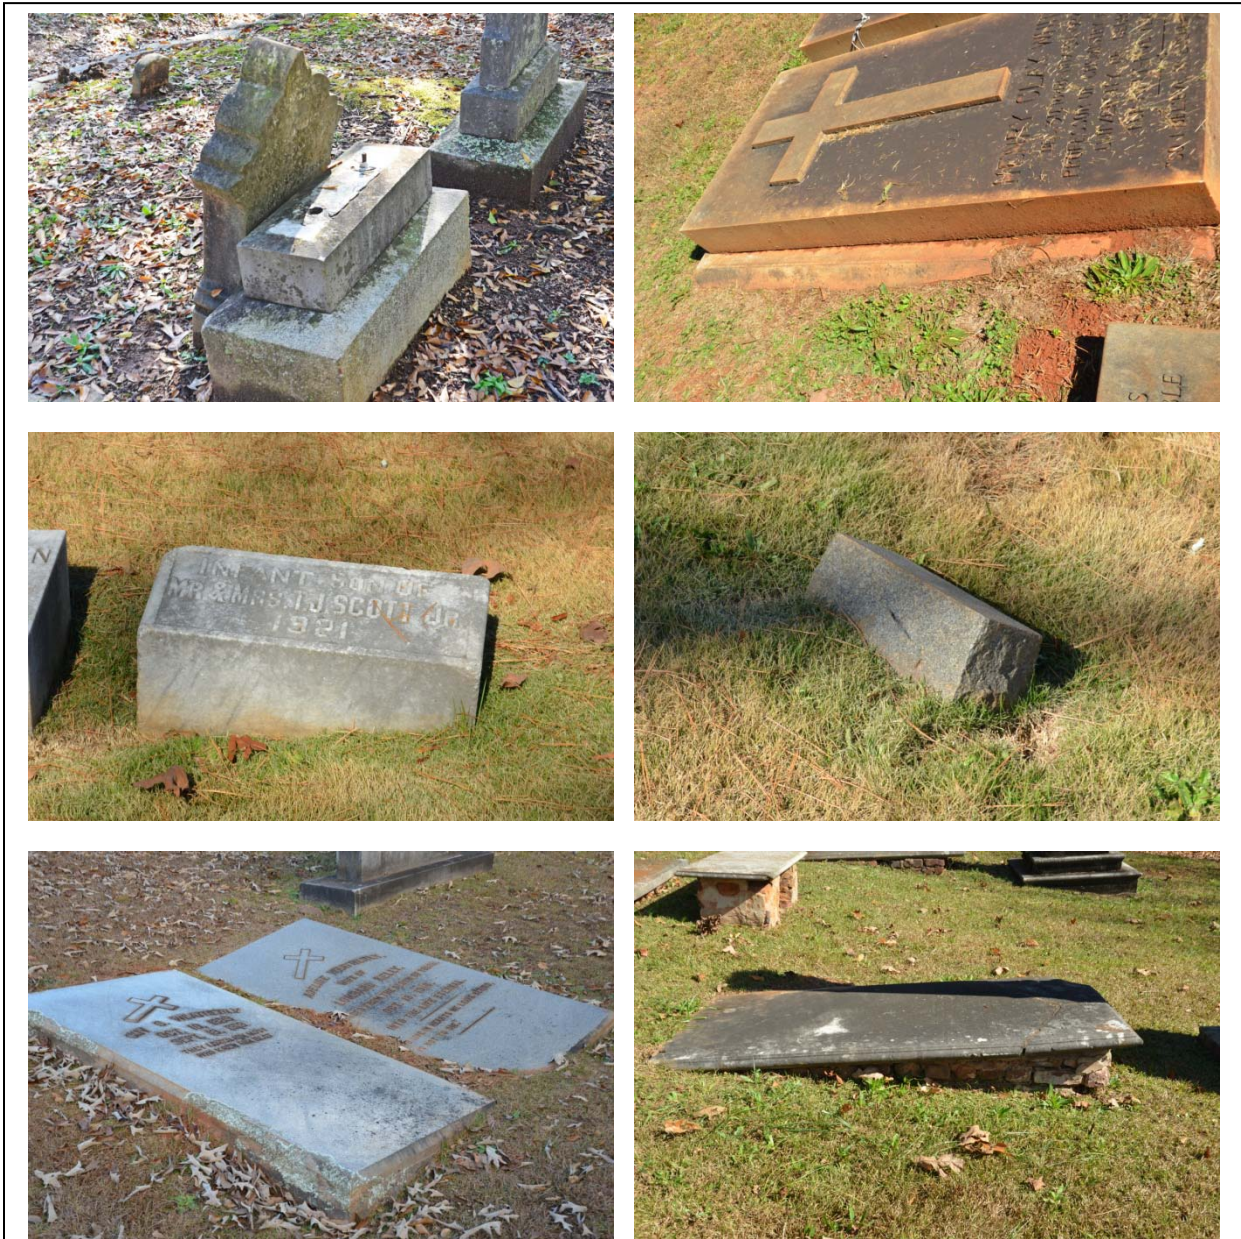
Figure 112. Displaced or sunken monuments. The upper left photo shows a die on base that has fallen off and requires resetting. The existing pins may need to be replaced. The upper right photo shows a granite ledger displaced off its base, probably by a mower. The middle left and right photos show monuments sinking into their graves for lack of a good foundation. The lower left photo shows a very large granite ledger sinking into a grave. The lower right photo shows what appears to be a brick box tomb that has sunk out of sight at one end, while the other is still partially supported by remnant bricks.

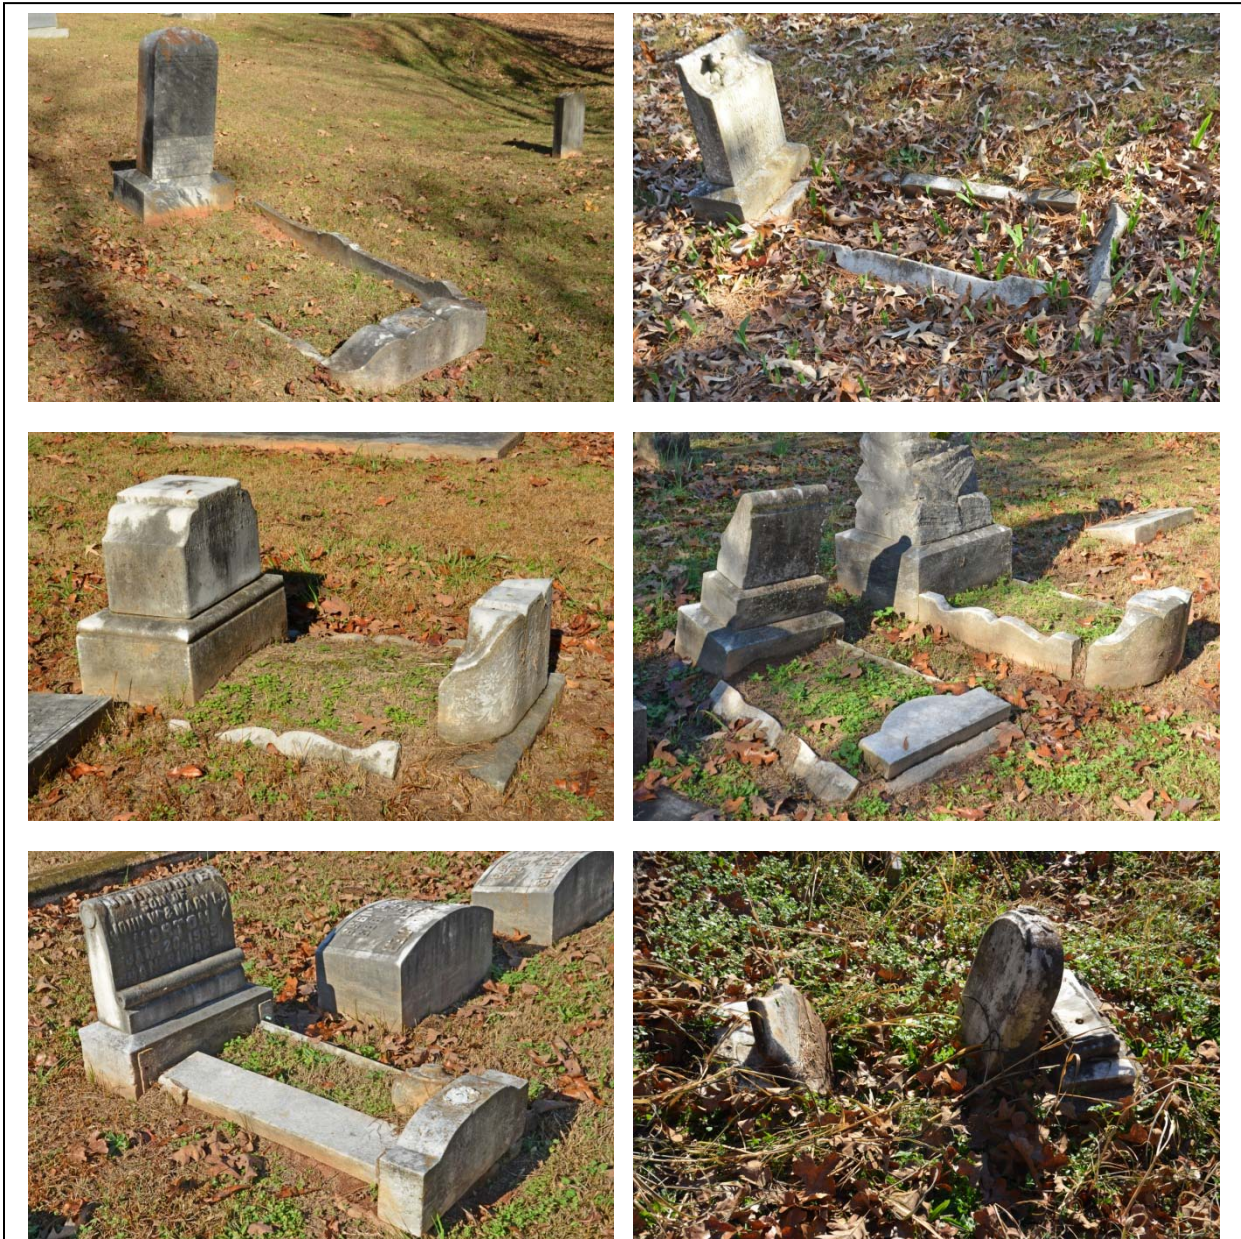
Figure 113. Cradle grave problems. These photos show a range of cradle graves that are tilting and collapsing. Some, such as the lower left example, have clearly visible pins connecting the side rails to the headstone. All require disassembly and resetting to repair their appearance. Some may also require repair of broken side rails.

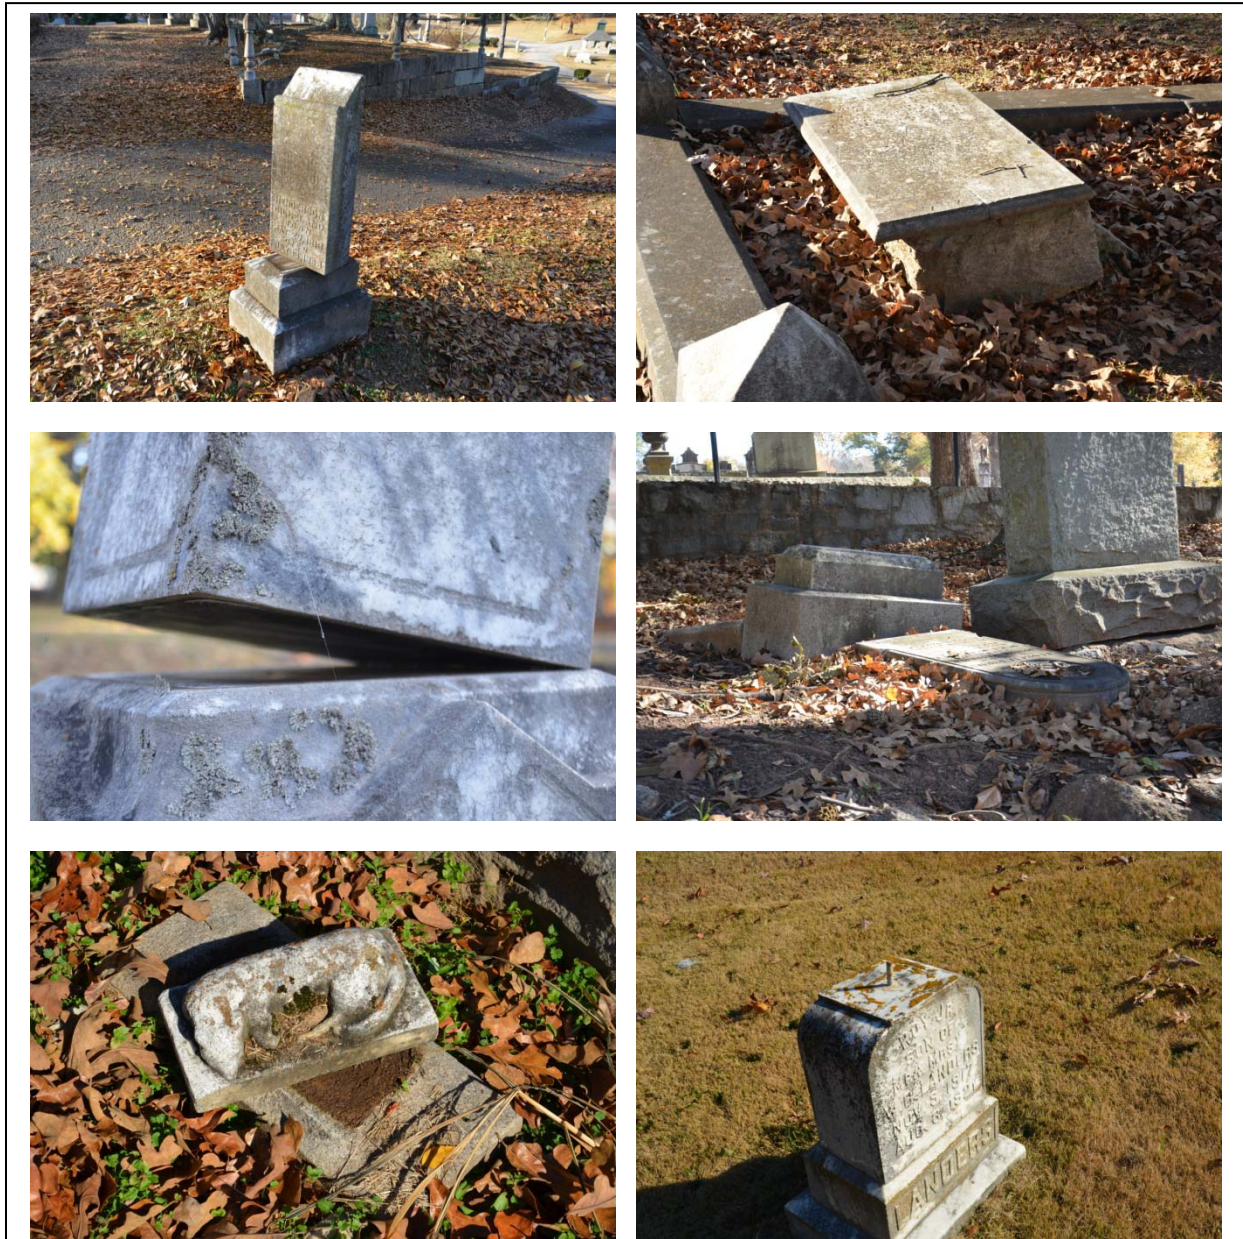
Figure 114. Examples of loose or fallen monuments. The upper left photo shows a monument twisted on its base and ready to collapse. The upper right photo shows a ledger loose and displaced on its box tomb. The middle left photo shows how easy it is to tip over a monument that is not pinned to its base. The middle right photo shows an unpinned monument that has fallen in the Cemetery. The lower left photo shows a lamb decoration loose on its stone. This could be easily stolen and is the type of monument sought for garden decoration. The lower right photo shows a monument that has lost its urn already. Note the pin is still in place.

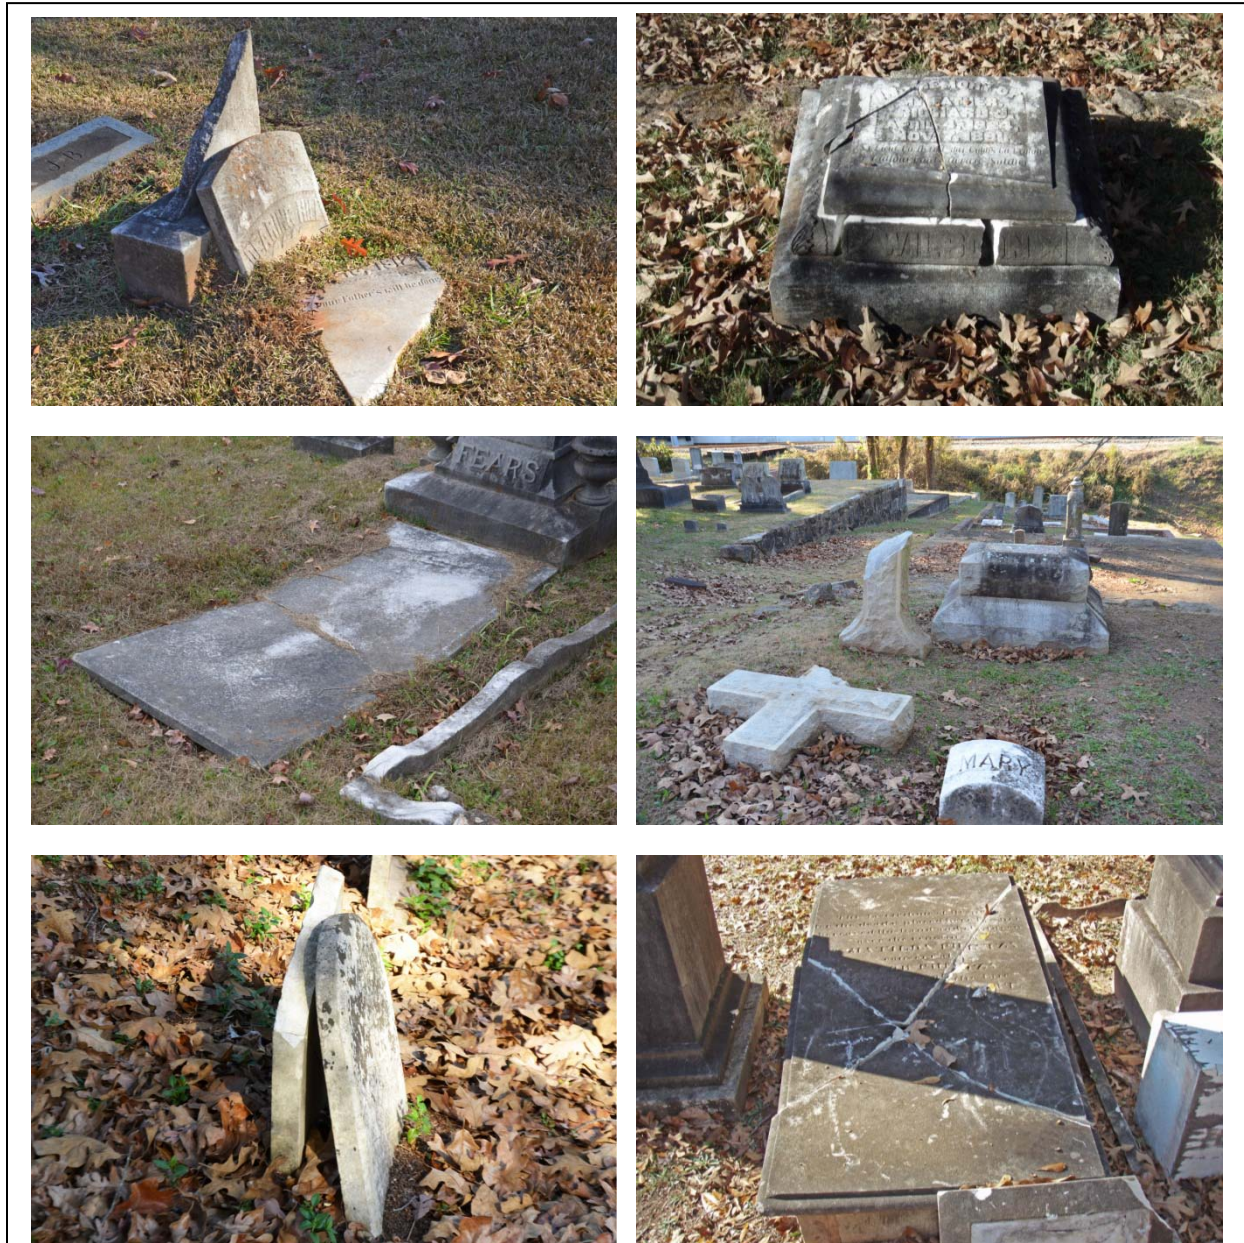
Figure 115. Examples of broken monuments. The upper left photo shows a marble tab in socket stone with a badly broken die. The upper right photo shows a variant of marble pillow monument that is shattered. The middle left photo shows a marble ledger that is both undermined and broken. The middle right photo shows a broken cross. The lower left photo shows a broken marble tablet. The lower right photo shows a badly shattered marble ledger. All of these stones require a conservation treatment involving drilling and pinning the broken fragments back together.

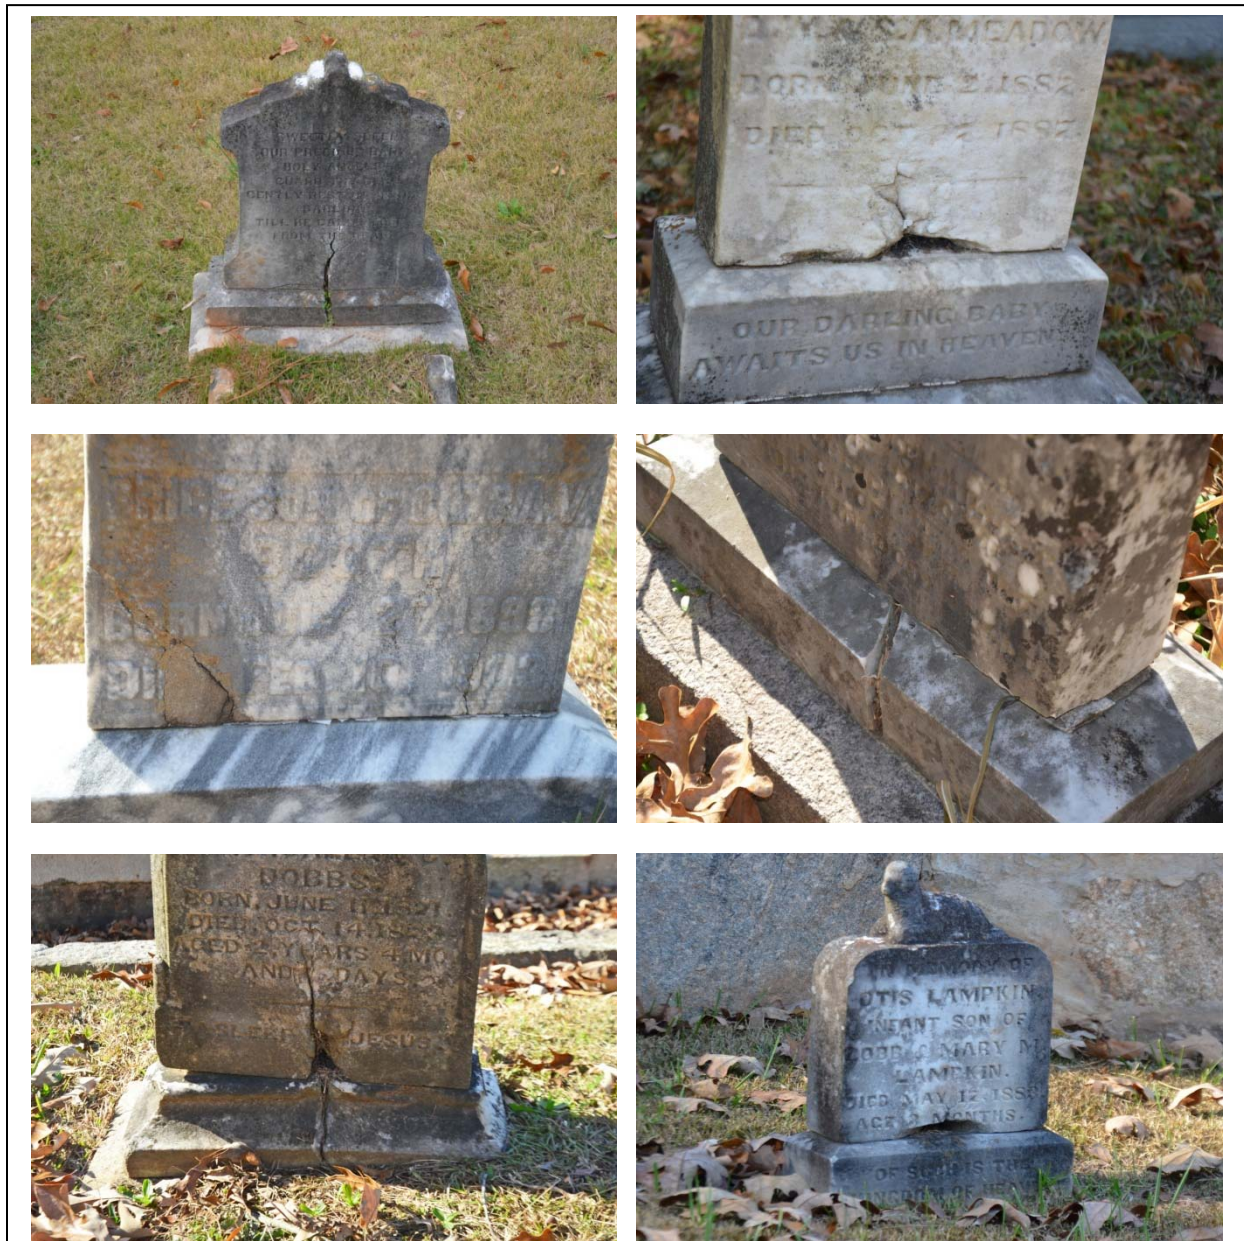
Figure 116. Examples of damage caused by ferrous pins. The upper left photo shows iron jacking that has broken the base and cracked the die. The upper right photo shows loss and spalling on the die resulting from iron jacking. The middle left photo shows iron jacking damage with an unsuccessful effort to repair the damage using ordinary Portland cement. The middle right photo shows a broken base. The lower left photo shows extensive damage to both the base and the die, with iron staining on the marble. The lower right photo show loss of the die and staining of the base.

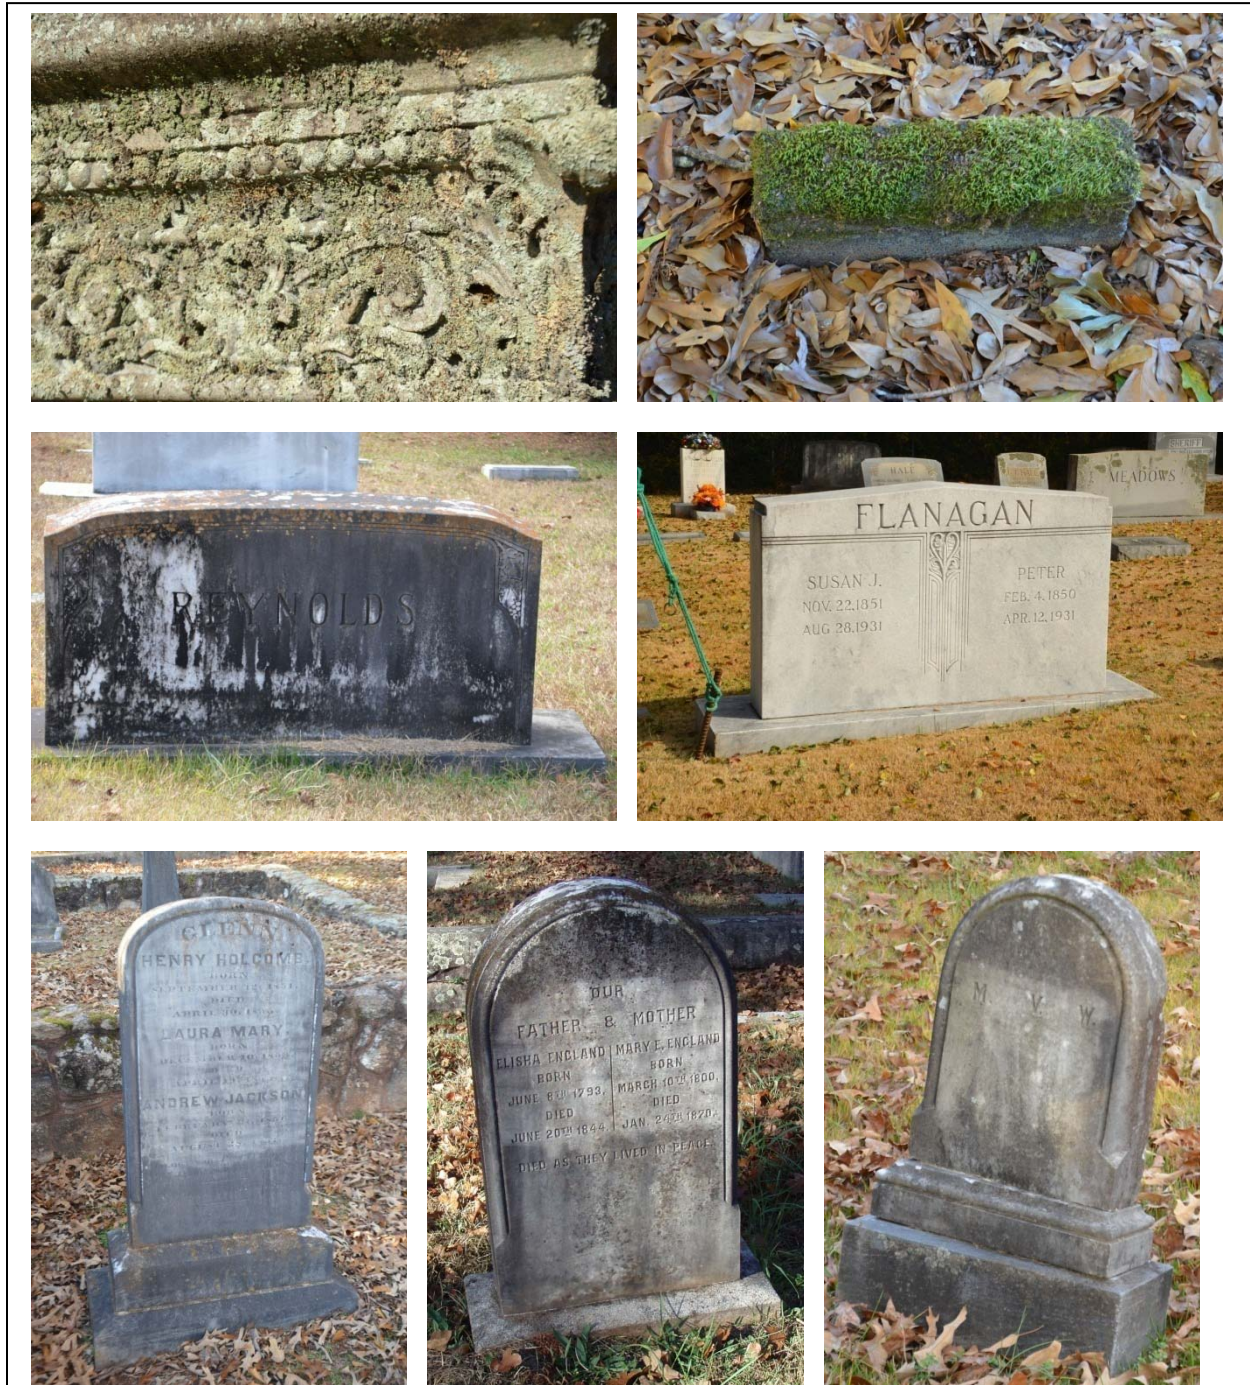
Figure 117. Cleaning issues at Oconee Hill Cemetery. The upper left photo shows dense lichen obscuring monument details. The upper right photo shows moss on a stone. The middle left photo shows dense biologicals that are found throughout the cemetery. The middle right photo shows an acid cleaned marble monument. The lower row photos all show improper cleaning using bleach only in the area of the inscription. This is typical of genealogists.

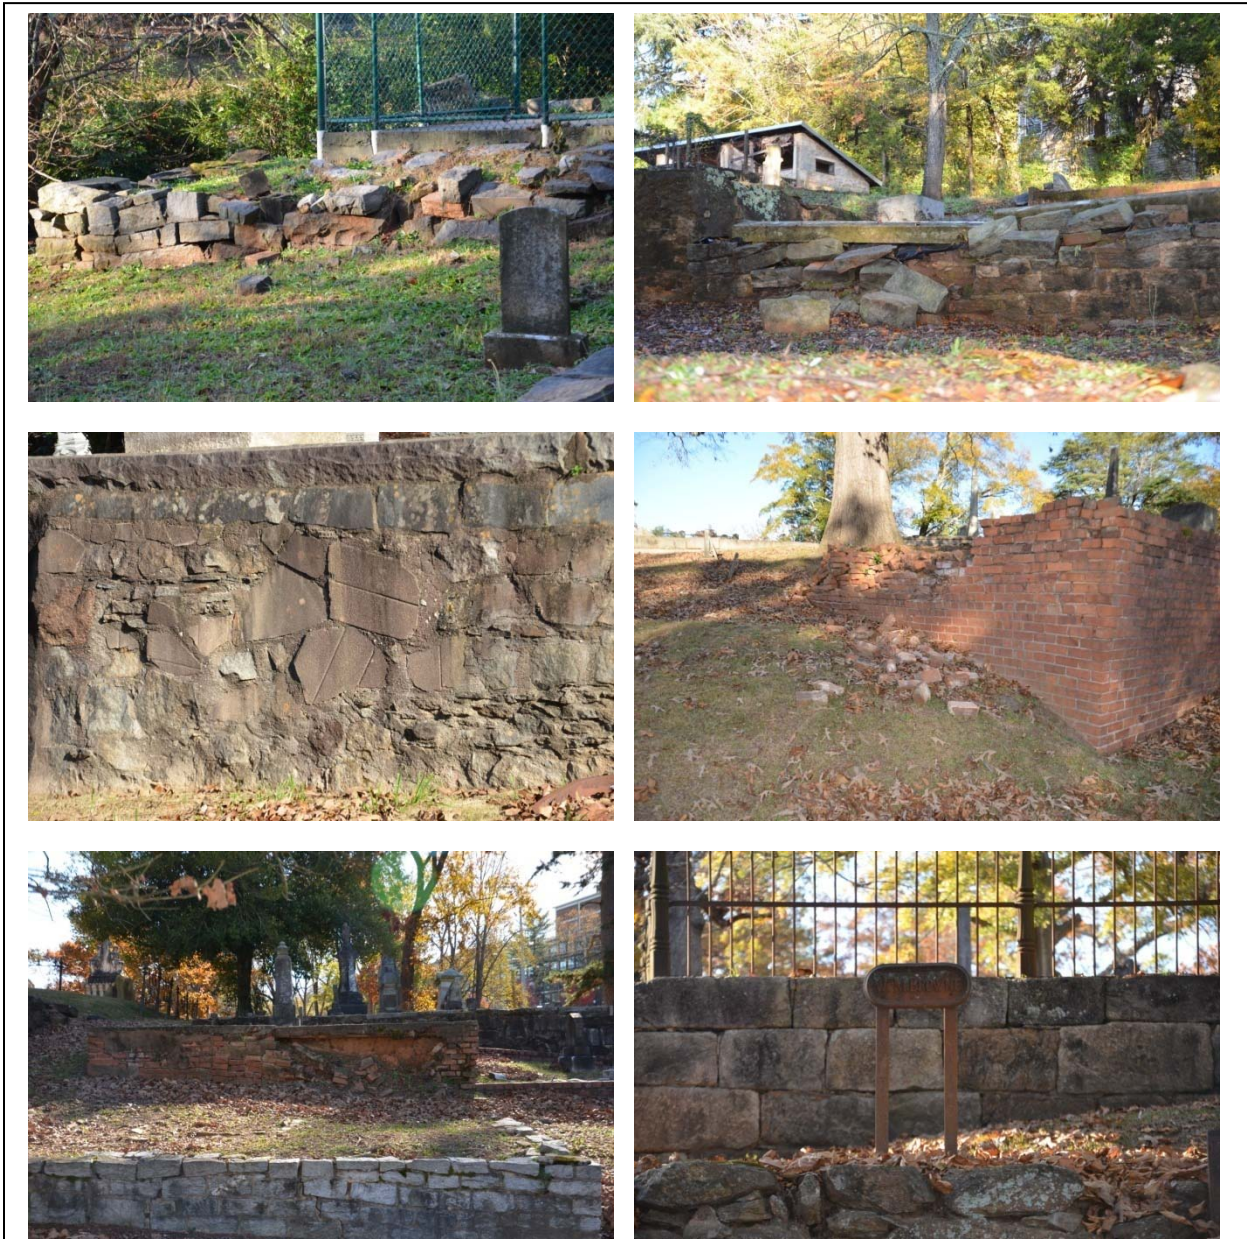
Figure 118. Variation in wall designs. Upper left photo shows a dry laid wall of pitched-face granite in Factory Cemetery (wall is in failure). Upper right is a coursed rubble granite mortared wall in Factory Cemetery (in failure). Middle left photo shows a mortared random rubble wall in West Hill that is in good condition. Middle right photo shows a brick wall in West Hill laid up in running bond, although there are two courses of headers at irregular intervals. This wall is in poor condition. The lower left photo shows a mortared coursed rubble wall (bottom) in West Hill (wall is in good condition). Lower right photo shows a squared rubble wall laid in mortar in West Hill (wall is in good condition).

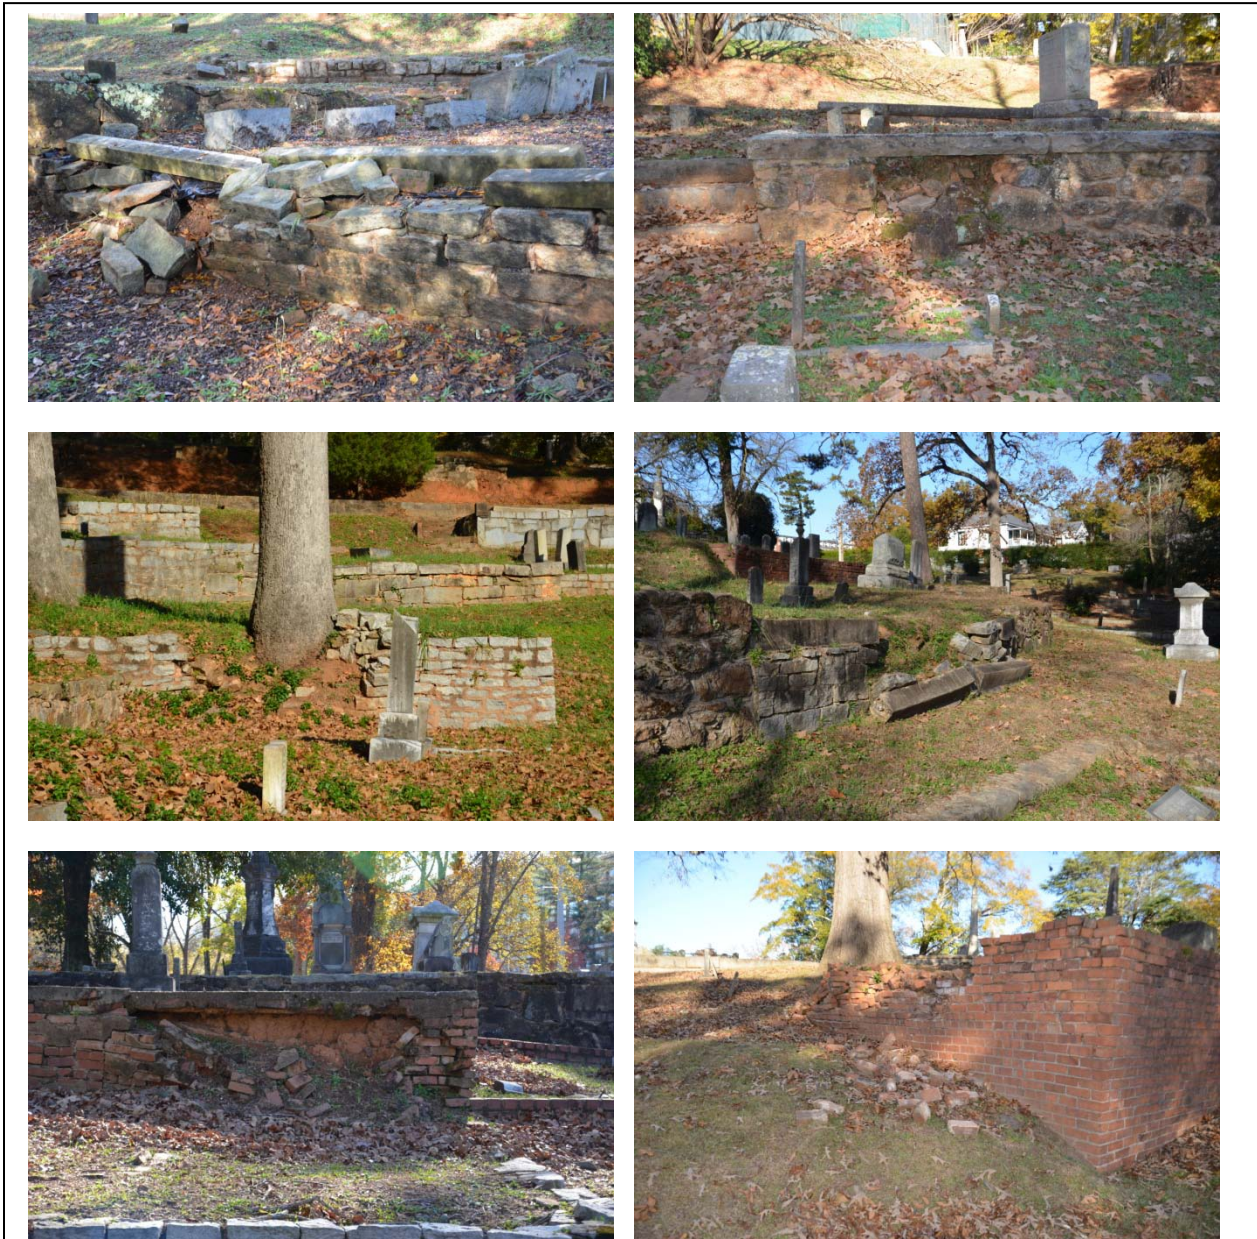
Figure 119. Examples of walls requiring repair or replacement. Damage has resulted from foundation settling which causes diagonal cracking through masonry units or the bed joints; displacement of walls, at times by out-of-plane loading, but more often by pressure resulting from trees; or failure to maintain the walls (including a lack of pointing).
