OCONEE HILL CEMETERY ASSESSMENT, ATHENS-CLARKE COUNTY, GEORGIA

Research Contribution 557

Michael Trinkley
Debi Hacker

February 2014

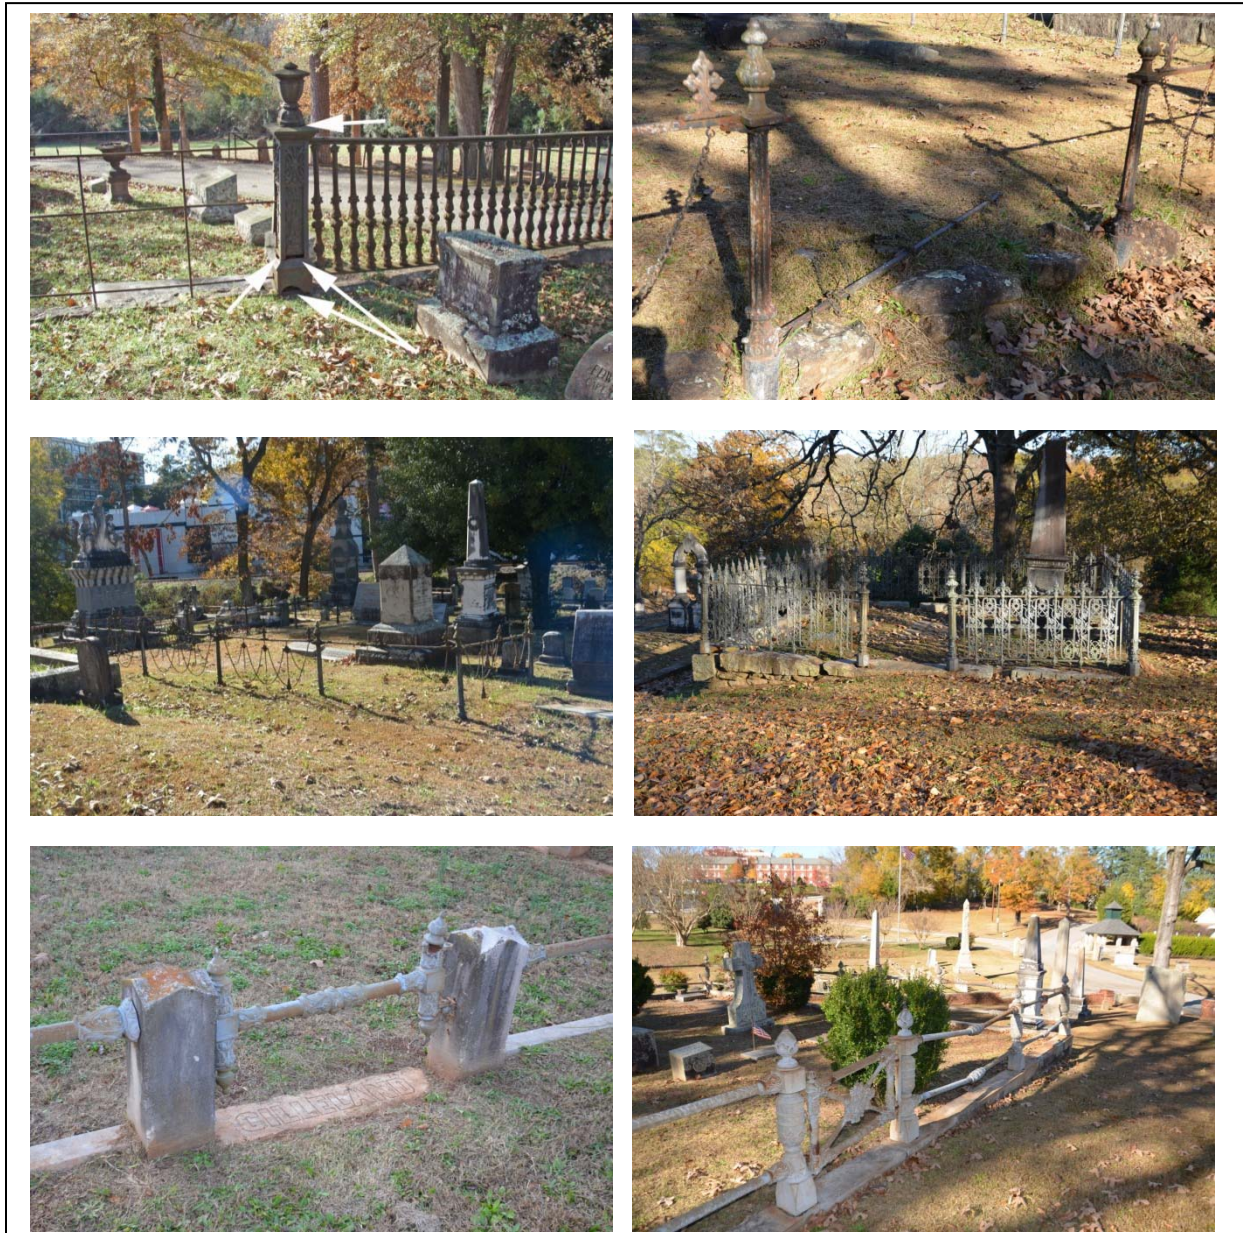
Figure 122. Fence types and common problems at Oconee Hill Cemetery. The upper left photo shows an iron fence in East Hill that has made good use of a “ghost” section to provide support and enclose the lot with minimal expense. The arrows, however, point to areas where water is entering the fence and causing damage. The upper right photo shows a fence in poor condition with parts lying on the ground. The middle left photo shows an iron fence in fair condition. The middle right photo shows an iron fence that had been painted white, but is now in failing condition. The lower two photos show typical gas pipe fences with corrosion breaking through the galvanized coating.

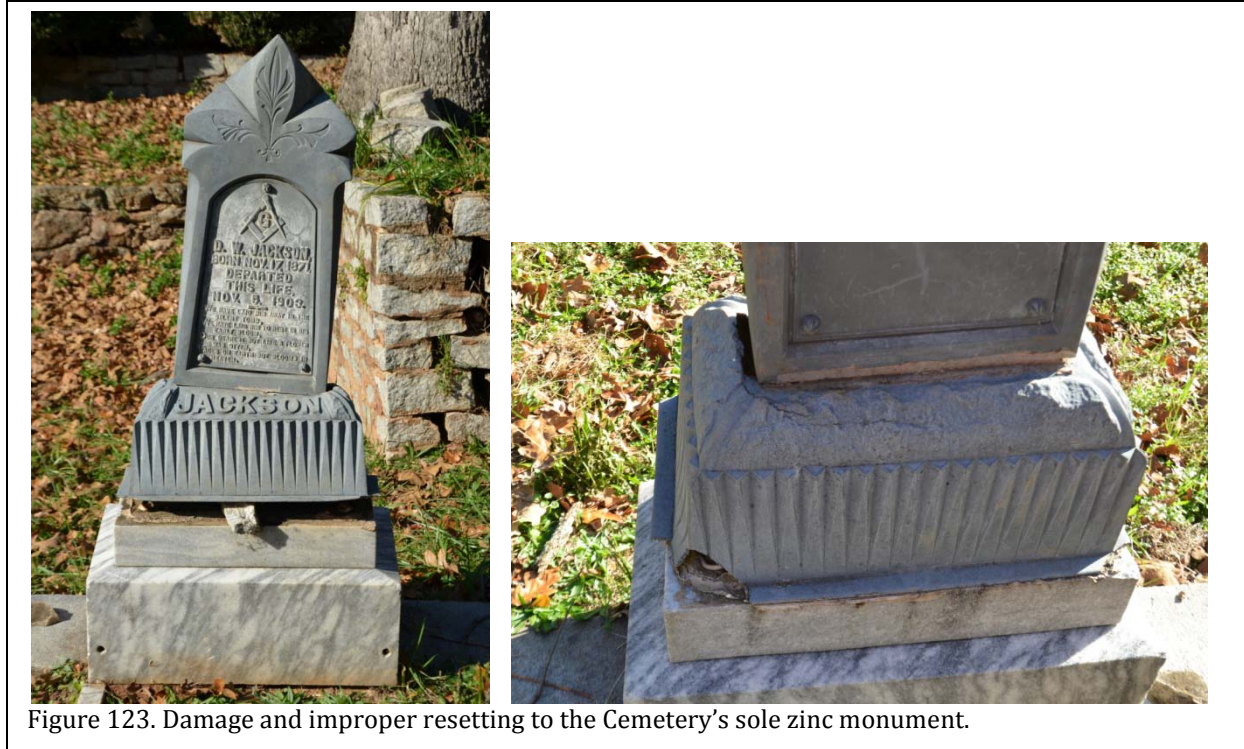
Figure 123. Damage and improper resetting to the Cemetery's sole zinc monument.
