ASSESSMENT OF THE CHURCH OF THE ADVENT CEMETERY, SPARTANBURG, SOUTH CAROLINA

Chicora Research Contribution 571

August 2016

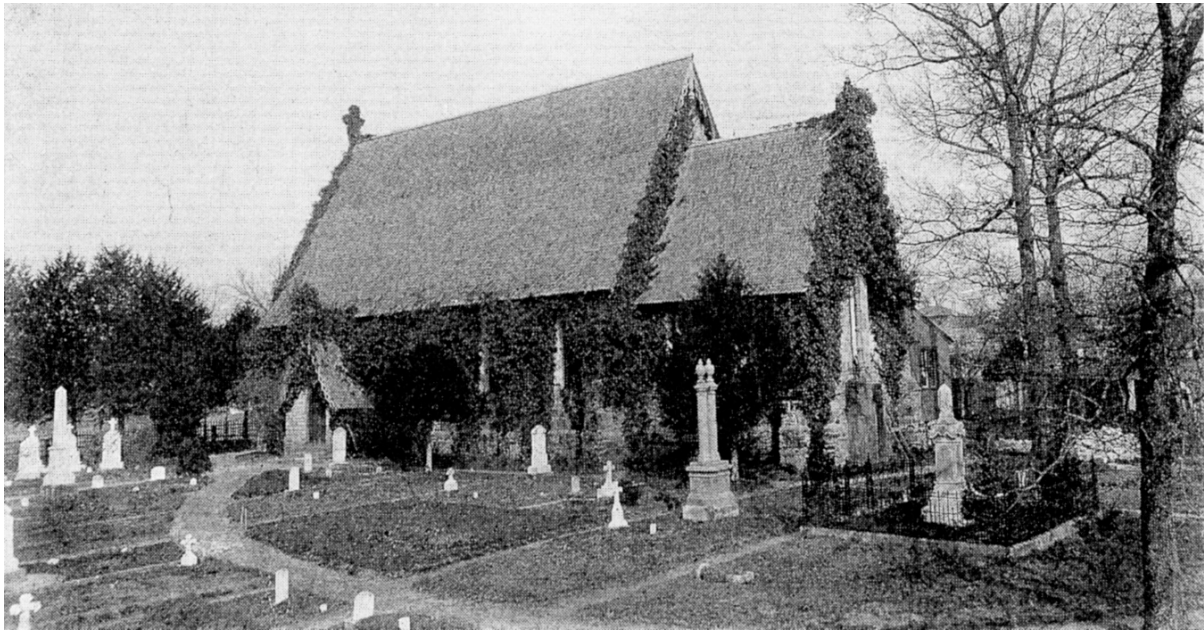
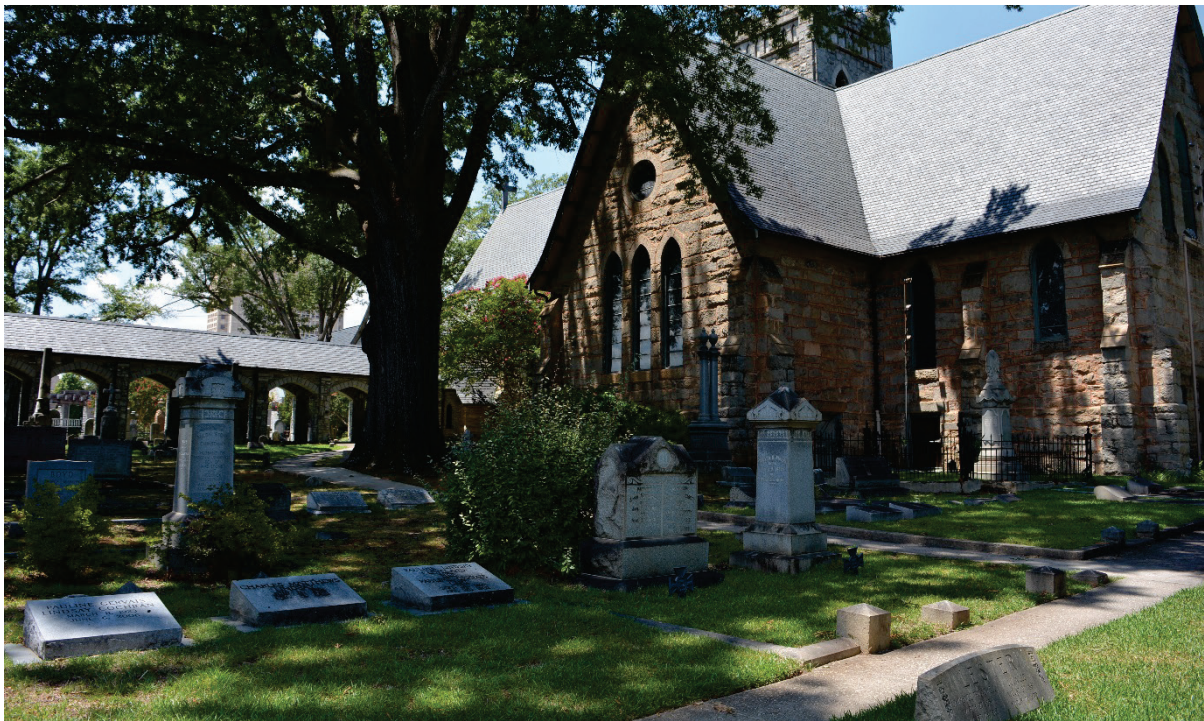
Figure 4. Photograph of the church and surrounding cemetery about 1893, prior to the first modifications in 1897 at top. This photo is looking northwest from the southeast corner of the cemetery. Below is the same view today.

These are especially critical issues for the Advent Church cemetery. The cemetery has been fighting gradual – and at times exponential – deterioration since at least the late nineteenth century. At least some of these changes can be seen in Figures 4, 5, 6, 7, 9, and 10.

Photographs reveal that originally the cemetery had dirt paths between plots (see, for example, Figures 4 and 5). By at least 1946 some of these were replaced by poured concrete walkways, most being 3-4 feet in width. Widths change without warning and in at least one case the walkway has been made steep by wrapping partially around a tree. Otherwise, these concrete pathways are in good condition and the grass is being trimmed away from them to establish a clear boundary between the walkway and grassed area. There are several areas where the concrete has developed cracks and grass is growing in these areas. This indicates a lack of adequate maintenance.

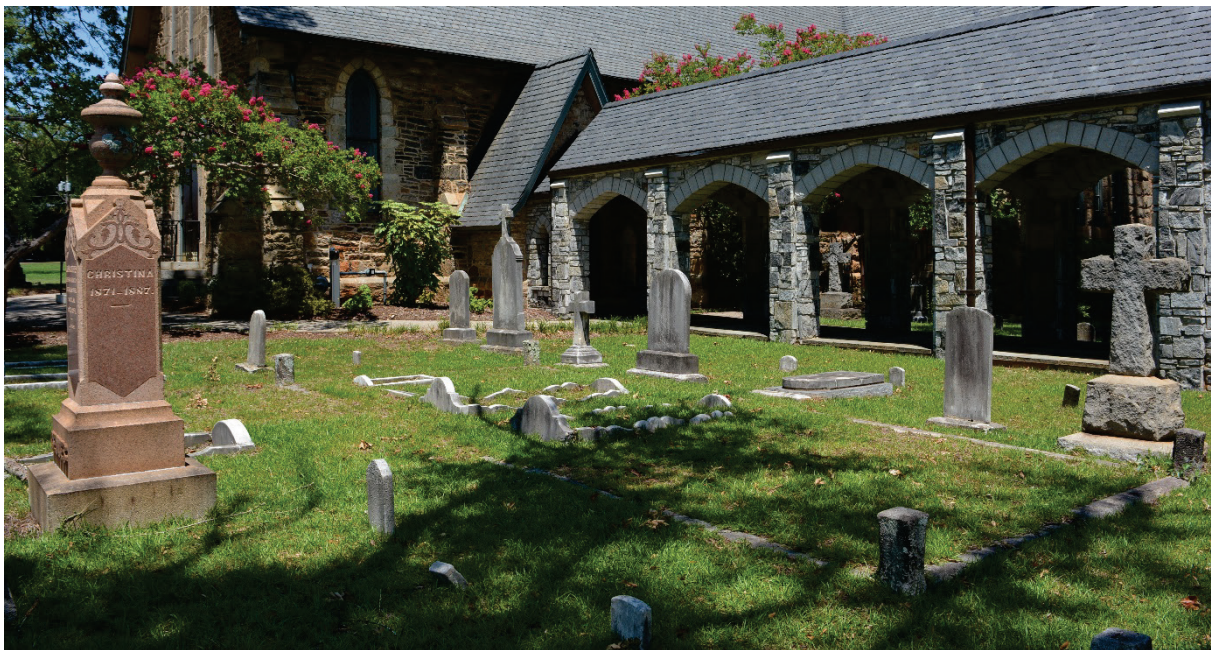
Figure 5. Photographs of the church and surrounding cemetery about 1893, prior to the first modifications in 1897 at top. This photo is looking north at the James Geddes plot (the obelisk far left is on the John Geddes plot). Below is the same view today.

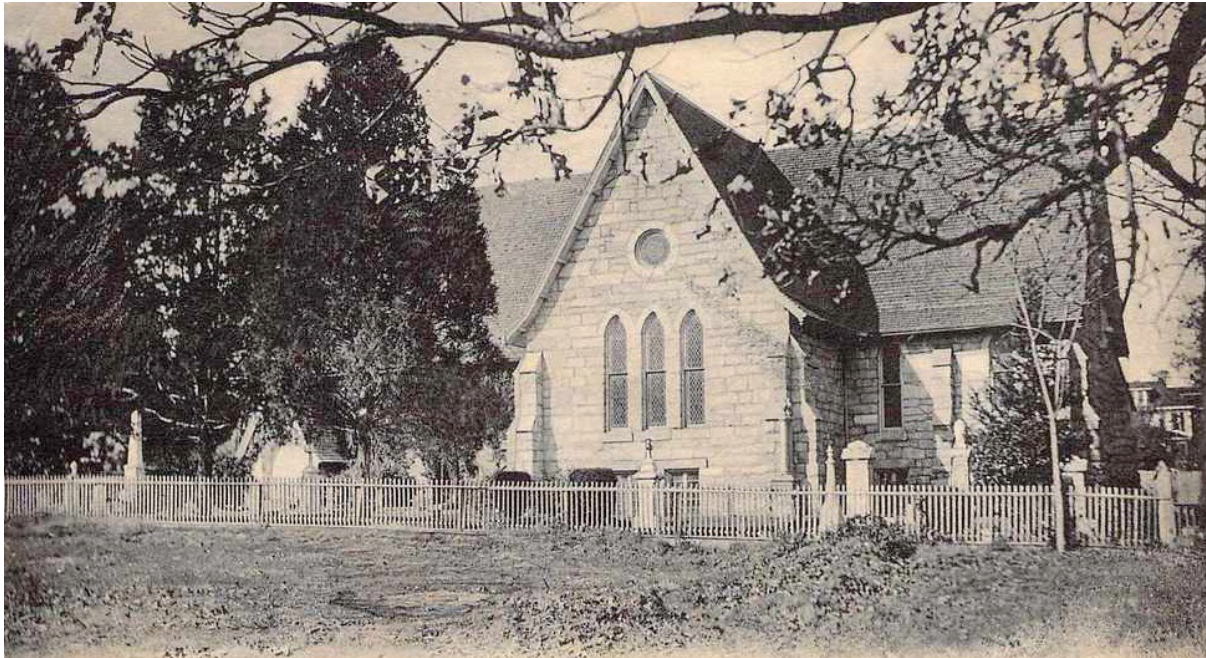
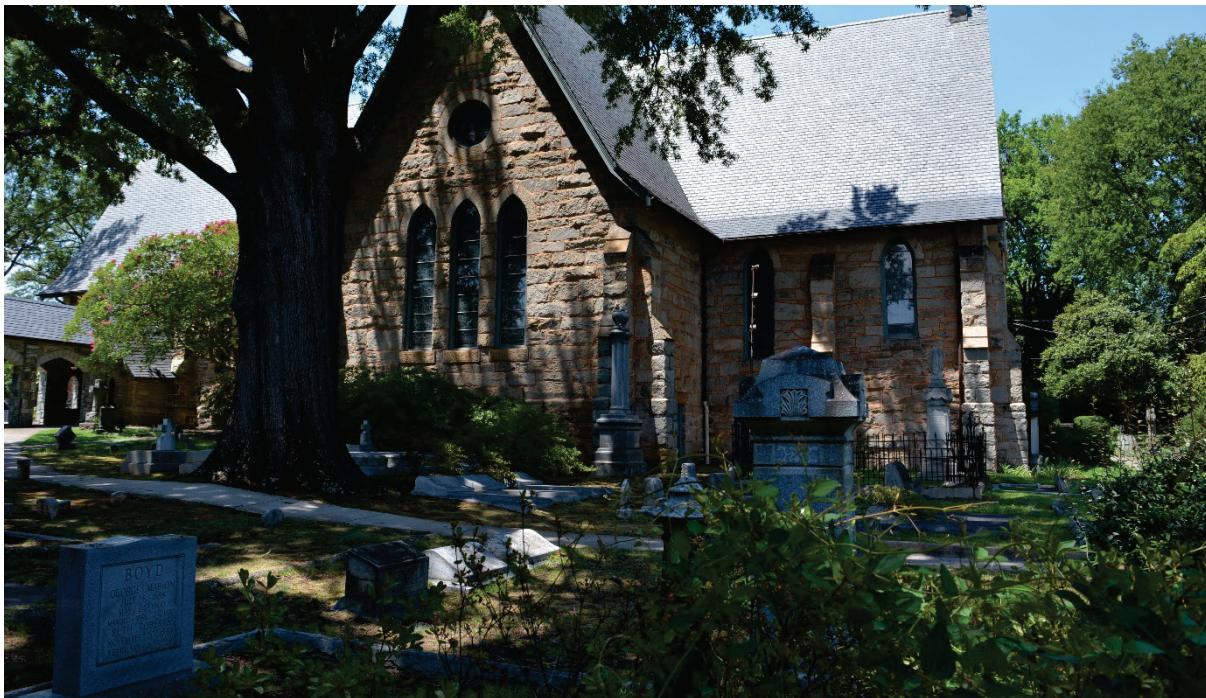
Figure 6. Photo dating from 1909 taken from the south of the cemetery, looking north. This postdates the 1897 addition to the rear of the church building and shows a wood picket fence along the south edge of the churchyard and cemetery. Below is the same view today.

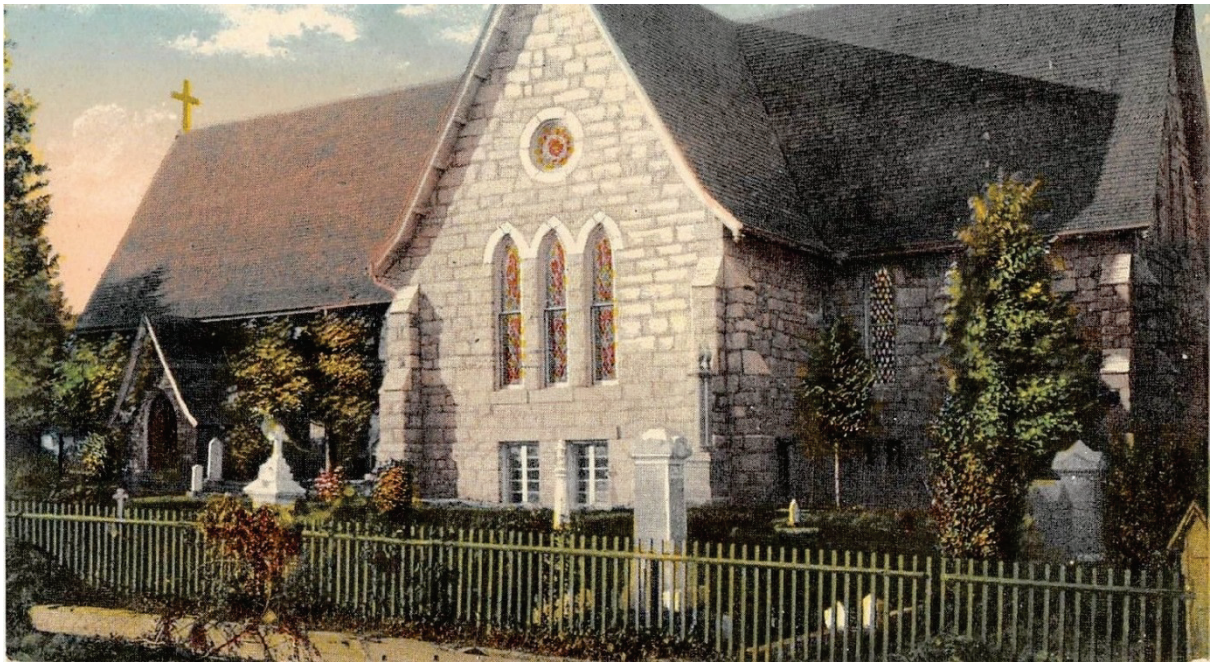
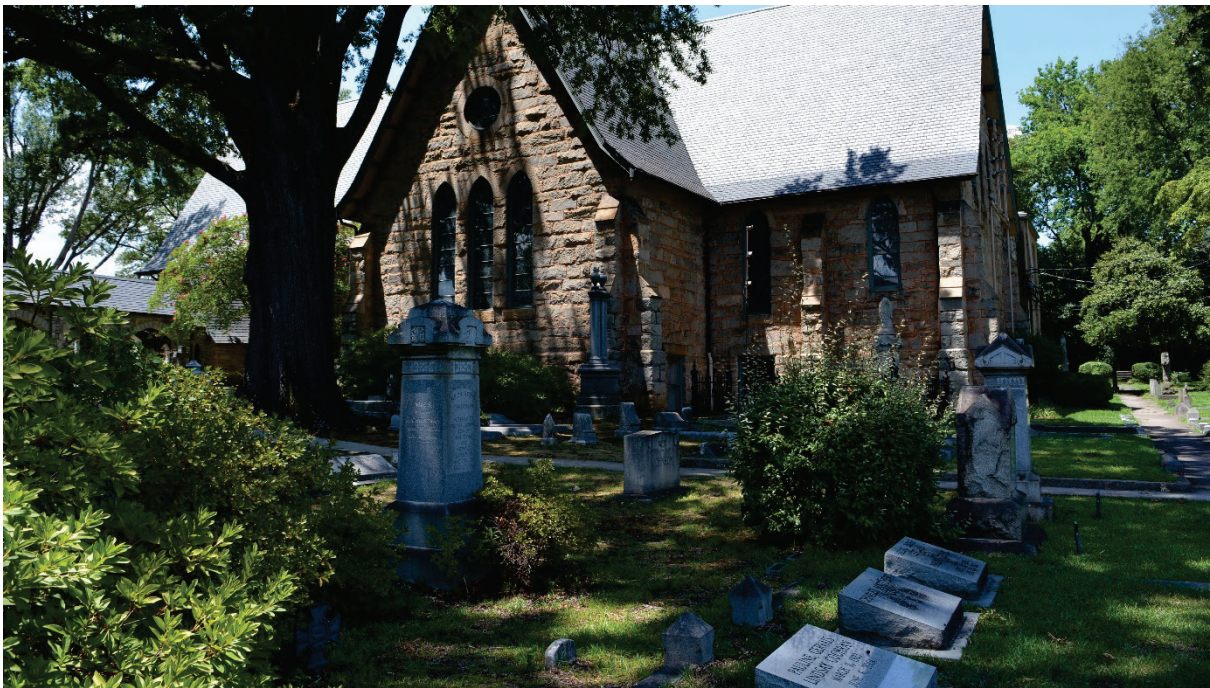
Figure 7. Photo dating from 1910, taken from the south of the cemetery, looking north. This postdates the 1897 addition to the rear of the church building and shows a wood picket fence along the south edge of the churchyard and cemetery. Below is the same view today.

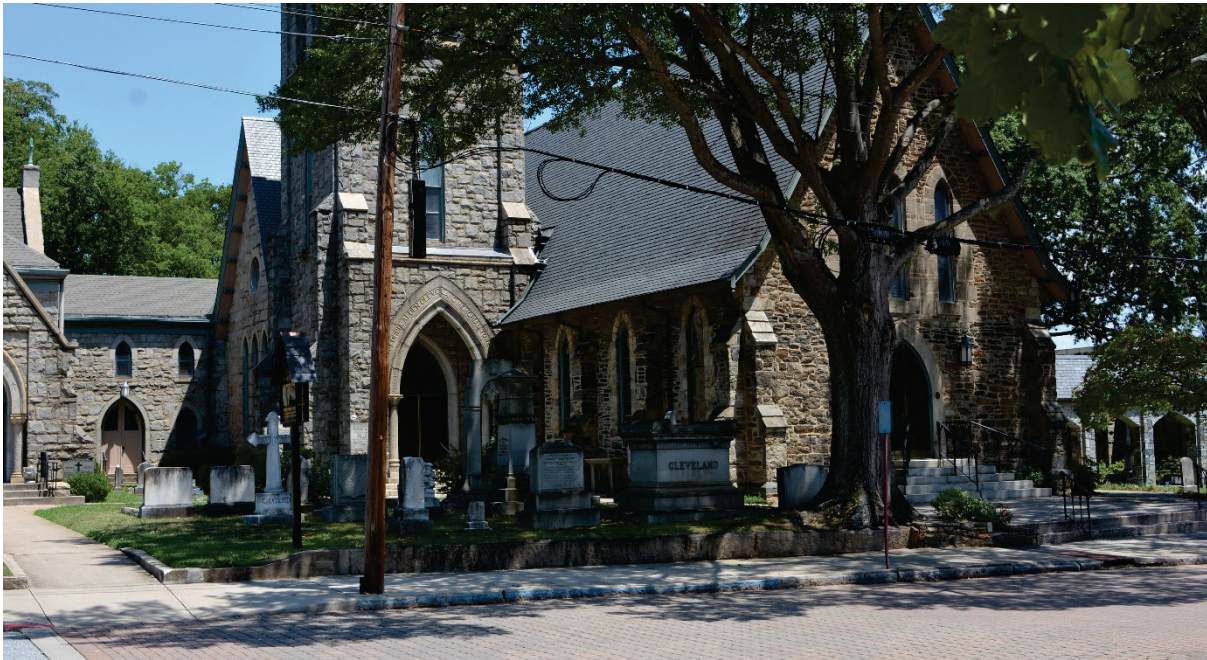
Figure 9. Image of the church dating prior to 1915, failing to show the bell tower, constructed in 1915, but does reveal what appears to be a granite and pipe rail fence along Advent (formerly Hall) Street. This fence is not shown by 1937. Below is the same view today.

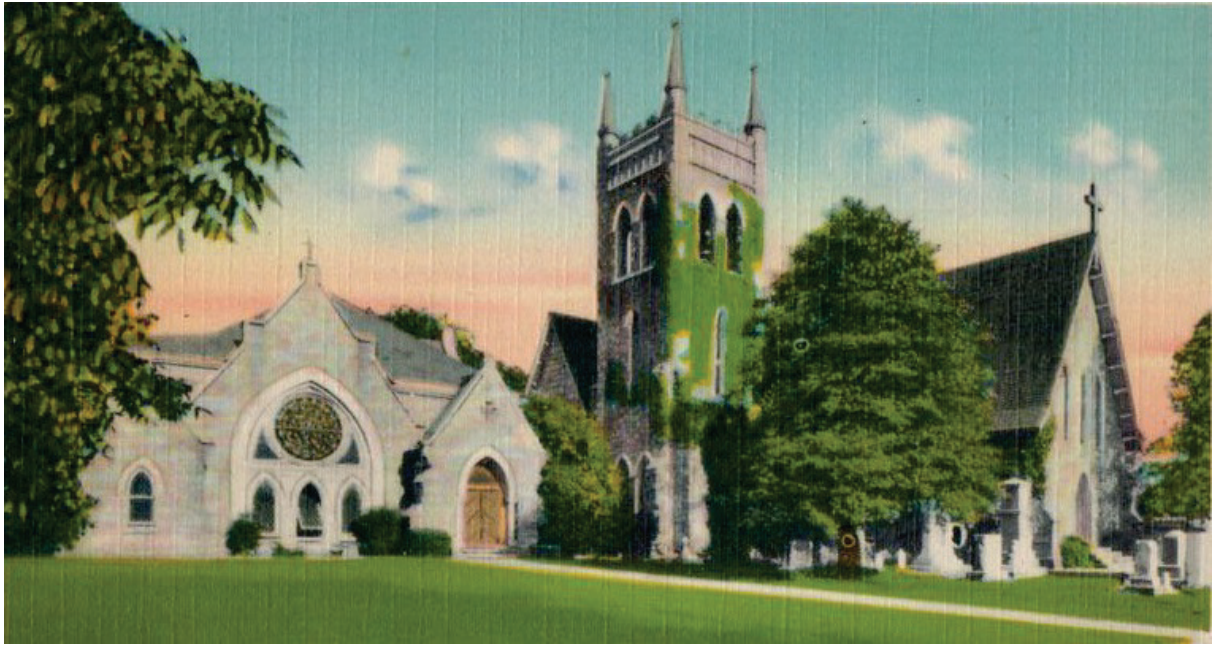
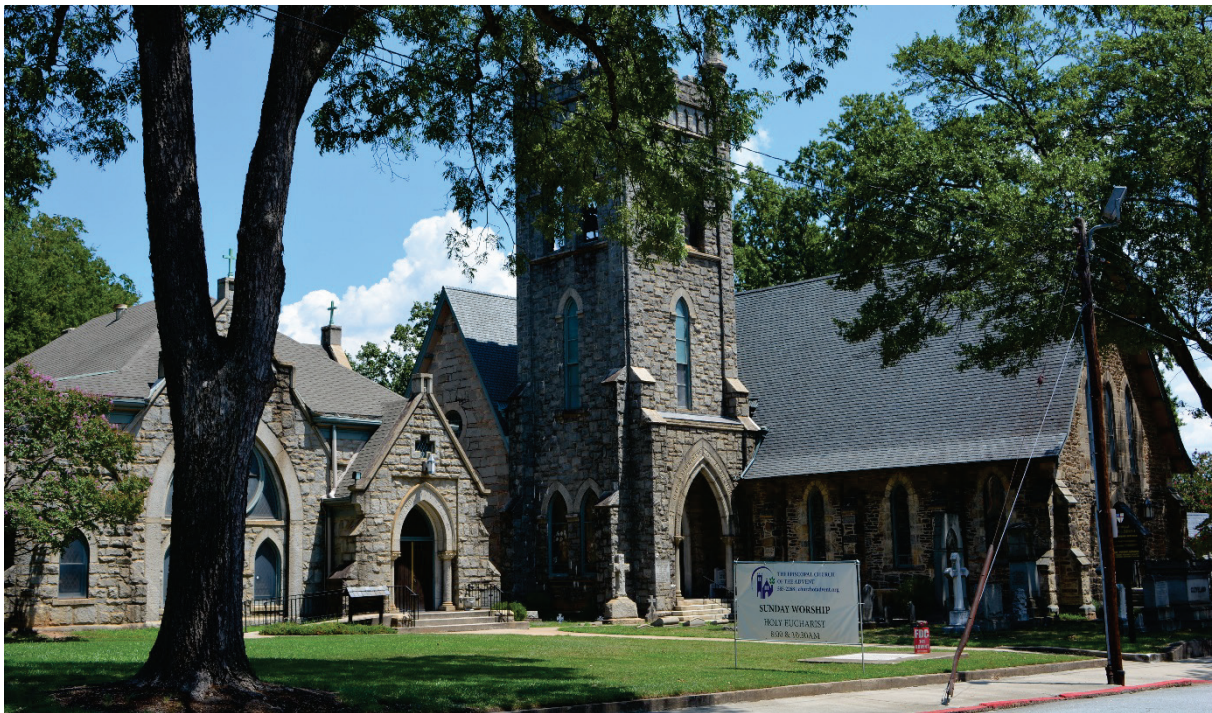
Figure 10. Image of the church about 1937. The pipe rail fence shown earlier is not present in this photo. Below is the same view today.

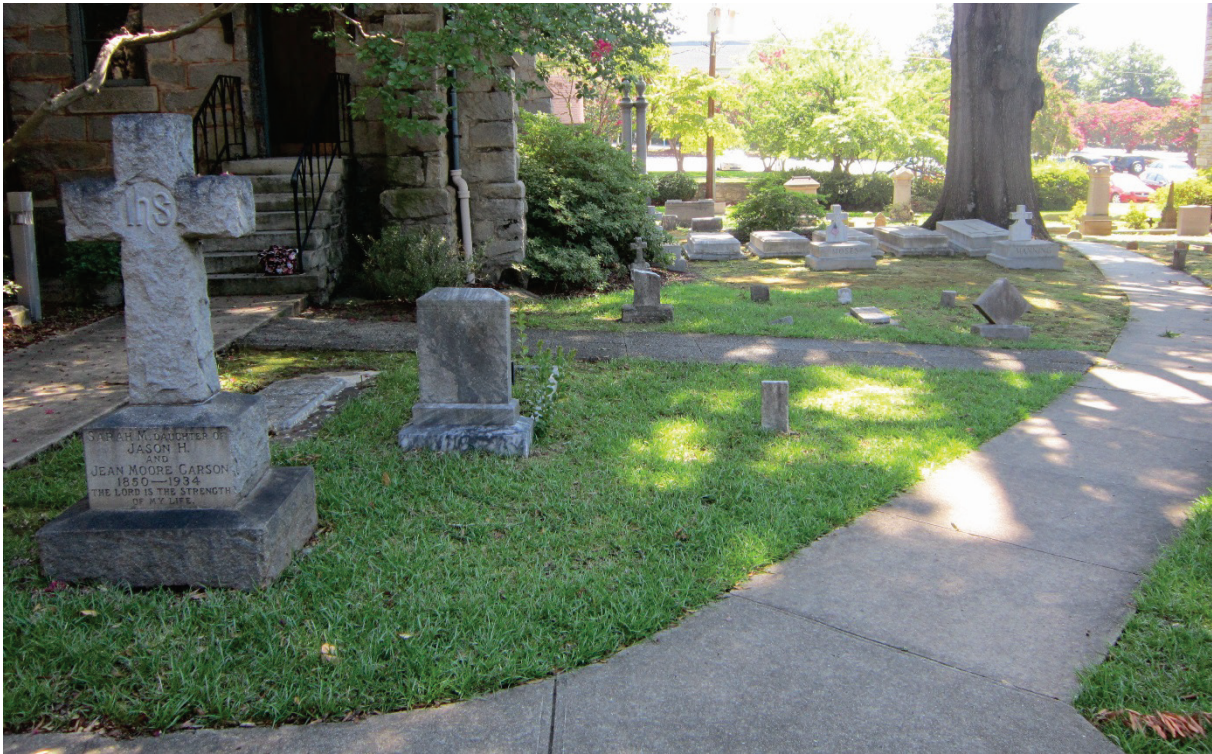
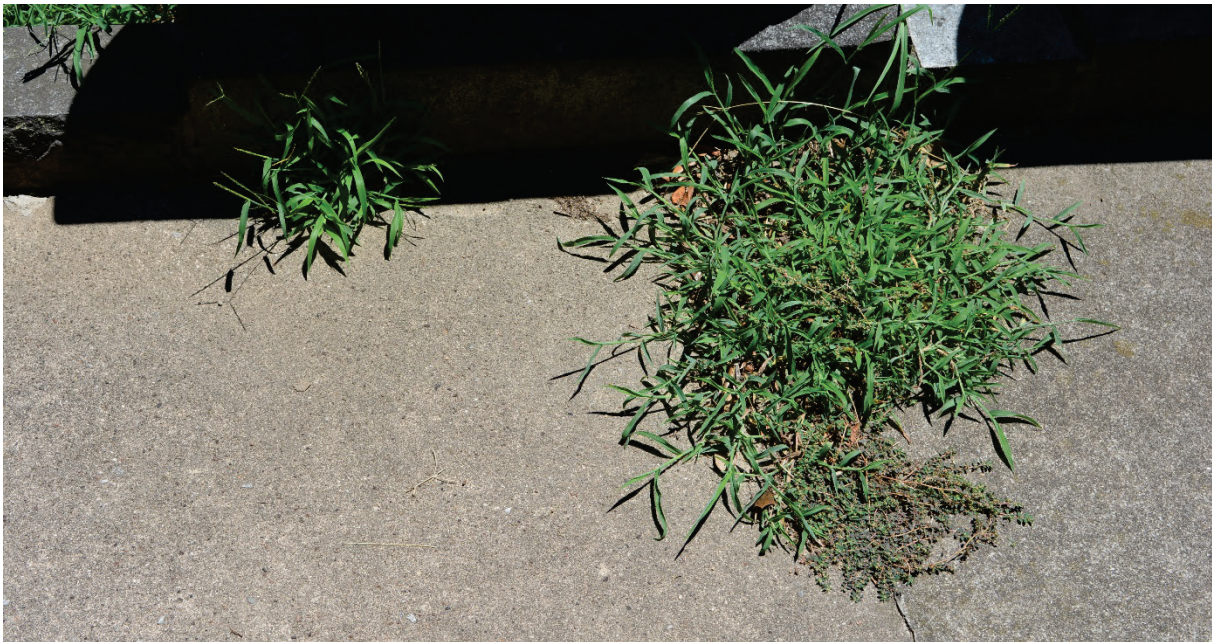
Figure 19. Concrete sidewalks in the cemetery. Upper view shows multiple widths. Lower view shows grass growing in cracks.

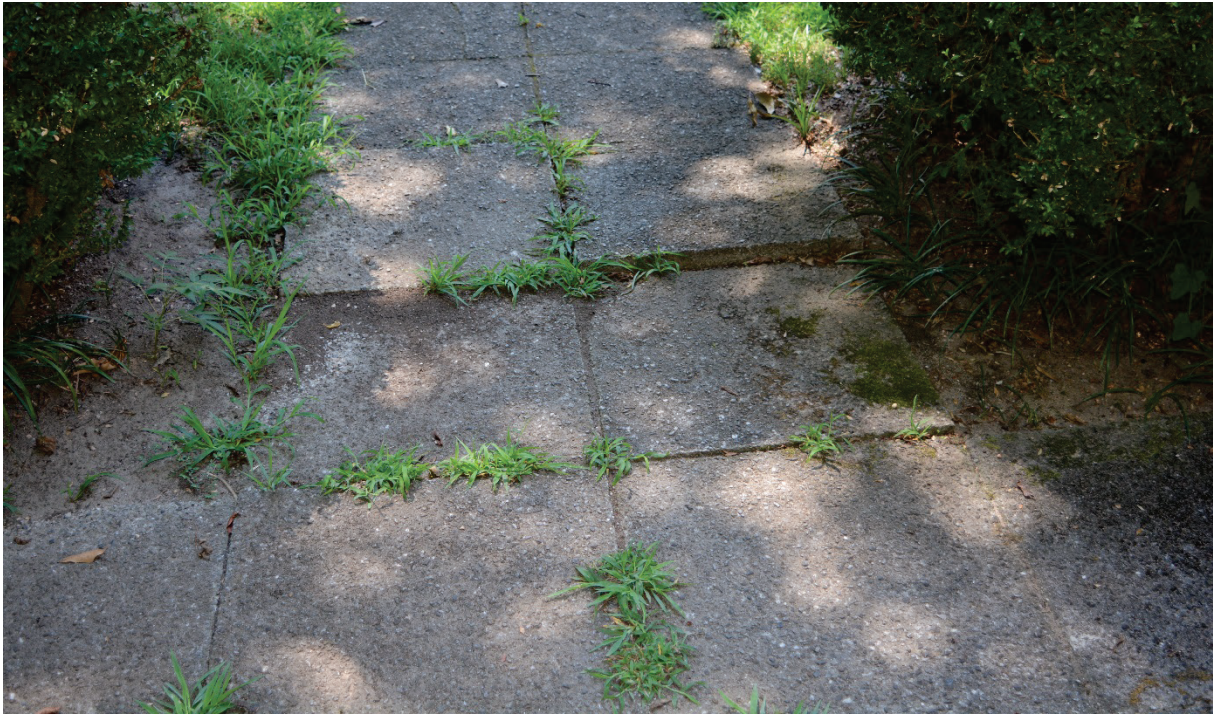
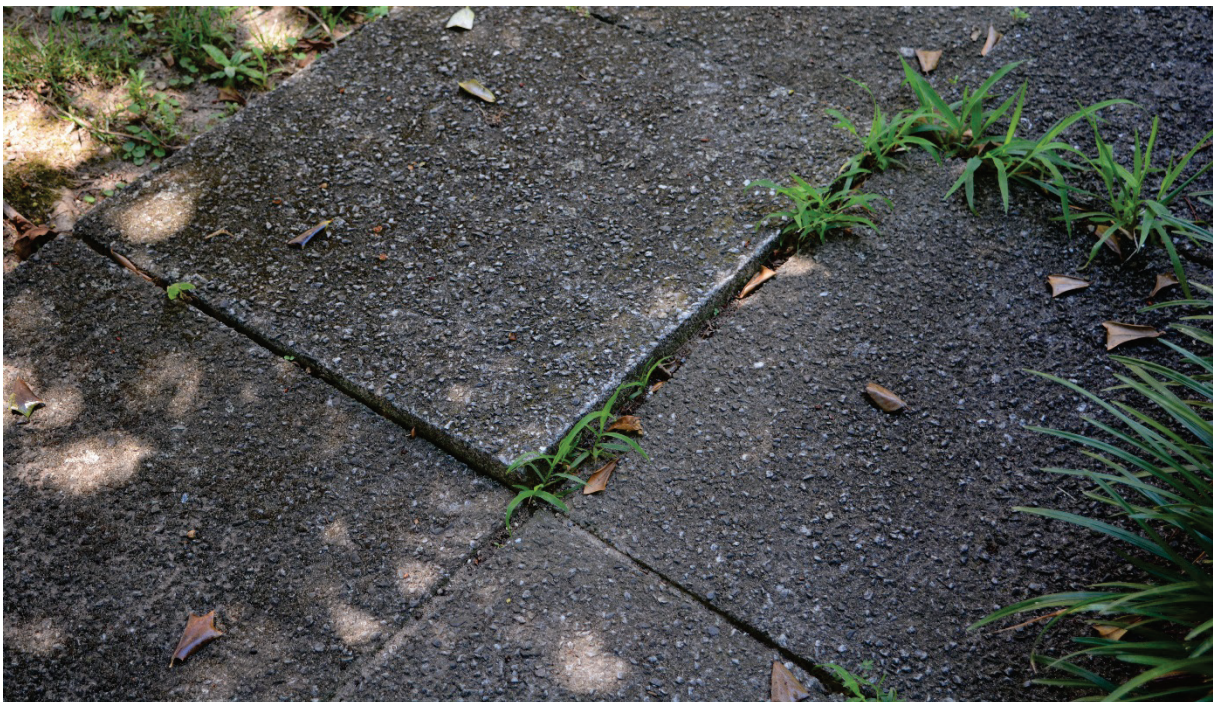
Figure 20. Poorly maintained paver pathway on east side of the cemetery. Many pavers pose a trip hazard and no effort has been made to control grass and weeds.

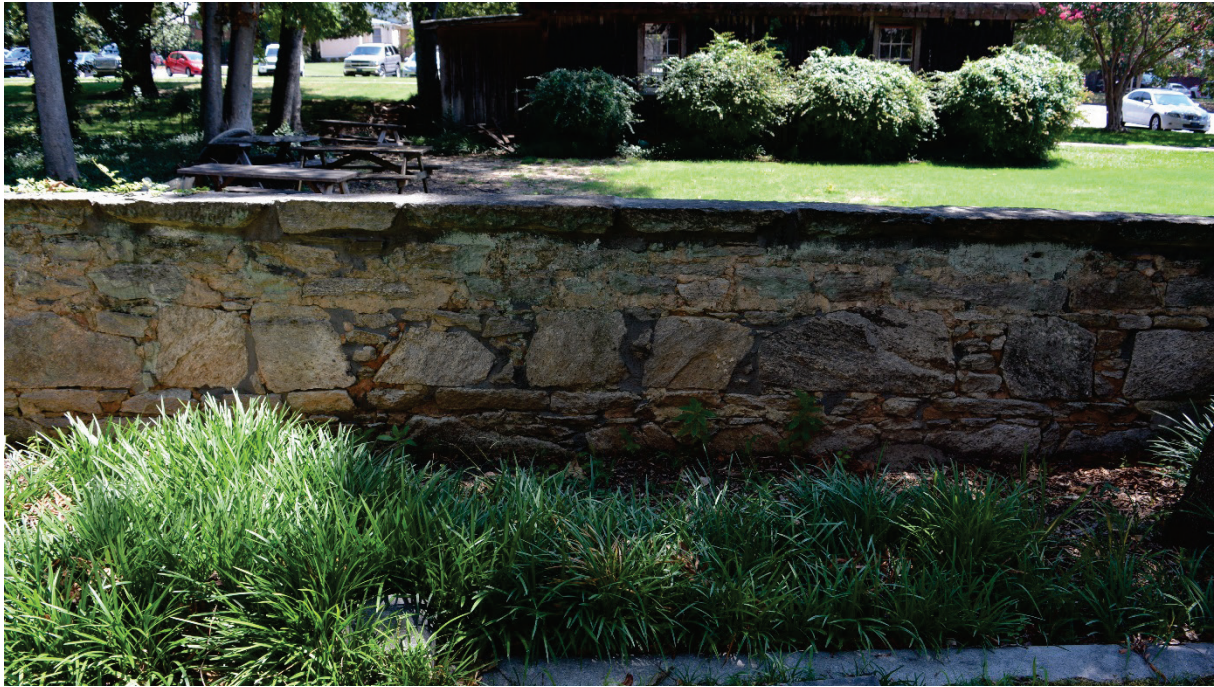
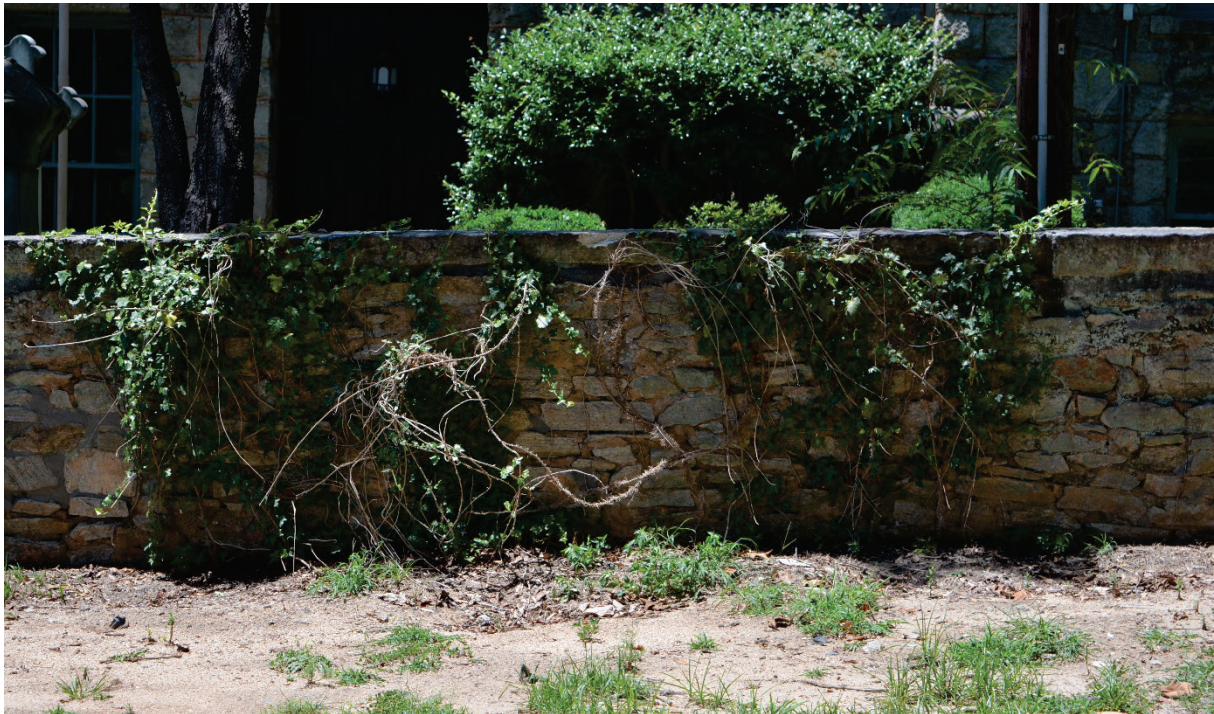
Figure 22. Stone wall along the east edge of the cemetery. Upper photo shows the three courses of random rubble. The lower photo shows heavy vine growth that must be removed.

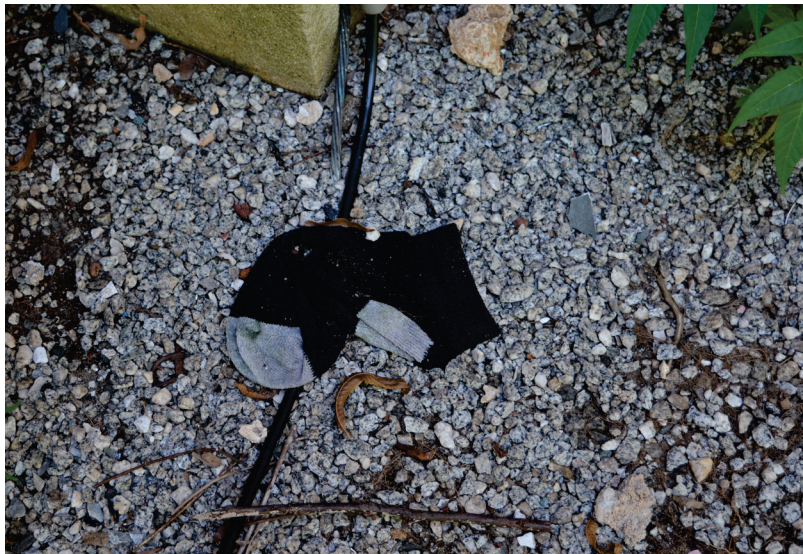
Figure 23. Clothing found during the cemetery assessment.

We are told that homelessness is not currently an issue, but there is an officer with the Spartanburg City Police skilled in dealing with the issue. We did, however, find one article of clothing which is often an indication of homeless activity (Figure 23).

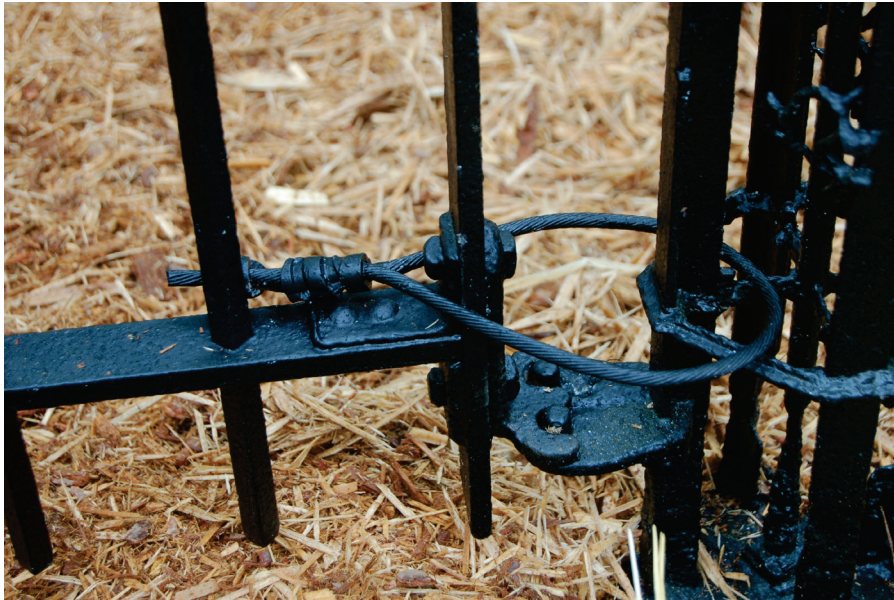
Figure 25. Example of a gate protected with stainless steel cabling that has been painted to blend with the fence.

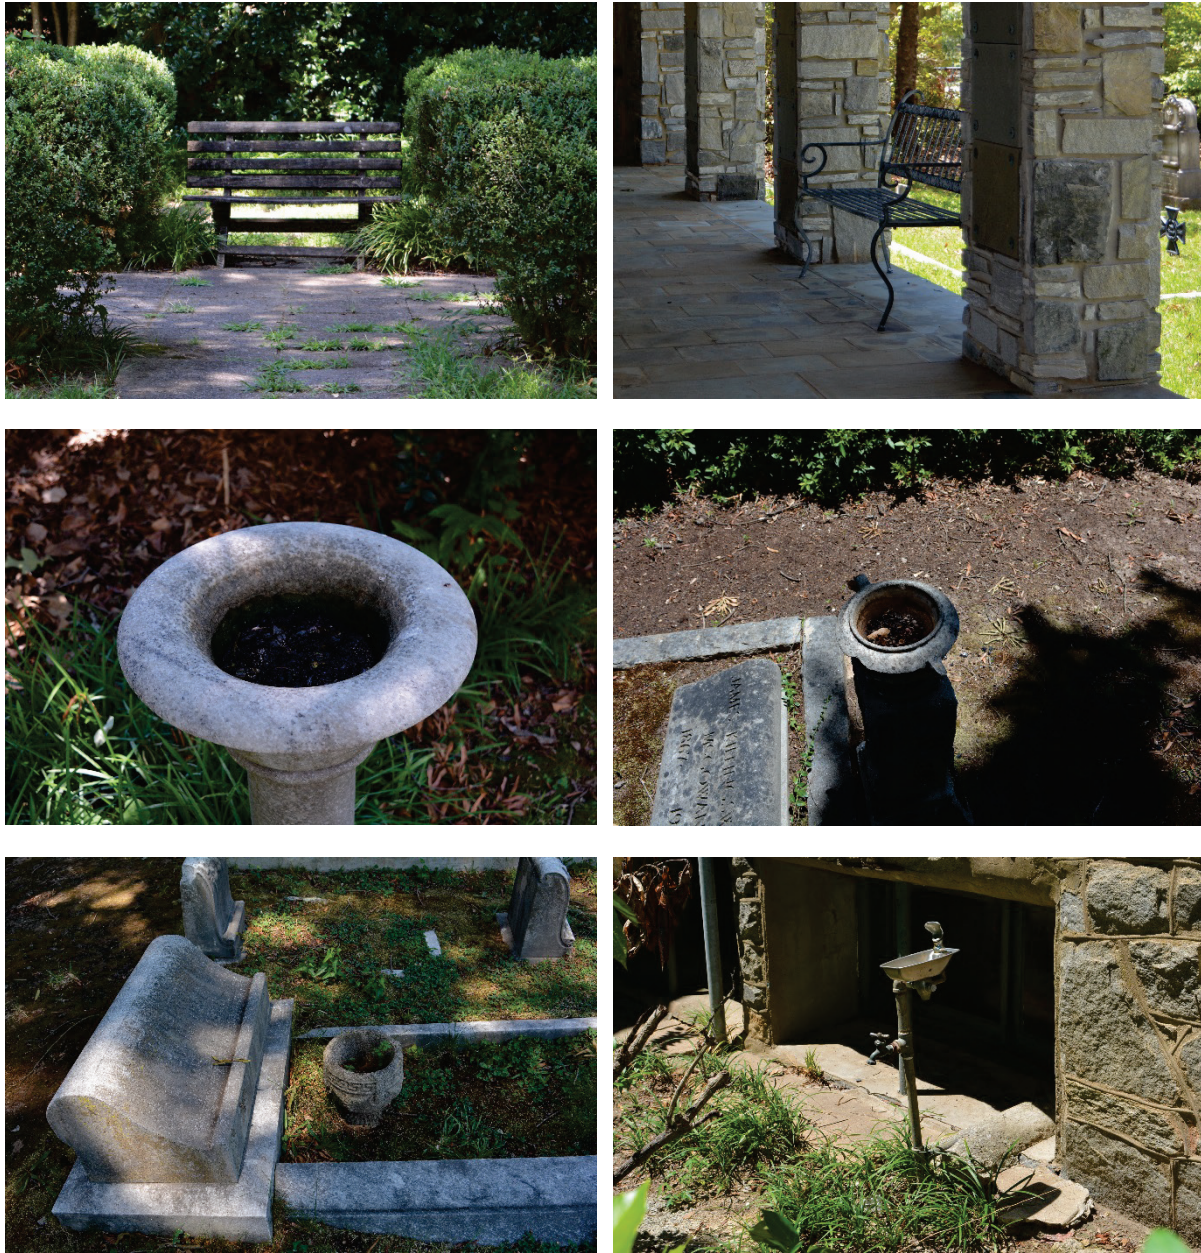
Figure 26. Examples of various amenities in the cemetery. Upper row shows a deteriorating wooden bench on the east side of the church and an iron bench in the Cloisters; middle left shows the bird bath filled with trash; middle right shows an urn filled with trash; lower left shows a vase filled with trash and weeds; lower right shows the old water fountain that may originally have been associated with the playground east of the cemetery.

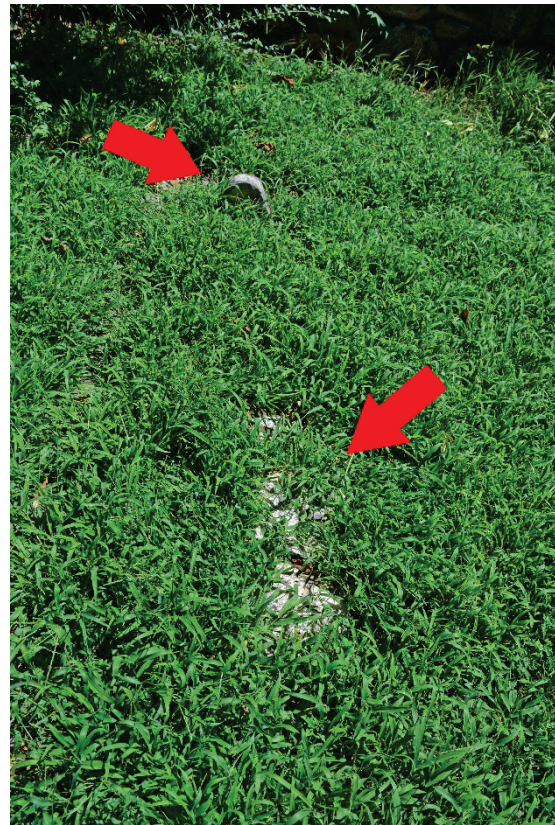
Figure 30. Grass not mowed and covering several monuments.

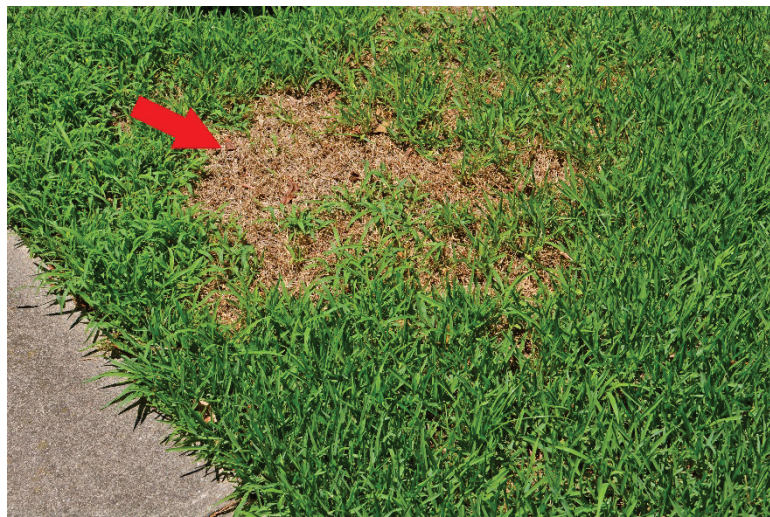
Figure 32. Build-up of dead grass in the turf.

(Figure 32) where trimming has resulted in the development of dead grass. This is promoting

disease and reducing the health of the turf. This is the result of using only a nylon trimmer, which cannot appropriately mulch the grass blades, resulting in large clumps of dead vegetation.

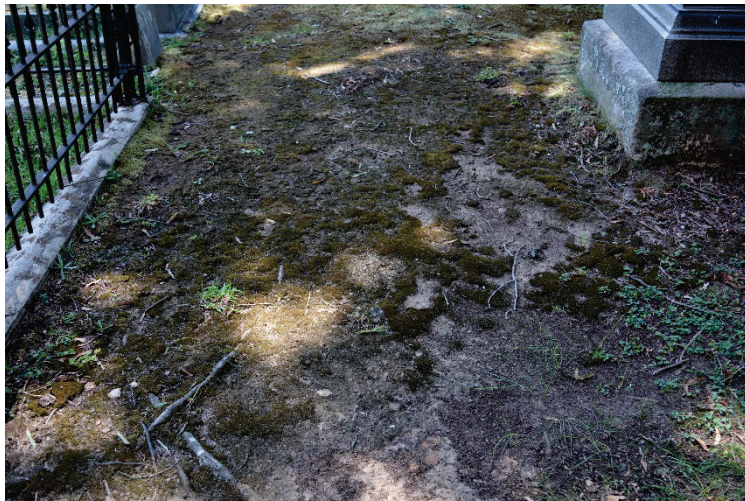
Figure 34. Soil and turf problems. The upper photo shows bare soil and moss in a densely shaded area. The lower photo shows a similar area, with the addition of a nylon mesh indicating that unsuccessful sodding or seeding has taken place in the past. Areas such as these should be converted to mulch.

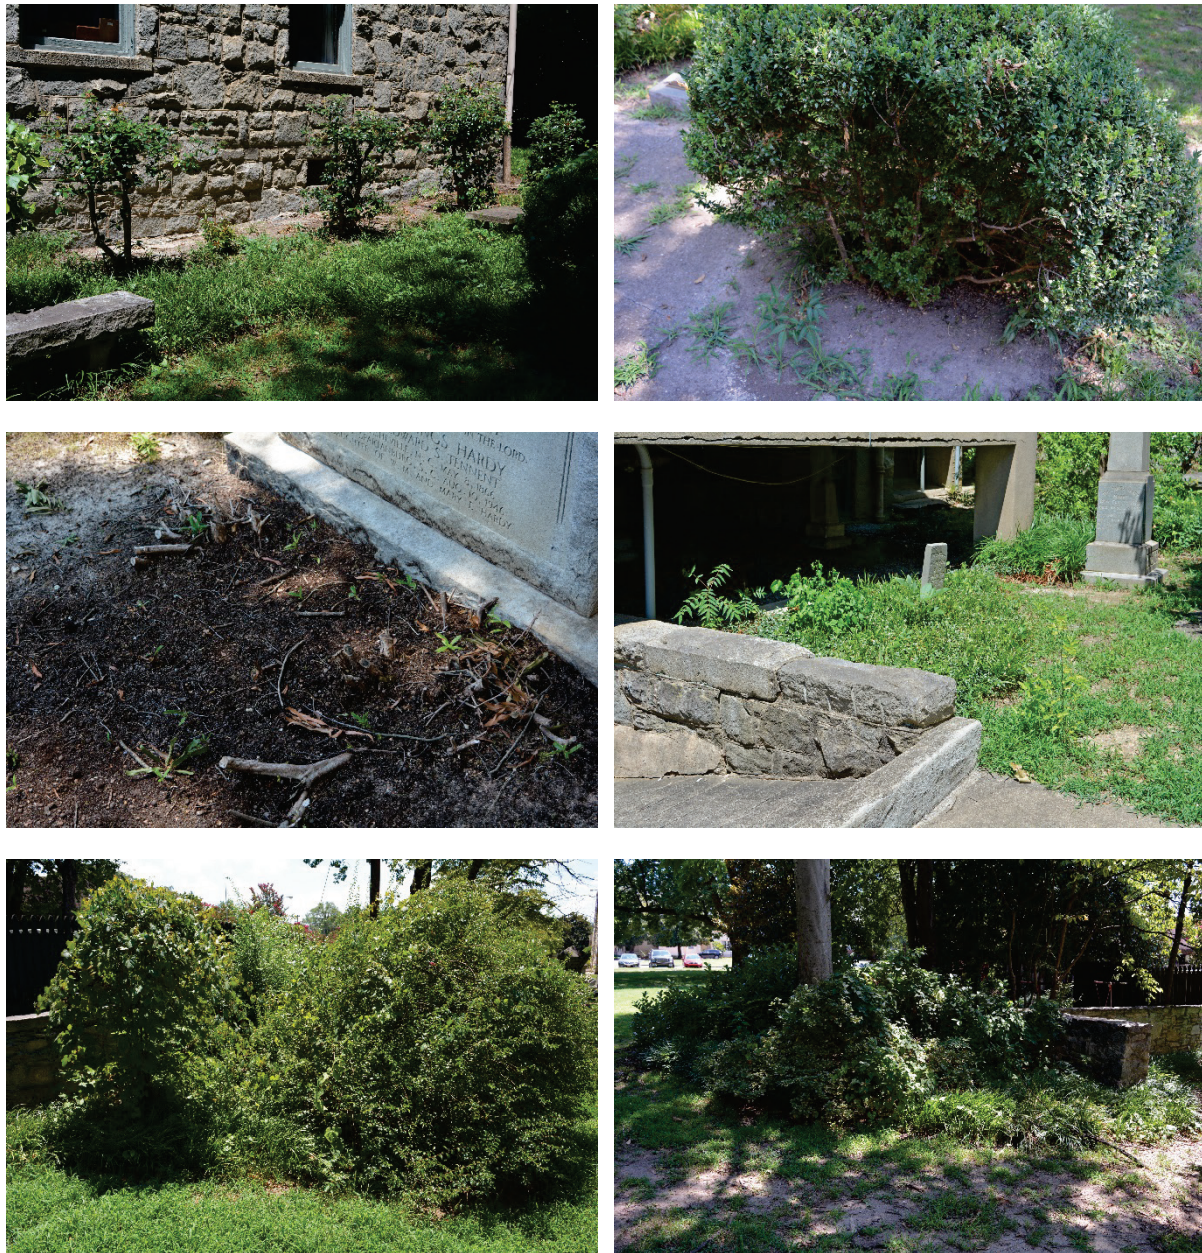
Figure 35. Shrubby problems. Upper row photos show improperly pruned and damaged shrubs. Middle row left photo shows a shrub that has been chopped down to the ground. Middle row right shows weeds overtaking liriope bed. Lower row photos show two clumps of shrubs that are entirely overtaken by weeds and vines to the point that it has become impossible to distinguish the shrubs from the invasive vegetation.

As with trees, when shrubs require replacement, they should generally be replaced with like material, especially if they represent plants traditionally used in cemetery settings. If planting lists cannot be located for the cemetery, plants such as forsythia, hydrangea, lilac, and memorial rose (in addition to those listed) are all known to be period appropriate.

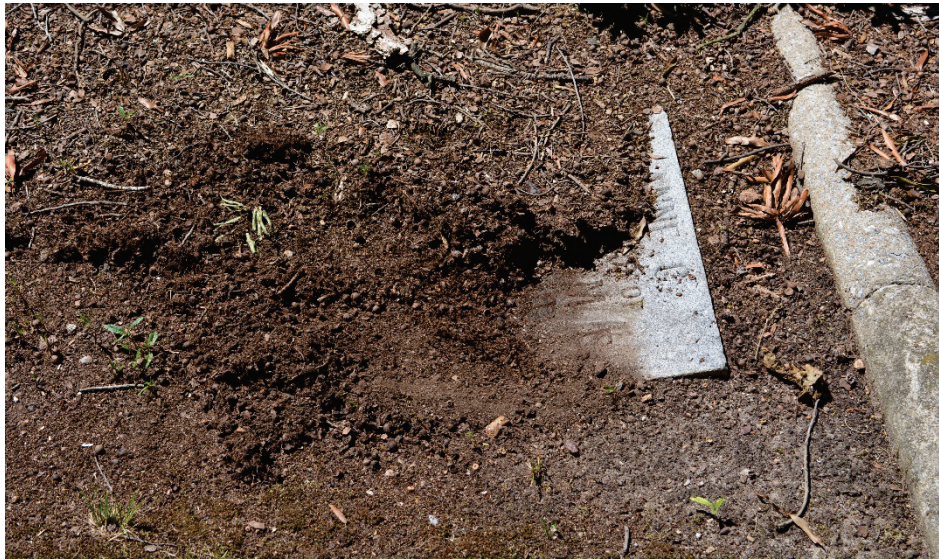
Figure 36. Example of inappropriate mulch covering a monument.

Crews should be closely supervised to prevent over mulching of vegetation. It should never exceed 3-4 inches and should never be placed over monuments – as was observed in at least one location (Figure 36).

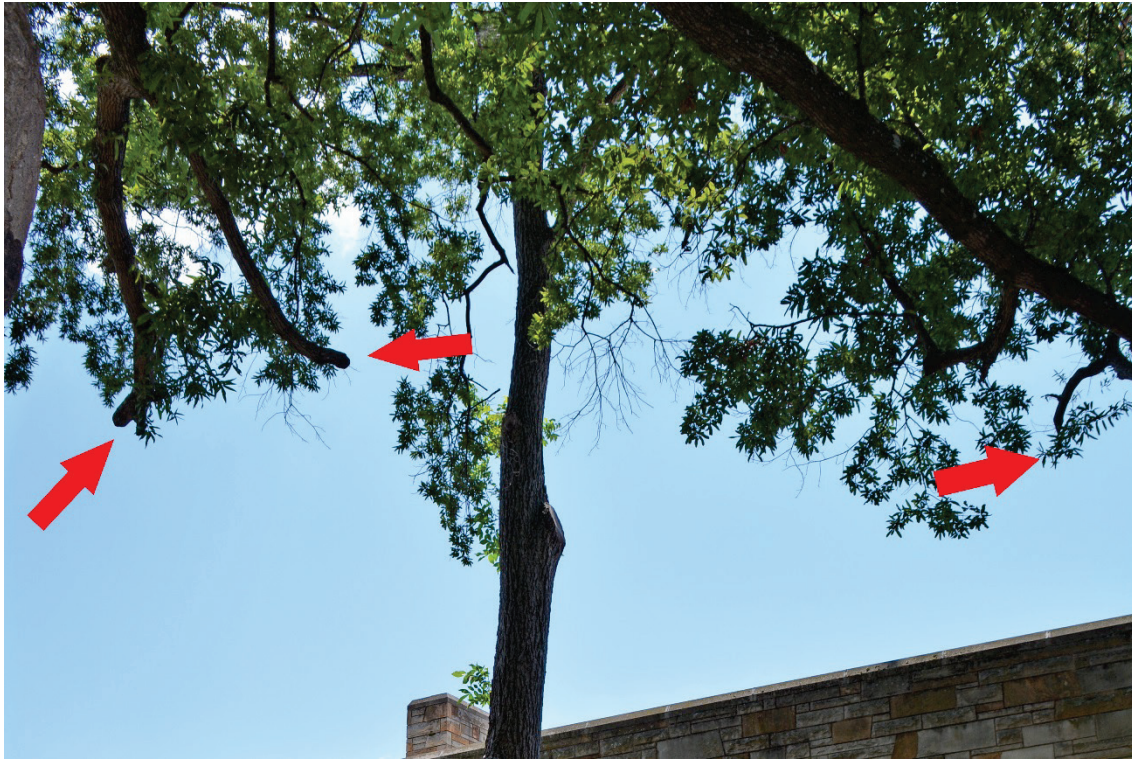
Figure 37. Tree pruning issues. The upper photo shows a tree within the cemetery that has been incorrectly pruned, leaving stubs. The figure below shows correct pruning technique, removing the limb back to the branch collar to allow the wound to heal properly.

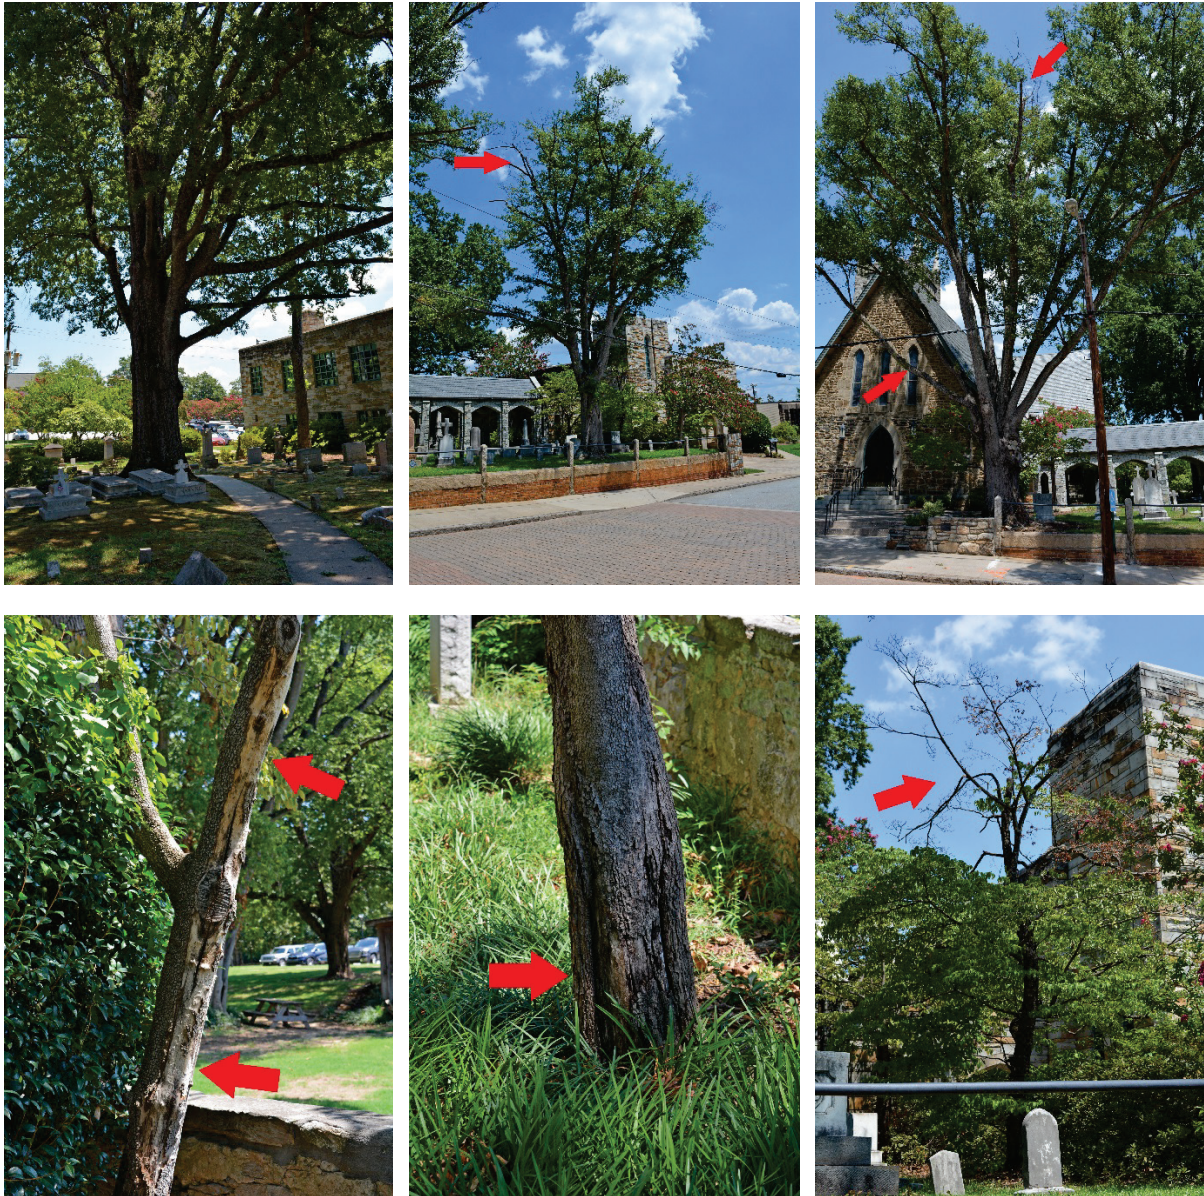
Figure 38. Tree problems. Upper left photo shows the grand oak, which needs pruning to thin the canopy, allowing in additional light and air. The upper middle and right photos show trees with dead wood in the canopy which should be pruned out to reduce litter and storm damage. The lower row of photos show a variety of problems in the cemetery dogwoods, including two examples of rot and another with extensive decline and die-back. These dogwoods should be removed and new, replacement trees planted.
