ASSESSMENT OF THE CHURCH OF THE ADVENT CEMETERY, SPARTANBURG, SOUTH CAROLINA

Chicora Research Contribution 571

August 2016

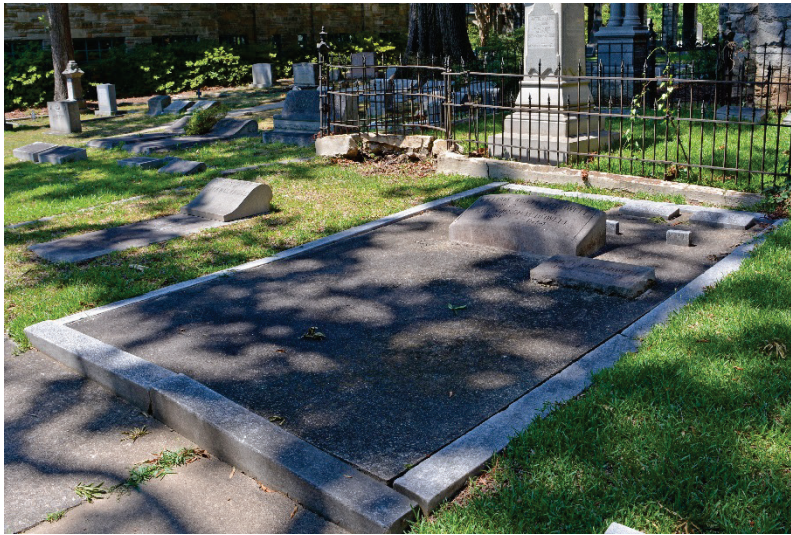
A few lot owners have chosen to use concrete in the plot, setting their stones in this material. Sometimes lot owners do this thinking that it will reduce maintenance. Absent

Figure 39. Plot covered in concrete, with monuments set into the concrete.

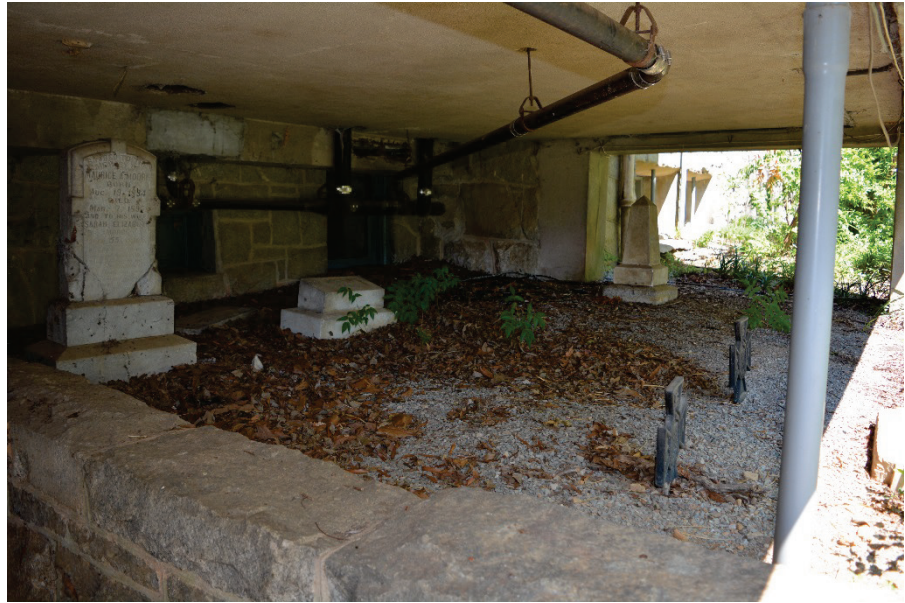
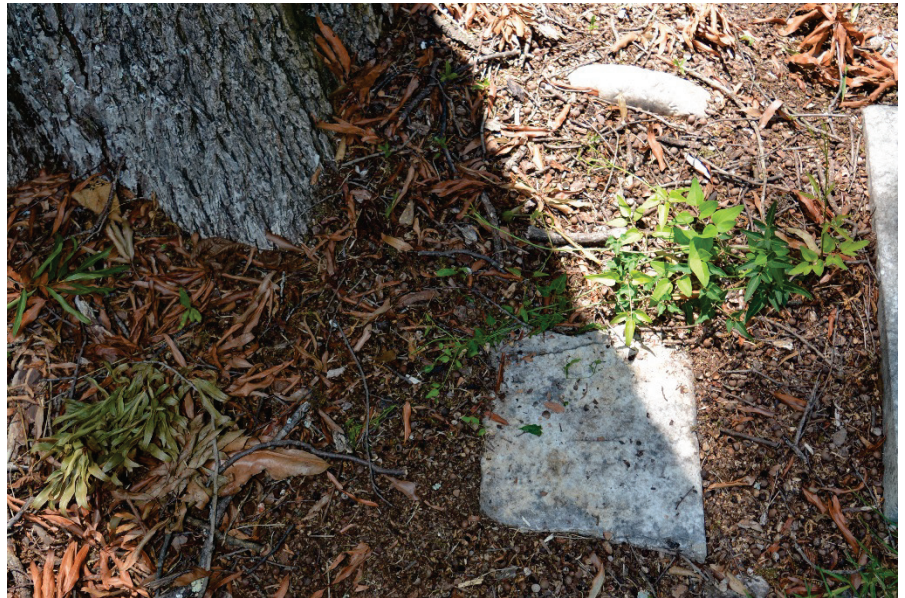
Figure 41. Orphan stones. Are these stones associated with graves or are they orphan or replaced stones?

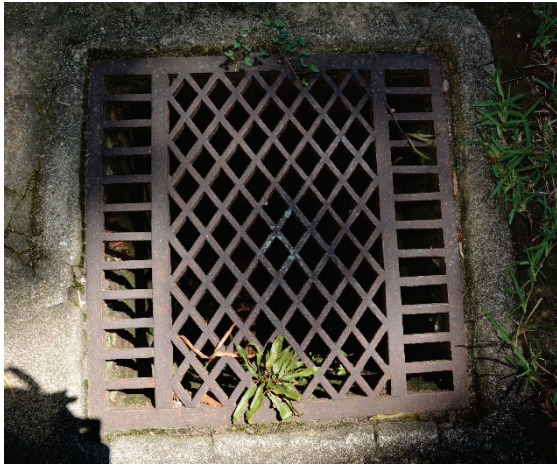
Figure 42. Drain in the cemetery.

These will require snaking or the use of a high pressure water jetting device (with pressures

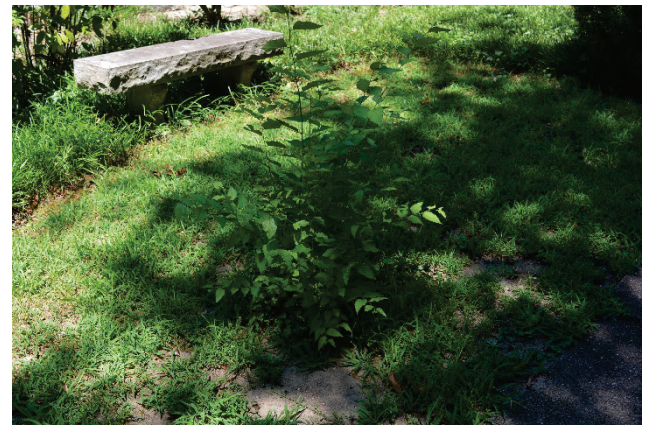
Figure 44. Condition of the existing "memory garden". The upper photo shows the bench with the inscription that the garden is in the memory of two individuals. The lower photo shows the weedy, untended appearance of this space.

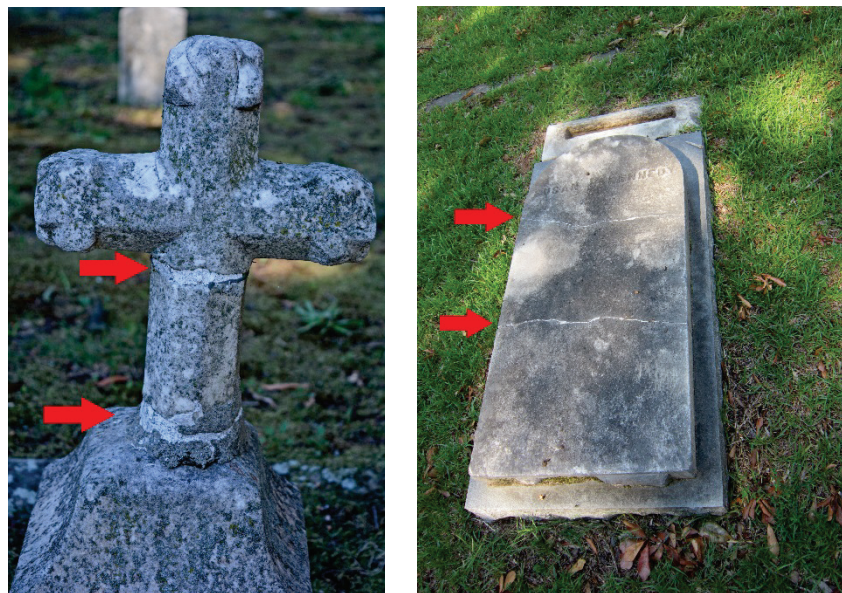
Figure 45. Examples of previous repairs in the cemetery. On the left is a cross with two breaks, probably repaired with a white Portland cement. On the right is a tab in base broken in two locations and missing its tab, laid flat on a OPC slab.

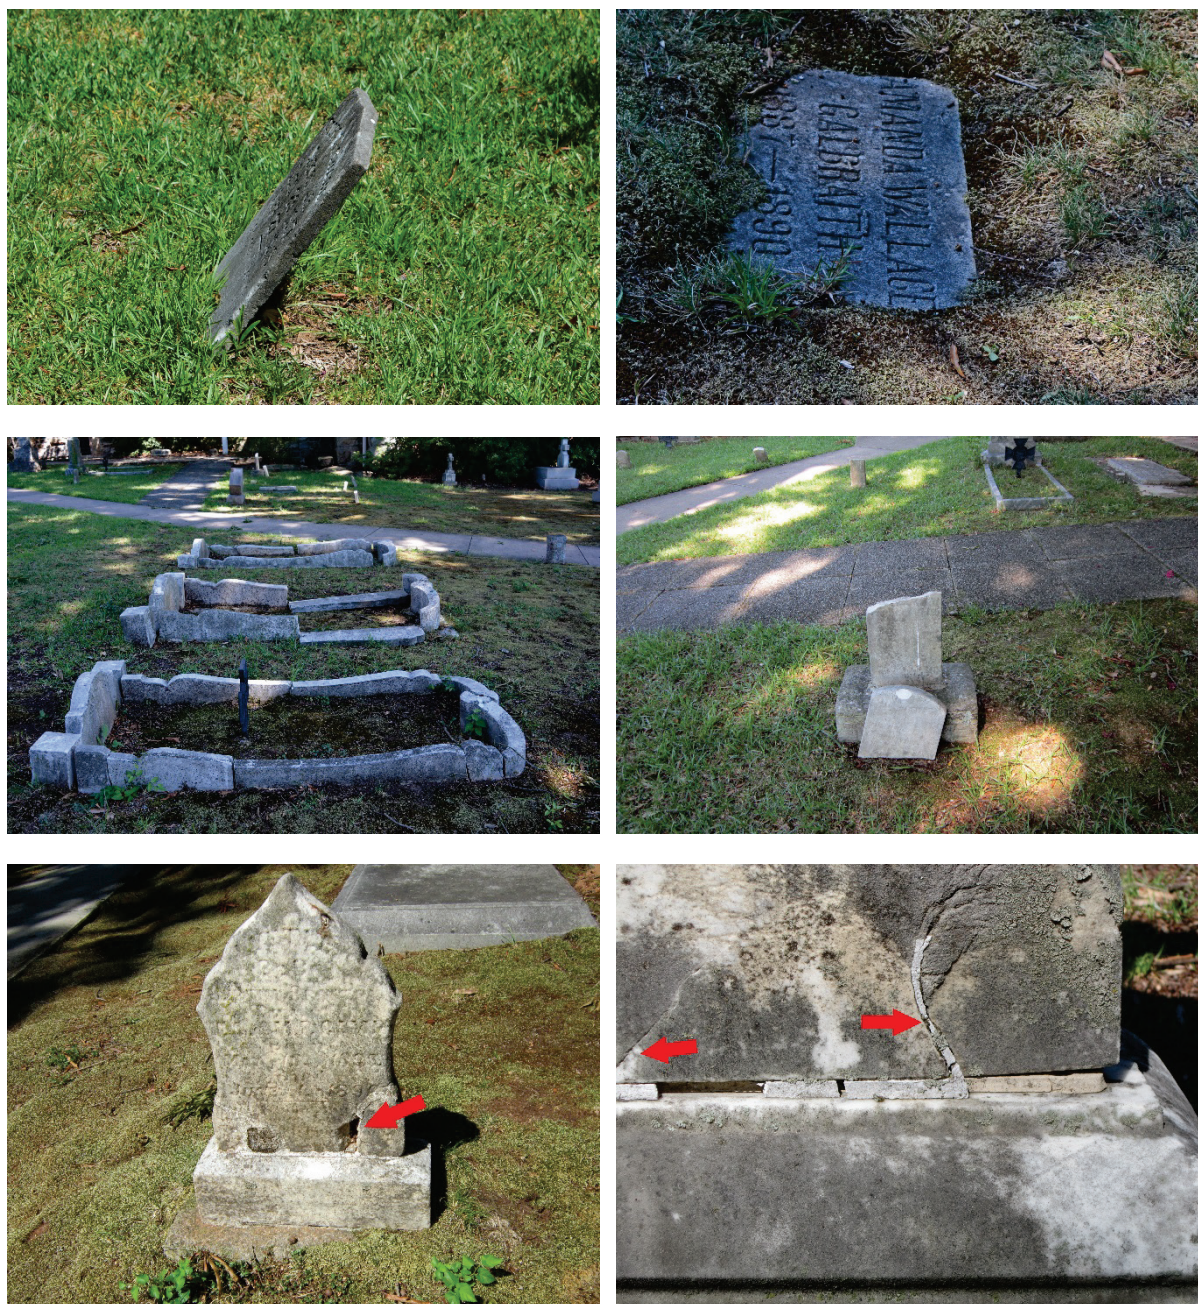
Figure 46. Examples of stones requiring conservation treatment. Upper row left shows a badly tilted stone. Upper right shows a sinking lawn marker. Middle left shows three cradle graves that are broken, displaced, and sinking. Middle right shows a broken tab in socket stone. The lower photos show two die on base markers attached using ferrous pins that have corroded and caused damage to the monuments.

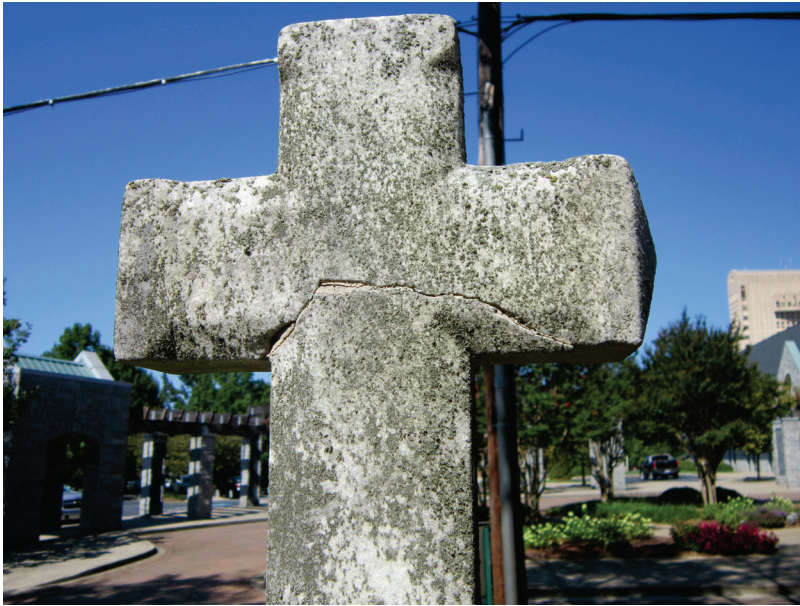
Figure 47. Example of heavy lichen growth.
