# **WILLOWBROOK CEMETERY ASSESSMENT, TOWN OF EDGEFIELD, EDGEFIELD COUNTY, SOUTH CAROLINA**

**WILLOWBROOK CEMETERY ASSESSMENT,  
TOWN OF EDGEFIELD, EDGEFIELD COUNTY,  
SOUTH CAROLINA**

**Research Contribution 591**

September 2018

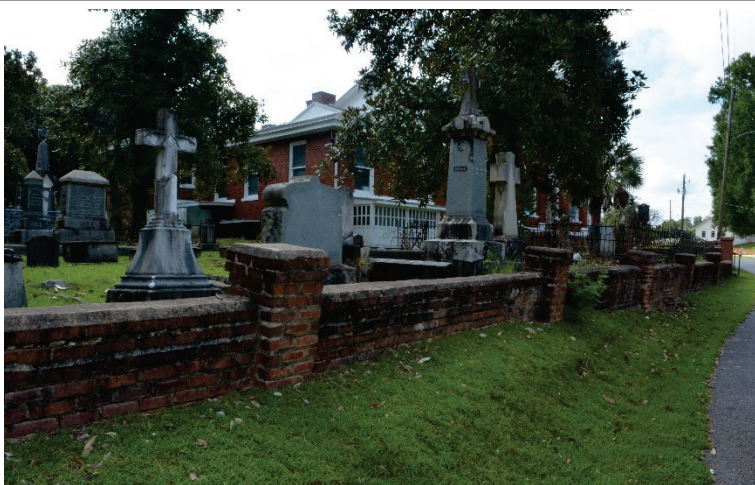
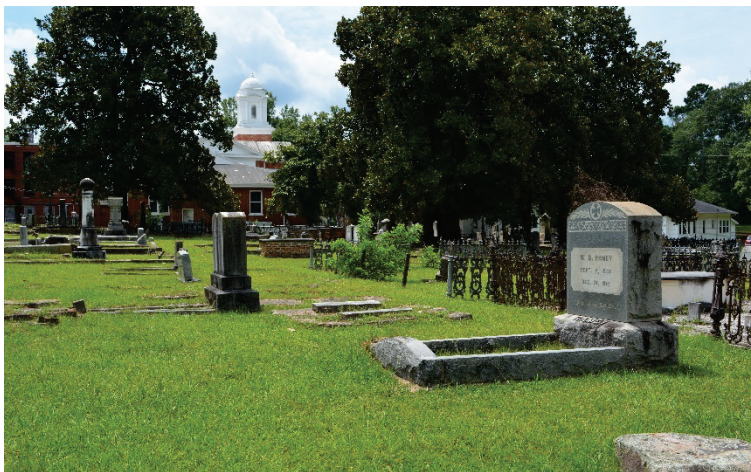
Figure 1. Views of Willowbrook Cemetery. At the top is a view along the edge of Church Street (S-84), looking south. Below is the central area of the cemetery looking south, toward the Baptist Church.

News accounts mention the need to repair walls “where they have fallen down” and there are still intact walls in a few sections along Church Street (see, for example, Figure 1). We therefore are inclined to believe the walls we are talking about (one of which is illustrated by Figure 16) are likely part of the historic fabric of the cemetery and every effort should be taken to ensure their survival.

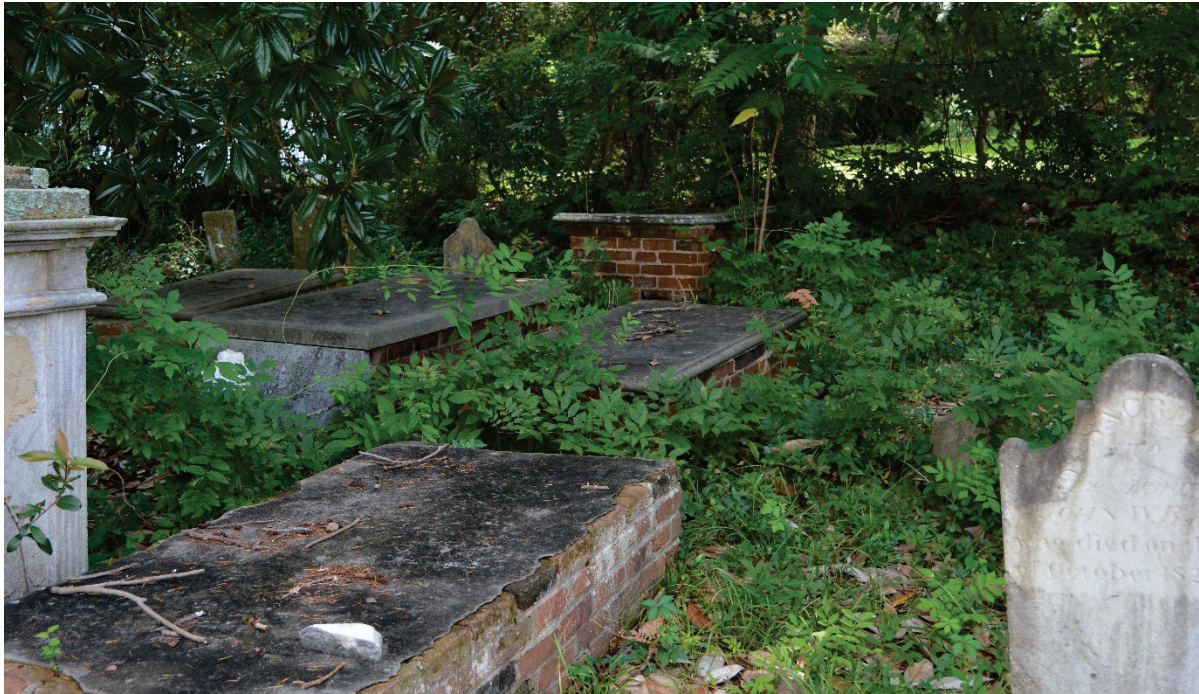
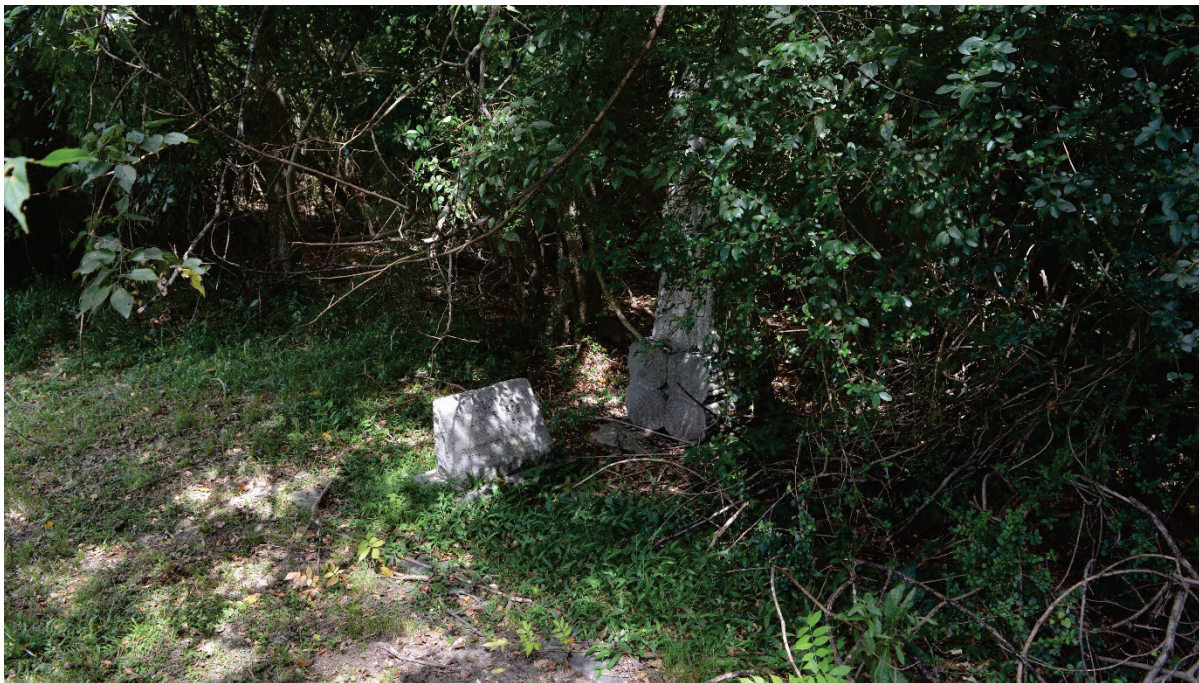
Figure 9. Poorly maintained property boundaries. At the top is the eastern line. At the bottom is the northern line. Both require immediate attention.

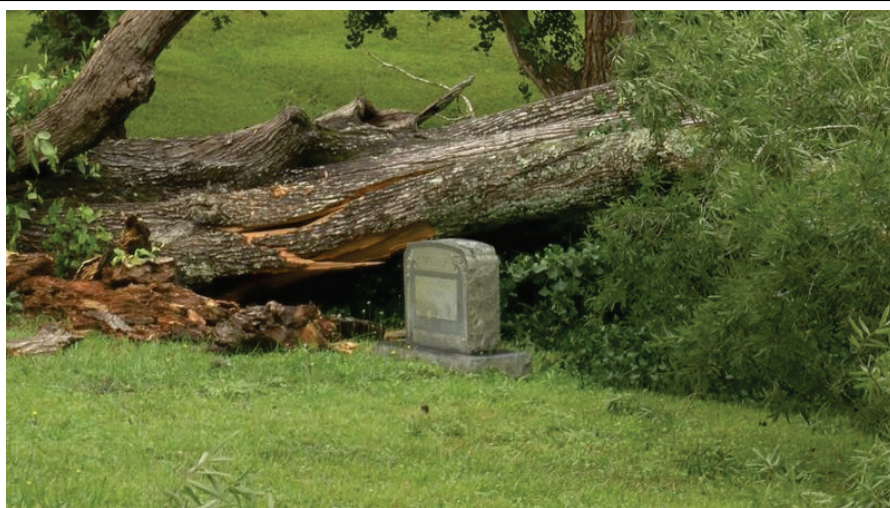
Figure 13. Significant damage created by the May 29, 2018 storms (photograph courtesy WMBF news).

One example of this is a large hardwood that fell during the May 2018 storm (see Figure 13 for a view of the damage at the time). The problem with this deferred maintenance program is that when something does occur, it is likely to create extensive damage. In this case, Figure 32 shows the damage that is still present, including six toppled or broken stones.

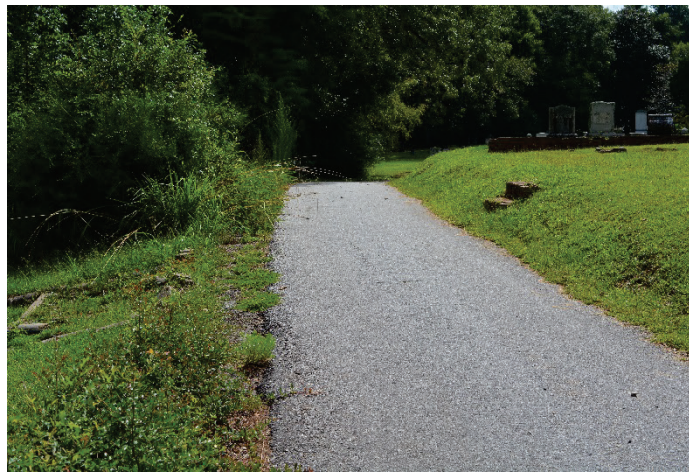
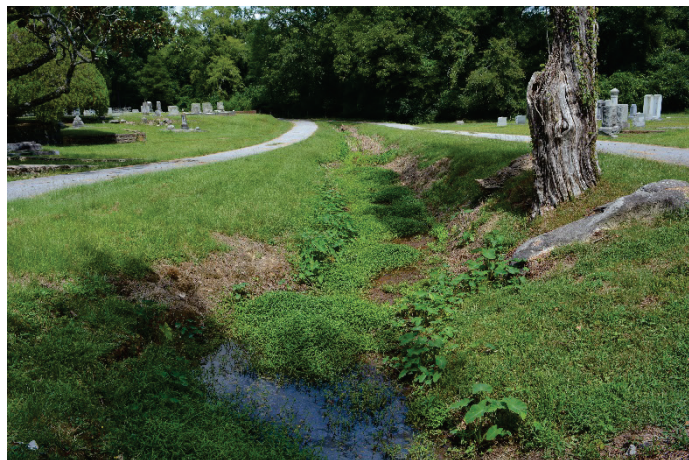
Another issue we observed is that the road, lacking curbs, has grass overtaking the margins because it is never (or rarely) trimmed. This results in two significant problems. The first is

Figure 14. One-lane S-123 off Church Street, providing access to the Thurmond Plot. The top photo is looking east, the lower photo is looking west with the creek in the center of the loop.

that the roadside has an unkempt appearance, detracting from the cemetery landscape. The second problem is that this vegetation growth exacerbates edge cracks and serves to deteriorate further the asphalt pavement.

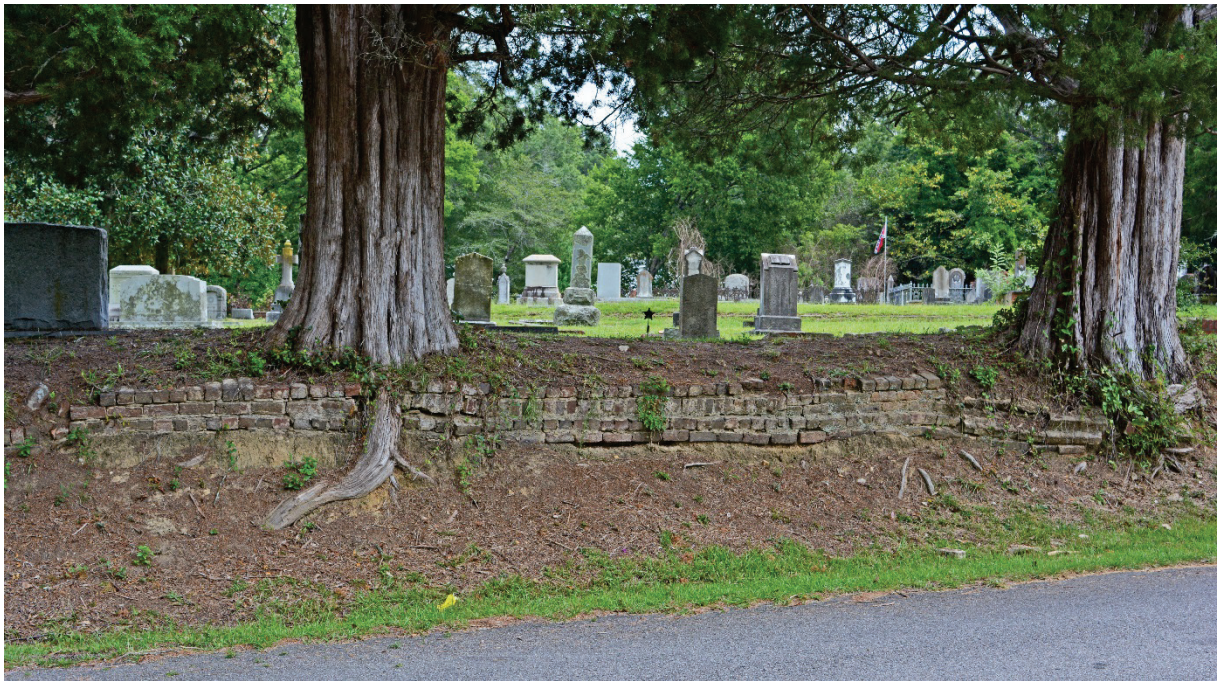
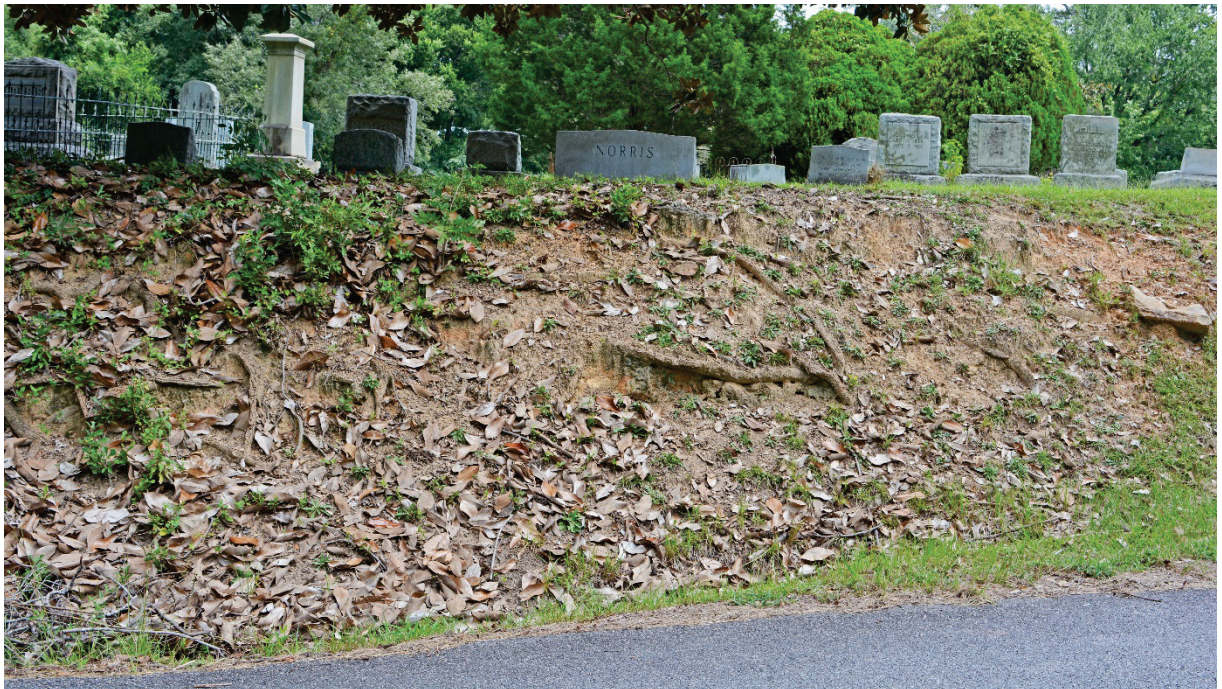
Elsewhere, at least today, there is only bare soil with steep cuts (see Figure 16). It is well understood that the highest erosion rates are observed on road cuts with steep slopes, low vegetation cover, and the presence of loose colluvium. One mechanism for stabilizing such cuts is to terrace or slope the cut further into the cemetery. This, obviously, is impossible given the density of burials.

Figure 16. Erosion along Church Street. The upper photograph shows a section of failing brick wall with significant tree damage. The lower photograph shows a very steep soil bank.

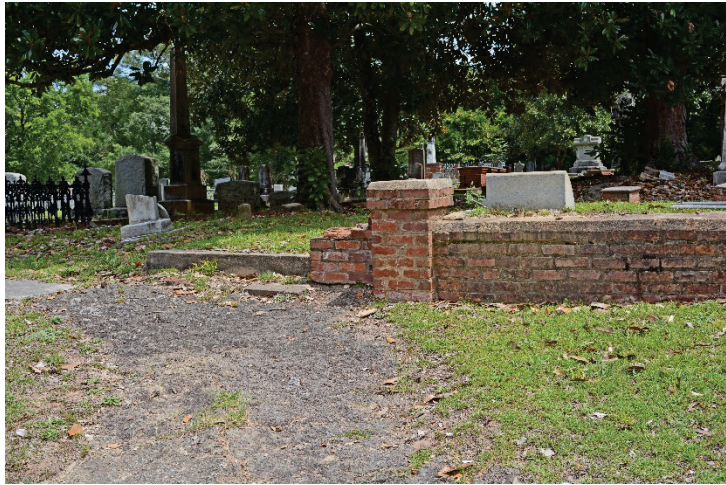
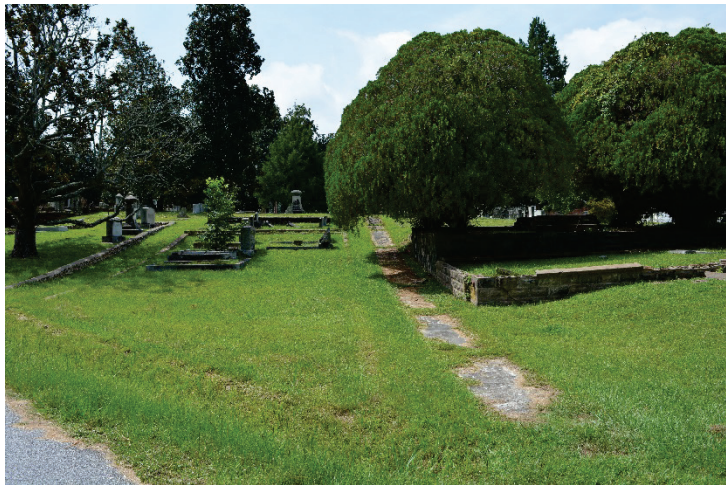
Figure 17. Pedestrian access. The upper photo shows the asphalt leading from the parking space up to the sidewalk. The lower photograph shows the partially obscured and obstructed sidewalk leading to the road in the northern section (in foreground on left).

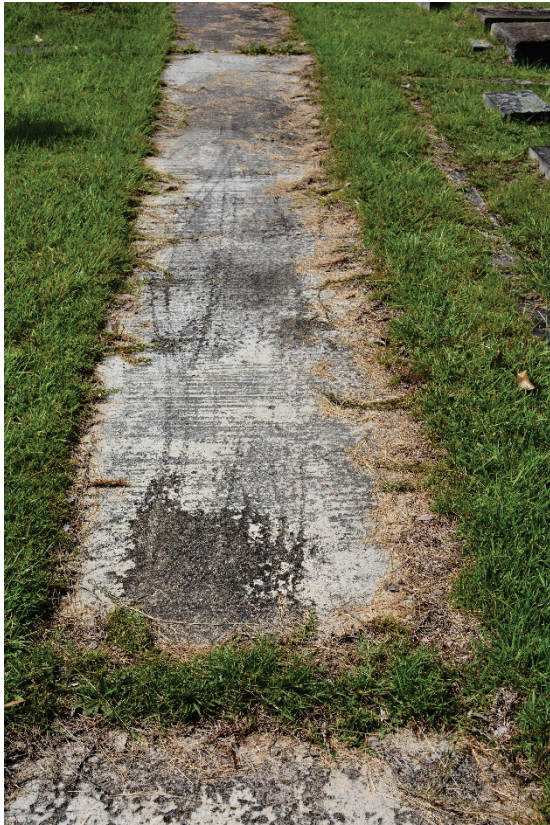
Figure 18. Concrete sidewalk showing its neglected condition with grass growing in cracks and mowed grass accumulating along the edges.

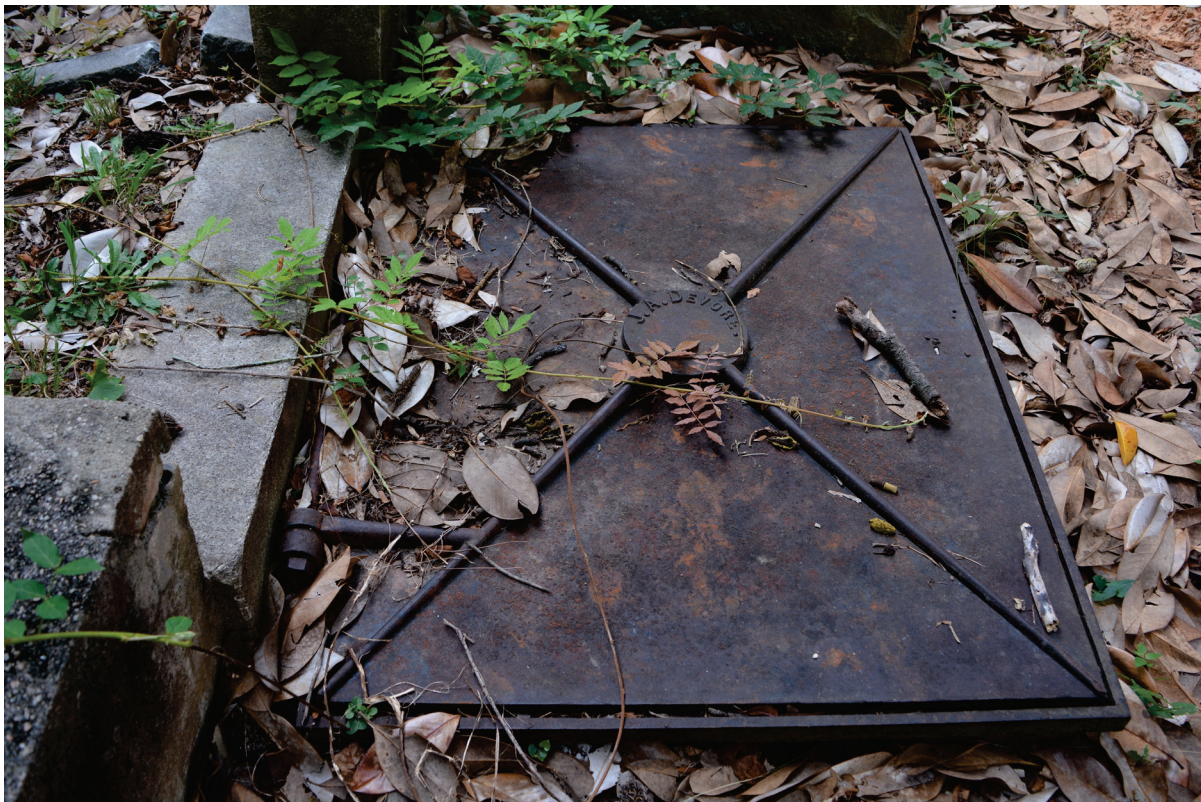
Figure 19. The DeVore vault.

frame (Figure 19). The treatment necessary for this door will be discussed in a following section where we discuss the other ironwork in the cemetery.

Having a coffin behind glass is not inconceivable. Having a glass viewing plate in the coffin for a burial in 1884 is also entirely plausible. Having an individual “mounted” in a chair is rather implausible.

Nevertheless, this vault has the potential for an exceptional educational and promotional opportunity. In addition, filling in the vault is likely a violation of South Carolina’s laws concerning

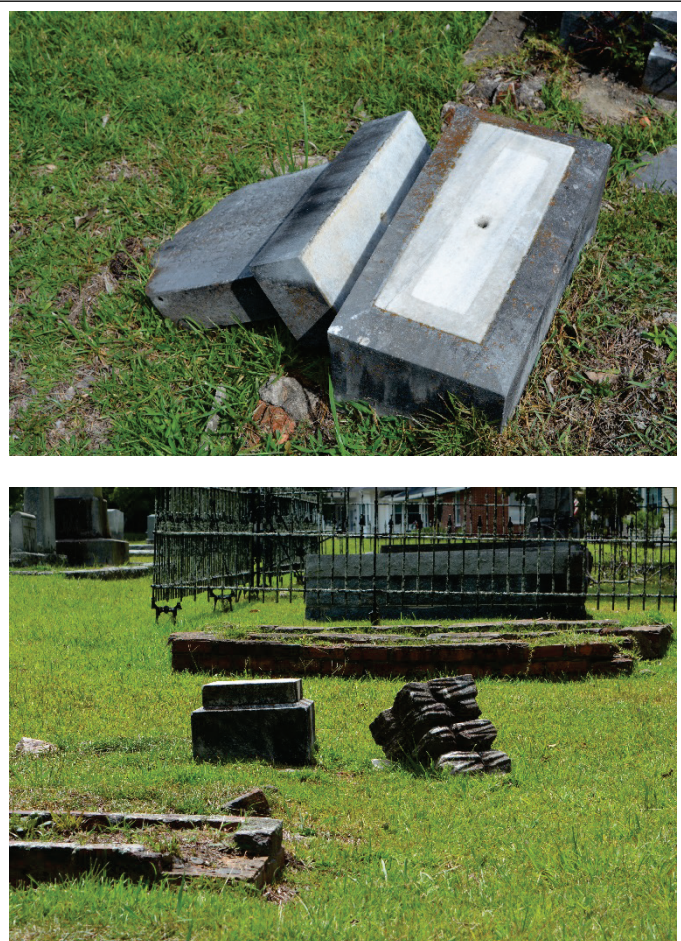
Figure 20. Probable examples of vandalism. The photograph at the top shows a very heavy monument recently toppled (note the very white color). The lower photograph shows a child's monument kicked over (based on the low center of gravity and the distance the die is from the base).

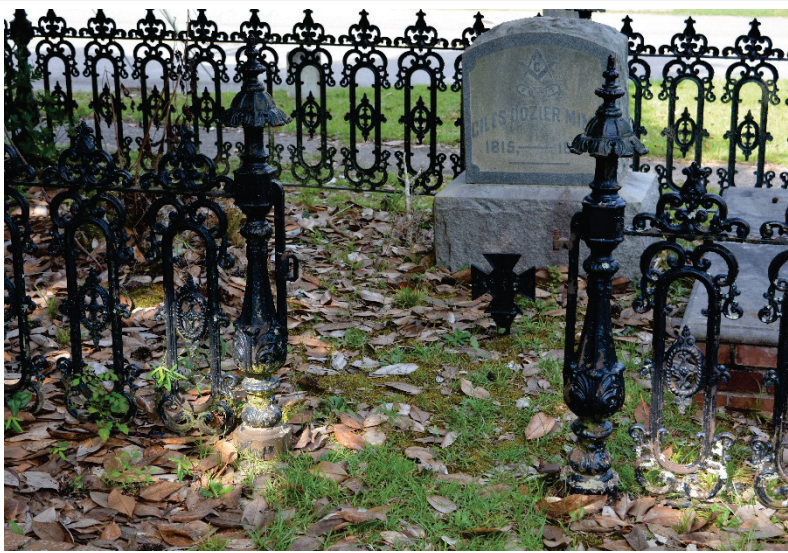
Figure 22. Every fence without a gate is evidence of previous theft. The cemetery's ironwork is in jeopardy of additional losses.

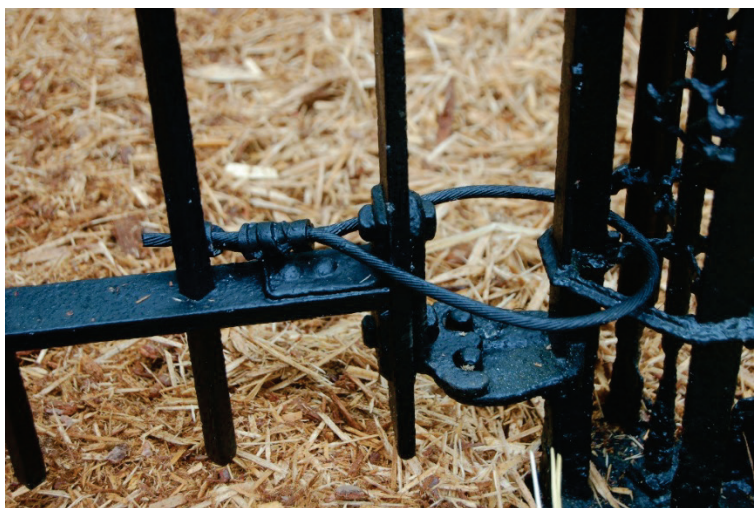
Figure 23. Example of a gate protected with stainless steel cabling that has been painted to blend with the fence.

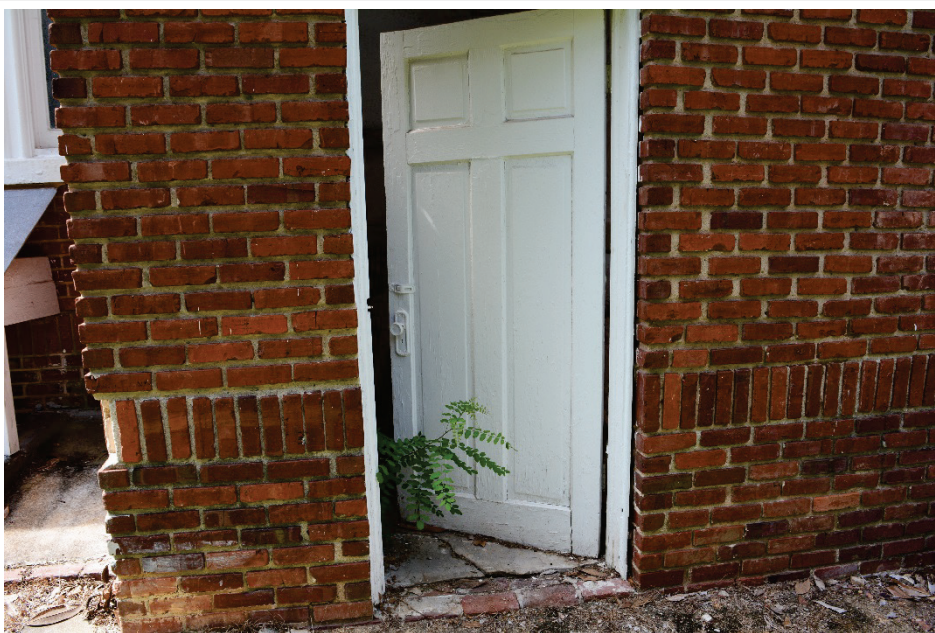
Figure 24. Open storage room door at the south side of the cemetery. This should be secured to improve visitor safety.

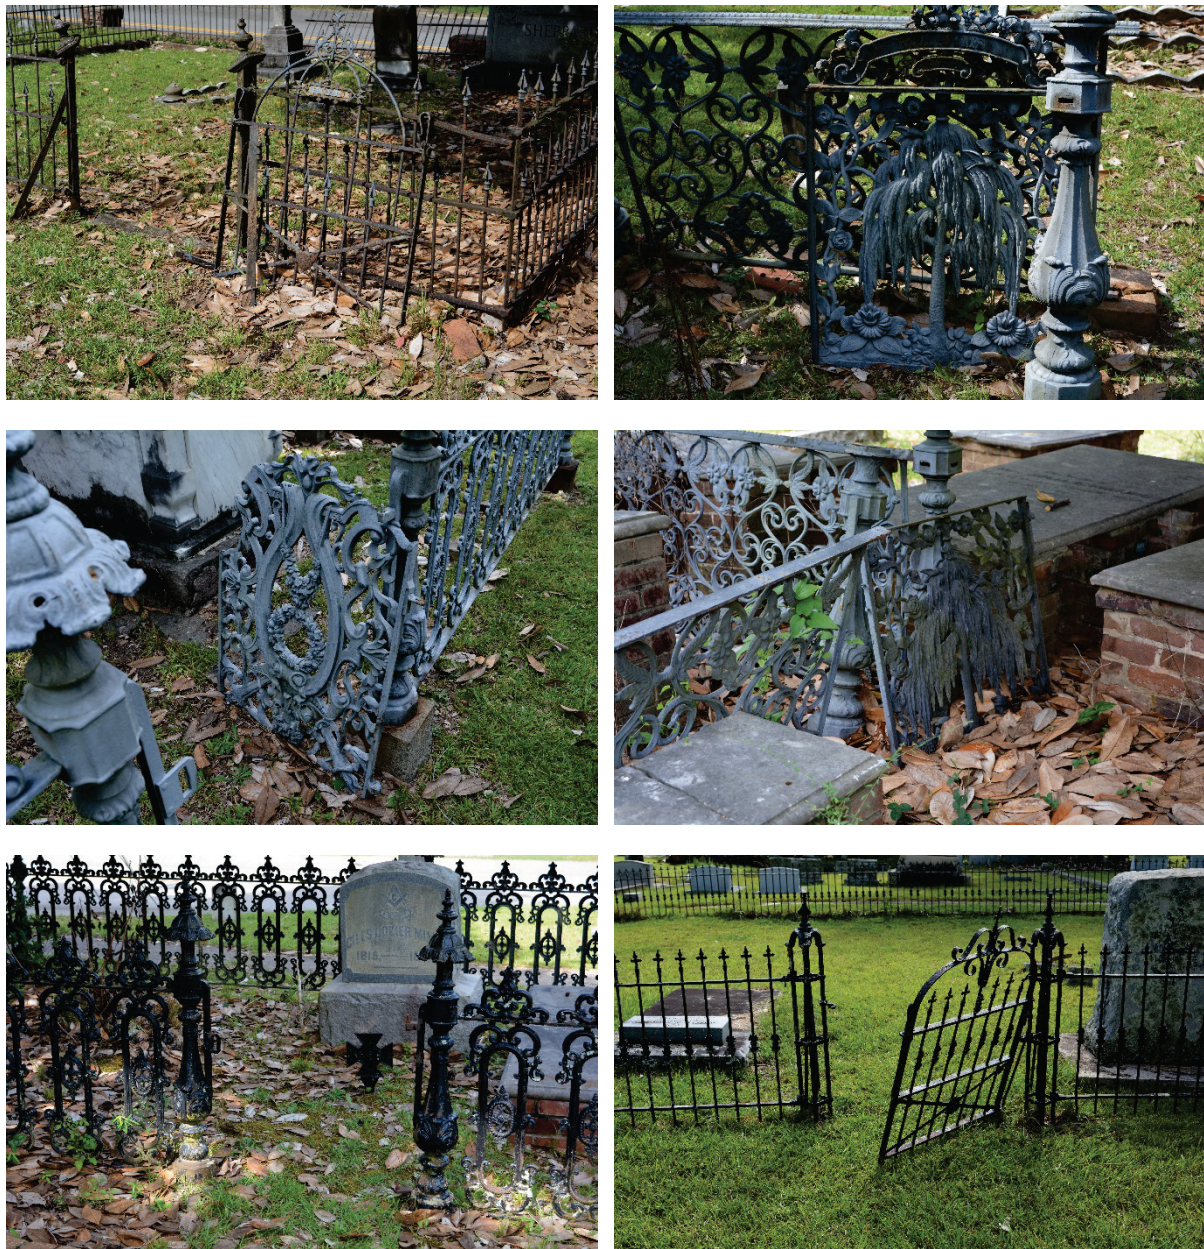
Figure 25. Examples of fence conditions. Upper left, gate no longer attached, post missing elements; upper right, gate and gate post no longer attached, iron jacking of granite foundation, missing elements; middle left, gate broken and elements missing; middle right, gate and gate post no longer attached, sections leaning; lower left, fence painted, but gate missing; lower right, fence painted, but gate no longer attached.

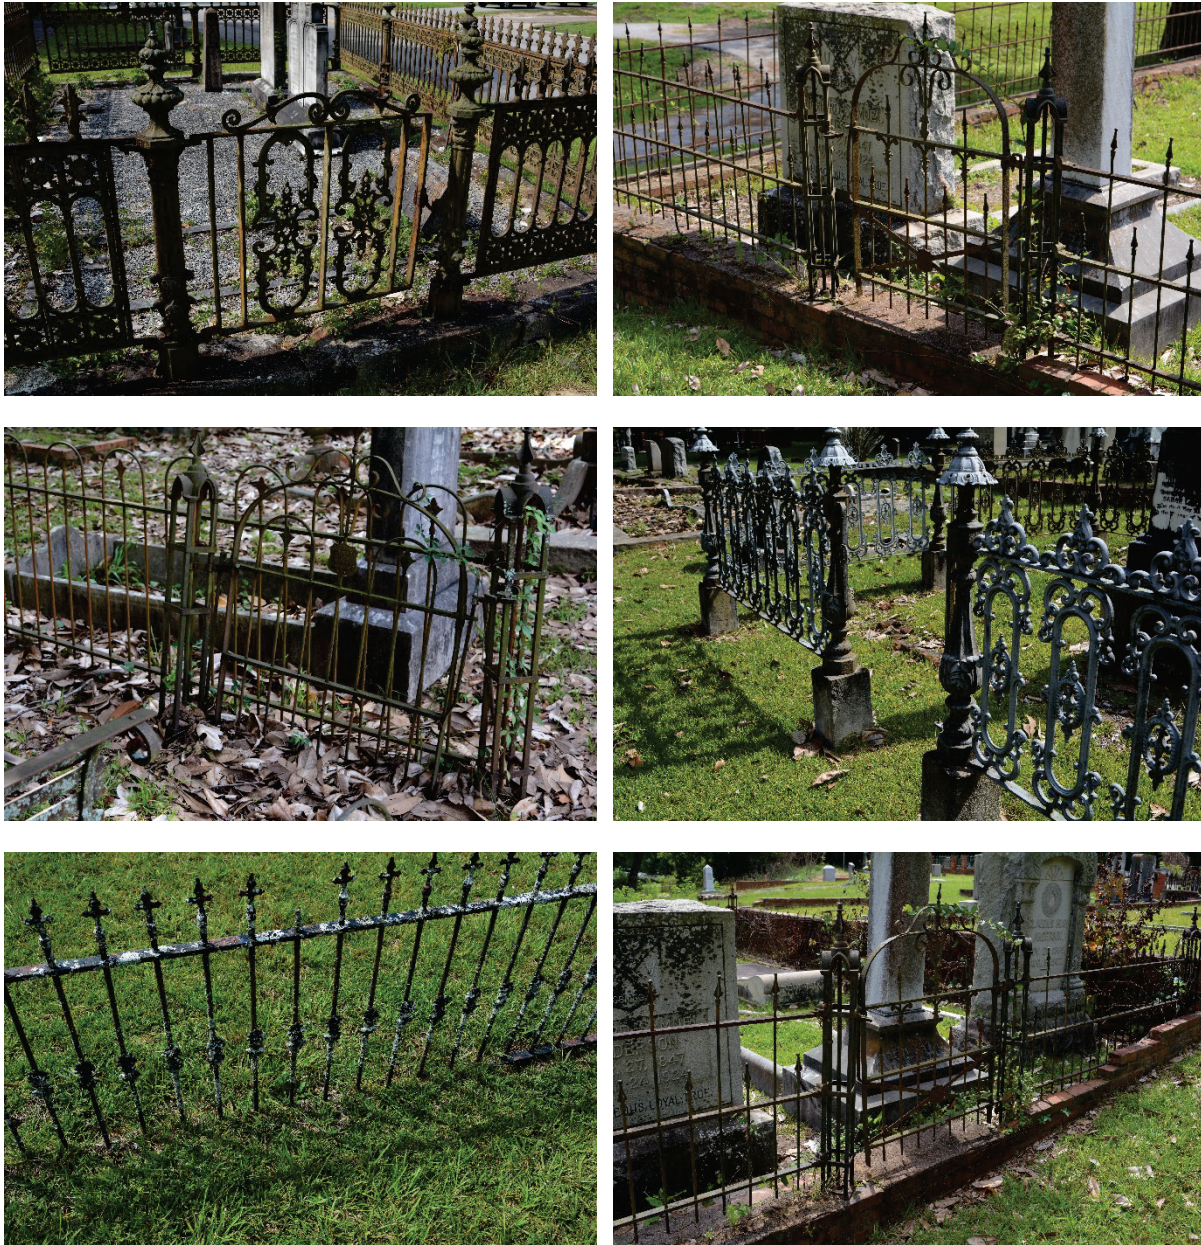
Figure 26. Examples of fence conditions. Upper left, cast and wrought fence in good condition, but it requires painting; upper right, mild steel fence in good condition, but it requires painting; middle left, mild steel fence with damaged gate and gate posts, that also requires paint; middle right, gate is missing, but fence is otherwise in fair to good condition; lower left, the fence bottom rail is buried in soil and requires resetting and painting; lower right, fence in good condition, but it requires paint.

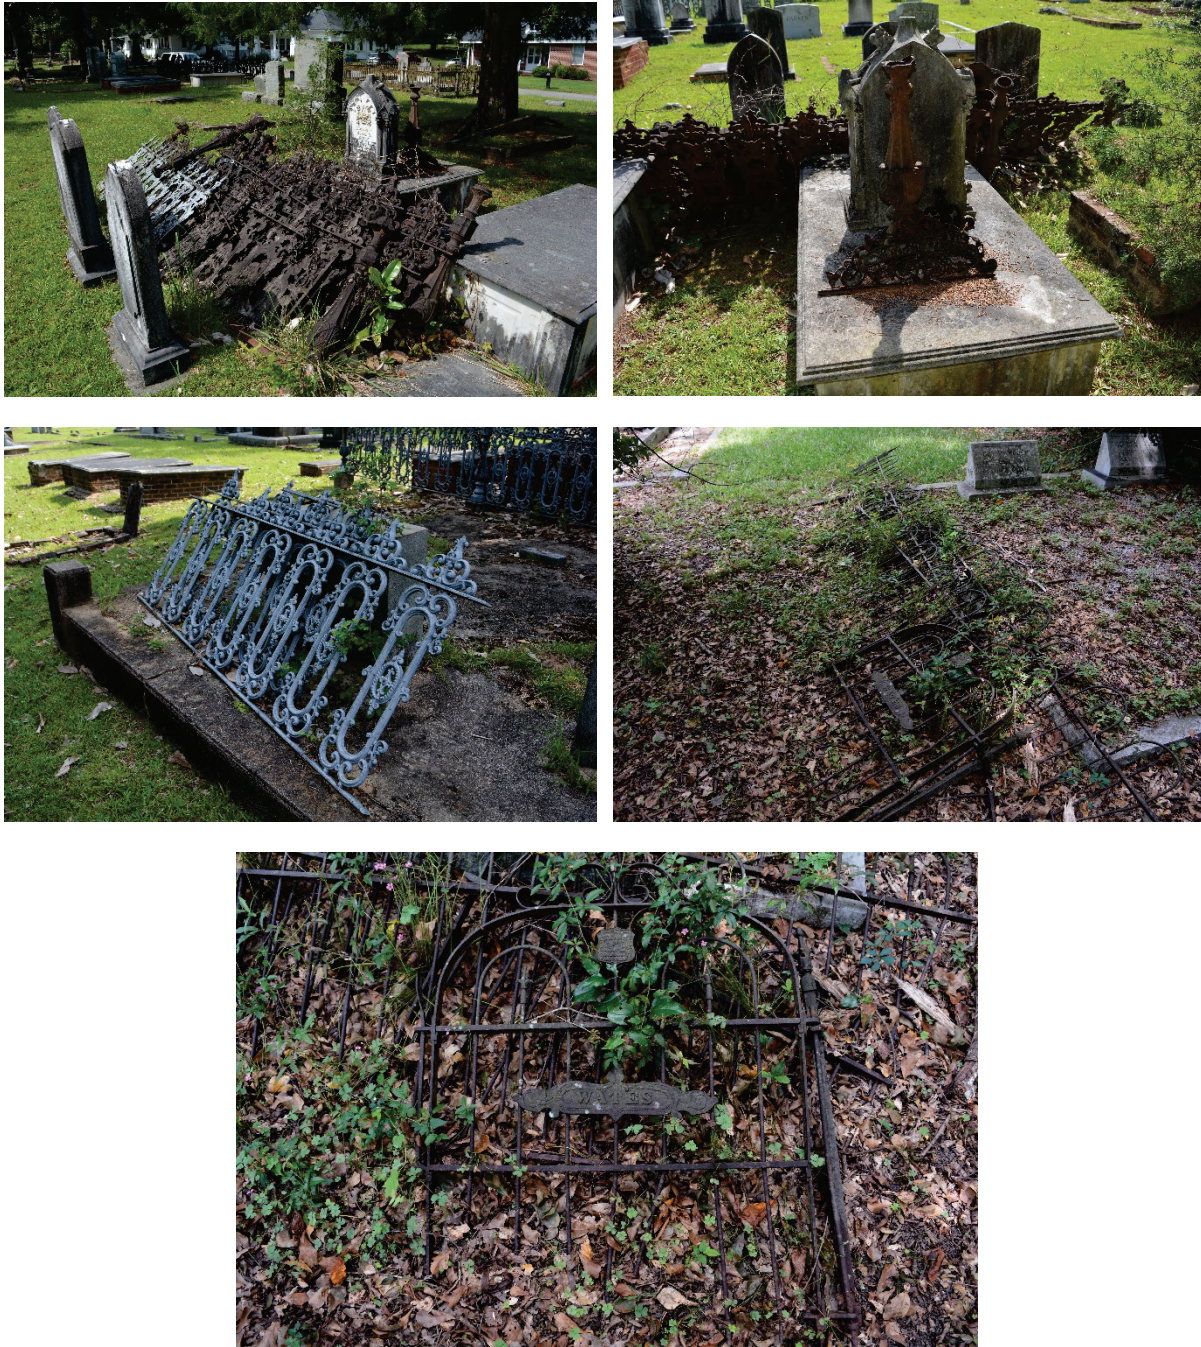
Figure 27. Dismantled and poorly stored fences. Upper left, unsecured fence sections leaned against marble monuments; upper right, metal fence parts stacked on top of marble box tomb; middle left, unsecured fence section leaning against monument; middle right, fence sections stacked and partially covered by leaves and weeds; lower photograph, a gate from the Wates plot, essentially discarded.

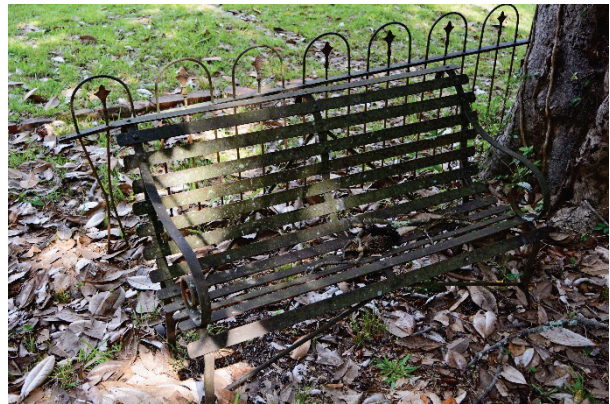
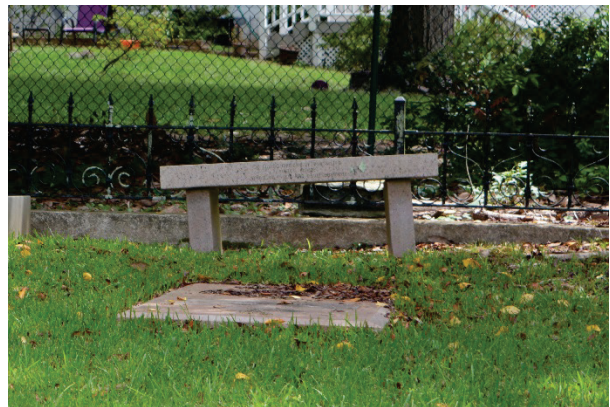
Figure 28. Benches in Willowbrook also require maintenance. The iron bench at the top requires securing to the fence or tree, as well as cleaning and painting. The granite bench below requires resetting to make it stable and safe.

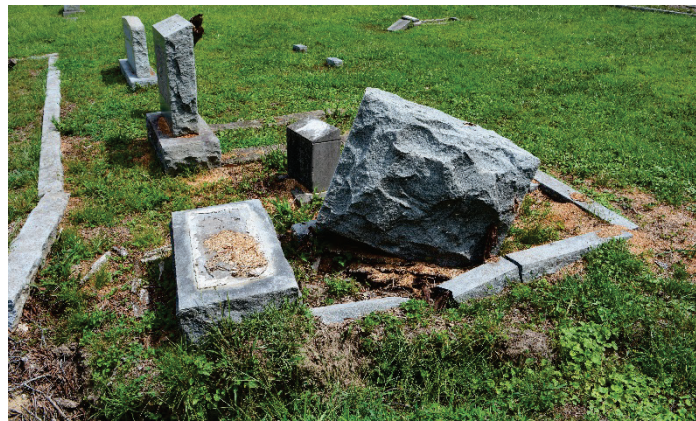
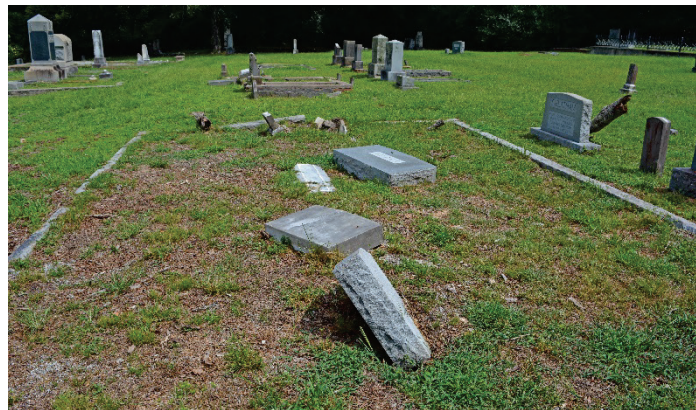
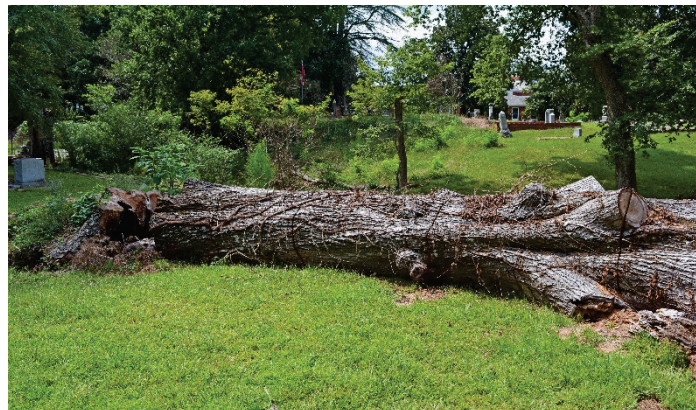
Figure 32. Tree damage from May 2018. Top and middle photographs shows damaged stones still not repaired. Lower photo shows the tree, still in the cemetery.

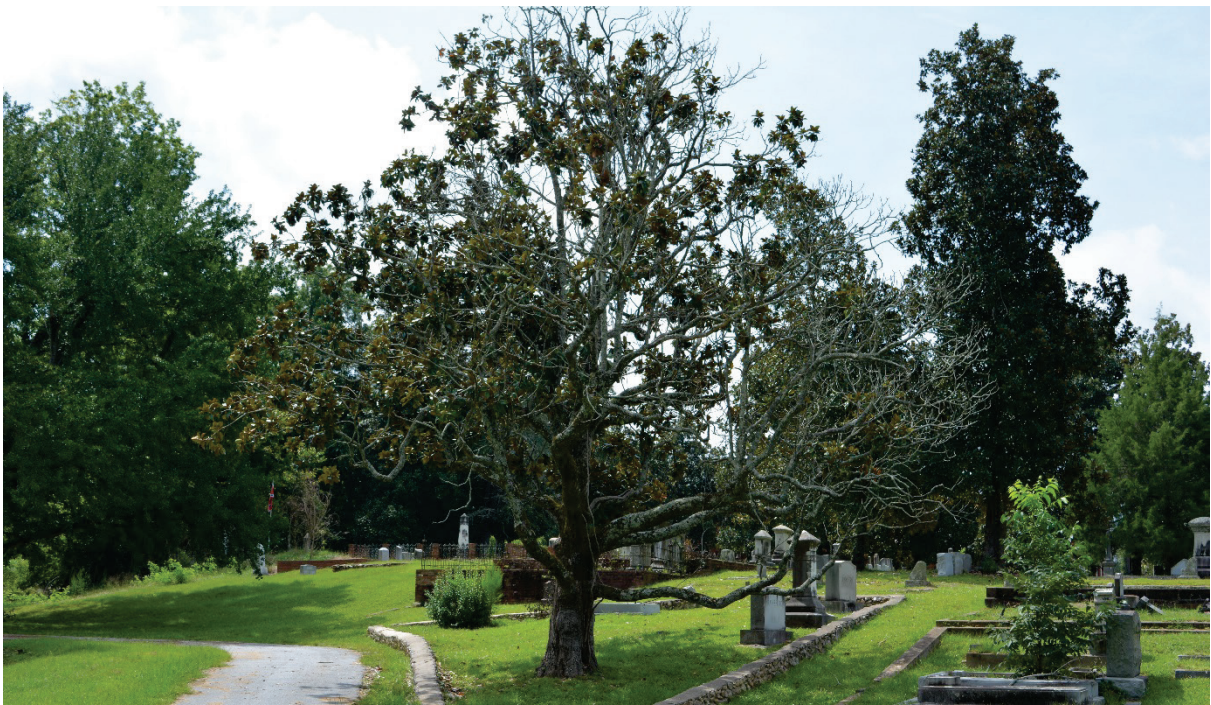
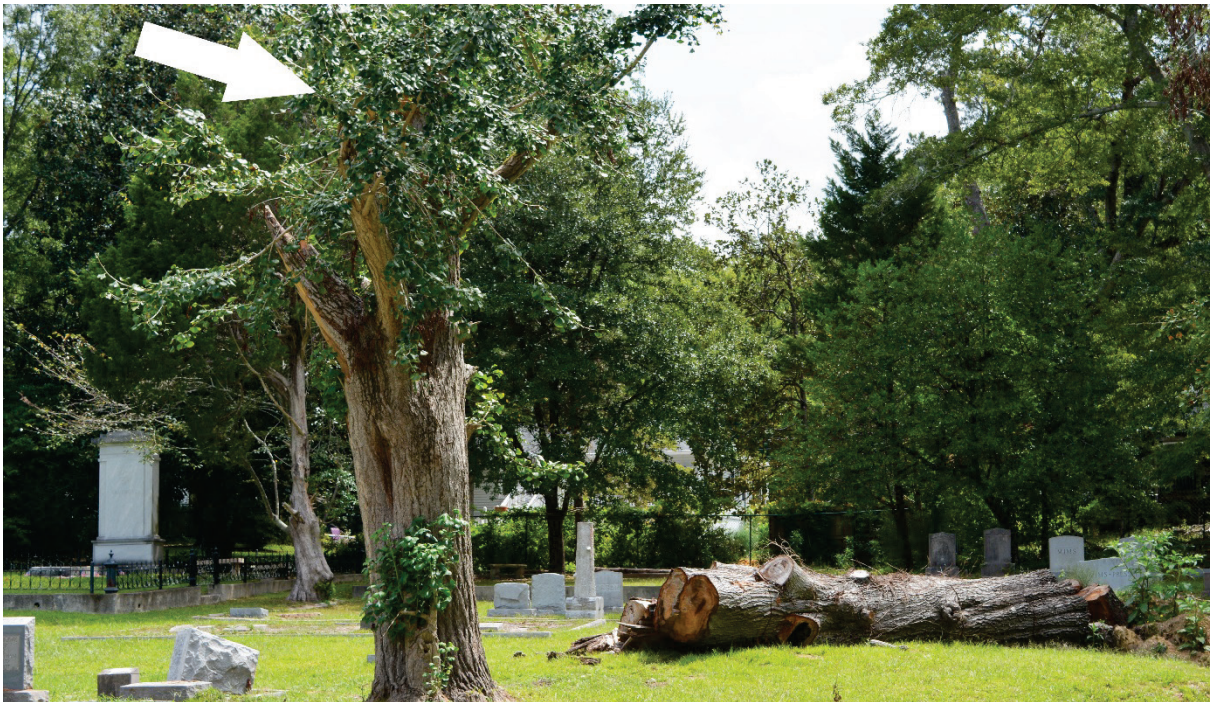
Figure 33. Hazardous trees that should be removed and replaced. The tree at the top is essentially dead. The tree below has been severely topped.

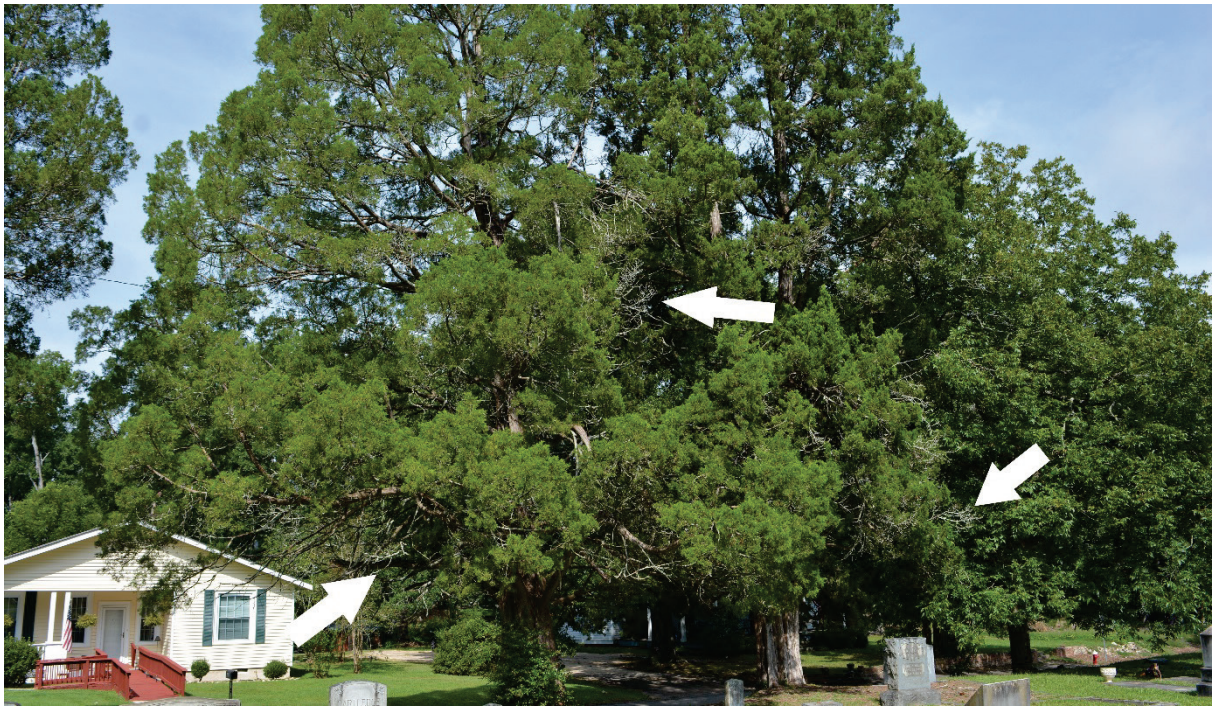
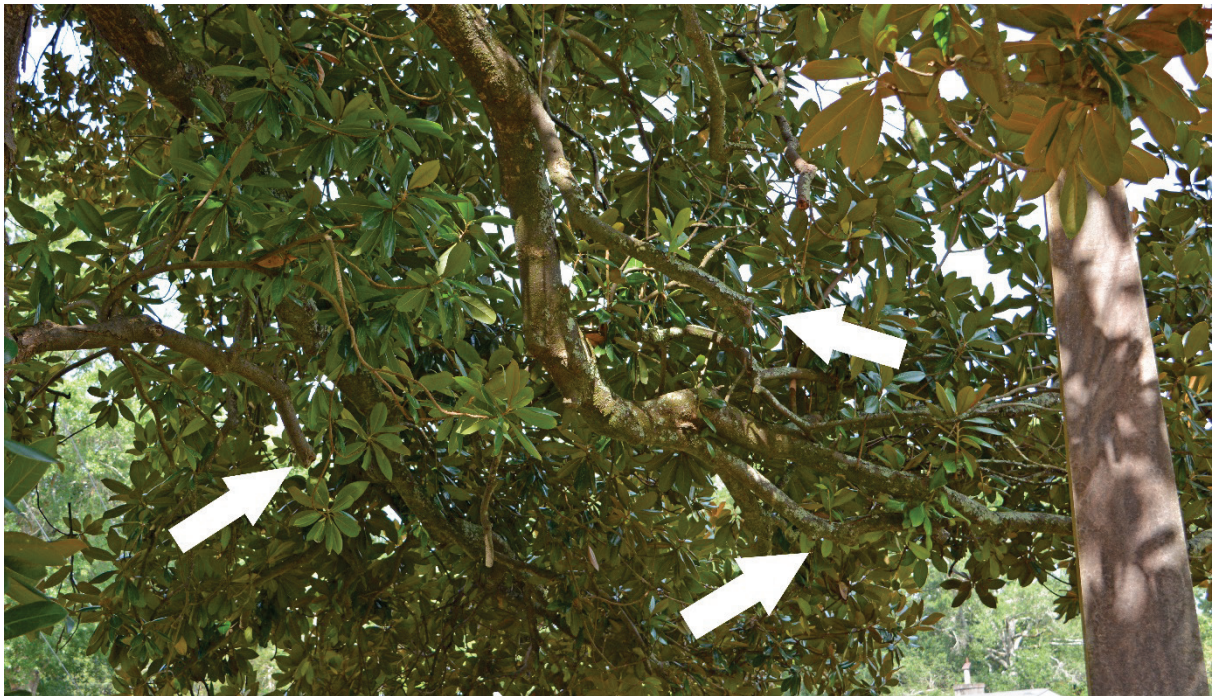
Figure 34. Tree problems at Willowbrook. Upper photo shows cedars with abundant dead wood that requires pruning. Lower photo shows improper pruning leaving stubs.

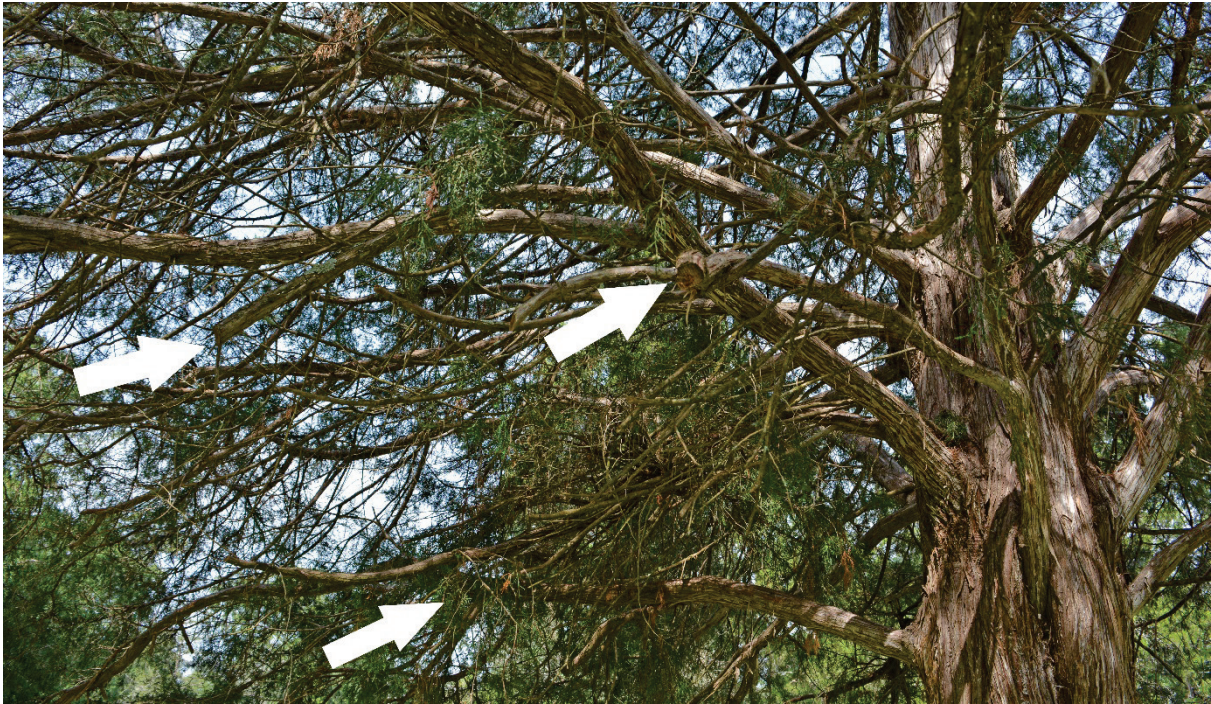
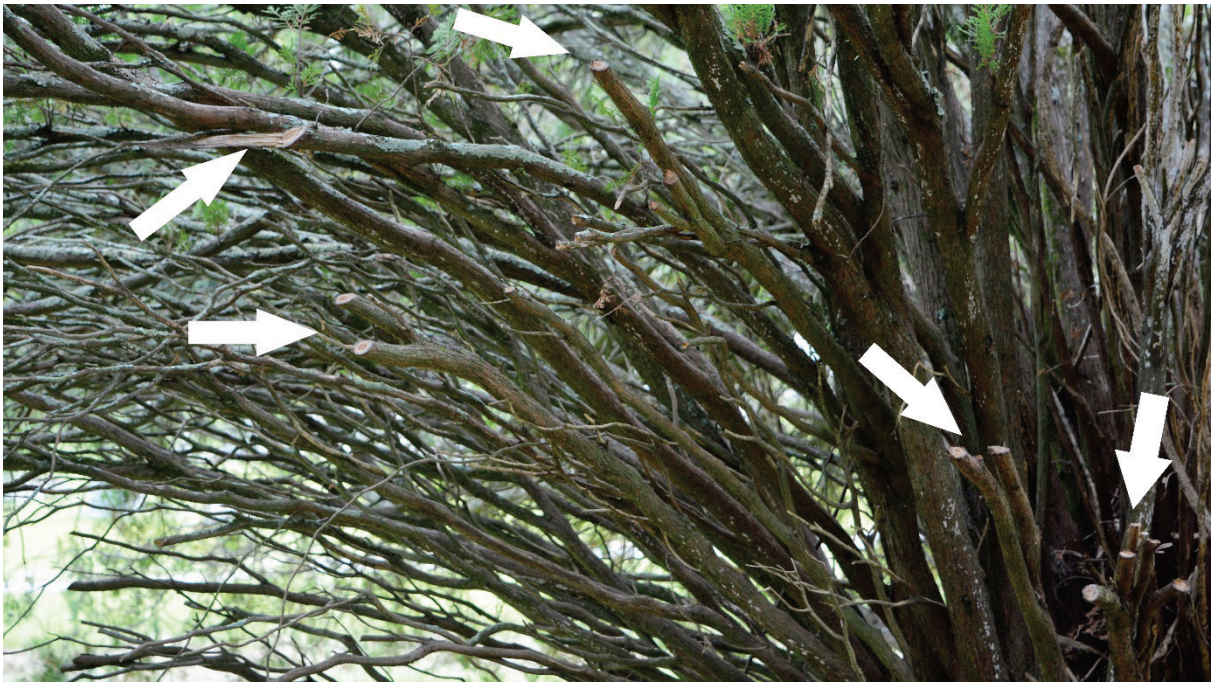
Figure 35. More examples of improper pruning showing torn branches and stubs.
