# **WILLOWBROOK CEMETERY ASSESSMENT, TOWN OF EDGEFIELD, EDGEFIELD COUNTY, SOUTH CAROLINA**

**WILLOWBROOK CEMETERY ASSESSMENT,  
TOWN OF EDGEFIELD, EDGEFIELD COUNTY,  
SOUTH CAROLINA**

**Research Contribution 591**

September 2018

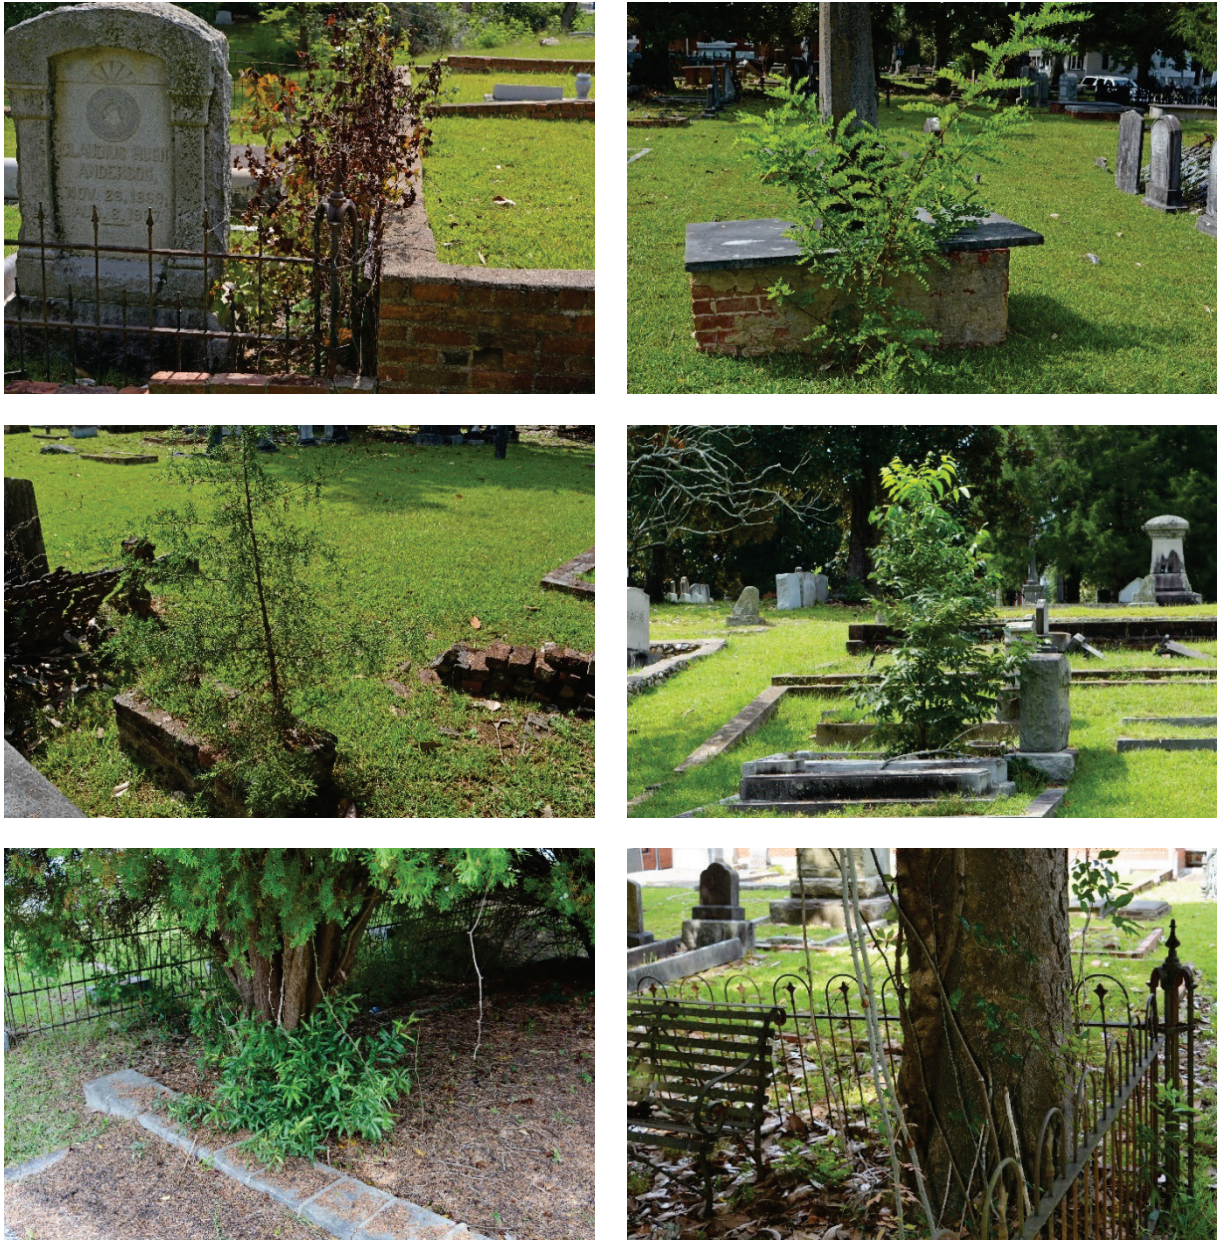
Figure 37. Tree problems. Upper left photograph shows trash vegetation growing up between a brick wall and iron fence. Upper right photograph shows a scrub tree immediately adjacent to a brick box tomb. Middle left photograph shows a bird-planted cedar growing up in a child's box tomb. Middle right photograph shows a trash tree growing up in a cradle grave. Lower left photograph shows scrub oak at the base of an arborvitae. Lower right photograph shows a tree that has been allowed to grow too close to an iron fence and is now impacting the stability of the fence.

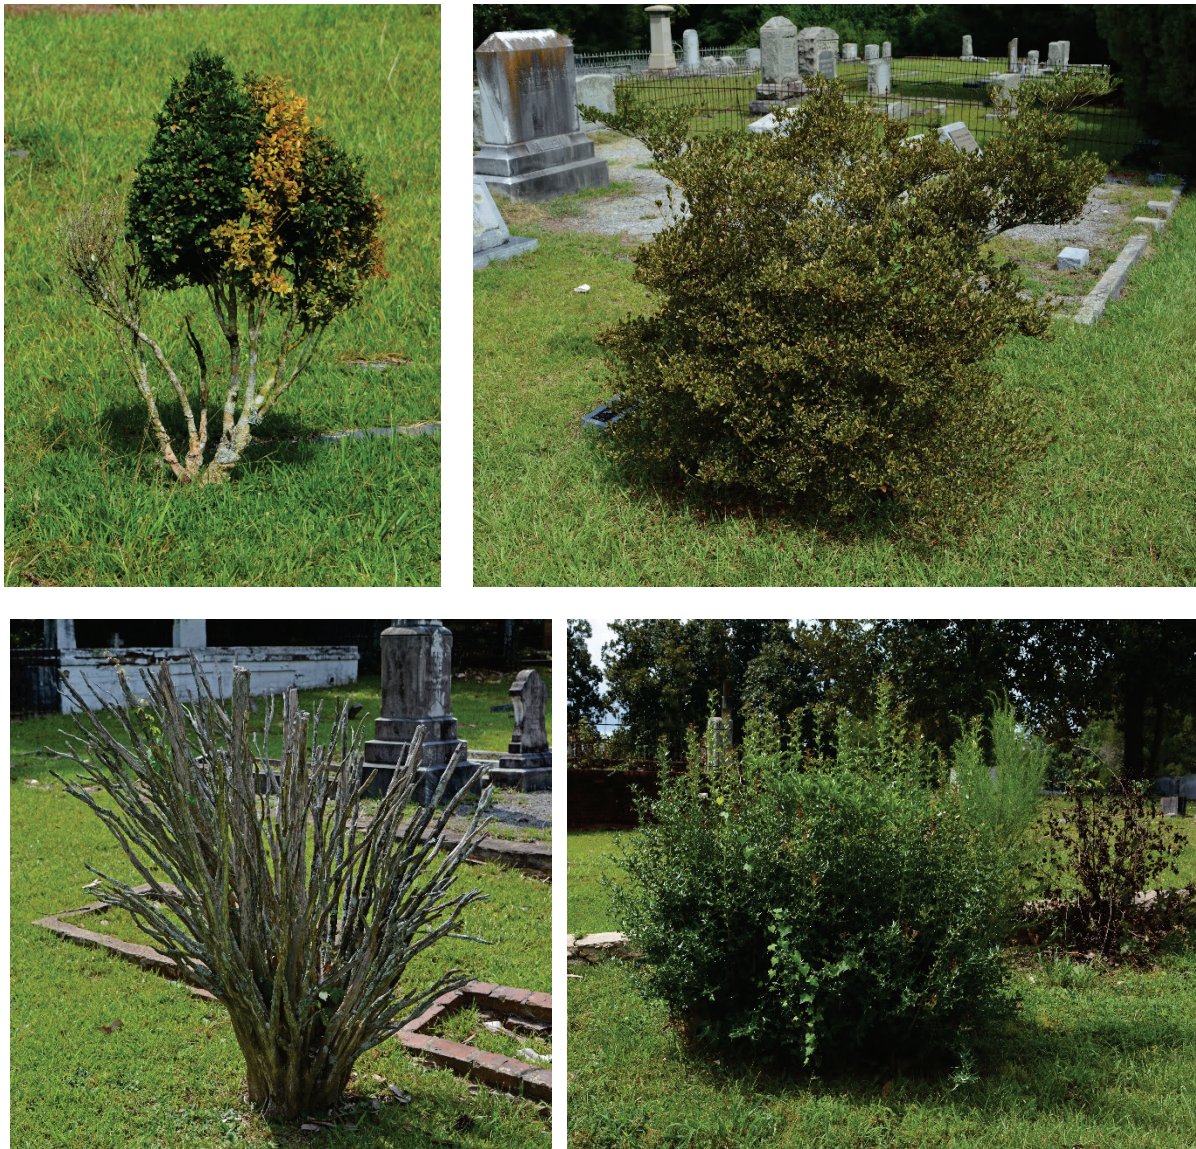
Figure 38. Shrubby issues at Willowbrook. The upper photographs show boxwoods. On the left is a small specimen that is dying and should be removed. The specimen on the right requires appropriate pruning. The bottom left photograph is an example of a long dead shrub that has never been removed. At the bottom right is a holly that has been overtaken by trash vegetation and that has not been appropriately pruned.

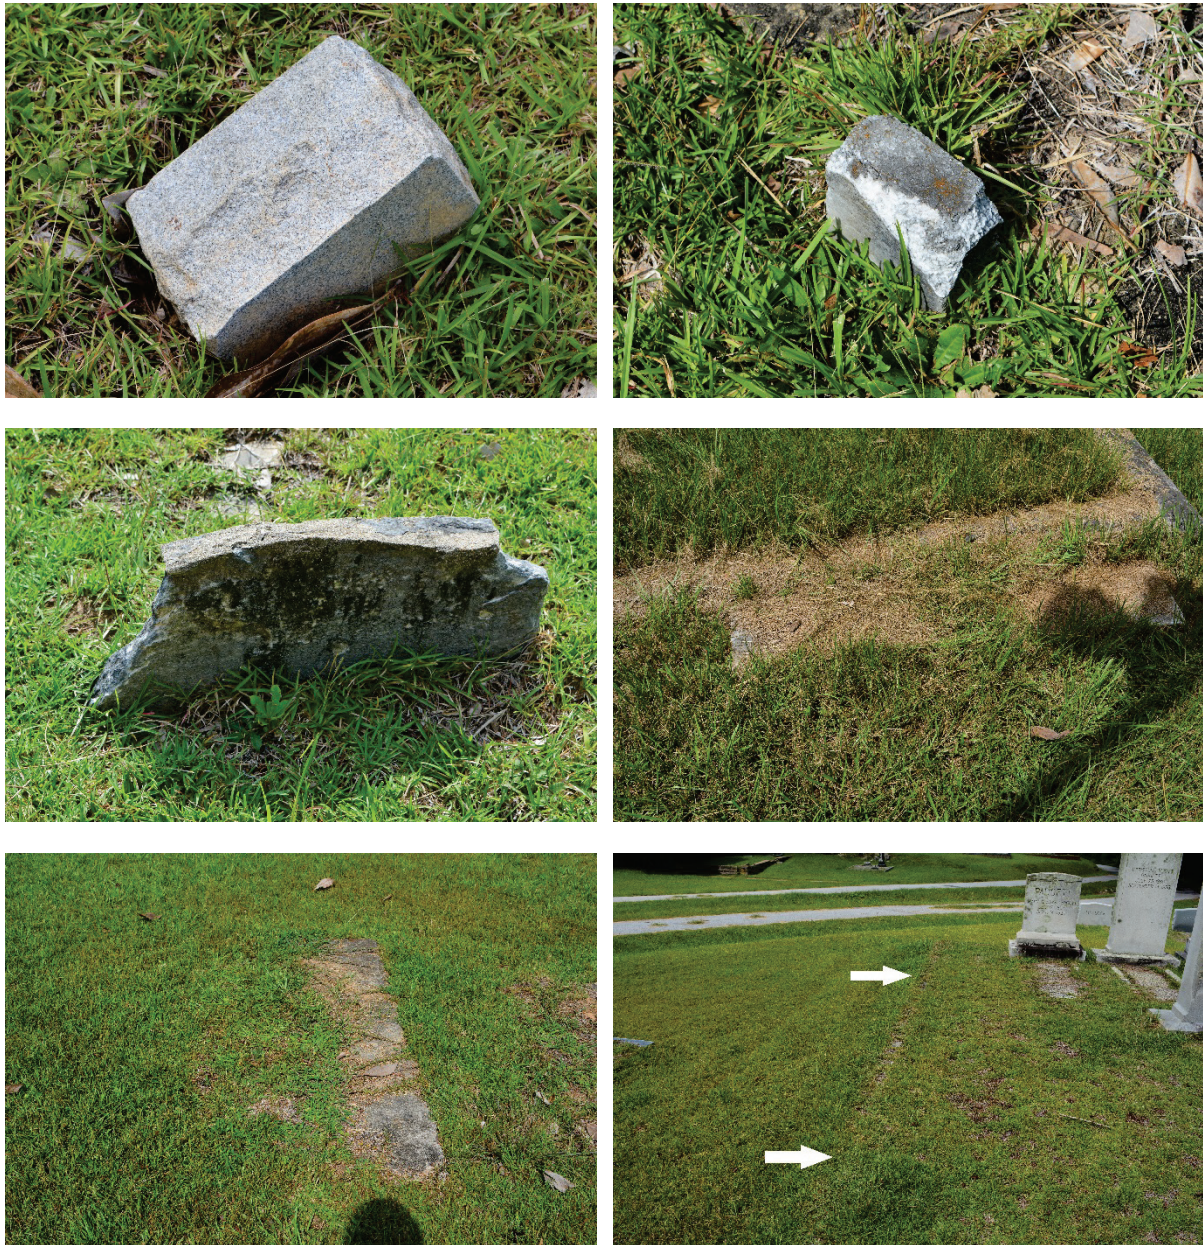
Figure 40. Mowing and damage of monuments at Willowbrook Cemetery. Upper left photograph shows a stone dislodged from the ground by a mower strike. Upper right photograph shows extensive edge damage resulting from the stone being scalped or mowed over by power equipment. The middle left photograph shows multiple edge impacts from equipment. Middle right photograph shows mowing of tall grass left on stones. This must be blown off. Lower left photograph shows a ledger almost totally covered by grass that has never been trimmed off. Lower right, coping that has been allowed to disappear under the grass.

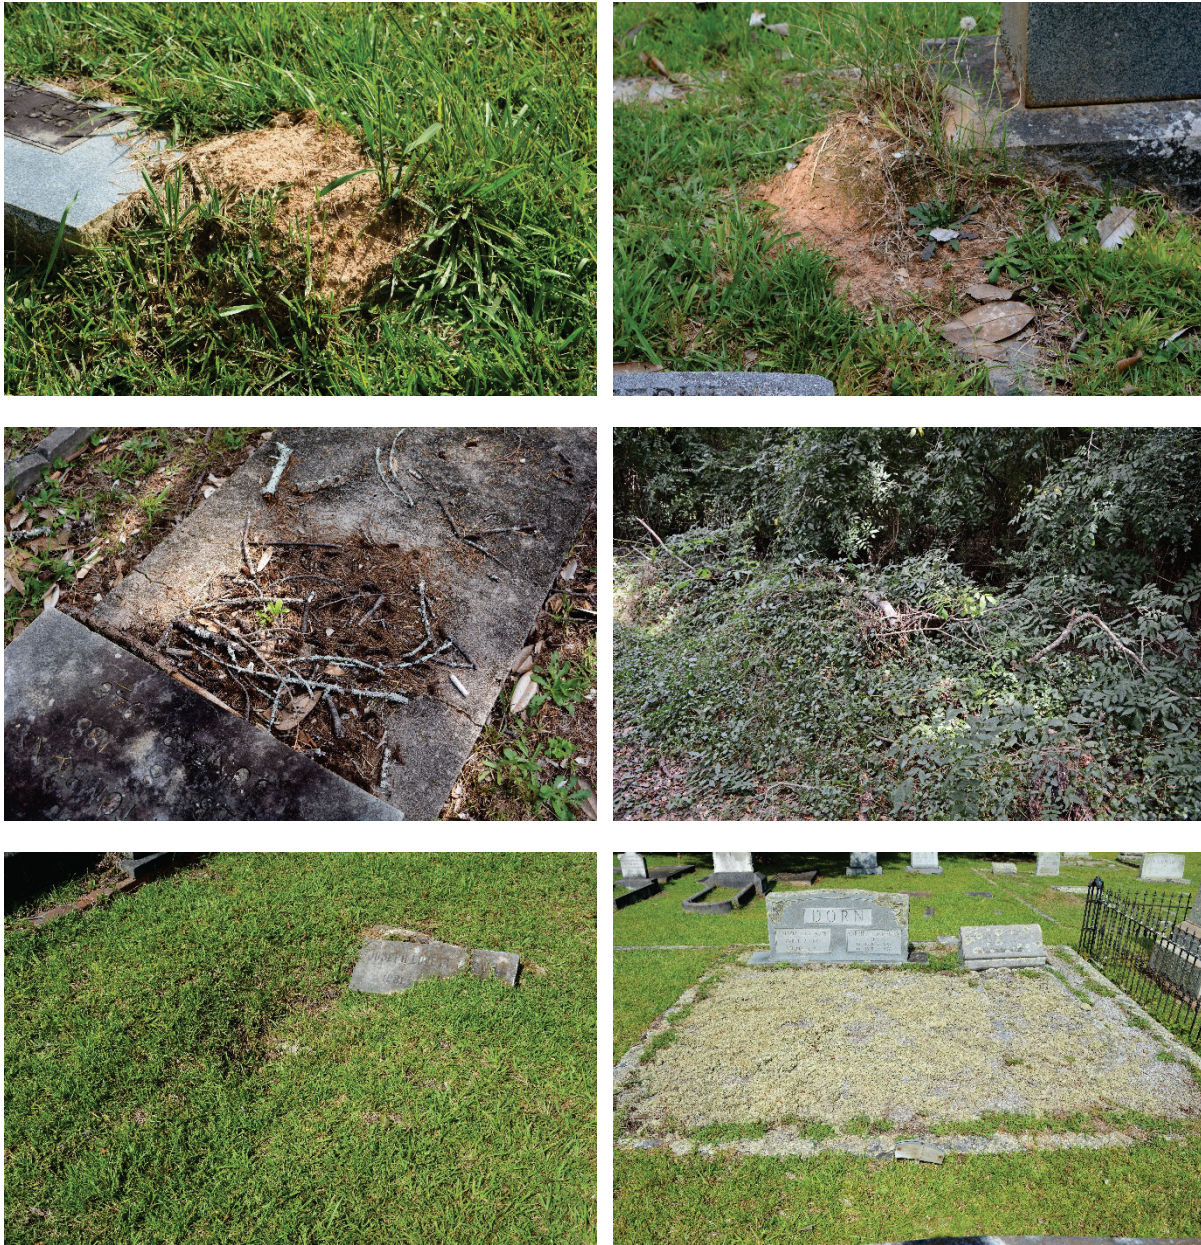
Figure 42. Other landscape maintenance issues at Willowbrook Cemetery. Upper photographs show very large fire ant mounds in the cemetery. These pose a significant liability to the Association and require immediate and on-going treatment. The middle left photograph shows debris allowed to collect on a grave so long that seeds are beginning to sprout. Middle right shows landscape trash dumped at the cemetery edge, creating an eyesore. The lower left photograph shows a sunken grave that requires infill and seeding. The lower right photograph shows a graveled plot with dense lichen growing on it.

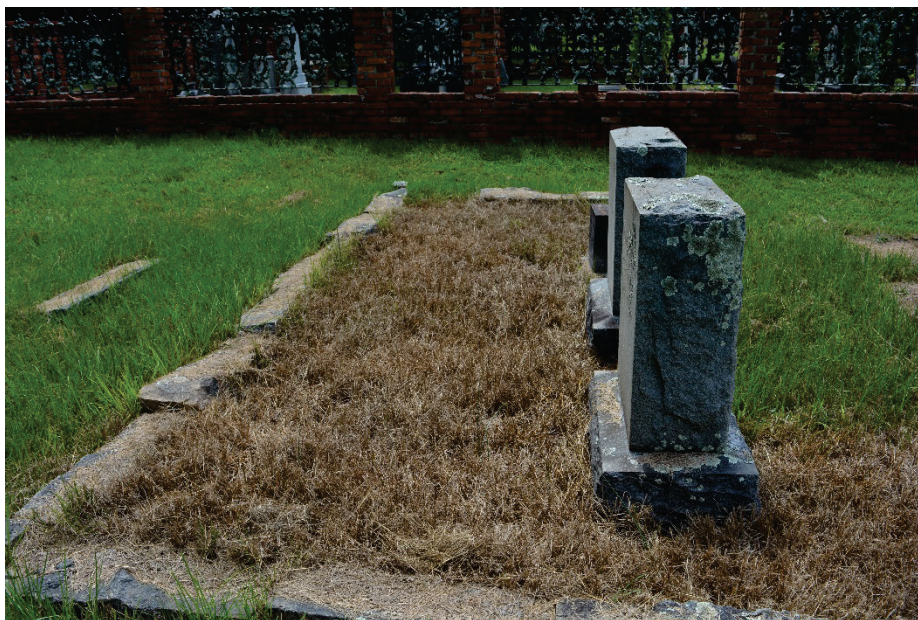
Figure 43. Lot partially treated with herbicide creating a very unattractive appearance in the cemetery.

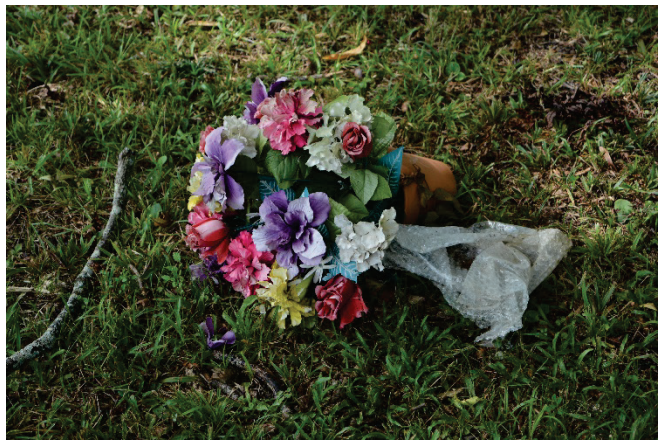
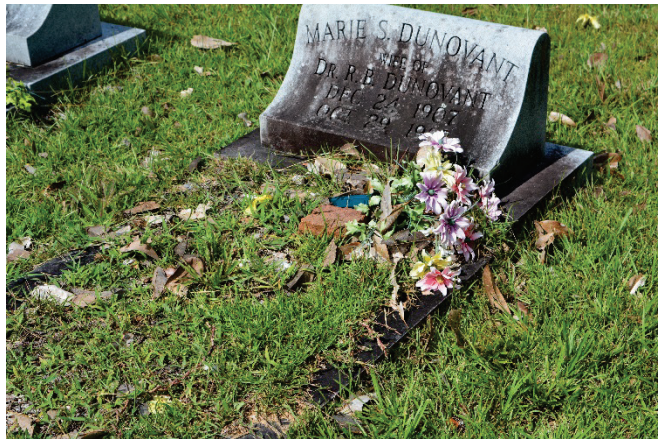
Figure 45. Flower issues at Willowbrook. At the top is a photograph of a bunch of artificial flowers blowing around the cemetery. At bottom is a faded arrangement, tipped over, but still on a grave. Both should be removed and discarded.

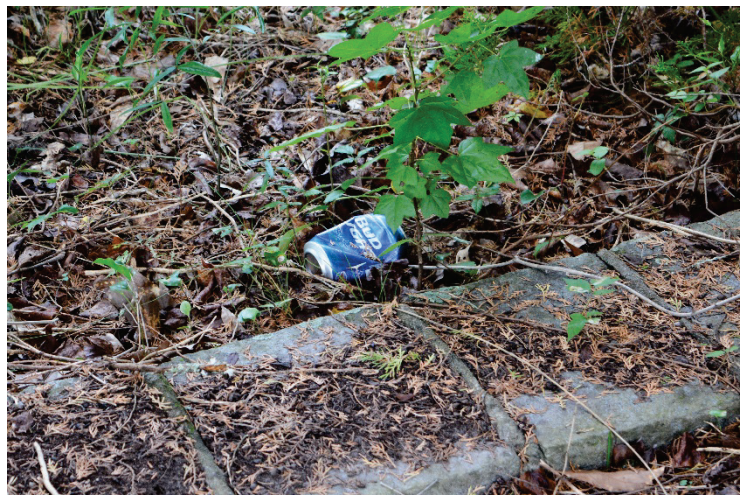
Figure 46. Example of trash in the cemetery.

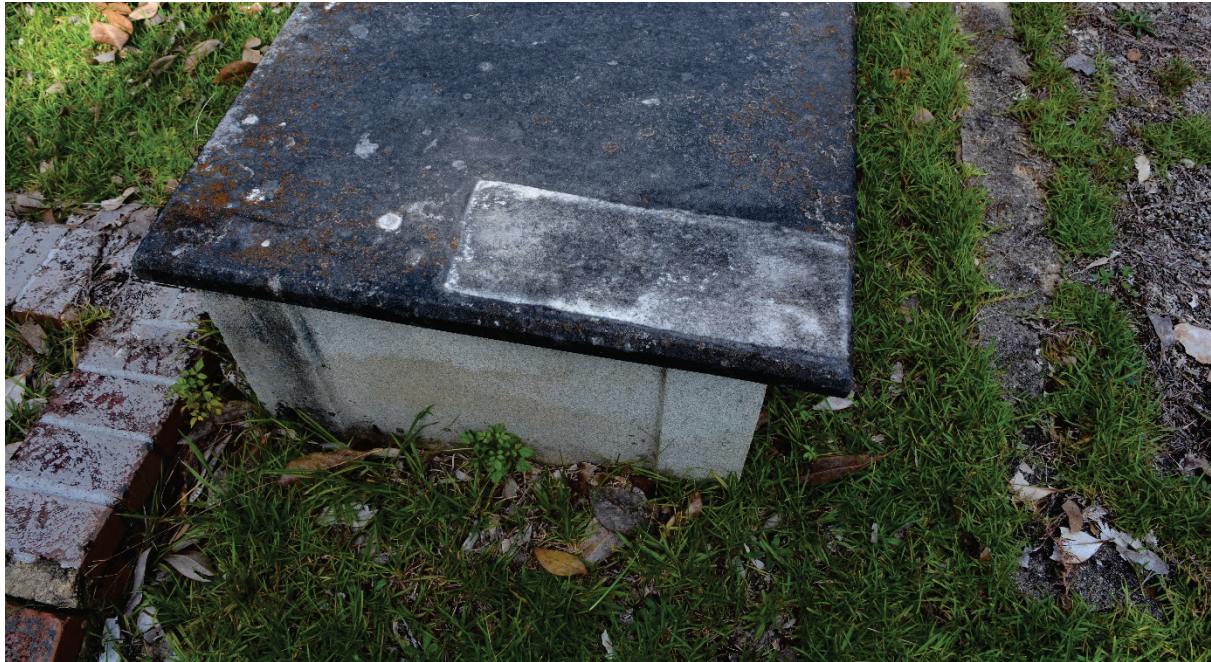
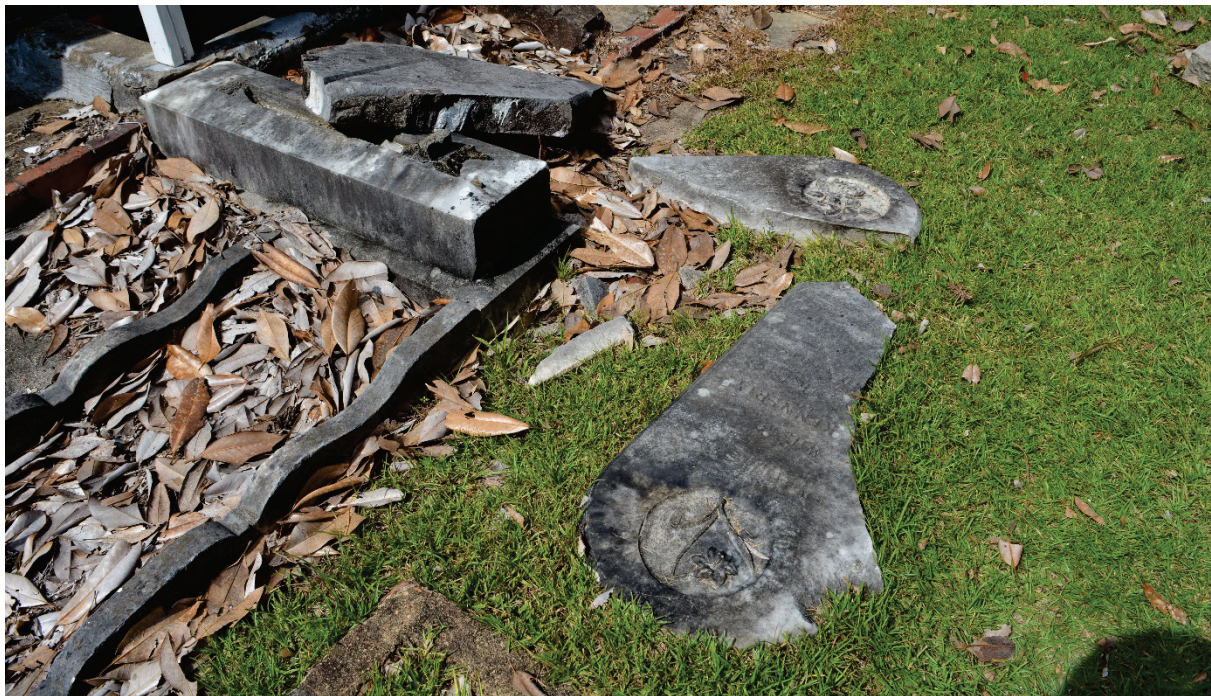
Figure 48. Examples of orphan stones at Willowbrook Cemetery. The top photograph reveals all that is left of a displaced footstone – the stain on top of a ledger. The photograph below shows broken stones that are perhaps associated with the nearby cradle grave, but have been left scattered.

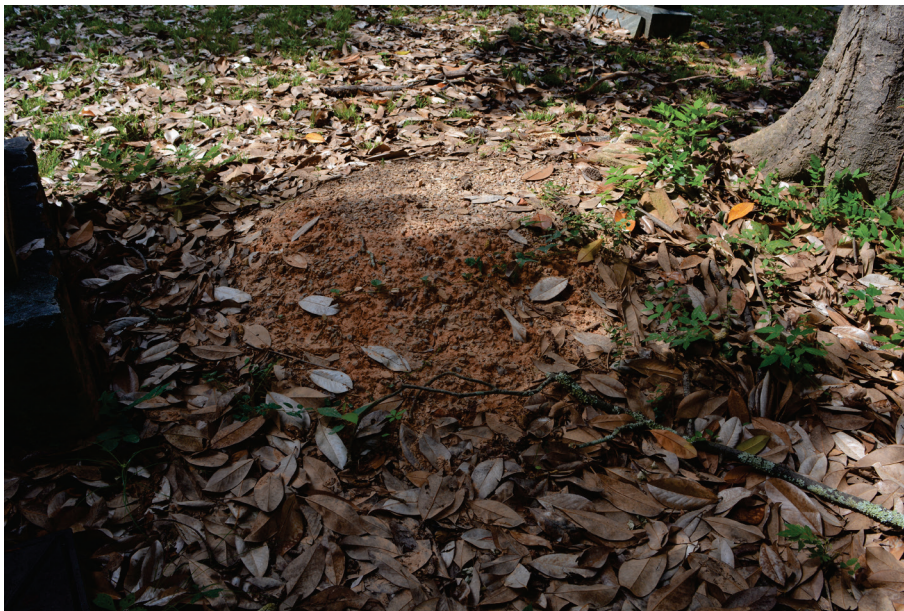
Figure 49. Spoil soil left in the cemetery from a grave.

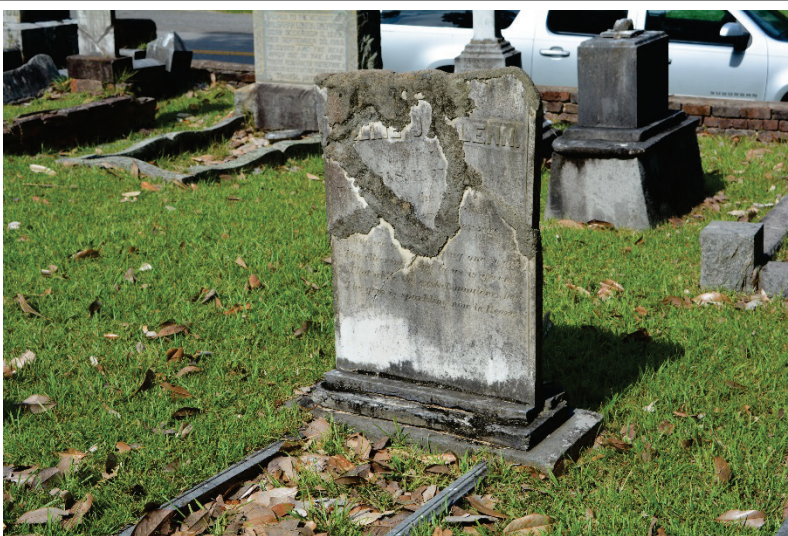
Figure 51. Very old repair using ordinary Portland cement (OPC). This is no longer an acceptable treatment option as the material is too hard for the marble.

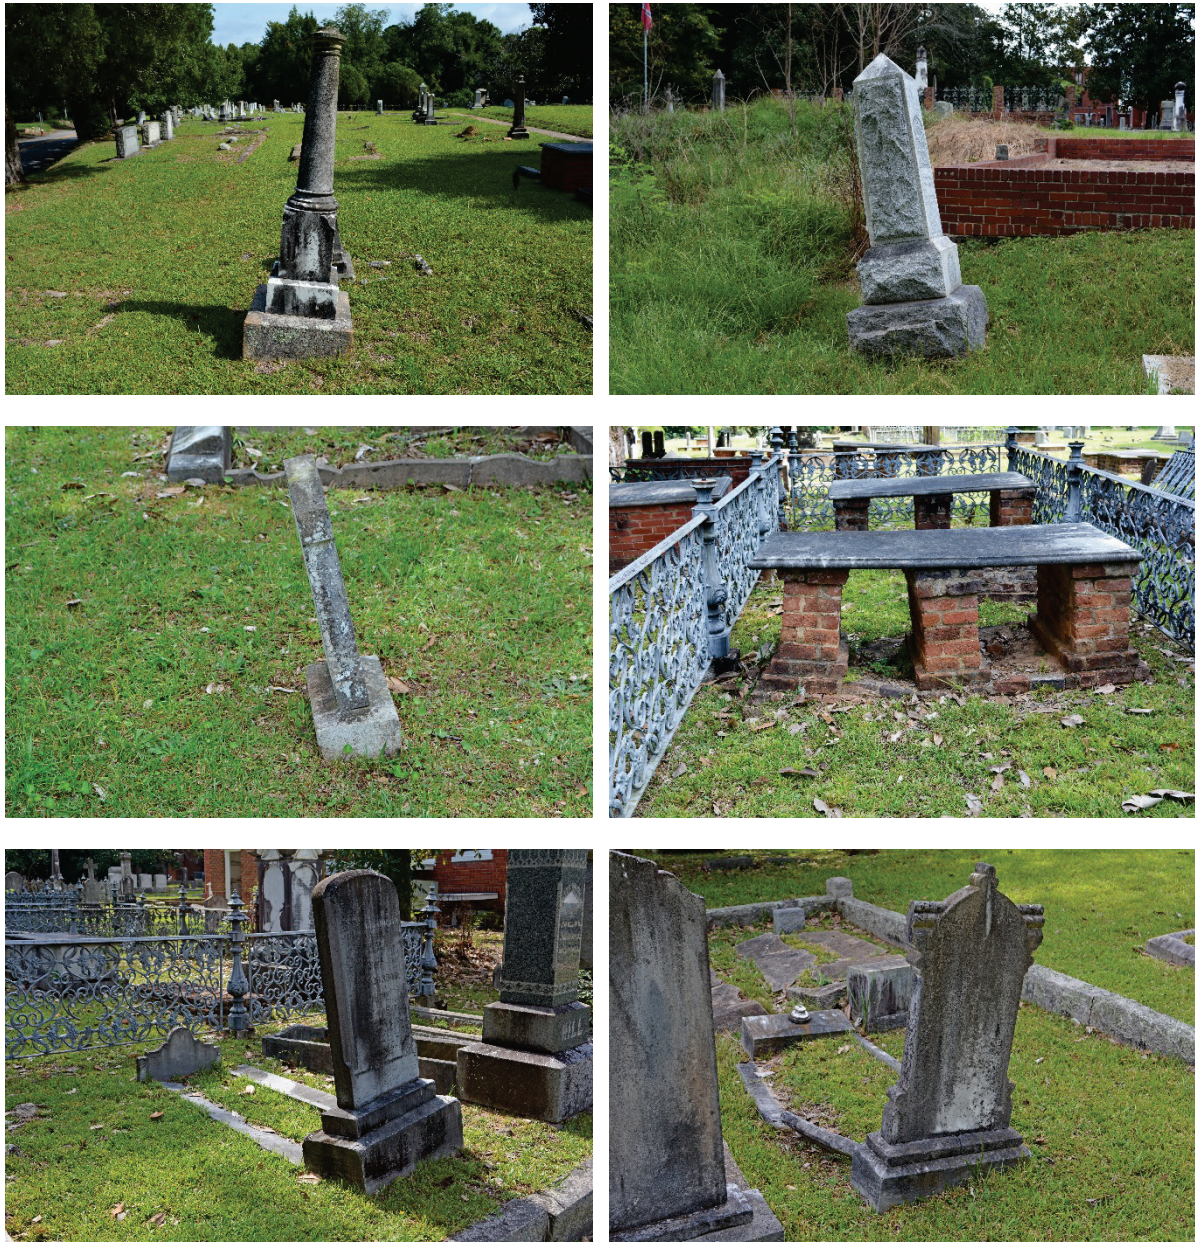
Figure 52. Examples of sinking and tilted monuments that require resetting, before additional (and more expensive) damage is done. Upper row photographs shows pedestal tombs with poor foundations sinking into graves. The middle left photograph is a simple die on base tilting into the grave. Middle right photograph shows a marble ledger beginning to bow as its supports collapse into the grave. Lower photographs show two cradle graves with collapsed sideboards and the headstone tilting.

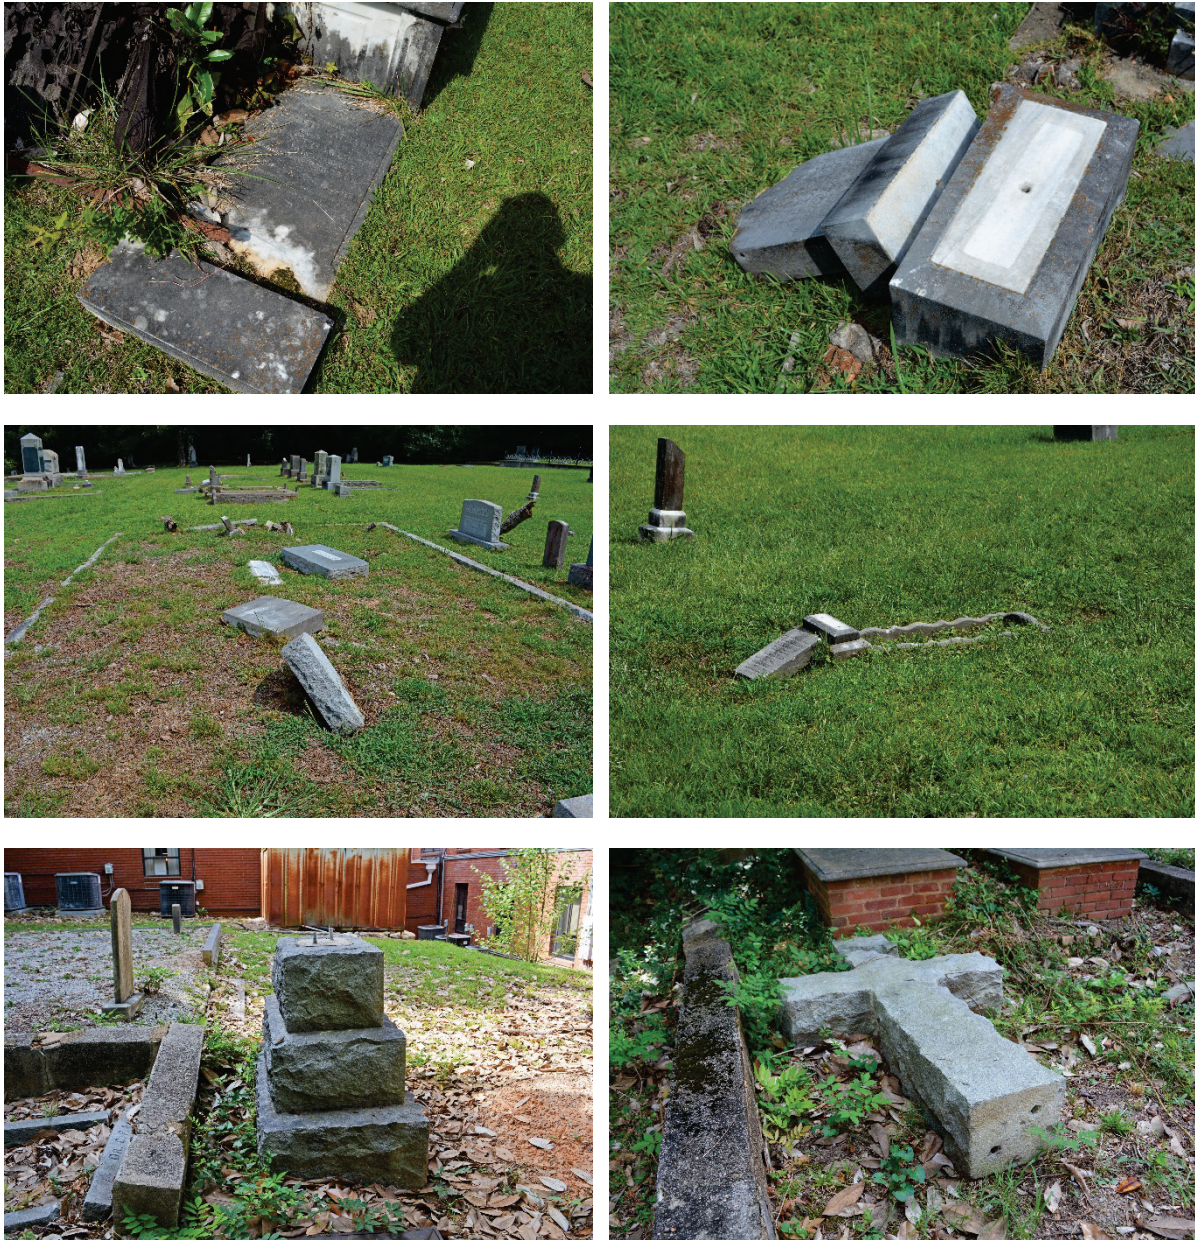
Figure 53. Fallen monuments. Upper row photographs show two die on base monuments that have fallen and require resetting with pins. The middle left photograph shows stones toppled by a tree. Middle right photograph is another toppled die on base. The lower two photographs show the large granite cross at the DeVore grave, likely toppled by vandalism or tree (based on the presence of still intact pins). The cross is now broken into three pieces, making the repair even more expensive.

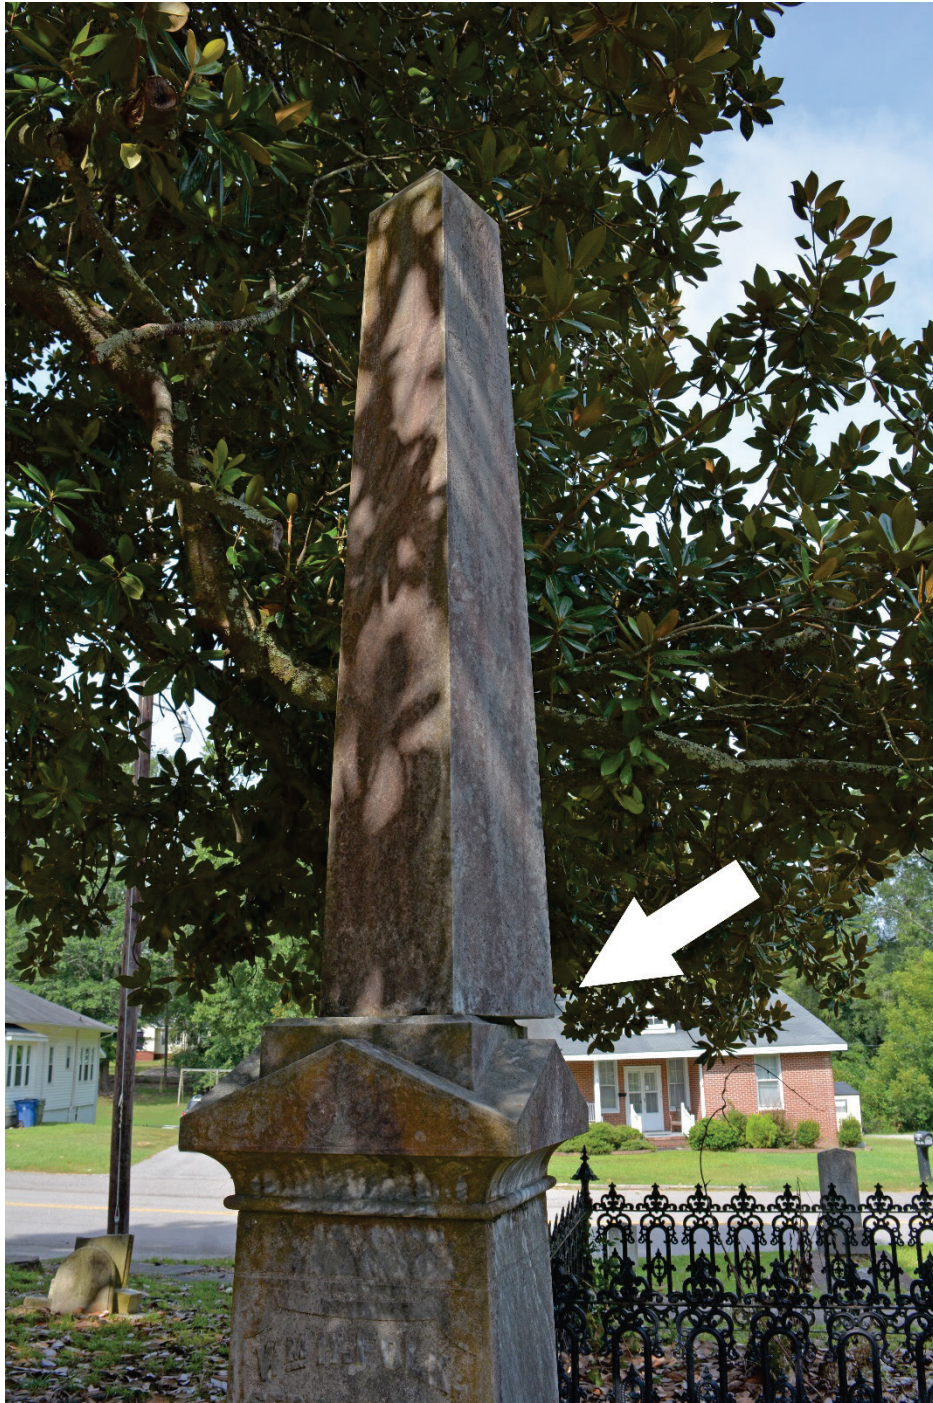
Figure 54. Extremely dangerous monument. This monument, which is clearly not pinned, has shifted on its base (note arrow) and poses a significant threat to the public.

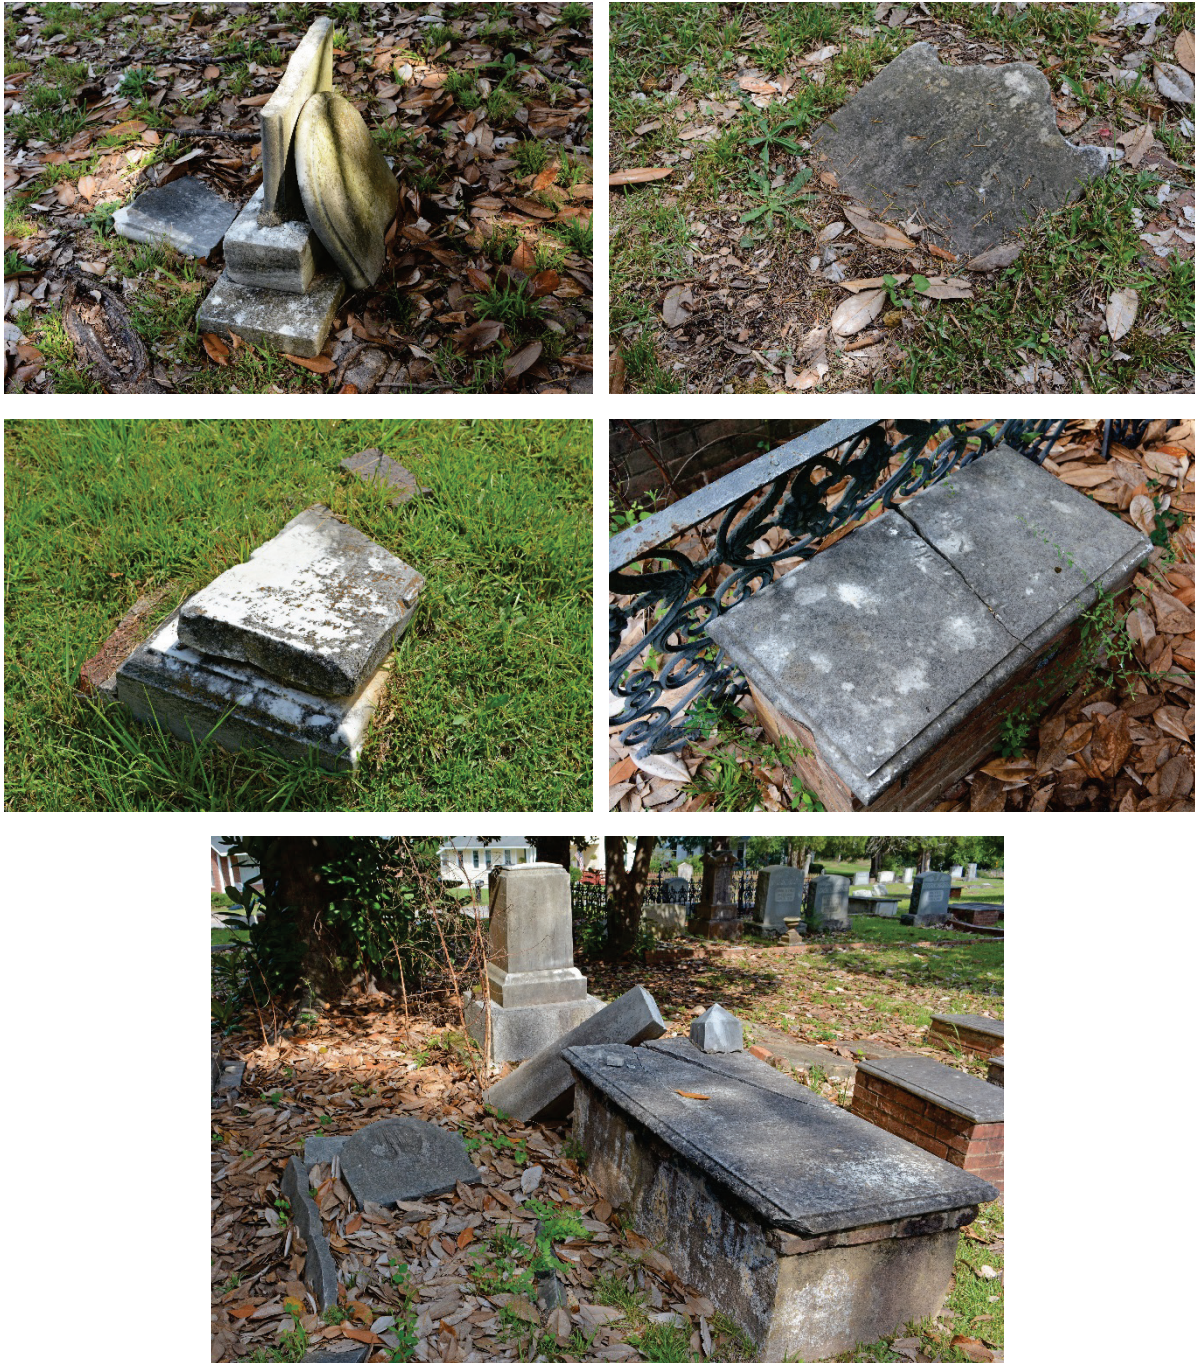
Figure 55. Broken stones. Upper left tab in socket is broken into three pieces and the tab was previously repaired using inappropriate OPC. Middle right shows a ledger cracked in two. The lower photograph reveals extensive damage. Not only is the obelisk toppled and broken, but its impact also broke the ledger and toppled an adjacent monument.

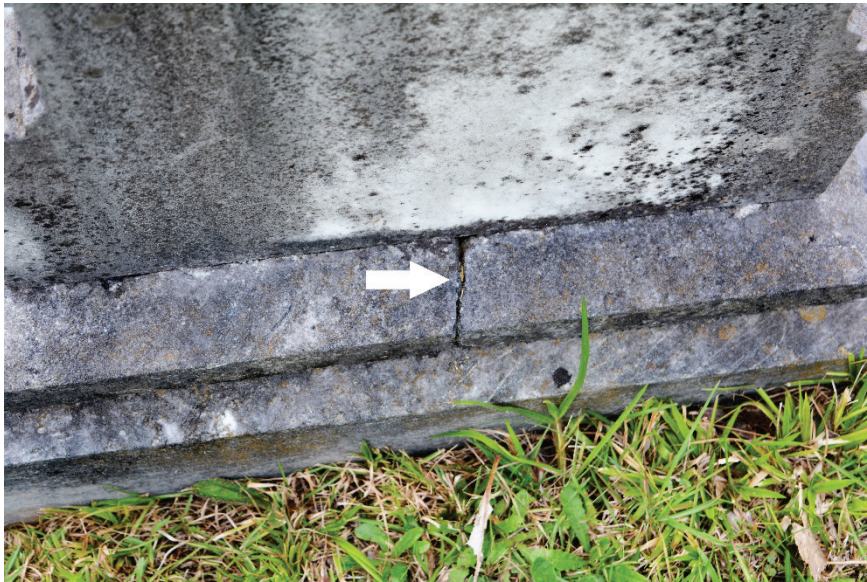
Figure 56. Example of iron jacking in the cemetery.

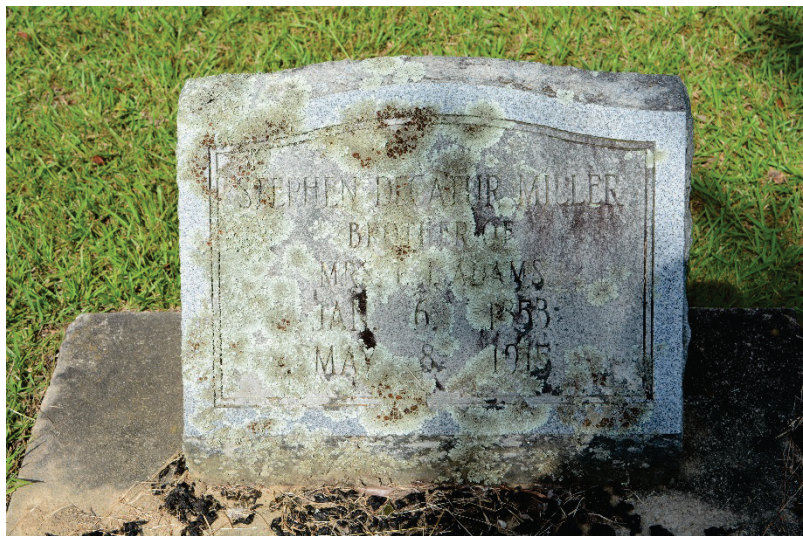
Figure 57. Example of dense lichen growth obscuring the inscription.
