# AN ARCHAEOLOGICAL EXAMINATION OF FOUR FAMILY TOMBS AT COLONIAL CEMETERY, SAVANNAH, GEORGIA

Research Series 58

Michael Trinkley  
Debi Hacker

December 1999

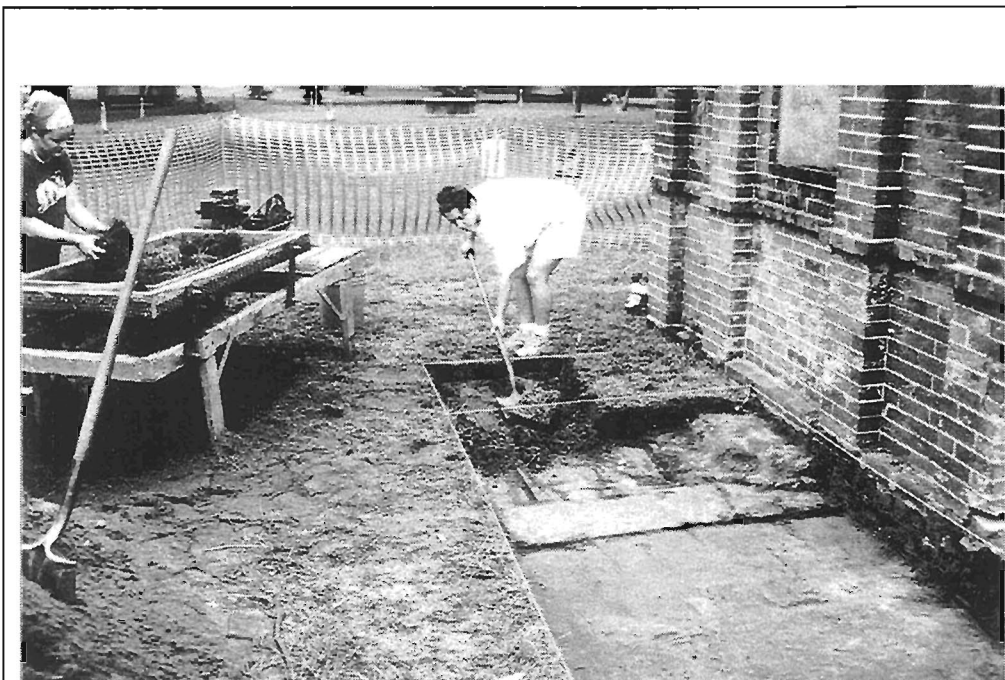
Figure 7. Excavation in Units 2 and 3, Tomb I-86, view to the north-northeast.

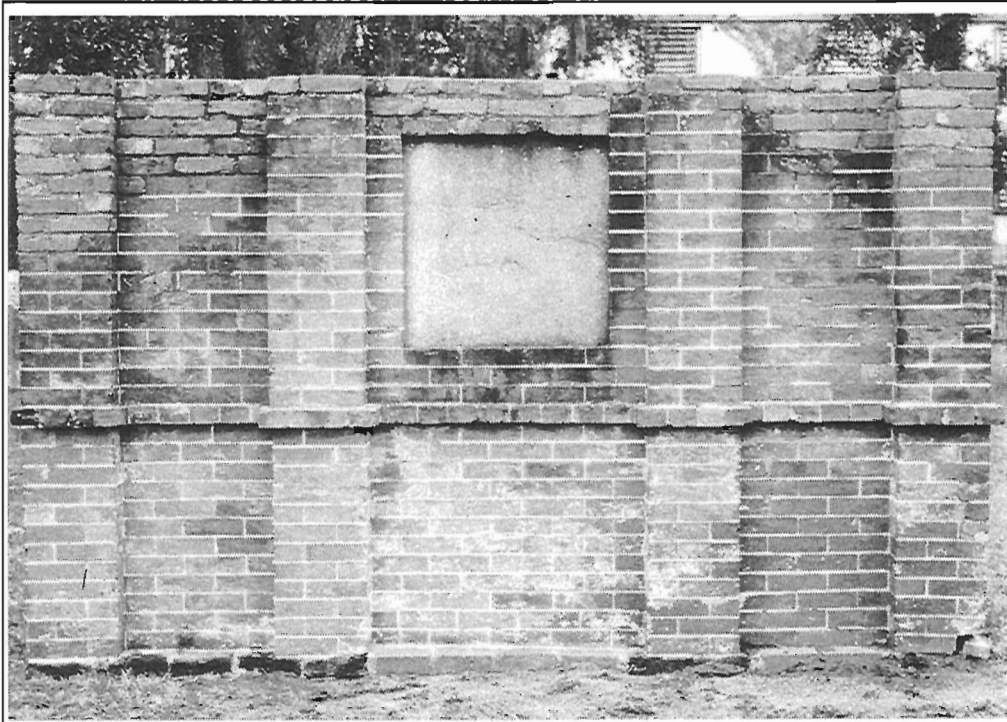
Figure 10. Tomb I-83, west elevation.

Tomb I-83 measures 10 feet 9½ inches in width by 13 feet 8 inches in length. It has a stepped parapet wall at the west end of the tomb and the roof is a complex barrel. A large rock or concrete mass was

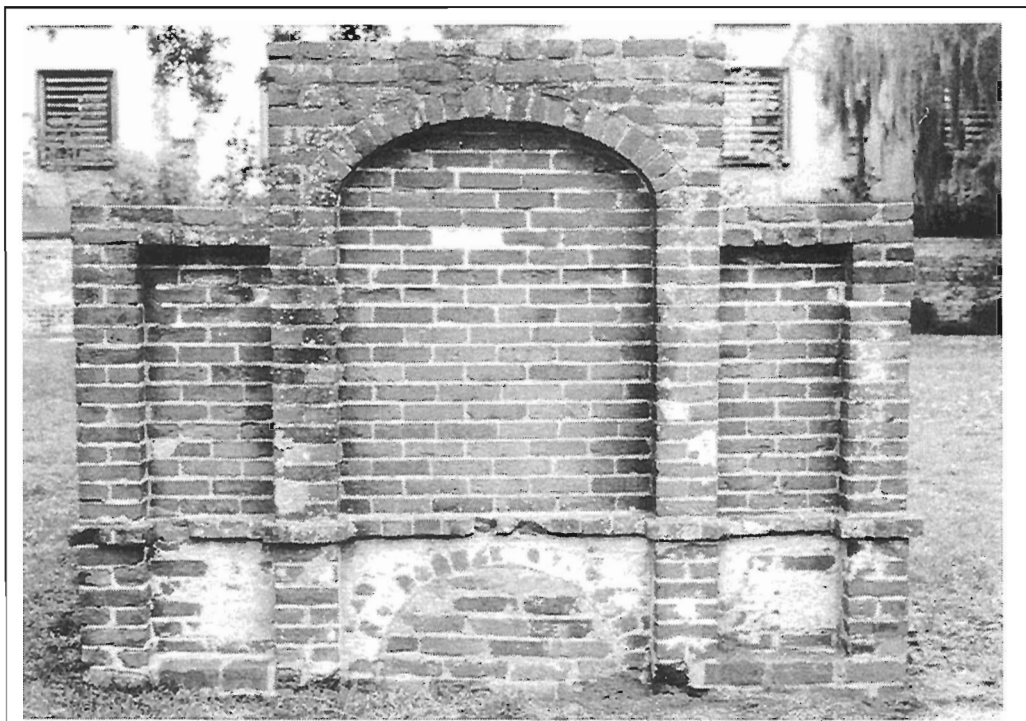
Figure 11. Tomb I-86, west elevation.

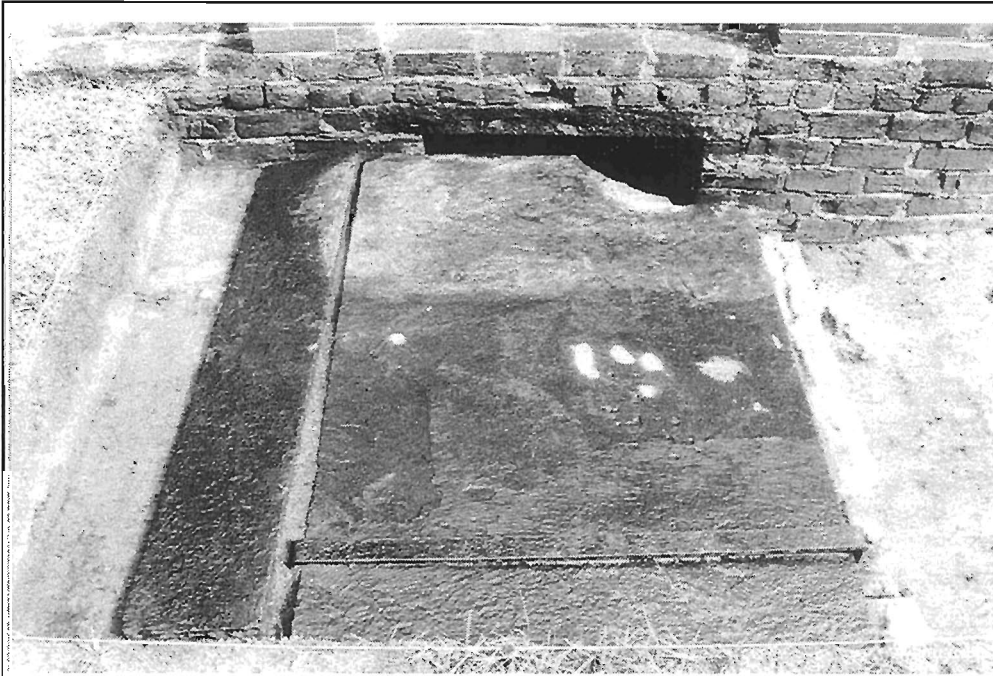
Figure 17. Units 2 and 3, view of slate cover with side slate removed and brick wall exposed. Tomb entrance is also exposed with the removal of the slate slab and concrete.

The excavation also revealed that the slate surrounds were placed just on the edge of a brick wall surrounding the tomb entrance and were largely supported by soil. These surrounds, and the tomb cover, would originally have been at the original ground level. They have been covered by the foot or more of fill soil brought into this section of the cemetery (Figure 17).

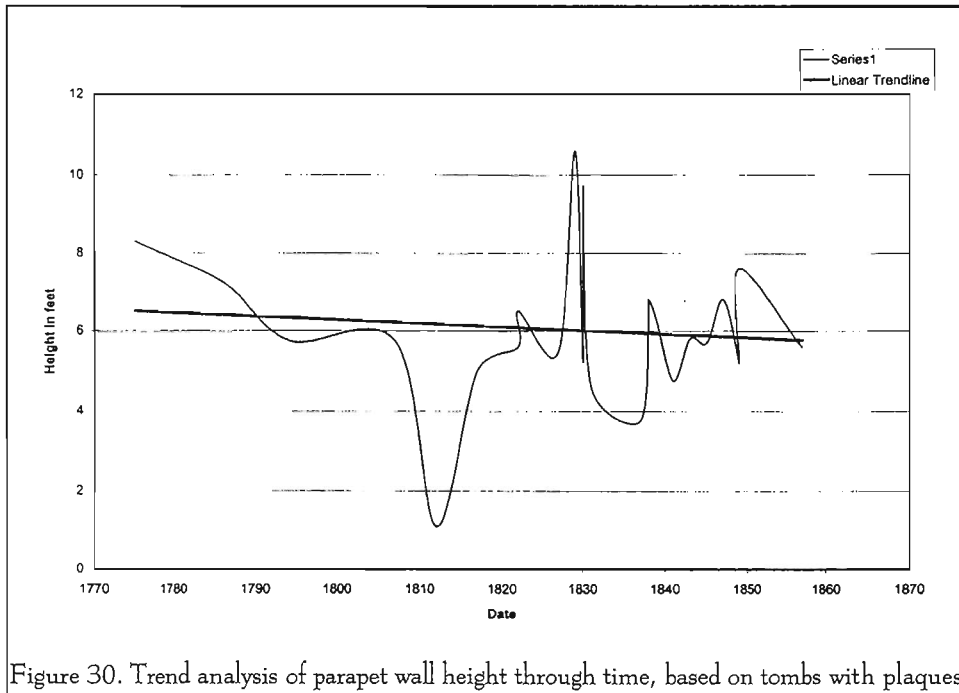
Figure 30. Trend analysis of parape wall height through time, based on tombs with plaques.

Curiously, this evolutionary sequence seems to also be exhibited by the mean height of the various parapet walls. The arched parapets have a mean height above grade of 8.9 feet, followed by the stepped parapets with a mean height of 6.1 feet. The lowest are the flat end walls, with a mean height of only 4.8 feet. In fact, as Figure 30 reveals, the parapet walls tend to decline in height through time when only those with dated plaques

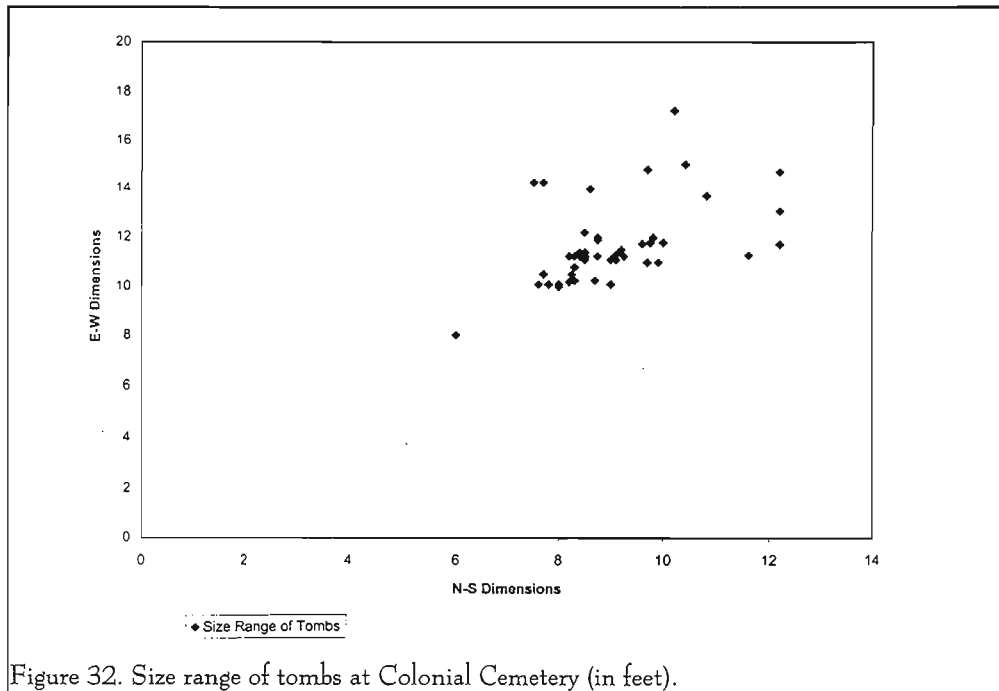
Figure 32. Size range of tombs at Colonial Cemetery (in feet).

We might expect that tomb size to be directly related to number of individuals expected to be interred, although it seems likely that status, wealth, prestige, and other factors may also have played roles. Regardless, Figure 32 reveals that there is a clustering of tomb sizes between 7.5 to 10 feet north-south by 10 to 12.5 feet
