# **ST. ELIZABETHS WEST CAMPUS CEMETERY: PRESERVATION PLANNING UPDATE**

**Chicora Research Contribution 573**

Prepared By:  
Michael Trinkley, Ph.D.  
and  
Debi Hacker

November 2016

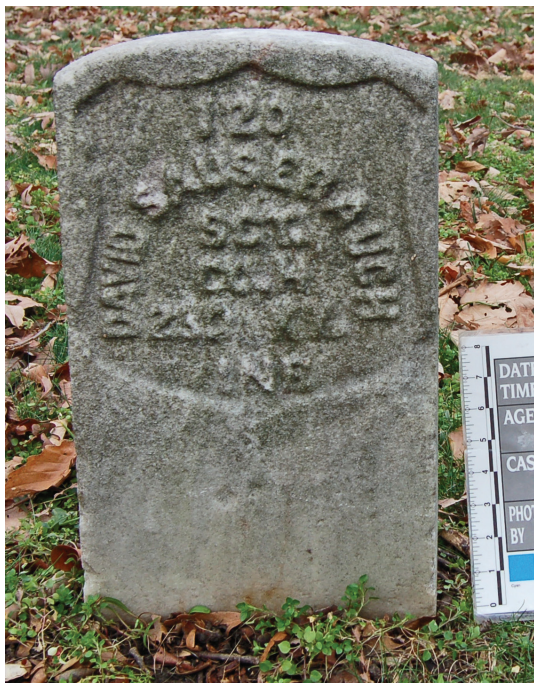
Figure 2. Example of the “Civil War” type marker used at St. Elizabeths West Campus cemetery (from 2007).

regimental affiliation is included (there is no date of death on any of the stones). The National Cemetery Administration refers to the number above the name as simply “the number of the grave.” These early markers were intended to be set with 12 inches above grade.

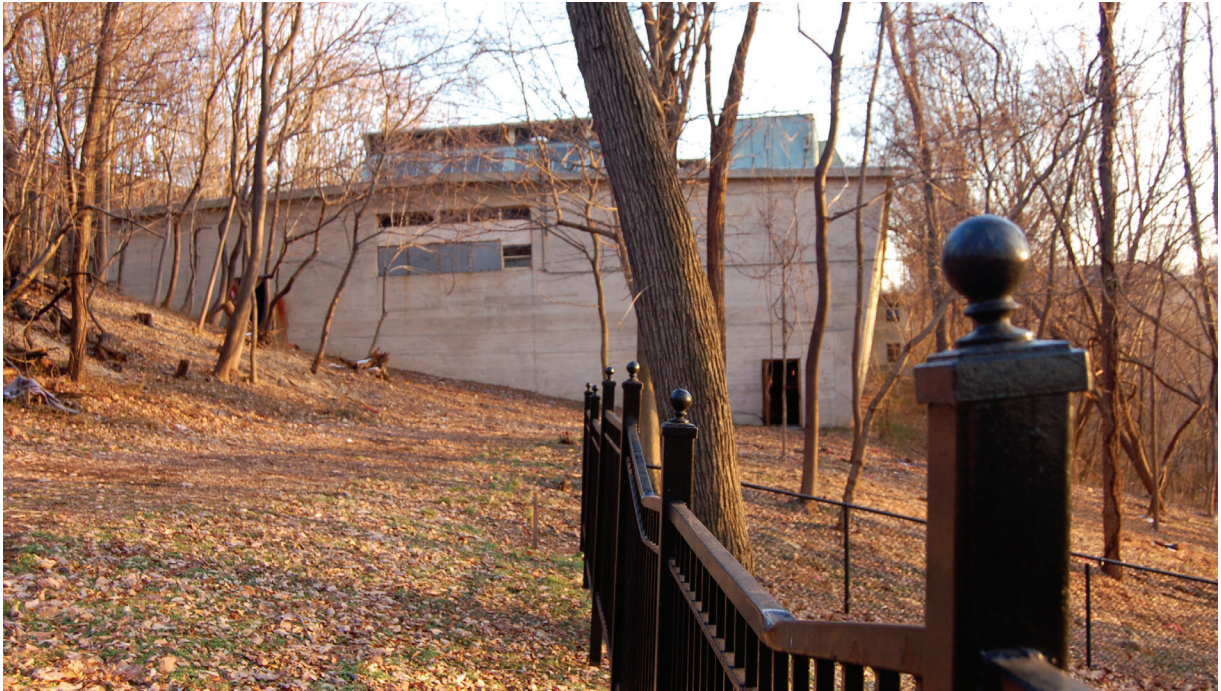
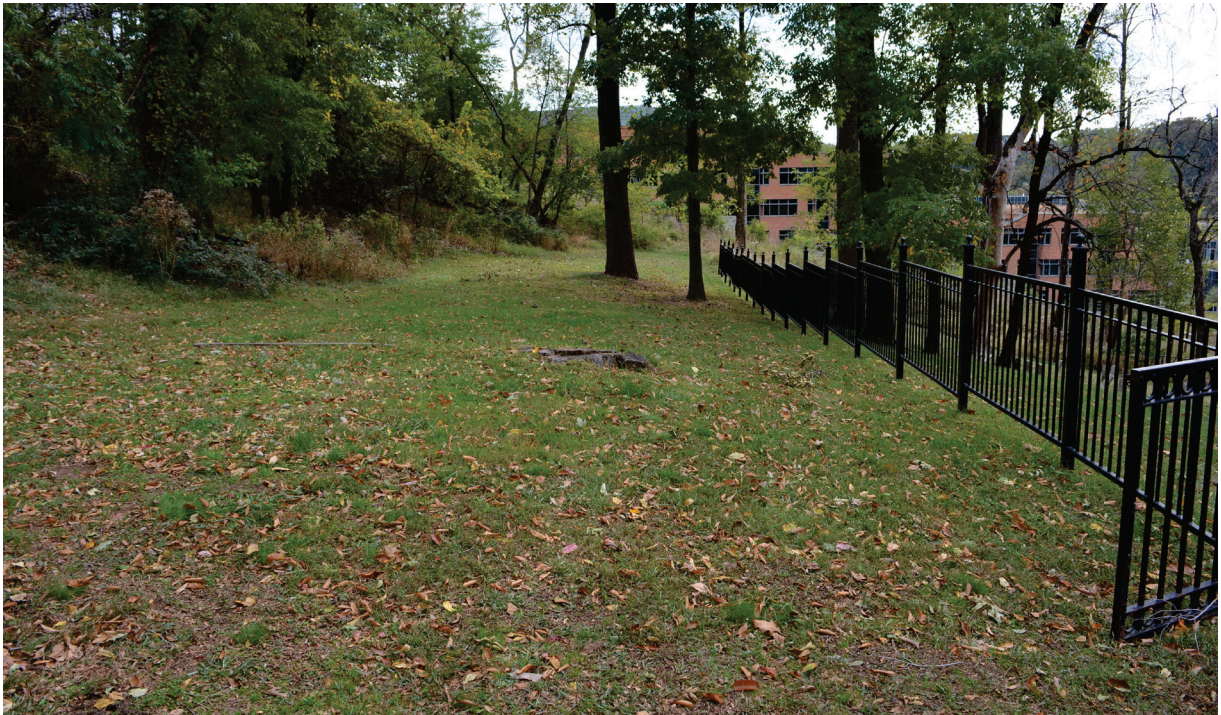
The cemetery has been protected in the sense that it has not been damaged by primary construction activities. It has not, however, been protected from secondary construction impacts, most especially in regard to its viewshed.

Figure 3. Area just outside the cemetery, looking east. Top shows the viewshed in 2007; bottom shows the viewshed in 2016.

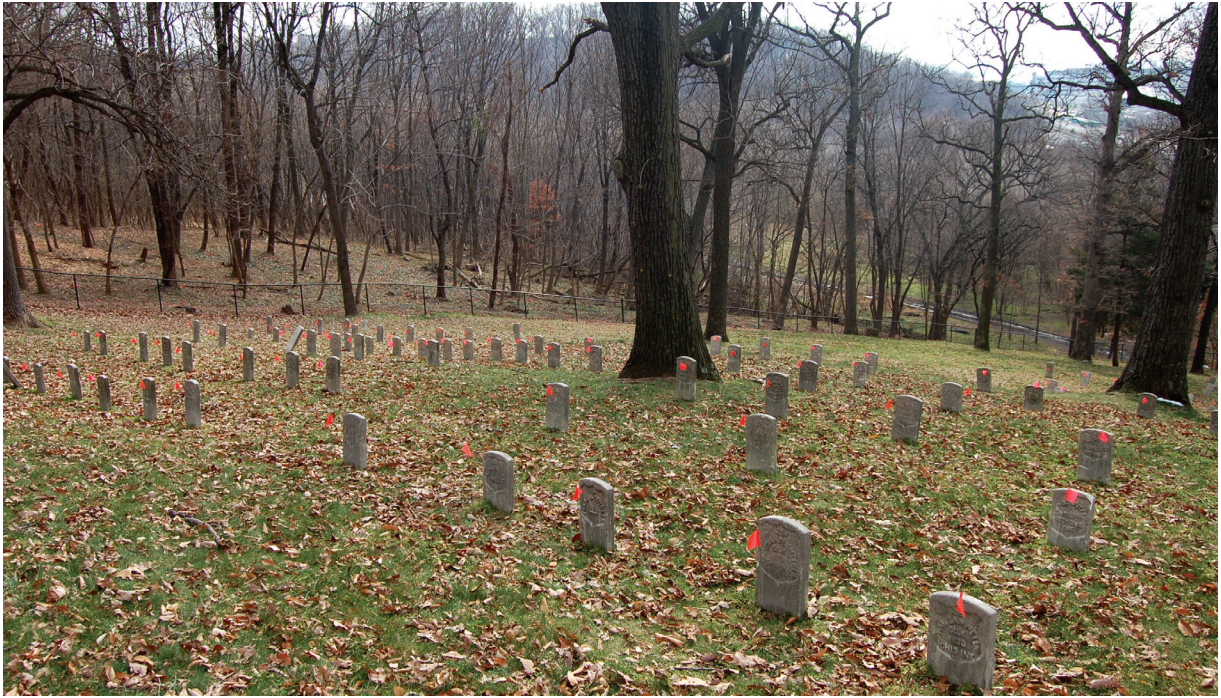
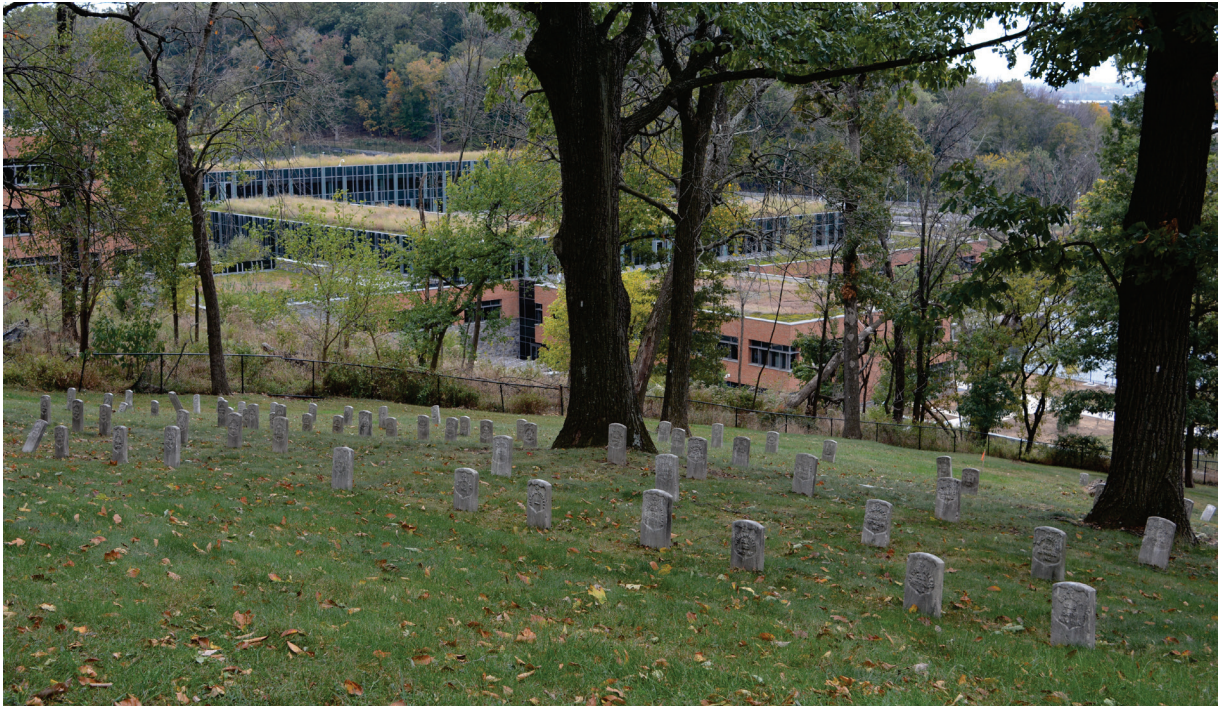
Figure 4. Northeastern section of the cemetery looking south. Top shows the viewshed in 2007; bottom shows the viewshed in 2016.

Some aspects of this have been accomplished, but only in the direction of the Coast Guard facilities (see Figure 4). Elsewhere, no effort has been made to clean up downed trees or thin vegetation (Figure 5).

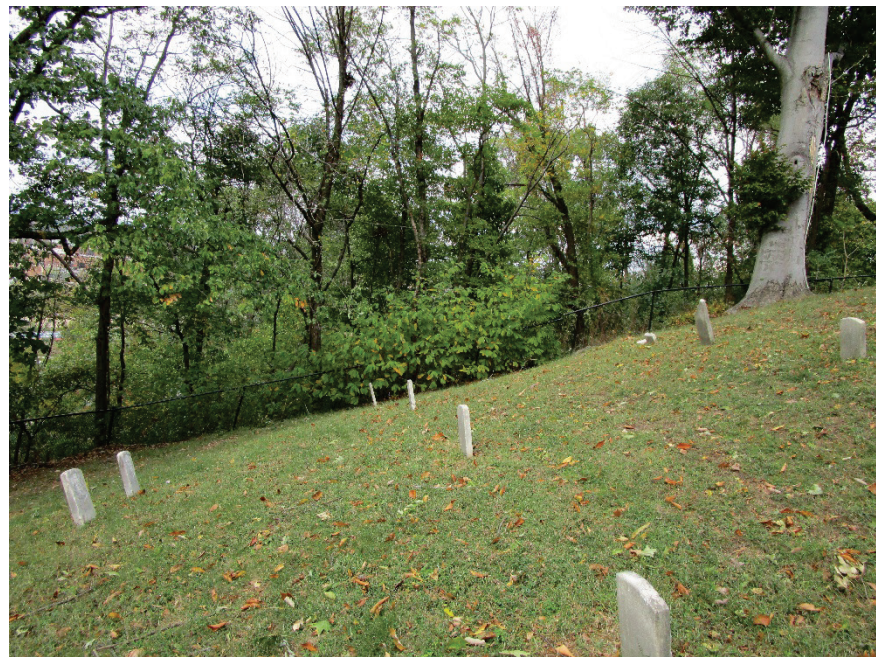
Figure 5. Thick vegetation along the west side of the cemetery.

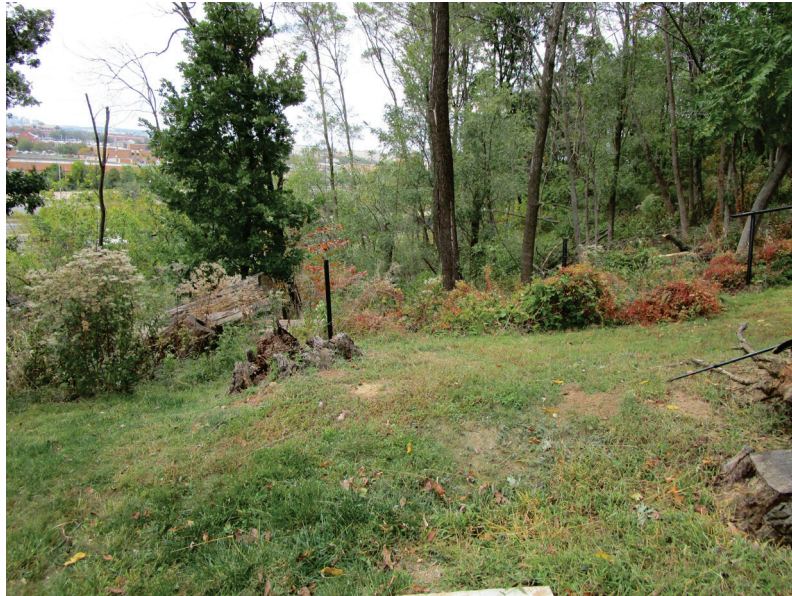
Figure 6. One of multiple areas where the cemetery fence has been taken down by falling timber and no effort has been made to repair or replace the fence.

be given immediate attention. The GSA Regional Horticulturist acknowledges that there has been “severe degradation” of the site in regards to tree loss in the past seven years, but efforts are planned to removed dead and dying trees, as well as to replace those trees lost.

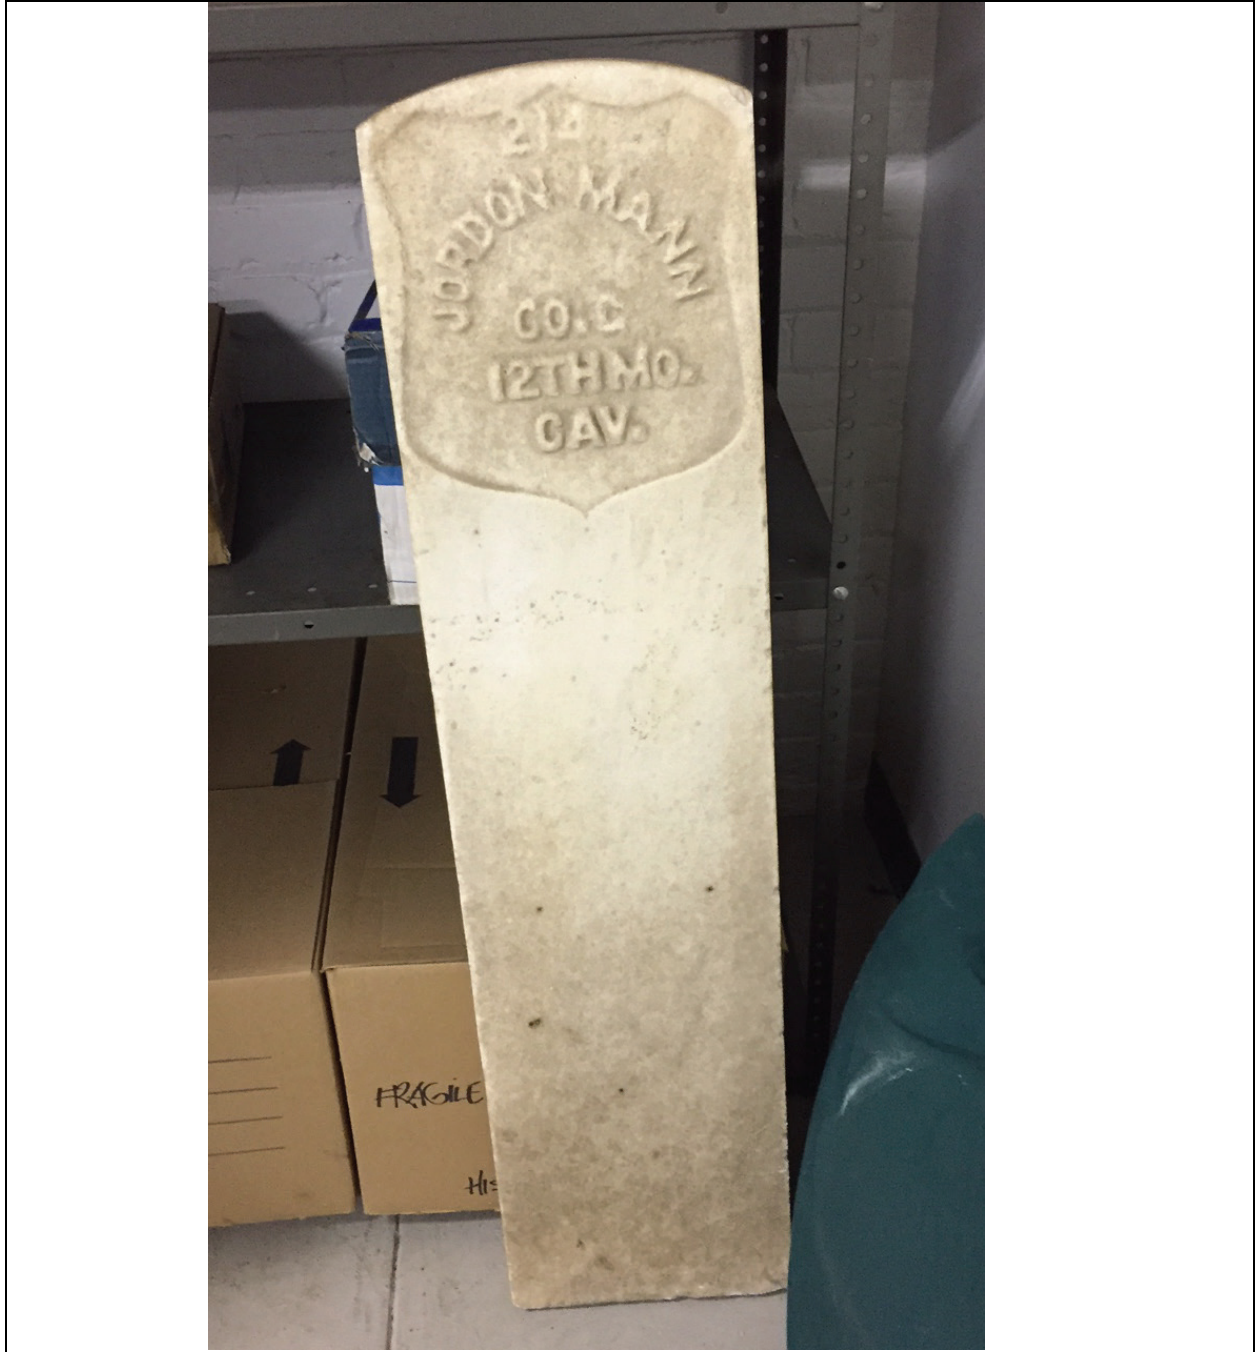
Grave #: 214

A second stone was recently returned to the GSA from an auction house which recognized the stone as stolen government property (*The Washington Times*, June 11, 2012). Why it was removed remains a mystery, but it is one of the 23 that have gone missing since originally inventoried in the 1990s. It is stone 214, for Jordon Mann, and is included in this assessment.
