PRESERVATION ASSESSMENT AND PLAN FOR THE OLD ATHENS CEMETERY, ATHENS, GEORGIA

Chicora Research Contribution 459

Prepared By: Michael Trinkley, Ph.D. and Debi Hacker

December 22, 2006

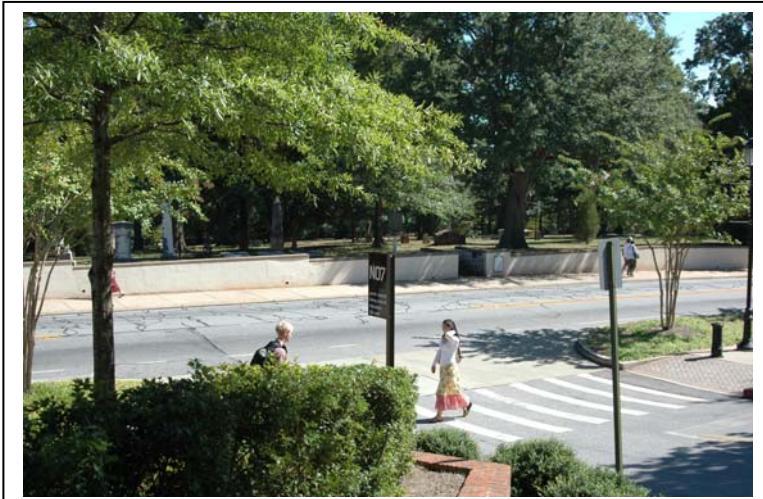
Figure 4. View of the cemetery and recessed gate entrance from the Main Library parking lot entrance, looking east.

Since the cemetery is no longer active, what is considered the main entrance is a pedestrian gate placed into the western third of the cemetery from Jackson Street (Figure 4). This Other informal entrances include another cut-off from the Art School sidewalk through the eastern third of the cemetery to the retaining wall at Baldwin Hall. This is also a heavily worn dirt pathway.

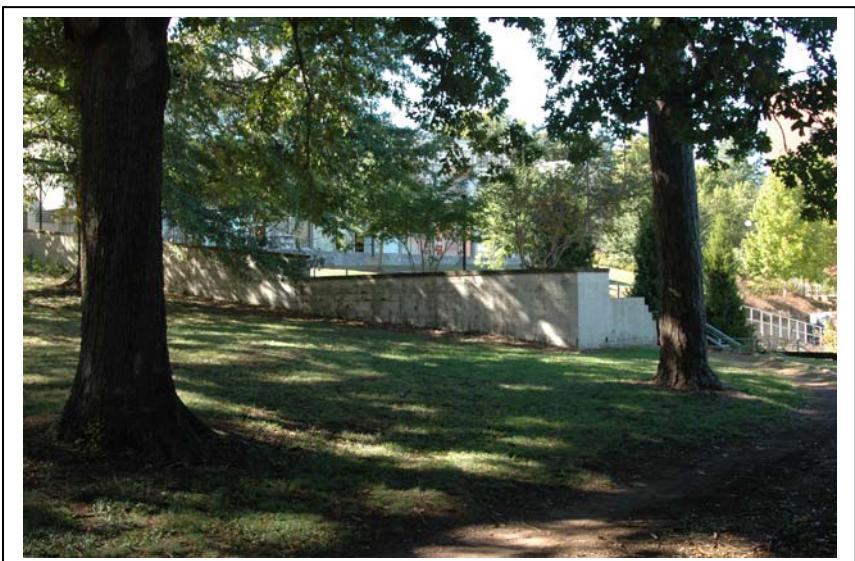
Today the peace and tranquility of the cemetery is compromised by its location adjacent to Jackson Street and the heavy use of this artery for mass transit. The vista to the east has been protected by the historic lowering of Thomas Street. Given the scale and setting of Baldwin Hall to the south, the vista in this direction is not objectionable. To the north, however, the construction of the art school and parking garage have created very discordant and intrusive settings (Figure 6). This is further aggravated by the CMU wall along the northern boundary of the cemetery (Figure 7). This wall is entirely out of context and is too low to offer any

Figure 7. CMU wall along the northern cemetery boundary. This wall is out of character and intrudes into the cemetery landscape.

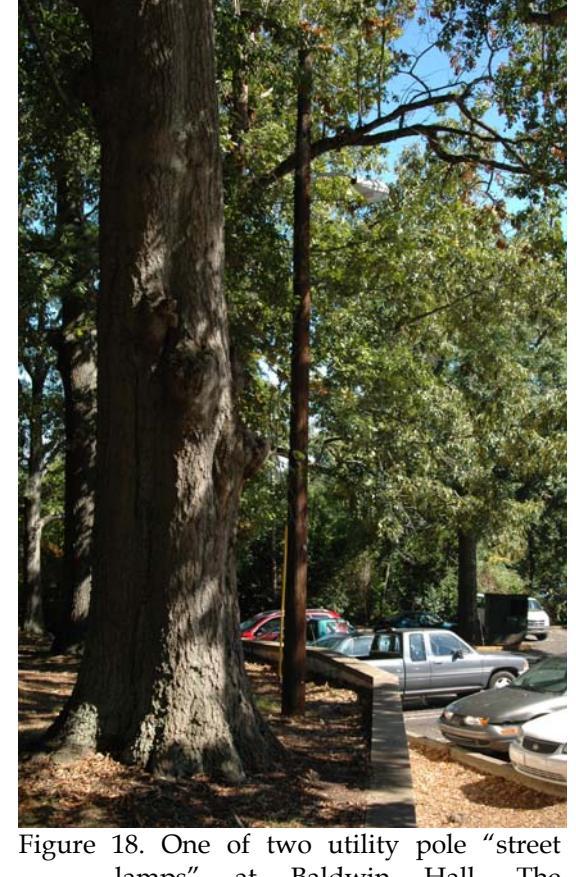
lamps" at Baldwin Hall. The University should immediately install additional lighting in the cemetery.

The only lighting that is present comes from two wood utility poles with High pressure sodium vapor lamps directed into the Baldwin Hall parking and walkway areas on the south. To the north is an equally sparse assortment of globe lamps designed to light the pathway along the side of the Art Building. There is no lighting along Jackson Street.

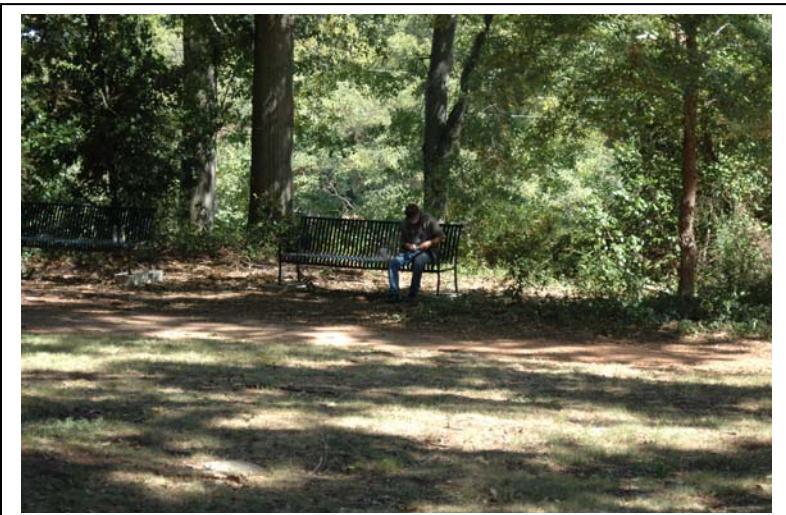
Figure 20. Homeless use of the cemetery can discourage legitimate use.

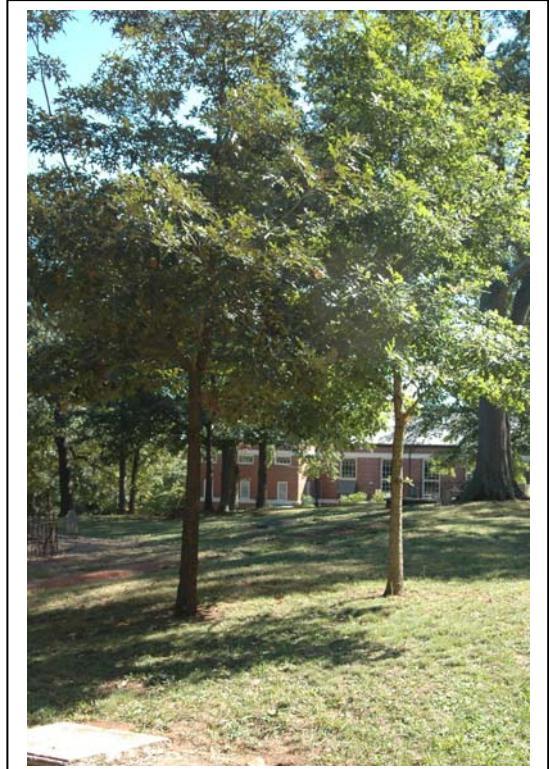
In addition, it is important that the eventual spread and coverage of the trees being planted be considered. There is at least one example of two relatively recently planted trees that were inexplicably placed in very close proximity to one another. This creates a future problem and one should be removed immediately (Figure 29).

Figure 29. The white oak (right) and red oak (left) have been planted only 12 feet apart. But within 10 years the white oak will spread 10-12 feet and the red oak will spread 12-15 feet. Within 20 years both will spread 12-15 feet. One tree should be removed to provide adequate growing space for the other.

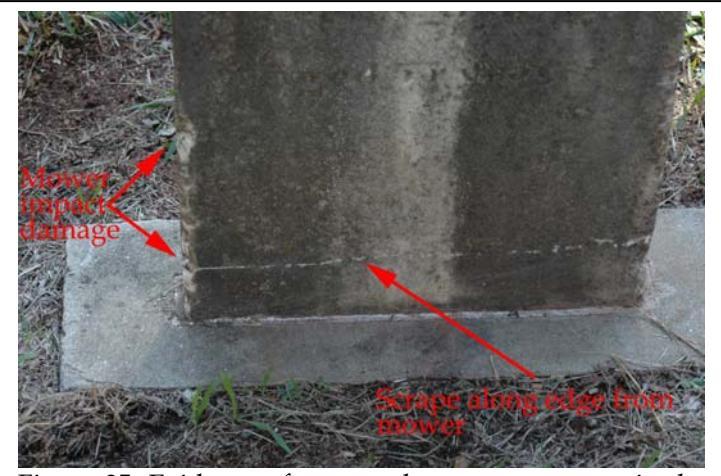
Figure 35. Evidence of mower damage on a stone in the Old Athens Cemetery.

We note that there is abundant evidence of mower damage in the cemetery, although we can't determine if this has occurred since the University has resumed maintenance or before. Nevertheless, Figure 35 clearly illustrates

the potential damage that careless use of mowers can cause to stones.

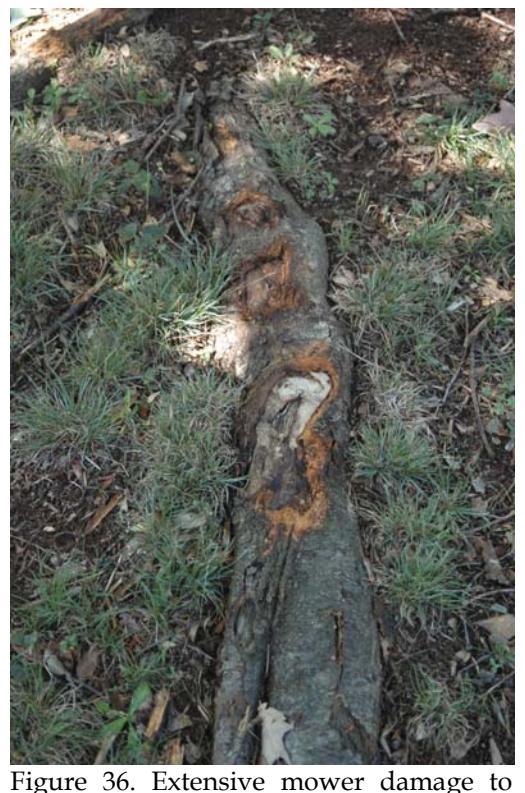
Figure 36 illustrates the damage that is

igure 36. Extensive mower damage to roots.

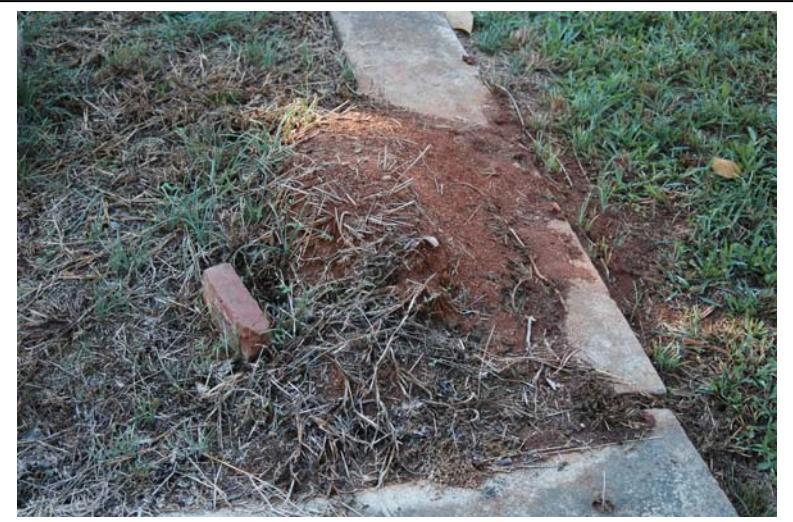
Figure 37. Example of the fire ant problem in the cemetery.

spray to treat limited areas. Using this approach it would be possible to treat for many annual weeds and over several years dramatically improve the appearance of the cemetery. Care must be taken to avoid spraying the monuments, so we realize the application will not be complete or perfect, but over several years the prevalence of these weeds will decline. Postemergent weeds may be controlled in the same manner.

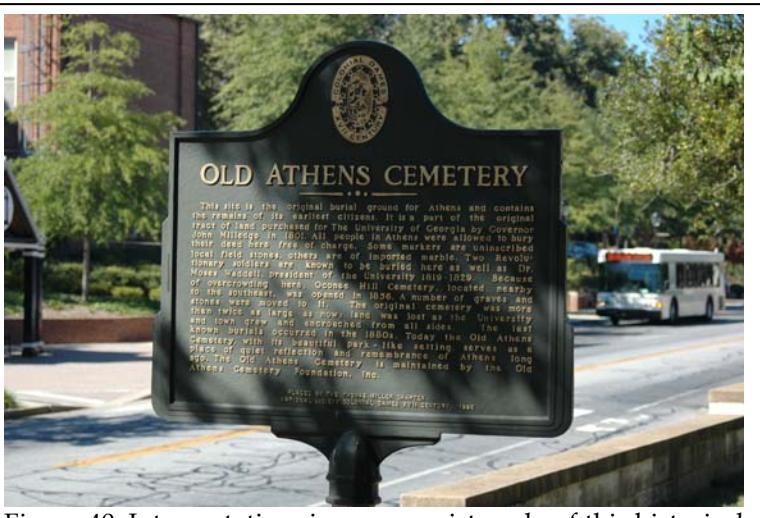
Figure 40. Interpretative signage consists only of this historical marker.

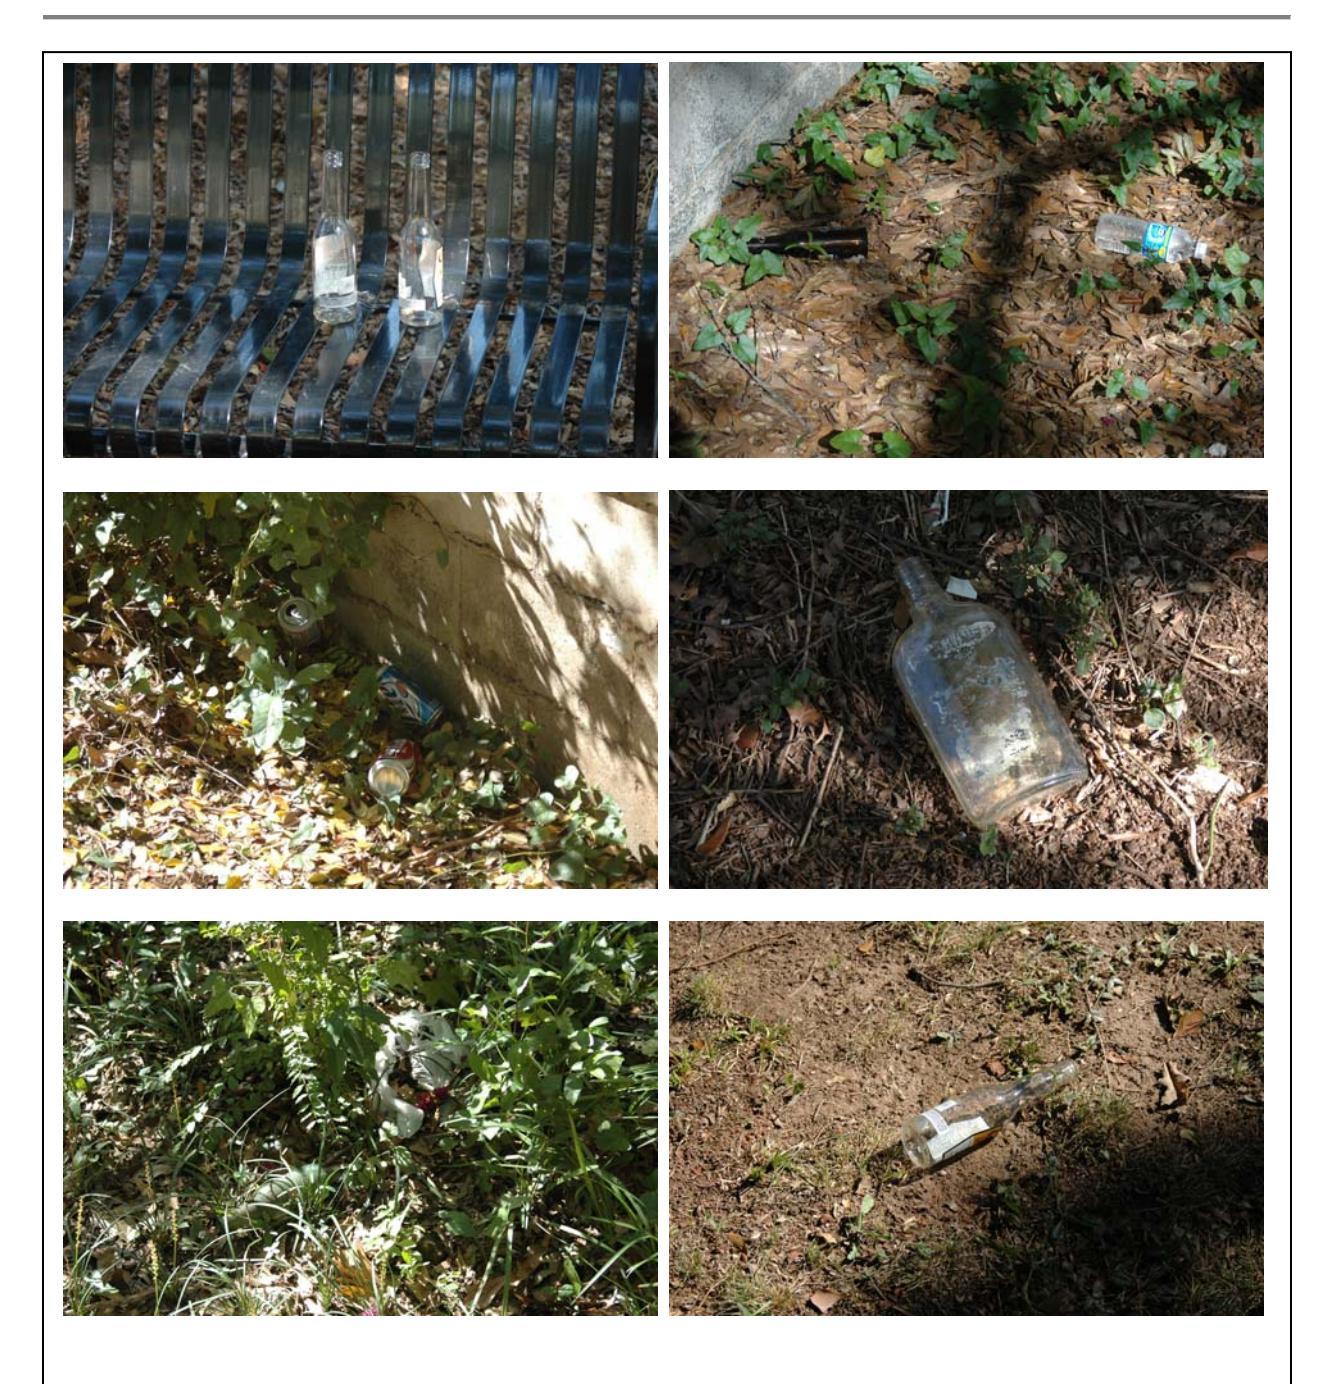
Figure 41. Extensive evidence of trash throughout the cemetery. The University must immediately begin tackling this problem. Allowing trash to remain gives the impression that there is nothing wrong with this practice and only encourages additional trash. Related to the problem of trash is the vandalism that goes along with intoxication. Dealing with the problem involves increasing litter patrols and posting (and enforcing) the ban against alcohol in the cemetery.

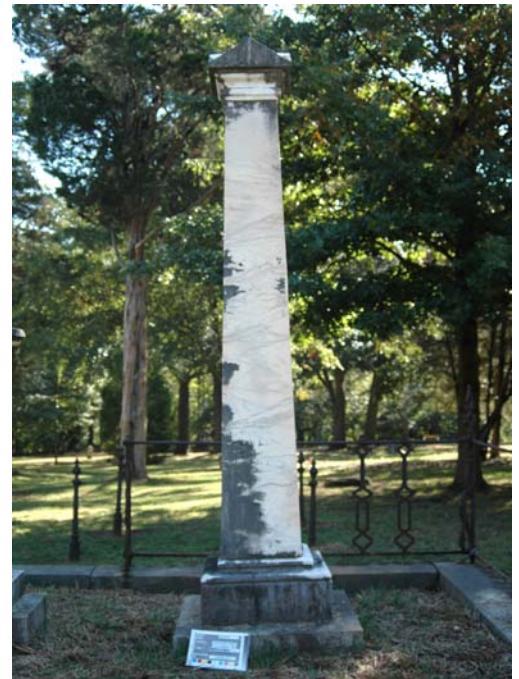
Old Moi	Athens Ceme nument Treatr	tery, Athens, GA nent Proposal	Section:	Plo	ot: 2
Namo	e: Edward Lampkir	n Material: 🖂	marble 🗌 granite 🗌	brick 🛛 othe	r: reported to be Italian
Туре	pe: headstone footstone die on base tab in socket box other: obelisk				
	Position: faller	ı 🛛 tilted 🗌 unstable 🗌	unattached/loose 🗌 m	ussing	
ondition	Deterioration: delamination/	broken 🗌 cracked 🔲 loss detachment 🗌 spalling 🗌	ses □ flaking/sugaring] missing fragments □	$\frac{1}{2}$ ferrous pi other:	ns 🗌 brass pins
ng Cc	Extent: 🗌 extensi	ve >50%	⊠ minimal <25% □ 1	not applicable	
Existi	Failed/Old Treatn	nents: metal adhesive	es/coatings	other:	
	Soiling: 🔀 biolog	ical 🗌 staining 🗌 efflores	scence 🛛 other: atmosj	pheric, probably	y gypsum crust
egy	Position: reset possible new b	/level in ground reset/ ase required stabilize for	level to existing base [undation] reset with (] construct new 0:1:3 mix 🔲 re	base 🗌 resquare set with compound

t Strat	Failed Treatments	∷ ☐ drill/grind ☐ hand to	ools 🗌 solvents 🗌 oth	her:	
reatmen	Treatment: cor	e drill 🔲 drill and pin 🛄 : point 🗌 other:	simple adhesive repair	injection gro	out 🗌 replace bricks
F	Cleaning: 🗌 low	pressure water \Box D/2 and	d flush 🗌 poultice 🗌	other:	
Prior	riority: 41) hazardous, immediate action; 2) unstable, requires treatment ASAP; 3) ongoing deterioration, treatment required 2-3 years; 4) re-inspect in 5- 10 years; 5) irreparableCost: n/c

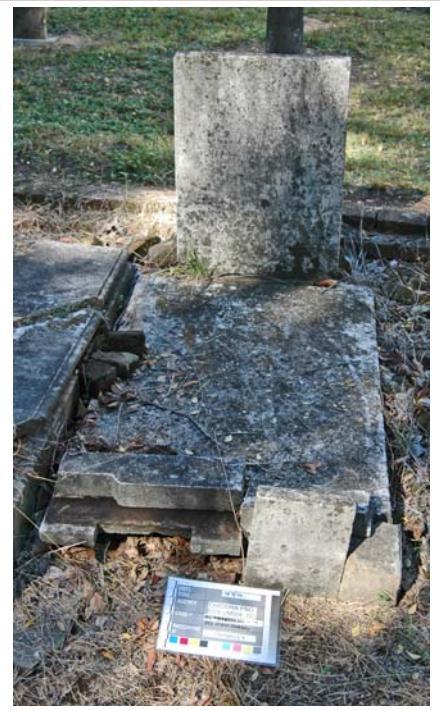
Old Moi	Athens Cemel nument Treatm	tery, Athens, GA nent Proposal	Section:	Plo	t: 20	
Name	e: Julia Emeline Lyle	e Material: 🔀 1	narble 🗌 granite 🗌]brick 🗌 other	:	
Туре	headstone	footstone 🗌 die on base 🗌] tab in socket 🗌 box	🕻 🖂 other: ledge	er	
	Position: fallen	☐tilted ☐ unstable ⊠ u	nattached/loose 🗌 n	nissing		
ndition	Deterioration: \square I delamination/ d	oroken 🗌 cracked 🗌 losse letachment 🗌 spalling 🔲 1	s 🔲 flaking/sugarin missing fragments 🗌	g 🔲 ferrous pir] other:	ns 🗌 brass pins	
ng Cc	Extent: 🔀 extensiv	re >50% 🔲 partial 25-50% [minimal <25%	not applicable		
Existi	Failed/Old Treatm	ents: metaladhesives,	/coatings	🔀 other: Portlar	nd cement	
	Soiling: 🔀 biologi	cal 🛛 staining 🗌 effloresc	ence other:			
egy	Position: reset	/level in ground ⊠ reset/le ase required □ stabilize four	evel to existing base [ndation 🛛 reset with	☐ construct new 0:1:3 mix ☐ res	base 🗌 resquare set with compound

: Strat	Failed Treatments	: ☐ drill/grind ⊠ hand too	ls 🗌 solvents 🗌 ot	her:		
reatment	Treatment: core	e drill ⊠ drill and pin □ si point ⊠ other: remove OPC	imple adhesive repair ; infill with Jahn M120	injection gro Marble Mortar	ut 🗌 replace bricks	
F	Cleaning: low	pressure water $\square D/2$ and	flush 🗌 poultice 🔲	other:		
Prior	riority: 2 1) hazardous, immediate action; 2) unstable, requires treatment ASAP; 3) ongoing deterioration, treatment required 2-3 years; 4) re-inspect in 5- 10 years; 5) irreparable Cost: \$1400

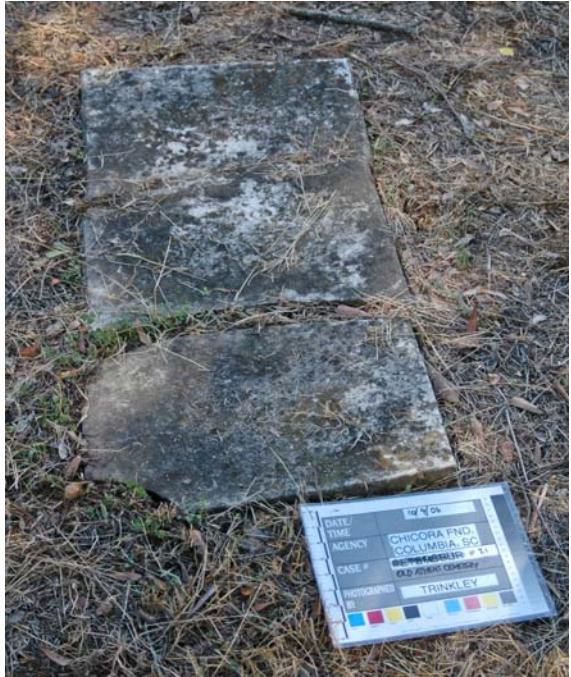
Old Moi	Athens Ceme nument Treatn	tery, Athens, GA nent Proposal	Section:	Plot: 21		
Namo	e: unknown	Material: 🔀 n	narble 🗌 granite 🗌	brick other:		
Туре	: \square headstone \square	footstone 🗌 die on base 🗌] tab in socket 🗌 box	x i other:		
	Position: X faller	tilted unstable un	nattached/loose 🗌 n	nissing	_	
ondition	Deterioration: delamination/	broken 🗌 cracked 🔲 losses detachment 🗌 spalling 🔲 r	s 🔲 flaking/sugarin missing fragments 🗌	ng 🔲 ferrous pins 🗌 brass pins] other:		
ng Cc	Extent: 🔀 extensive >50% 🗌 partial 25-50% 🗌 minimal <25% 🗌 not applicable					
Existi	Failed/Old Treatn	nents: metaladhesives/	coatings mortar	other:		
	Soiling: 🔀 biolog	ical 🛛 staining 🗌 effloresco	ence 🗌 other:			
egy	Position: I reset	/level in ground reset/le ase required stabilize four	vel to existing base [ndation] reset with	☐ construct new base ☐ resquare .0:1:3 mix ☐ reset with compound	_	
t Strat	Failed Treatments	: drill/grind hand tool	ls 🗌 solvents 🗌 ot	ther:

reatment	Treatment: cor	e drill ⊠ drill and pin □ si point ⊠ other: infill with Jah	mple adhesive repair ın M120 Marble Morta	injection grout I replace bricks ar		
L	Cleaning: low	pressure water $\square D/2$ and f	flush 🗌 poultice 🔲	other:		
Prior	1) hazardous, immediate action; 2) unstable, requires treatment ASAP;3) ongoing deterioration, treatment required 2-3 years; 4) re-inspect in 5-10 years; 5) irreparable

ss pins ng & broken				
esquare ompound				
ace bricks				
Priority: 21) hazardous, immediate action; 2) unstable, requires treatment ASAP; 3) ongoing deterioration, treatment required 2-3 years; 4) re-inspect in 5- 10 years; 5) irreparableCost: \$900

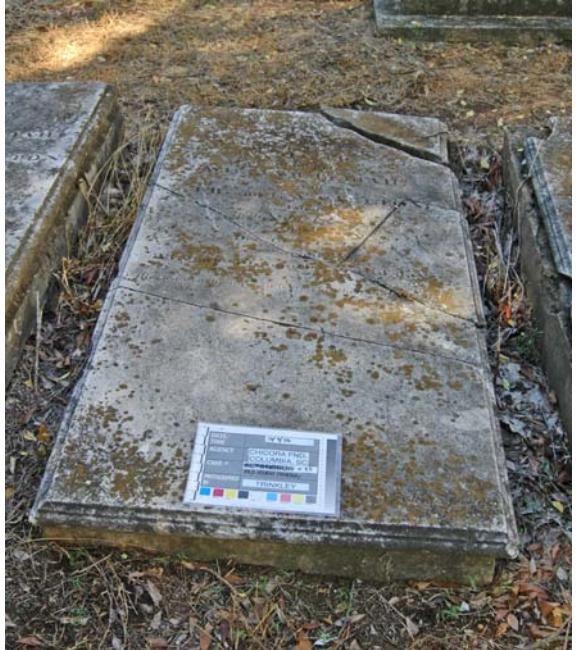
Old Moi	Athens Ceme nument Treatn	tery, Athens, GA nent Proposal	Section:	Plot: 23		
Namo	e: William Elijah	Material: 🔀	marble 🗌 granite 🗌] brick 🔲 other:		
Туре	: headstone	footstone 🗌 die on base 🗌] tab in socket 🗌 bo>	🕻 🖂 other: ledger		
	Position:fallen	tilted 🗌 unstable 🛛 u	ınattached/loose 🗌 r	nissing		
ondition	Deterioration: A delamination/o	broken 🗌 cracked 🔲 losse detachment 🗌 spalling 🔲	es 🔲 flaking/sugarin missing fragments 🗌	g 🔲 ferrous pins 🔲] other:	brass pins	
ng Co	Extent: 🔀 extensive >50% 🗌 partial 25-50% 🗌 minimal <25% 🗌 not applicable					
Existi	Failed/Old Treatments: metal adhesives/coatings mortar other:					
	Soiling: 🔀 biolog	ical 🛛 staining 🗌 efflorese	cence other:			
egy	Position: reset	/level in ground ⊠ reset/le ase required □ stabilize fou	evel to existing base [ndation 🛛 reset with	☐ construct new base 0:1:3 mix ☐ reset wit	resquare th compound	
t Strat	Failed Treatments	\therefore drill/grind \square hand too	ols 🗌 solvents 🗌 ot	her:

reatment	Treatment: cor	e drill ⊠ drill and pin □ s point □ other: infill with Jal	imple adhesive repair hn M120 Marble Morta	injection grout ir	replace bricks	
F	Cleaning: low	pressure water \boxtimes D/2 and	flush 🗌 poultice 🗌	other:		
Prior	1) hazardous, immediate action; 2) unstable, requires treatment ASAP; 3) ongoing deterioration, treatment required 2-3 years; 4) re-inspect in 5- 10 years; 5) irreparableCost: \$1200

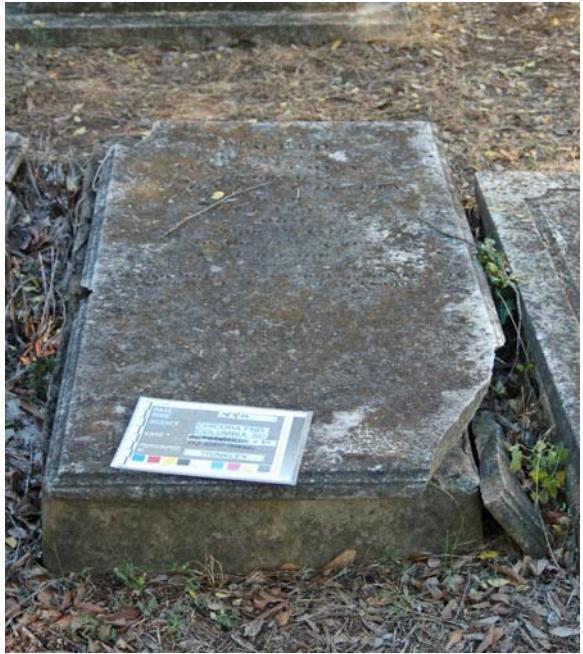
Old Moi	Athens Ceme nument Treatr	tery, Athens, GA nent Proposal	Section:	Plot: 24	
Namo	Name: Frances Mily Material: 🛛 marble 🗌 granite 🗌 brick 🔲 other:				
Туре	: headstone	footstone 🗌 die on base [tab in socket box	x 🛛 other: ledger	
	Position: fallen	tilted unstable	unattached/loose 🗌 n	nissing	
ondition	Deterioration: delamination/	broken 🗌 cracked 🔲 loss detachment 🗌 spalling 🔀	ses □ flaking/sugarin] missing fragments □	g 🔲 ferrous pins 🗌 bras] other:	s pins
ng Cc	Extent: 🗌 extension	ve >50%	\square minimal <25% \square	not applicable	
Existi	Failed/Old Treatn	nents: metaladhesive	s/coatings	other:	
	Soiling: 🔀 biolog	ical \boxtimes staining \square efflores	scence other:		
egy	Position: reset possible new b	/level in ground ⊠ reset/ ase required □ stabilize for	level to existing base [undation ⊠ reset with	☐ construct new base $⊠$ r 0:1:3 mix \Box reset with co	esquare ompound
: Strat	Failed Treatments	: drill/grind hand to	ols 🗌 solvents 🗌 ot	her:

Treatment	Treatment: cor	e drill \square drill and pin \square point \square other: infill with Ja	simple adhesive repair ahn M120 Marble Morta	☐ injection grout ☐ repl r	ace bricks
	Cleaning: low	pressure water $\square D/2$ and	l flush 🗌 poultice 🔲	other:	
Priority: 21) hazardous, immediate action; 2) unstable, requires treatment ASAP; 3) ongoing deterioration, treatment required 2-3 years; 4) re-inspect in 5- 10 years; 5) irreparableCost: \$550					50

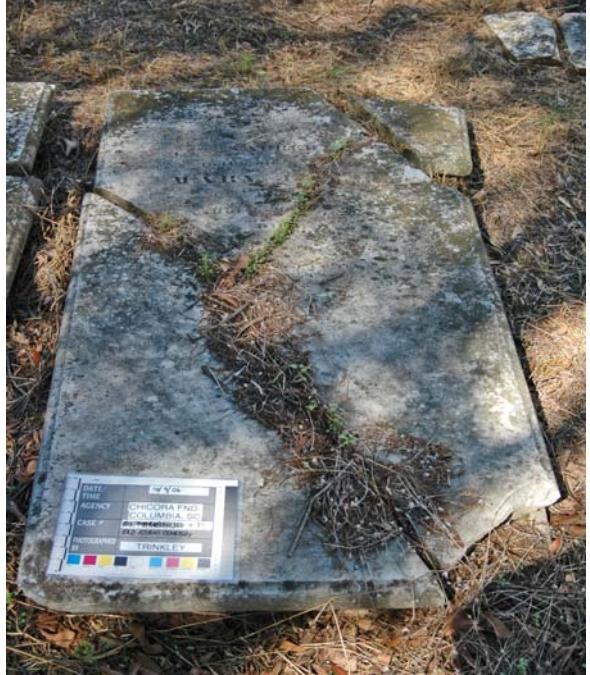
Monument Treatment Proposal			Section:	Plo	ıt: 25
Name: Mary [] Material: Marble granite brick other					
Type	headstone	footstone 🗌 die on base	🗌 tab in socket 🔲 box	t 🛛 other: ledge	er
	Position:fallen	tilted 🗌 unstable 🛛	unattached/loose 🗌 m	nissing	
ondition	Deterioration: A delamination/o	broken 🗌 cracked 🔲 lose detachment 🗌 spalling 🔀	ses 🔲 flaking/sugaring missing fragments 🗌	g 🔲 ferrous pii] other:	ns 🗌 brass pins
ng Cc	Extent: 🔀 extensiv	ve >50%	minimal <25%	not applicable	
Existi	Failed/Old Treatm	nents: metaladhesive	es/coatings	other:	
	Soiling: 🔀 biolog	ical 🛛 staining 🗌 efflore	scence other:		
egy	Position: \Box reset \boxtimes possible new base	/level in ground ⊠ reset/ ase required □ stabilize fo	level to existing base □ undation ⊠ reset with	☐ construct new 0:1:3 mix ☐ res	base 🗌 resquare set with compound
Strat	Failed Treatments	: drill/grind hand to	ools 🗌 solvents 🗌 otl	her:	
reatment	Treatment: cor	e drill ⊠ drill and pin □ point ⊠ other: infill with J	simple adhesive repair ahn M120 Marble Morta	injection gro r	out 🗌 replace bricks

L	Cleaning: low	pressure water \boxtimes D/2 and	d flush 🗌 poultice 🔲	other:	
Priority: 21) hazardous, immediate action; 2) unstable, requires treatment ASAP; 3) ongoing deterioration, treatment required 2-3 years; 4) re-inspect in 5- 10 years; 5) irreparableCost: \$1200			Cost: \$1200

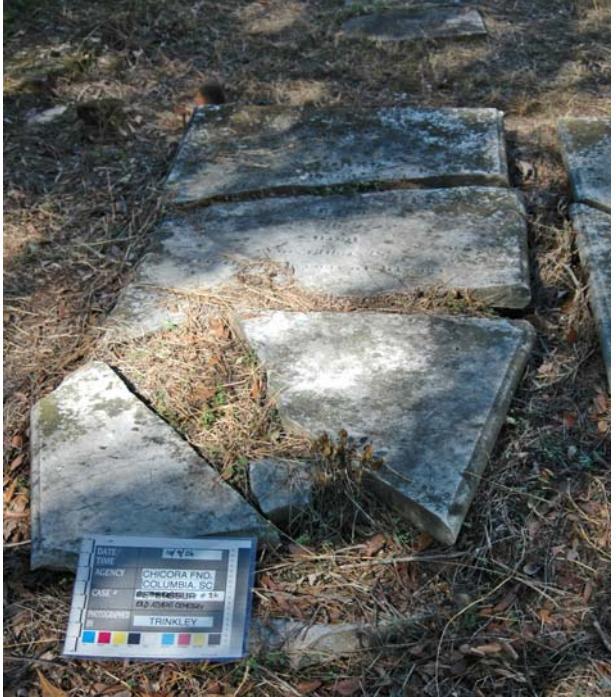
Old Moi	Athens Ceme nument Treatn	tery, Athens, GA nent Proposal	Section:	Plot: 26	
Namo	Name: Joseph [] Material: 🛛 marble 🗌 granite 🗍 brick 🗍 other:				
Туре	headstone	footstone 🗌 die on base [] tab in socket 🗌 box	a 🛛 other: ledger	
	Position: faller	tilted unstable	unattached/loose 🗌 n	nissing	
ndition	Deterioration: delamination/	broken 🗌 cracked 🔲 loss detachment 🗌 spalling 🔲	es 🔲 flaking/sugaring missing fragments 🗌	g 🔲 ferrous pins 🗌 b] other:	prass pins
ing Co	Extent: 🔀 extensiv	ve >50%	minimal <25%	not applicable	
Existi	Failed/Old Treatn	aents: metaladhesives	s/coatings	other:	
	Soiling: 🔀 biolog	ical 🛛 staining 🗌 efflores	cence other:		
egy	Position: \Box reset \boxtimes possible new b	/level in ground ⊠ reset/l ase required □ stabilize fou	evel to existing base [indation 🔀 reset with	☐ construct new base [0:1:3 mix ☐ reset with	resquare compound
t Strat	Failed Treatments	: drill/grind hand to	ols 🗌 solvents 🗌 otl	her:

Treatment	Treatment: cor	e drill ⊠ drill and pin □ s point □ other:	simple adhesive repair	injection grout Ir	eplace bricks
	Cleaning: low	pressure water $\square D/2$ and	flush poultice	other:	
Priority: 21) hazardous, immediate action; 2) unstable, requires treatment ASAP; 3) ongoing deterioration, treatment required 2-3 years; 4) re-inspect in 5- 10 years; 5) irreparableCost: \$1200				\$1200

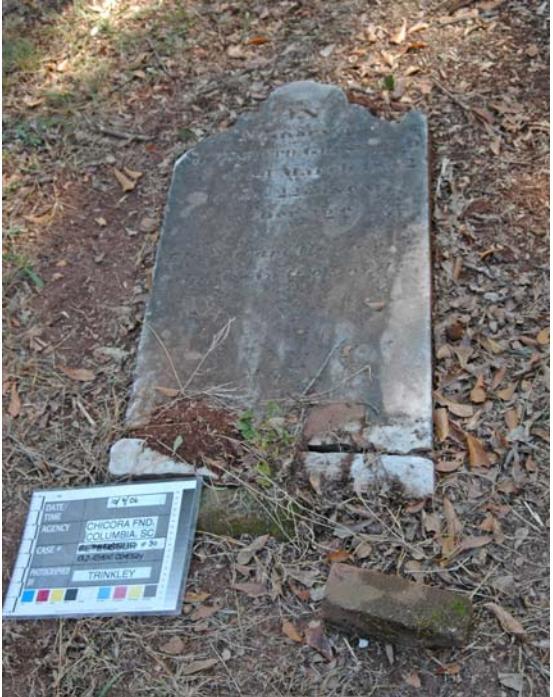
Athens Cemetery, nument Treatment	, Athens, GA Proposal	Section:	Plo	ot: 30	
e: Elizabeth Griswold	Material: 🔀	marble 🗌 granite 🗌] brick 🔲 othe	er:	
\Box headstone \Box foots	tone 🔲 die on base 🗌] tab in socket 🗌 box	other:		
Position: X fallen t	ilted 🗌 unstable 🗌 ı	ınattached/loose 🗌 m	nissing		
Deterioration: ⊠ broken □ cracked □ losses □ flaking/sugaring □ ferrous pins □ brass pins □ delamination/detachment □ spalling ⊠ missing fragments □ other:					
Extent: 🗌 extensive >50% 🛛 partial 25-50% 🗌 minimal <25% 🔲 not applicable					
Failed/Old Treatments: metal adhesives/coatings mortar other:					
Soiling: X biological	⊠ staining □ efflores	cence other:			
Position: I reset/leve possible new base re	l in ground ☐ reset/le quired	evel to existing base [ndation] reset with] construct new 0:1:3 mix □ re	v base 🔲 resquare eset with compound	
Failed Treatments:	drill/grind 🗌 hand too	ols 🗌 solvents 🗌 otl	ner:

Treatment: core drill mortar repoint	drill and pin \Box s s drill and pin \Box s	imple adhesive repair hn M120 Marble Morta	injection gro	out 🗌 replace bricks	
Cleaning: low press	sure water $\square D/2$ and	flush 🗌 poultice 🔲	other:

1) hazardous, immediate action; 2) unstable, requires treatment ASAP;3) ongoing deterioration, treatment required 2-3 years; 4) re-inspect in 5- 10 years; 5) irreparable10 years; 5) irreparable					
	Athens Cemetery, nument Treatment e: Elizabeth Griswold : A headstone foots Position: fallen t Deterioration: broke delamination/detach Extent: extensive >50 Failed/Old Treatments: Soiling: biological f Position: reset/leve possible new base re Failed Treatments: core drill mortar repoint Cleaning: low press fity: 2 1) ha 3) on 10 ye	Athens Cemetery, Athens, GA nument Treatment Proposal e: Elizabeth Griswold Material: [\$] :: [\$] headstone footstone die on base [\$] constitution: [\$] footstone die on base [\$] Position: [\$] fallen [\$] tilted [\$] unstable [\$] unstable [\$] unstable [\$] unstable Position: [\$] fallen [\$] tilted [\$] unstable [] unstable [] uns	Athens Cemetery, Athens, GA nument Treatment Proposal Section: nument Treatment Proposal Section: e: Elizabeth Griswold Material: \rightarrow marble \rightarrow granite Image: Section: e: Elizabeth Griswold Material: \rightarrow marble \rightarrow granite Image: Section: e: Elizabeth Griswold Material: \rightarrow marble \rightarrow granite Image: Section: e: Elizabeth Griswold Image: Section: Image: Section: Position: \rightarrow fallen Itilded Image: Section: Position: \rightarrow fallen Itilded Image: Section: Deterioration: \rightarrow fallen Image: Section: Image: Section: Deterioration: \rightarrow fallen Image: Section: Image: Section: Deterioration: \rightarrow fallen Image: Section: Image: Section: Extent: Image: Section: Image: Section: Image: Section: Failed/Old Treatments: Image: Image: Section: Image: Section: Image: Section: Soiling: Image: Image: Section: Image: Section: Image: Section: Image: Section: Position: Image: Section: Image: Section: Image: Section: Image: Section: Image: Se	Athens Cemetery, Athens, GA nument Treatment Proposal Section: Ph e: Elizabeth Griswold Material: [an marble] granite] brick] other other: e: Elizabeth Griswold Material: [an marble] granite] brick] other: other: Position: [and fallen] tilted] unstable] unattached/loose] missing other: Position: [and fallen] tilted] unstable] unattached/loose] missing other: Position: [and fallen] tilted] unstable] unattached/loose] missing other: Position: [and fallen] tilted] unstable] unattached/loose] missing other: Position: [and fallen] tilted] unstable] unattached/loose] missing other: Position: [and fallen] tilted] unstable] unattached/loose] missing other: Extent: [] extensive >50% [and partial 25-50%] minimal <25%] not applicable not applicable Failed/Old Treatments: [] metal [] adhesives/coatings][mortar] other: other: Soiling: [] biological [] staining [] efflorescence [] other: other: Position: [] reset/level in ground [] reset/level to existing base [] construct new other: possible new base required [] stabilize foundation [] reset with 0:1:3 mix [] re Failed Treatments: [] drill/grind [] hand tools [] solvents [] other: Treatment: [] core drill [] drill and pin [] simple adhesive repair [] injection gr

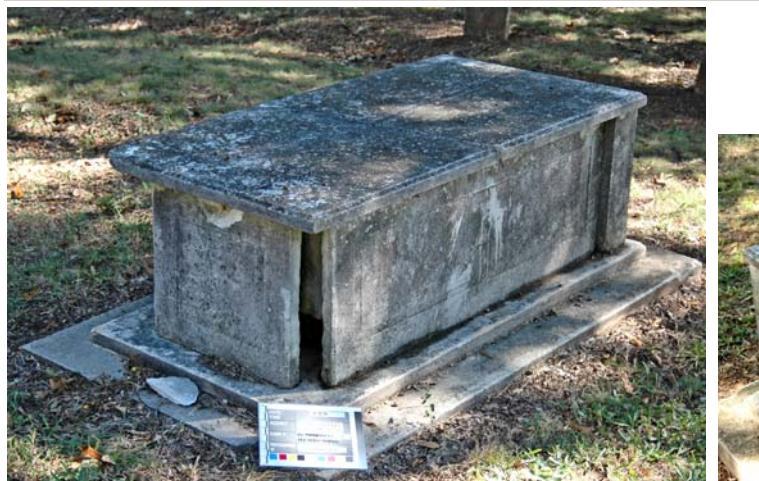
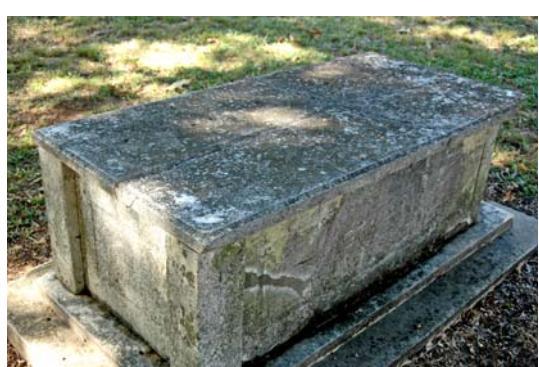
Old Mor	Athens Ceme nument Treatn	tery, Athens, GA nent Proposal	Section:	Plot: 32	
Name	e: unknown	Material: 🔀 m	arble 🗌 granite 🗌	brick other:	
Type:	headstone	footstone 🗌 die on base 🗌	tab in socket 🛛 boy	c i other:	
	Position: fallen	tilted 🛛 unstable 🖾 ur	nattached/loose 🗌 r	nissing	
ondition	Deterioration:	broken □ cracked □ losses detachment □ spalling ⊠ n	flaking/sugarin fissing fragments	g 🔲 ferrous pins 🗌 brass pins] other:	
ng C(Extent: 🗌 extensiv	ve >50% 🛛 partial 25-50% 🗌] minimal <25%	not applicable	
Existi	Failed/Old Treatm	nents: metaladhesives/	coatings	other:	
	Soiling: 🔀 biolog	ical 🛛 staining 🗌 effloresce	nce other:		
egy	Position: reset	/level in ground ⊠ reset/lev ase required □ stabilize foun	vel to existing base [dation] reset with	☐ construct new base ☐ resquare 0:1:3 mix ☐ reset with compound	
t Strat	Failed Treatments	: drill/grind hand tools	s 🗌 solvents 🗌 ot	her:	
reatmen	Treatment: cor	e drill □ drill and pin □ sir point ⊠ other: replace two m	nple adhesive repair issing corners that se	injection grout replace bricks rve to tie together side and end panels

L	Cleaning: low	pressure water $\square D/2$ and fl	ush 🗌 poultice 🗌	other:	
Prior	Priority: 21) hazardous, immediate action; 2) unstable, requires treatment ASAP; 3) ongoing deterioration, treatment required 2-3 years; 4) re-inspect in 5- 10 years; 5) irreparableCost: \$1850				
101010

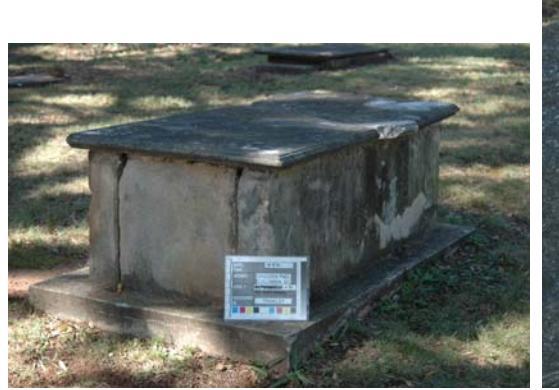
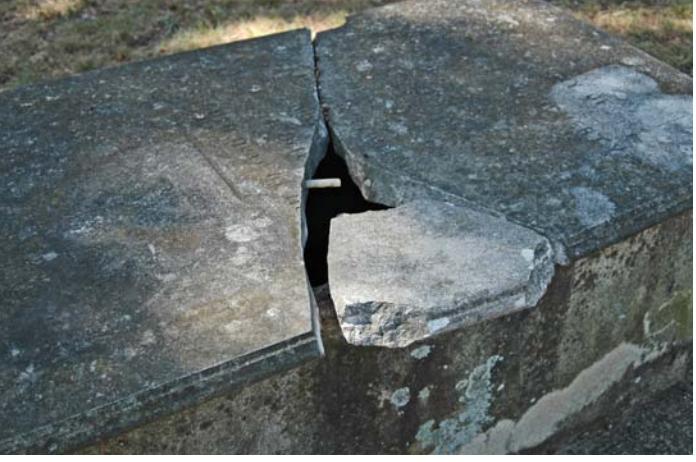
Old Mor	Athens Cemel nument Treatn	tery, Athens, GA nent Proposal	Section:	Ple	ot: 34
Name	:[]Dougherty	Material: 🔀 n	narble 🛛 granite 🗌] brick 🗌 othe	er:
Туре:	headstone	footstone 🗌 die on base 🗌	tab in socket 🛛 boy	x 🗌 other:	
	Position: fallen	☐tilted ☐ unstable ⊠ u	nattached/loose 🗌 r	nissing	
ondition	Deterioration: ⊠ broken □ cracked □ losses □ flaking/sugaring □ ferrous pins □ brass pins □ delamination/detachment □ spalling ⊠ missing fragments □ other:				
ing Co	Extent: extensiv	ze >50% ⊠ partial 25-50% [] minimal <25%	not applicable	
Existi	Failed/Old Treatm	ents: metaladhesives/	coatings mortar	🛛 other: nylon	pins
	Soiling: 🔀 biologi	cal 🛛 staining 🗌 effloresce	ence 🗌 other:		
8y	Position: reset, possible new ba	/level in ground ⊠ reset/le ase required □ stabilize four	vel to existing base [ndation 🔀 reset with	☐ construct new 0:1:3 mix ☐ re	v base 🔲 resquare eset with compound
Strate	Failed Treatments	: drill/grind hand tool	ls 🗌 solvents 🛛 ot	ther: remove exis	sting pins

Treatment (Treatment: core mortar rej Jahn M120 Marble	e drill 🛛 drill and pin 🗌 si point 🖾 other: may be neces Mortar	mple adhesive repair sary to infill box in or	injection gr der to support re	out 🗌 replace bricks epair; infill ledger with
	Cleaning: low	pressure water $\square D/2$ and f	lush 🗌 poultice 🗌	other:	
Prior	Priority: 21) hazardous, immediate action; 2) unstable, requires treatment ASAP; 3) ongoing deterioration, treatment required 2-3 years; 4) re-inspect in 5- 10 years; 5) irreparableCost: \$1200

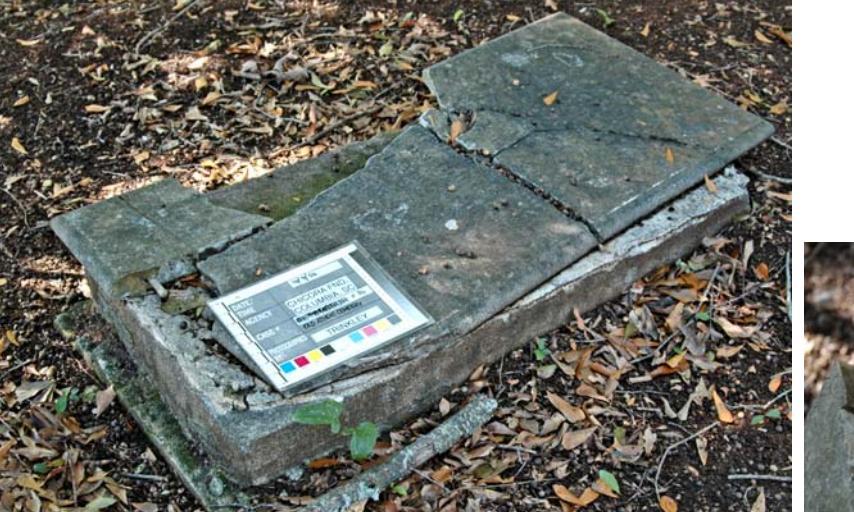
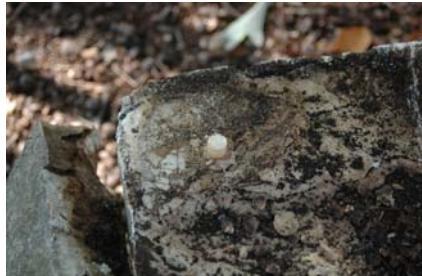
Old Mo	Athens Cemetenument Treatm	ery, Athens, GA ent Proposal	Section:	Plot: 36
Nam	e: unknown	Material: 🔀 m	arble 🗌 granite 🗌	brick 🗌 other:
Туре	: 🗌 headstone 🔲 fe	ootstone 🗌 die on base 🗌	tab in socket 🗌 box	t 🔀 other:
	Position: fallen	☐tilted ☐ unstable ⊠ un	attached/loose 🗌 n	nissing
ndition	Deterioration: D beterioration beterioration/de	roken 🗌 cracked 🔲 losses etachment 🗌 spalling 🔀 rr	☐ flaking/sugarin ussing fragments ☐	g 🔲 ferrous pins 🗌 brass pins other:
ng Co	Extent: 🛛 extensive	e >50% 🗌 partial 25-50% 🗌] minimal <25%	not applicable
Existi	Failed/Old Treatme	ents: metal adhesives/o	coatings	🛛 other: nylon pins
	Soiling: 🔀 biologic	al 🛛 staining 🗌 effloresce	nce 🗌 other:	
egy	Position: reset/	level in ground ⊠ reset/lev se required □ stabilize found	vel to existing base [dation ⊠ reset with	☐ construct new base ☐ resquare 0:1:3 mix ☐ reset with compound
t Strat	Failed Treatments:	drill/grind hand tools	s 🗌 solvents 🛛 ot	her: remove nylon pins

reatmen	Treatment: core core rep	drill \square drill and pin \square sin oint \square other: infill with Jahr	nple adhesive repair 1 M120 Marble Morta	☐ injection grout ☐ replace bricks r
F	Cleaning: low p	pressure water $\square D/2$ and fl	ush 🗌 poultice 🔲	other:
Priority: 21) hazardous, immediate action; 2) unstable, requires treatment ASAP; 3) ongoing deterioration, treatment required 2-3 years; 4) re-inspect in 5- 10 years; 5) irreparableCost: \$1300

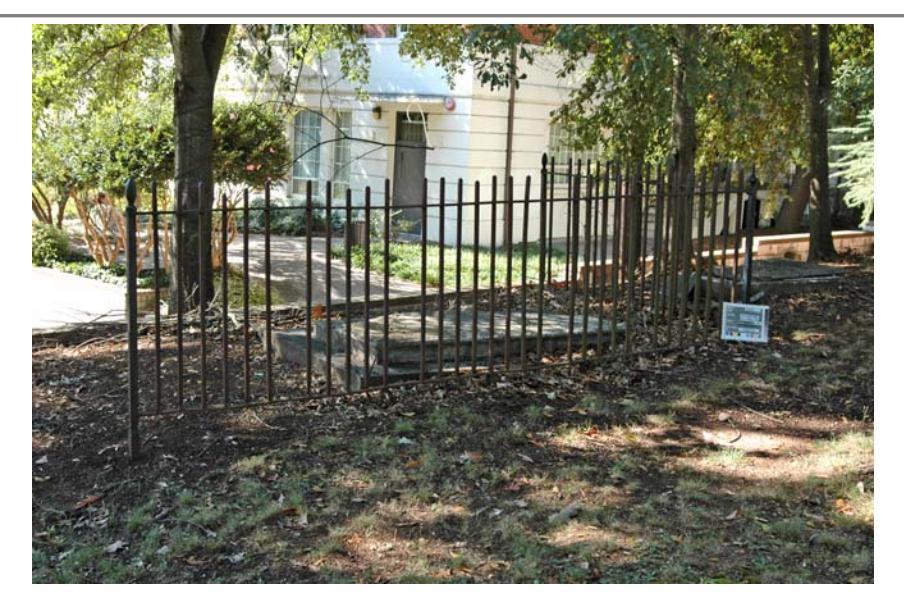
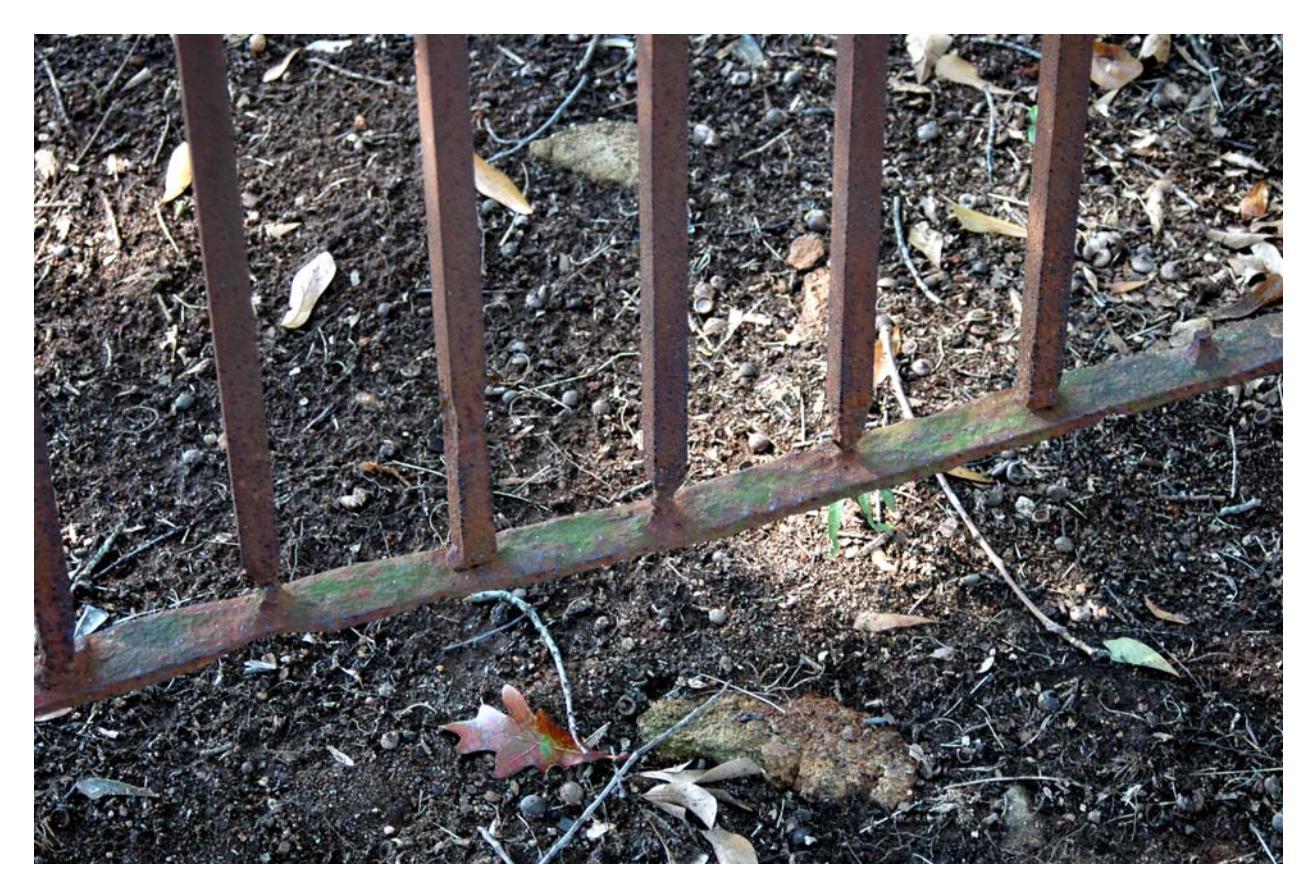
Old Athens Cemetery, Athens, GA Plot: 37 Section: **Fence Treatment Proposal** Fence Type: woven wire gas pipe ornate other: unknown Name: unknown **Type:** ☐ hairpin ☐ hairpin & picket ☐ bow & picket ☐ bow & hairpin ⊠ milled point ⊠ other: ca. 12x6½ feet; one corner post is replacement **Position:** fallen tilted unstable unattached/loose missing **Elements Present:** 2 of 4 corner posts 0 of 0 line posts 0 of ? gate posts 0 of ? gate(s) **Existing Condition Deterioration:** broken Cracked losses corrosion covered in soil missing fragments 💢 other: one post is a replacement; match is marginally acceptable; much loss from soil burial; five pickets are missing Extent: 🛛 extensive >50% 🗌 partial 25-50% 🗌 minimal <25% 🗌 not applicable **Failed/Old Treatments:** welds adhesives/coatings ferrous metals other: Foundations: brick concrete granite other: **Position:** stabilize foundation reset line posts reset corner posts reset/realign gate posts/gate **Freatment Strategy** Paint: 🗌 test for lead 🔲 air abrasion 🖾 hand tools 🖾 rust converter primer 🖾 top coat alkyd flat paint (two coats) other: **Treatment:** I remove soil from fence bottom rails re-attach fence sections straighten sections caulk elements prior to painting 🛛 other: will be necessary to stabilize soil to prevent future erosion and covering of fence bottom rail - all work to be performed within scope of repairs

Priority: 2

1) hazardous, immediate action; 2) unstable, requires treatment ASAP; 3) ongoing deterioration, treatment requires 2-3 years; 4) re-inspect in 5-10 years; 5) irreparable Cost: \$950

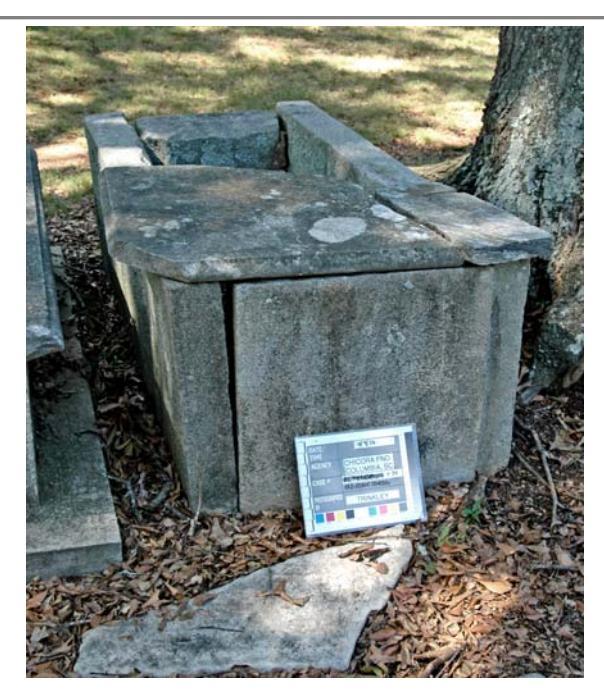
Old Mor	Athens Cemet	tery, Athens, GA nent Proposal	Section:	Ple	ot: 38
Name	: Abner Graham	Material: 🔀	marble 🛛 granite 🗌] brick 🗌 othe	er:
Type:	headstone	footstone 🗌 die on base 🗌] tab in socket 🛛 box	other:	
	Position: 🗌 fallen	□tilted □ unstable ⊠ u	ınattached/loose 🗌 n	nissing	
ndition	Deterioration: N t	broken 🗌 cracked 🔲 losse letachment 🗌 spalling 🔀	es 🔲 flaking/sugaring missing fragments 🗌	g 🔲 ferrous pi] other:	ins 🗌 brass pins
ng Cc	Extent: 🔀 extensiv	7e >50%	minimal <25%	not applicable	
Existi	Failed/Old Treatm	ents: metaladhesives	/coatings	other:	
	Soiling: 🔀 biologi	ical 🛛 staining 🗌 efflores	cence other:		
SY .	Position: reset/ possible new ba	/level in ground ⊠ reset/le ase required □ stabilize fou	evel to existing base [ndation 🛛 reset with] construct new 0:1:3 mix □ re	v base 🔲 resquare eset with compound
Strate	Failed Treatments:	: drill/grind hand too	ols 🗌 solvents 🗌 otl	her:

Treatment	Treatment: core mortar rep Marble Mortar; rep	e drill ⊠ drill and pin □ s point ⊠ other: cast OPC lid place lost dogs with 316 stainl	imple adhesive repair for box – remaining lee ess steel	injection gr dger set on this	out 🗌 replace bricks lid; infill with Jahn M120
	Cleaning: low	pressure water $\square D/2$ and	flush 🗌 poultice 🔲	other:	
Prior	ity: 2	 hazardous, immediate action ongoing deterioration, treatm years; 5) irreparable 	; 2) unstable, requires trea ent required 2-3 years; 4)	tment ASAP; re-inspect in 5-	Cost: \$1800

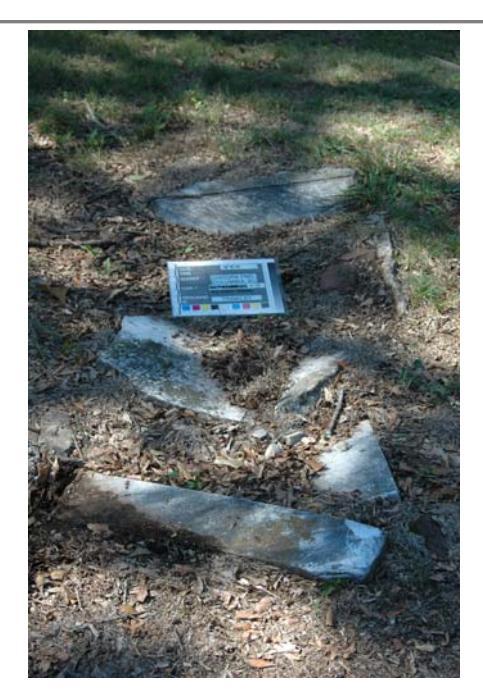
Old Moi	Athens Cemeter nument Treatmer	y, Athens, GA nt Proposal	Section:	Plo	ot: 42	
Name	e: Dorothy Randolph	Material: 🛛	🛾 marble 🔲 granite 🗌	brick 🗌 othe	er:	
Туре	: headstone foo	tstone 🗌 die on base	tab in socket box	🛛 other: ledg	ger	
	Position:fallen]tilted 🗌 unstable 🗵] unattached/loose 🗌 m	issing		
ondition	Deterioration: A brod	ken 🗌 cracked 🔲 los achment 🗌 spalling [sses 🔲 flaking/sugaring] missing fragments 🗌	g 🔲 ferrous pi other:	ins 🗌 brass pins	
ng Cc	Extent: 🗌 extensive >50% 🛛 partial 25-50% 🗌 minimal <25% 🗌 not applicable					
Existi	Failed/Old Treatment	t s: metaladhesiv	res/coatings	other:		
	Soiling: 🔀 biological	Staining efflor	escence 🗌 other:			
egy	Position: reset/lev	vel in ground 🗌 reset required 🗌 stabilize f	/level to existing base 🛛 🛛 oundation 🖾 reset with (] construct new):1:3 mix 🔲 re	v base 🔲 resquare eset with compound	
t Strat	Failed Treatments:] drill/grind 🔲 hand t	tools 🗌 solvents 🗌 oth	ier:

reatment	Treatment: core dr	rill ⊠ drill and pin] simple adhesive repair	injection gro	out 🗌 replace bricks	
T	Cleaning: \Box low pressure water \boxtimes D/2 and flush \Box poultice \Box other:					
Prior	Priority: 21) hazardous, immediate action; 2) unstable, requires treatment ASAP; 3) ongoing deterioration, treatment required 2-3 years; 4) re-inspect in 5- 10 years; 5) irreparableCost: \$1000

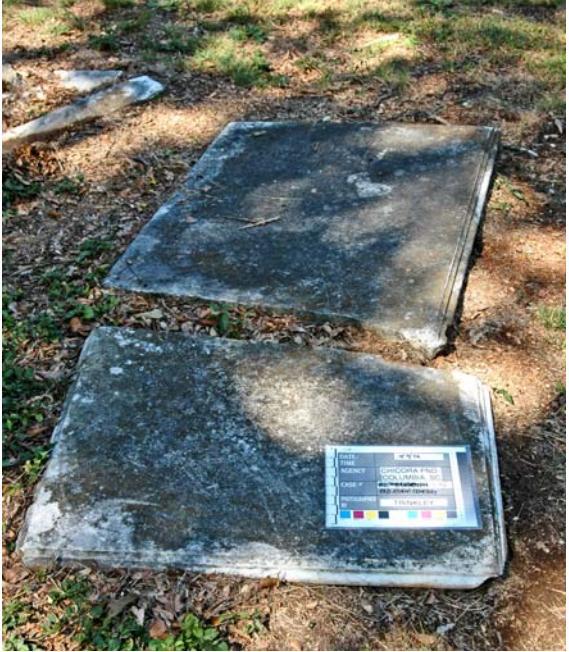
Moi	nument Treatn	nent Proposal	Section:	Plo	t: 43
Nam	e: unknown	Material: 🔀 n	narble 🗌 granite [] brick 🔲 other	÷
Туре	Type: ☐ headstone ☐ footstone ☐ die on base ☐ tab in socket ☐ box ⊠ other: ledger				
	Position:fallen	tilted 🗌 unstable 🛛 un	nattached/loose 🗌 1	nissing	
ndition	Deterioration: delamination/o	broken 🗌 cracked 🔲 losses detachment 🗌 spalling 🔲 r	s 🔲 flaking/sugarin nissing fragments 🗌	g 🔲 ferrous pir] other:	ns 🔲 brass pins
ing Co	Extent: 🗌 extensiv	ve >50% 🛛 partial 25-50% [minimal <25%	not applicable	
Existi	Failed/Old Treatm	nents: metaladhesives/	coatings mortar	other:	
	Soiling: 🔀 biolog	ical 🛛 staining 🗌 effloresce	ence 🗌 other:		
egy	Position: reset	/level in ground □ reset/le ase required □ stabilize four	vel to existing base [adation 🔀 reset with	∑ construct new .0:1:3 mix □ res	base 🔲 resquare set with compound
t Strat	Failed Treatments	: drill/grind hand tool	s solvents of	her:

Treatment	Treatment: cor	e drill \square drill and pin \square sin point \square other: infill grave pr	mple adhesive repair ior to pouring new fo	injection gro oundation slab	ut 🗌 replace bricks
	Cleaning: 🗌 low	pressure water $\square D/2$ and f	lush 🗌 poultice 🗌	other:

1) hazardous, immediate acti9) ongoing deterioration, treat10 years; 5) irreparable		 hazardous, immediate action; ongoing deterioration, treatment years; 5) irreparable 	2) unstable, requires trea ent required 2-3 years; 4)	atment ASAP; re-inspect in 5-	Cost: \$950

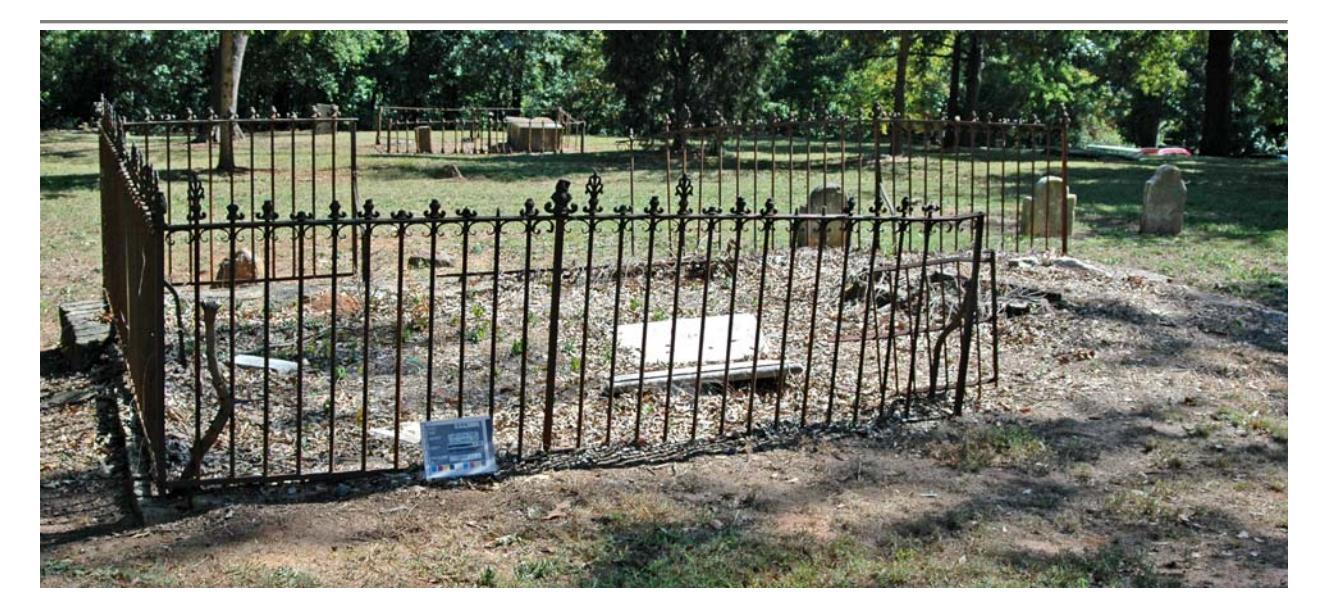
Fence Treatment Proposal			Section:	Plot: 44		
Name: unknown Fence T		Fence Type:] woven wire 🔲 gas p	pipe 🛛 ornate 🗌 other: ur	nknown	
Type finial	e: ☐ hairpin ☐ hairpin & picket ls; ca. 10x20′	🗌 bow & picke	et 🗌 bow & hairpin	🗌 milled point 🛛 other: pi	icket with	
	Position: \square fallen \square tilted \square] unstable 🛛 ur	nattached/loose 🛛 m	vissing		
Existing Condition	Elements Present: 3 of 4 corner p	posts 3 of 6 lin	e posts 1 of 2 gate po	osts 0 of 1 gate(s)		
	Deterioration: \Box broken \Box cracked \boxtimes losses \boxtimes corrosion \boxtimes covered in soil \Box missing fragments \boxtimes other: granite support blocks unstable and displaced; much loss of decorative finials; spalling of stone supports; much corrosion of support posts.					
	Extent: \square extensive >50% \square p	oartial 25-50%] minimal <25% 🗌 n	not applicable		
	Failed/Old Treatments: 🗌 weld	ls 🗌 adhesives/	coatings 🗌 ferrous n	netals 🗌 other:

Foundations: Dirick Concrete granite other:					
	Position: Stabilize foundation	on 🛛 reset line j	posts 🛛 reset corner	posts 🗌 reset/realign gate	posts/gate	
Treatment Strategy	Paint: test for lead air about two coats) other:	rasion 🛛 hand	tools 🛛 rust converte	er primer 🛛 top coat alkyd	flat paint	
	Treatment: \square remove soil from \square caulk elements prior to painti extensions onto posts (1-1/8")	fence bottom rai ing 🛛 other: cor	ls ⊠re-attach fence se e drill out corroded pc	ections 🔲 straighten sections osts, reset in epoxy; may need	3 l to weld	
	Recast/Replace: describe:
