PRESERVATION ASSESSMENT AND PLAN FOR THE OLD ATHENS CEMETERY, ATHENS, GEORGIA

Chicora Research Contribution 459

Prepared By: Michael Trinkley, Ph.D. and Debi Hacker

December 22, 2006

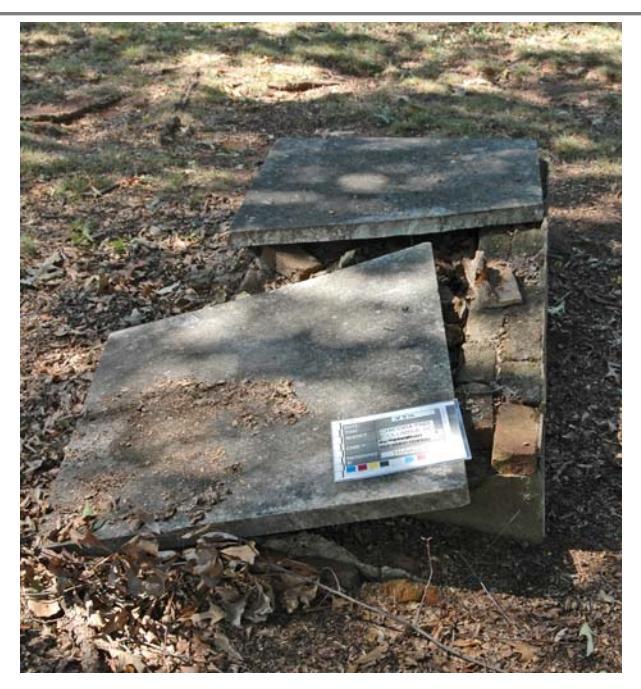
Old Mon	Athens Cemet	tery, Athens, GA nent Proposal	Section:	Plo	ot: 47	
Name	Name: Benjamin Ph[i]zyMaterial: \square marble \square granite \square brick \square other:					
Type:	$\mathbf{ype:}$ \Box headstone \Box footstone \Box die on base \Box tab in socket \boxtimes box \Box other:					
	Position: fallen	☐tilted ☐ unstable ⊠ unat	tached/loose 🗌 m	nissing		
ndition	Deterioration: H	broken 🗌 cracked 🔲 losses [letachment 🗌 spalling 🔀 miss] flaking/sugaring	g 🔲 ferrous pi] other:	ins 🗌 brass pins	
ng Cc	Extent: 🛛 extensiv	re >50% □ partial 25-50% □ n	ninimal <25%	not applicable		
Existi	Failed/Old Treatm	ents: metaladhesives/coa	atings 🗌 mortar	other:		
	Soiling: 🔀 biologi	cal 🛛 staining 🗌 efflorescenc	e 🗌 other:			
5y	Position: reset/ possible new ba	/level in ground ⊠ reset/level ase required □ stabilize founda	to existing base [tion 🛛 reset with	\Box construct new 0:1:3 mix \Box re	v base 🔲 resquare eset with compound

Strate	Failed Treatments:	: drill/grind hand tools	solvents ot	her:		
Treatment	Treatment: ☐ core drill 🖾 drill and pin ☐ simple adhesive repair ☐ injection grout ☐ replace bricks ☐ mortar ☐ repoint 🖾 other: infill box with sand to create stable support for repairs – may be necessary to support box with interior walls; infill ledger with Jahn M120 Marble Mortar					
	Cleaning: low j	pressure water \square D/2 and flus	h 🗌 poultice 🔲	other:		
Priority: 21) hazardous, immediate action; 2) unstable, requires treatment ASAP; 3) ongoing deterioration, treatment required 2-3 years; 4) re-inspect in 5- 10 years; 5) irreparable			tment ASAP; re-inspect in 5-	Cost: \$1800

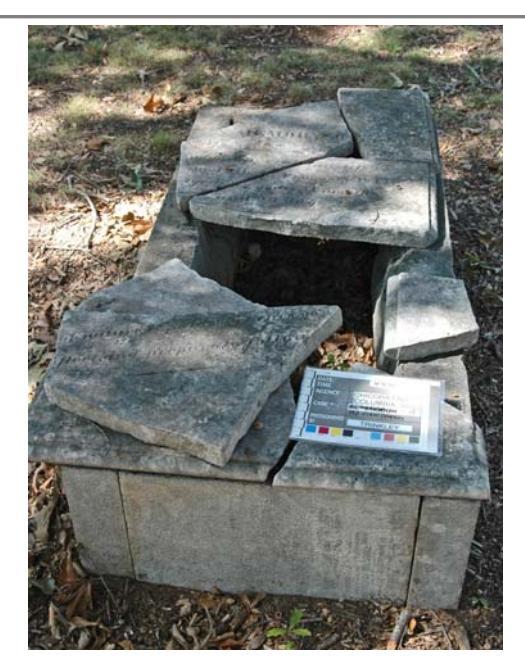
Old Moi	Athens Ceme nument Treatr	tery, Athens, GA nent Proposal	Section:	Plot: 48		
Nam	e: Louisa Ann Whit	field Material:	🛛 marble 🔲 granite 🗌	brick 🗌 other:		
Туре	: headstone	footstone 🗌 die on base	e 🗌 tab in socket 🗌 box	🔀 other: ledger		
	Position: faller	ו ☐tilted ☐ unstable [🛛 unattached/loose 🗌 m	issing		
ondition	Deterioration: delamination/	broken 🗌 cracked 🔲 le detachment 🗌 spalling	osses 🔲 flaking/sugaring 🗌 missing fragments 🔲	g \Box ferrous pins \Box brass pins other:		
ng Ct	Extent: 🗌 extension	Extent: □ extensive >50% 🛛 partial 25-50% □ minimal <25% □ not applicable				
Existi	Failed/Old Treatments: metaladhesives/coatingsmortar other: set on marble slab					
	Soiling: 🔀 biolog	çical 🛛 staining 🗌 efflo	prescence other:			
egy	Position: reset	t/level in ground 🗌 rese pase required 🔲 stabilize	et/level to existing base foundation reset with 0	$]$ construct new base \square resquare $D:1:3$ mix \square reset with compound

t Strat	Failed Treatments	s: 🗌 drill/grind 🔲 hand	l tools 🗌 solvents 🗌 oth	ner:		
reatment	Treatment: cor	e drill ⊠ drill and pin [point ⊠ other: infill lost	simple adhesive repair sections to prevent water a	injection grout replace bricks		
F	Cleaning: low	pressure water $\sum D/2a$	and flush \Box poultice \Box of	other:		
Prior	1) hazardous, immediate action; 2) unstable, requires treatment ASAP;3) ongoing deterioration, treatment required 2-3 years; 4) re-inspect in 5- 10 years; 5) irreparable10 years; 5) irreparable

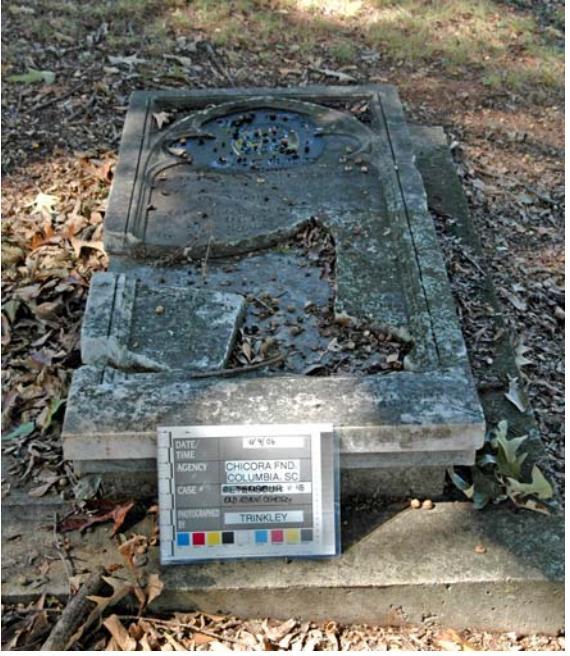
Old Mor	Athens Cemel nument Treatm	tery, Athens, GA nent Proposal	Section:	Plo	ot: 49
Name	e: Ann J. Con[ger]	Material: 🗌 m	arble 🗌 granite 🗌] brick 🗌 othe	er:
Type:	headstone	footstone 🗌 die on base 🗌	tab in socket 🗌 box	other:	
	Position: fallen	tilted unstable un	attached/loose 🗌 m	nissing	
dition	Deterioration:	broken 🗌 cracked 🔲 losses letachment 🗌 spalling 🗌 m	flaking/sugaring	g 🔲 ferrous pi] other:	ins 🗌 brass pins
g Cor	Extent: 🗌 extensiv	re >50%] minimal <25%	not applicable	
Existin	Failed/Old Treatm	ents: metaladhesives/o	coatingsmortar	other:	
	Soiling: 🔀 biologi material applied to	ical \boxtimes staining \square efflorescent stone?	nce 🛛 other: unusu	al staining patte	ern; possibly some
egy	Position: reset	/level in ground □ reset/lev ase required □ stabilize found	rel to existing base [dation] reset with] construct new 0:1:3 mix □ re	v base 🔲 resquare eset with compound
t Strat	Failed Treatments	: drill/grind hand tools	s solvents otl	her:

reatmen	Treatment: Core	e drill 🔲 drill and pin 🔲 sin point 🗌 other:	nple adhesive repair	injection gr	out 🗌 replace bricks
Cleaning: \square low pressure water \square D/2 and flush \square poultice \square other:					
Prior	riority: 3 1) hazardous, immediate action; 2) unstable, requires treatment ASAP; 3) ongoing deterioration, treatment required 2-3 years; 4) re-inspect in 5- 10 years; 5) irreparable Cost: \$100

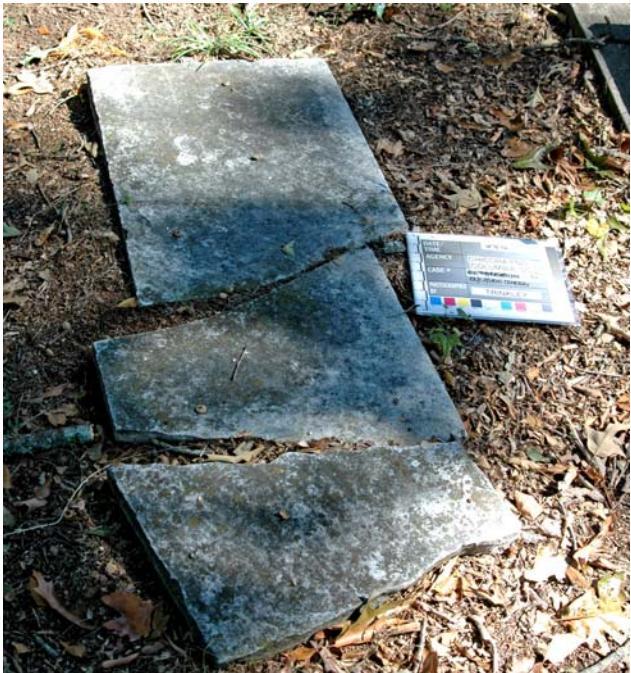
Monument Treatment Proposal			Section:	Plo	t: 53		
Name	e: Lucius Pittard	Material: 🔀 ma	arble 🗌 granite 🗌] brick 🗌 other	:		
Туре	ype: \square headstone \square footstone \square die on base \square tab in socket \square box \square other:						
	Position: A fallen	☐tilted ☐ unstable ⊠ una	attached/loose 🗌 n	nissing			
ndition	Deterioration: \square b delamination/d	rroken 🗌 cracked 🔲 losses etachment 🗌 spalling 🔀 m	☐ flaking/sugarin issing fragments ☐	g 🔲 ferrous pir] other:	ns 🔲 brass pins		
ng Cc	Extent: 🛛 extensive >50% 🗌 partial 25-50% 🗌 minimal <25% 🗌 not applicable						
Existi	Failed/Old Treatments: metal adhesives/coatings mortar other:						
	Soiling: 🔀 biologic	cal 🛛 staining 🗌 efflorescer	nce 🗌 other:				
egy	Position: reset/	level in ground 🗌 reset/leve se required 🔲 stabilize found	el to existing base [lation 🔀 reset with	\bigcirc construct new 0:1:3 mix \square res	base 🔲 resquare set with compound

t Strat	Failed Treatments:	drill/grind hand tools	solvents ot	her:			
reatment	Treatment: core	drill \square drill and pin \square simpoint \square other: place on OPC s	ple adhesive repair lant top support	injection gro	ut 🗌 replace bricks		
L	Cleaning: 🗌 low p	pressure water $\square D/2$ and flu	ish 🗌 poultice 🔲	other:			
Prior	1) hazardous, immediate action; 2) unstable, requires treatment ASAP;3) ongoing deterioration, treatment required 2-3 years; 4) re-inspect in 5- 10 years; 5) irreparable10 years; 5) irreparable

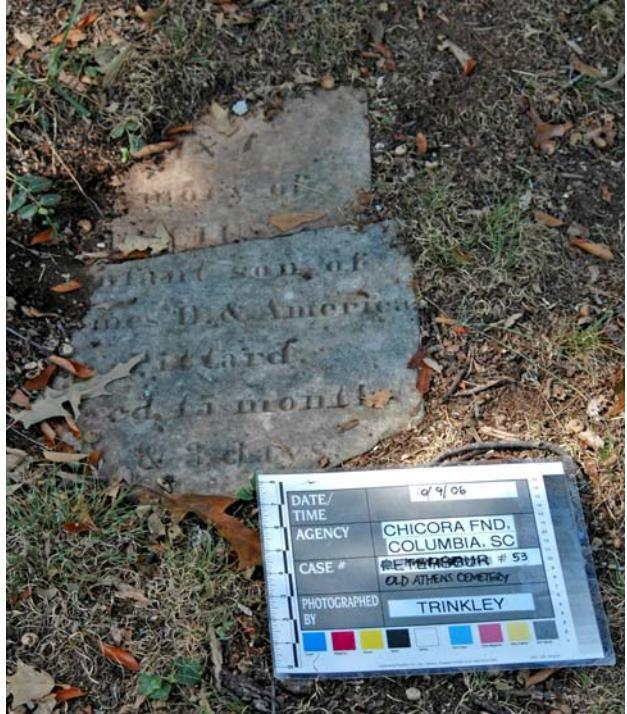
Old Moi	Athens Cemetery, nument Treatment	, Athens, GA Proposal	Section:	Plot: 54			
Nam	e: Arabella Rebecca Hard	eman Material: 🛛	marble 🗌 granite 🔲	brick 🗌 other:			
Туре	y pe: headstone footstone die on base tab in socket box other: obelisk						
	Position: fallen	ilted 🗌 unstable 🗌	unattached/loose 🗌 mi	issing			
ondition	Deterioration: Divoke delamination/detach	n 🗌 cracked 🔲 loss nment 🗌 spalling 🗌	es	ferrous pins brass pins other:			
ng Cc	Extent: extensive >50	0% 🗌 partial 25-50%	🗌 minimal <25% 🛛 n	ot applicable			
Existi	Failed/Old Treatments: metal adhesives/coatings mortar other:						
	Soiling: 🛛 biological [\boxtimes staining \square efflores	scence 🗌 other:				
egy	Position: I reset/level possible new base re	l in ground □ reset/ quired ⊠ stabilize for	level to existing base \Box undation \Box reset with 0	construct new base resquare	1		
: Strat	Failed Treatments: 🗌 d	lrill/grind 🗌 hand to	ols 🗌 solvents 🗌 oth	er:

reatment	Treatment: core drill mortar repoint	drill and pin	simple adhesive repair	injection grout 🗌 replace brick	ĸs		
Η	Cleaning: \Box low pressure water \boxtimes D/2 and flush \Box poultice \Box other:						
Prio	1) hazardous, immediate action; 2) unstable, requires treatment ASAP;3) ongoing deterioration, treatment required 2-3 years; 4) re-inspect in 5- 10 years; 5) irreparable10 years; 5) irreparable

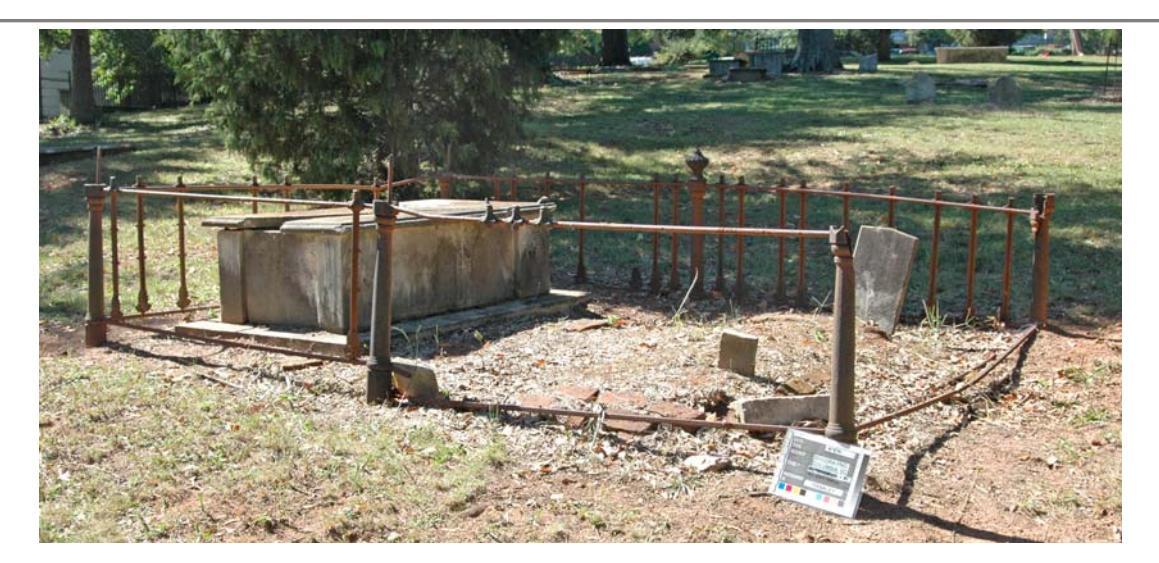
Monument Treatment Proposal			Section:	Plot: 59	
Name	e: unknown	Material: 🔀 marb	le 🗌 granite 🗌 brick 🗌	other:	
Type	: 🛛 headstone 🗌	footstone 🗌 die on base 🗌 tab	in socket 🗌 box 🗌 other:	:	
	Position: fallen		iched/loose 🛛 missing		
ndition	Deterioration: \square delamination/c	broken 🗌 cracked 🔲 losses 🗌 letachment 🗌 spalling 🔀 missi] flaking/sugaring 🔲 ferro ng fragments 🗌 other:	ous pins 🗌 brass pins	
g Cor	Extent: 🗌 extensiv	7e >50% ⊠ partial 25-50% □ m	inimal <25% 🔲 not applica	ıble	
Existin	Failed/Old Treatm	nents: ☐ metal ⊠adhesives/coat	ings 🗌 mortar 🛛 other: p	previous repair failed, top	
	Soiling: 🔀 biologi	ical 🛛 staining 🗌 efflorescence	other:		
egy	Position: reset, possible new ba	/level in ground 🔲 reset/level t ase required 🔲 stabilize foundati	o existing base \Box construct on \Box reset with 0:1:3 mix	t new base 🔲 resquare 🗌 reset with compound	
t Strat	Failed Treatments	: drill/grind hand tools] solvents 🔲 other:

reatment	Treatment: core	e drill 🔲 drill and pin 🔲 simple point 🗌 other:	e adhesive repair 🔲 injectio	on grout 🗌 replace bricks	
Η	Cleaning: 🗌 low	pressure water $\Box D/2$ and flush	poultice other:		
Prior	Priority: 51) hazardous, immediate action; 2) unstable, requires treatment ASAP; 3) ongoing deterioration, treatment required 2-3 years; 4) re-inspect in 5- 10 years; 5) irreparableCost: n/c

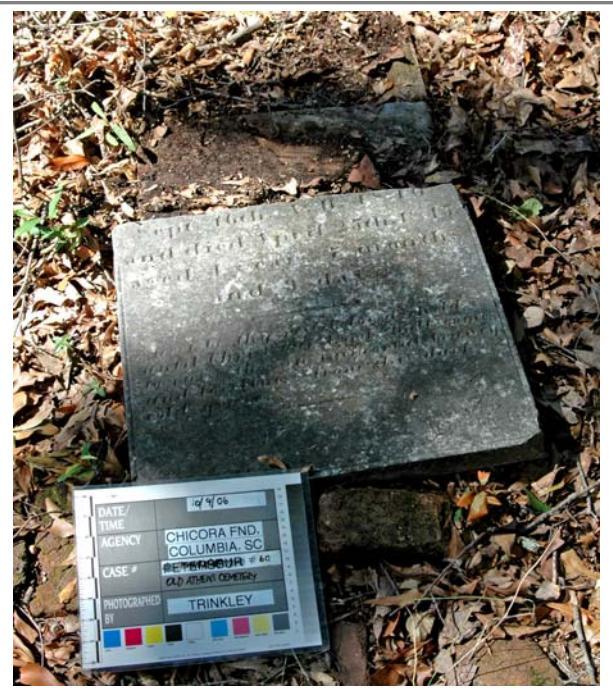
Old Mor	Athens Cemel nument Treatn	tery, Athens, GA nent Proposal	Section:	Plot: 61	
Name: Elizabeth Julie McKinley Material: X marble granite brick other:					
Type:	' ype: ☐ headstone ☐ footstone ☐ die on base ☐ tab in socket ☐ box ⊠ other: ledger				
	Position: 🗌 fallen	tilted unstable	⊠ unattached/loose □ missing		
ng Condition	Deterioration: Deterioration delamination/c	broken 🗌 cracked 🔲 detachment 🗌 spalling	losses \Box flaking/sugaring \Box feg \boxtimes missing fragments \Box other:	errous pins 🗌 brass pins	
	Extent: 🔀 extensive >50% 🗌 partial 25-50% 🗌 minimal <25% 🗌 not applicable				
Existi	Failed/Old Treatments:metaladhesives/coatingsmortarother:				
	Soiling: 🔀 biologi	ical 🛛 staining 🗌 eff	lorescence other:		
Treatment Strategy	Position: reset, possible new ba	/level in ground ⊠re ase required □ stabiliz	set/level to existing base 🔲 const re foundation 🗌 reset with 0:1:3 m	ruct new base 🗌 resquare ix 🔲 reset with compound

Failed Treatments	: 🗌 drill/grind 🔲 har	nd tools 🗌 solvents 🗌 other:		
	Treatment: ☐ core drill				
	Cleaning: \Box low pressure water \Box D/2 and flush \Box poultice \Box other:

1) hazardous, immediate actPriority: 23) ongoing deterioration, treat10 years; 5) irreparable		action; 2) unstable, requires treatment A treatment required 2-3 years; 4) re-inspe	SAP; ct in 5- Cost: \$1700

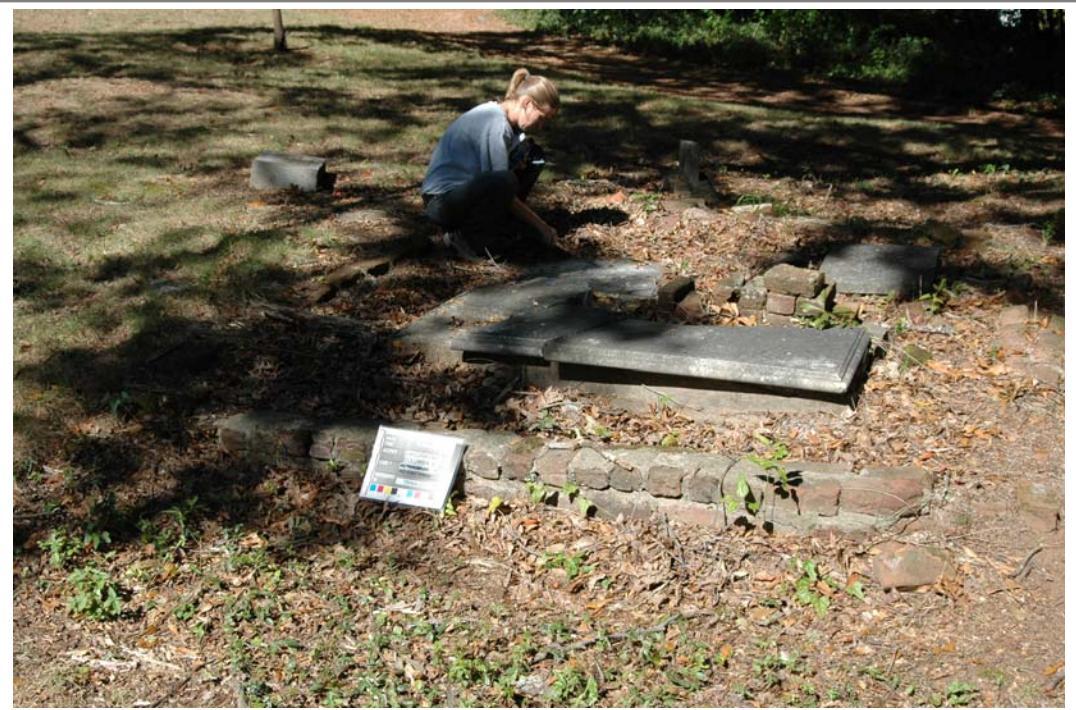
Old Mor	Athens Cemet nument Treatn	tery, Athens, GA nent Proposal	Section:	Plot: 63		
Name	: Sarah T. Church	Material: 🖂 n	narble 🗌 granite 🗌] brick 🔲 other:		
Type:	Type: ☐ headstone ☐ footstone ☐ die on base ☐ tab in socket ☐ box ☐ other:					
	Position: fallen	☐tilted ⊠ unstable ☐ un	nattached/loose 🗌 r	missing	_	
ndition	Deterioration: ⊠ broken □ cracked □ losses □ flaking/sugaring □ ferrous pins □ brass pins □ delamination/detachment □ spalling □ missing fragments □ other:					
ng Co	Extent: 🗌 extensive >50% 🔀 partial 25-50% 🗌 minimal <25% 🗌 not applicable					
Existi	Failed/Old Treatments:metaladhesives/coatingsmortarother:					
	Soiling: 🔀 biologi	ical 🛛 staining 🗌 effloresco	ence 🗌 other:			
egy	Position: ⊠ reset/level in ground □ reset/level to existing base □ construct new base □ resquare □ possible new base required □ stabilize foundation □ reset with 0:1:3 mix □ reset with compound

t Strat	Failed Treatments: drill/grind hand tools solvents other:					
reatmen	Treatment: ☐ core drill					
L	Cleaning: \Box low pressure water \Box D/2 and flush \Box poultice \Box other:					
Priority: 2 1) hazardous, immediate 3) ongoing deterioration, 10 years; 5) irreparable		 hazardous, immediate action; ongoing deterioration, treatment years; 5) irreparable 	2) unstable, requires trea ent required 2-3 years; 4)	atment ASAP;) re-inspect in 5- Cost: \$800

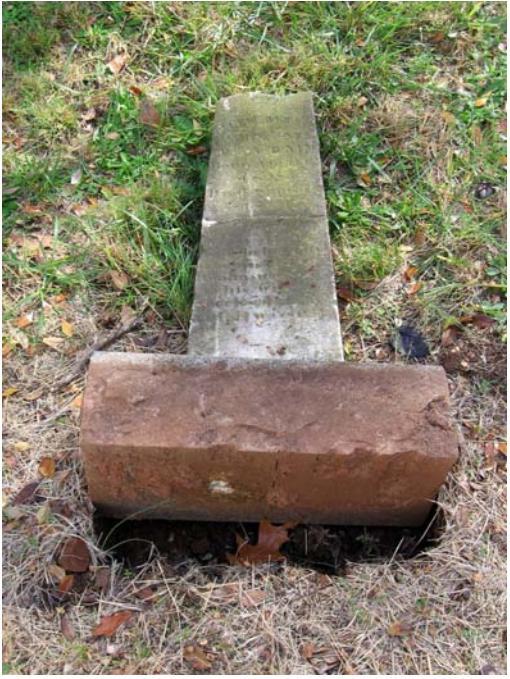
Moi	Athens Ceme nument Treatr	tery, Athens, GA nent Proposal	Section:	Plo	ot:	
Nam	ame: Ellen Bain Material: 🛛 marble 🗌 granite 🗌 brick 🗌 other:					
Туре	\therefore headstone	footstone 🗌 die on base 🗌	tab in socket 🗌 boy	x 🗌 other:		
	Position: X fallen	tilted unstable un	nattached/loose 🗌 r	nissing		
ondition	Deterioration:	broken 🗌 cracked 🔲 losses detachment 🗌 spalling 🗌 n	flaking/sugarin	lg □ ferrous pi] other: old repa	ns 🗌 brass pins ir, now failed	
ng Cc	Extent: extensive >50% partial 25-50% minimal <25% not applicable					
Existi	Failed/Old Treatments:					
	Soiling: 🔀 biolog	ical 🛛 staining 🗌 effloresce	ence 🗌 other:			
egy	Position: 🛛 reset	/level in ground ⊠ reset/lev ase required □ stabilize found	/el to existing base [dation □ reset with	☐ construct new 0:1:3 mix ☐ re	base 🗌 resquare eset with compound	
t Strat	Failed Treatments	: \boxtimes drill/grind \boxtimes hand tools	s 🗌 solvents 🗌 ot	her:

reatmen	Treatment: ☐ core drill					
F	Cleaning: low	pressure water $\square D/2$ and fl	ush 🗌 poultice 🗌	other:		
Prior	riority: 21) hazardous, immediate action; 2) unstable, requires treatment ASAP; 3) ongoing deterioration, treatment required 2-3 years; 4) re-inspect in 5- 10 years; 5) irreparableCost: \$800

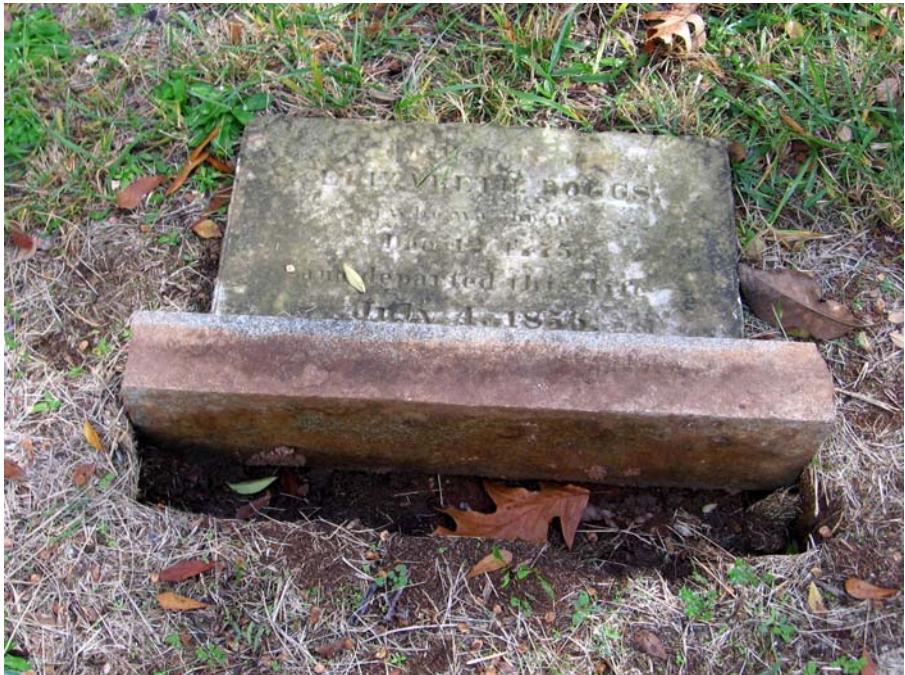
Moi	Athens Ceme nument Treatn	nent Proposal	Section:	Plot	•		
Name	Jame: Elizabeth Boggs Material: 🛛 marble 🗌 granite 🗌 brick 🗍 other:						
Туре	: 🛛 headstone 🗌	footstone 🗌 die on base 🗌] tab in socket 🗌 bo:	x 🗌 other:			
	Position: 🔀 fallen	tilted unstable u	nattached/loose 🗌 1	nissing			
ndition	Deterioration: delamination/o	broken 🗌 cracked 🔲 losses detachment 🗌 spalling 🔲 1	s 🔲 flaking/sugarin missing fragments 🛛	ıg 🔲 ferrous pins] other: old break,	s 🔲 brass pins top missing		
ng Cc	Extent: 🔀 extensive >50% 🗌 partial 25-50% 🗌 minimal <25% 🗌 not applicable						
Existi	Failed/Old Treatments: metal adhesives/coatings mortar other:						
	Soiling: 🔀 biolog	ical 🛛 staining 🗌 effloresc	ence other:				
egy	Position: I reset	/level in ground □ reset/le ase required □ stabilize four	vel to existing base [ndation] reset with	☐ construct new b 0:1:3 mix ☐ rese	pase 🔲 resquare et with compound		
: Strat	Failed Treatments	: drill/grind hand too	ls 🗌 solvents 🗌 of	ther:

reatment	Treatment: cor	e drill 🔲 drill and pin 🗌 si point 🗌 other:	mple adhesive repair	injection grou	ut 🗌 replace bricks		
L	Cleaning: 🗌 low	pressure water $\square D/2$ and f	flush 🗌 poultice 🗌	other:			
Prior	ity: 2	 hazardous, immediate action; ongoing deterioration, treatme 10 years; 5) irreparable 	2) unstable, requires trea ent required 2-3 years; 4)	atment ASAP; re-inspect in 5- (Cost: \$100

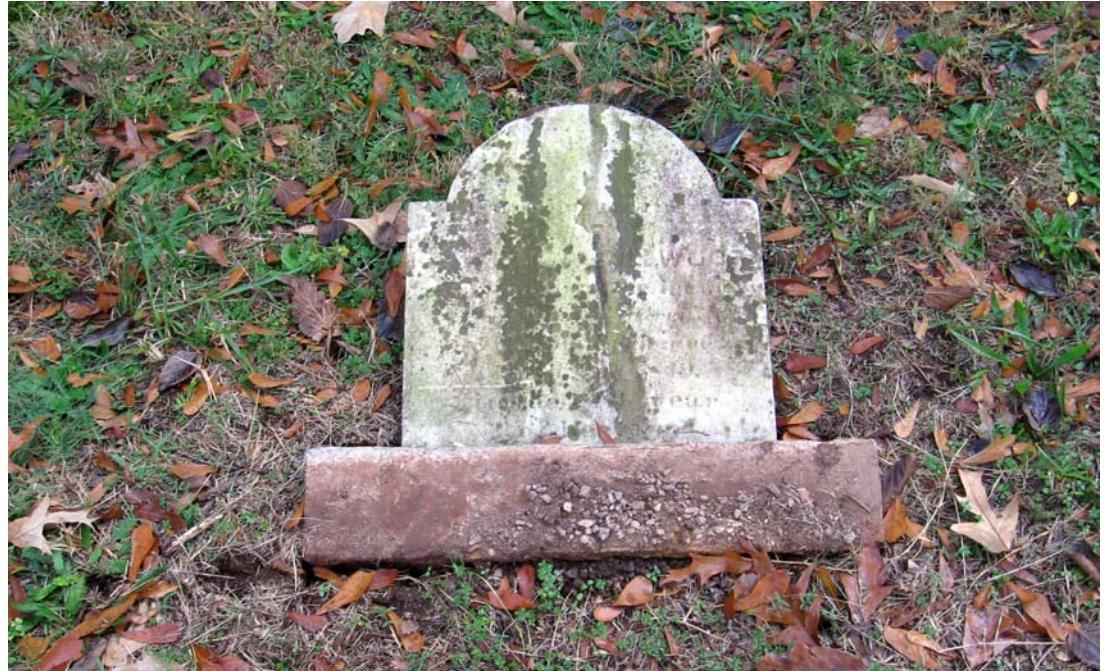
Monument Treatment Proposal			Section:	P1	ot:
Name	e: Jane Fullwood	Material: 🔀 ma	arble 🗌 granite 🗌] brick 🗌 othe	er:
Type	\boxtimes headstone	footstone 🗌 die on base 🗌 t	tab in socket 🔲 boy	x 🗌 other:	
	Position: X faller	n 🗌 tilted 🗌 unstable 🗌 una	attached/loose 🗌 r	nissing	
ondition	Deterioration: delamination/	broken 🗌 cracked 🔲 losses detachment 🗌 spalling 🗌 m	flaking/sugarin issing fragments	ng 🔲 ferrous p] other:	ins 🗌 brass pins
ing Co	Extent: extensive >50% partial 25-50% minimal <25% not applicable				
Existi	Failed/Old Treatments: metal adhesives/coatings mortar other:				
	Soiling: 🔀 biolog	ical 🛛 staining 🗌 efflorescer	nce 🗌 other:		
egy	Position: 🛛 reset	/level in ground 🗌 reset/leve ase required 🗌 stabilize found	el to existing base [lation] reset with	□ construct new 0:1:3 mix □ re	v base 🔲 resquare eset with compound
: Strat	Failed Treatments	: drill/grind hand tools	solvents ot	ther:

reatment	Treatment: cor	e drill 🔲 drill and pin 🗌 sim point 🗌 other:	nple adhesive repair	injection gr	out 🗌 replace bricks
L	Cleaning: low	pressure water $\square D/2$ and flu	ush 🗌 poultice 🔲	other:	
Prior	Priority: 21) hazardous, immediate action; 2) unstable, requires treatment ASAP; 3) ongoing deterioration, treatment required 2-3 years; 4) re-inspect in 5- 10 years; 5) irreparableCost: \$100

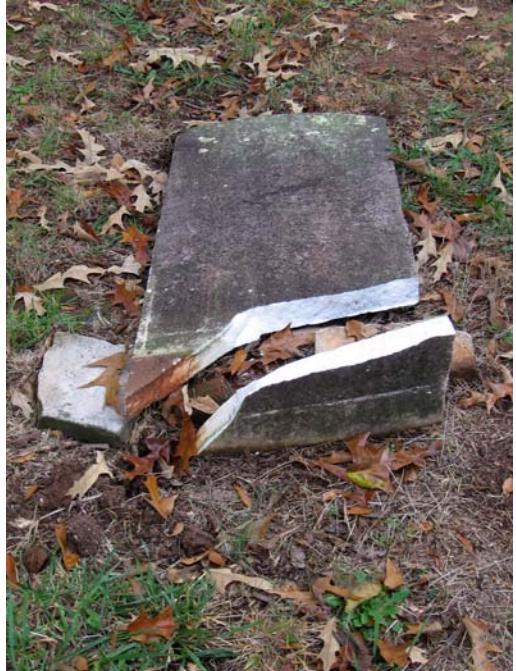
Old Moi	Athens Ceme nument Treatr	tery, Athens, GA nent Proposal	Section:	Ple	ot:		
Namo	ame: William Cherry Material: ⊠ marble □ granite □ brick □ other:						
Туре	: \square headstone \square	footstone 🗌 die on base 🗌	tab in socket 🗌 box	x 🗌 other:			
	Position: 🔀 faller	tilted unstable un	nattached/loose 🗌 r	nissing			
ondition	Deterioration: delamination/	broken 🗌 cracked 🔲 losses detachment 🗌 spalling 🔲 r	s 🔲 flaking/sugarin nissing fragments 🗌	g 🔲 ferrous pi] other:	ins 🗌 brass pins		
ng Cc	Extent: extensive >50% partial 25-50% minimal <25% not applicable						
Existi	Failed/Old Treatments: metal adhesives/coatings mortar other:						
	Soiling: 🔀 biolog	ical 🛛 staining 🗌 effloresce	ence 🗌 other:				
egy	Position: 🛛 reset	/level in ground ☐ reset/levase required ☐ stabilize foun	vel to existing base [dation] reset with	□ construct new 0:1:3 mix □ re	v base 🔲 resquare eset with compound		
t Strat	Failed Treatments	: drill/grind hand tool	s 🗌 solvents 🗌 ot	her:

reatment	Treatment: cor	e drill ⊠ drill and pin □ sin point ⊠ other: infill with Jah	mple adhesive repair n M120	injection gr	out 🗌 replace bricks		
L	Cleaning: 🗌 low	pressure water $\square D/2$ and f	lush 🗌 poultice 🗌	other:			
Prior	1) hazardous, immediate action; 2) unstable, requires treatment ASAP;3) ongoing deterioration, treatment required 2-3 years; 4) re-inspect in 5-10 years; 5) irreparable

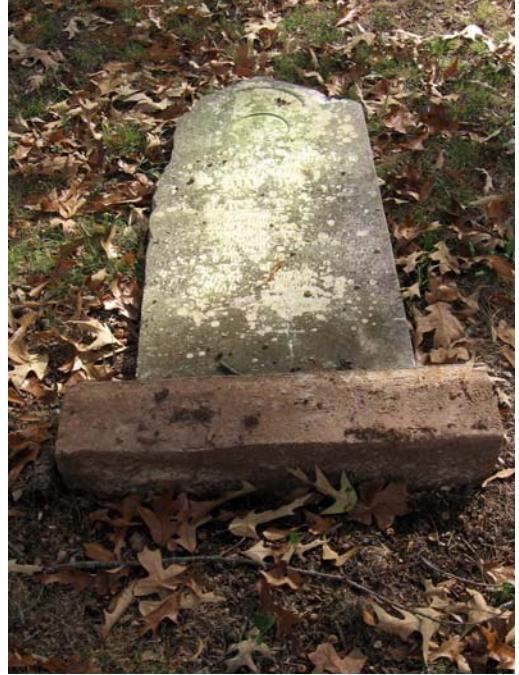
Athens Ceme nument Treatr	nent Proposal	Section:	Plot:		
e: "Little Sis"	Material: 🖂 n	narble 🗌 granite 🗌	brick other:		
: headstone	footstone 🗌 die on base 🗌	tab in socket 🗌 boy	x 🗌 other:		
Position: 🔀 faller	tilted unstable un	nattached/loose 🗌 r	missing		
Deterioration: delamination/	broken 🗌 cracked 🔲 losses detachment 🗌 spalling 🔲 r	inissing fragments	ng 🔲 ferrous pins 🗌 brass pins] other:		
Extent: 🗌 extensiv	Extent: 🗌 extensive >50% 📋 partial 25-50% 🔀 minimal <25% 🔲 not applicable				
Failed/Old Treatments:					
Soiling: 🔀 biolog	ical 🛛 staining 🗌 effloresce	ence 🗌 other:			
Position: I reset	/level in ground ☐ reset/levase required ☐ stabilize foun	vel to existing base [idation] reset with	□ construct new base □ resquare 0:1:3 mix □ reset with compoun	d	
Failed Treatments	: drill/grind hand tool	s solvents ot	ther:		
Treatment: cor	e drill 🔲 drill and pin 🗌 sin point 🗌 other:	mple adhesive repair	• 🔲 injection grout 🗌 replace bric	ks

Cleaning: low	pressure water $\square D/2$ and f	lush 🗌 poultice 🔲] other:		
riority: 2 1) hazardous, immediate action; 2) unstable, requires treatment ASAP; 3) ongoing deterioration, treatment required 2-3 years; 4) re-inspect in 5- 10 years; 5) irreparable Cost: \$100					
	Athens Ceme nument Treatm e: "Little Sis" headstone Position: A fallen Deterioration: A fallen Deterioration: A fallen Deterioration: A fallen Columnation / of Extent: A fallen extensive Failed/Old Treatm Soiling: A biology Position: A reset possible new back Failed Treatments Treatment: Correct Cleaning: A low fity: 2	Athens Cemetery, Athens, GA hument Treatment Proposal e: "Little Sis" Material: [] n : [] headstone [] footstone [] die on base [] Position: [] fallen [] tilted [] unstable [] un Deterioration: [] broken [] cracked [] lossee] delamination/detachment [] spalling [] r Extent: [] extensive >50% [] partial 25-50% [] Failed/Old Treatments: [] metal [] adhesives/ Soiling: [] biological [] staining [] effloresco Position: [] reset/level in ground [] reset/lee [] possible new base required [] stabilize four Failed Treatments: [] drill/grind [] hand tool Treatment: [] core drill [] drill and pin [] sin<[] mortar [] repoint [] other:	Athens Cemetery, Athens, GA Section: nument Treatment Proposal Section: nument Treatment Proposal Section: e: "Little Sis" Material: [] marble [] granite [] iii headstone [] footstone [] die on base [] tab in socket [] bo bo Position: [] fallen [] tilted [] unstable [] unattached/loose [] Deterioration: [] broken [] cracked [] losses [] flaking/sugarin [] delamination/detachment [] spalling [] missing fragments [] Extent: [] extensive >50% [] partial 25-50% [] minimal <25% []	Armen's Cemetery, Armen's, GA nument Treatment Proposal Section: Plot: nument Treatment Proposal Section: Plot: nument Treatment Proposal Material: marble granite brick other: :: Interview Material: marble granite brick other: :: headstone footstone die on base tab in socket box other: Position: fallen tilted unstable unattached/loose missing Deterioration: broken cracked losses flaking/sugaring ferrous pins brass pins delamination/detachment spalling missing fragments other: brass pins Extent: extensive >50% partial 25-50% minimal <25%

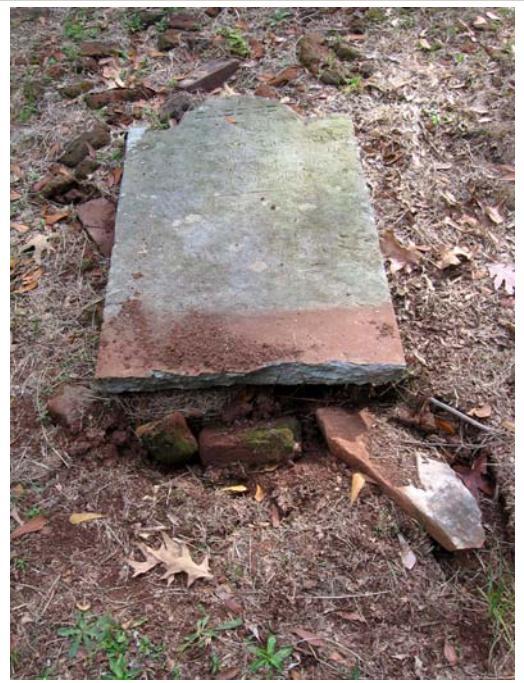
Old Moi	Athens Ceme nument Treatr	tery, Athens, GA nent Proposal	Section:	Plo	ot:	
Name	e: Dr. Thomas King	Material: 🔀 n	narble 🗌 granite 🗌] brick 🗌 othe	r:	
Туре	\therefore headstone	footstone 🗌 die on base 🗌] tab in socket 🗌 boy	∝ □ other:		
	Position: 🔀 faller	n 🗌 tilted 🗌 unstable 🗌 u	nattached/loose 🗌 r	nissing		
ndition	Deterioration: Spalling States and States					
ng Cc	Extent: extensive >50% partial 25-50% minimal <25% not applicable					
Existi	Failed/Old Treatments: metal adhesives/coatings mortar other:					
	Soiling: 🔀 biolog	ical 🛛 staining 🗌 effloresce	ence other:			
egy	Position: I reset	/level in ground 🗌 reset/le ase required 🔲 stabilize four	vel to existing base [ndation] reset with	\Box construct new 0:1:3 mix \Box re	base 🗌 resquare eset with compound	
t Strat	Failed Treatments	: drill/grind hand tool	ls 🗌 solvents 🗌 ot	her:		
reatment	Treatment: cor	e drill ⊠ drill and pin □ si point ⊠ other: infill with Jah	mple adhesive repair ın M120; may be neces	injection grossary to repair be	out 🗌 replace bricks elow grade brick

L	Cleaning: low	pressure water $\square D/2$ and f	flush 🗌 poultice 🔲	other:		
Prior	1) hazardous, immediate action; 2) unstable, requires treatment ASAP;3) ongoing deterioration, treatment required 2-3 years; 4) re-inspect in 5-10 years; 5) irreparable

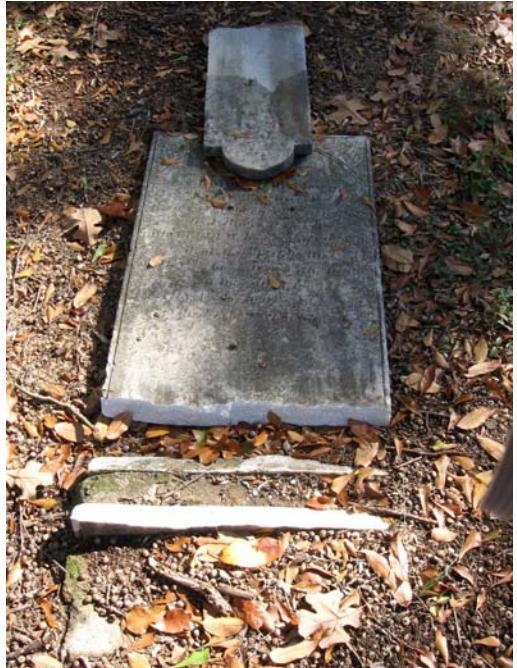
Old Moi	Athens Cemetery, Athens nument Treatment Propos	s, GA al	Section:	Plo	ot:	
Namo	e: Church children	Material: 🔀 marbl	e 🗌 granite 🗌] brick 🔲 othe	er:	
Туре	:⊠headstone ⊠footstone □d	ie on base 🔲 tab i	in socket 🗌 box	other:		
	Position: ⊠ fallen □ tilted □ u	nstable 🗌 unatta	ched/loose 🗌 m	uissing		
ndition	Deterioration: Spalling States Stat					
ng Cc	Extent: 🗌 extensive >50% 🔀 partial 25-50% 🗌 minimal <25% 🗌 not applicable					
Existi	Failed/Old Treatments:					
	Soiling: 🛛 biological 🖾 staining	efflorescence	other:			
egy	Position: I reset/level in ground possible new base required	d 🔲 reset/level to stabilize foundation	\circ existing base \Box	$]$ construct new 0:1:3 mix \square re	v base 🔲 resquare eset with compound	
: Strat	Failed Treatments: drill/grind	hand tools] solvents 🔲 oth	ner:		
reatment	Treatment: ☐ core drill					
L	Cleaning: low pressure water	\boxtimes D/2 and flush	poultice	other:

Prior	Priority: 21) hazardous, immediate action; 2) unstable, requires treatment ASAP; 3) ongoing deterioration, treatment required 2-3 years; 4) re-inspect in 5- 10 years; 5) irreparableCost: \$1350
