PRESERVATION PLAN AND RECOMMENDATIONS FOR THE COTTAGE CEMETERY, AUGUSTA, GEORGIA

Prepared By:
Michael Trinkley, Ph.D.
and
Debi Hacker

CHICORA RESEARCH CONTRIBUTION 493

May 2008

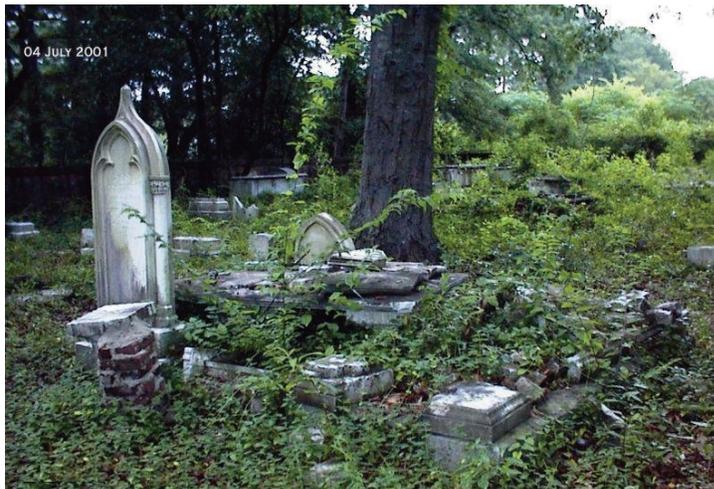
Figure 6. View of the cemetery in 2001 prior to being cleaned by the Augusta Chapter of VMI Alumni.

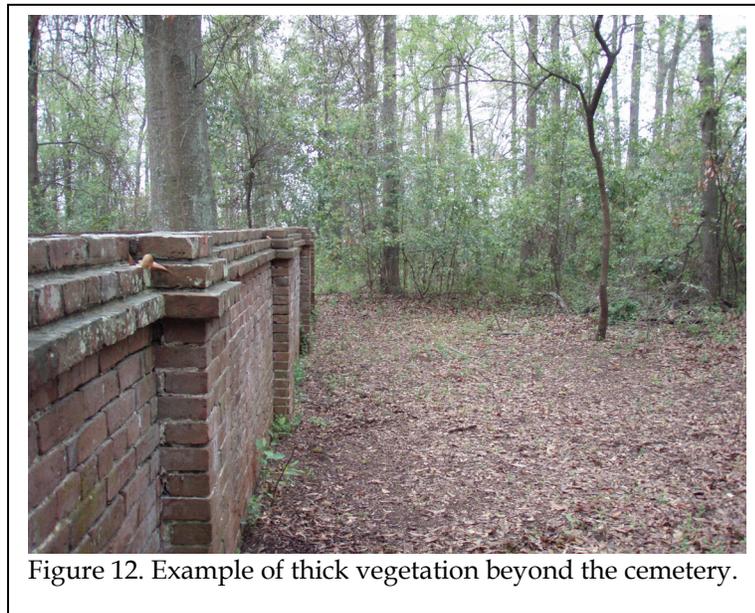
Figure 12. Example of thick vegetation beyond the cemetery.

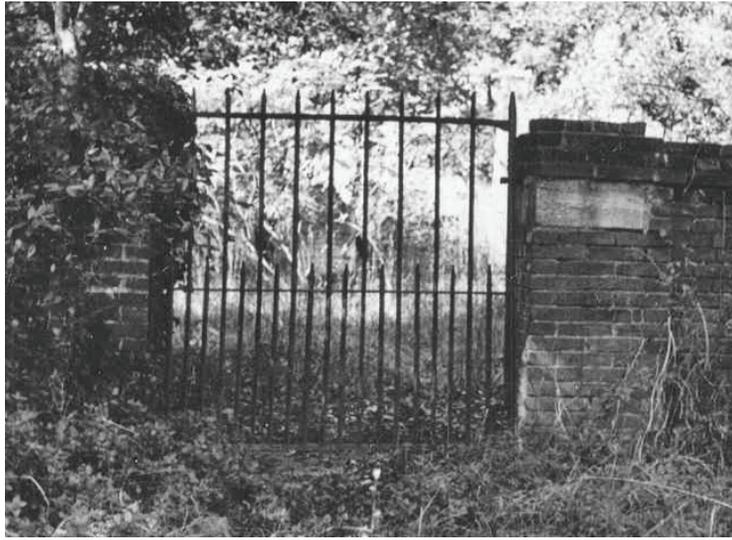
Figure 19. Photo showing the original gate and columns.

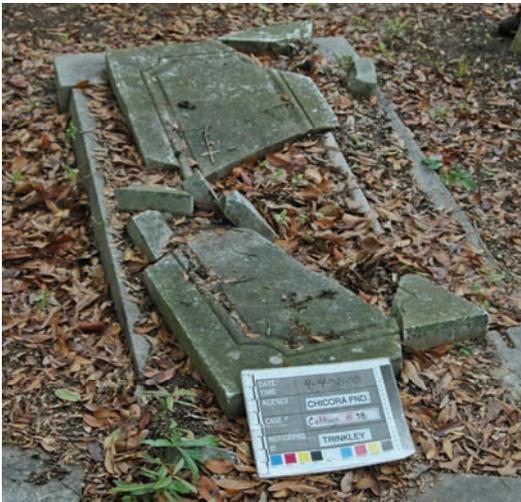
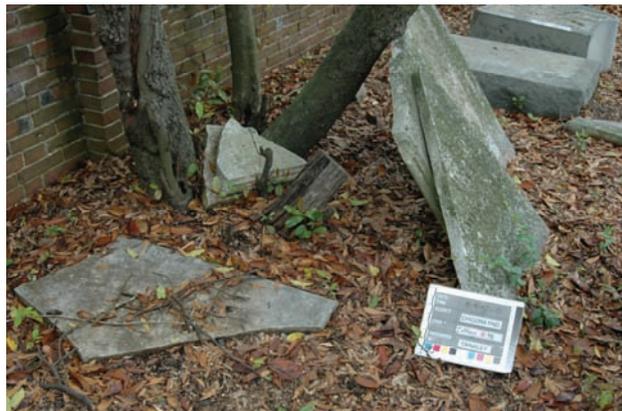
Treatment: core drill drill and pin simple adhesive repair injection grout replace bricks
 mortar repoint infill other: ledger appears intact, but threatened by lack of support.

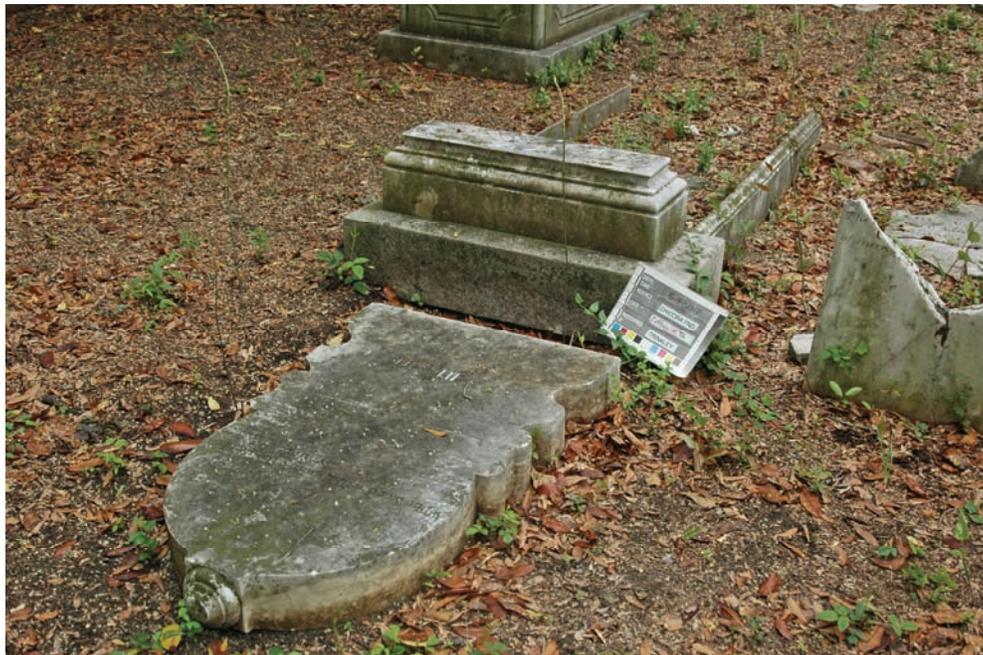
Position: fallen tilted unstable unattached/loose missing

Deterioration: broken cracked losses flaking/sugaring ferrous pins brass pins
 delamination/detachment spalling missing fragments other:

Position: reset/level in ground reset/level to existing base construct new base resquare
 possible new base required stabilize foundation reset with 0:1:3 mix reset with compound

Treatment: core drill drill and pin simple adhesive repair injection grout replace bricks
 mortar repoint infill other: ability to repair depends on the soundness of the stone.

Cost: **\$1,400**

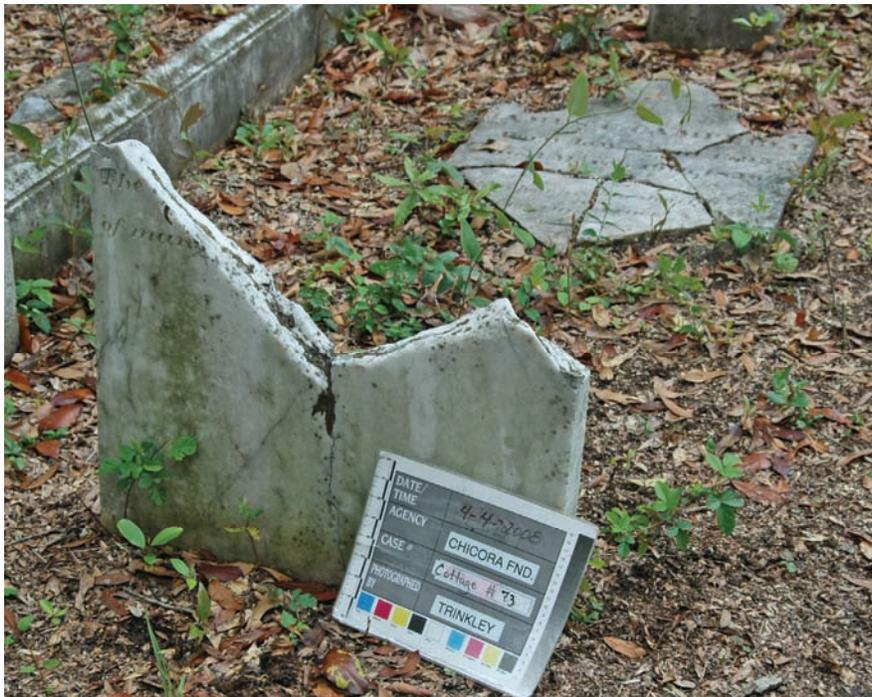
Position: fallen tilted unstable unattached/loose missing

Deterioration: broken cracked losses flaking/sugaring ferrous pins brass pins
 delamination/detachment spalling missing fragments other:

Position: reset/level in ground reset/level to existing base construct new base resquare
 possible new base required stabilize foundation reset with 0:1:3 mix reset with compound

Treatment: core drill drill and pin simple adhesive repair injection grout replace bricks
 mortar repoint infill other:

Cost: \$850

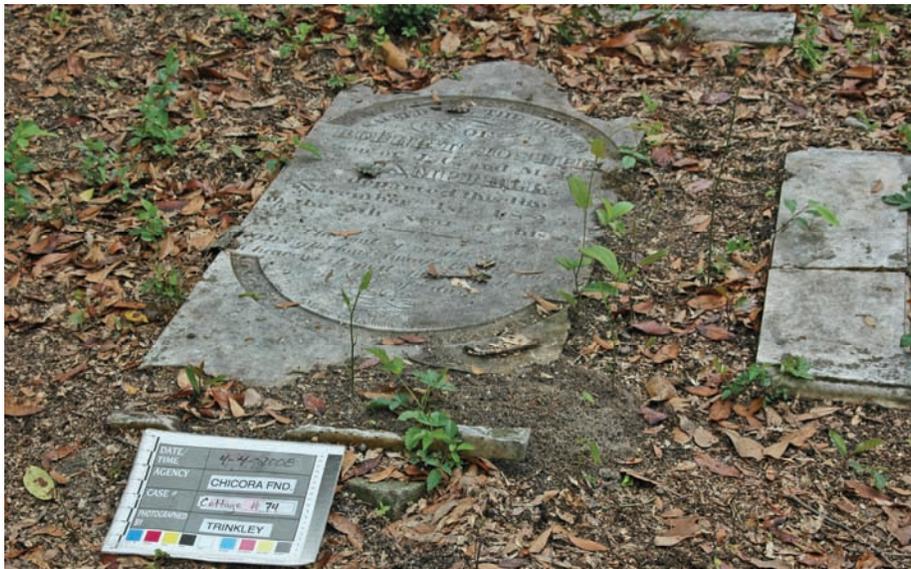
Position: fallen tilted unstable unattached/loose missing

Deterioration: broken cracked losses flaking/sugaring ferrous pins brass pins
 delamination/detachment spalling missing fragments other:

Position: reset/level in ground reset/level to existing base construct new base resquare
 possible new base required stabilize foundation reset with 0:1:3 mix reset with compound

Treatment: core drill drill and pin simple adhesive repair injection grout replace bricks
 mortar repoint infill other: ability to repair depends on the soundness of the stone.

Cost: \$1,400

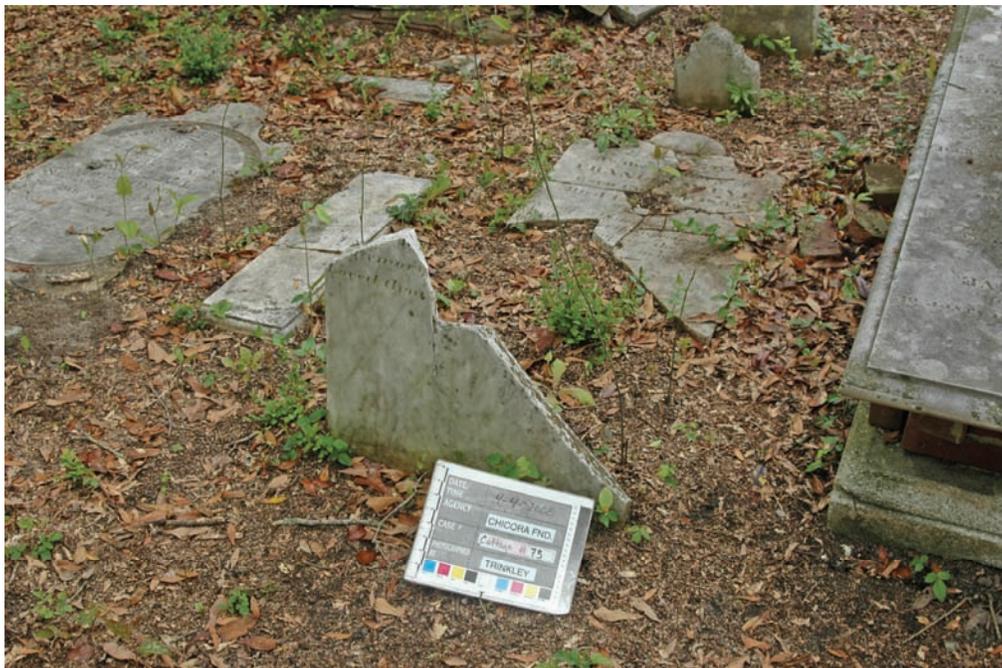
Position: fallen tilted unstable unattached/loose missing

Deterioration: broken cracked losses flaking/sugaring ferrous pins brass pins
 delamination/detachment spalling missing fragments other: bricks loose

Position: reset/level in ground reset/level to existing base construct new base resquare
 possible new base required stabilize foundation reset with 0:1:3 mix reset with compound

Treatment: core drill drill and pin simple adhesive repair injection grout replace bricks
 mortar repoint infill other:

Cost: \$550

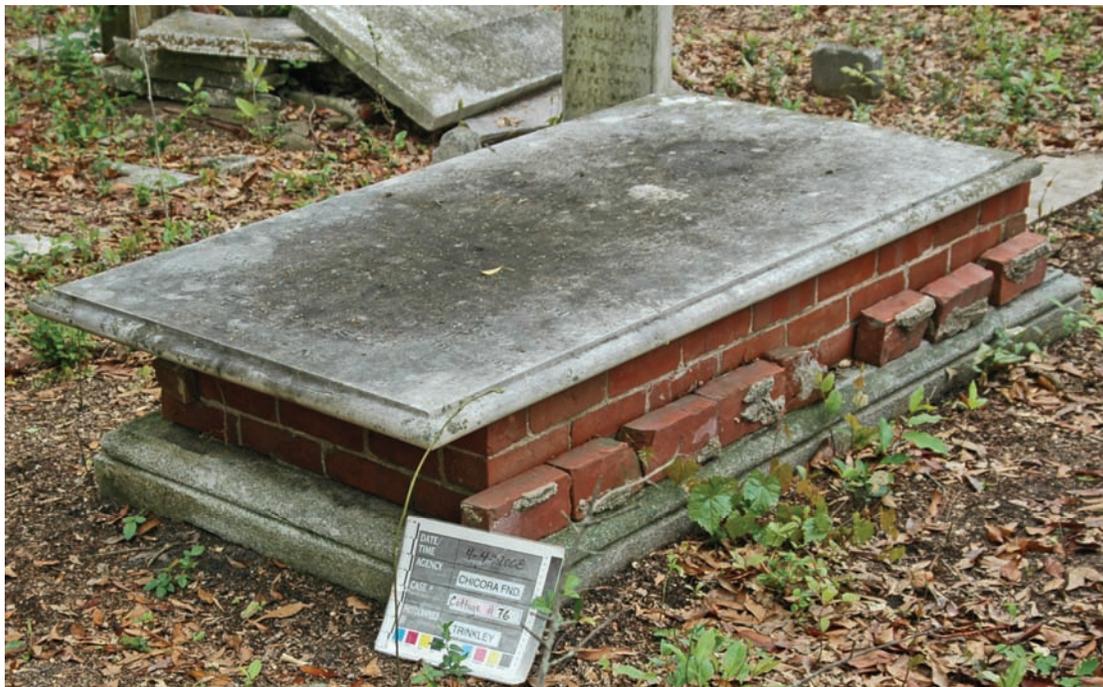
Position: fallen tilted unstable unattached/loose missing

Deterioration: broken cracked losses flaking/sugaring ferrous pins brass pins
 delamination/detachment spalling missing fragments other: damage to brick

Position: reset/level in ground reset/level to existing base construct new base resquare
 possible new base required stabilize foundation reset with 0:1:3 mix reset with compound

Treatment: core drill drill and pin simple adhesive repair injection grout replace bricks
 mortar repoint infill other: box may need to be filled to support ledger

Cost: \$1,050

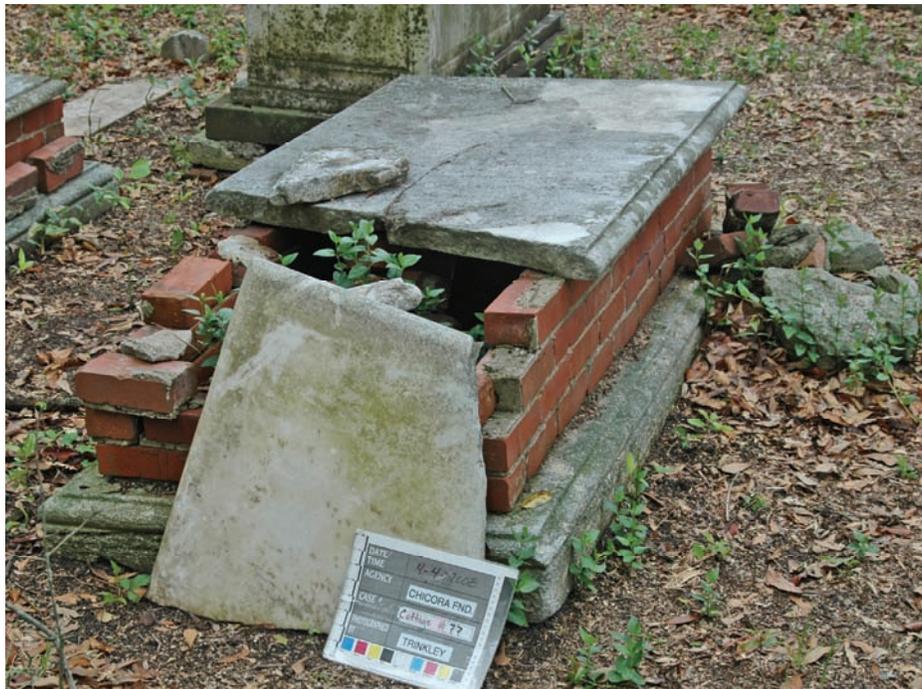
Position: fallen tilted unstable unattached/loose missing

Deterioration: broken cracked losses flaking/sugaring ferrous pins brass pins
 delamination/detachment spalling missing fragments other:

Position: reset/level in ground reset/level to existing base construct new base resquare
 possible new base required stabilize foundation reset with 0:1:3 mix reset with compound

Treatment: core drill drill and pin simple adhesive repair injection grout replace bricks
 mortar repoint infill other:

Cost: \$600
