PHOTOGRAPHS, SKETCH PLANS AND DESCRIPTIVE DATA FOR THE SPRINGFIELD/S&O CANAL FLOODGATES, CITY OF SAVANNAH, CHATHAM COUNTY, GEORGIA

Springfield/S&O Canal Floodgate
North of Oglethorpe Street and east of Canal Street
Savannah
Chatham County
Georgia

PHOTOGRAPHS, SKETCH PLANS, AND DESCRIPTIVE DATA

Springfield/Savannah-Ogeochee Canal Tidal Floodgate (City of Savannah, 1995)

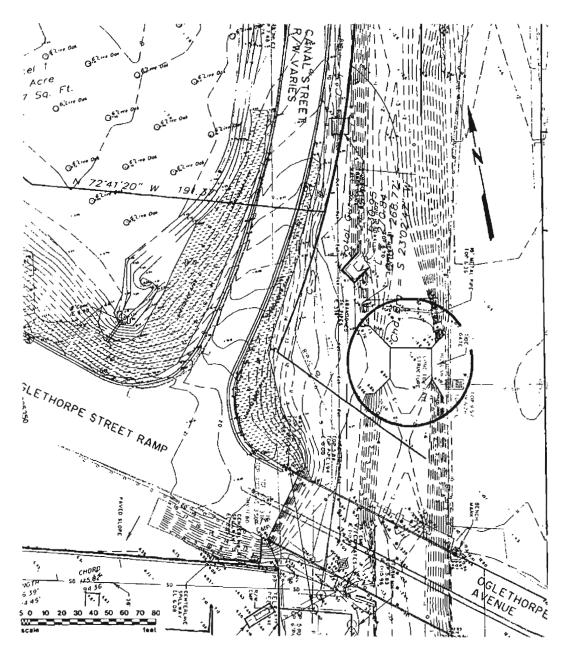
SITE PLAN

TAKEN FROM SITE PLANS PROVIDED BY THOMAS & HUTTON ENGINEERS, SAVANNAH, GA.

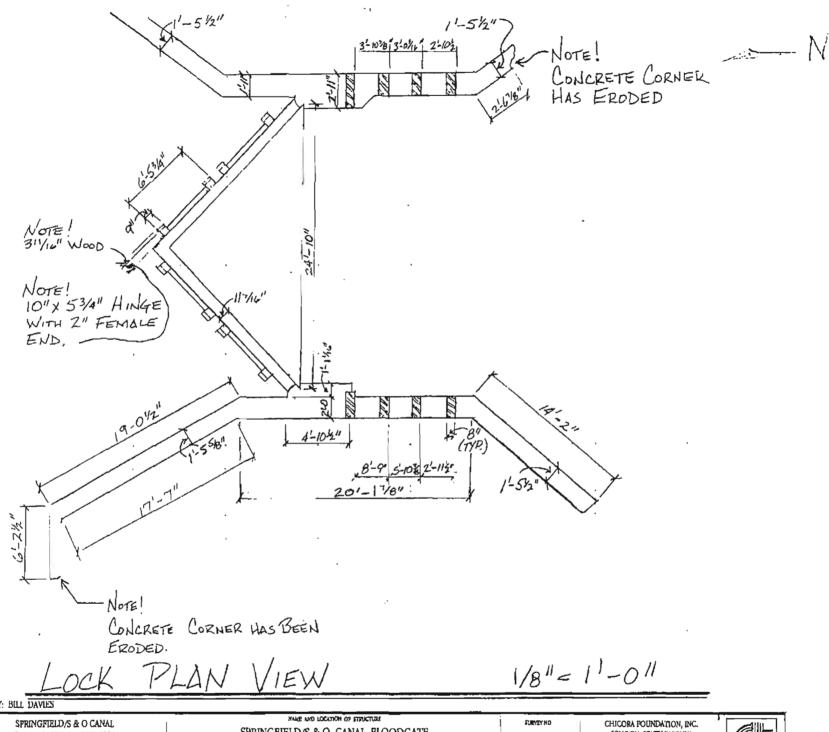
SPRINGFIELD/S & O CANAL FLOODGATE NORTH OF OGLETHORPE STREET AND EAST OF CANAL STREET

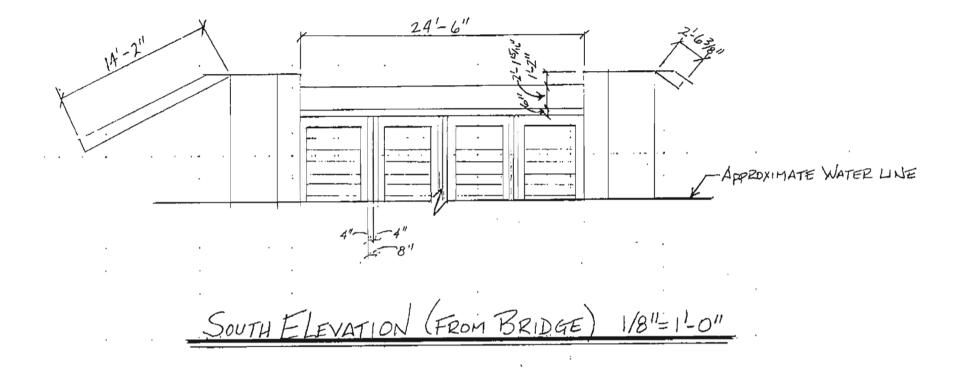
SHEET 4 OF 5

SPRINGFIELD/S & O CANAL FLOODGATE NORTH OF OCLETHORFE STREET AND EAST OF CANAL STREET

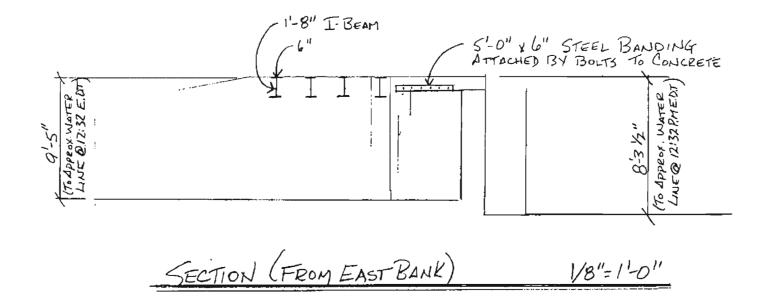
SHEET 5 OF 5

SPRINGFIELD/S & O CANAL FLOODGATE

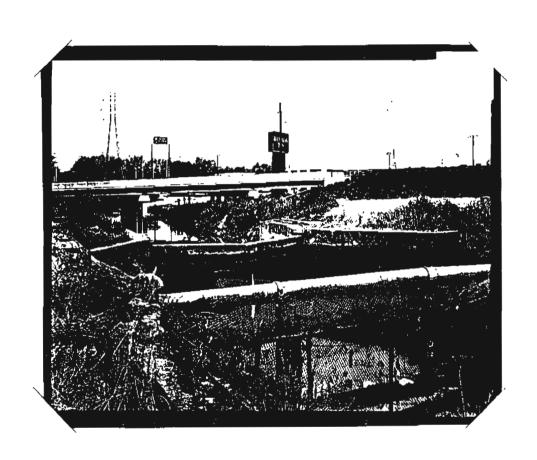
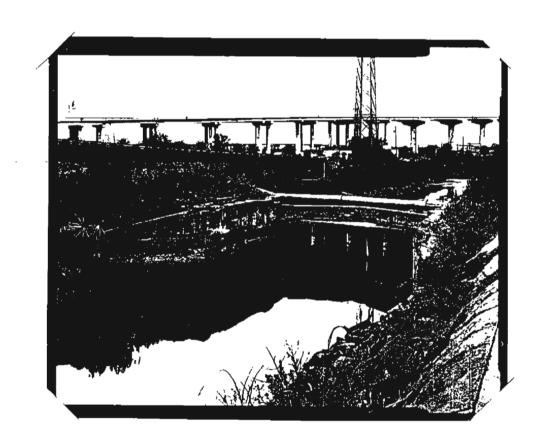
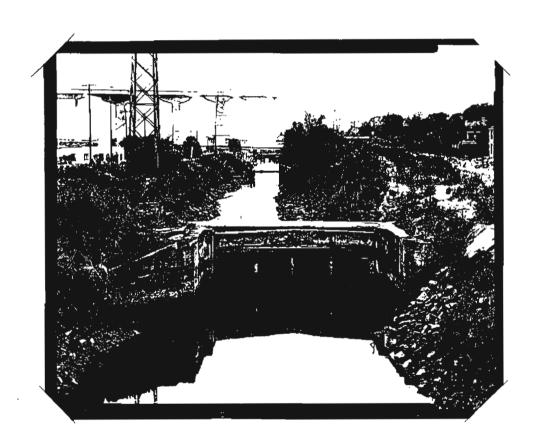
CHICORA FOUNDATION, INC. INDEX TO BLACK AND WHITE PHOTOGRAPHS

- Oblique view of north elevation of gates from the west bank of the canal, taken as the tide was dropping (view is to the southeast)
- Near frontal view of the north elevation of gates from the east bank of the canal, taken as the tide was dropping (view is to the southwest)
- Oblique view of the south elevation of gates from the east bank of the canal, taken as the tide was approaching its lowest point (view is to the northeast)
- 4 Close-up view of the eastern side-wall from the gate platform, showing I-beams additions and iron band (view is to the east)
- View of the south elevation of the gates from the Oglethorpe Street bridge, showing the canal in its overall context (view is to the north)
- 6 Close-up view of the western two gates from the west bank of the canal, taken at dead low tide (view is to the southeast)

A good view of the north elevation was not possible since the tide did not drop sufficiently low to allow entry into the canal during the photo shoot. On this day, even at low tide, the water north of the gates was ranged from 4½ to over 6 feet in depth, with an irregular bottom. Obstructions in the canal also prevented moving further northward. The water to the south of the gates was at least 4½ to 5 feet in depth. Consequently, the north elevation was shot from the east and west banks and the south elevation was shot from the Oglethorpe Street bridge. The view of the north elevation from the eastern bank is compromised by the presence of a fence and a large pipe crossing the canal.
