RESTHAVEN CEMETERY ASSESSMENT, CITY OF WASHINGTON, WILKES COUNTY, GEORGIA

Chicora Research Contribution 585

November 2017

The study examines Washington's city cemetery, founded in 1857. It includes 41.1 acres, most of which has been developed, and it includes both African American and white citizens. It is included on the National Register of Historic Places as part of the Washington National Register Historic District.

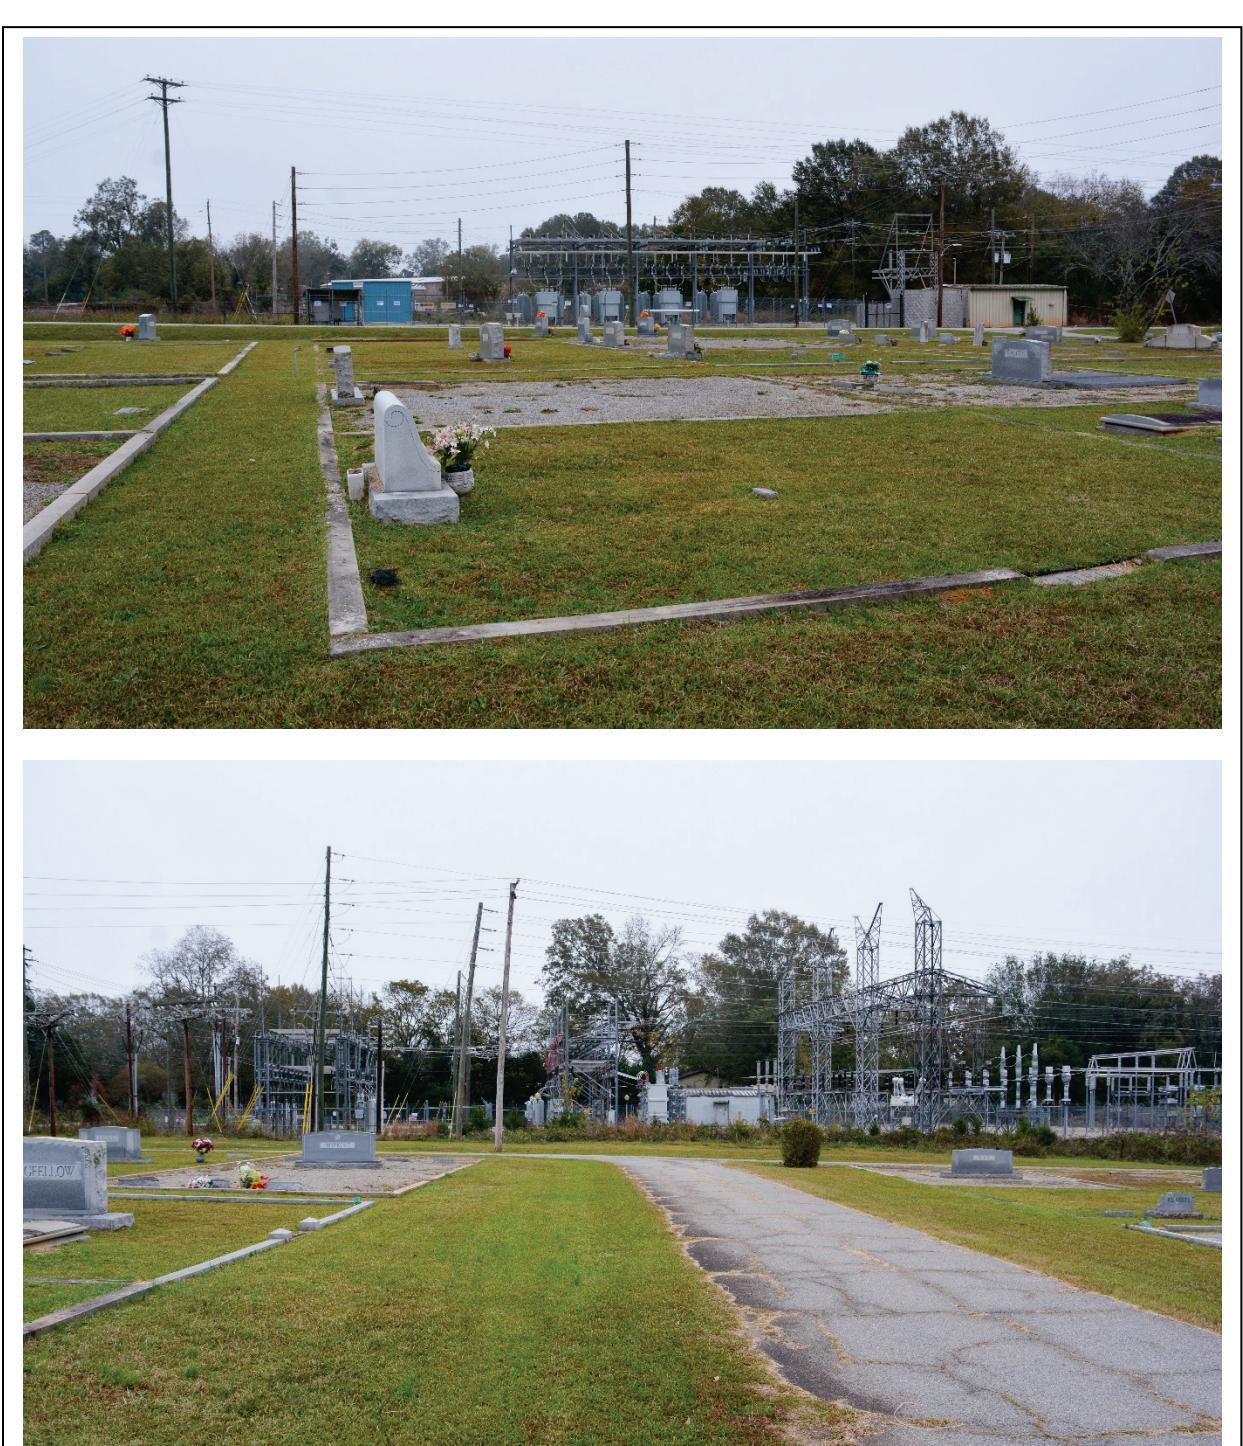
Figure 10. Screening issues at Resthaven Cemetery. Above, the electrical substation north of the cemetery, affecting the 1947 additions. Below, the electrical substation east of the cemetery, affecting the 1947 additions .

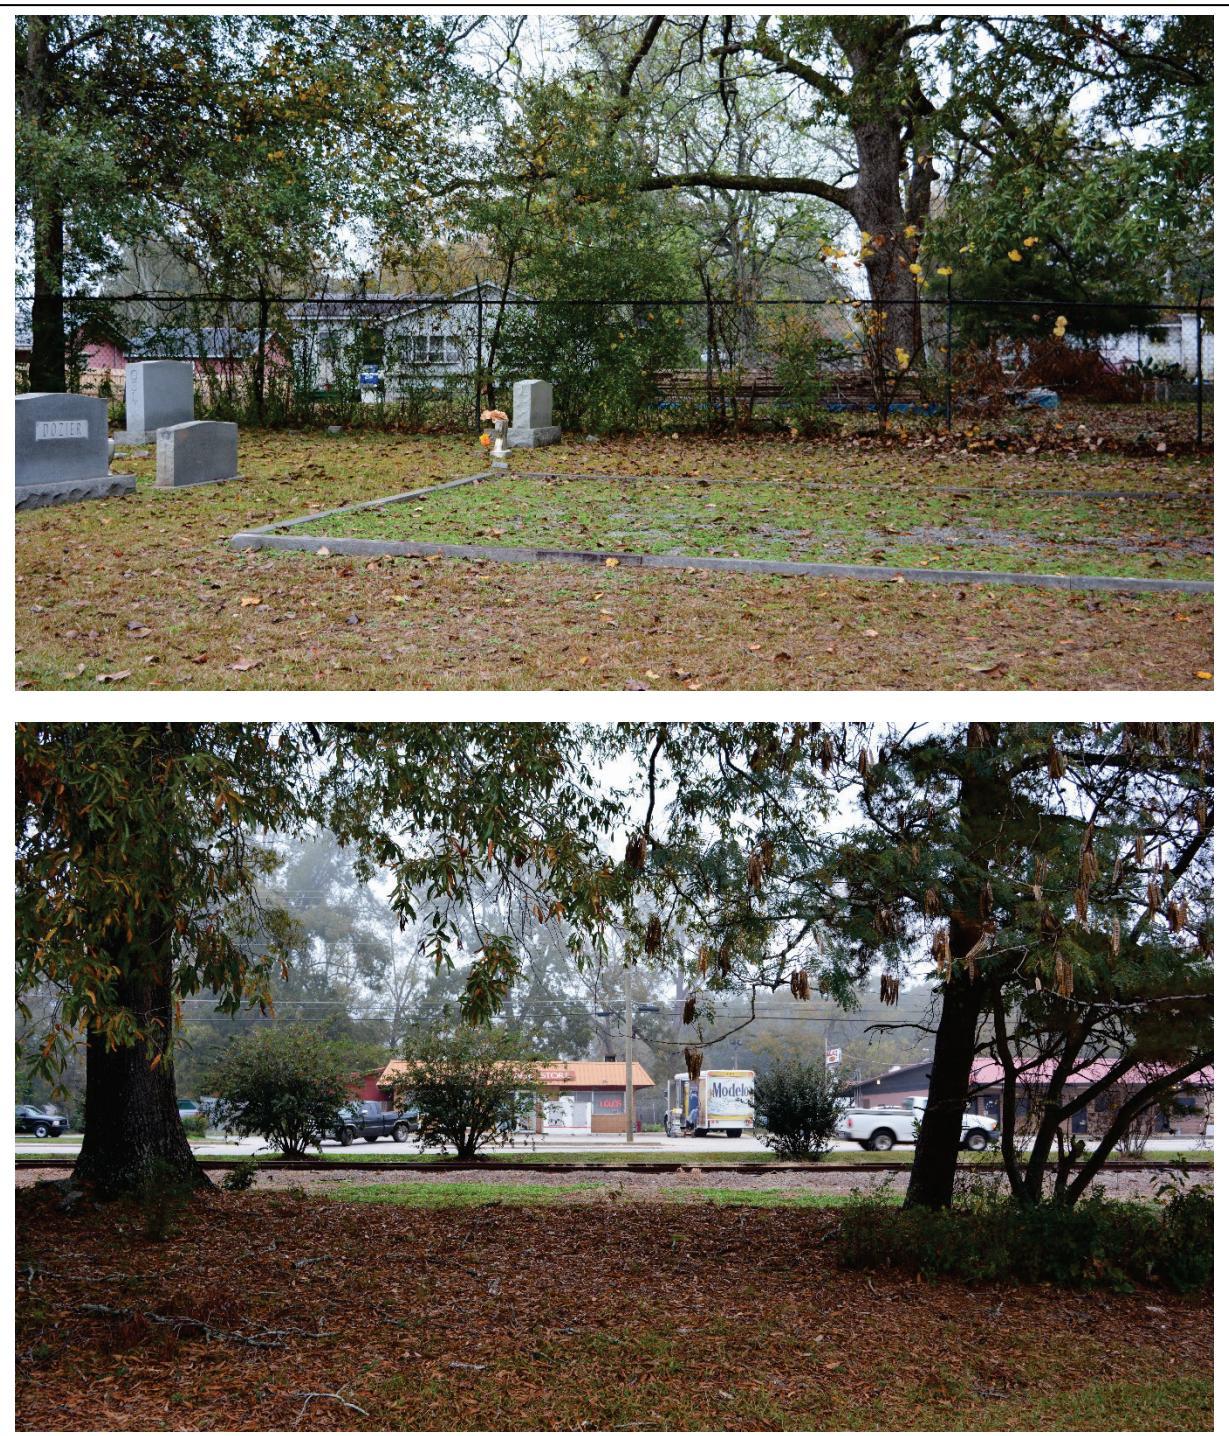
Figure 11. Screening issues at Resthaven Cemetery. Above, lack of screening into the adjacent neighborhood, affecting the SW Annex and the Third Addition. Below, lack of screening for about half of the 1923 Section.

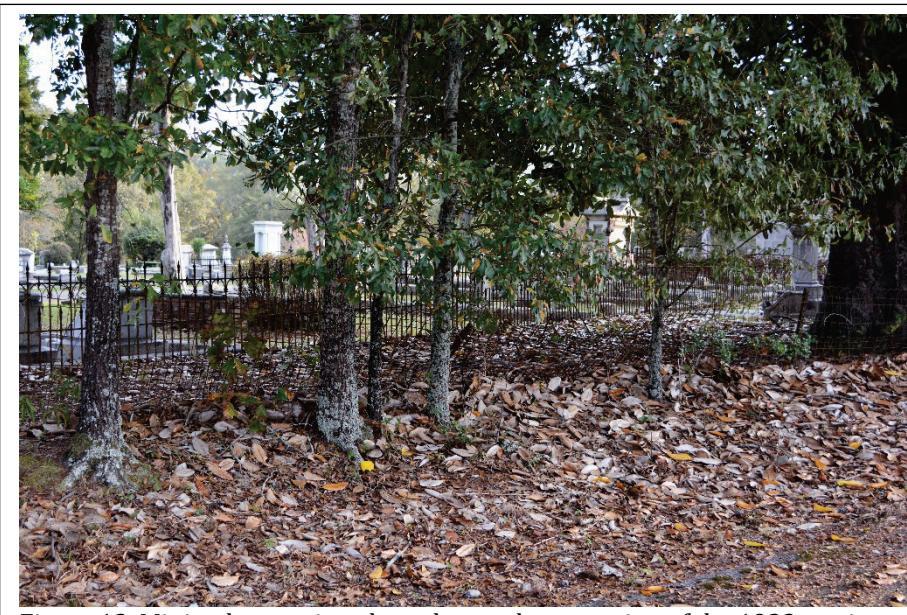
Figure 12. Minimal screening along the northern portion of the 1923 section.

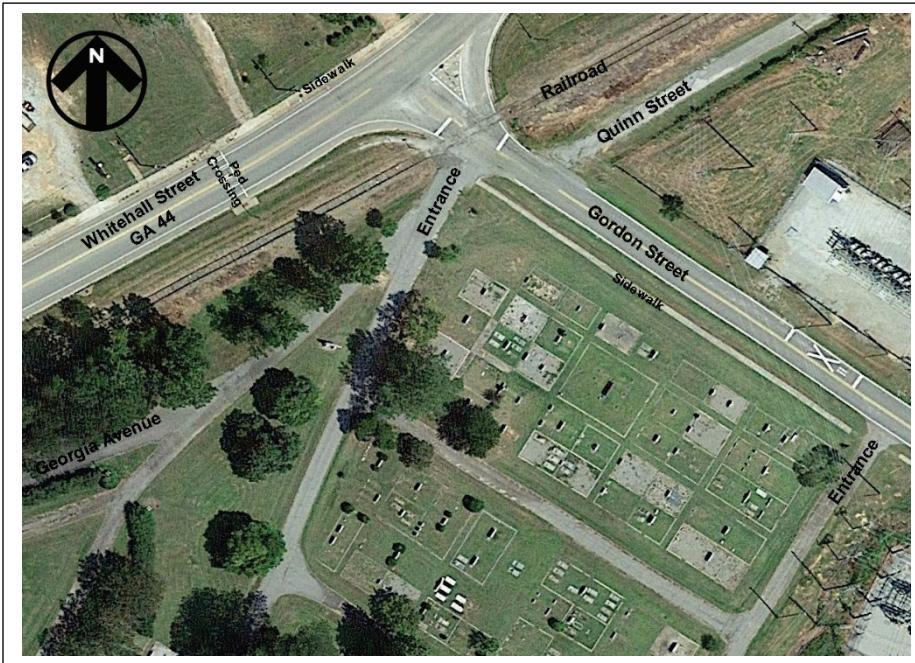
Figure 21. North cemetery entrance showing convergence of four roads and a railroad.

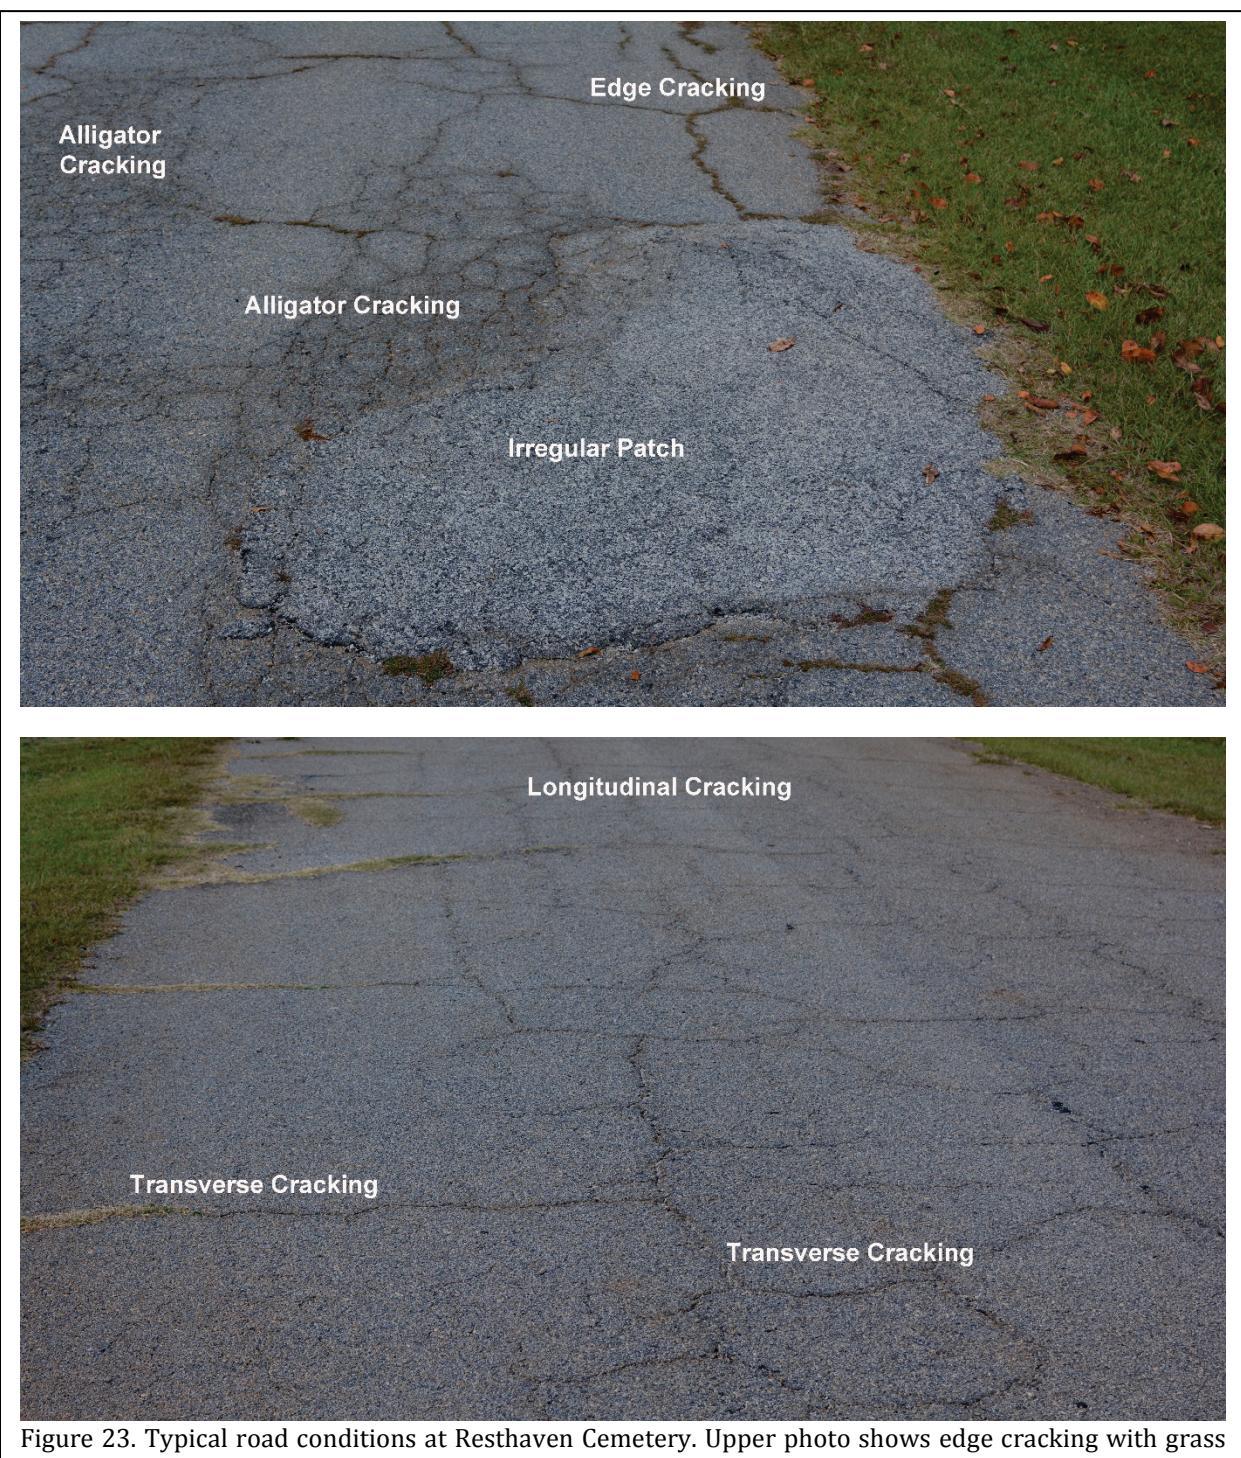
Figure 23. Typical road conditions at Resthaven Cemetery. Upper photo shows edge cracking with grass growing in the cracks, alligator cracking, and irregular patching. Lower photo shows transverse and longitudinal cracks, again with grass growing in multiple examples.

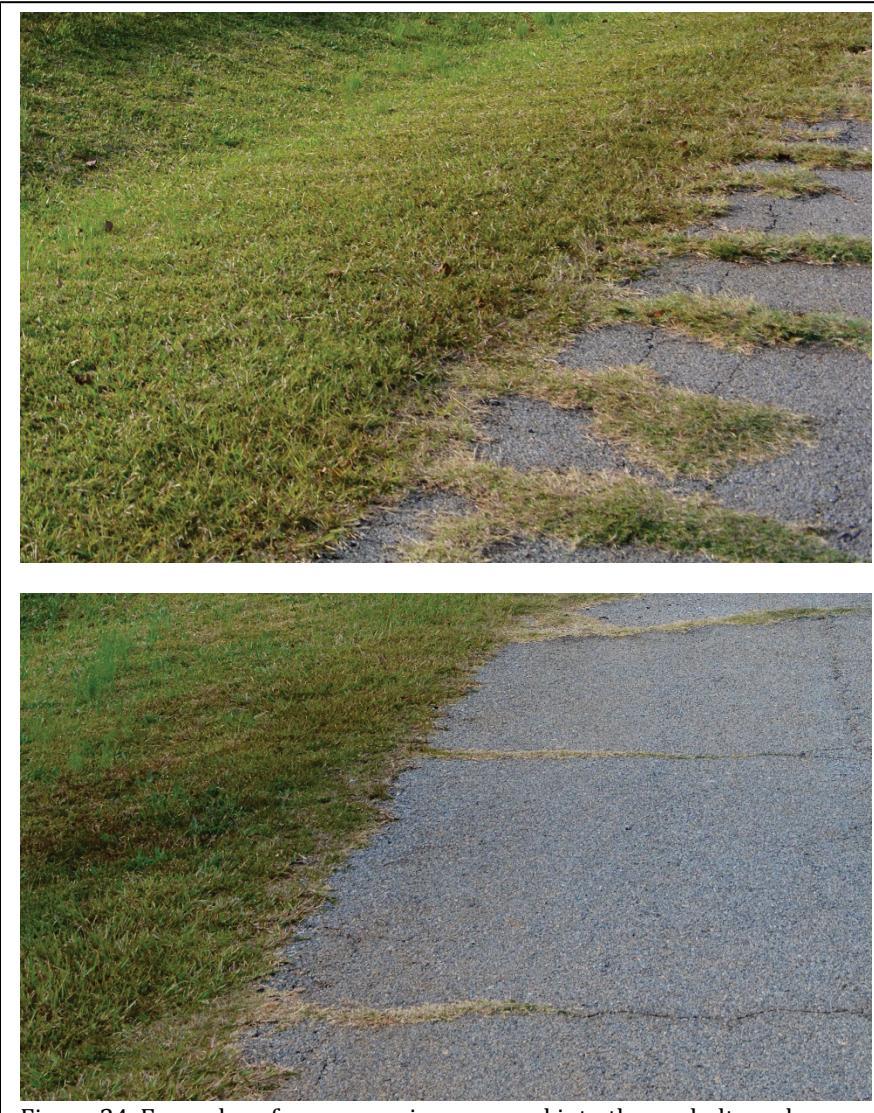
Figure 24. Examples of grass growing over and into the asphalt roadway.

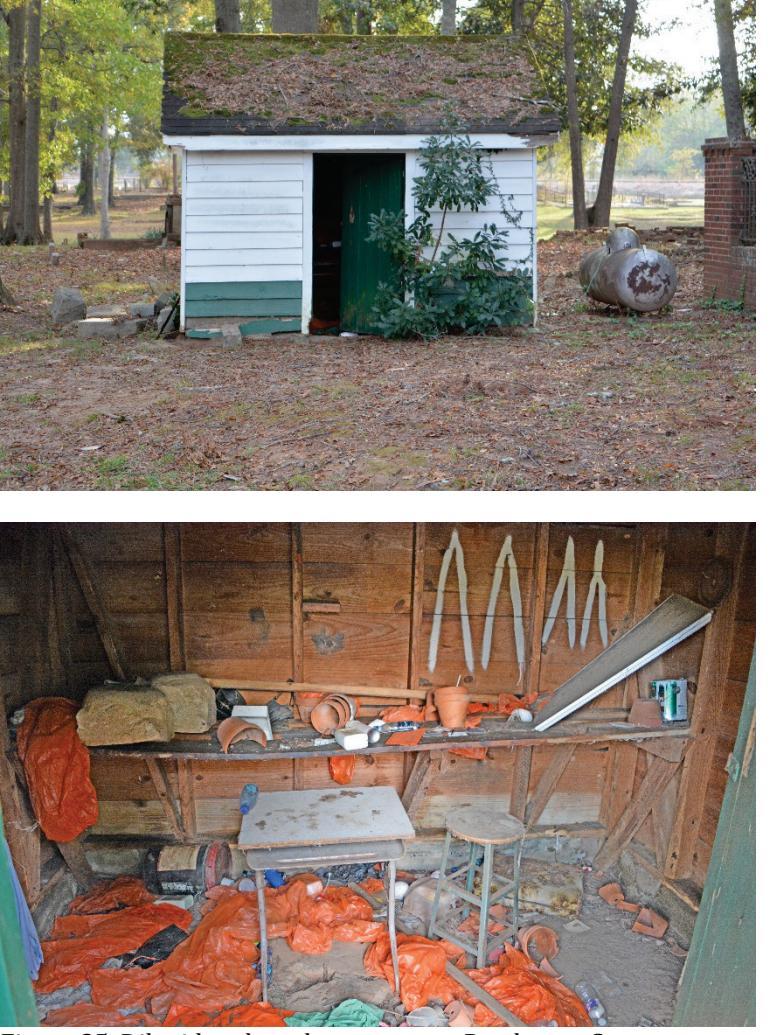
Figure 25. Dilapidated work structure at Resthaven Cemetery.

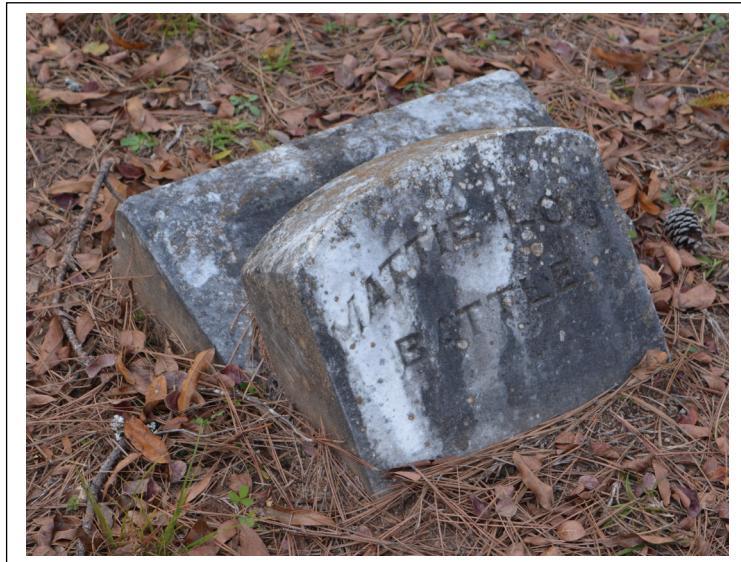
Figure 27. Situations like this are often attributed to vandalism, but are caused by poor foundations and the sinking of graves.

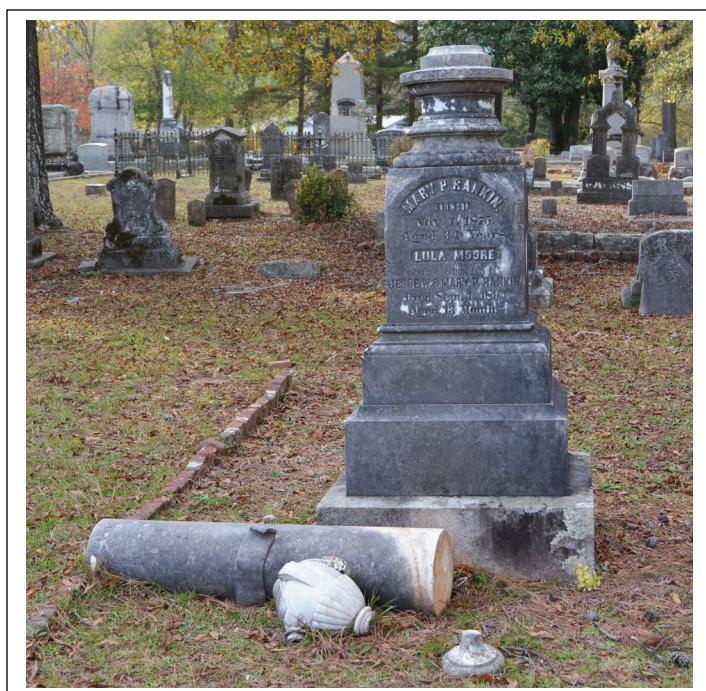
Figure 28. The single example of documented vandalism. Repair of this one monument will cost in excess of \$3,000.

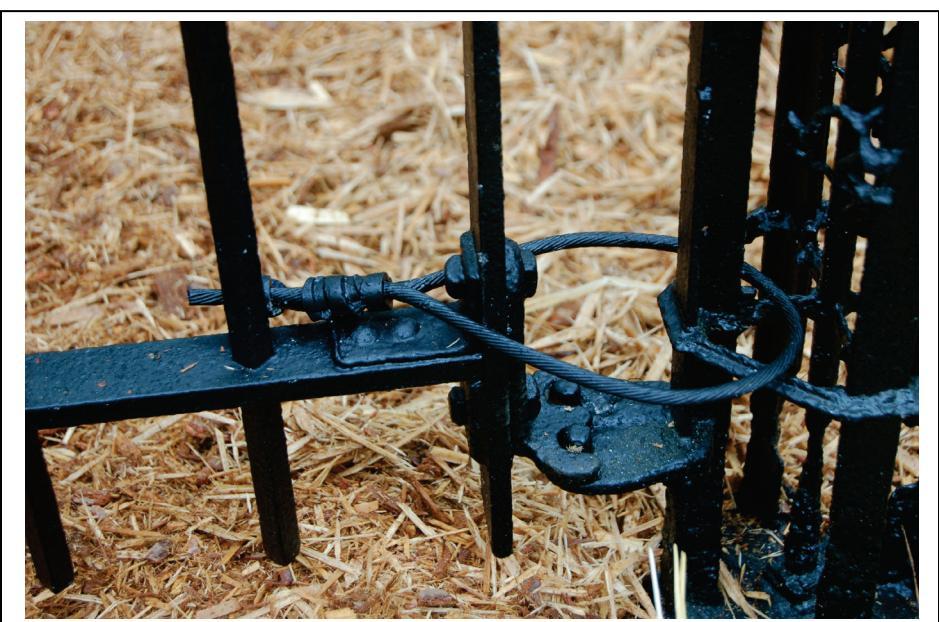
Figure 30. Example of a gate protected with stainless steel cabling that has been painted to blend with the fence.

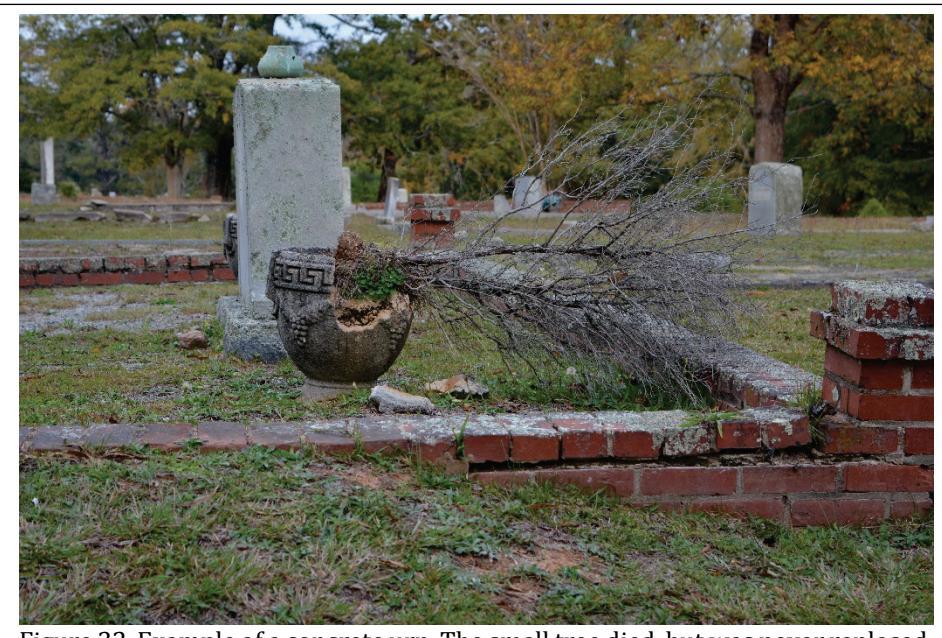
Figure 32. Example of a concrete urn. The small tree died, but was never replaced. The urn is now broken, but remains on the plot creating an eye sore.

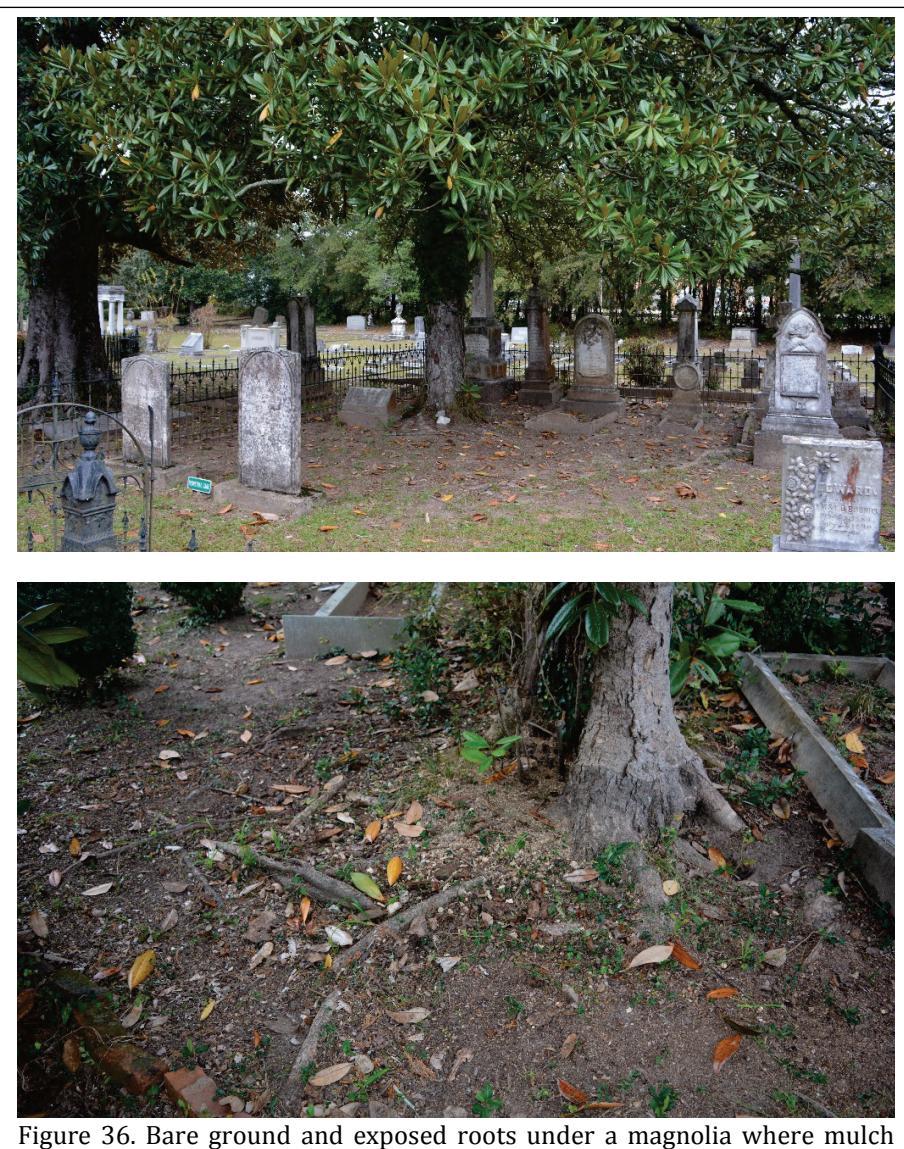
Figure 36. Bare ground and exposed roots under a magnolia where mulch should be installed in lieu of turf.

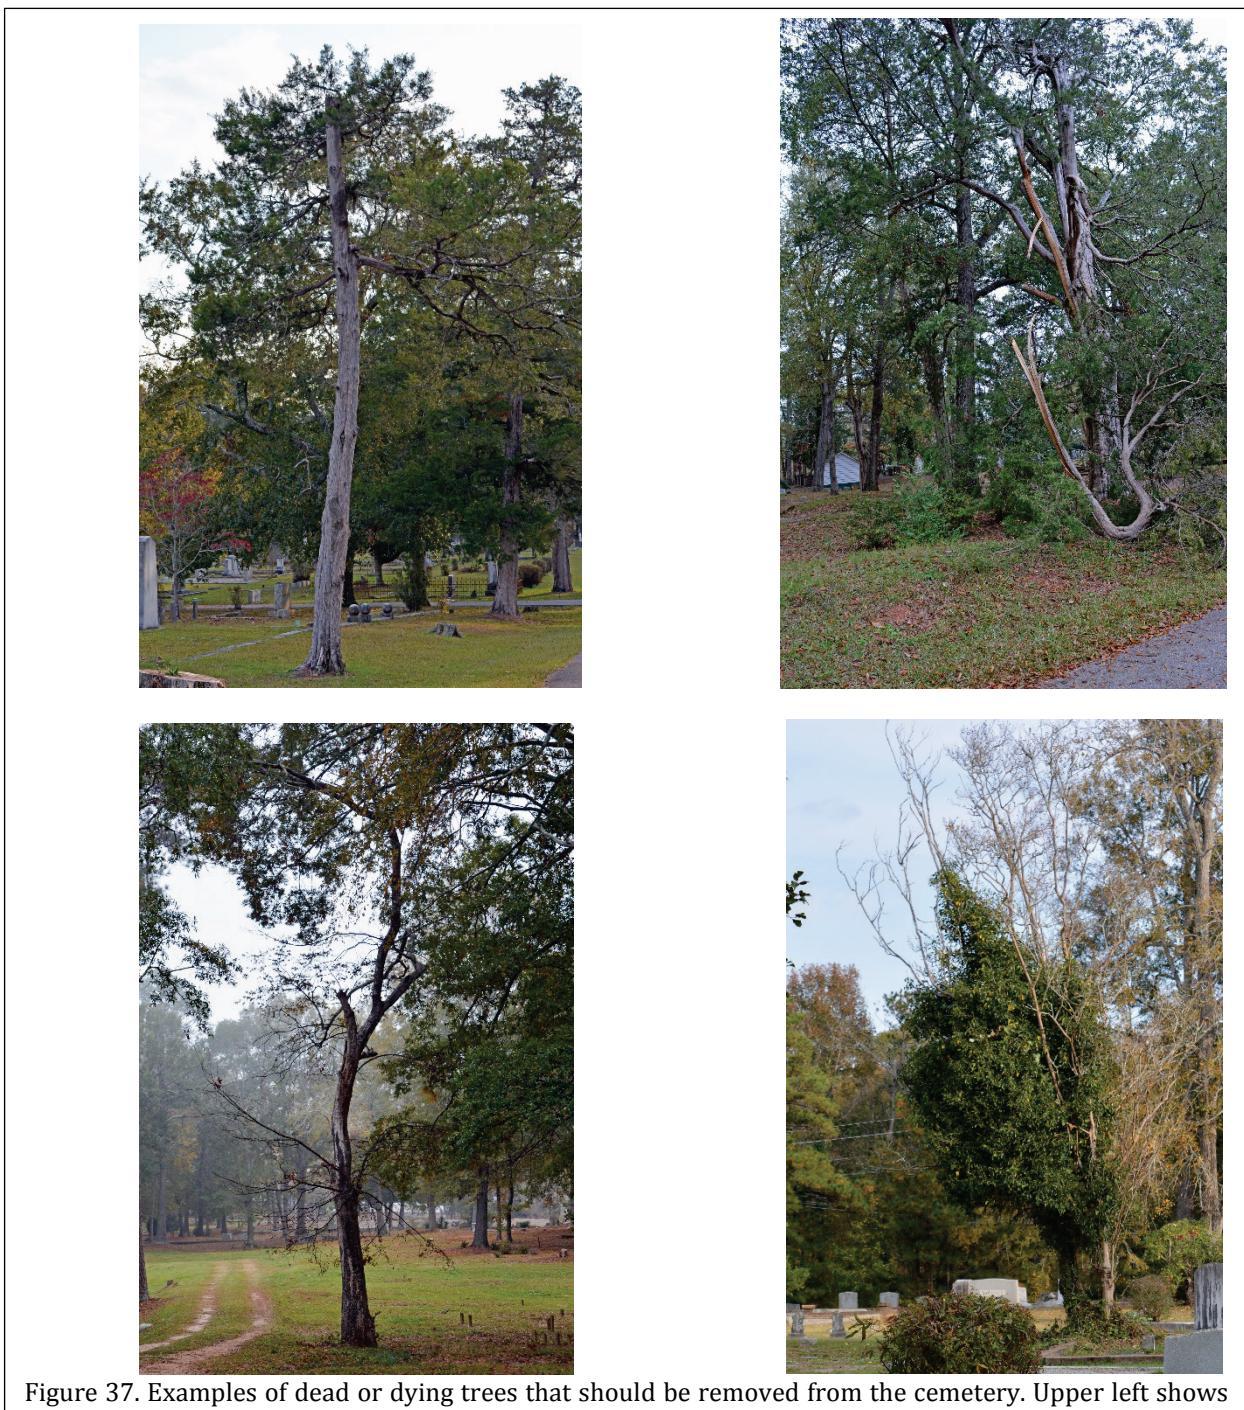
Figure 37. Examples of dead or dying trees that should be removed from the cemetery. Upper left shows dying cedar that has been topped and has few branches left; upper right shows severely damaged cedar, where pruning may be sufficient; lower left shows dead tree; lower right shows dead tree in the midst of one still alive.

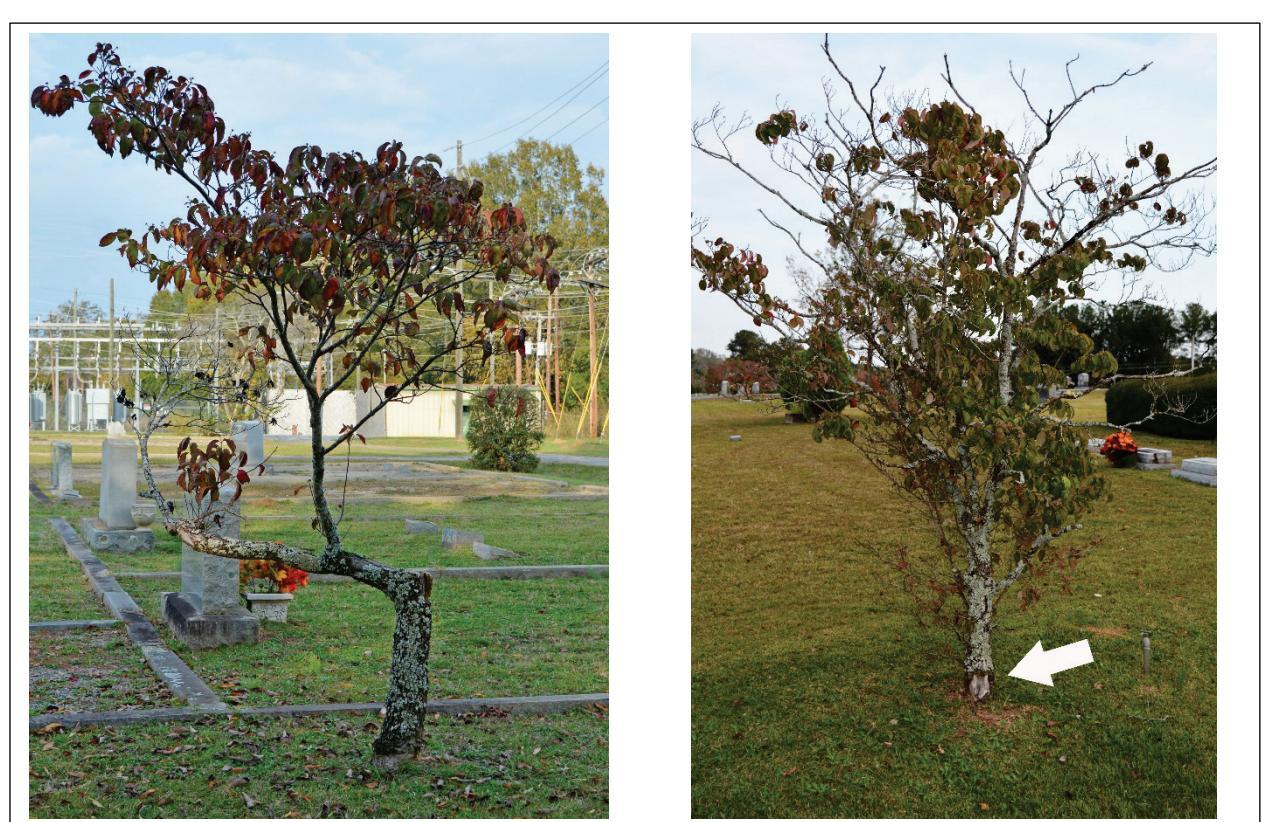
Figure 41. Dogwoods in poor health. The specimen on the left is spindly and exhibits abundant lichen. The specimen on the right has die back and extensive damage of the trunk, probably from mower hits.

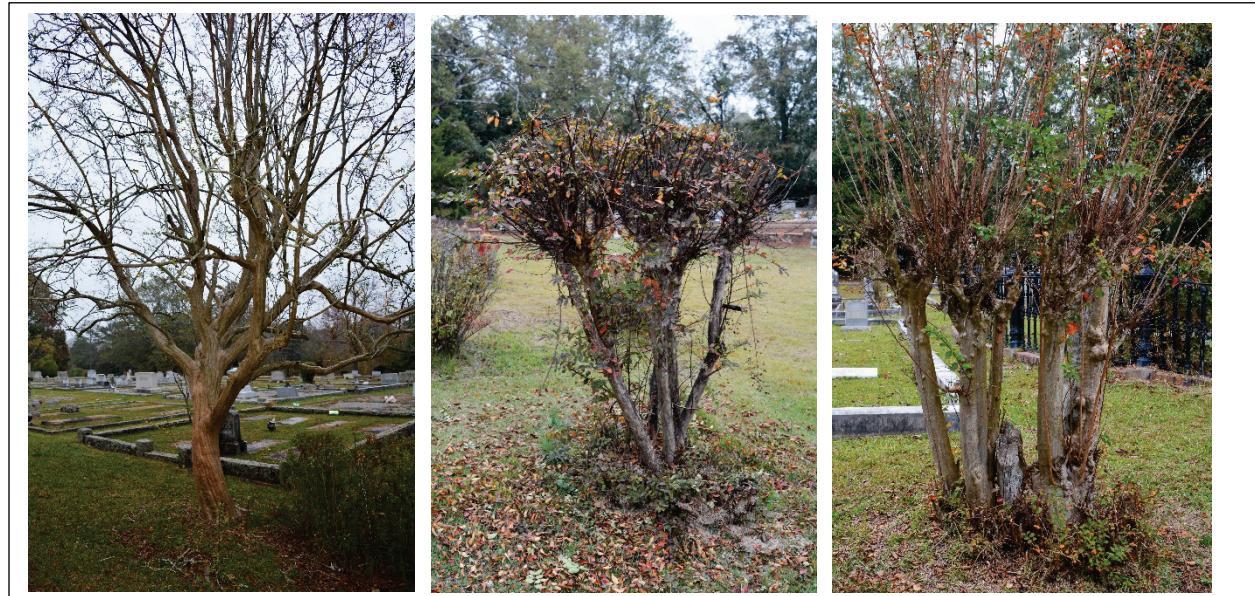
Figure 43. Crepe myrtle murder. On the left is a crepe myrtle that shows its natural proportions and beauty. On the right are two photos of improper pruning, the resulting "witches broom" growth, and the beginning formation of knobs at the far right.

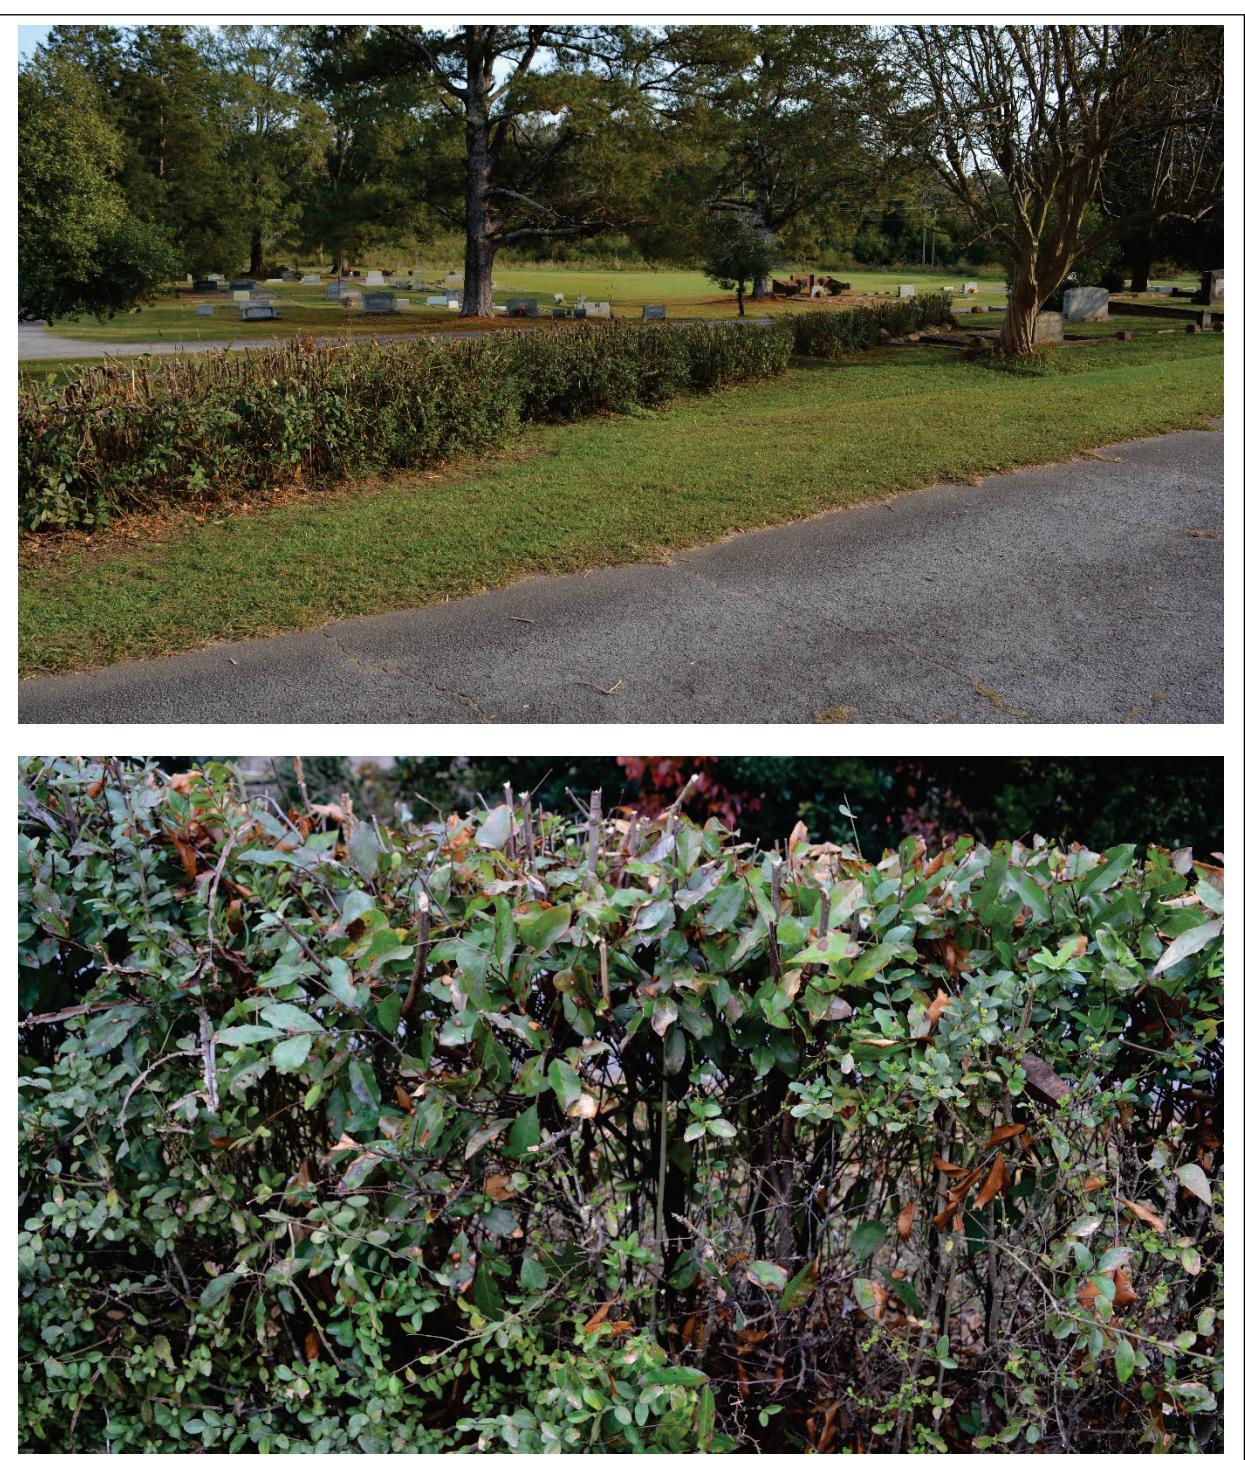
Figure 44. Poorly pruned shrubs at north entrance. Top photo shows what is left and bottom photo shows a mix of boxwood shrubs and cherry laurel trees.

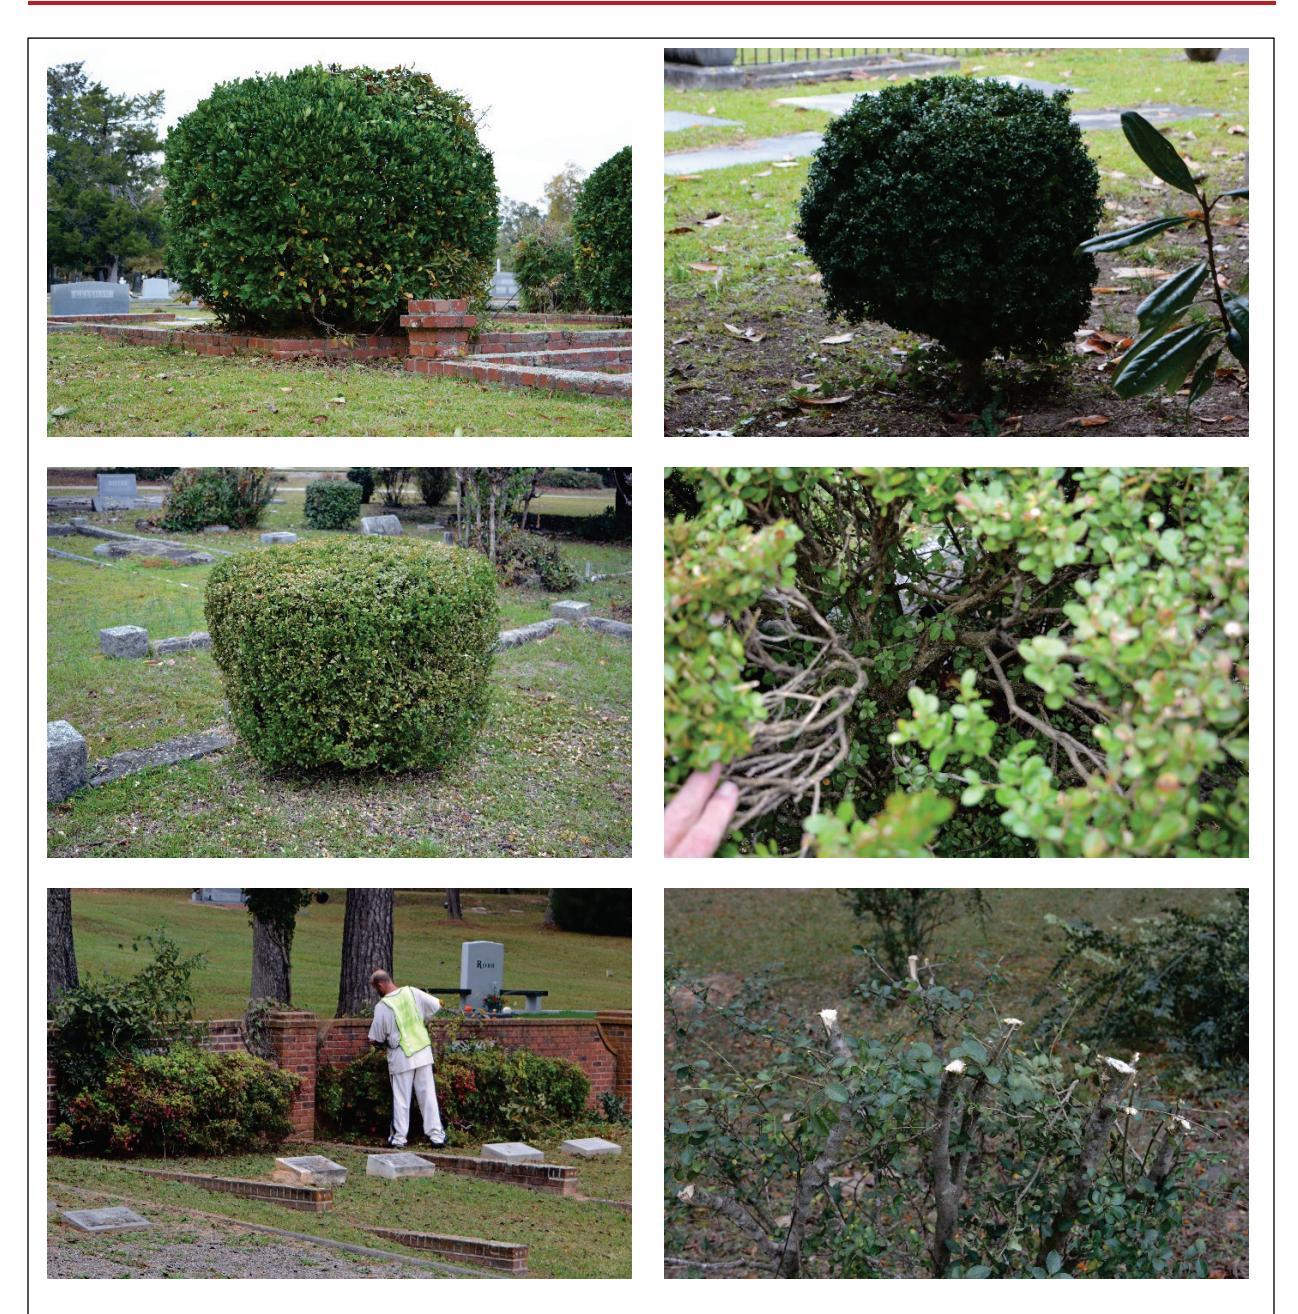
Figure 45. Improper pruning. Top photos show fanciful, unnatural shapes that prevent light from entering and promote excessive exterior growth. Middle left photo shows an improperly pruned boxwood from the outside. Middle right photo shows the dead wood on the interior that same boxwood. Lower left photo shows prison detail using a gasoline shear. Lower right photo shows improper pruning, leaving nothing from woody stalks with jagged, torn cuts.

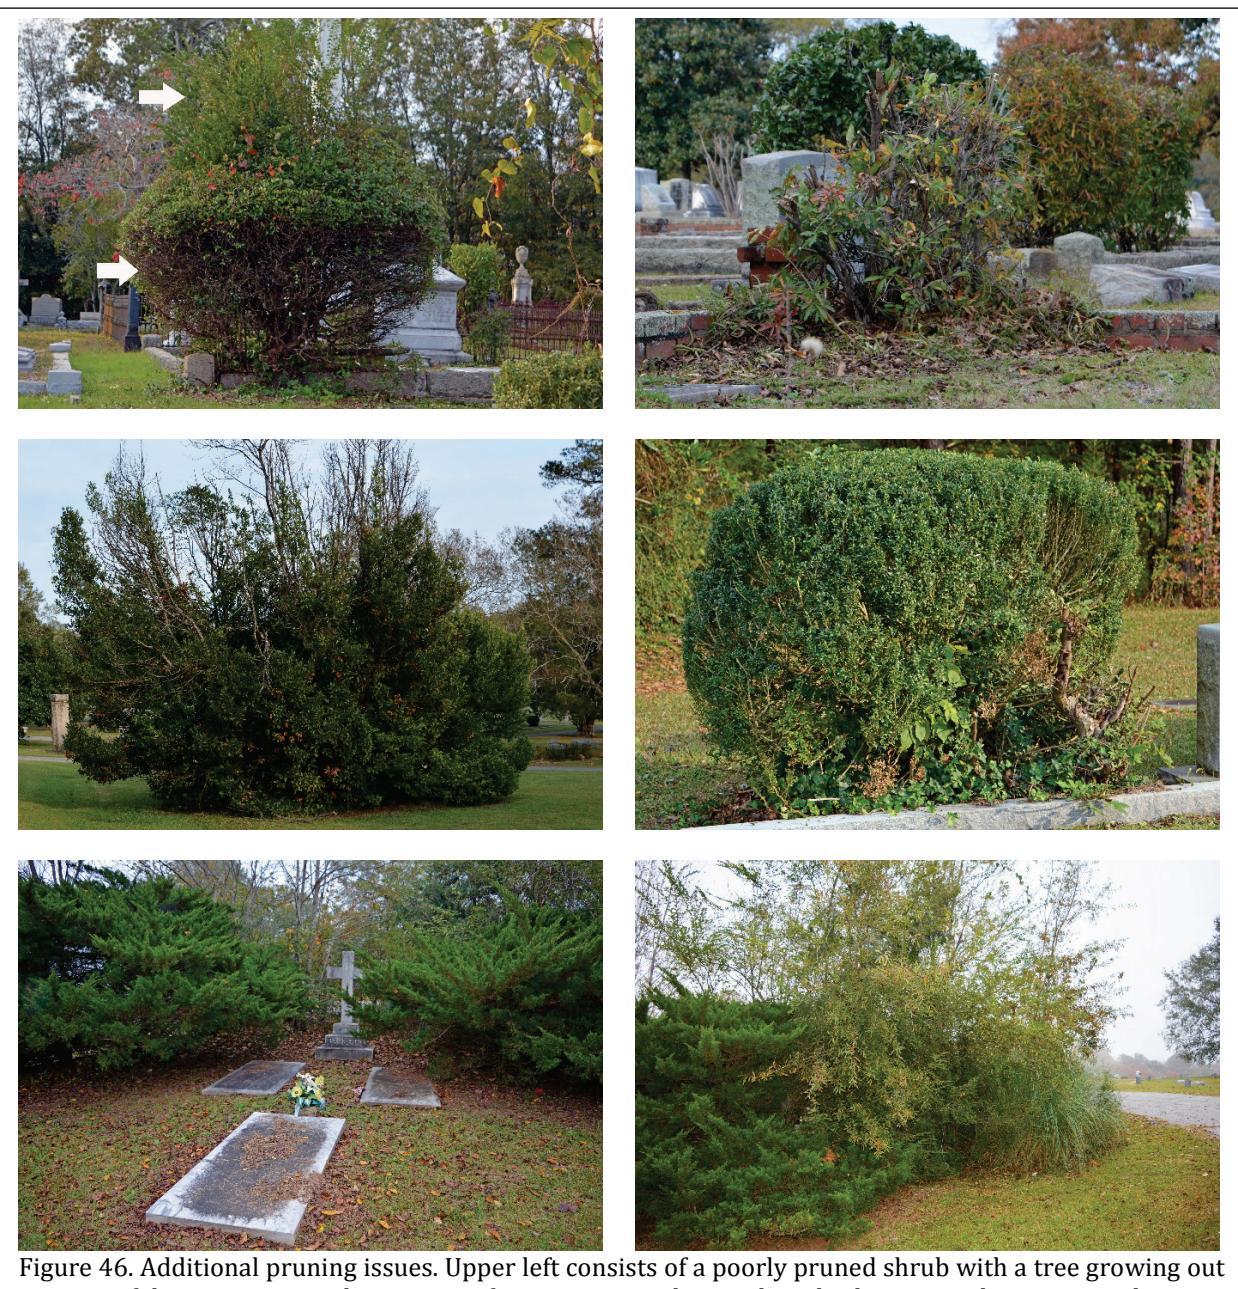
Ingure 46. Additional pruning issues. Upper left consists of a poorly pruned shrub with a tree growing out of the top. Upper right consists of a remnant nandina with multiple trees and vines overtaking it – and all pruned to the same height. Middle left shows a clump of vegetation consisting of a tea olive, dead wood, and multiple trees all grown together. Middle right shows a poorly pruned boxwood with vines and dead wood. Lower left shows a family plot with overgrowing arborvitae. Lower right shows the opposite side of that same lot with multiple scrub trees that were allowed to grow and were not appropriately removed.

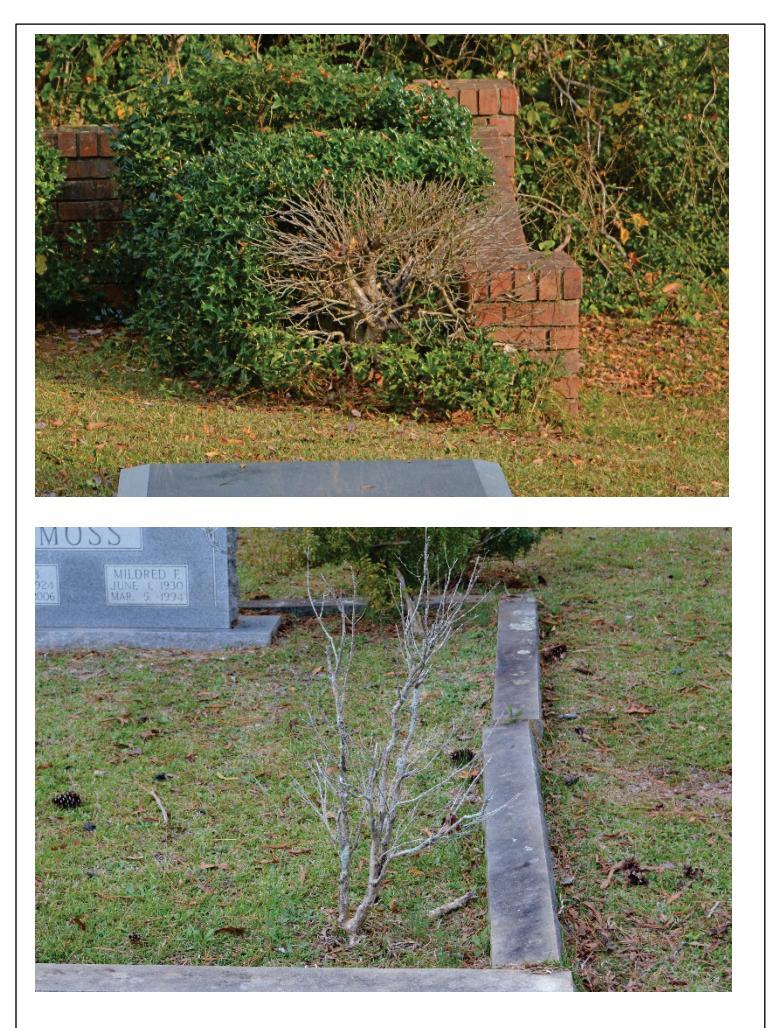
Figure 47. Dead shrubs are a blight on the landscape and should be removed.
