RESTHAVEN CEMETERY ASSESSMENT, CITY OF WASHINGTON, WILKES COUNTY, GEORGIA

Chicora Research Contribution 585

November 2017

The study examines Washington's city cemetery, founded in 1857. It includes 41.1 acres, most of which has been developed, and it includes both African American and white citizens. It is included on the National Register of Historic Places as part of the Washington National Register Historic District.

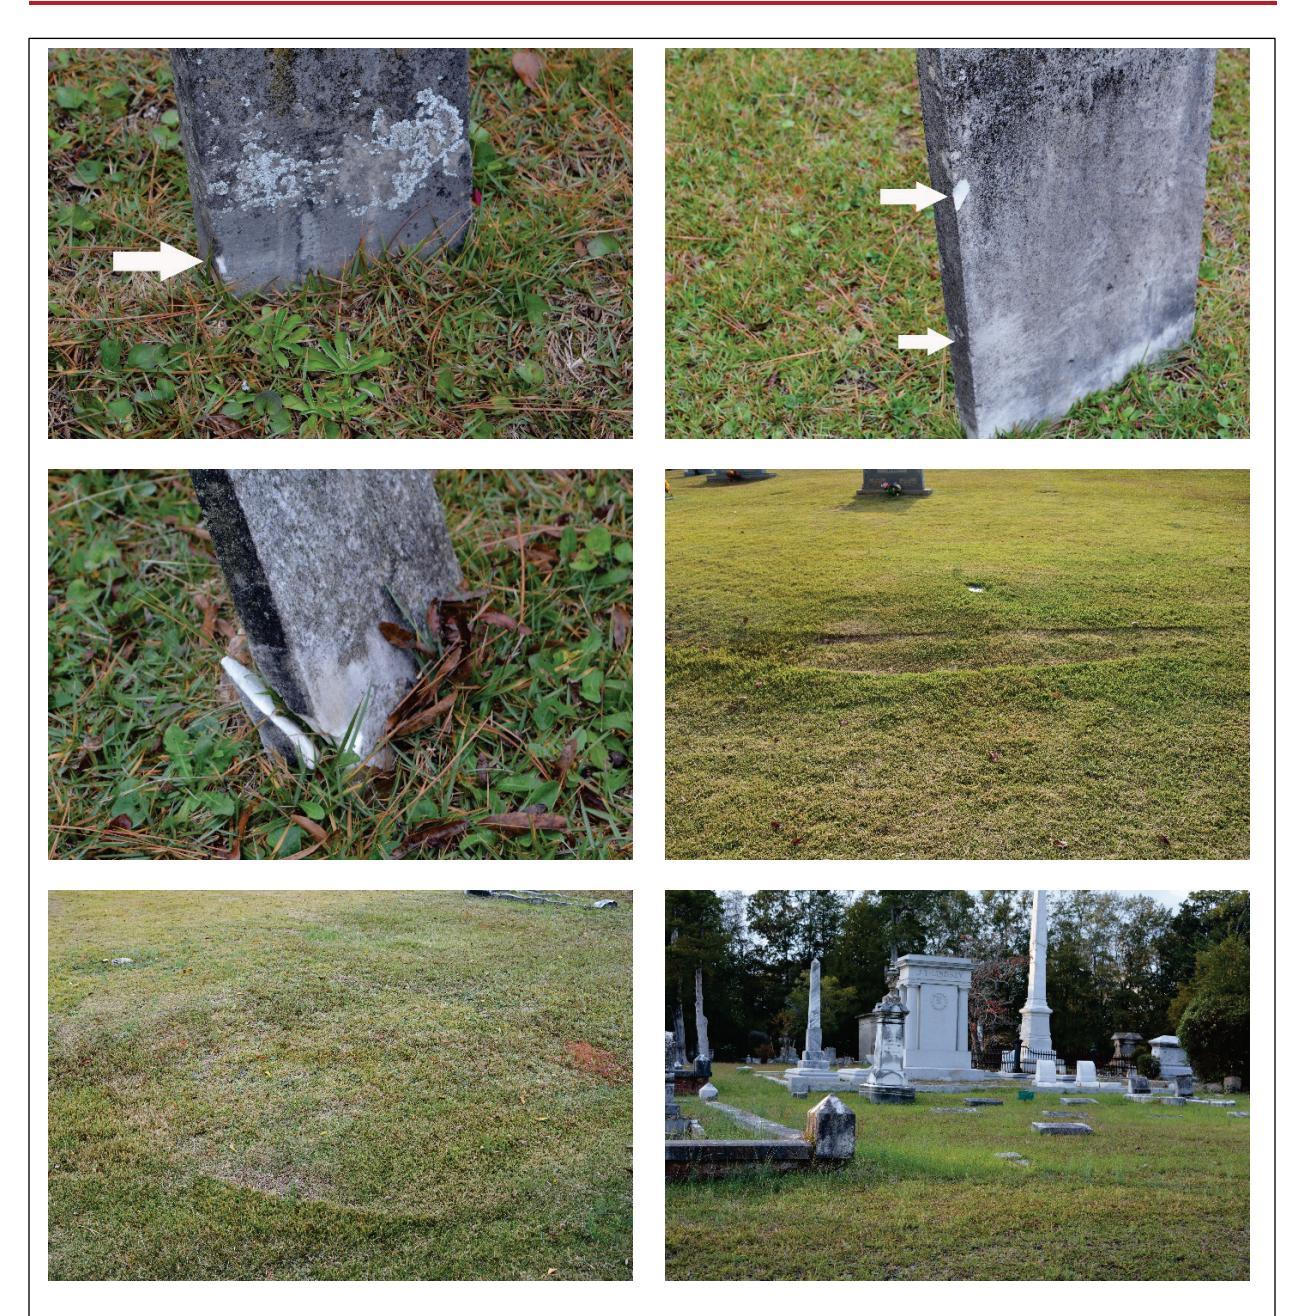
Figure 49. Mowing concerns. Upper left shows a chip likely removed by impact from a mower. Upper right shows a chip removed by mowing (top arrow) and numerous nylon trimmer abrasions (lower arrow). Middle left shows a stone hit with such impact that it has been broken. Middle right shows scalped grass on a slope. Lower left shows scalped grass in a "zero-turn" circle caused by a large deck mower. Lower right shows multiple heights of grass caused by poor mowing techniques.

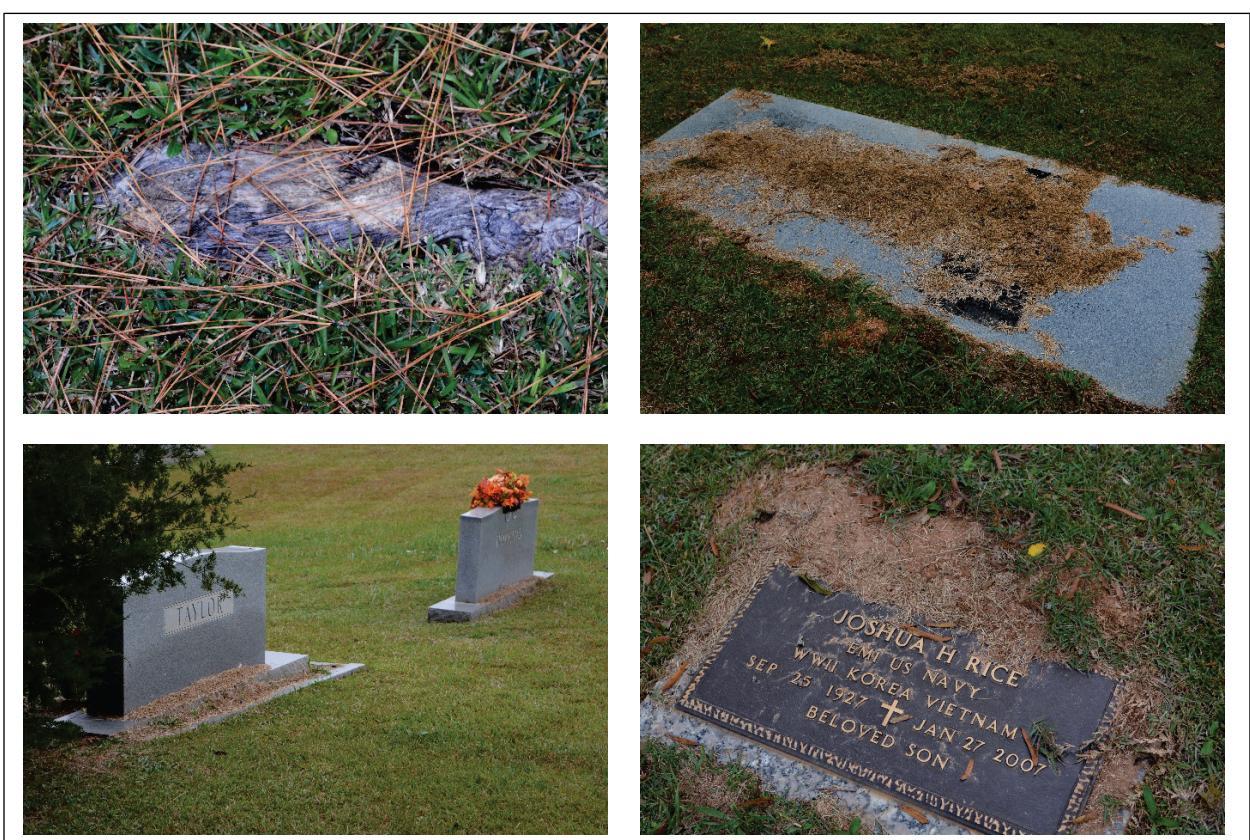
Figure 50. Mower problems. Upper left shows a scalped tree root. The remaining photographs show examples of grass not blown off stones.

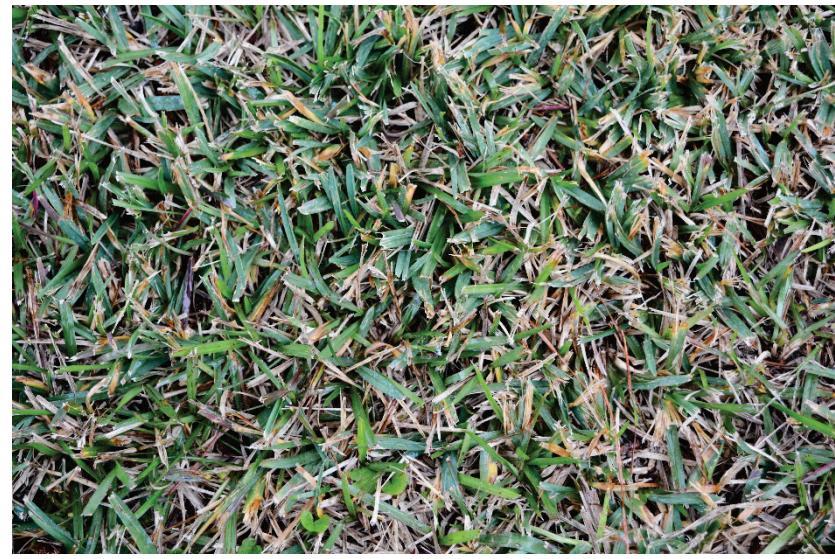
Figure 51. Example of torn grass, indicating that mower blades are not being routinely sharpened.

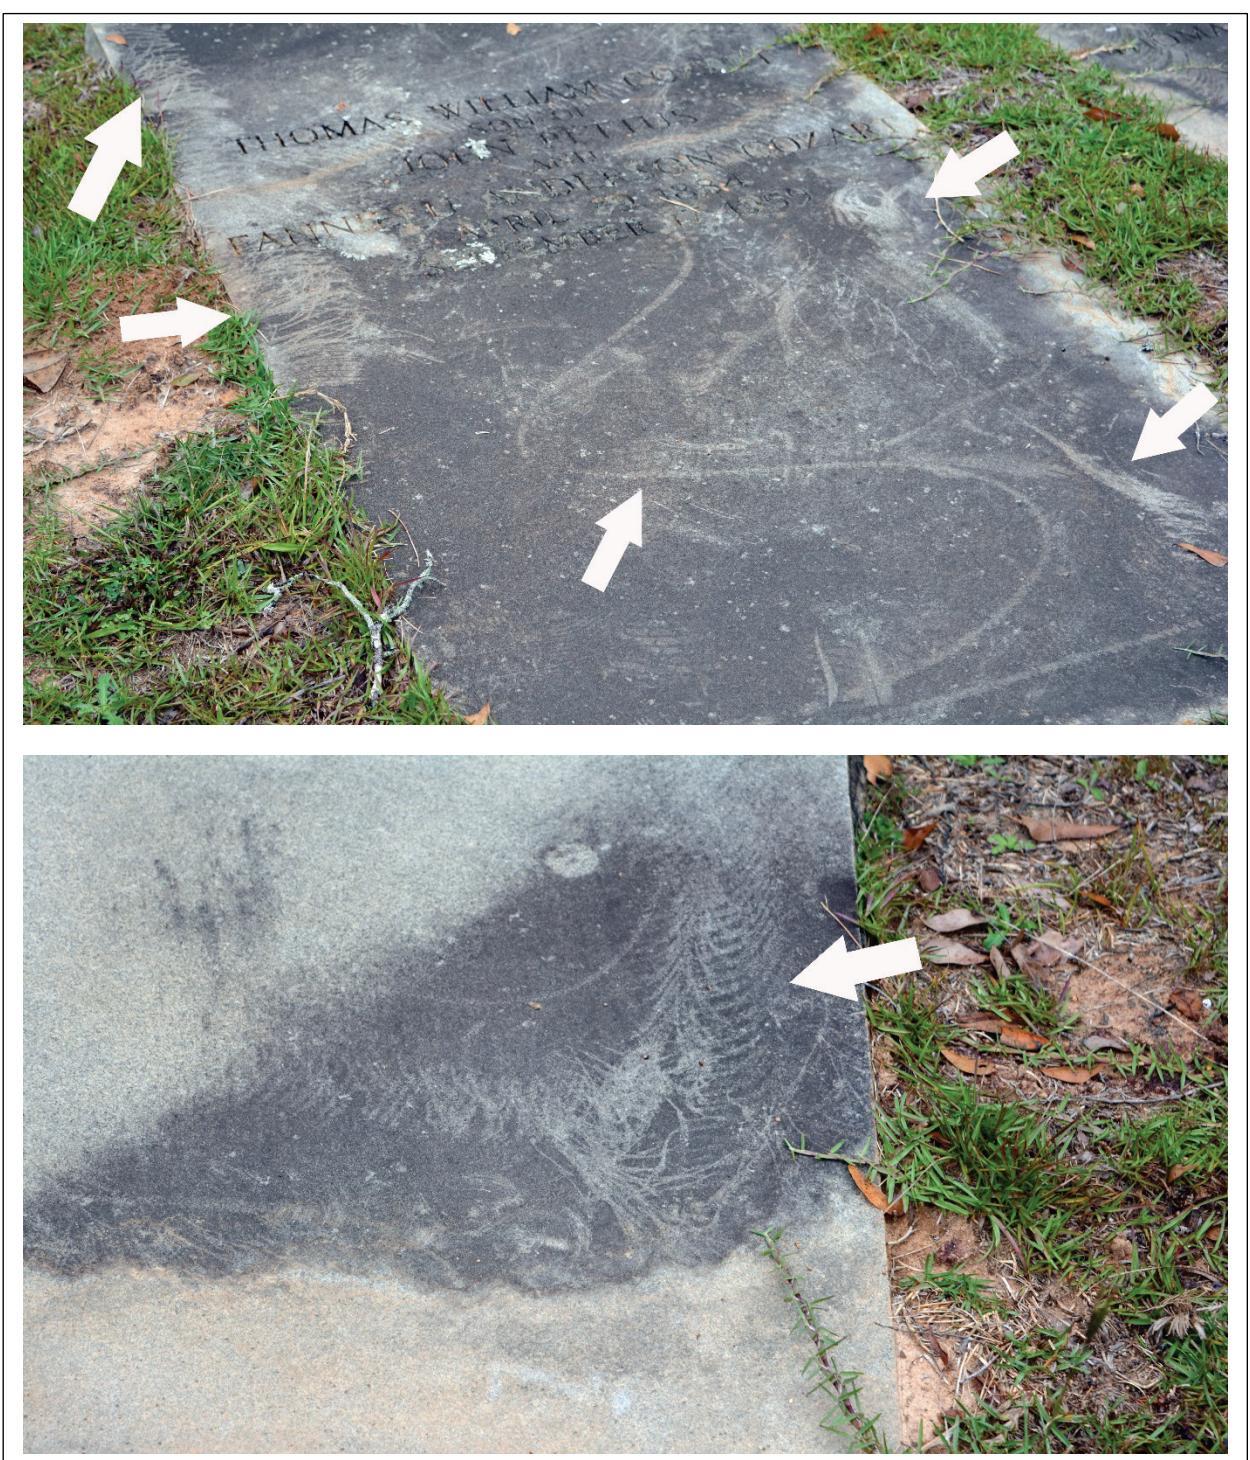
Figure 52. Examples of trimmer damage to two ledgers showing the trimmer line scratching the surfaces. These suggest the trimmer was held on the stone to produce the repetitive marks.

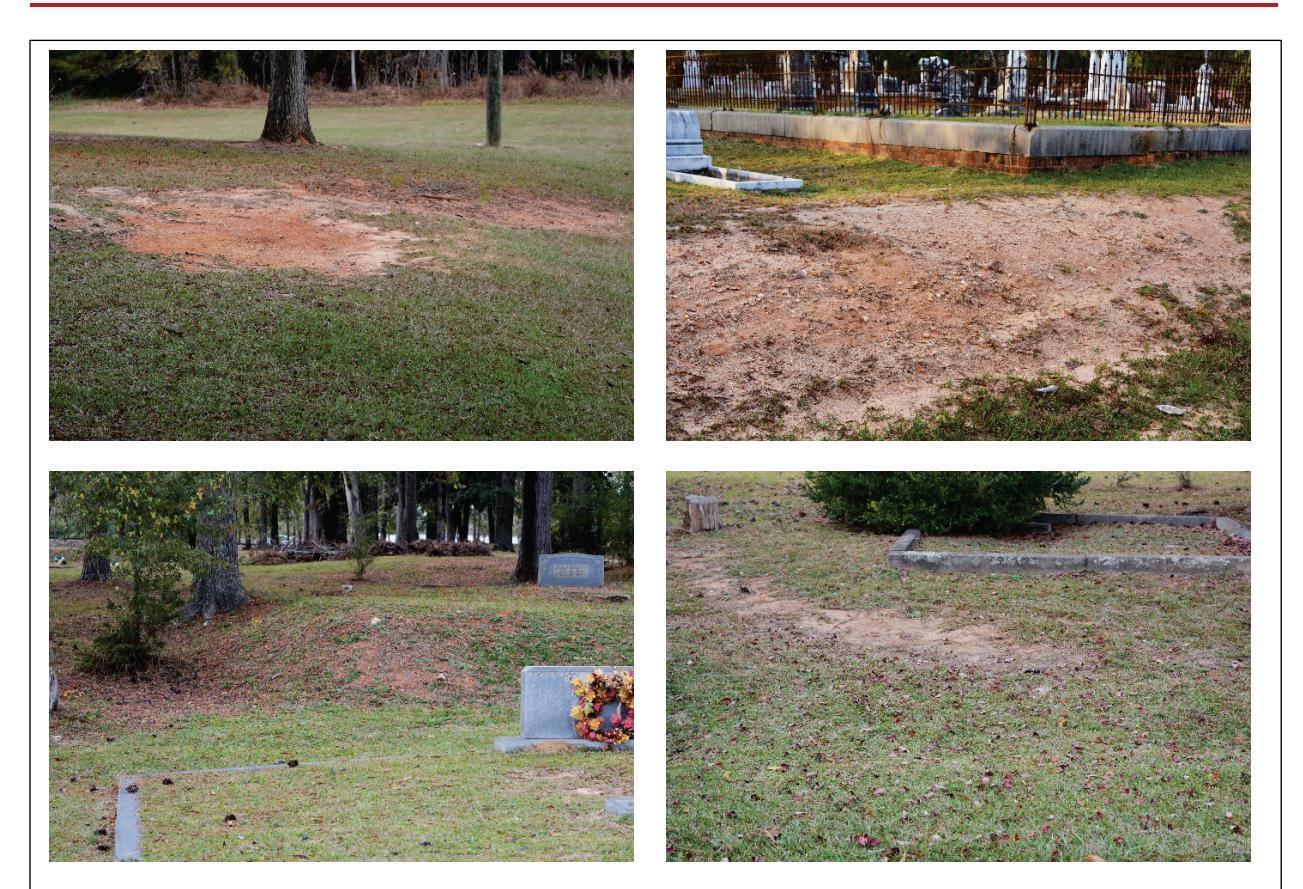
Figure 53. Examples of erosion and bare soil in the cemetery. Upper photos show area of significant sheet erosion on slopes. Lower left photo shows early stage erosion. Lower right photo shows bare soil that can be renovated.

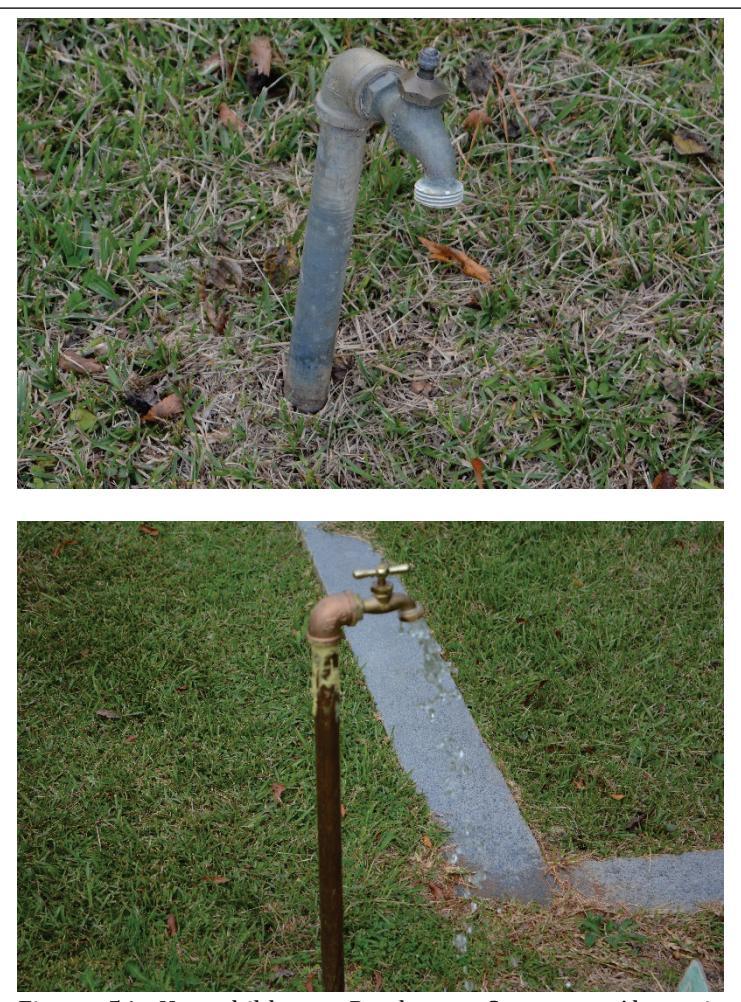
Figure 54. Hose bibbs at Resthaven Cemetery. Above is inoperable, below has been recently repaired and is operable.

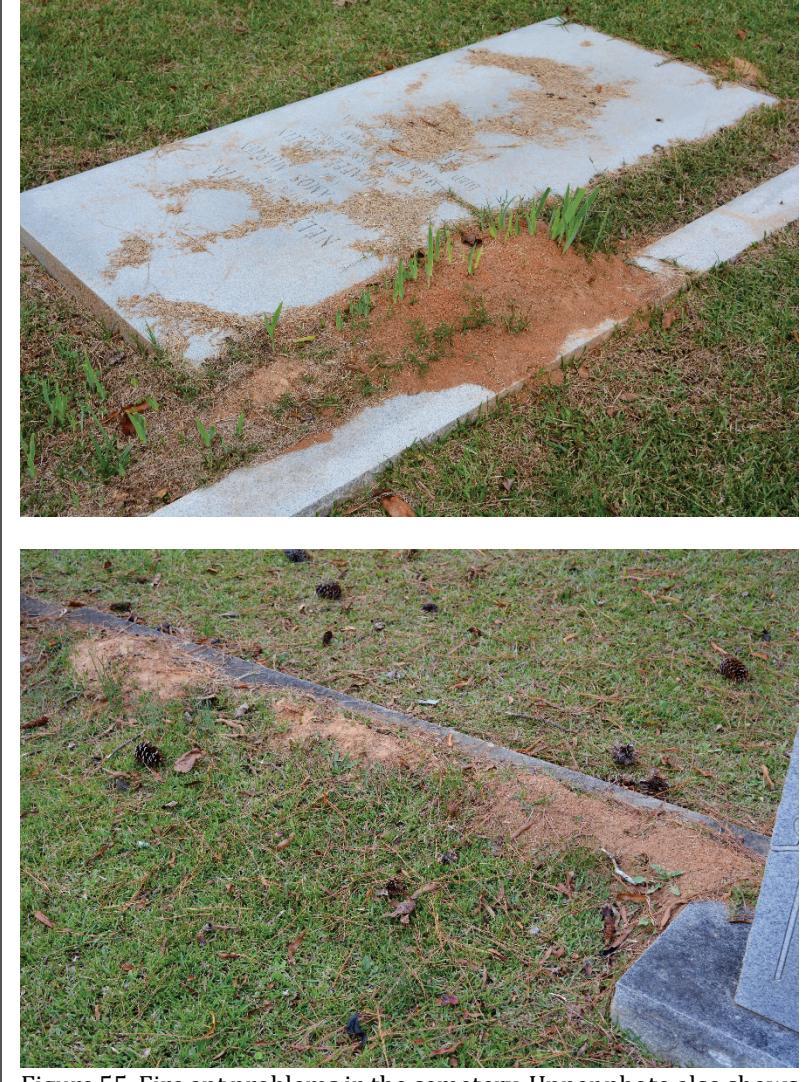
Figure 55. Fire ant problems in the cemetery. Upper photo also shows another monument covered with mown grass.

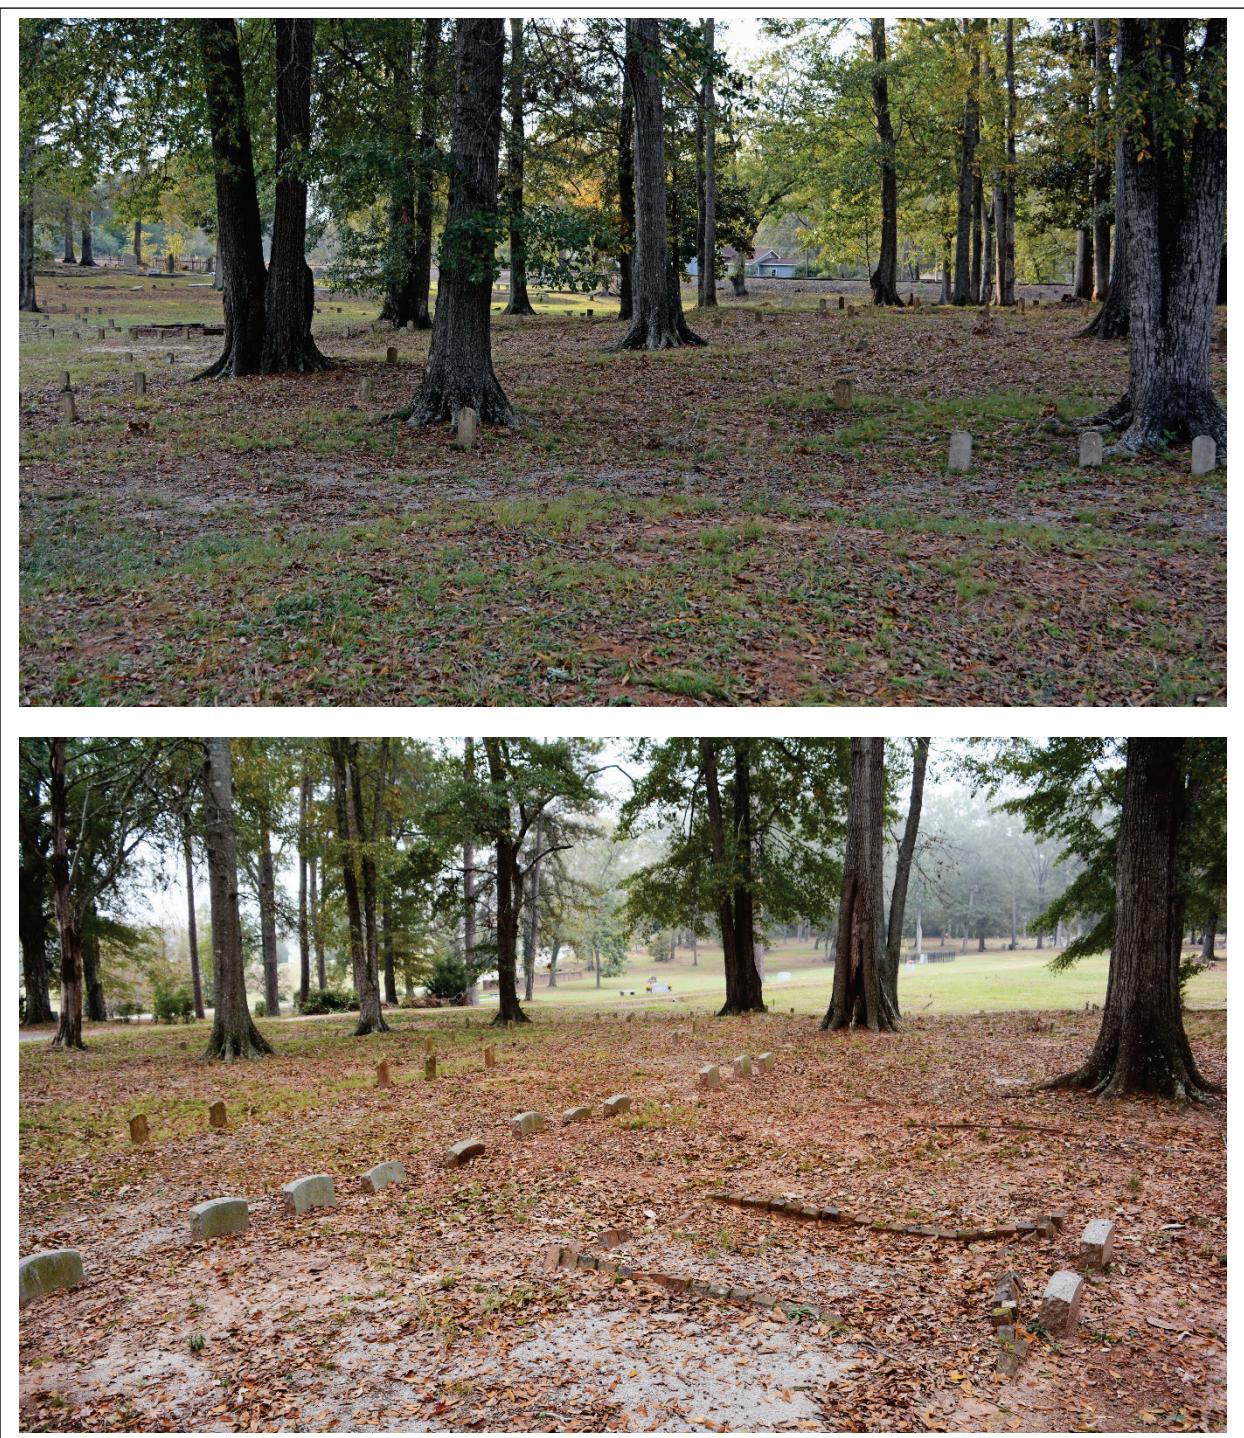
Figure 56. African American section showing light grass, woods, leaves, and bare ground.

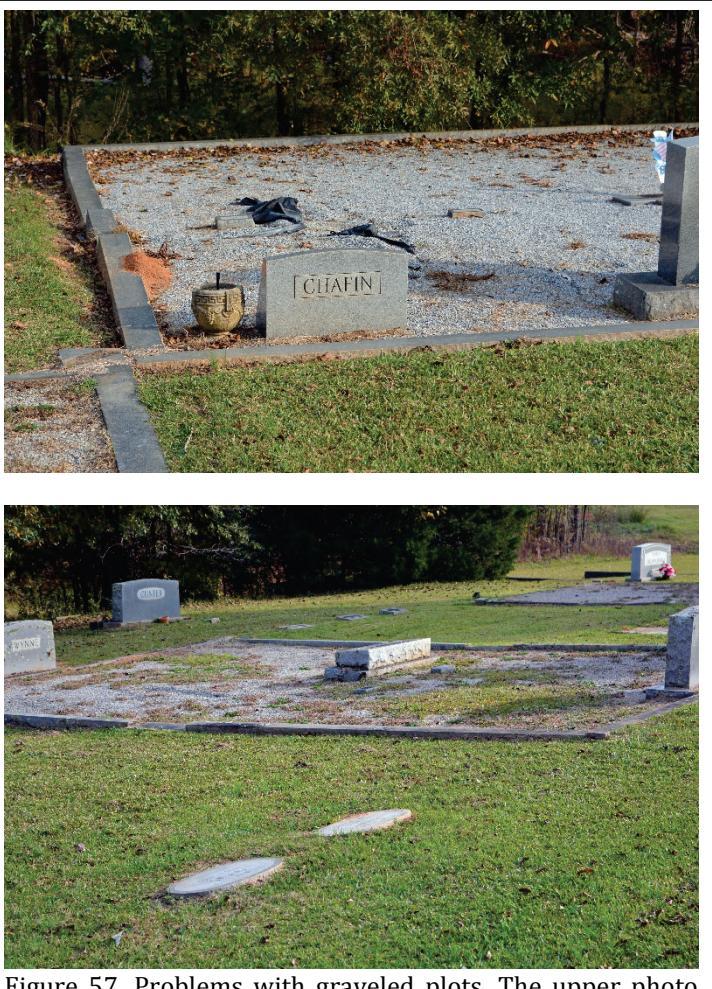
Figure 57. Problems with graveled plots. The upper photo shows exposed landscape fabric. Even fire ants penetrate the block. The lower photo shows grass growing on a graveled plot.

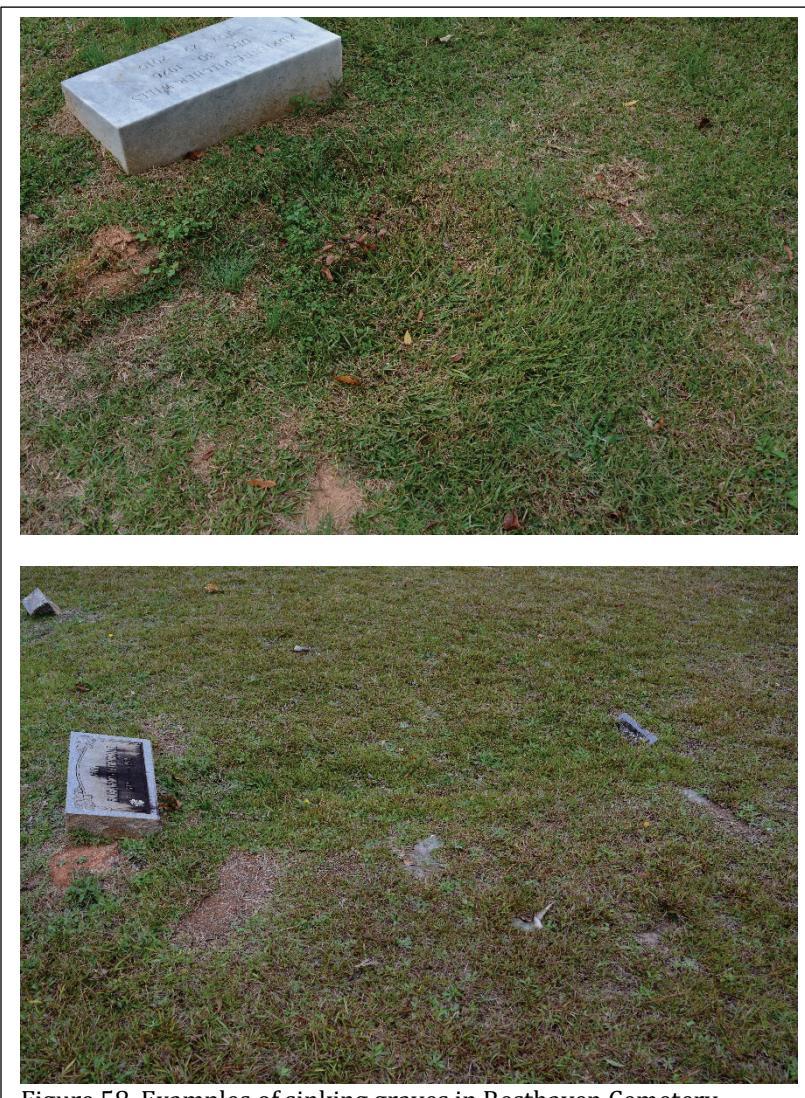
Figure 58. Examples of sinking graves in Resthaven Cemetery.

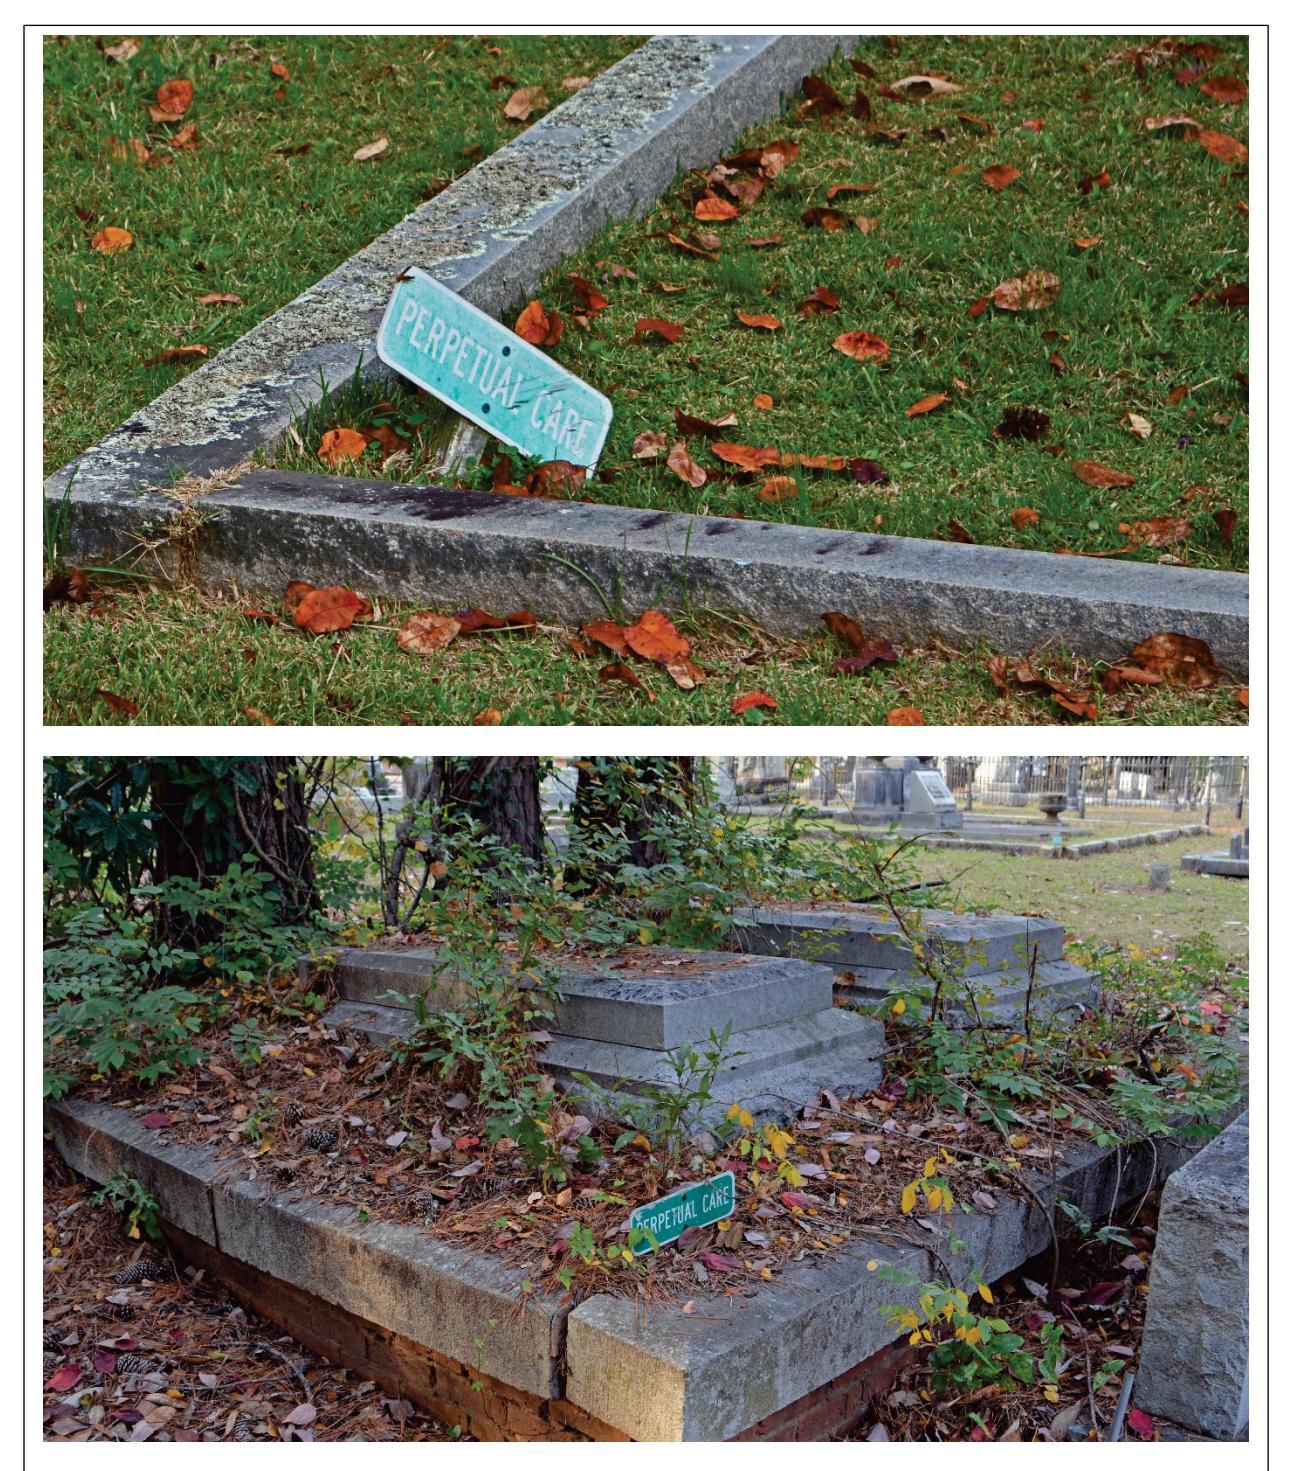
Figure 61. Perpetual care signs should be removed, most especially when they clearly have no meaning as the lower photo shows.

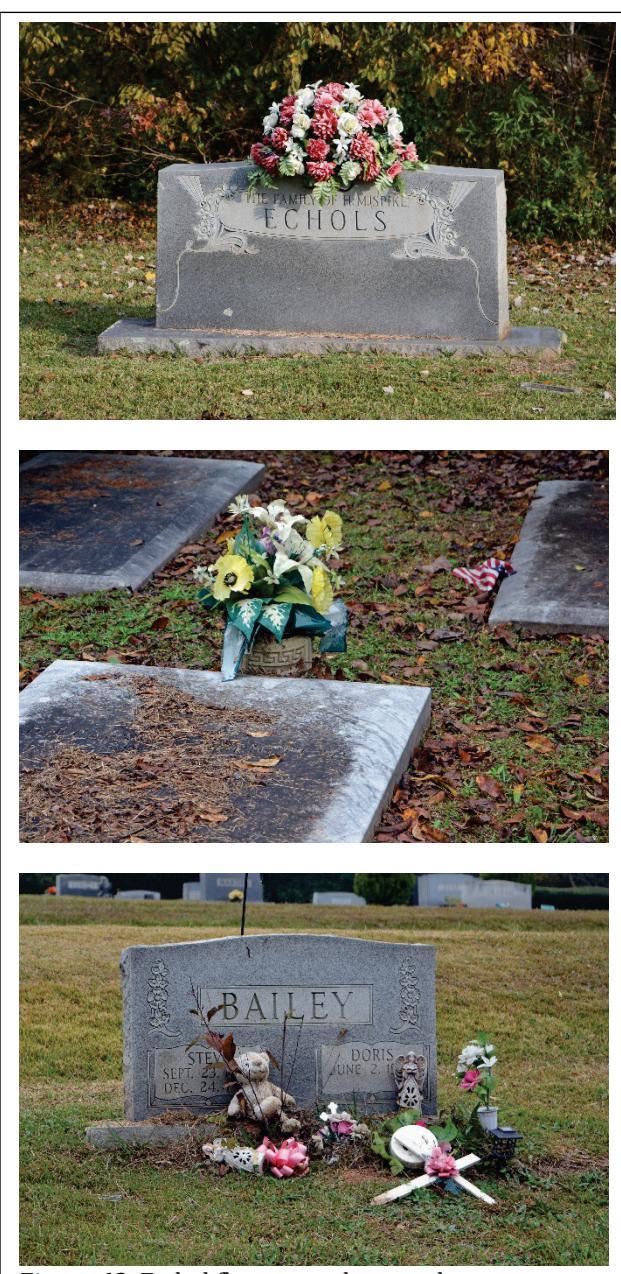
Figure 62. Faded flowers and grave clutter.

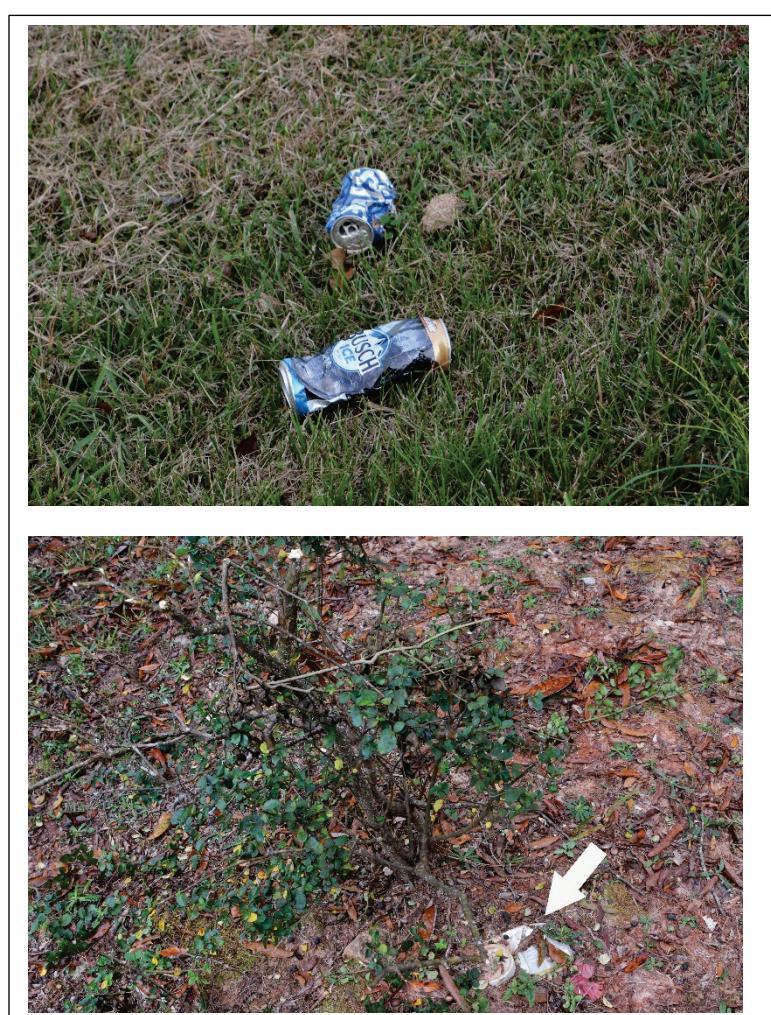
Figure 63. Trash in the cemetery. The upper photo shows recent beer cans, although they are damaged by at least one mowing. The lower photo shows a long abandoned, faded beer can beneath a boxwood pruned only days before the assessment.

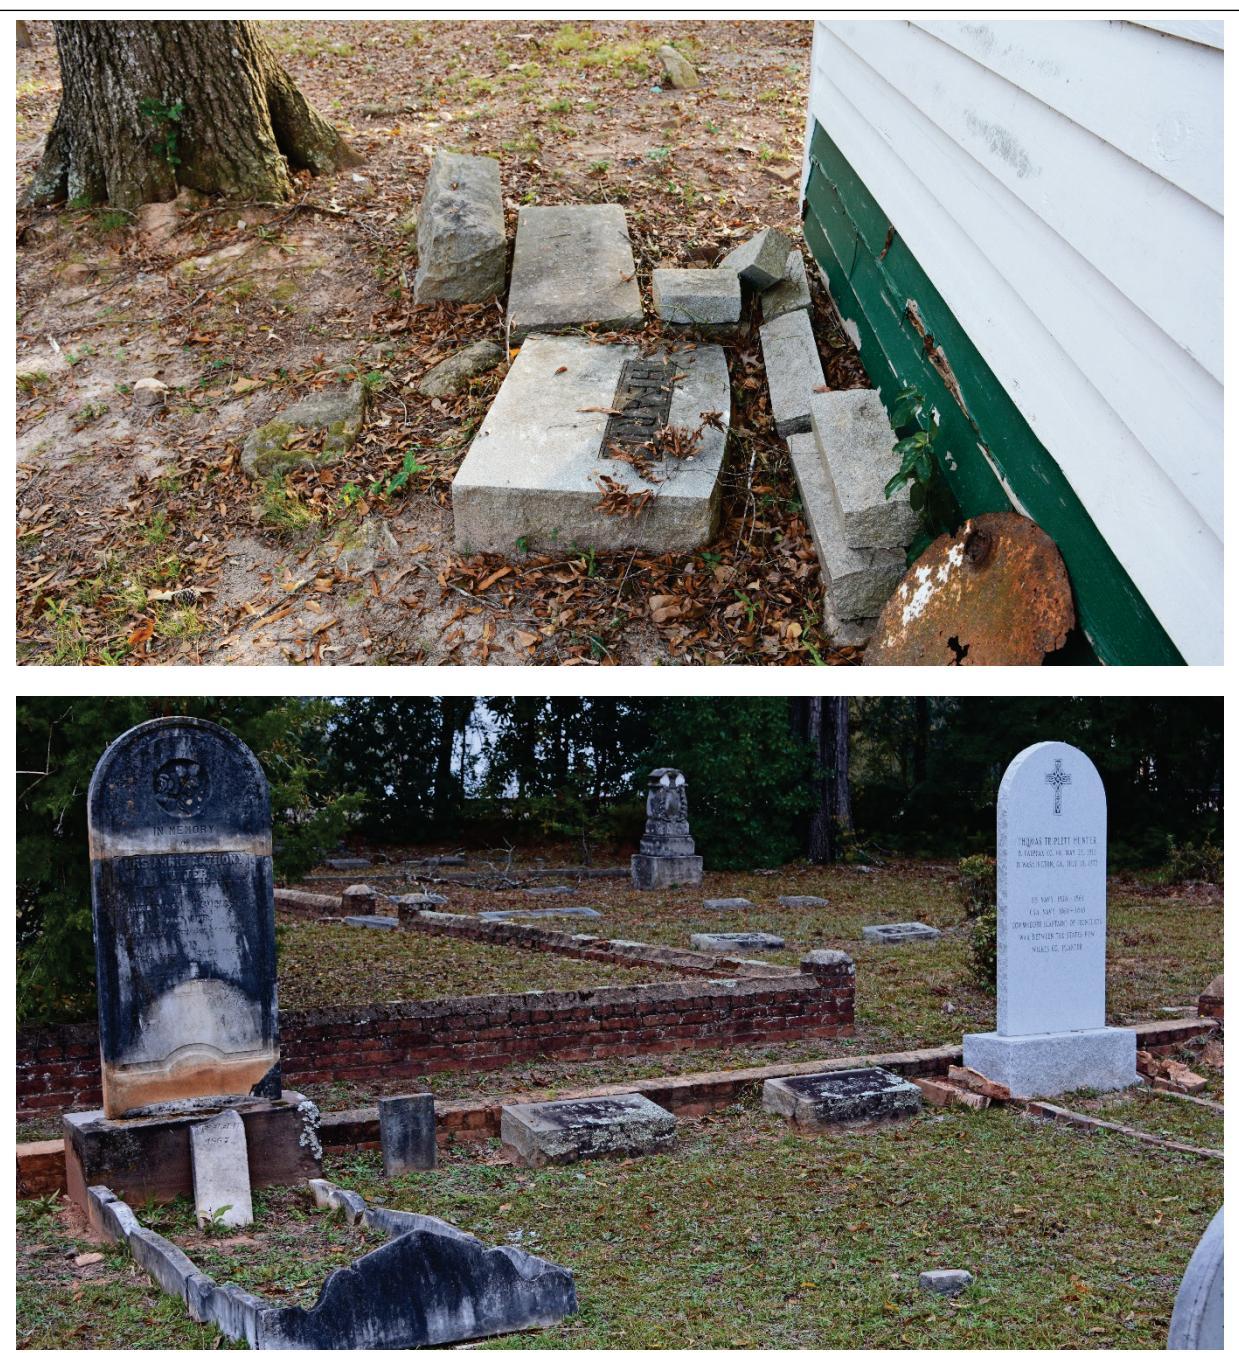
Figure 64. Orphan and replacement stones. The photo above shows at least one granite die laying at the side of the maintenance building with several fragments of coping. The lower photo shows a replacement stone. Although of granite rather than marble, an effort was made to match the original design (on the left). It does not, however, indicate the replacement date on the reverse.

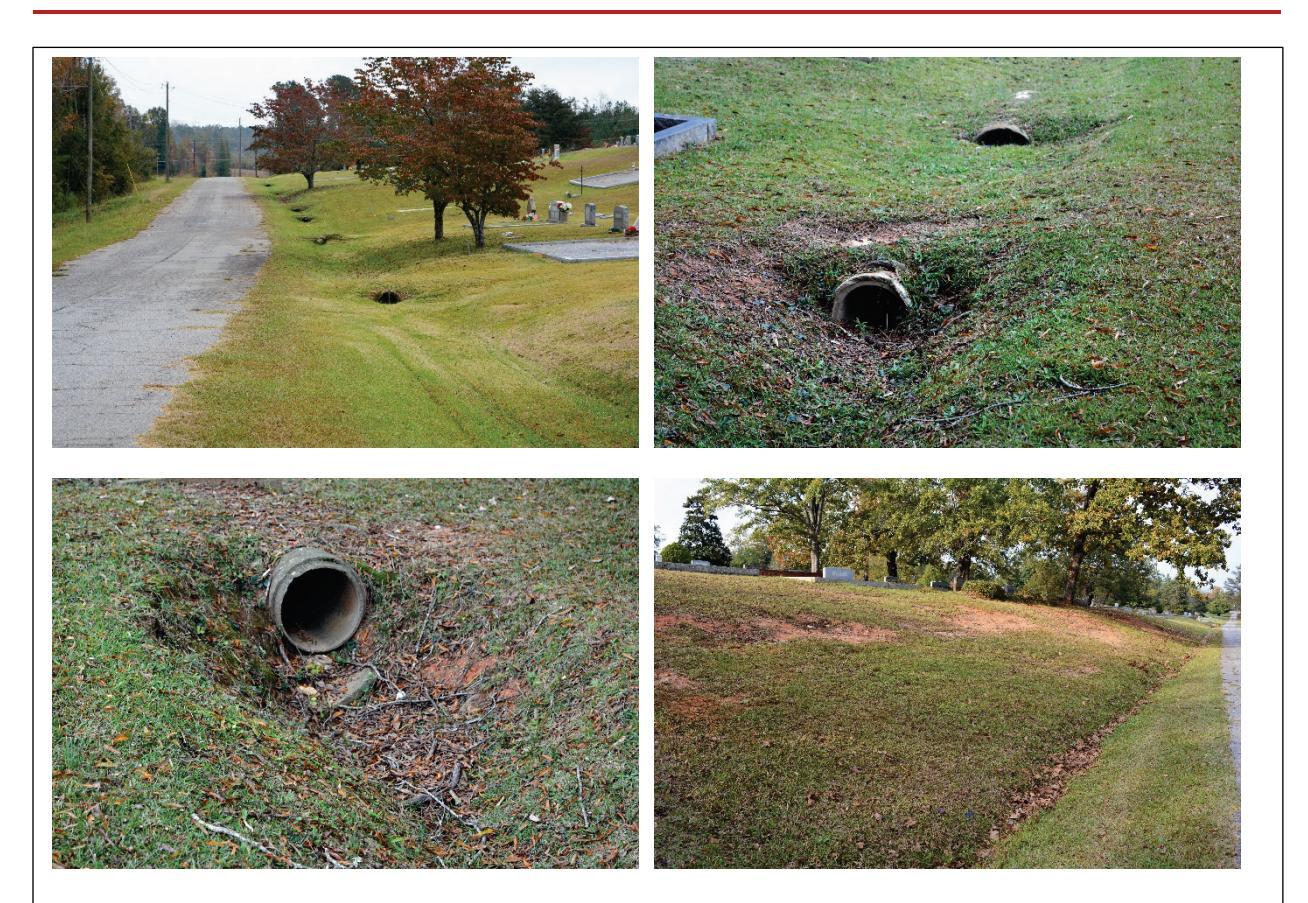
Figure 66. Open drains at Resthaven Cemetery. Upper left shows the west side of Cemetery Street looking south. Note that pipes have been filled in to different depths. Upper right shows different sizes pipes being used on the road at the Pope section. Lower left shows erosion at the outfall of the pipe. Lower right shows a road ditch without culverts.

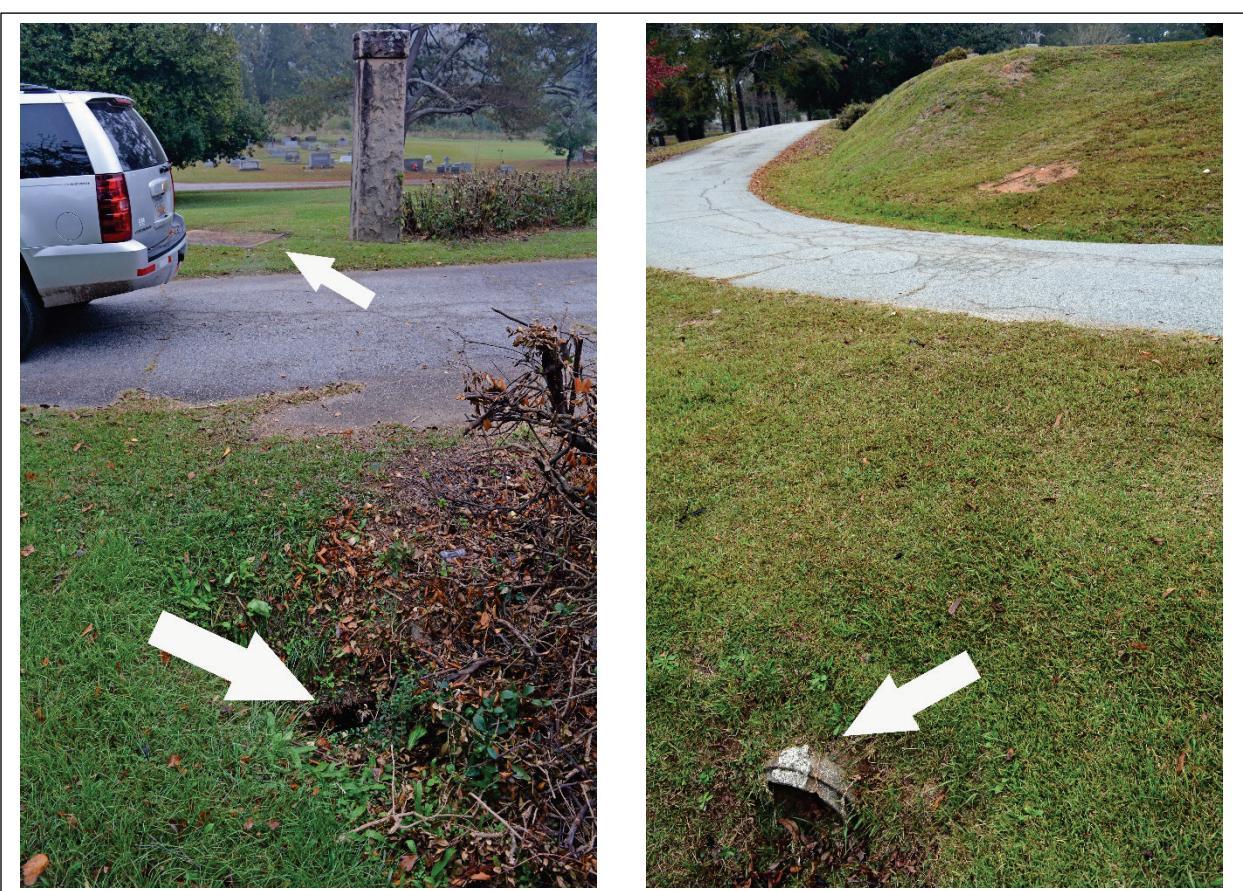
Figure 67. Underground drainage. On the left is the nearly overgrown and infilled drain from the railroad tracks. In the background is the covered drain with fox damage. It is unknown where this drain is run. On the right is a culvert on the east side of the road separating the 1902 addition and the 1954 addition. Its origin is unknown, but the outflow is significantly blocked.

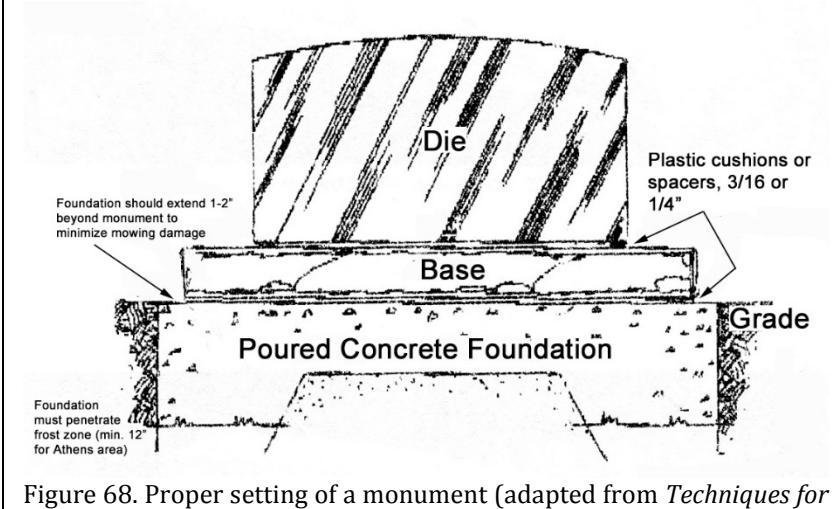
Figure 68. Proper setting of a monument (adapted from *Techniques fo Erecting Granite Monuments*).

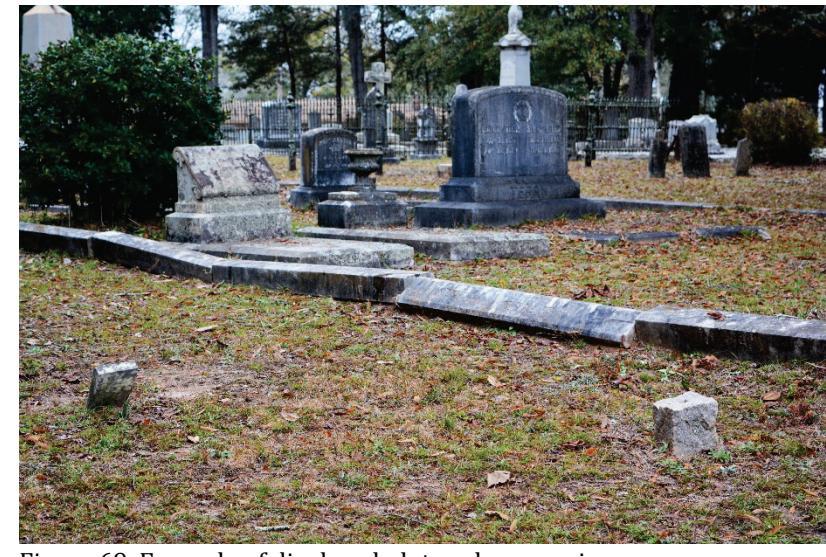
Figure 69. Example of displaced plot curbs or coping.

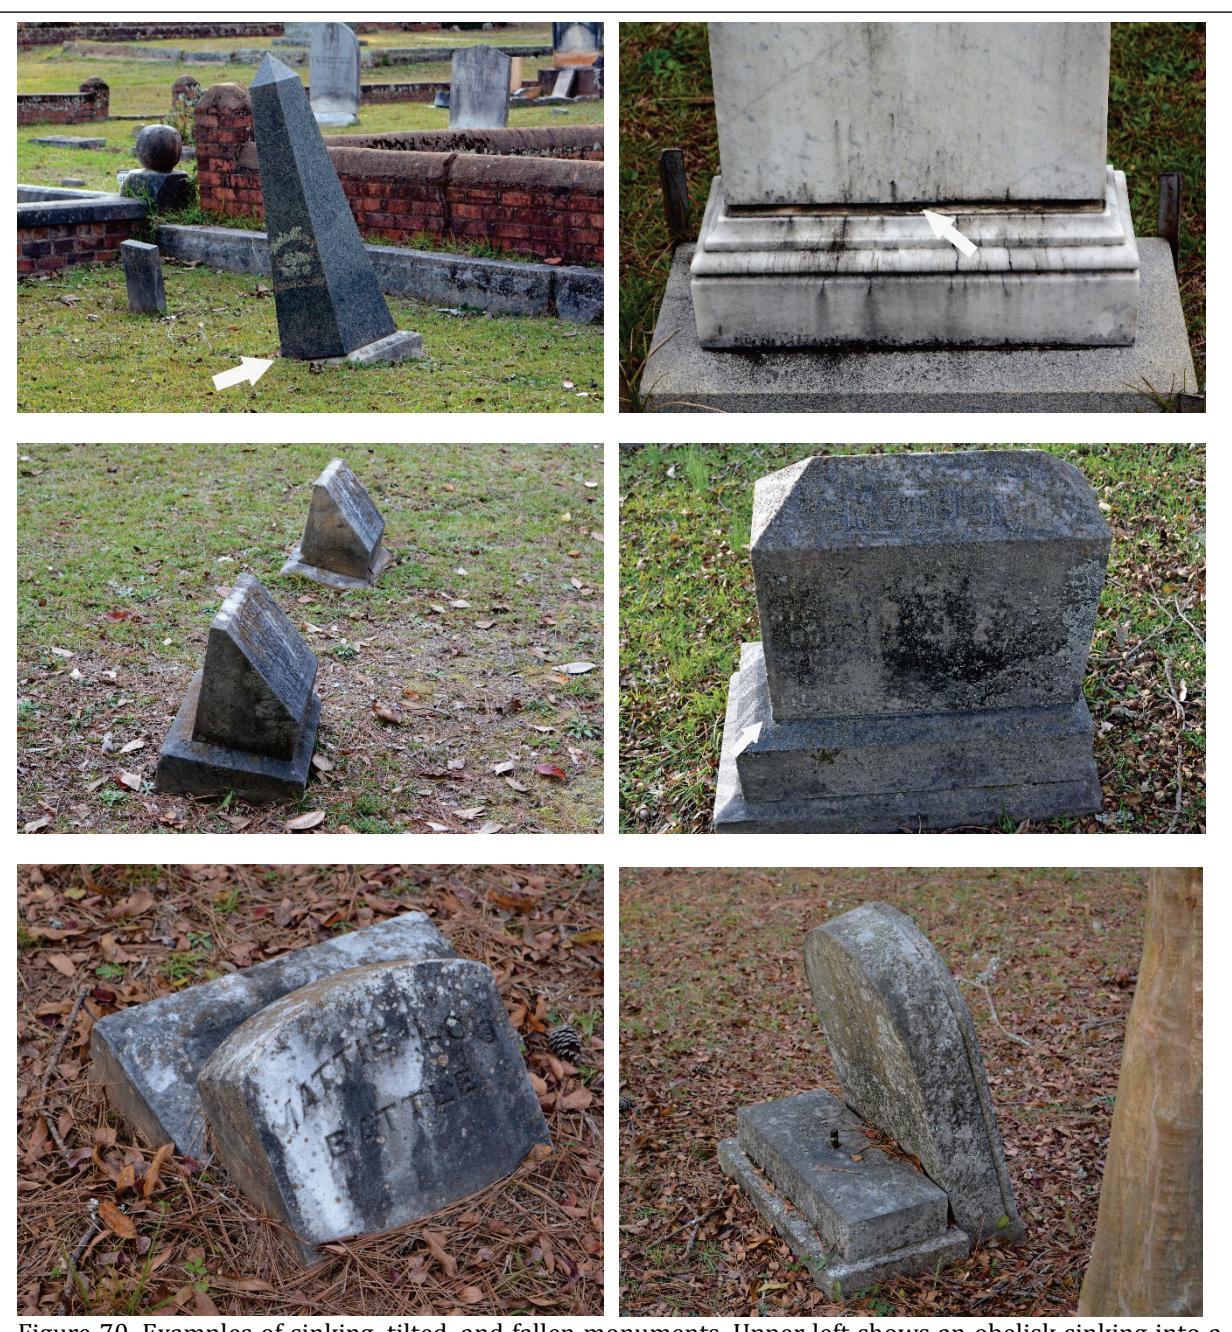
Figure 70. Examples of sinking, tilted, and fallen monuments. Upper left shows an obelisk sinking into a grave and beginning to slide off its base. Upper right shows on die on base sinking and leaning. It is retained only by a pin. Middle left, monuments sinking. Middle right, a monument is beginning to slip off its base, indicating that there is no retaining pin. Lower left, monument has fallen from it sinking base. Lower right, monument has fallen, showing a pin.
