RESTHAVEN CEMETERY ASSESSMENT, CITY OF WASHINGTON, WILKES COUNTY, GEORGIA

Chicora Research Contribution 585

November 2017

The study examines Washington's city cemetery, founded in 1857. It includes 41.1 acres, most of which has been developed, and it includes both African American and white citizens. It is included on the National Register of Historic Places as part of the Washington National Register Historic District.

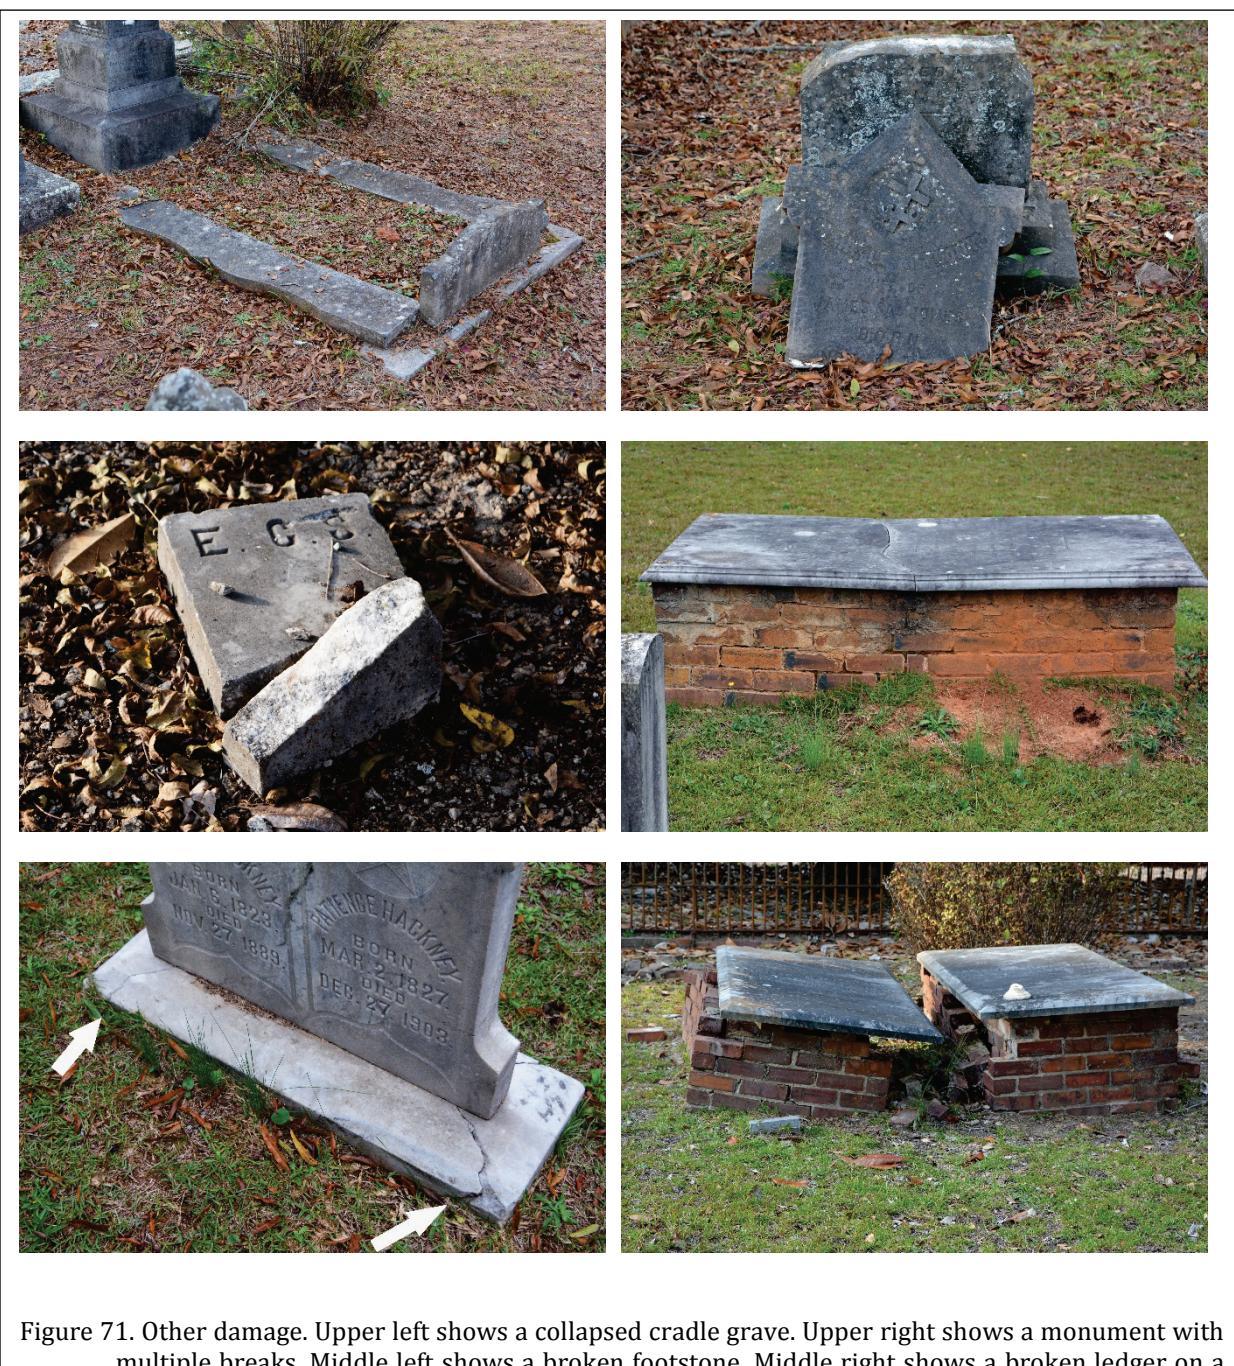
Figure 71. Other damage. Upper left shows a collapsed cradle grave. Upper right shows a monument with multiple breaks. Middle left shows a broken footstone. Middle right shows a broken ledger on a brick box tomb. Lower left shows an iron jacked base. Lower right shows two severely damaged brick box tombs, with ledgers in danger of being broken.

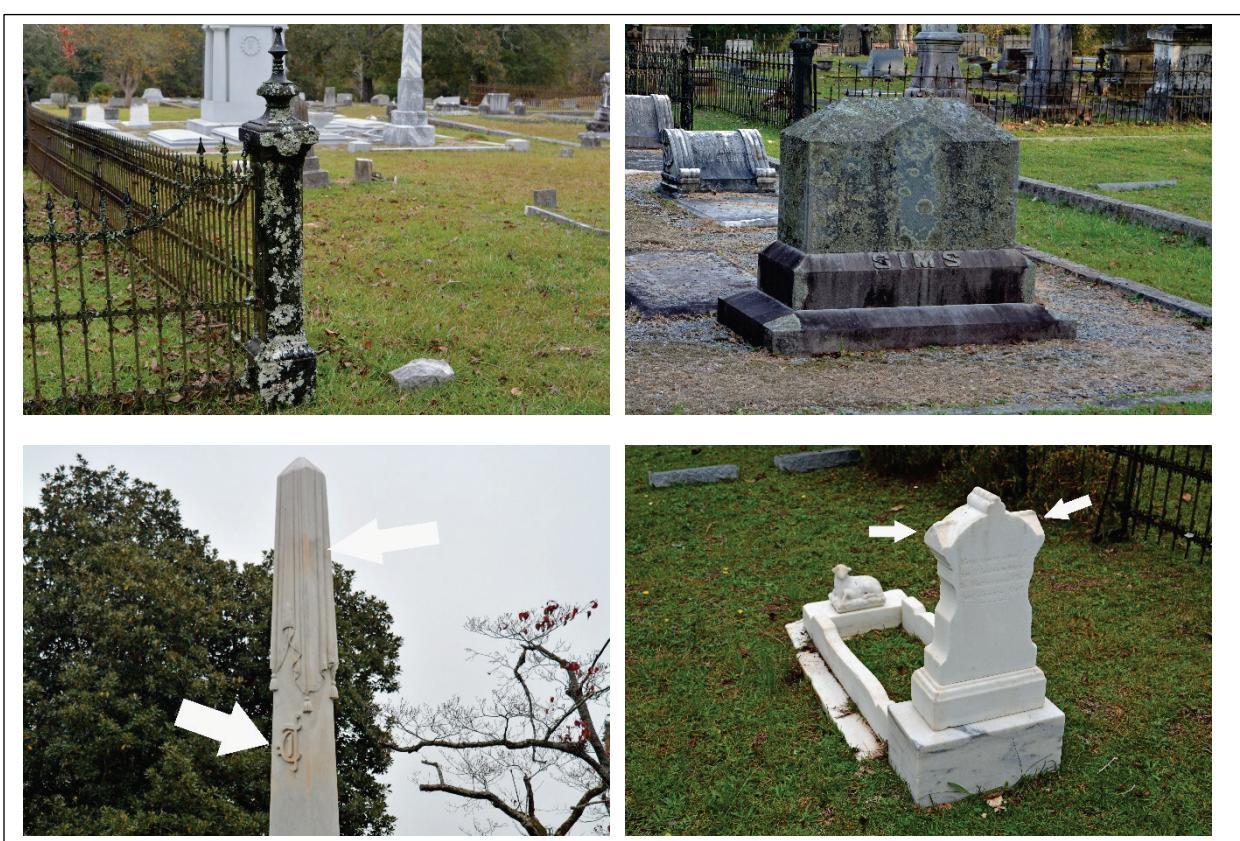
Table 72. Cleaning issues. Upper left shows lichen growing on iron fence. Upper right shows thick lichen on a granite die on base. Lower two photos show yellow staining from improperly cleaning marble with bleach.

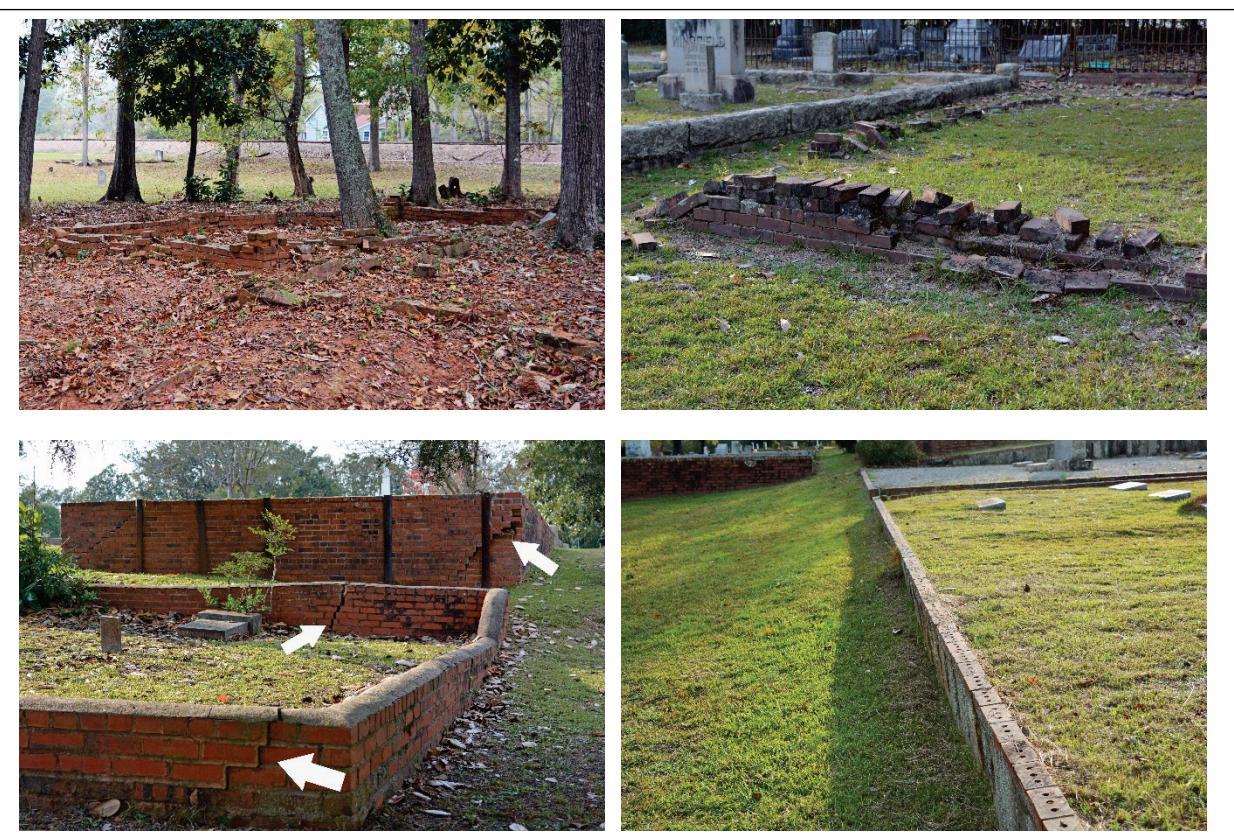
Figure 73. Wall problems. Upper left photo shows non-structural plot walls that are collapsing. Upper right photo shows a brick wall in failure. Lower left photo shows several brick walls with significant foundation issues showing settlement cracks. The wall in the rear was previously reinforced using iron rods. The lower right photo shows an wall bowing outward because of a poor foundation and inadequate strength.

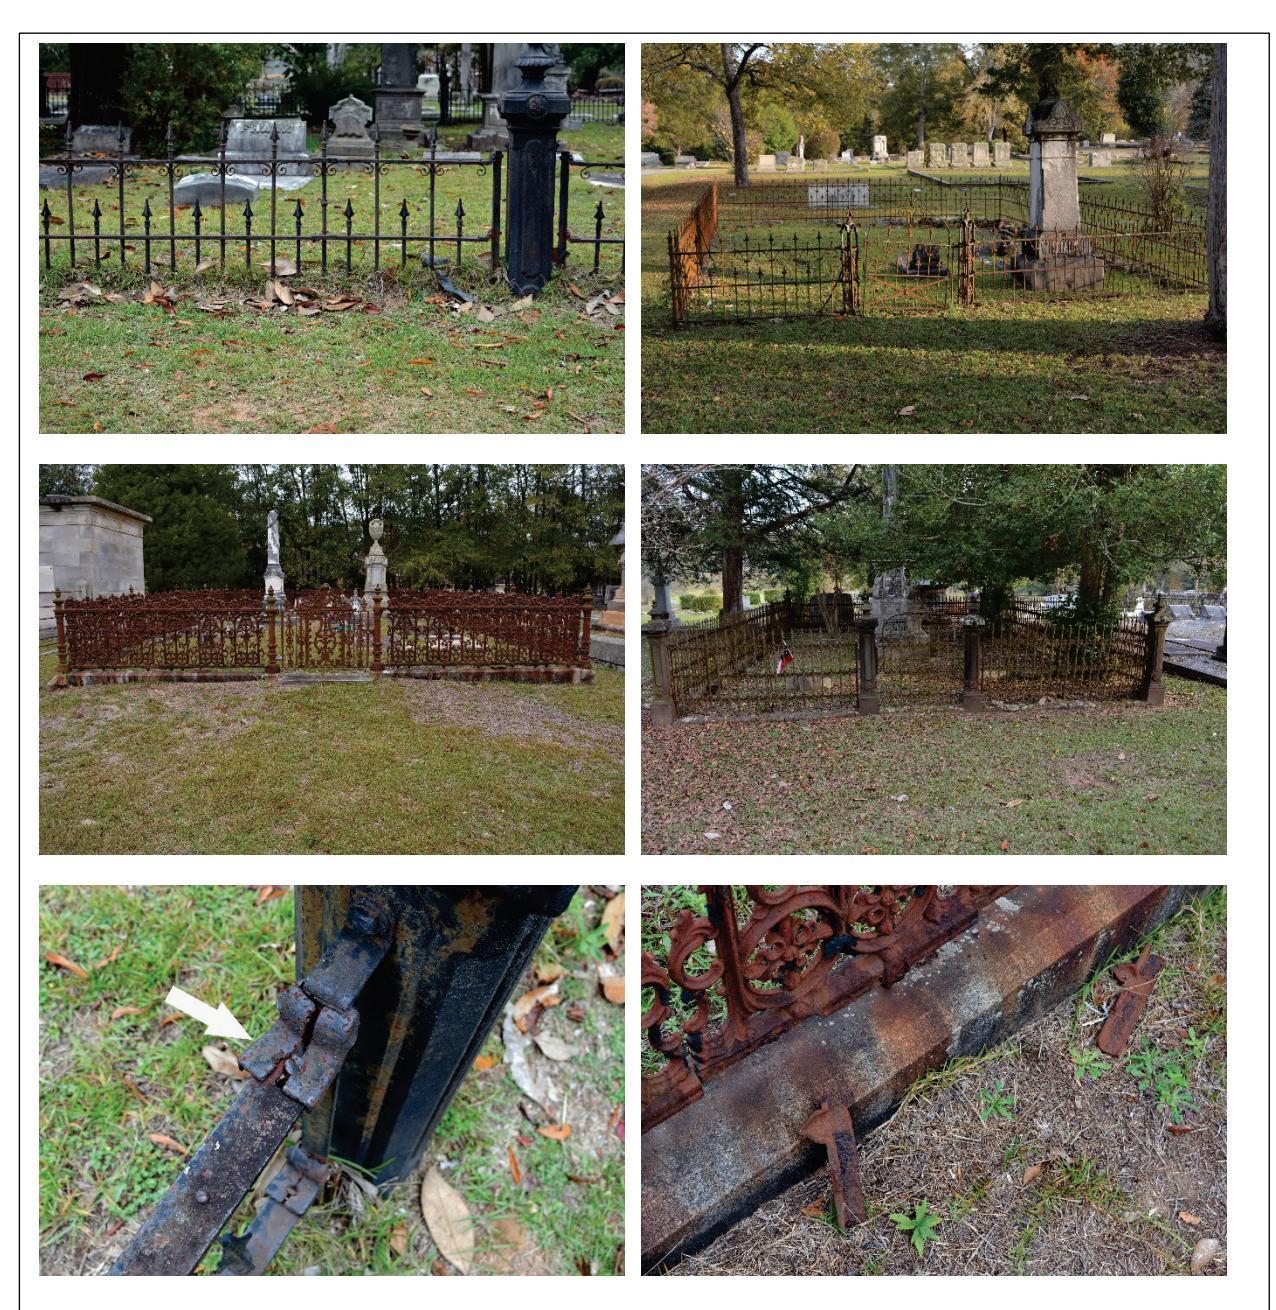
Figure 74.Fences. Upper left photo shows a fence that is today buried under about 10-inches of soil and must be removed to allow reinstallation. Upper right shows a fence requiring painting and resetting of the gate. Middle row shows two fences that require painting. Lower left shows a fence that requires brushing and painting, as well as damaged fittings requiring repair. Lower right photo shows loose parts that should be collected and documented for eventual repair.
